# BIG SEWICKLEY CREEK WATERSHED ASSESSMENT, RESTORATION, & PROTECTION PLAN

OCTOBER 2010

BIG SEWICKLEY CREEK  
WATERSHED ASSESSMENT, RESTORATION, AND PROTECTION PLAN

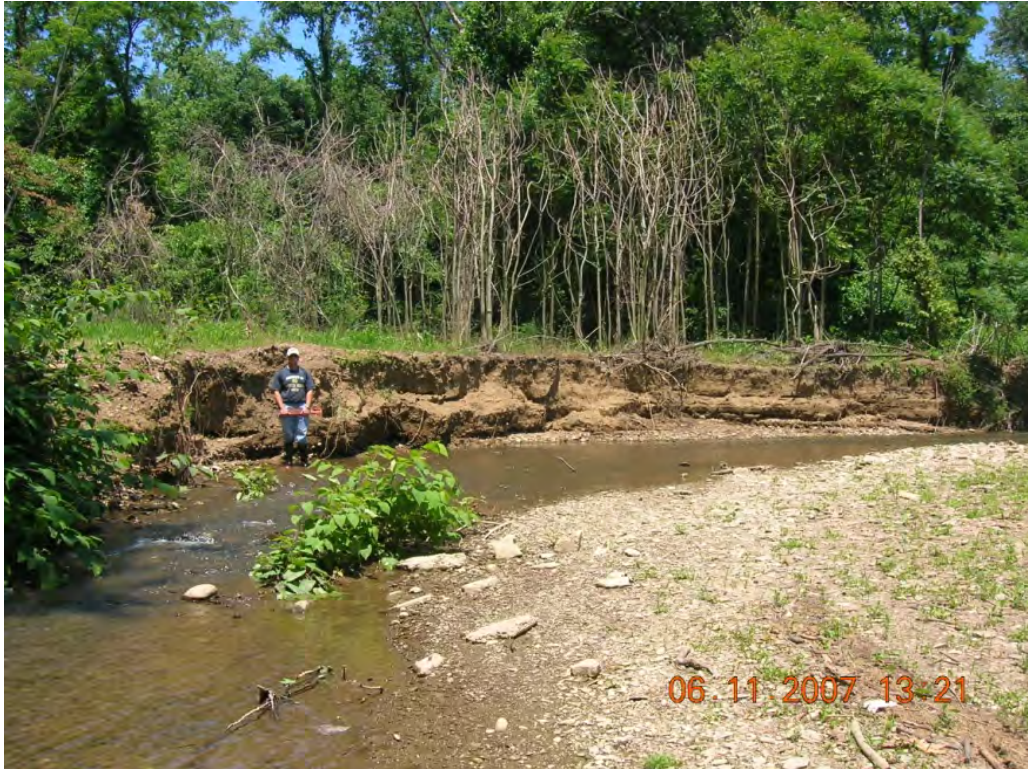
This section of Big Sewickley Creek received a visual assessment score of 6.36 out of 10 which means it is in Fair condition, according to the scoring system provided by the USDA visual assessment protocol. There is a lot of stream bank erosion in this section of main stem of Big Sewickley Creek.

Photo 1: A six foot high by 100 foot long section of streambank erosion. (BSC-12)

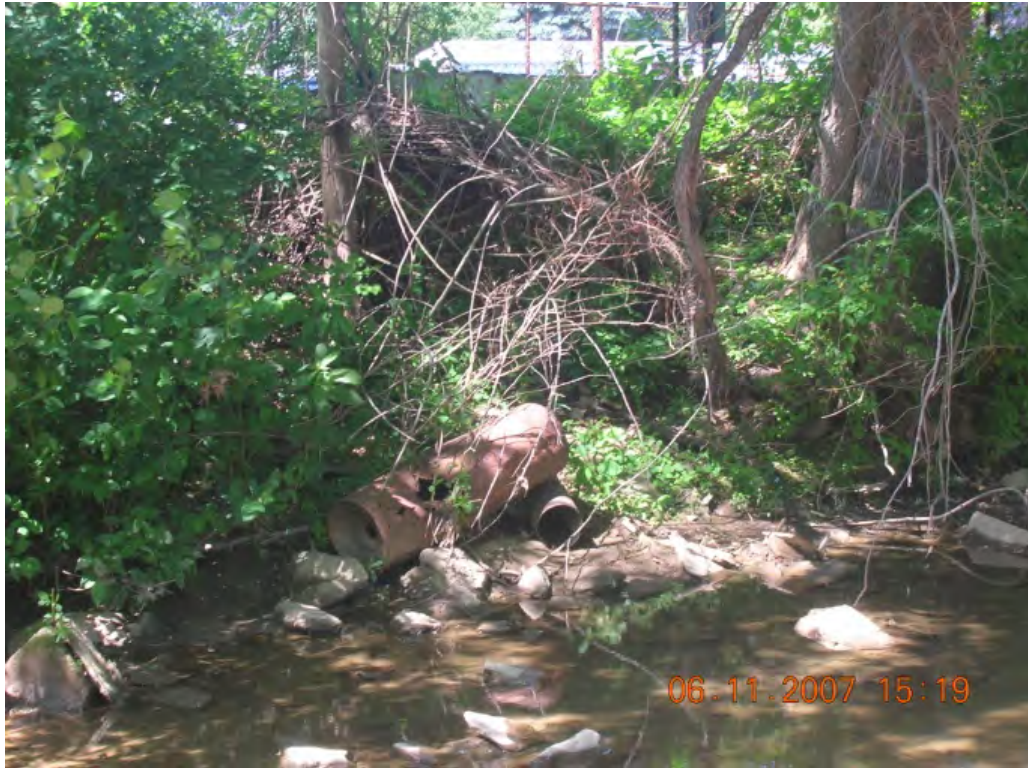
Algal growth indicates this reach of the stream is high in nutrients. This may be caused by treated effluent from the sewage treatment plant having high levels of nutrients. Effluent from the sewage treatment plant should be monitored to insure that concentrations of nutrients and Total Suspended Solids do not exceed effluent discharge limits.

Photo 1: Sewage plant discharge from trailer court. (BSC-25)

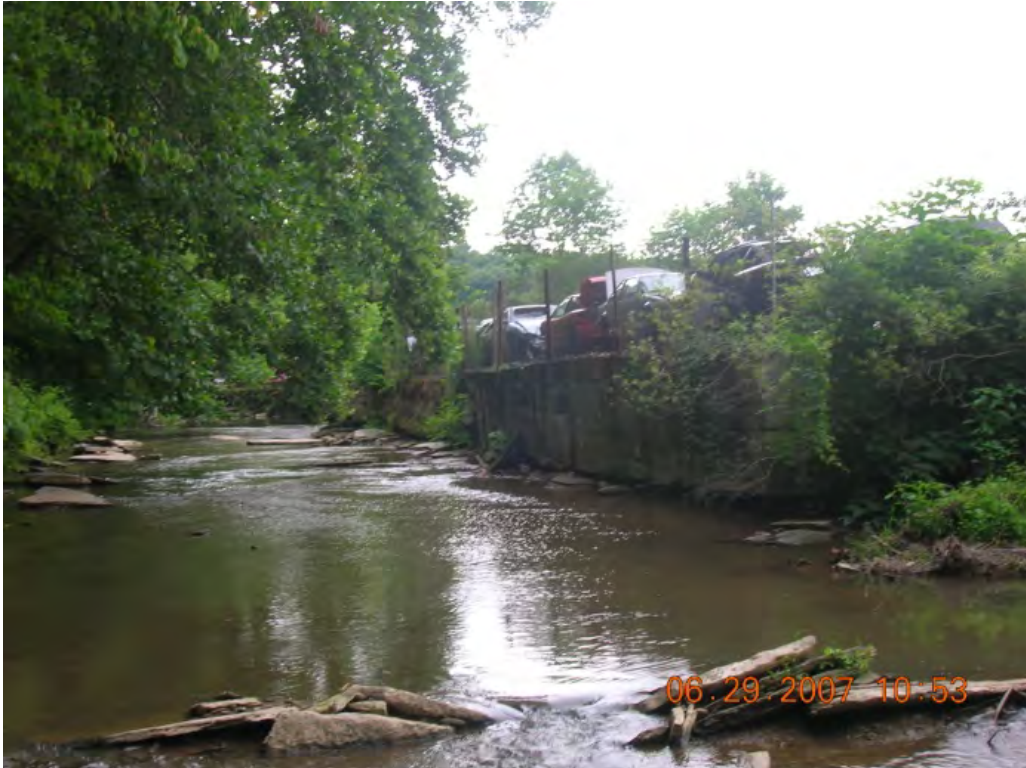
This section of Big Sewickley Creek received a visual assessment score of 6.73 out of 10 which means it is in Fair condition. There is erosion and sediment buildup in this region of the stream at BSC30.

Photo 1: Concrete wall at Ed Wagner Auto Salvage constricting channel. (BSC-30)

The eroded stream banks should be stabilized or stream channel restoration work could be done to direct the flow into the middle of the channel and away from the stream banks.

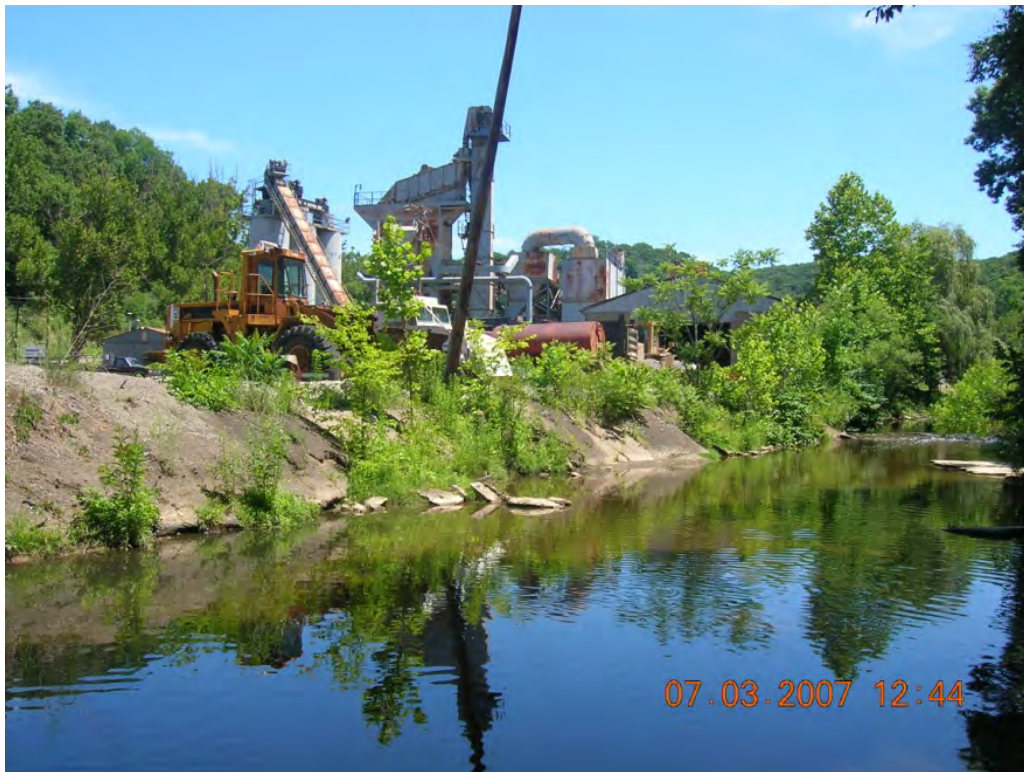
The Hanson-Sewickley Creek Plant is located immediately adjacent to the stream (see photo 1). There is also a sewage treatment plant (see photo 2) located on this section of the stream, and it is discharging liquid with a greenish/black color (see photo 3). There is also a Blue Heron Rookery (heronry) nearby (see photo 4). BAI observed bird droppings and dead fish around the ground which is creating a strong smell.

Photo 1: Hanson-Sewickley Creek Plant located right up on stream bank. (BSC-34)

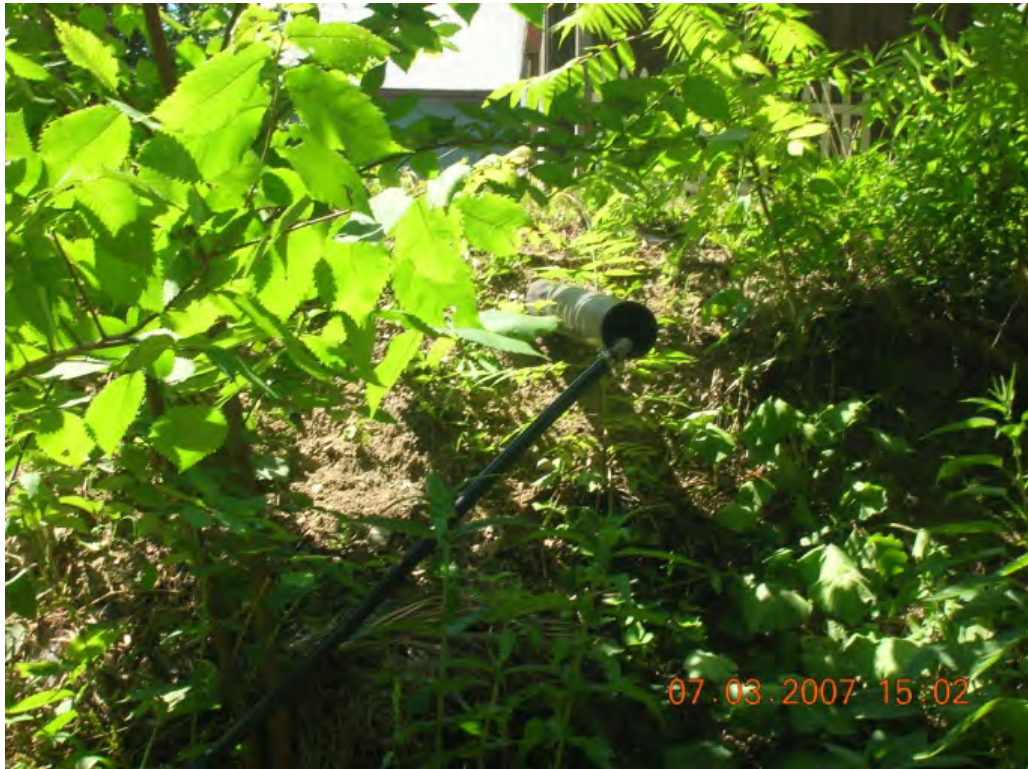
Photo 1: Black pipe with hose coming off of Chem-Dry property. (BSC-46)

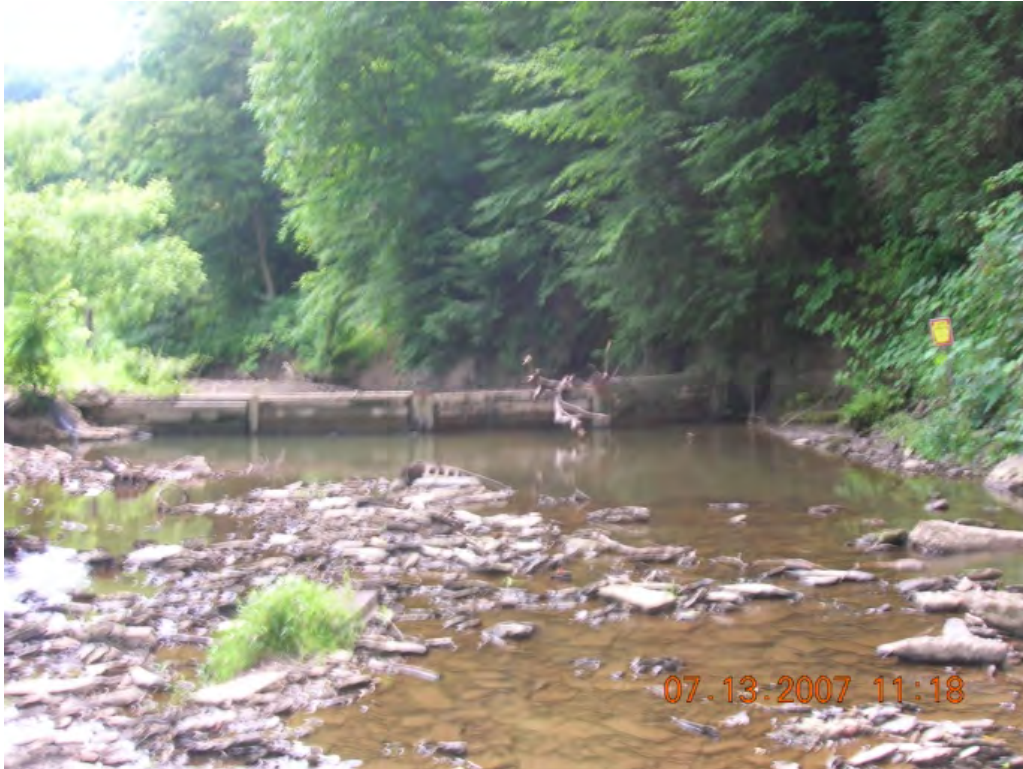
There was an abundance of dark brown and black algae growth in the area where a dam was placed in the stream by the PA Game Commission (see photo 1). The dam is there because that area is protected by the PA Game Commission as a waterfowl preservation area. The dam acts as a fish impasse as fish cannot swim past it to get up or downstream.

Photo 1: Area protected by the PA Game Commission for waterfowl. (BSC-58)

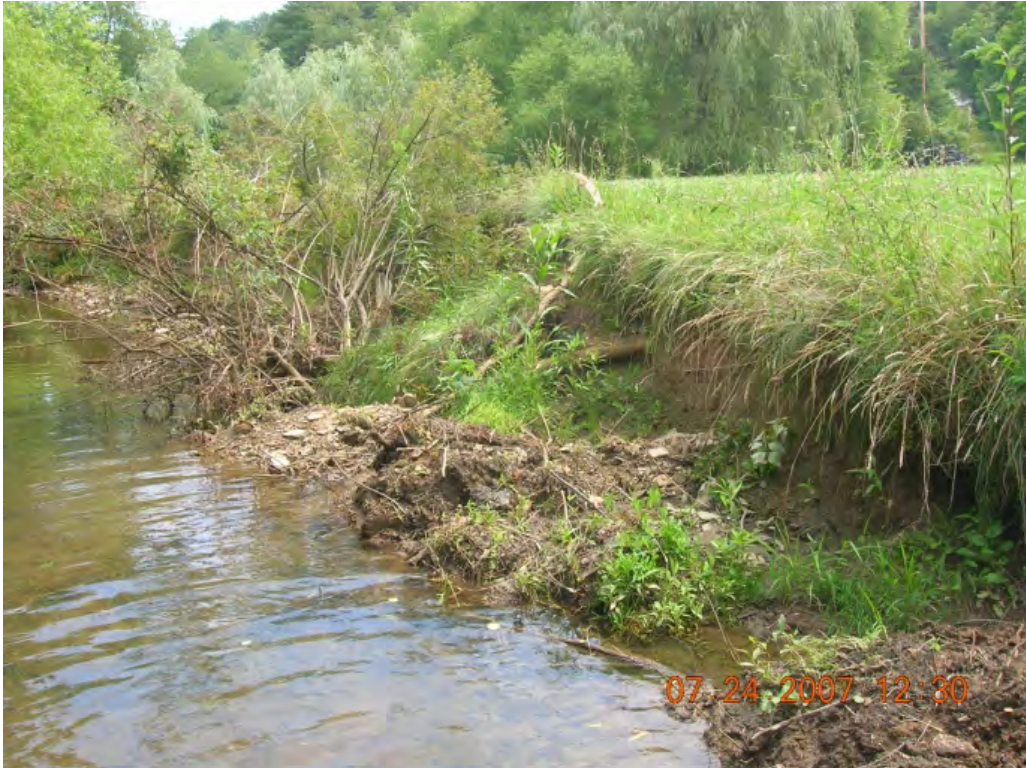
This section of Big Sewickley Creek received a visual assessment score of 7.7 out of 10 which means it is in Good condition. This section of the stream has some bank erosion. Marshall Township has completed a new sanitary line installation in this section of stream, as of October 2010. The eroded stream banks should be stabilized or stream channel restoration work could be done to direct the flow into the middle of the channel and away from the stream banks.

Photo 1: Bank erosion and massive slope failure in a homeowner's front yard. (BSC-67)

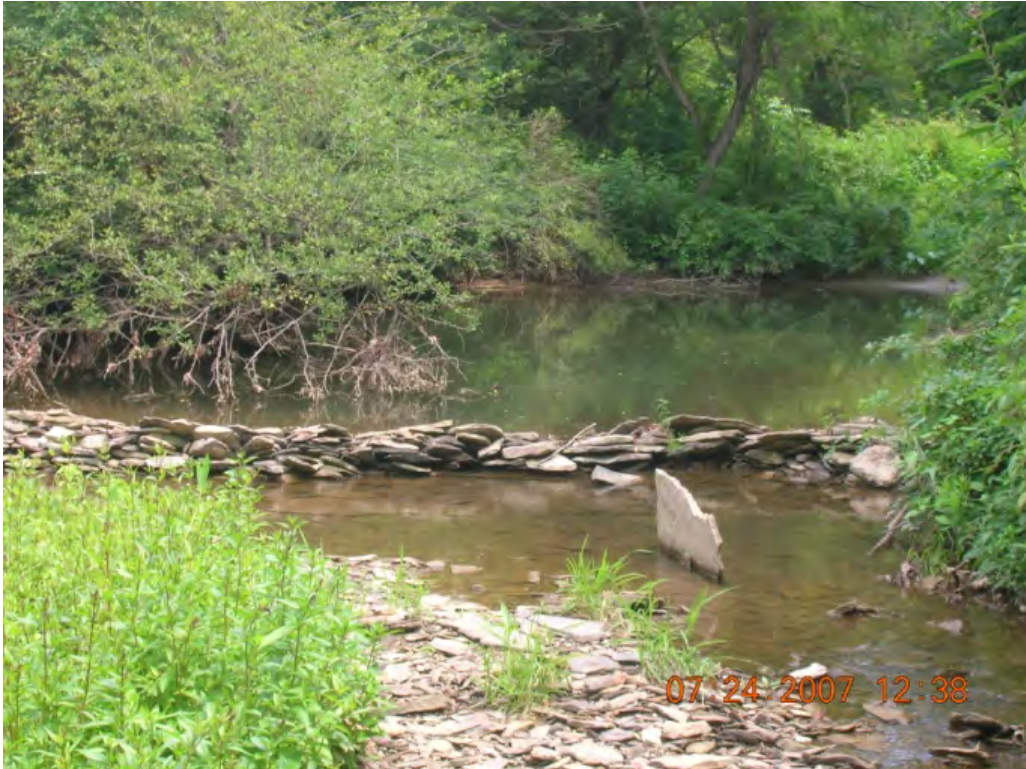
Photo 2: Rock dam contributing to sediment bar problem due to reduced water flow. This has been removed as of 10/05/10 field check (BSC-69).

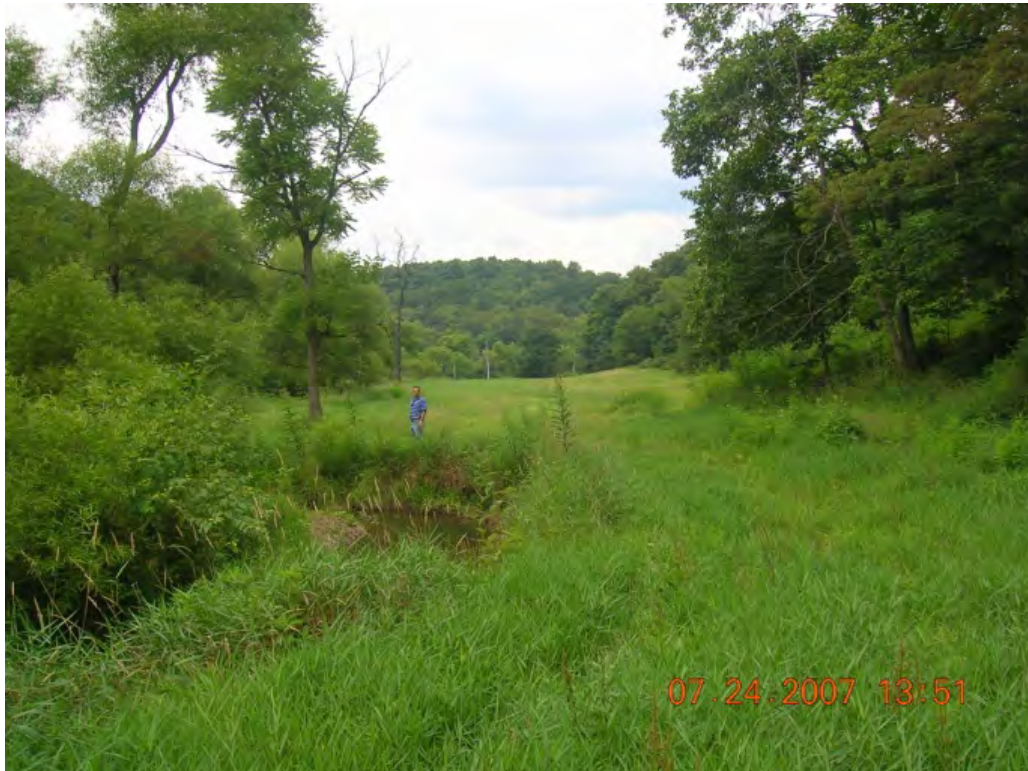
encroachment on the stream channel and floodplain. This stream reach would be a tremendous area to construct a regional storm water management facility and/or wetland mitigation bank.

Photo 1: Large grassland floodplain. (BSC-77)

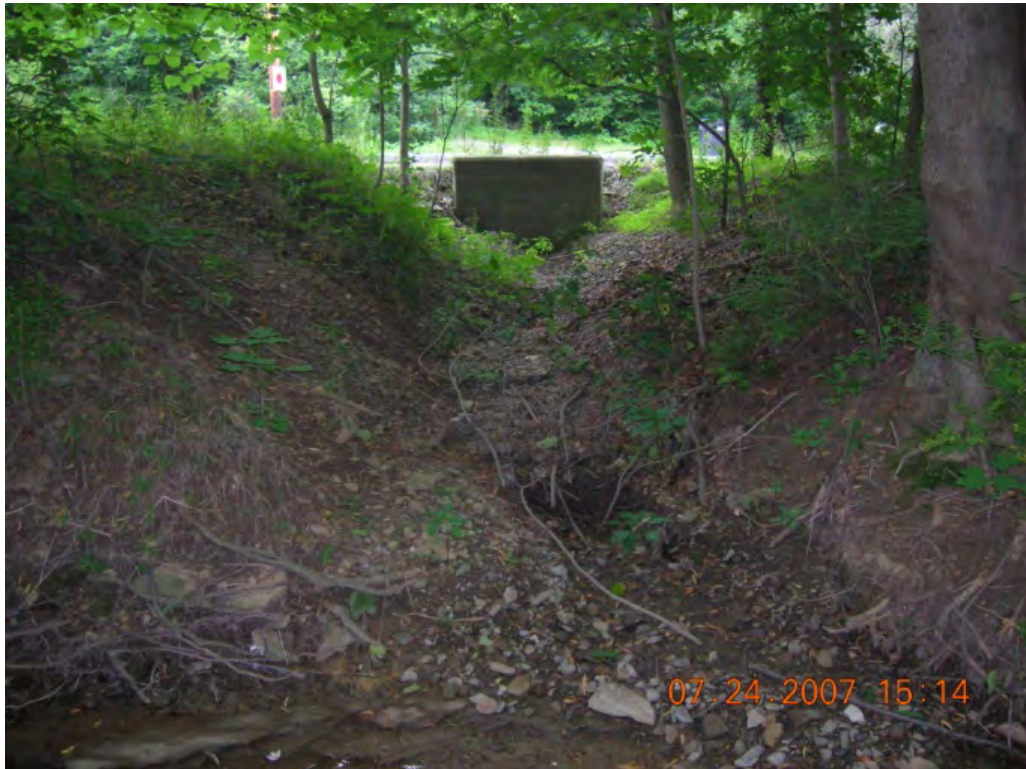
Photo 1: Drainage area coming off of road bringing in excess sedimentation. (BSC-84)

The eroded stream banks should be stabilized or stream channel restoration work could be done to direct the flow into the middle of the channel and away from the stream banks. ATVs should be discouraged from driving through the channel, but this is sometimes difficult to enforce on private property.

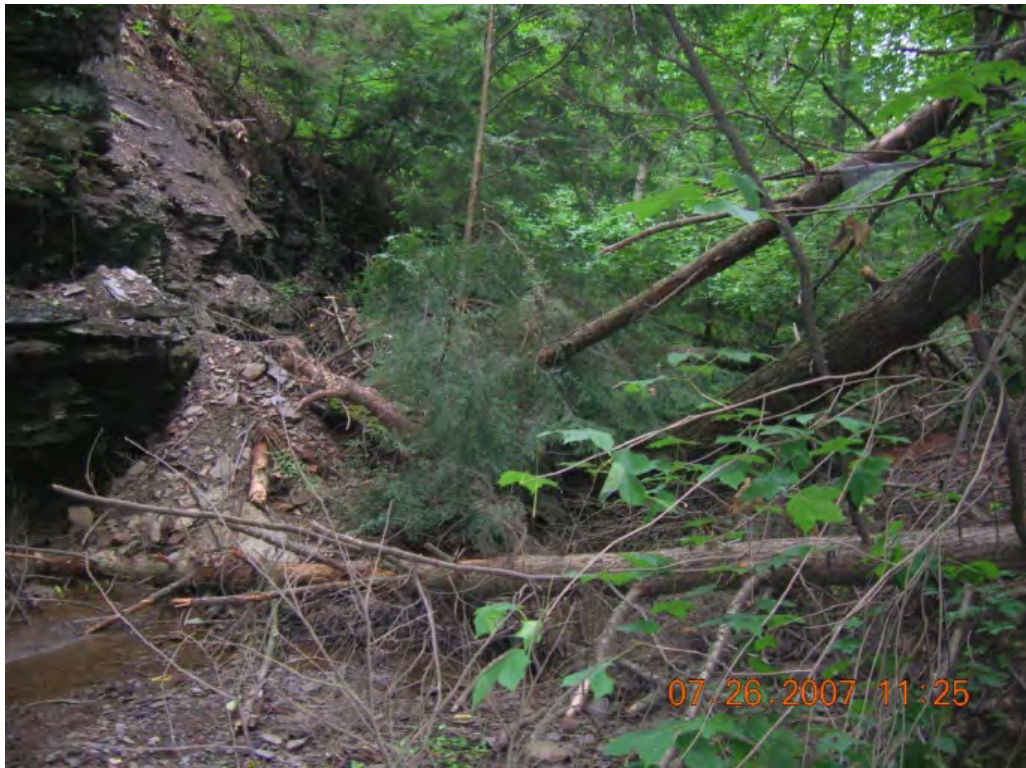
Photo 1: Landslide off hill into stream. (BSC-87)

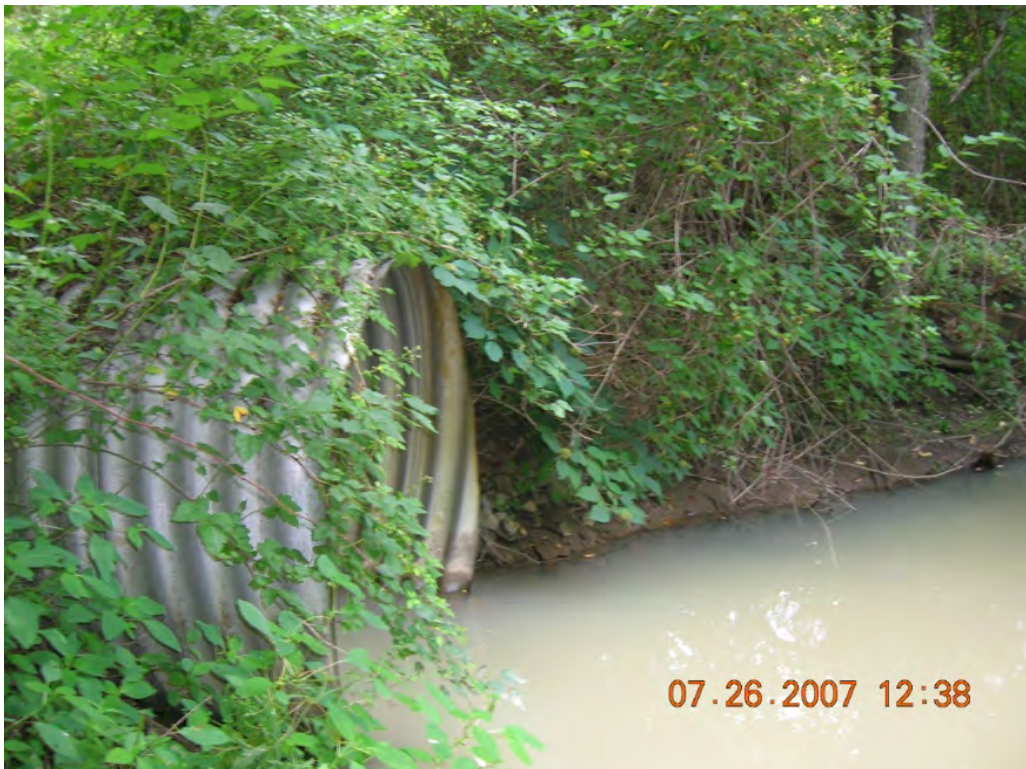
There was a man made dam made from a sheet of metal (see photo 4) that is acting as a fish impasse and causing downstream sedimentation. Downstream there were also a few culverts along the stream, one of which was too small and squeezes the channel (see photo 5), and another allowing a tributary to pass under a road (see photo 6).

Photo 5: Improperly sized culvert squeezing the channel. (BSC-94)

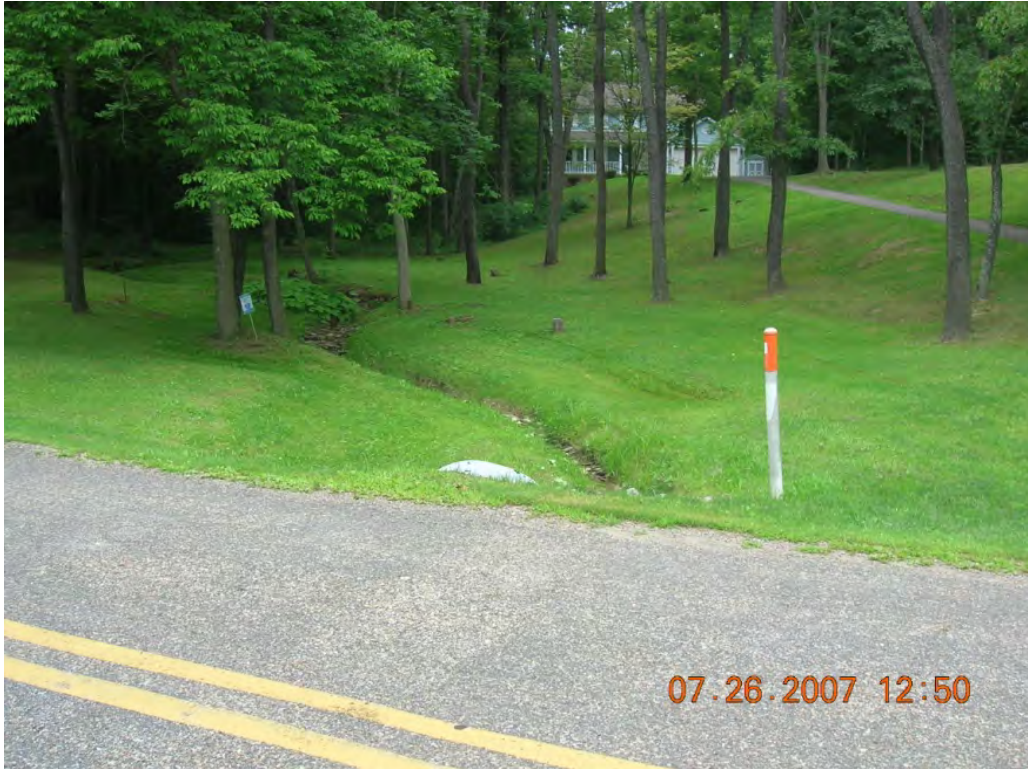
Photo 6: An incoming tributary from across the road. (BSC-96)

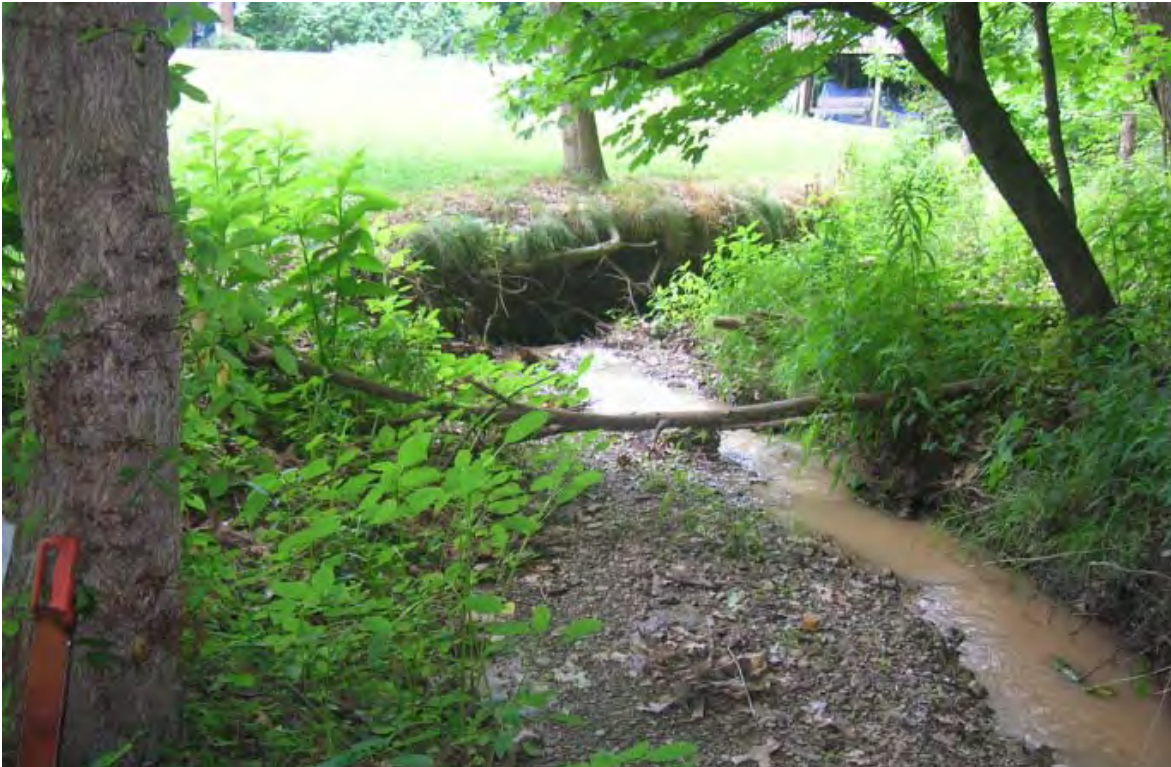
Photo 1: Heavy sedimentation and undercut bank on the tributary. (BSC-T1W2)

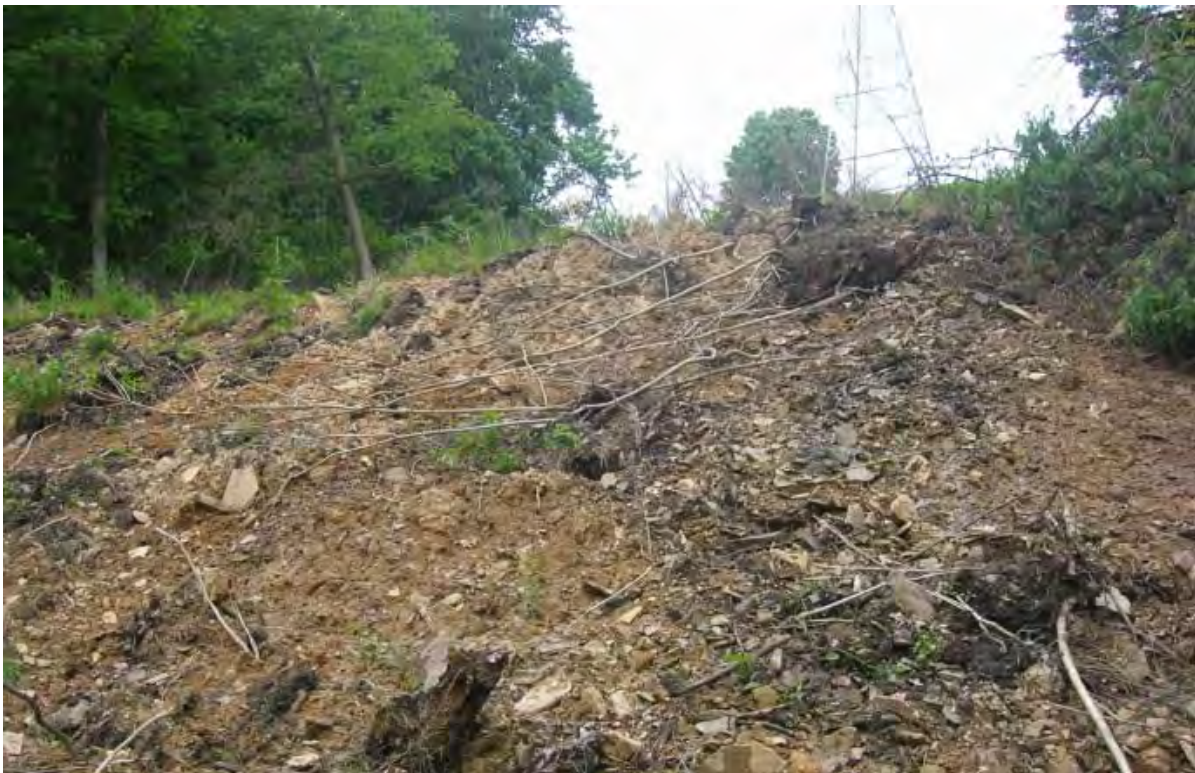
Photo 3: A landslide occurring along a power line, dumping sediment into the stream. (BSC-T1W7)

The hill that the power lines are on must also be restored and preventative actions must be taken to stop landslides from happening in the future. The trash needs to be cleaned up, removed, and disposed of properly. Dump sites could be monitored by Economy Borough code enforcement.

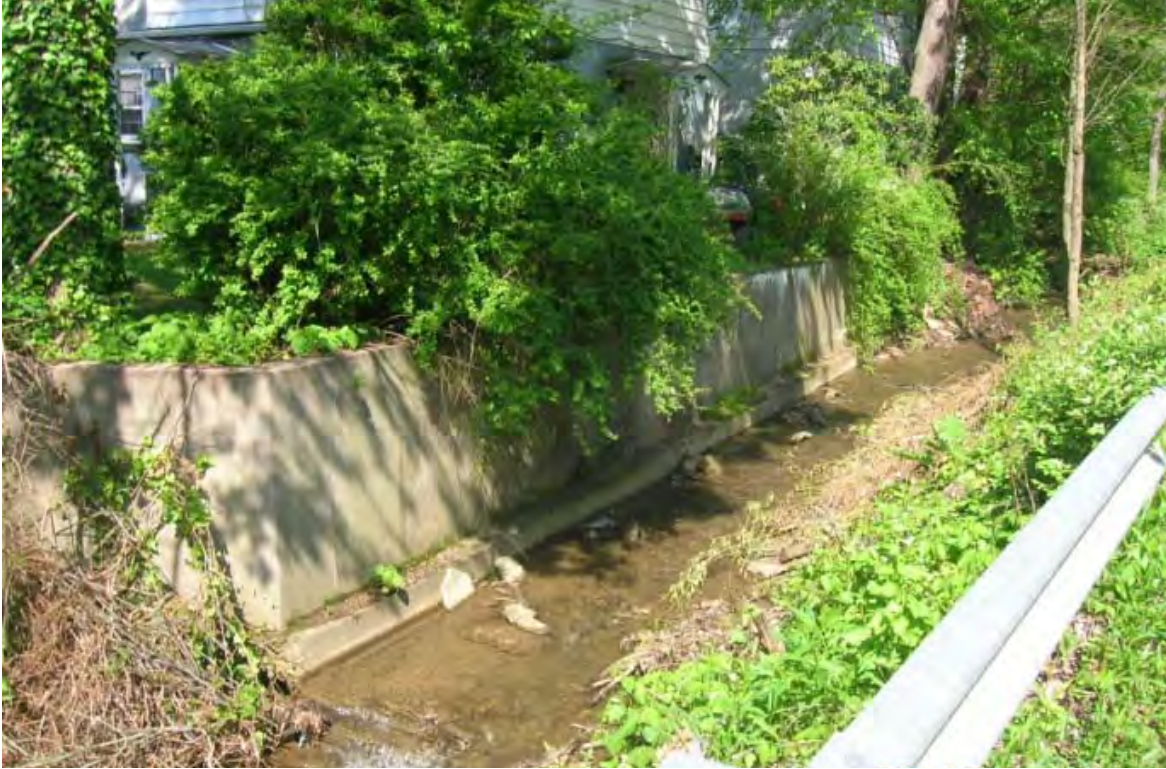
Photo 1: Tributary along Shaffer Road squeezed by the road and a concrete retaining wall. (BSC-T3W2)

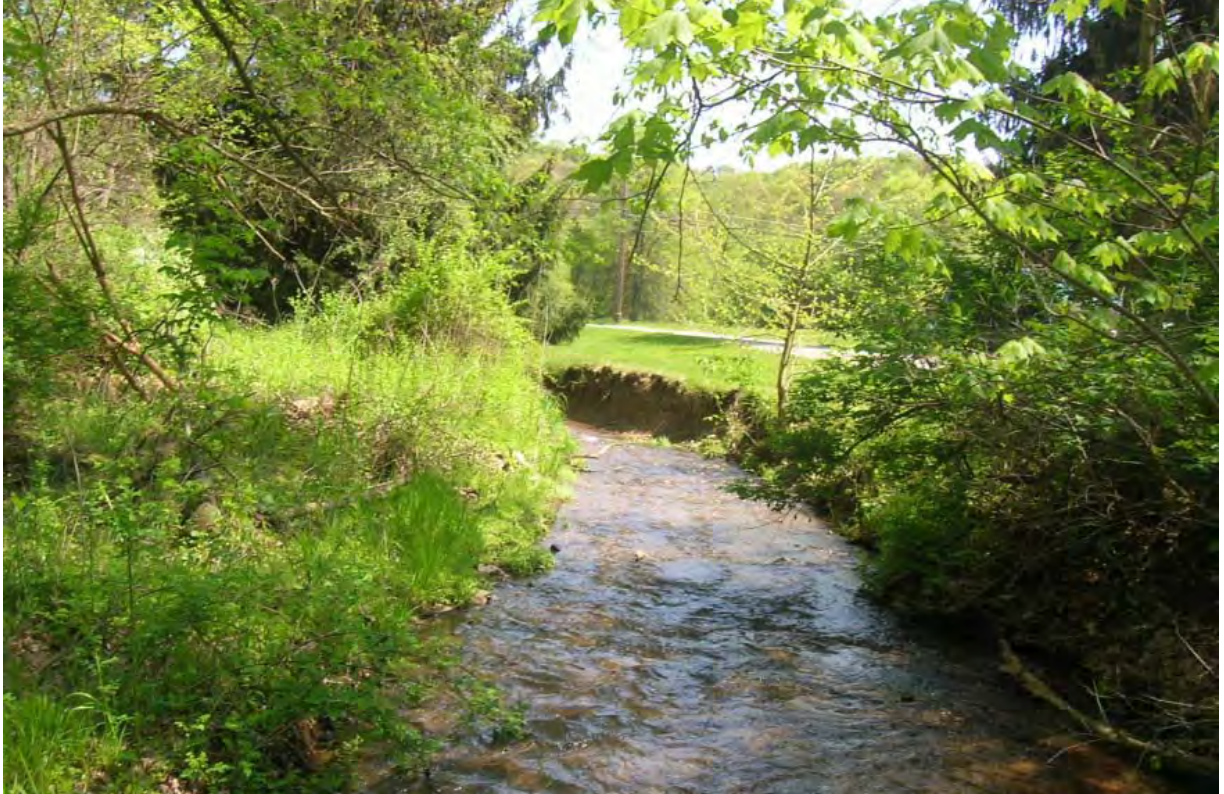
Photo 1: Tributary along Conway-Wallrose Road with some bank erosion near the mouth. (BSC-T4W1)

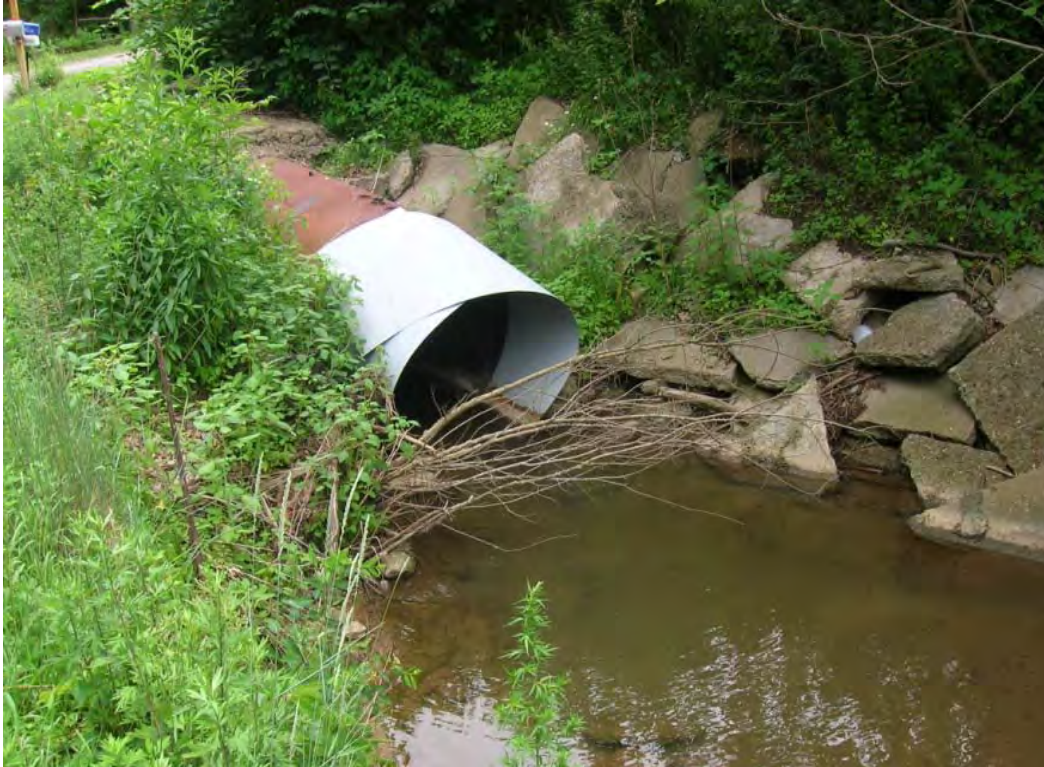
Photo 1: Here, an old tank was improperly used as a driveway culvert on a tributary that runs along Turkeyfoot Road. (BSC-T1E3)

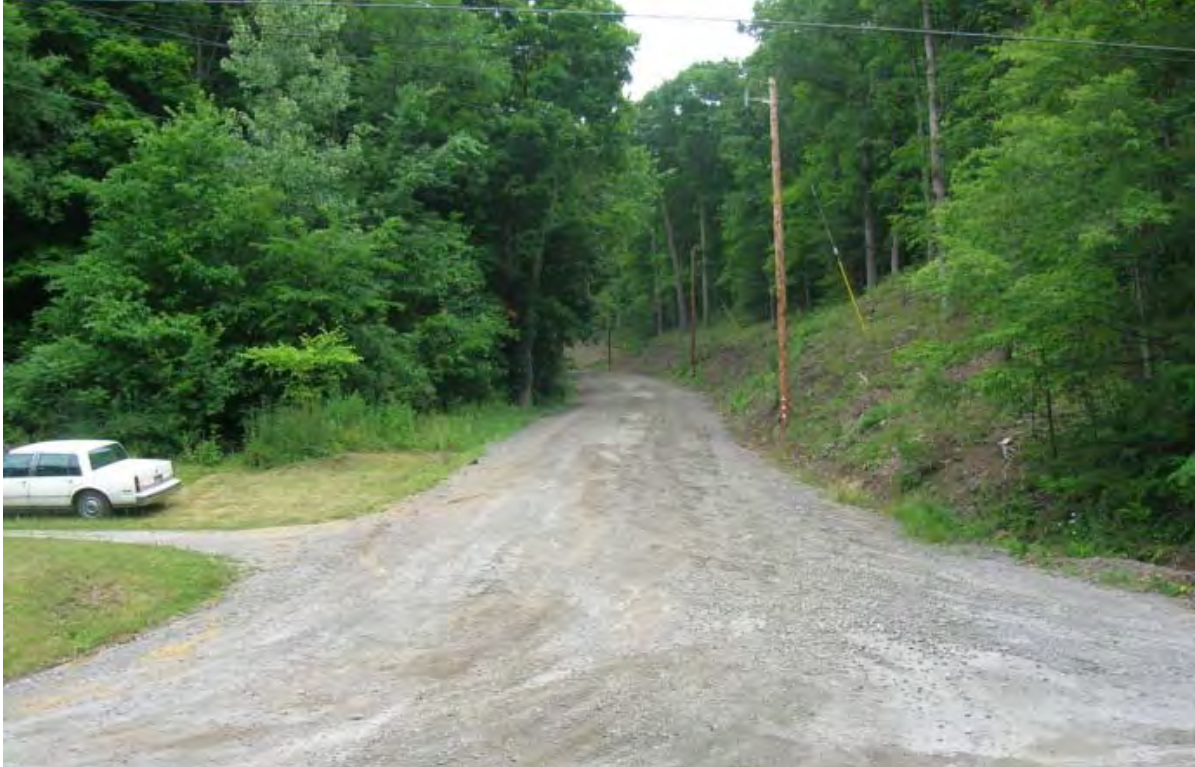
Photo 3: Dirt and gravel from Beadnell Drive is going into the stream. (BSC-T1E4)

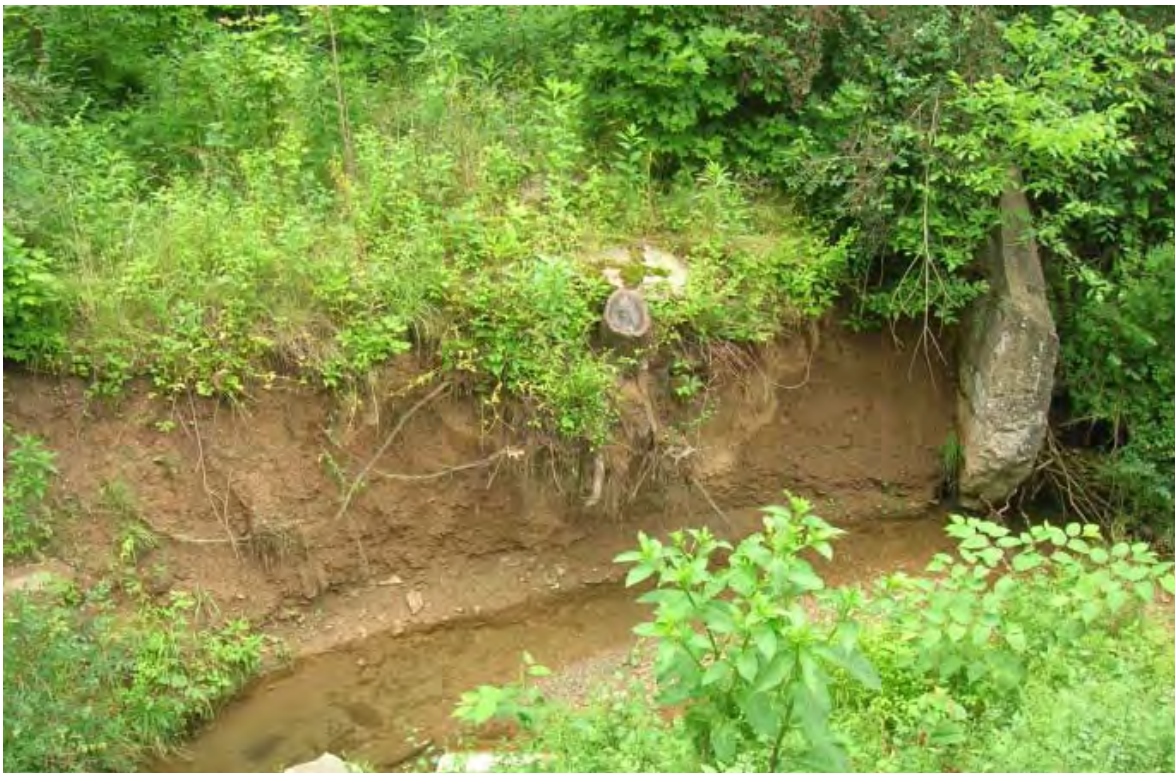
Photo 4: Bank erosion occurring across the road from Beadnell Drive. (BSC-T1E4)

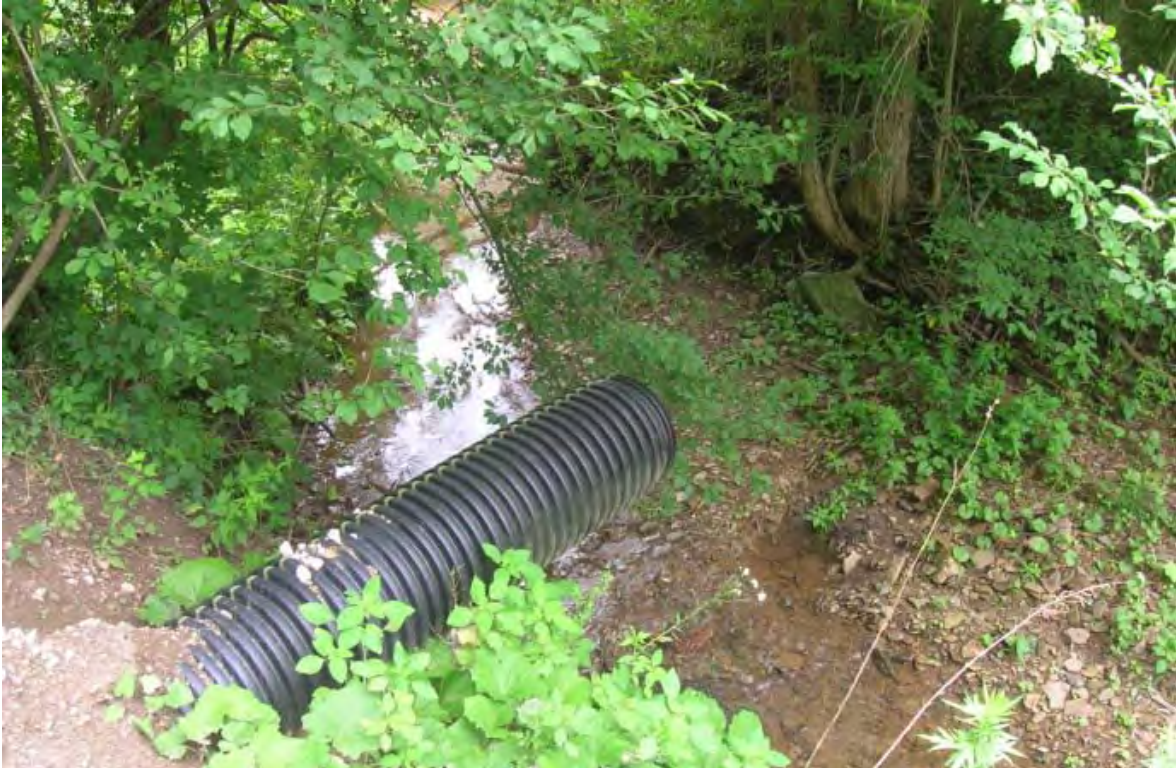
Photo 5: Storm water outfall that is sticking out too far into the stream channel. (BSC-T1E4)

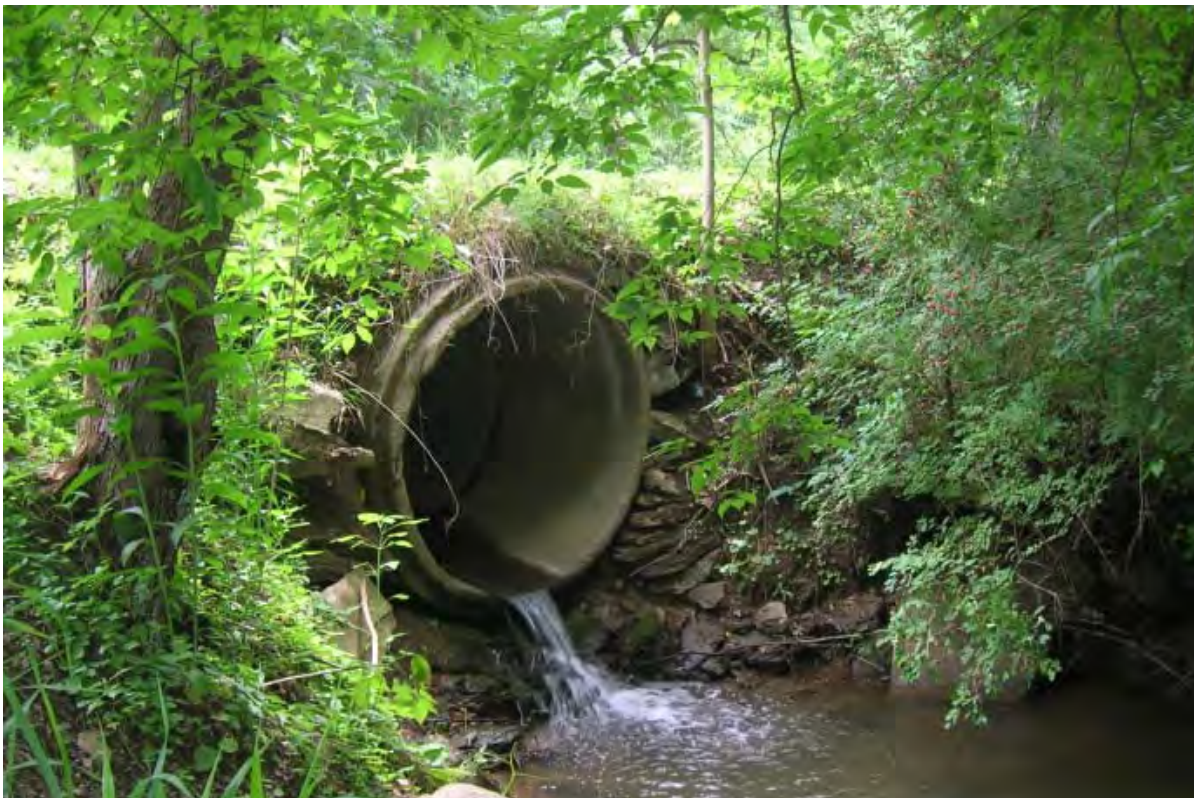
Photo 6: Culvert under Sevin Road at intersection with Turkeyfoot Road placed too high. This creates a passage fish barrier. (BSC-T1E6)

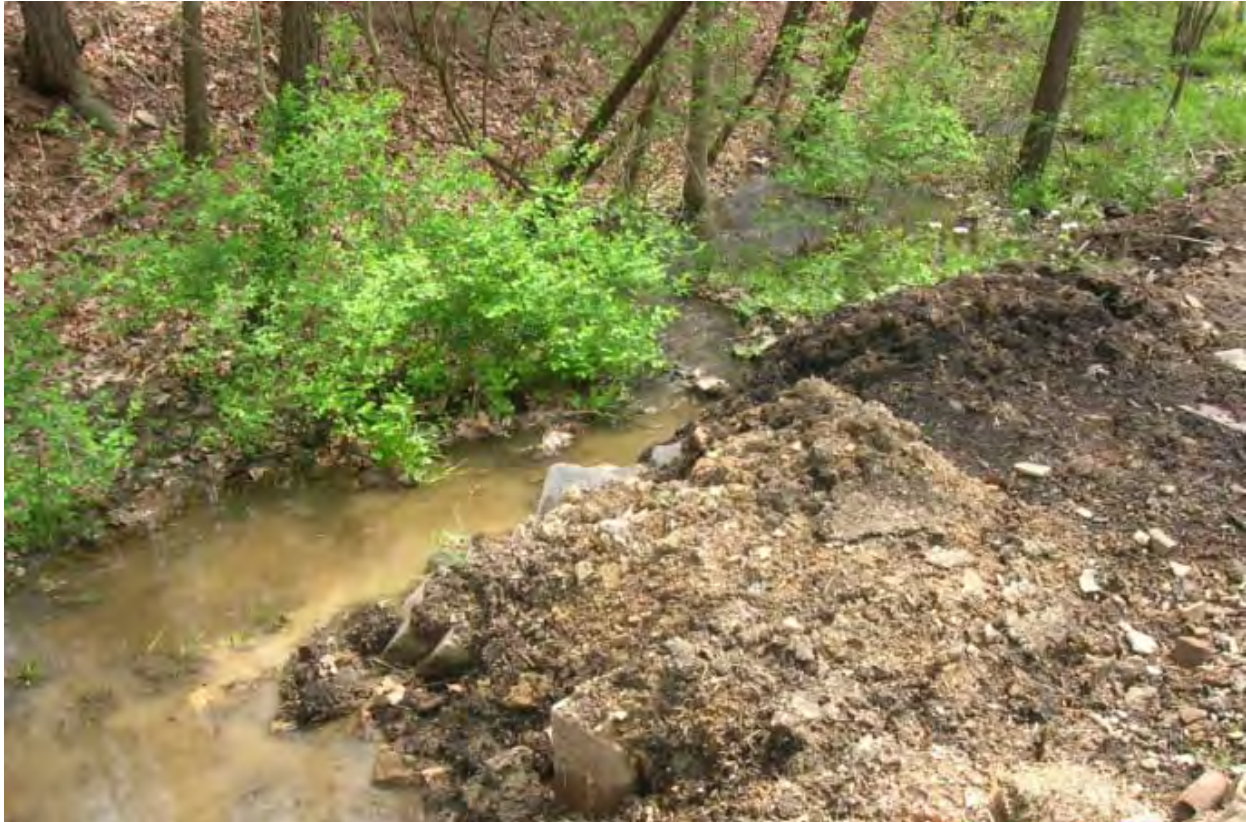
Photo 1: Mulch pile and disturbed ground encroaching on tributary off of Markman Park Road. (BSC-T3E2)

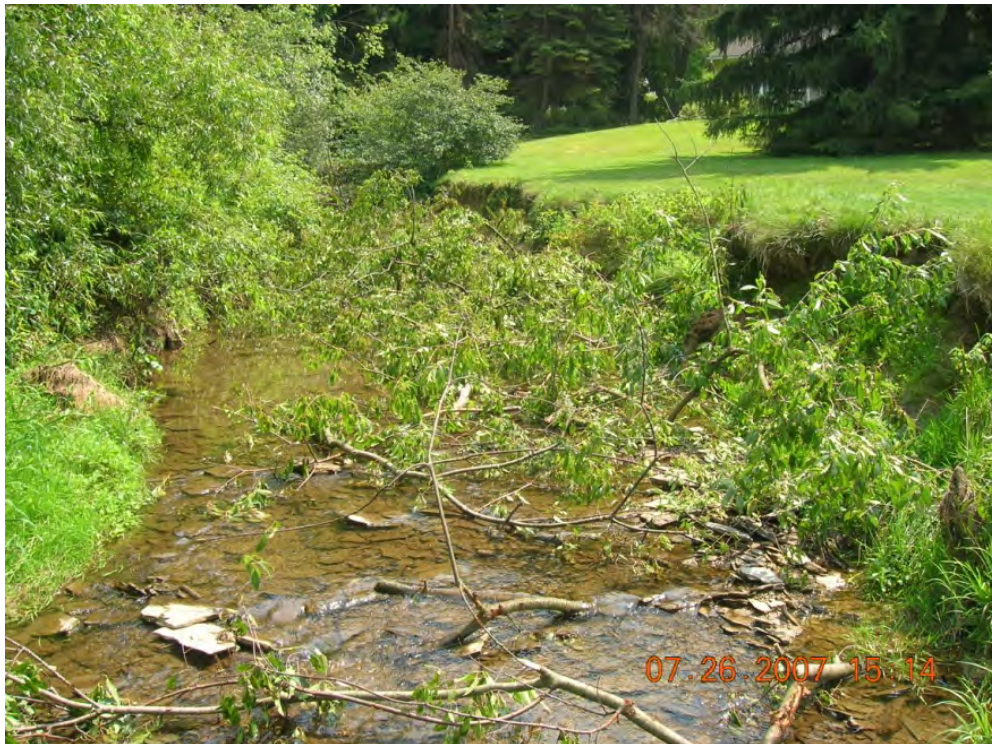
Photo 1: Near the mouth of East Branch Big Sewickley Creek, a homeowner has discarded cut limbs in the stream. There is also bank erosion due to the cutting of grass right up to the stream bank. (EF-05)

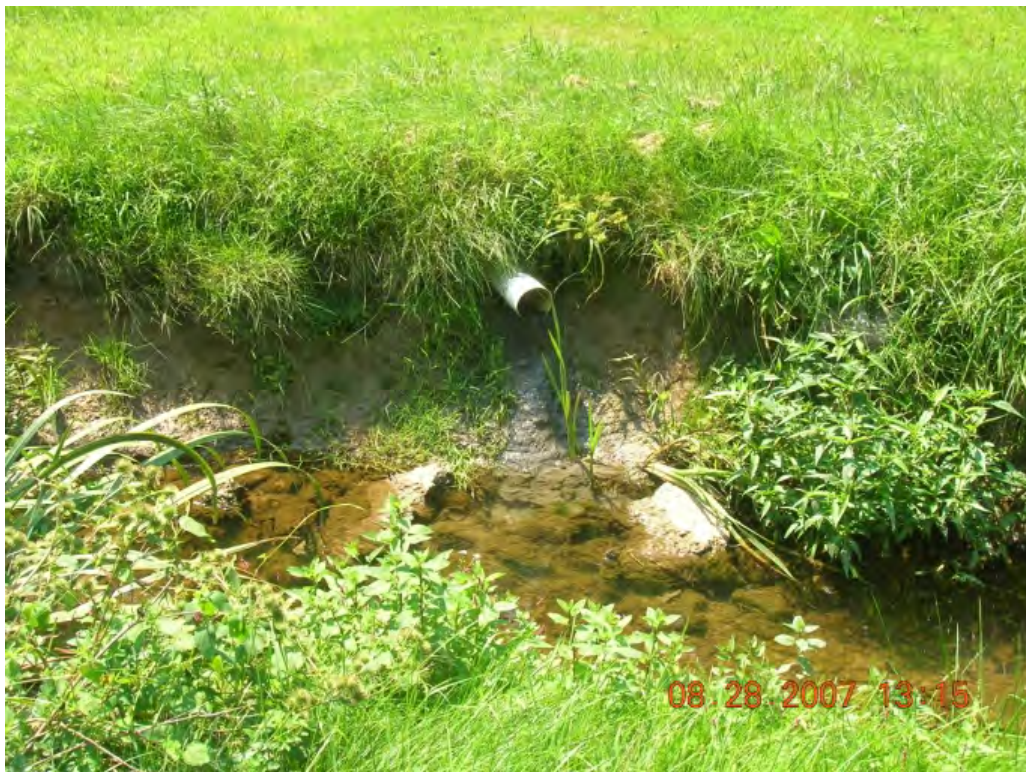
Photo 1: A white pipe discharging fluids with white precipitate out of a front yard.  
(EF-26)
