# BIG SEWICKLEY CREEK WATERSHED ASSESSMENT, RESTORATION, & PROTECTION PLAN

OCTOBER 2010

BIG SEWICKLEY CREEK  
WATERSHED ASSESSMENT, RESTORATION, AND PROTECTION PLAN

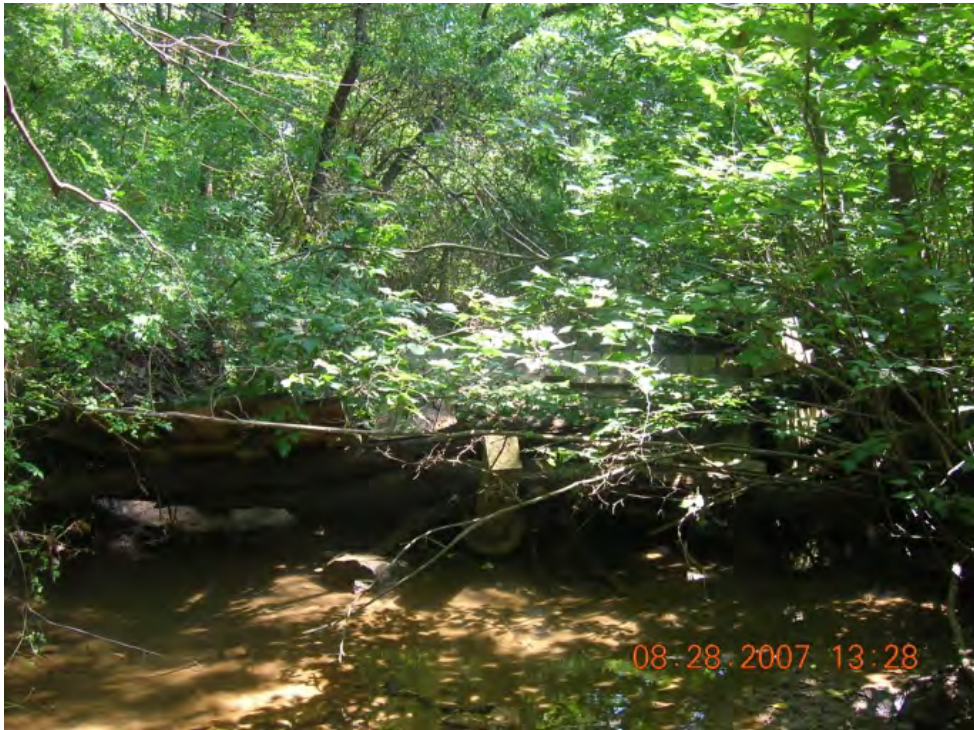
Photo 1: A collapsed wooden bridge creating a debris jam. (EF-29)

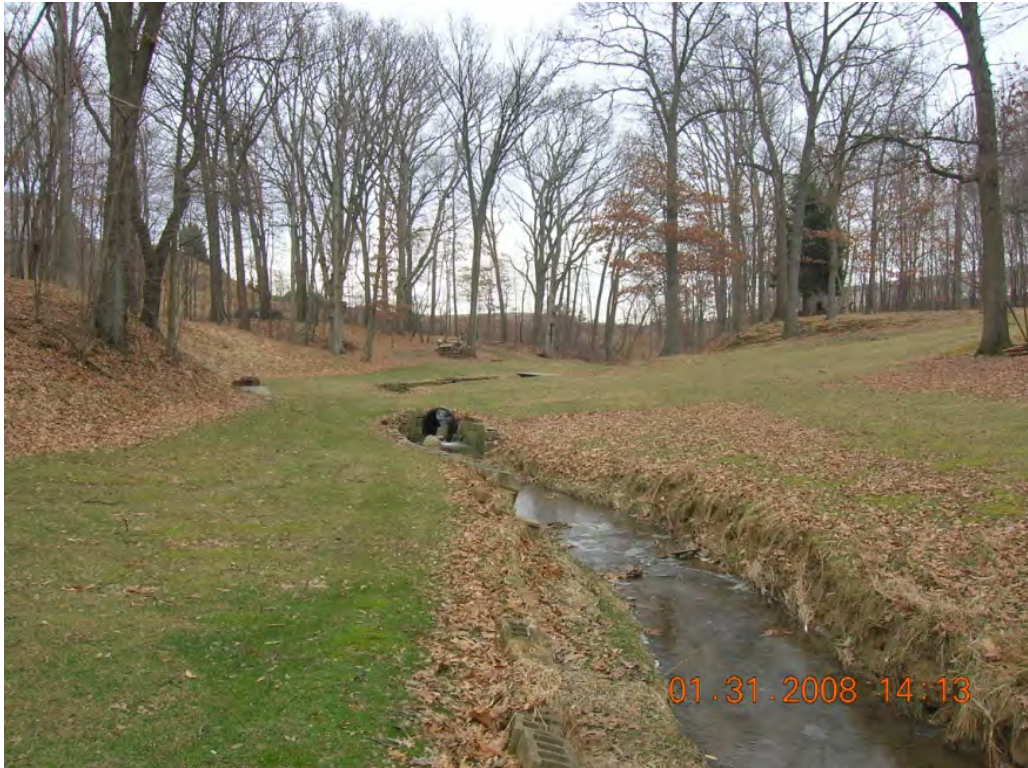
Photo 1: An improper attempt at bank stabilization using concrete blocks. (NF-37)

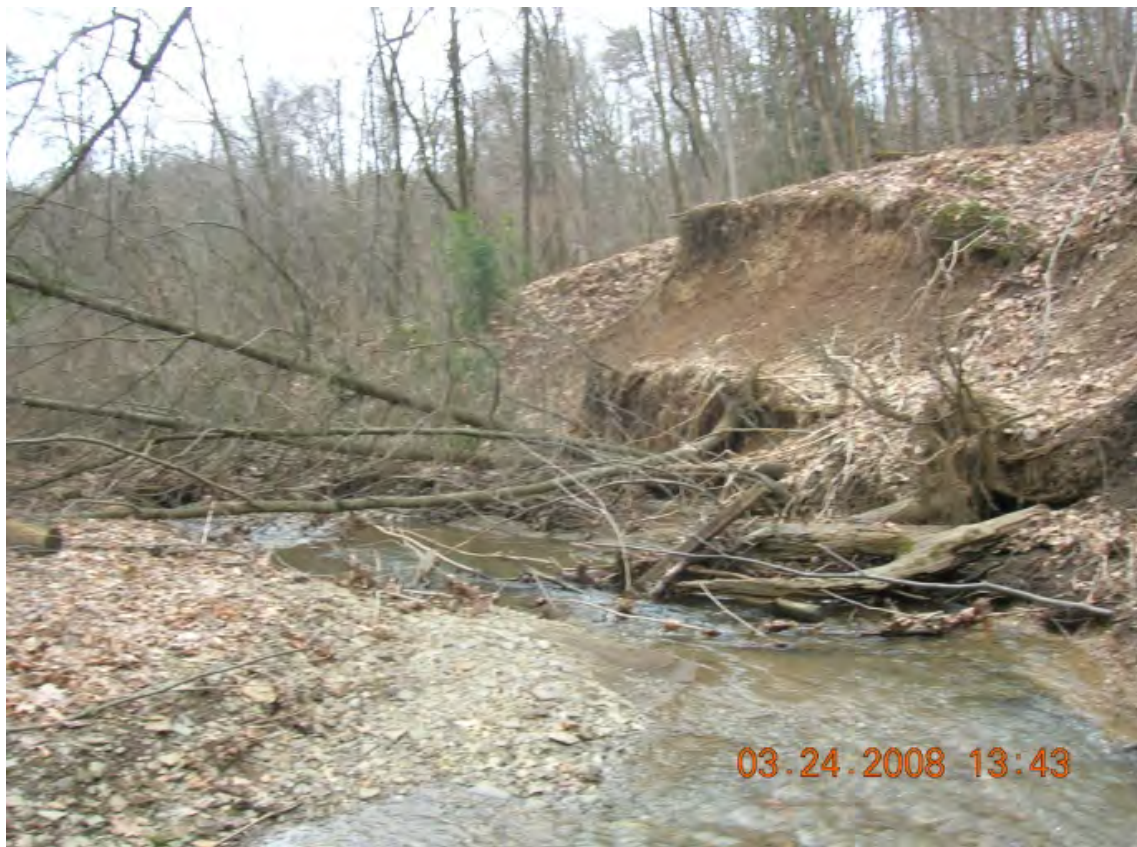
Photo 1: At a tributary of the North Fork, this slope failure and bank erosion was observed. (NF-T2W7)

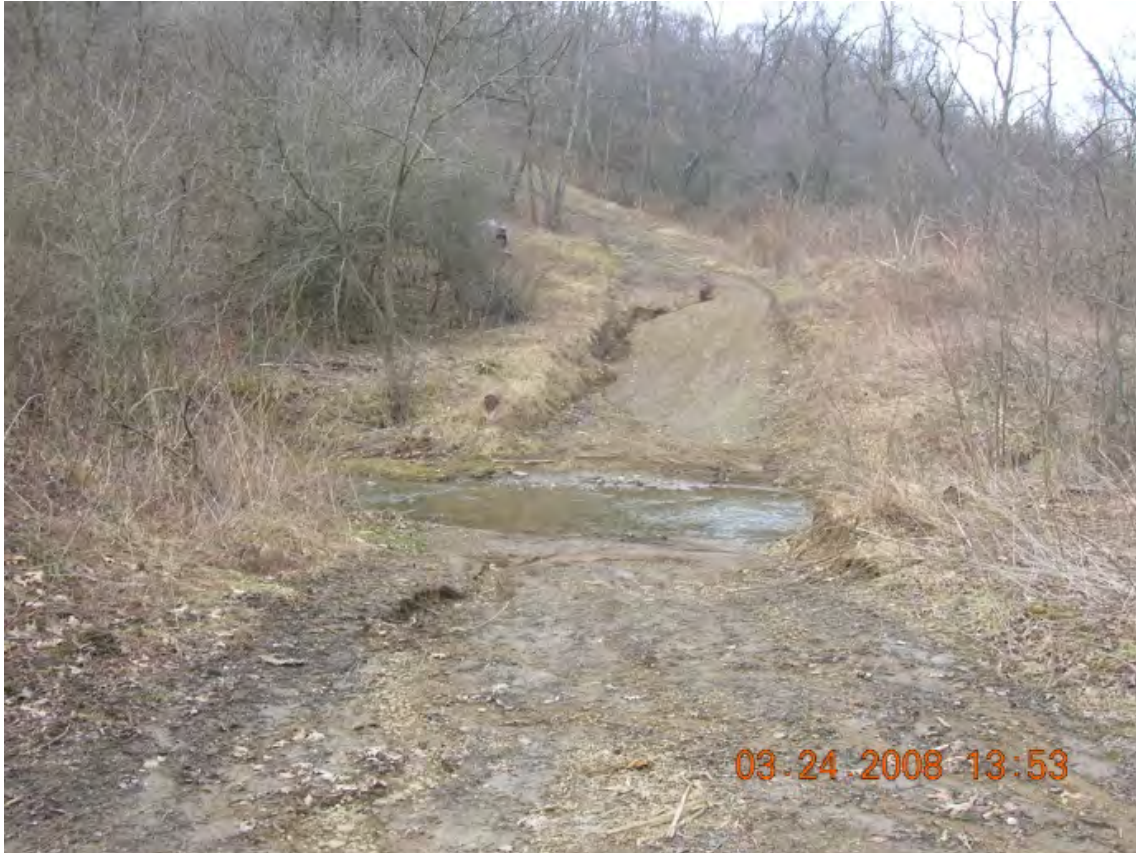
Photo 2: Another instance of erosion just upstream from a large gully on ATV trail. (NF- T2W8)

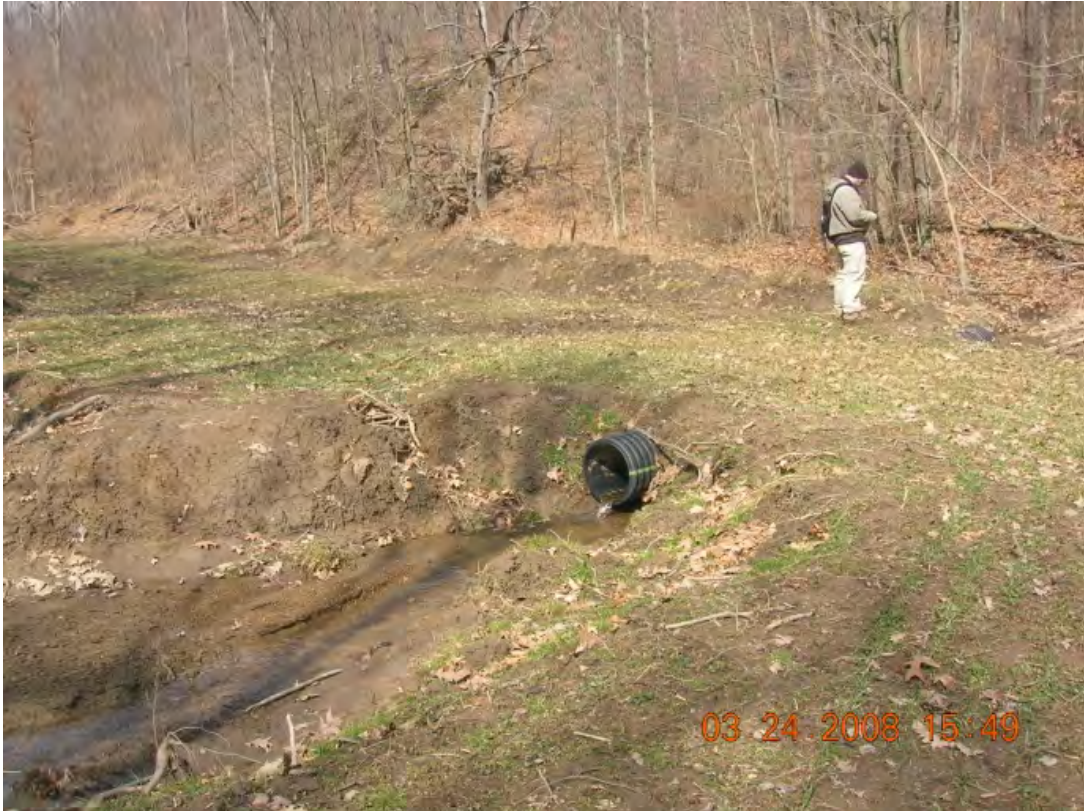
Photo 1: A stream crossing culvert causing down cutting and erosion. (NF-T3W2)

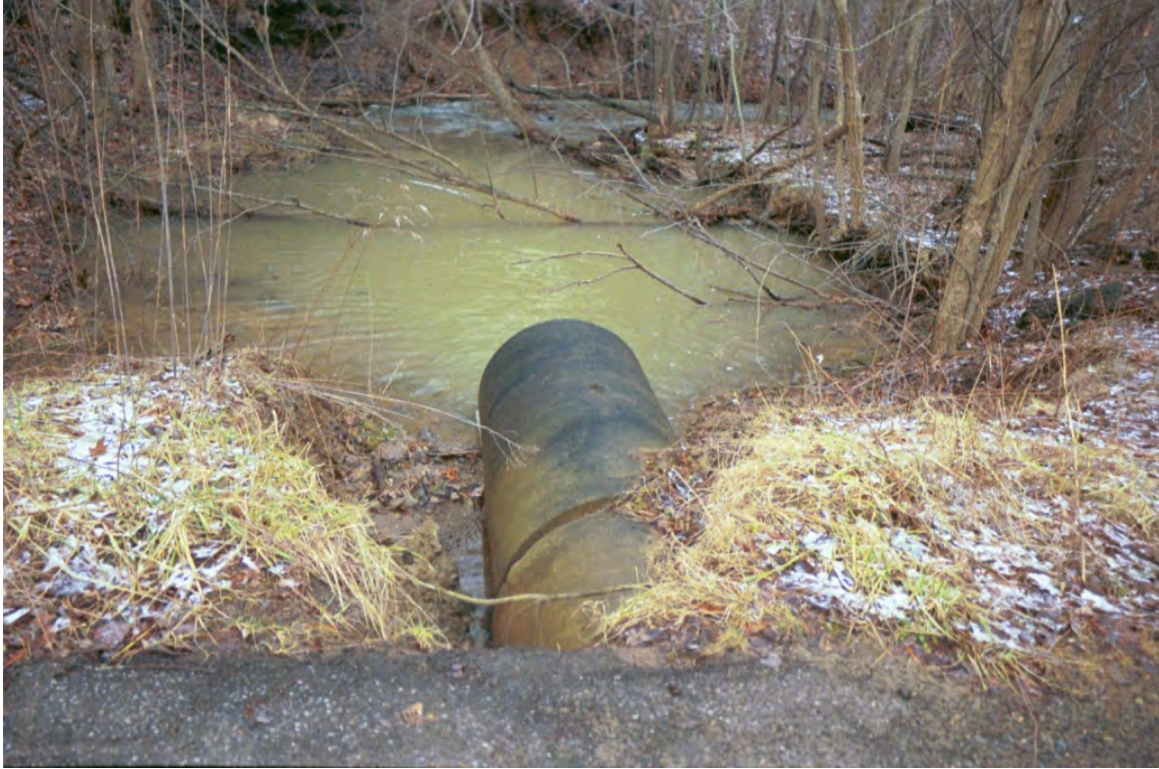
Photo 3: Severe erosion around concrete pipe that is improperly sized. (NF-T5W7)
