**PINE CREEK WATERSHED
CHANNEL and RIPARIAN ASSESSMENT
and
RESTORATION PLAN**

NORTH AREA ENVIRONMENTAL COUNCIL
in partnership with the
PINE CREEK WATERSHED COALITION

ALLEGHENY COUNTY, PENNSYLVANIA

March 2010

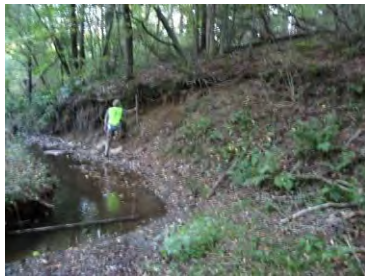
Erosion on a scour bank at a bend in the stream destabilizes a steep bank.

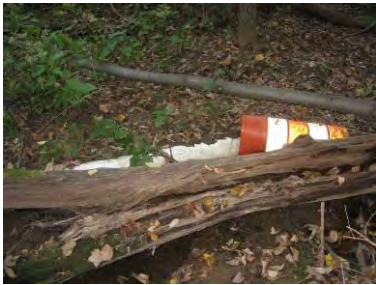
Could this have been moved by a storm? Dumping affects stream and riparian quality.

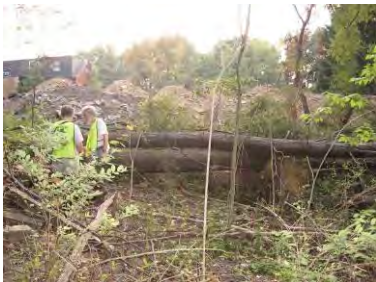
Fill piles without erosion control to prevent erosion can impact stream life and channel capacity.

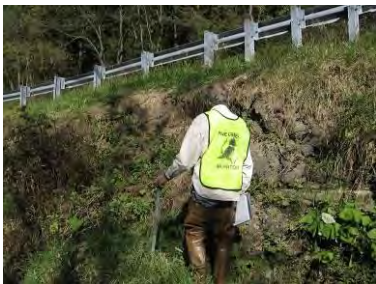
Streambank erosion along roadways can result in roadbed collapse...an expensive infrastructure repair.

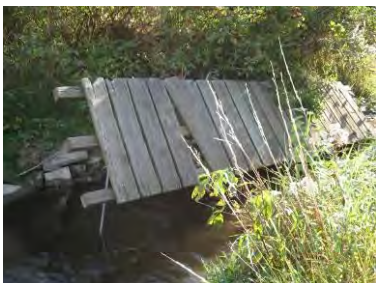
Improperly and illegally constructed bridges and streamside structures can wash away and block streams, increasing flood damage.

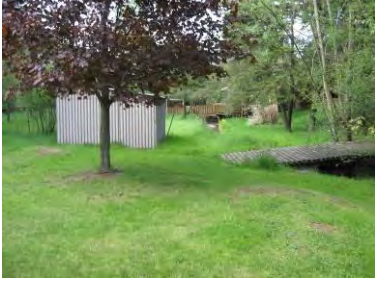
Streamside structures and bridges can create stream blockages during high water events.

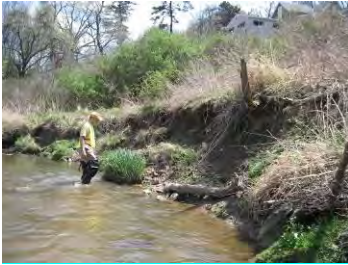
A number of places along MP3 have severe bank erosion. In this area the erosion could eventually impact the properties above it.

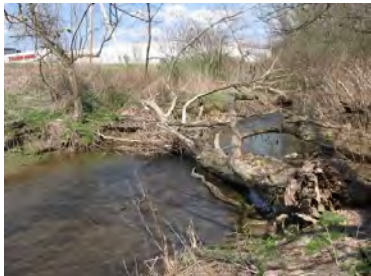
Trees that have fallen across the stream can create dams and present a flooding hazard.

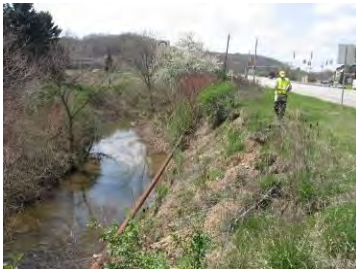
MP3 along McKnight Road has several pipes that are at severe risk of collapse as the streambank has eroded away, leaving them suspended and without support.

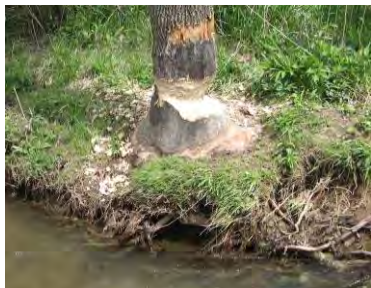
The impact of beaver activity as a contribution to flooding along MP3 should be studied.

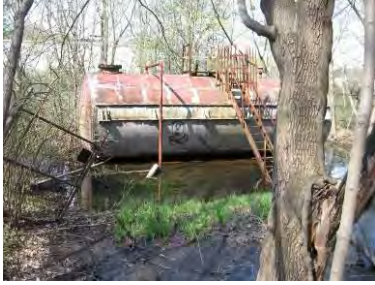
An inactive storage tank near the stream presents a significant hazard of stream contamination or damage to vegetation or structures if dislodged and floated downstream.

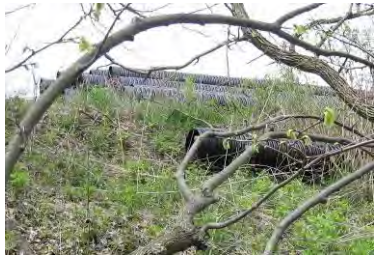
Improper streamside storage, for example this drainage pipe that has rolled over the hill, could create a dam during a high water event. Extreme high water could carry away the entire pile of pipes.

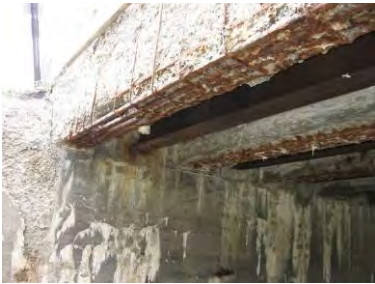
The decaying infrastructure of bridges such as this one on MP3 impacts stream quality and increases the risk of the structure failing in a high flow event.

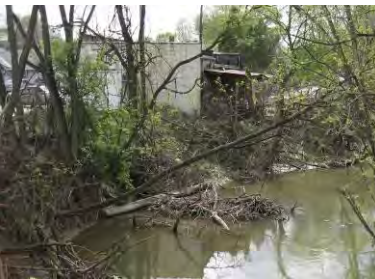
Development close to the stream channel has decreased flood zone capacity and promotes increased flood damage to property.

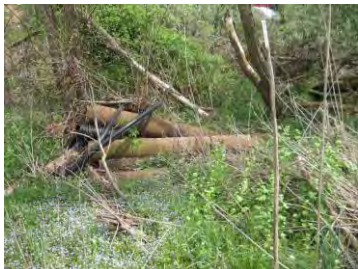
Improper disposal of materials in several places creates potential hazards if large items such as these pipes are swept downstream during a high flow event.

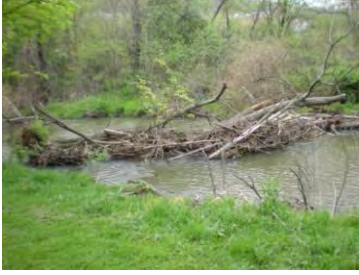
Trees brought down by bank erosion create traps for smaller debris and ultimately create debris jams and enhanced opportunities for localized flooding.

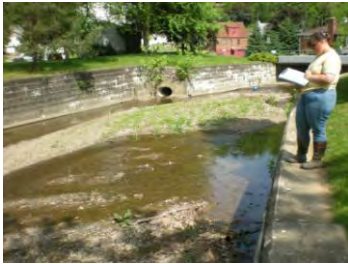
Sedimentation of channelized portions of main Pine Creek and its tributaries reduces their capacity during high flow events.

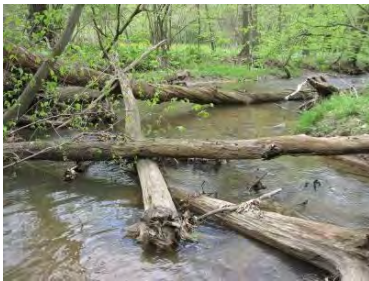
There are several debris jams in different stages of development. This is one in the early stages.

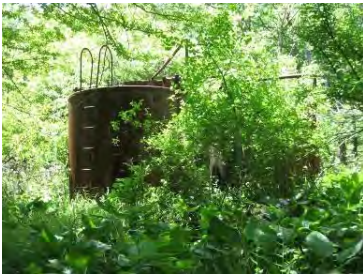
Three abandoned oil tanks were found with evidence of oil leakage.

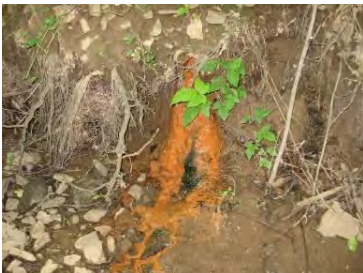
Small amount of orange seepage resembling AMD was seen draining from a pipe near a cleared, stone paved area.

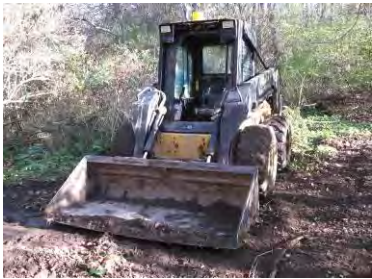
Protection of headwater portions of the watershed are critical because that is where large percentages of rain water infiltration occurs. Disruption of the riparian edges in upstream areas as seen by this Bobcat contributes large amounts of sediment to downstream reaches and reduces infiltration.

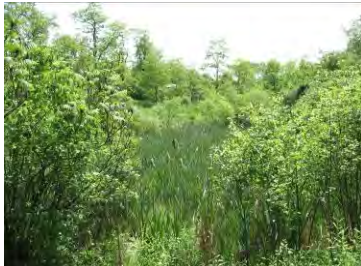
A wetland was identified near the confluence of Crouse Run with Pine Creek stream. This area can absorb large volumes of rain water.

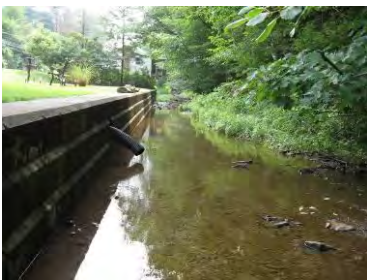
Retaining walls increase erosion of flowing water in high flow events by narrowing channel

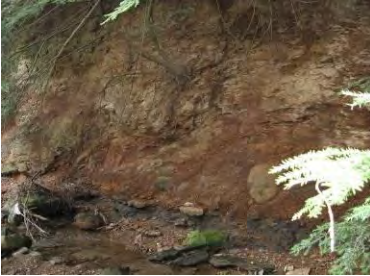
Severe erosion near the mouth of Harts Run on the south side of the stream puts a large hillside at risk.

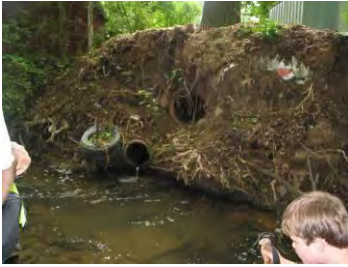
The most common issue observed on West Little Pine is streambank erosion in various forms. Here the erosion threatens businesses and a large tree that could block the channel if it falls.

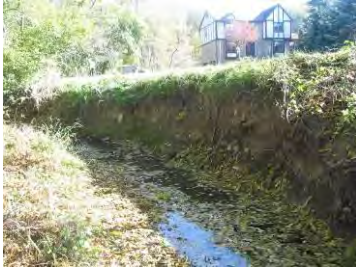
Erosion is impacting residential properties, in this case as it is decreasing the size of a residential yard.

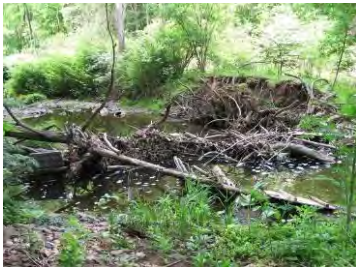
As elsewhere, debris from fallen trees presents a real hazard to streambank stability as water deflected by the debris seeks an alternate route, here eroding the far bank.

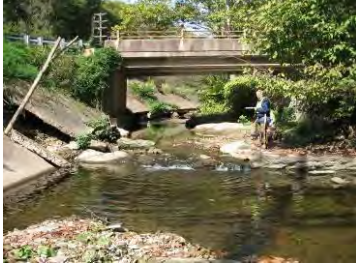
Even the most sturdy bank armoring designs have proven unequal to the force of West little Pine in its southern reaches. Here, a road is in jeopardy if the wall fails.

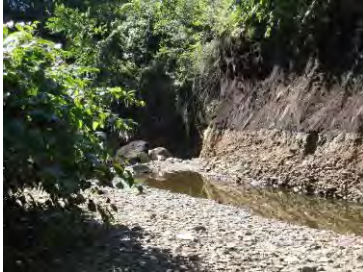
Soil types directly impact erodibility of streambanks. Here, an old fill pile, perhaps of ash from historical steel plants nearby has eroded into a high wall.

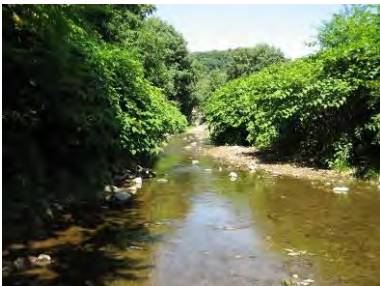
West Little Pine hosts an enormous amount of Japanese Knotweed, the invasive exotic plant that shades out native bushes that provide critical nutrient base to a healthy stream ecosystem.
