South Fayette Visual Watershed Assessment

August 2013

**South Fayette
Watersheds Visual Assessment**

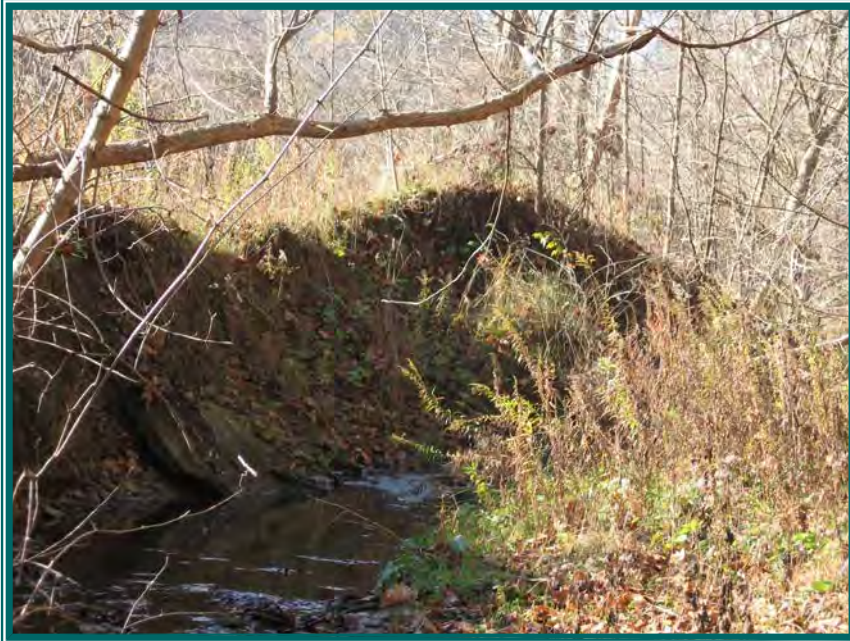
Area of stream bank erosion (CR-1 Photo 2)

Action Item CR-1.1: Streambank stabilization

Evaluate streambank stabilization methods, including gabion walls, live cribbing, dump rock, and vegetative plantings. In addition, evaluate the possibility of installing in-stream structures upstream to slow and re-direct water flow through the section.

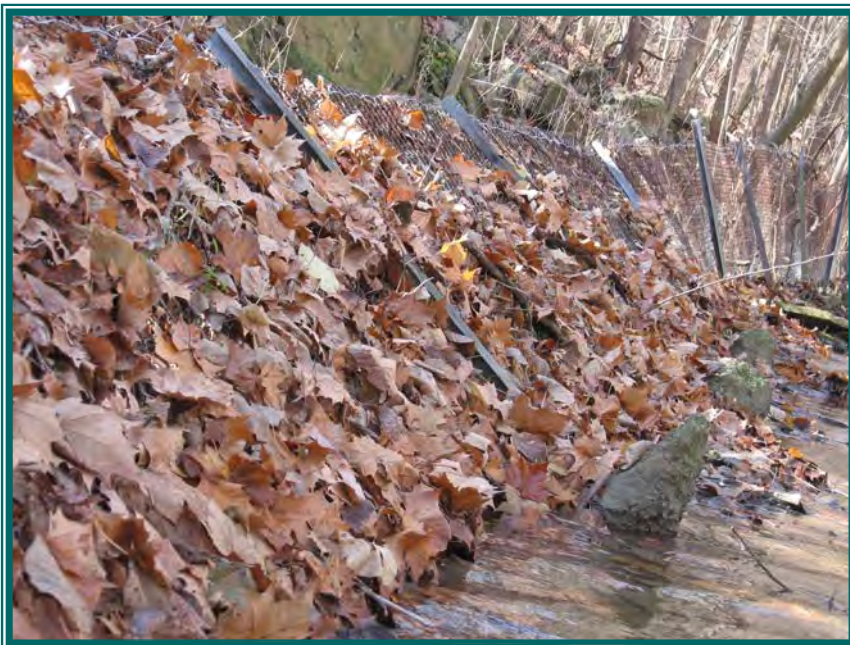
Failing fence (CR-1 Photo 5)

Action Item CR-1.2: Repair or replace fencing

Contact the landowner or persons responsible for the fencing along this section. Discuss possibility of replacing fencing with natural stabilizing techniques for increased longevity and context sensitivity. These techniques include placing gabion walls or cribbing along the fenced area. If fencing remains the only option, talk to the landowner about repairing or replacing the fencing.

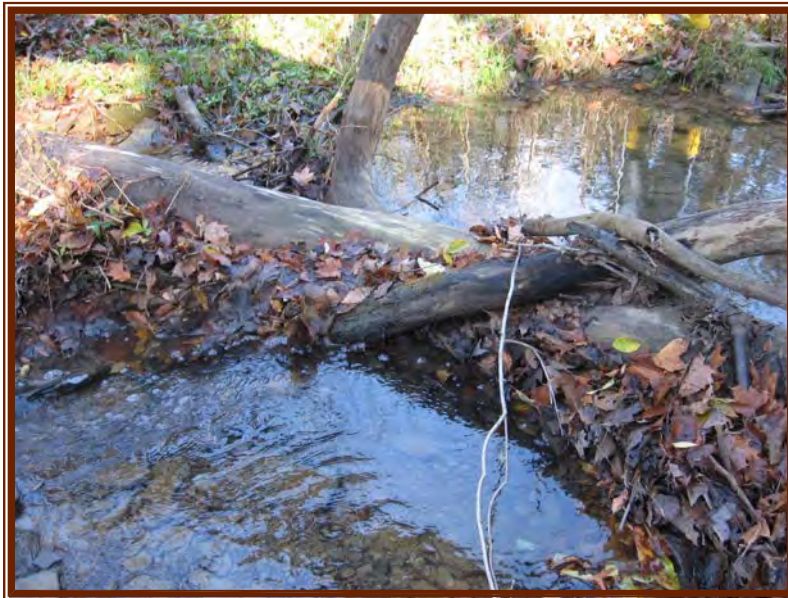
Natural log barrier to fish passage (CR-2 Photo 1)

Action Item CR-2.1: Investigate removal of barrier to fish passage

Although likely impeding the passage of fish upstream, this barrier is likely acting as an in-stream structure reducing the velocity of the flow through this reach. Investigate the possibility of removing or adjusting the structure to act more like a cross vane or j-hook.

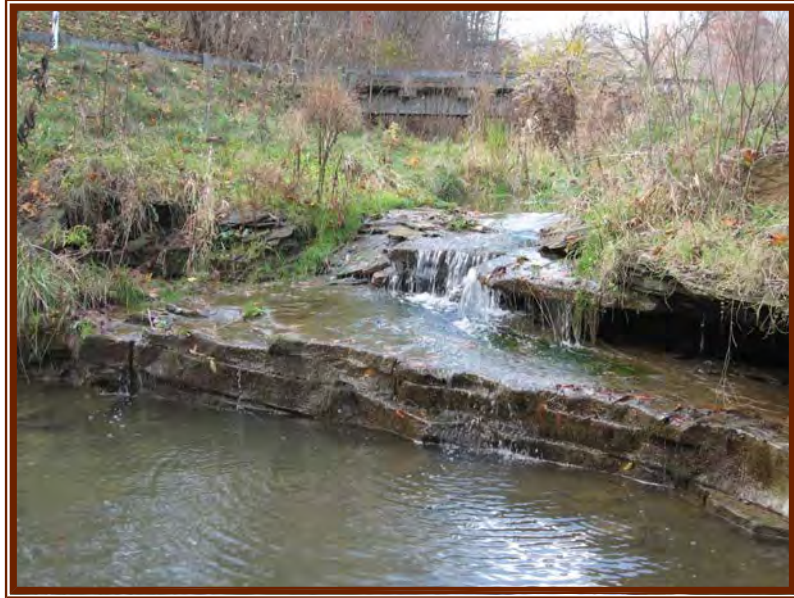
Concrete barrier (CR-3 Photo 15)

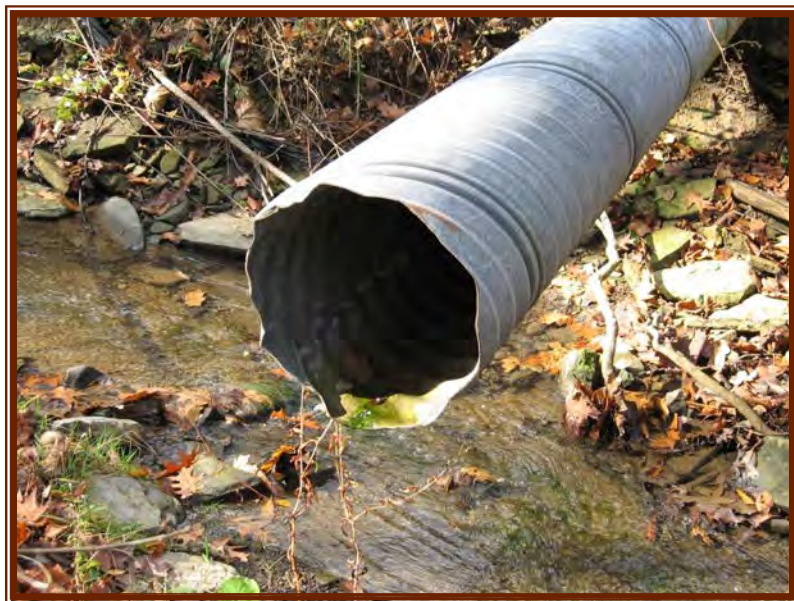
CMP Pipe outfall directly to Coal Run (CR-3 Photo 4)

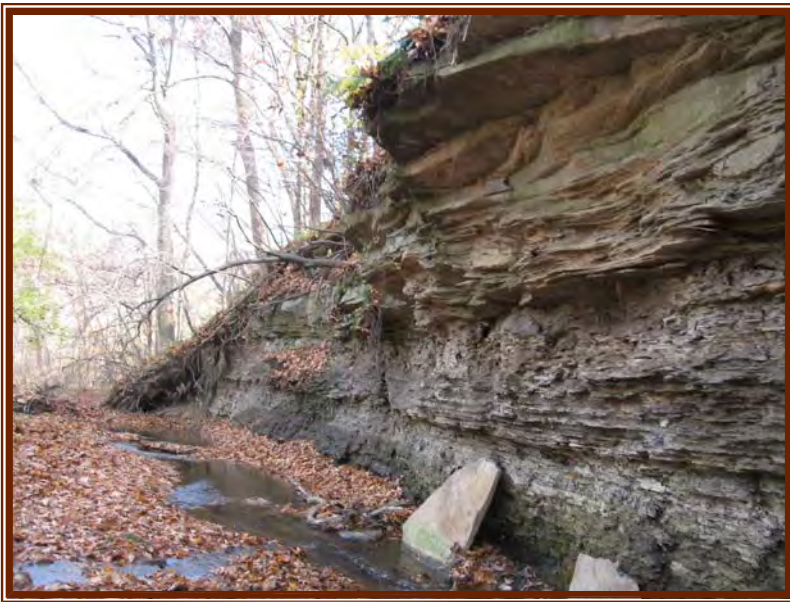
Severe bedrock erosion (CR-3 Photo 6)

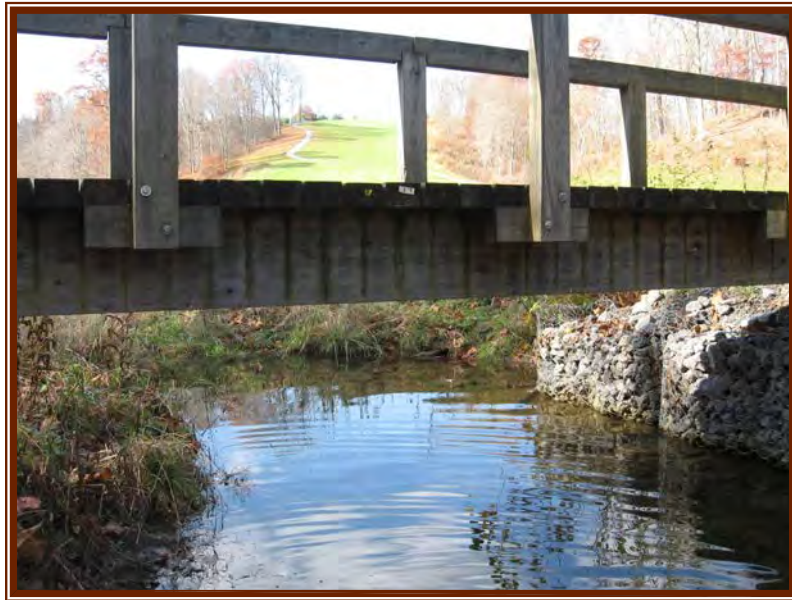
Mowed area adjacent to golf course in background (CR-3 Photo 21)

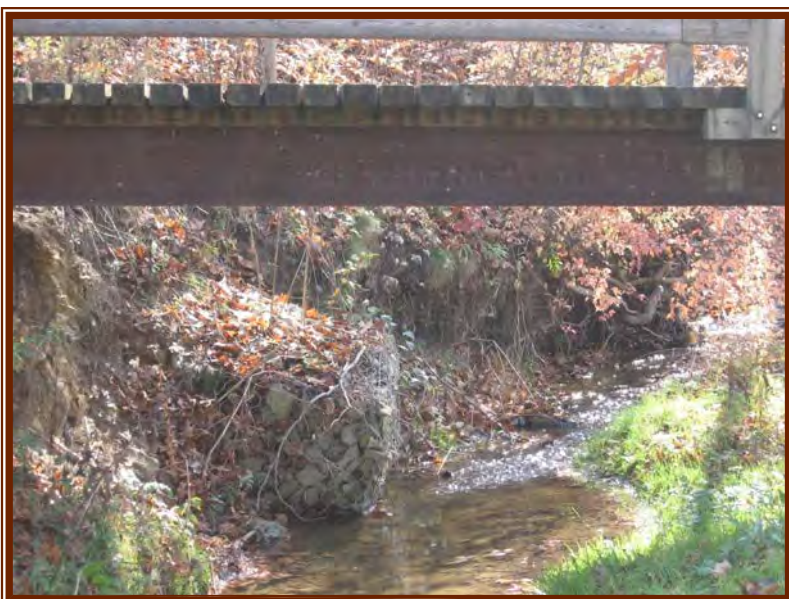
Golf Course Road Bridge; note failing gabion basket (CR-3 Photo 25)

Action Item CR-3.5: Repair failing gabion baskets under the golf course road bridge

Coordinate with the owner of the road/structure to repair the failing gabion baskets. Evaluate the feasibility of placing in-stream structures upstream to divert water flow away from gabions to reduce scouring and future damage.

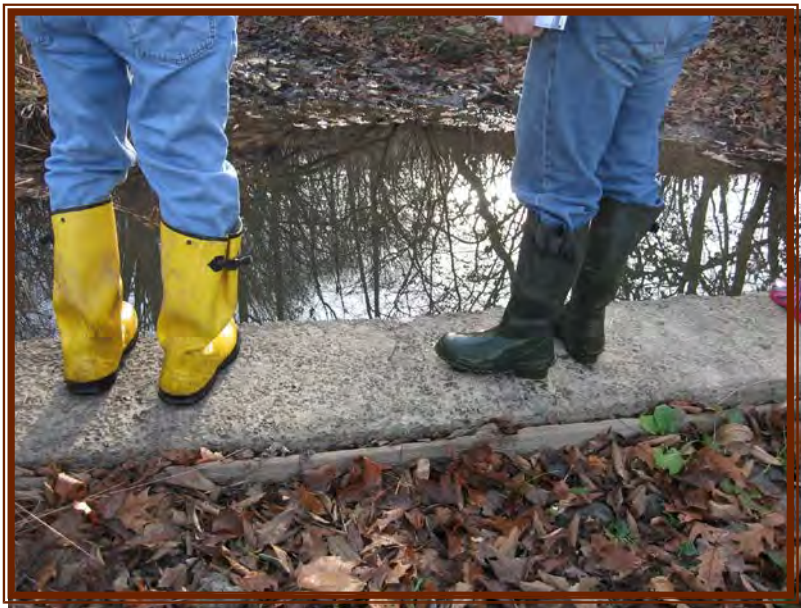
Concrete encased pipe (CR-4 Photo 2)

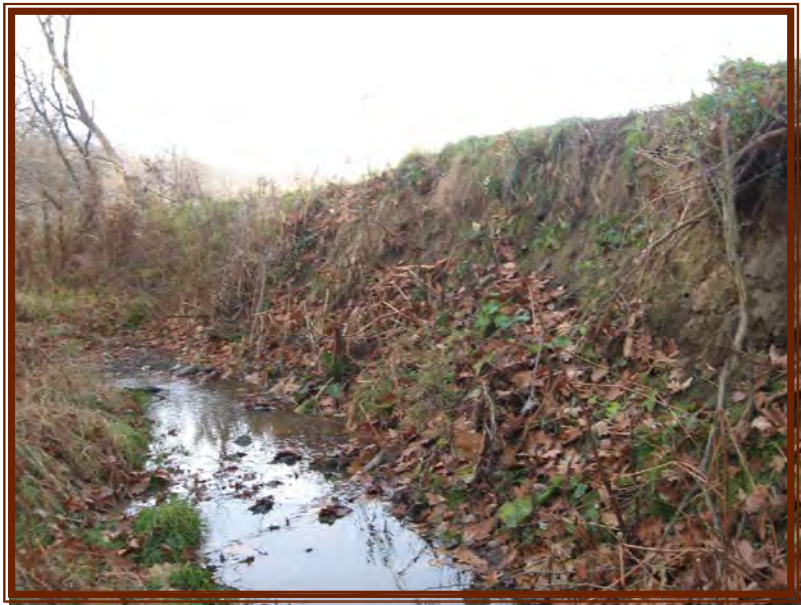
Severe cut; erosion (CR-4 Photo 5)

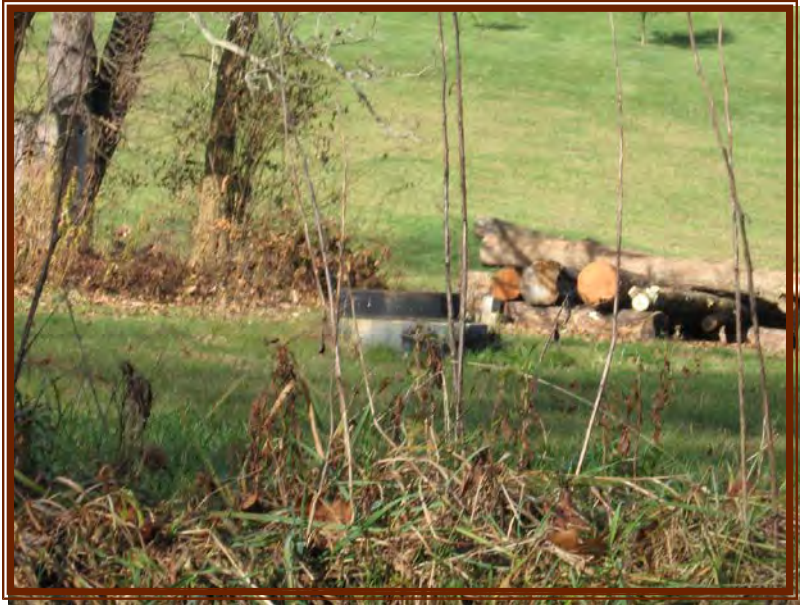
Mowed residential area (CR-5 Photo 2)

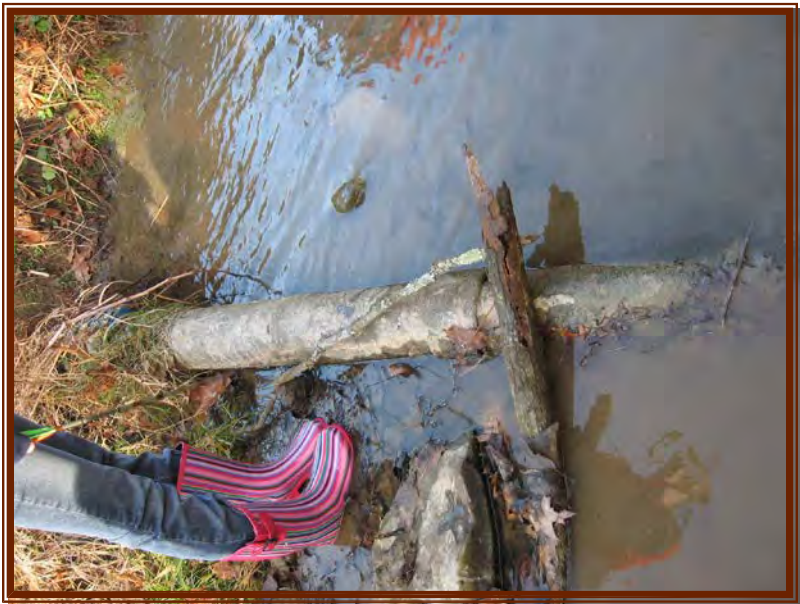
Sewer line crossing in stream (CR-5 Photo 1)

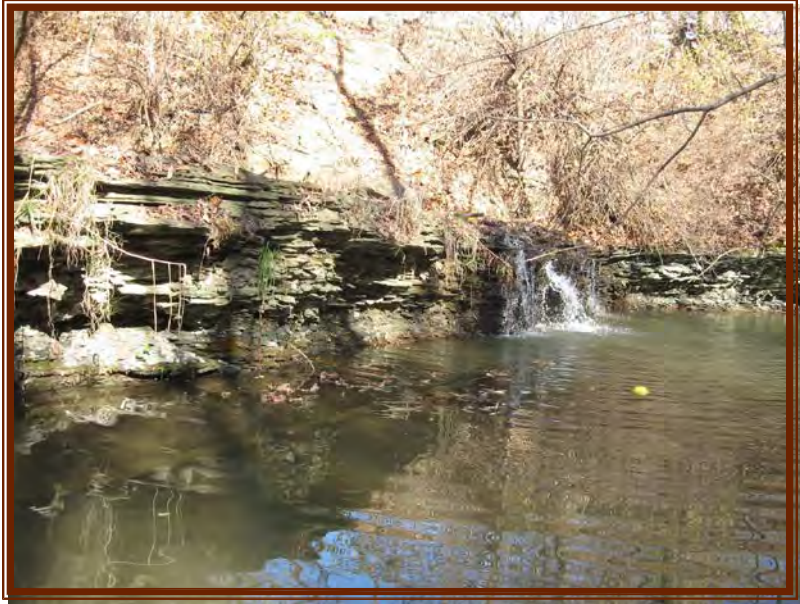
Natural stream bottom barrier (CR-6 Photo 2)

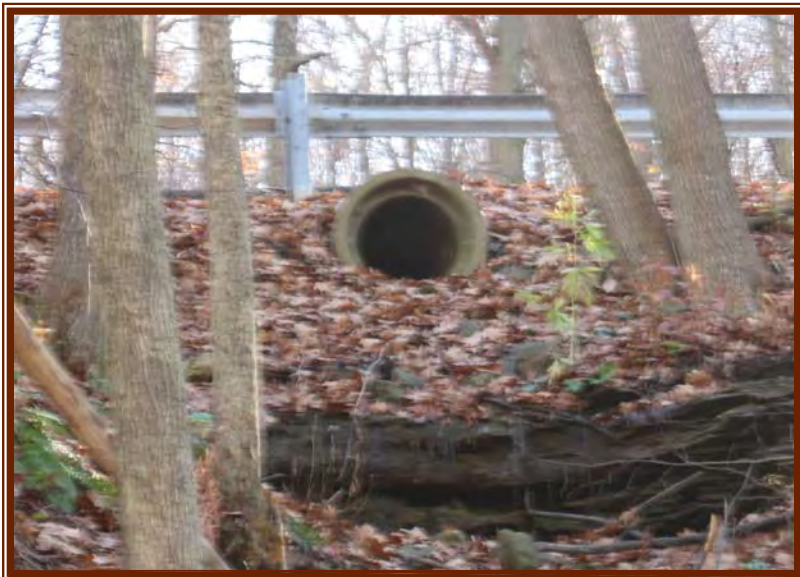
One of many pipe outfalls in this reach (CR-6 Photo 8)

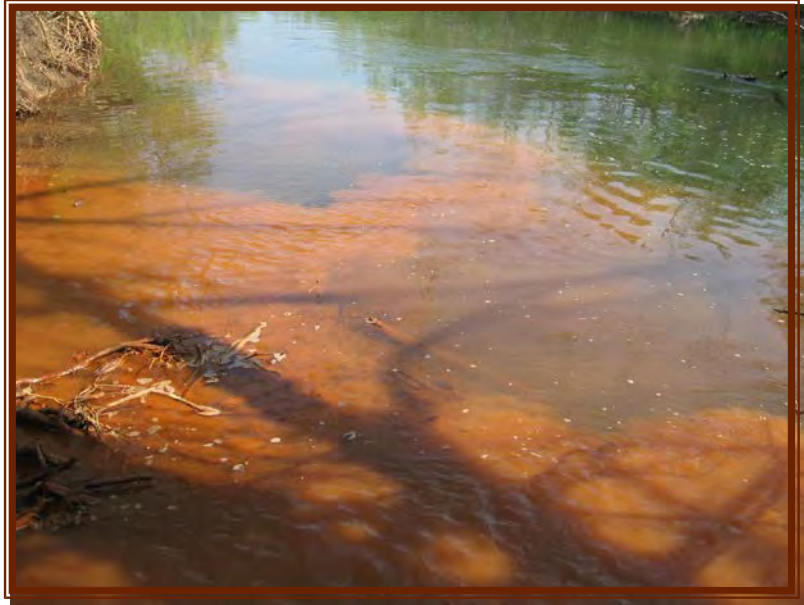
Confluence of Coal Run and Chartiers Creek; note AMD (CR-7 Photo 1)

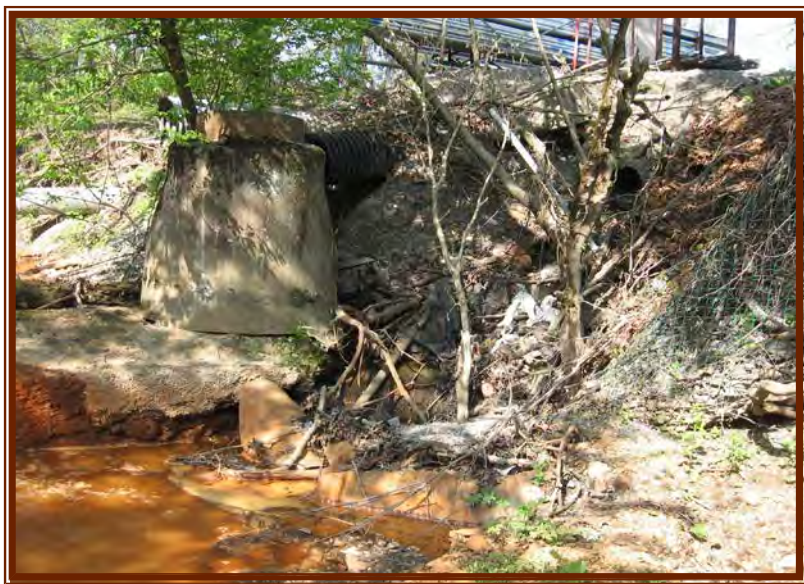
Severe erosion compromising bank stability and CSO System (CR-7 Photo 4)

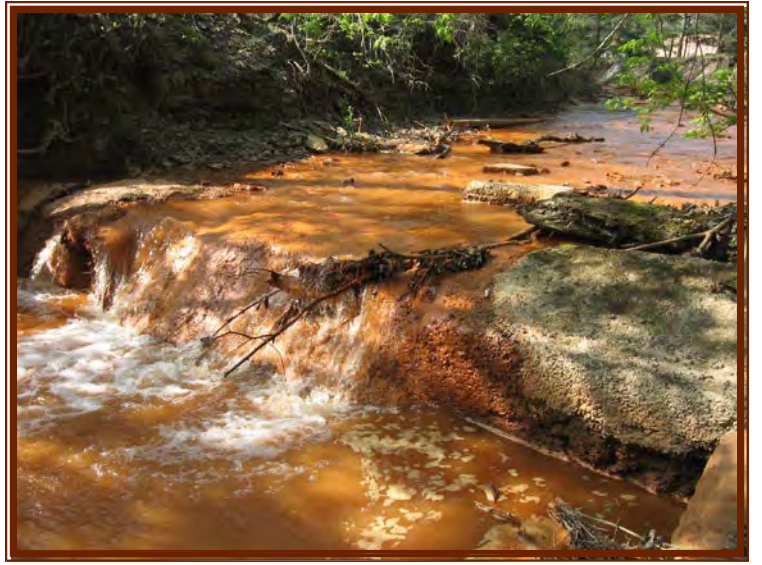
CSO pipe crossing; concrete encased causing barrier to fish passage (CR-7 Photo 5)

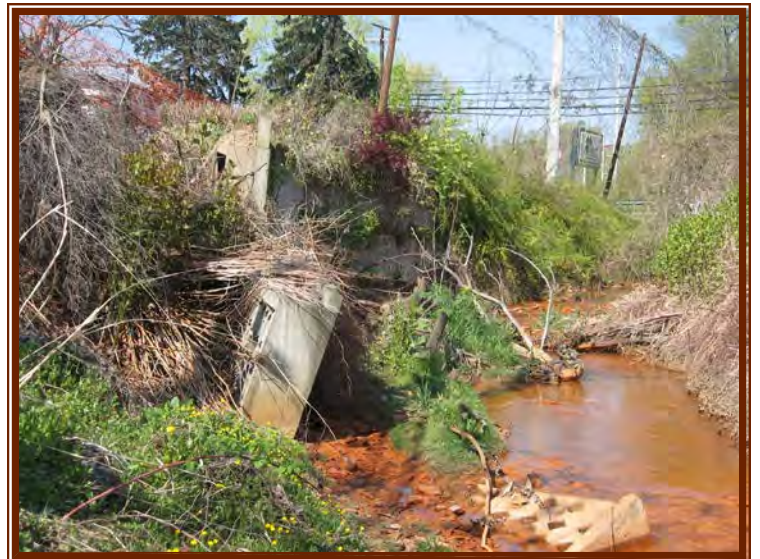
Collapsing retaining wall (CR-7 Photo 13)

Action Item CR-7.7: Repair the retaining wall along Coal Pit Run Road

Coordinate with the owner of the road/structure to repair the retaining wall. Evaluate the feasibility of placing in-stream structures upstream to divert water flow away from gabions to reduce scouring and future damage.

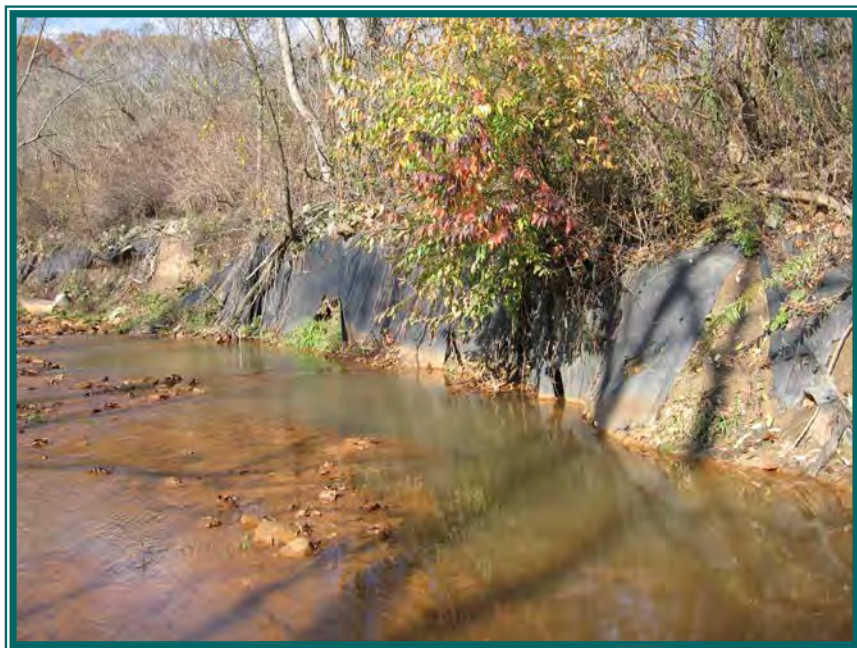
Area of stream bank erosion (MR-2 Photo 2)

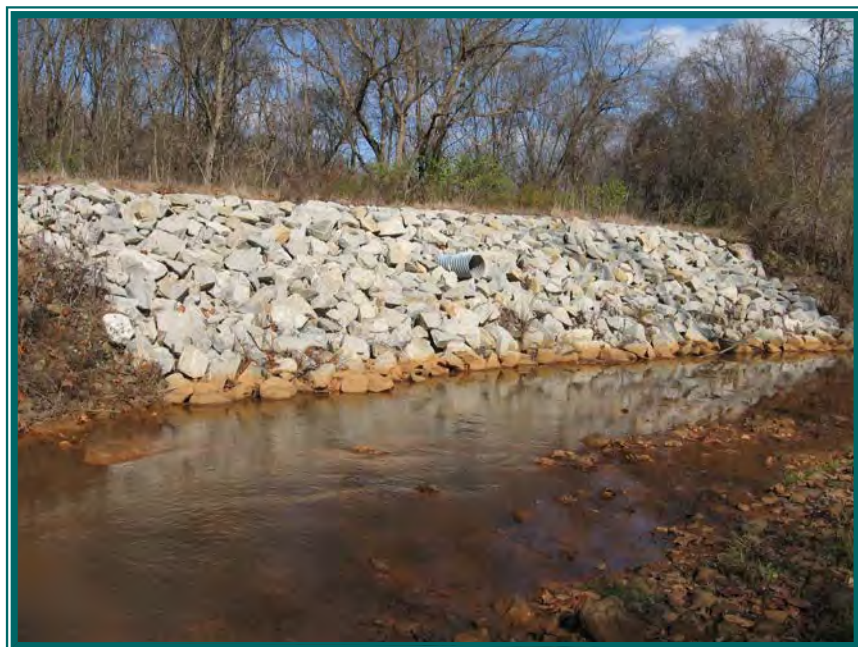
Rip rap and AMD staining (MR-2 Photo 3)

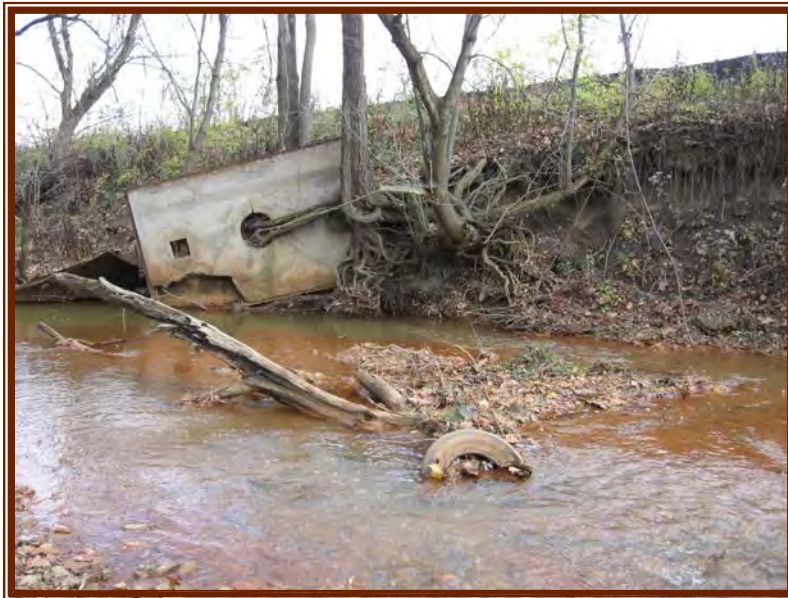
Debris jam (MR-3 Photo 6)

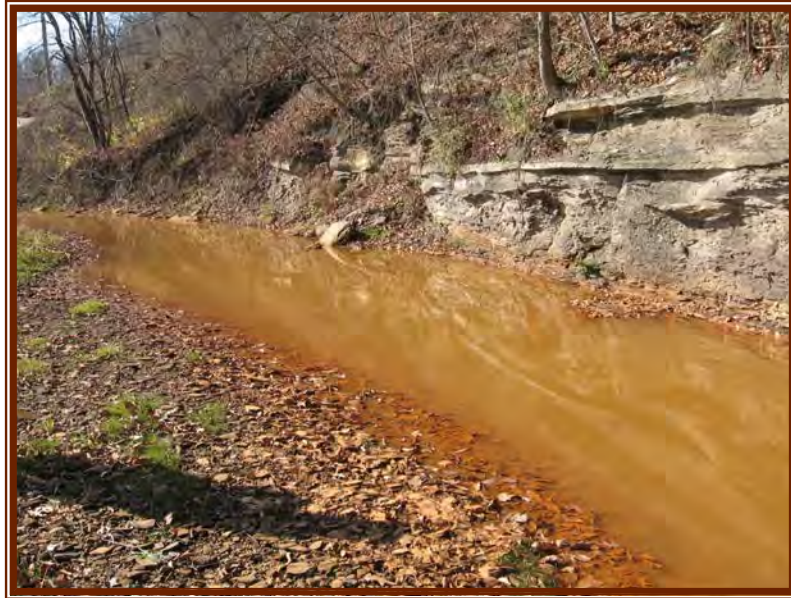
Deeply channeled (MR-4 Photo 10)

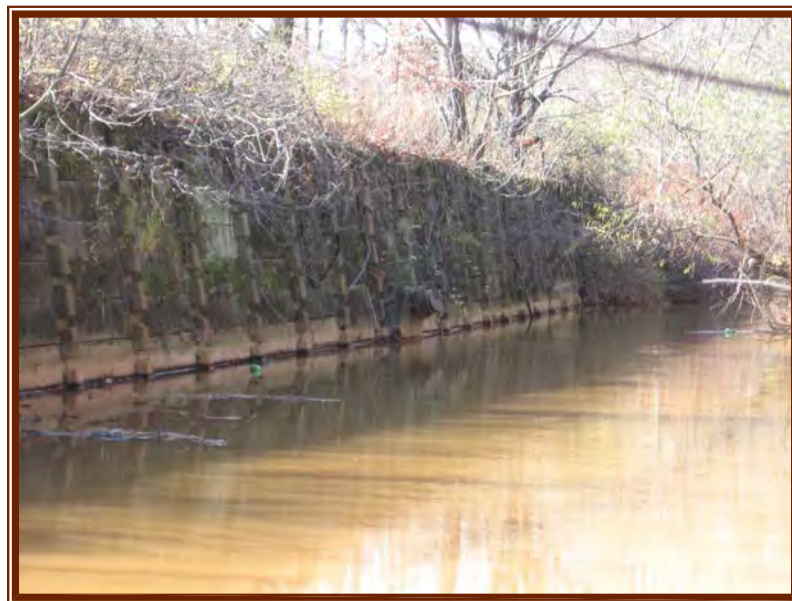
Retaining walls (MR-4 Photo 4)

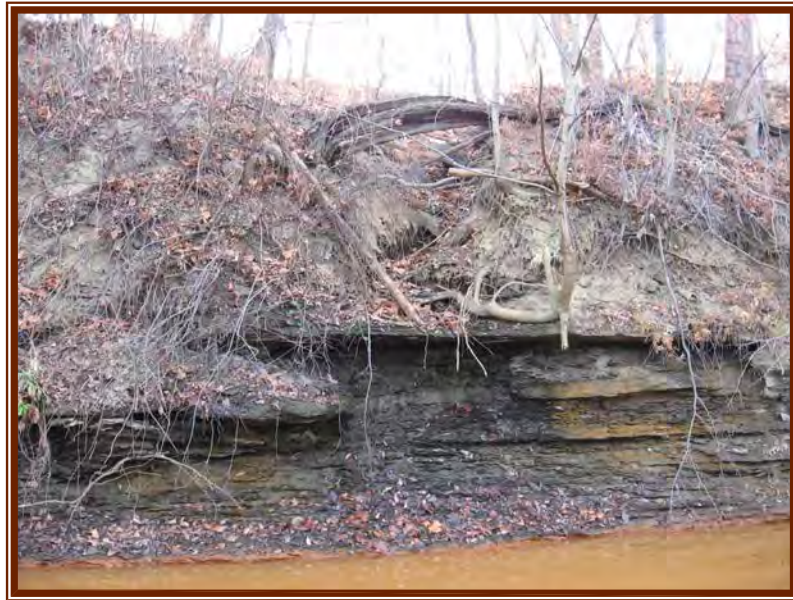
Steep banks/Incised channel (MR-5 Photo 7)

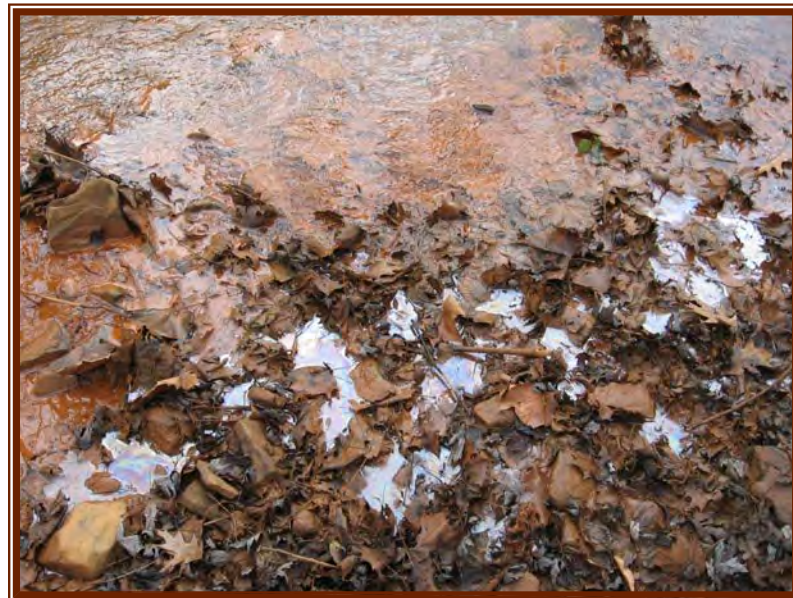
Biological sheen from AMD (MR-5 Photo 8)

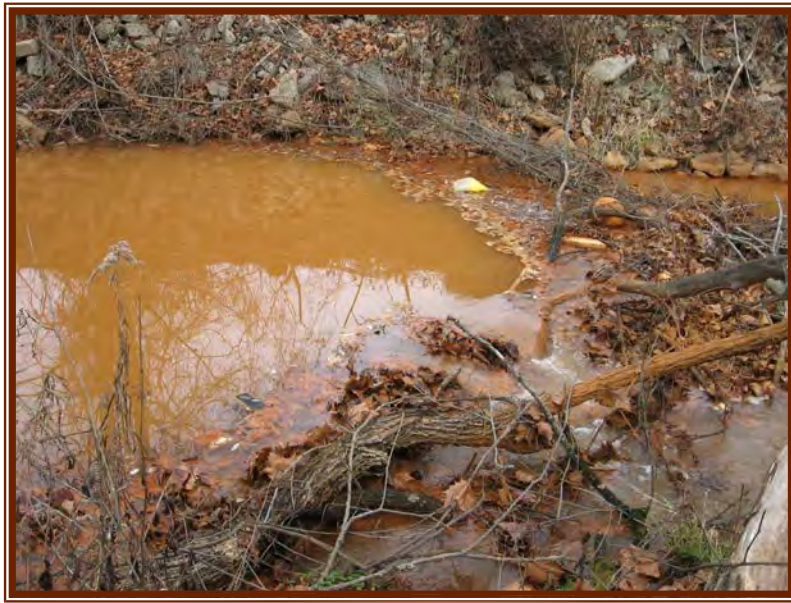
Deep pools (MR-6 Photo 23)

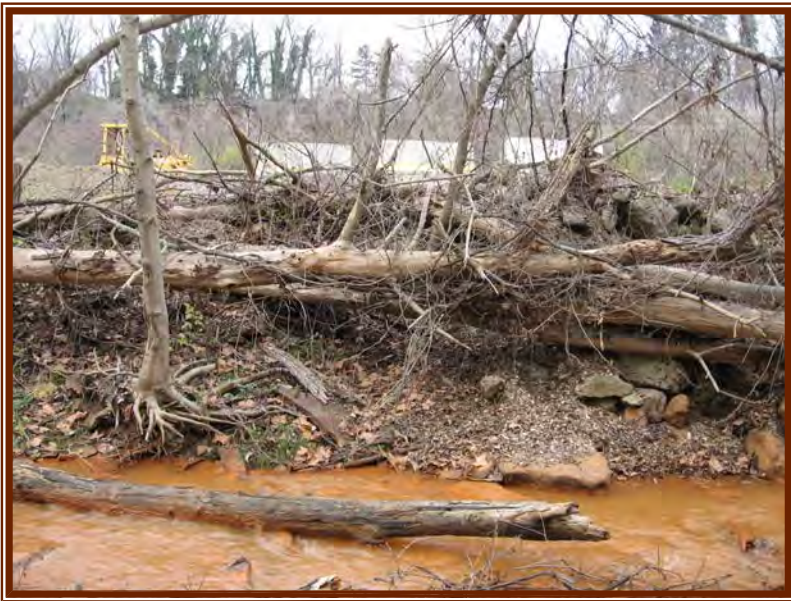
Obstructions (MR-6 Photo 25)

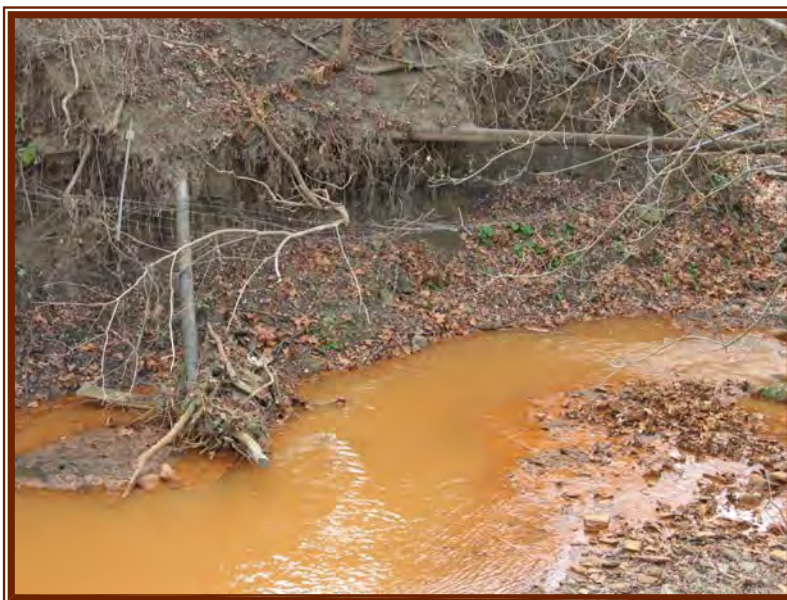
Severe Erosion (MR-6 Photo 16)

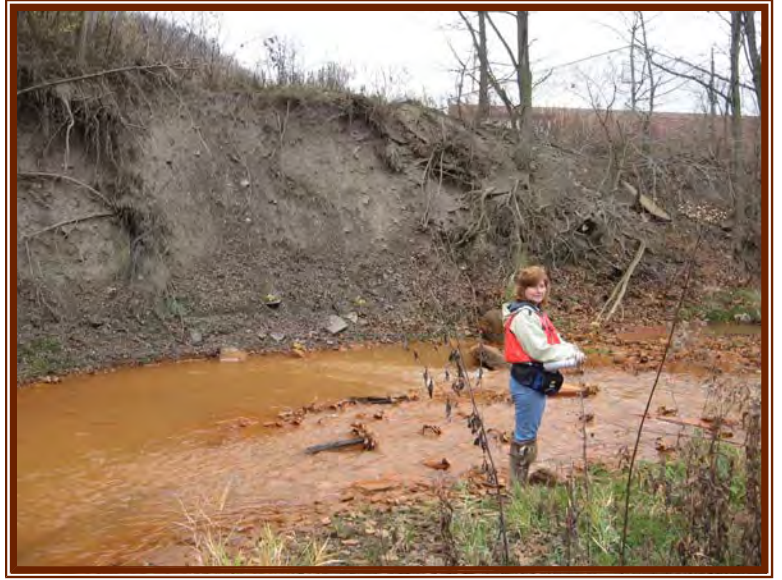
Severe Erosion (MR-7 Photo 6)

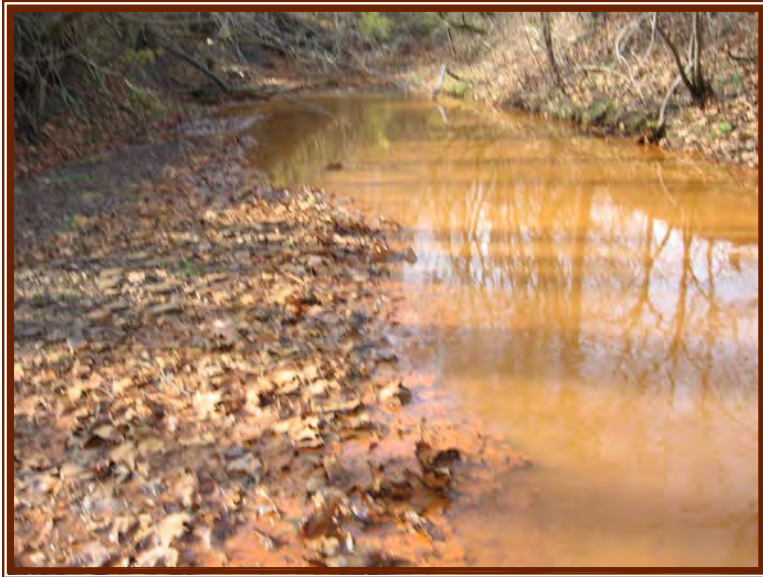
Sediment Deposition (MR-6 Photo 14)

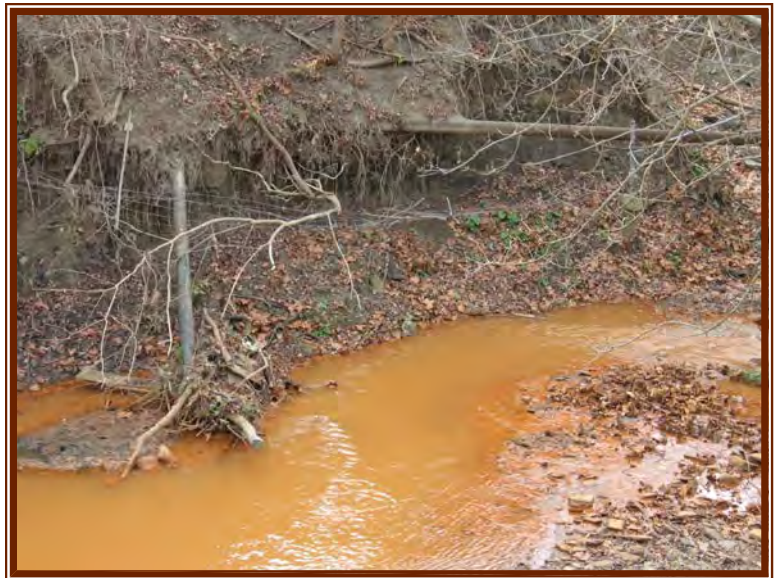
Exposed Pipes (MR-6 Photo 16)

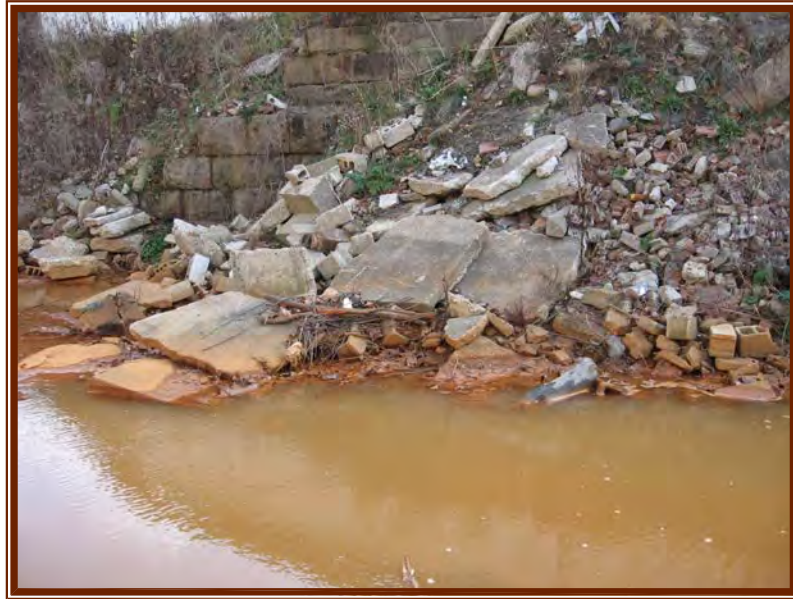
Unstable banks (MR-8 Photo 10)

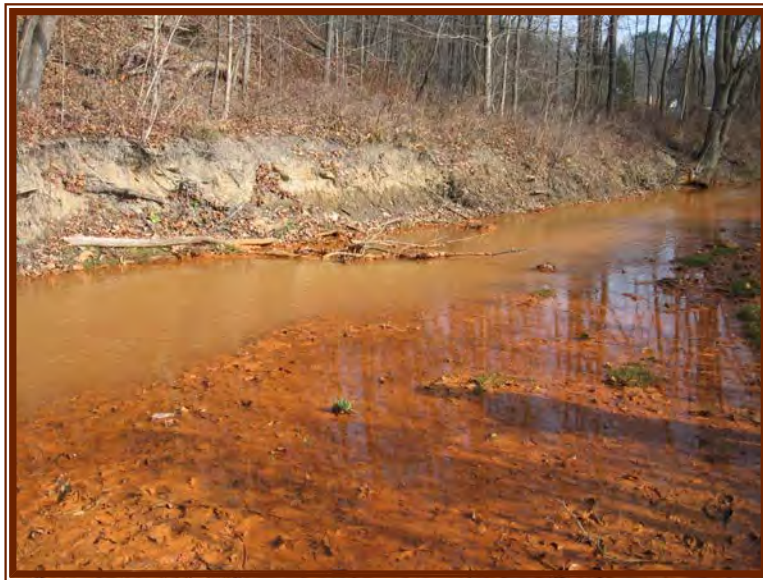
Deposition (MR-9 Photo 3)

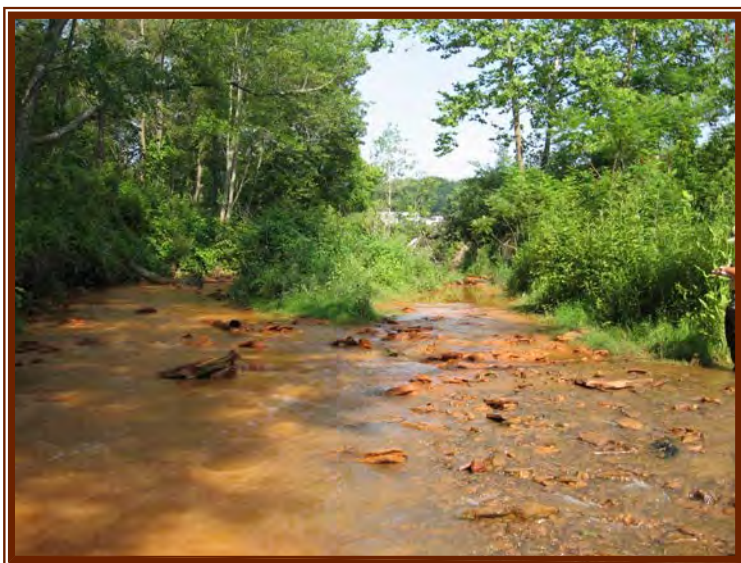
Dolphin Run entering (MR-12 Photo 7)

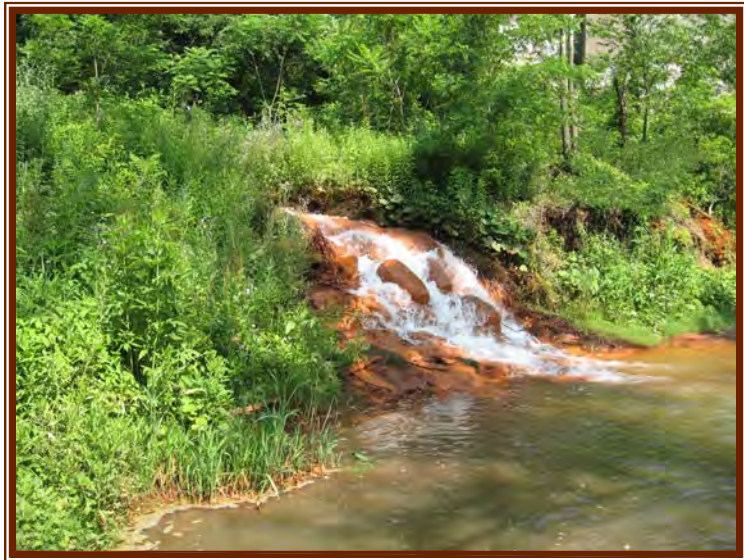
Gladden discharge (MR-12 Photo 15)

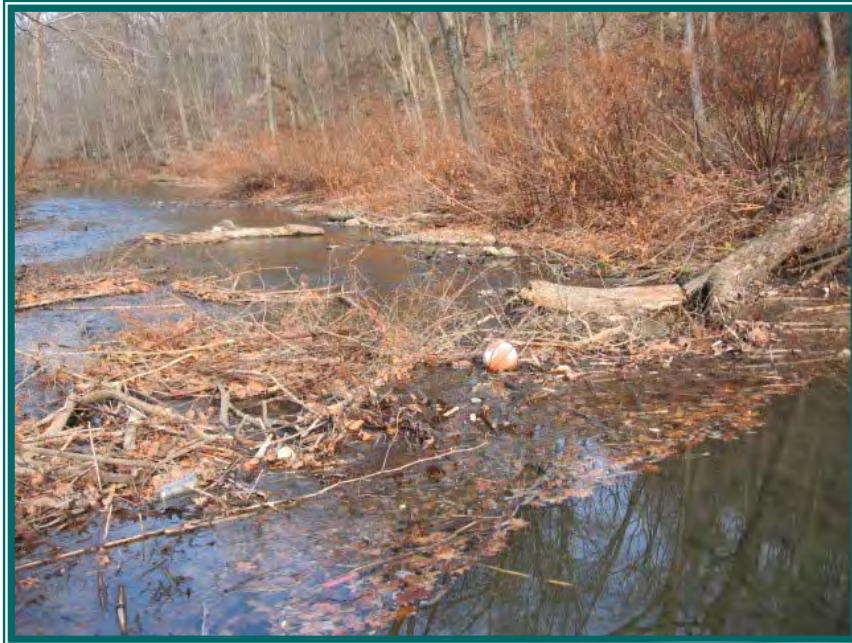
Natural dam (RR-1 Photo 2)

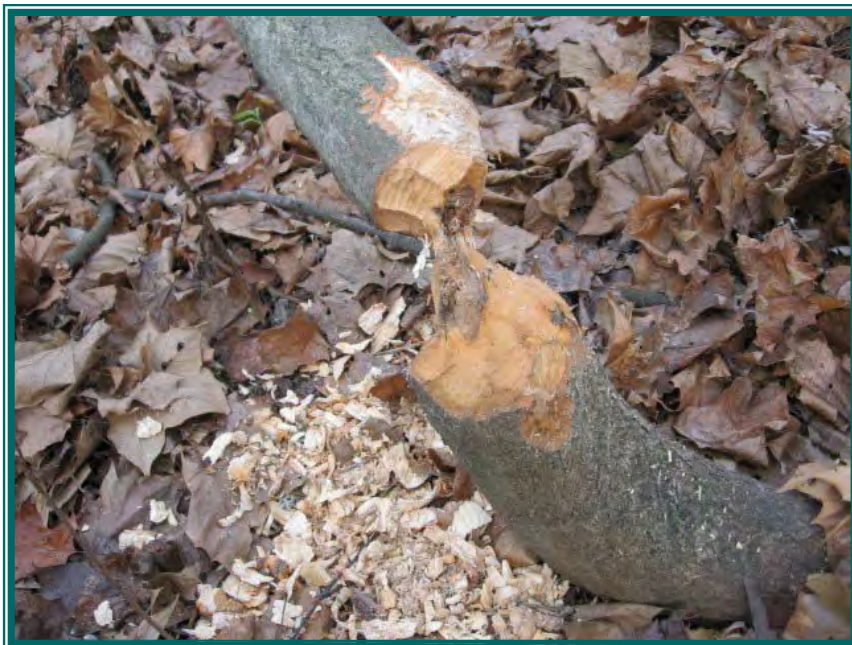
Beaver problem (RR-1 Photo 7)

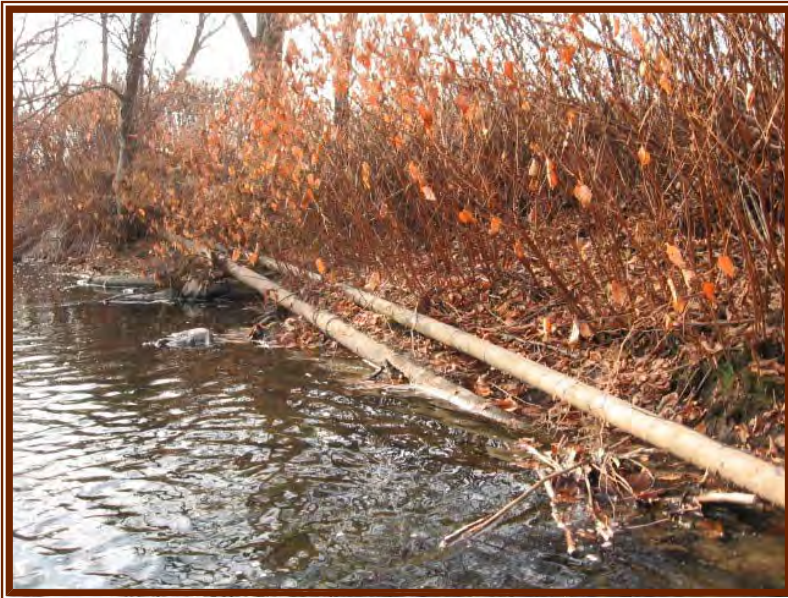
Broken Pipes (RR-2 Photo 1)

Action Item RR-2/3.1: Investigate broken and abandoned pipes

Coordinate with local water and sewer authorities to determine ownership of abandoned and/or cracked pipes in this reach. Discuss possibilities to repair or remove pipes.

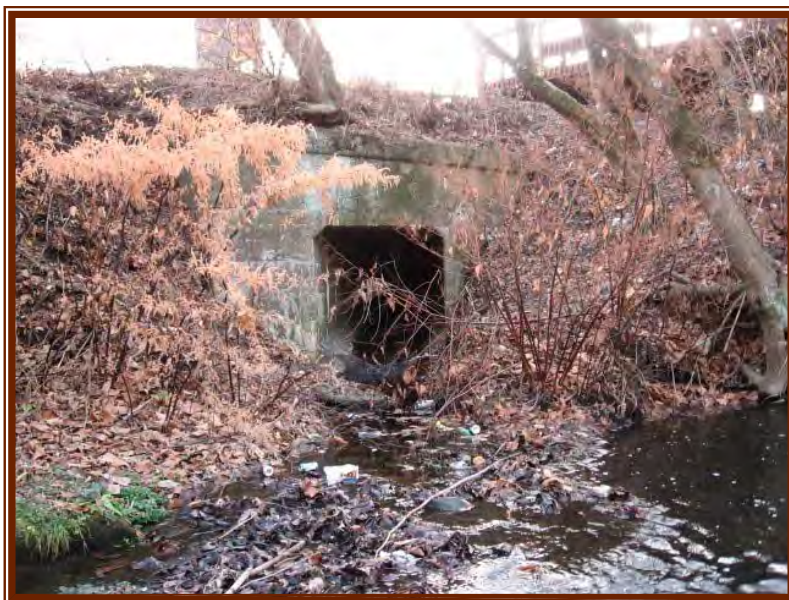
Artificial Tributary (RR-3 Photo 2)

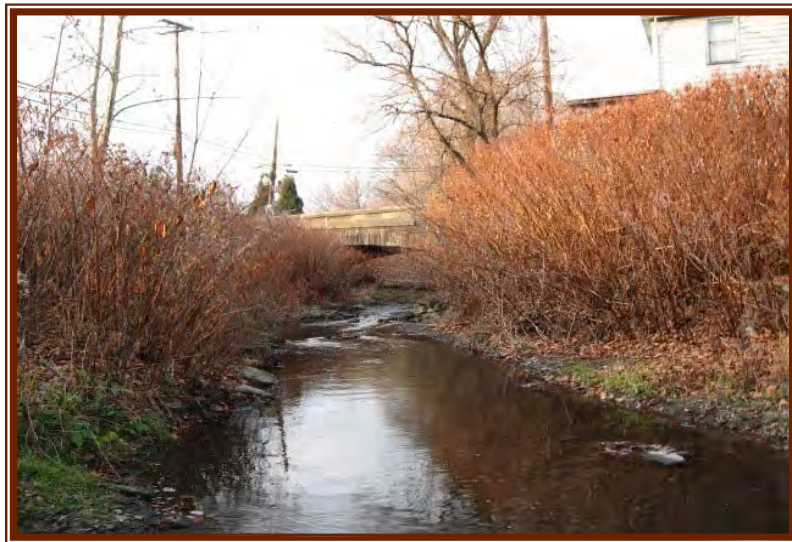
Japanese Knotweed prevalence (RR-3 Photo 3)

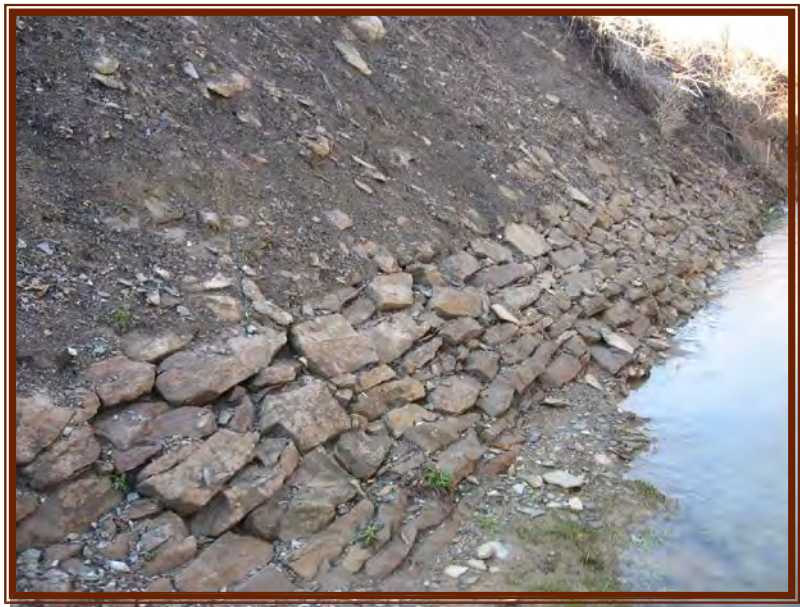
Trail stabilization (RR-4 Photo 2)

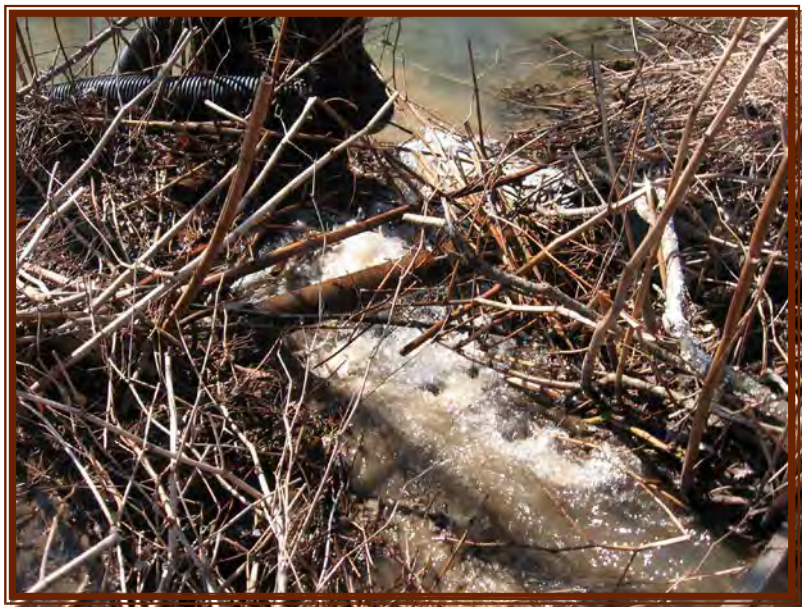
Mine discharge (RR-4 Photo 5)

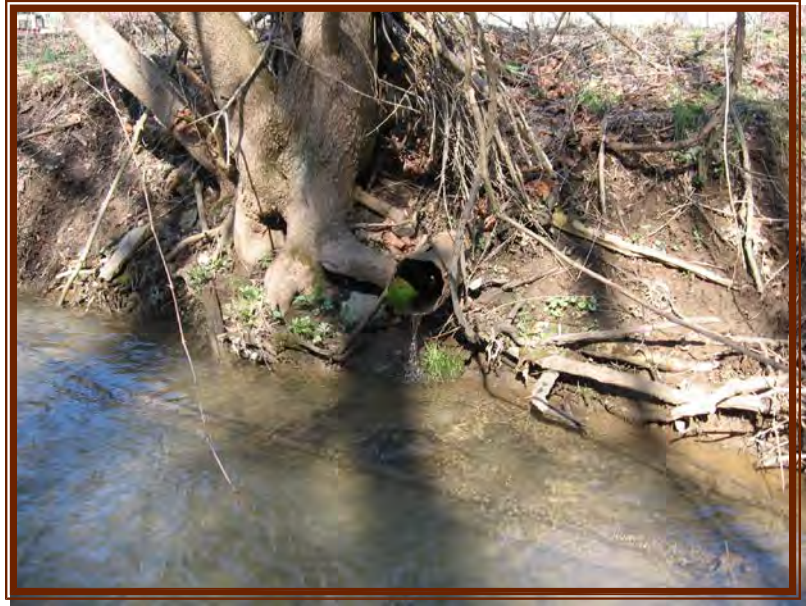
One of many outfalls in reaches (RR-5 Photo 3)

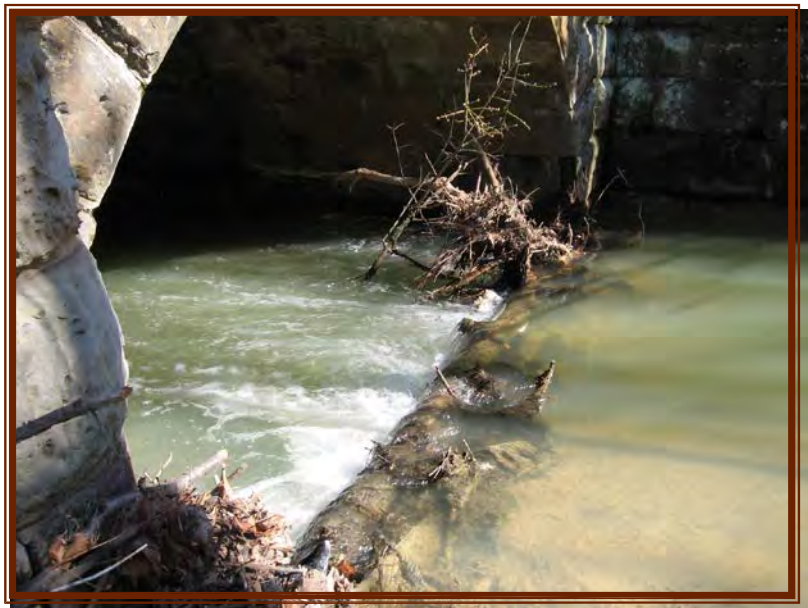
Fish barrier (RR-5 Photo 7)

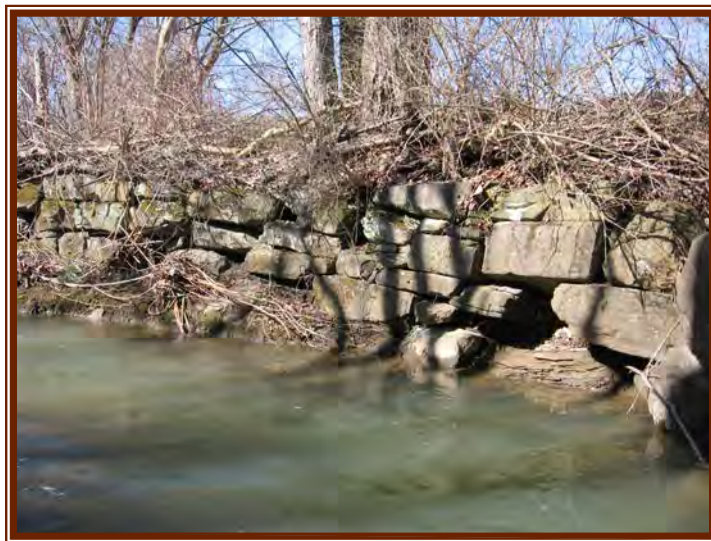
Retaining wall in poor condition (RR-5 Photo 5)

Action Item RR-5/6.4 Repair or replace stone retaining wall

Contact the landowner or persons responsible for the retaining wall within this section. Discuss possibility of repairing the existing wall or replacing with natural stabilization techniques for increased longevity and context sensitivity. These techniques include placing gabion walls or cribbing to encourage natural drainage and vegetation establishment.

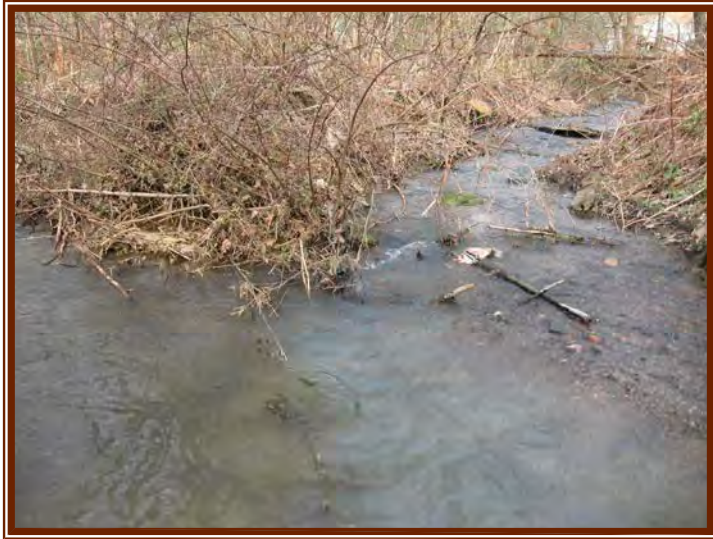
Tributary with cloudy flow (RR-8 Photo 1)
