South Fayette Visual Watershed Assessment

August 2013

**South Fayette
Watersheds Visual Assessment**

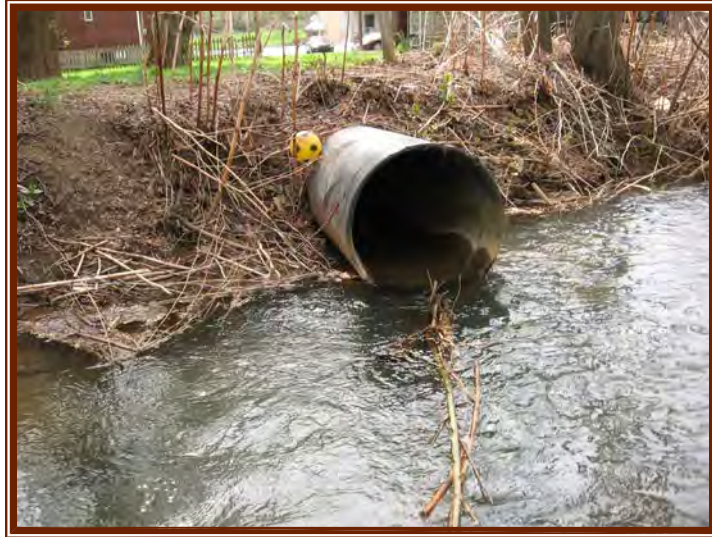
One of many outfalls (RR-8 Photo 3)

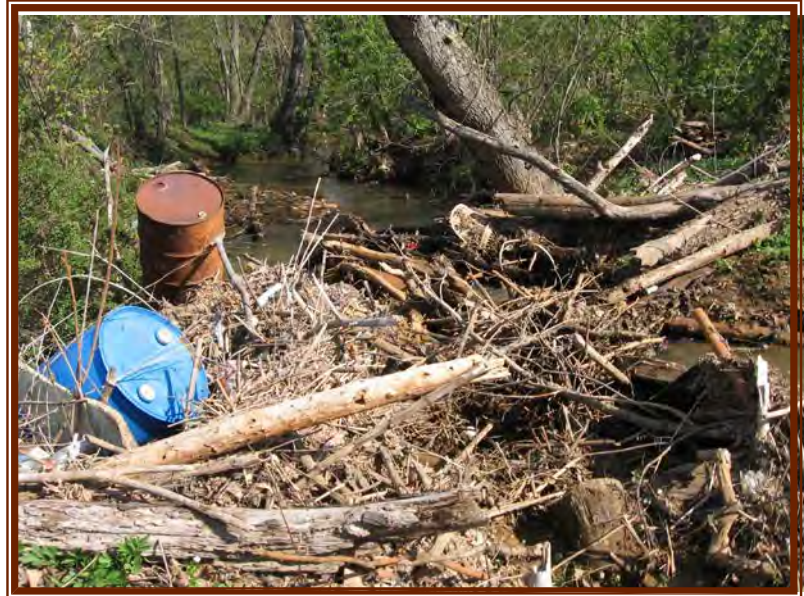
Major obstruction (RR-9 Photo 3)

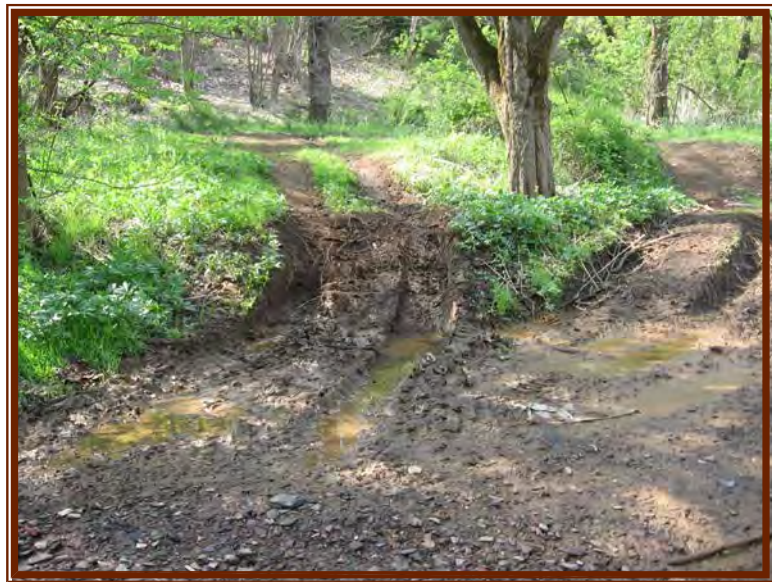
Quad damage (RR-9 Photo 6)

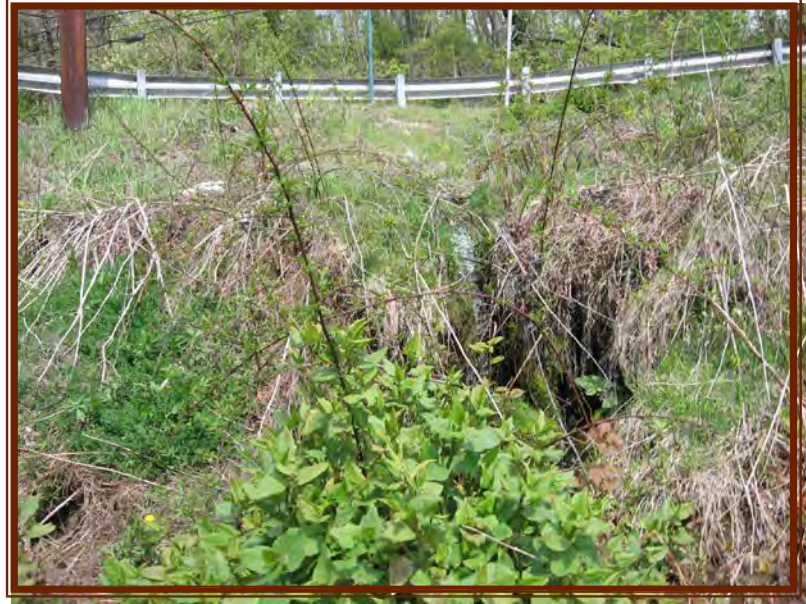
AMD flow (RR-10 Photo 4)

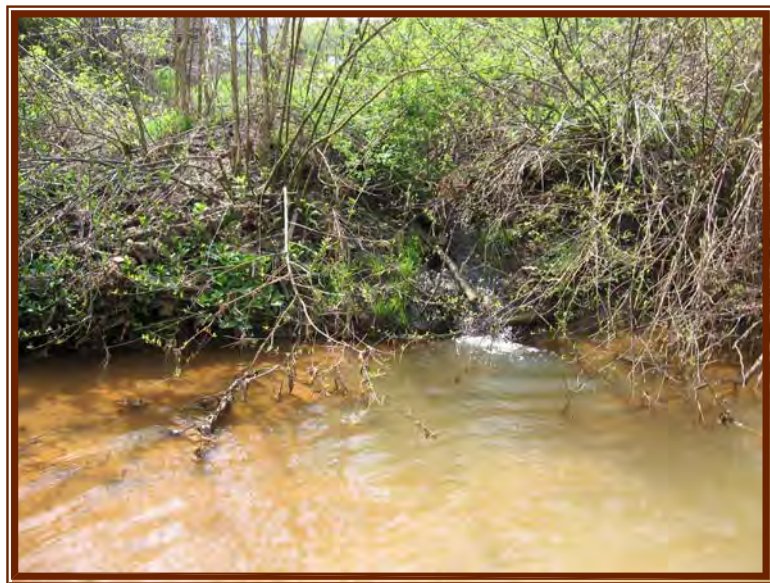
Drainage (RR-10 Photo 6)
