East Branch Tionesta Creek

COLDWATER CONSERVATION PLAN

McKean, Warren, and Elk Counties

May 2017

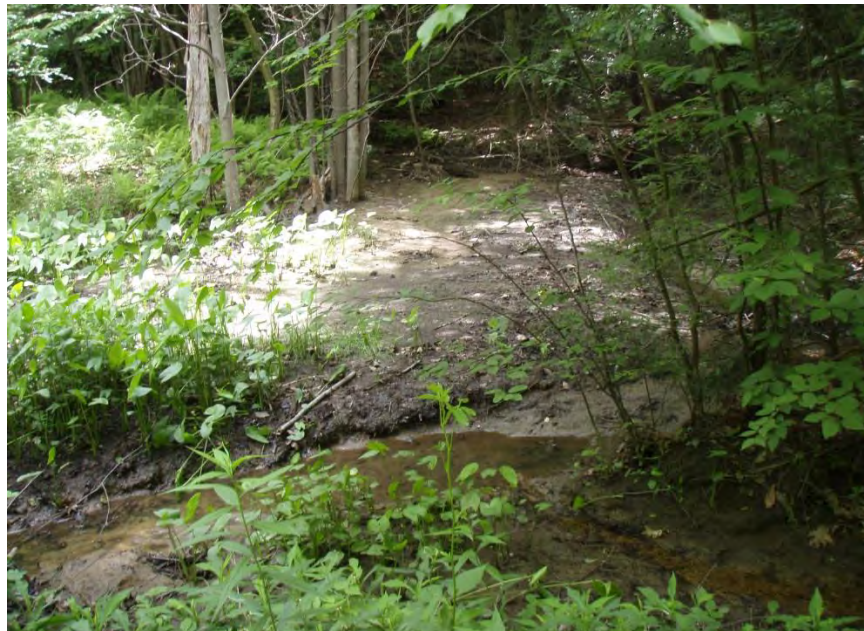
6114: Sediment slug upstream of entrance to channelized/underground section of stream.

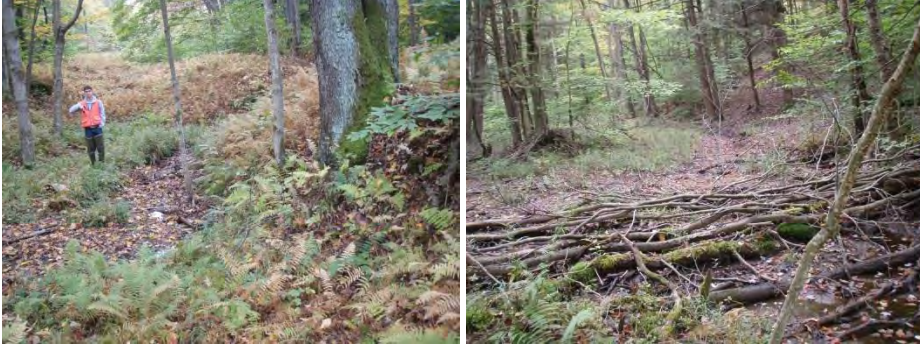
5964: Historic logging railroad (left) impacted original course of stream, potentially leading to seasonal connection through floodplain wetland and sediment (right).

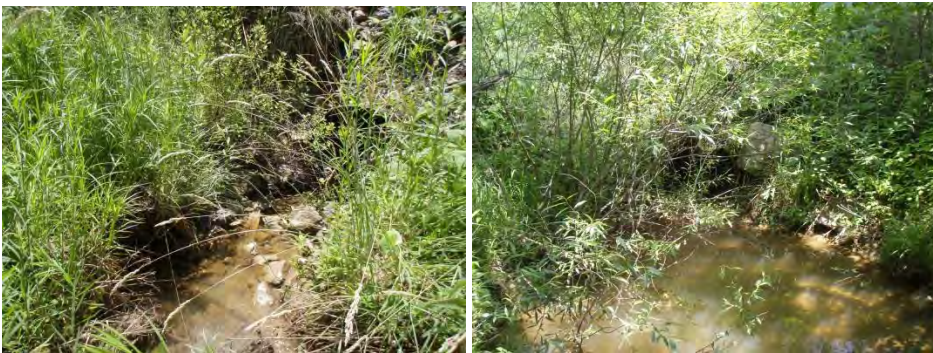
5965: Undersized culvert inlet (left) and outlet with scour pool (right).

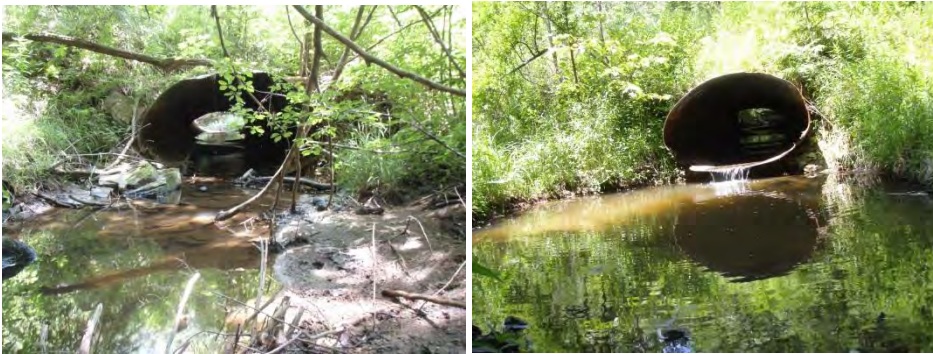
5966: Culvert inlet (left) and perched outlet (right) with scour pool.

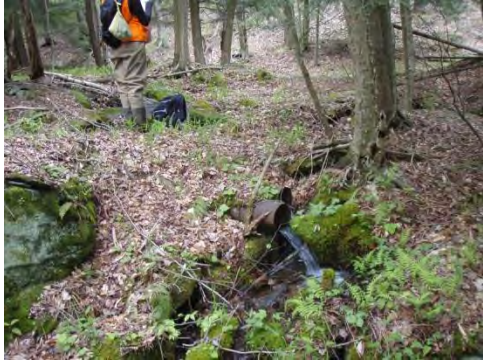
5978: Perched culvert outlet, 1 of 3 channels on this UNT at this inactive pipeline crossing.

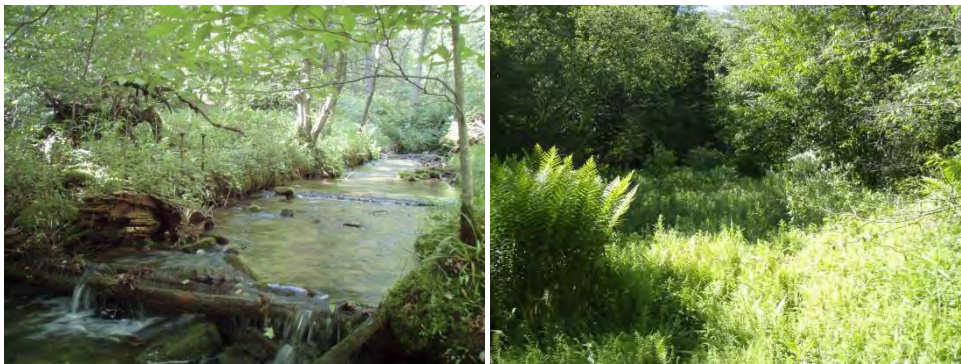
6033: A relic mill dam (breached, left photo) and aggraded sediment upstream from it (right) forced the stream to flow subterranean.

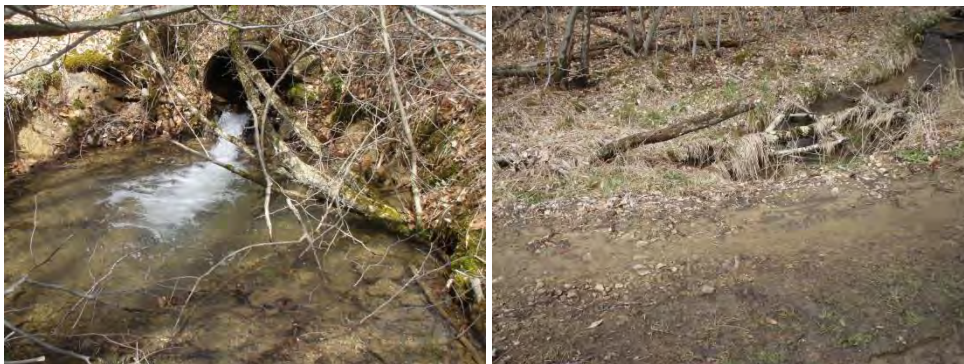
6041: Several undersized/perched culverts for multiple sinuous DGR crossings. Outlet on the left and clogged inlet on the right.

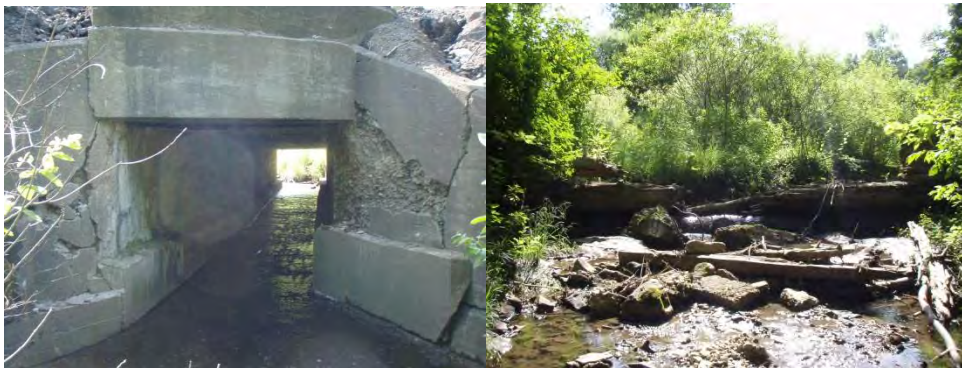
6099: Undersized box culvert under State Route 66 (left); old, breached dam (right).

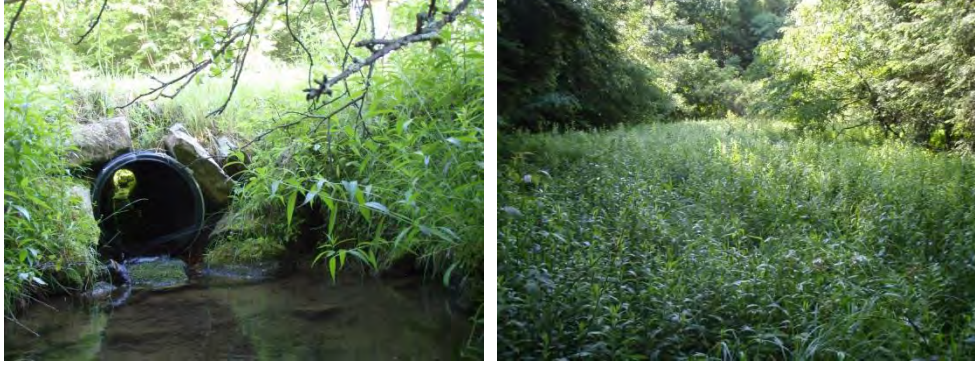
6110: Undersized culvert at West Kane Road (left); sedimented basin of relic log pond (right).

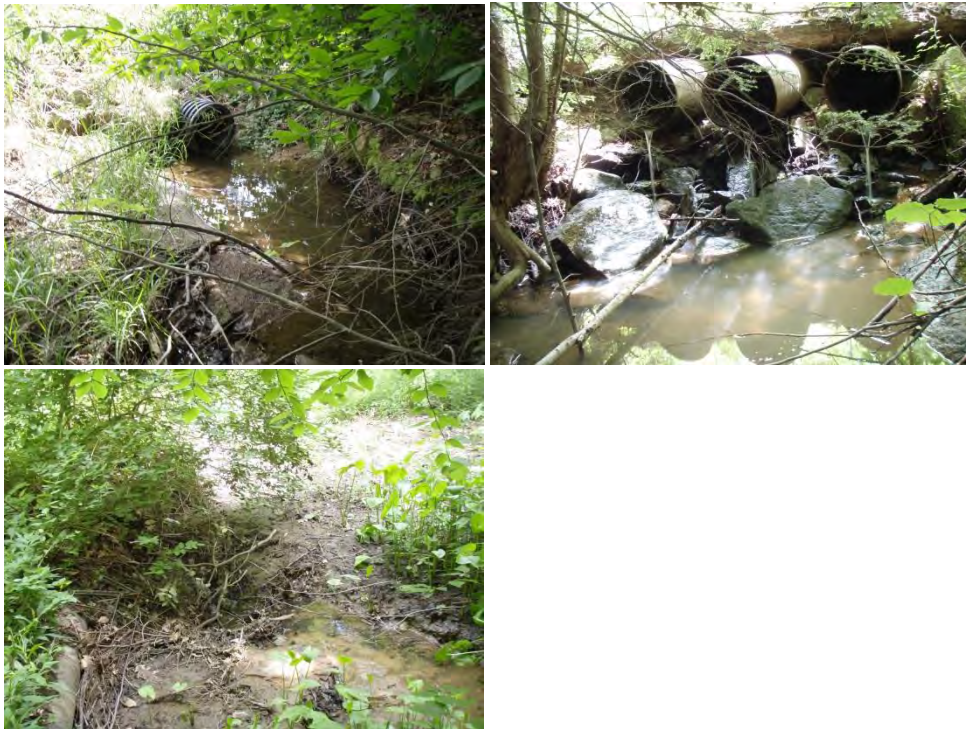
6114: Clockwise from bottom left: Inlet to underground section; outlet of undersized culvert on Pennsylvania Avenue, three undersized pipes on private gas road crossing.

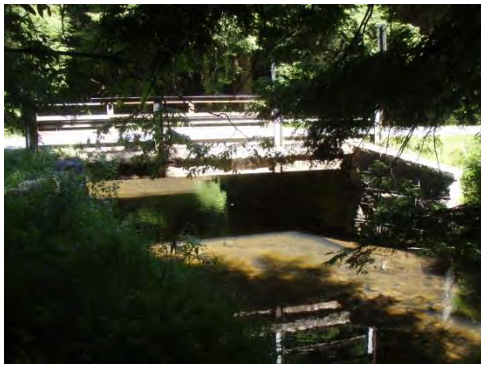
6141: Potential AOP barrier due to narrowness and lack of floodplain beneath bridge.

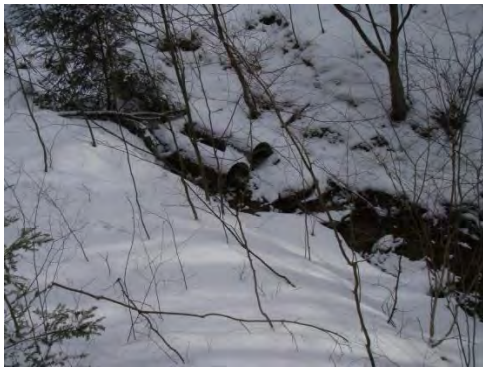
7202: Two dilapidated culverts on a gasline right of way.
