SANDY LICK CREEK HEADWATERS COLDWATER CONSERVATION PLAN

Spring 2015

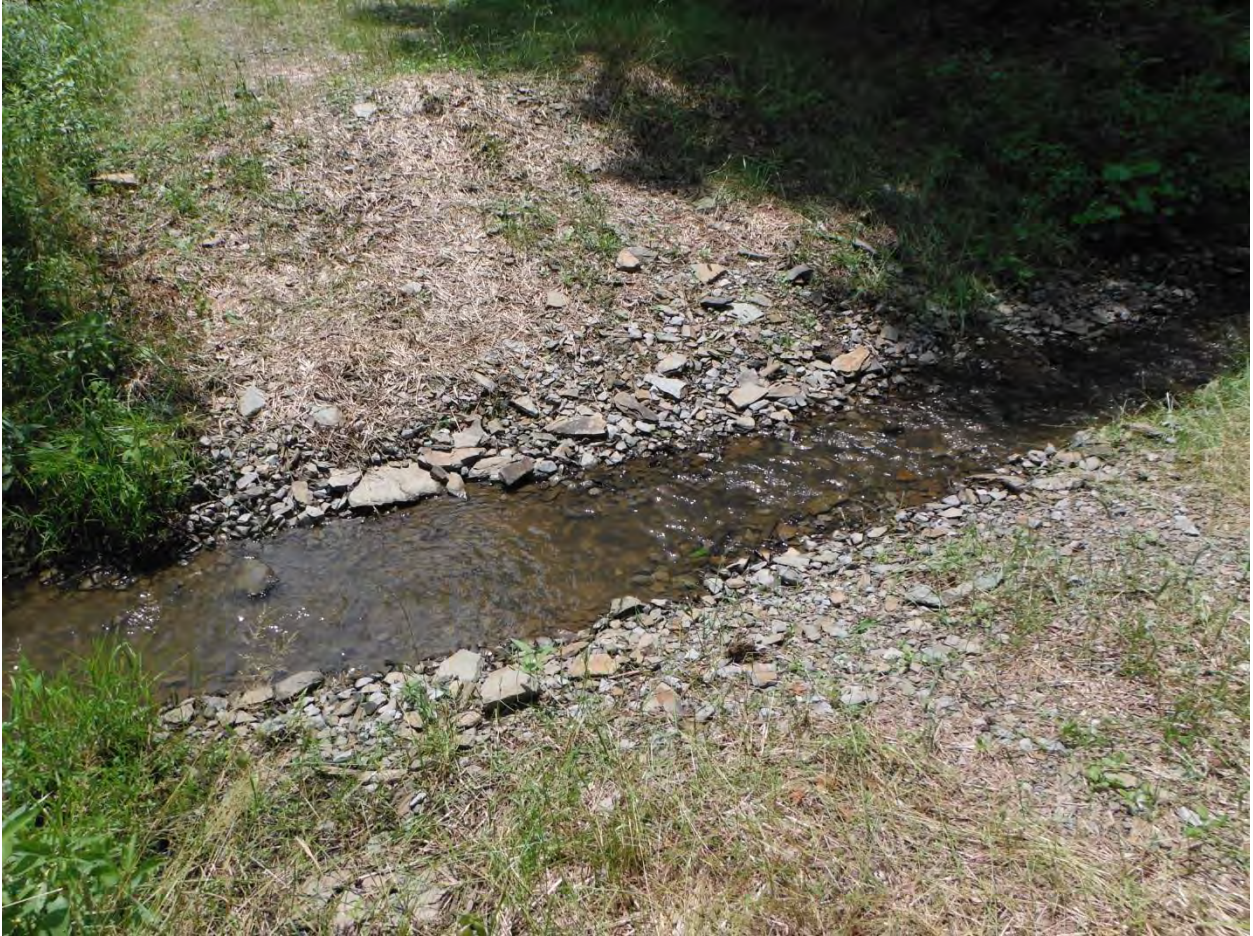
Sandy Lick passes over dirt road on surface at site SL5.

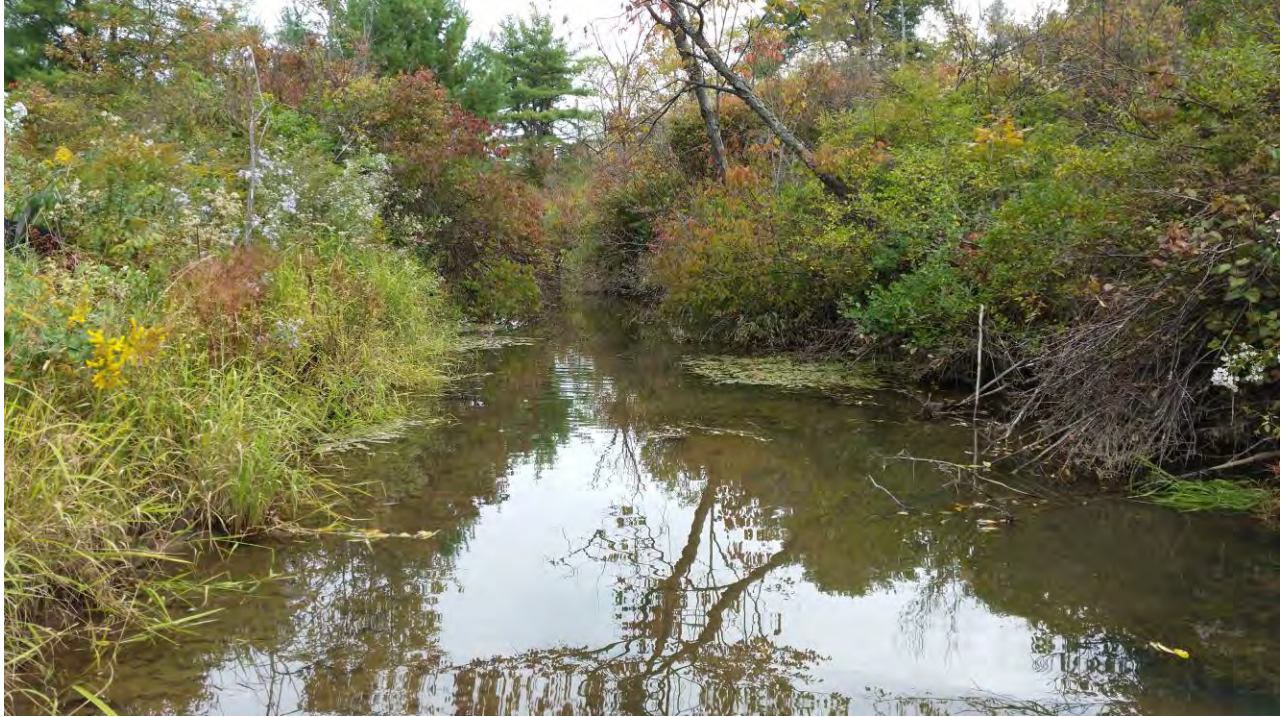
Figure D-1: SL1 looking upstream from SR 255 Bridge

Sample site SL1 is upstream of the SR 255 Bridge which is upstream of Sabula Lake. This site was influenced by the impounded water at Sabula Lake during each sampling event. Flow was almost always very slow and the water was deeper than one would expect for the size of stream. This site was specifically chosen for its location just upstream of the lake to determine how much of an influence the impoundment has on the Sandy Lick Creek headwaters.

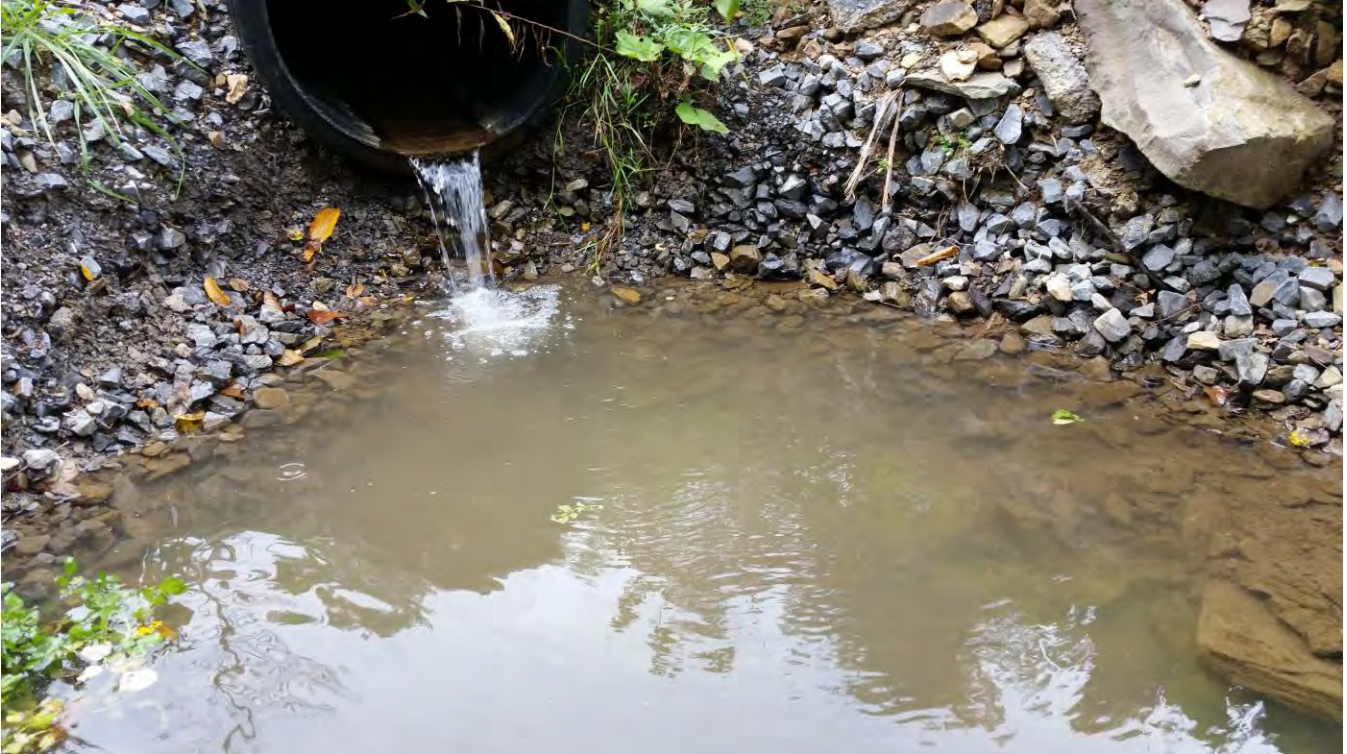
Figure D-5: Culvert at SL4

There are five road crossings on the headwaters of the Sandy Lick Creek. Of these, two are bridges while the remaining three are culverts. The bridges are located where SR255 crosses the Sandy Lick just upstream of Sabula Lake and where Paul Short Road crosses the Sandy Lick. Both bridges appear to be constructed in a manner that does not visually appear to hamper fish passage. The culvert installed where UNT #3 crosses Mountain Run Road is severely perched and impedes aquatic organism passage. The downstream end of the culvert sits two feet above the top of bank and causes a waterfall into a small pool.

As detailed in the results below, there were brook trout discovered upstream of the culvert but not downstream. There was however one occasion during the water sample collection that a single native brook trout was discovered below the culvert. Due to water levels and the height of the culvert from the pool, it was not able to go upstream or downstream. Given the results of the fishery survey, it is believed that this trout was swept through the culvert from the upstream population.

1. A more in depth culvert inventory and aquatic organism passage study should be conducted on the culverts in the watershed. The culvert on the unnamed tributary #3 is the primary area of concern as it prevents fish passage freely through this tributary. Efforts should be made to work with Sandy Township to pursue proper replacement of this culvert.

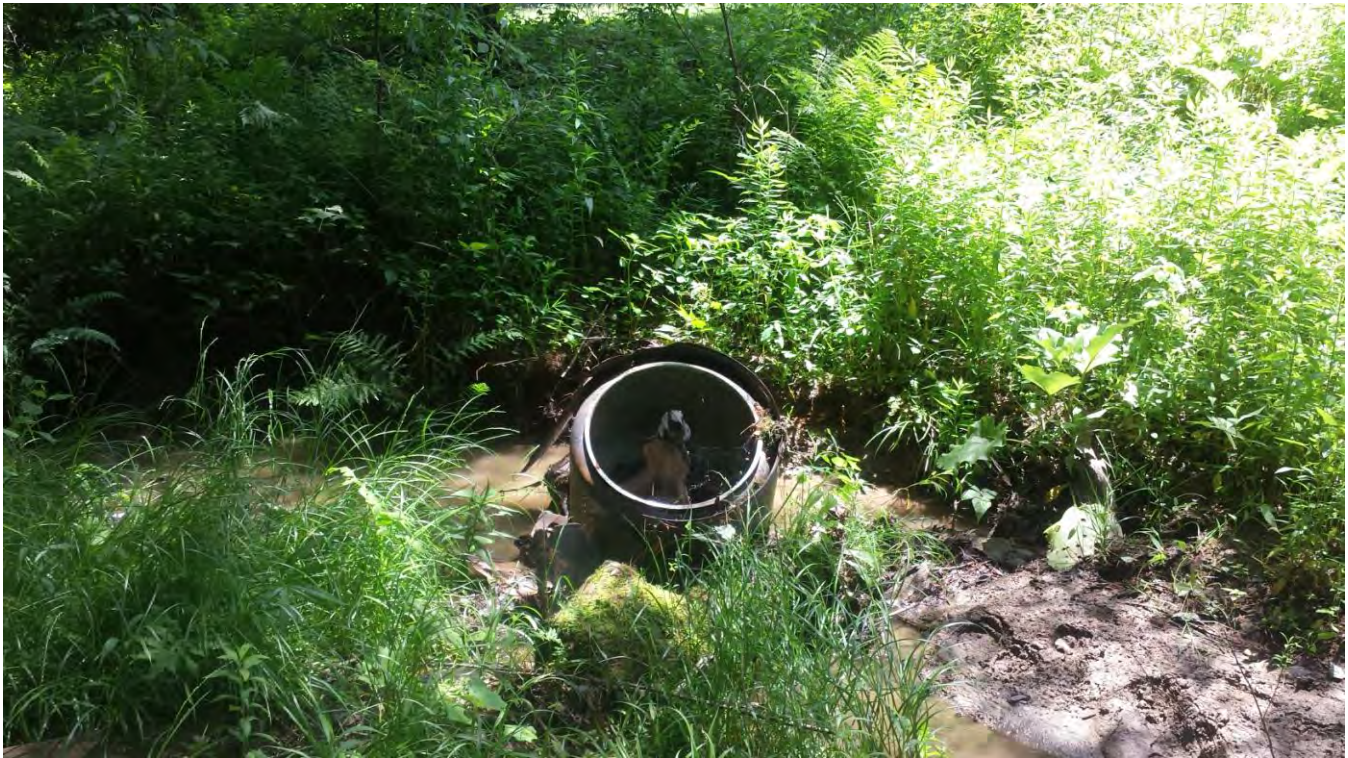
Figure D-6: SL4 upstream of culvert

Site SL4 is at the mouth of unnamed tributary #3, adjacent to Brown School Road. The entirety of this tributary flows through forested land although there is an area near the mouth where the riparian area has narrowed due to Brown School Road on one side and a yard on the other. Additionally, in this same area there is some trash including an old wringer washer and tires among other things.

4. There are larger trash items such as a wringer washer and car parts located within the first 100 yards upstream of the previously mentioned culvert on unnamed tributary #3. A trash clean up at this site is recommended.

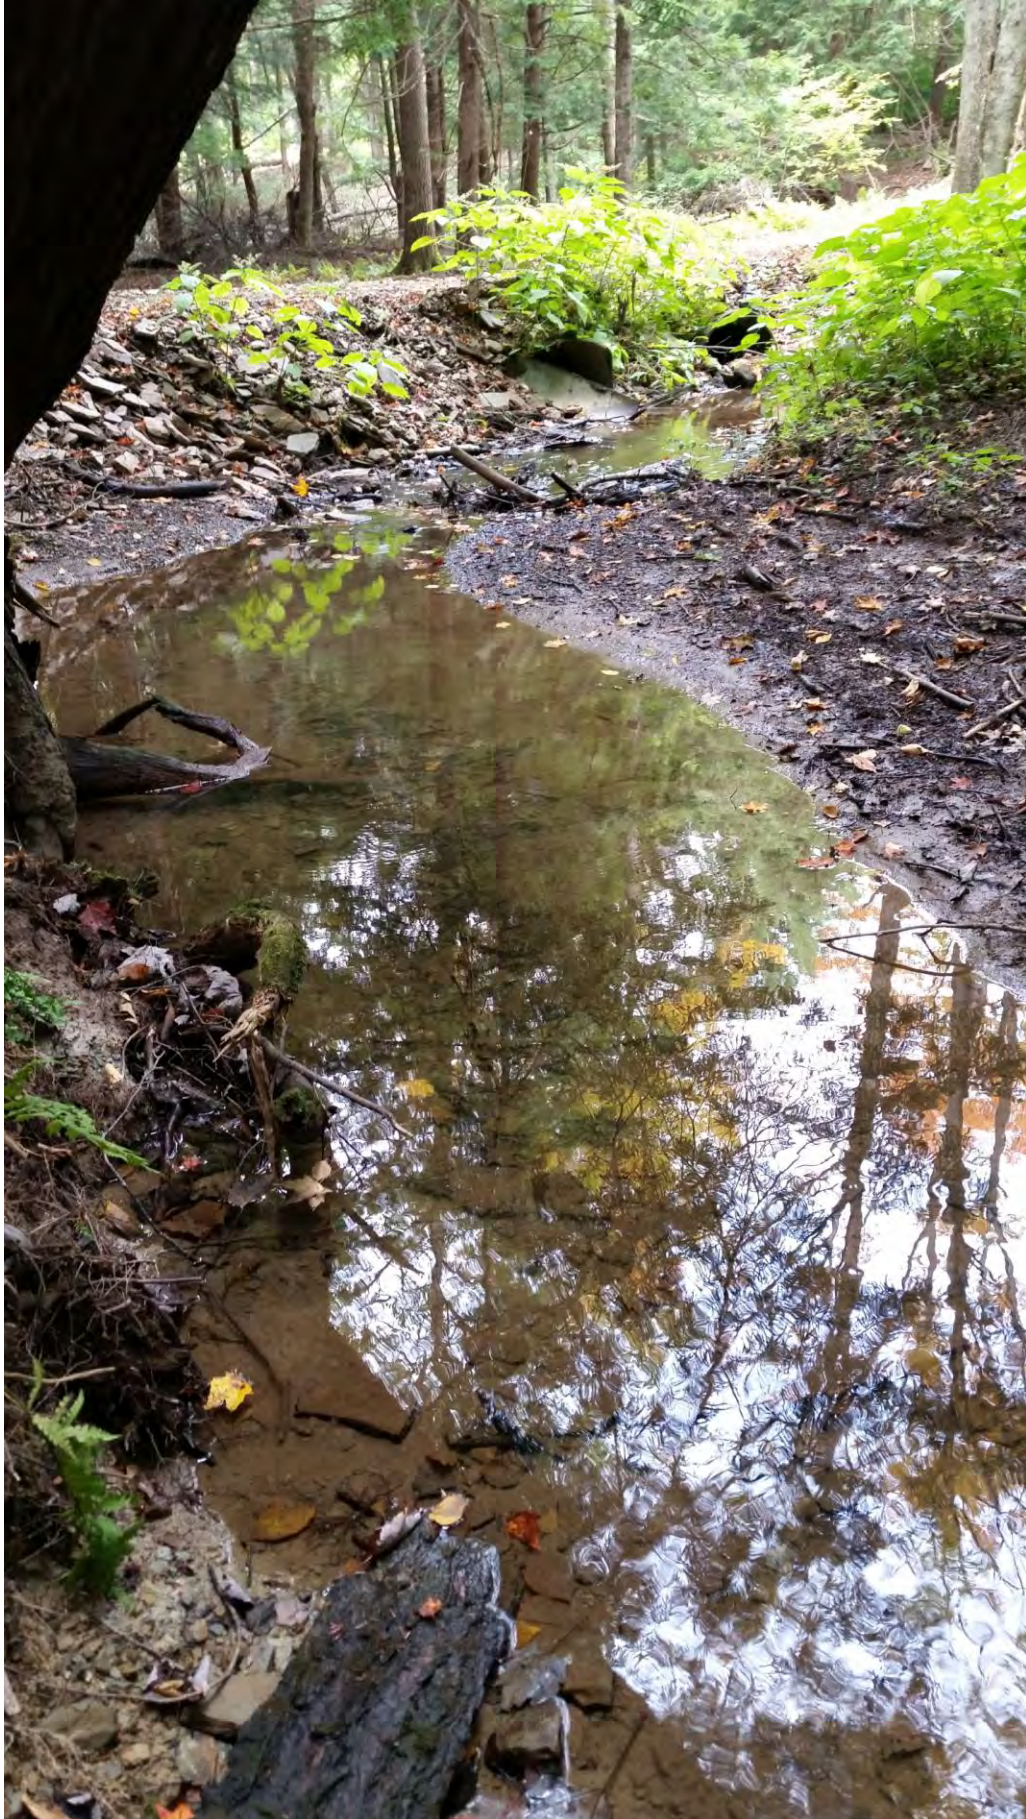
Figure D-8: Site SL6

At Site SL 6 there is a private drive used for past logging. The culvert at this location though not perched, may be undersized and is misaligned causing some erosion issues on the upstream end.
