**MUNICIPAL SEPARATE STORM
SEWER SYSTEM (MS4)
COMPLIANCE INSPECTION**

**FINAL REPORT DATE: September 24, 2009
EVALUATION CONDUCTED: April 7-9, 2009**

BALTIMORE CITY, MARYLAND

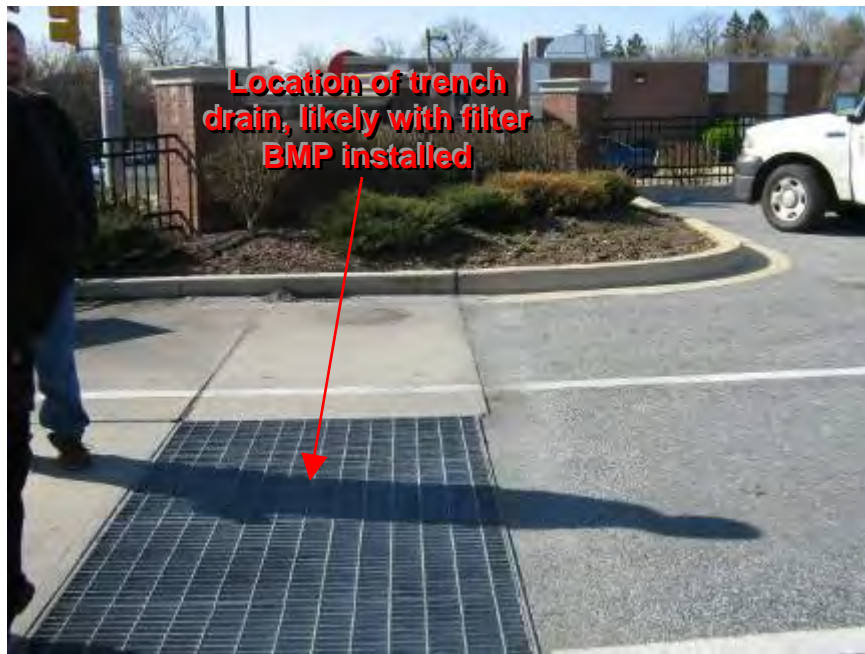
Photograph 2. Rite Aid – Location where City SWM Program staff believed an inlet filter BMP was installed.

The City's Year 4 Annual Report summarizes a number of issues that are indicative of inadequate tracking and inspection procedures which are exemplified by the lack of adequate tracking for the SWM-BMP located at the Rite Aid at York Road and Gittings Avenue. Based on these issues and the individual SWM site assessments, the City did not demonstrate that SWM BMPs are effectively tracked, identified onsite, and inspected. Without effective tracking and inspection procedures, the City cannot ensure that adequate long-term maintenance is performed as required by Part III.E.2.c of the Permit and specified in COMAR 26.17.02.11. The City must develop and implement specific written procedures for tracking of all new BMPs to ensure effective construction and maintenance inspections as required by Part III.E.2 of the Permit.

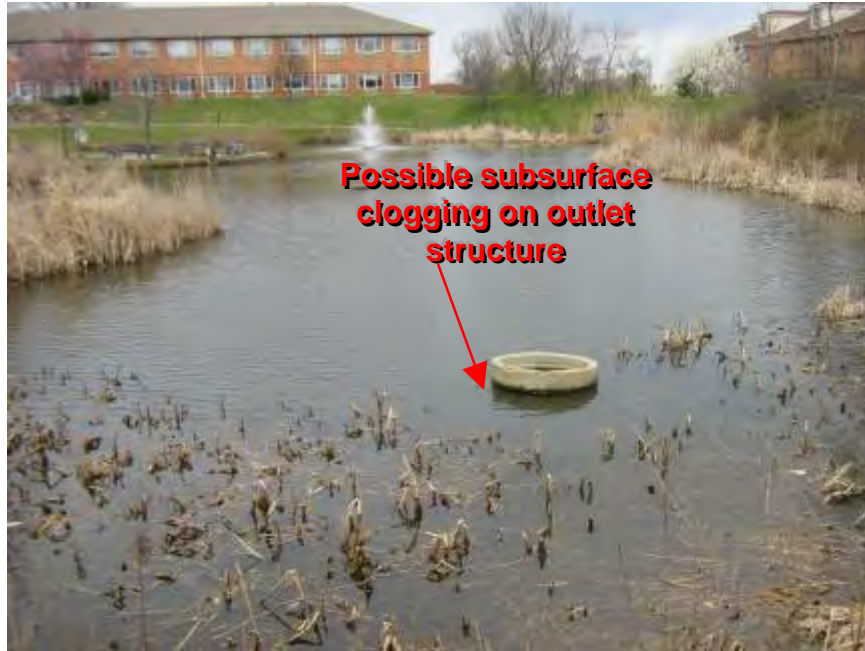
Photograph 3. Good Samaritan Nursing Center – Review of as-built plans indicated the potential for prolonged water storage.

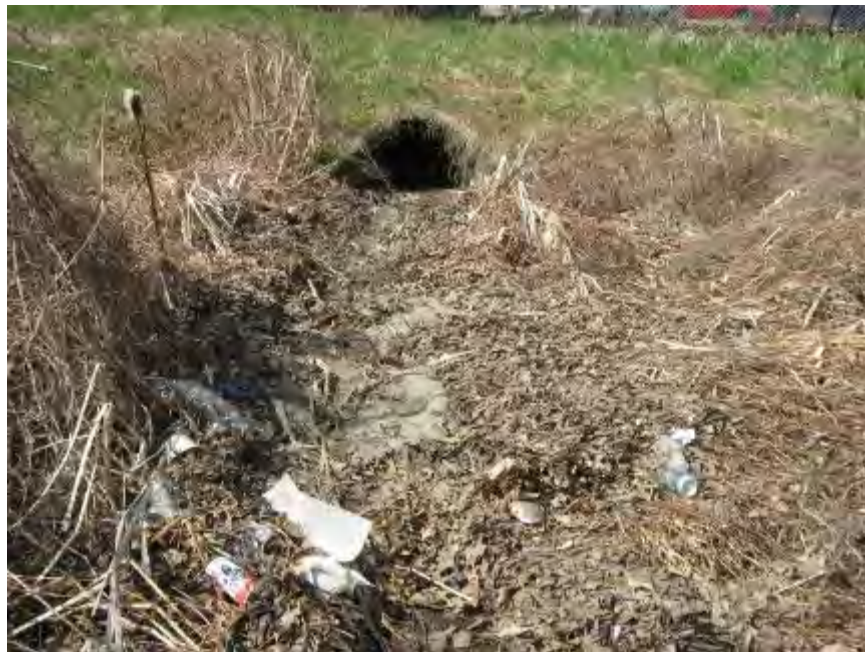
Photograph 4. American Red Cross (SWM No. 32) – View of fugitive trash and fine debris accumulation at inlet.

The EPA Inspection Team visited a number of new development and redevelopment projects of varying age to observe SWM BMP selection, placement, operation, and maintenance. During these site visits, instances of unsatisfactory maintenance were observed, including the potential for prolonged water storage (refer to Photograph 3) at the Good Samaritan Nursing Center (SWM Nos. 077, 191, 035), and fugitive trash and fine debris accumulation in SWM BMPs (for example, refer to Photographs 4 and 5). The EPA Inspection Team conducted a review of the as-built plans for the Good Samaritan Nursing Center and concluded that the riser pipe outlet structure should have included a discharge outlet lower on the riser pipe than the observed water level. The as-built plans also indicated that the top of the outlet structure should have included a trash rack which was not implemented in the field. Moreover, the City maintenance inspector had not adequately referenced the as-built plans to determine whether the pond was functioning according to the design. These site conditions further suggest that City staff are not adequately trained to identify operation and maintenance issues.

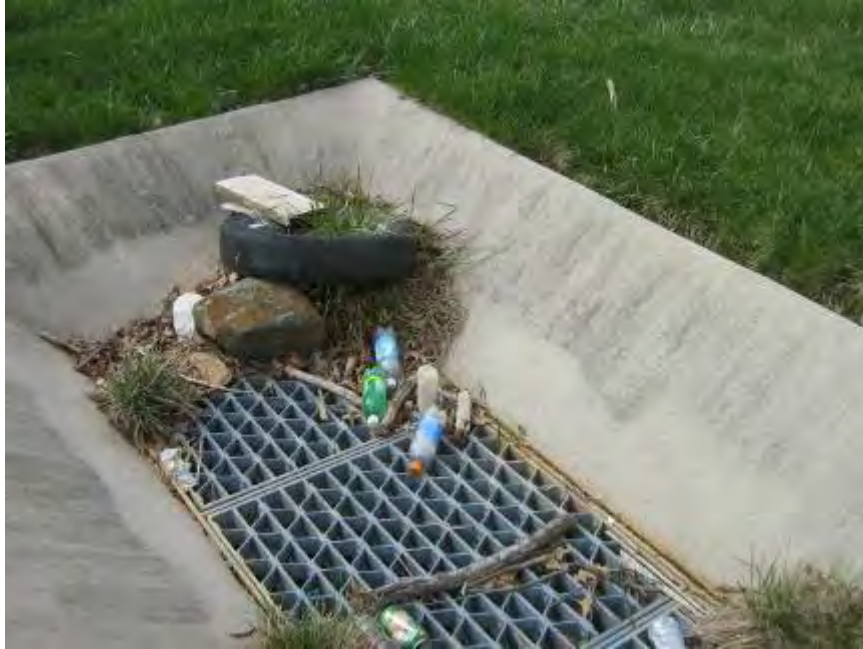
Photograph 5. Girl Scouts of America (SWM Nos. 56 and 180) – View of trash and debris accumulation at inlet structure appurtenant to detention facility.

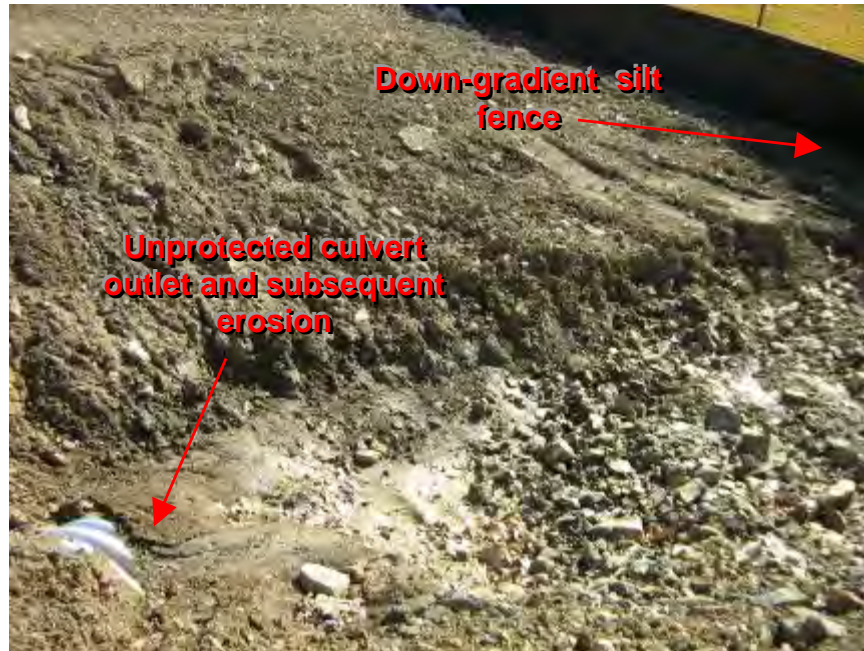
Photograph 7. Cylburn Arboretum – Silt fence BMPs had been improperly selected and implemented in an area of concentrated flow down-gradient of the culvert outlets.

The Cylburn Arboretum, for example, is a City-sponsored (Department of Recreation and Parks) construction project which is located at 4915 Greenspring Avenue in Baltimore, MD 21209. It was observed during the EPA Inspection that BMPs were not implemented to prevent down-gradient BMP failure at the City’s Cylburn Arboretum construction site, which may be attributed to an inspection scope which does not ensure compliance with the approved plan. Specifically, the approved ESC plan specified the implementation of culvert outlet protection, but flow dissipation BMPs were not in place below the culvert outlets, nor were there control devices wrapping up and around the outlets (refer to Photographs 6 and 7). Furthermore, silt fence BMPs had been improperly selected and implemented in an area of concentrated flow down-gradient of the culvert outlets. As a result, there was a potential for failure of the silt fence BMP and the subsequent discharge of sediment beyond the construction site boundary. BMPs must be properly selected, installed, and maintained to prevent the discharge of sediment from the site. As evidenced by this and other discrepancies between ESC plans and site conditions, collectively the City’s inspection scope does not ensure compliance with the approved plan.

Using the approved plans as a basis for inspection, the City ESC inspectors would be provided with a more enforceable and consistent measure in making inspection determinations. Furthermore, when sites are inspected for compliance with the approved plan it may help to deliver a clear message to the development community on the City’s expectations for BMP implementation. *It is strongly recommended that the City utilize the broad authority granted under its ordinance to inspect each construction site within its jurisdiction for compliance with the approved ESC plan.*

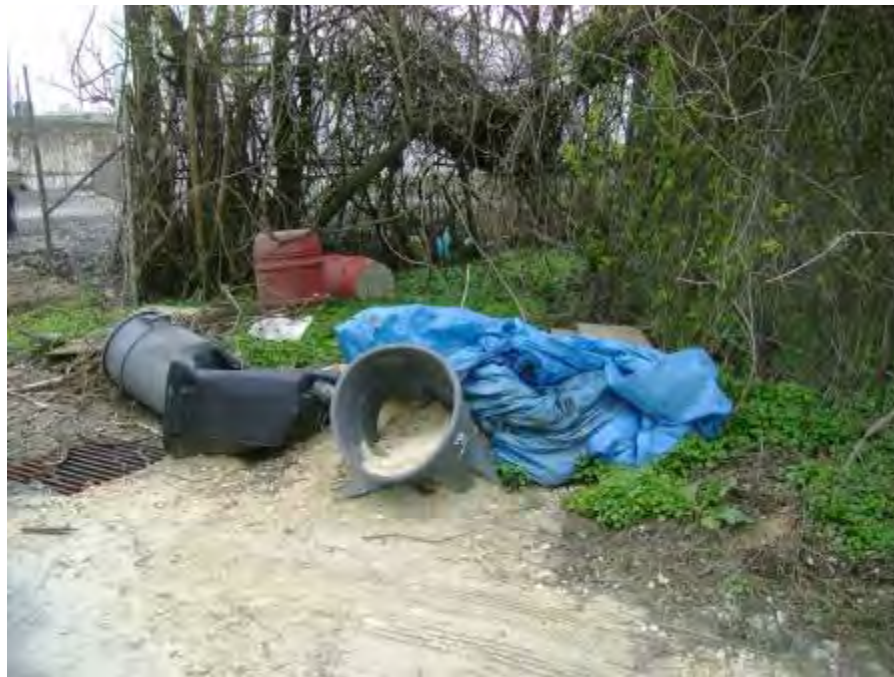
During the site visit to the outfall, the EPA Inspection Team noted that a significant amount of sediment was entering the storm drain from a random pile of dirt next to the storm drain on the edge of the road (refer to Photographs 8 and 9). A significant amount of trash was also noted along the stream bank. During the trip up the storm sewer line the EPA Inspection Team noted what appeared to be an employee of JK Technologies, an automobile repair and service facility, using an unknown detergent to wash a wheel outside on an impervious surface. The City personnel accompanying the EPA Inspection Team, two Pollution Control Analysts (PCAs), did not identify the noted issues and stated that they typically did not actively try to identify those types of issues.

Photograph 8. Clipper Mill Monitoring Location – Location of a previously identified storm sewer/sanitary sewer cross connection identified through monitoring efforts. (NOTE: Debris and dirt around storm drain)

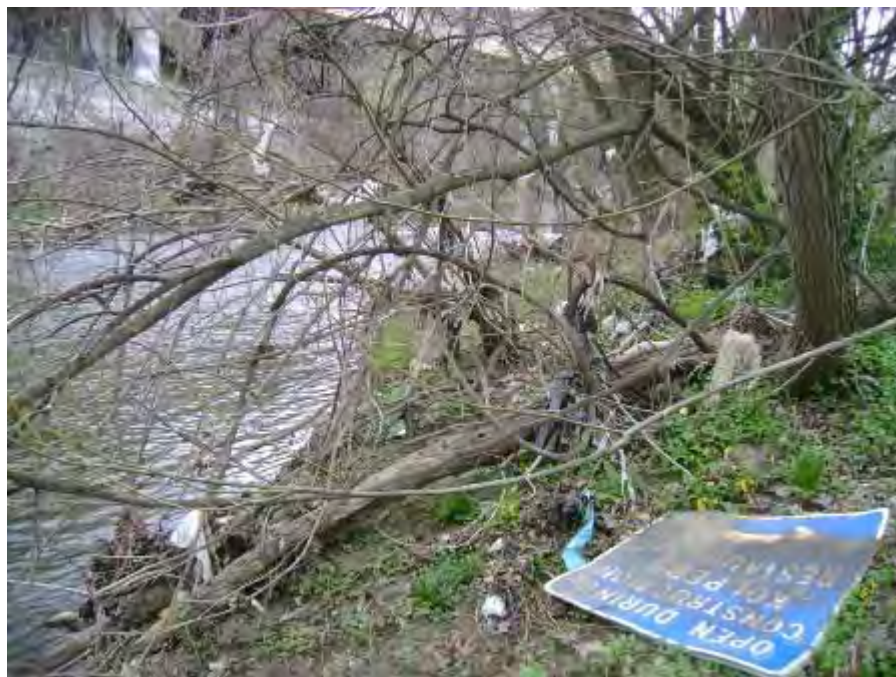
Photograph 10. Clipper Mill Monitoring Location – View of trash and debris along stream bank.

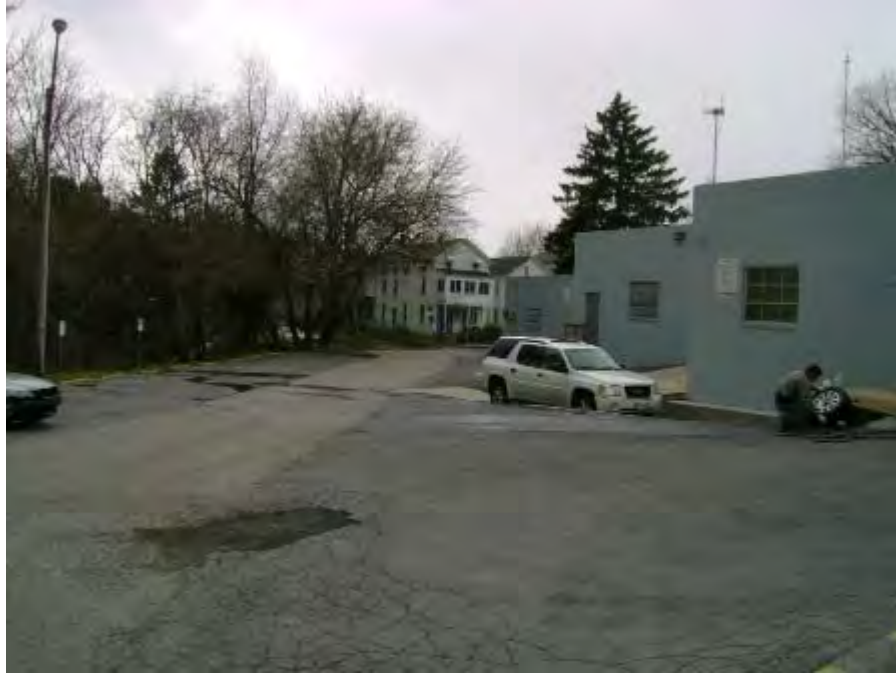
Photograph 11. JK Technologies – Potential illicit discharge of washwater.

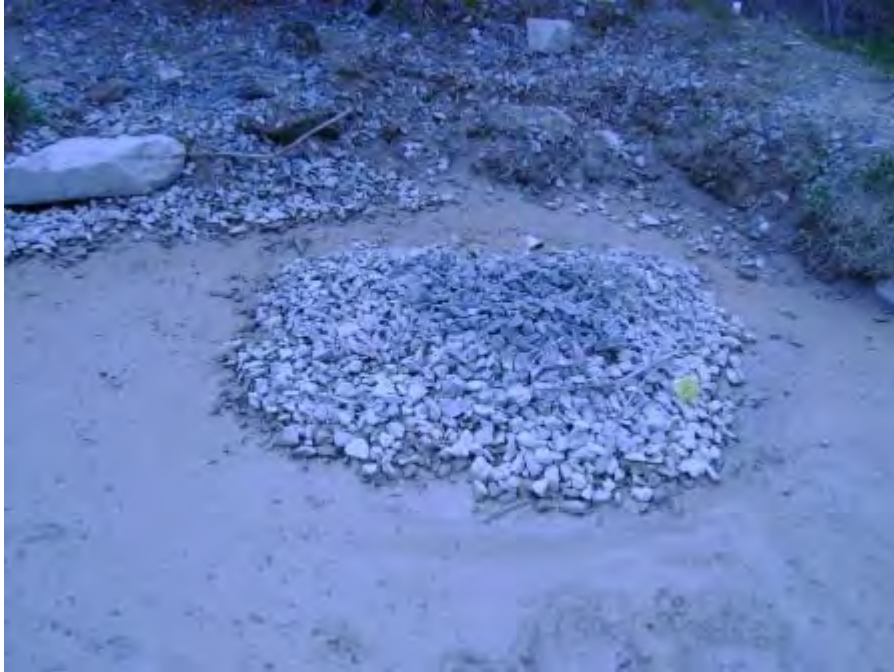
The EPA Inspection Team noted that the storm drain was covered with rock and City representatives stated that a silt fabric had been placed under the rock to prevent a discharge of concrete materials to the storm drain. The procedures used to track the suspected illicit discharge appeared to be appropriate and resulted in the identification of the illicit discharge to the storm sewer. At the time of the EPA Inspection, no evidence of an illicit discharge was observed.

Photograph 13. S&G Concrete – Another view of drain covered with filter fabric and stone.

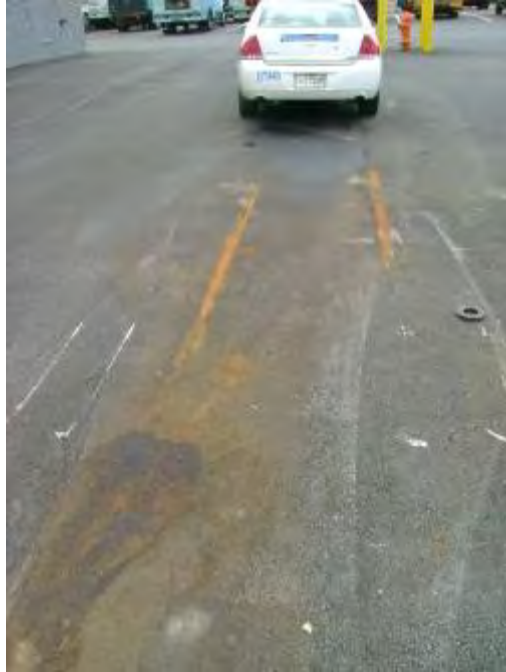
The EPA Inspection Team noted several physical issues throughout the facility, including excessive staining and small spills/vehicle fluid leaks on paved areas throughout the facility, a failure to implement BMPs (i.e., good housekeeping and proper storage of fluids and equipment) resulting in significant staining throughout the facility and an oil sheen on the surface of the water and around the edges of the facility's extended detention micro pool storm water management pond's pretreatment forebay (refer to Photographs 15 through 44). The EPA Inspection Team also noted that the impervious area of the garage's fueling station was not designed to direct spills and potentially contaminated runoff from the area to the garage's stormwater management pond as it would flow directly to the City's MS4 via unprotected storm drain inlets along the roadway (refer to Photographs 44 through 46).

Photograph 15. Central Garage – Example of staining on paved area.

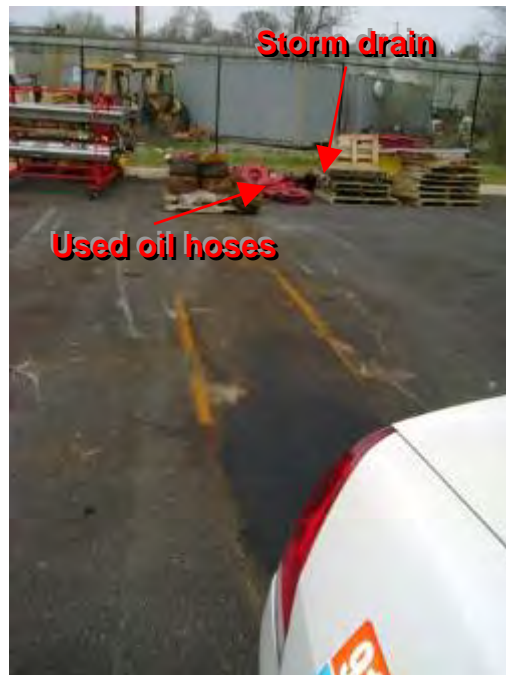
Photograph 16. Central Garage – Staining on paved area throughout facility and used oil hoses stored near and on top of storm drain.

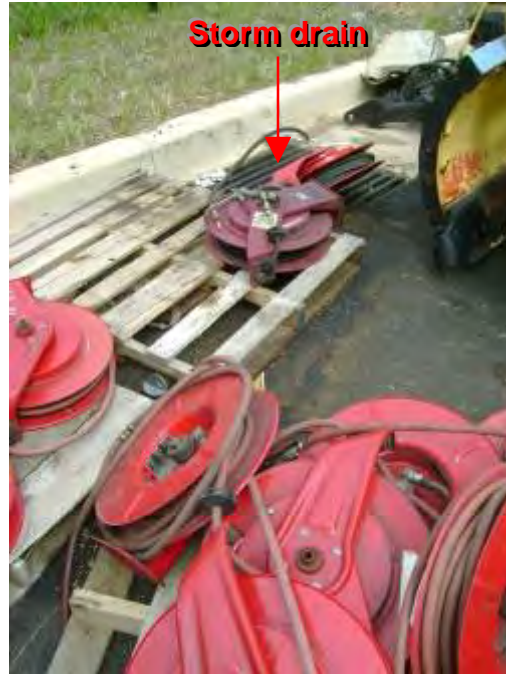
Photograph 17. Central Garage – Close up of used oil hoses near and on top of storm drain (NOTE: Staining around storm drain).

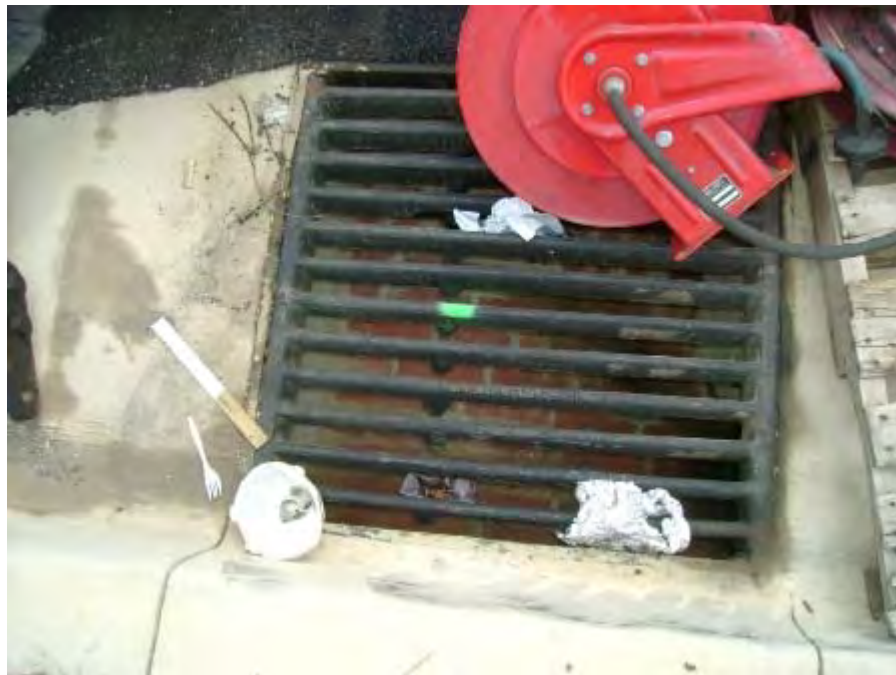
Photograph 18. Another close up view of oil hose on top of storm drain. Also note used paint funnel, paint stir stick and trash.

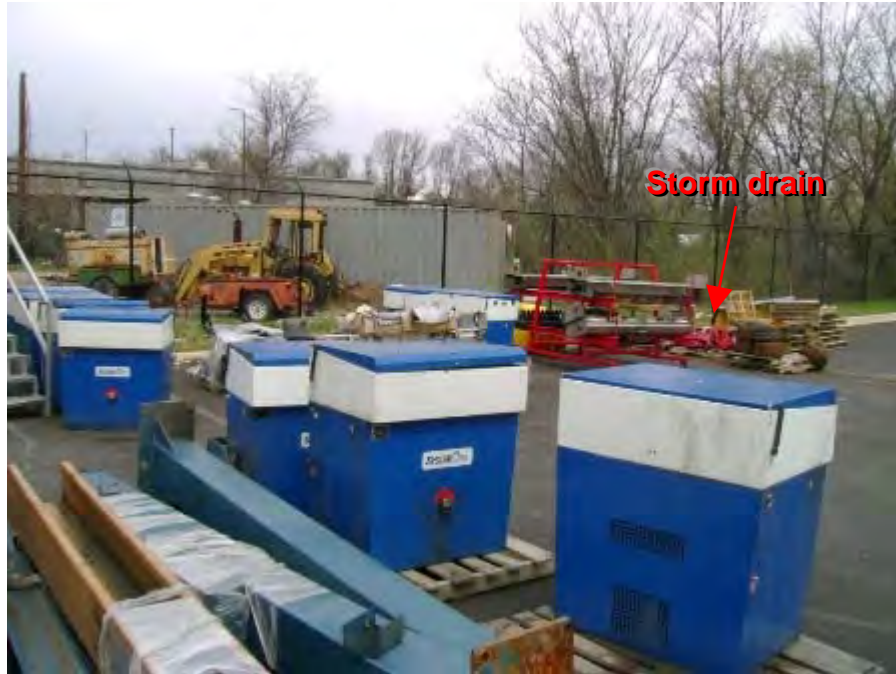
Photograph 19. Central Garage – Parts washers full of parts washing solvent located outdoors and close proximity to storm drain

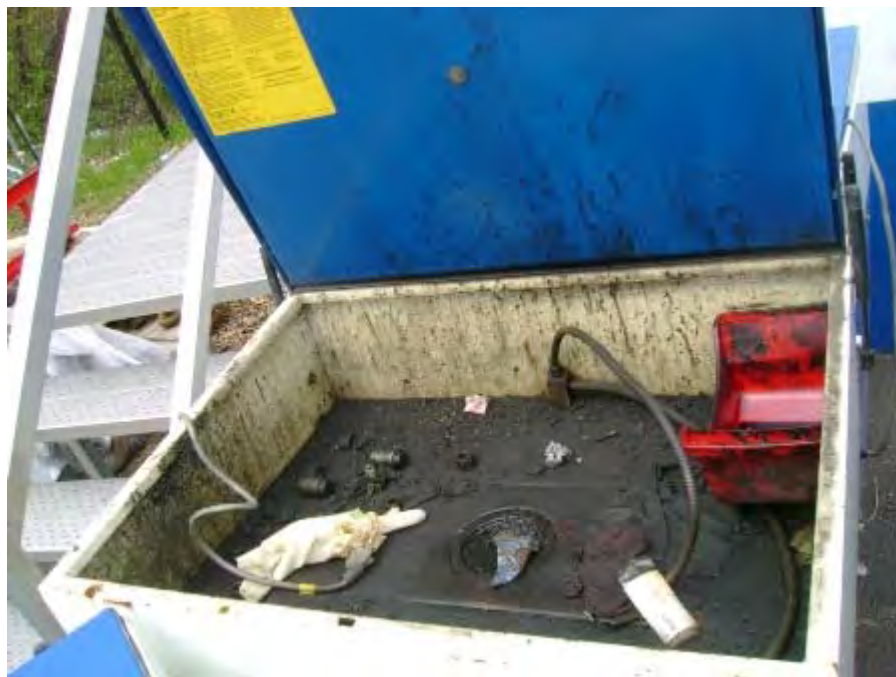
Photograph 20. Central Garage – Example view of the interior portion of the parts washer. (NOTE: Rags and parts still contained within parts washer)

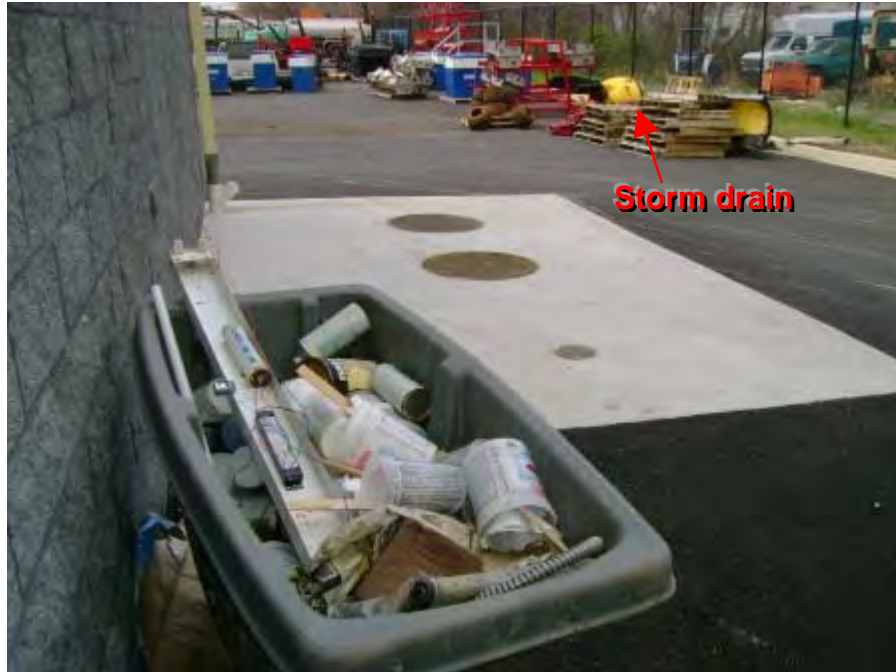
Photograph 21. Central Garage – View of small dumpster containing paint waste and other materials stored in close proximity to storm drain.

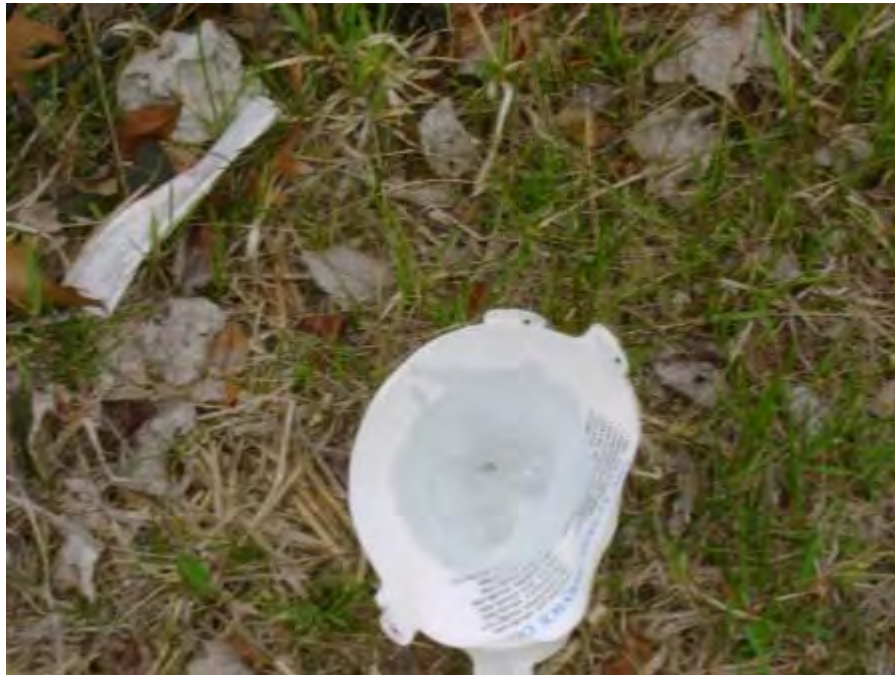
Photograph 24. Central Garage – View of a paint funnel on the ground along the northern boundary of the facility.

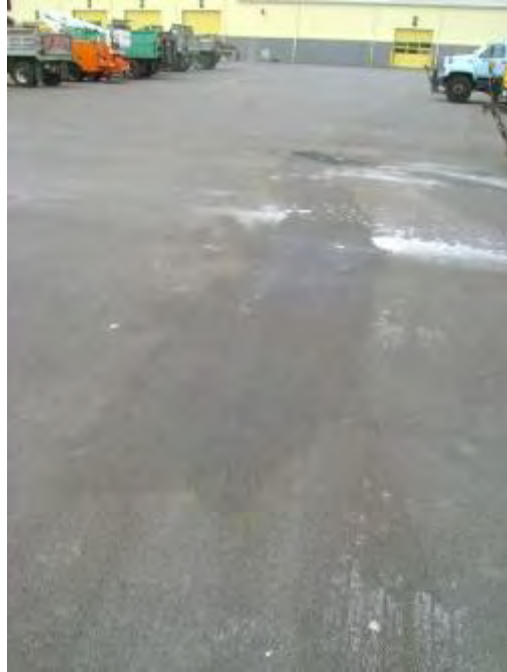
Photograph 25. Central Garage – Example of staining on paved area.

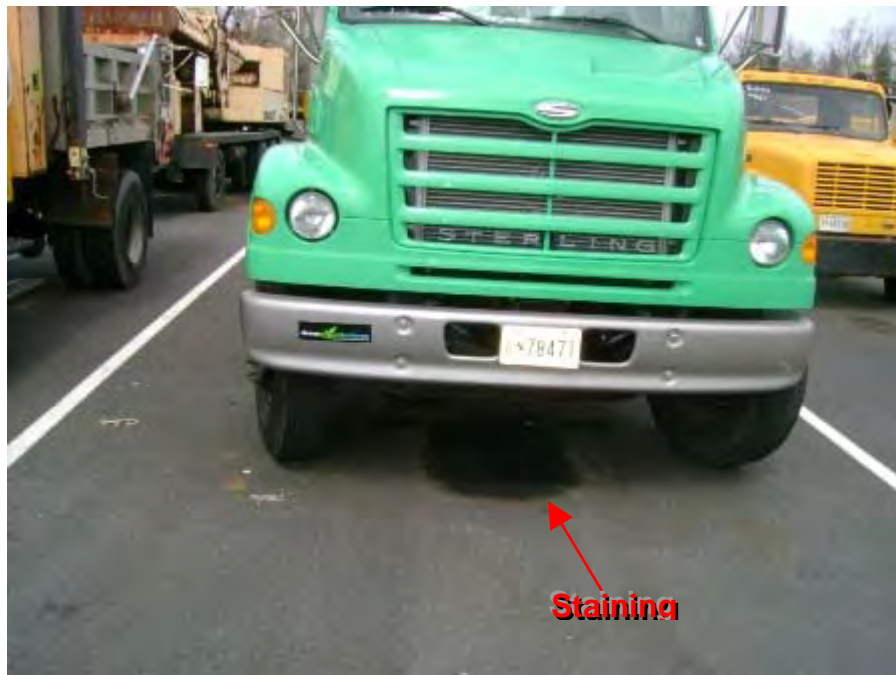
Photograph 26. Central Garage – Staining underneath vehicle indicates a lack of BMP implementation.

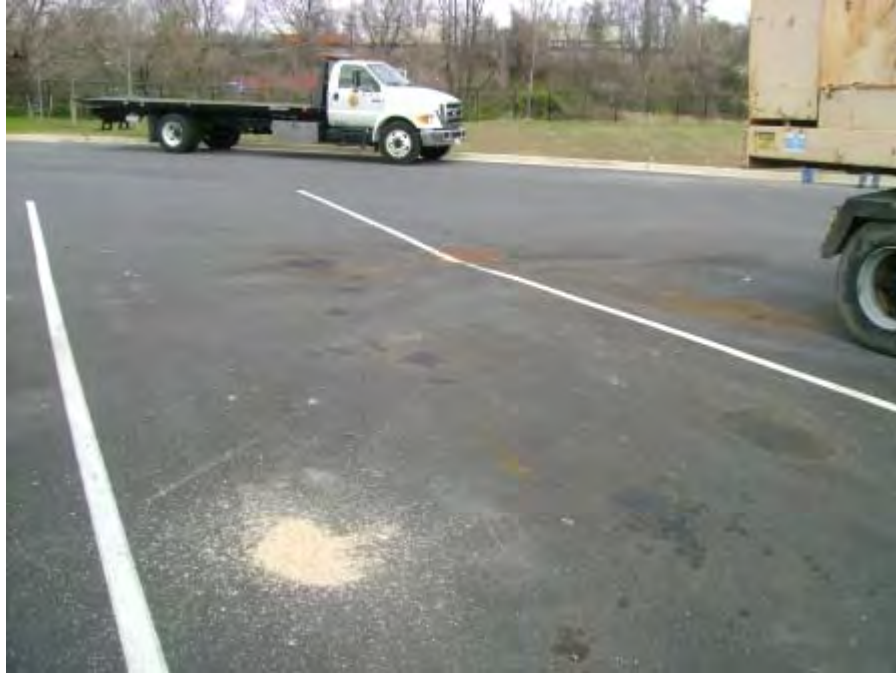
Photograph 27. Central Garage – Example of staining on paved area and absorbent left on spill.

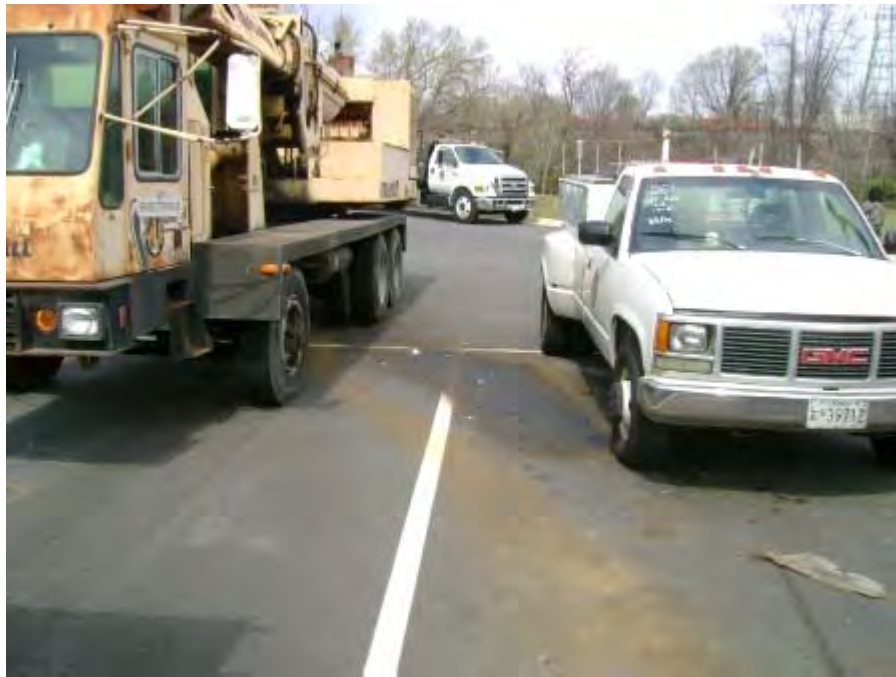
Photograph 28. Central Garage – Example of staining on paved area.

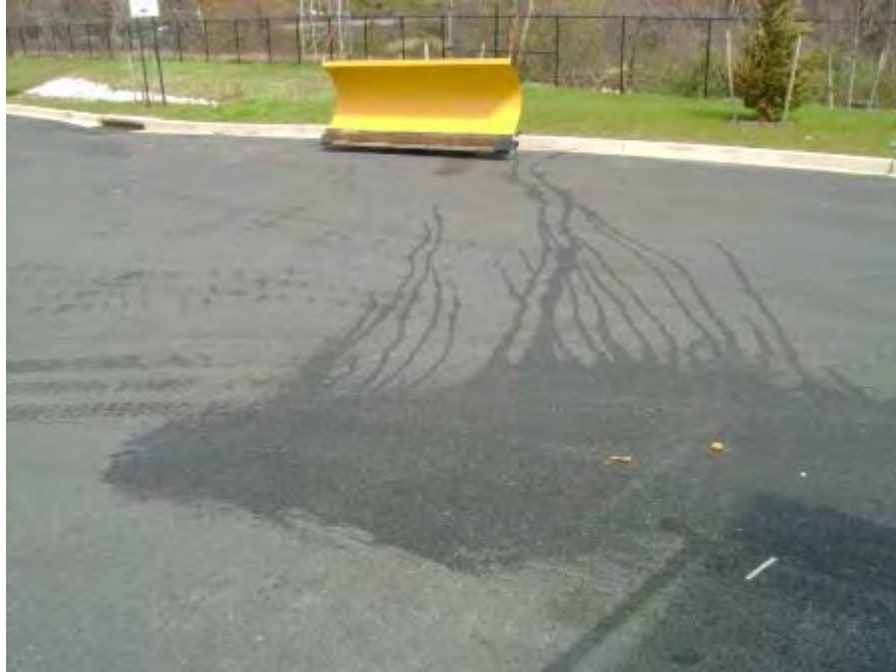
Photograph 29. Central Garage – Example of staining on paved area.

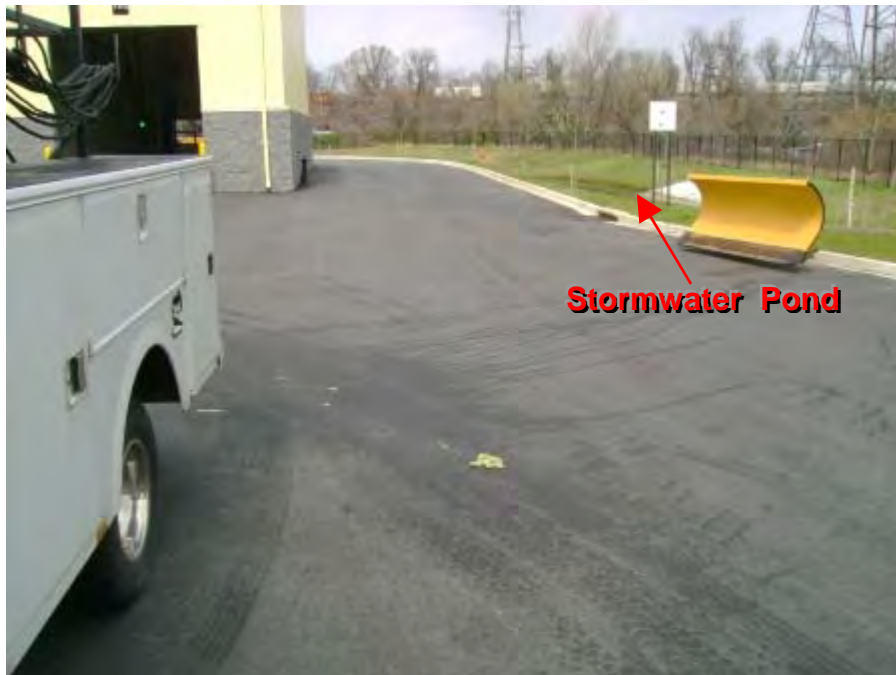
Photograph 30. Central Garage – Example of staining on paved area.

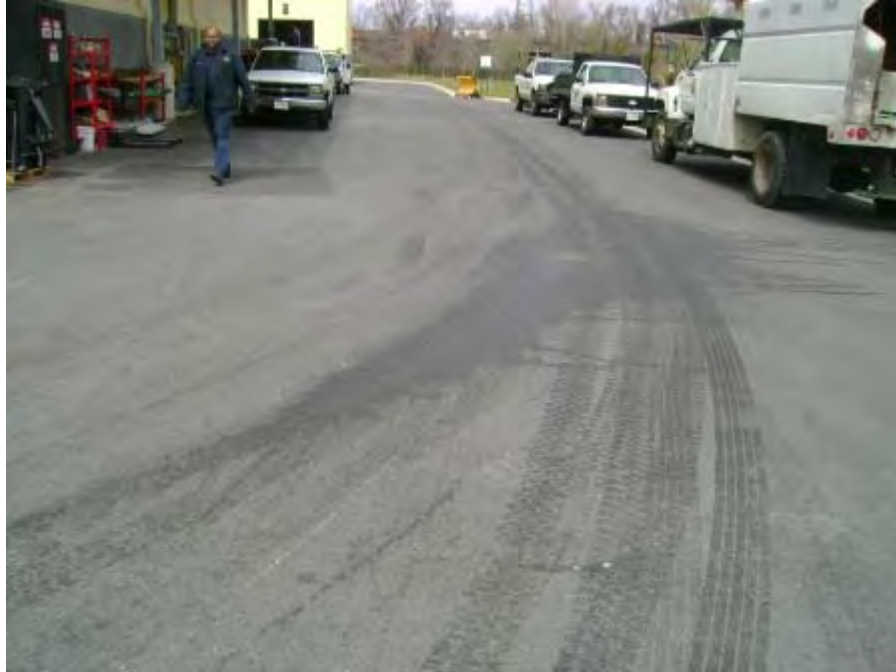
Photograph 31. Central Garage – Example of staining on paved area.

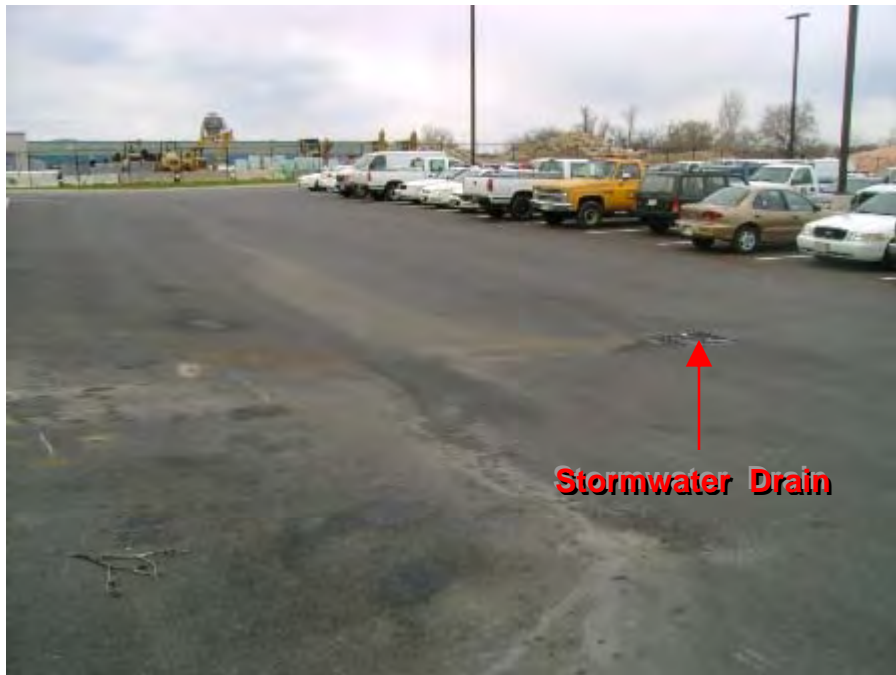
Photograph 32. Central Garage – Example of staining on paved area with stains evident into storm drain.

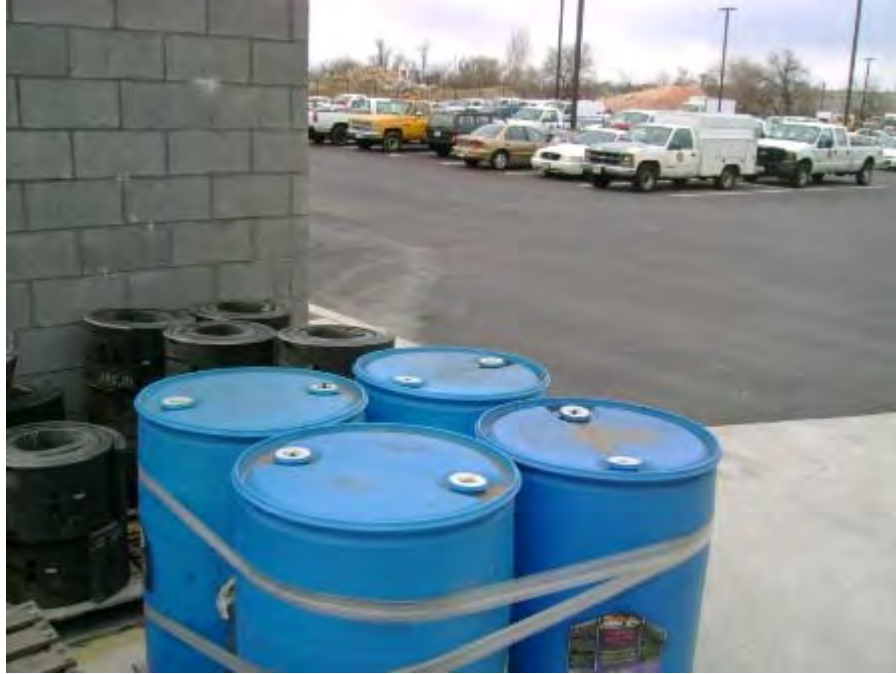
Photograph 33. Central Garage – New materials stored outdoors (Ride-On – Tire Protection).

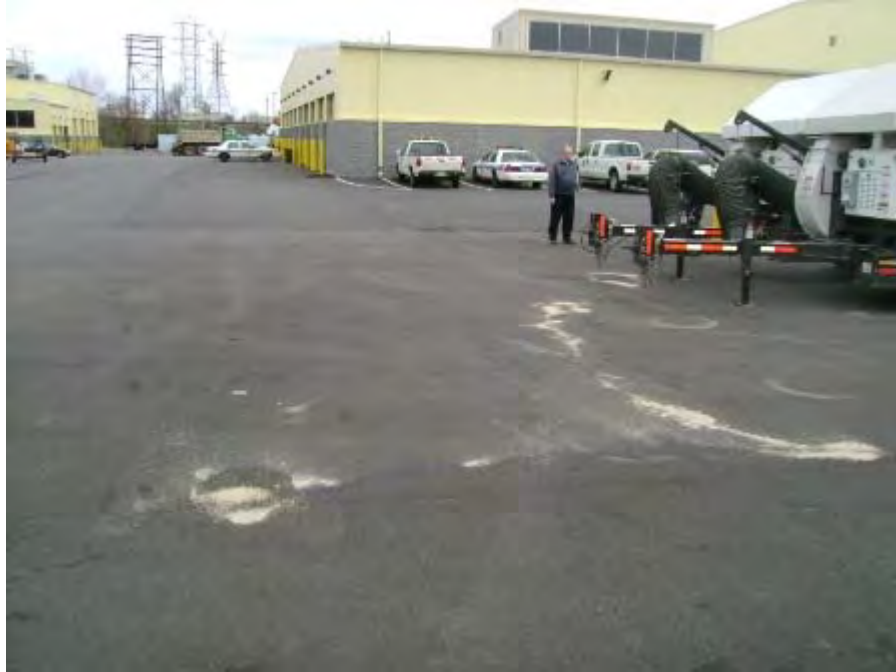
Photograph 35. Central Garage – View of oil absorbent placed on pavement to clean up a small spill.

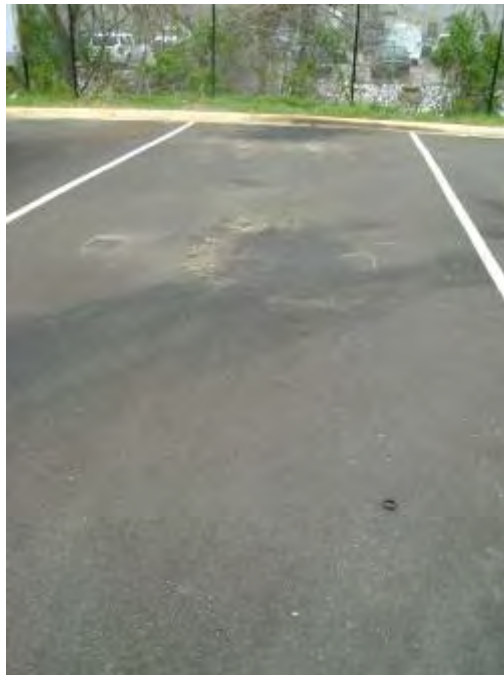
Photograph 36. Central Garage – Example of staining on paved area.

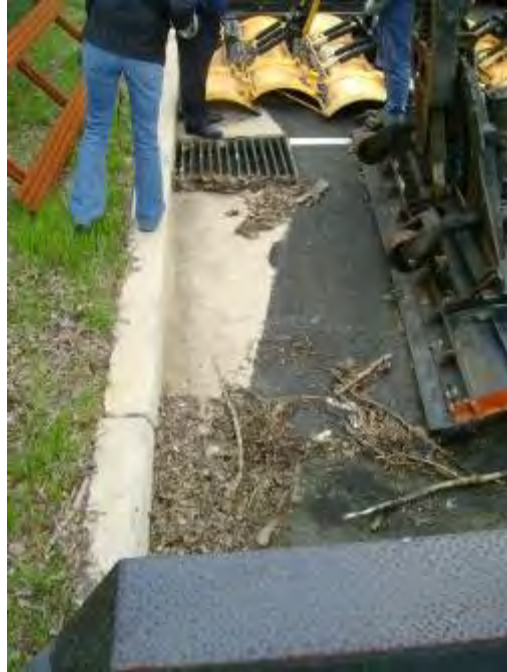
Photograph 37. Central Garage – View of debris around around storm drain.

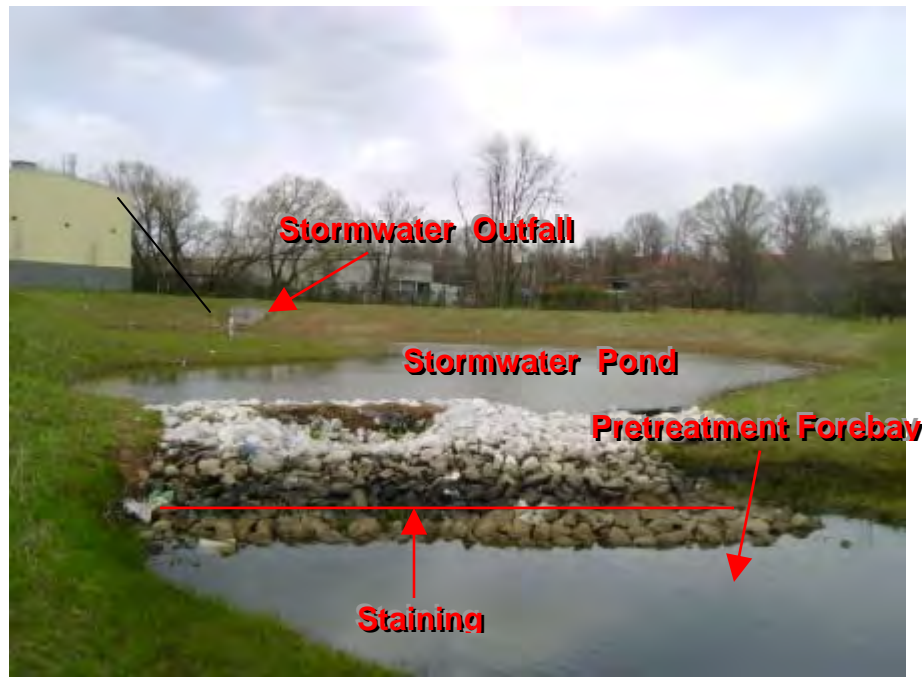
Photograph 38. Central Garage – View of stormwater pond and outfall. (NOTE: Oil stains around pretreatment forebay)

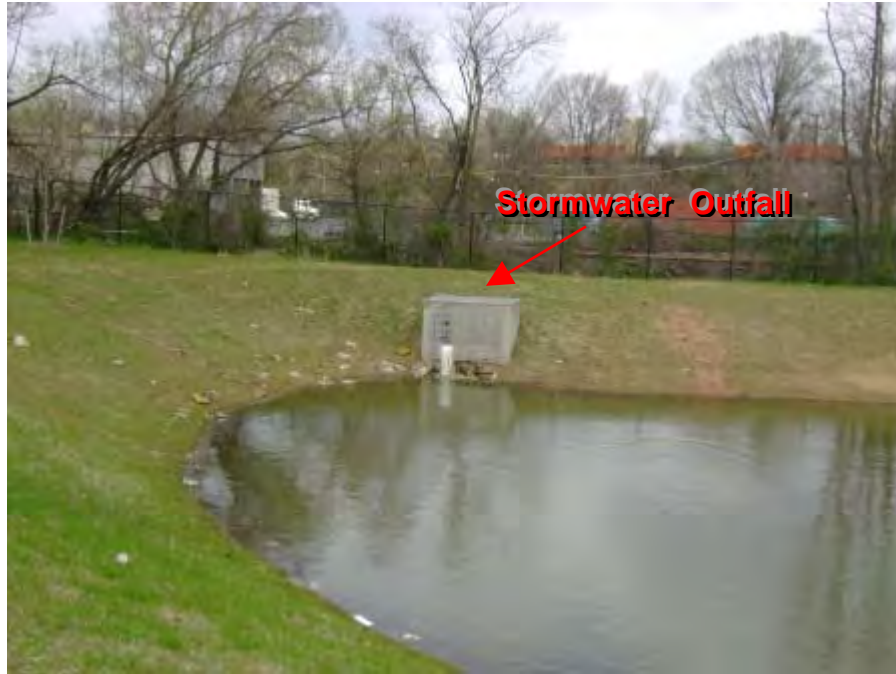
Photograph 39. Central Garage – View of stormwater pond and outfall (NOTE: General trash and debris around outfall area)

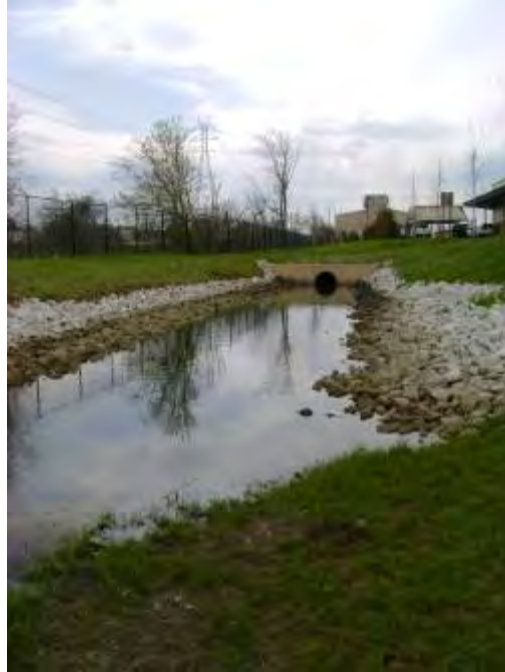
Photograph 41. Central Garage – View of pretreatment forebay with staining noted around the perimeter and a sheen on top of the water.

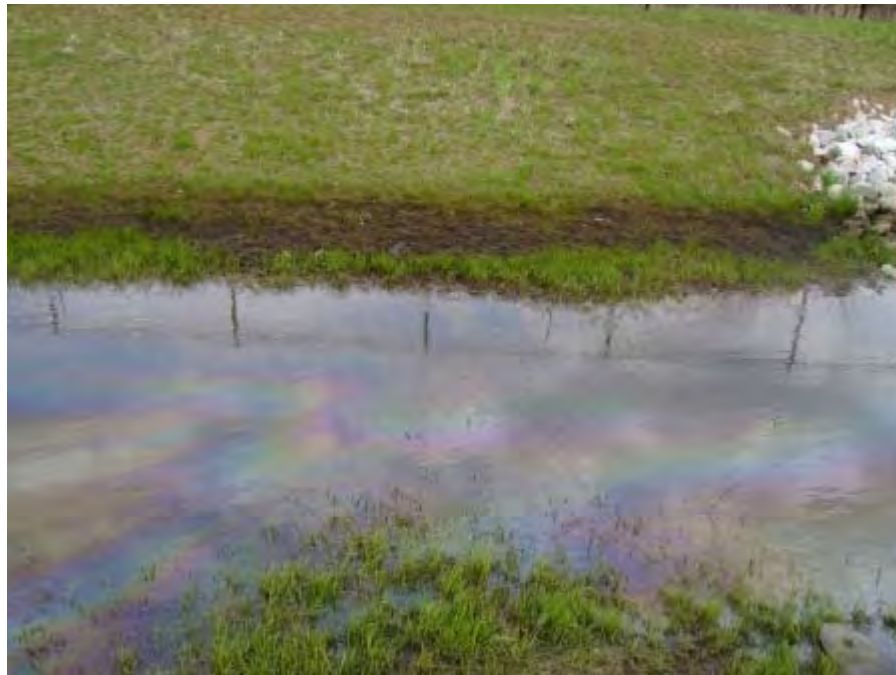
Photograph 42. Central Garage – Close up of sheen on water in pretreatment forebay.

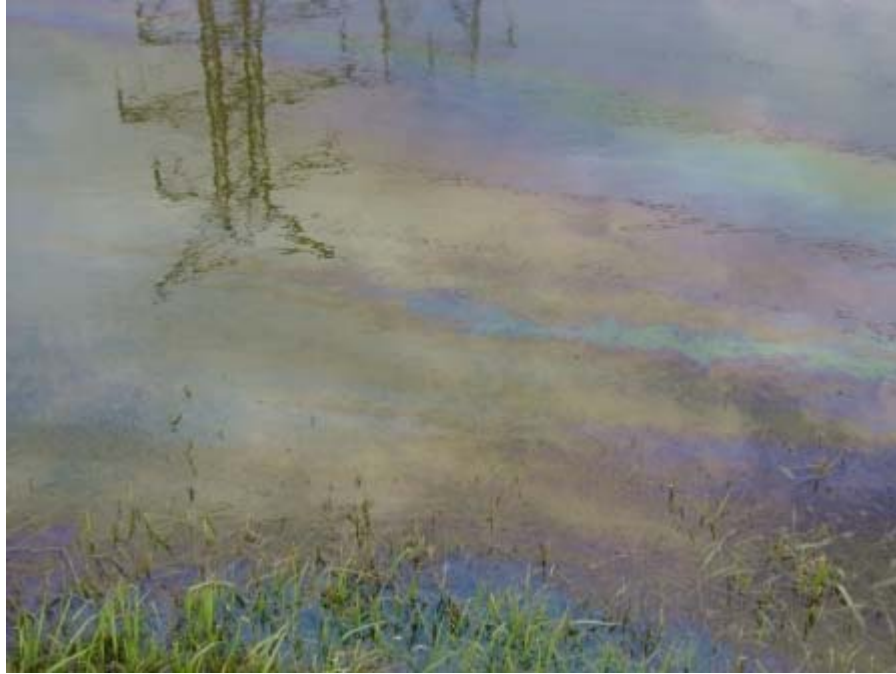
Photograph 43. Central Garage – Close up of sheen on water in pretreatment forebay.

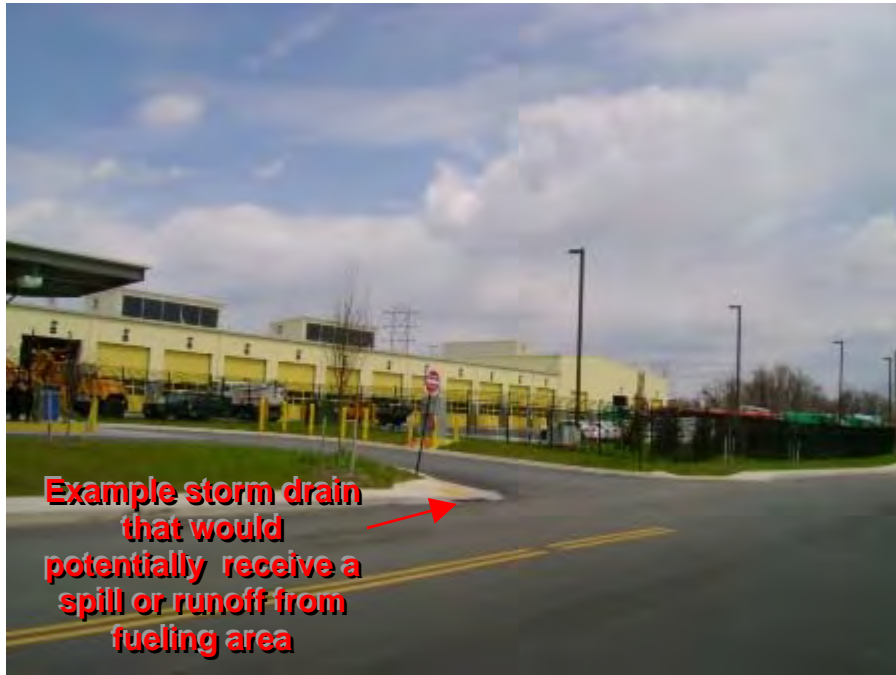
Photograph 44. Central Garage – View of drainage area from fueling station.
(NOTE: Spills resulting from fueling activities and runoff from the area will flow to one of several City storm drains along East Biddle Street)

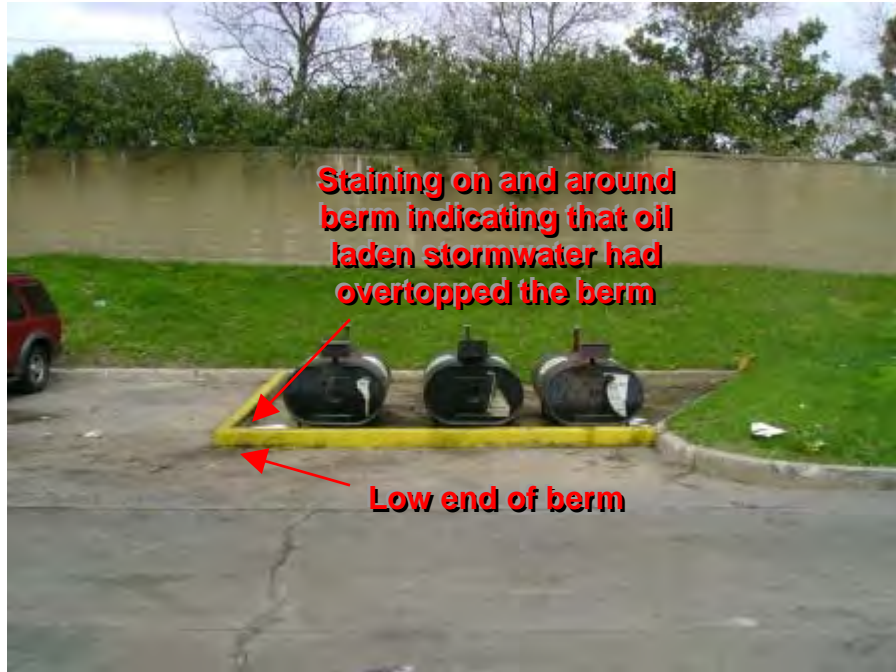
Photograph 47. Northwest Transfer Station – View of waste oil tanks with small berm to contain a spill and there are no BMPs to prevent stormwater contact with the tanks. It appears that a good sized rain event would result in stormwater overtopping the berm as evidenced in next photo.

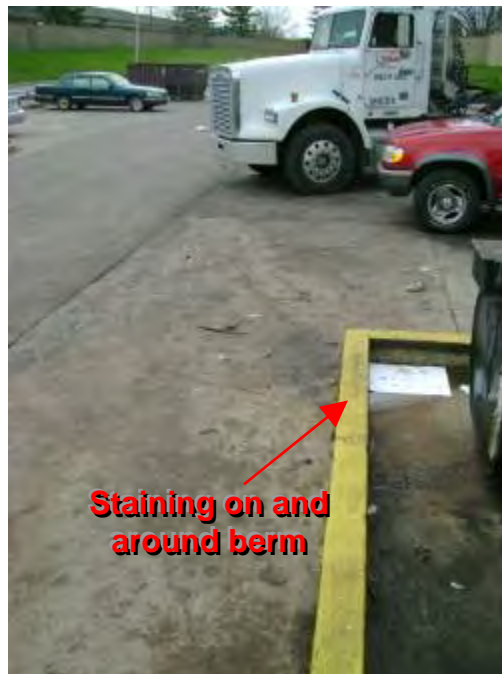
Photograph 48. Northwest Transfer Station – View of staining on and around outside of berm indicating that oil-laden stormwater had overtopped the berm.
