**MUNICIPAL SEPARATE STORM
SEWER SYSTEM (MS4)
COMPLIANCE INSPECTION**

**FINAL REPORT DATE: September 24, 2009
EVALUATION CONDUCTED: April 7-9, 2009**

BALTIMORE CITY, MARYLAND

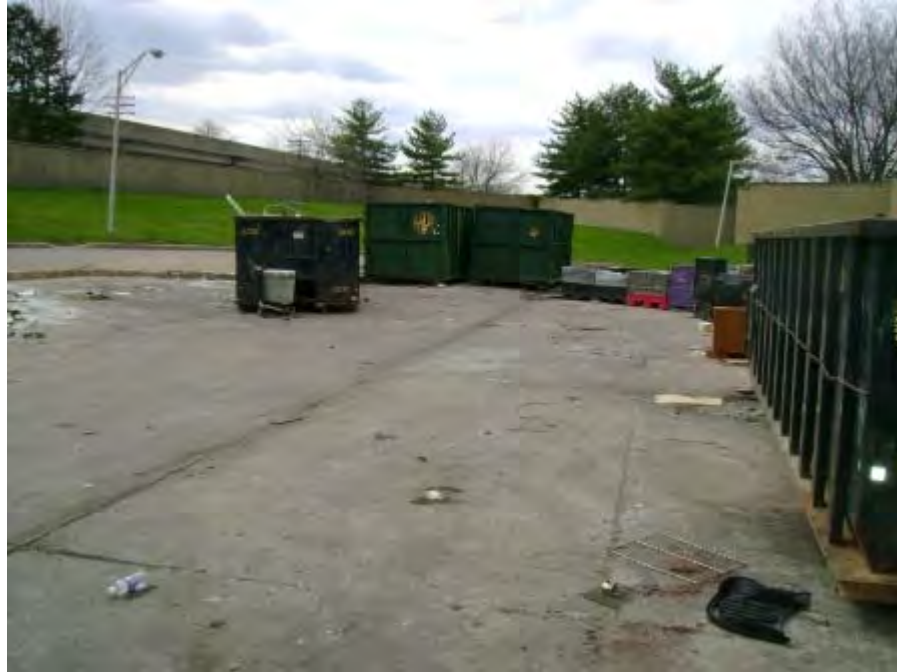
Photograph 49. Northwest Transfer Station – View of recyclable drop off area. Dumpsters contain metals, cardboard, and tires while totes contained electronics. Poor housekeeping was noted as well as a failure to provide BMPs such as inlet protection for storm drains.

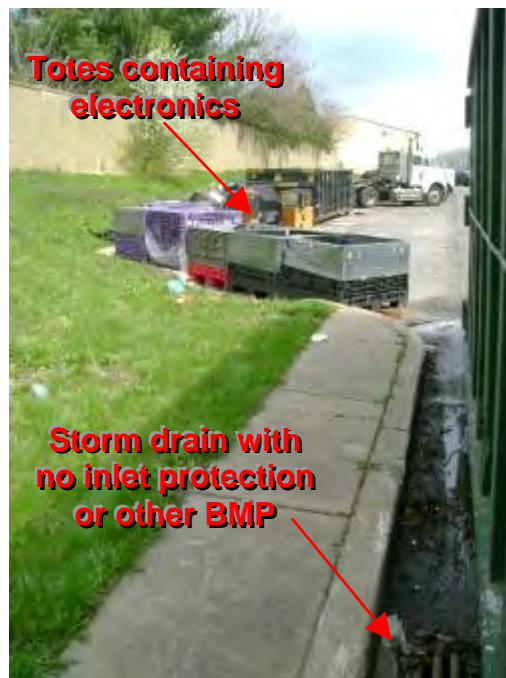
Photograph 50. Northwest Transfer Station – View of drainage area for storm drain. (NOTE: Poor housekeeping and lack of BMPs to protect storm drain)

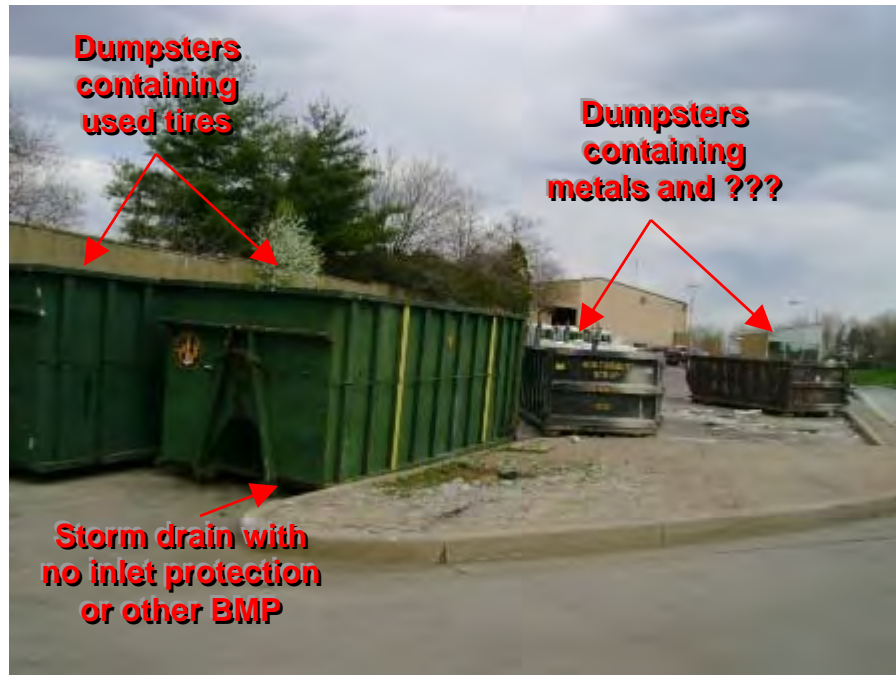
Photograph 52. Northwest Transfer Station – View of drainage area for another storm drain. (NOTE: Poor housekeeping and lack of BMPs to protect storm drain)

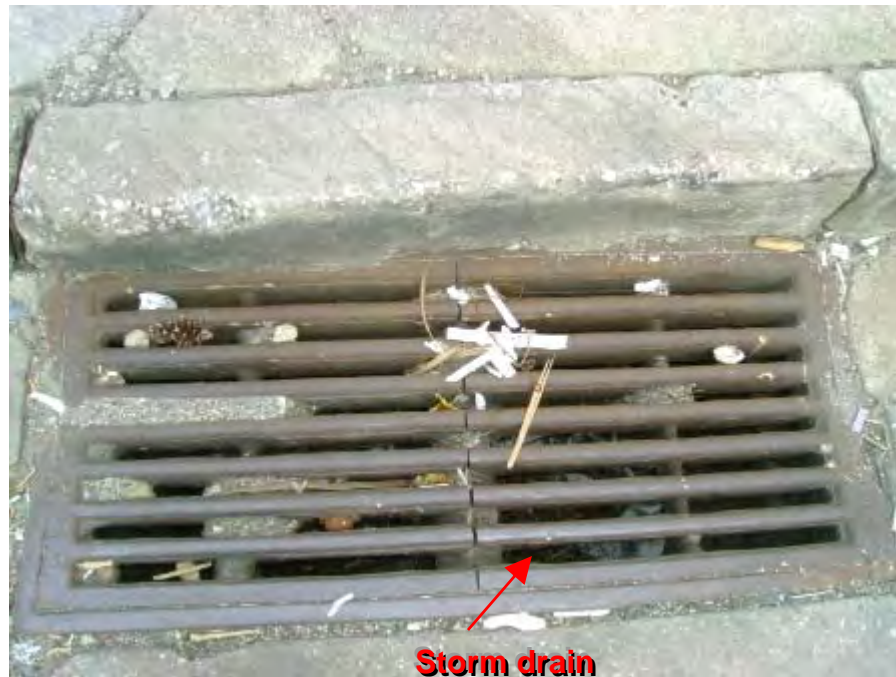
Photograph 58. Northwest Transfer Station – Close up of storm drain in previous photo. (NOTE: Debris and sediment within storm drain)

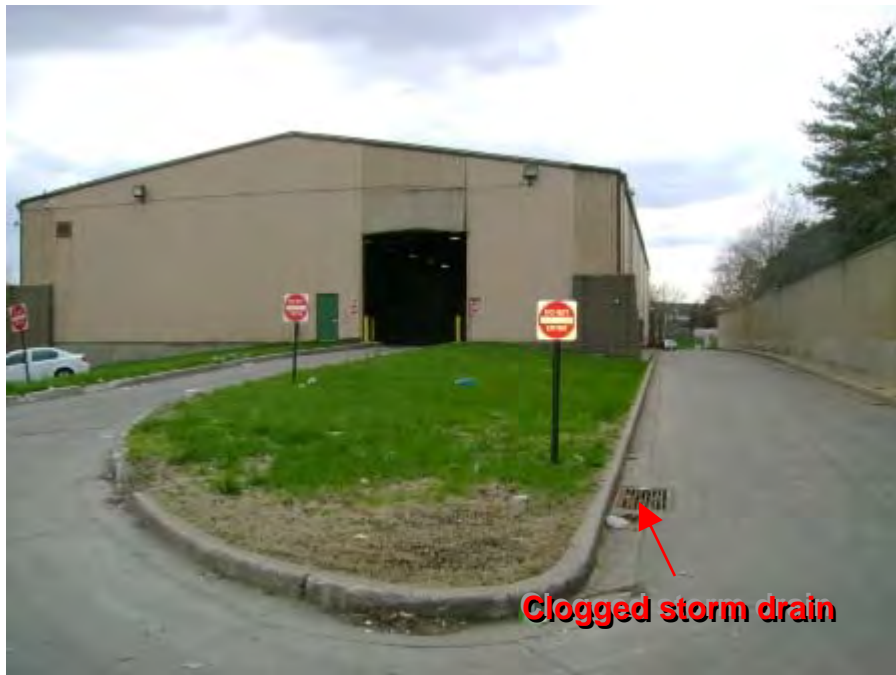
Northwest Transfer Station – View of recycling processing building exit. Storm drain in lower right is approximately 75% full of debris and sediment.

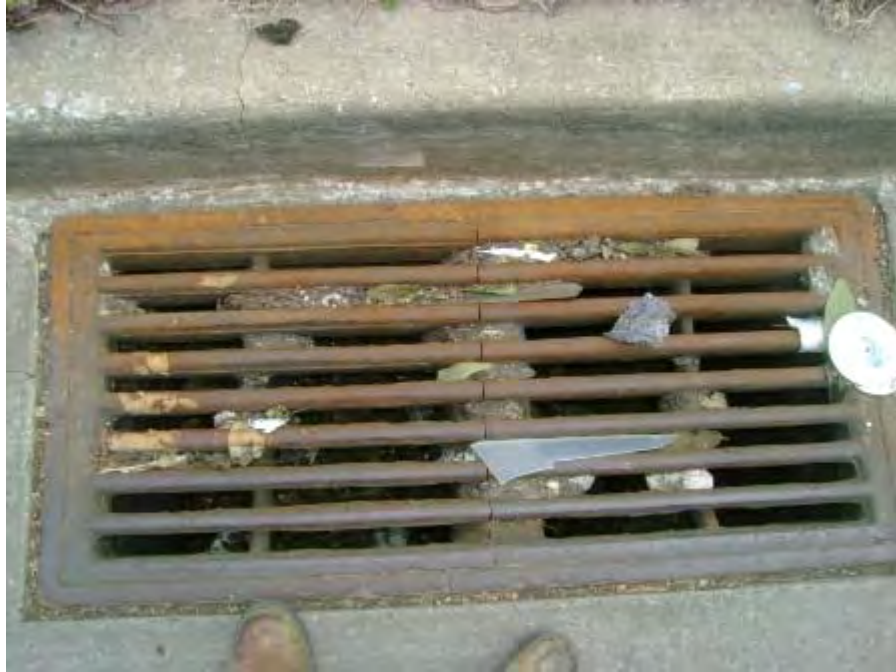
Northwest Transfer Station – Close up of storm drain in previous photo approximately 75% full of debris and sediment.

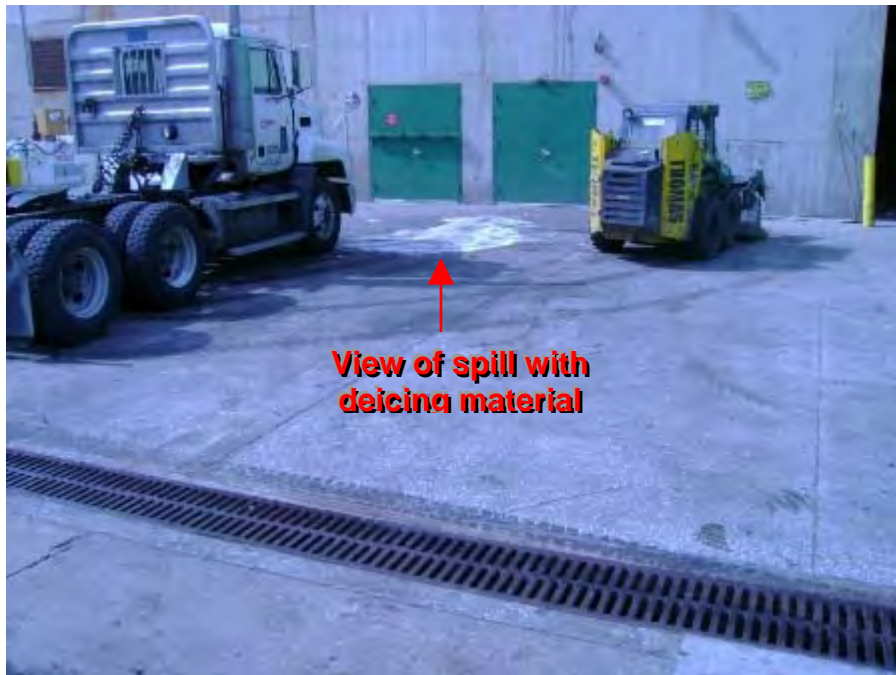
Photograph 60. Northwest Transfer Station – View of an apparent petroleum spill at the loading dock. The inspectors noted that deicer had been placed on the spill in an apparent attempt to clean up the spill.

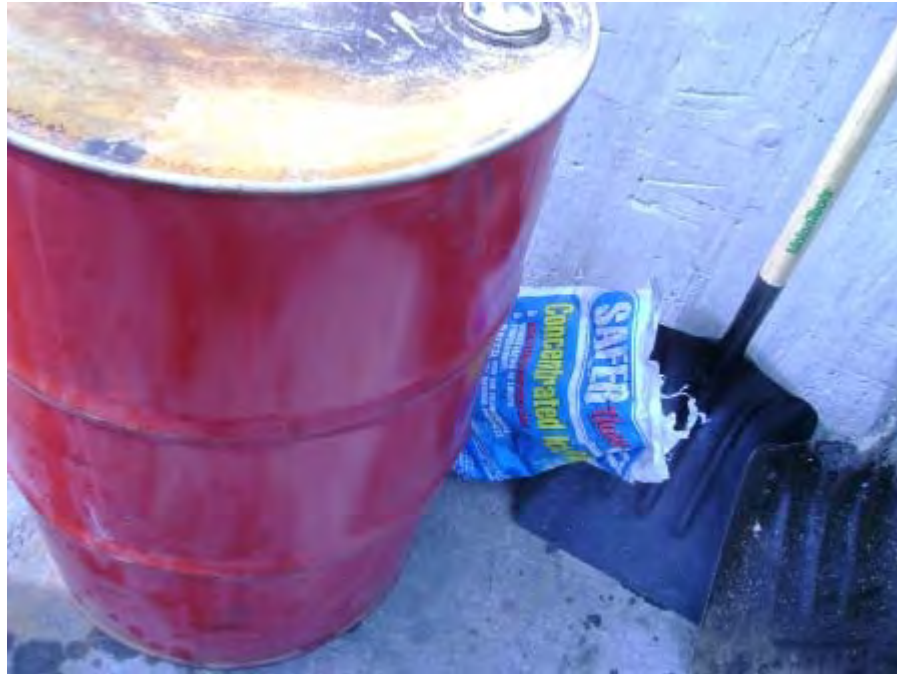
Photograph 61. Northwest Transfer Station – View of deicing material used for petroleum spill control/cleanup in previous photo.

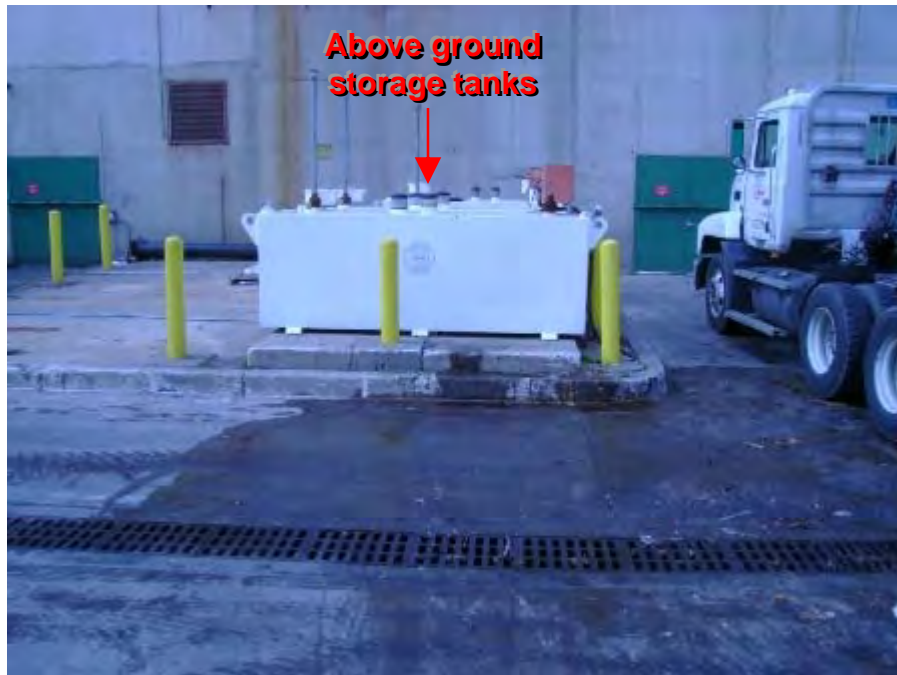
Photograph 62. Northwest Transfer Station – View of a large spill in the loading dock area (separate from spill with deicing material) to a trench drain. The facility representative stated that he was not aware of the cause of the spill, but did state that the three above ground storage tanks were not in use.

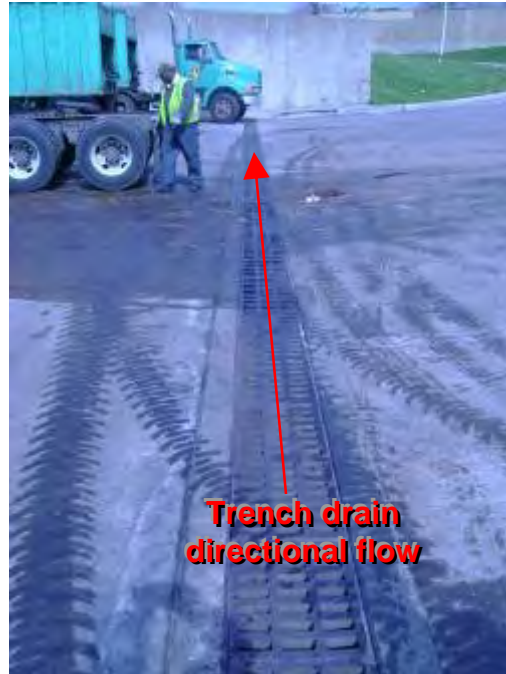
Photograph 63. Northwest Transfer Station – Another view of the larger spill to a trench drain.

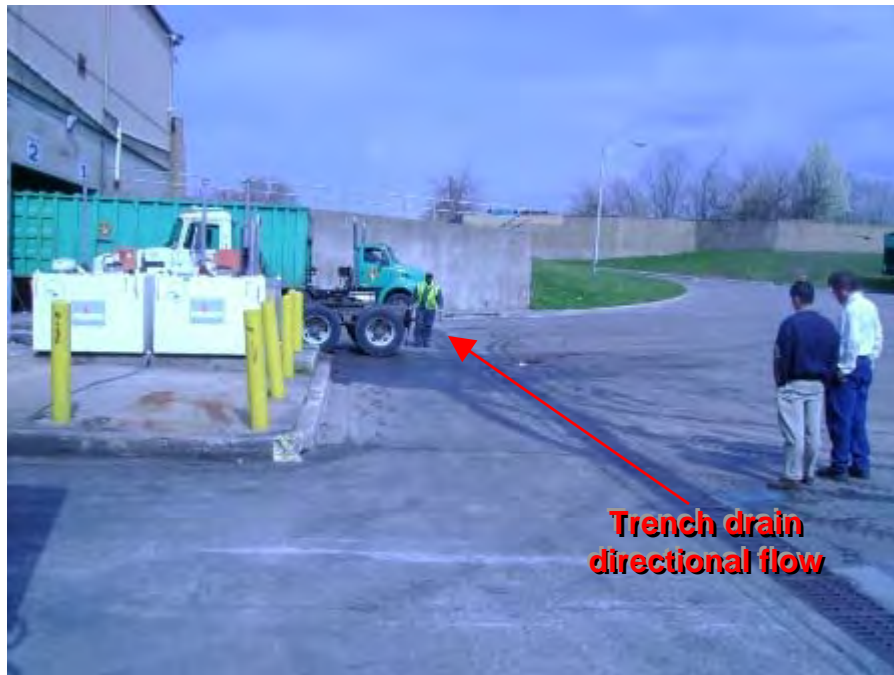
Photograph 64. Northwest Transfer Station – Another view of the larger spill to a trench drain.

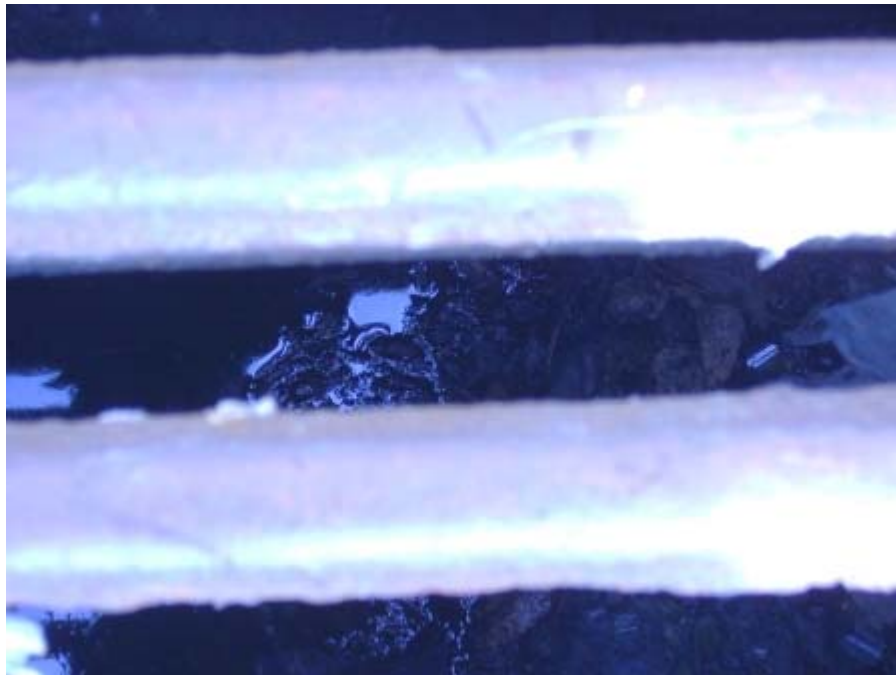
Photograph 66. Northwest Transfer Station – View into the trench drain outlet.
(NOTE: Oily substance inside drain)

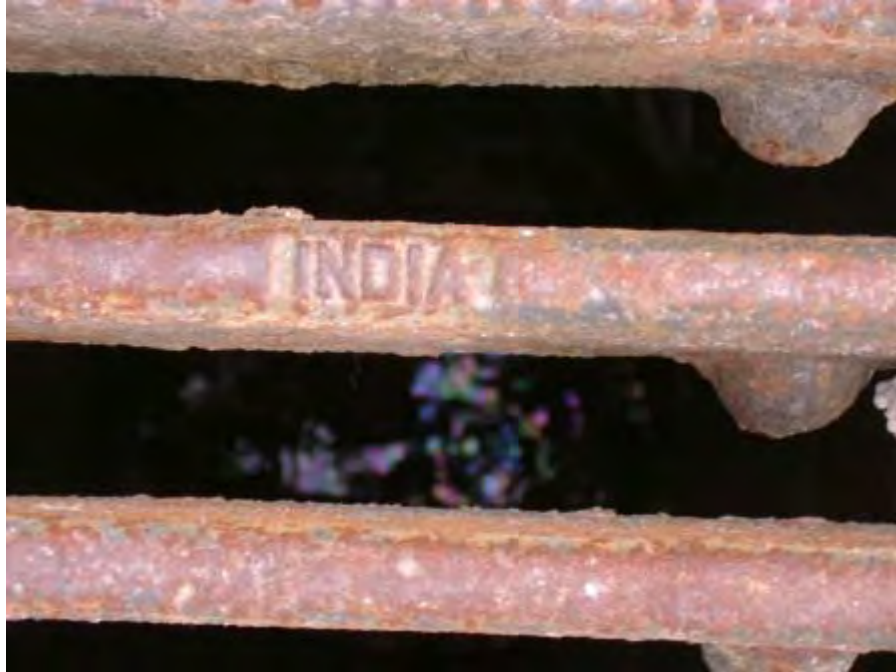
Photograph 67. Northwest Transfer Station – View of sheen on flowing water inside storm drain downstream of larger spill.

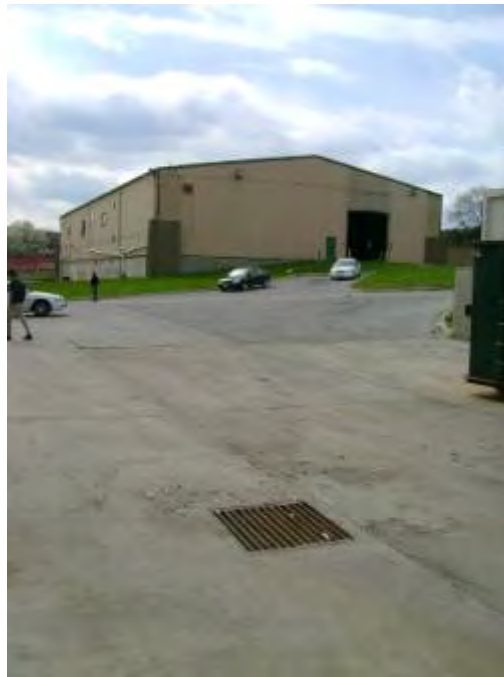
Photograph 68. Northwest Transfer Station – View of storm drain from previous photo noted downstream of larger spill.

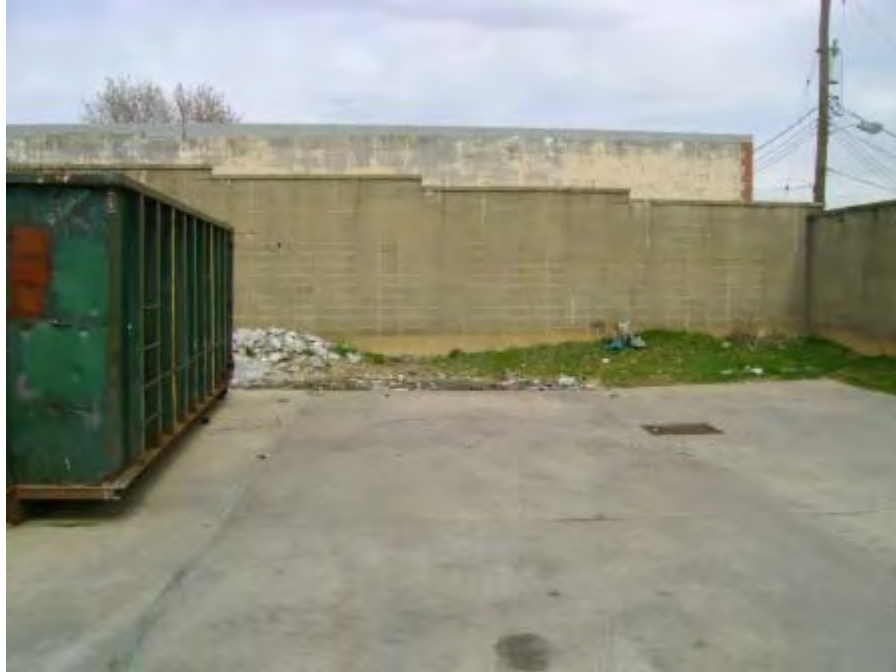
Photograph 69. Northwest Transfer Station – Another view of storm drain from previous photos noted downstream of larger spill. According to City personnel, the dumpster to left was previously used for the collection of tailings from street sweepers which would potentially result in an illicit discharge to the City’s storm sewer system.
No street sweeping storage was noted during the visit.

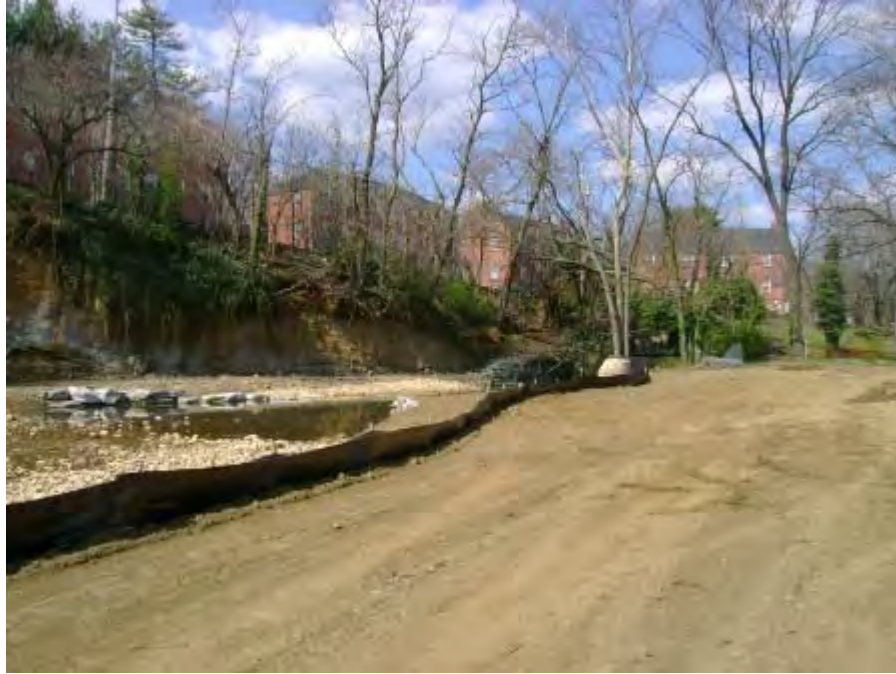
Photograph 75. Maiden's Choice Stream Restoration Project – View of silt fence along stream restoration project.

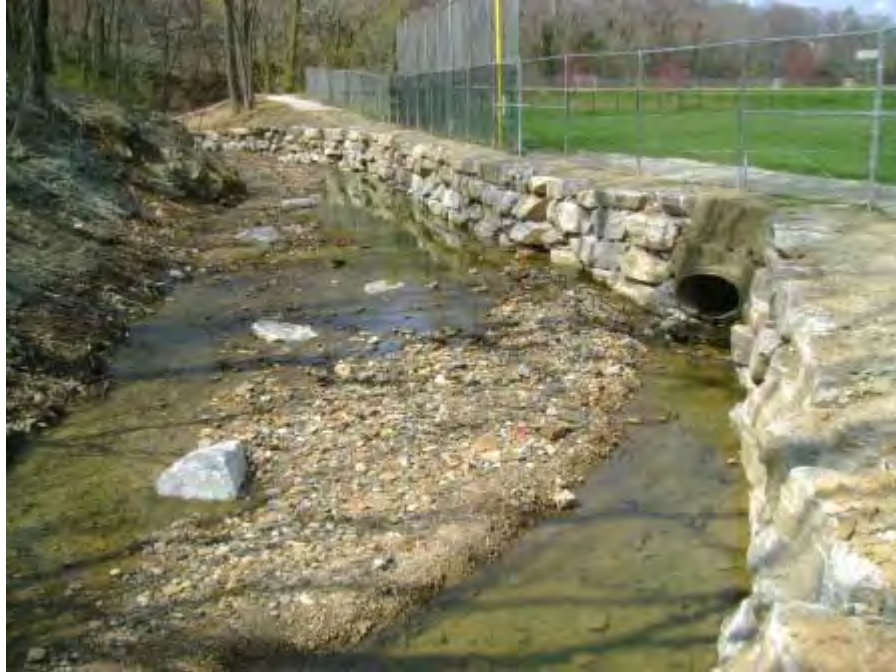
Photograph 77. Maiden's Choice Stream Restoration Project – View of stream restoration activities. (NOTE: Retaining wall and new outfall along bank)
