Big Sewickley Creek Watershed Management Recommendations

## **Big Sewickley Creek Biological Assessment**

July 24 & 25, 2008

# Big Sewickley Creek Biological Assessment

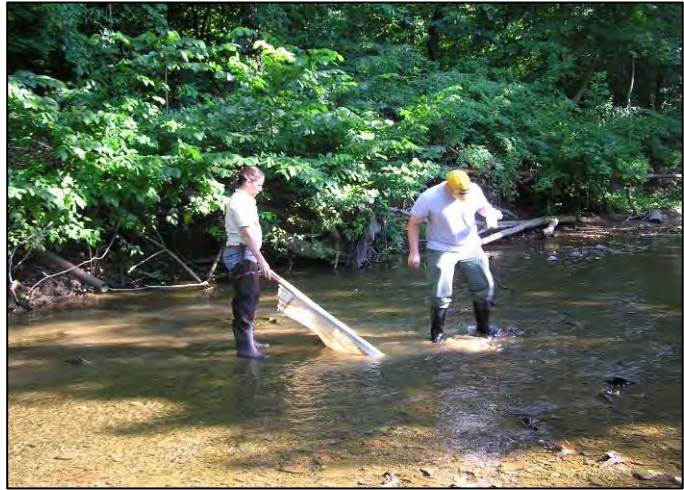
Figure 1 exhibits the water chemistry analysis for this site. Site 1 had one of the four highest pH levels at 8.20 and all other measurable levels were relatively average. The water chemistry analysis summary can be found in Figure 26 (Page 21).

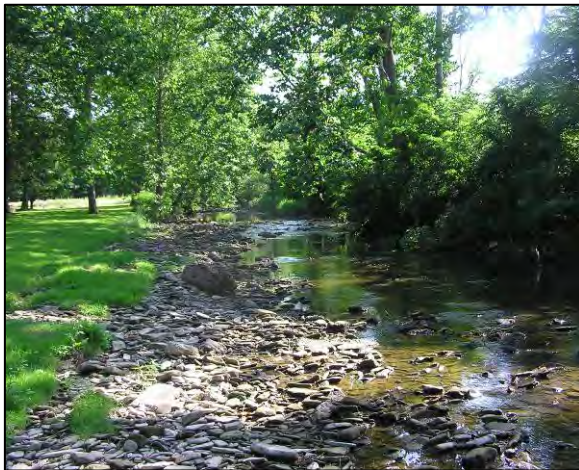
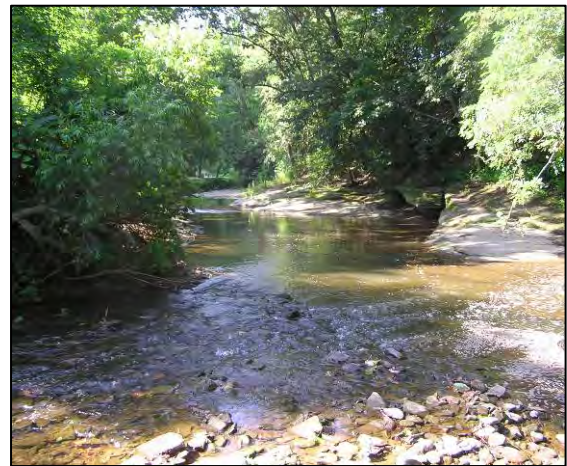
Figure 3 (Page 7) exhibits the water chemistry analysis. This site resulted in the highest phosphate level. Otherwise, the site ranked relatively average compared to other sites. The water chemistry analysis summary can be found in Figure 26 (Page 21).

Site 2 is the first site where a fish survey was conducted. The data from the survey resulted in the highest count of species, 14 of the 20 species, found at the three sites. This site also resulted in the largest amount of individuals identified (491 of the 766). Thus, Site 2 composed 64% of the total individuals identified in the watershed. Six of the 14 species identified at Site 2 contained five or fewer individuals collected in the sample. This group consisted of 42.8% of all species found on site and 2.8% of all individuals on site. Eight of the 14 species collected included eight or greater individuals collected at Site 2. This group consisted of 57.1% of the species sampled on site and 97.4% of the individuals sampled at Site 2. Figure 5 (Page 7) reflects the fish species and their abundance at this site.

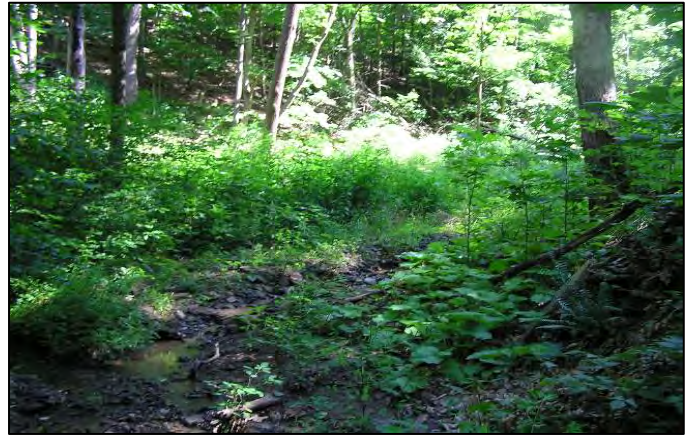
Figure 7 exhibits the water chemistry analysis. This site had one of the four highest pH levels at 8.20 and the highest turbidity level. However, this site also had the lowest recorded water temperature at 65.6 degrees Fahrenheit. It must also be noted that this site was one of three sites with the lowest reading of nitrates. The water chemistry analysis summary can be found in Figure 26 (Page 21).

Figure 8 lists the metrics that the macroinvertebrates were measured against. The Shannon Diversity Index (H) resulted in a score of 0.41605. This site scored the lowest on the Shannon Diversity Index, showing this site had the lowest richness and relative abundance of macroinvertebrate species. Pollution Tolerance Index (PTI) resulted in a “poor” ranking.

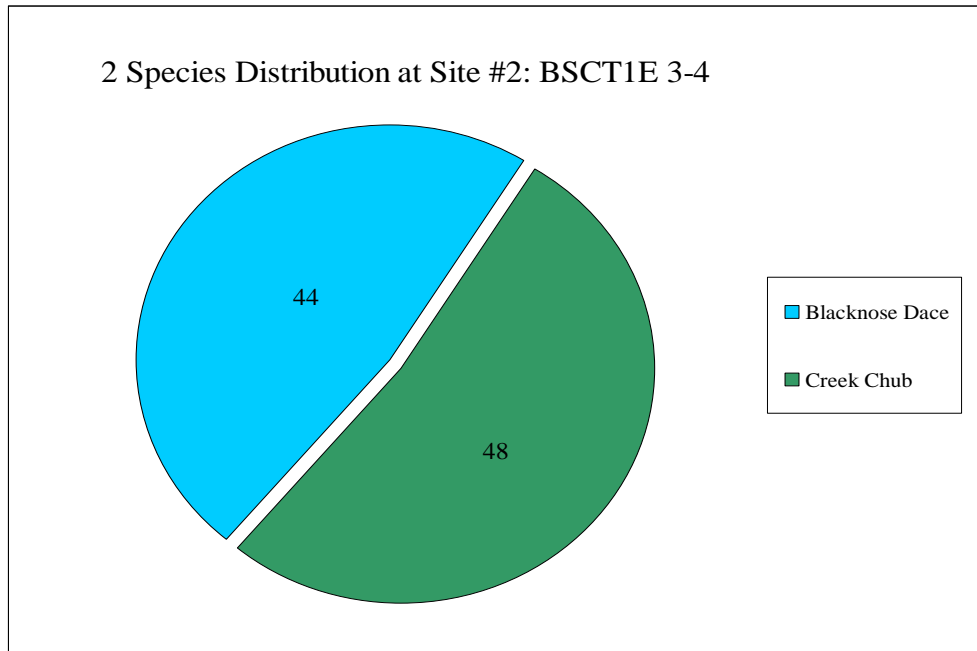
The only two species that were surveyed at this site were the blacknose dace (*Rhinichthys atratulus*), Illustration 3, and the creek chub (*Semotilus atromaculatus*), Illustration 4. These species were found in nearly equal quantities; creek chub (52.17% of the sample and 48 individuals) and the blacknose dace (47.82% of the sample and 44 individuals). Figure 11 (Page 12) reflects the fish species and their abundance at this site.

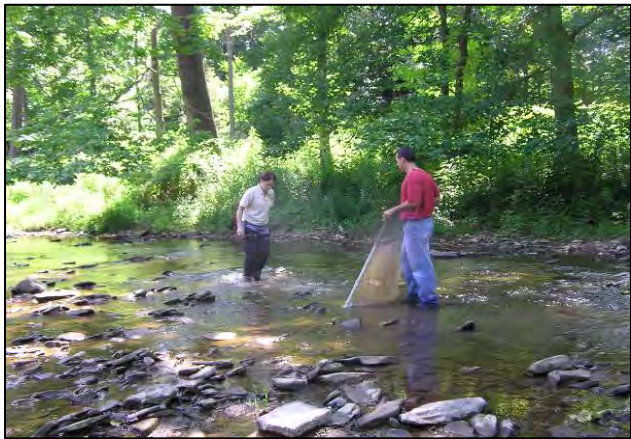
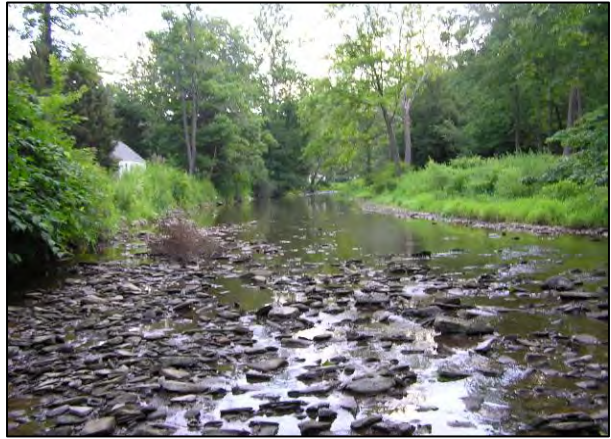
Figure 13 (Page 14) exhibits the water chemistry analysis. This site had one of the four highest pH levels at 8.20. Conversely, this site demonstrated the highest dissolved oxygen, one of the four lowest turbidity readings, and one of the three lowest nitrate readings. The water chemistry analysis summary can be found in Figure 26 (Page 21).

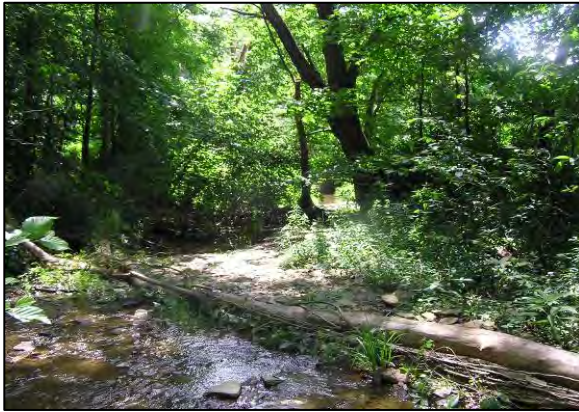
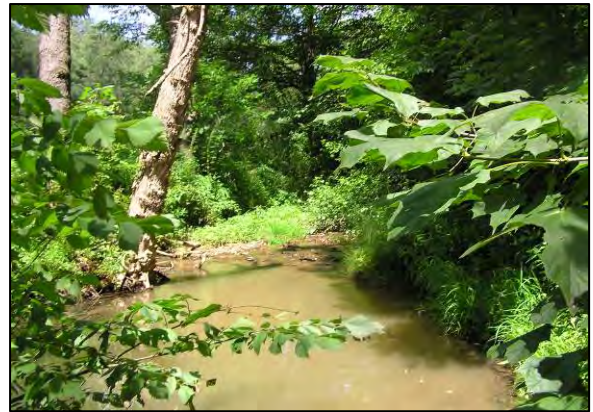
Figure 15 (Page 16) exhibits the water chemistry analysis. This site demonstrated one of the two lowest pH levels at 7.80, one of the two lowest total dissolved solids (TDS) levels at 320ppm, and did not register any phosphates or nitrates. However, this site also had the lowest dissolved oxygen and the highest water temperature at 74.5 degrees Fahrenheit. Site 6 possessed the best water quality readings overall, of the nine sampled sites in the Big Sewickley Watershed assessment. The water chemistry analysis summary can be found in Figure 26 (Page 21).

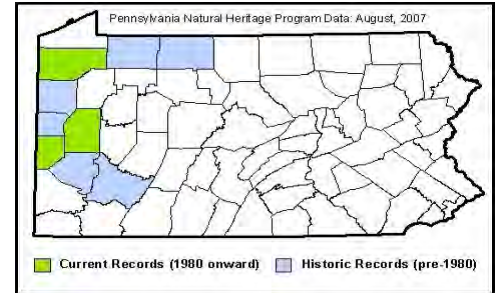
Chart 1 Pennsylvania Range of the Southern Redbelly Dace

It is important to note that one atypical fish species, the southern redbelly dace (*Phoxinus erythrogaster*), was identified at this site, Illustration 5. This is an atypical sampling since this species is found in low levels of abundance throughout the state. The southern redbelly dace is a temperate freshwater fish found in spring-fed headwater creeks. Southern redbelly daces are found throughout North America, but are found in isolated communities in Pennsylvania, see Chart 1. Current records show southern redbelly daces occurring in three Pennsylvania counties.

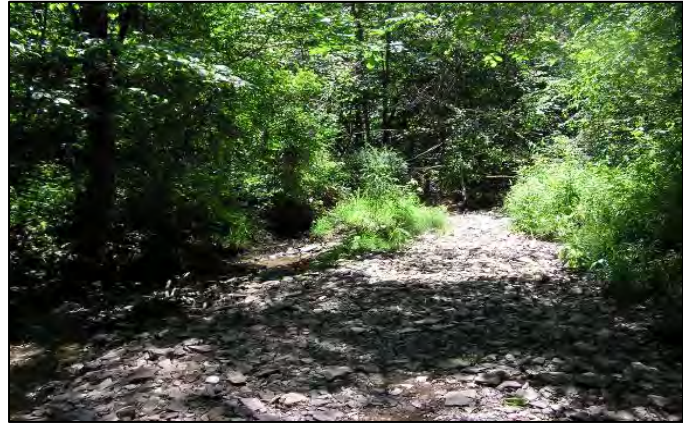
Figure 19 exhibits the water chemistry analysis. This site had the lowest level of conductivity and one of the four lowest levels of turbidity. The water chemistry analysis summary can be found in Figure 26 (Page 21).

Figure 20 lists the metrics that the macroinvertebrates were measured against. The Shannon Diversity Index (H) resulted in a score of 1.92131. Shannon Diversity indicated that this site had an average rank, meaning that this site had an average richness and relative abundance of macroinvertebrate species. Pollution Tolerance Index (PTI) resulted in a “fair” ranking.

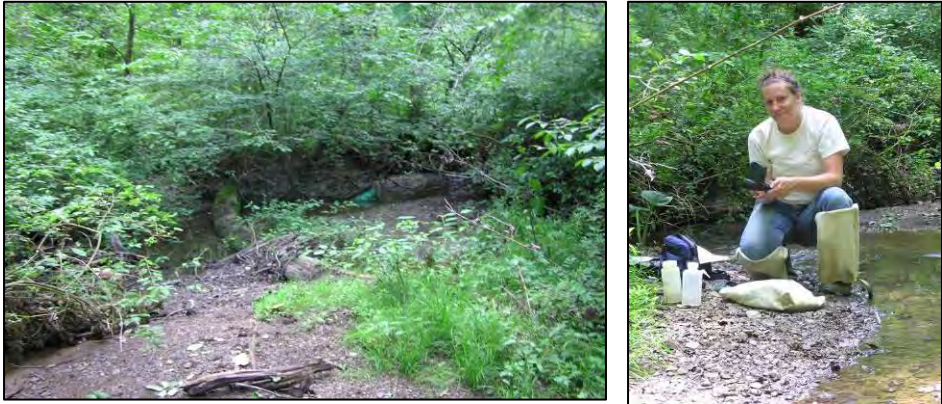
Figure 21 exhibits the water chemistry analysis. This site had one of the two lowest pH levels of 7.80. Conversely, this site also has the highest levels of; total dissolved solids, conductivity, and nitrates. The water chemistry analysis summary can be found in Figure 26 (Page 21).
