Buffalo Creek Watershed Assessment and Protection Plan

(Washington County, PA and Brooke and Ohio Counties, WV)

June 2005

Western Pennsylvania Conservancy
Watershed Assistance Center
246 South Walnut Street
Blairsville, PA 15717

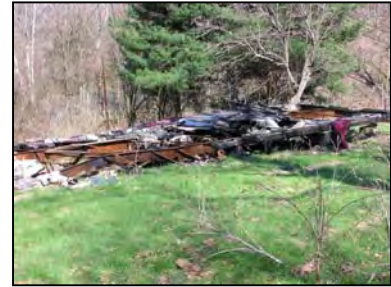
An old trailer foundation and trash at Polecat Hollow

Illegal trash and animal carcass dumping is a frequent problem cited by residents. This dumping most commonly occurs within State Game Lands 232 because the area is infrequently traveled. However, the Pennsylvania Game Commission maintains a number of video cameras and will enforce its no dumping policy if violators are identified. Locations of dump piles that were identified during this plan existed mainly along Buffalo Camp Road and the path leading to Polecat Hollow. These roads have been closed, and as of publication remain closed, likely decreasing the ease of dumping. Trash piles were also identified at the intersection of Dutch Fork Creek and Buffalo Creek. This trash often enters the stream during rain events. Besides being an eyesore, trash piles can be environmental and safety hazards. Old tires are breeding grounds for mosquitoes and many old refrigerators and other appliances contain dangerous chemicals.

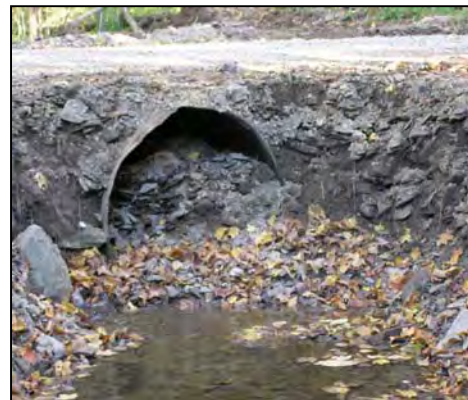
An inadequately designed culvert and endwall from a Buck Run tributary filled with sediment after a flood in 2004.

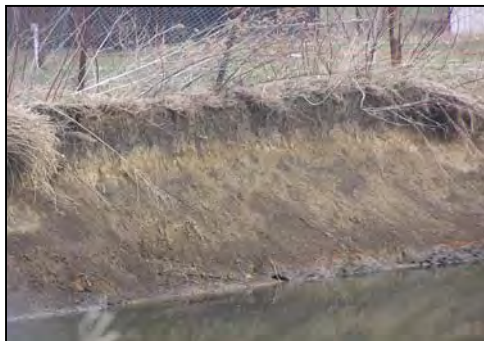
Severe erosion along a section of Buffalo Creek, resulting in significant loss of streambank each year
