14 digit Hydrologic Unit Code (HUC) 05010008020220 encompasses the Blackleggs Creek Watershed located in southwestern Indiana County and southeastern Armstrong County. The portion of this HUC located in Armstrong County consists of 6.06 square miles of the Whiskey Run (1.17 square miles) and Big Run (4.89 square miles) Sub Watersheds (Figure 1). This comprises 24% of the entire Whiskey Run Sub Watershed and 55% of the entire Big Run Sub Watershed. The Pennsylvania Department of Environmental Protection (PA DEP 2001) list both these sub watersheds as cold water fisheries (CWF).

14 digit Hydrologic Unit Code (HUC) 05010008020240 encompasses an approximately 33.0 square mile portion of the Kiskiminetas River Watershed located in Armstrong County (Figure 10). Eleven tributaries (Sulphur Run, Long Run, Flat Run, Roaring Run, Sugar Hollow, and six unnamed) enter the Kiskiminetas River in this section (Figure 11 and Table 5). The Pennsylvania Department of Environmental Protection (PA DEP 2001) lists all these streams, except Sulphur Run and Roaring Run, as warm water fisheries (WWF). Sulphur Run and Roaring Run are listed as cold water fisheries (CWF).

14 digit Hydrologic Unit Code (HU

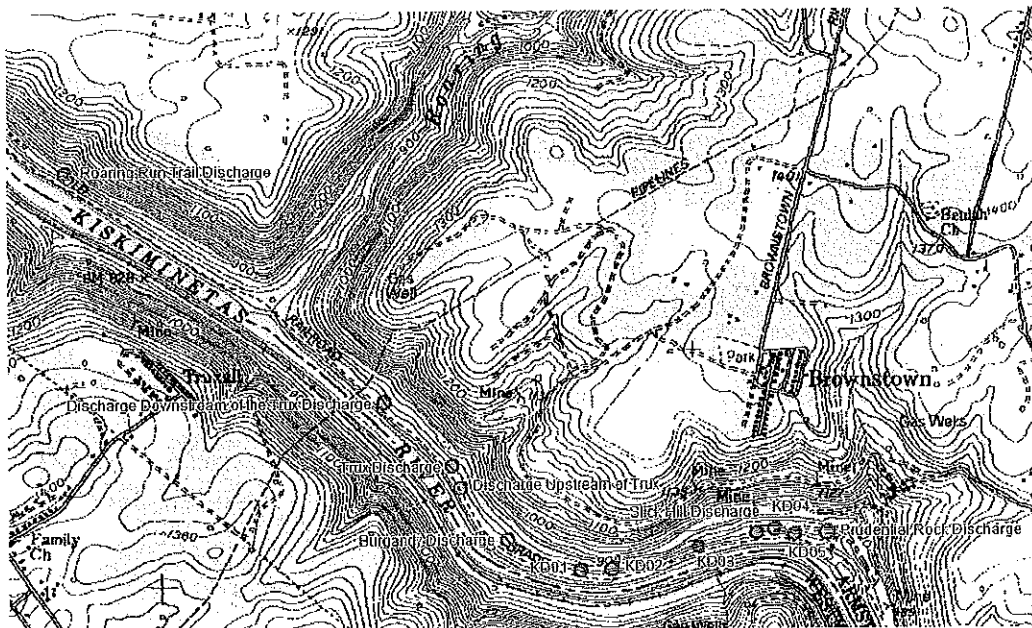
Eleven discharges enter the Kiskiminetas River between UT03 and Roaring Run. An additional discharge is found between Roaring Run and the parking lot for the Roaring Run Trail (Figure 15 and Table 10). All are acidic and range in flow from virtually 0.0 GPM to as high as 500 GPM. Table 10 organizes the water quality collected through this assessment, by Stream Team volunteers, and the United States Department of Agriculture Natural Resources Conservation Service.

Figure 15. The twelve discharges entering the Kiskiminetas River on the present Roaring Run Trail and the planned extension.

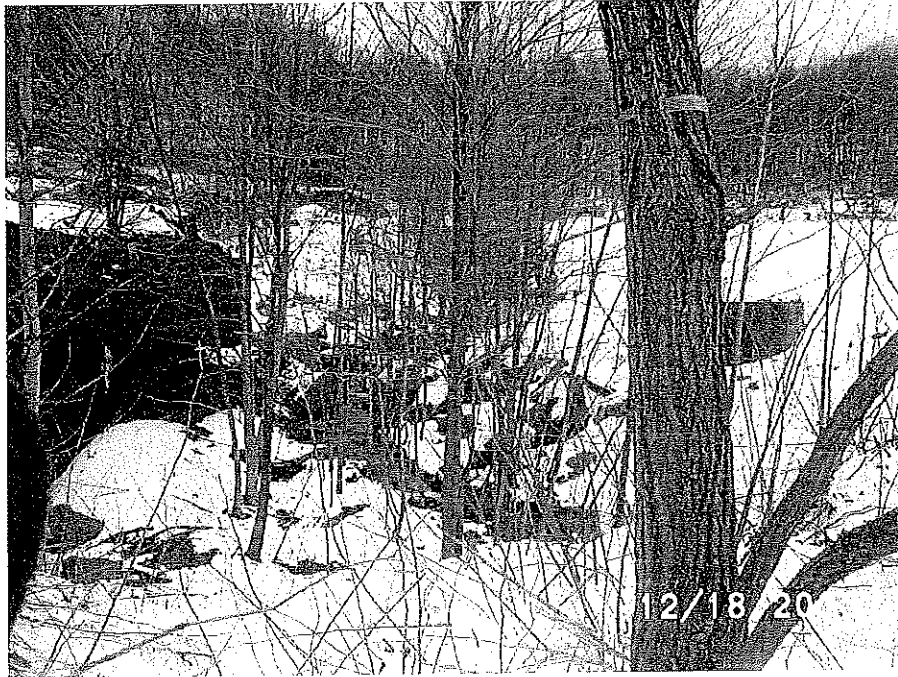
Figure 16. Picture of the Prudential Rock Discharge.

KR05 and KR04 are smaller flow discharges originating from the same general area as the Prudential Rock Discharge (Table 10). The water qualities of these two discharges need to be sampled on a regular basis as only field parameters were collected. Once collected, treatment options and funding should be obtained by the KWA and RRWA. These two discharges are so close to the Prudential Rock Discharge that all three could very well be treated in one system, thus decreasing treatment size and cost.

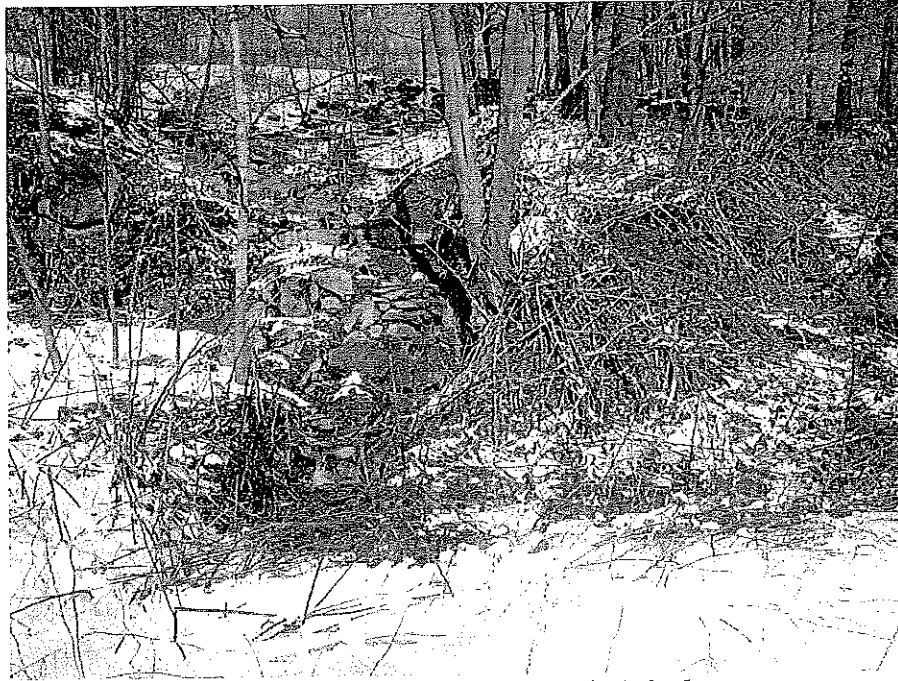
Figure 17. Picture of the Slick Hill Discharge.

KR03, KR02, and KR01 are smaller flow discharges originating between the Slick Hill Discharge and the Burgundy Discharge from the same general mining impacted stretch of the north bank (Table 10). The water qualities of these three discharges need to be sampled on a regular basis as only field parameters were collected. Once collected, treatment options and funding should be obtained by the KWA and RRWA.

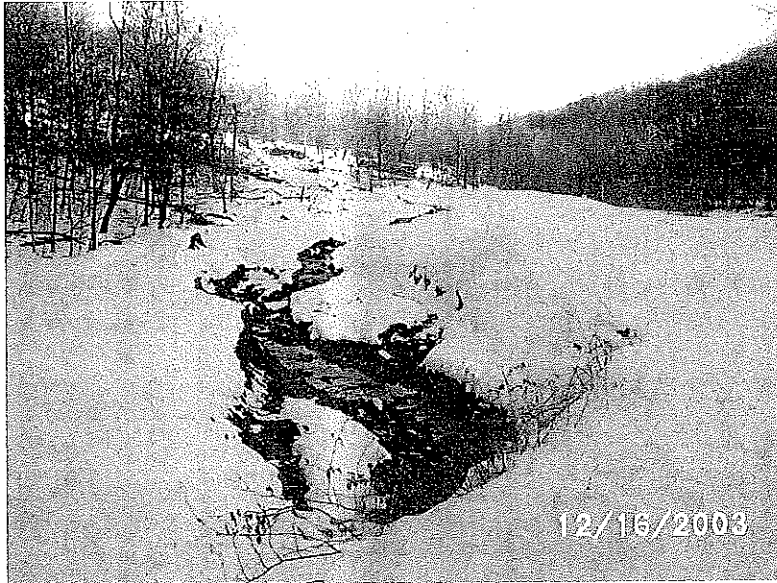
The Burgundy Discharge is the first discharge sampled monthly by employees of CWM Environmental (Figure 18 and Table 10). The reasons it was selected were the degraded quality of the water, the land available for treatment, and the location is very close to the beginning of the planned extension of the Roaring Run Trail. The Burgundy Discharge's average input to the Kiskiminetas River is 150.79 tons/year of acidity, 81.33 tons/year of Fe, 3.43 tons/year of Mn, and 18.91 tons/year of Al.

Figure 18. Picture of the Burgundy Discharge.

There seems to be enough room to be able to treat this discharge, however, the quality of the discharge may make passive treatment difficult. The area where it originates also resembles the Trux Discharge area before it was reclaimed by the RRWA through a PA DEP Growing Greener Grant (Figure 19). If, upon further study, passive treatment would not be successful, the RRWA and KWA should obtain funding to complete a similar land reclamation project as was completed at the Trux Discharge.

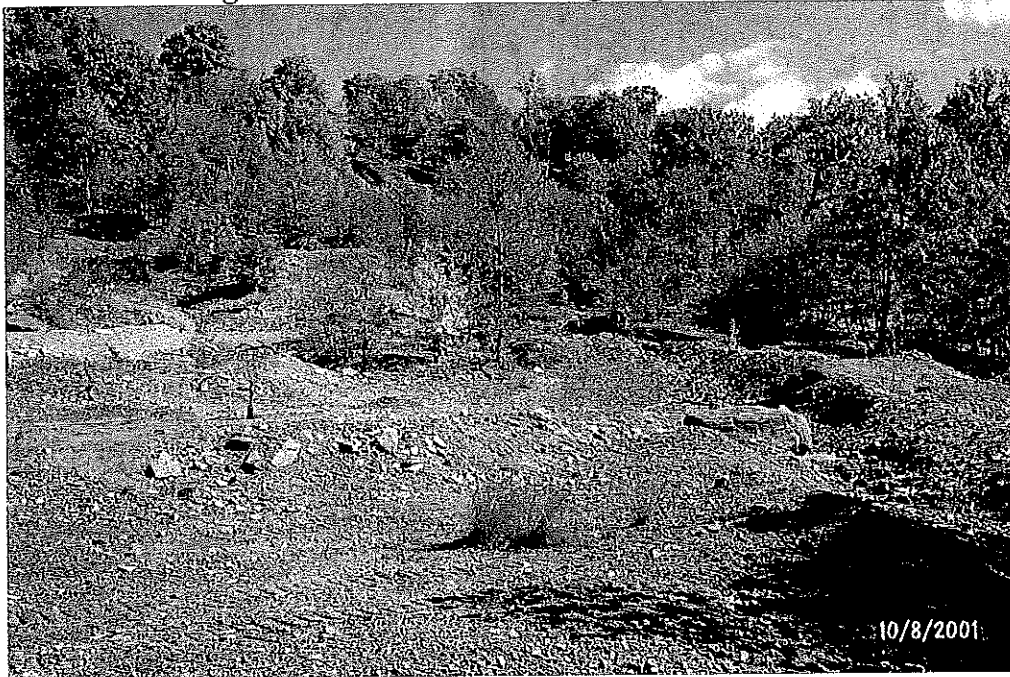
Figure 19. The area that needs reclaimed at the Burgundy Discharge.

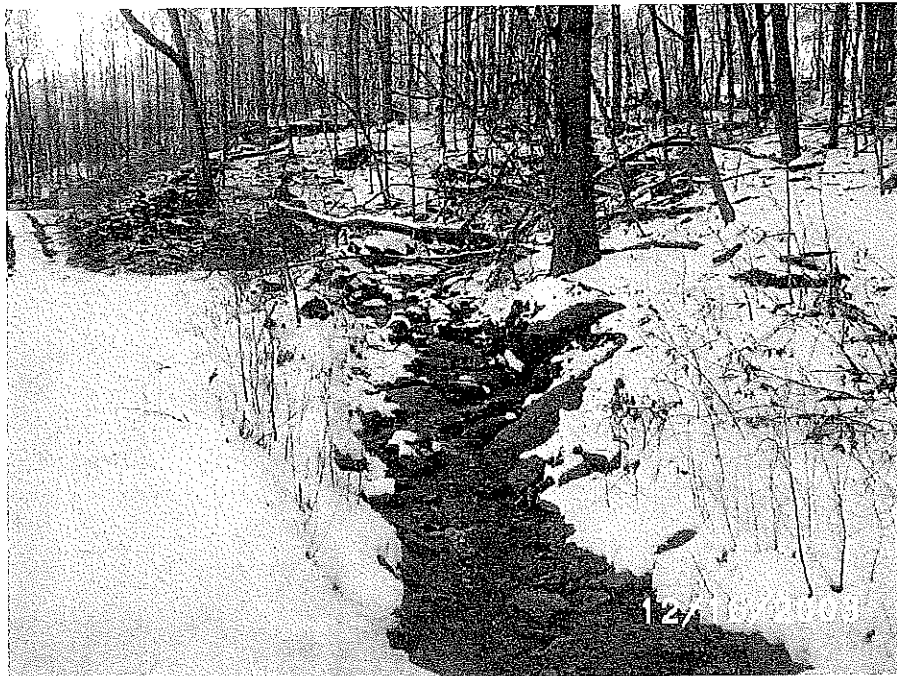
Figure 20. Picture of the Discharge Upstream of Trux.

Ninevah Borehole Alkaline Fly Ash Pilot Project is a success, the RRWA and KWA should look into this for possible in-situ treatment.

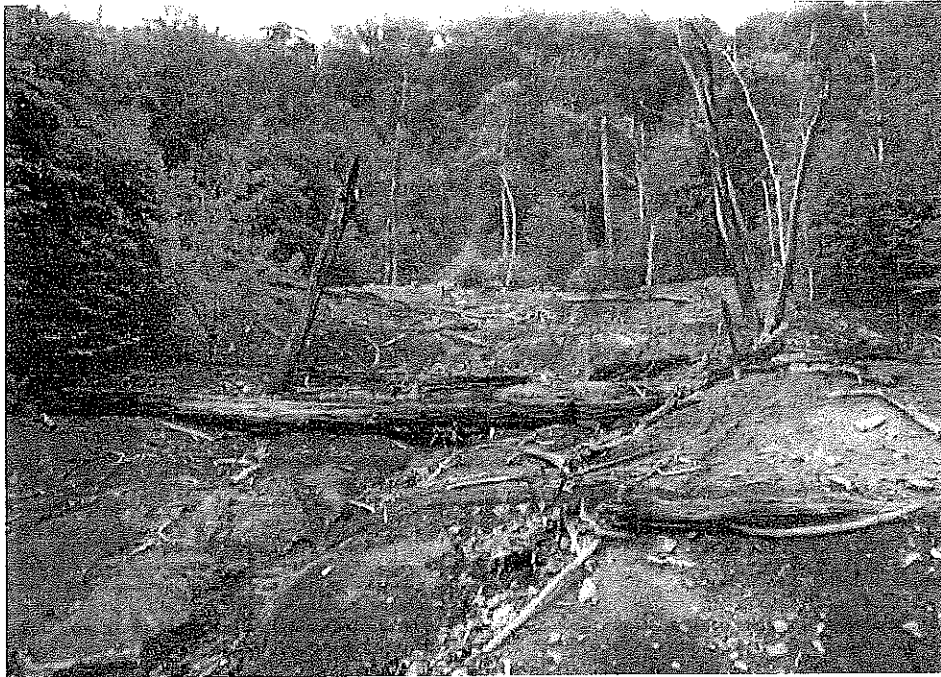
Figure 21. The area surrounding the Trux Discharge before reclamation.

also included riverbank reinforcement and construction of a fish habitat structure (Figure 21 and 22). The project was a huge success for the RRWA; however, the Trux Discharge could not be treated and still greatly degrades the Kiskiminetas River. As stated before, if the Ninevah Borehole Alkaline Fly Ash Pilot Project is a success, it may be applicable to the Trux Discharge. This may be a perfect candidate for the next fly ash injection project and PA DEP BAMR should be contacted in the future to gauge interest.

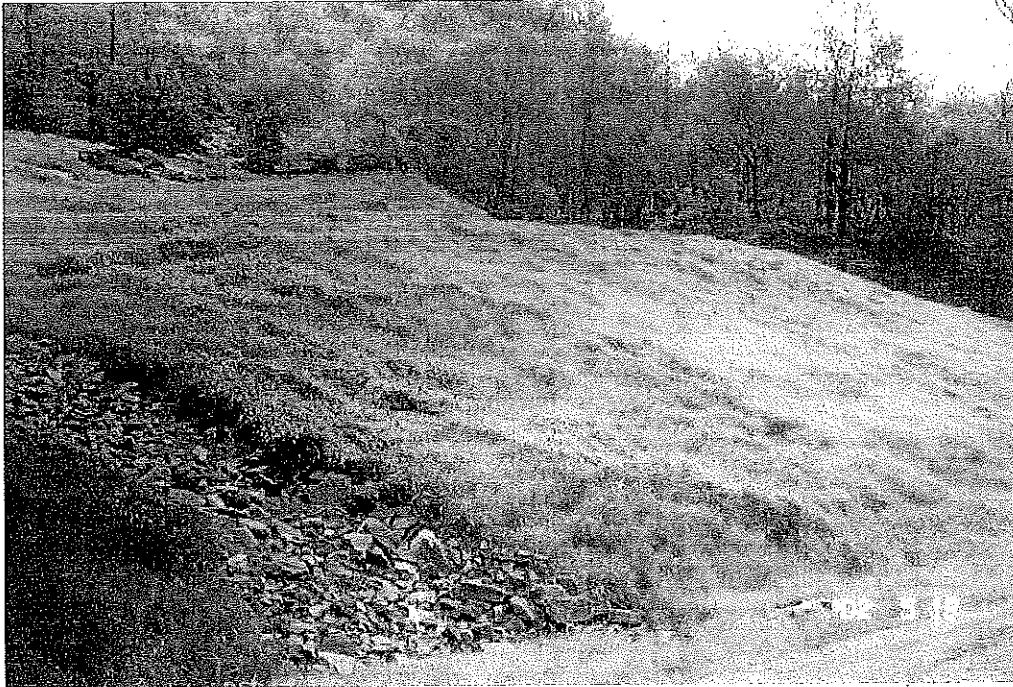
Figure 22. The area surrounding the Trux Discharge after reclamation.

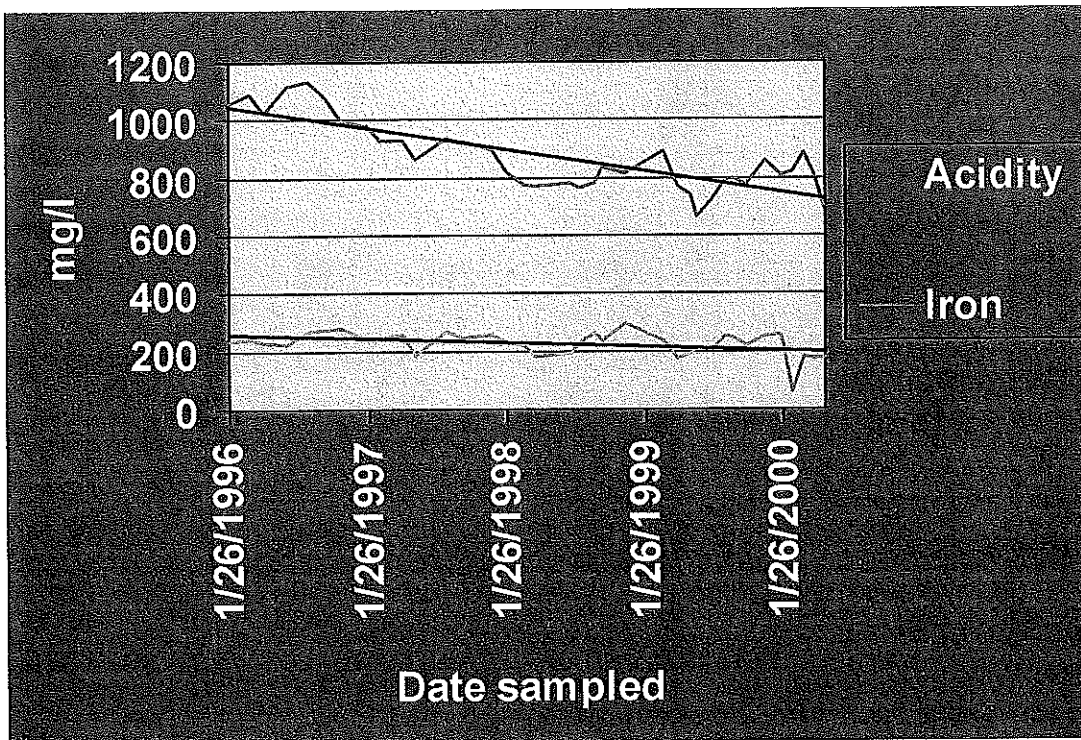
The one positive of the Trux Discharge is that its water quality seems to be improving, especially in terms of the two major constituents, acidity and Fe (Figure 23).

Figure 23. Acidity and Fe concentration of the Trux Discharge over time.

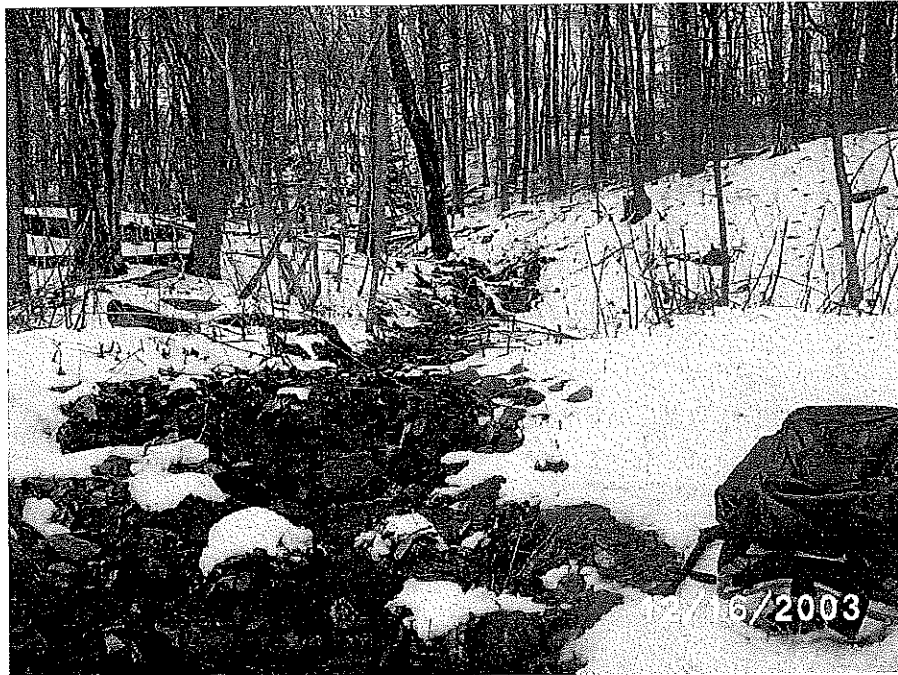
Figure 24. Picture of the Discharge Downstream of Trux.

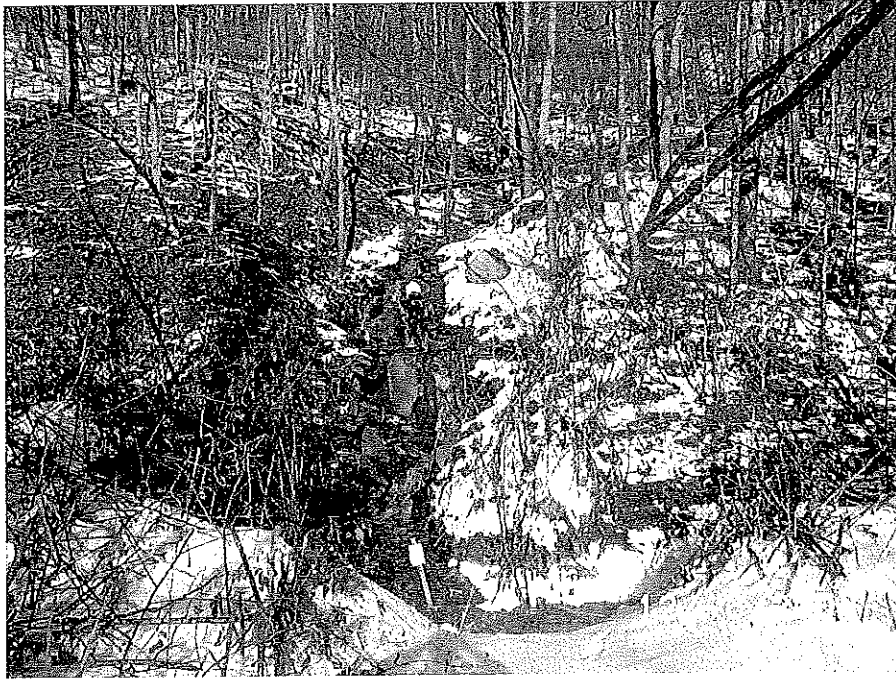
The Roaring Run Trail Discharge also originates on a steep slope, limiting the available passive treatment area (Figure 25 and Table 10). The Roaring Run Trail Discharge's average input into the Kiskiminetas River is 21.06 tons/year of acidity 2.90 tons/year of Fe, and 3.46 tons/year of Al

Figure 25. Picture of the Roaring Run Trail Discharge.

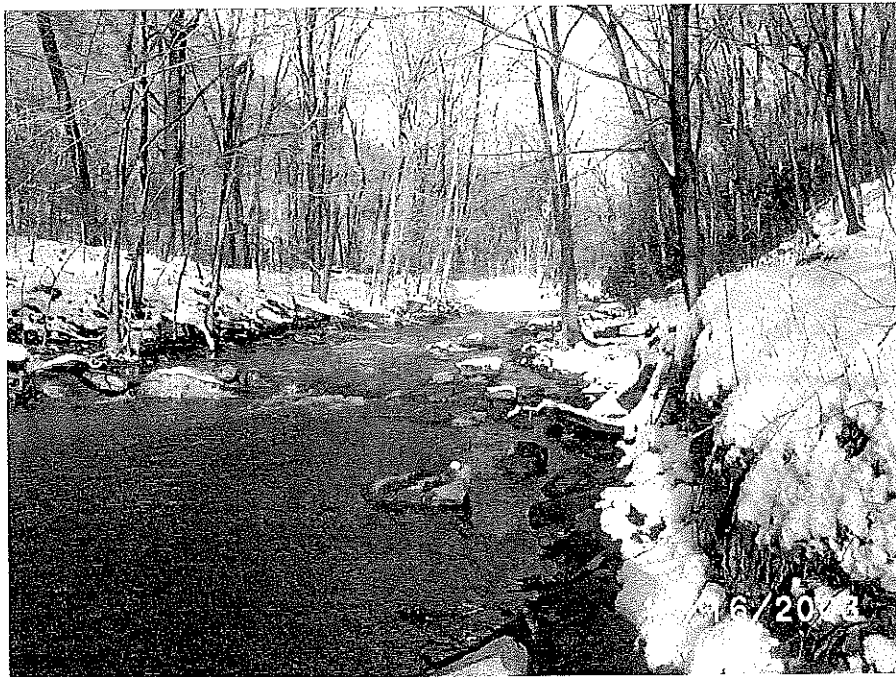
Figure 26. Roaring Run near its confluence with the Kiskiminetas River.

Roaring Run (13.85 square miles), the largest sub watershed in the Armstrong County section of this HUC and the second largest Kiskiminetas River tributary in Armstrong County, has sections that are slightly to moderately impacted by AMD (Figure 11 and 26 and Tables 11 and 13). However, Roaring Run is also arguably the tributary with the most potential in the Kiskiminetas River Watershed proper.

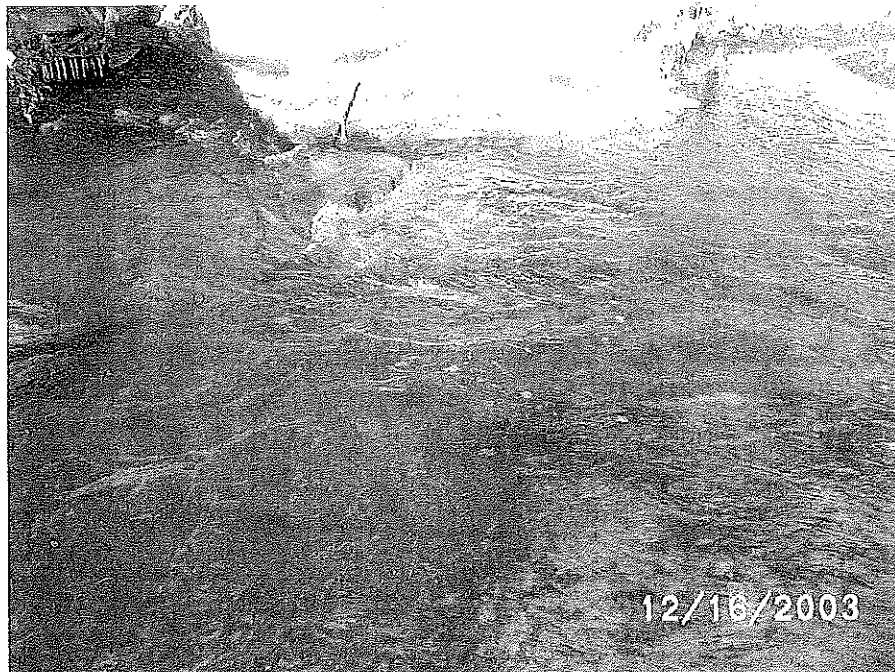
A short study was completed in this section of Roaring Run in December of 2003 to document the impacts these discharges have on the water quality of Roaring Run. The pH and conductivity of Roaring Run decreases by 1.8 units and increases by 30 from upstream to downstream of these five discharges. Fe and Al precipitation is also visible in Roaring Run upstream of the confluence of Rattling Run (Figure 29). Rattling Run then enters and dilutes Roaring Run, improving the water quality slightly.

Figure 29. Fe and Al precipitation in Roaring Run upstream of Rattling Run.

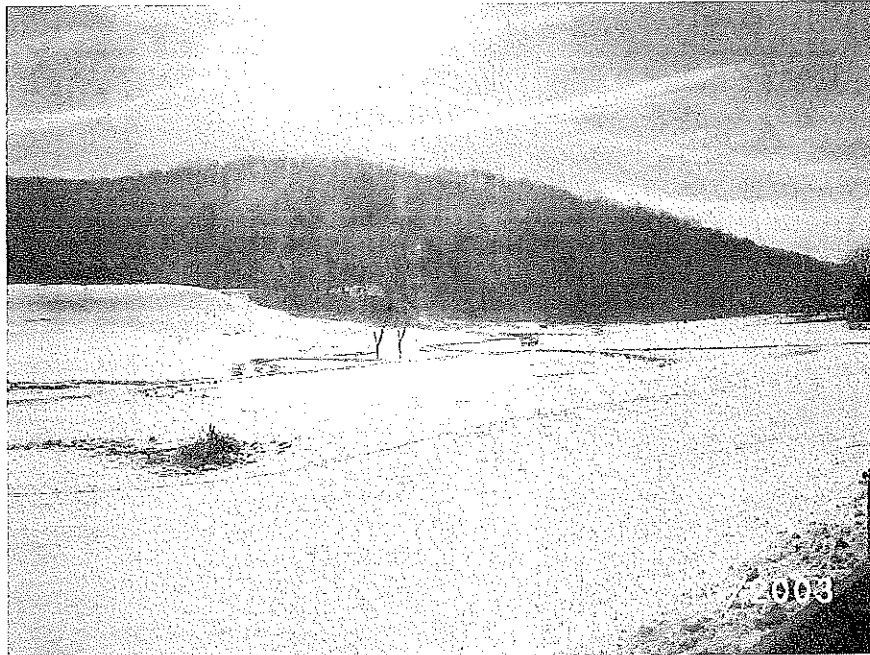
Figure 34. Stretch of Long Run in need of stream bank fencing.

The RRWA and KWA, in partnership with the Armstrong Conservation District (ACD), should approach the owners of these stretches in order to gauge interest in a stream bank fencing/stabilized cattle crossing cost share grant proposal. If there is interest and the grant is funded, completed projects could then be used as demonstration projects for other farmers around the watershed.

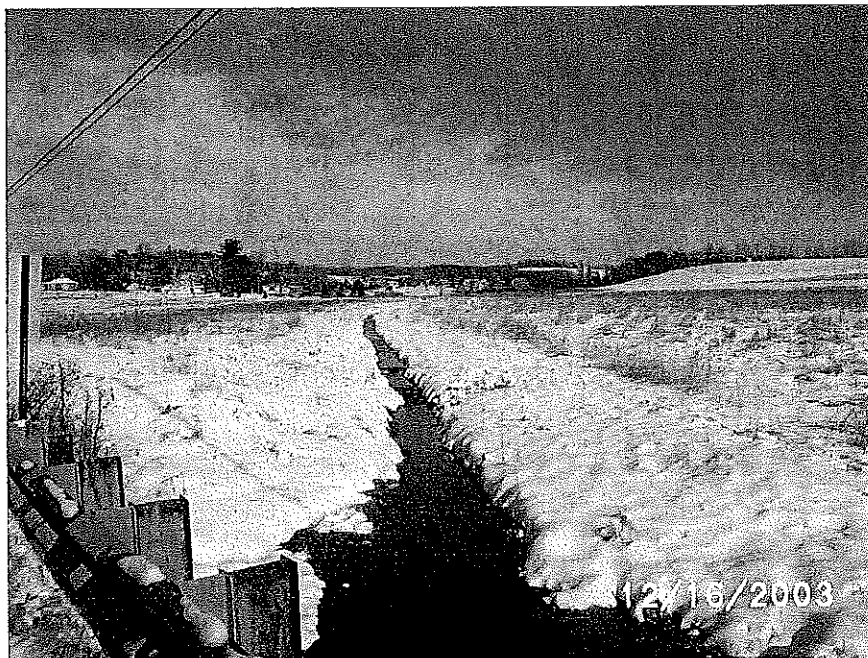
There are also other areas in the watershed where cropland infringes upon the stream channel, especially in the headwaters of Flat Run (Figure 35). The RRWA and KWA should encourage the ACD to work with farmers in this area to increase the riparian buffer along stream banks.

Figure 35. Cropland/hayfields infringing on Flat Run's riparian area.

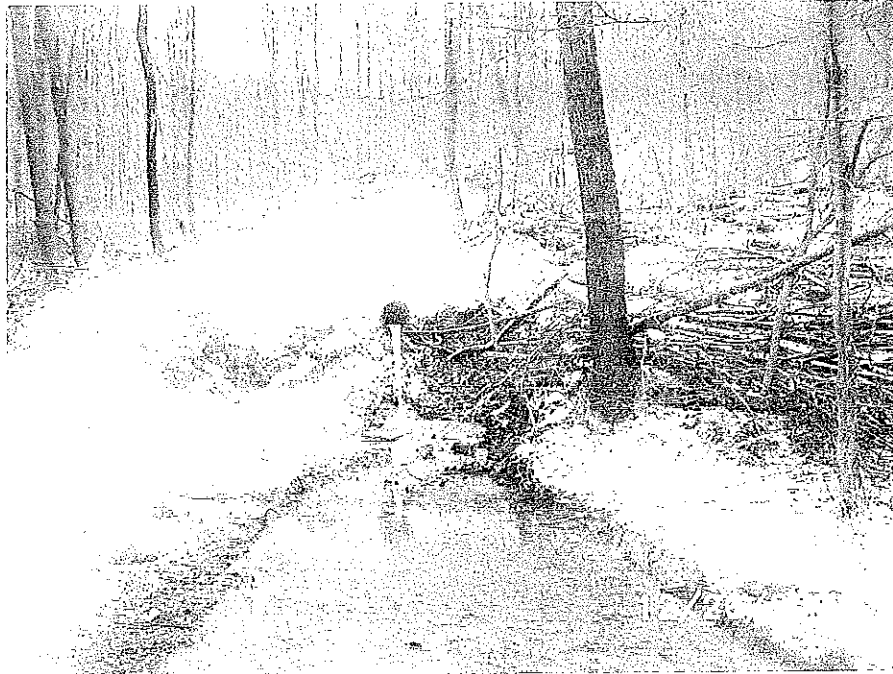
Figure 42. The Clark Hollow Discharge after discharge pipe installation.

same PA DEP personnel to discuss if there is the possibility of this mine as the cause of the Clark Hollow Discharge. If it is, the mining company may be responsible for the elimination/treatment of the discharge.

4. Contact the PA DEP about possible active mining causing the Clark Hollow Discharge. If it is not being caused by active mining, study area for possible site to treat passively.

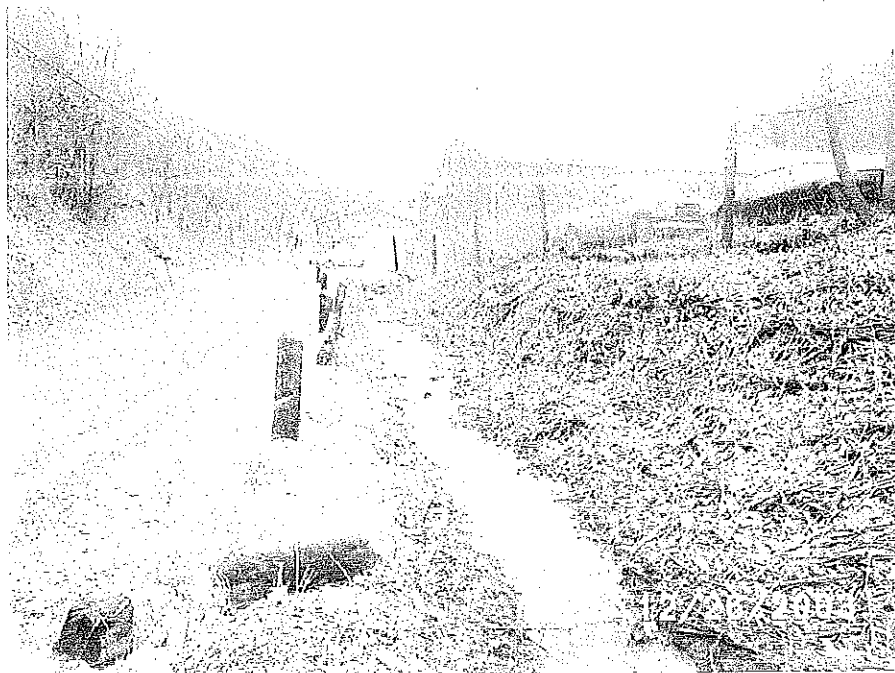
Figure 45. The Hungry Hollow Discharge before entering Guffy Run.
