NORTHERN BEAR RUN

Coldwater Conservation Plan

PREPARED BY:
WESTERN PENNSYLVANIA CONSERVANCY

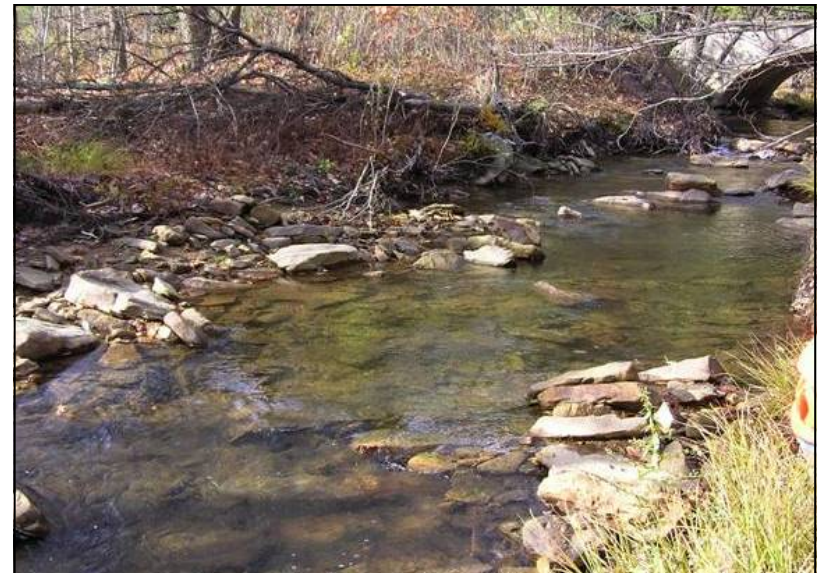
BR-3 directly above confluence with South Branch .

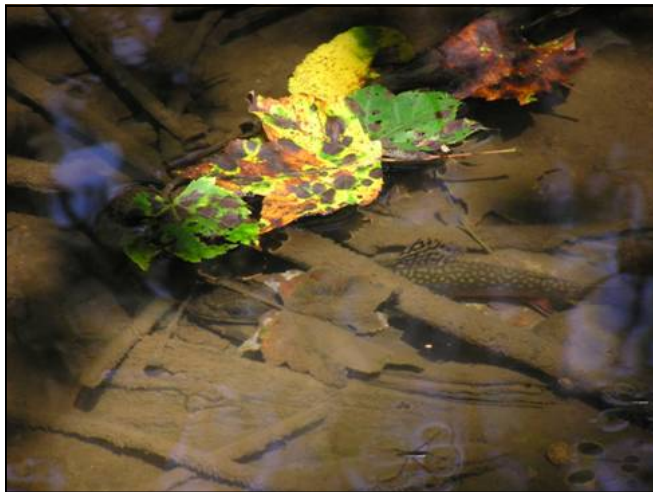
At BR-4, a native brook trout survives within a slow-moving, sediment-filled stretch of the stream.

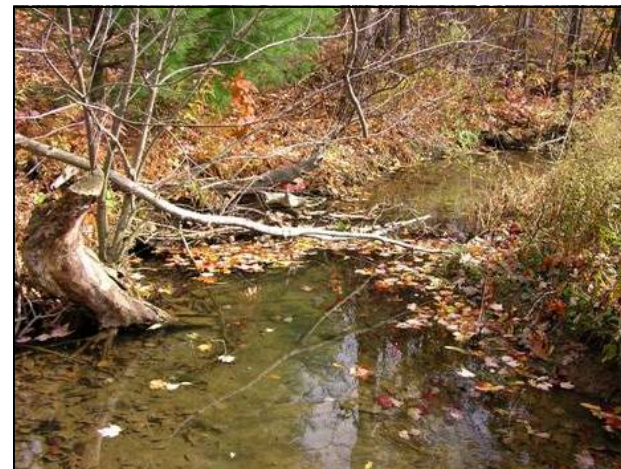
BR-4 displays increased sedimentation.

The headwaters of the main stem flow through hayland, pasture, row crops, residential properties, and under SR 1053 and SR 1054, before entering SGL 174. Site BR-4 is located upstream from Trib 27064, directly above the point at which the stream flows under SR 1053 and before entering SGL 174 (Map #1). This site possessed the most significant sedimentation when compared with the other three. The extensive agricultural land uses surrounding the tributaries of the North Branch have impacted the stream bottom in a way that is similar to site BR-1, leaving few macroinvertebrates with the ability to tolerate such sedimentation. In addition, these unnamed tributaries flow through scattered residential properties, where streambanks are maintained as part of manicured lawns. The shallow root system of the grasses provide little soil stabilization and promote undercutting and erosion of the streambanks. This, coupled with a lack of vegetative cover due to overgrazing and/or cultivation has added significantly to the sedimentation in the headwaters and throughout the watershed.

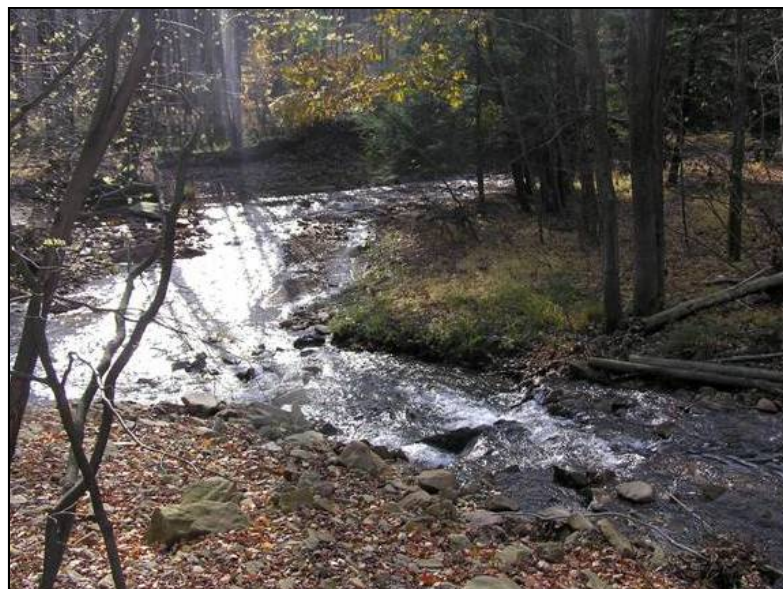
North Branch, directly above its confluence with South Branch.

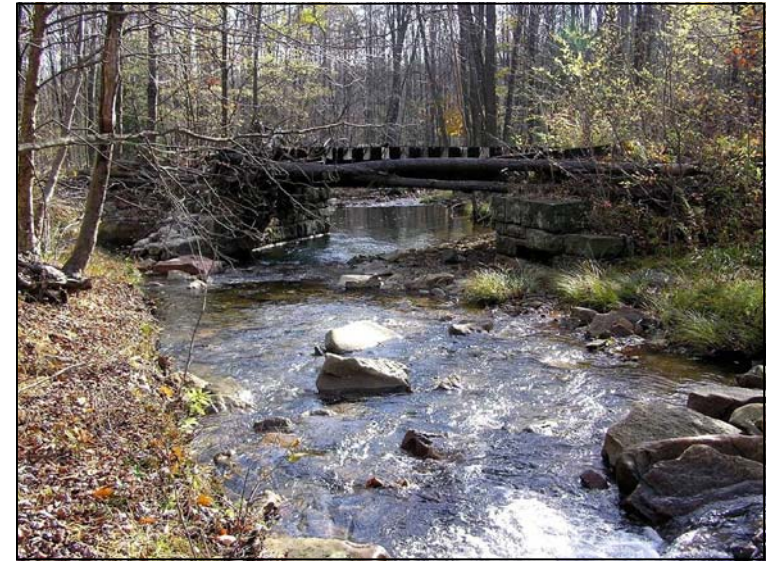
A bridge, no longer used by trains, spans Bear Run at BR-3.

Erosion can also be found near railroad crossings. The railroad tracks run alongside the South Branch and main stem of Bear Run and cross all of the four main North Branch tributaries directly north of their confluences with the main stem. Streamside stabilization in these four areas would improve the banks and help prevent erosion.

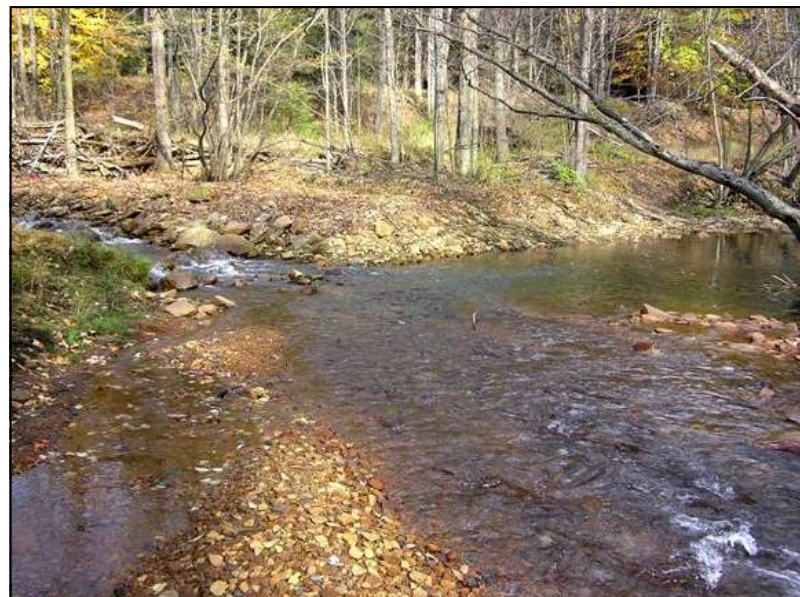
Reddish, iron-stained substrate is visible at the confluence of the North Branch and South Branch.

Excess iron in a stream is usually caused by mine discharges. At higher pH levels, iron forms ferric hydroxide. This yellowish precipitate settles to the bottom of the stream and clogs the gills of fish, as well as suffocating bottom-dwelling invertebrates.
