Peters Creek Watershed Assessment & Management Plan

April 2014

1.0 PETERS CREEK WATERSHED BACKGROUND

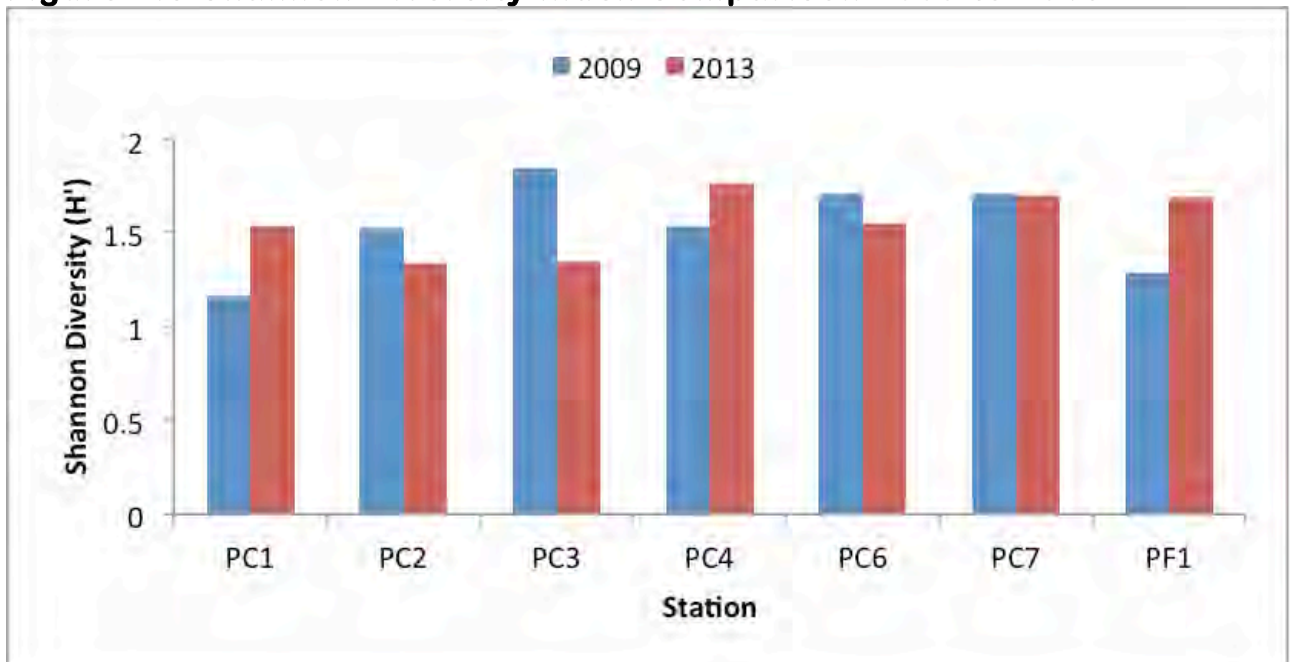
Figure 2.5 Shannon Diversity Index Comparison 2009 to 2013

Shannon's Diversity Index combines information regarding species abundance, taxa richness and species composition at a given site to provide an overall diversity rating for the site. Figure 2.5 depicts the change in Shannon's Diversity Index at individual sites from 2009 to 2013.

Shannon's Diversity comparisons indicate that overall diversity increased at sites PC1, PC4 and PF1 from 2009 to 2013, decreased at sites PC2, PC3 and PC6 and remained virtually unchanged at site PC7.

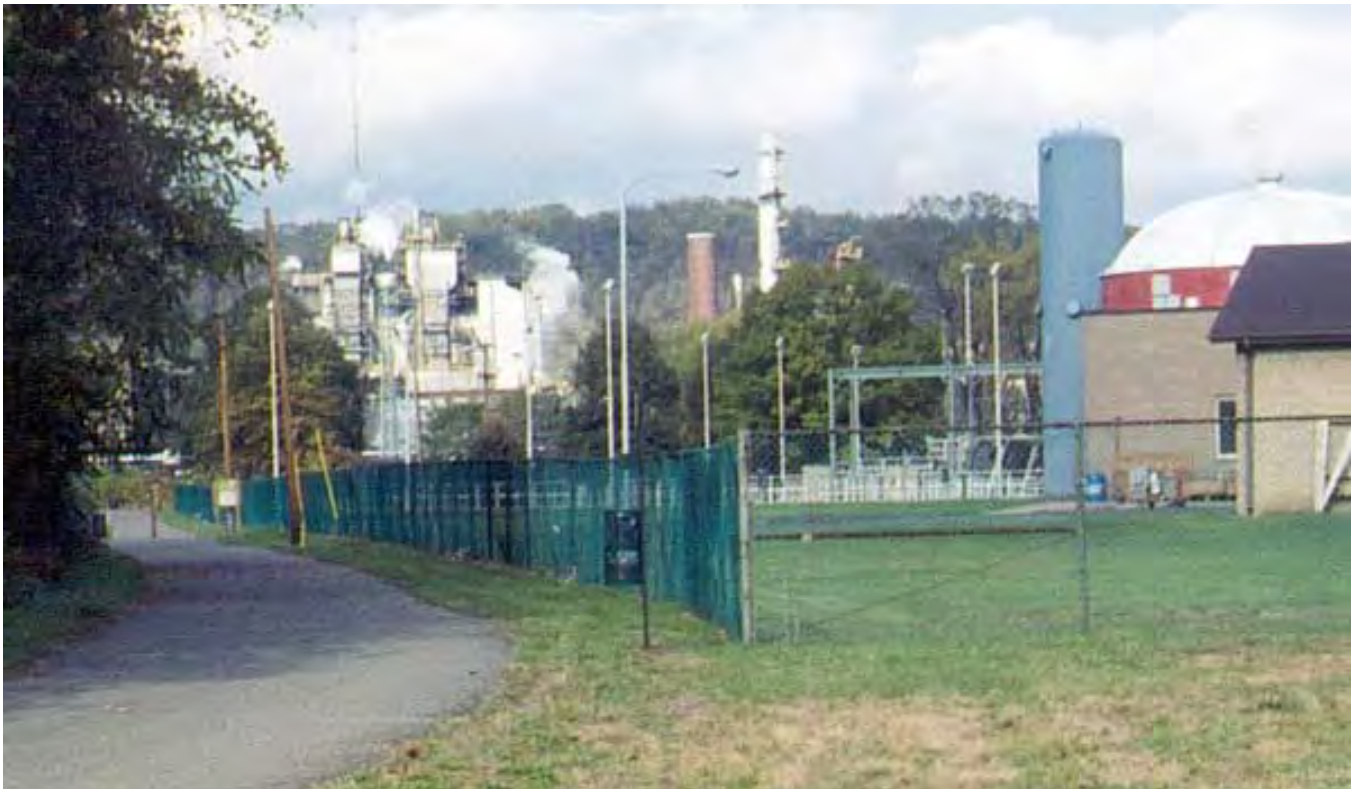
PCL07- The Clairton Municipal Authority Sewage Treatment Plant is along Peters Creek's northern shore just west of State Route 837 (State St) in Clairton. The plant currently discharges into Peters Creek at this location. This regional sewage treatment facility serves the City of Clairton, Jefferson Hills, Finleyville, Union Twp, Nottingham Twp and parts of South Park Twp and Peters Twp. The Authority is currently under a consent decree from the PA Department of Environmental Protection to expand wet weather capacity from 18 million gallons per day to 40 million gallons per day, to separate all storm sewers from sanitary sewers and to repair all malfunctioning sewer lines. The sewage plant expansion will require a rerouting of the Montour Trail and will move the discharge from Peters Creek to the Monongahela River. All combined sewer overflows into Peters Creek will also be removed. The plant expansion will eliminate the need for an additional sewage treatment plant along Peters Creek in Union Twp. Expansion upgrades are to be completed by the end of 2015.

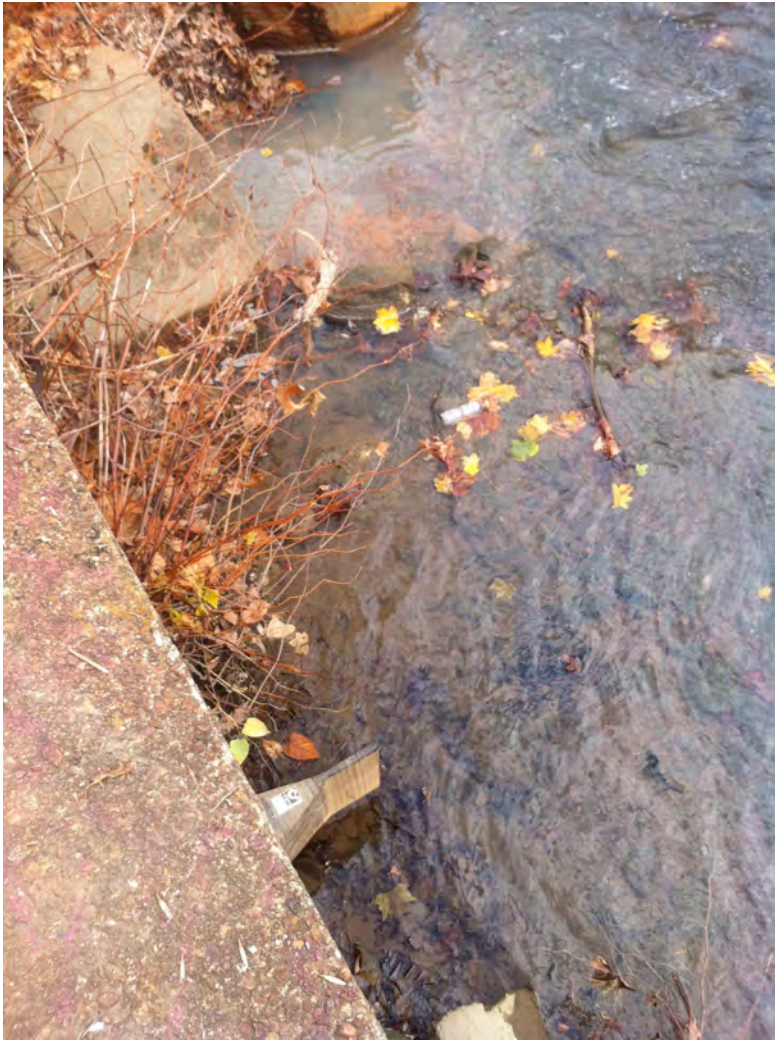
PCL10 - A Combined Sewer Overflow (CSO) and a milky discharge from a culverted pipe enter Peters Creek's right ascending bank in close proximity. A number of CSO's discharge into Peters Creek from just upstream of Ravensburg Bridge to its confluence with the Mon River. The City of Clairton is the only community within this sewer-shed that does not have a separated sewer system. They are currently under a consent decree to remedy this situation.

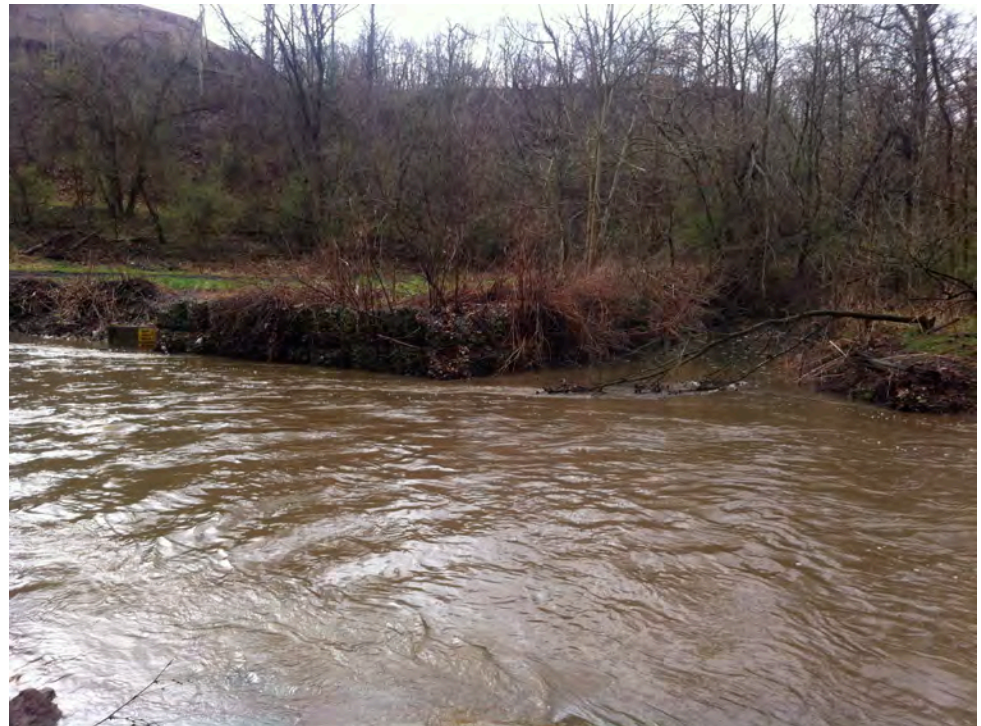
PCL20 - An intermittent Un-Named Tributary (002032) locally called Dry Run drains the valley between St Clair Ave and Worthington Ave in Clairton and enters Peters Creek's left ascending bank just downstream of the US Steel coal waste pile. The downstream bank is gabion rip-rapped to protect a CSO with a yellow warning sign. The upper reaches of Dry Run are polluted with raw sewage. This stream is little more than an open sewage conveyance channel.

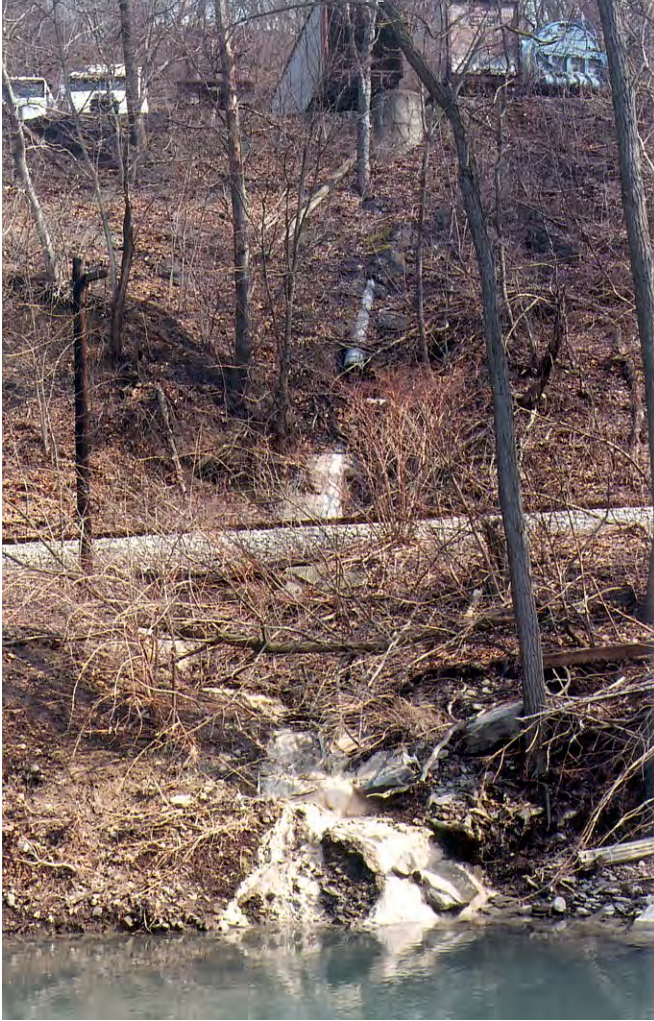
PCL38 – An alkaline discharge with pH of 11.5 enters Peters Creek’s left ascending bank across from the Large Park & Ride Lot. The discharge is culverted under a deck hockey facility off of Worthington Avenue and under the Wheeling & Lake Erie Railroad tracks prior to entry into Peters Creek.

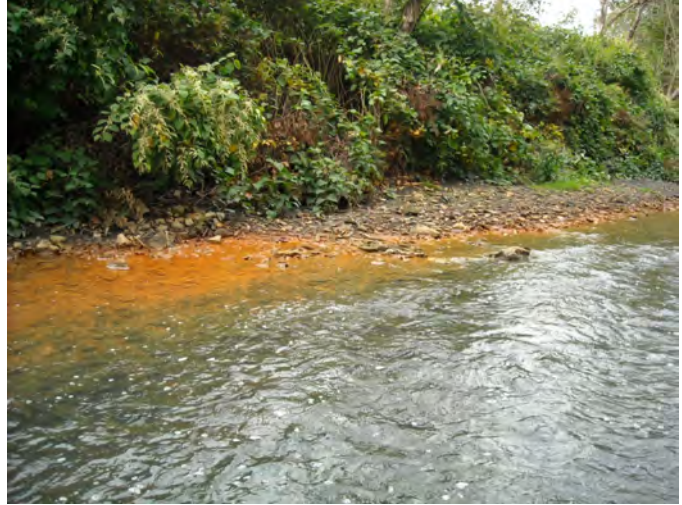
PCL21 – Metals leaching into Peters Creek at toe of US Steel 100 million ton coal waste pile.

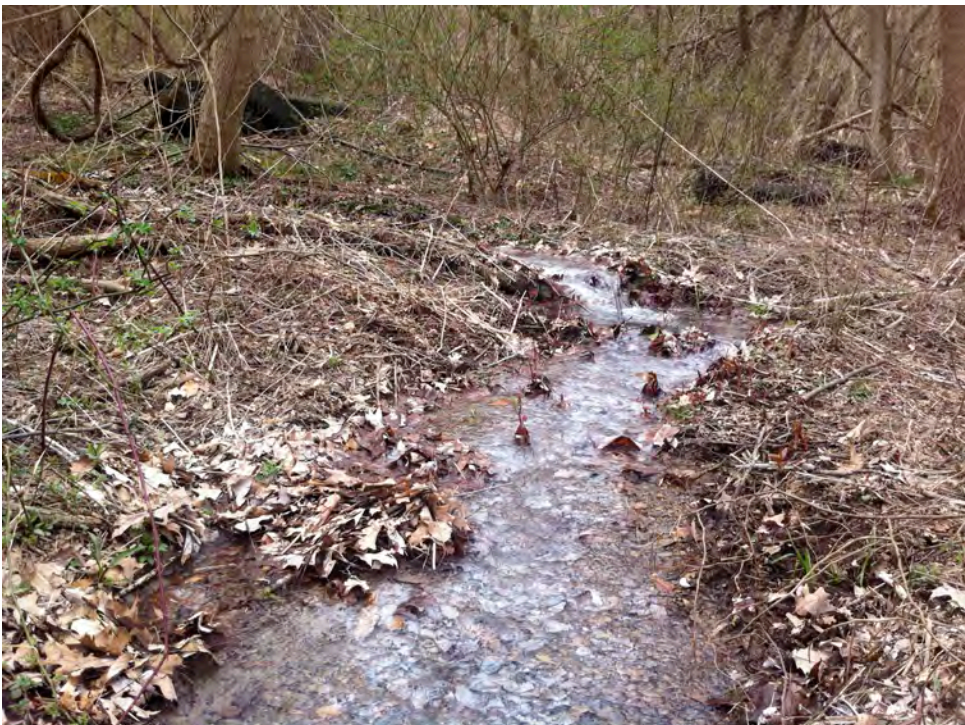
PCL28 – Ravensburg Wetland is fed by a number of metal-laden tributaries and seeps along the steep slopes to the south of the wetland.

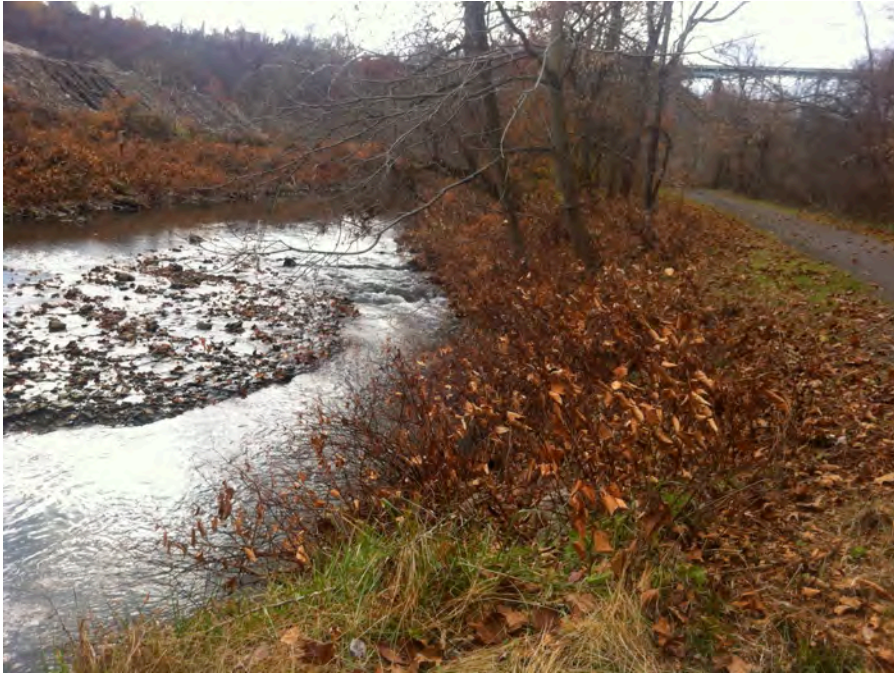
PCL14 - Large sediment build up in middle of channel alters flow pattern of Peters Creek downstream of Ravensburg Bridge crossing of the stream. The right ascending bank is experiencing increased erosion that is beginning to impact the Montour Trail. Knotweed covered banks downstream do little to stabilize the riparian zone.

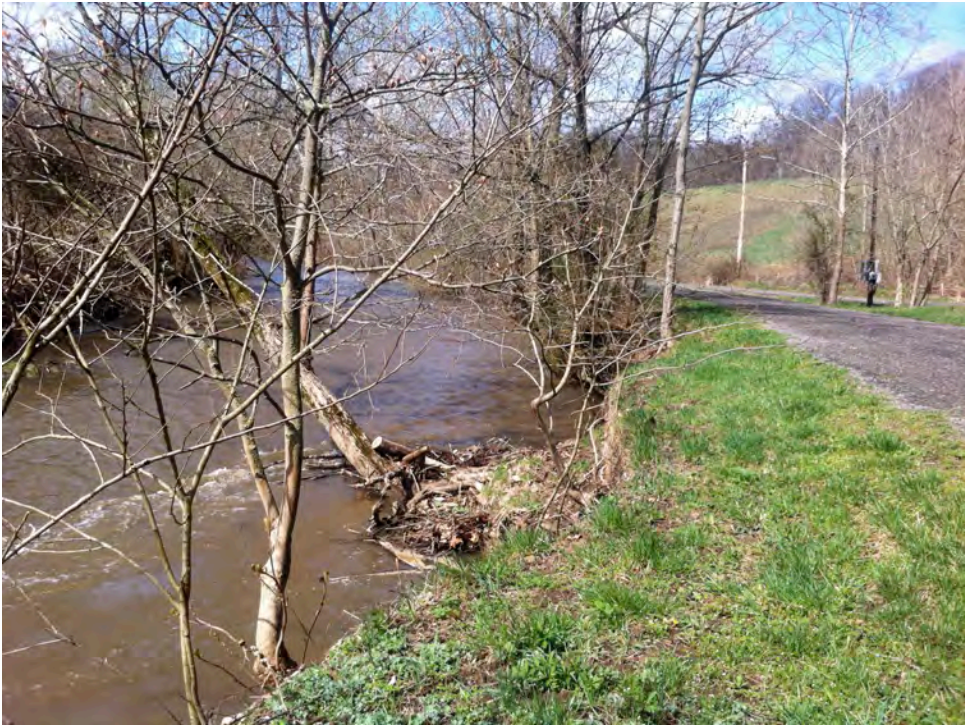
PCL31 - Bank erosion on the right ascending bank of Peters Creek is beginning to undercut the Montour Trail and impact the sewer interceptor under the trail. Jefferson Hills received a PA DEP Growing Greener grant to stabilize the banks and mitigate the problem utilizing Natural Stream Channel Design techniques. This project is scheduled to be completed in 2014.

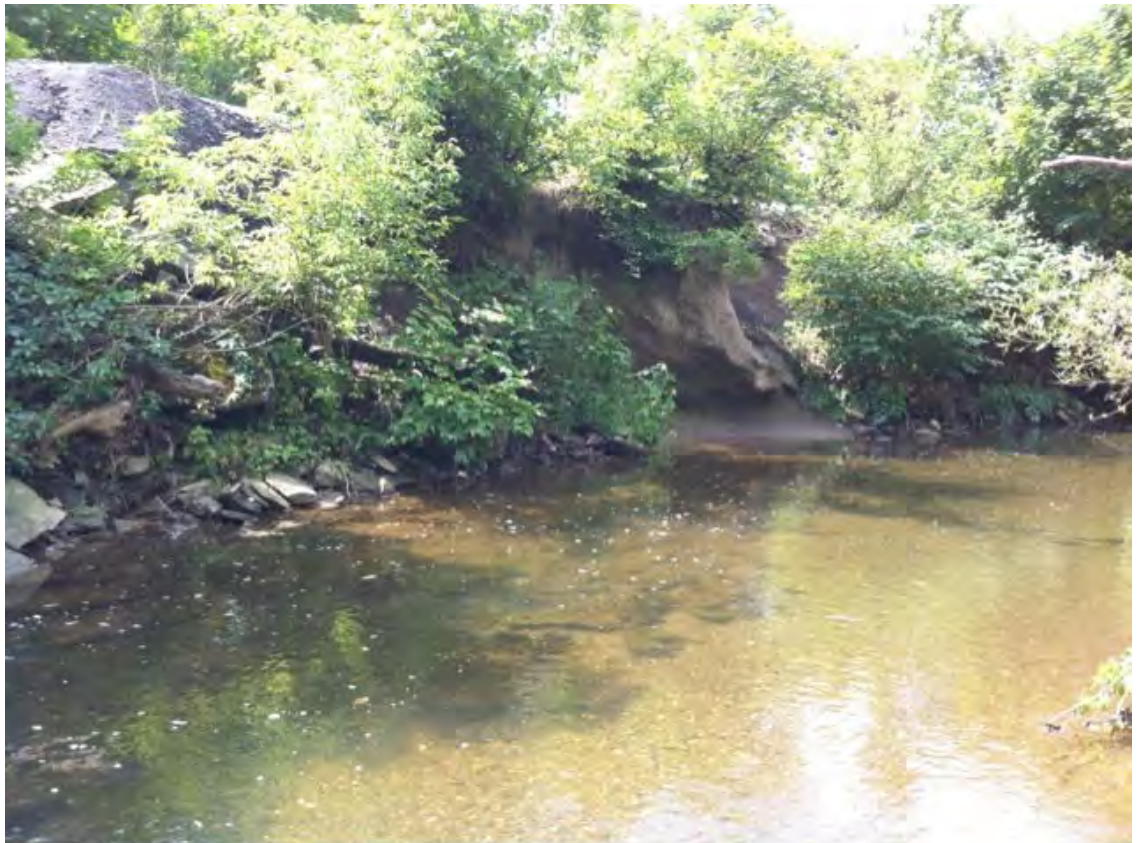
PCL39 - Peters Creek's left ascending bank is being severely undercut just downstream of the pedestrian bridge crossing from Leskers to the Large Park & Ride Lot. The Wheeling & Lake Erie Railroad tracks run immediately adjacent to the left ascending bank from State Route 51 to the Ravensburg Tunnel.

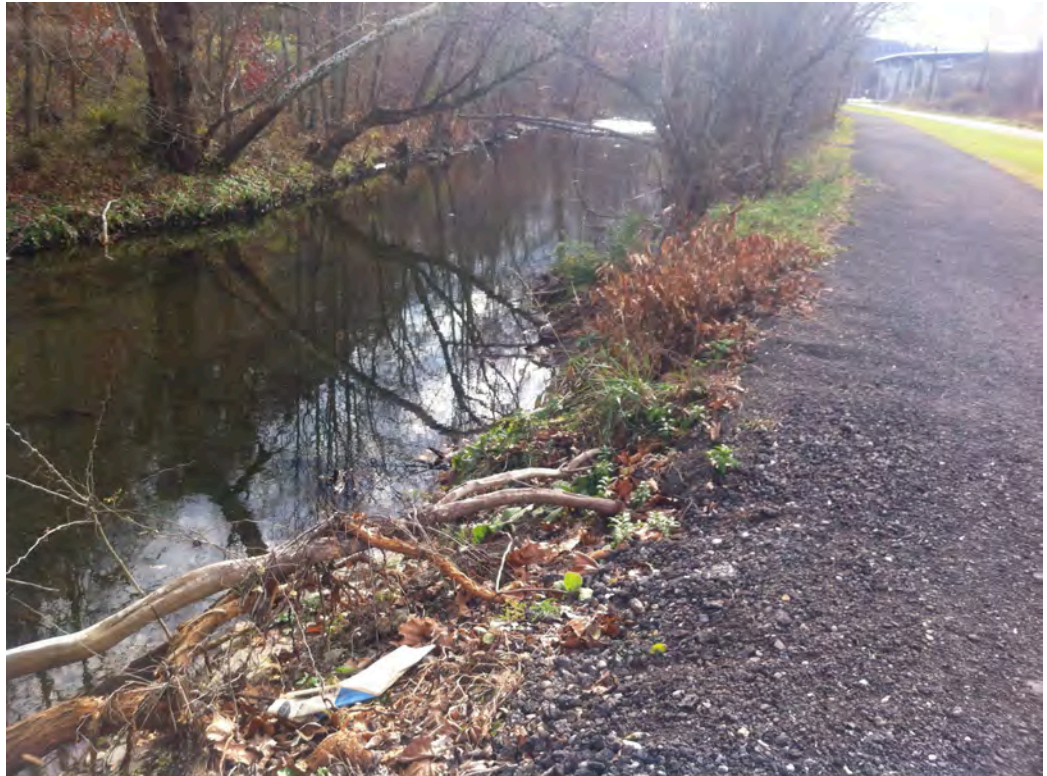
PCL33 – Severe erosion along Peters Creek’s right ascending bank downstream of the Large Park & Ride Lot is undercutting the Montour Trail and uprooting trees.

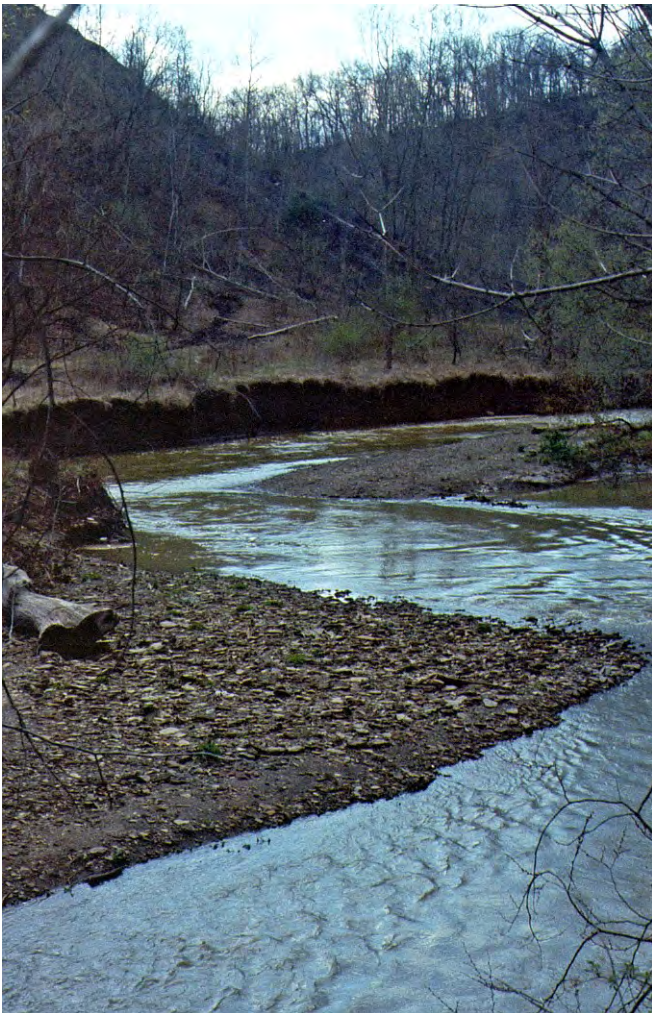
PCL22 – A tight meander just downstream of the natural stream channel design bank stabilization project with scoured and eroding outer banks. The US Steel coal waste pile is adjacent to and eroding into the floodplain at this location. Coal waste material is eroding into the channel of Peters Creek. Meanders are an important component of stream morphology and help to lessen flow energy within the stream channel. The steep scoured outer banks are often stable enough to provided nesting habitat for animals such as the Belted Kingfisher.

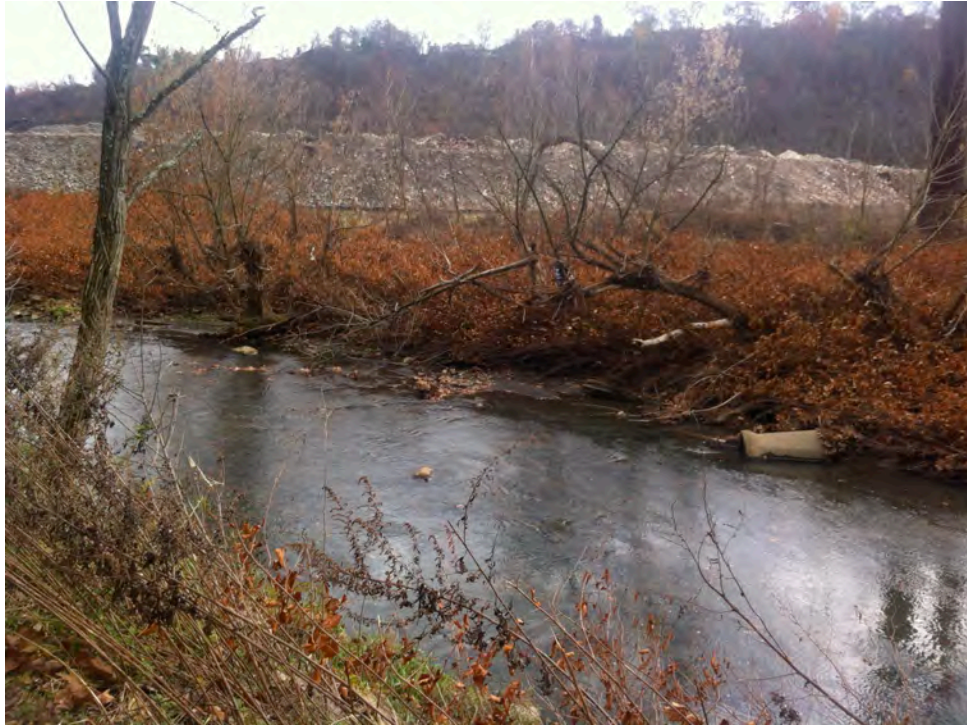
PCL17 – A massive fill operation in Peters Creek’s southern floodplain just east of the Ravensburg Bridge crossing of the stream. Japanese Knotweed and invasive vines infest the riparian zone along this stretch of Peters Creek.

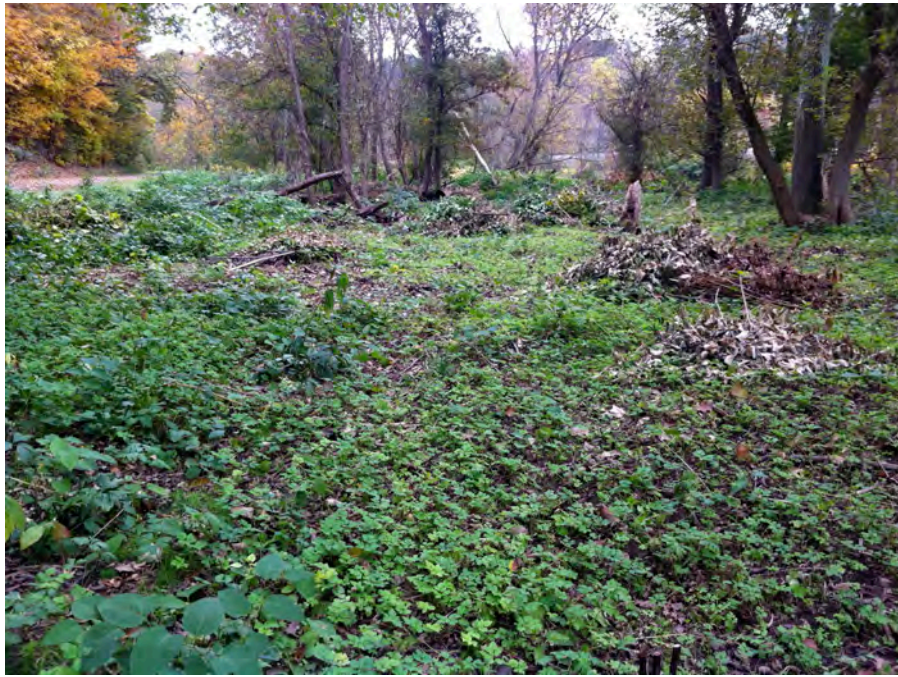
PCL29 – Japanese Knotweed is a problem along much of the lower reach of Peters Creek’s floodplain. A monoculture of knotweed covered approximately two acres of the right ascending bank floodplain between the Montour Trail and the creek. The Peters Creek Watershed Association is working to control knotweed along this section of stream. Lessons learned will be applied to other parts of the Peters Creek watershed.

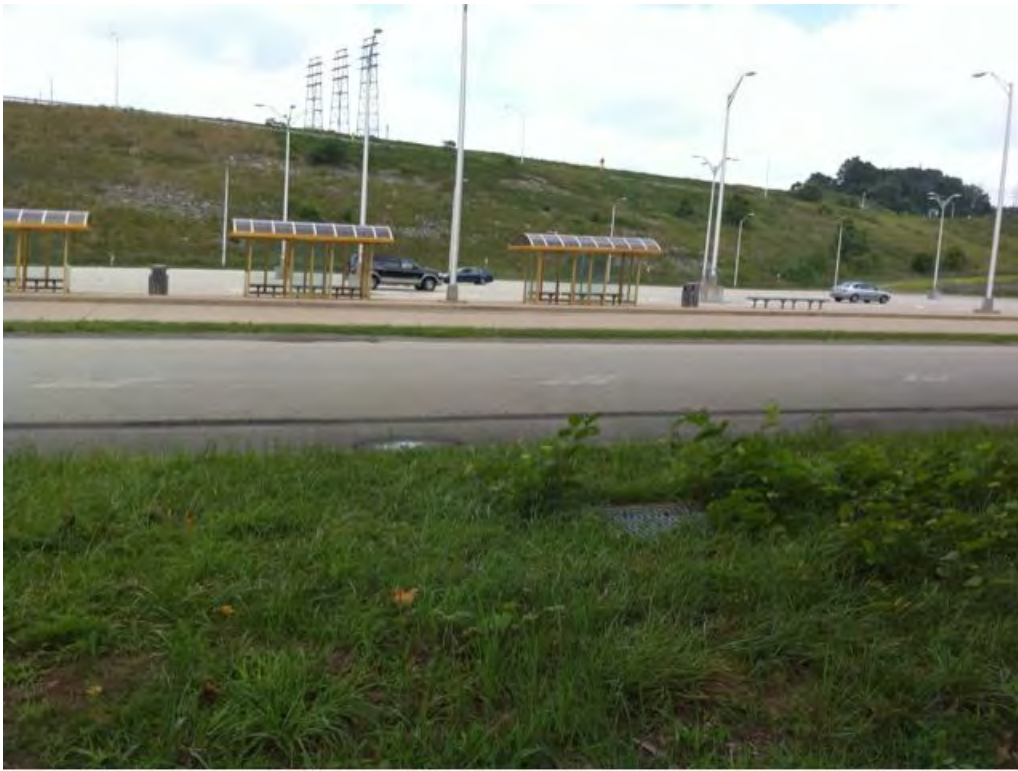
PCL40 – An approximately six acre park & ride lot with bike lane included (part of Montour Trail) was constructed as part of the Mon-Fayette Turnpike project on Peters Creek’s right ascending bank. A one acre constructed wetland detention basin was installed to control storm water runoff from this impervious surface as well as from the expressway on top of the hillside behind the parking area.

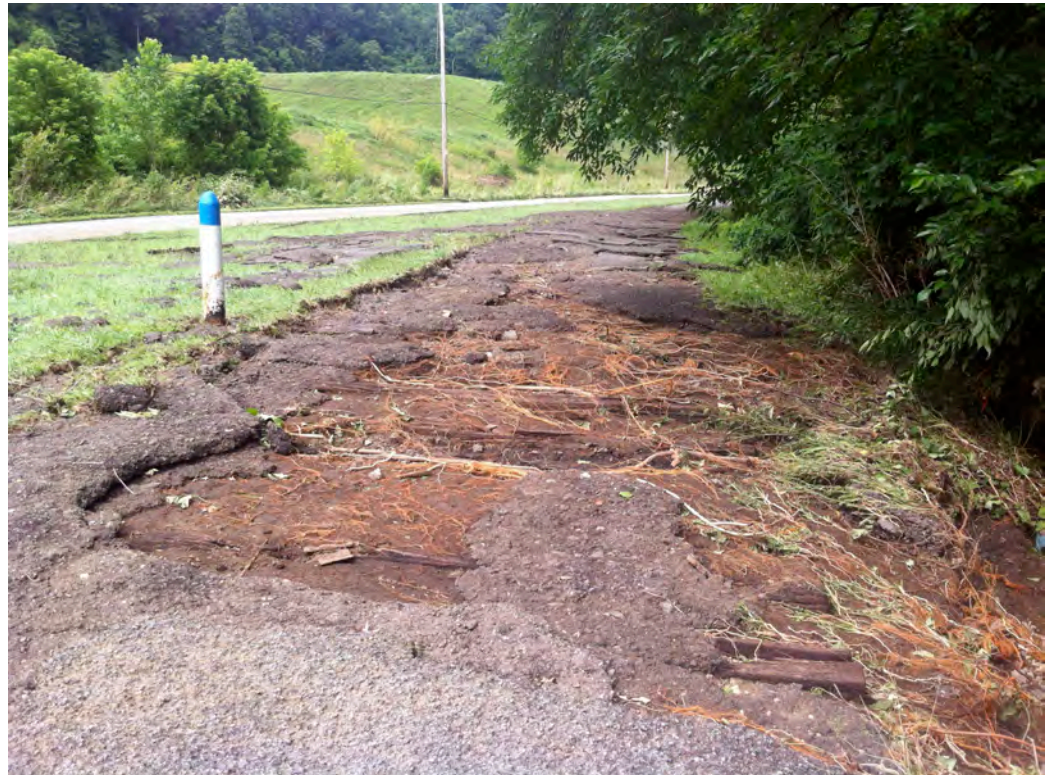
PCL33 – Damage to the Montour Trail due to Peters Creek exceeding its banks during flooding in July of 2013.

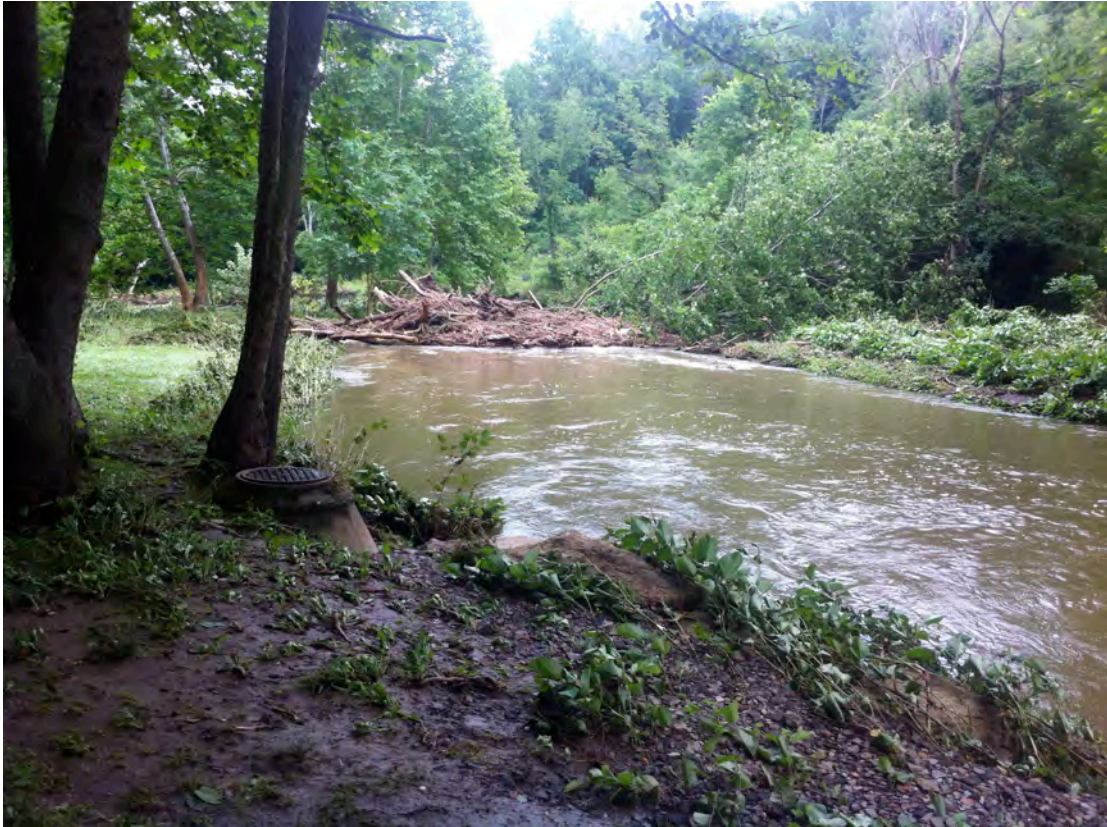
PCL23 – Debris jam deposited by floodwaters in July of 2013 dams Peters Creek below Natural Stream Channel Design Project.

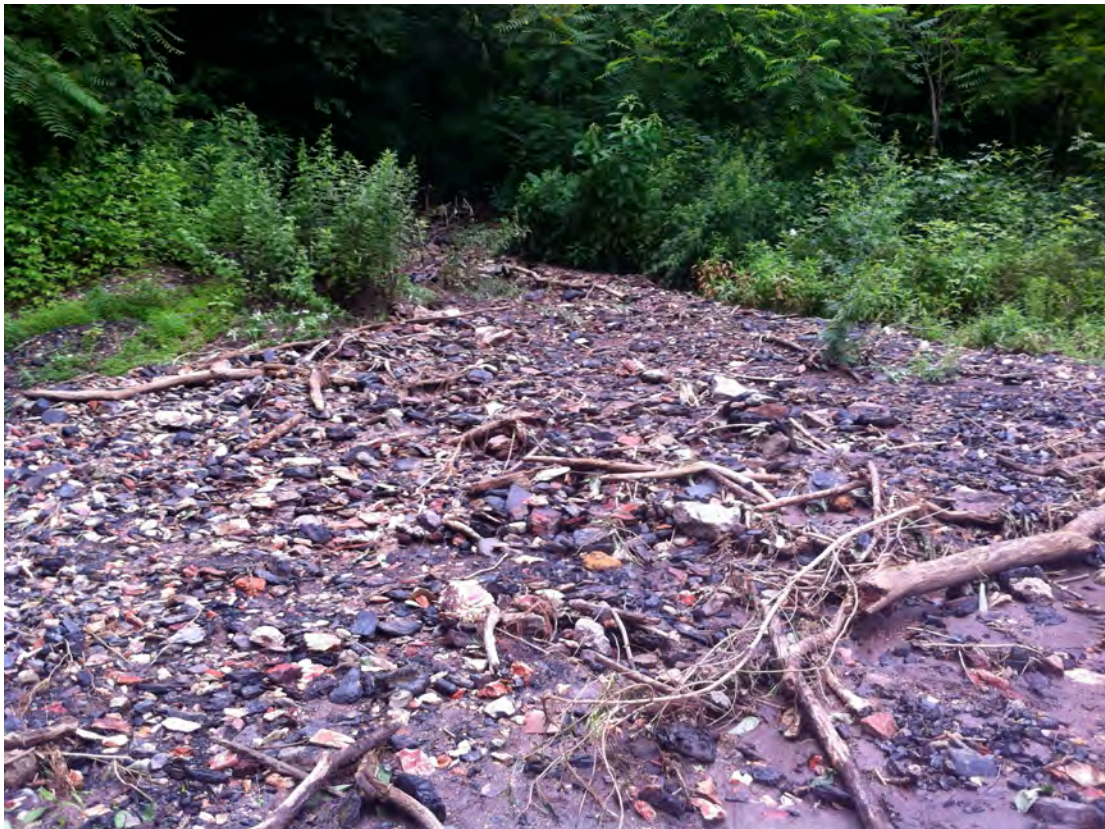
PCL24 – Large quantities of coal waste were carried by floodwaters from a tributary valley and deposited onto the Montour Trail during flooding in July of 2013. Coal waste and overburden was deposited in this stream valley during strip mining operations prior to modern regulations.

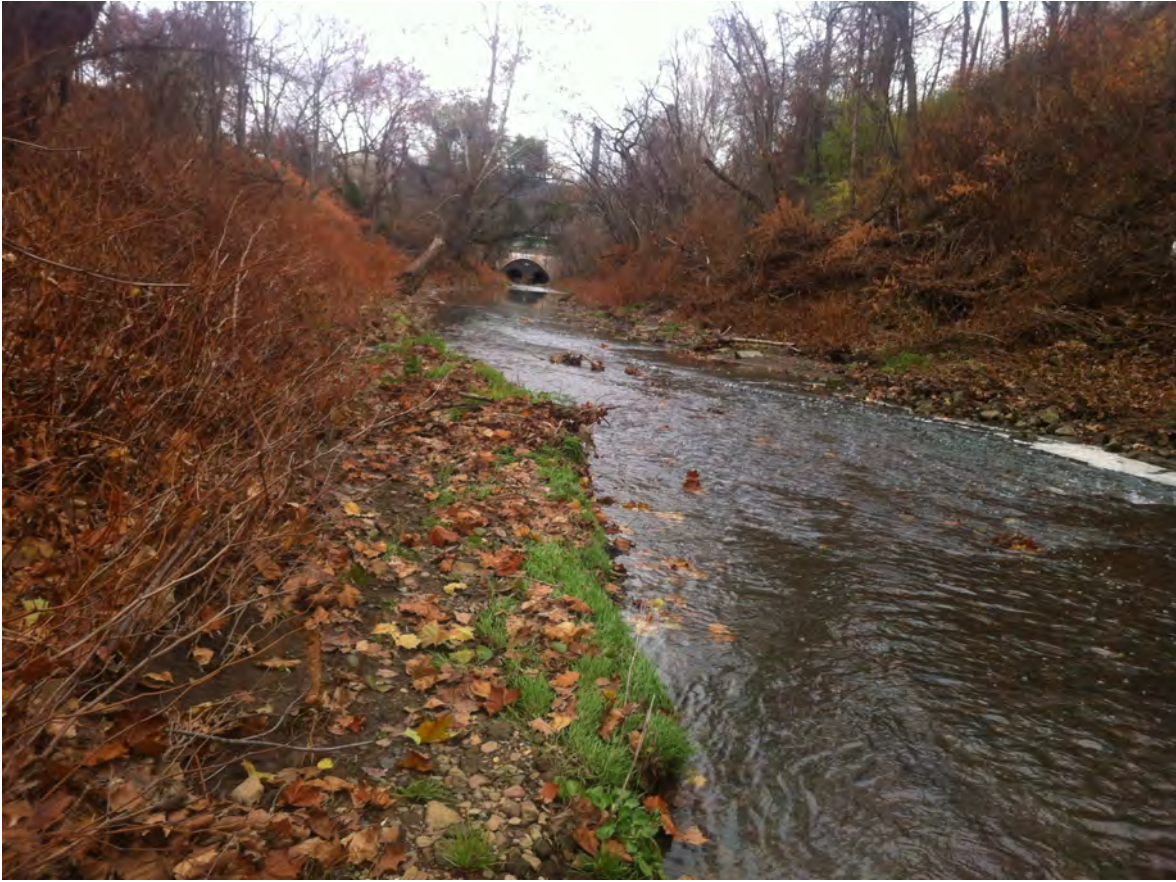
PCL04-PCL07 – Last few hundred feet of free-flowing Peters Creek prior to being culverted under US Steel’s Clairton Coke Works in the distance. The stream is culverted for approximately 2000 ft before it enters the Monongahela River just upstream of the Clairton-Glassport Bridge. Peters Creek flows under Rt837, receives the discharge from the Clairton Municipal authority on its right ascending bank and a combined sewer overflow on its left ascending bank prior to entering the culvert.

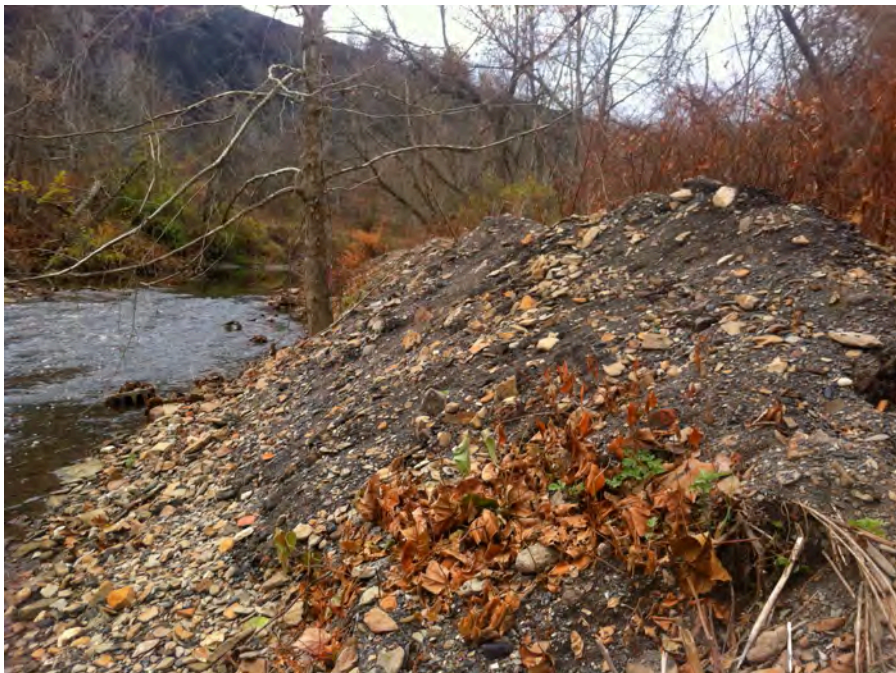
PCL19 – Dredge material/coal waste fill illegally dumped on Peters Creeks right ascending bank just upstream of Ravensburg Bridge.

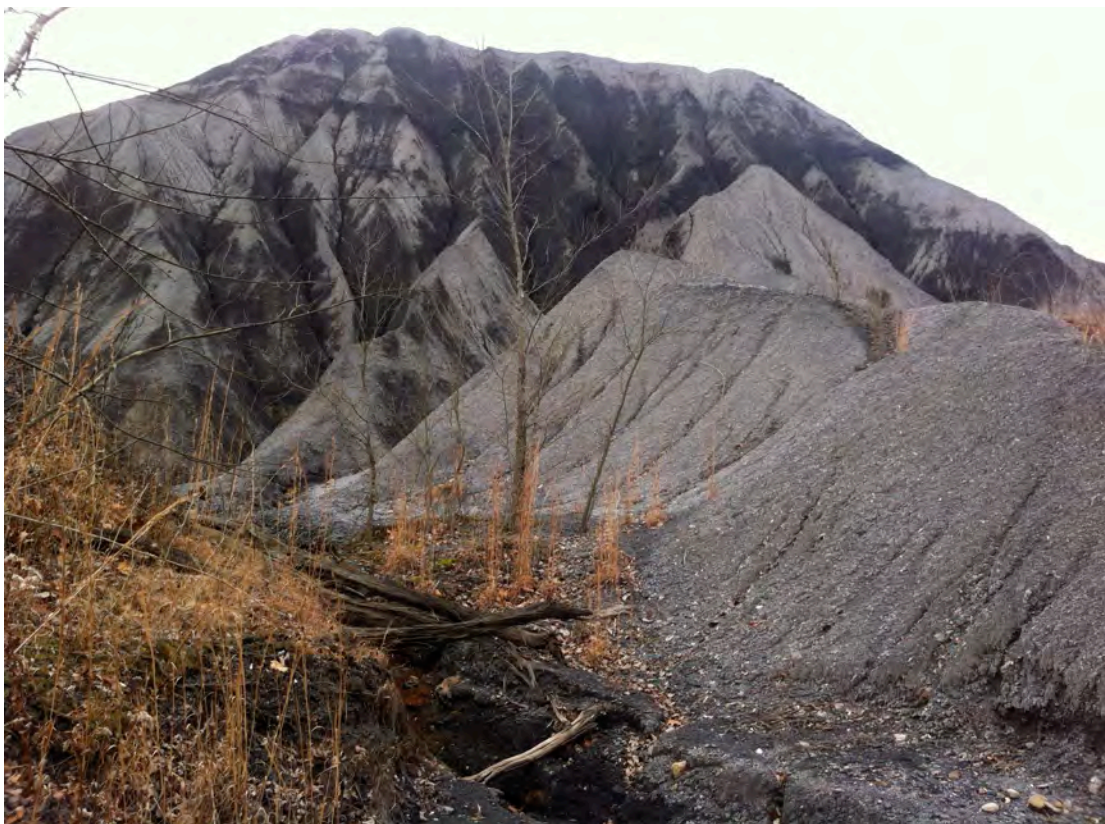
PCL21 – This 30 acre, 120 foot coal waste pile of approximately 100 million tons encroaches on Peters Creek’s southern shore for nearly 3,000 feet from just upstream of the Ravensburg Bridge to the western portal of the Ravensburg Tunnel. Material from this waste pile erodes into Peters Creek and metals and other chemicals leach into the creek. The waste pile was created by United States Steel Clairton Coke Works as part of a coal cleaning operation. The exact composition is unknown since it was created prior to modern regulations.

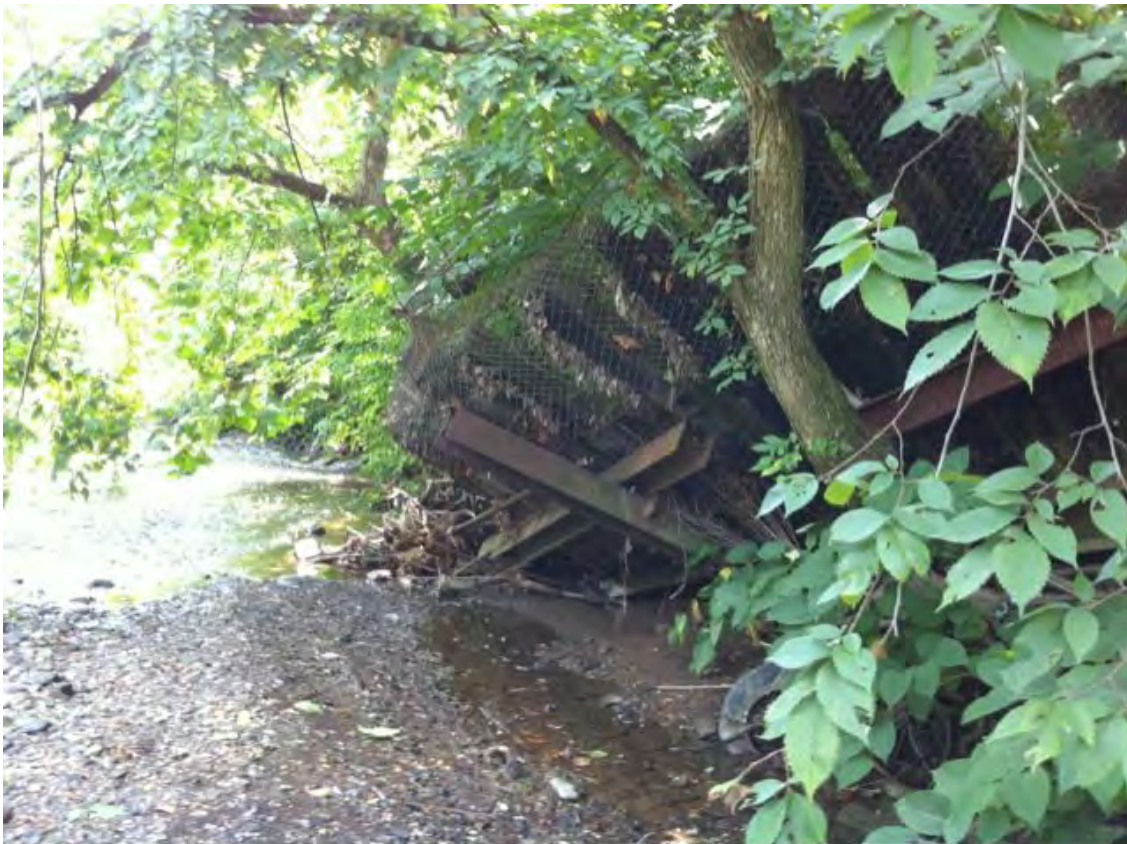
PCL43 – A collapsing retaining wall that appears to be part of a defunct railroad siding operation encroaches on Peters Creek’s left ascending bank across from the Large Park & Ride Lot. The Wheeling & Lake Erie tracks follow and encroach on Peters Creek’s southern shore from this point to the western portal of the Ravensburg Tunnel.

A retaining wall along Peters Creeks left ascending bank at PCL43 is encroaching on the stream channel and should be repaired or removed.

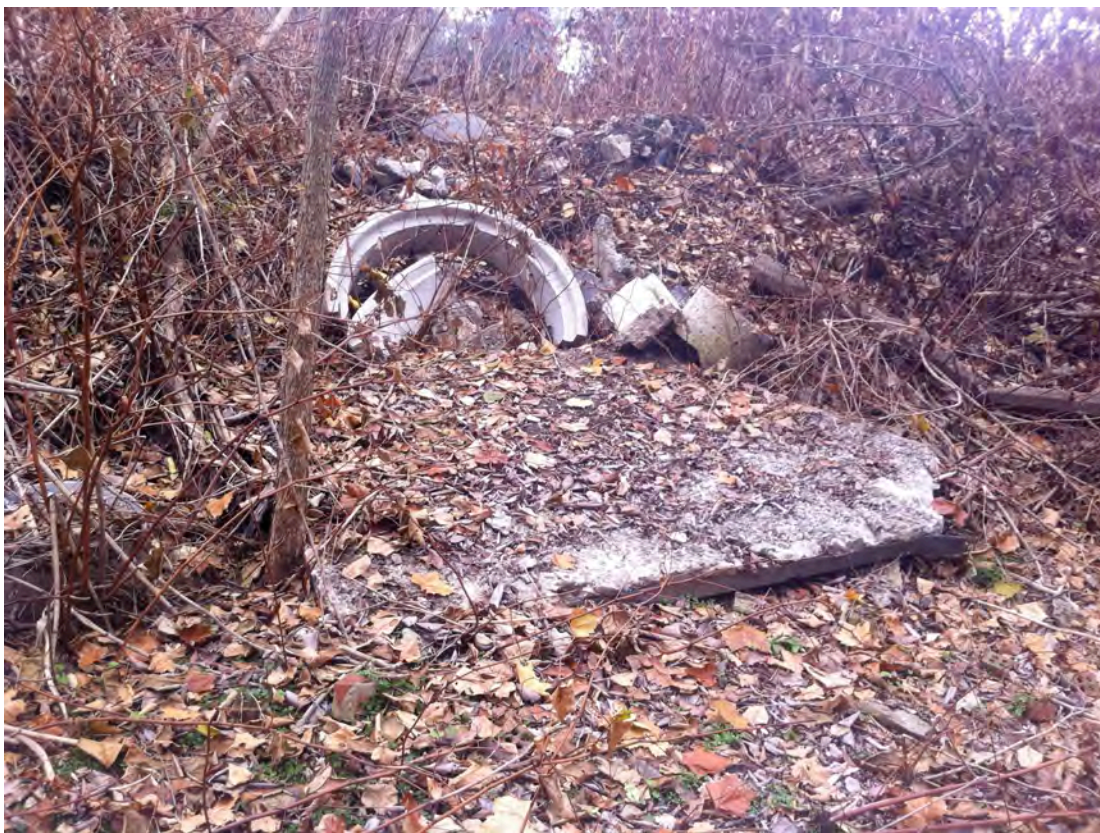
PCL08 - Construction debris illegally dumped along Peters Creek's right ascending bank just upstream of the Clairton Municipal Authority Sewage Plant. Much of the garbage and construction material within the floodplain of lower Peters Creek was deposited by floodwaters from upstream locations. Materials are often stored along the creek that should not be.

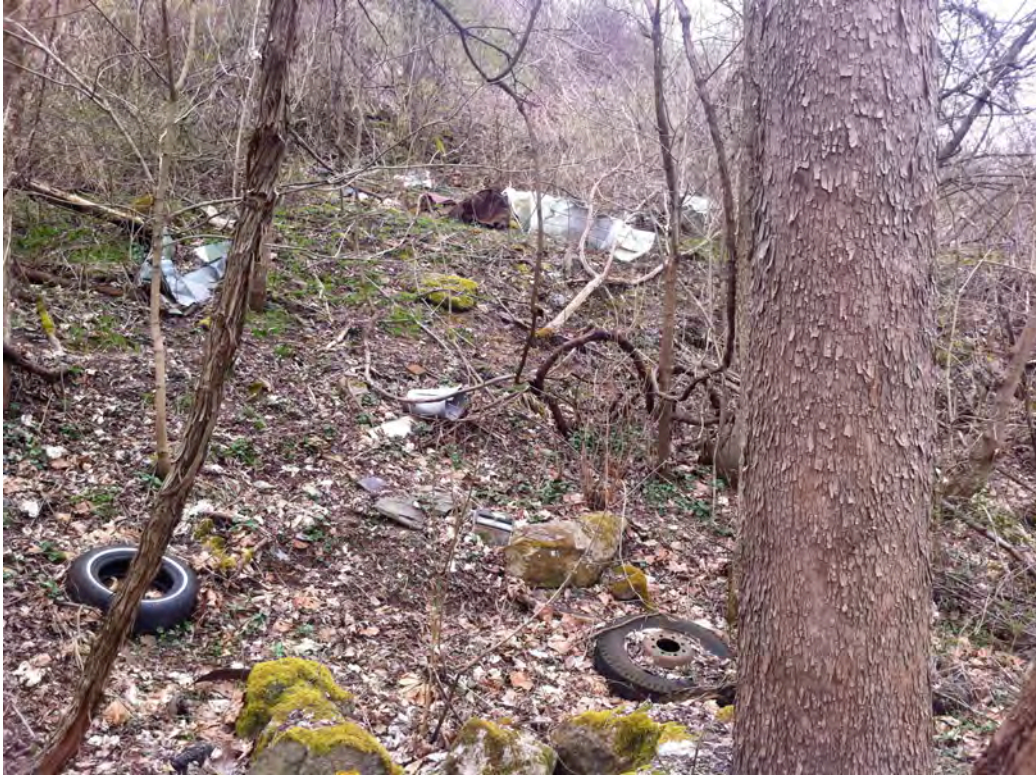
PCL27 - A large number of illegally dumped tires and other debris pollutes the secluded floodplain south of the Ravensburg Wetland. A steeply sloped hillside off of Worthington Avenue provides easy access.

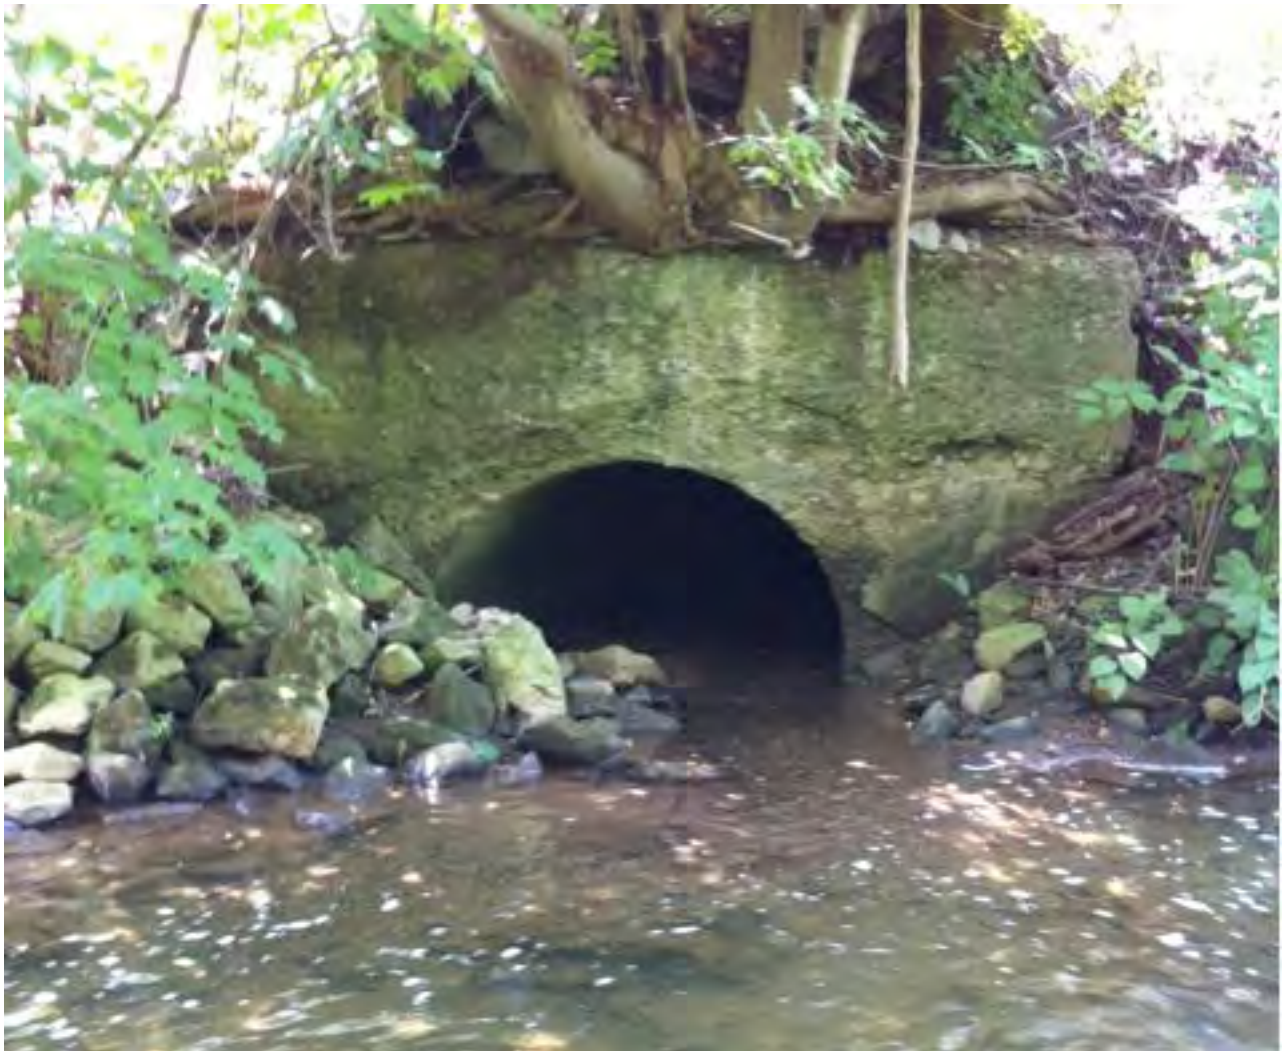
PCL41 – Scotia Run enters Peters Creek's left ascending bank after being culverted for approximately 250 feet under Kurt J. Lesker's back lot.
