Peters Creek Watershed Assessment & Management Plan

April 2014

1.0 PETERS CREEK WATERSHED BACKGROUND

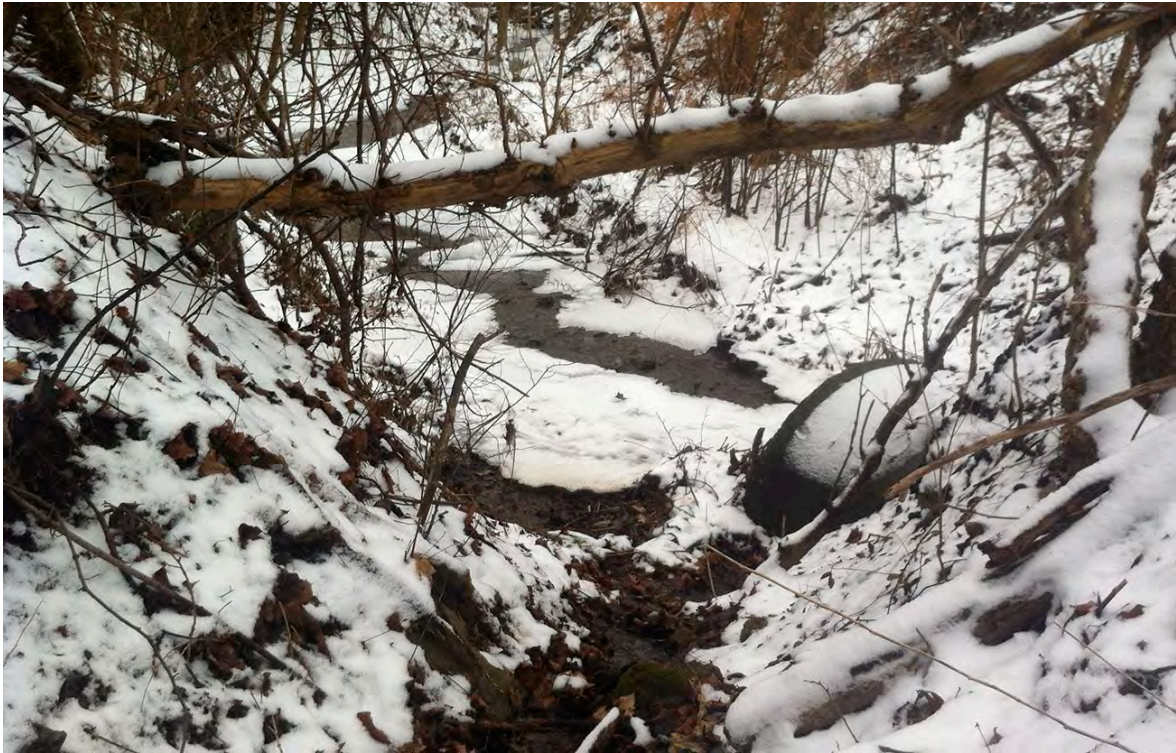
SCR01 – Scotia Run enters culvert to Peters Creek under Lesker's back lot. Small tributary enters on left ascending bank.

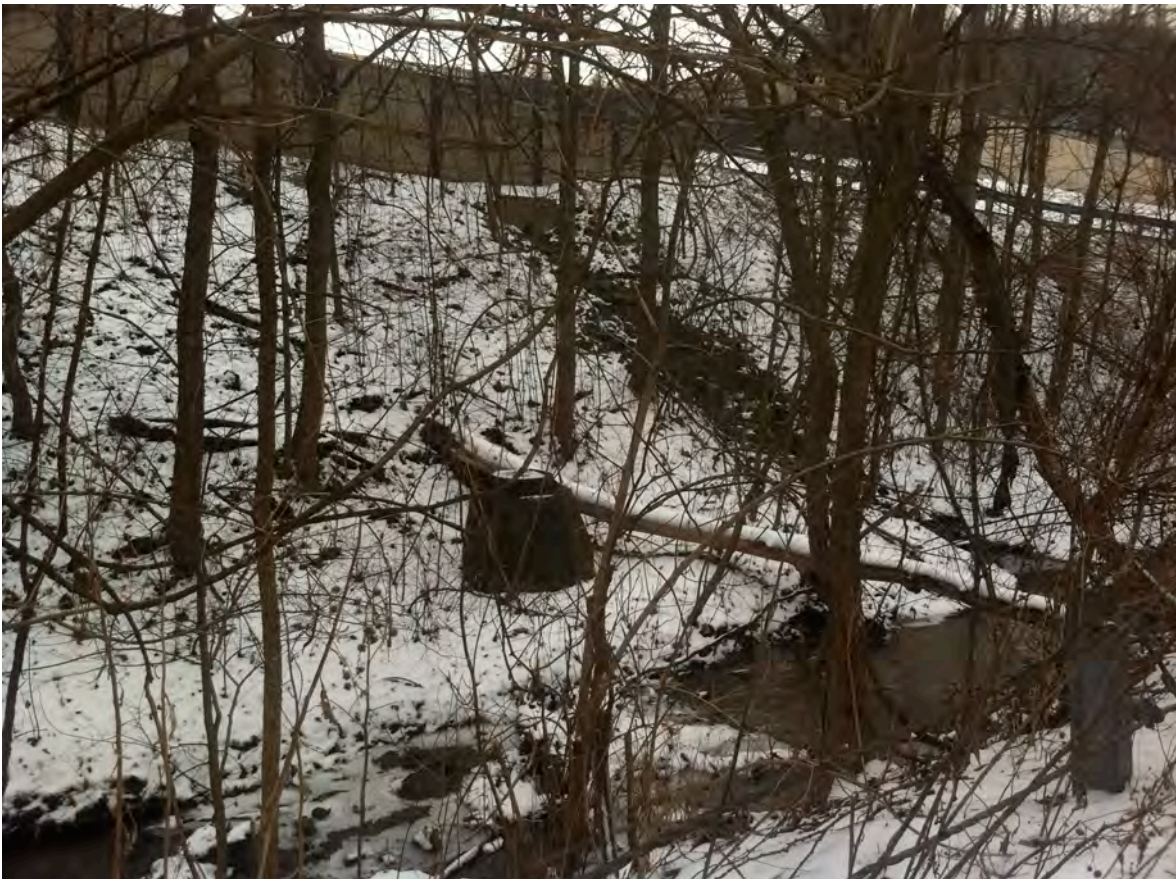
SCR02 – Scotia Run flows between Worthington Avenue and Kurt J. Lesker's parking lot. A number of storm water outfalls from Worthington Avenue enter on the left ascending bank. A sanitary sewer line parallels the left bank along this section of Scotia Run as well.

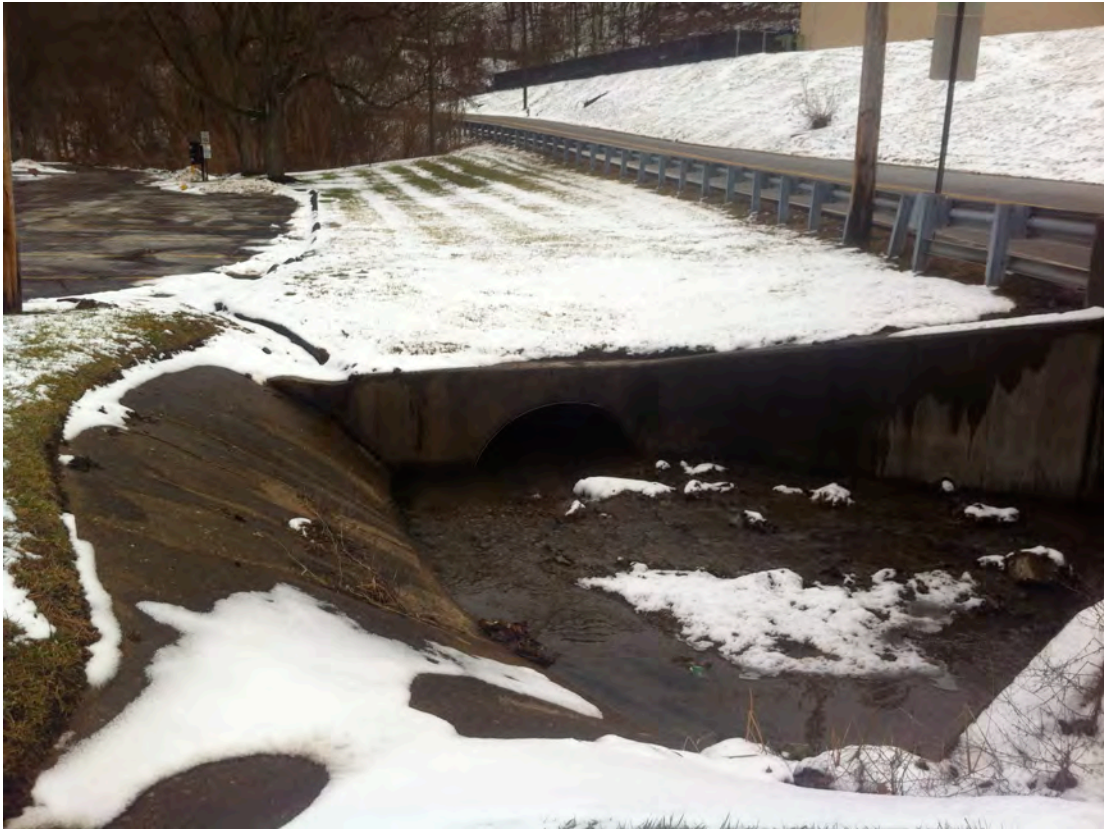
SCR03 - Scotia Run flows under Worthington Avenue and then is immediately culverted again for approximately 150 feet between Lesker's parking lot and Worthington Avenue. It then flows freely for a couple of hundred feet before being culverted again.

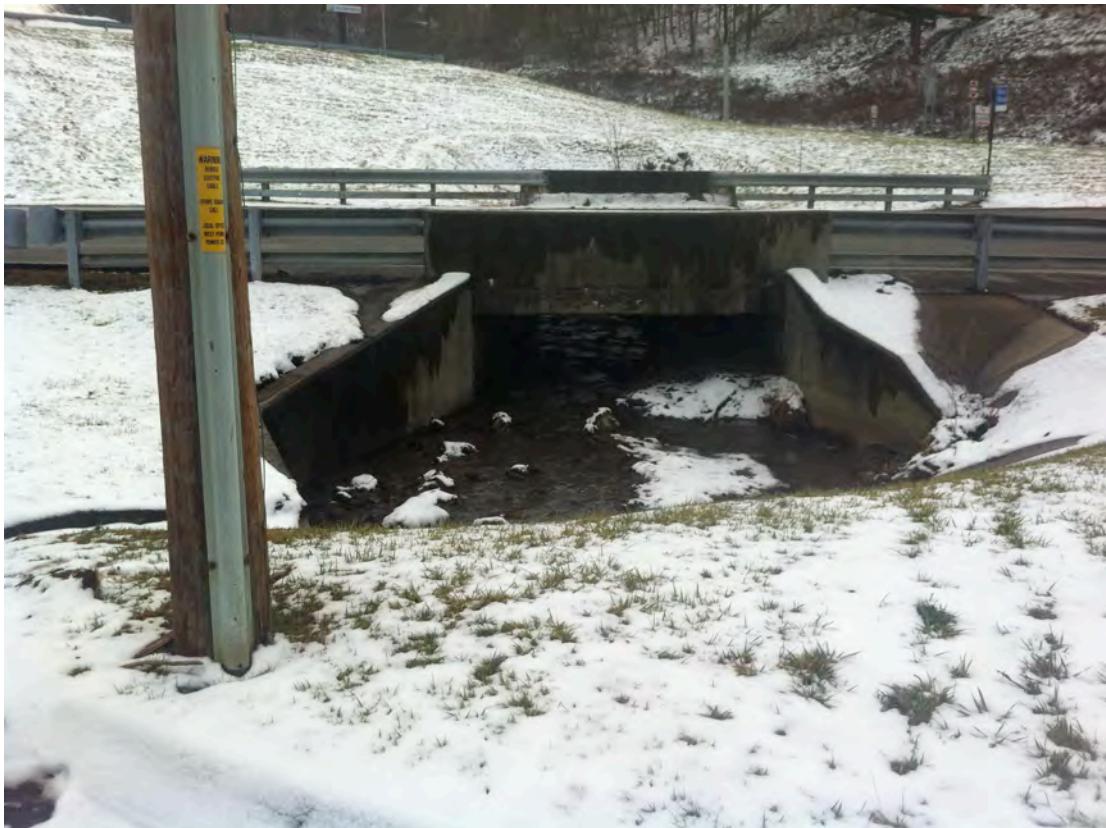
SCR04 - Scotia Run flows under Worthington Avenue. Sediment is being deposited along the right ascending wall of the culvert.

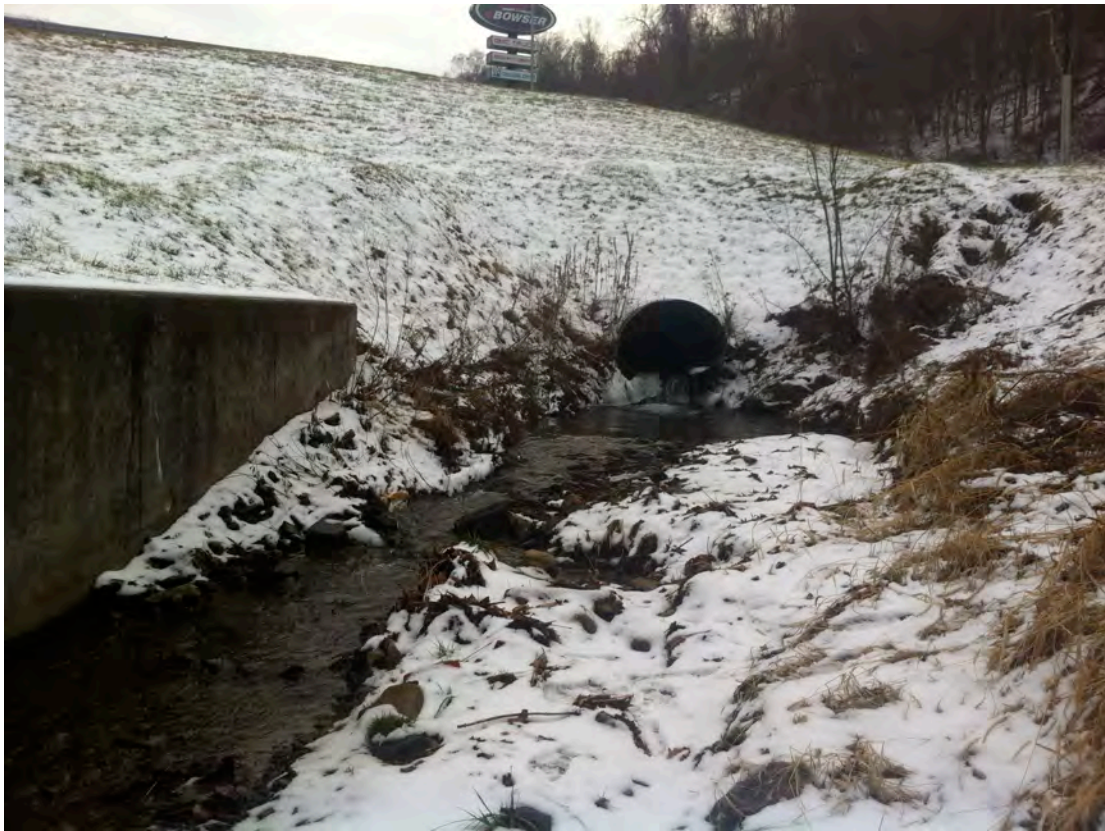
SCR05 – Scotia Run exits the culvert under Bowser Auto and storm water enters Scotia Run from the right ascending bank. The stream is culverted for approximately 700 feet under Bowser Auto's building and lot and then immediately flows under Worthington Avenue.

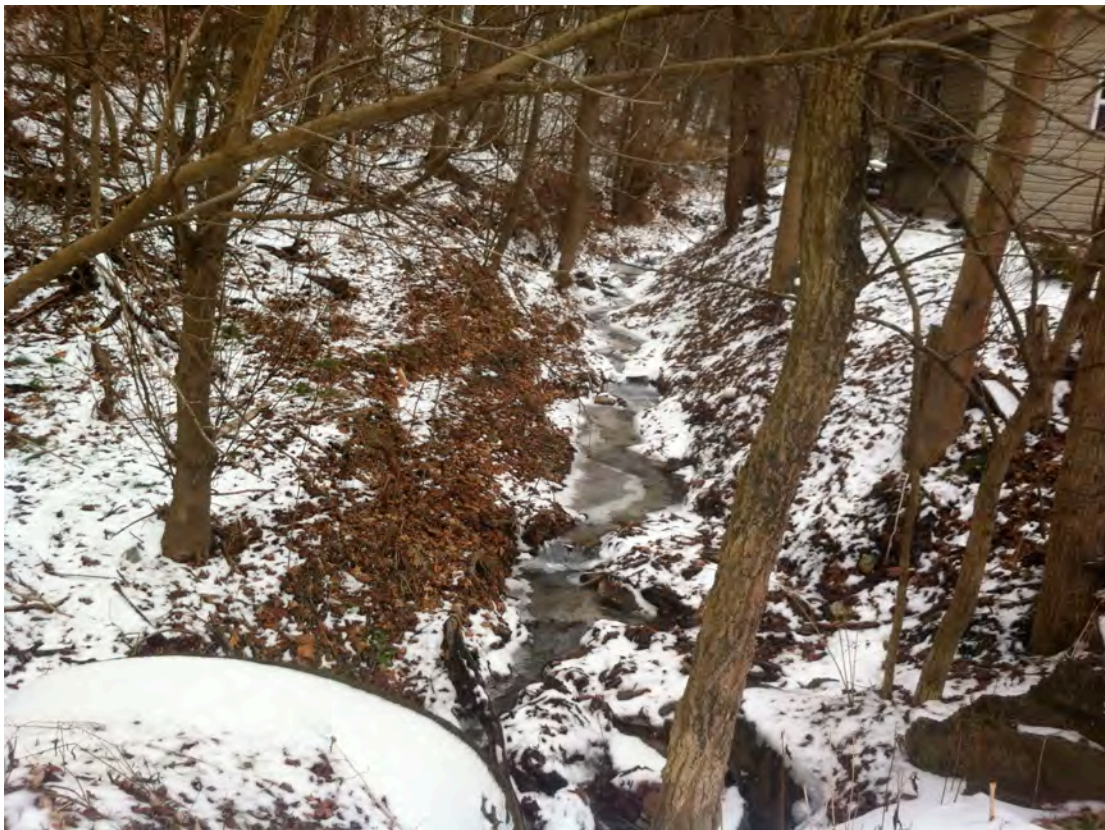
SCR07 – Tributary draining wooded valley to east of McGrew Rd is culverted under the road and under the back edge of Bowers lot. The tributary enters Scotia Run while it is culverted under the lot. The upper reaches of this tributary have been surface mined. This may contribute to the high conductivity levels of Scotia Run.

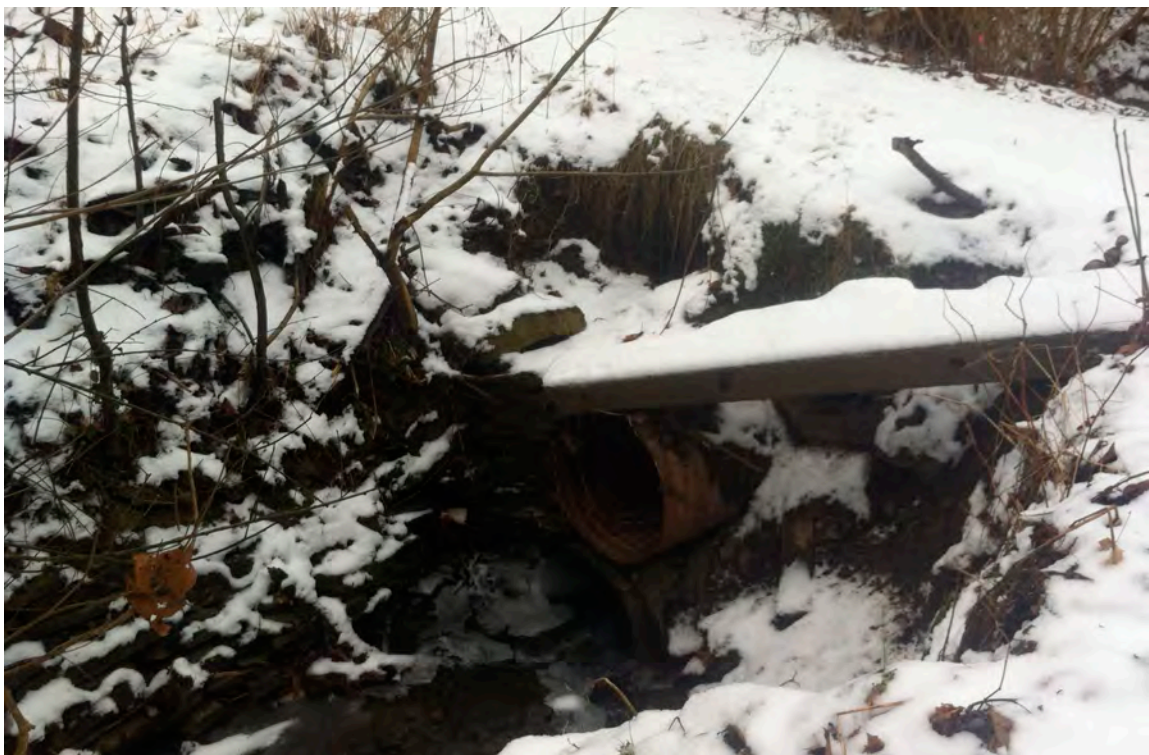
SCR11 – Scotia Run is culverted under a pedestrian access trail to a billboard along Route 51. Two culverts are placed one on top of the other. They are incorrectly sized for the given flow during rain events and are causing the trail to erode and are also creating bank erosion upstream.

Encroachment is also a significant issue along Scotia Run. An inadequately sized culvert at SR11 is creating severe bank erosion upstream and downstream of the culvert and should be replaced an adequately sized culvert or removed. The stream is also culverted for much of its lower reach. Opportunities for daylighting portions of the lower reach should be explored.

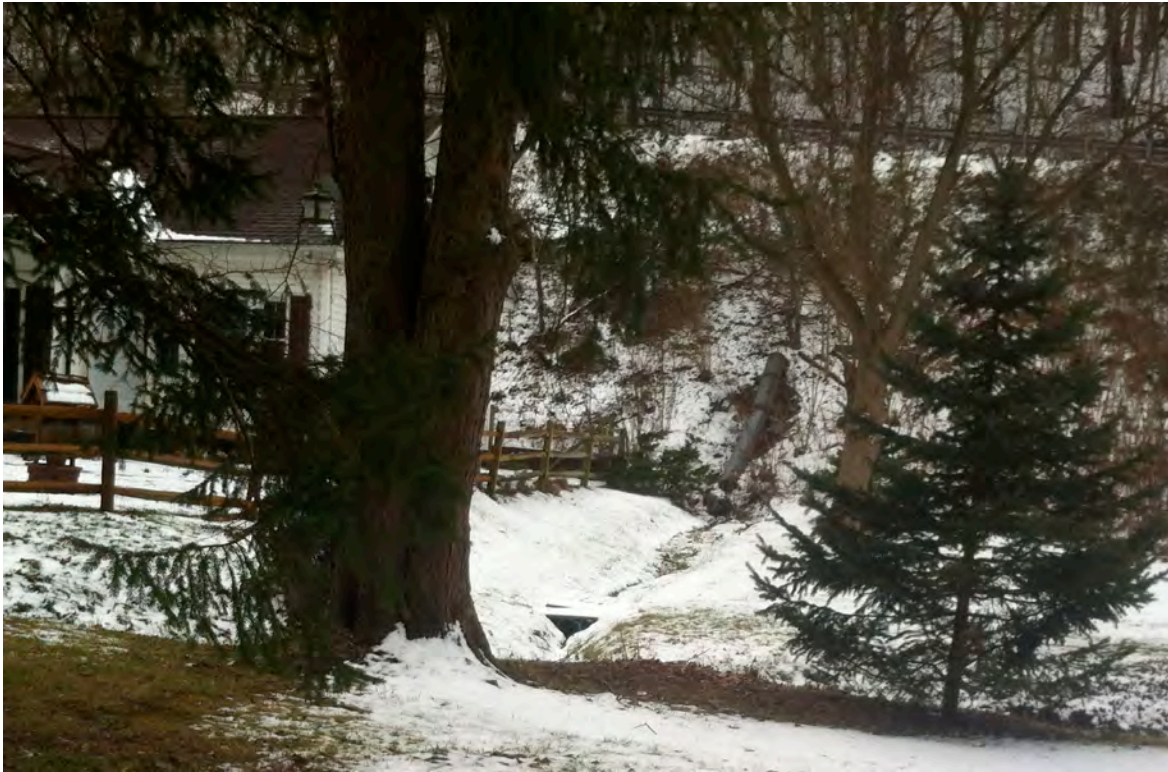
SCR12 - A storm water outfall from Rt51 along the steep hill in the upper part of photo is piped to Scotia Run's right ascending floodplain. It flows across the floodplain in an open drainage channel and enters Scotia Run which flows between the house and McGrew Rd. A number of such outfalls from Rt51 exist along this section of Scotia Run.

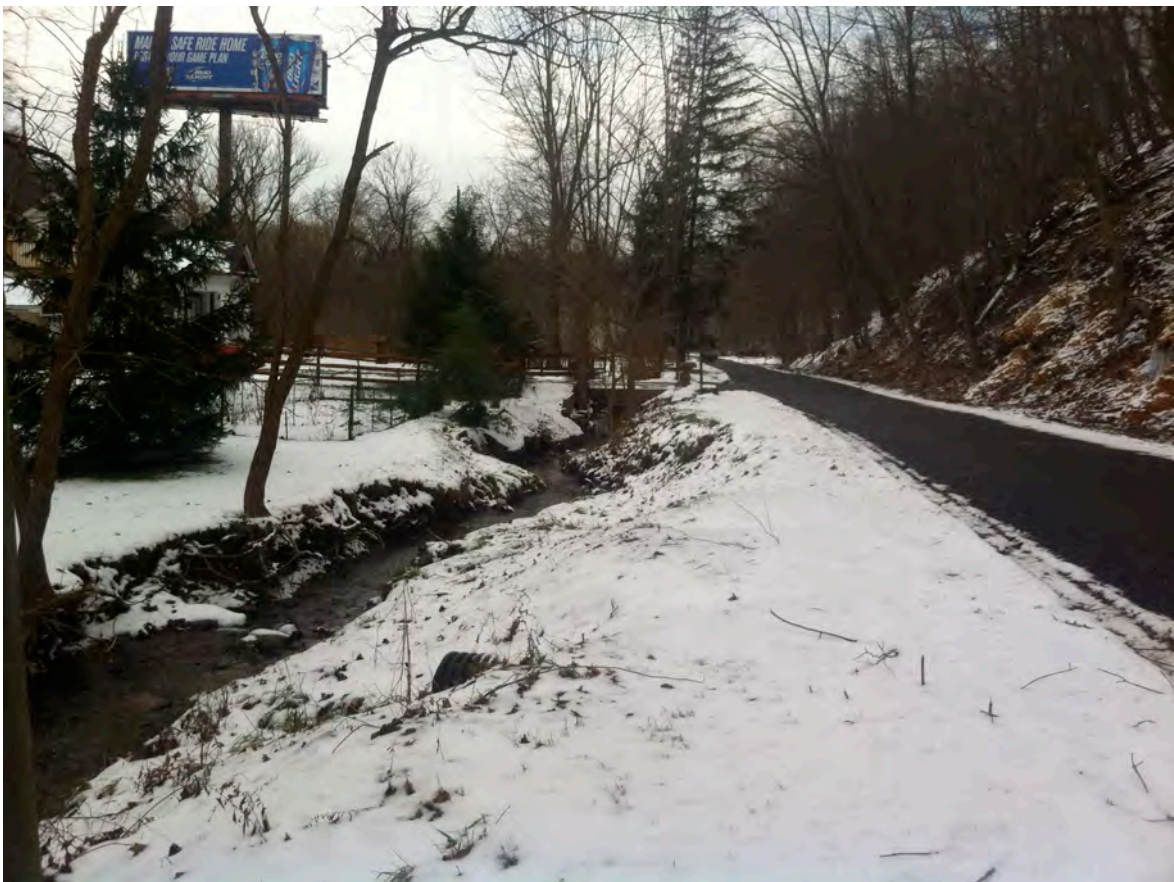
SCR13 - Scotia Run along McGrew Rd. Storm water from drainage channel on opposite side of road enters Scotia Run in foreground. Scotia Run is culverted under private driveway and pedestrian bridge in middle of photo. Large billboard along Rt51 in upper left. Looks like homeowner has built levee along stream in front of house.

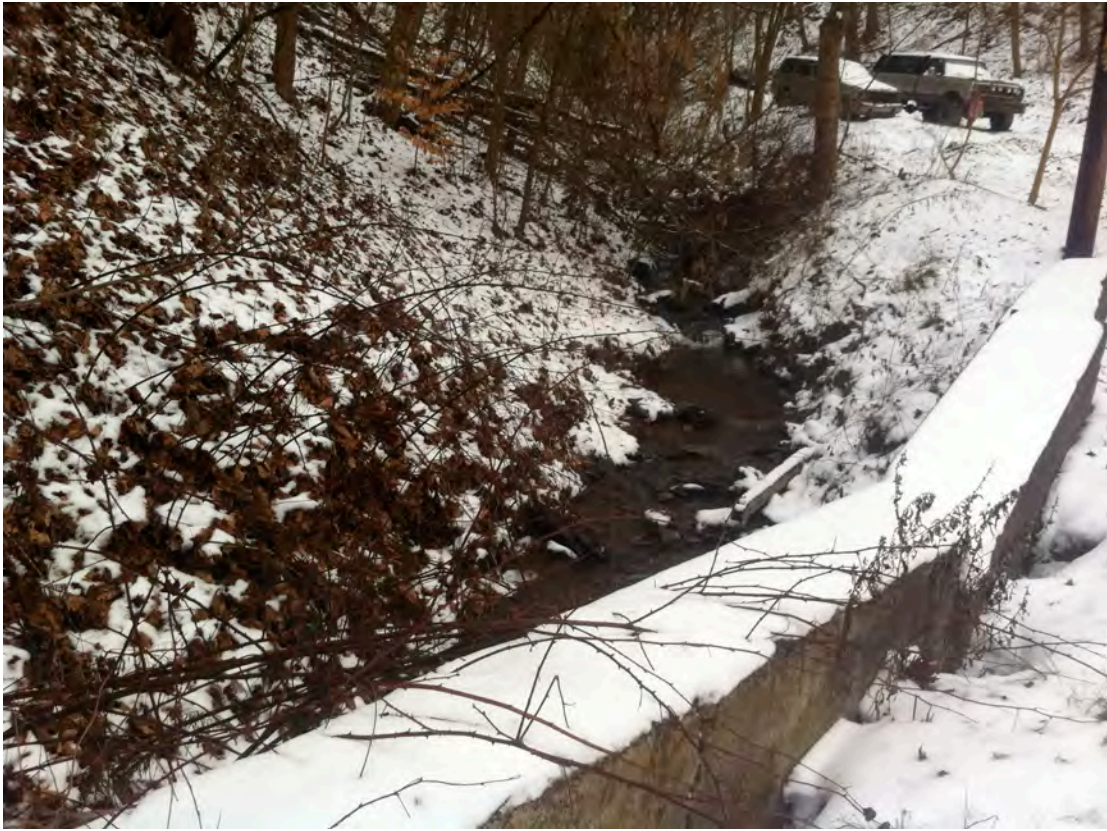
SCR15 – The tributary that drains the valley to the southeast of Scotia Run with headwaters near Ridge Rd and flowing along the commercial district along Century Dr is culverted under McGrew Rd and enters Scotia Run's left ascending bank.

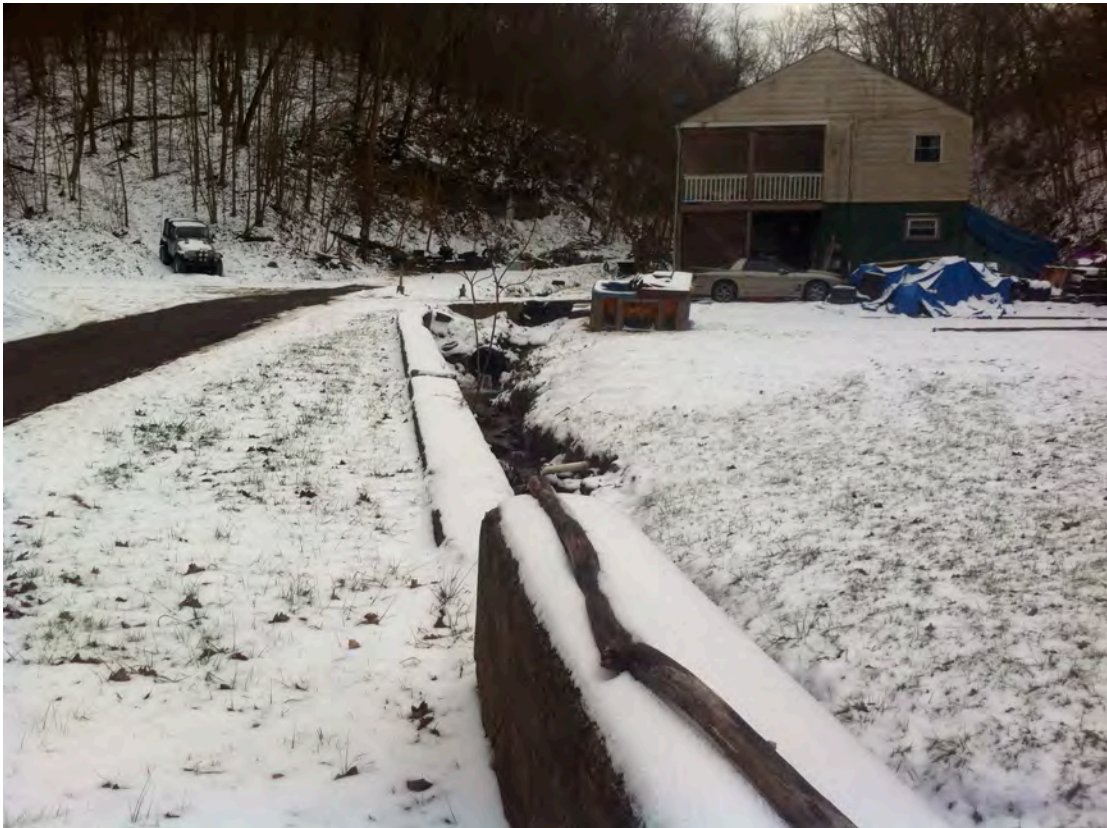
SCR16 - Scotia Run is culverted under a private driveway. A concrete wall constrains the left ascending bank for a few hundred feet downstream. The stream continues upstream in a southerly direction in a steep narrow wooded valley paralleling Rt51.

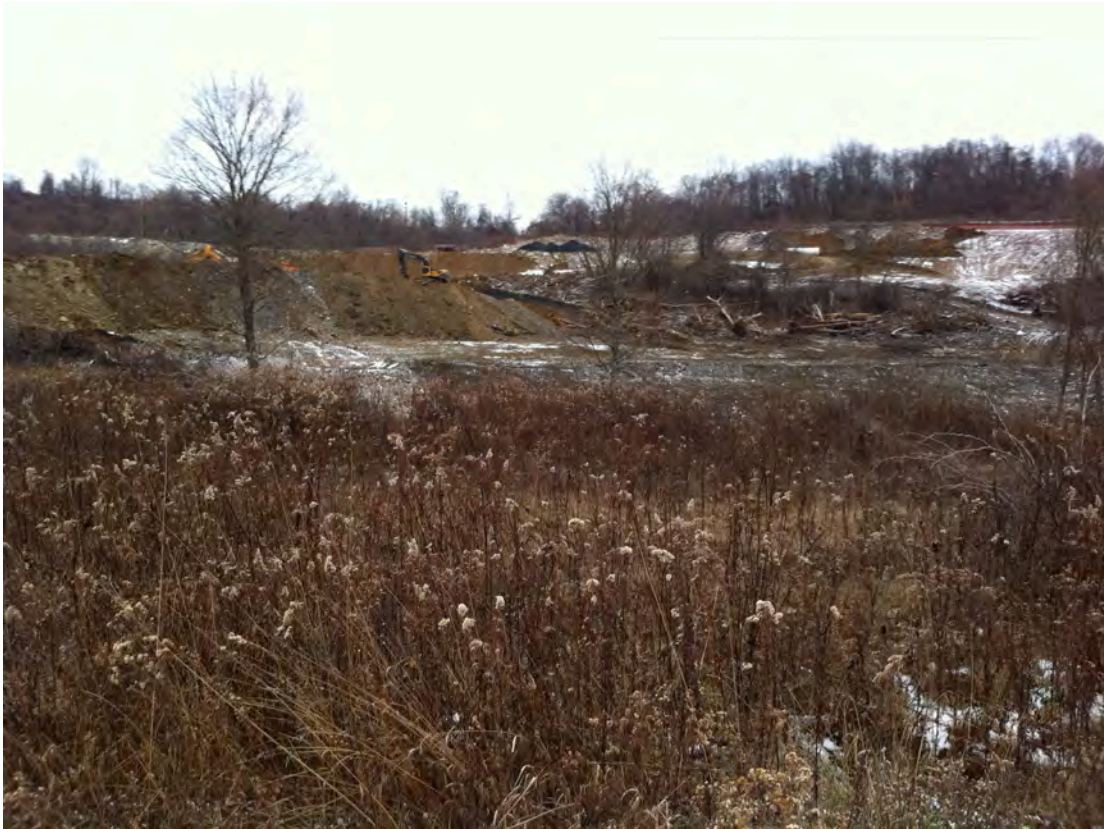
PCLT02 – A view of the Rochez #2 surface mine while in operation during the winter/spring of 2011. The mine is located along the slope above the Rt885 tributary's right ascending bank not far from the headwaters of the stream. A temporary detention basin was constructed to collect storm water runoff from the site prior to it entering the tributary.

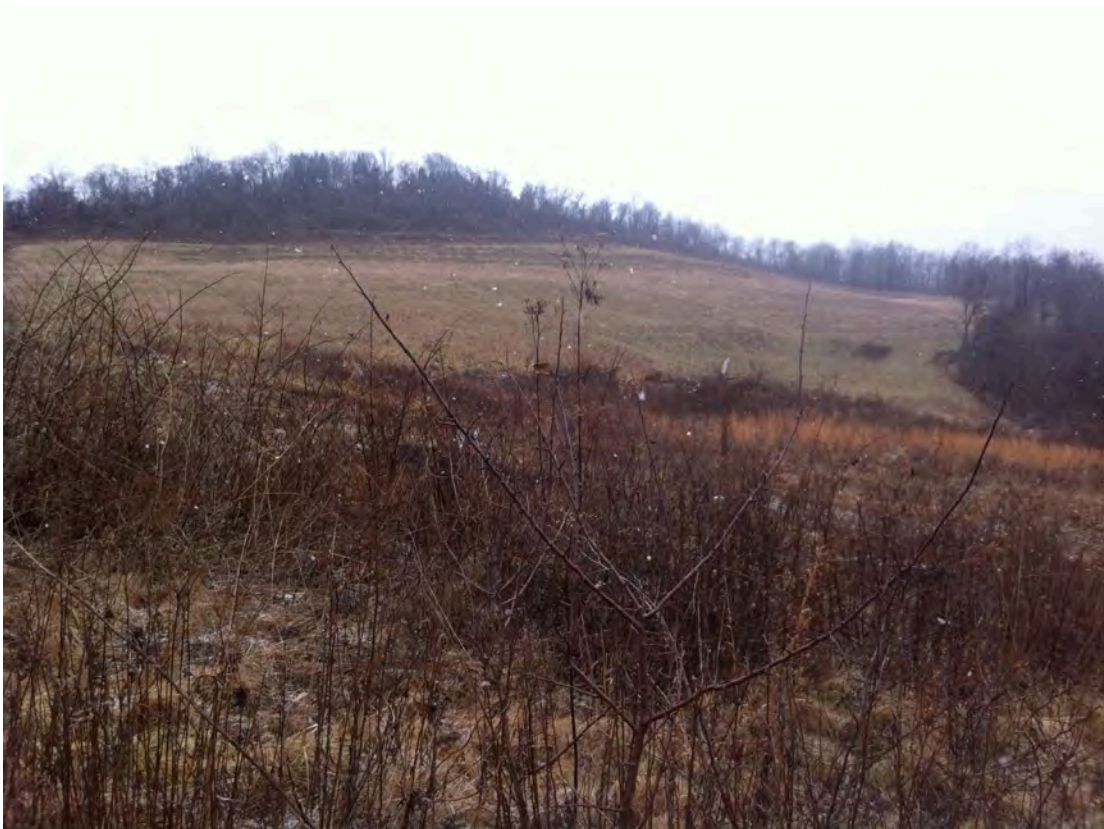
PCLT02 – The Rochez #2 mine in late 2013 following reclamation. The Rt885 tributary flows in the valley just to the right of the photo. This area was a thicket prior to mining. The total area disturbed for this mine was approximately 15 acres. Two other recent surface mines, Rochez #1 and Guillli Mine, are on the opposite side of Rt885.

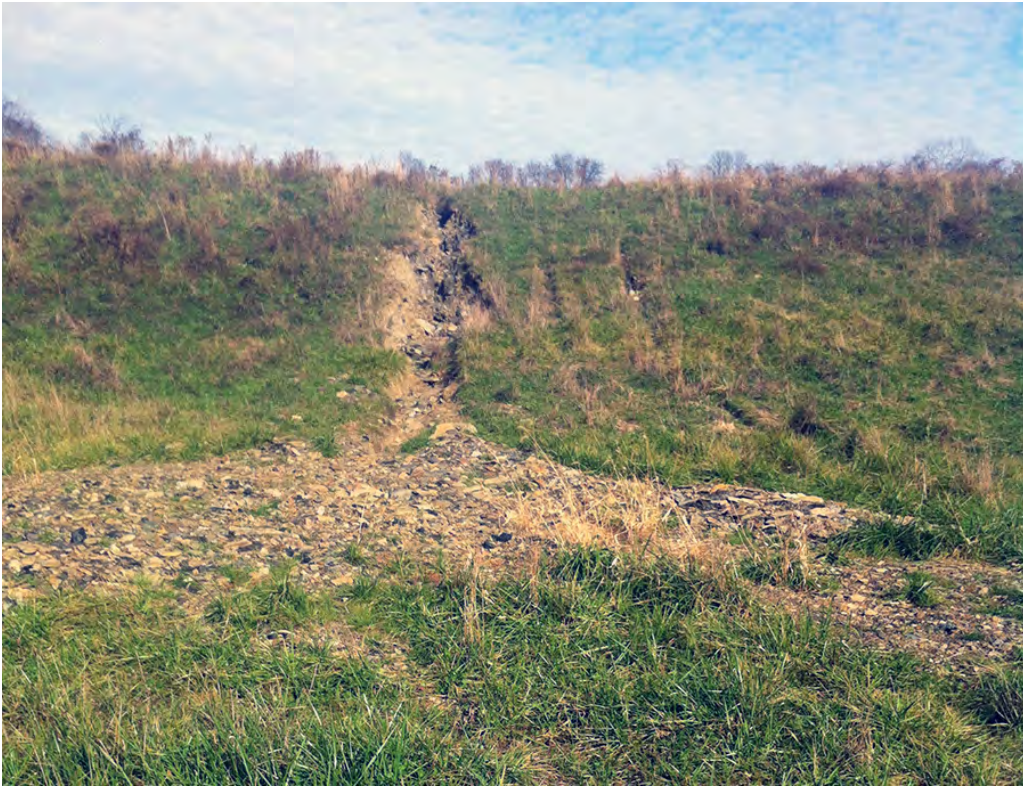
PCLT03 – An erosion gully has developed at the western end of the Rochez #2 site. Otherwise, reclamation at the site appears to be going well. The mining did not seem to affect water quality within the Rt885 tributary to a great degree. It appears that some regrading and planting at the site occurred in 2012/2013 to resolve erosion issues. This entire valley would most likely be altered dramatically if the section of the Mon-Fayette Expressway from Jefferson Hills to Pittsburgh/Monroeville is completed.

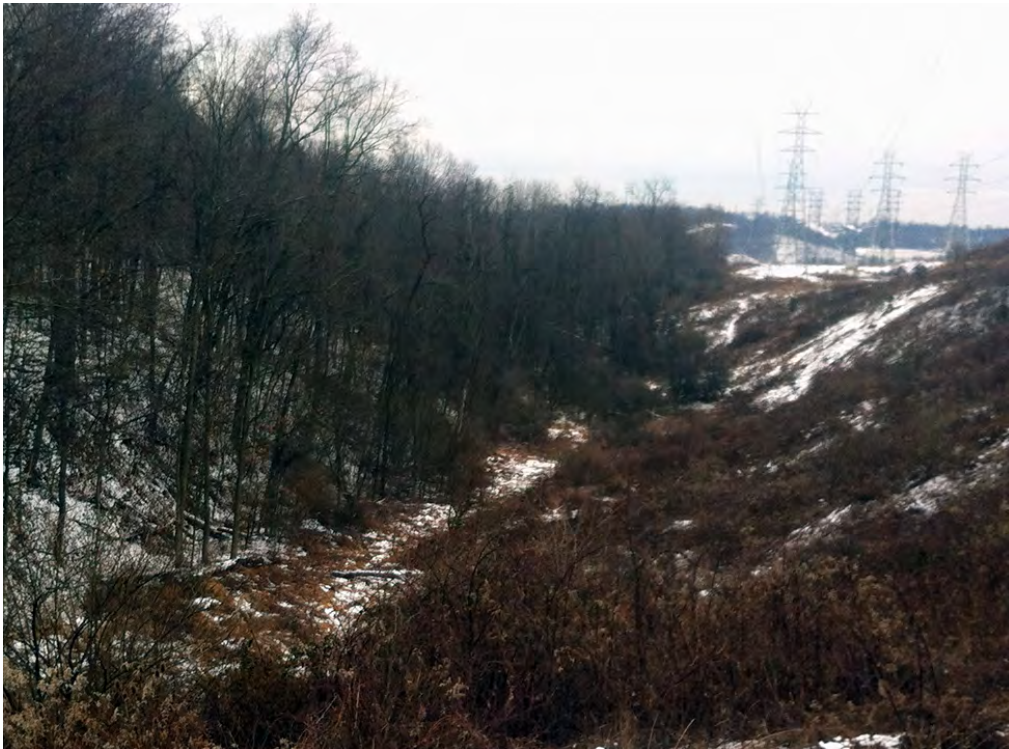
Looking south along the Rt885 tributary valley toward the Peters Creek valley. The stream is intermittent along this section. The steeply sloped right ascending bank remains wooded but the left ascending slope has been logged along this section of stream.

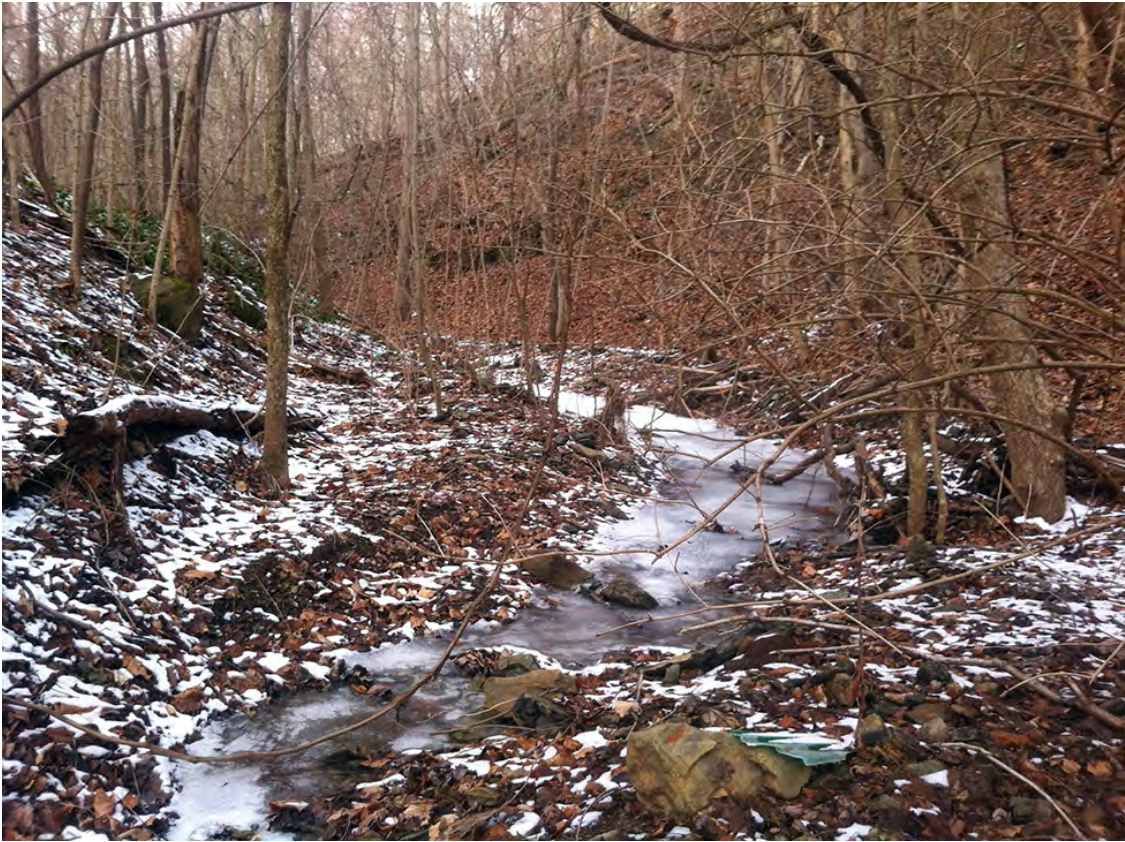
PCLT04 – Downstream of this waypoint the RT885 tributary becomes a permanently flowing stream. Much of the riparian area surrounding the creek was surface mined prior to adequate regulations. Spoil piles and high walls are common in this area.

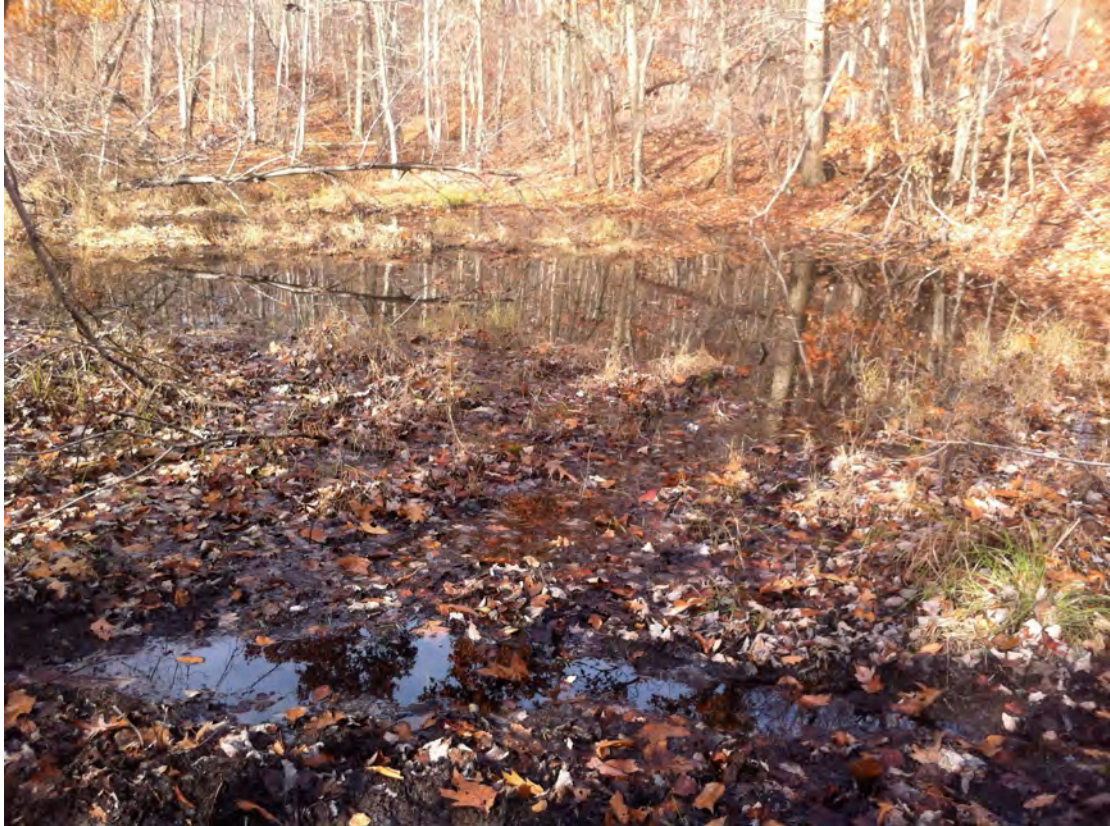
PCLT05 – A permanent pond of approximate ½ acre developed within a spoil pile on a bench above the tributaries right ascending bank. This area as well as a number of other smaller ponding areas along ATV trails provides breeding habitat for amphibians including Wood Frogs.

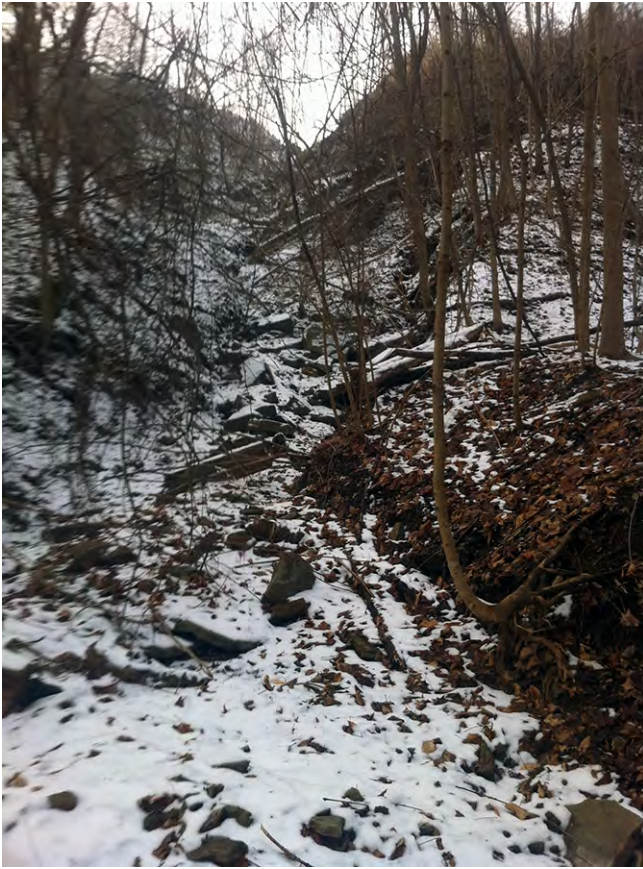
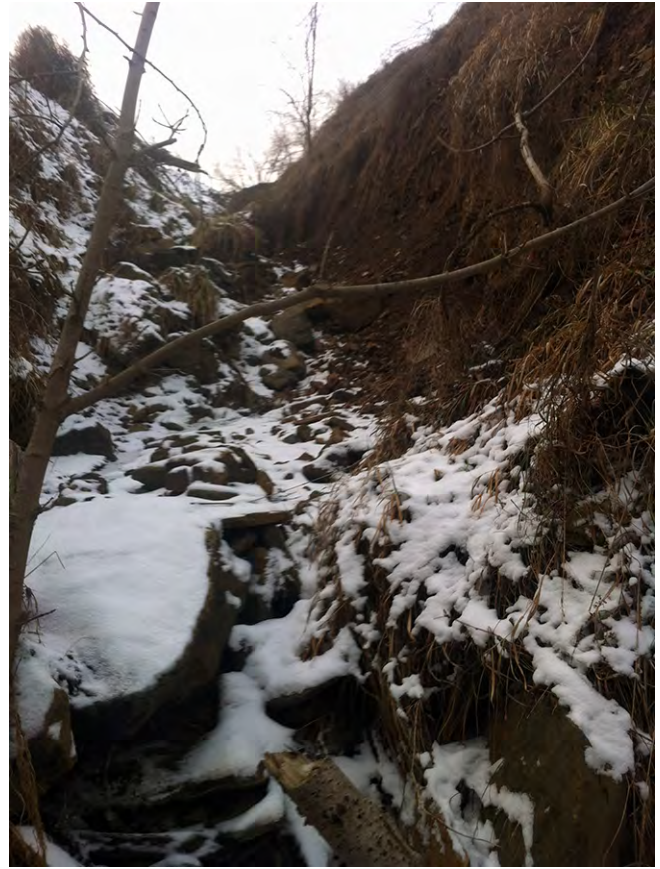
PCLT06 - A major drainage erosion gully has developed along the RT885 tributary's steeply sloped left ascending bank from the bench about 100 feet above. Left photo is a view of the entire gully from stream level. Right photo is a view of the gully as you near the bench.

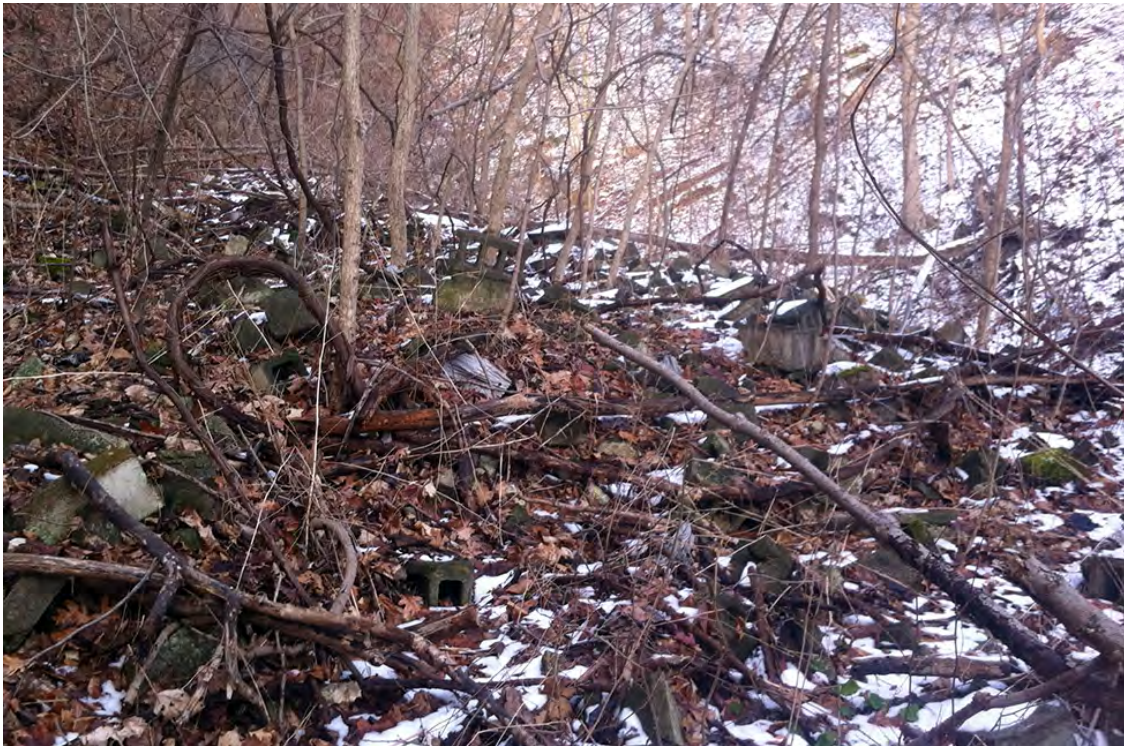
PCLT06 - Just upstream of the erosion gully is a large construction debris dump on the left ascending floodplain.

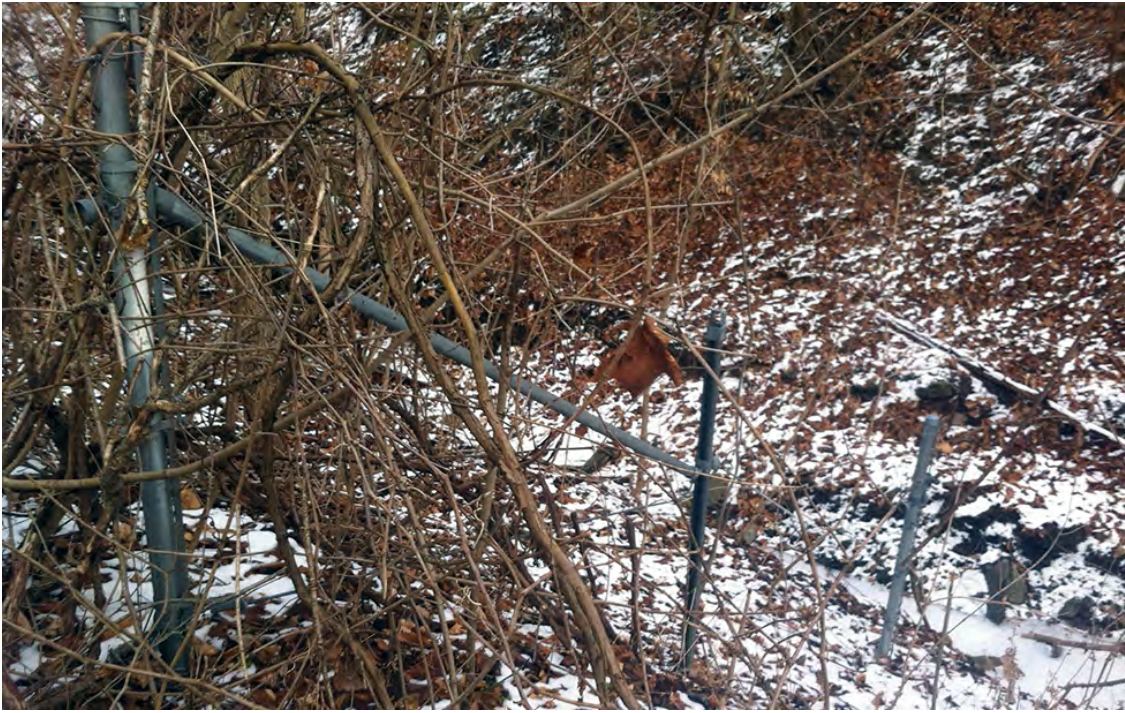
PCLT06 – Remnants of fencing installed as part of the Mon-Fayette Expressway project just downstream of the erosion gully. This fencing was placed across the stream channel. The value of this fencing in this location is questionable. The fencing is often vandalized by local off-road enthusiasts. There is little to no maintenance provided following installation and the unintended affects on local wildlife can be quite negative.

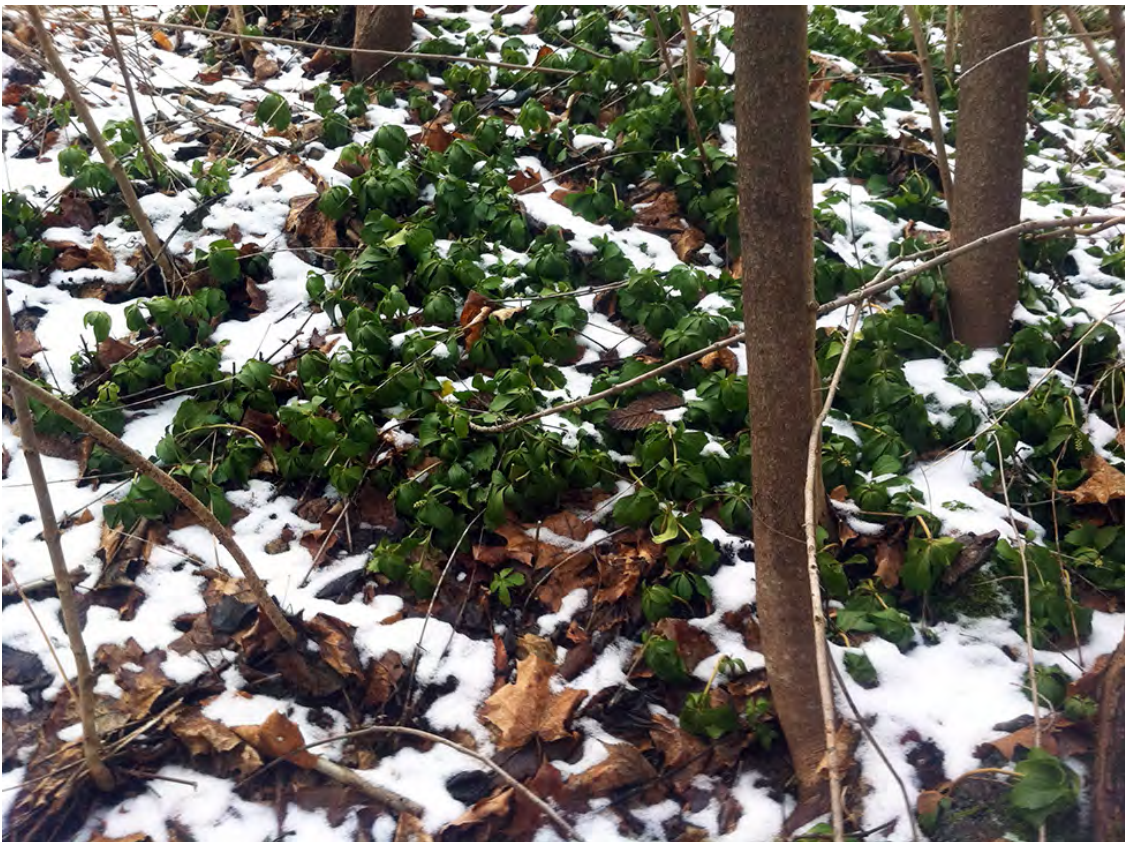
PCLT07 – A population of Japanese Pachysandra (*Pachysandra terminalis*) has taken over part of the tributary's left ascending bank. This shade tolerant ornamental groundcover often escapes from cultivation and establishes on riparian floodplains. It provides little in the way of wildlife benefit and is on Pennsylvania's watchlist of invasive species. It has established colonies at a number of locations throughout the Peters Creek watershed.

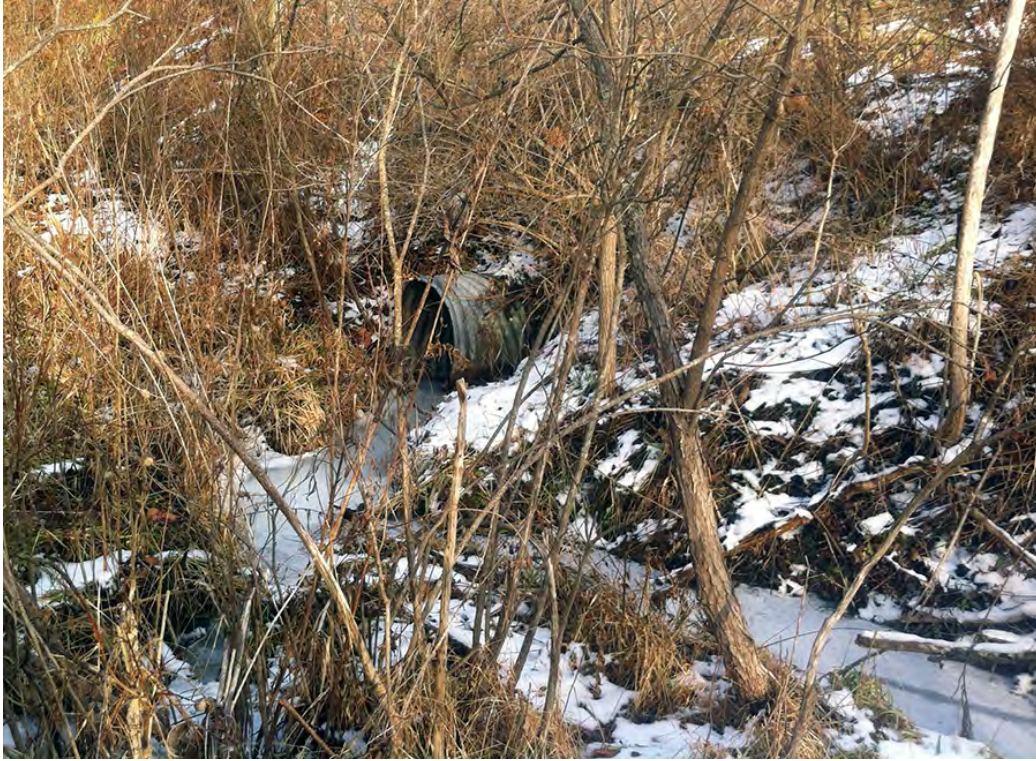
PCLT08 – The RT885 tributary is culverted under an access road to a power line transmission tower prior to entering a seven acre wetland within Peters Creek’s right ascending bank floodplain.

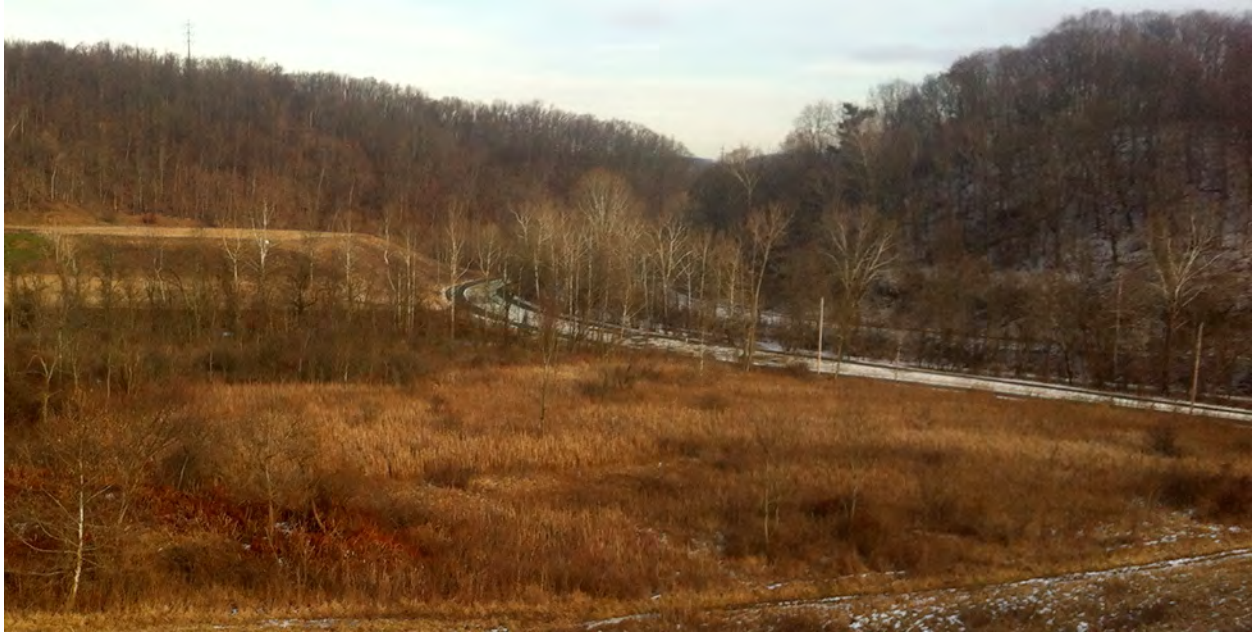
*PCL35 – A view of what is locally known as the Timberdoodle Wetland for the American Woodcock (*Scolopax minor*) that breed there. The RT885 tributary flows through the wetland and crosses under Peters Creek Rd and the Montour Trail prior to entering Peters Creek's right ascending bank. The fill platform behind the wetland in the photo's center left was placed there during the construction of the Mon-Fayette Expressway.*
