Peters Creek Watershed Assessment & Management Plan

April 2014

1.0 PETERS CREEK WATERSHED BACKGROUND

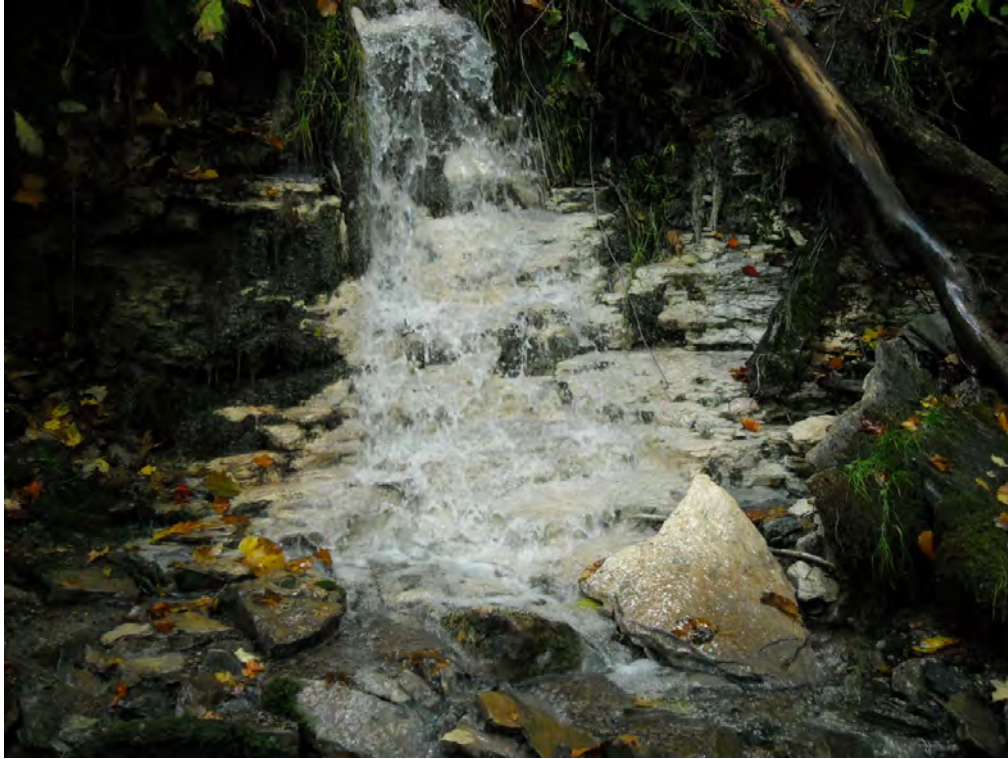
LW18 – Many of the tributaries to Lewis Run are impacted by abandoned mine discharge. This tributary drains a steep valley behind the Jefferson Hills Municipal Building before entering Lewis Run’s left ascending bank and contributes to the streams metal load.

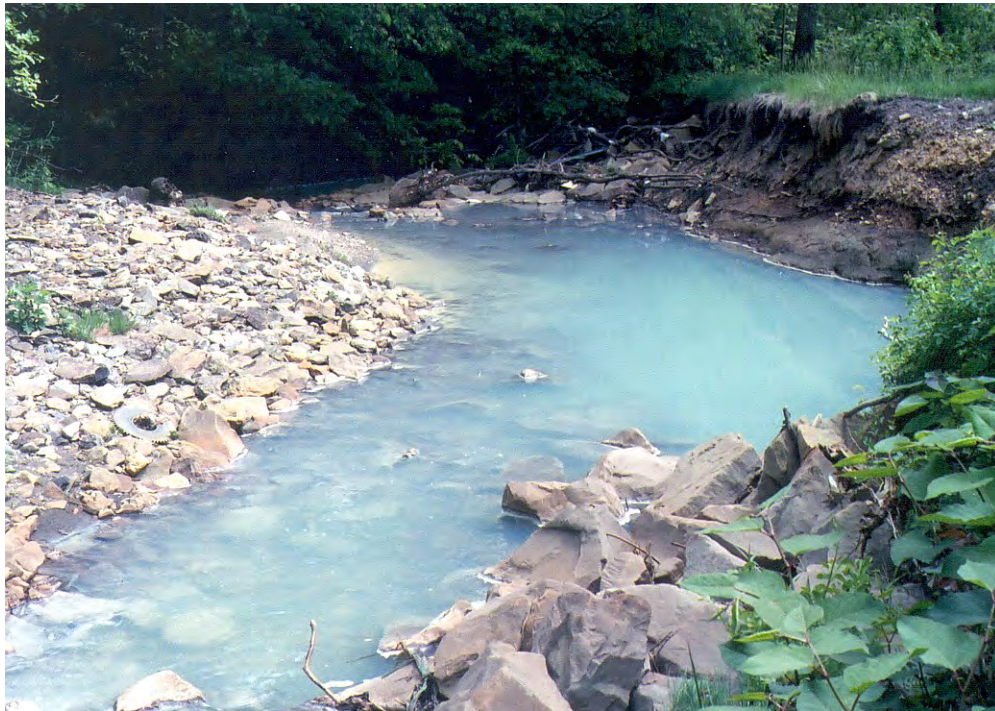
LW32 – Lewis Run just downstream of its confluence with the Oakwood Rd Tributary. Lewis Run is clearly impacted by the heavy metal load of this stream. Stream bank erosion and a large Japanese Knotweed infestation are also a problem along this section of Lewis Run.

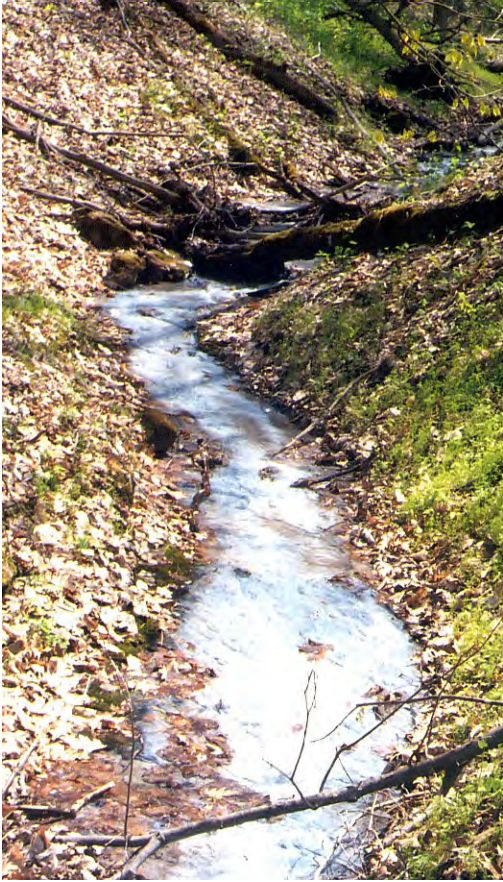
LW23 – The AMD impacted tributary in the photo to the left drains the steep valley between Alta Vista Dr and the sports field complex that is behind the Jefferson Elementary School. This tributary is culverted under Rt51 just prior to entering Lewis Run's left ascending bank downstream of the Blue Flame Restaurant.

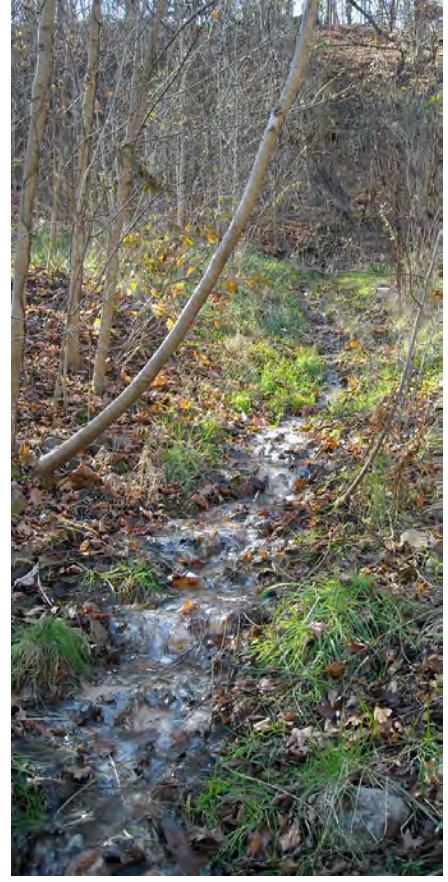
WLT05 – The AMD seep in the photo to the right is one of many that impact the Wray Large Rd Tributary as it flows within the steep valley between Andrew Reilly Park and the streams confluence with Lewis Run.

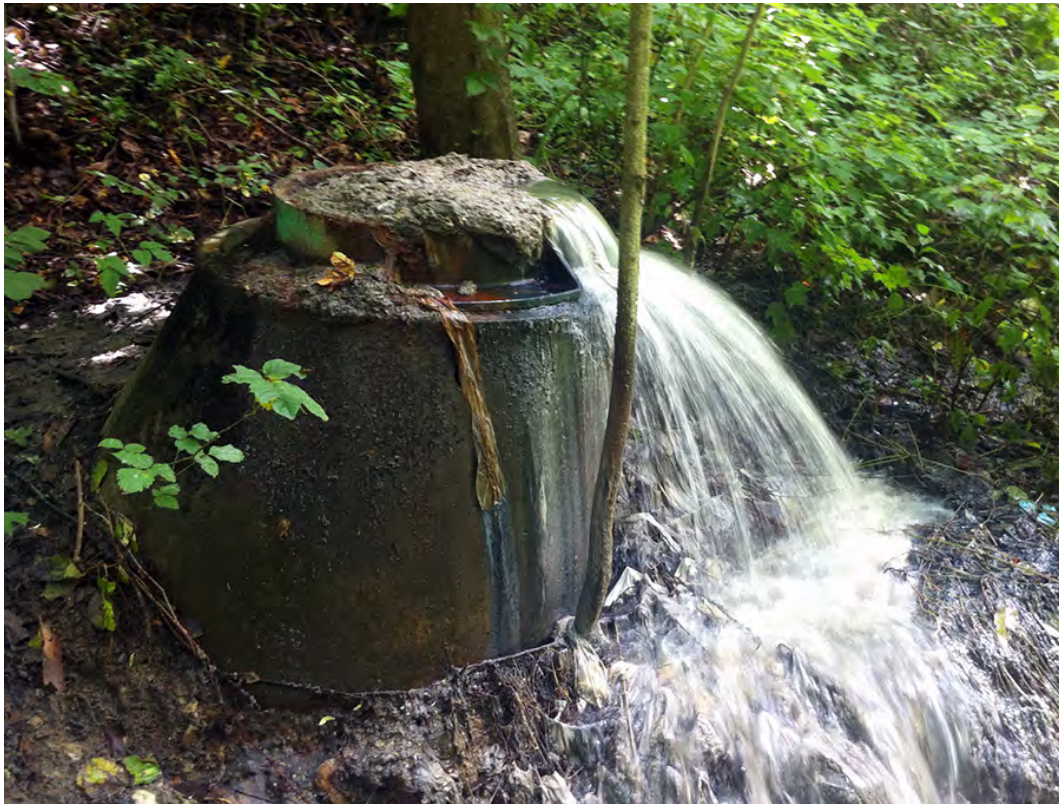
JHT04 – This overflowing sanitary sewer line along the Jefferson Hospital Tributary was dumping its contents directly into the tributary. Sanitary sewer lines often follow tributary valleys and in Jefferson Hills many are in fairly remote locations like this one. They also often end up within the stream channel due to the dynamic nature of streams. Malfunctioning sewers and those in stream channels contribute to the bacterial and nutrient load within Lewis Run.

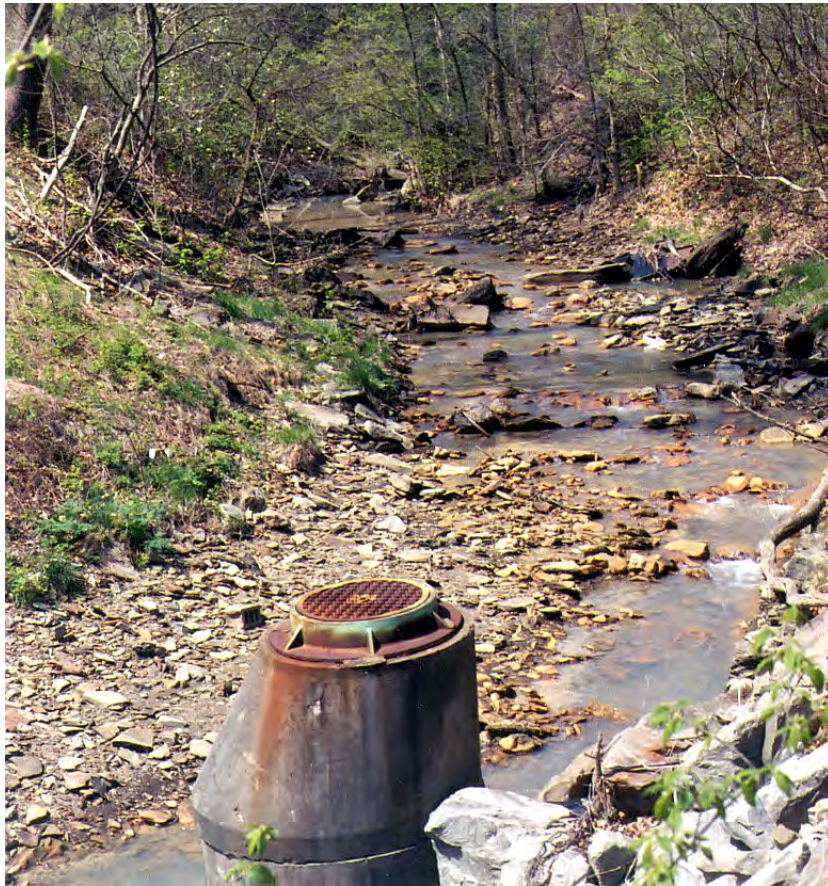
LW20 – A sanitary sewer manhole downstream of Lewis Run’s confluence with the Jefferson Hospital Tributary is within the streams channel. The sewer contents combine with the stream during high water events.

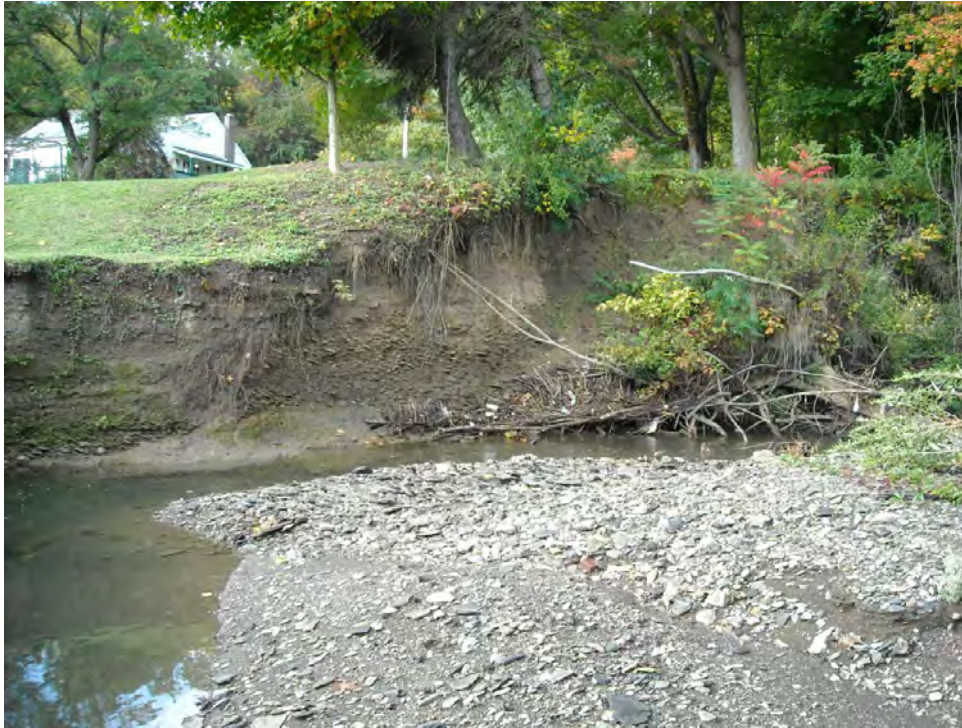
LW07 – Severe outer bank erosion and inner bank deposition along a tight S-bend near the Mon-Fayette Expressway Rt51 entrance ramp. Stream bank erosion is a problem at numerous locations along the Rt51 portion of the stream due to large quantities of storm water entering Lewis Run from the large commercial district in Lewis Run's headwaters.

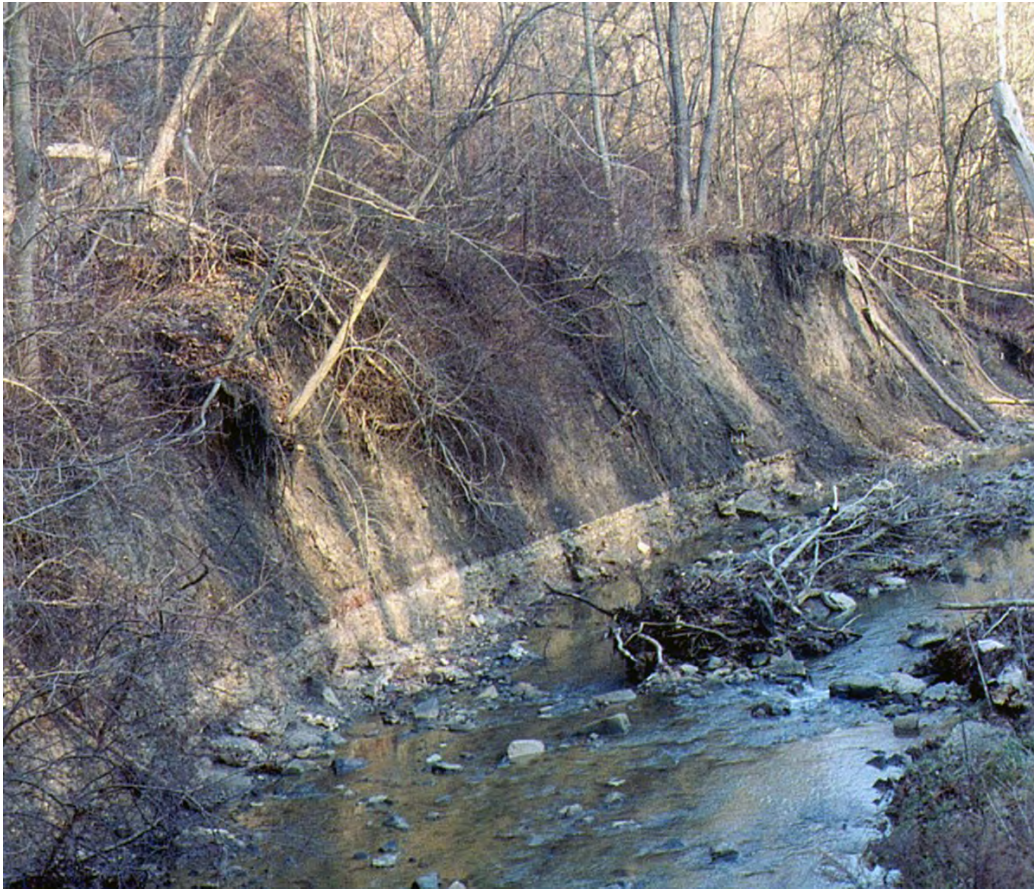
LW24 – Severe right ascending bank erosion along Lewis Run downstream of the Blue Flame Restaurant.

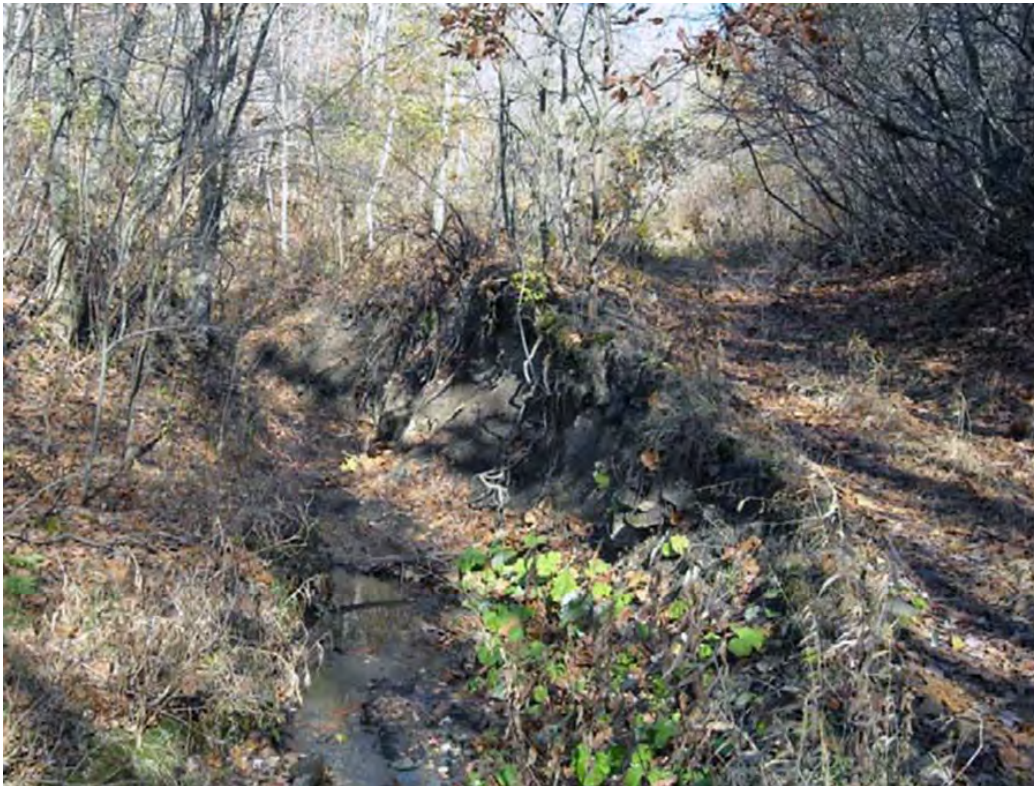
JHT03 – Bank erosion along the lower reaches of the Jefferson Hospital Tributary just prior to the stream entering the Lewis Run floodplain.

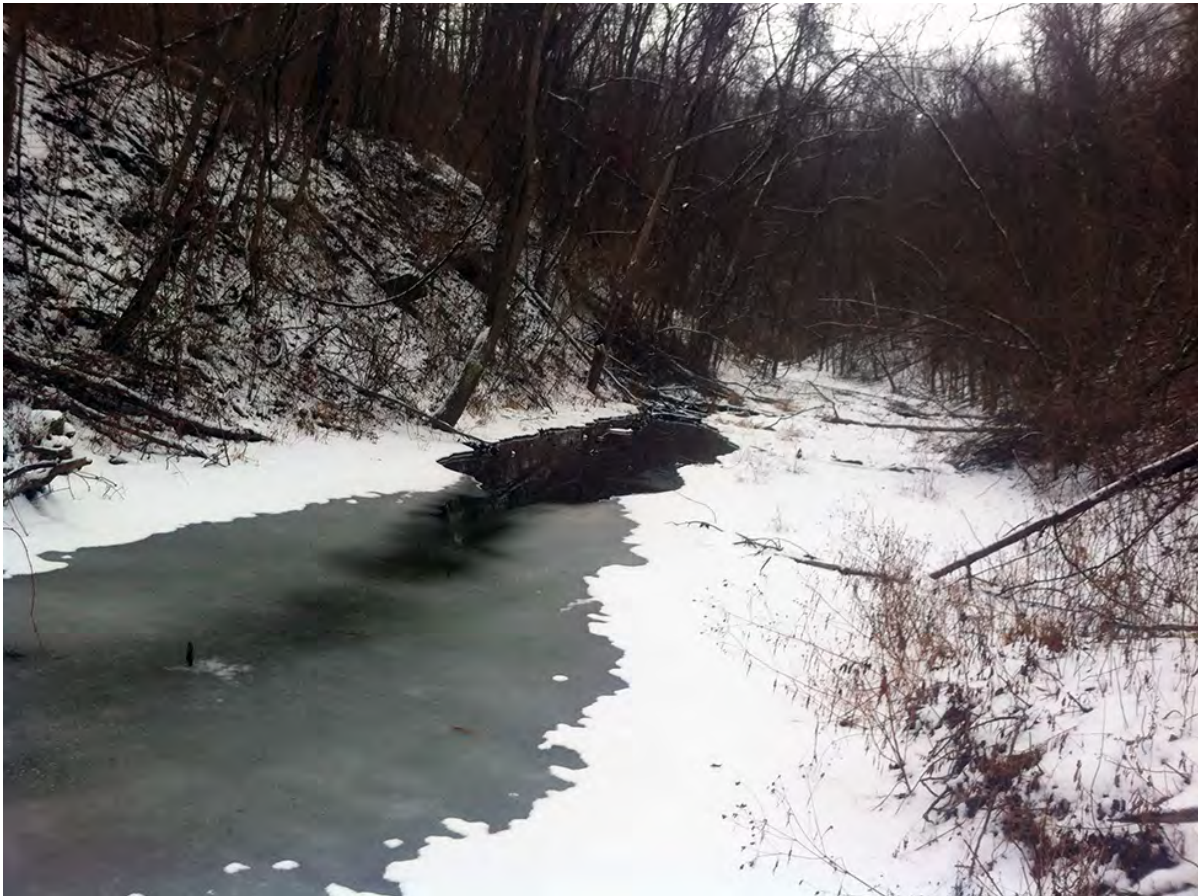
JHT05 - This ponding of the Jefferson Hospital Tributary formed between an overburden pile and a mining high wall created by surface mining of the area in the late 1960s prior to modern regulations. There had been a natural pond in the area prior to mining. The outlet of this pond is deeply incised and continues to erode and cut down the streams channel downstream. A number of other wetland areas have formed along the Jefferson Hills Tributary.

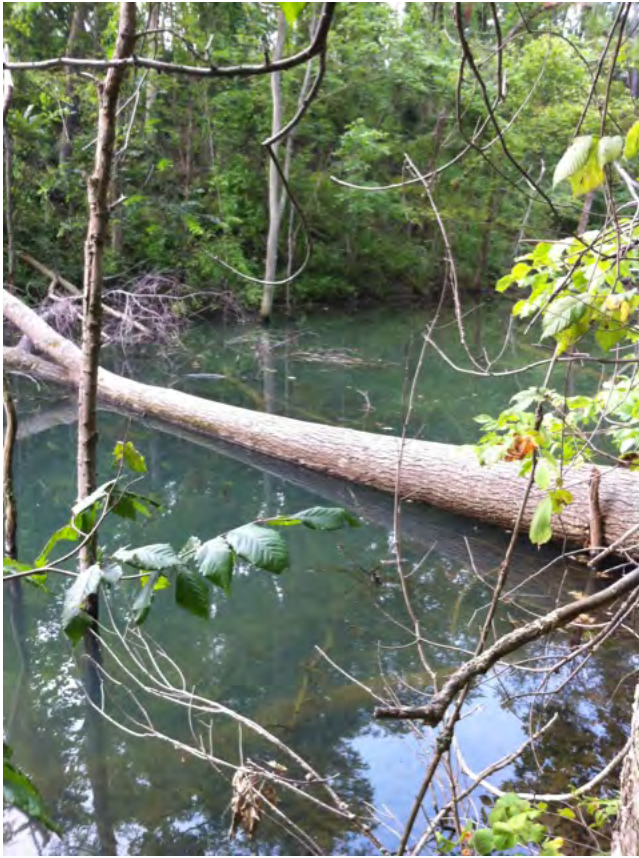
LW 29 - Impoundment along Elliot Rd Tributary to Lewis Run. The surrounding area was surface mined prior to modern regulations and the impoundment is impacted by abandoned mine drainage. The outlet of this impoundment flows along Elliot Rd and enters Lewis Run via a storm sewer.

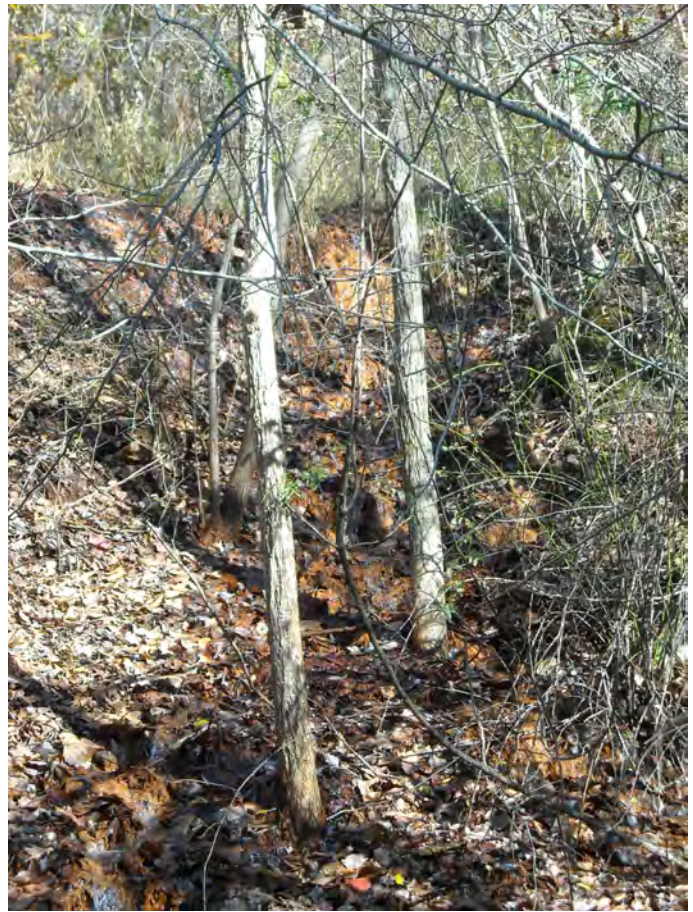
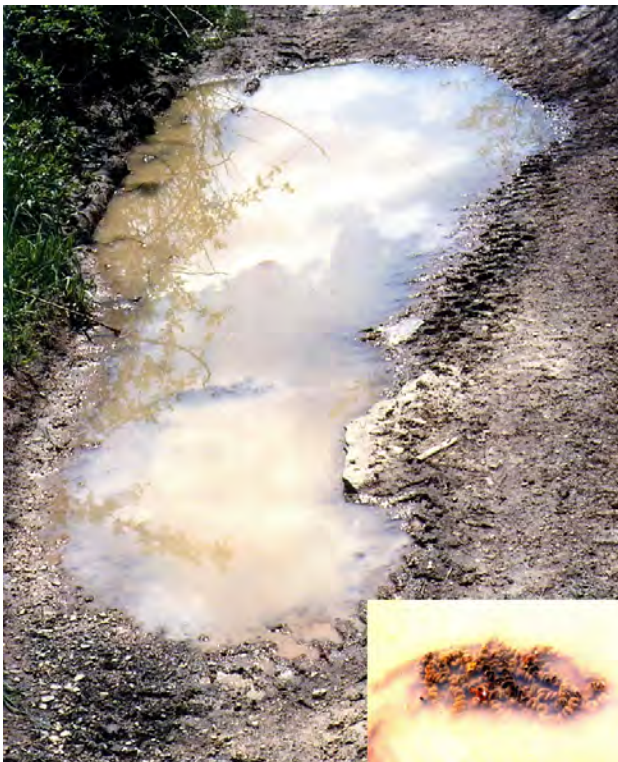
WLT06 - Numerous seeps, many impacted by AMD, such as the one in the photo to the right form wetland areas along the middle portion of the Wray Large Rd Tributary. There is little to no development along this tributary.

Temporary vernal ponds such as the one in the photo to the left along the Jefferson Hospital Tributary provide breeding habitat for many amphibians, especially Eastern American Toads (*Anaxyrus americanus*) and woodland frogs such as the Wood Frog (*Lithobates sylvaticus*). Unregulated ATV and mini-bike activity throughout the Peters Creek watershed compromises much of this habitat. Photo inset is American Toad eggs in the temporary pond.

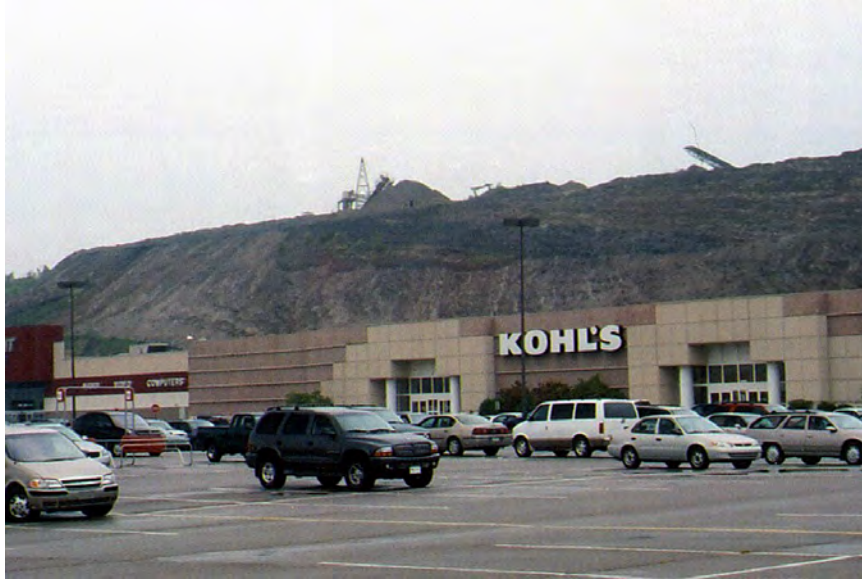
The Pleasant Hills Tributary along State Route 51 is culverted under a commercial district in West Mifflin that was built on top of a reclaimed slag dump. Reclamation of the slag dump has continued over the past several years with additional commercial development added to the district.

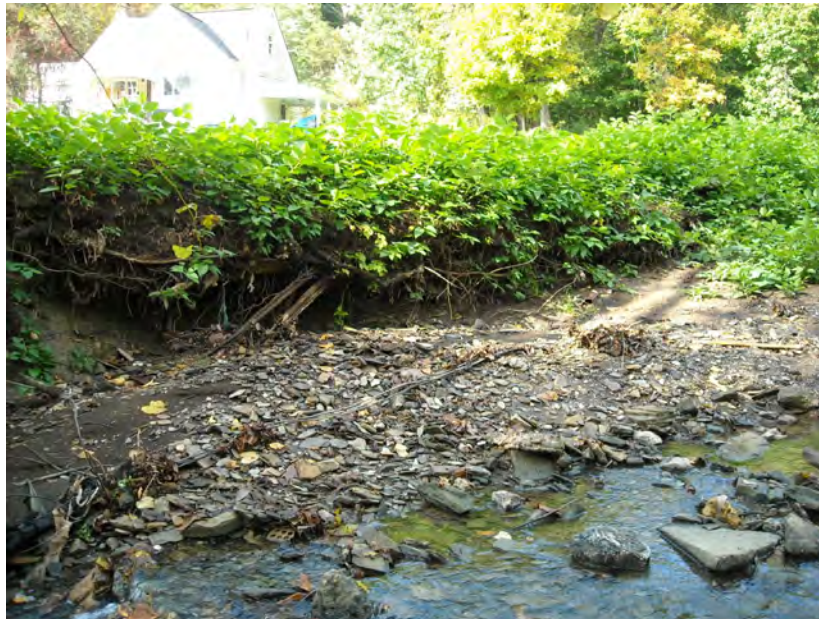
LW07 – Significant patches of Japanese Knotweed have developed within the Lewis Run Rt51 floodplain at a number of locations including near the Mon-Fayette Expressway RT51 entrance and upstream of the Coal Valley Rd and RT51 intersection.

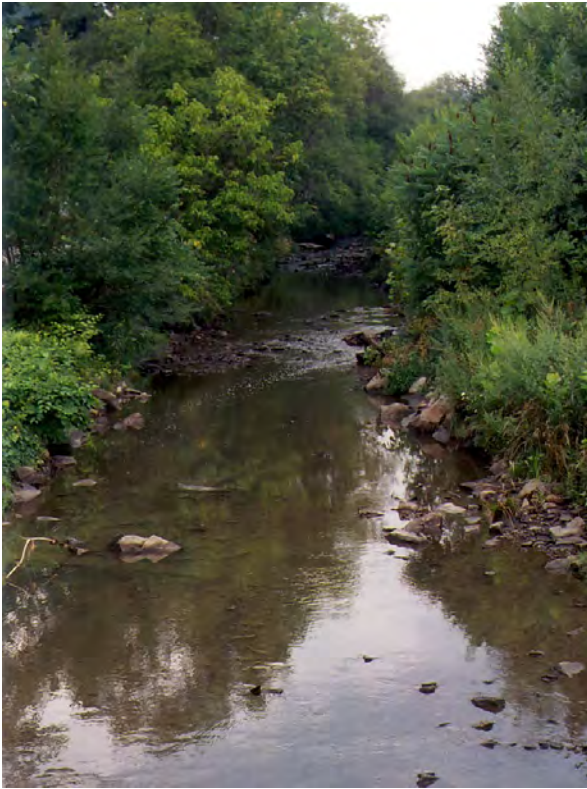
LW03 – Lewis Run just upstream of the Old Clairton Rd Bridge crossing. Even though the lower section of Lewis Run is constrained by Rt51 and some commercial development there remain a number of areas with some wooded floodplain at least along one side of the stream.

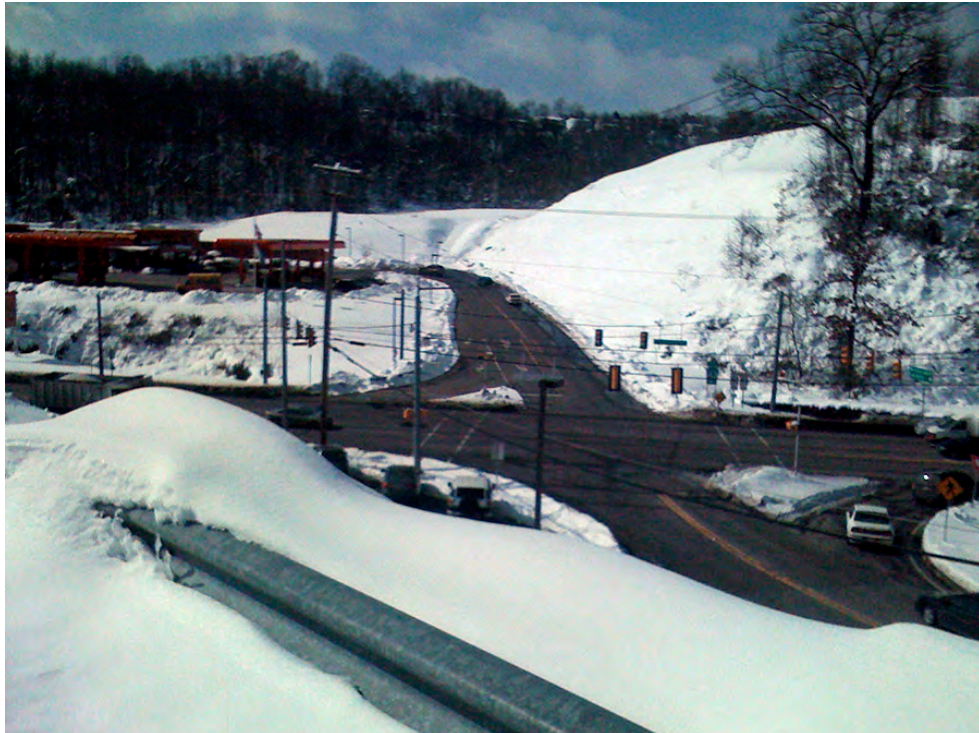
LW40 – This section of Rt51 at its junction with N Lewis Run Rd floods during heavy rain events. Lewis Run meets the RT51 Tributary just to the right of the photo and is immediately culverted under Rt51 and the Sheetz access road.

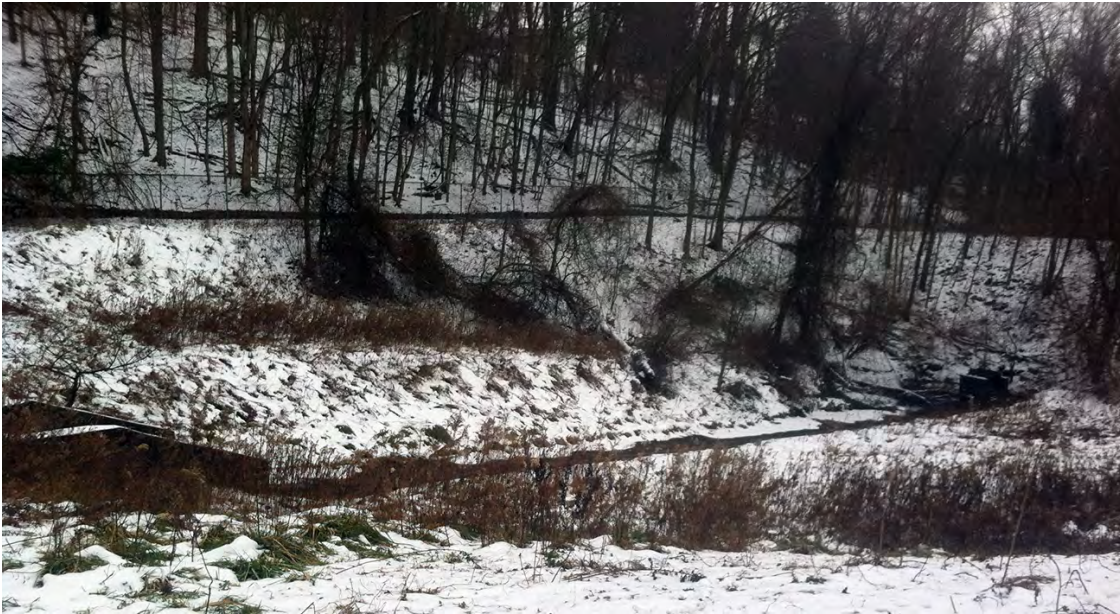
There is inadequate storm water control throughout most of the Lewis Run sub-watershed. This large detention basin is part of the Jefferson Hospital complex. More recent projects including the Mon-Fayette Expressway, newer development along the Rt51 commercial district and recently completed residential developments are implementing storm water controls.

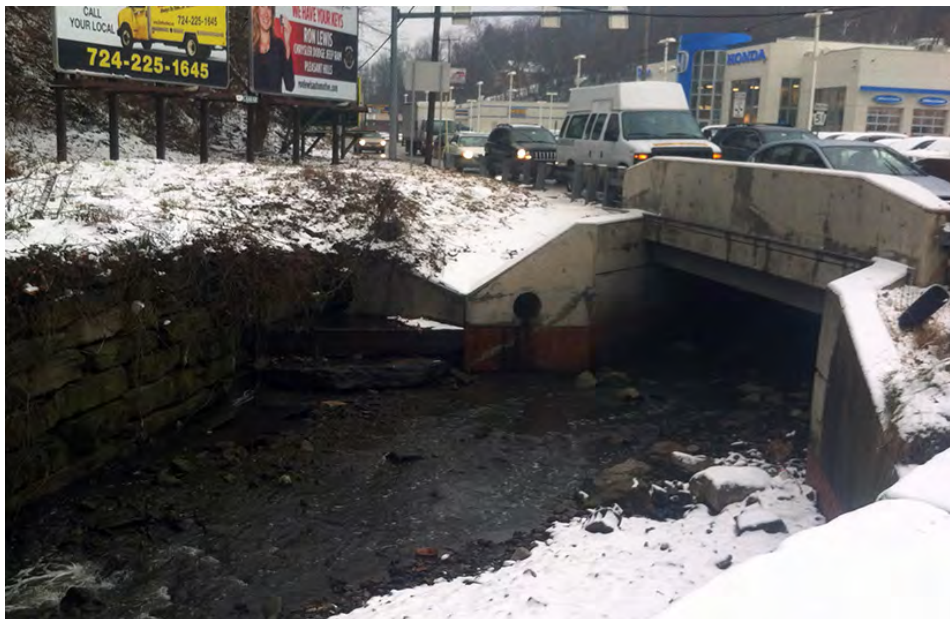
LW40 – Most upstream crossing of Lewis Run under RT51 just above its junction with N. Lewis Run Rd. The culverted Rt51 Tributary is daylighted on the far side of Rt51 where it enters Lewis Run as Lewis Run exits a 200 ft culvert under the Dean Honda lot. Flooding is a problem at this site.

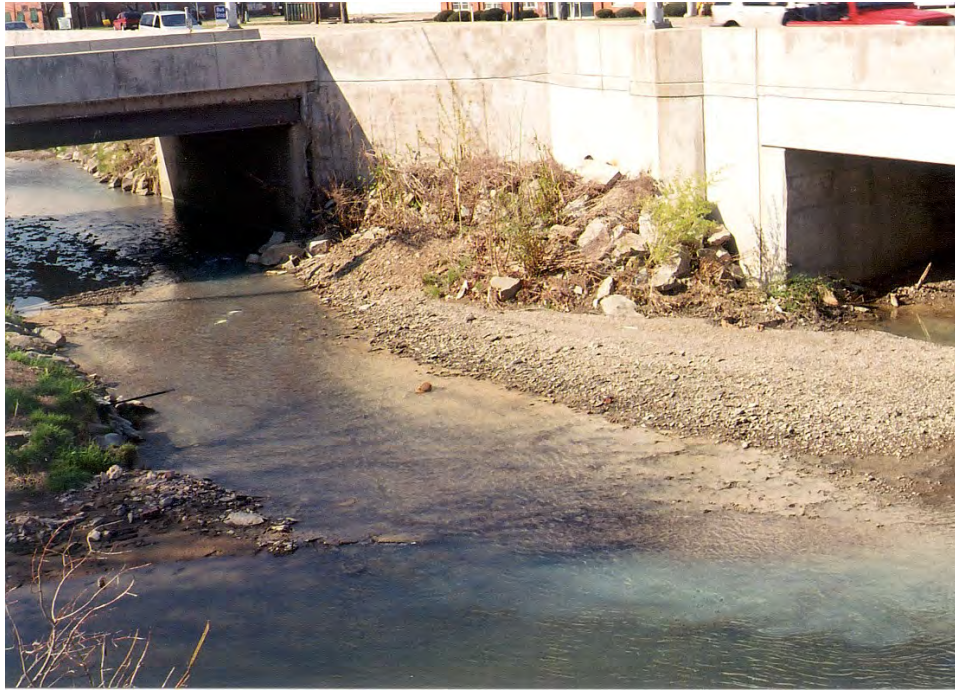
LW01 – Lewis Run passes under its final encroachment, an access driveway bridge to the former Dick Corporation headquarters, and enters Peters Creek along Rt51 in Large, PA.

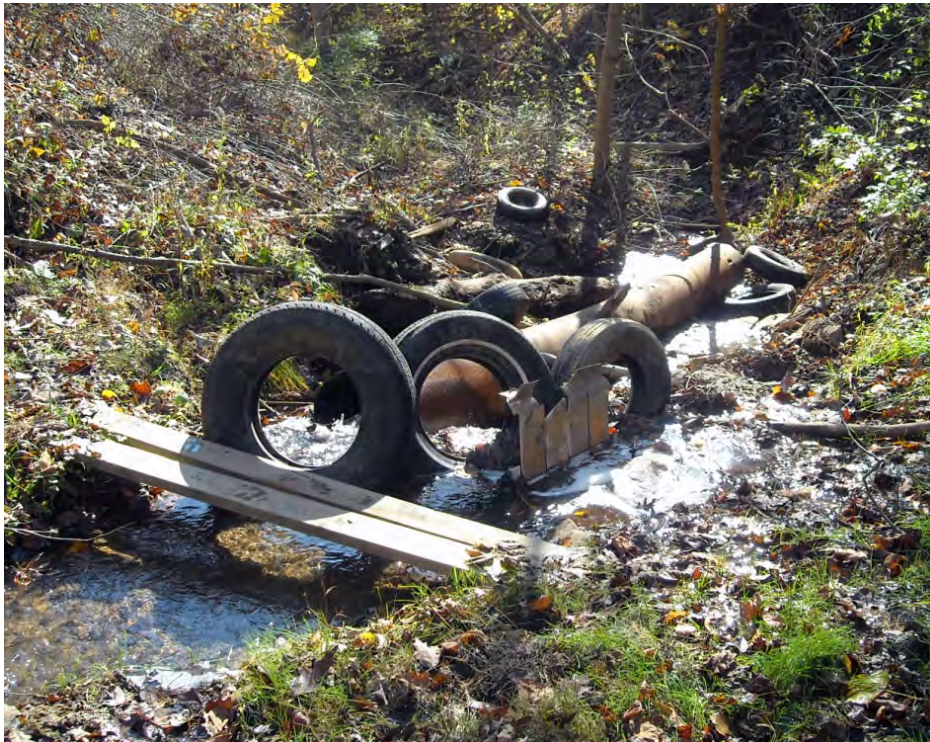
Illegally discarded tires and other debris accumulates at a non-functional pipe blocking the channel of the Jefferson Hospital Tributary. There is also an abandoned truck along this section of stream.

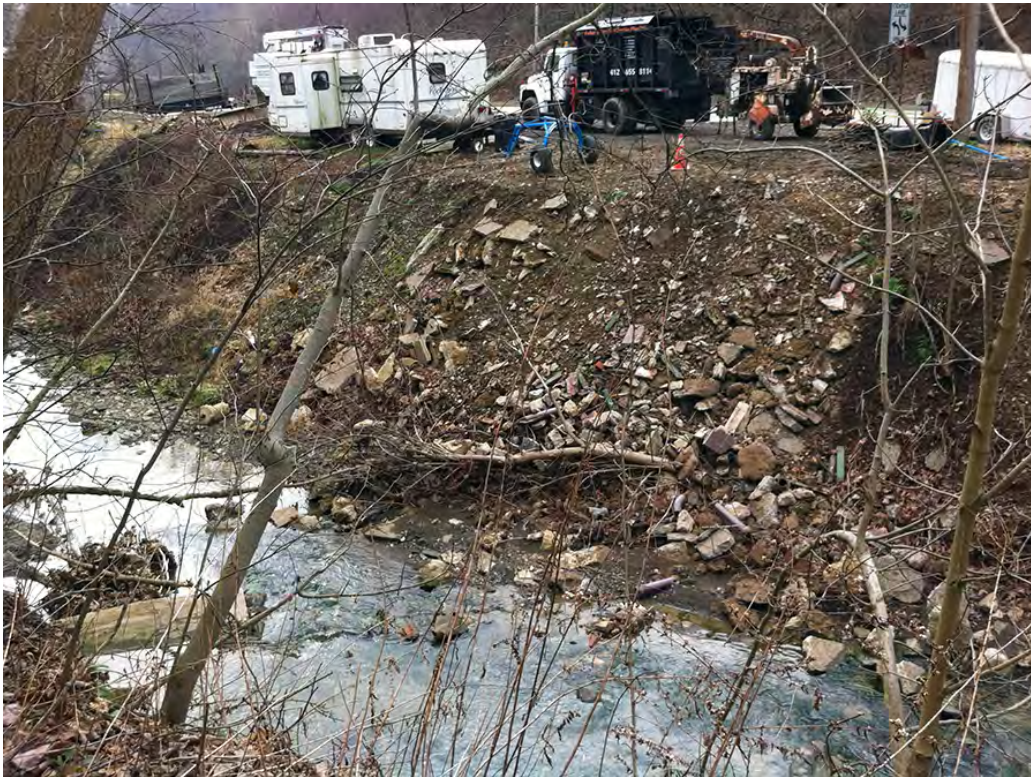
LW24 – Illegal dumping of construction material and other debris into Lewis Run from a landscape yard along Rt51.

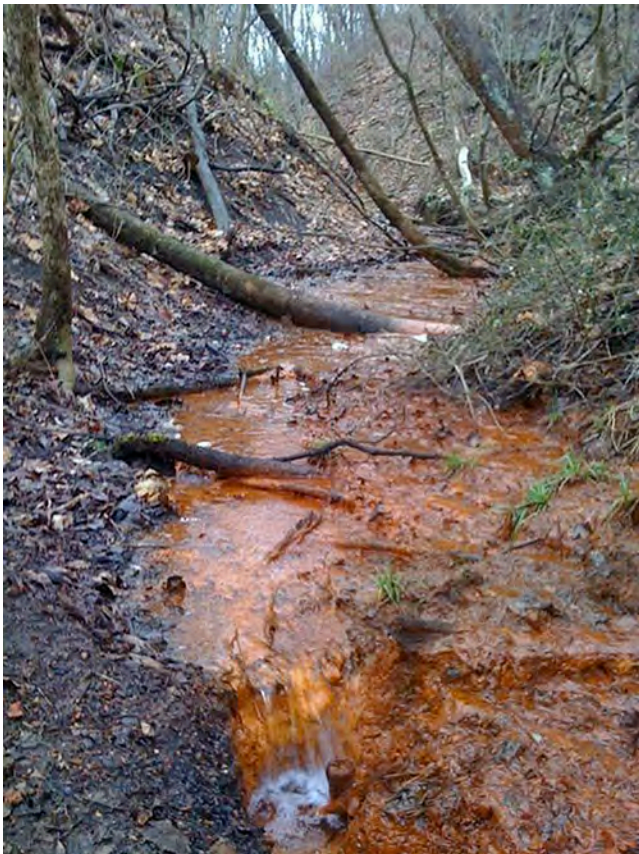
PCM21 - Abandoned mine discharge flows between a highwall and a gob pile at an old mining surface mining site just west of the "Coal Patch" , flows down a steep hillside and enters a wetland within Peters Creeks right ascending bank floodplain.

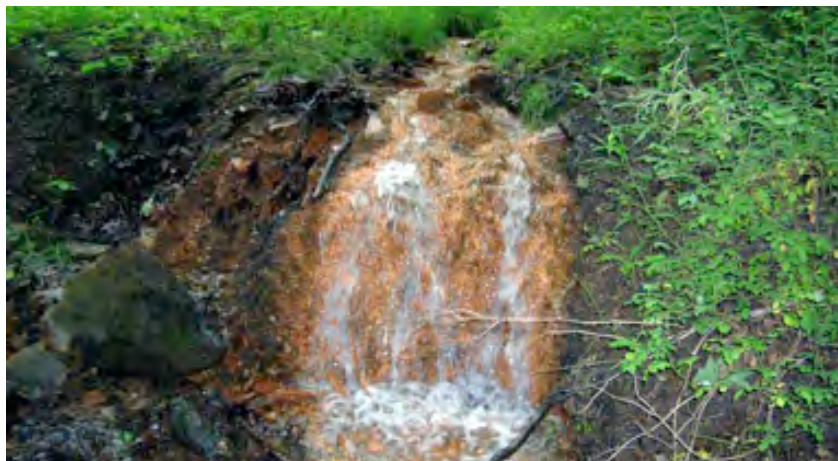
SR11 – Metals impacted alkaline discharge enters Sneer Run's right ascending bank.

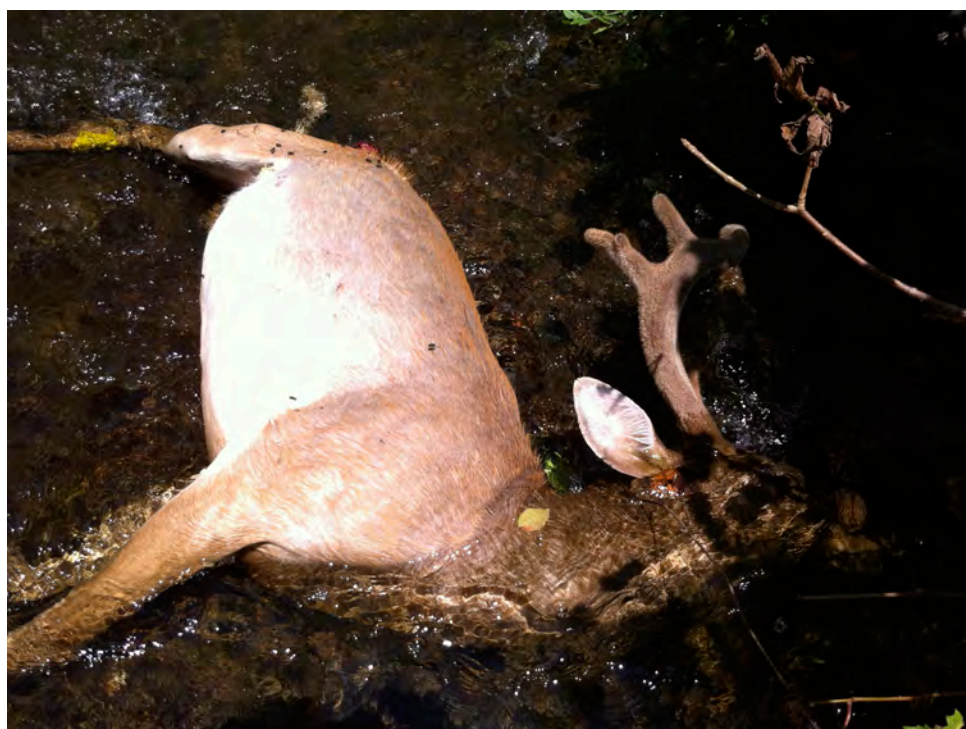
PCM11 – Dead animals within the stream channel as well as their feces is a natural contribution to the bacterial load of Peters Creek.

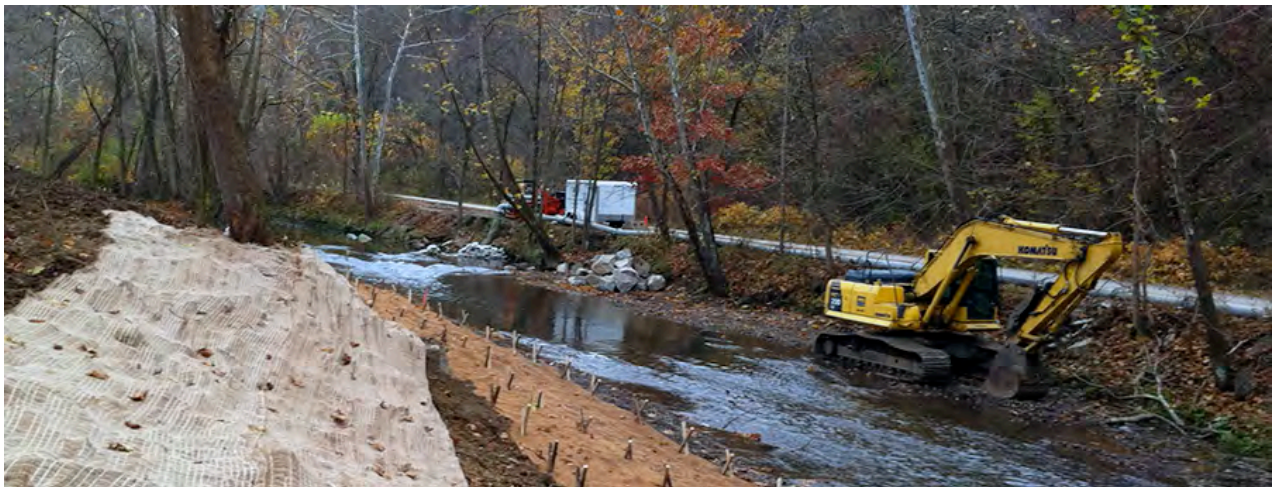
PCM28 – At a number of locations along Peters Creek Rd in Jefferson Hills the road is pinched between the stream and steep cliffs. Stream bank erosion, especially on outer banks, compromises the road at some of these locations. Jefferson Hills is proactively utilizing natural stream channel design concepts to protect infrastructure while maintaining the natural integrity of the riparian zone, improving transport within the stream channel and increasing habitat for fish and other aquatic organisms. PA DEP Growing Greener Grants are helping to fund these Best Management Practices implementations.

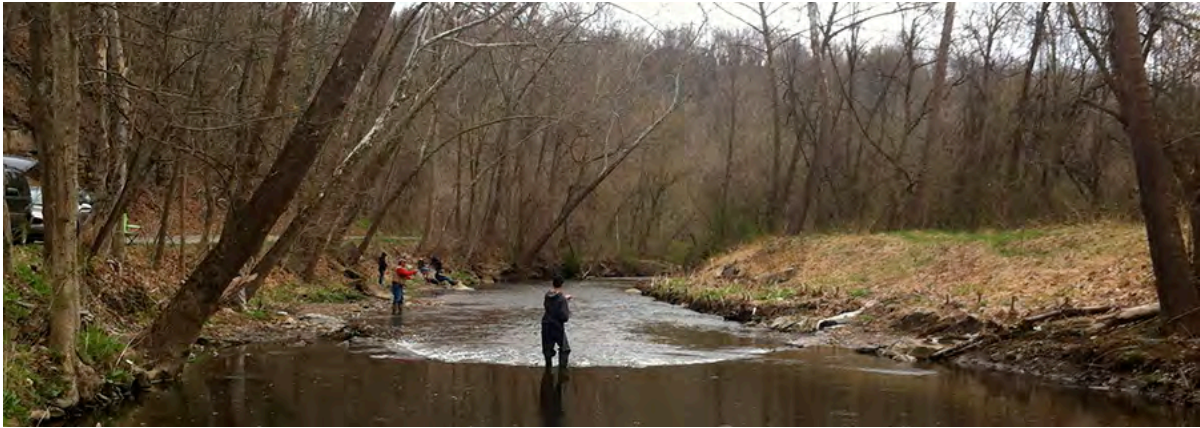
PCM28 – This restored section of Peters Creek has become a favorite of fishermen. This photo was taken on Trout opening day 2013. Peters Creek is stocked by Jefferson Hills, South Park Twp and the Tri-Community Anglers.

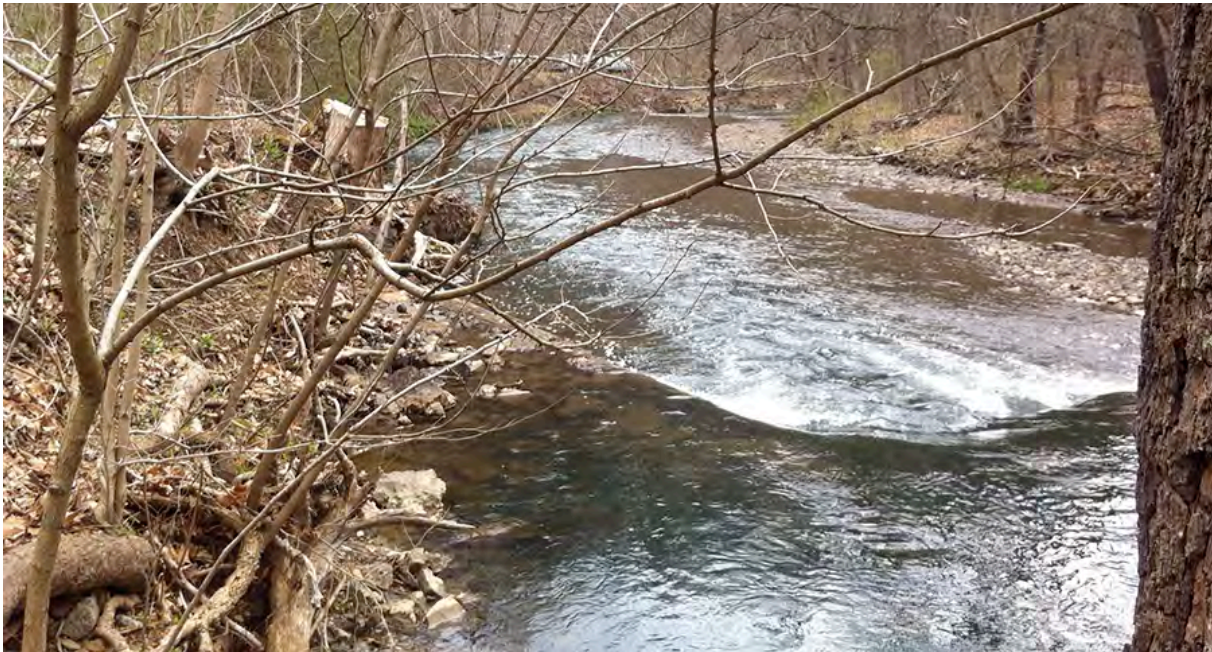
PCM42 – A log vane structure helps to direct the energy of the streams flow toward the center of the channel and away from the eroding bank along the road at Jefferson Hills Phase 2 Natural Stream Channel Design Restoration Project along Peters Creek Rd. A rootwad just downstream provides added protection to the stream bank.

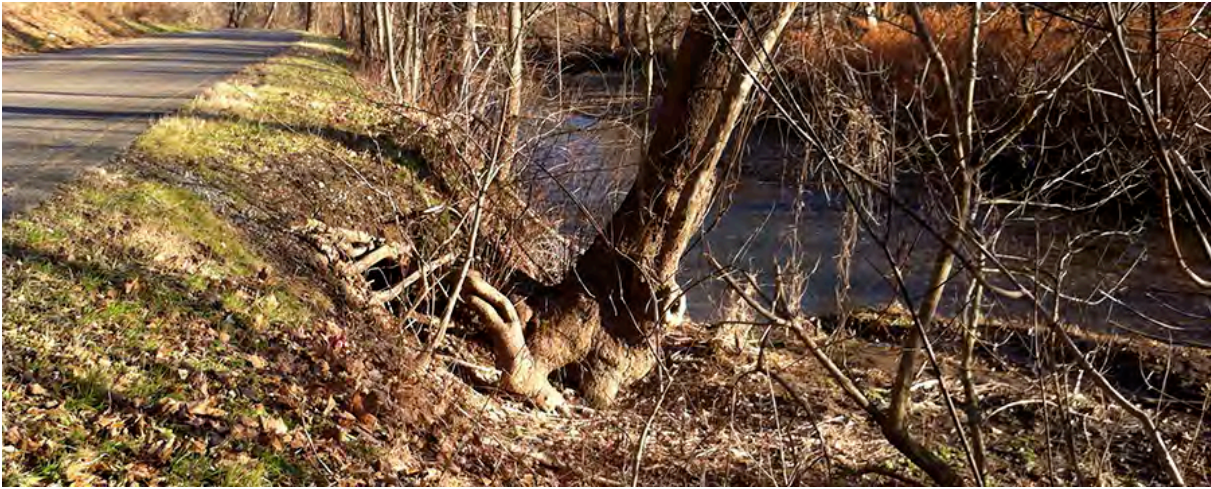
PCM22 – Severe stream bank erosion along Peters Creek Rd just upstream of the Iron Bridge and downstream of a retaining wall along Peters Creek at the now closed National Strategic Minerals Site. The streams energy is directed at Peters Creek Rd and is eroding tree roots and beginning to compromise the road. Jefferson Hills recently received a PA DEP Growing Greener Grant to address this problem with a best management practices solution.

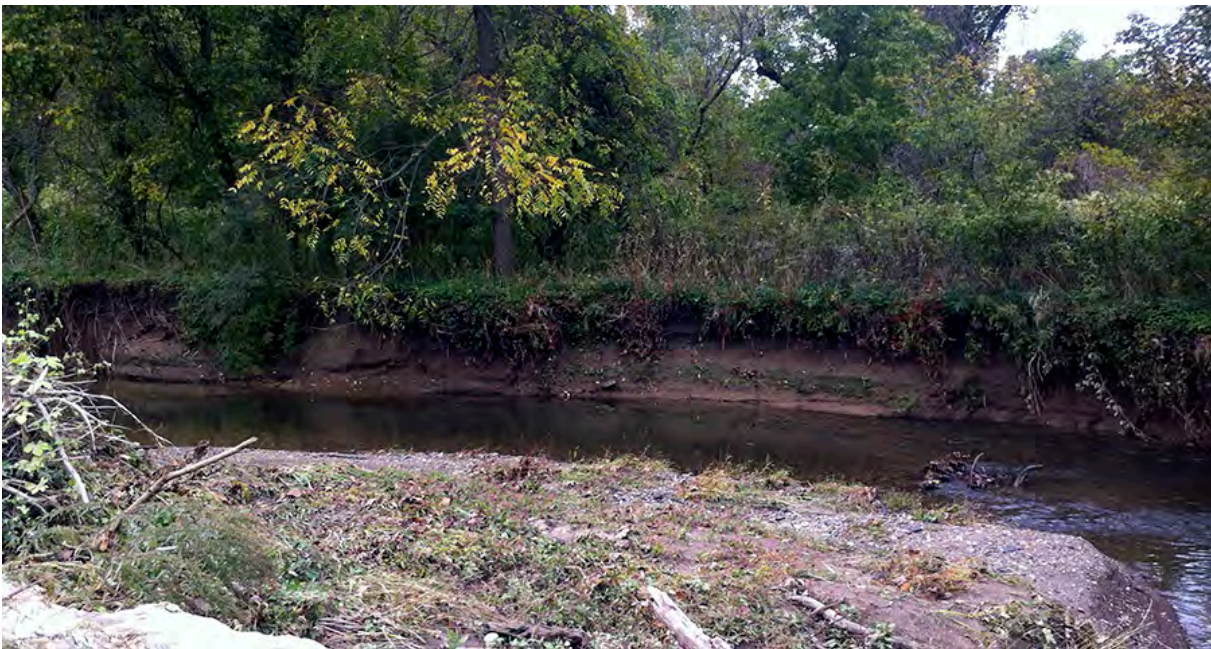
PCM16 – Stream bank erosion is a natural process, especially on sinuous segments of a stream. The section of Peters Creek depicted above is just downstream of the Iron Bridge south of Peters Creek Rd. The vertical walls of the eroding outer bank are relatively stable and provide nesting habitat for Kingfishers who dig into the upper bank wall to build a nesting burrow.

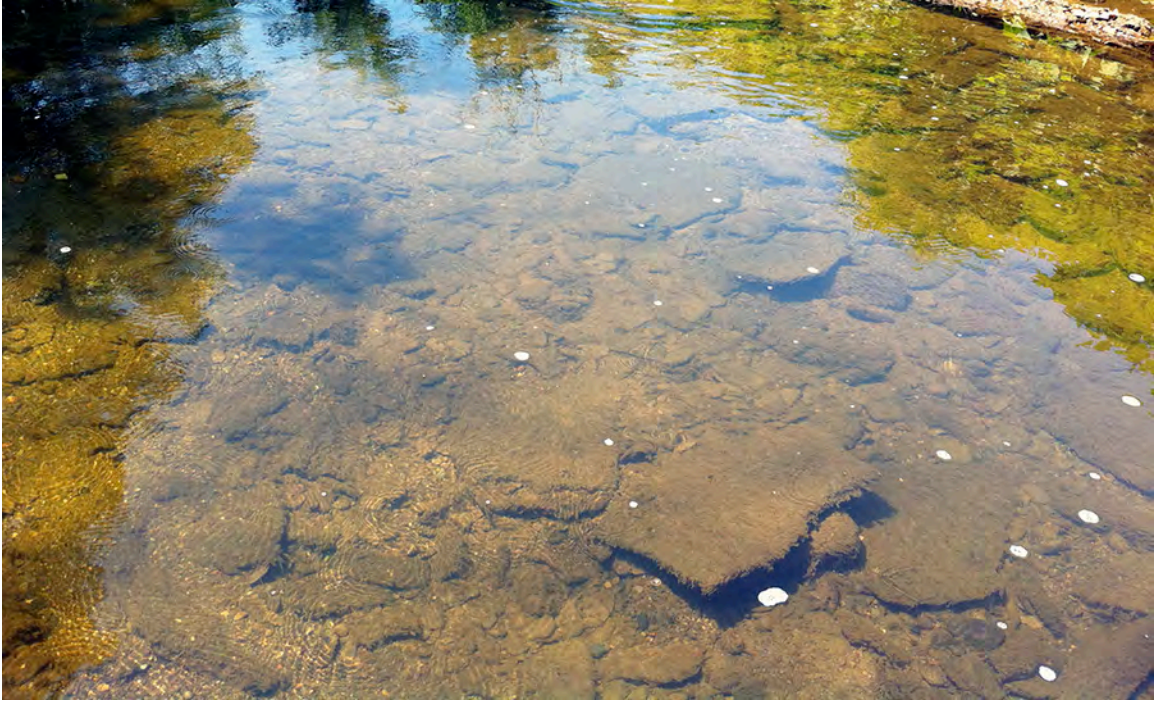
PCM09 – The bottom of Peters Creek is fairly embedded (estimated at 40%-50%) along the entire Middle sub-watershed reach. The stream is silted and carries a heavy sediment load during precipitation events. This silt and embeddedness decreases diversity of aquatic macroinvertebrates
