Peters Creek Watershed Assessment & Management Plan

April 2014

1.0 PETERS CREEK WATERSHED BACKGROUND

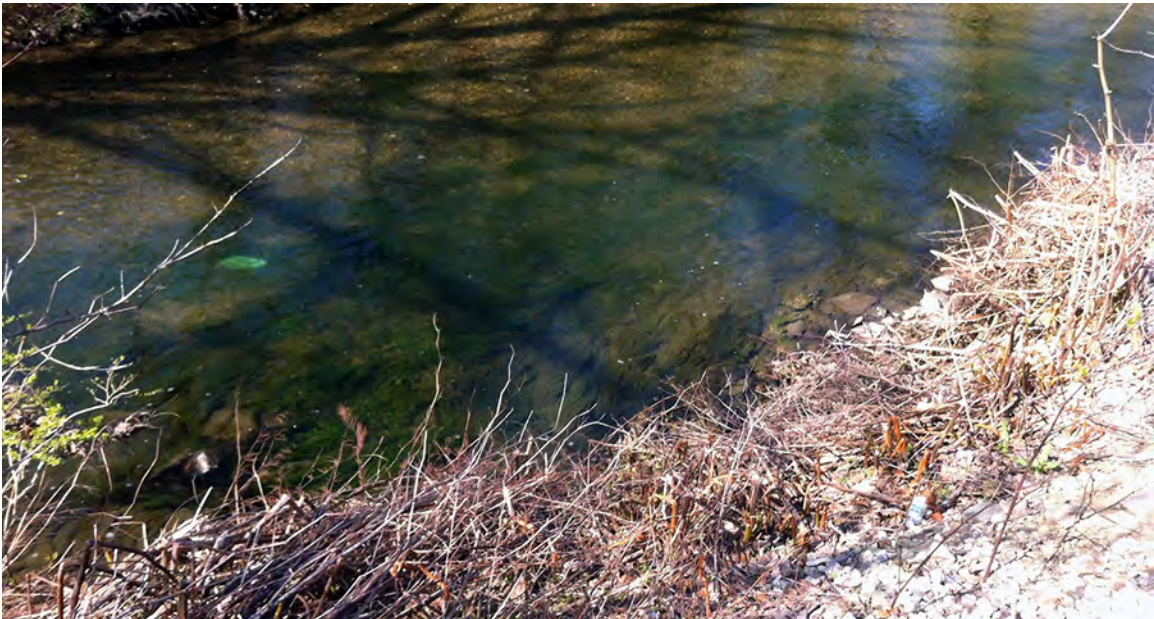
PCM34 – Filamentous algae covering the left ascending half of Peters Creek's channel just downstream of the Waterman Rd junction with Peters Creek Rd.

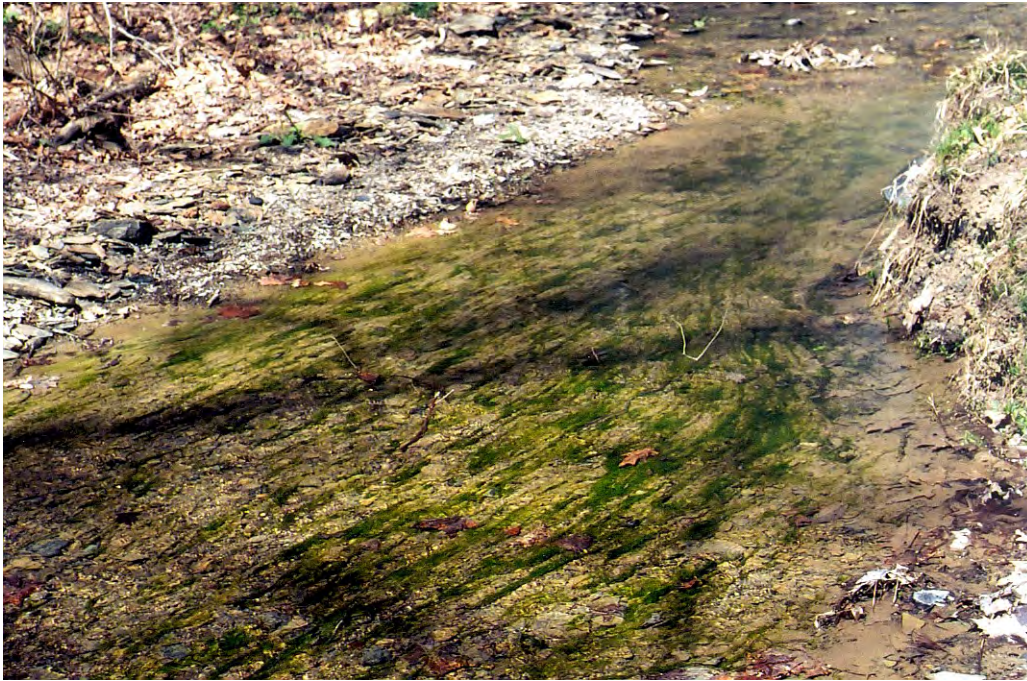
SR07 – Snee Run also appears to have an excess nutrient load and suffers from an overabundance of algae growing within its channel. The above algal bloom appears to be associated with a sanitary sewer line running through the valley. Other possible sources include runoff from residential development in the headwaters, runoff from a farm in the headwaters and abandoned mine drainage.

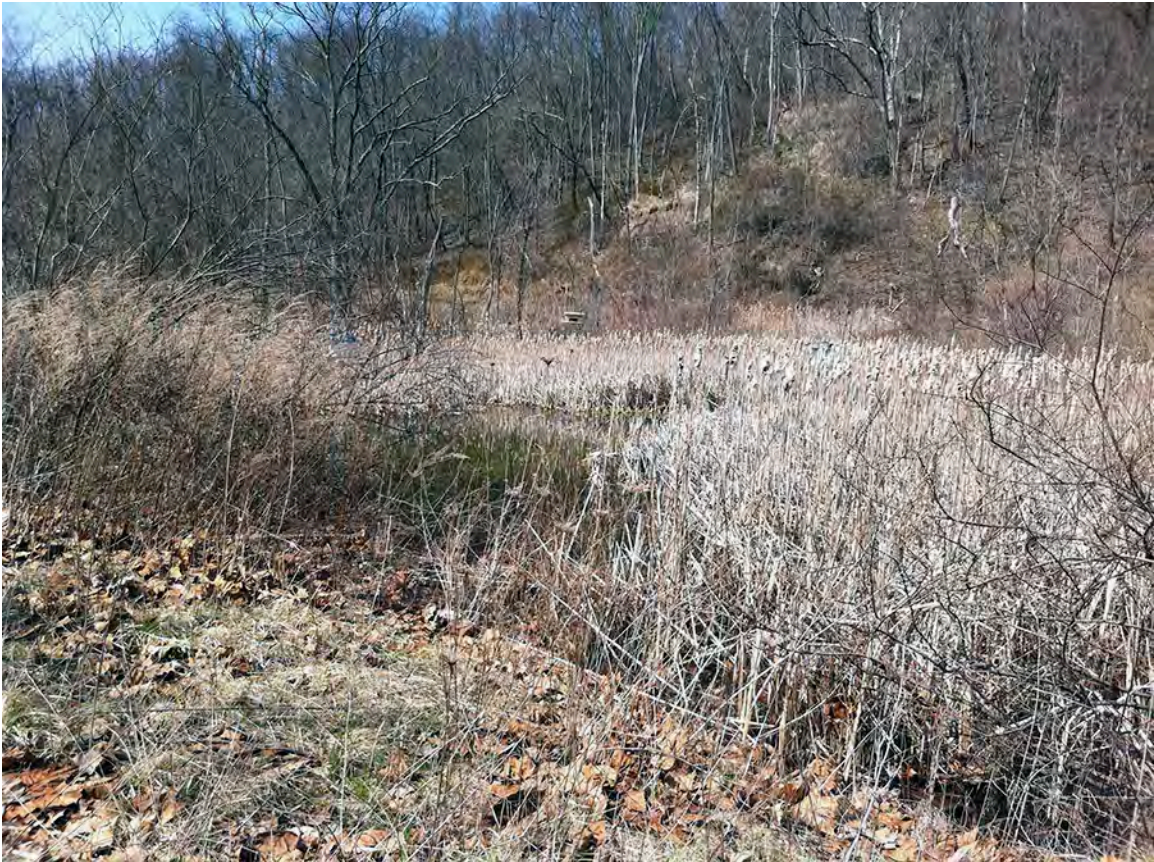
PCM19 – Wetlands along the north and south side of Peters Creek Rd just west of the “Coal Patch”. Wetlands north of Peters Creek Rd are being compromised by homeowner pushing soil and fill over the hillside into the wetland and redirecting a stream. There are drainage problems in this area along Peters Creek Rd.

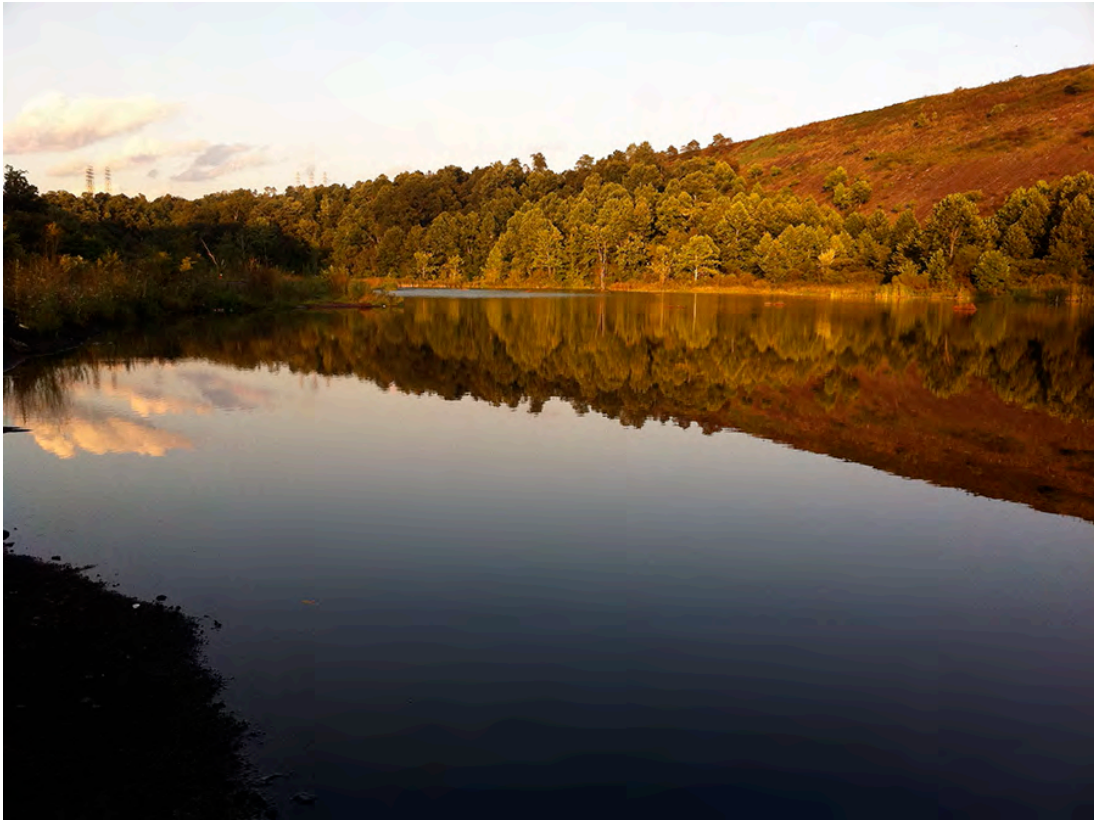
PCM18 – *The Iron Bridge Ponds are located on the site of the former National Strategic Mineral Stockpile between the Wheeling & Lake Erie Railroad tracks and the recently constructed Mon-Fayette Expressway. There are two ponds of approximately 7 acres in total area. Water quality within the ponds is relatively good and the ponds support a number of fish species as well as freshwater mussels. They also provide breeding habitat for Wood Ducks, a number of species of amphibians, muskrats and beaver. Recent groundwater testing at the site revealed high levels of arsenic.*

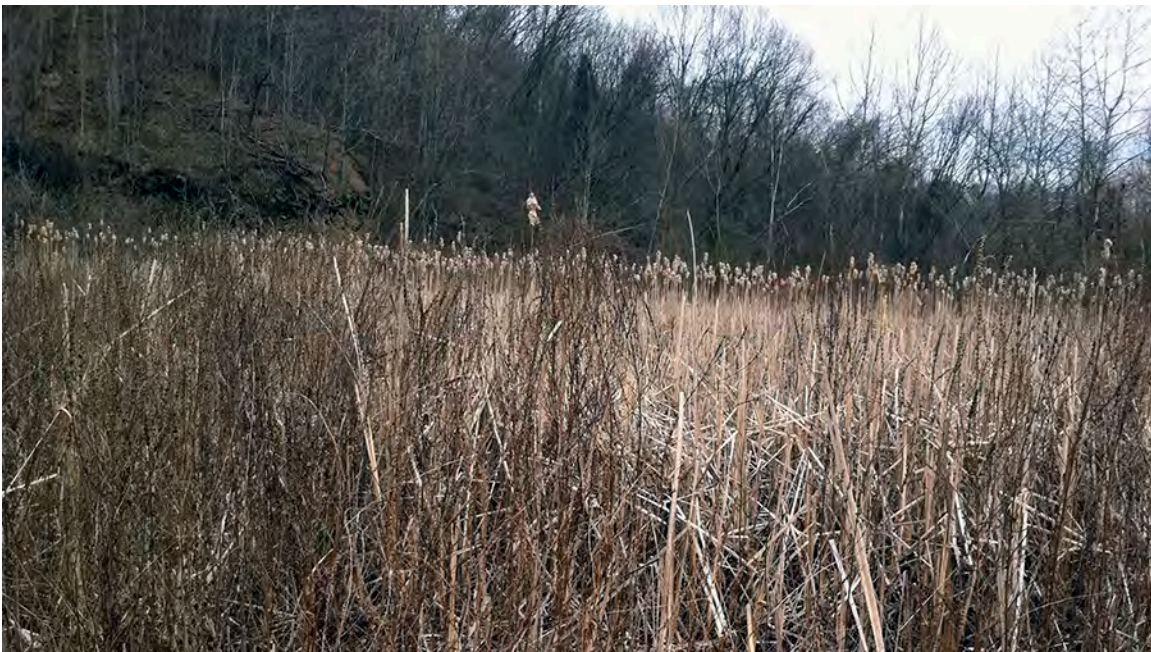
PCM26 – *A wetland is present in the floodplain of Peters Creek and Beam Run north of Peters Creek Rd just east of the confluence of Beam Run. Wetlands are also present across the road from the natural stream channel design Phase 1 project (PCM27); forested wetland east of Waterman Rd junction (PCM32); Vernal wetland just west of Waterman Rd junction (PCM34); forested wetland east of Snee Run confluence (PCM40); emergent wetland in Snee Run's left ascending floodplain just upstream of confluence with Peters Creek.*

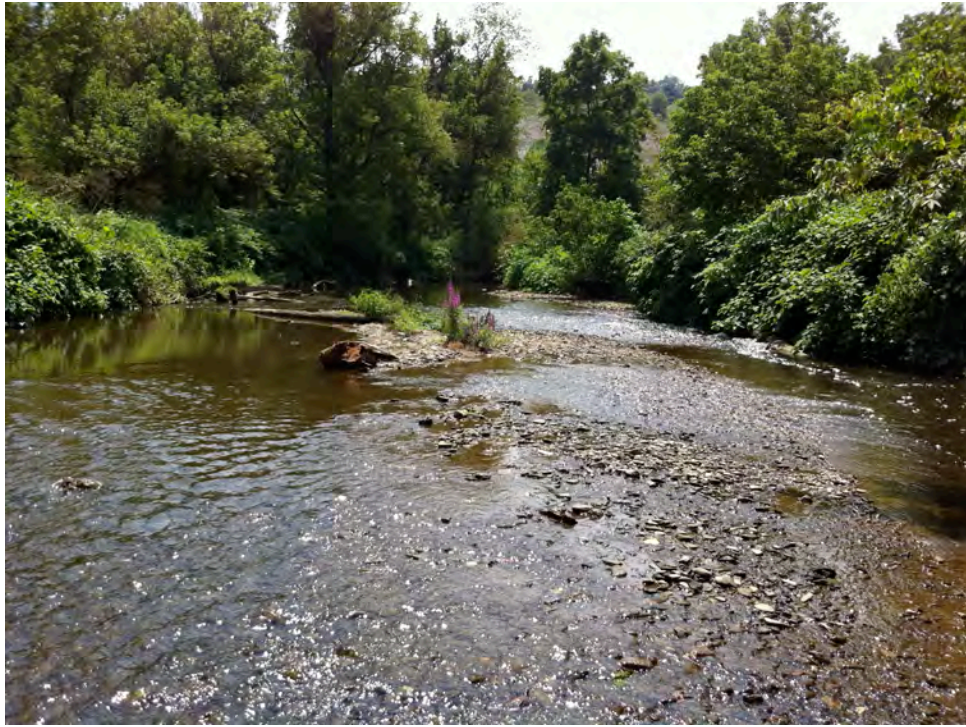
PCM16 – Japanese Knotweed is infesting the riparian zone along Peters Creek at a number of locations within the Middle sub-watershed as it is here just downstream of the Iron Bridge. Purple Loosestrife is colonizing the sediment bar in the middle of the creek. Japanese Hop (*Humulus japonicus*) has recently made an appearance along Peters Creek. It is a fast growing annual vine that can grow up to 35 feet a year and is found in disturbed habitats such as scoured stream banks. This species outcompetes most native floodplain flora and, in fact, has been known to smother populations of knotweed. Japanese Hop is related to native Hops and the species utilized in beer making but is not useful for that purpose.

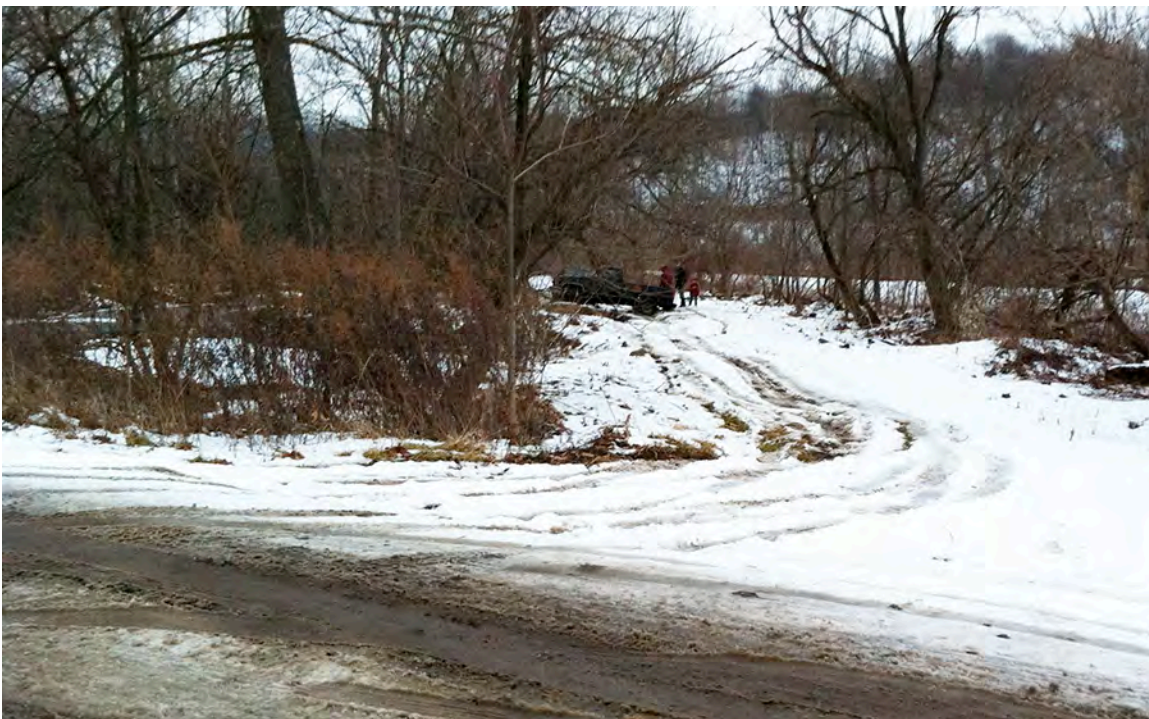
PCM17 – Heavy off-road use along a gas company access road along Peters Creek's left ascending bank just downstream of the Iron Bridge causes damage to the floodplain and pollution to Peters Creek in the form of sediment-laden runoff. The activity is also compromising a wetland along the stream.

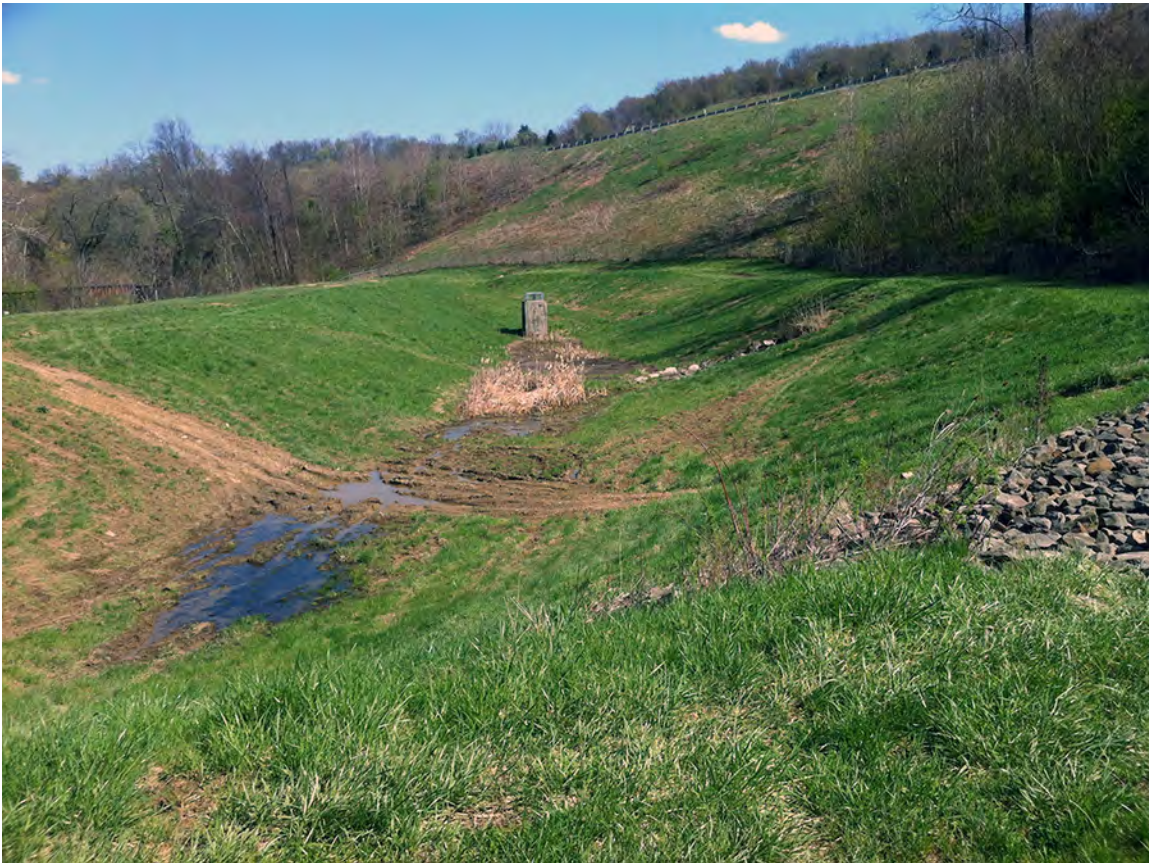
PCM36 – Stormwater detention basin for the Mon-Fayette Expressway above Peters Creek’s left ascending bank and south of the Wheeling & Lake Erie Railroad Clairton Branch. There are six stormwater detention basins along this section of Peters Creek to detain stormwater from the expressway and recent residential development along Ridge Rd. Note the off-road vehicle tracks through the middle of the detention basin even though the facility is supposedly fenced.

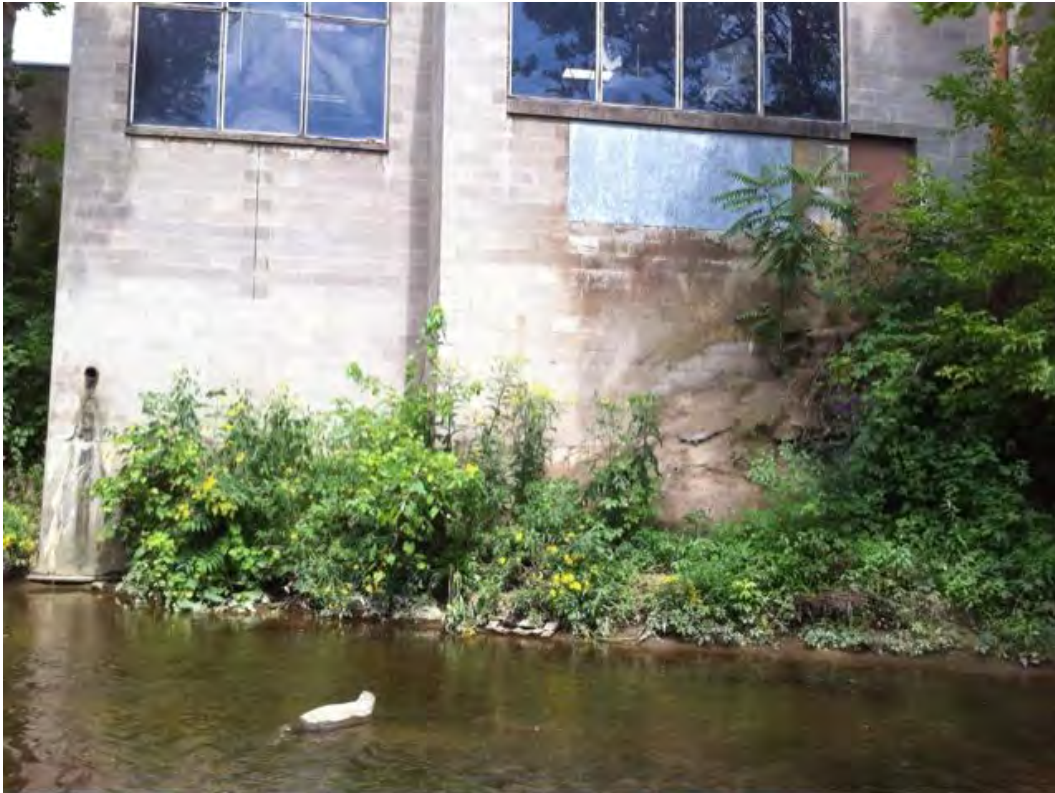
PCM05 - Dick Corporation Building encroaches on Peters Creek's channel at the eastern end of the Middle sub-watershed. A number of outfalls also drain from the building directly into the creek.

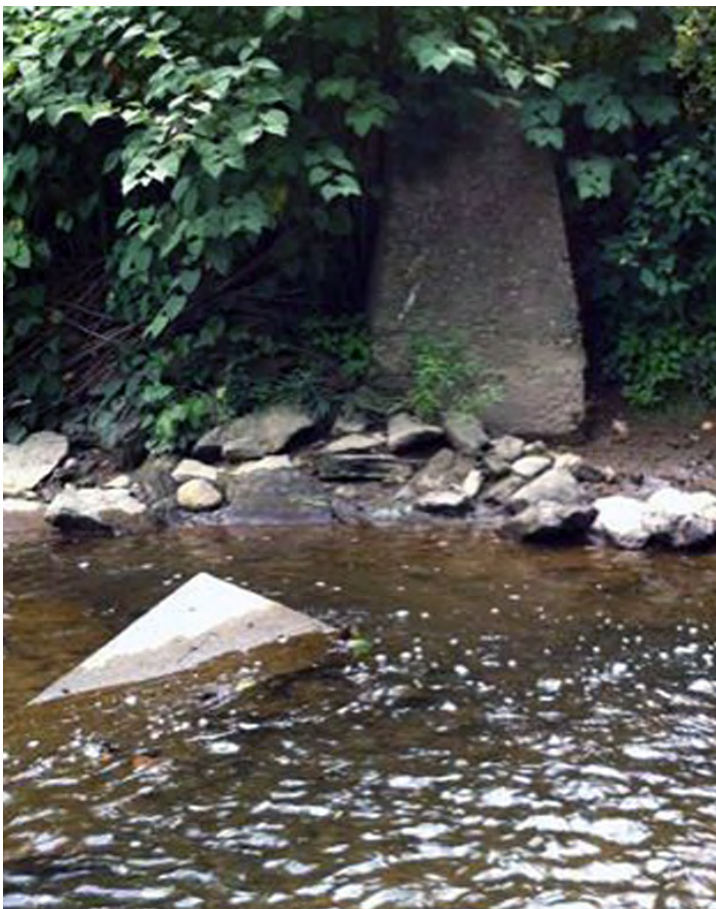
PCM06 - An abutment for what appears to be an old bridge crossing of Peters Creek encroaches on the left ascending bank. Concrete debris within the stream channel and knotweed infesting the bank.

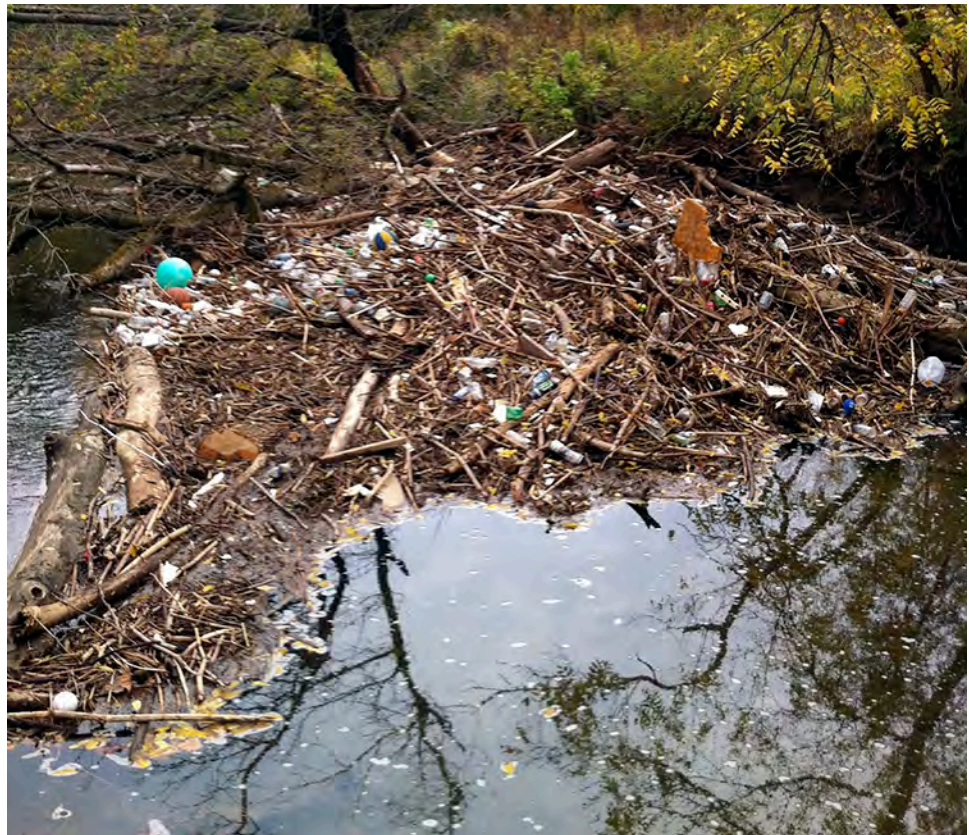
PCM17 – Looking upstream at the Iron Bridge. The bridges abutments encroach on the stream channel which is widened and eroded just downstream of the bridge. Peters Creek Rd runs along the creeks right ascending bank and a gas company access road runs along the left ascending bank.

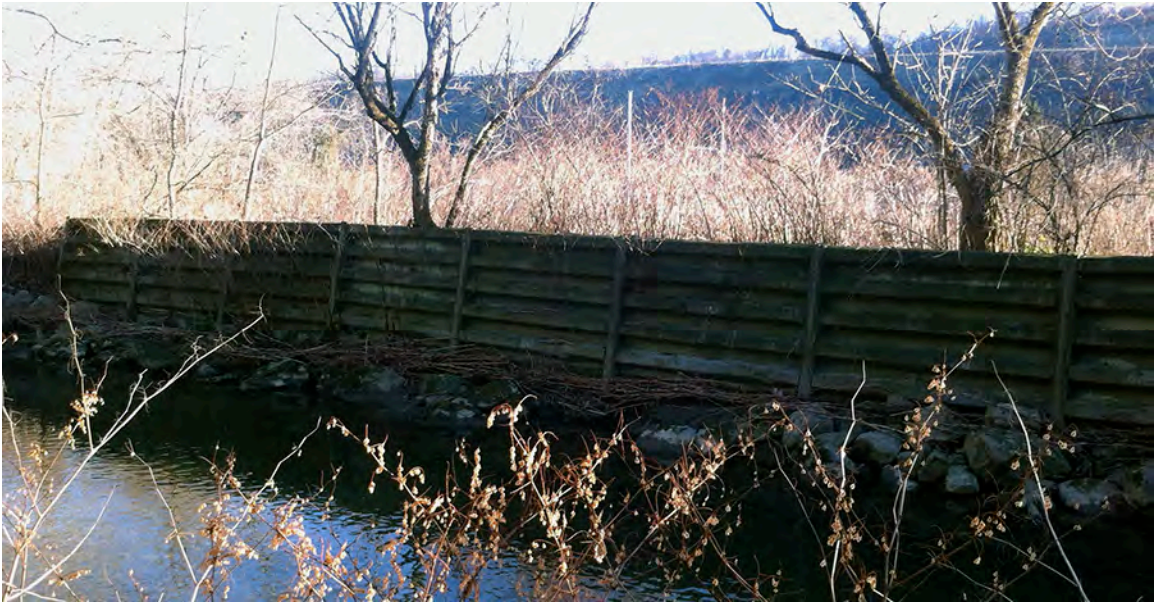
PCM23 – A metal retaining wall at the former National Strategic Mineral Stockpile site supported large piles of strategic minerals up until about 2005. The constructed hillside carrying the Mon-Fayette Expressway can be seen in the background.

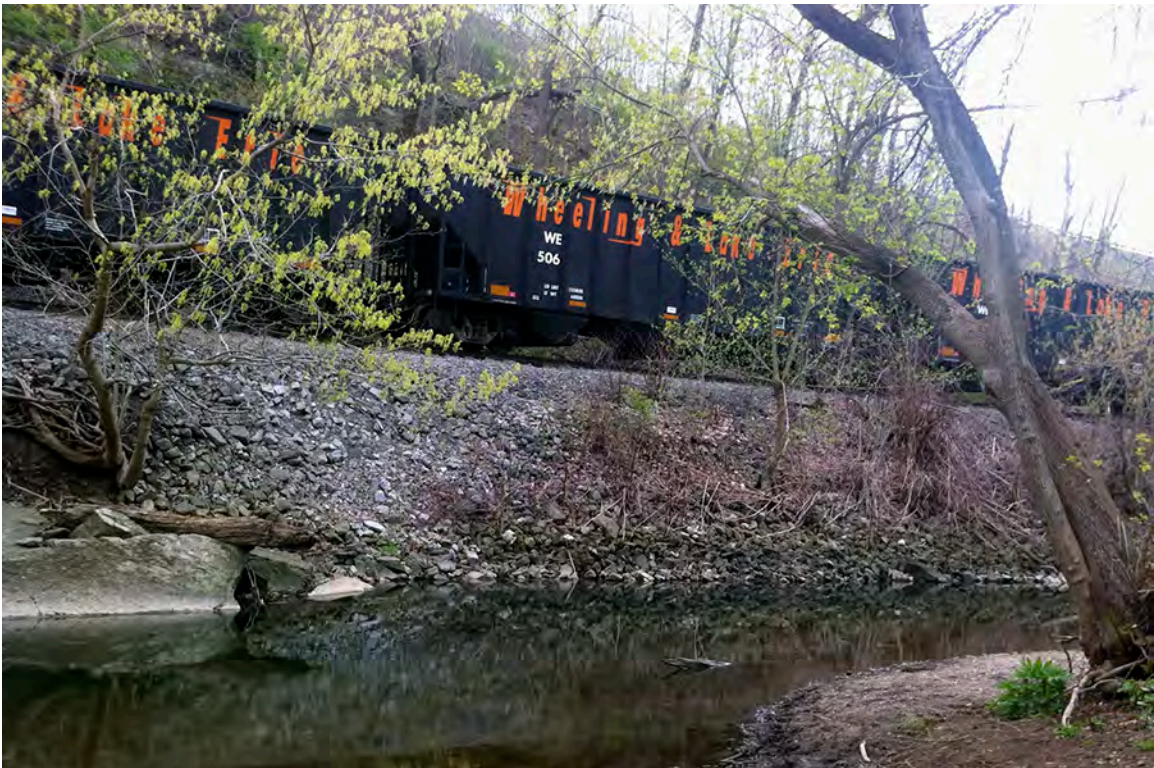
Just downstream of PCM35 the Wheeling & Lake Erie Railroad Clairton Branch tracks severely encroach on Peters Creek's channel on the left ascending bank at the site of a popular fishing hole. Large concrete debris has been placed along the bank to mitigate erosion and ballast erodes into the creek.

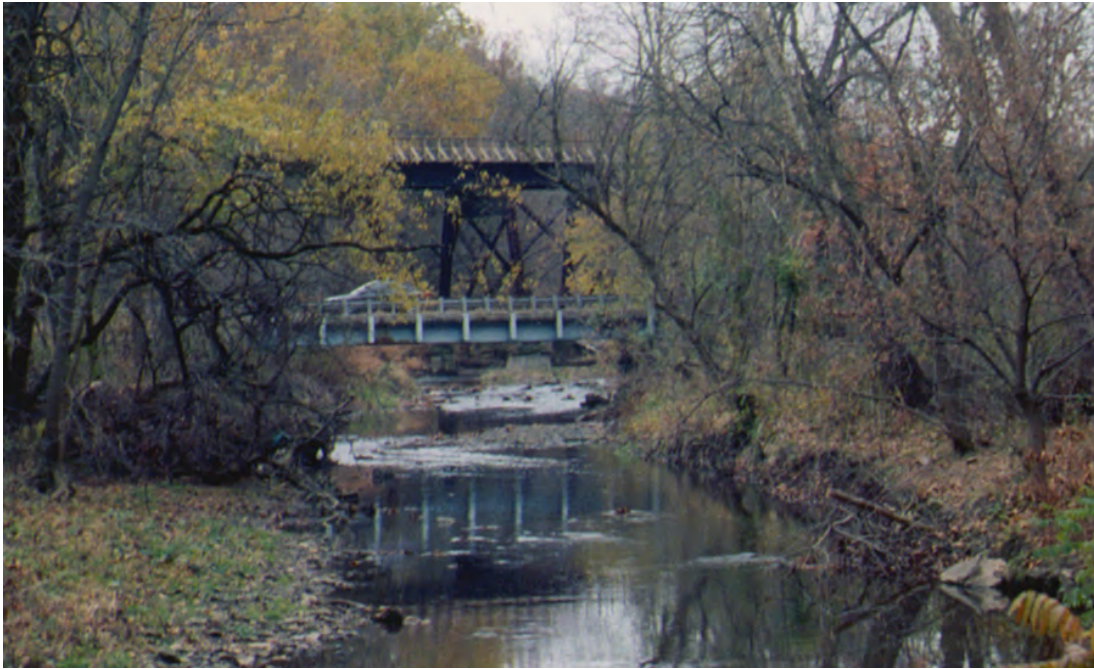
PCM45/PCM47 – Looking upstream at the Gill Hall Road bridge crossing of Peters Creek with the Wheeling & Lake Erie Railroad Trestle abutments encroaching on Peters Creek’s channel just upstream of the bridge in close proximity. Large debris jams form at the trestle abutments and cause severe bank erosion at the site. Downstream of Gill Hall Rd on Peters Creek’s right ascending bank Peters Creek Rd is pinched between a steep cliff and the stream along an outside bend. Severe bank erosion is compromising Peters Creek Rd at this location. Jefferson Hills recently received a PA DEP Growing Greener Grant to implement natural stream channel design restoration BMPs at this site.

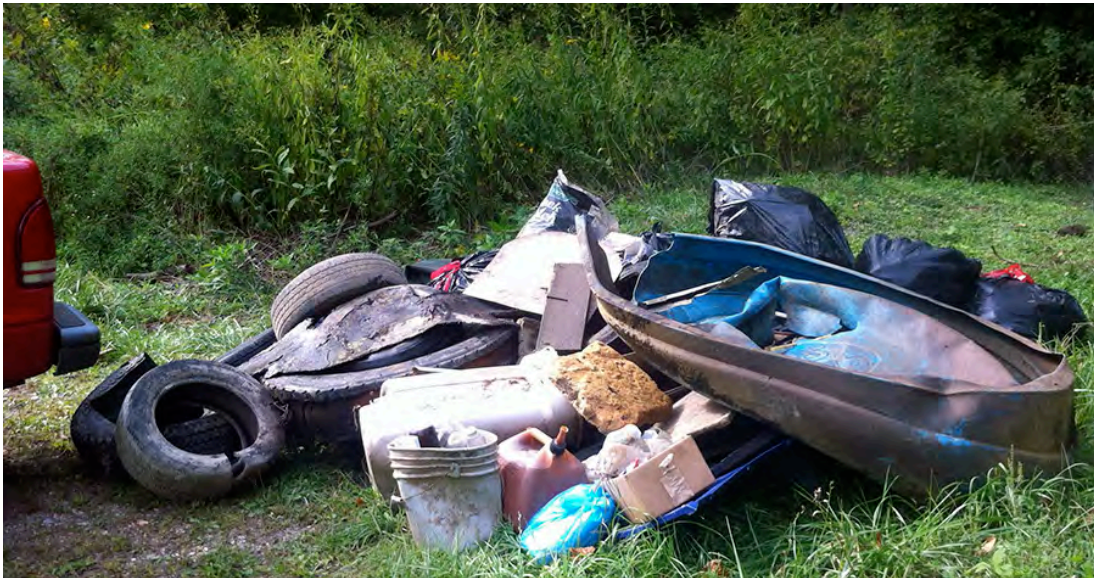
Littering and illegal dumping is a persistent problem within the Middle Peters Creek sub-watershed, especially around the Iron Bridge Ponds and along the access road to the Turnpike Maintenance Facility. Severe flooding in July of 2013 added significant amounts of garbage to the banks of Peters Creek from upstream. The Tri-Community Anglers has sponsored a spring and fall clean-up of the trout stocked portions of Peters Creek and Piney Fork since its inception in 1998. Volunteers from many other local groups pitch in to help and Jefferson Hills and South Hills Twp Public Works take care of trash removal. Above is the result of the Fall 2013 effort.

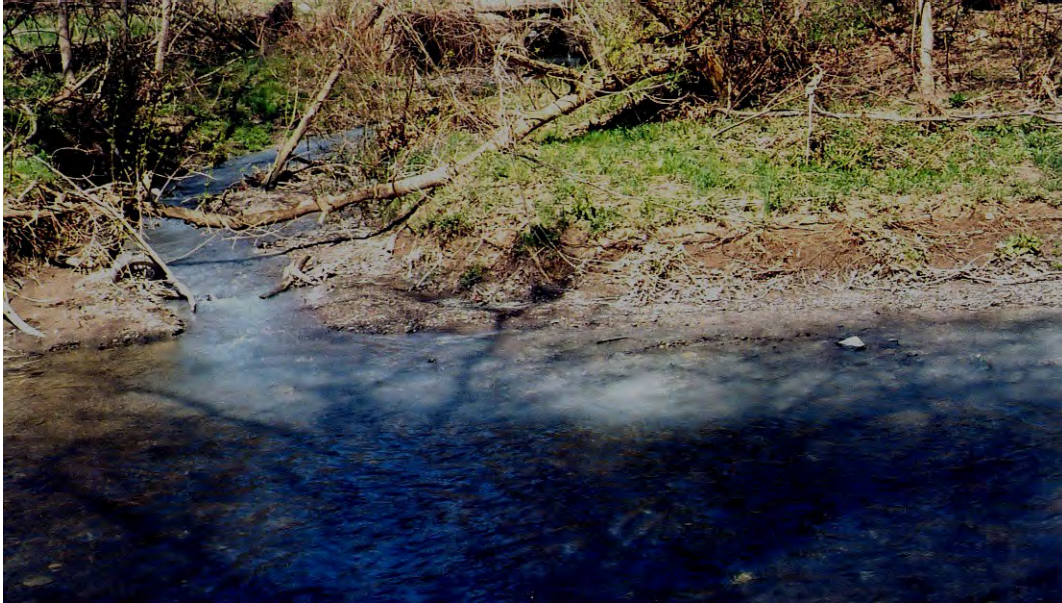
BR01 – A plume of aluminum precipitate can often be seen at the mouth of Beam Run as it enters Peters Creek. It is intermittent and most prevalent during periods of heavy precipitation.

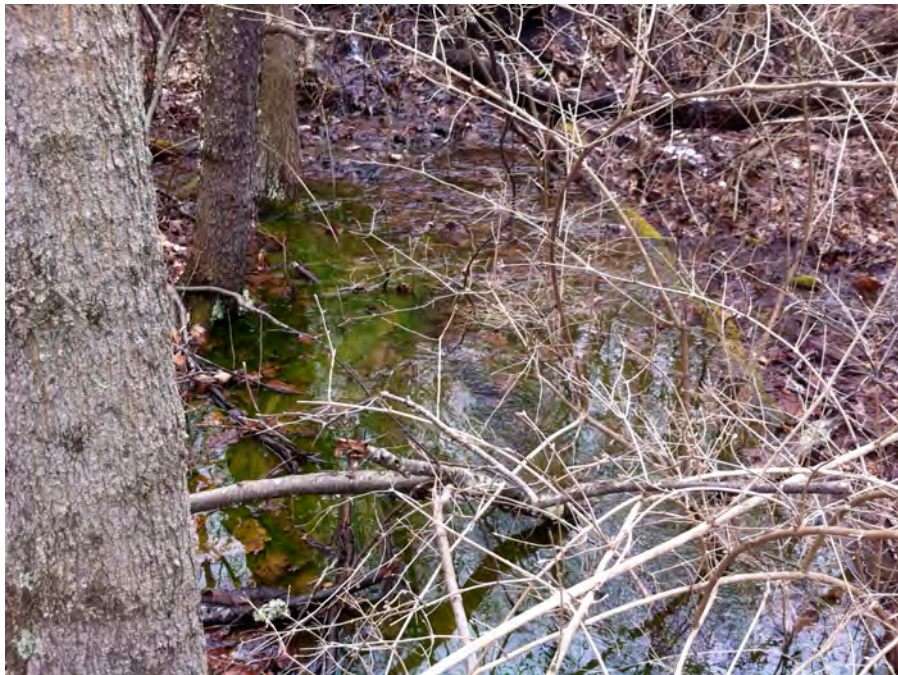
BR05 – There is a bench and high wall from old mining activity along Beam Run's right ascending bank within the lower reach of the stream. A number of abandoned mine drainage seeps and small tributaries emanate from this high wall. One of the largest seeps is found at BR05.

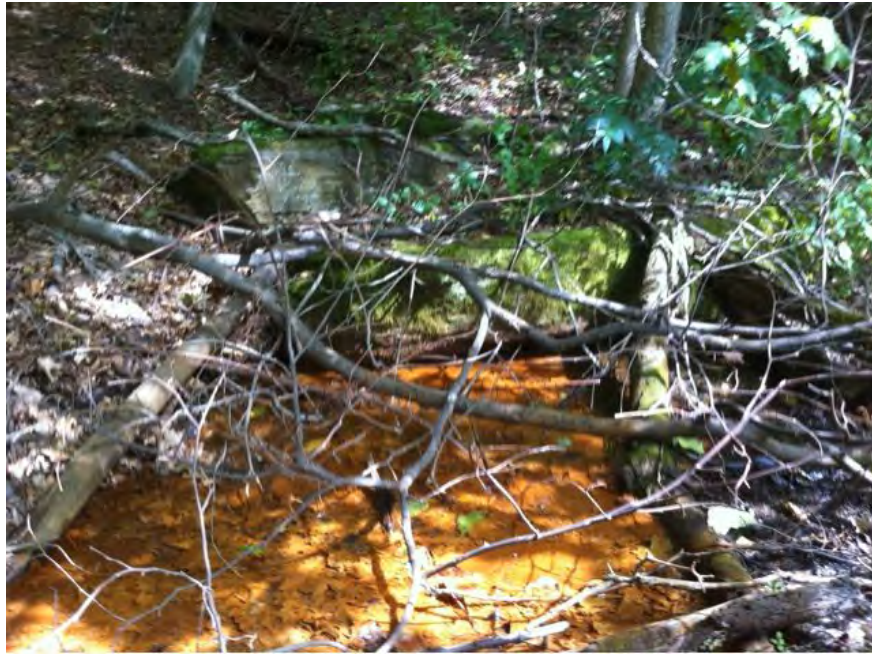
BR22 - A 30-40 GPM AMD laden spring with yellow boy covering the channels substrate enters a wetland along Beam Run's right ascending bank at BR22.

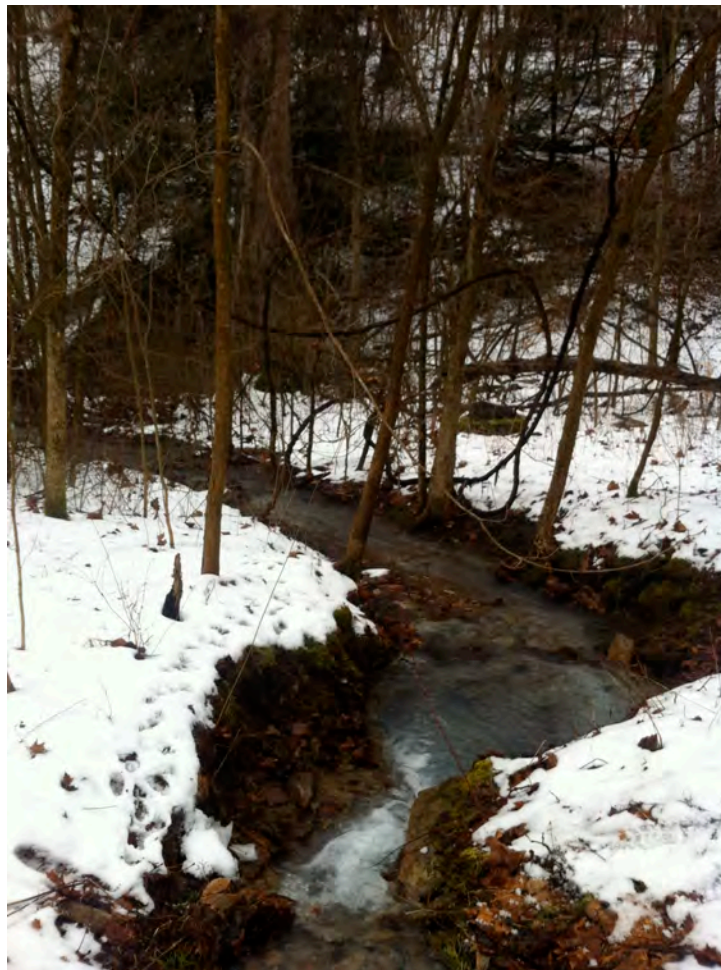
BR35 - An AMD impacted tributary south of Regency Drive of 40-50 GPM enters Beam Run's right ascending bank. Deep mine discharges MD-1, MD-2 and MD-3 enter this tributary. These discharges were sampled as part of the Zora Mine Reclamation Project.

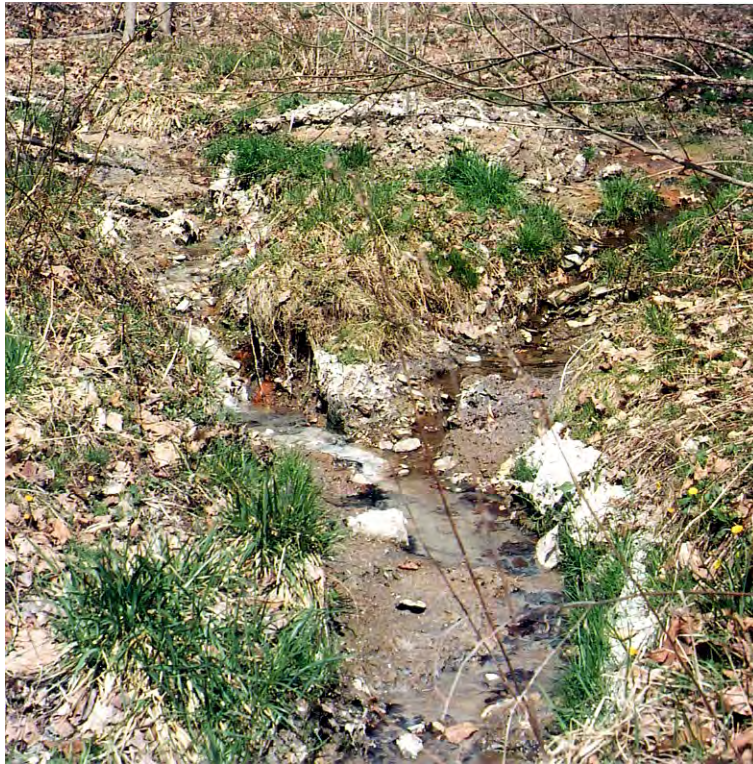
BR42 - The tributary that drains the valley between Old Clairton Road and the Chamberlain Ridge Plan and also the Zora Mine Reclamation Project area is impacted by deep mine discharges MD-4 and MD-5. It also has been impacted by sewage from a malfunctioning sewer line. Regular inspection of sewer infrastructure is essential to avoid pollution; especially in remote areas. Above is a photo of sewage entering this tributary from an overflowing manhole.

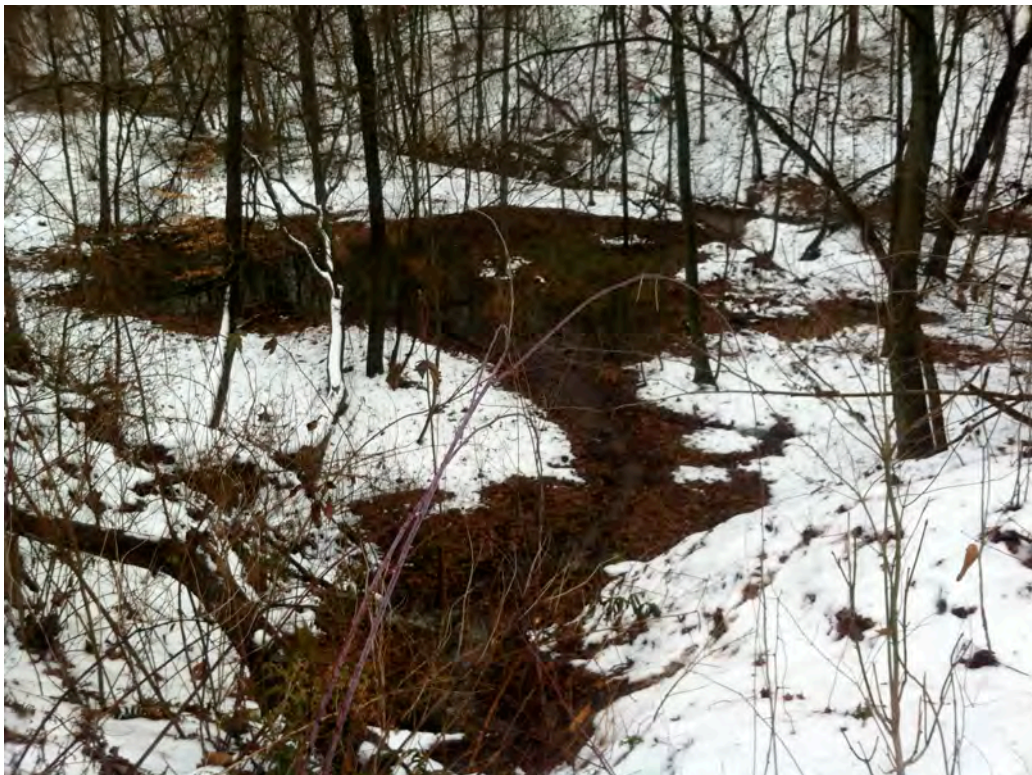
BR46 - An AMD discharge of ~ 15 GPM north of the Waterman Estates residential neighborhood forms a wetland along Beam Run's left ascending bank. (pH 4.02, Conductivity 1925 μ -s/cm)

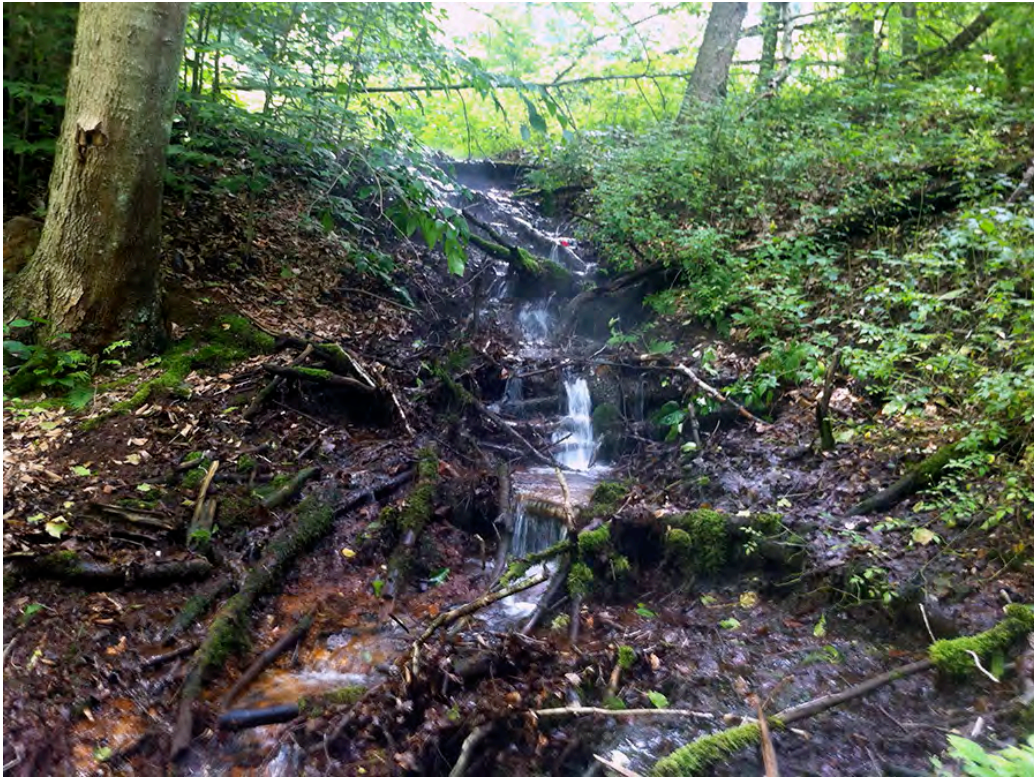
BR52 –A view of the east branch of an abandoned mine discharge of combined flow of ~ 75 GPM that is heavily impacted by aluminum. This is the most significant AMD discharge into Beam Run. The water temperature of this spring remains relatively constant throughout the year. The spring flows down a steep slope into a floodplain wetland.

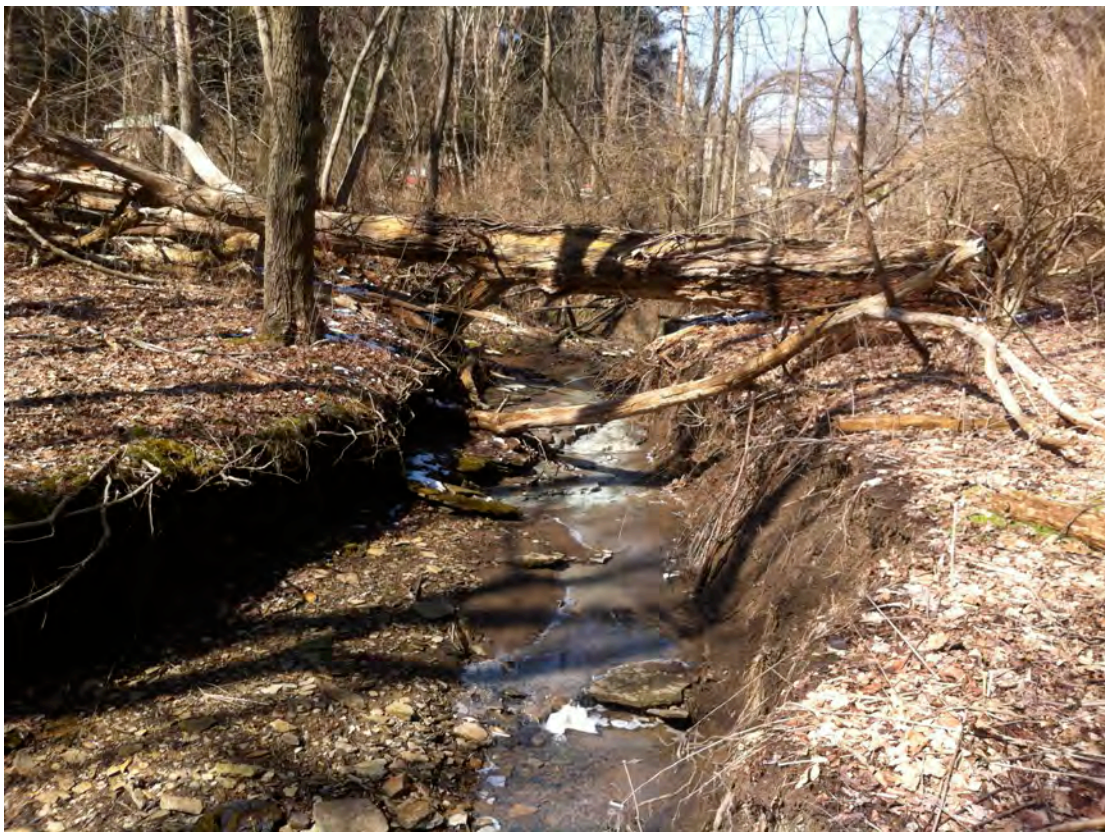
BR58 – White AMD precipitate evident on substrate of the main stem of Beam Run just downstream of the confluence of the Wakefield Road Tributary. The stream channel is deeply incised and the stream banks are eroded.

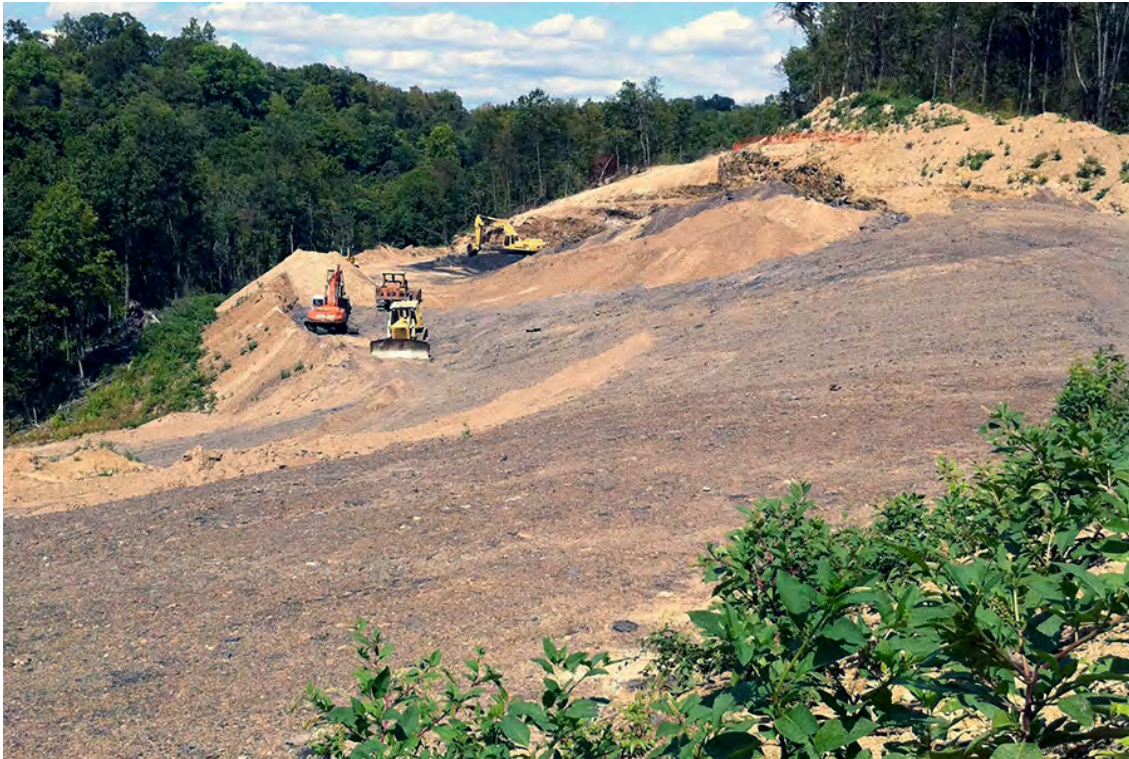
BR40 – Zora Mine Reclamation Project while in operation during 2010. Tributary 002034 to Beam Run flows in the bottom of the wooded section of the photo. This reclamation project was associated with Priority 3 abandoned mine lands (AML) and was financed via a Government Financed Construction Contract.

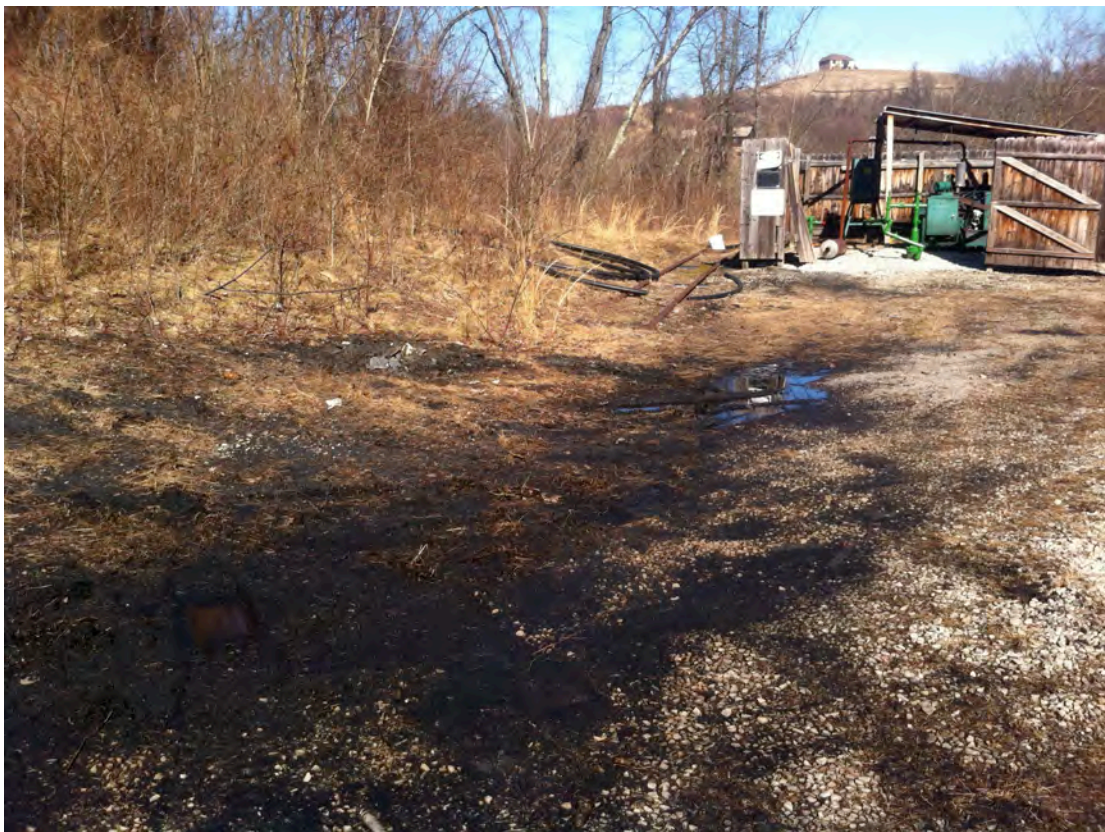
BR50 – A view of the gas well just north of the Chamberlain Road crossing of Beam Run. This is one of at least 12 gas wells within the Beam Run valley.

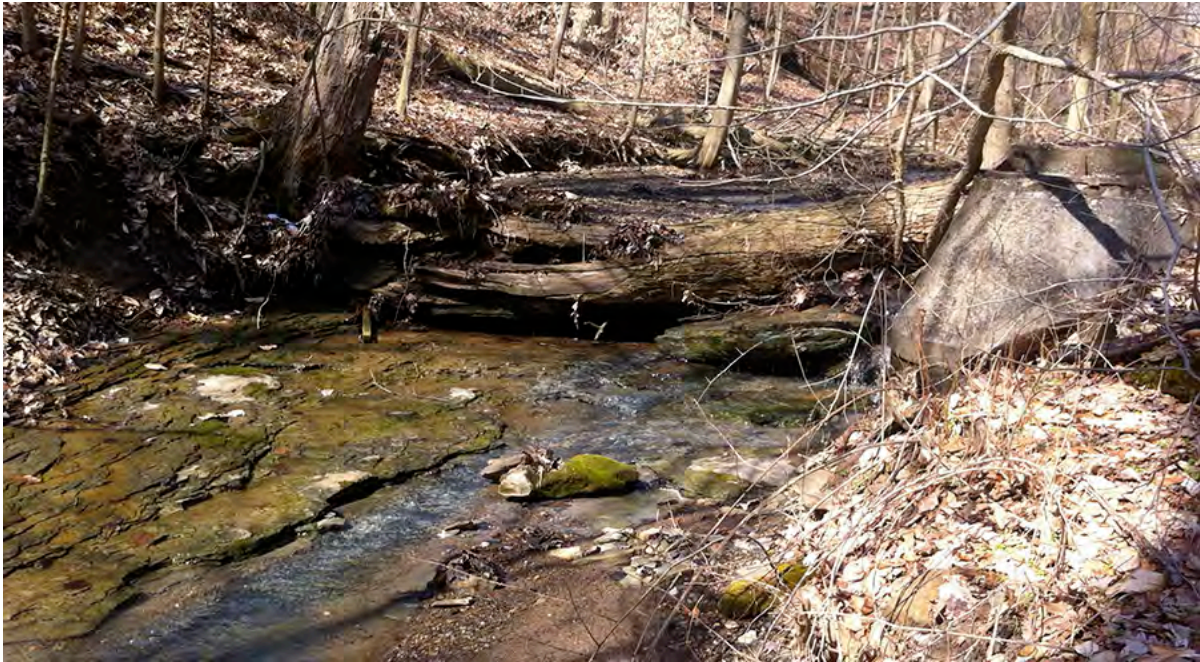
BR56 – Sanitary sewer infrastructure runs the entire length of Beam Run to Peters Creek. At a number of locations the infrastructure encroaches on the stream channel as seen above or stream bank erosion has exposed the sewer line as at BR15. Sewer infrastructure within the stream channel often leads to raw sewage within the stream.
