Peters Creek Watershed Assessment & Management Plan

April 2014

1.0 PETERS CREEK WATERSHED BACKGROUND

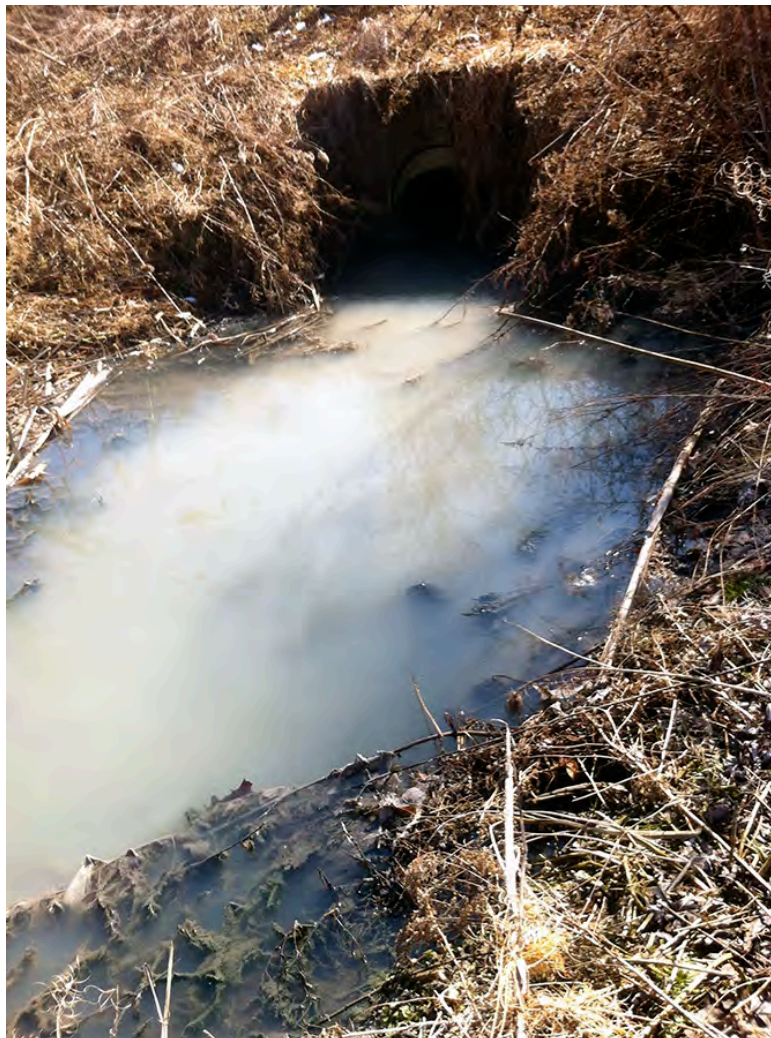
BR64 – Input into a stormwater detention basin along Beam Run Rd appears to be impacted by sewage.

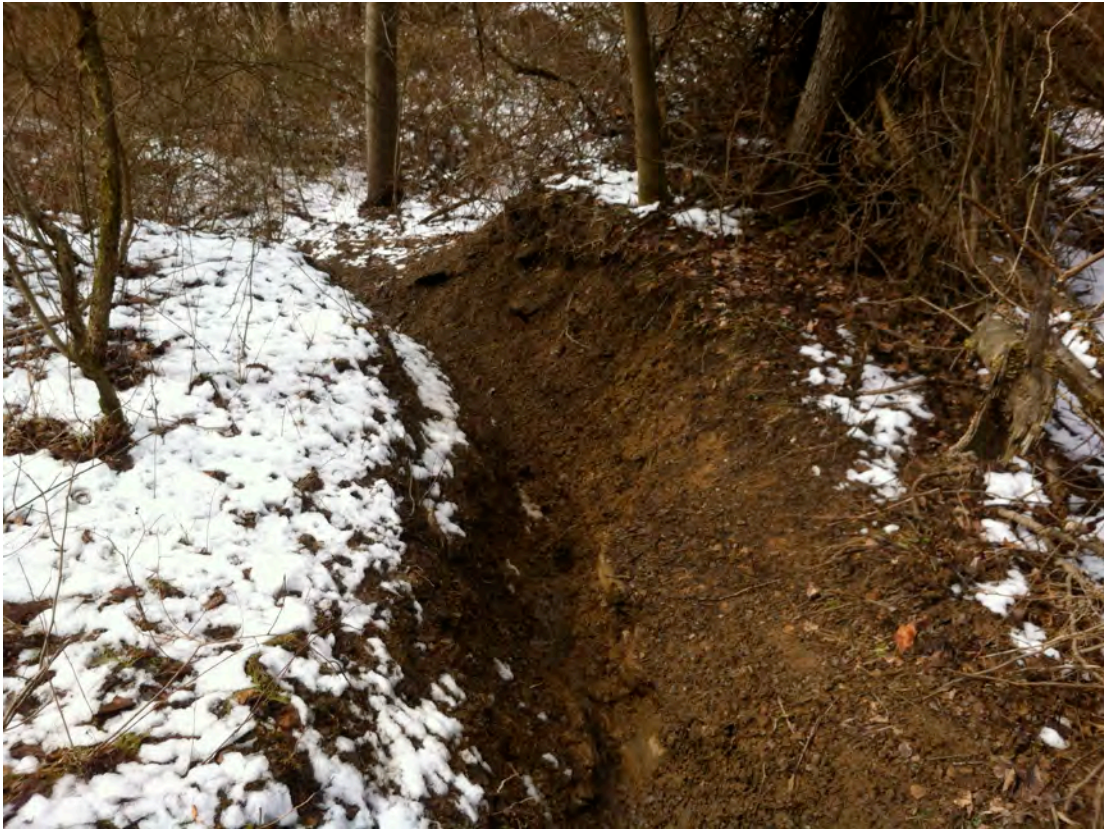
BR09 – An off-road trail on Beam Run's steep right ascending bank creates an erosion gully.

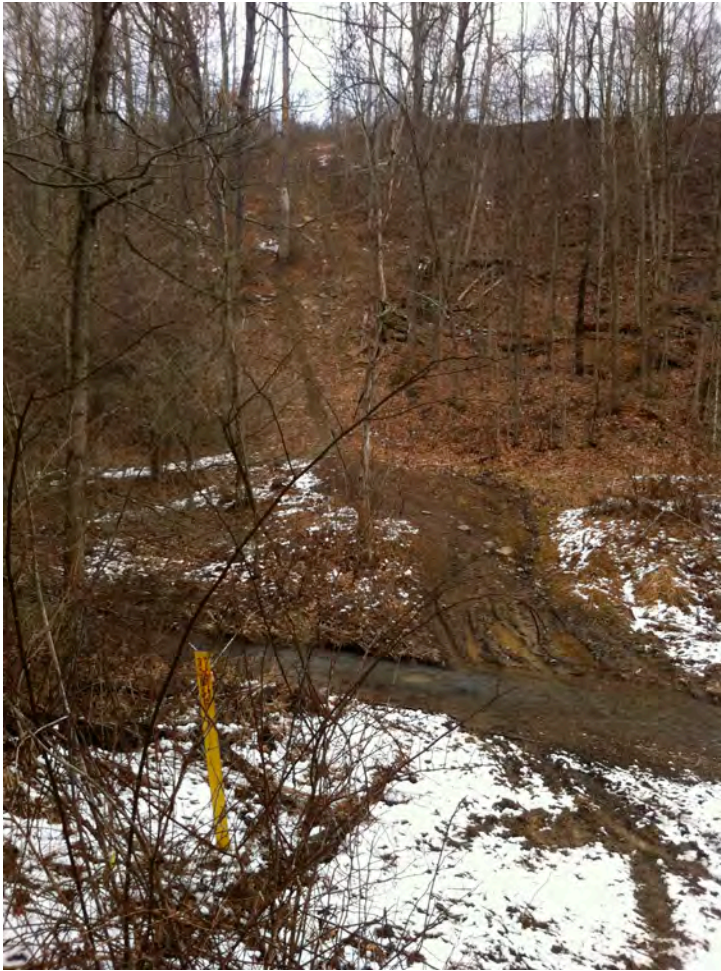
BR25 - Heavy off-road activity along a gas well access road has created a stormwater channel and increased stream sediment load. The road is no longer useable due to these severe erosion gullies.

- Develop and implement a plan for curtailing and managing excessive off-road activity within the valley to minimize damage to Beam Run and floodplain wetlands. Work to mitigate erosion damage and excessive runoff created by it. Installation of adequate gating along gas well access roads should be part of this effort.

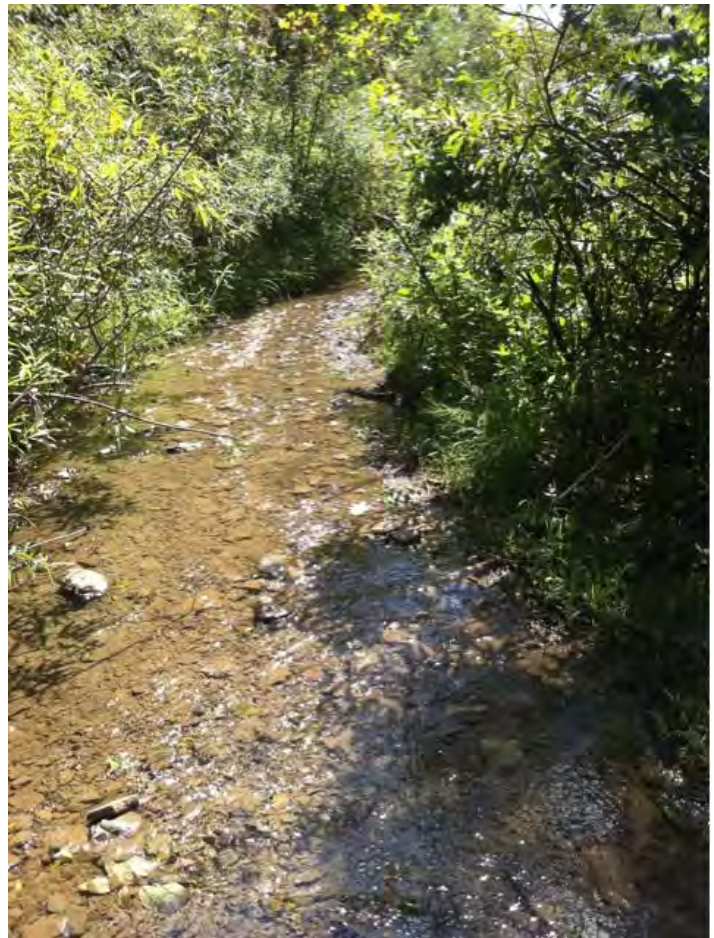
BR29 - An off-road vehicle trail in the floodplain has captured and diverted part of Beam Run's flow.

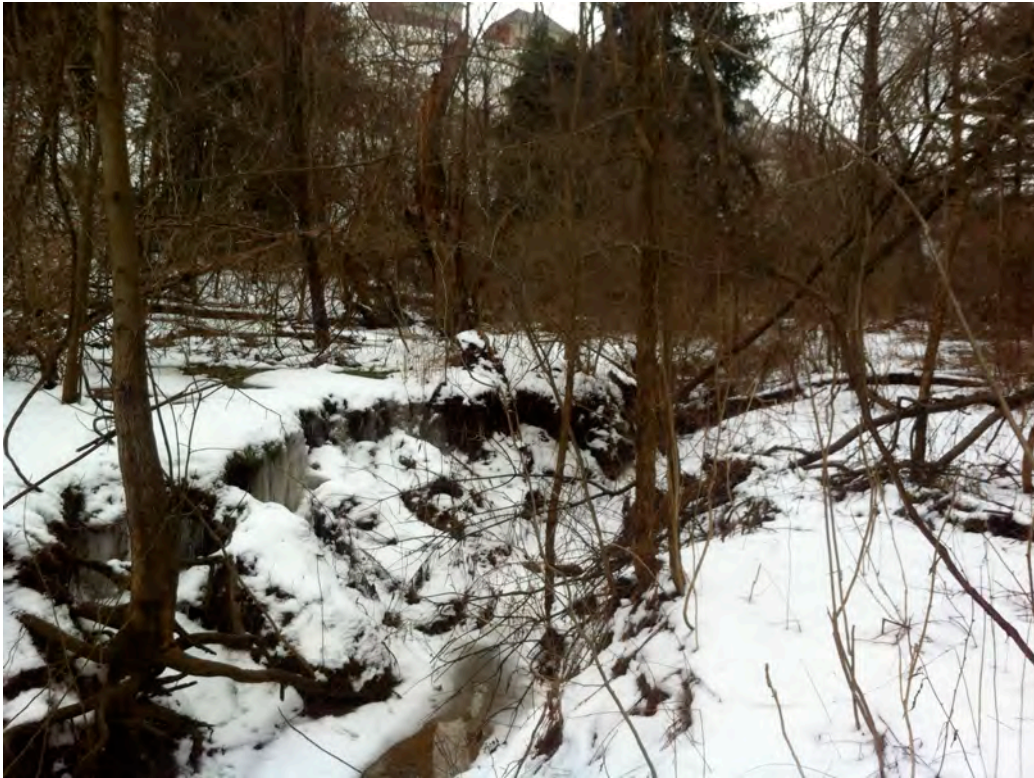
BR44 - This incised and eroding tributary (002034) to Beam Run drains the valley between Old Clairton Road and the Chamberlain Ridge residential development.

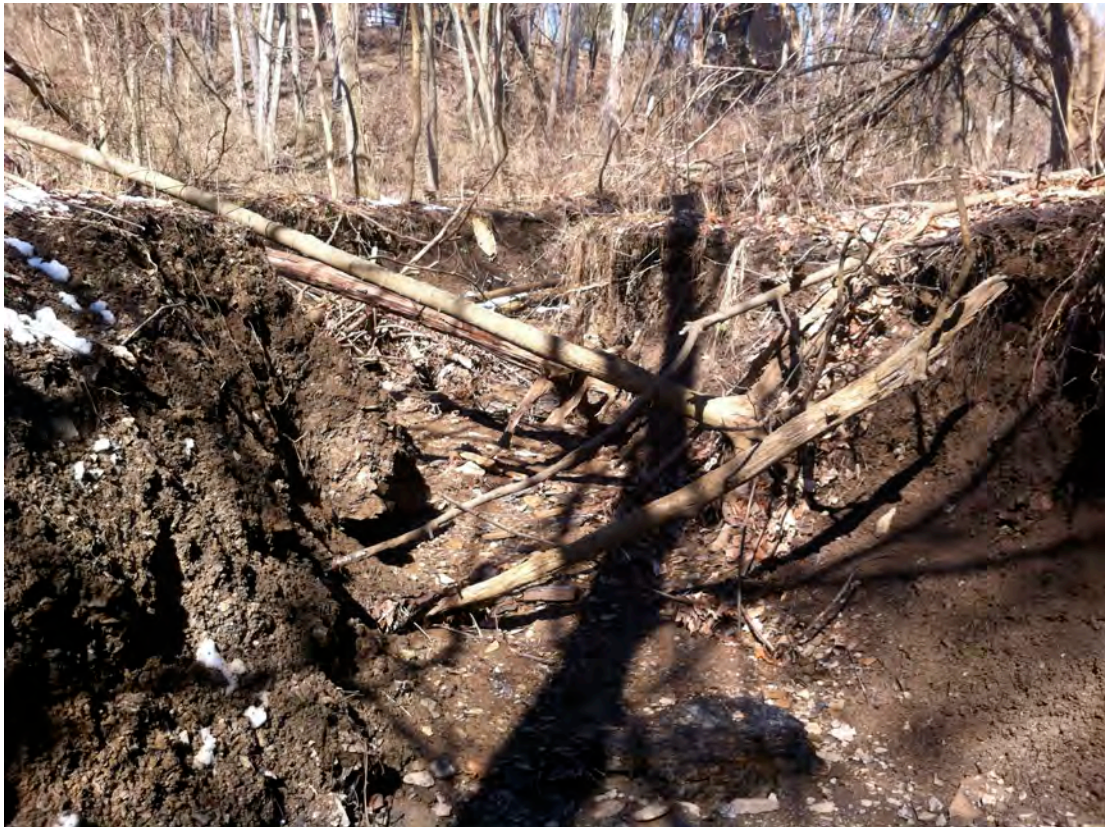
BR63 - The tributary draining the valley northwest of Wakefield Rd is deeply incised and eroded. It appears to function principally as a stormwater conveyance channel for neighborhoods along Wakefield Rd. These neighborhoods were built prior to stormwater control requirements.

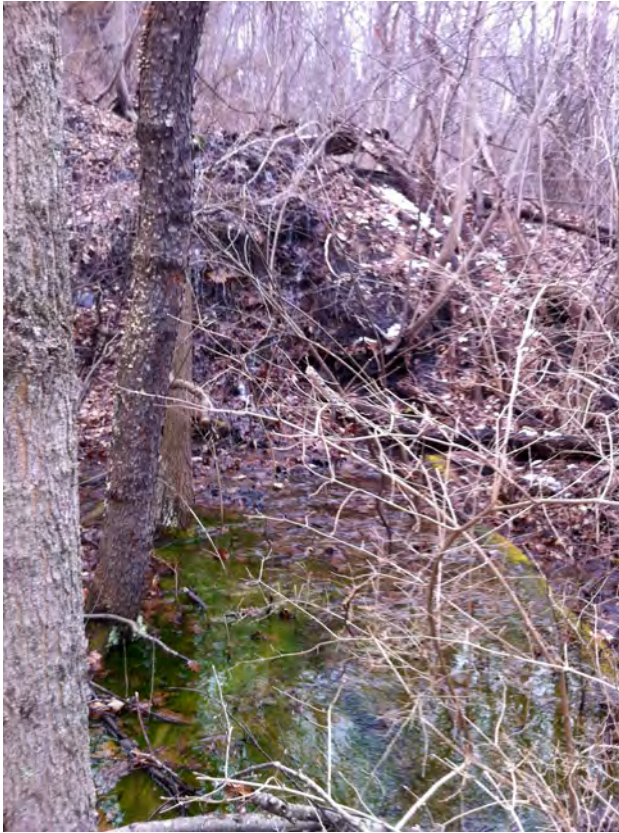
BR05 - Many of the AMD impacted seeps along an old mining highwall in Beam Run's lower valley are choked with algae which is an indication of excess nutrient enrichment.

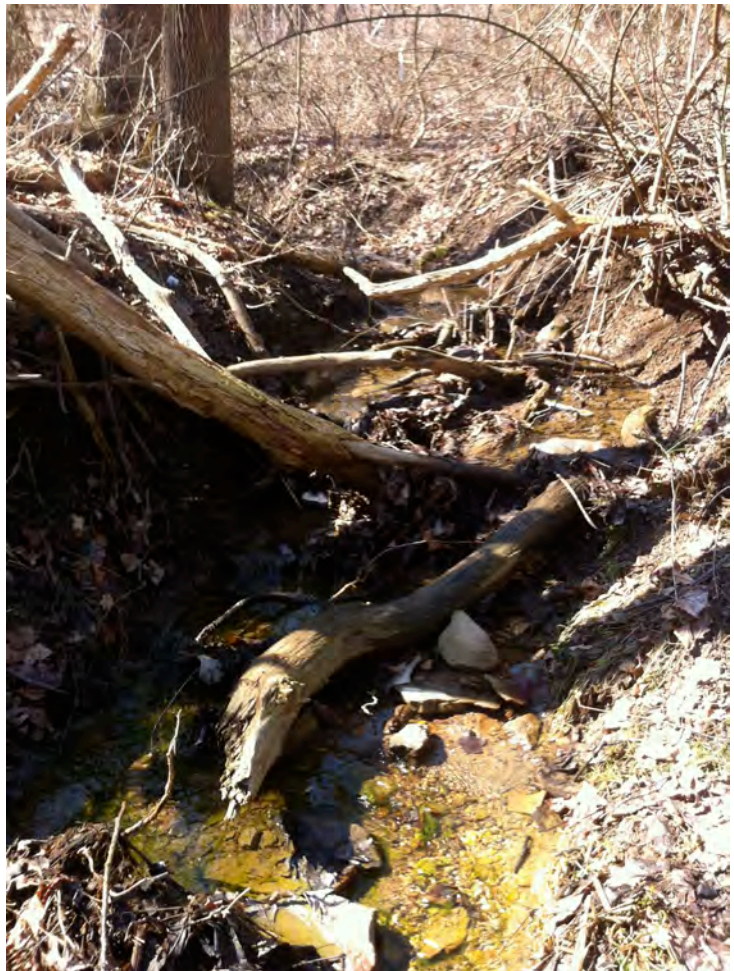
BR59 - A tributary to Beam Run just southwest of the Woods of Jefferson neighborhood along Beam Run Road is impacted by excess algae.

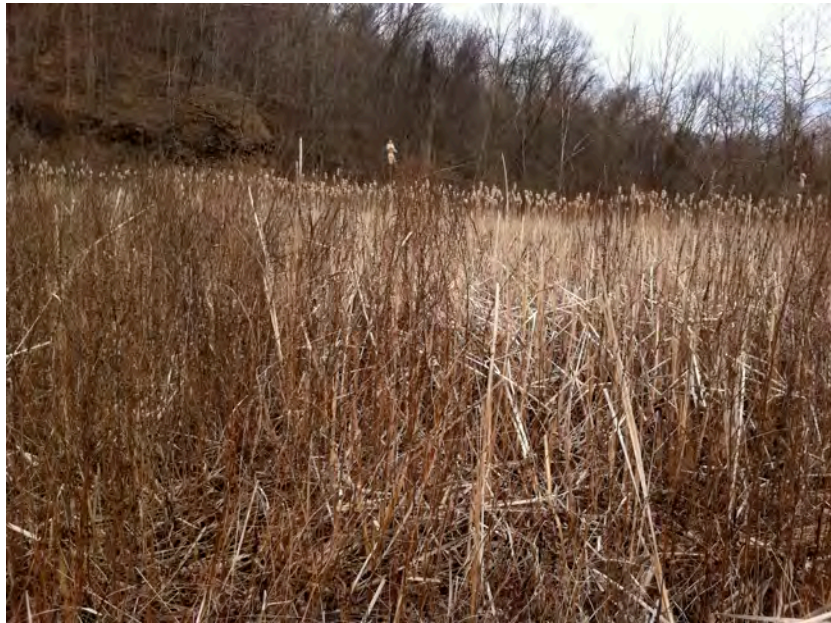
BR04 – Large floodplain emergent wetland along Beam Run's right ascending bank near mouth just above Peters Creek Rd. This wetland is impacted by heavy off-road activity.

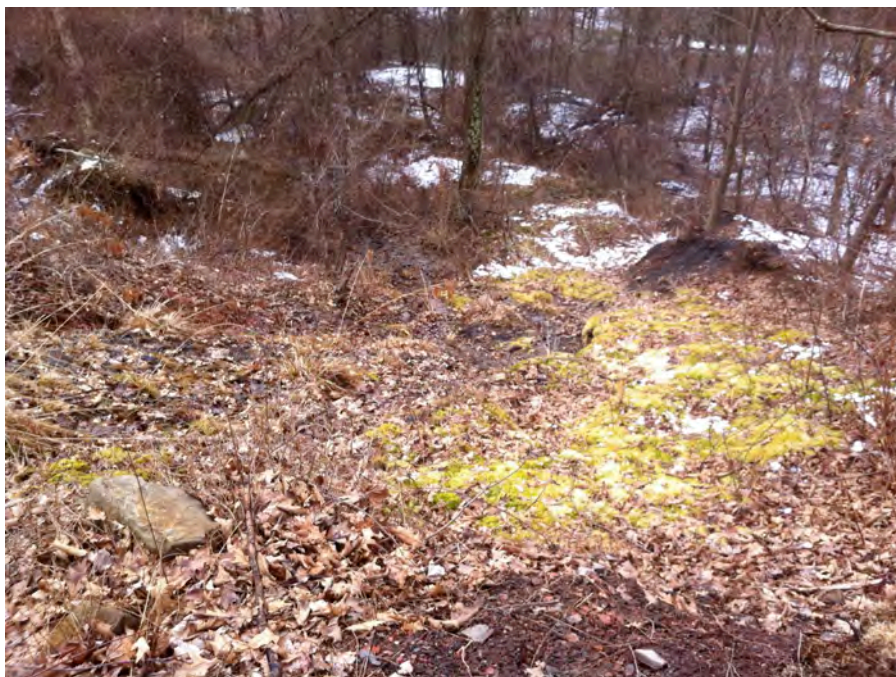
BR06 – An emergent wetland dominated by cattails on the slopes above Beam Run's right ascending bank drains to this sphagnum wetland just downslope.

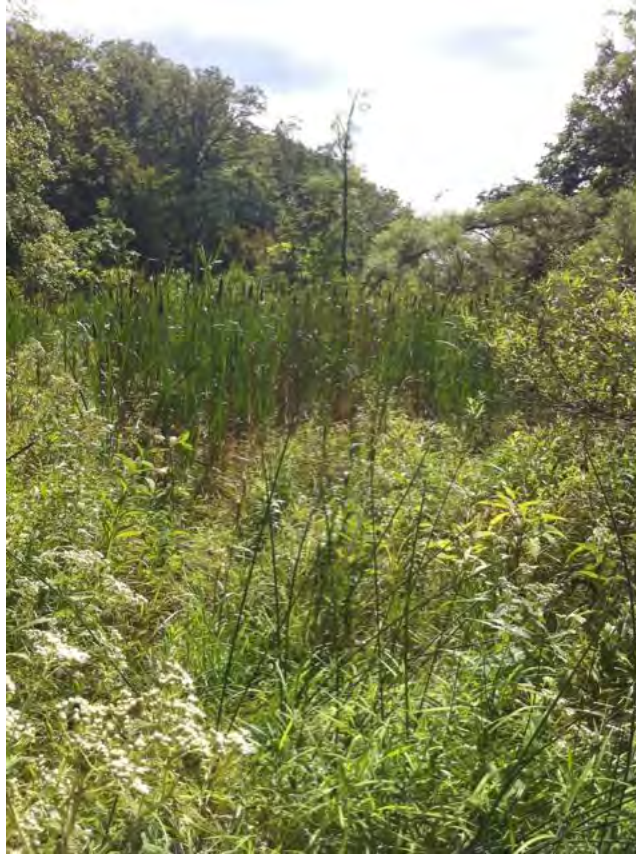
A large mainly scrub-shrub wetland fills Beam Run's floodplain for 500-600 ft between BR20 and BR24. Willows and cattails dominate but there is also some good diversity within this wetland. The steep slopes on both sides of the valley make it difficult for ATV's to traverse this section of floodplain.

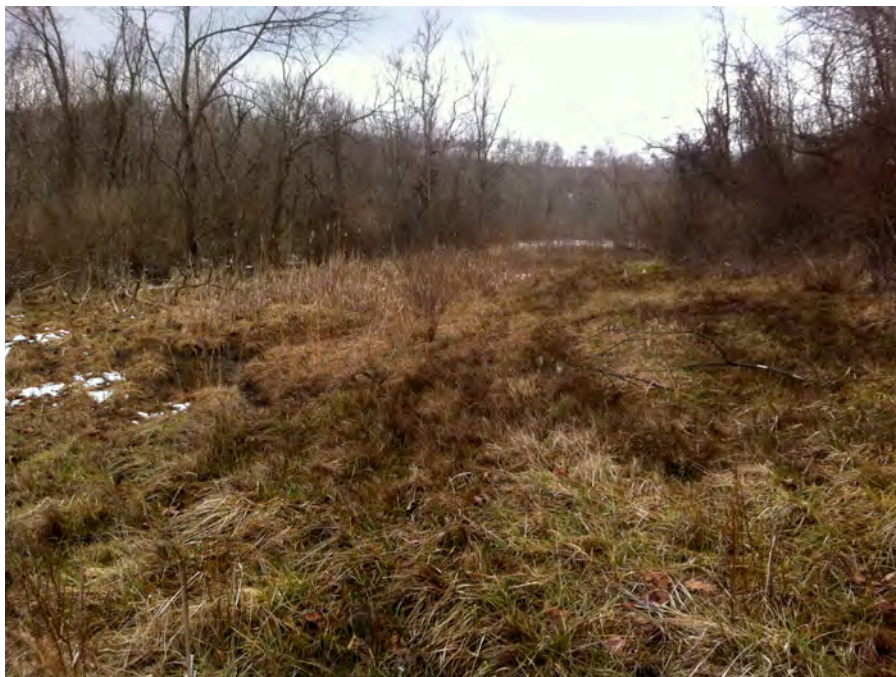
BR27 - This emergent wetland on a bench above Beam Run's right ascending bank has provided habitat for beaver. Beaver most likely helped to enhance this wetland.

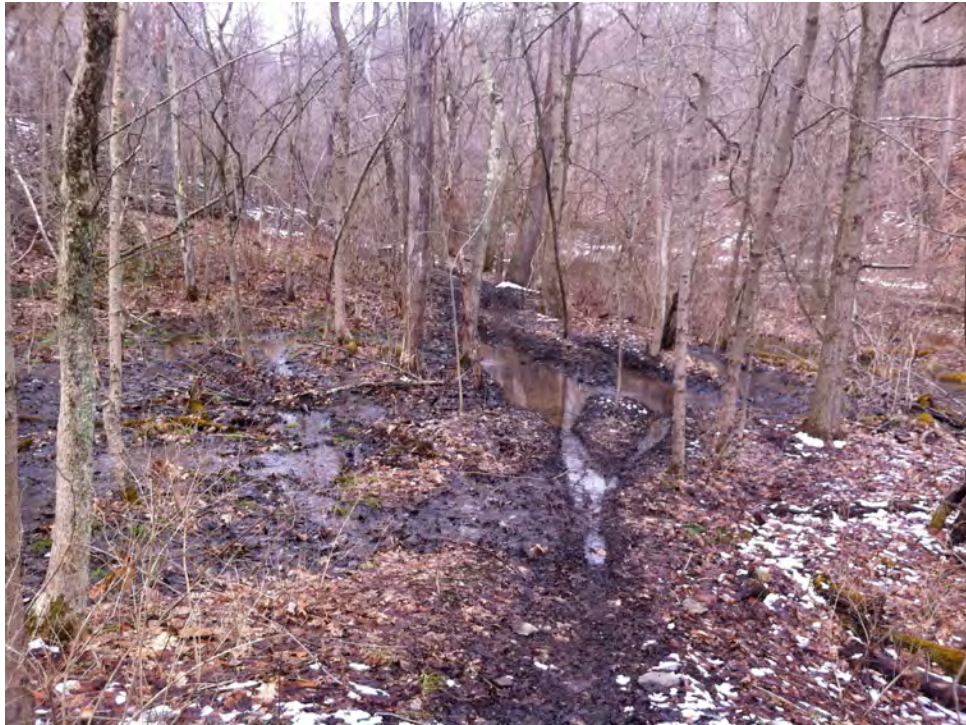
BR31 – Two small tributaries form a wetland on the left ascending bank. One tributary is captured by an erosion gully created by off-road vehicle use.

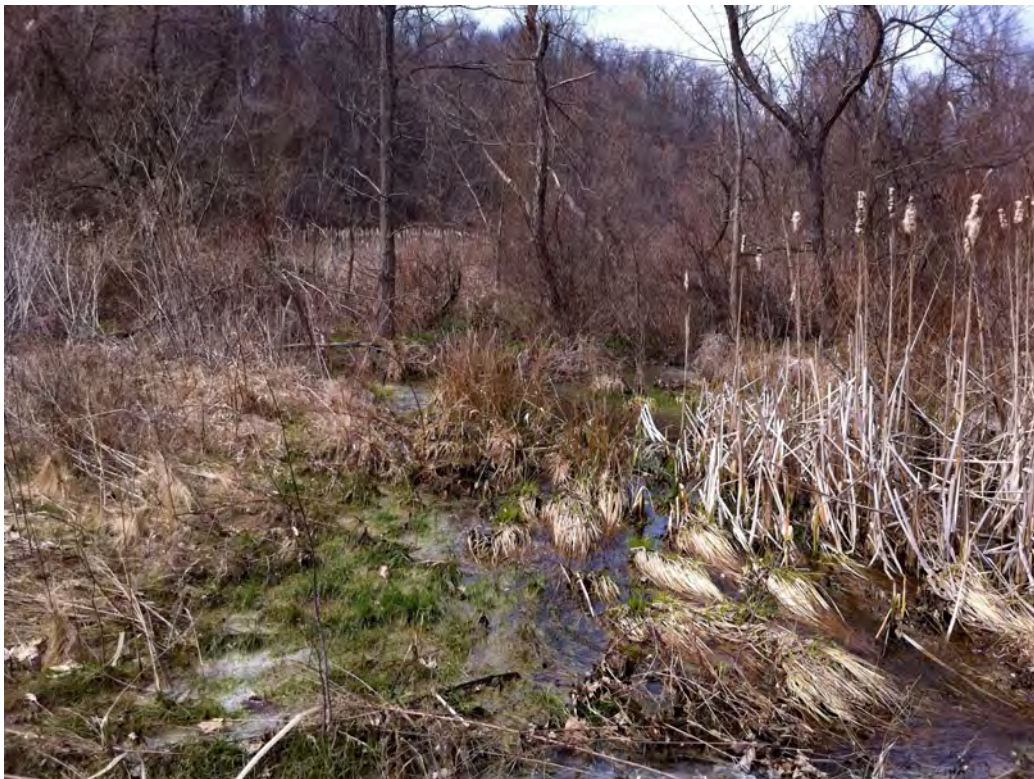
An emergent wetland fills the floodplain of Beam Run both south and north of the Chamberlain Road crossing of the stream. The wetland begins just downstream of an AMD impacted tributary's confluence with Beam Run at BR52 and extends downstream to below tributary 002029's entry into the wetland at BR48. The wetland also receives AMD impacted drainage from seeps along Chamberlain Road.

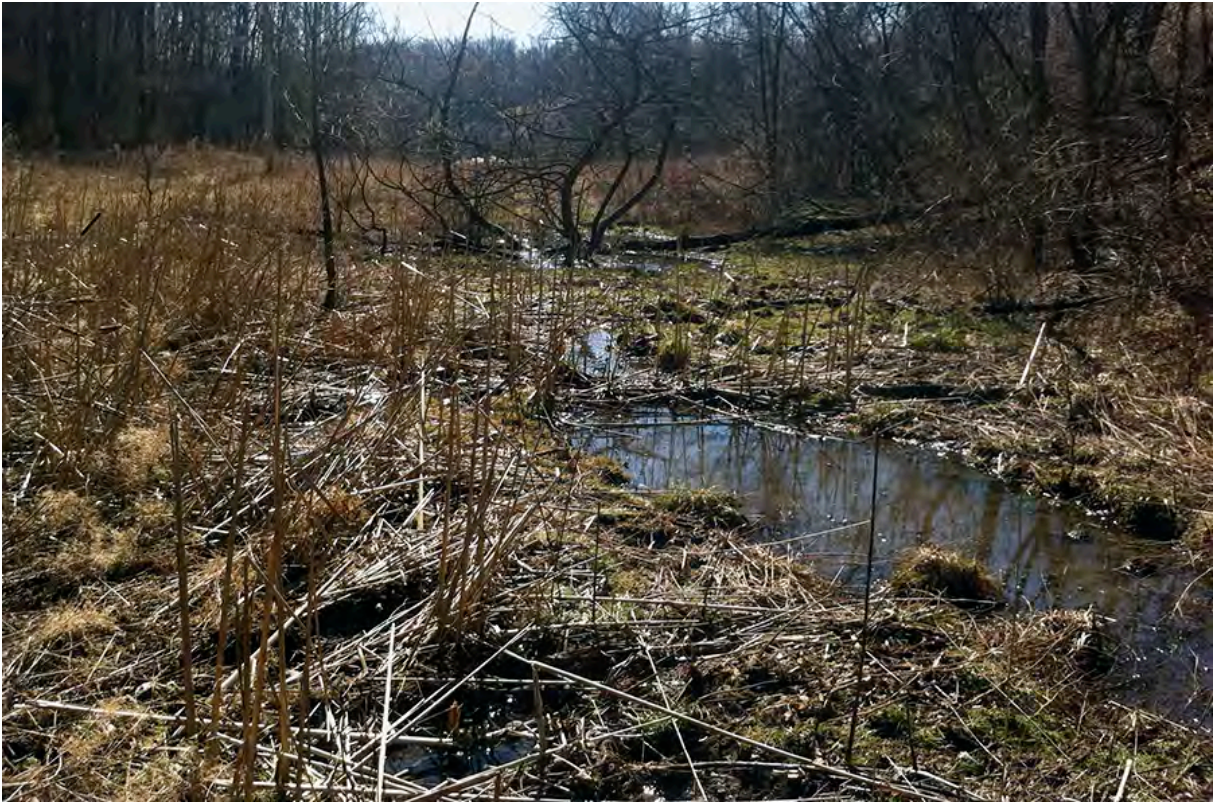
BR66 – Beam Run forms a wetland along the valley floor between Jefferson Pointe and Meadowfield Lane in the headwaters.

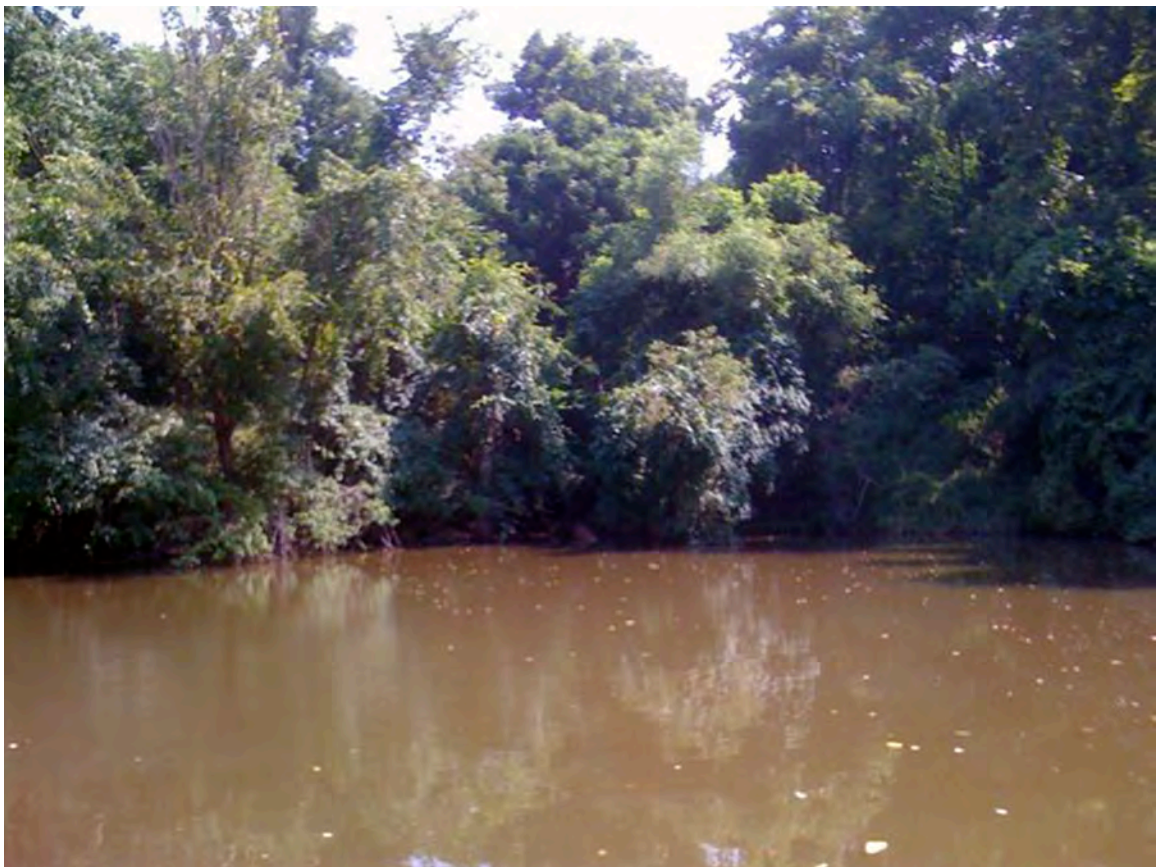
I-2 – There are a few old farm pond/impoundments within the Beam Run sub-watershed. The impoundment pictured above is located on the Zora parcel just west of the reclamation site.

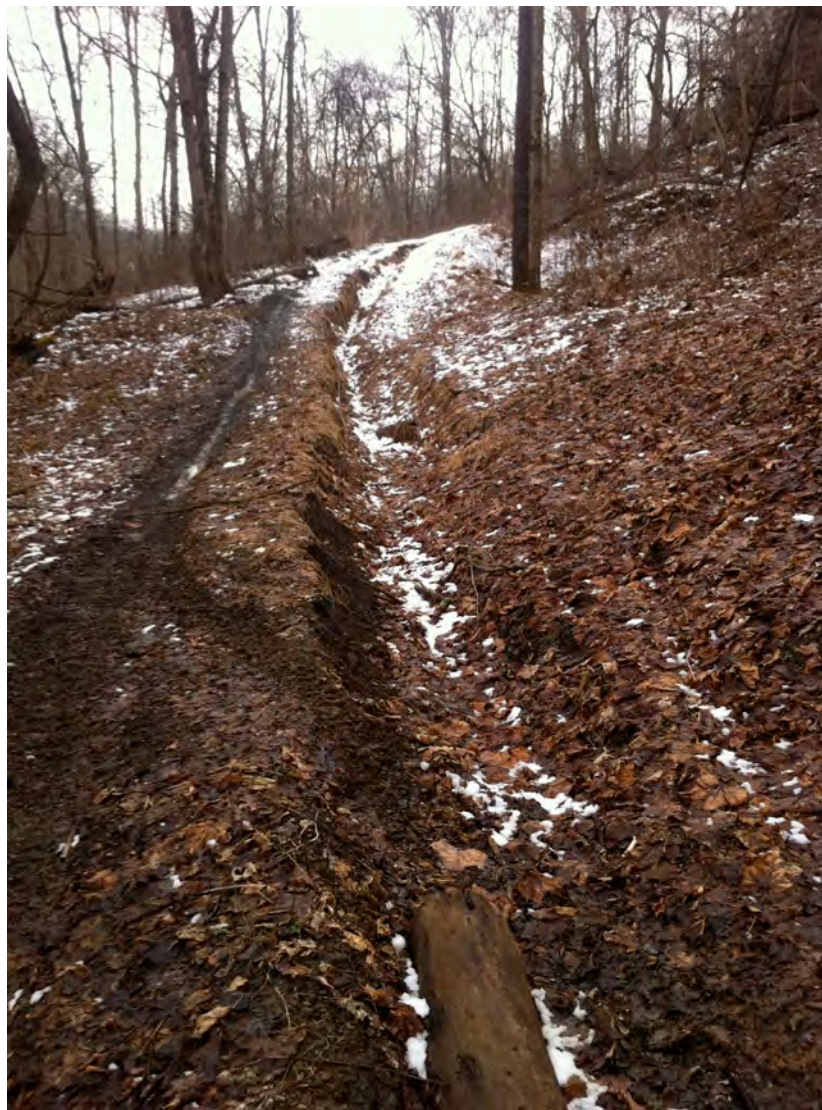
BR26 – An erosion channel created by off-road activity transports stormwater and sediment into Beam Run.

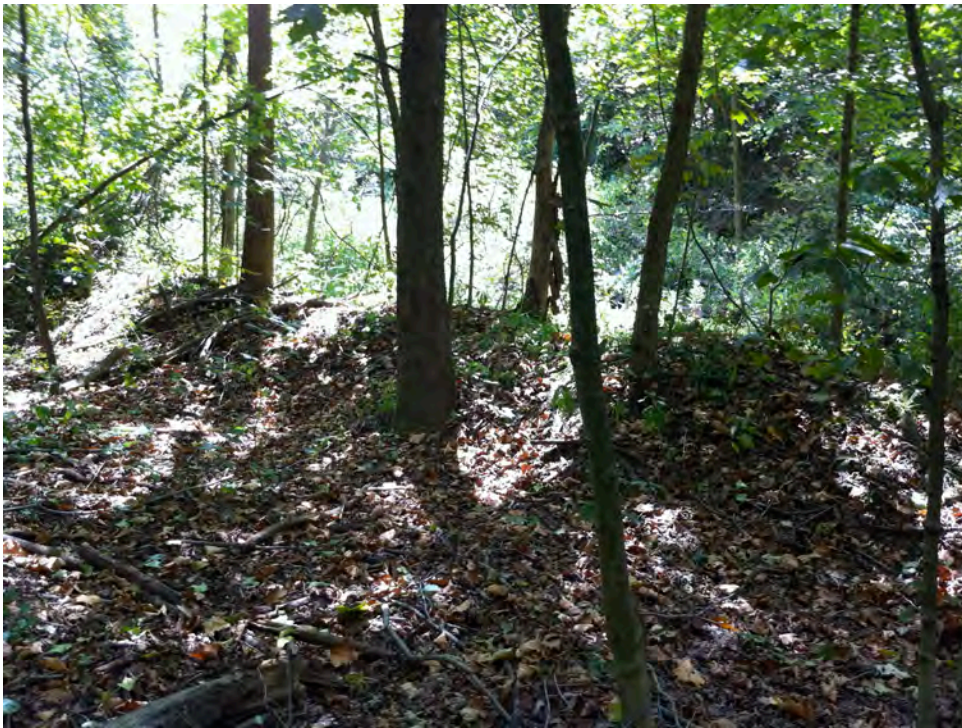
BR33 - The floodplain at this location has been altered by human activity in the past, most likely surface mining. Trees of maximum age of 20-30 years old are growing from piles of moved earthen material.

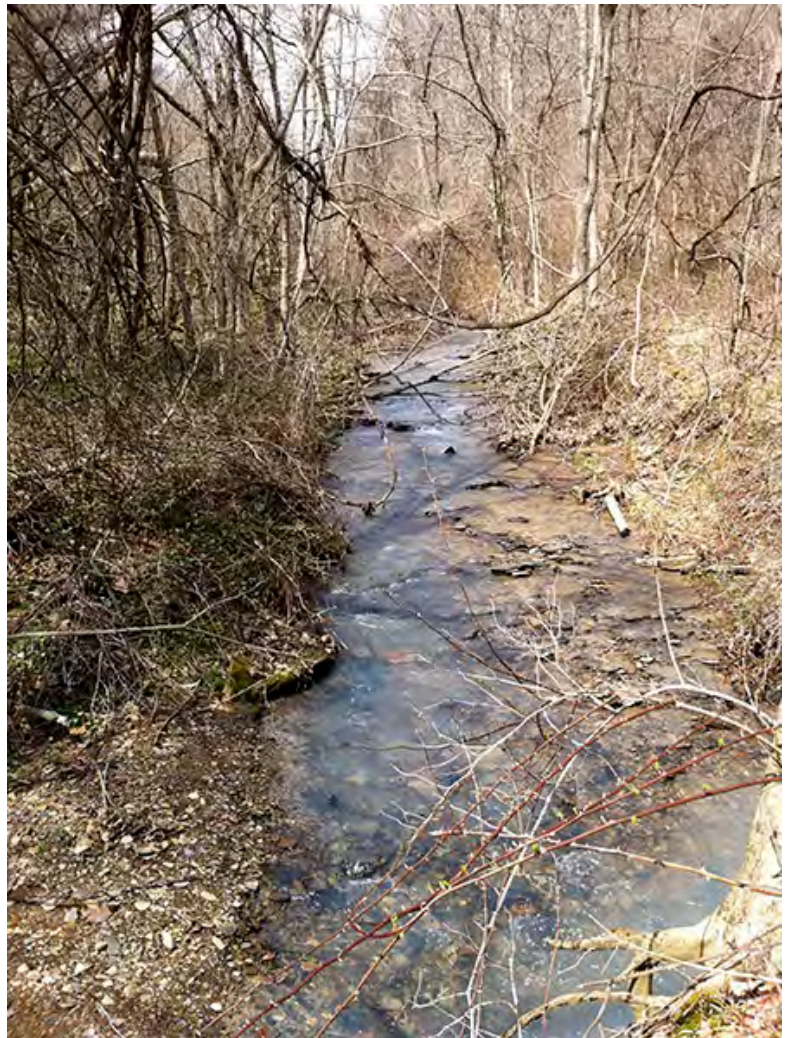
A wetland completely covers Beam Run's floodplain from just above BR20 to BR24. Steep wooded slopes along both sides of the floodplain force off-road activity onto the slopes in this location and protects the wetland from excessive degradation.

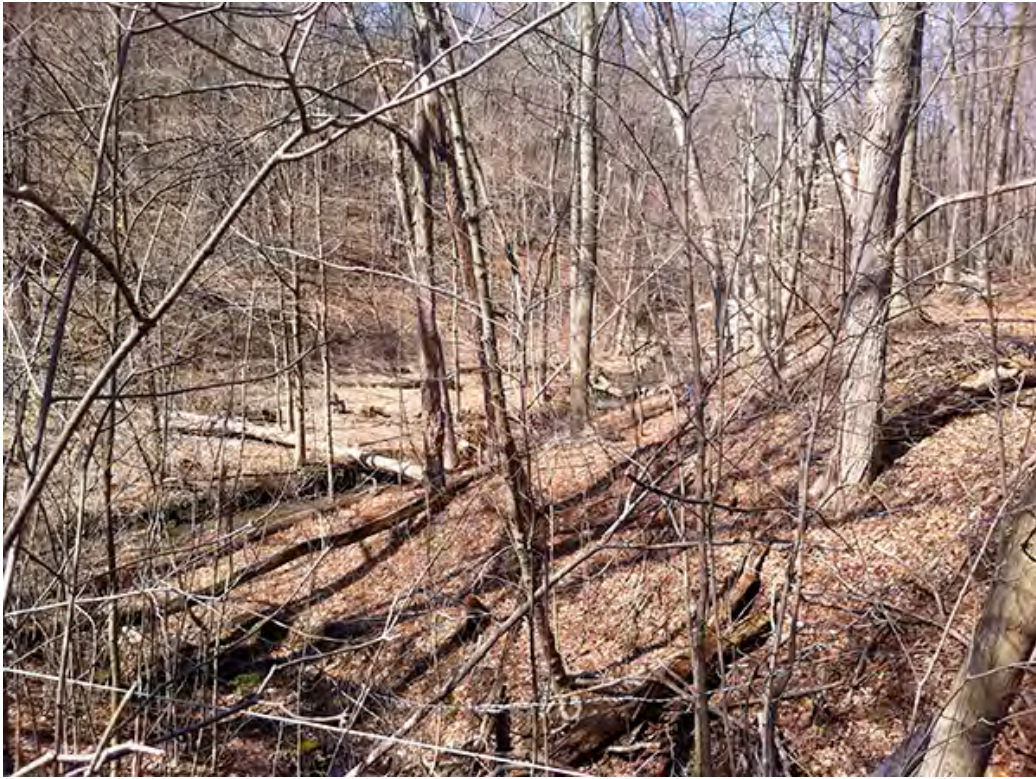
A fairly typical view of Beam Run and its floodplain and wooded slopes between Chamberlain Rd to just below Wakefield Rd. The floodplain broadens and the slopes become less steep along this section of stream.

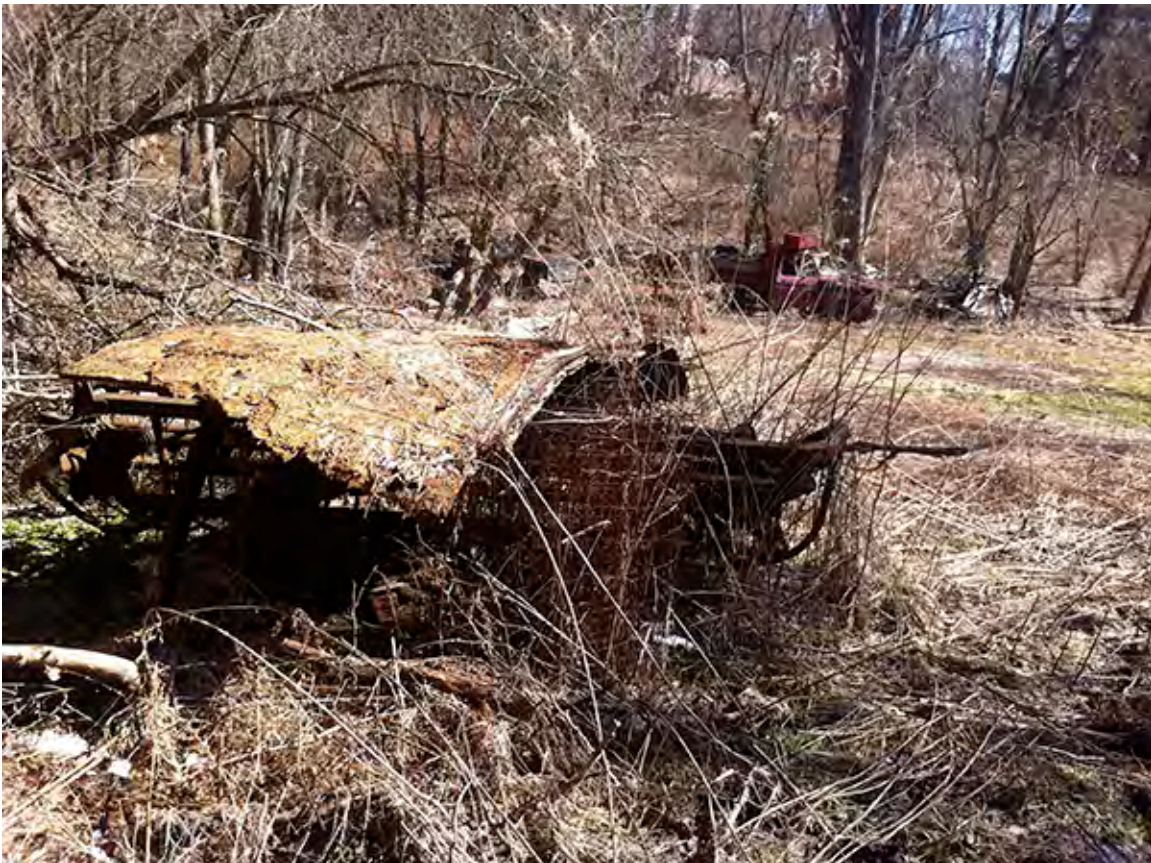
Beam Run's floodplain in the headwaters upstream of Beam Run Road is littered with all manner of garbage, construction material, tires, numerous abandoned vehicles, old machinery and farming equipment. There are also a number of abandoned houses along this section of Beam Run.

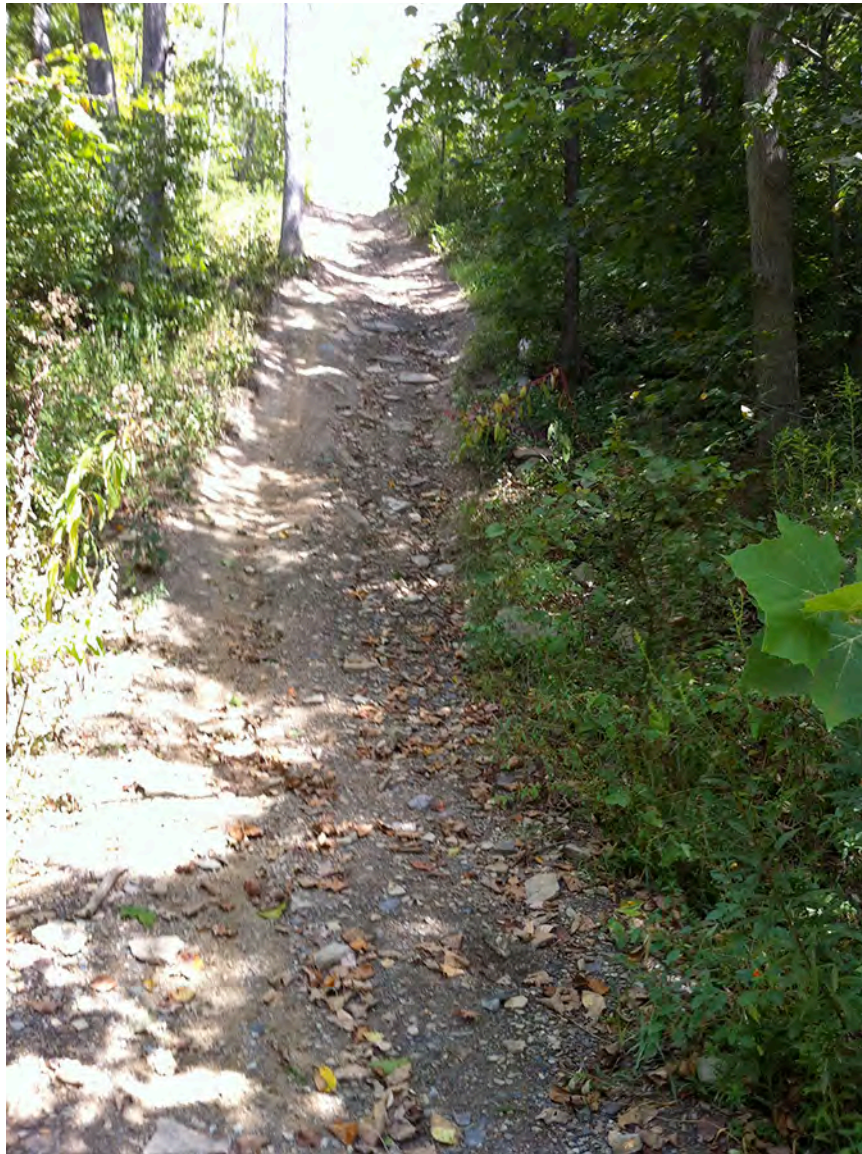
BR25 – Off-road trails ascending Beam Run’s steep valley slopes create stormwater runoff channels that alter drainage patterns, create excess erosion and add to Beam Runs siltation load.

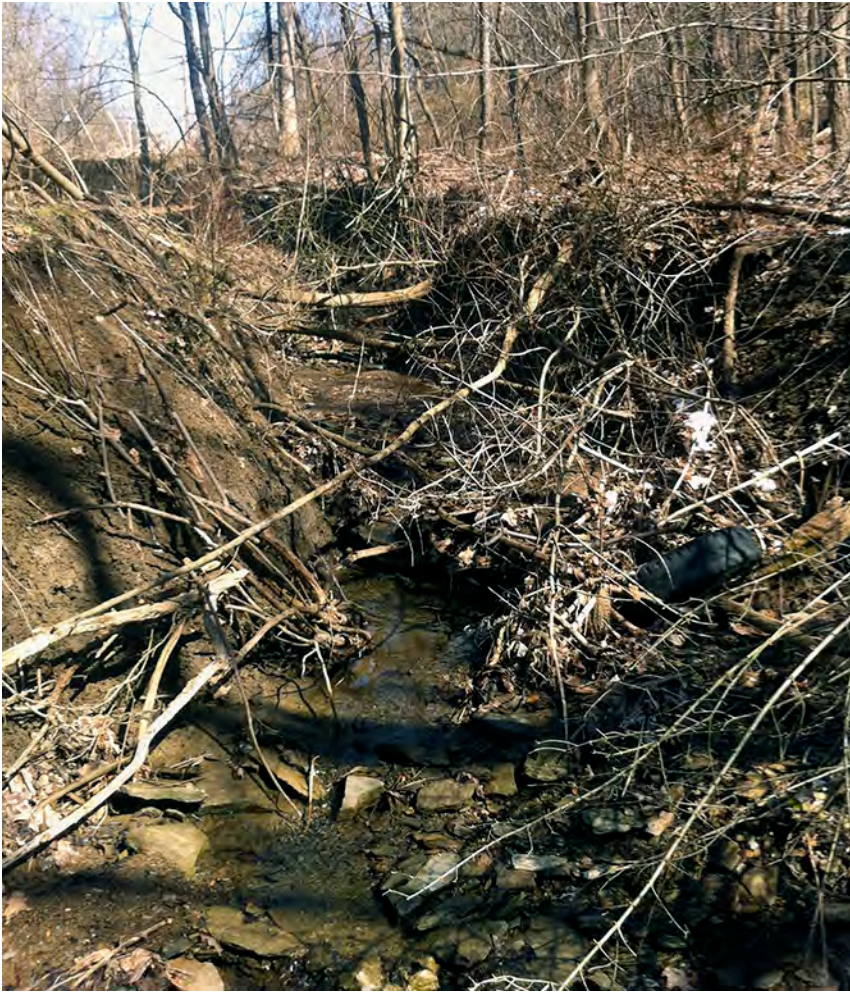
BR59 – The Wakefield Road Tributary at its confluence with Beam Run is deeply incised and eroded due to excess stormwater

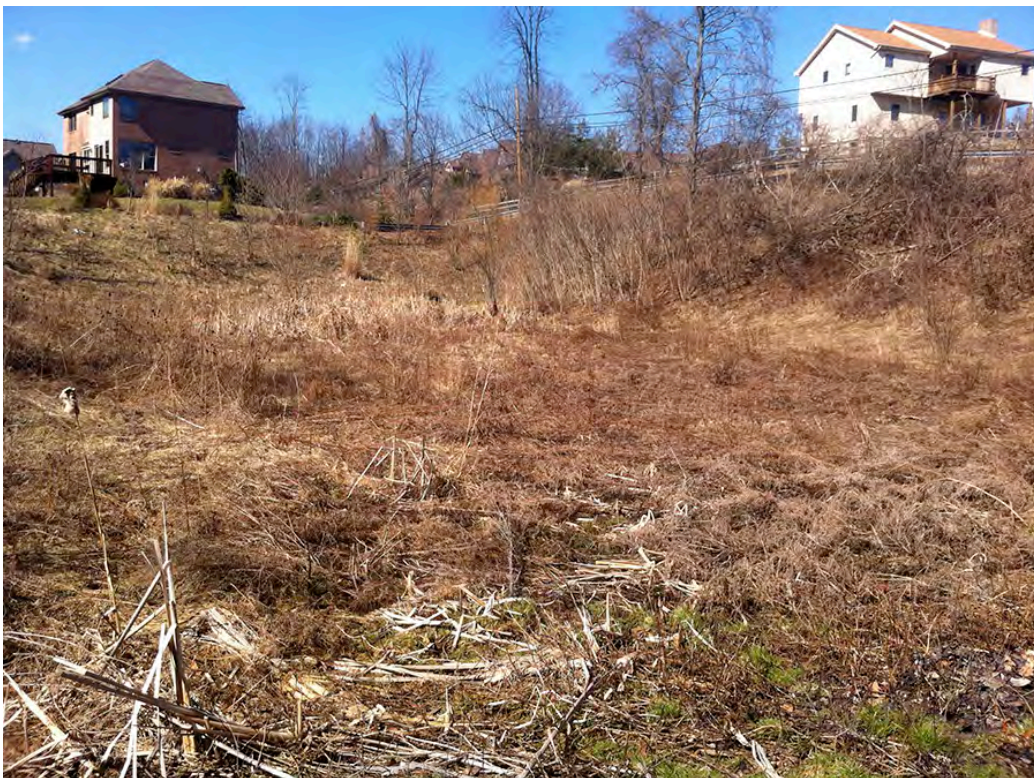
BR64 – Stormwater detention basin accepting stormwater from the Woods of Jefferson residential development along and off of Beam Run Road.

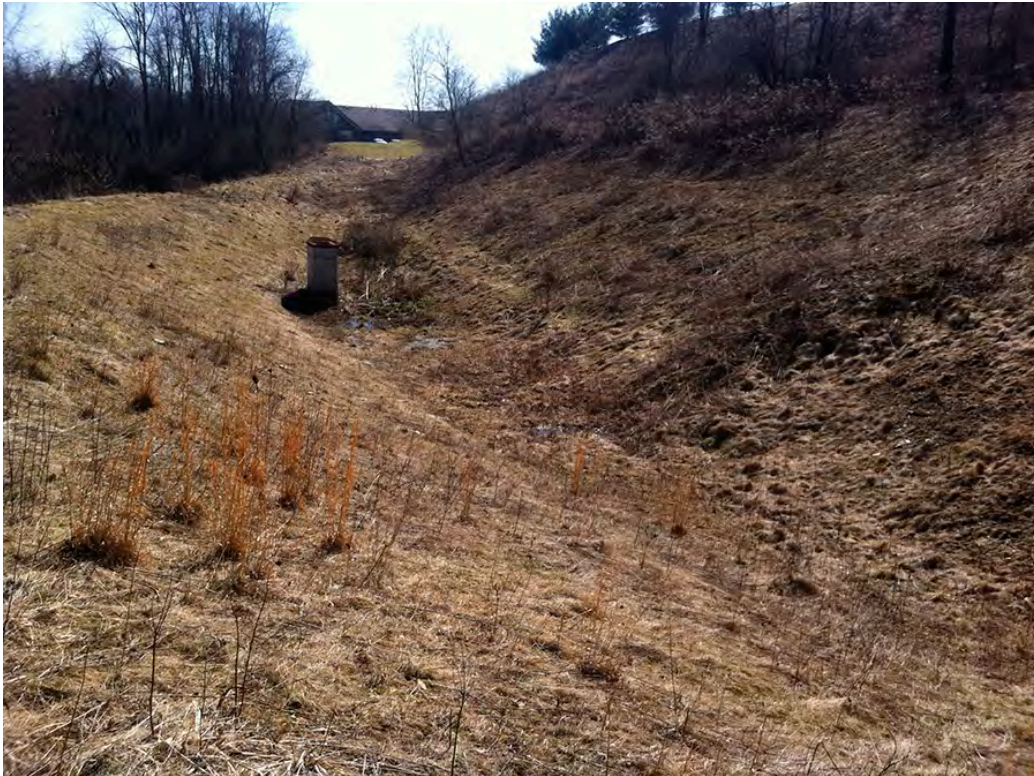
BR69 – Stormwater detention basin for the Jefferson Pointe residential townhome development of of Gill Hall Road.

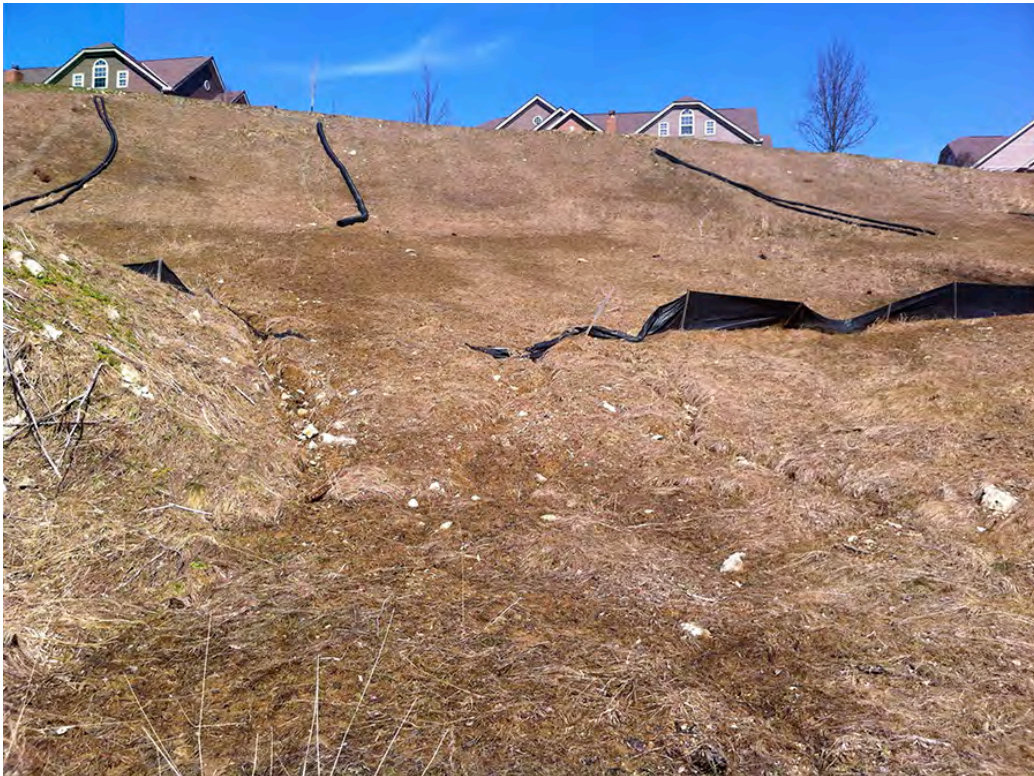
BR70 – An unstable slope along Beam Run Road at the Jefferson Pointe residential development creates a number of public and private problems. Inadequate drainage and excess stormwater are most like contributors to the problem.

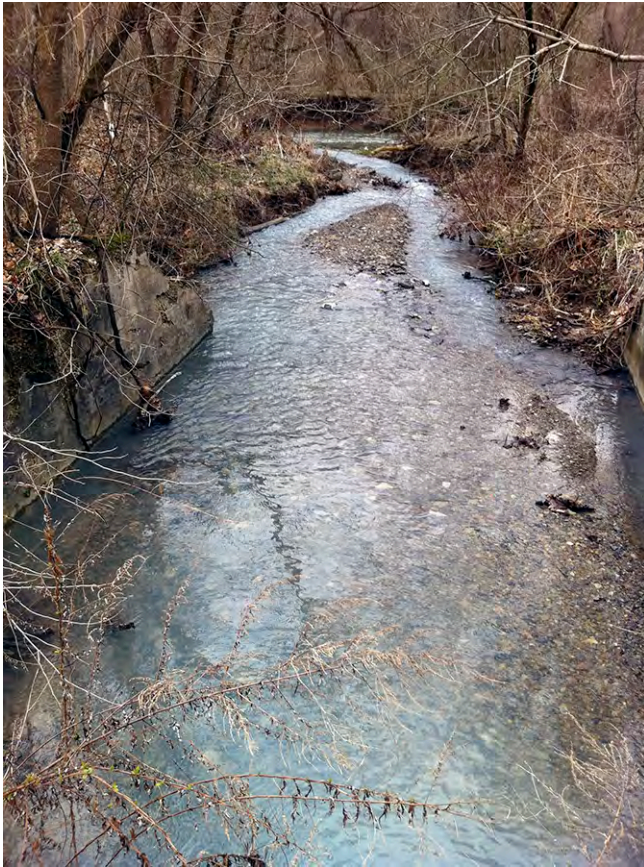
BR02 – Beam Run below Peters Creek Rd to Peters Creek. The culvert carrying Beam Run under Peters Creek Road is eroding and appears to be too small for the flow it carries. The stream channel is eroded upstream of the culvert and concrete debris in the channel is obstructing flow. This stream crossing is in need of replacement.
