Peters Creek Watershed Assessment & Management Plan

April 2014

1.0 PETERS CREEK WATERSHED BACKGROUND

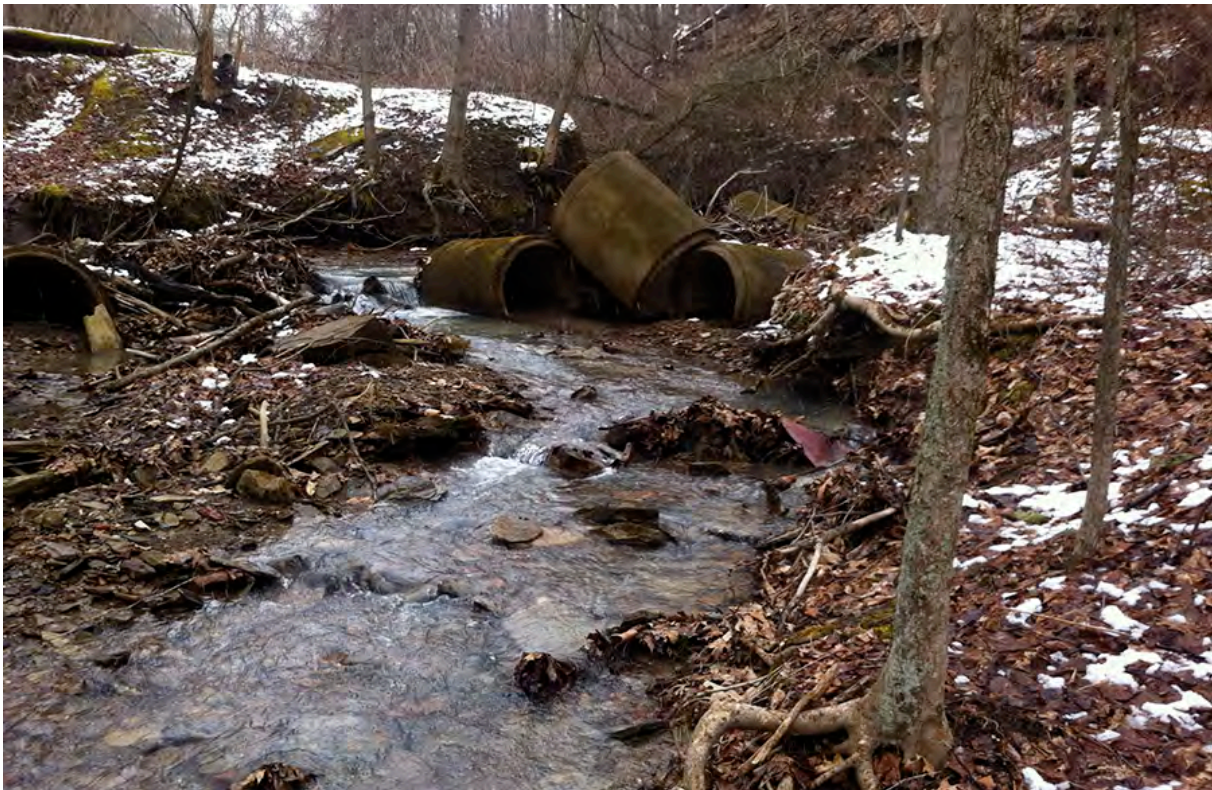
BR37 – A number of sanitary sewer sections encroach on Beam Run's channel and create alteration of flow pattern and erosion.

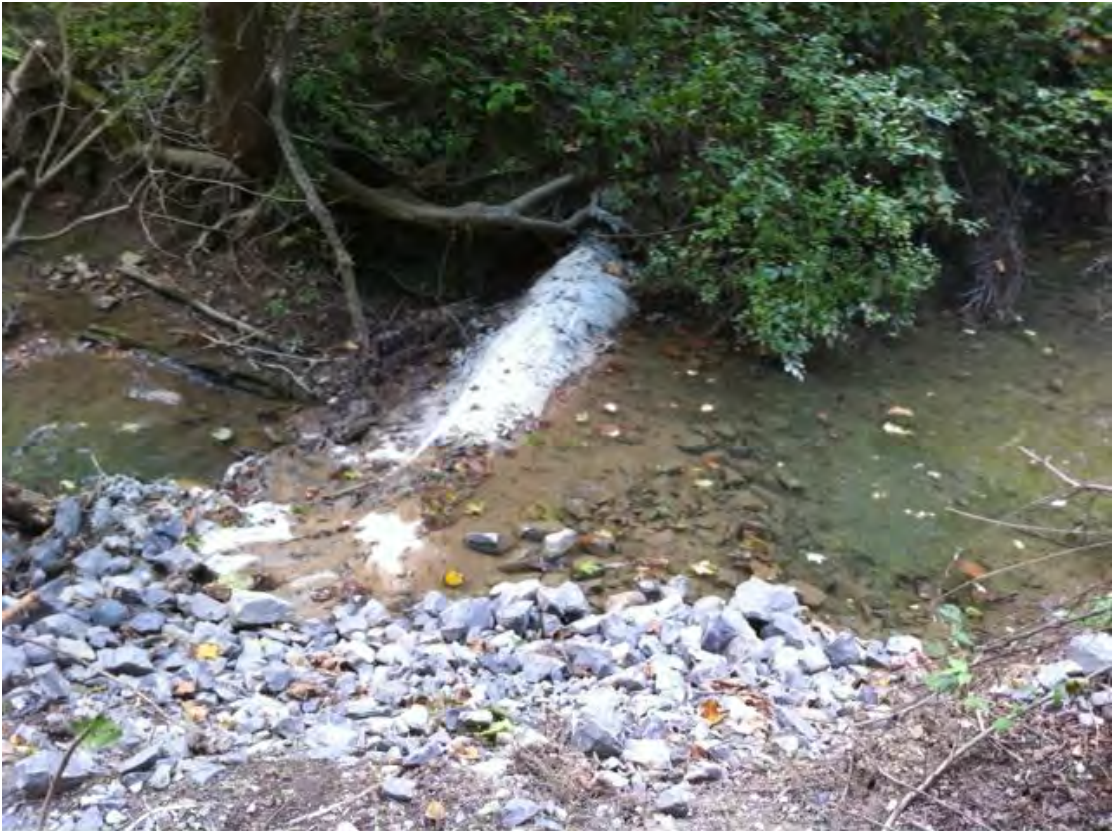
BR38 – Pipe crossing of Beam Run creates a plunge pool and totally obstructs the stream channel creating a fish barrier and erosion downstream.

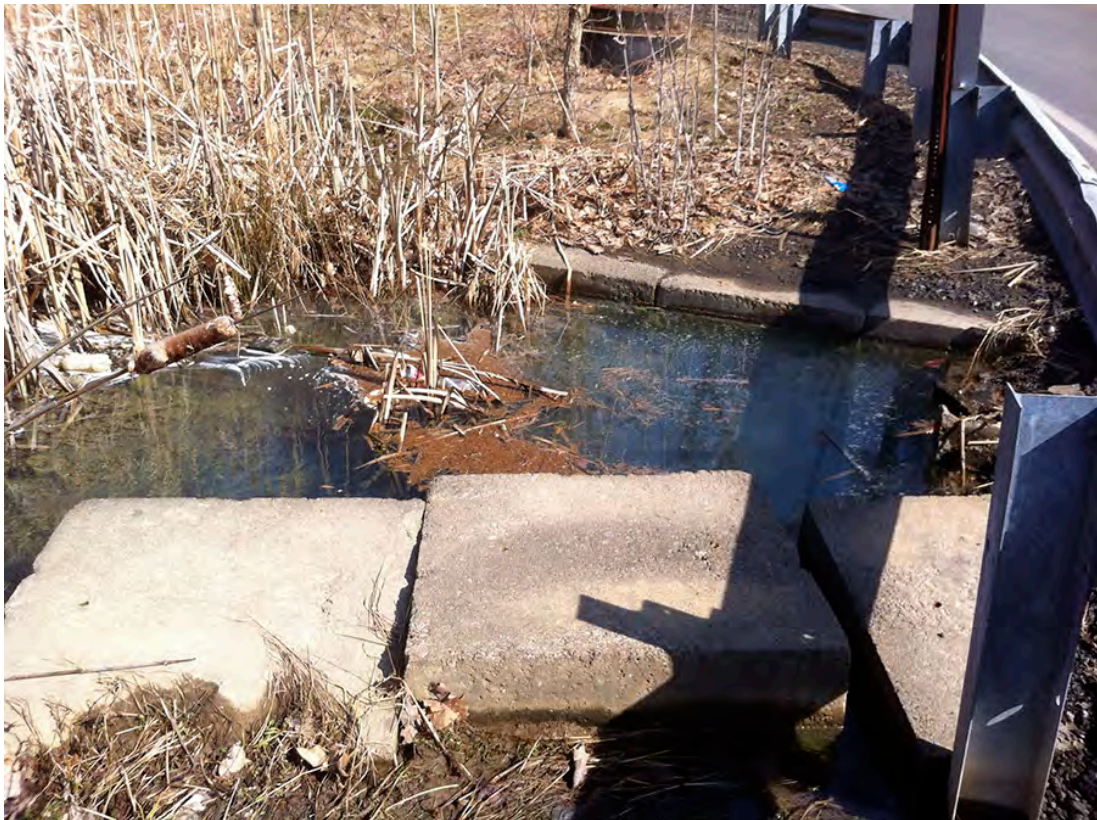
BR49 – The culvert carrying Beam Run under Chamberlain Road is either too small or clogged with debris.

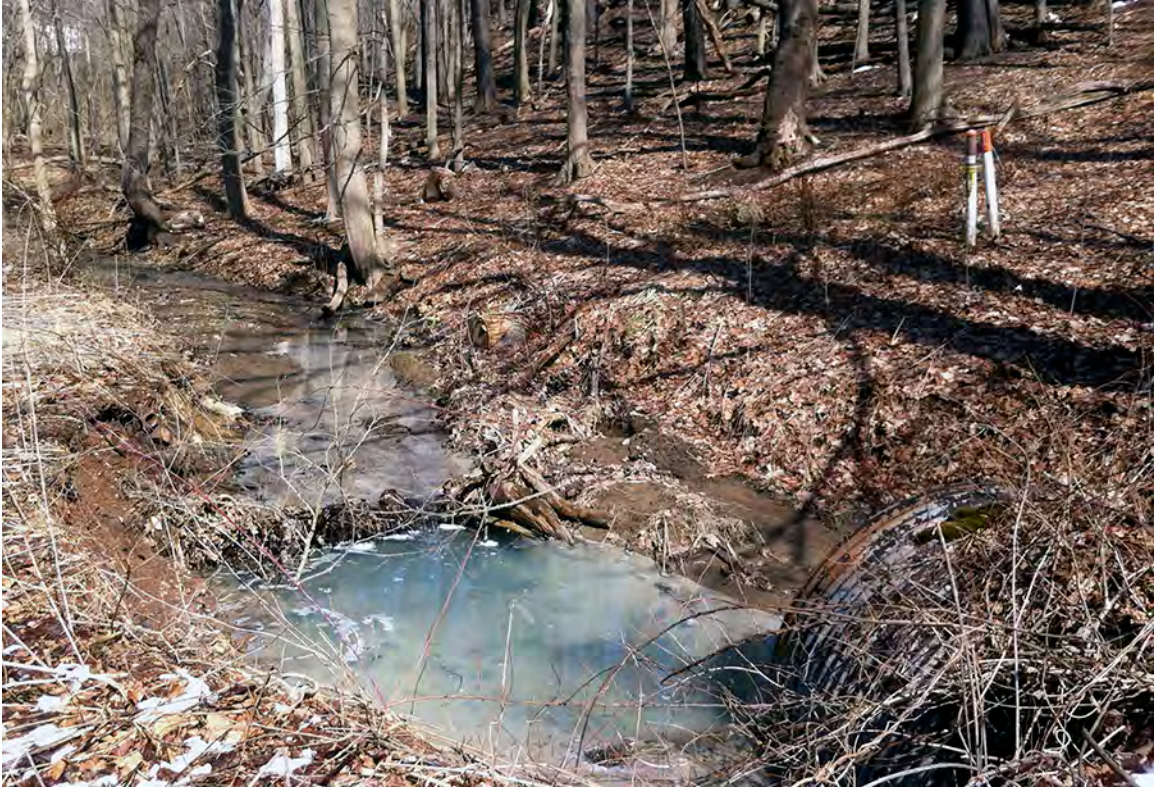
BR57 – A gas line crossing of the stream creates an obstruction and an old culverted undeveloped road crossing encroaches on the channel. The stream is also impacted by abandoned mine drainage at this location.

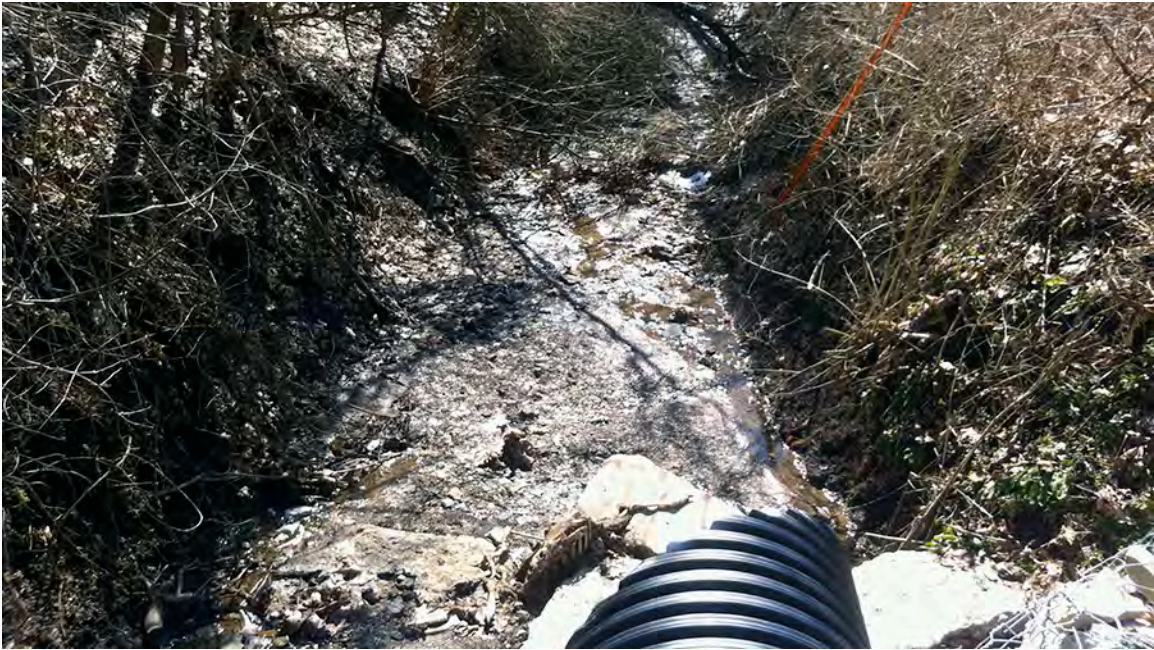
BR61 – The culvert carrying the Wakefield Road Tributary under Wakefield Road is not adequately sized. Severe erosion occurs both upstream and downstream of the crossing. The 002025 tributary to Beam Run flows within an enclosed channel for its entire length. Its confluence with Beam Run occurs in the culvert as the headwaters of Beam Run are piped under Beam Run Road. Beam Run then emerges from the culvert just downstream of the junction of Beam Run Road and Wakefield Road.

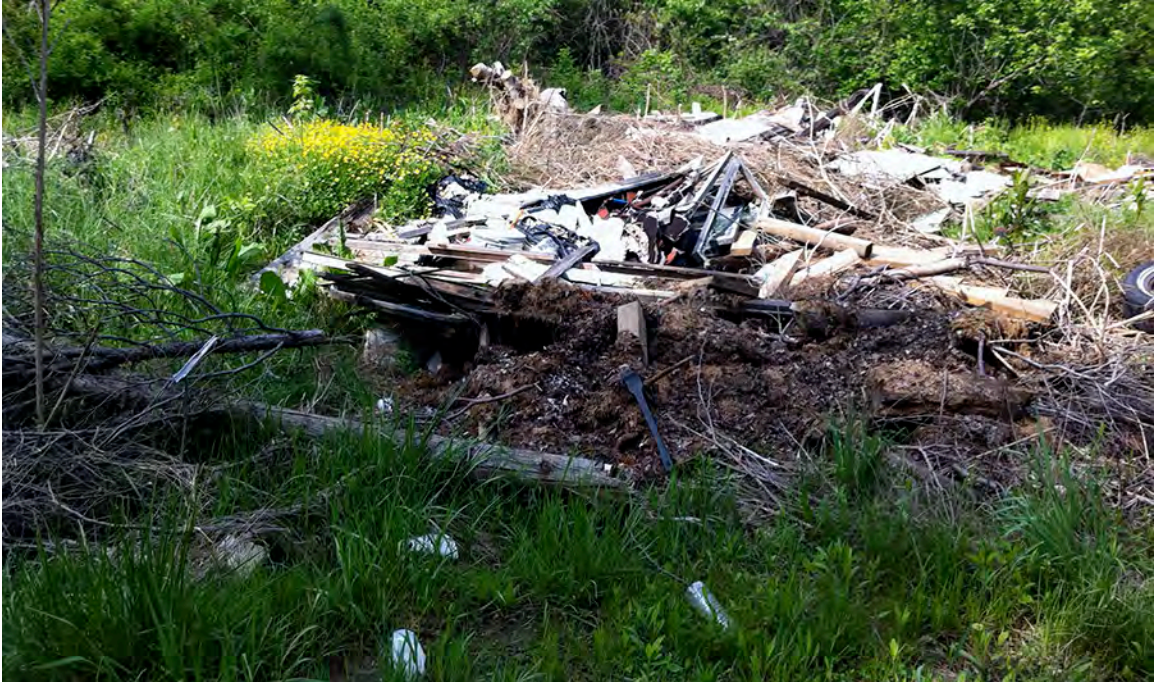
BR10 – Illegal dump site at the top of a tributary along the western slope of Beam Run.

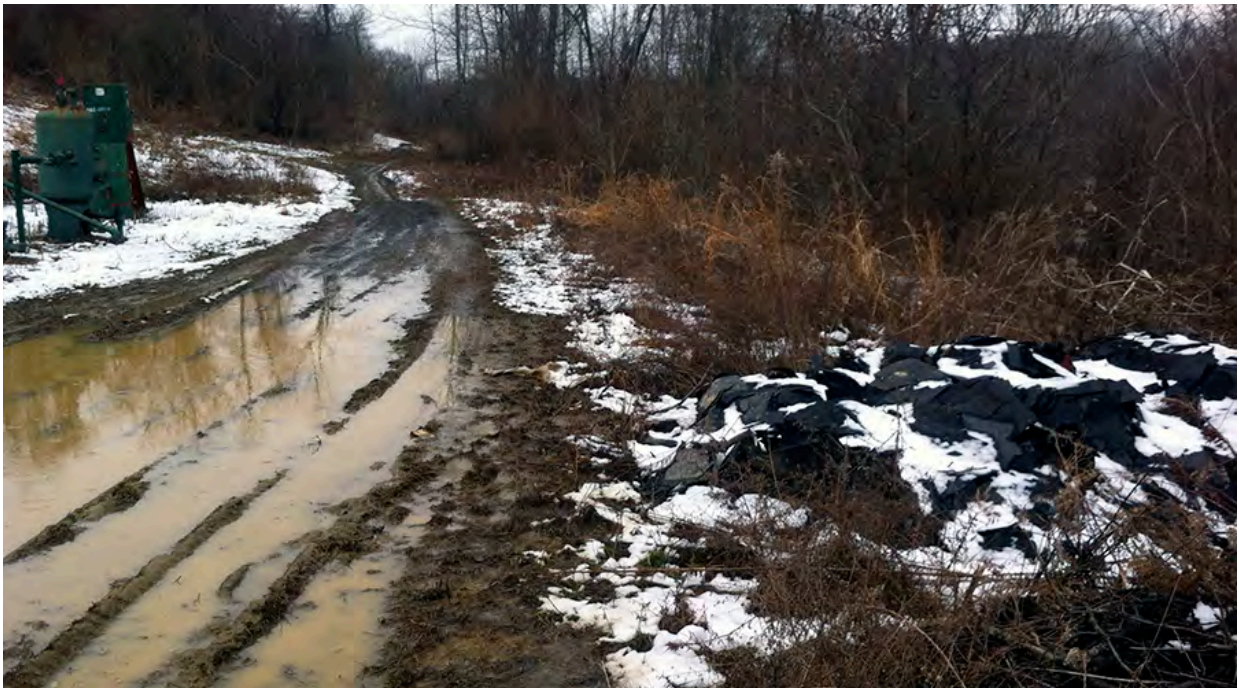
BR13 – An illegal dump site along a gas well access road that is heavily eroded by heavy off-road activity near the top of Beam Run's western slope.

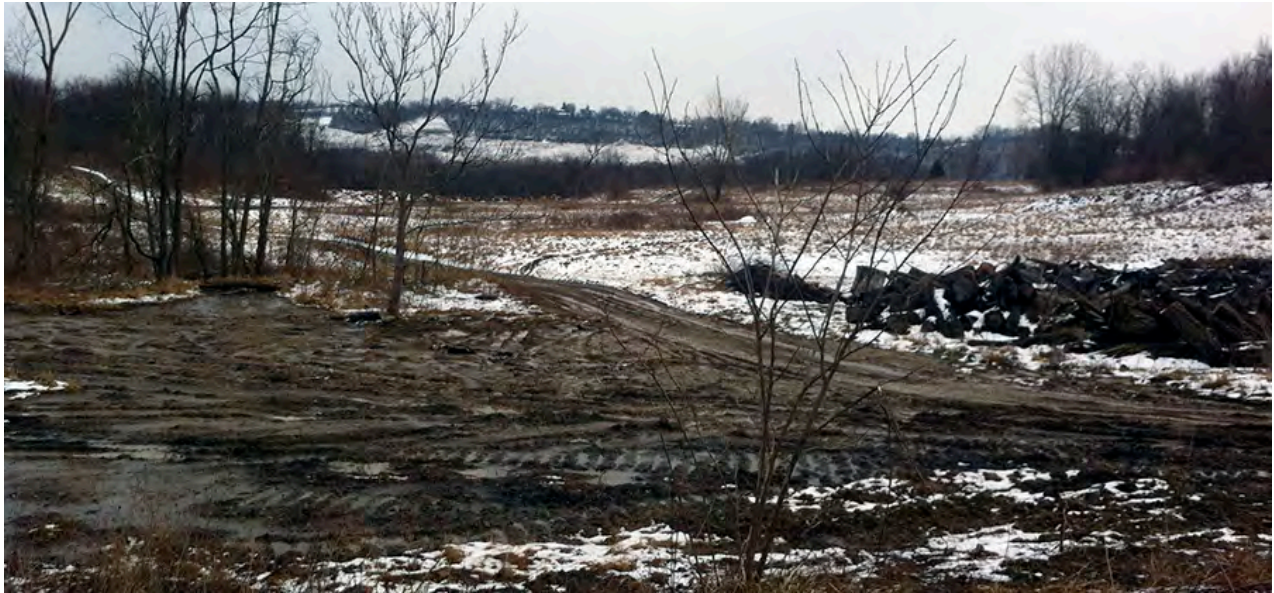
BR16 – A tree and compostable dumpsite in the foreground and a large fill operation in the distance at the edge and over a ravine at a site off of Waterman Road at the head of a tributary (002054) to Beam Run.

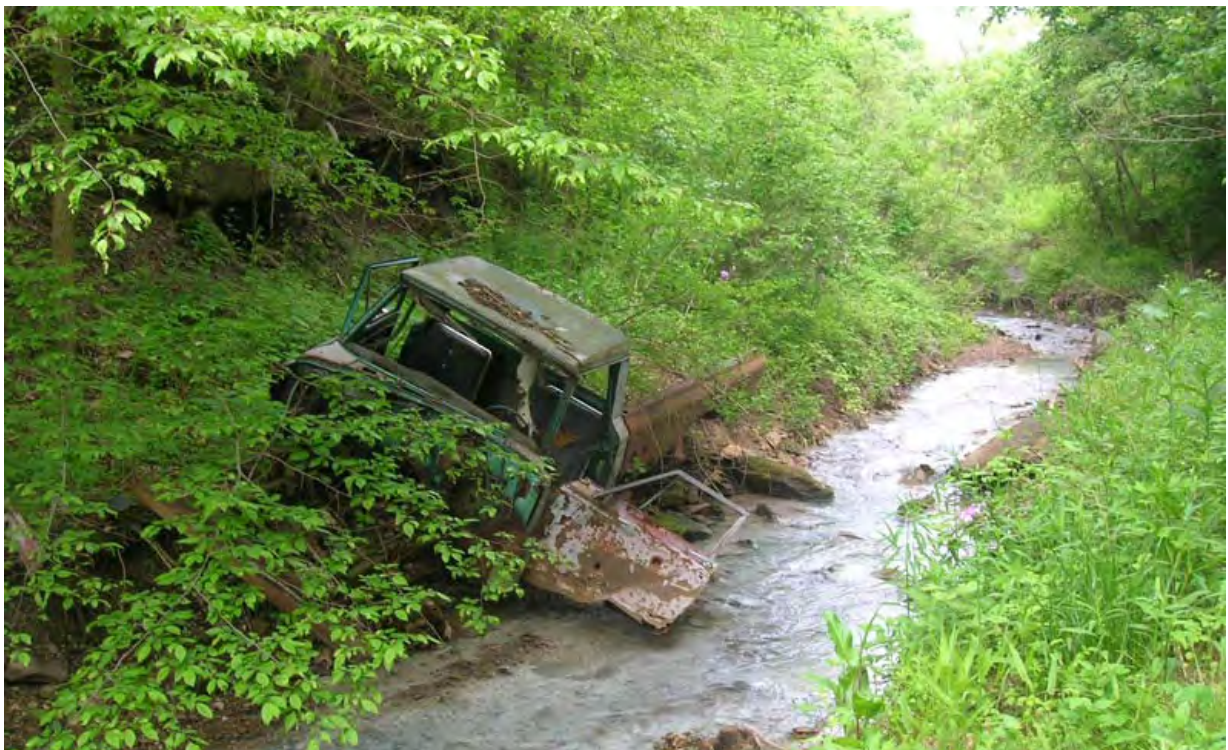
BR33 – A rotting, illegally dumped truck encroaching on Beam Run's channel in a remote section of the stream.

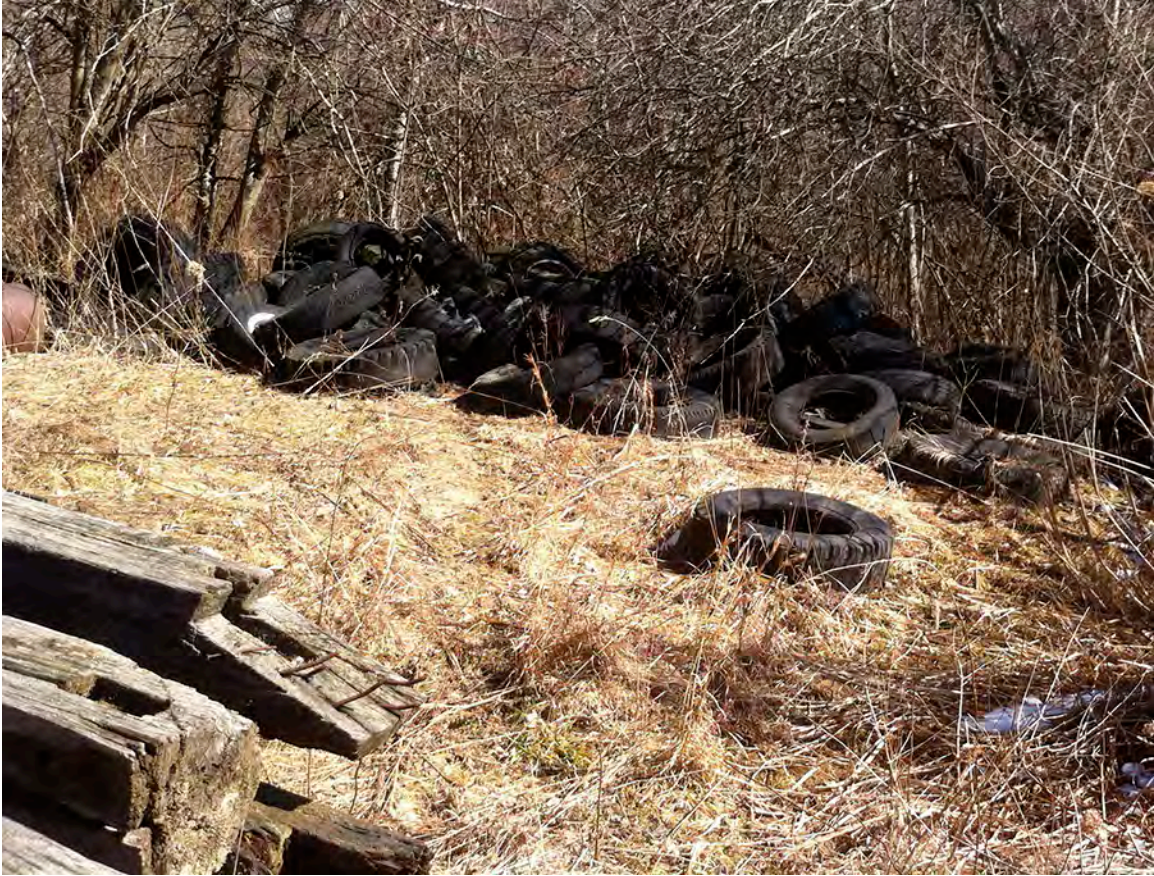
BR71 - The headwaters of Beam Run upstream of Beam Run Road is one massive dump site with all manner of concrete block, hundreds of tires, numerous rotting abandoned vehicles, old machinery, farm equipment, deteriorating abandoned houses and railroad ties with rusty nails sticking out of them as seen above and below.

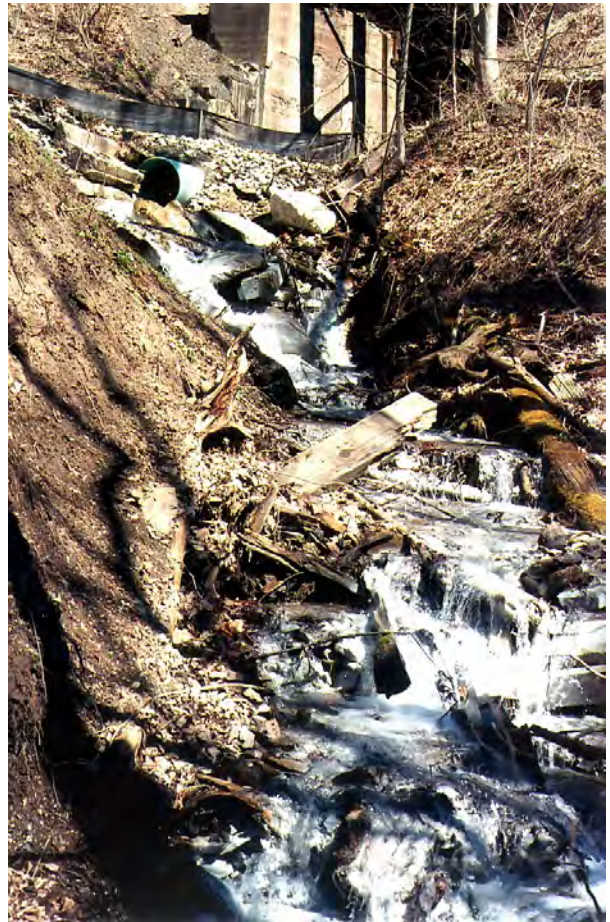
LR07 - AMD discharge flows along the east side of the Wheeling & Lake Erie railroad tracks in a remnant woodlot along the Patriot Pointe residential development prior to being culverted under an unimproved access road under the tracks. The discharge then flows into a wetland within Lick Run's right ascending bank floodplain. Construction debris and other garbage including industrial grade tires with rims discarded along discharge.

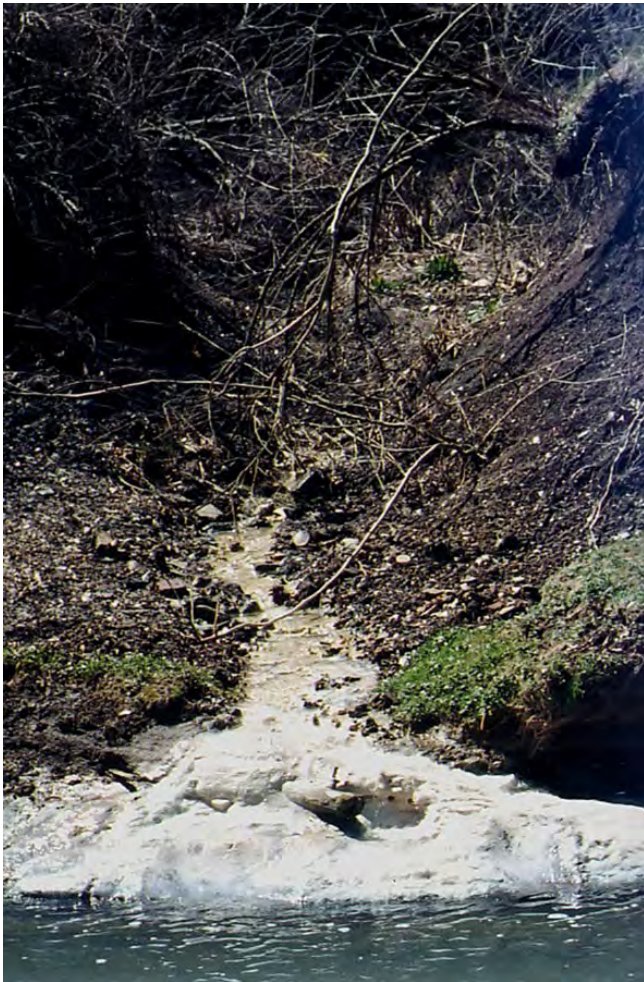
LR08 - AMD impacted seep erodes through a coal waste pile on Lick Run's left ascending bank leaving a heavy deposit at its mouth.

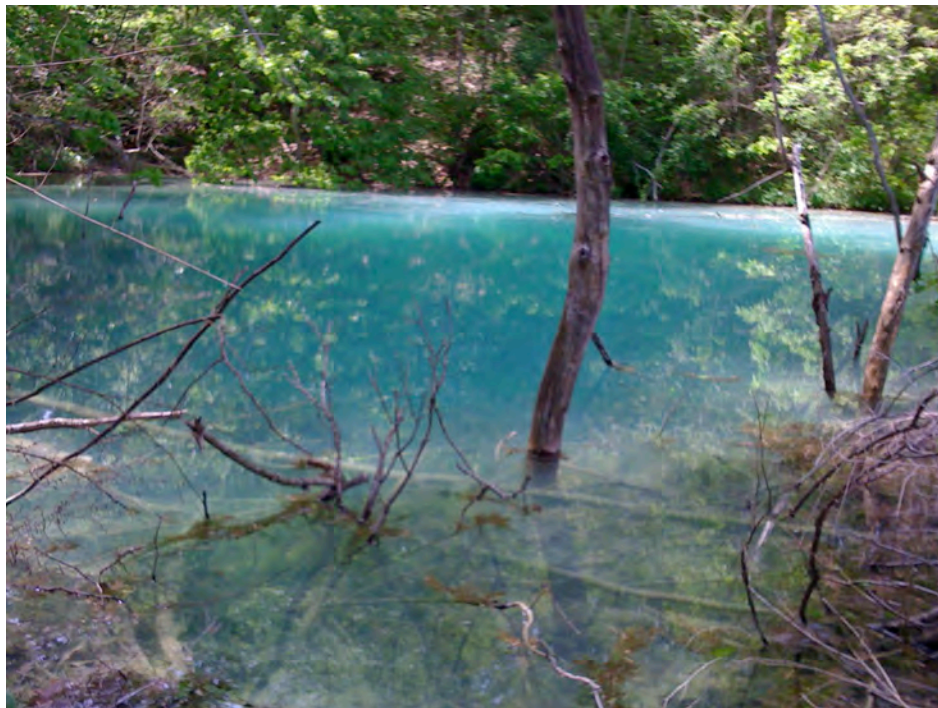
LR10 - An AMD impacted tributary draining a small, steep valley east of Snowden Rd impounds up against the Allegheny Valley Railroad tracks.

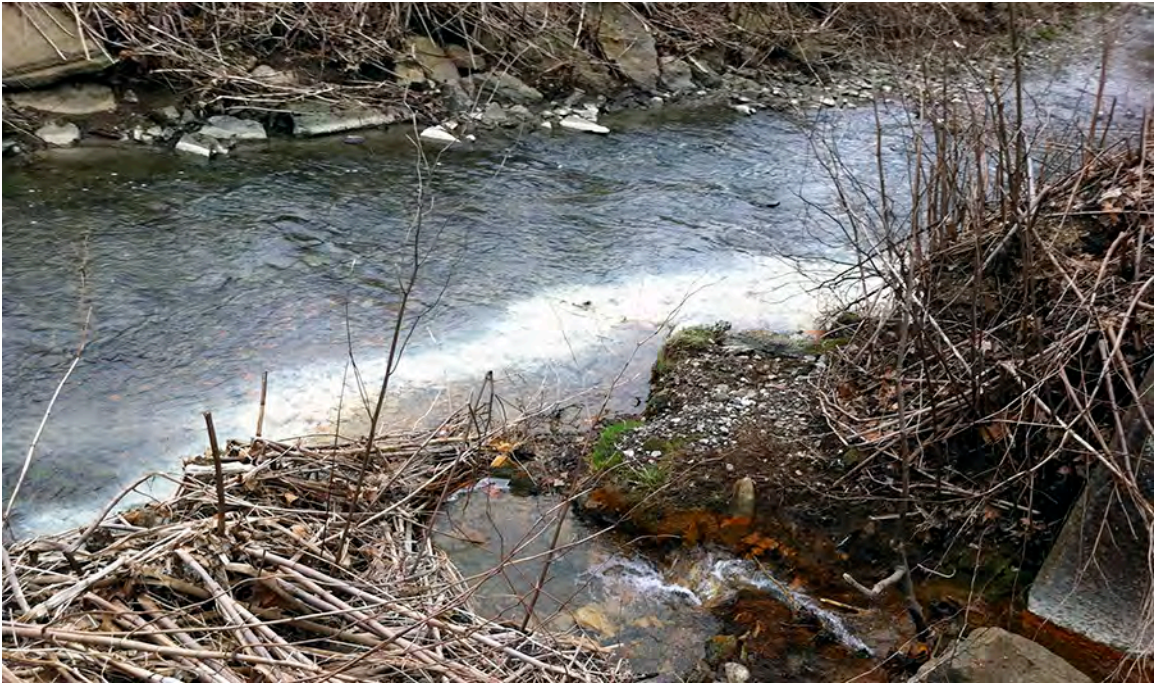
LR16 – AMD impacted tributary draining valley along Riggs Rd enters Lick Run's left ascending bank after being culverted under the Cochran Mill Rd tunnel. Severe erosion problems on the streams right ascending bank along the road from Snowden Rd junction to tunnel.

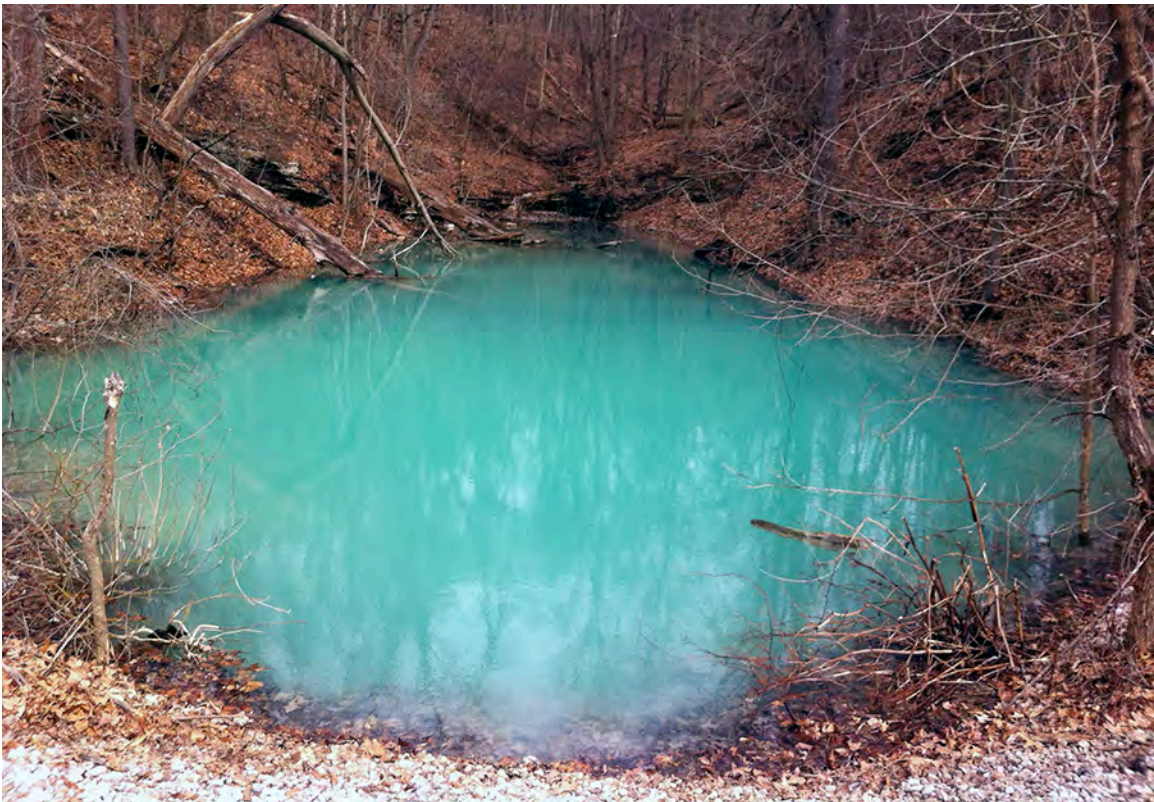
LR19 – AMD impacted tributary to Lick Run draining the valley between Klein Rd and the Washington Square residential development in Jefferson Hills creates an impoundment up against the Wheeling & Lake Erie Railroad tracks prior to entering Lick Run's right ascending bank just downstream of the Cochran Mill Rd Bridge.

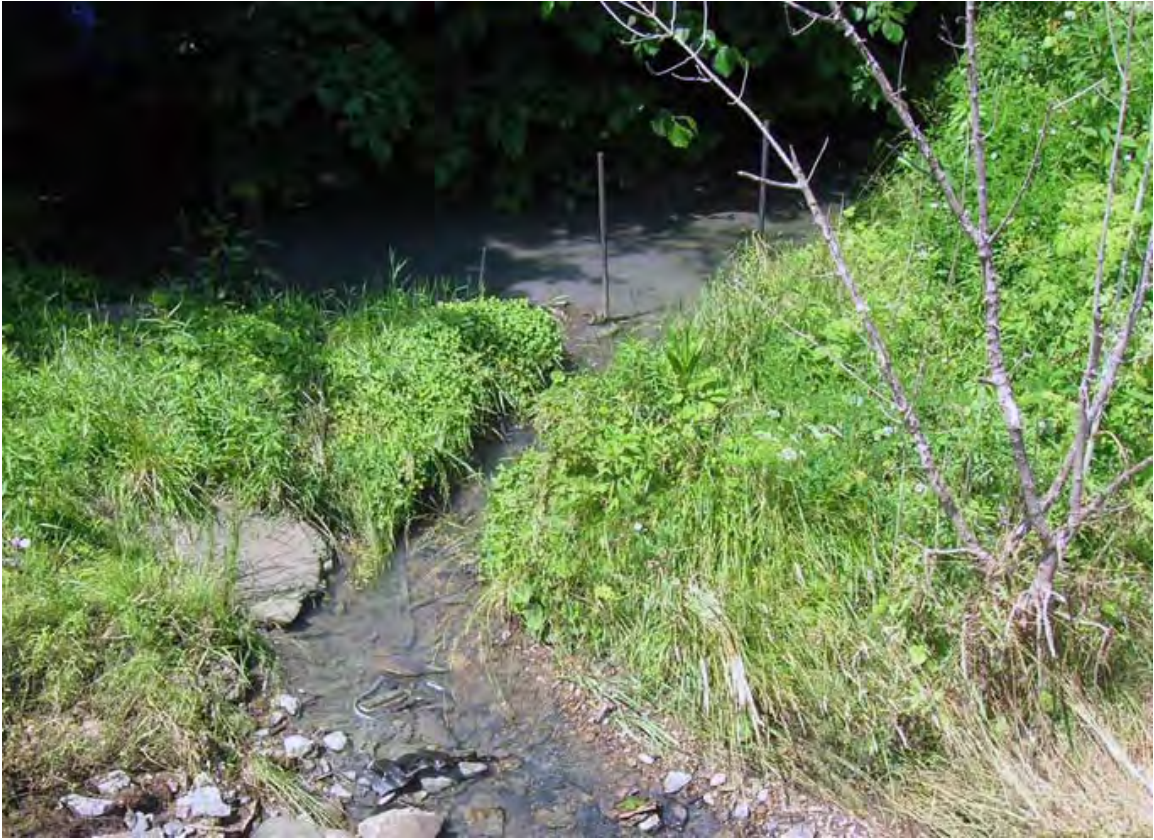
LR28 - A culverted AMD impacted discharge ponds along the Allegheny Valley Railroad tracks just downstream of Wallace Rd prior to entering Lick Run's left ascending bank.

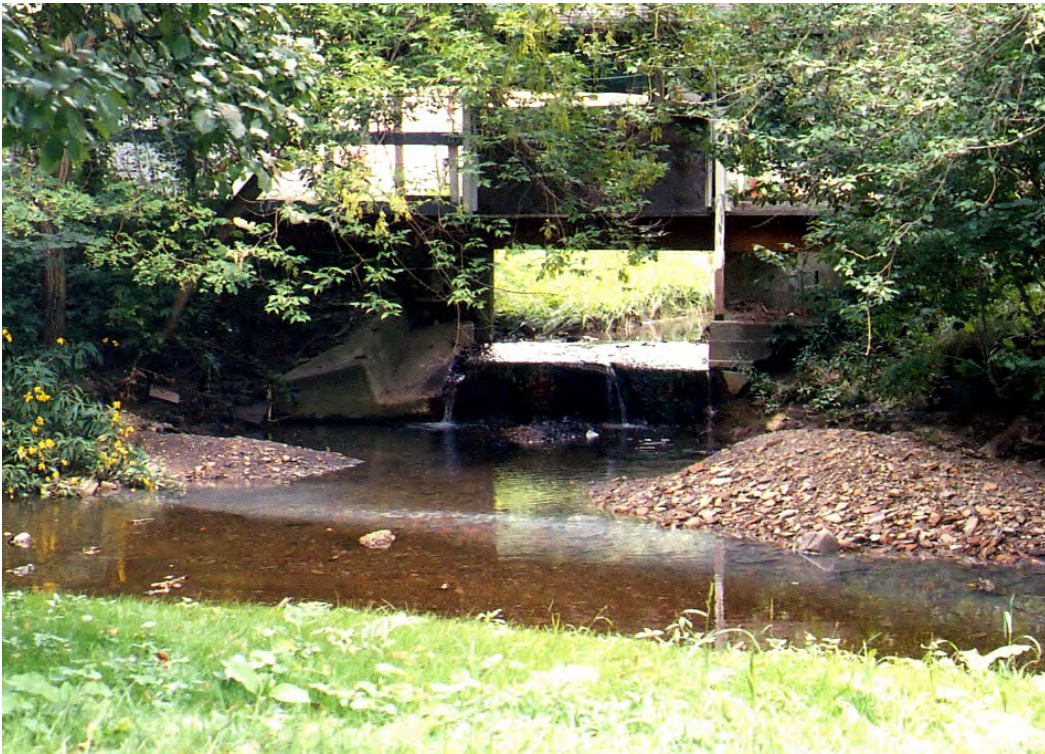
LR40 - Mineral Run Tributary enters Lick Run's right ascending bank just west of Cochran Mill Rd near its junction with Stilley Rd. This tributary is impacted by several AMD discharges depicted below.

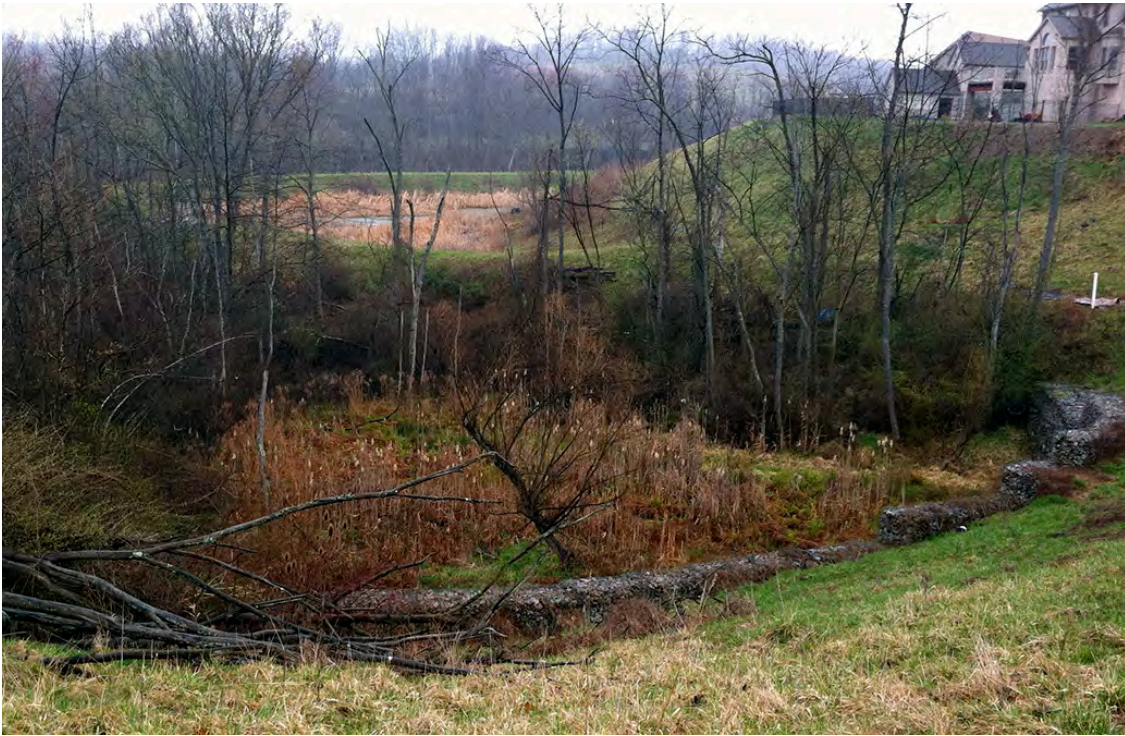
MRT17/MRT16 – An AMD discharge flows from under the gabion rip-rapped retaining wall and enters a wetland just west of Thomas Jefferson Dr and Jefferson Estates. In background is a stormwater detention basin that is impacted by AMD.

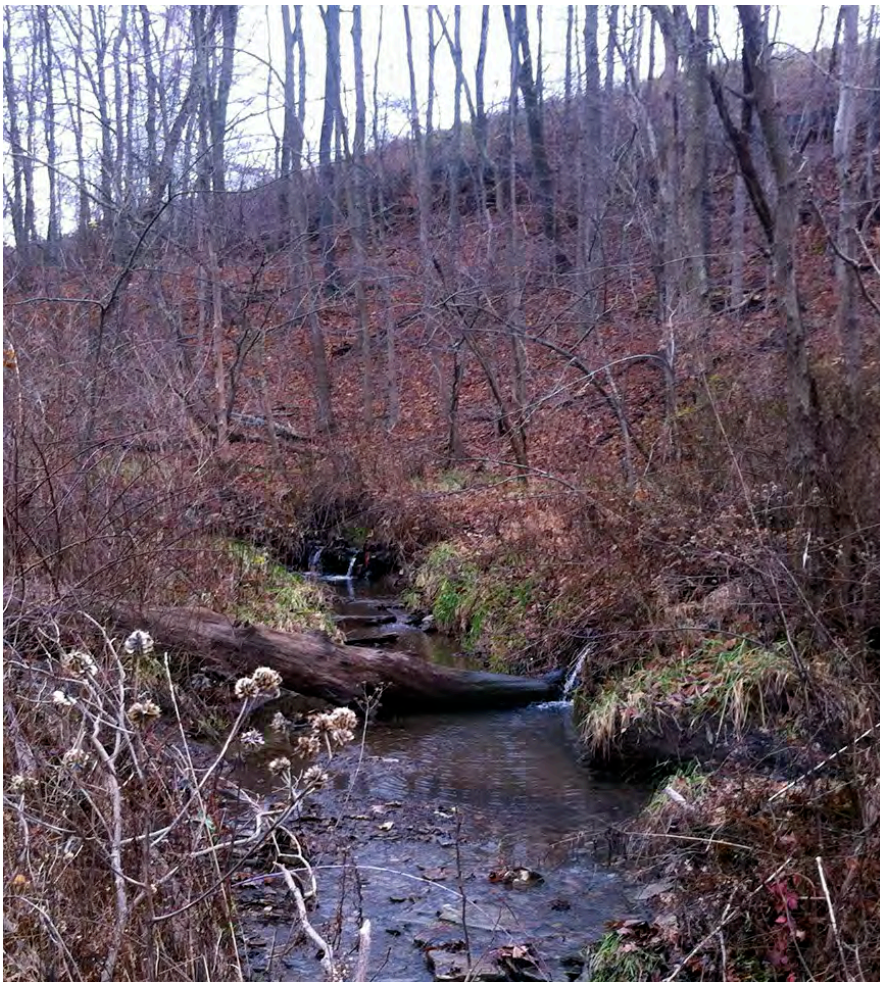
MRT15 – Discharges from the wetland and detention basin enter Mineral Run's right ascending bank in the valley between Jefferson Estates and West Bruceton Rd.

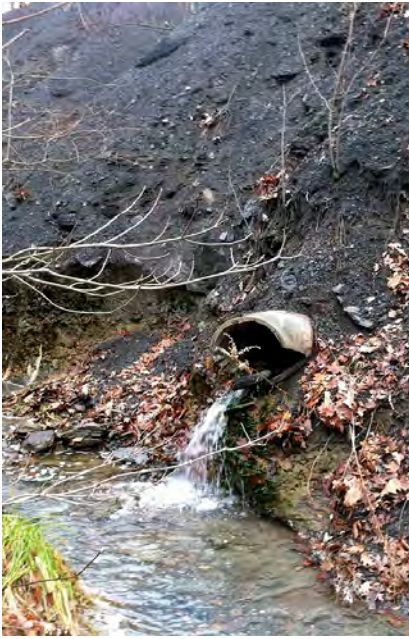
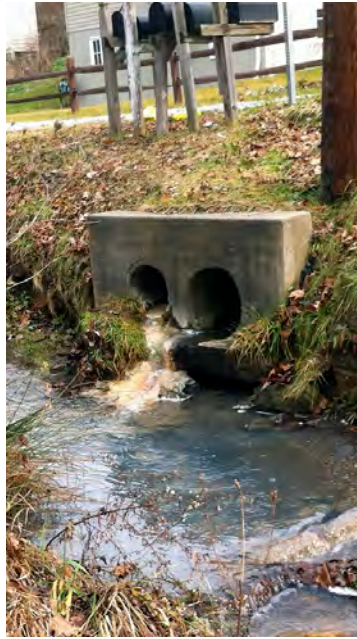
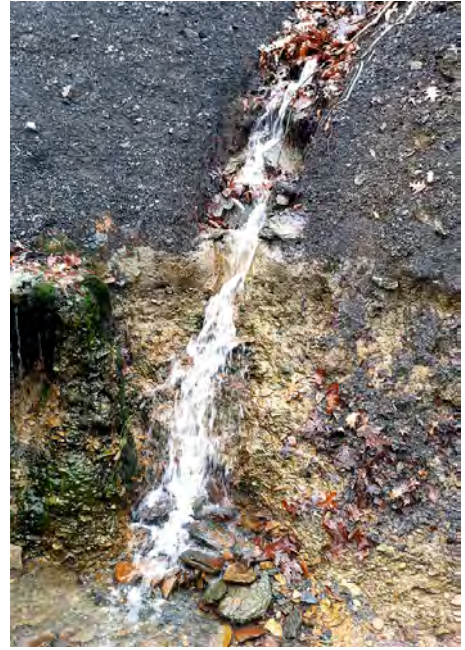
MRT13/MRT05/MRT14 – Several other AMD discharges enter Mineral Run’s right ascending bank downstream along a large coal waste pile and further downstream along Stilley Rd.

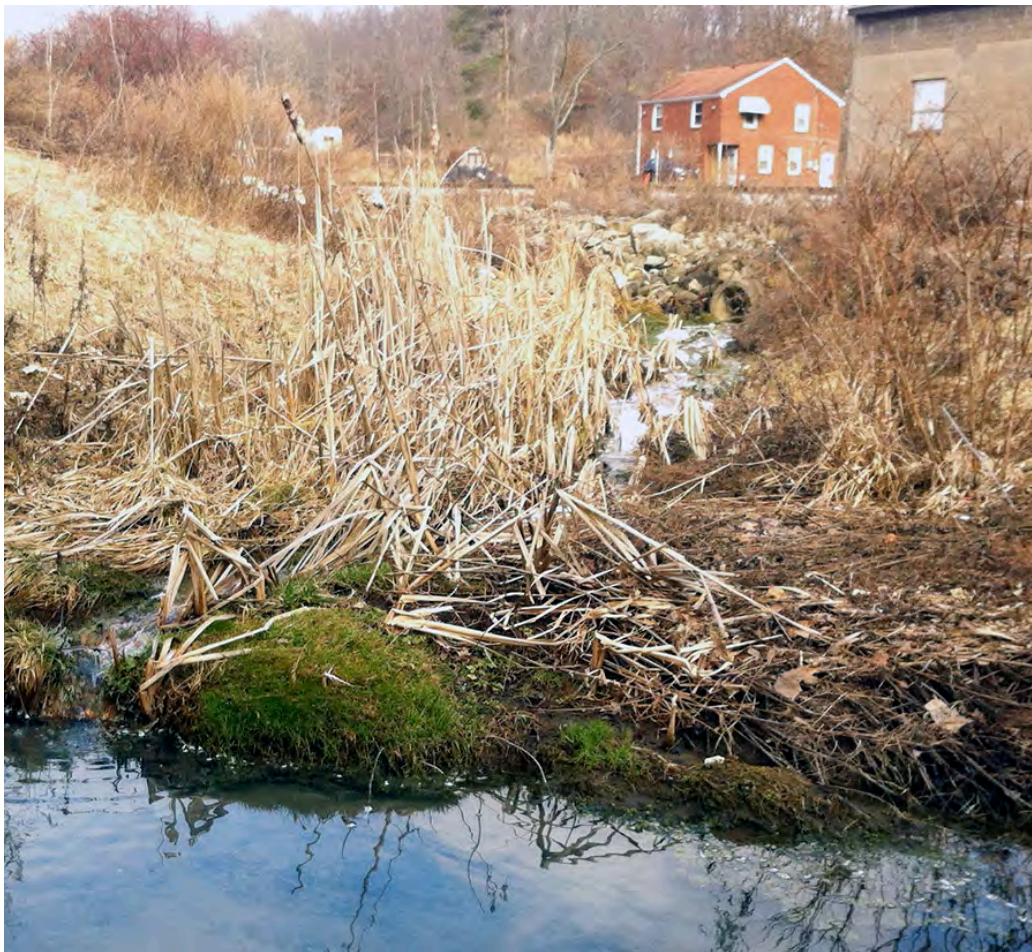
JMT04 – A culverted AMD discharge flows under the Allegheny Valley Railroad tracks and enters the Jefferson Memorial Tributary’s right ascending bank at the AVR and W&LE interchange at Bruceton.

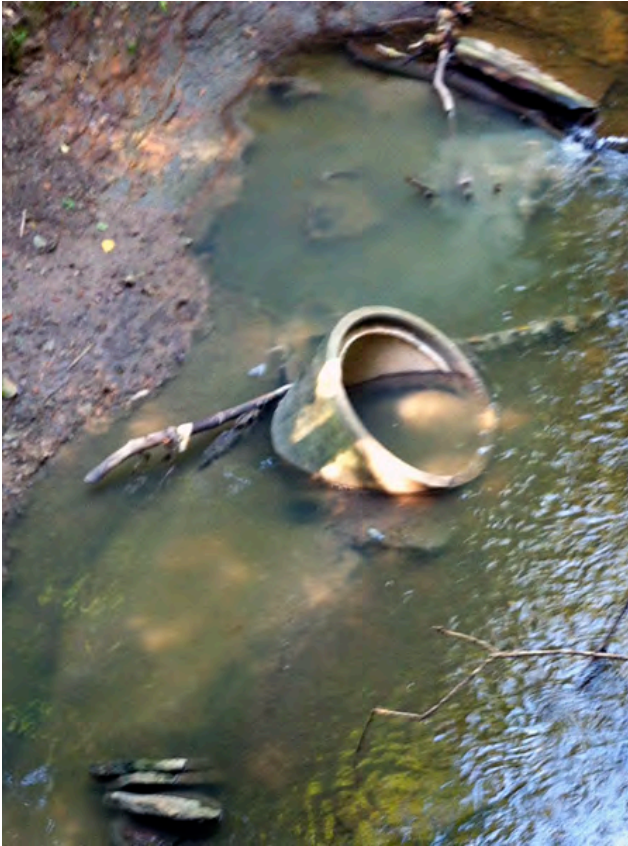
LR05 – Raw sewage enters Lick Run just upstream of the W&LE overpass as the result of a sanitary sewer manhole malfunction. Sewage infrastructure within the stream channel is often compromised by flooding and debris jams.

Several sewer manholes were found within Lick Run's and the Jefferson Memorial Tributary's low flow channel during the visual assessment. This can lead to many problems including debris jams, damage to sewage infrastructure and additional raw sewage within the stream.

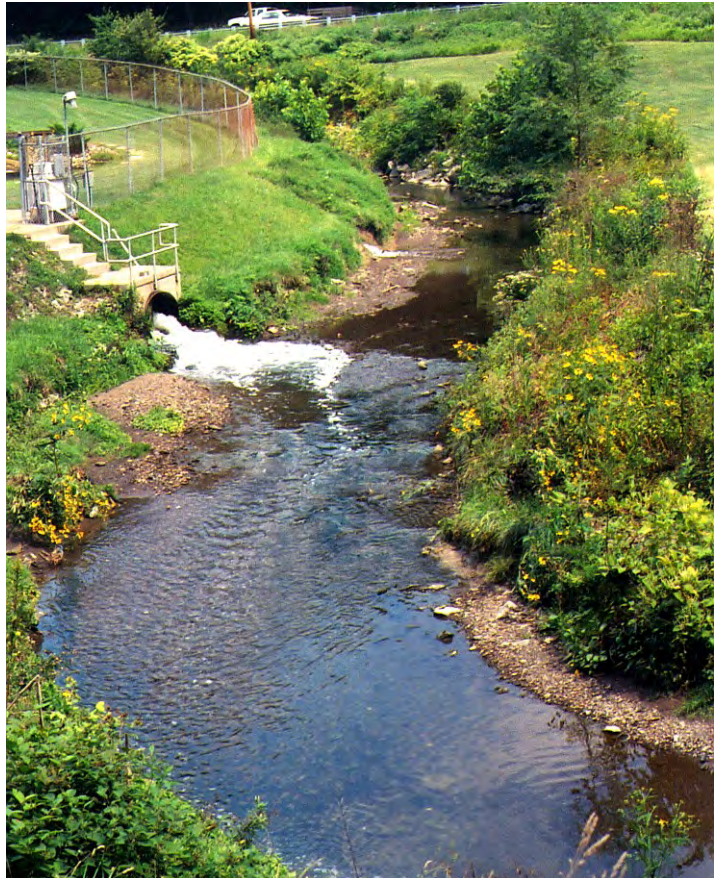
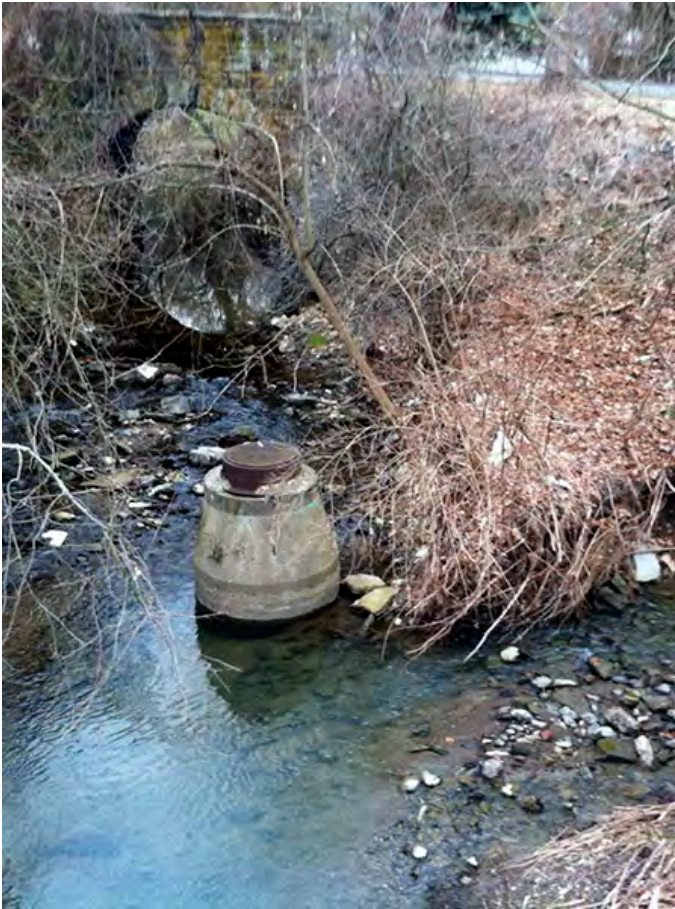
LR30/LR31 – Pleasant Hills Authority Sewage Treatment Plant outfall into Lick Run just upstream of Wallace Rd bridge. Further upstream a smaller outfall from the sewage plant can be seen entering Lick Run's left ascending bank.

The Pleasant Hills Sewage Authority and communities contributing to the sewage plant including Whitehall Borough, Baldwin Borough, Pleasant Hills Borough and South Park Township are currently under a consent decree to decrease infiltration and sewage overflows into Lick Run. This will require facility upgrades to the wastewater treatment plant (LR30) along Lick Run in South Park Township, added storage at Colewood Park (CRT01) in Baldwin Borough and monitoring and corrective maintenance of infrastructure within the municipalities.

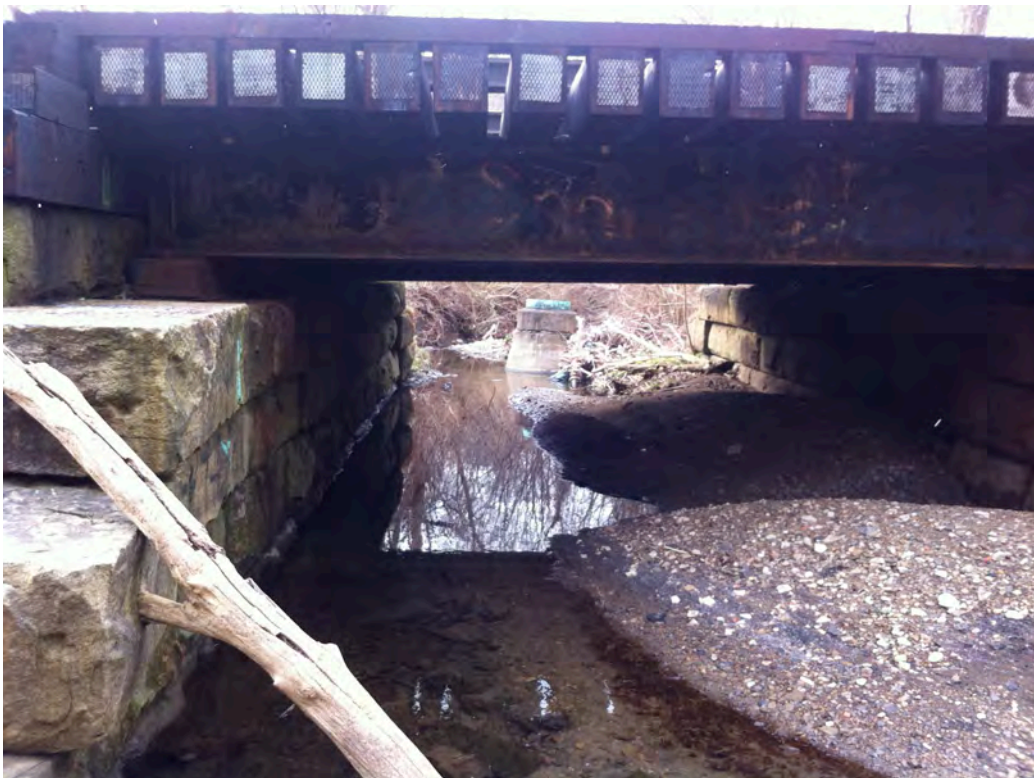
JMT10 - A sanitary sewer manhole within the channel of the Jefferson Memorial Tributary along Allegheny Valley Railroad tracks.

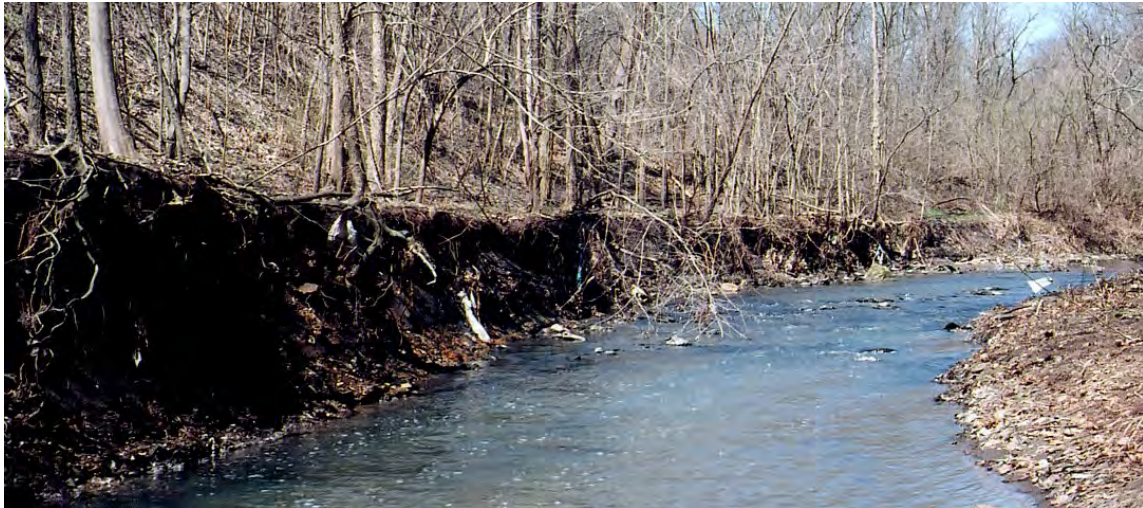
LR08 to LR09 – Stream bank erosion is a natural process, however, in the lower relatively undeveloped reaches of Lick Run there are sections of erosion that appear to be excessive and unstable.
