Peters Creek Watershed Assessment & Management Plan

April 2014

1.0 PETERS CREEK WATERSHED BACKGROUND

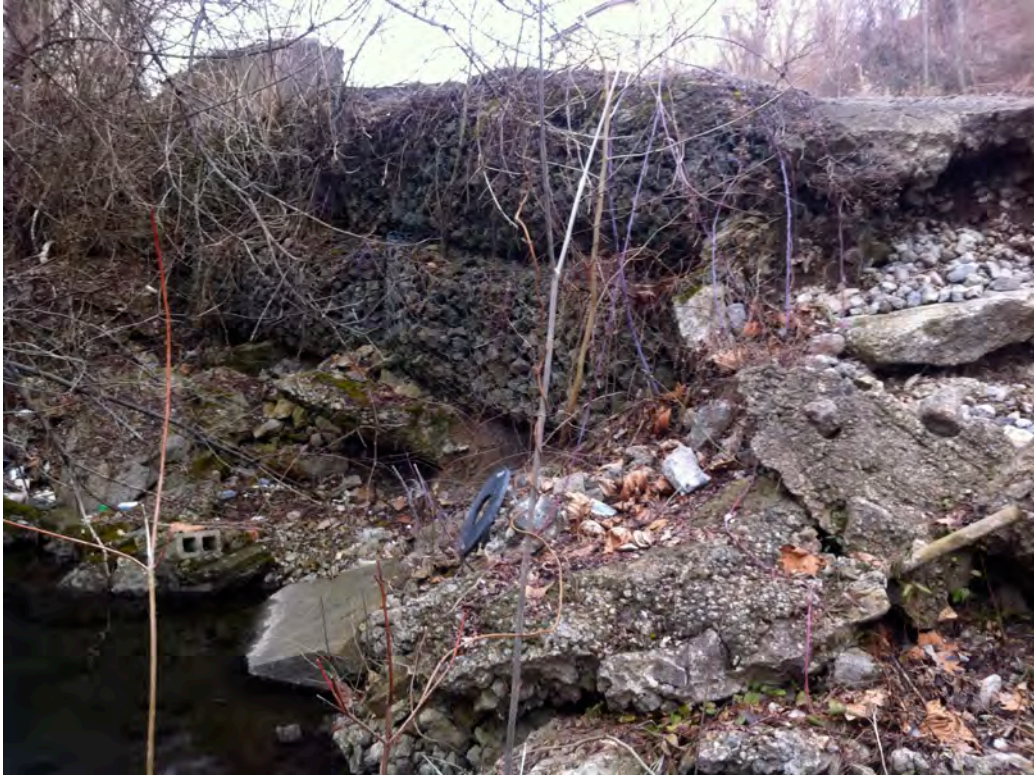
JMT17 – Severely eroding right ascending bank of Jefferson Memorial Tributary just downstream of the streams exit from an approximately 700 foot culvert under a commercial district along Old Curry Hollow Rd. Attempts to stabilize this bank have not been successful.

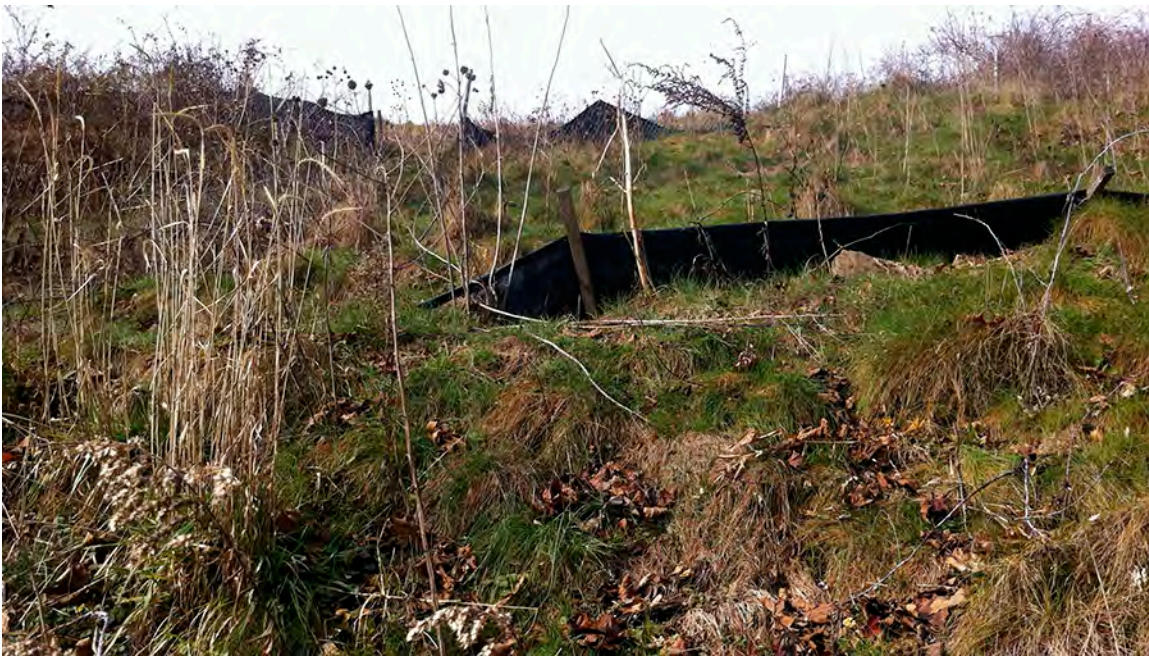
MRT06 – Unstable and eroding slope above Mineral Run's left ascending bank that was recently re-graded as part of the Hunters Field residential development along West Bruceton Rd in Jefferson Hills.

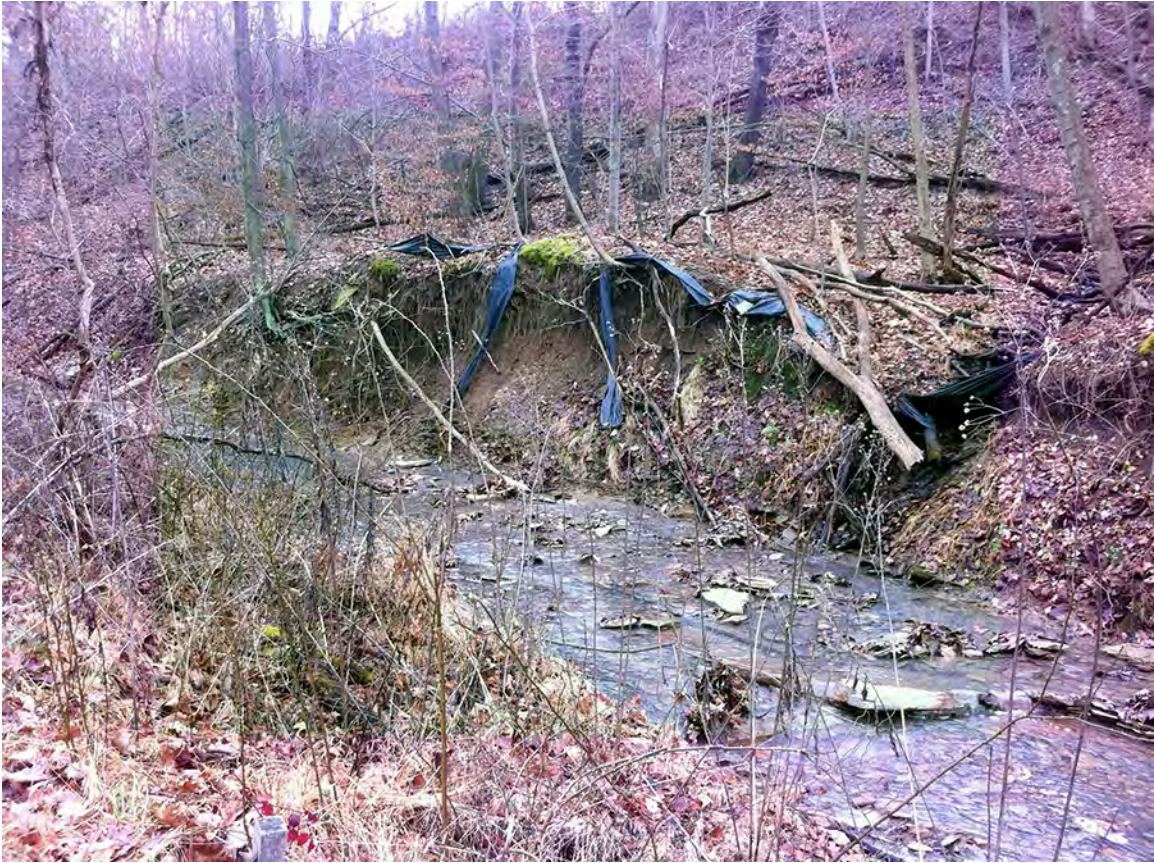
MRT11 – Eroding right ascending bank of Mineral Run. Remnants of silt fence that is little more than refuse.

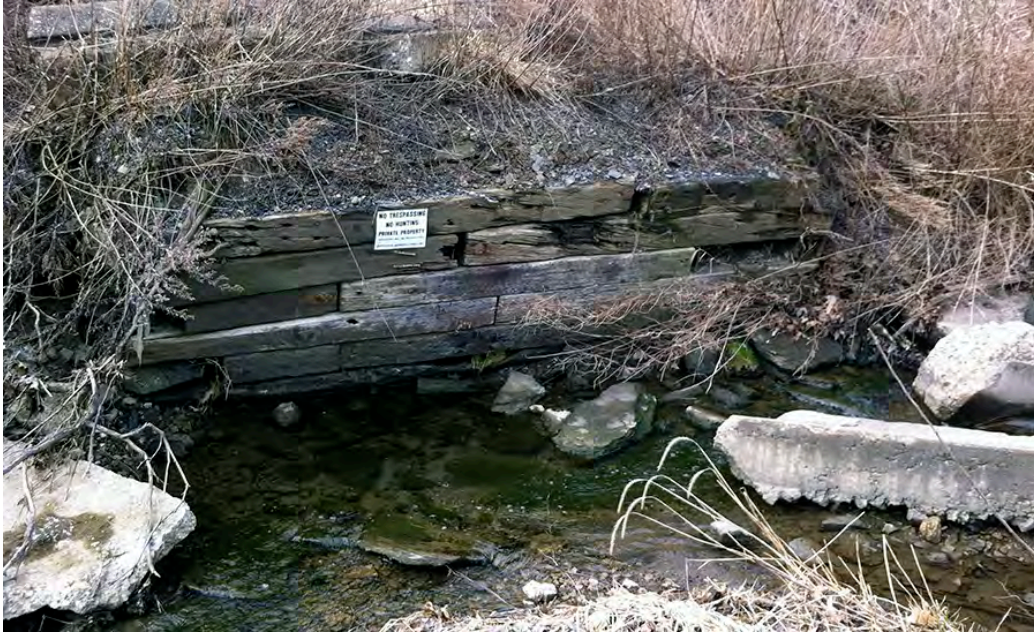
JMT05 – A number of issues are illustrated in this photo taken along the lower reach of the Jefferson Memorial Tributary. An overabundance of algal growth is evident as is encroachment from an old railroad tie wall along the streams left ascending bank, construction debris within the floodplain and concrete debris obstructing the stream channel.

An overabundance of algae was found within the lower reach of Lick Run (LR08) and at numerous locations along the Jefferson Memorial Tributary (JMT03,JMT05,JMT19,JMT24). This excess algae is often an indication of nutrient overload. Abandoned mine drainage, sewage

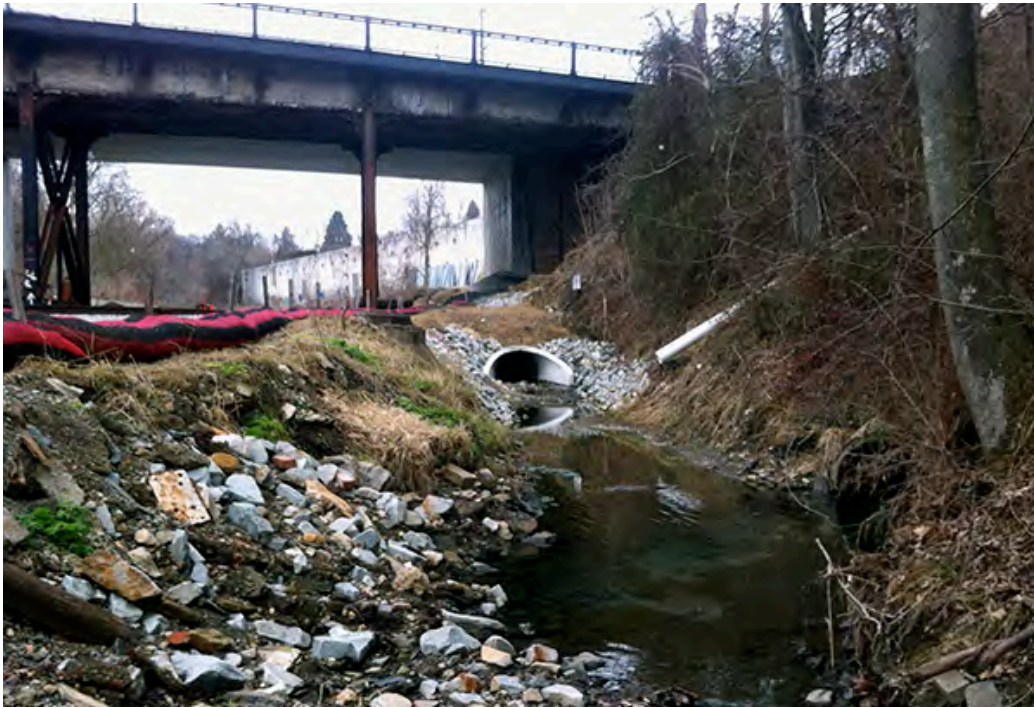
JMT20 – Numerous discharges of stormwater from the commercial district along Terence Drive enter Jefferson Memorial Tributary just downstream of the Curry Hollow Rd overpass. There are also several discharges upstream of the bridge to the headwaters near Whitehall Tunnel. Many of these discharges are choked with algae as is the stream channel itself.

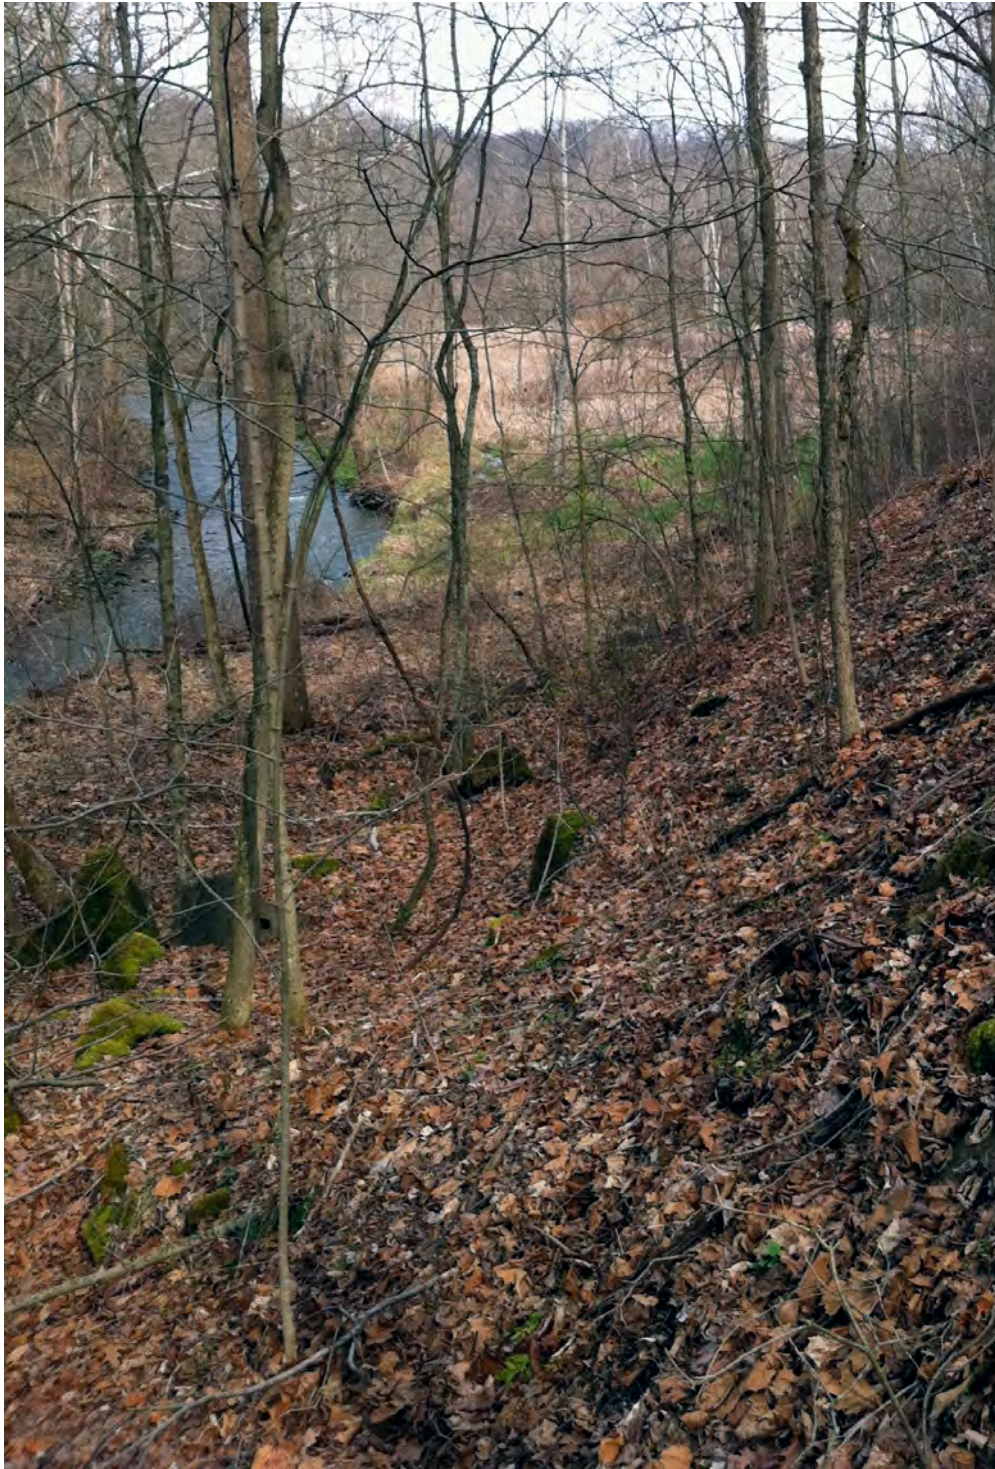
LR06 - A significant wetland within Lick Run's right ascending floodplain just upstream of the Wheeling & Lake Erie Railroad tunnel, west of the Patriot Pointe residential development in Jefferson Hills and east of South Park Twp's Snowden neighborhood. The wetland is fed by at least one AMD discharge and is most likely helping to mitigate it. Queen Snakes, a species of special concern in Pennsylvania, are inhabiting this wetland.

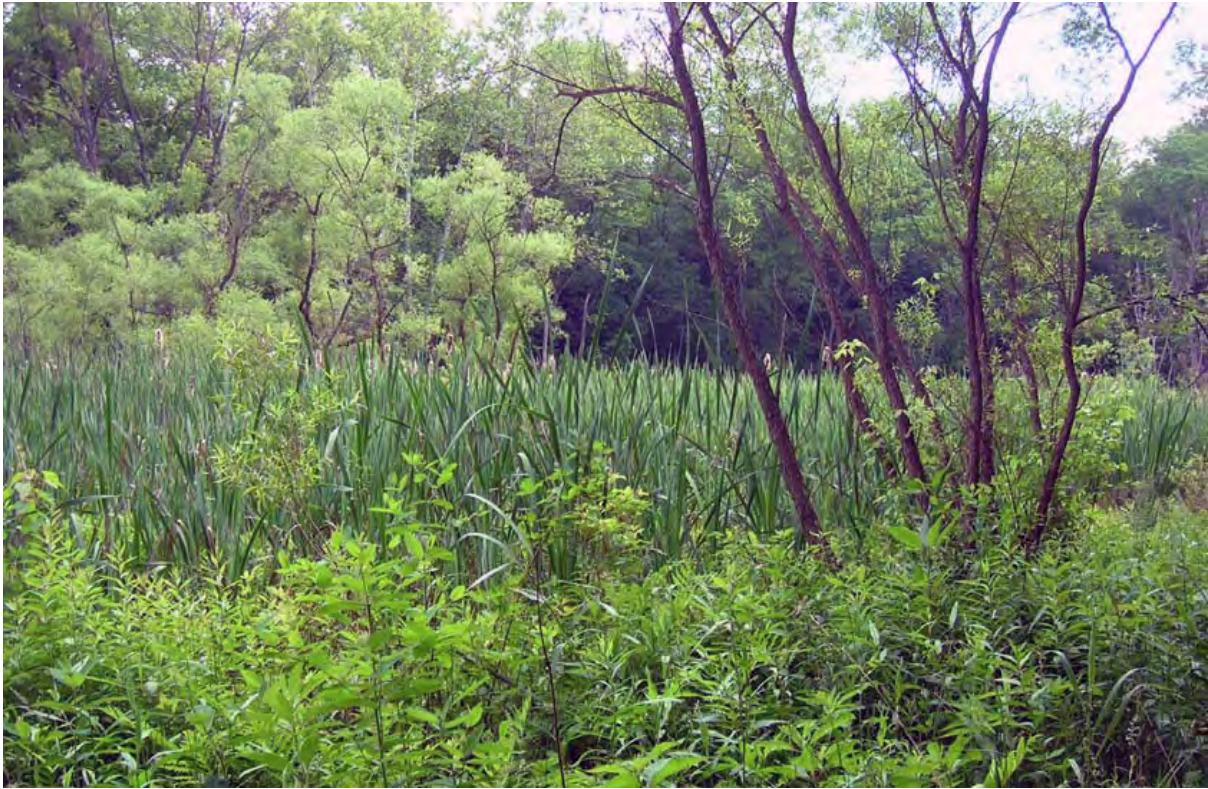
LR13 - Approximately .6 miles upstream another significant wetland exists within Lick Run's left ascending floodplain. There is some off-road erosion and bank erosion in this area. Further upstream just north of the Cochran Mill Rd Bridge at LR21 a landowner is attempting to drain a floodplain wetland with drainage ditches to Lick Run.

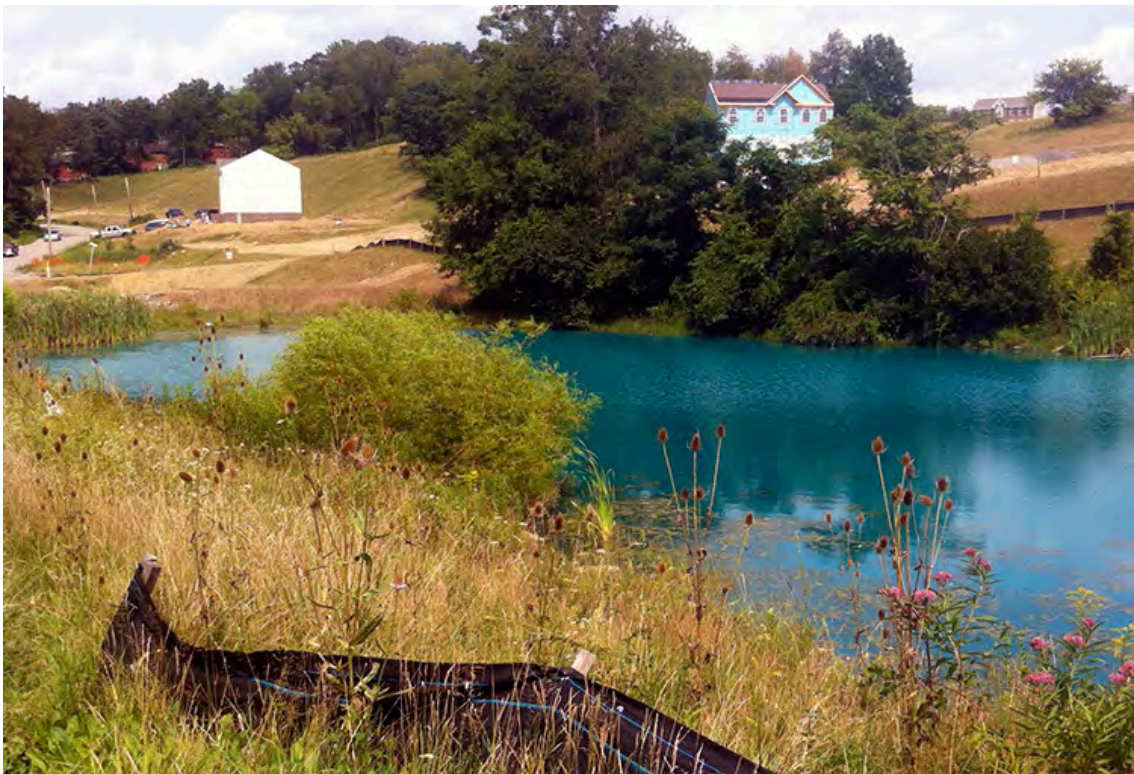
MRT22 - A view of what used to be the Barati farm pond toward new residential development along West Bruceton Road in 2013. The pond is being maintained as part of the Hunters Field residential development. A chemical has been added to the pond and provides it with a deep aqua tinge. A forebay was also included in the design to help to mitigate siltation problems within the pond.

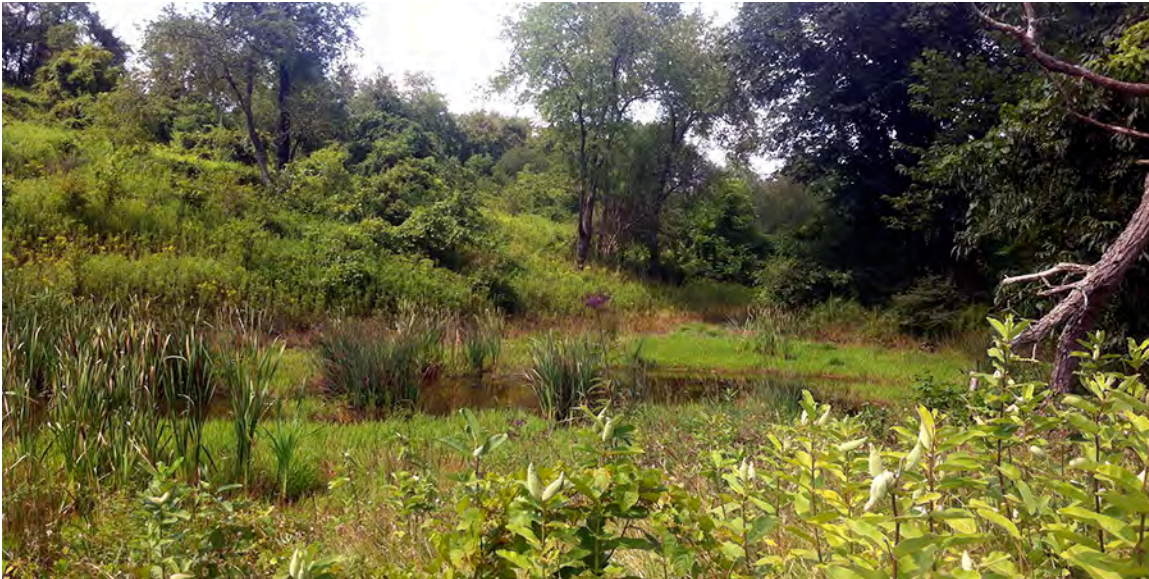
MRT23 – Pond/wetland west of West Bruceton Rd across from current Hunters Field development.

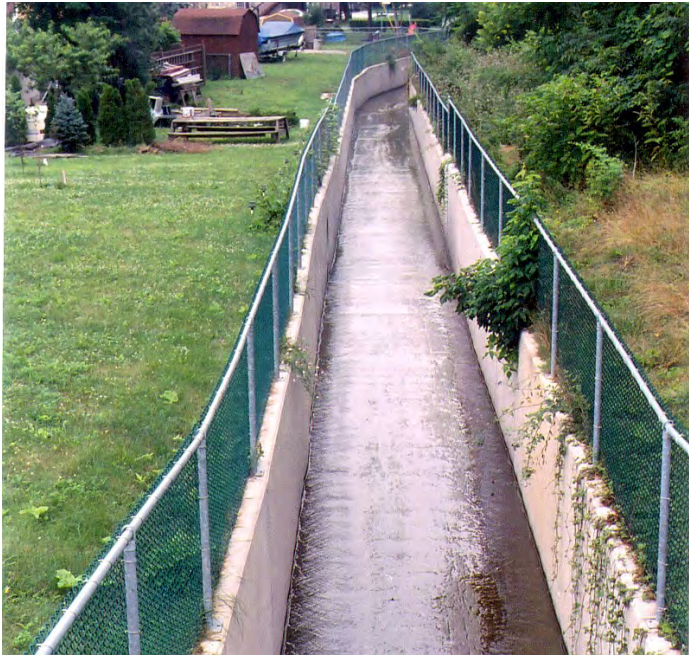
CRT06 – Dense residential and commercial development combined with inadequately sized stormwater infrastructure in the headwaters portion of the Lick Run sub-watershed contributes to flooding problems along Colewood Road and within residential areas east of Gardenville Rd. To the left is a view of a 2000 foot concrete flood control channel built along the entire length of Colewood Rd to mitigate flooding problems in the area. These types of projects are unnatural, costly, require long-term maintenance and cause erosion issues downstream of the project. Adequate stormwater control is essential during development to avoid these types of problems. Managing stormwater effectively on site is essential. Retrofitting solutions after the fact is often extremely difficult and costly.

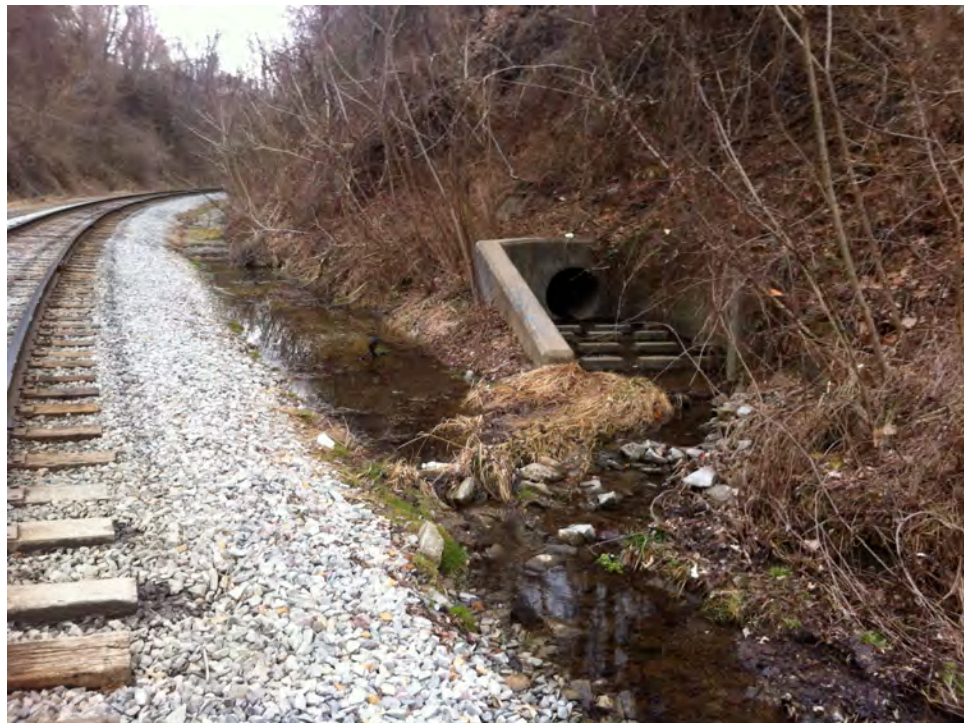
JMT24 – Stormwater enters the extreme upper reach of the Jefferson Memorial Tributary from Pleasant Hills and Baldwin Borough neighborhoods east of the Allegheny Valley Railroad near the Whitehall Tunnel. Excess algae is present along this entire section of the stream.

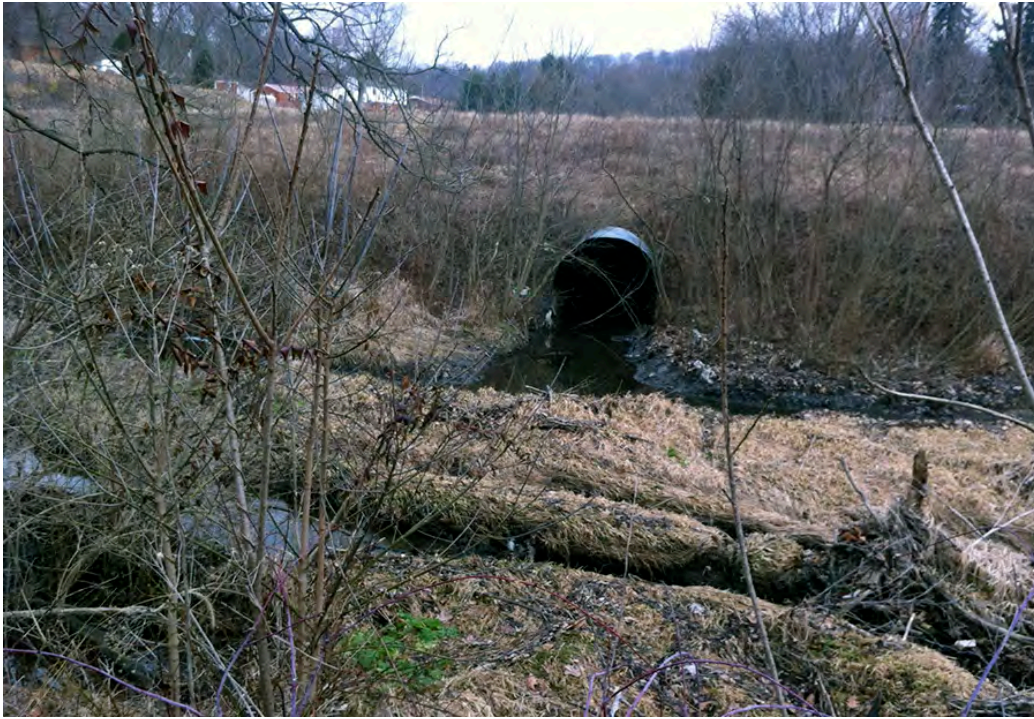
JMT11 – A culverted stream that accepts stormwater from a detention pond servicing Pleasant Hills residential neighborhoods west of West Bruceton Rd enters Jefferson Memorial Tributary's right ascending bank. The tributary channel is braided and eroded at this location. The stream appears to have been culverted and the area filled and graded in anticipation of additional commercial development along an extended Terence Drive.

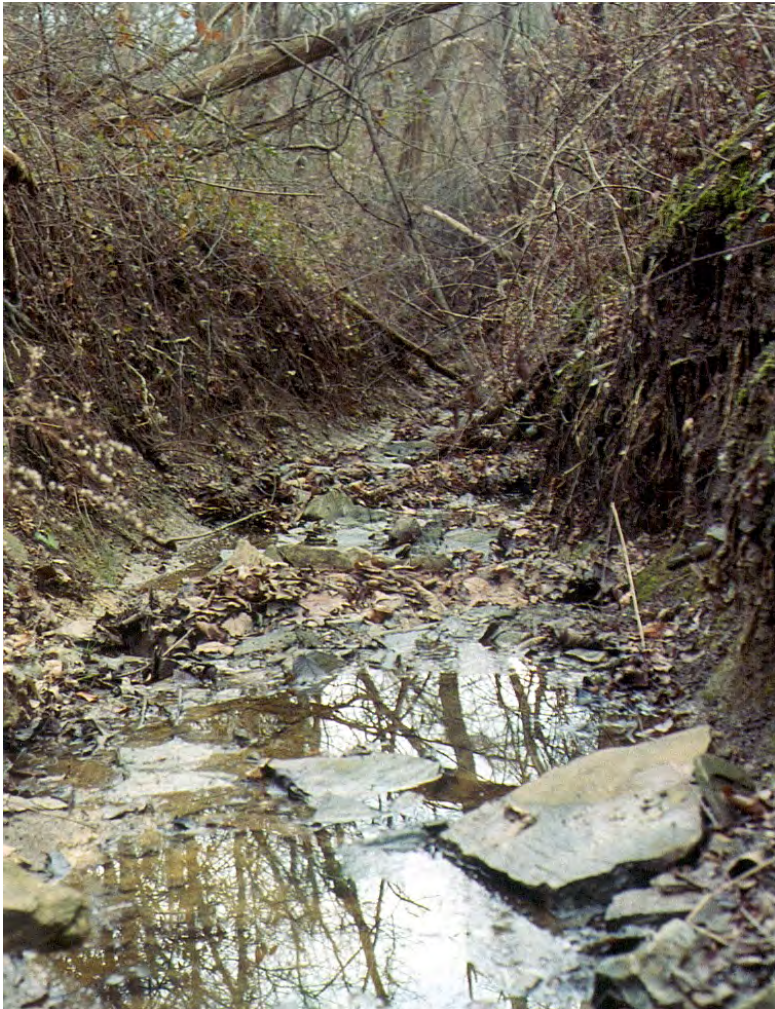
A view of a tributary that flows behind Wilson Park and then along one of South Park Township's few remaining farming operations along Wilson Road enters Lick Run at LR45. The tributary is deeply incised and channelized behind the park and appears to be functioning principally as a stormwater conveyance channel for neighborhoods north of Wilson Road.

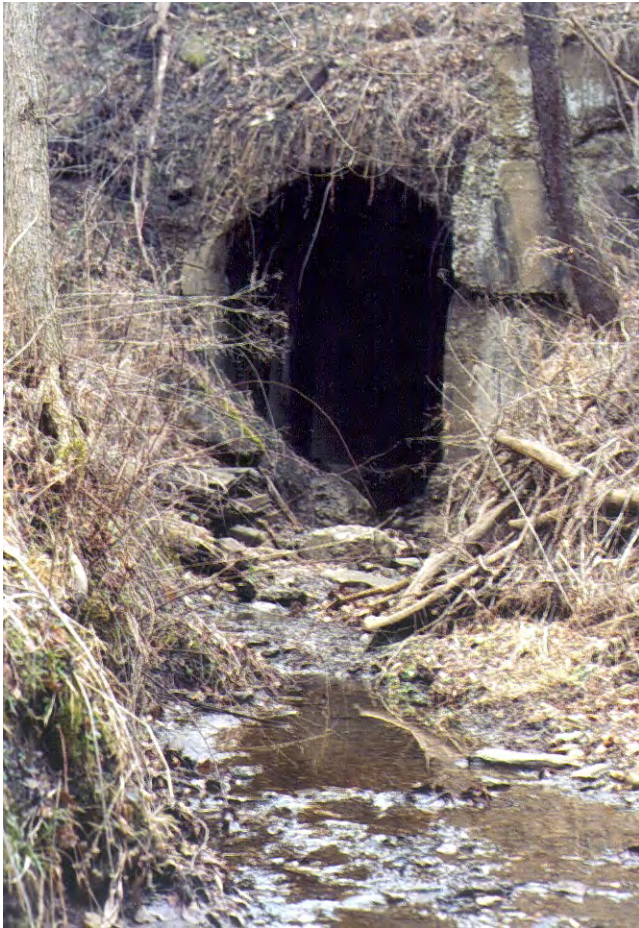
LR03 – A great deal of new development is taking place along the lower reaches of Lick Run. To the right is a view of another deeply incised and channelized tributary to Lick Run that accepts stormwater from the Patriot Pointe development along Gill Hall Road in Jefferson Hills. The tributary is seen exiting a culvert under the Wheeling & Lake Erie Railroad.

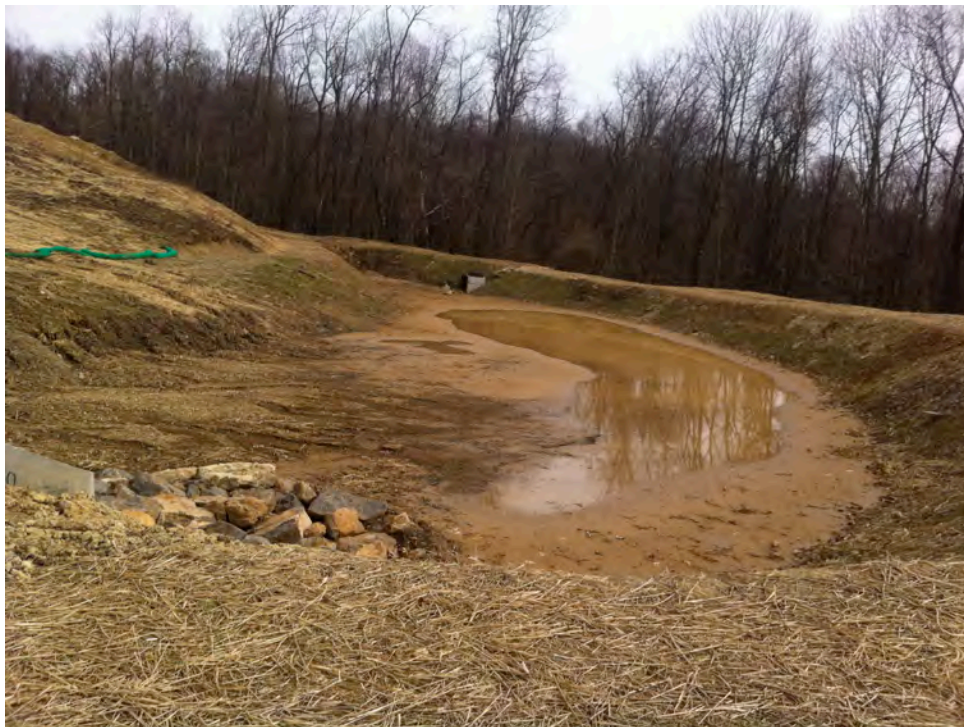
A stormwater detention basin within the Washington Square residential development along Gill Hall Road, Waterman Road and the Wheeling & Lake Erie Railroad tracks in Jefferson Hills. The lower reach of Lick Run forms the border between Jefferson Hills and South Park Township. Ordinances requiring effective stormwater control are absolutely essential in this rapidly developing sub-watershed. Retaining green infrastructure and stormwater on site and implementation of best management stormwater practices are most likely necessary to be protective of water quality in Lick Run.

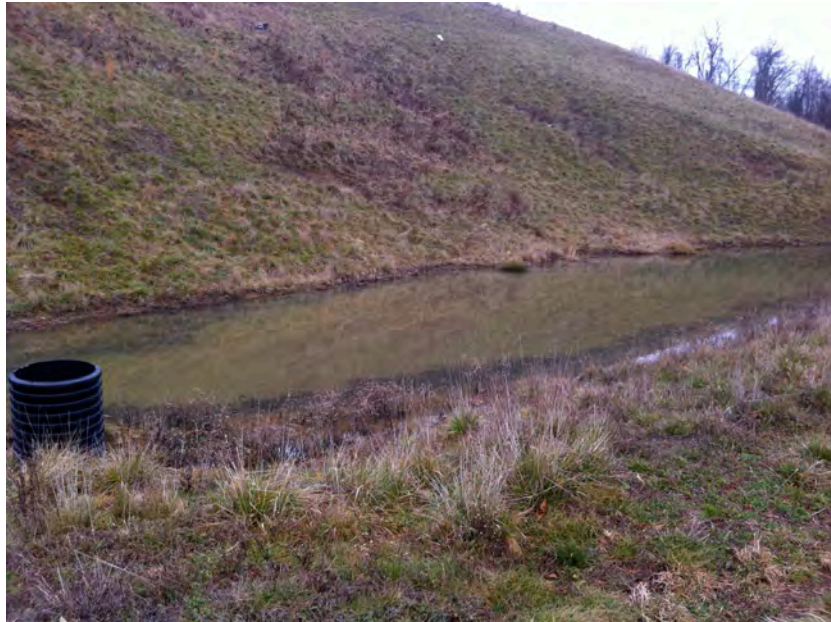
MRT07 – A stormwater detention basin that is part of the Hunter's Fields development along West Bruceton Road and Mineral Run in Jefferson Hills.

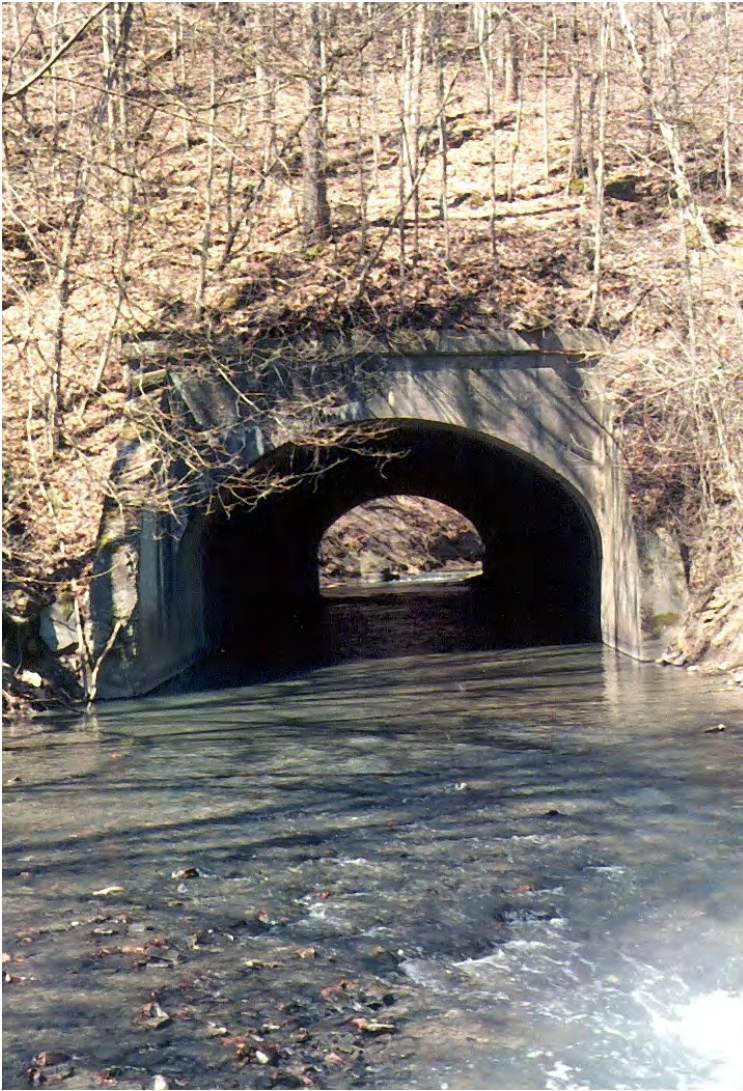
LR05 – Lick Run flows under the Wheeling & Lake Erie Railroad. A sewer manhole can be seen within the stream channel just upstream of the bridge.

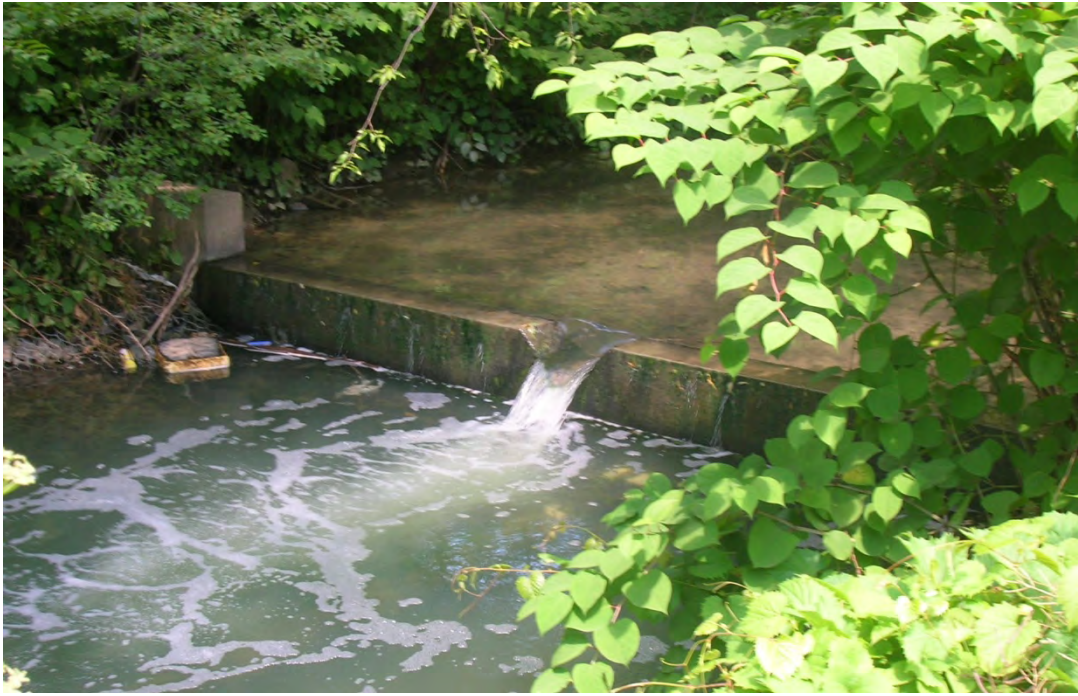
LR33 - A berm dam across Lick Run's channel creates a fish barrier within the stream.

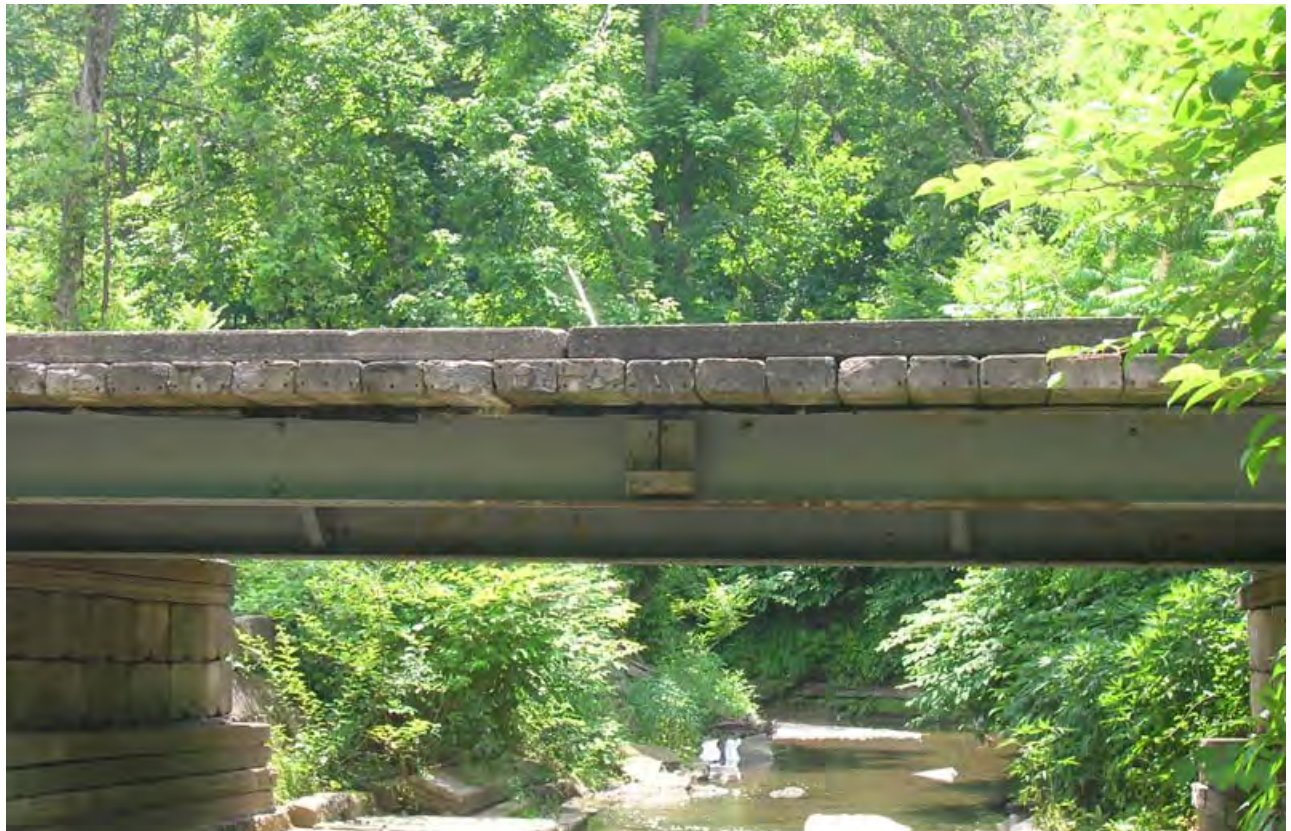
LR44 - A homeowner bridge crossing of Lick Run along a section of stream that runs primarily along bedrock. The bridge restricts the stream channel.

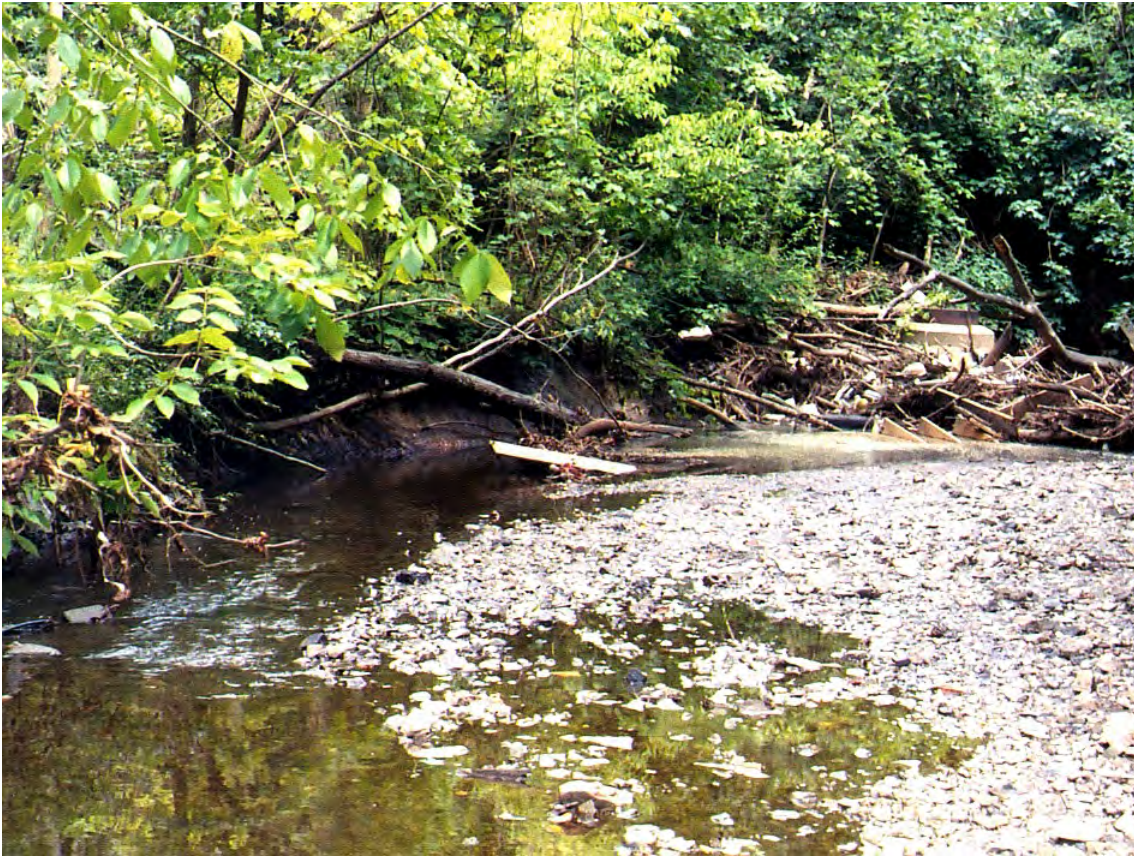
A debris jam within Lick Run along Cochran Mill Road has formed behind a sewer manhole within the stream channel. This is a common occurrence, compromises sewer infrastructure and often leads to raw sewage within the stream. The debris jam is comprised of assorted debris including litter and construction material.

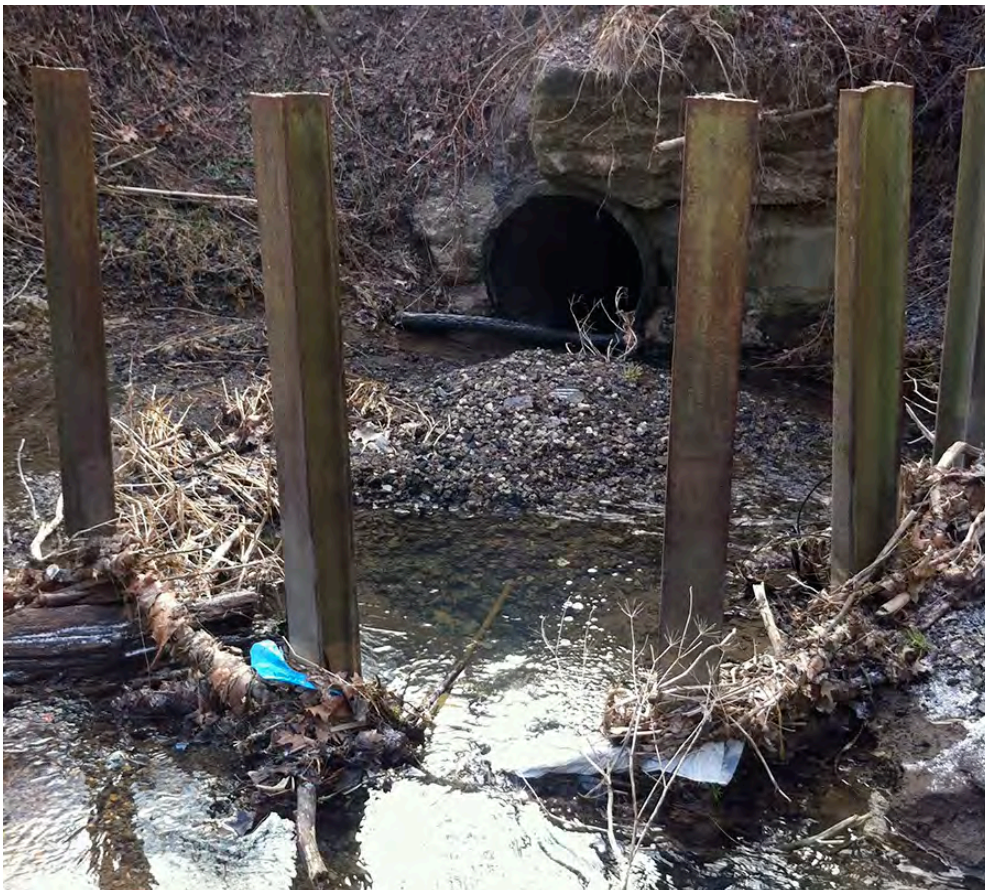
JMT02 - This culvert carries the Jefferson Memorial Tributary under the Wheeling & Lake Erie Railroad tracks and under a commercial area at the corner of Cochran Mill Rd and West Bruceton Rd near the mouth of the stream. The culvert is too small for the flow it must carry during precipitation events which causes erosion both upstream and downstream of the culvert. The obstructions placed in front of the culvert to keep it from clogging from debris create debris jams across the channel and require regular maintenance.

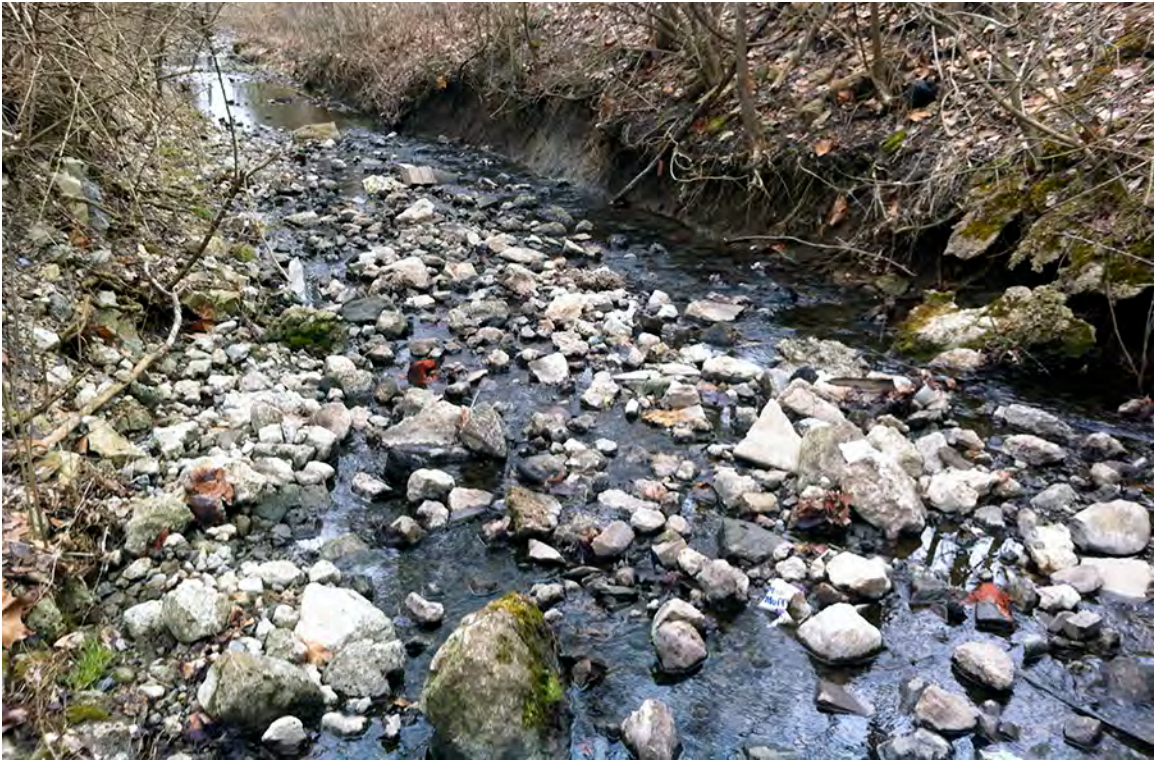
JMT17 - Jefferson Memorial Tributary channel clogged with concrete and other assorted rubble just downstream of its exit from a 700 foot culvert under a commercial district along Old Curry Hollow Road.

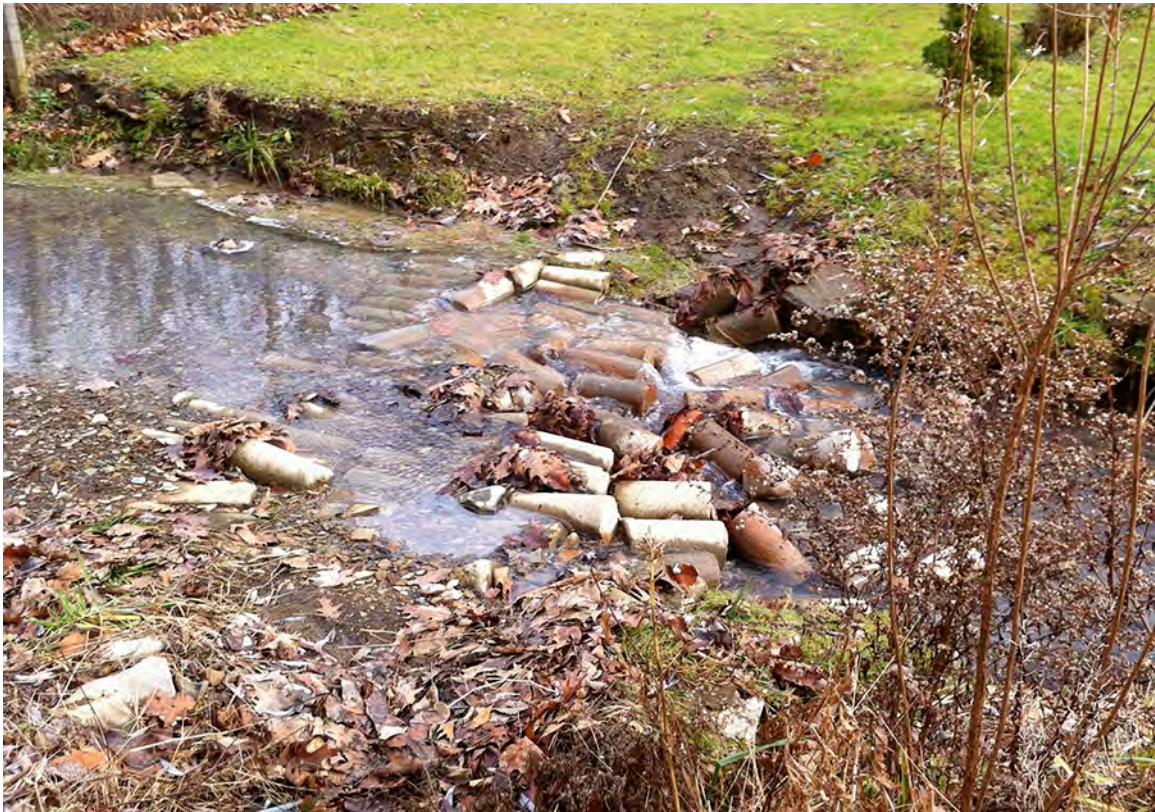
MRT08 - Homeowner attempt at a stream crossing of Mineral Run obstructs the stream channel, creates erosion issues, is eroding itself and should be removed.

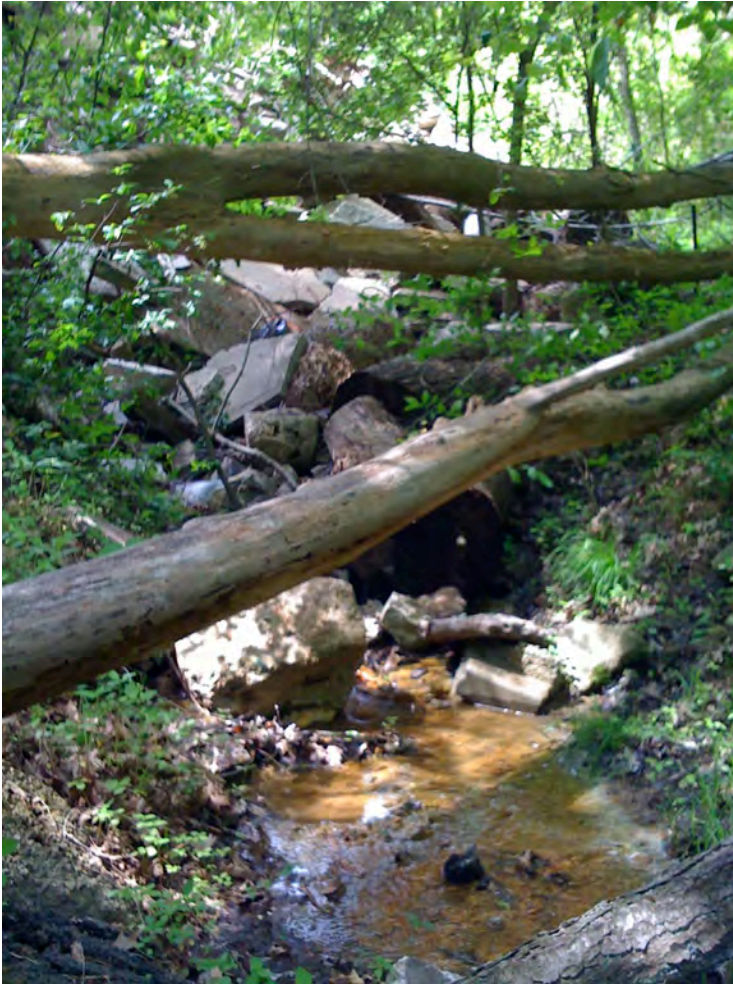
LR11 – Landowner along Snowden Road is pushing concrete construction debris into a tributary to Lick Run. The tributary also is impacted by abandoned mine drainage.

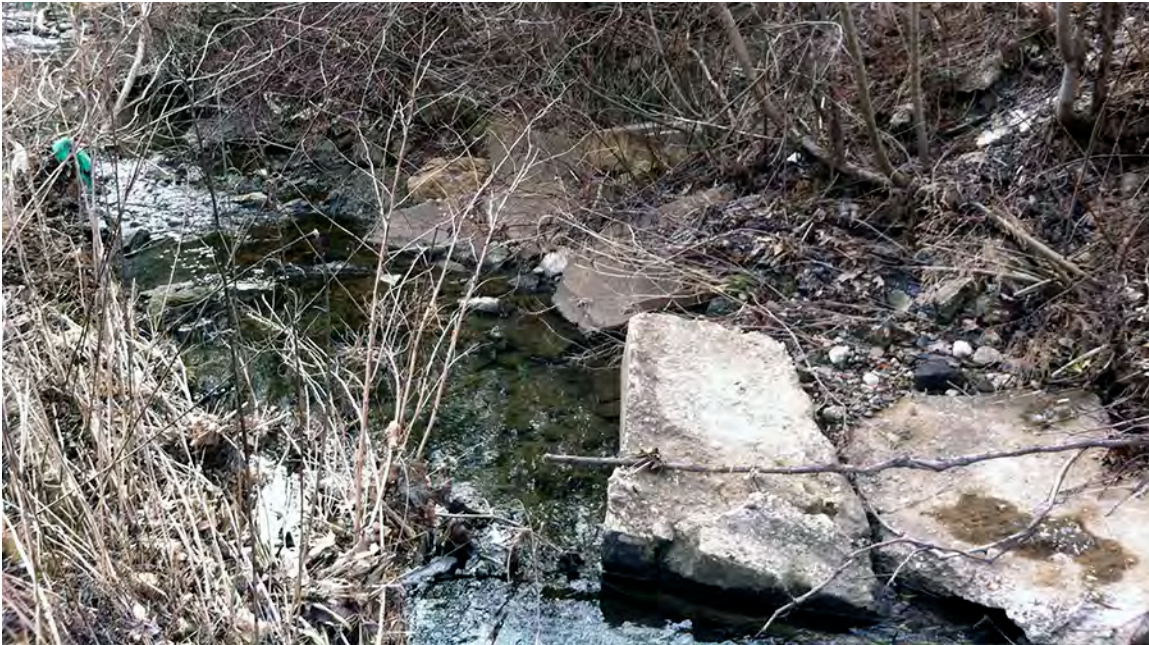
JMT05 – Concrete rubble is obstructing the channel of the Jefferson Memorial Tributary. Remnants of a concrete structure forms a low dam across the stream channel and creates a fish barrier at this location.
