Peters Creek Watershed Assessment & Management Plan

April 2014

1.0 PETERS CREEK WATERSHED BACKGROUND

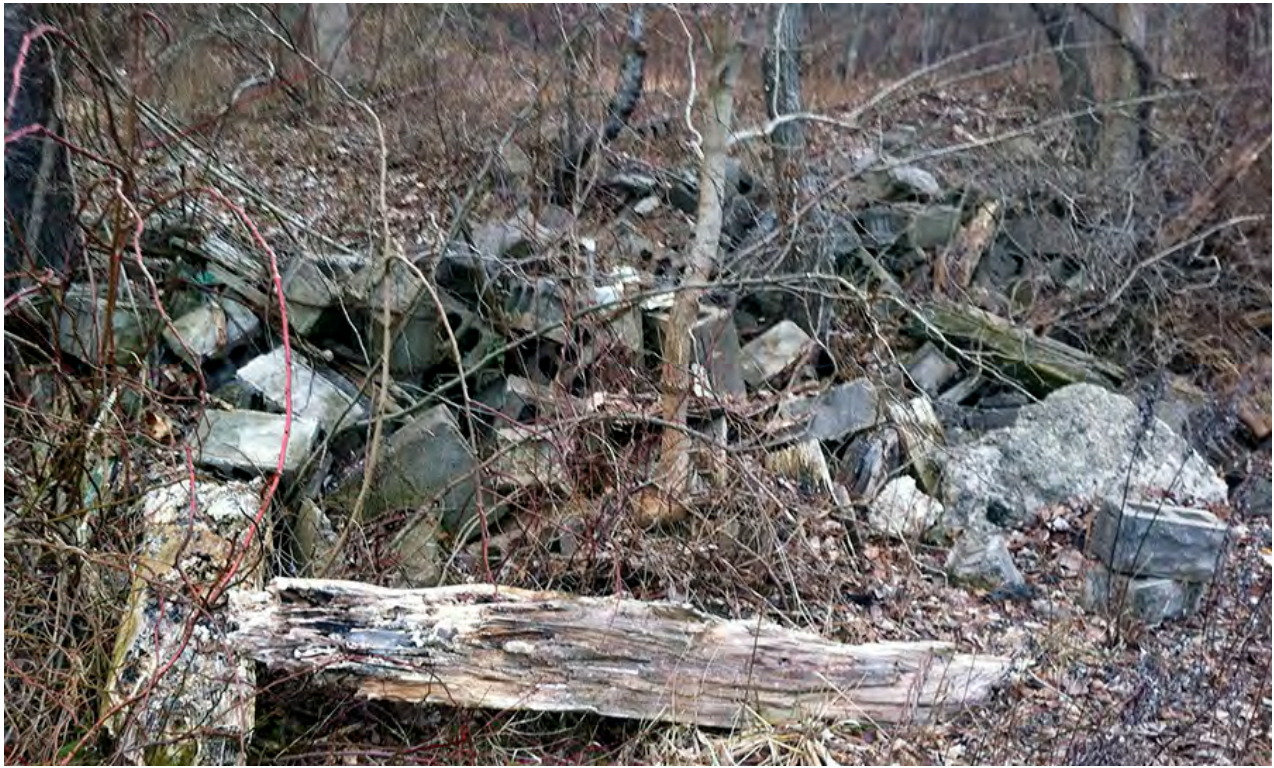
JMT06–JMT07 – Numerous piles of construction debris and rubble within the Jefferson Memorial Tributary's left and right ascending floodplain along this section of stream. Some of the debris piles appear to be recent and some appear to be of some age. It appears that the area has been utilized for illegal dumping for some time.

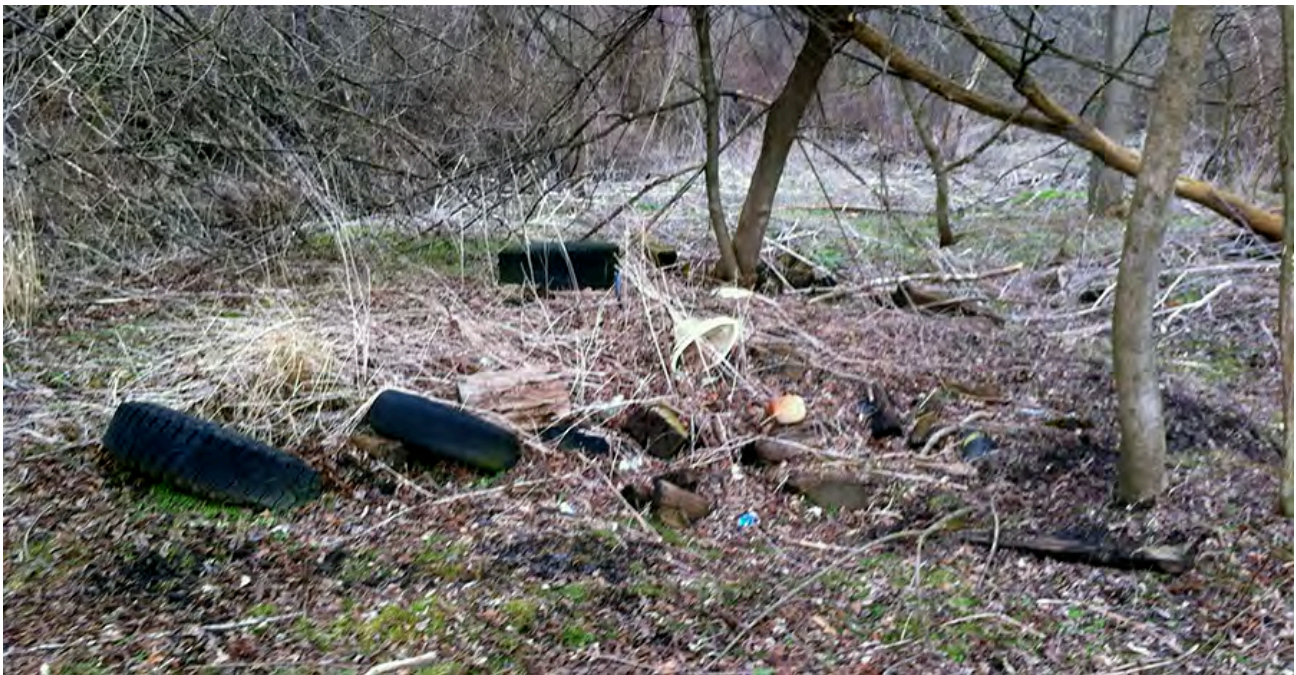
JMT09 – Jefferson Memorial Tributary's wide floodplain is littered with tires and other assorted litter, garbage and debris. The floodplain is also inhabited by numerous Black Walnut saplings and small trees.

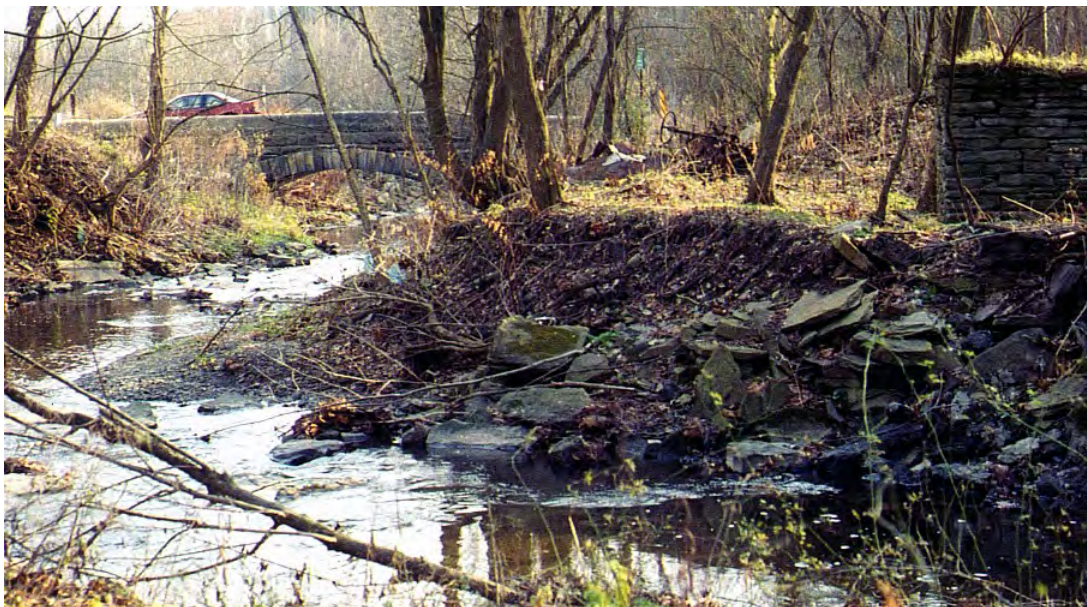
LR20 - The Cochran Mill Road Bridge is listed as stone arch bridge S-2 in the Pennsylvania Historical and Museum Commission survey of PennDOT bridges that have significant historical value. The structure is described as "segmental arch of high quality rock, faced ashlar construction; voussoirs dressed; parapet finished with curved course." The survey entry reports the date as 1901. Remnants of the the saw and grist mill of Joseph Cochran on Lick Run just upstream from this bridge can be seen in the upper right of the photo. The mill race - the water diverted from the stream to power the mill - ran to the west of the stream, through the mill near the western end of the bridge site.

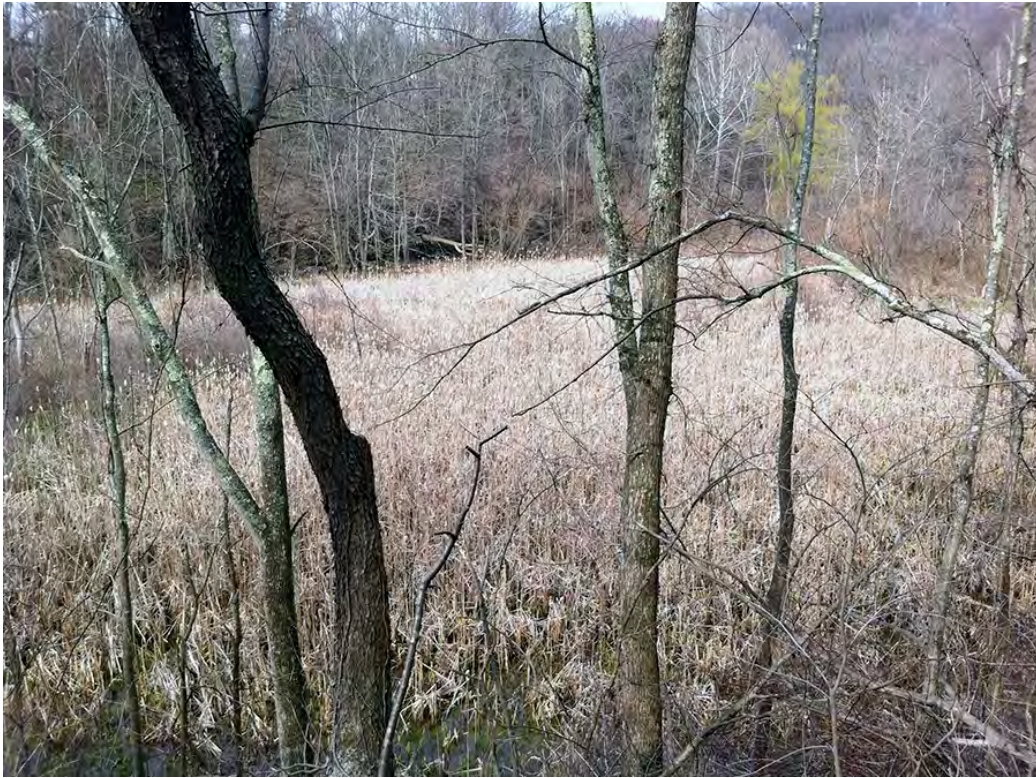
LR06 - An emergent wetland within Lick Run's right ascending floodplain just upstream of the Wheeling & Lake Erie Railroad Tunnel serves a number of functions. It filters abandoned mine waters from a discharge along the W&LE tracks near the Patriot Pointe development in Jefferson Hills prior to its entrance into Lick Run. The wetland also provides habitat for wildlife including the Queen Snake (*Regina septemvittata*), a species of special concern in Pennsylvania.

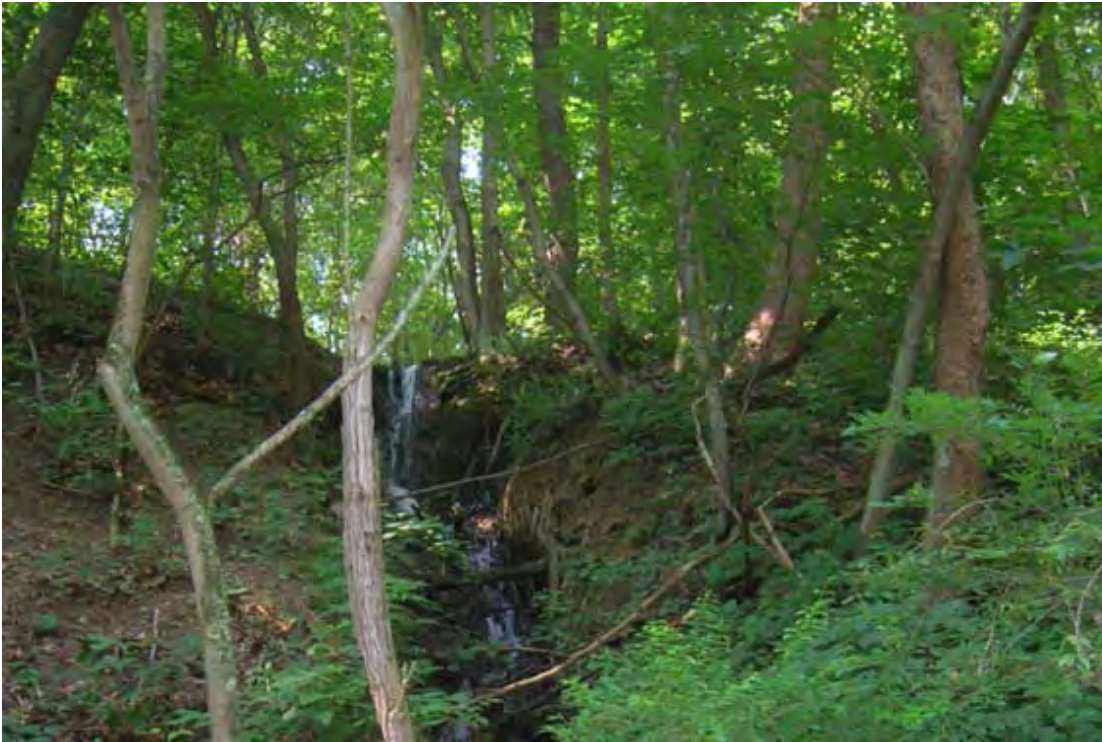
PF12-PF13 – An AMD impacted spring originates at PF12 on a plateau above Piney Fork's left ascending bank. It then flows over the hillside along the old Montour Railroad Right of Way just west of the recently installed section of Montour Trail along Piney Fork Rd, crosses the ROW and enters Piney Fork at PF13. This spring is associated with abandoned mine lands that extend along this section of Piney Fork for approximately $\frac{1}{4}$ mile.

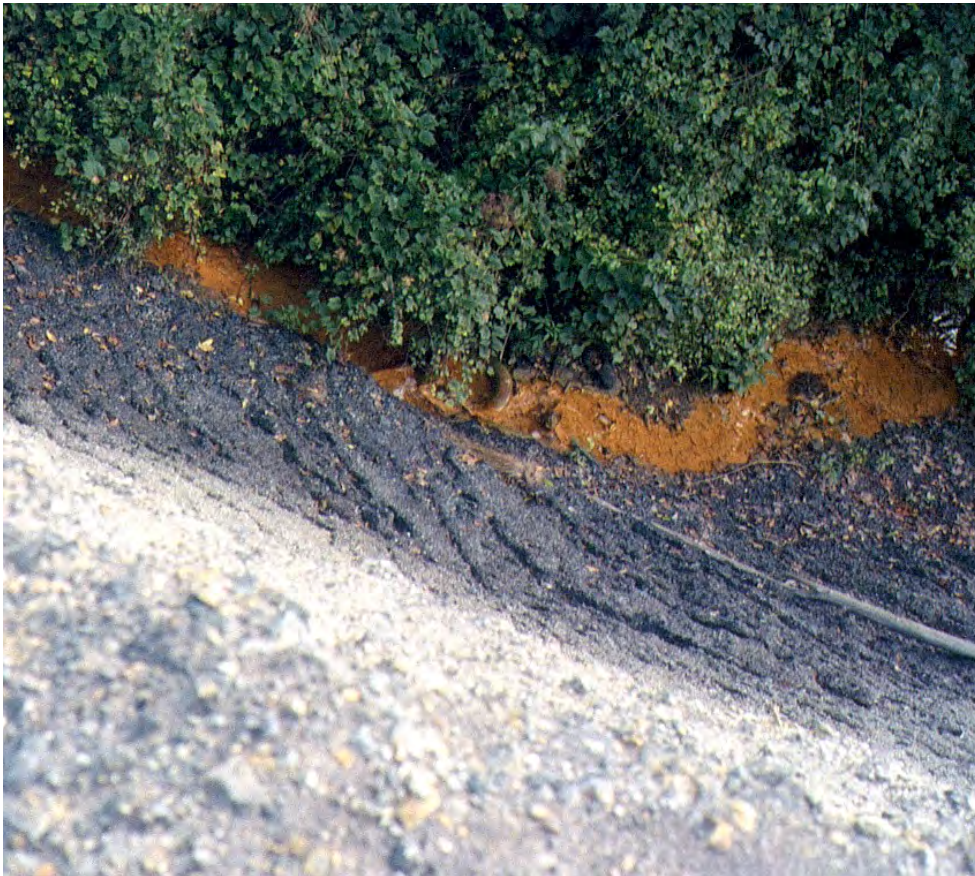
PF35 – An abandoned mine discharge impacted tributary flows along the base of a large, steeply sloped coal waste pile along Triphammer Rd just downstream of Evans Park. The discharge originates in Evans Park at PF37 and enters Piney Fork at PF34. The discharge and coal waste pile are associated with the old Knothole Mine.

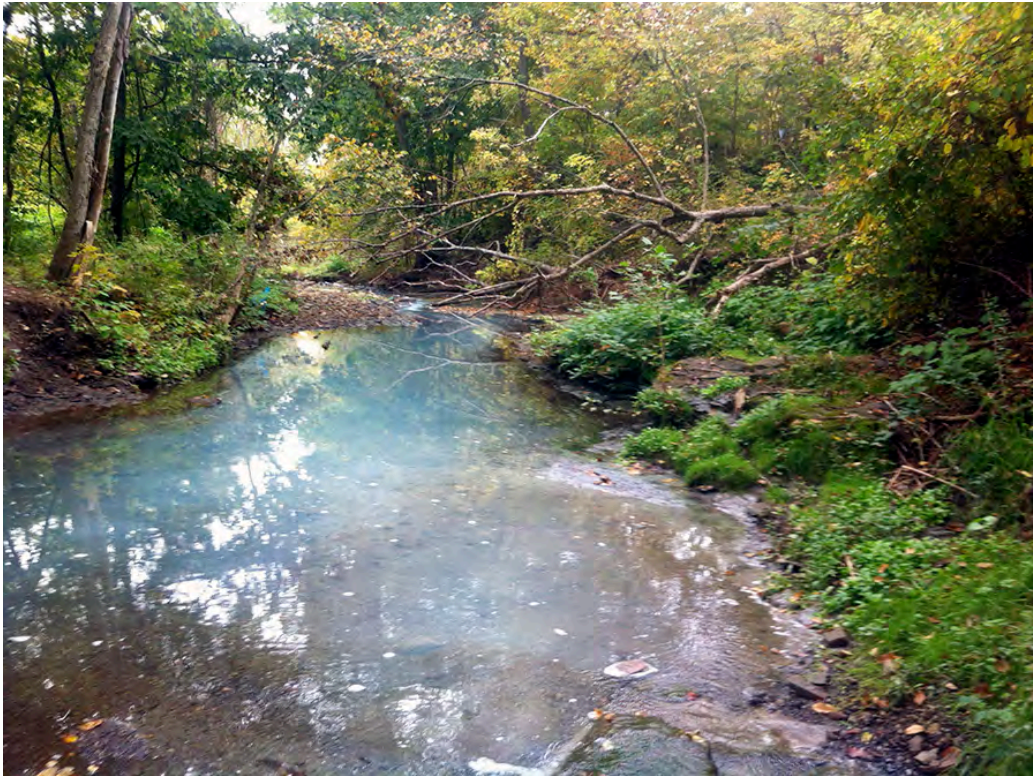
PF62 – An abandoned mine discharge associated with the old Montour 10 coal mine waste pile enters Piney Fork at Sebolt Rd in South Park Township. This discharge originates along Sebolt Rd at PF63 and is culverted along and under Sebolt Rd and Brownsville Rd prior to entering Piney Fork. A strong odor of volatile organic compounds has also been detected while sampling at this site.

There are a number of abandoned mine discharges along the main stem of Piney Fork from its mouth to the community of Library. The most significant discharges are found at Sebolt Rd (PF62) and at Evans Park (PF36), both in South Park Township. Aluminum is the major problem at the Sebolt Rd discharge with very little iron present but a significant load of manganese. The Evans Park discharge has significant concentrations of aluminum, iron and manganese. Both discharges should be studied further as the possibility of developing a treatment system at both sites is good.

There are also numerous abandoned mine lands (AML) within the Piney Fork sub-watershed. The Montour No. 10 coal waste pile is ranked as a priority 2 AML which means that it poses a threat to public health, safety, and general welfare from the adverse effects of past mining operations that do not constitute an extreme danger. There are also a number of priority 3 AMLs within the sub-watershed. Priority 3 AMLs do not pose a danger to public health but are lands that are environmentally damaged by past coal mining operations. A refuse reprocessing operation at the Montour No. 10 coal waste site is currently permitted to discharge to un-named tributaries to Piney Fork. The impact of this discharge on water quality in Piney Fork should be investigated.

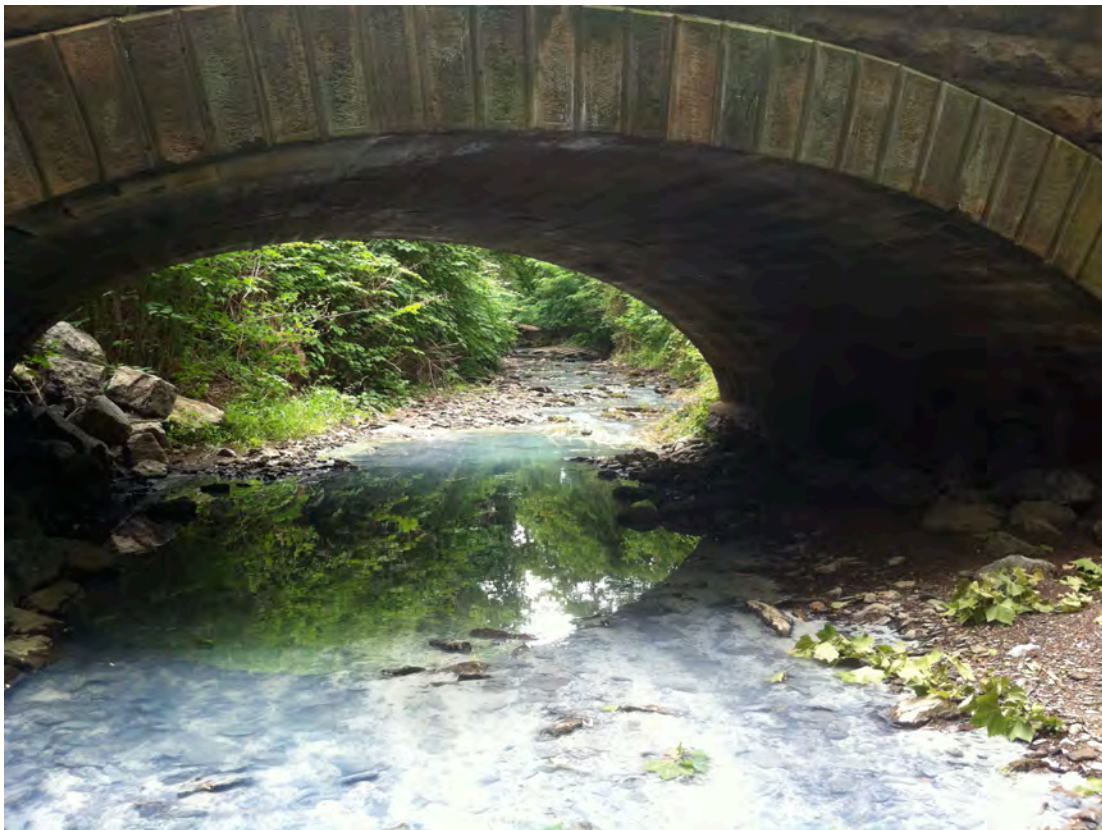
PF57 – Heavy aluminum precipitate covers Piney Fork's substrate at the Stewart Rd bridge crossing at about ½ mile downstream of the Sebolt Rd discharge into Piney Fork.

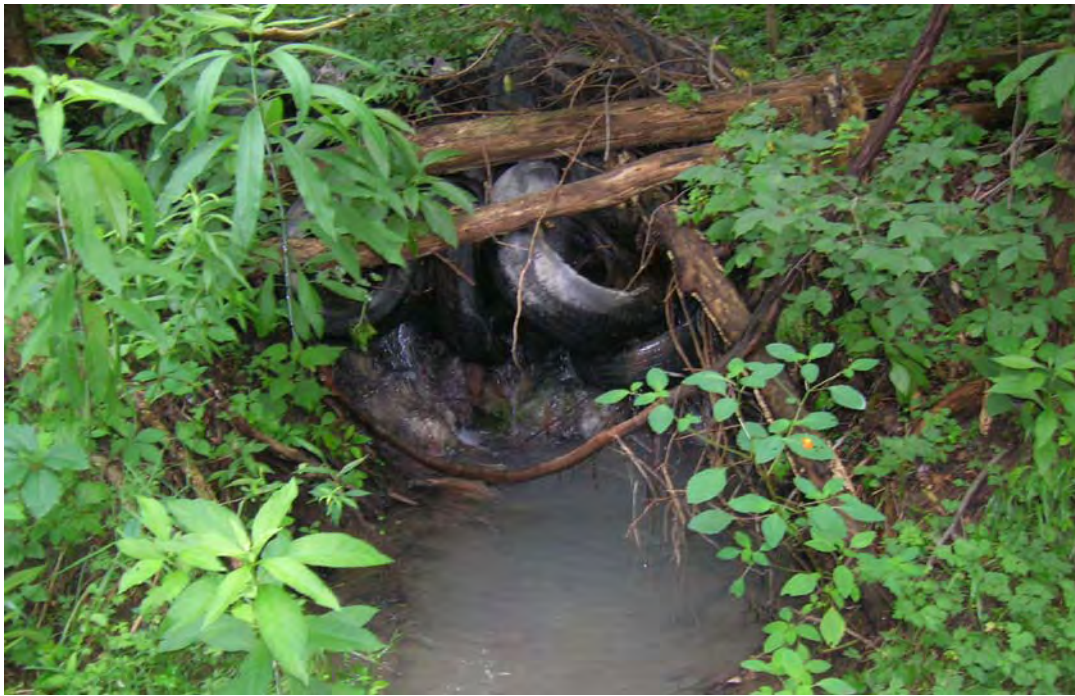
PF65 – An abandoned mine discharge enters Piney Fork just upstream of the Sebolt Rd discharge. This discharge appears to be culverted under Cardox Rd. A debris jam of tires and other assorted garbage has formed at the streams confluence with Piney Fork. Very little indication of AMD was found along Piney Fork upstream of this discharge.

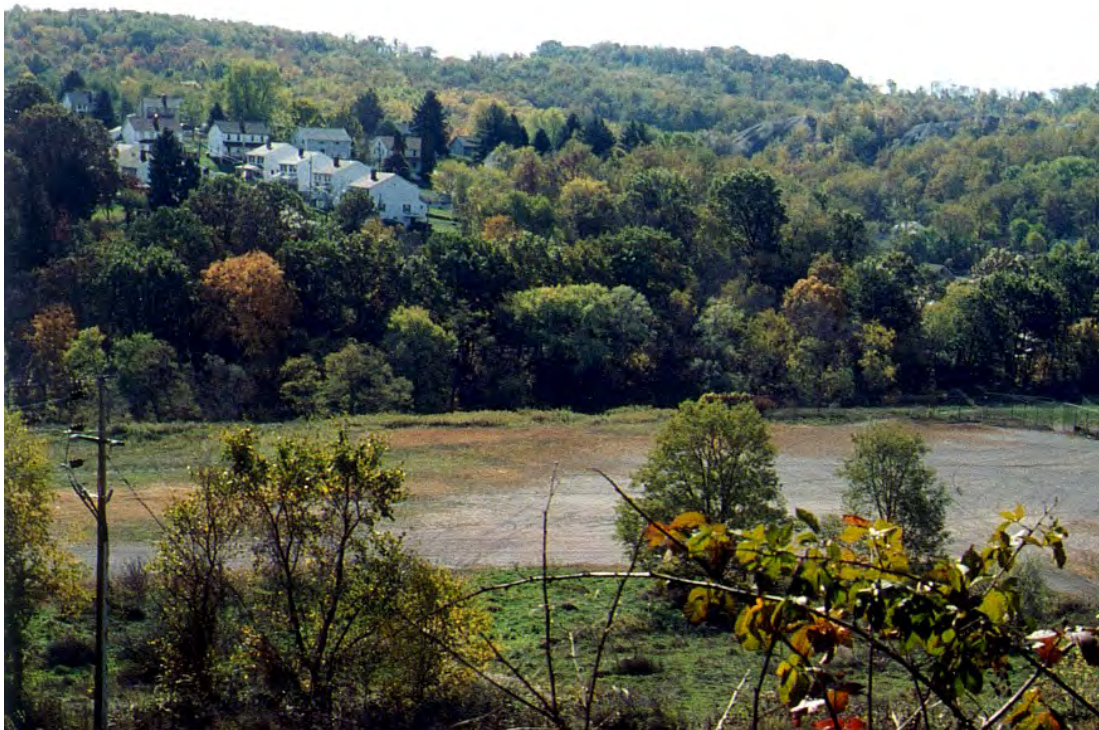
PF64 – Looking across the Piney Fork valley toward part of the Montour 10 coal waste pile on the right side of photo. Part of this coal waste pile is in Allegheny County and part is in Washington County. A refuse reprocessing operation is currently working on the coal waste pile in Washington County.

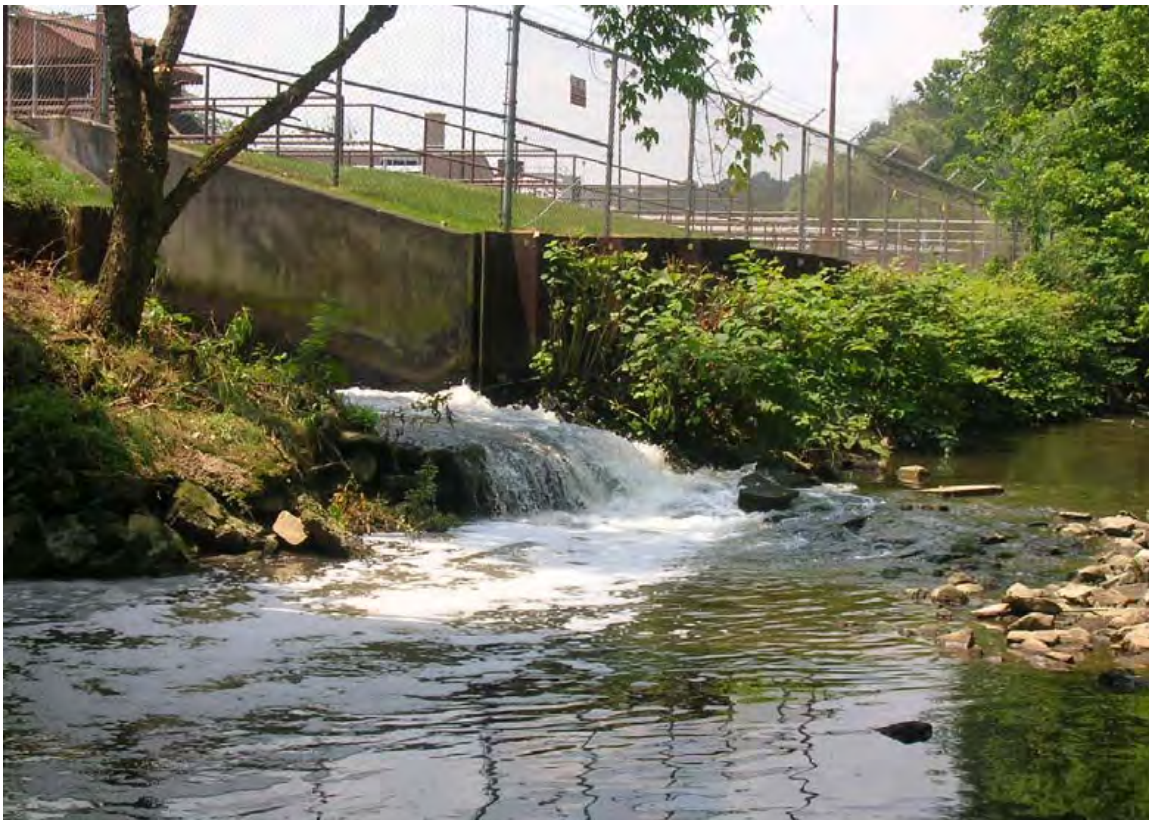
PF40 –The Piney Fork Wastewater Treatment Plant outfall into Piney Fork just downstream of Catfish Run's confluence with Piney Fork. The sewage treatment plant serves approximately two-thirds of Bethel Park and a portion of South Park Township. A small portion of Peters Township has also expressed interest in utilizing the facility.

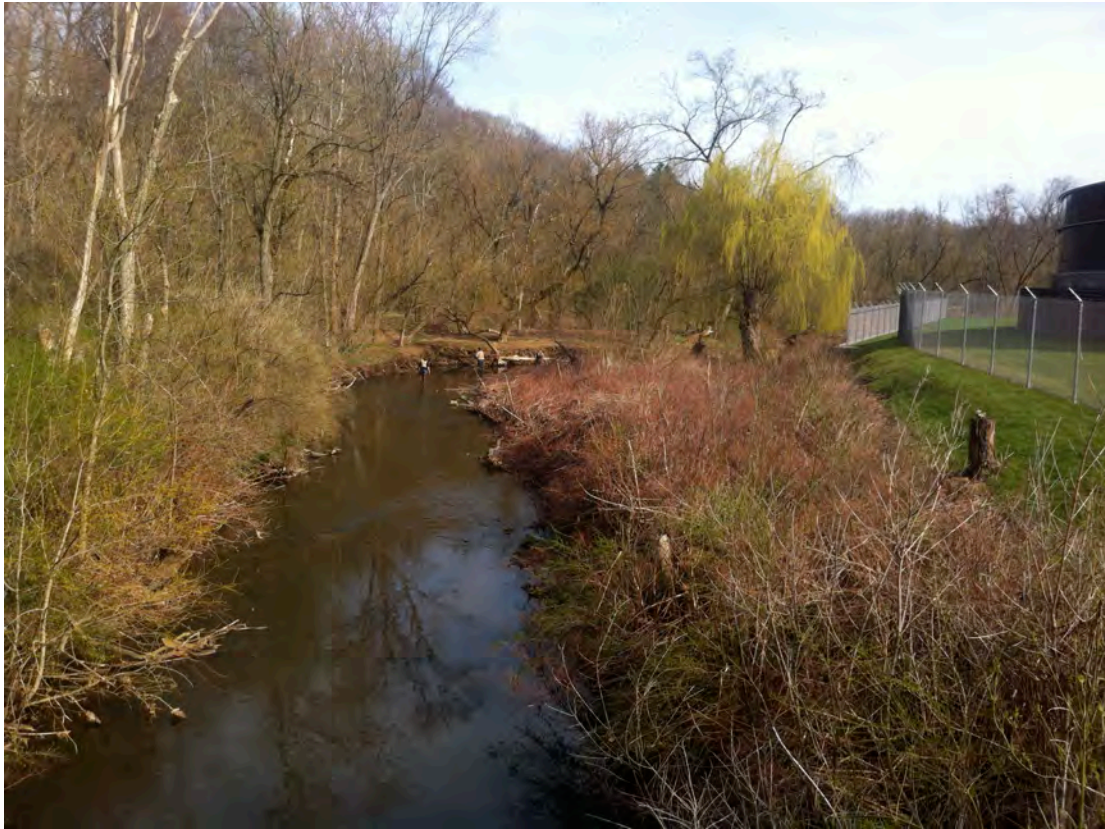
PF40 – A view of Piney Fork just downstream of the Piney Fork Wastewater Treatment Plant outfall. The Tri-Community Anglers and South Park Township stock this portion of stream with trout. Part of the upgrade to the treatment plant can be seen in the right of the photo.

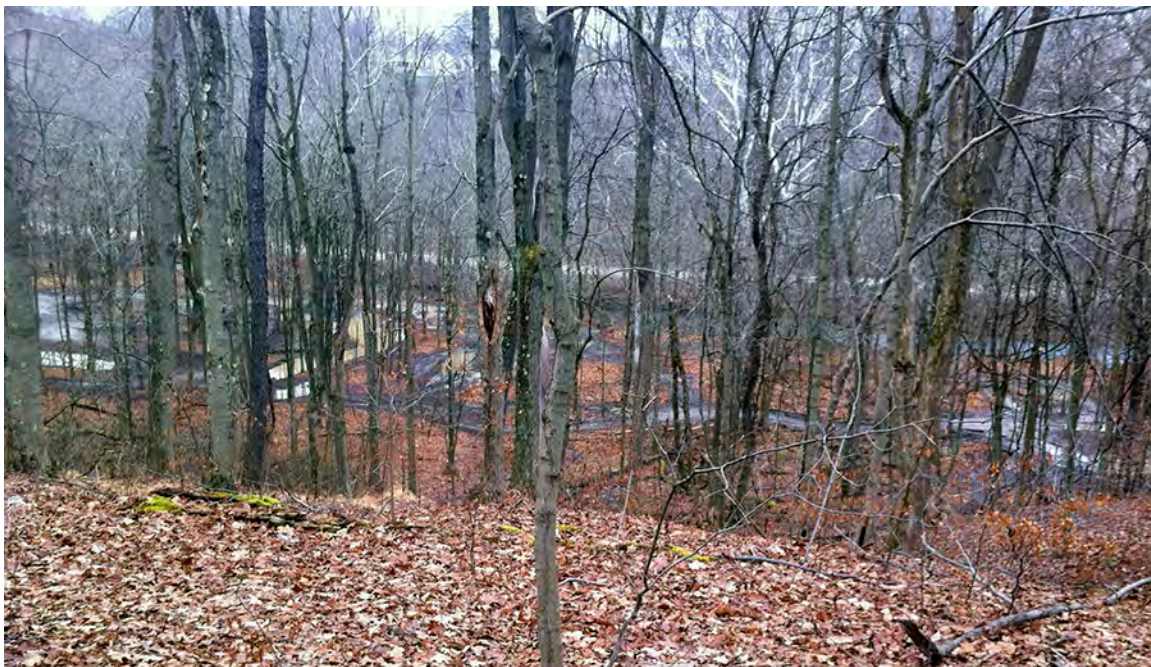
PF05 – A view of Piney Fork's left ascending floodplain from the Montour Railroad right of way. Heavy off-road use of this floodplain has created severe erosion, soil compaction, stream bank alterations and excess siltation from numerous stream crossings, destruction of the floodplain understory and alteration of drainage patterns into Piney Fork.

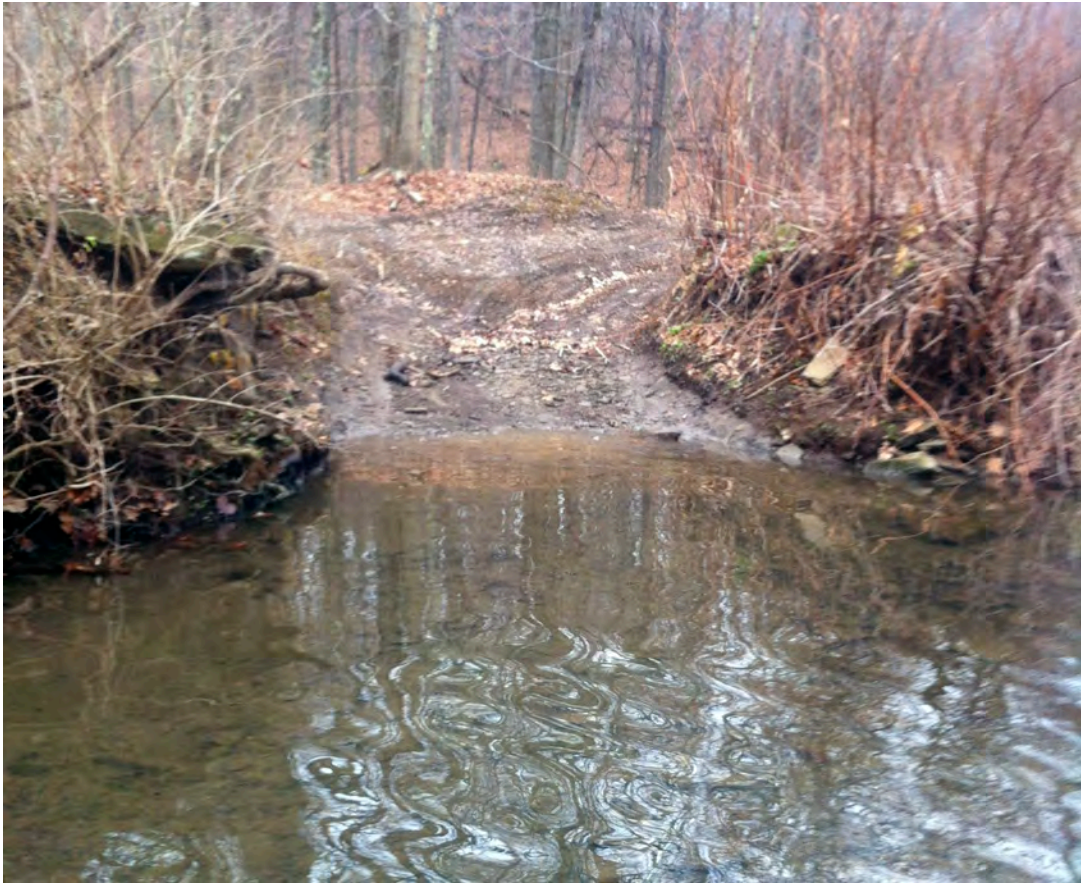
PF05 – One of numerous off-road stream crossings of Piney Fork just upstream of Corvette tunnel. These severe bank alterations are a conduit for stormwater and lead to excess siltation and increased erosion of the banks of Piney Fork. They also contribute to alteration of flow patterns within the stream channel.

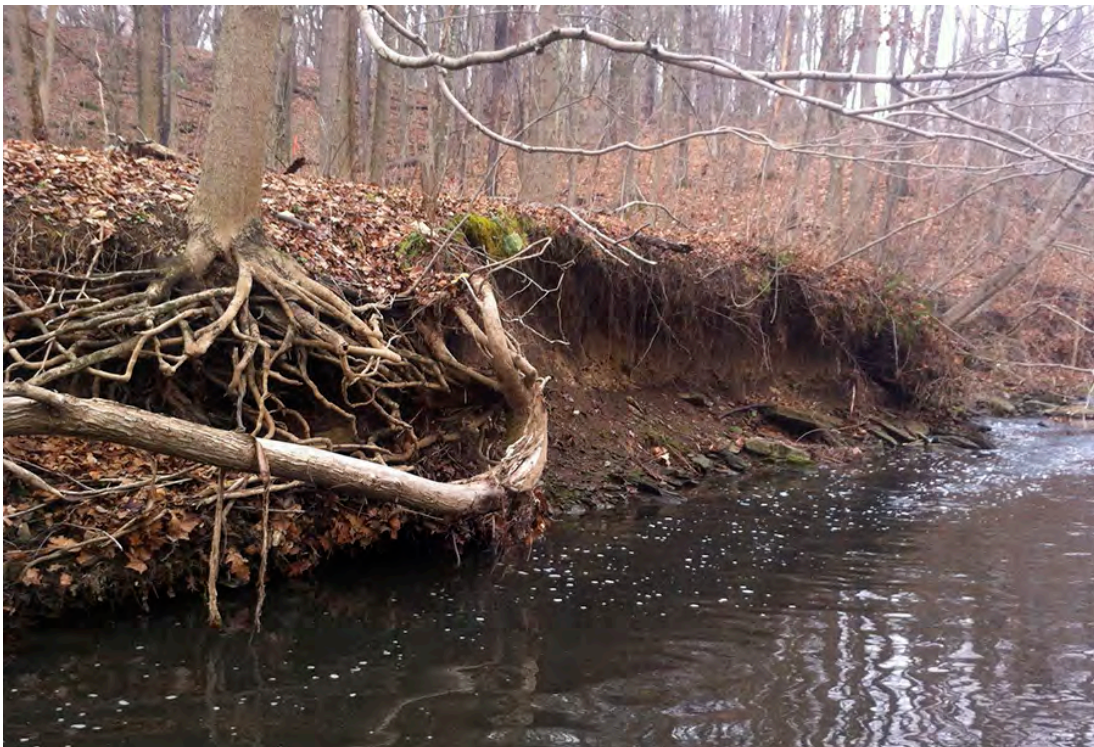
PF08 – Severe bank erosion along Piney Forks left ascending bank just downstream of a deeply incised stormwater channel. The stream is becoming increasingly detached from the floodplain along this section and the erosion is undercutting trees and adding to the sediment load of the stream.

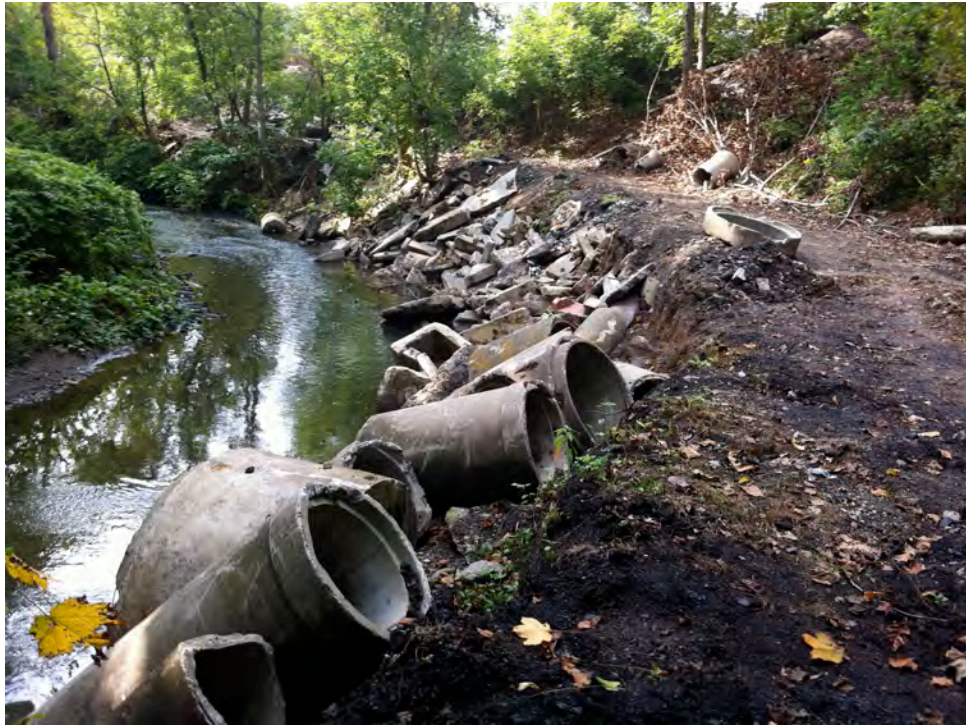
PF26 – The beginnings of a stream bank stabilization project along Piney Fork’s right ascending bank along the Montour Trail east of Triphammer Rd. This project appears to be as much about waste disposal as it does about streambank stabilization.

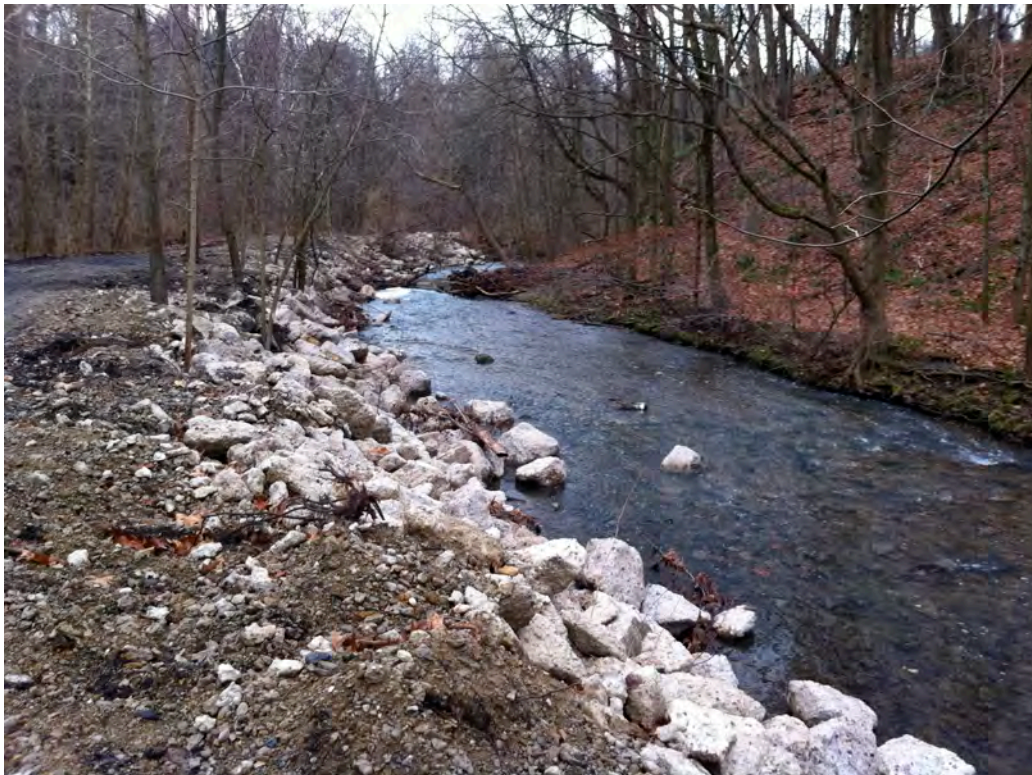
PF26 – Unsized rubble from a tunnel demolition project in Peters Township was thrown along approximately 800 feet of Piney Fork’s right ascending bank and at sites downstream. Little was done to protect trees along the bank and rubble ended up within the low flow stream channel and continues to slide into the channel during high water events. PA DEP Growing Greener Grants have been utilized successfully to implement Natural Stream Channel Design (NSCD) Projects along Peters Creek in Jefferson Hills. A stream stabilization project designed by an engineer trained in NSCD along this portion of Piney Fork would have maintained the natural integrity of the corridor and enhanced fish habitat along this stocked portion of Piney Fork while also achieving the necessary bank stabilization.

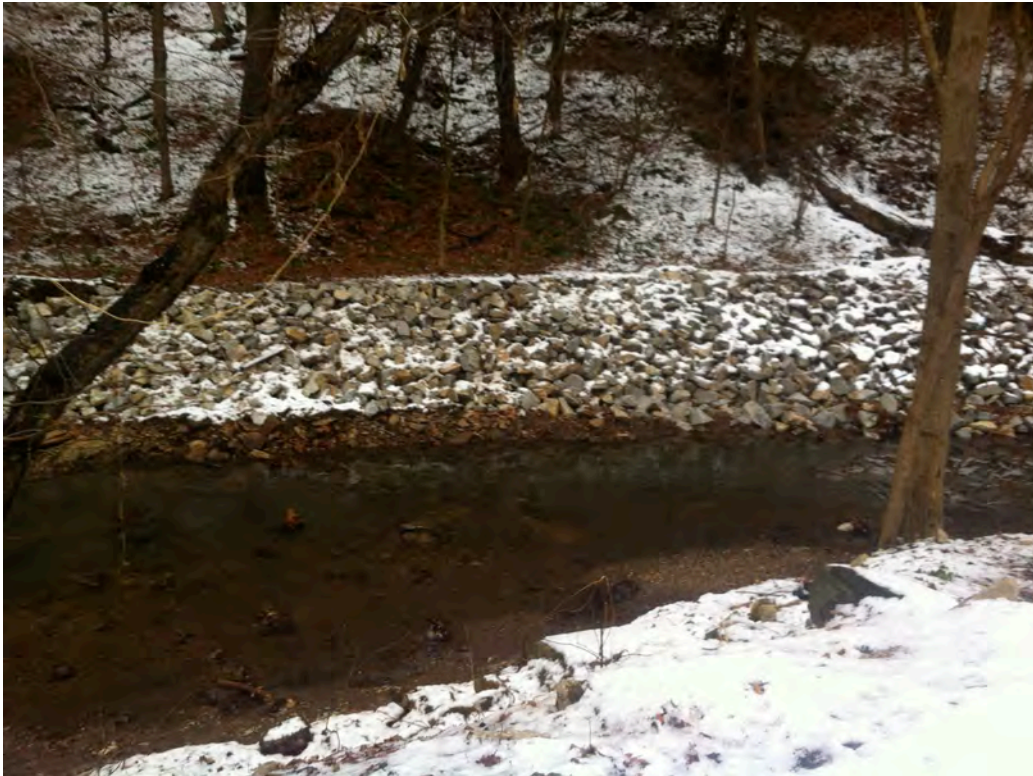
PF27 – An eroding section of Piney Fork’s left ascending bank just downstream of the Montour Trail bridge just east of Triphammer Rd is riprapped to protect it and a sewer line from further erosion.

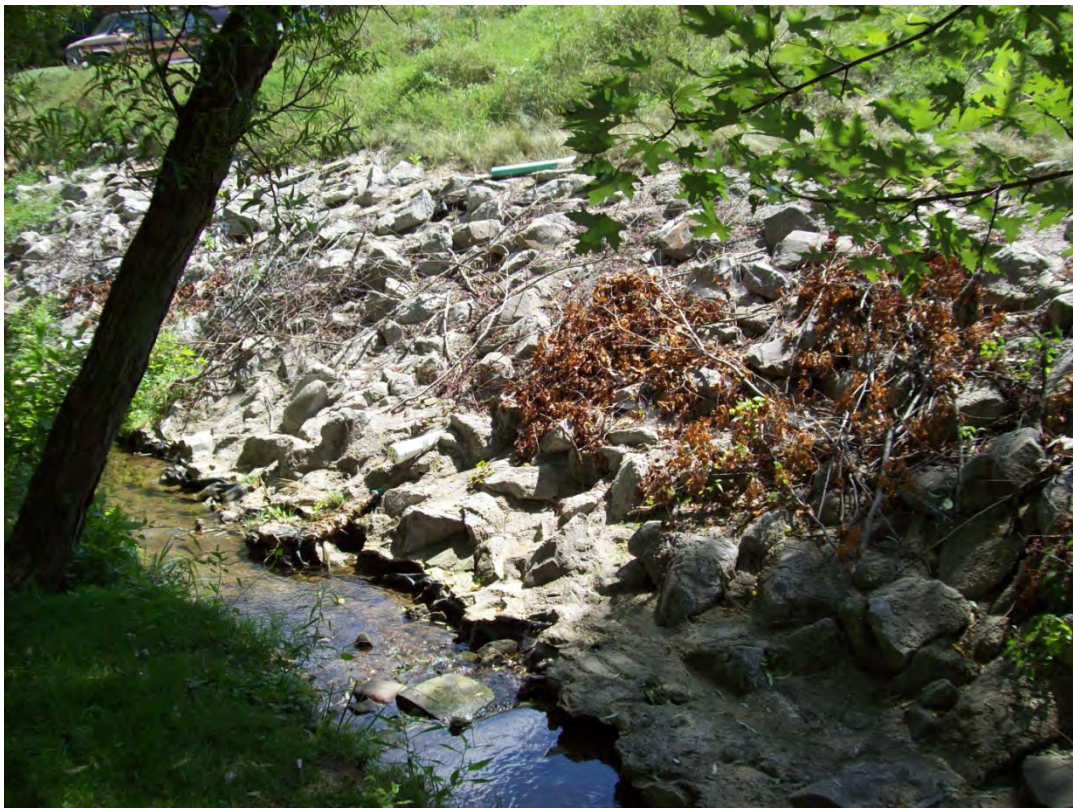
CRC28 – Grouted riprap applied to the eroding left ascending bank of the Clifton Rd Branch of Piney Fork just upstream of the Havengate Street crossing of the stream.

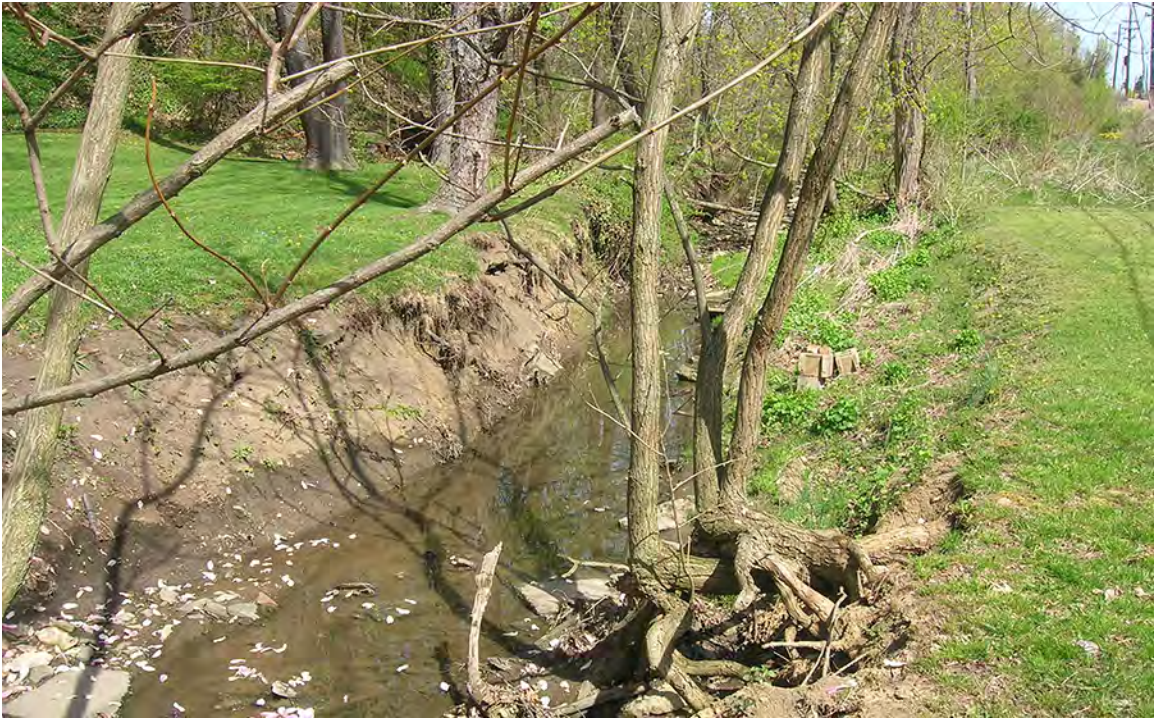
The banks of the upper reach of the Brightwood Road Branch of Piney Fork are eroding and detached from the floodplain. The stream appears to be functioning principally as a stormwater conveyance channel along this section of stream.

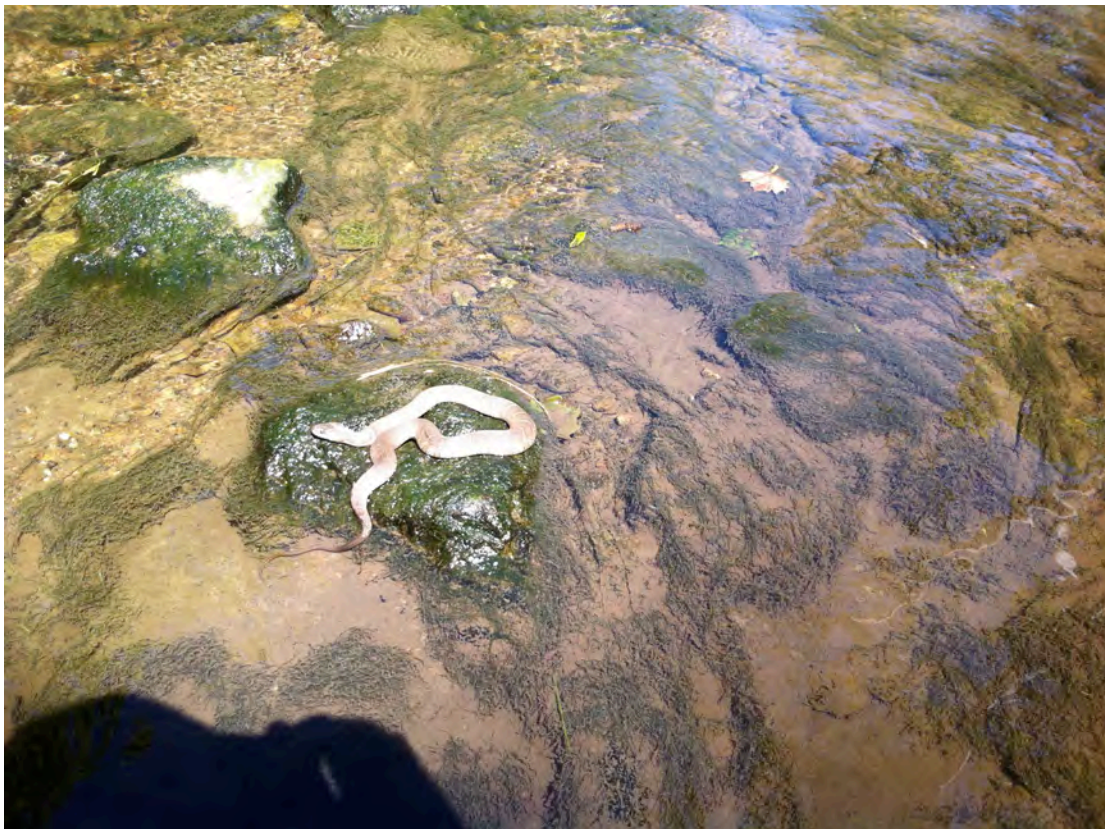
PF05 – Excess algae growing on Piney Fork’s substrate is a problem at a number of locations downstream of the sewage plant outfall. In this photo a Northern Water Snake basks on an algae-laden rock just upstream of Corvette Tunnel.

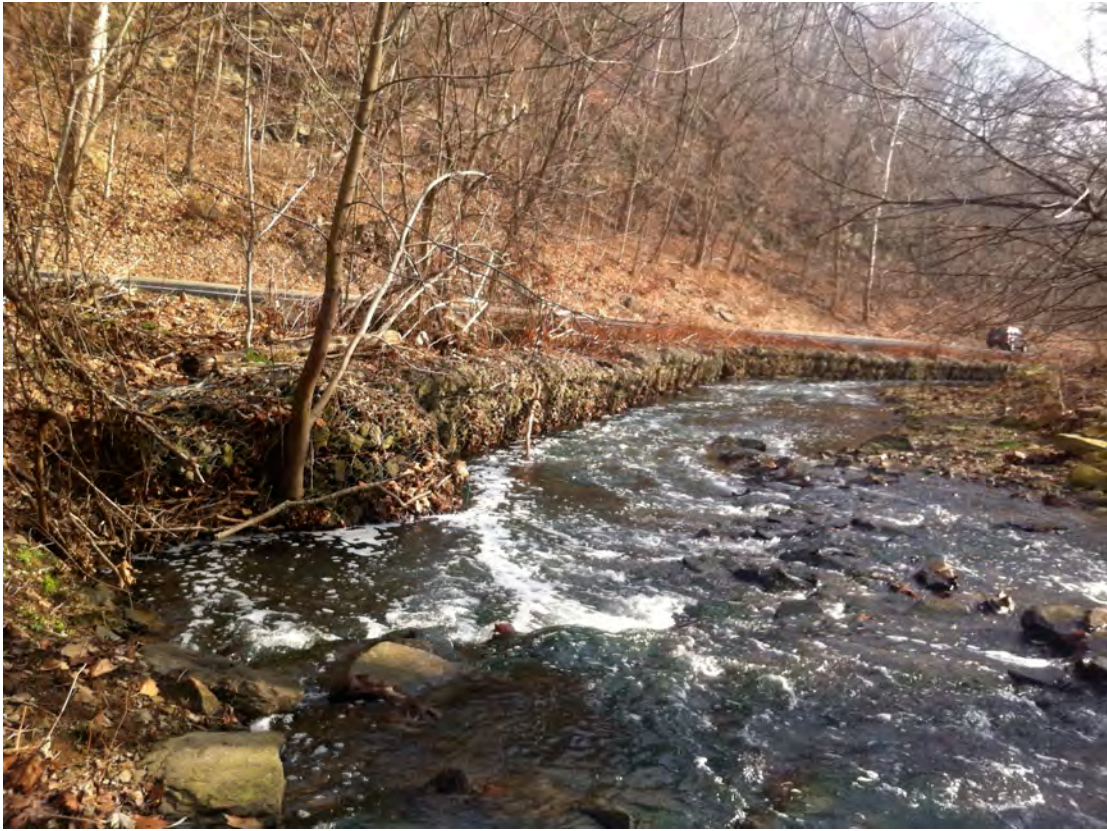
PF11 – Gabioned riprap creates right ascending bank of Piney Fork with Piney Fork Rd nearby. Japanese Knotweed infests the entire length of the gabioned riprap. Bank erosion at the head of the riprap.

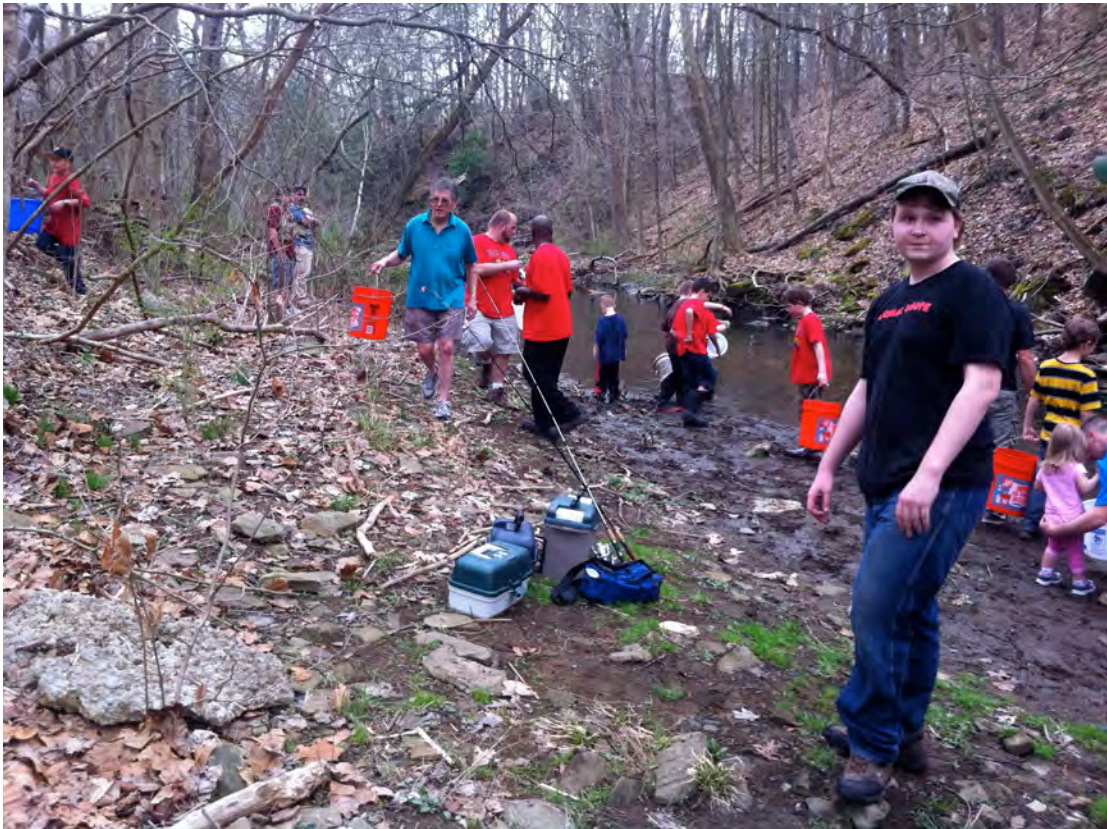
PF15 - Much of Piney Fork's stream bank is wooded and steeply sloped from the confluence of Peters Creek to the Piney Fork Wastewater Treatment Plant. Invasive plants within the floodplain, especially Japanese Knotweed, are a problem at a number of locations. The photo above depicts Piney Fork below the most downstream bridge crossing of Piney Fork Road. A local Cub Scout Pack is helping with stocking the creek with trout in the spring of 2013.

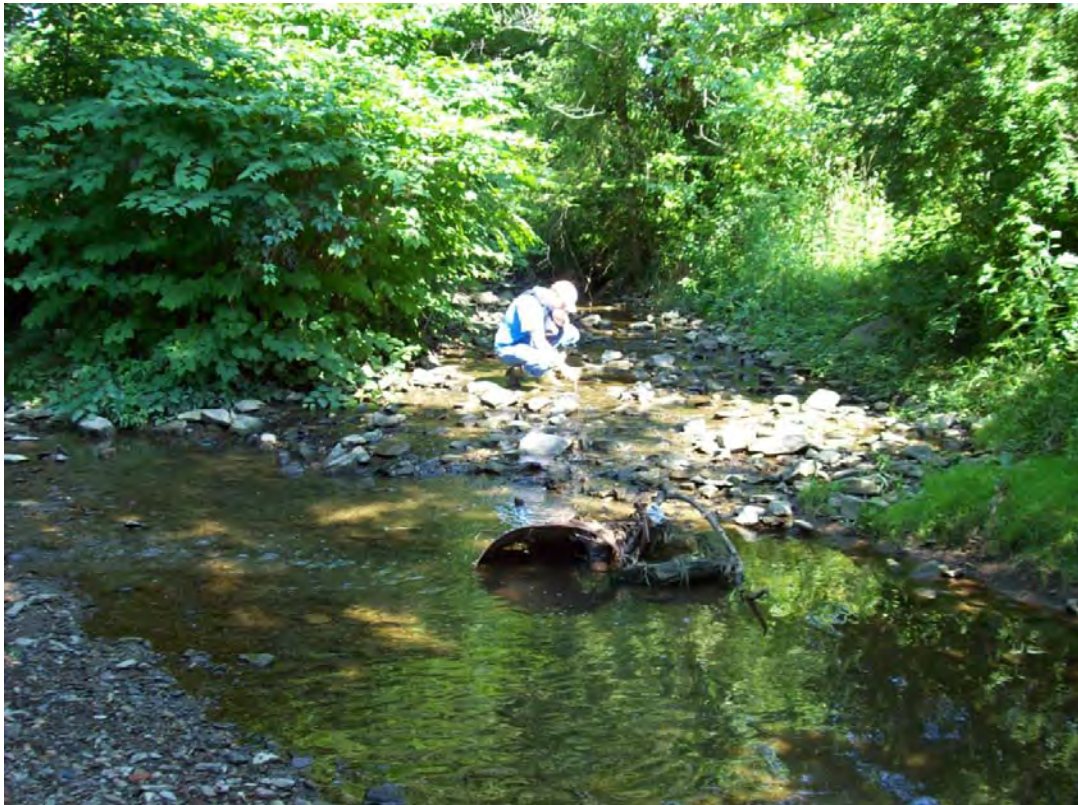
PF81 – Piney Fork at the confluence of the Brightwood Rd branch and the Clifton Rd branch just downstream of State Route 88. The floodplain is vegetated in this area but Japanese knotweed is becoming prevalent.
