Peters Creek Watershed Assessment & Management Plan

April 2014

1.0 PETERS CREEK WATERSHED BACKGROUND

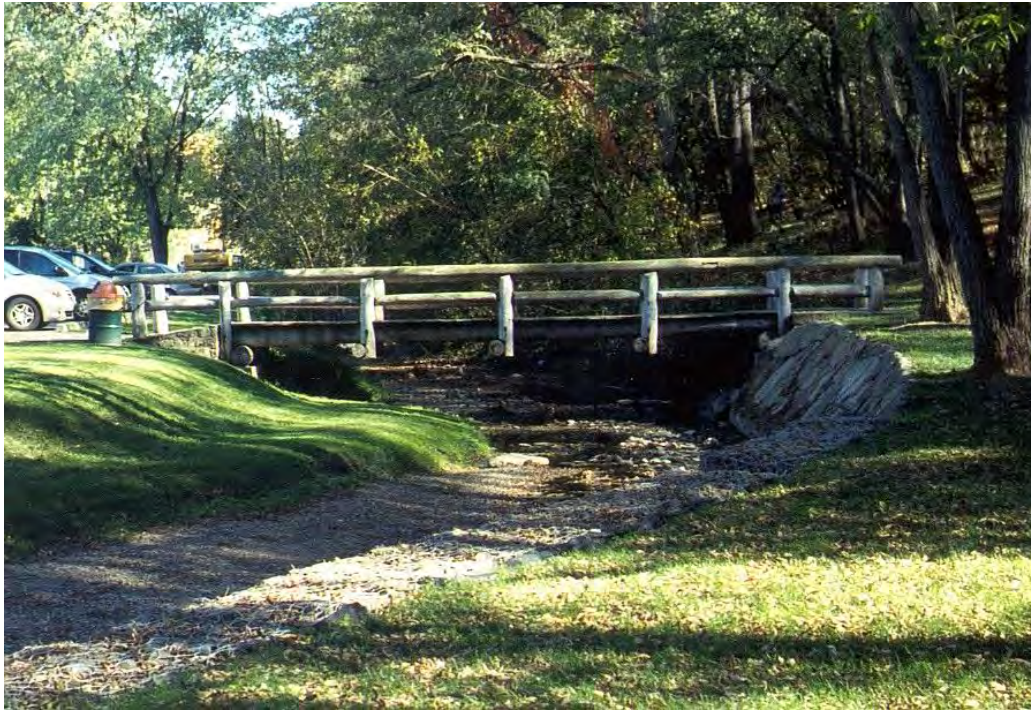
CRB06 – The Clifton Rd branch of Piney Fork at Simmon's Park. Much of the stream bank is modified within the park and the stream is detached from the floodplain.

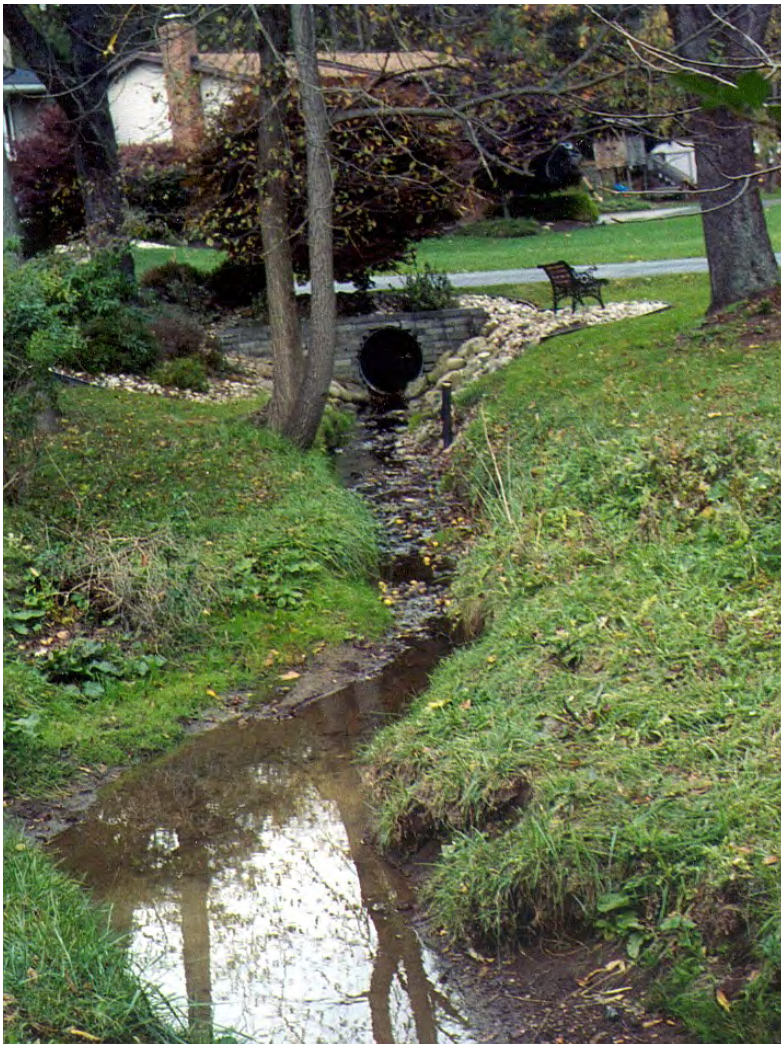
CRB37 – Piney Fork flows through front and back yards of residences along Clifton Rd. The stream is also culverted at a number of locations along Clifton Rd.

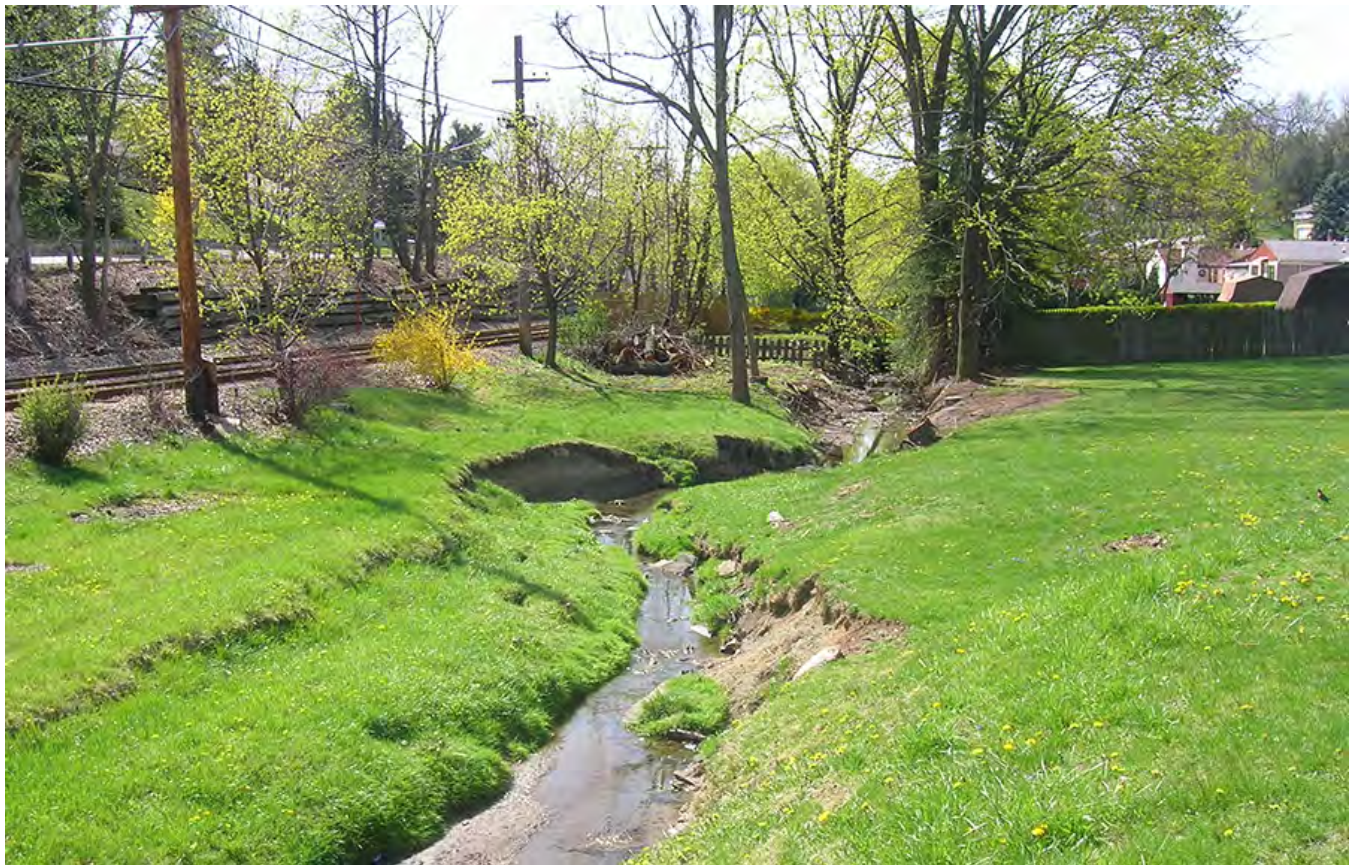
BRB25 – The upper reach of the Brightwood Road branch of Piney Fork along the Allegheny County Light Transit tracks to the left in the photo. The banks are eroding along this section of stream with little natural vegetation within the floodplain, numerous stream crossings, bank modifications and mowing right up to the stream.

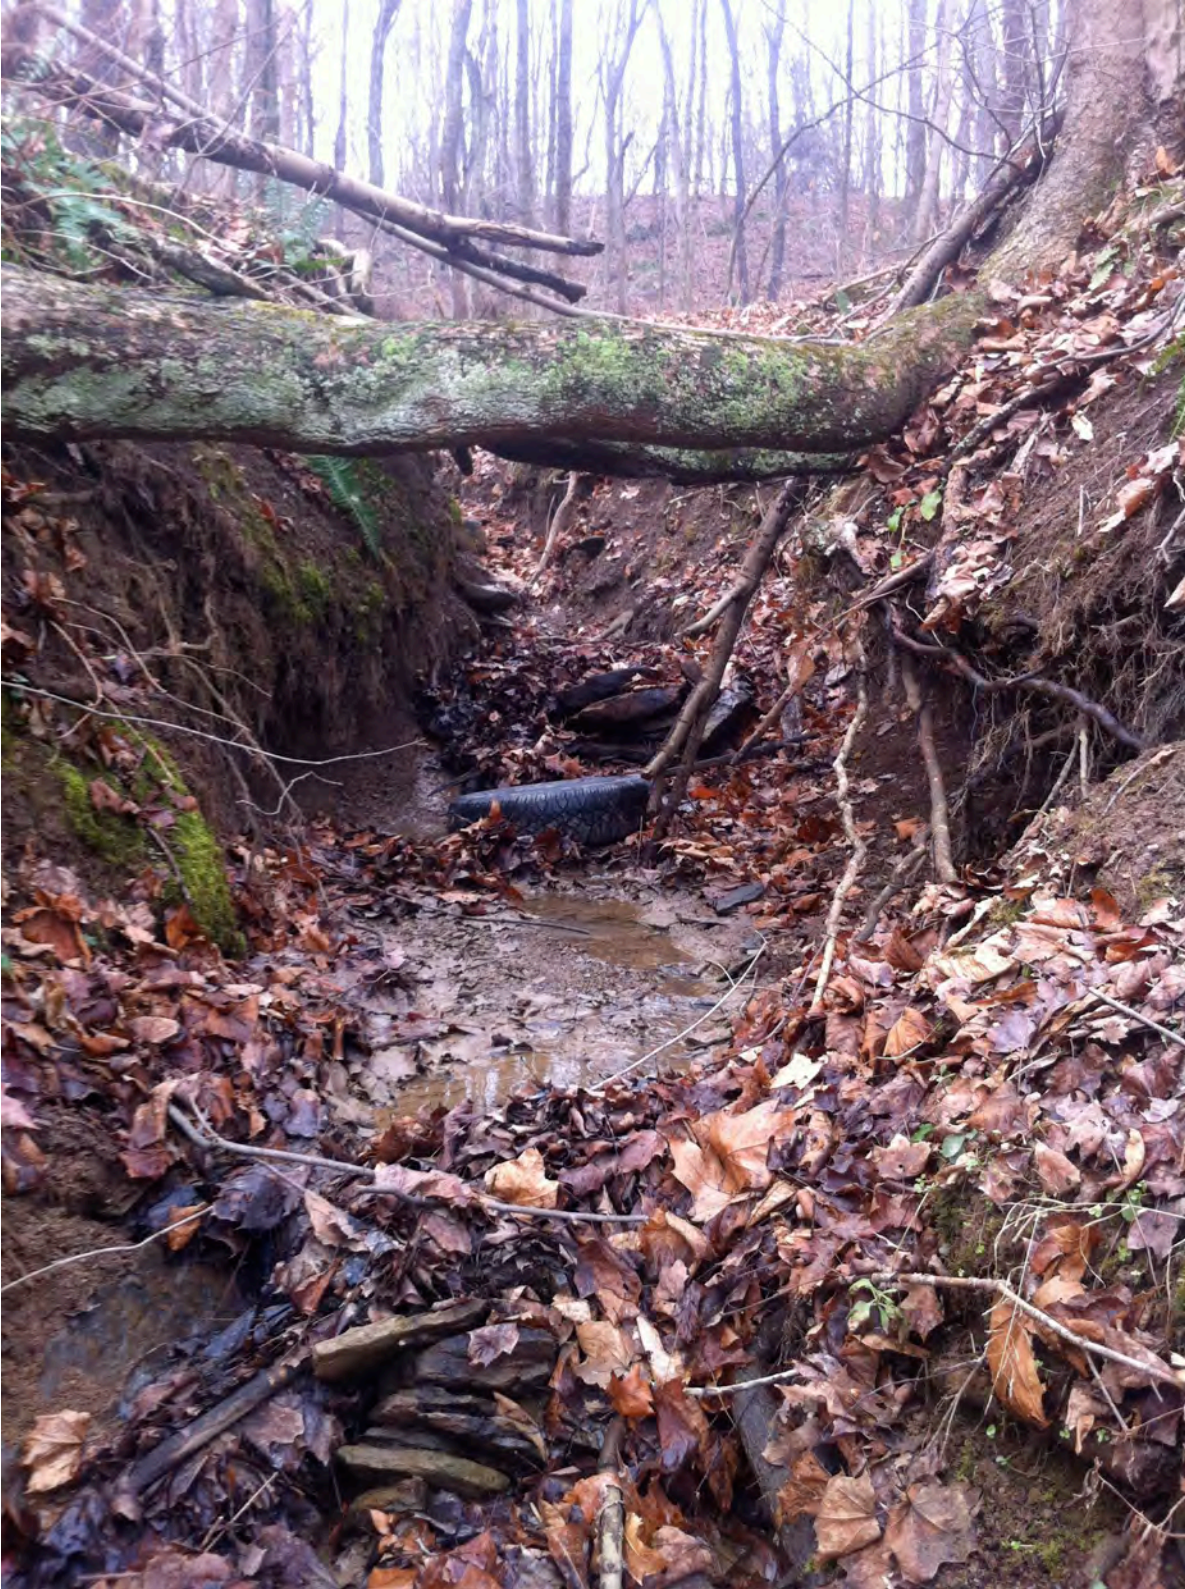
PF08 – A deeply incised tributary that conveys excessive quantities of stormwater from the old Montour Railroad right of way through Piney Fork’s left ascending floodplain to the stream. This creates severe bank erosion downstream. Heavy off-road activity along the right of way and lack of understory vegetation within the floodplain has exacerbated the problem.

Extremely heavy off-road vehicle activity within the lower portion of Piney Fork within its left ascending floodplain and along the undeveloped section of the Montour Railroad right of way is contributing to severe bank erosion, bank and stream channel modifications and floodplain damage. This activity also creates drainage pattern alterations that increases Piney Fork's stormwater and siltation load. Off-road activity needs to be effectively managed along this section of Piney Fork. Stream bank and floodplain remediation is definitely needed along the lower portion of Piney Fork.

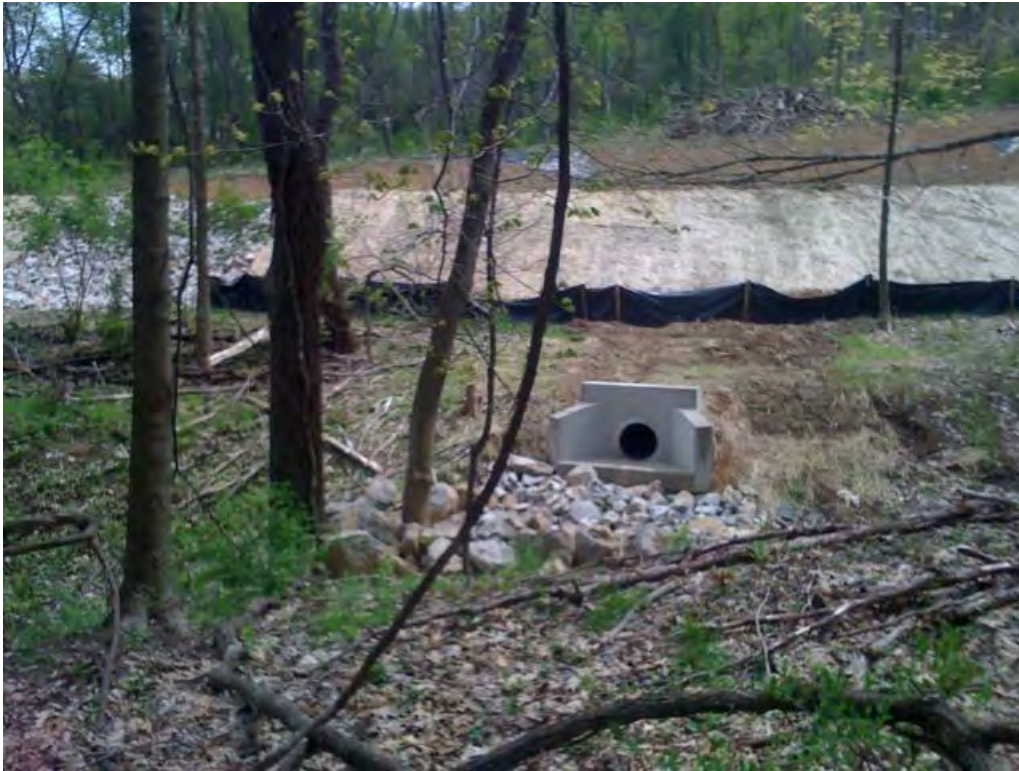
PF52 – A new stormwater detention basin off of Brownsville Road Ext discharges to a small tributary that is culverted under the Montour Trail and enters Piney fork's left ascending bank across from Georges Supply.

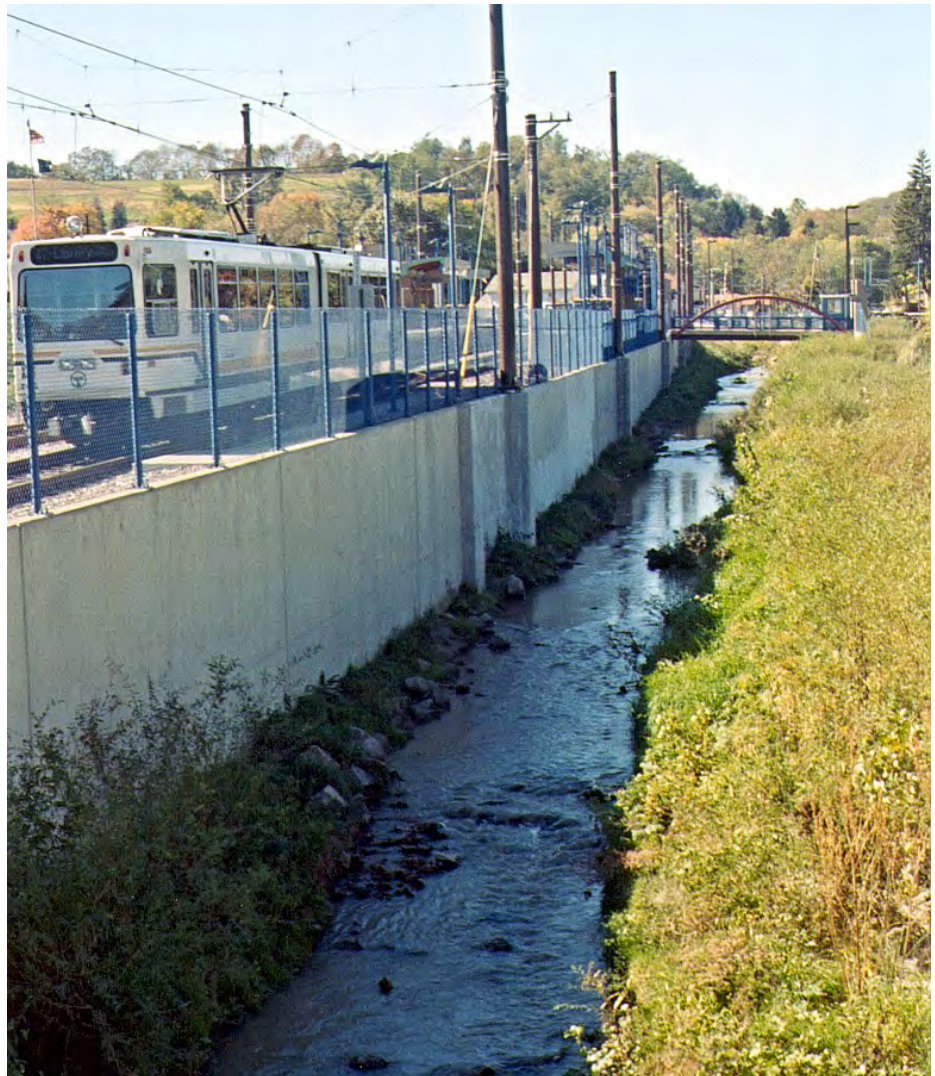
PF71 – Piney Fork, seen here channelized along the Library T-station, flooded on July 10, 2013 and inundated the station and adjacent Park & Ride Lot with 2-3 feet of water during a severe precipitation event. The infrastructure along the lower section of Piney Fork near Greenman Tunnel also incurred flood damage as a result of the storm. Piney Fork's channel was also significantly altered in this section by the flood.

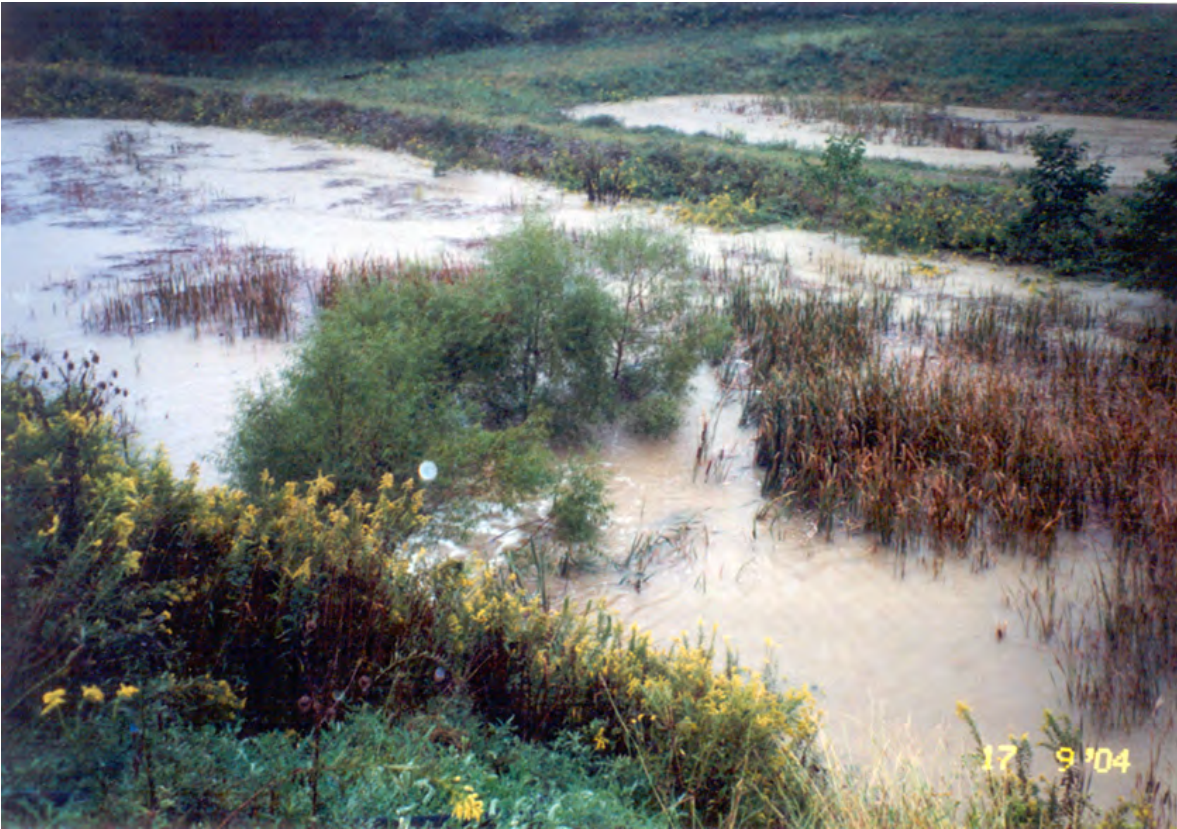
CRB14 – Two large over-engineered stormwater detention basins along the King’s School Village community in Bethel Park serve a regional stormwater function. The extra capacity of these basins helps to protect homes and infrastructure downstream during severe flooding events. The detention ponds did not overflow during the flooding of September 2004 due to remnants of Hurricane Ivan as seen above. Adequate stormwater controls are especially essential within the steeply sloped upper reaches of the Clifton Road branch of Piney Fork.

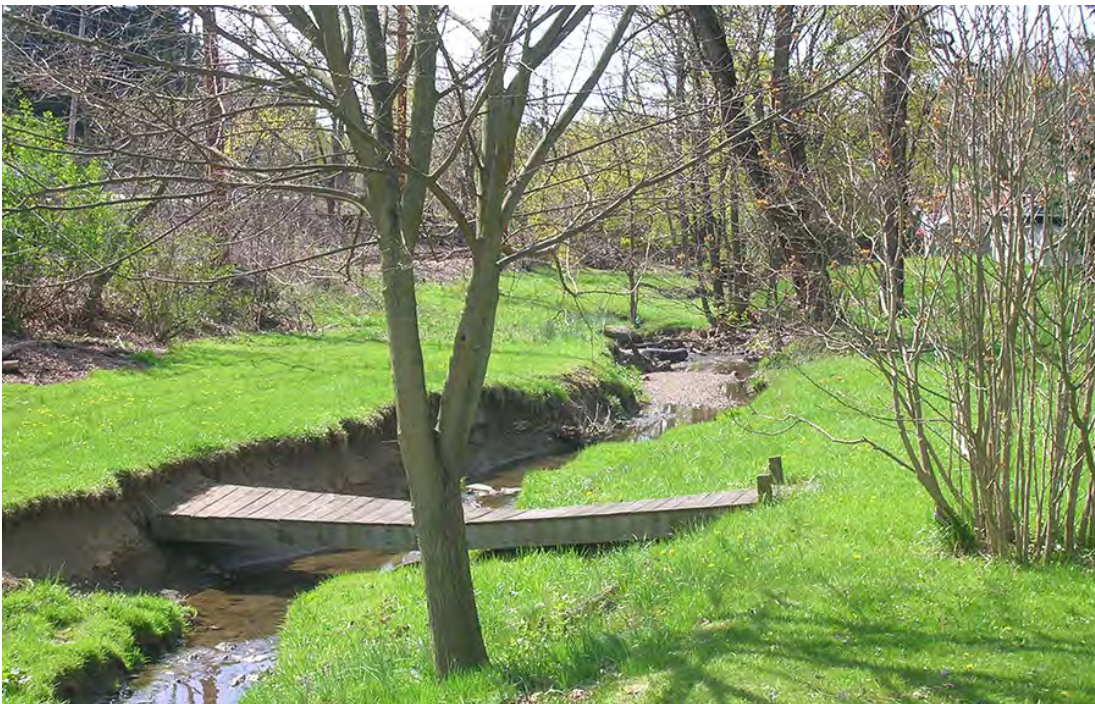
BRB26 – The Brightwood Road branch of Piney Fork is first daylighted just south of South Park Road. The stream appears to be culverted under a heavily developed older section of Bethel Park north of South Park Road and takes on great quantities of excess stormwater during precipitation events. The upper reaches of the daylighted stream are deeply incised and eroded. The stream continues to be impacted far downstream.

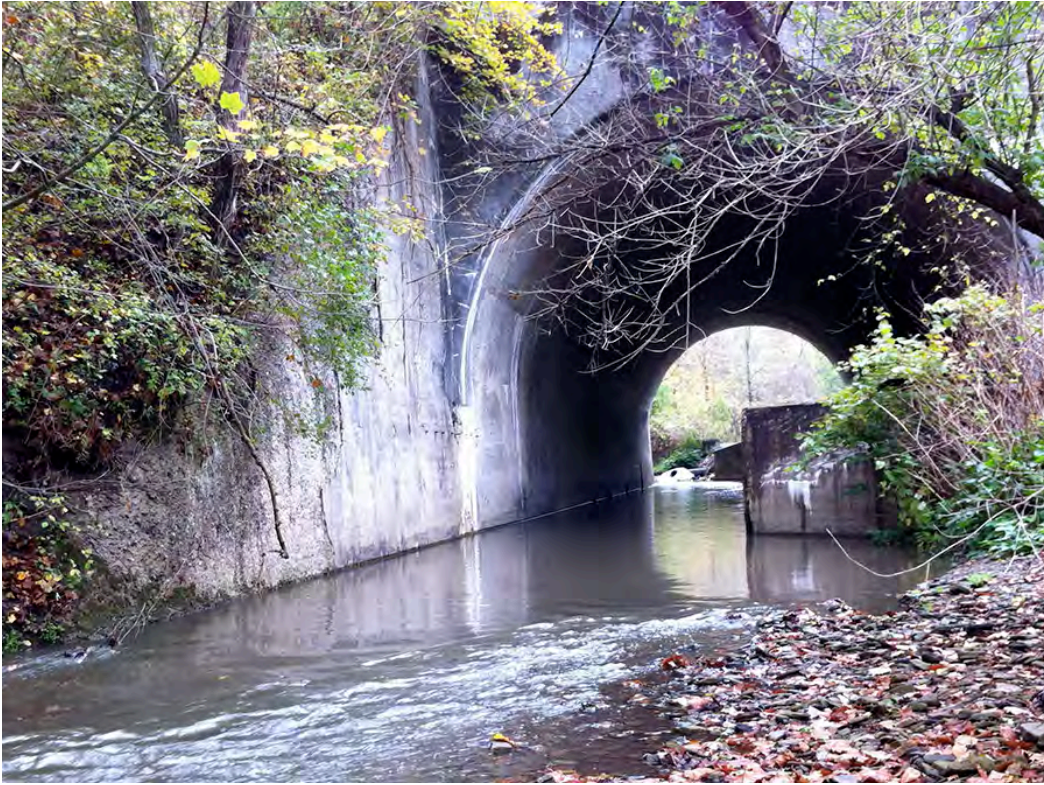
PF02 - Piney Fork channelized along Piney Fork Road through Corvette Tunnel near the streams confluence with Peters Creek. The tunnel carries the Allegheny Valley Railroad. Japanese Knotweed infests Piney Fork's right ascending floodplain just downstream of tunnel.

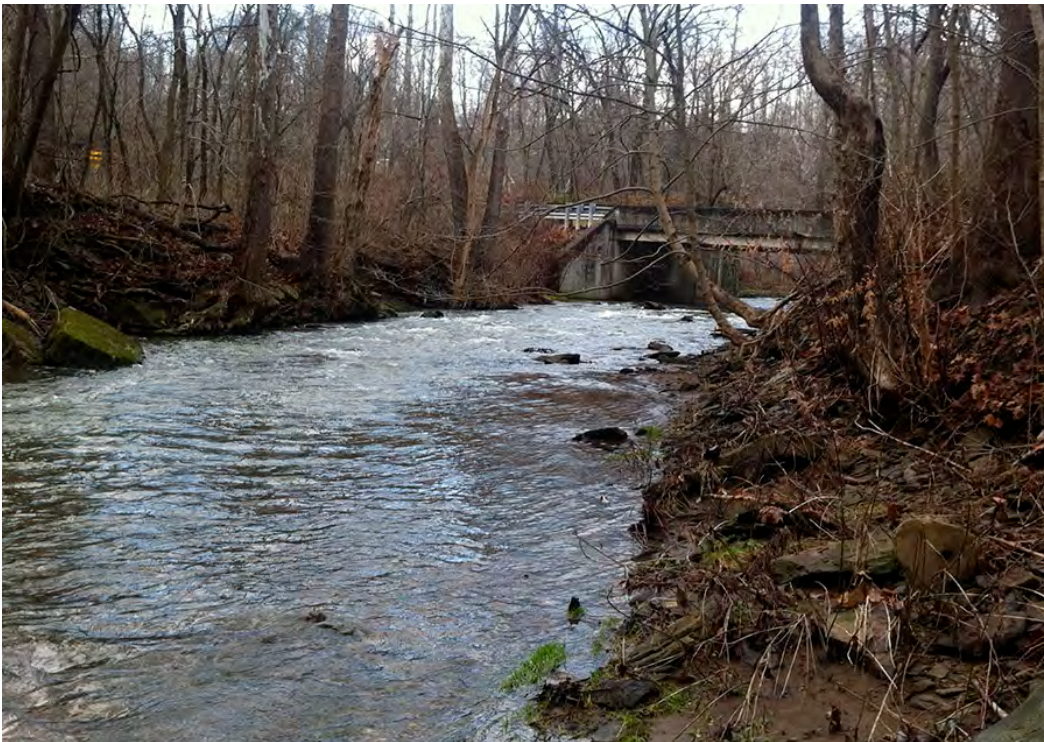
PF15 - Piney Fork passes under a bridge at the end of an entrenched meander along Piney Fork Rd near PennMont. PennMont was the interchange of the Pennsylvania Railroad and the Montour Railroad. Just upstream of the bridge are abutment remnants of a railroad crossing of the stream. Another bridge crossing of Piney Fork is located a few hundred feet upstream near the head of the meander.

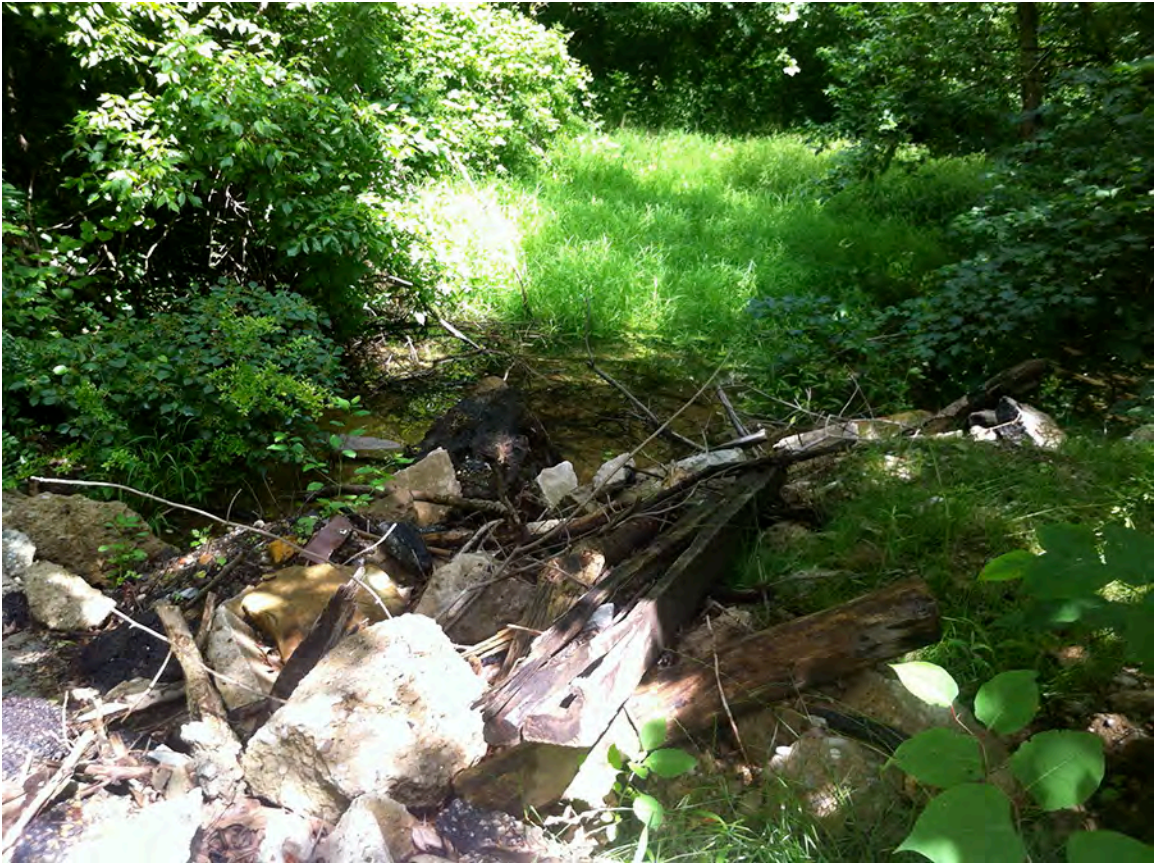
PF25 – Landowner pushing concrete rubble and other assorted debris into a wetland along the Montour Trail downstream of the new Montour Trail bridge crossing of Piney Fork east of Triphammer Rd.

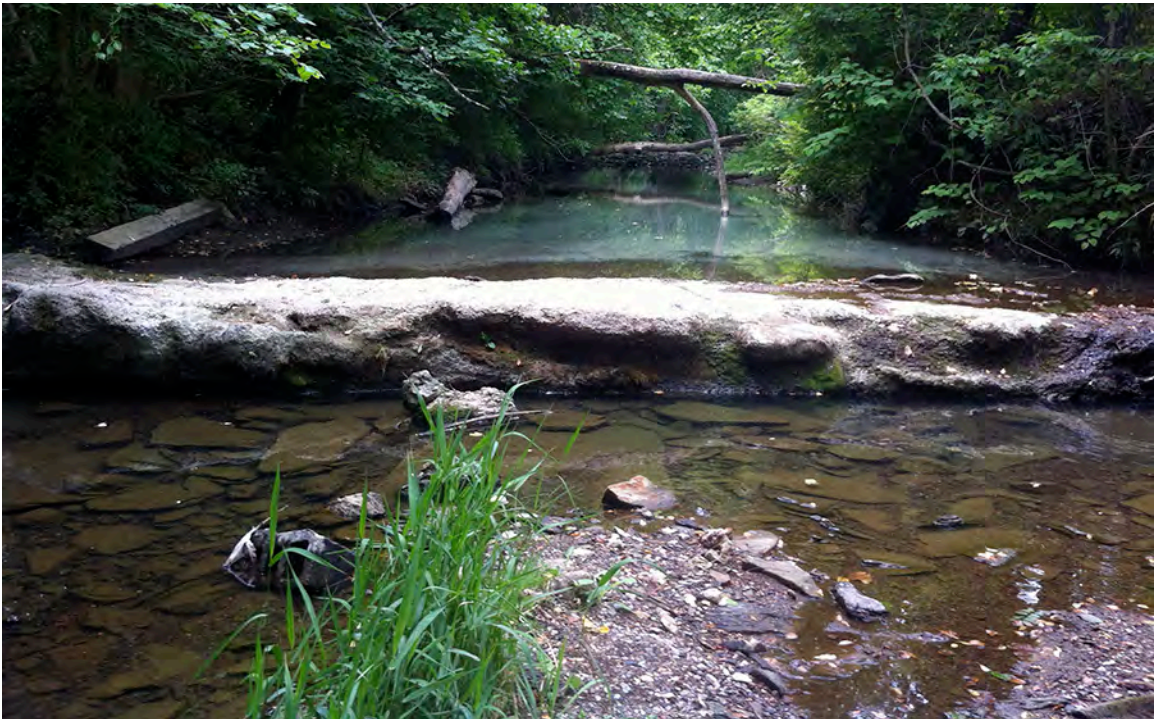
PF65 – a low dam across Piney Fork just below an AMD discharge near Cardox Road's junction with Brownsville Rd. The dam is most likely remnants of infrastructure associated with the Montour 10 Mine.

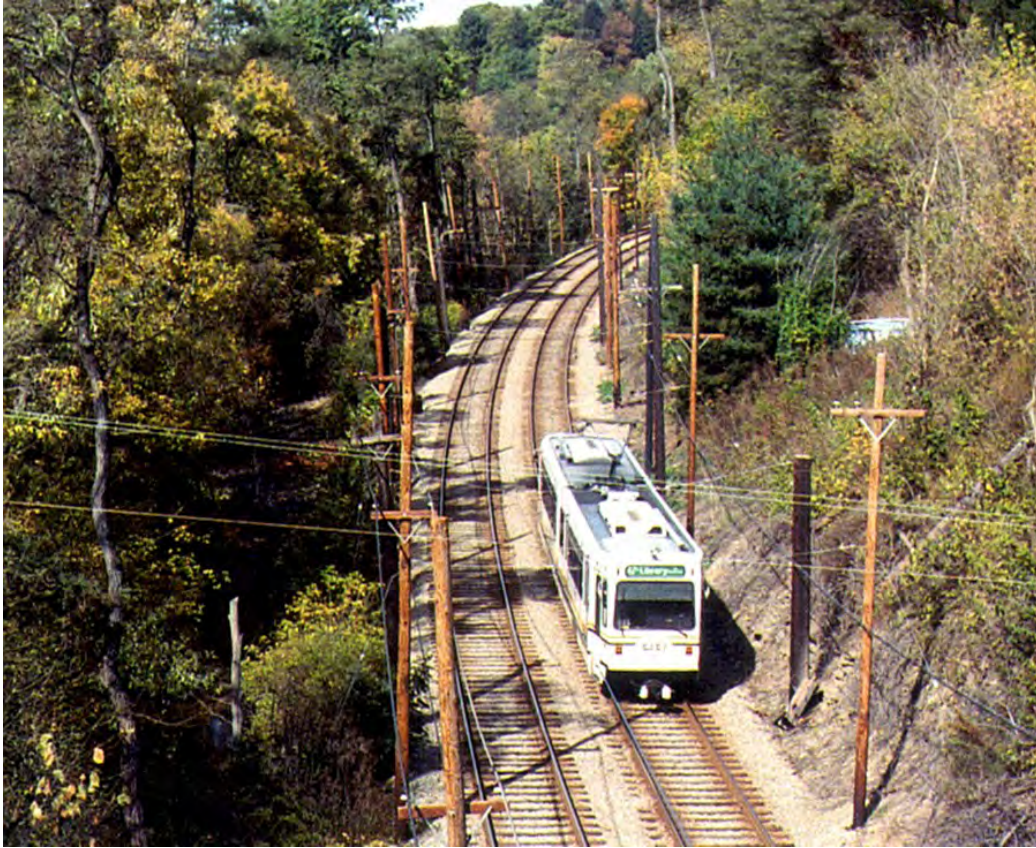
Allegheny County's Light Rail Transit tracks parallel Piney Fork and the Brightwood Road branch of Piney Fork for approximately 3 ¼ miles. The tracks encroach on the stream at a number of locations especially along the Brightwood Road branch with numerous crossings and culverts.

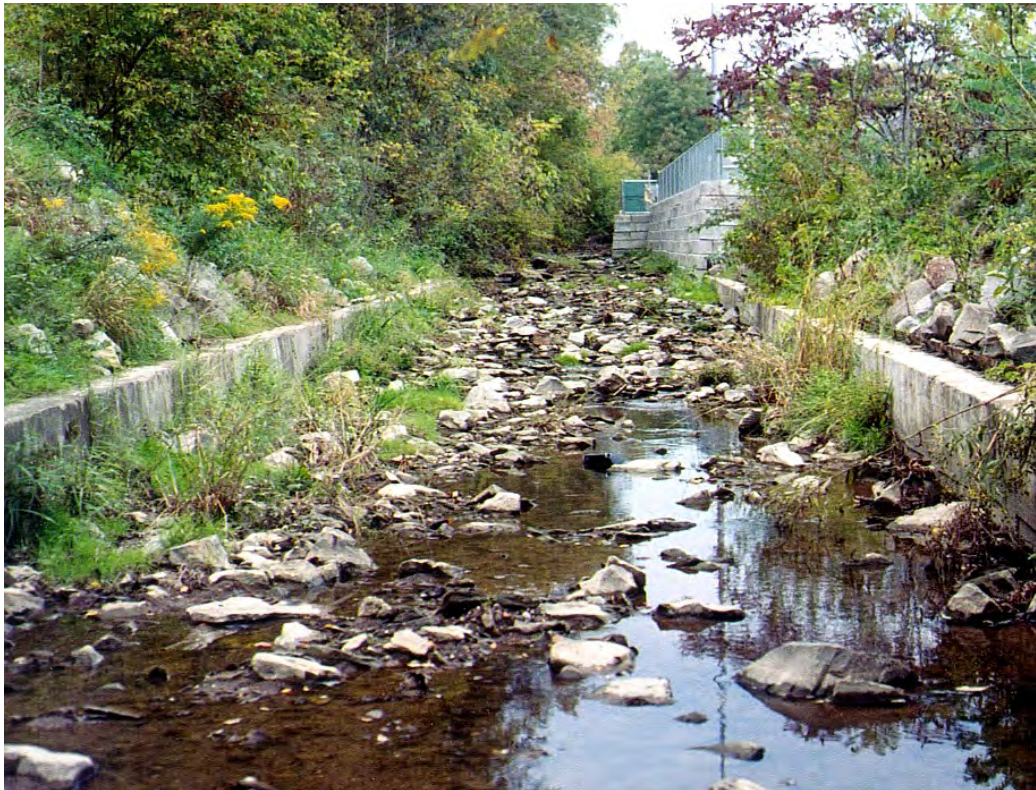
CRB03 – The Clifton Road branch of Piney Fork is channelized for approximately 120 feet at the lower end of Simmons Park. Severe bank erosion occurs downstream of the culvert.

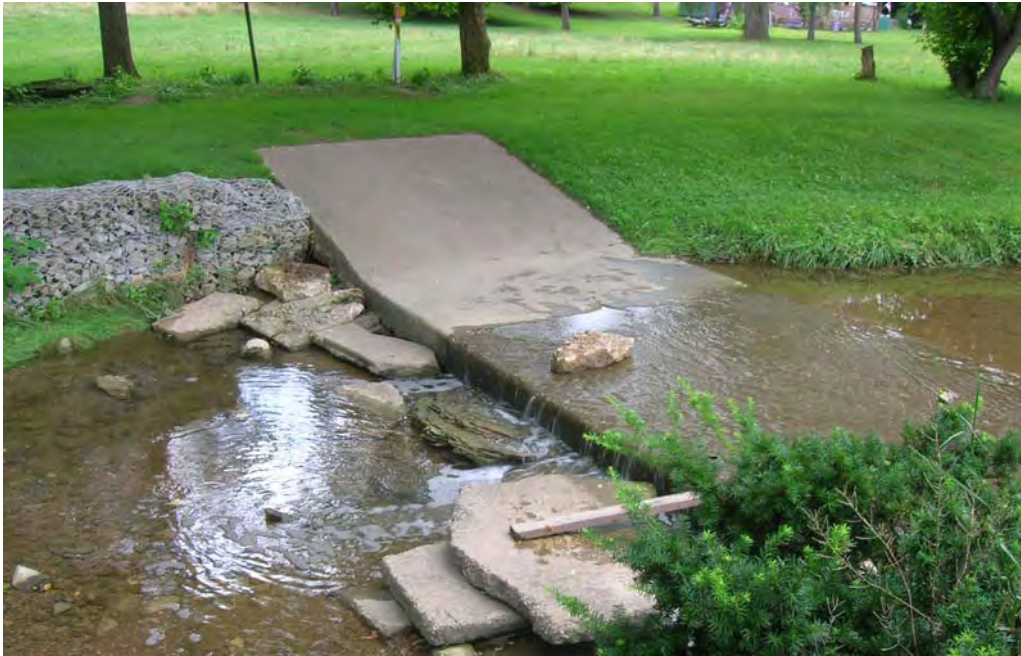
PF07 – A concrete access ramp across the Clifton Road branch of Piney Fork at Simmon's Park obstructs the stream channel, creates a fish barrier in the stream and accelerates erosion downstream of the structure. The left ascending bank of Piney Fork is gabion riprapped downstream of the ramp.

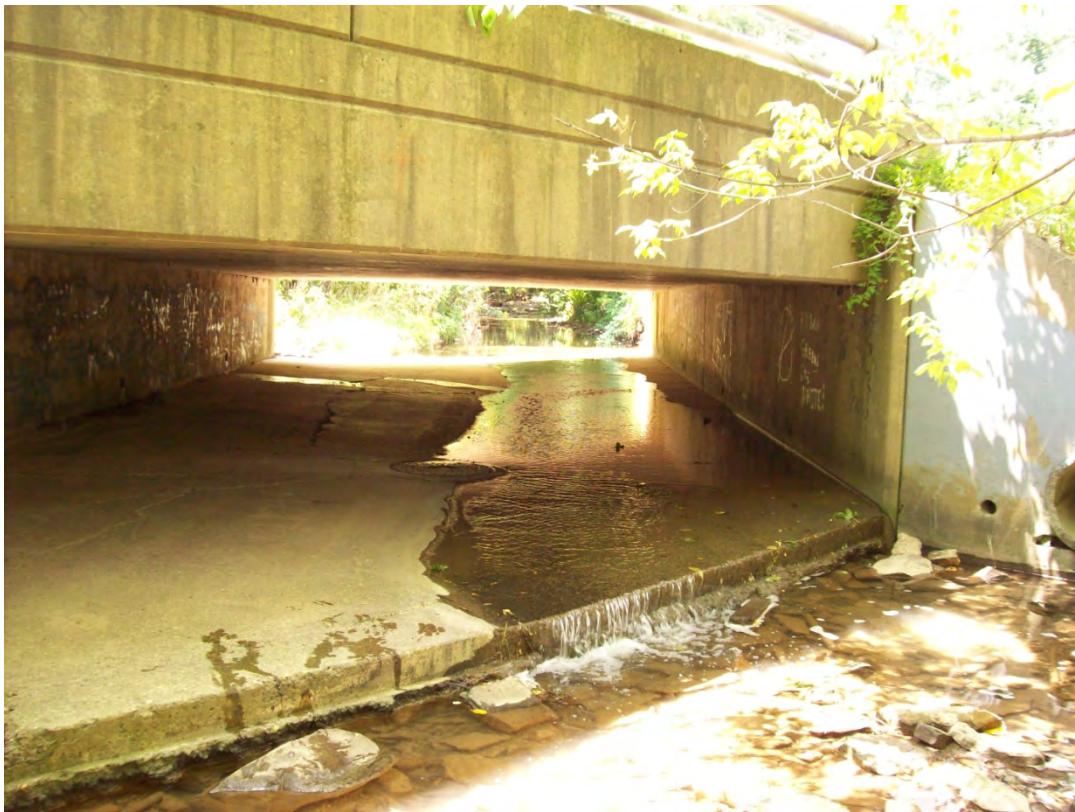
CRB16 – The Irishtown bridge over the Clifton Road branch of Piney Fork obstructs the stream channel and creates a fish impasse.

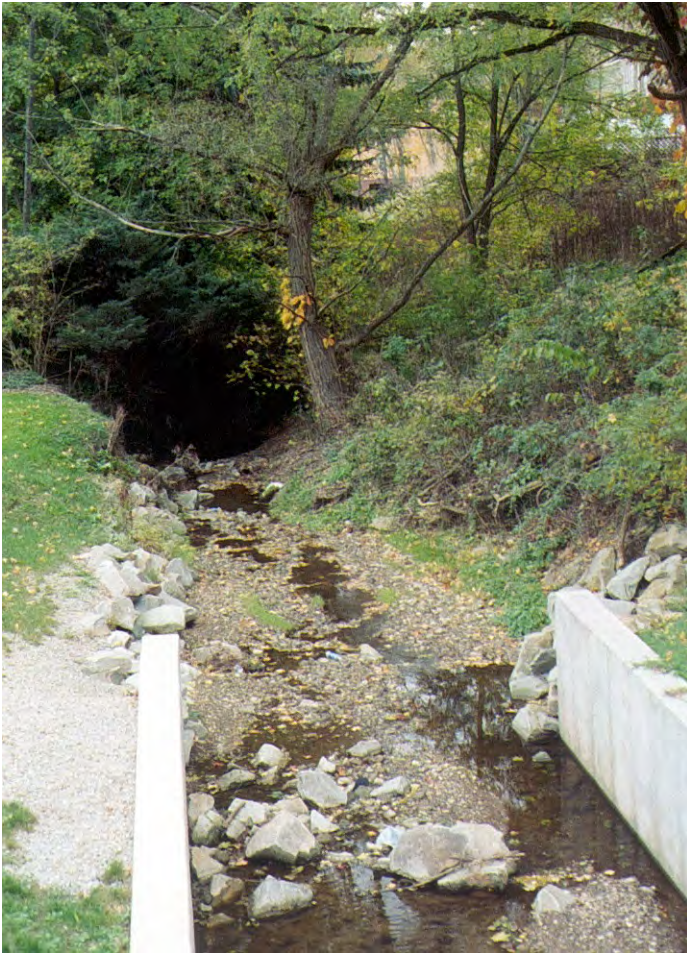
CRB28 – The Clifton Road branch of Piney Fork is channelized downstream of the culvert carrying Havengate Street over the stream. Severe erosion is occurring downstream of the channel and upstream of the culvert as well indicating that the culvert may be inadequately sized.

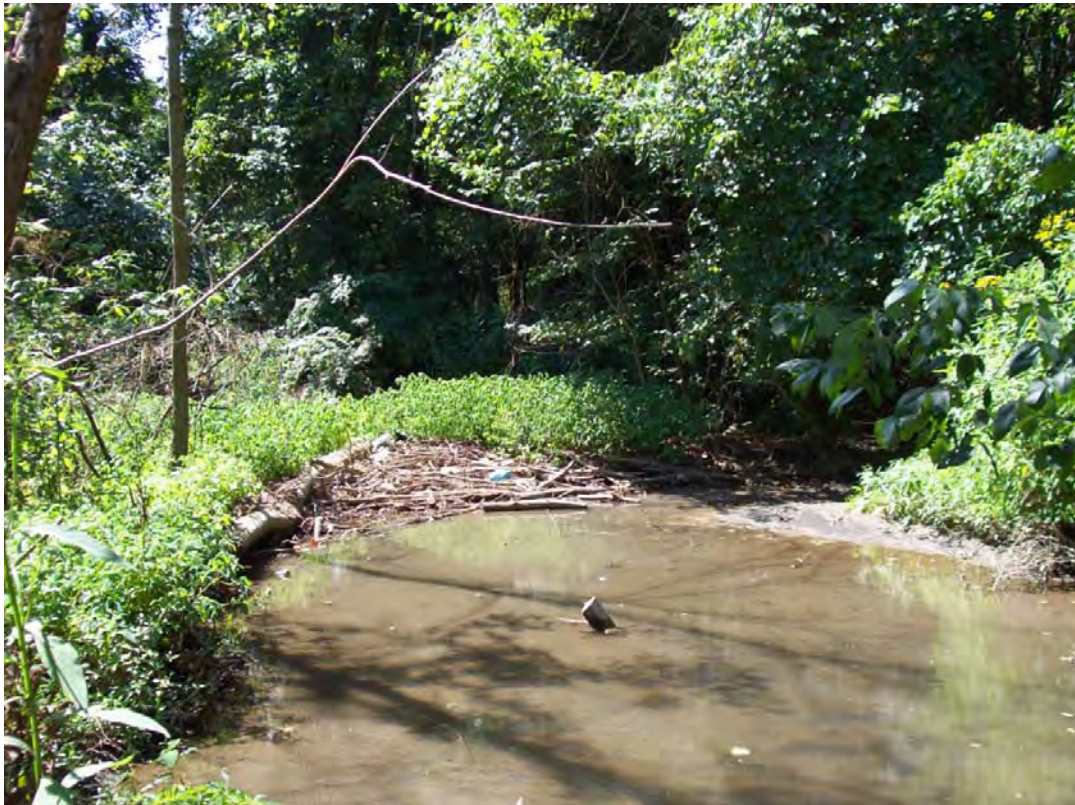
BRB14 – A debris jam along a 2000 foot long free flowing section of the Brightwood Road branch of Piney Fork through a woodlot downstream of the King's School Road crossing creates ponding and sediment build up.

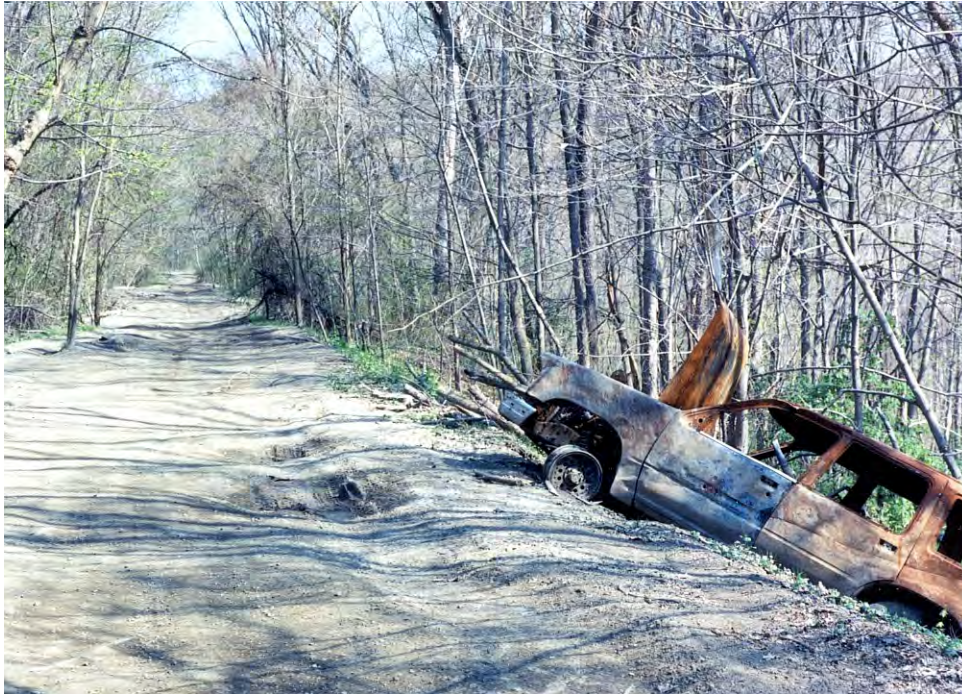
Illegal dumping of appliances, vehicles and all manner of garbage is a significant problem along the undeveloped portion of the Montour Railroad right of way from its junction with the Allegheny Valley Railroad tracks to the recently completed section of the Montour trail. Illegal dumping is also a problem along many of the off-road trails and ravines west of the right of way and along Piney Fork's left ascending floodplain upstream of Corvette Tunnel. The Tri-Community Anglers and South Park Township sponsor clean-up days during the year to keep the stream banks and local roads clear of trash. These have been quite successful and attract volunteers from a number of local organizations.

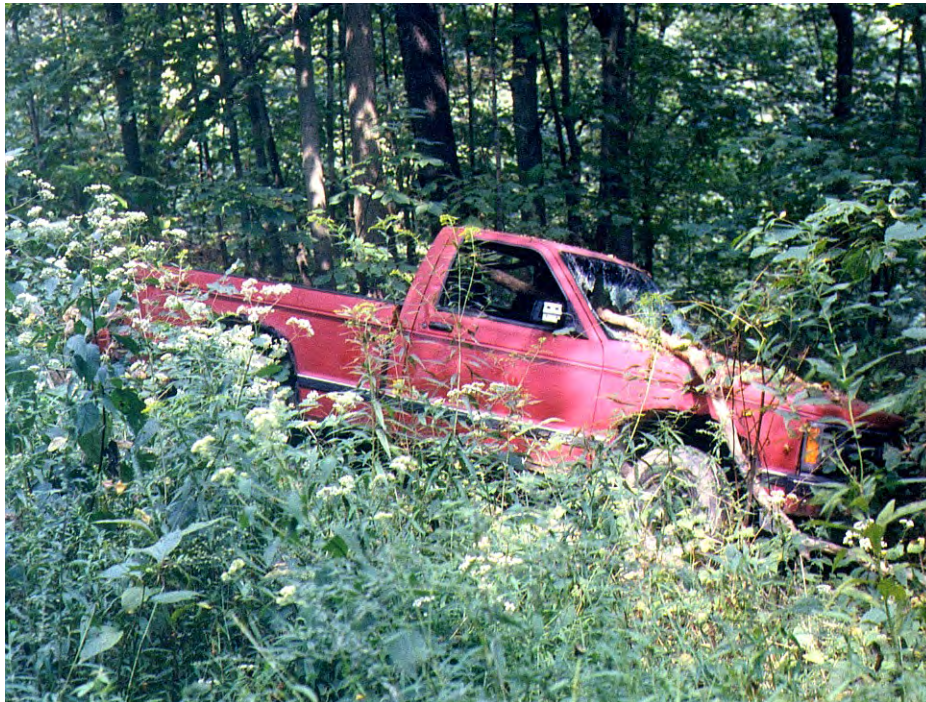
Illegal dumping of vehicles and other assorted garbage can also be found in the vicinity of Evans Park. Illegal dumping and littering occurs throughout the Piney Fork sub-watershed but appears to be a localized problem. Volunteers of the Montour Trail Council help to keep litter minimized along the trail which parallels Piney Fork for several miles from its confluence with Peters Creek to Library.

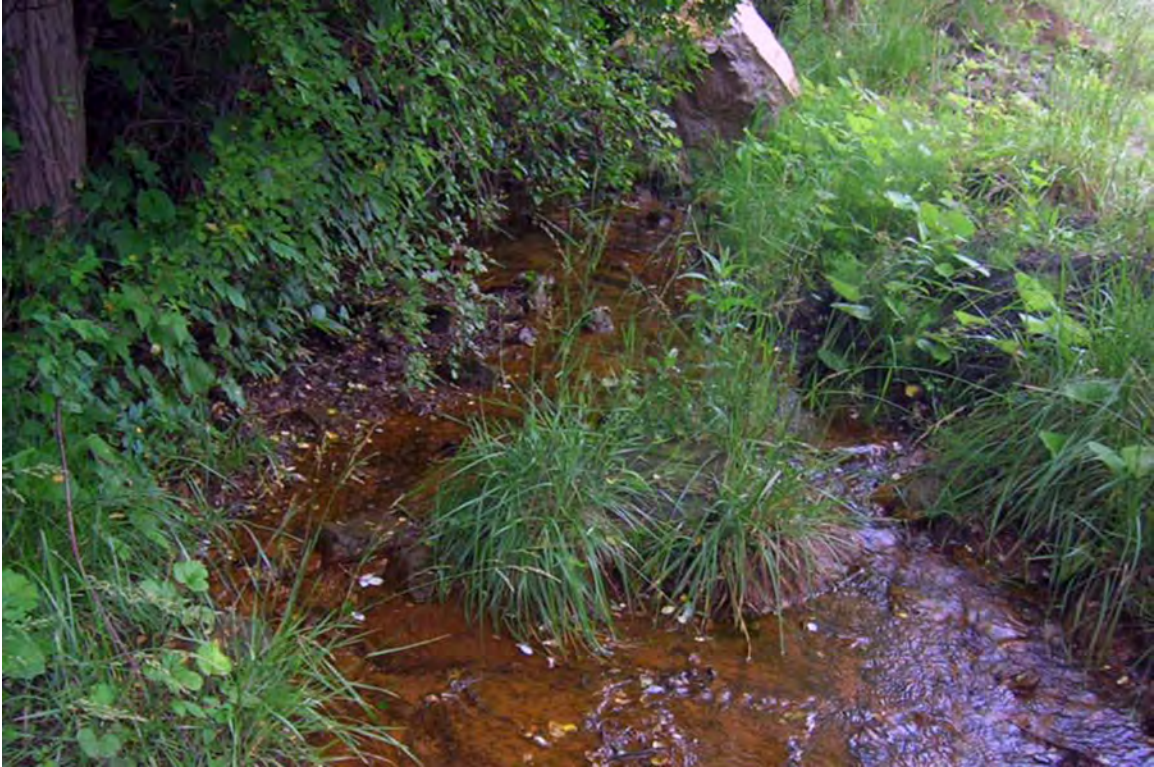
CR24 – The only significant abandoned mine discharge into Catfish Run starts in the very southern end of South Park County Park behind the fairgrounds and flows for approximately 600 feet behind the small commercial district immediately adjacent to the park along Brownsville Rd. A number of seeps and two significant discharges contribute to the flow prior to its entrance into Catfish Run just south of where Catfish Run exits the culvert under the commercial district.

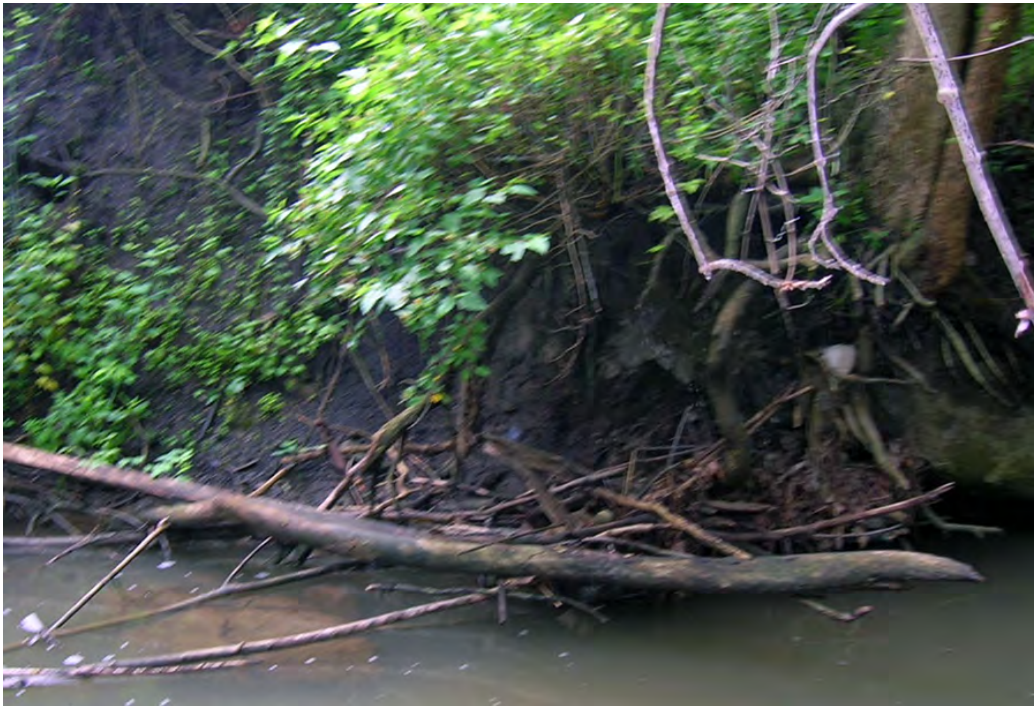
CR05 - Coal waste is being eroded into Catfish Run. The Gould Mine of the Bertha Consumers Fuel Company operated in the lower Catfish Run valley during the early part of the 20th century and created two large coal waste piles along the stream.

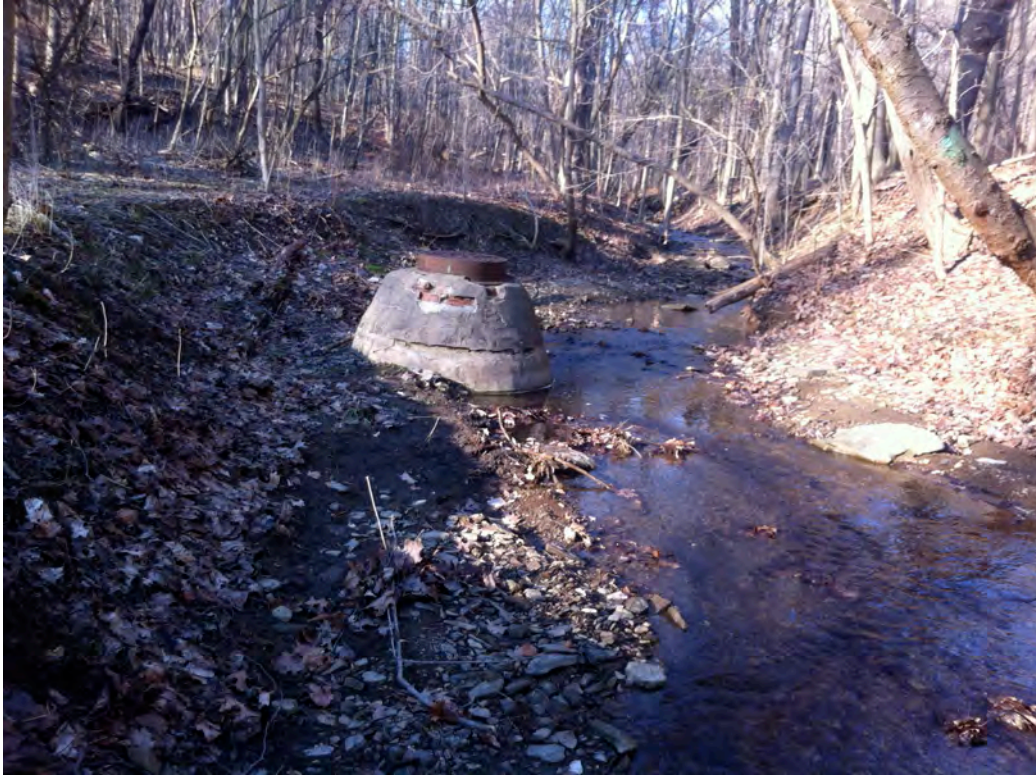
CRT06 – Catfish Run was found to be impaired for recreational use during a 2010 bacterial study. The bacteria level exceeded PA standards on 7 of the 10 samples retrieved during the summer sampling period. The exact cause of this impairment remains unknown and may be due to a number of factors. Excess algal build up was present in proximity to this sanitary sewer manhole along the East Branch Tributary of Catfish Run along East Park Drive. Another sanitary manhole is located within the channel of Catfish Run at Schoonmaker Hall (CR26) in the fairgrounds of South Park County Park.

Catfish Run was found to be impaired for recreational use by pathogens during a 2010 bacterial study. The source of this impairment is not known. It is important to identify the source and to eliminate it if possible since the stream is a regional recreational resource as it flows through South Park County Park. Regular inspection and maintenance of sanitary sewer infrastructure both within and upstream of South Park is imperative in order to mitigate bacterial load within the stream.
