Peters Creek Watershed Assessment & Management Plan

April 2014

1.0 PETERS CREEK WATERSHED BACKGROUND

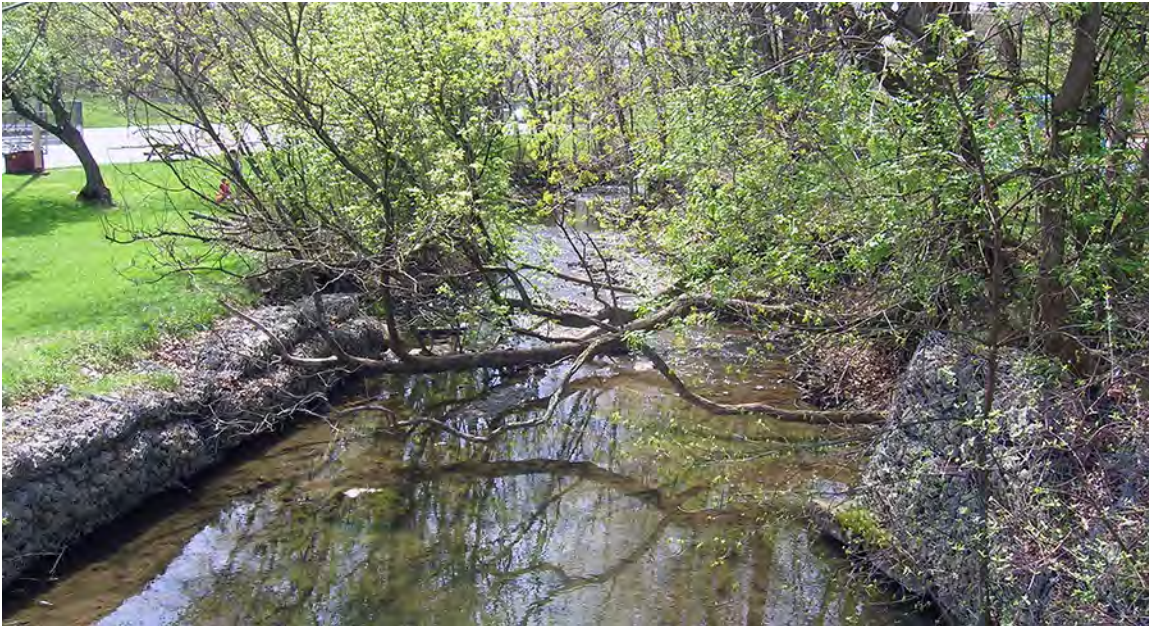
CR42 - Stream bank erosion is a recurring theme for Catfish Run along Corrigan Drive and along the East Branch Tributary as well. The stream is culverted under numerous roads and often the culverts are not sized correctly leading to severe bank erosion just downstream of the culvert. Gabioned rip-rap is utilized to protect the stream banks at many locations including the one depicted in the photo above at the Deck Hockey facility. This method of treating the symptoms of the problem has many shortcomings. It is aesthetically unappealing, often creates bank erosion downstream of the rip-rapped area, becomes undercut and requires long-term maintenance.

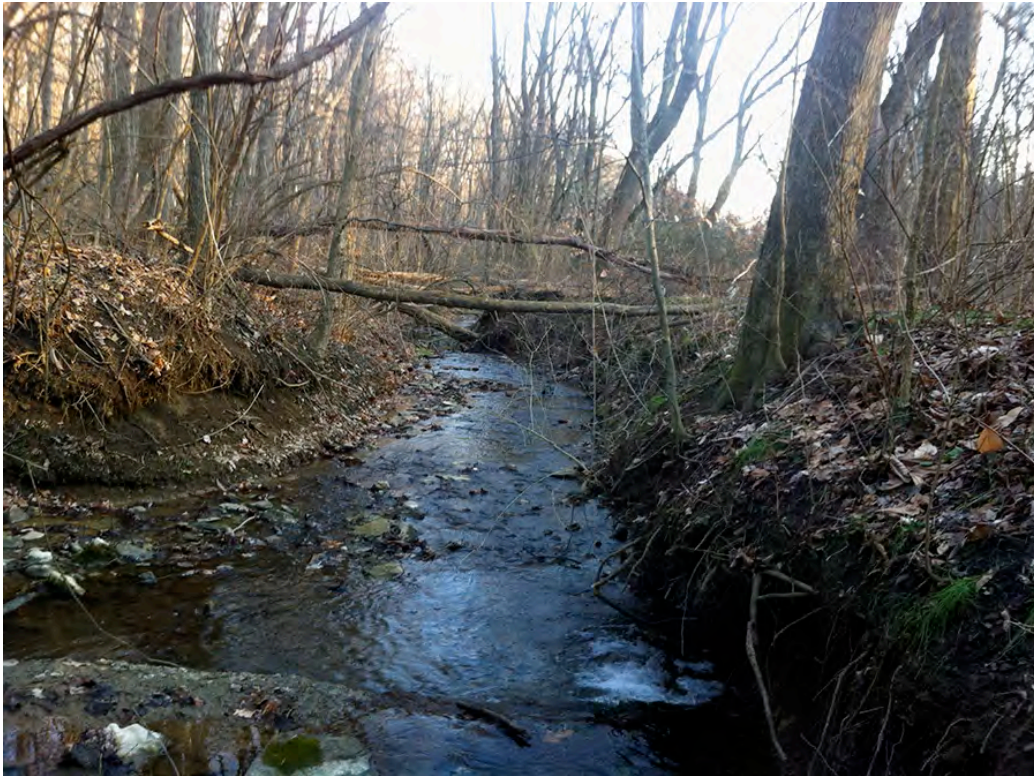
CRT17 - Severe bank erosion and undercutting along the East Branch of Catfish Run just downstream of the road connecting East Park Drive and Hundred Acre Drive. A small tributary in a deeply incised channel enters the East Branch on its right ascending bank (left foreground in photo). The channel carries excess storm water from the South Park Golf Course during precipitation events.

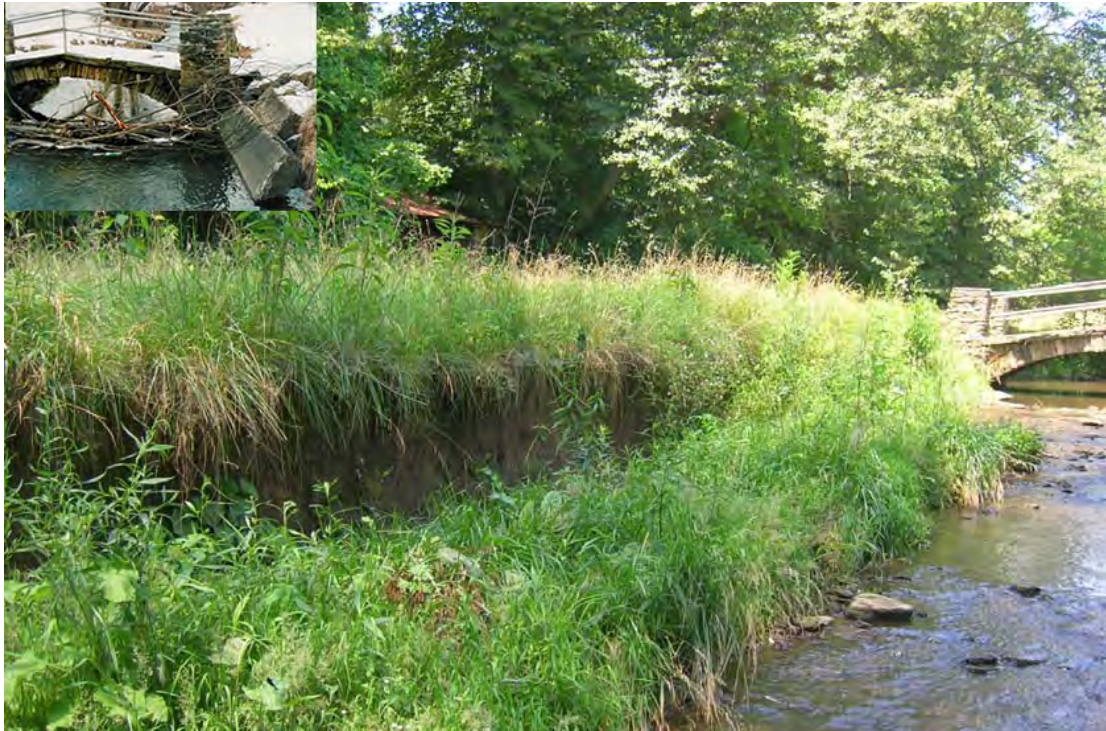
CR35 - Bank erosion downstream of a historically significant pedestrian bridge crossing Catfish Run between the soccer fields and Corrigan Dr. Catfish Run is effectively channelized along Corrigan Drive from the circle to the fairgrounds and is not permitted to meander as a stream normally would. Stream meanders dissipate energy during severe rain events and mitigate erosion. Inset shows bank erosion just upstream of the bridge.

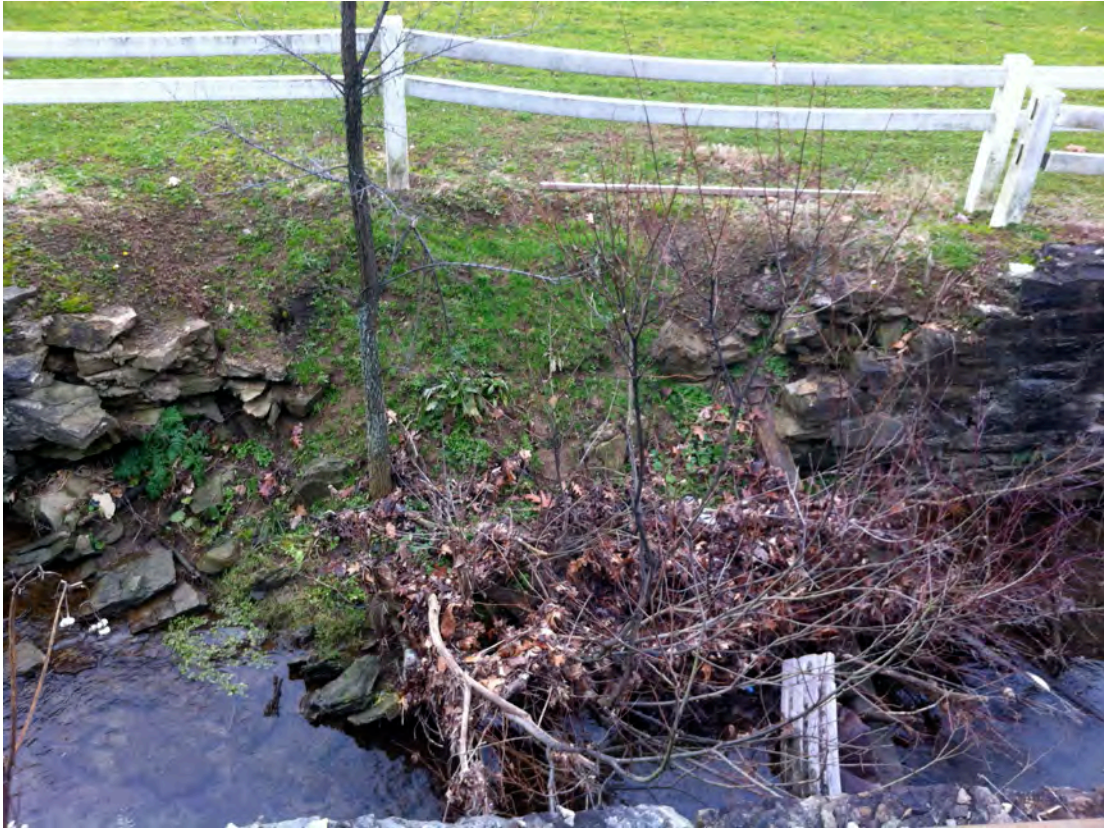
CR28 - Severe bank erosion along the channelized portion of Catfish Run at the fairgrounds has eroded away part of the retaining wall.

A South Park Fairgrounds Master Plan was completed in 2011. The plan was developed over the course of a number of years and involved a good deal of community input. The final recommendations included a long-term plan to decrease the impervious surface area of the Fairgrounds and to return it to a more natural state while maintaining the same amount of area for ball fields. The plan also recommends removing Catfish Run from the channel and returning the stream to a free-flowing state. These recommendations should be implemented.

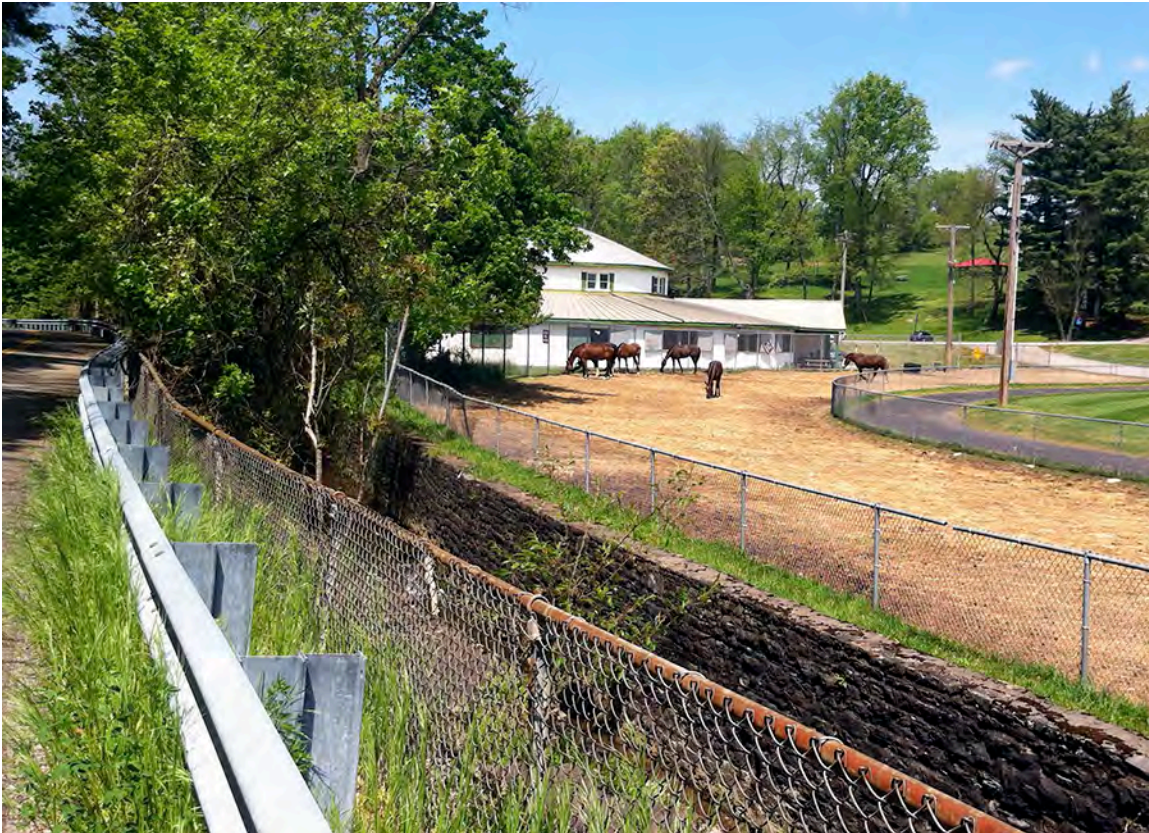
CR29 - Runoff from animal use areas and manure storage facilities along streams can increase the nutrient load within the stream especially when animals have access to the stream and the facilities are not maintained adequately. This animal use area is along Catfish Run at the fairgrounds along the channelized portion of the stream.

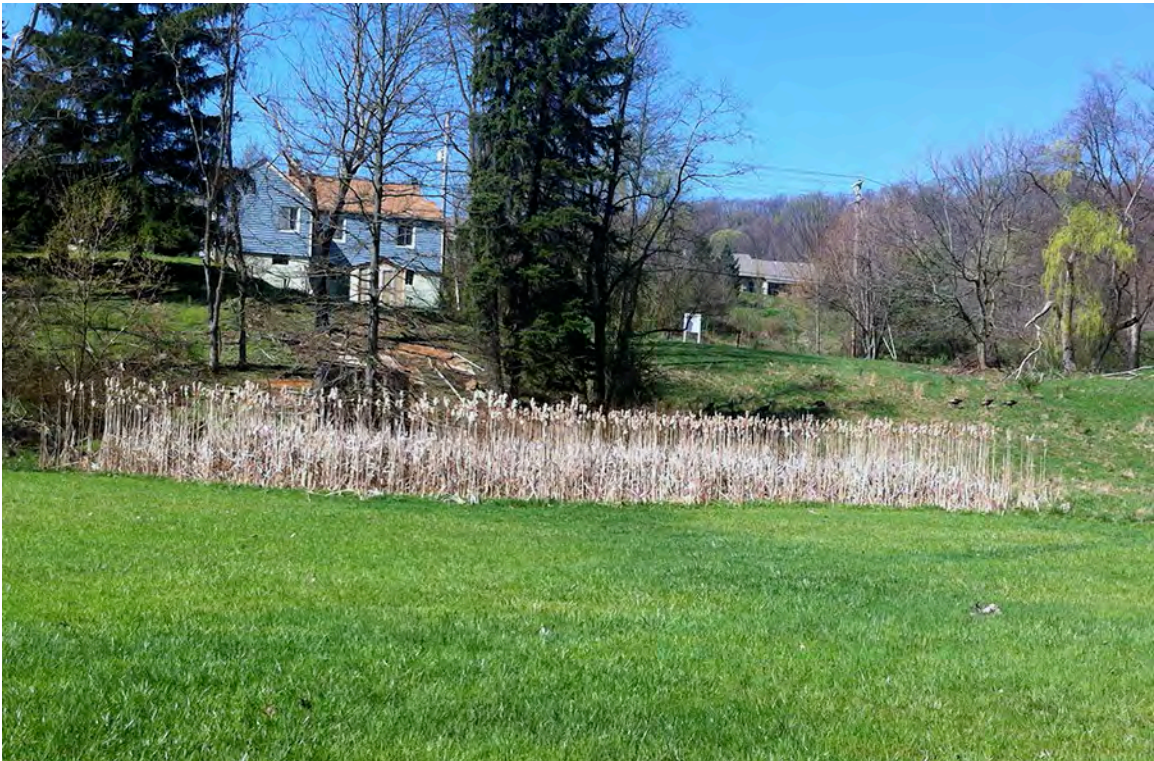
CR17 – A small wetland within Catfish Run's left ascending bank floodplain south of South Park County Park along Brownsville Rd. Floodplain drains to Catfish Run via a drainage ditch and the remainder of the floodplain is mowed with little wooded buffer along Catfish Run along this section.

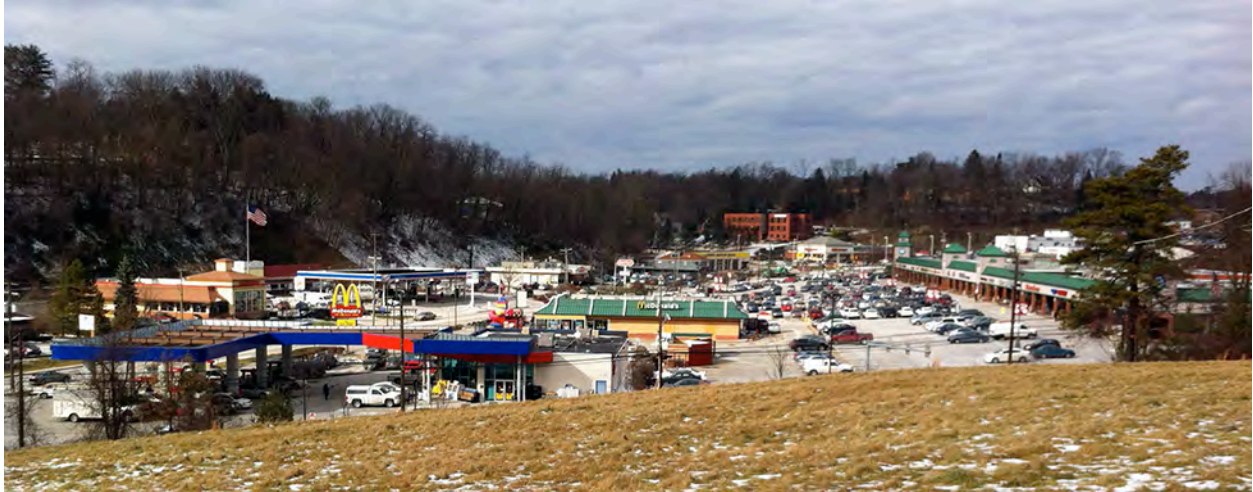
CR62 - The headwaters of Catfish Run's main stem are culverted under this commercial district along State Rt88 in Bethel Park. The stream is first daylighted in South Park County Park along Corrigan Drive.

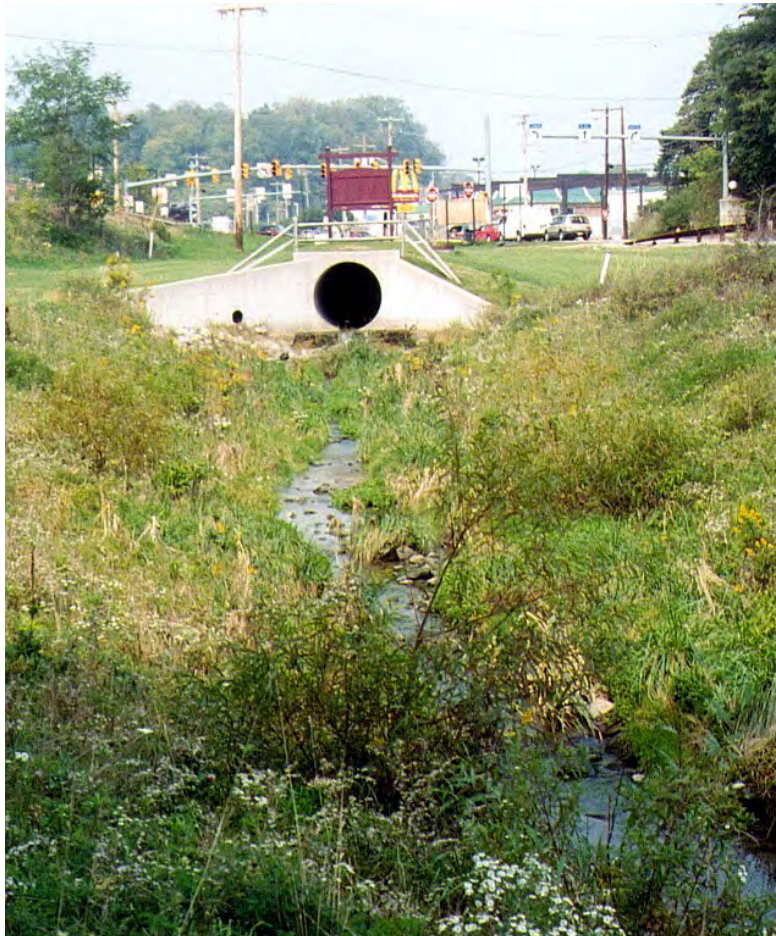
CR61 - Catfish Run exits the culvert near the South Park County Park's northern entrance. This photo was taken in approximately 2006. Subsequently, a riparian buffer was installed along 1200 feet of Catfish Run from the culvert to near the ice skating rink.

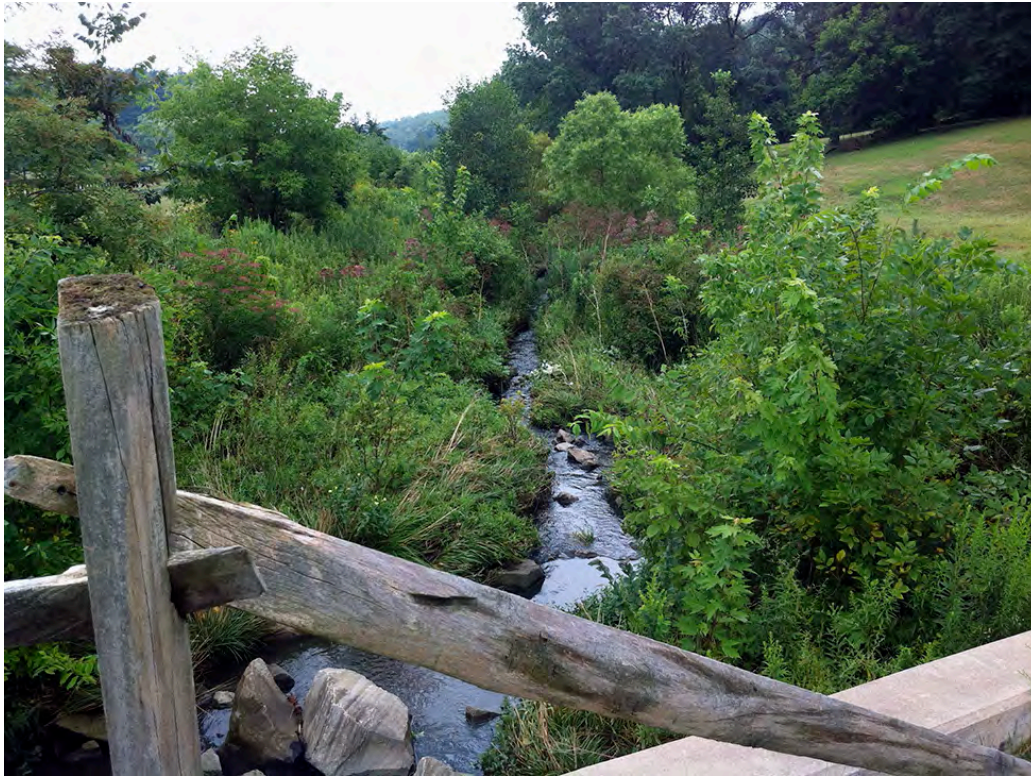
CR61 – This is a recent photo illustrating how well the riparian buffer is developing. This buffer helps to mitigate stream bank erosion during high water events and helps to maintain water quality within the stream. A recommendation of the Allegheny County Parks Comprehensive Master Plan of 2002 was to develop and maintain vegetated riparian buffers along all park streams. This provides a good start for South Park County Park. There are a number of other areas in the park that would benefit from installation of adequate vegetated buffers along both Catfish Run and Sleepy Hollow Run.

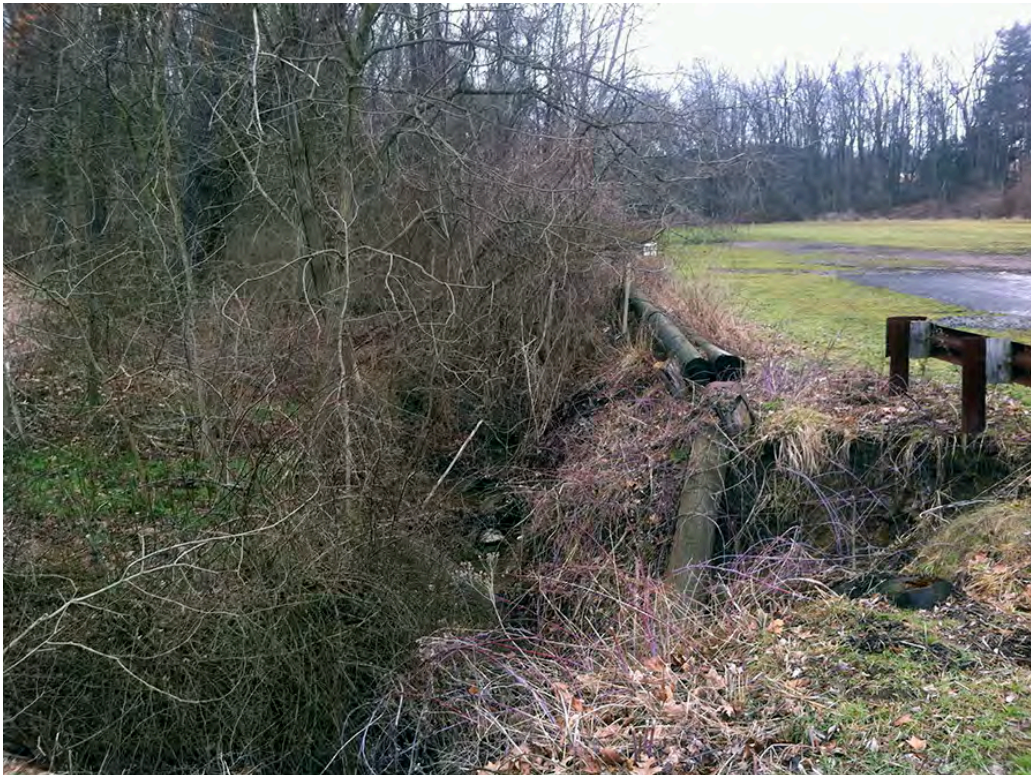
CRT29 – A fairly typical view of the East Branch Tributary and surrounding floodplain north of Hundred Acre Rd. The floodplain is choked with invasive plants and vines and the stream banks are eroding.

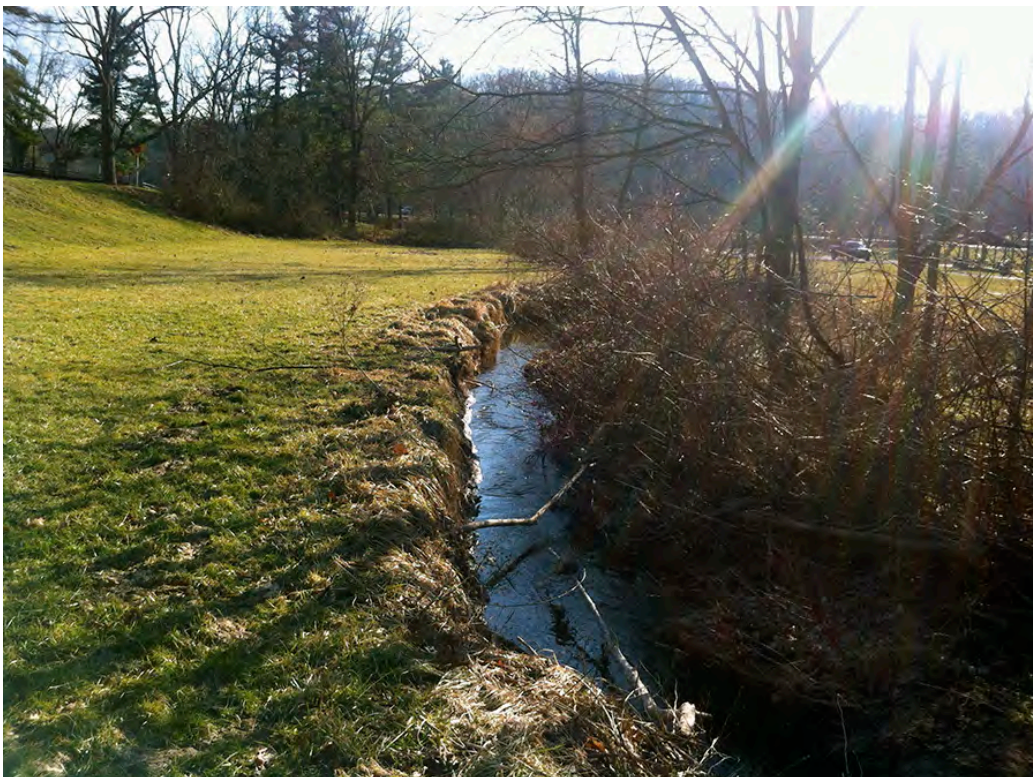
CRT05 - There are a number of areas along the East Branch of Catfish Run that have inadequate vegetative buffers such as this riparian zone along Grant Grove just north of the Oliver Miller Homestead.

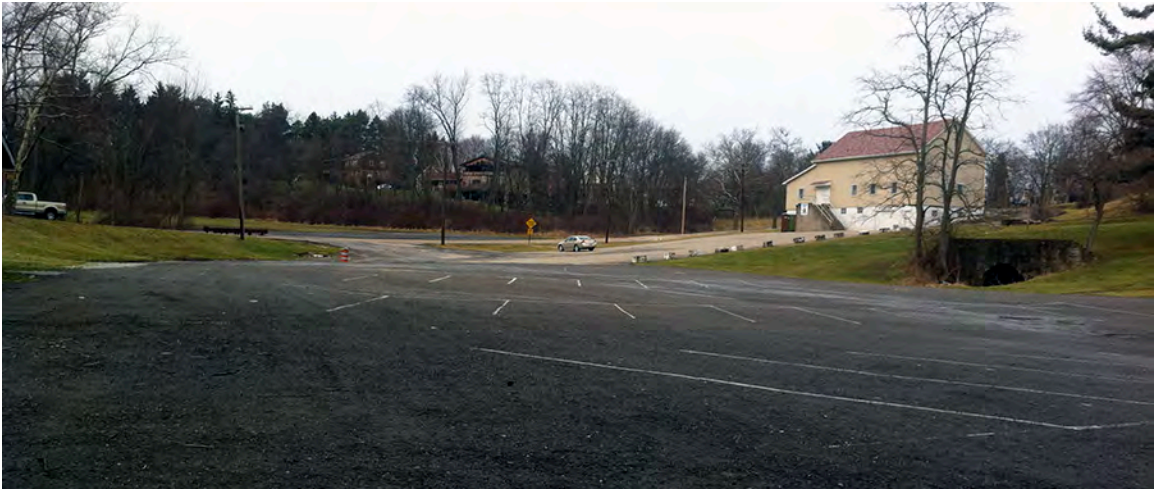
CRT27 – Catfish Run's East Branch Tributary is culverted for approximately 700 feet under this asphalted parking area and the Haunted House facility. A structure holding a natural spring can be seen to the right of the parking area. The spring flows into the East Branch under the culvert. The East Branch initially enters the culvert just north of Hundred Acre Drive.

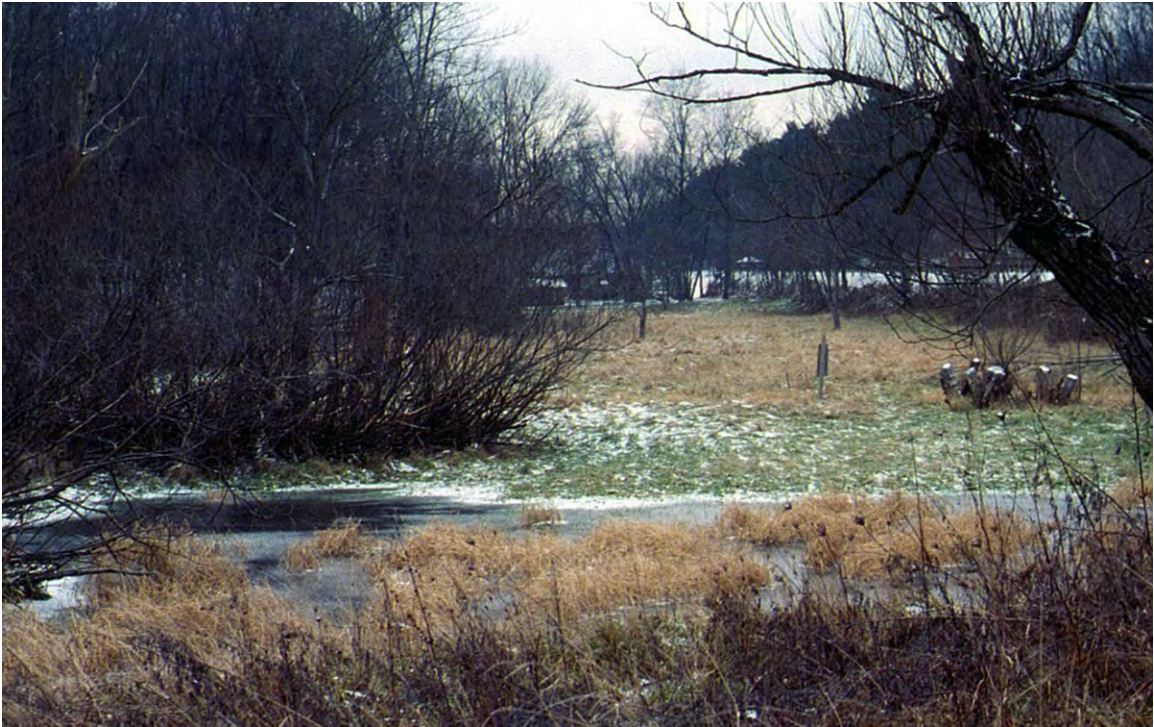
CR50 – Typical view of the main stem of Catfish Run's right ascending floodplain from the Corrigan Circle north to the VIP Zone. The riparian zone is naturally vegetated along this reach of Catfish Run. The right ascending floodplain is mostly wetland and the left ascending bank is comprised of wooded slope. The left ascending bank remains wooded to the ice skating rink and the right ascending bank becomes approximately 8 acres of impervious parking and recreational area.

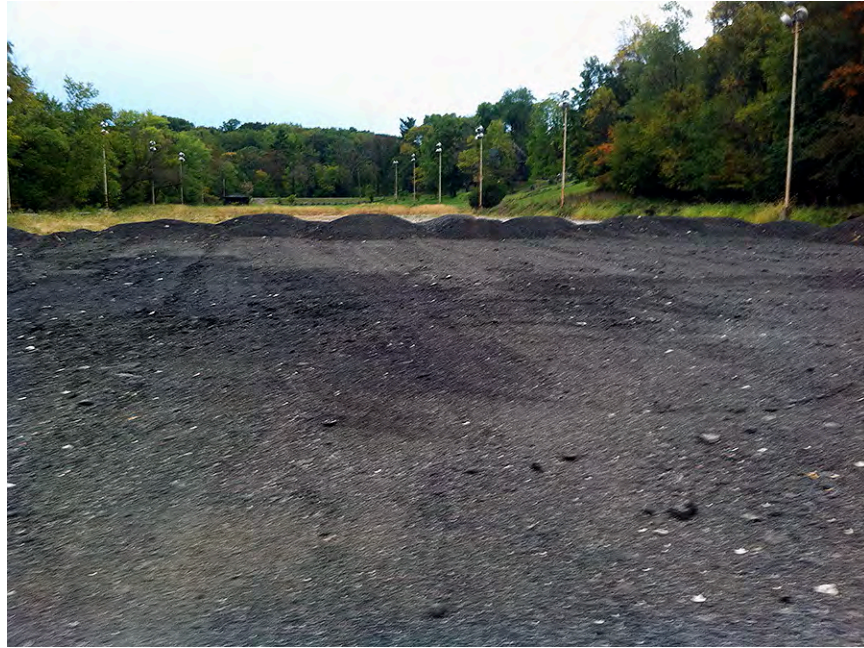
CR43 – A view of Catfish Run's right ascending floodplain from the Deck Hockey parking area toward Old Manse Drive. Catfish Run flows along the left side of the photo immediately behind the light poles. The Oliver Miller Homestead area is above the floodplain to the upper right. The tennis courts were recently removed from the floodplain to another part of the park. It appears that asphalt millings are being installed over the old tennis court area. The tennis courts encroached on Catfish Run and created problems with erosion. Now that they are gone the vegetated buffer along Catfish Run's right ascending bank should be improved and a thoughtful plan developed for this area that adequately buffers the Oliver Miller Homestead from incompatible activities.

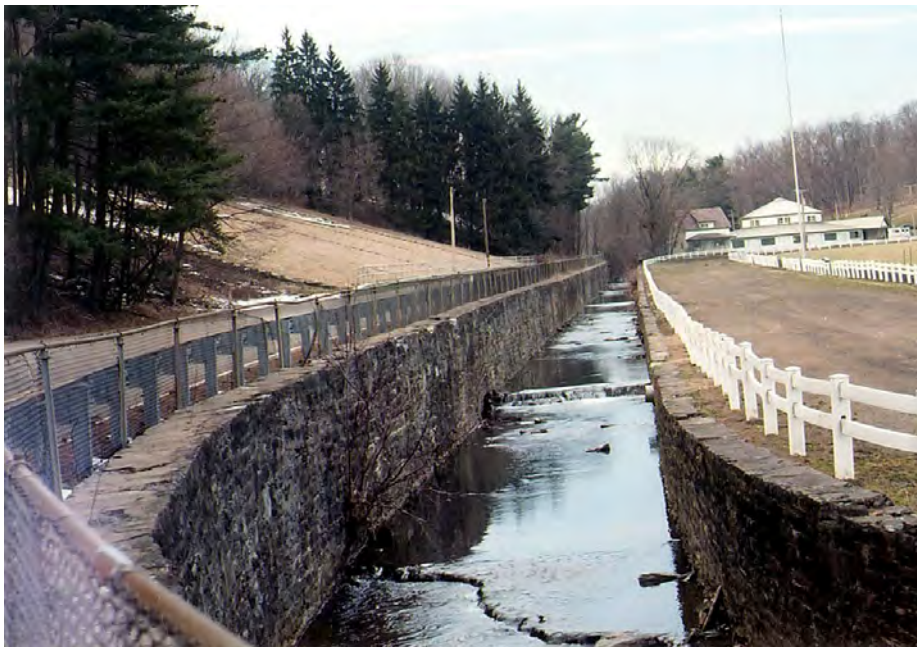
CR28 - Catfish Run is channelized for approximately 1000 feet along the fairgrounds fields and then is immediately culverted for 225 ft under a parking area. Recent plans to upgrade the fairgrounds area include options to naturalize Catfish Run along this area. The riparian zone is clearly in need of improvement.

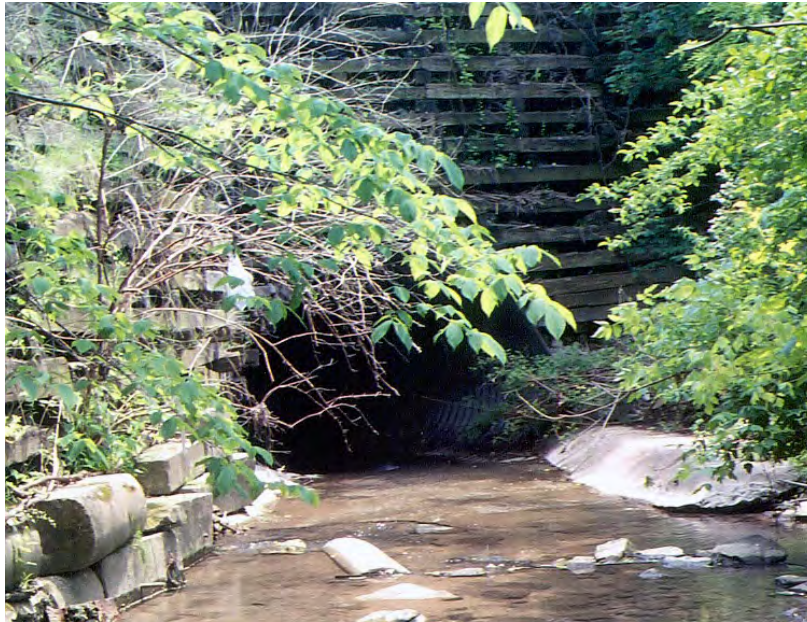
CR25 – Catfish Run exits South Park County Park via a 550 foot culvert under a commercial district just to the south of the park. Prior to entering the culvert the stream flows along and is constrained by Schoonmaker Hall then passes through a small wooded area behind the fairgrounds buildings. The wooded area has some issues with invasives as well as abandoned mine drainage on the slope above Catfish Run’s left ascending bank. The right ascending bank in this area is steep and has some erosion issues.

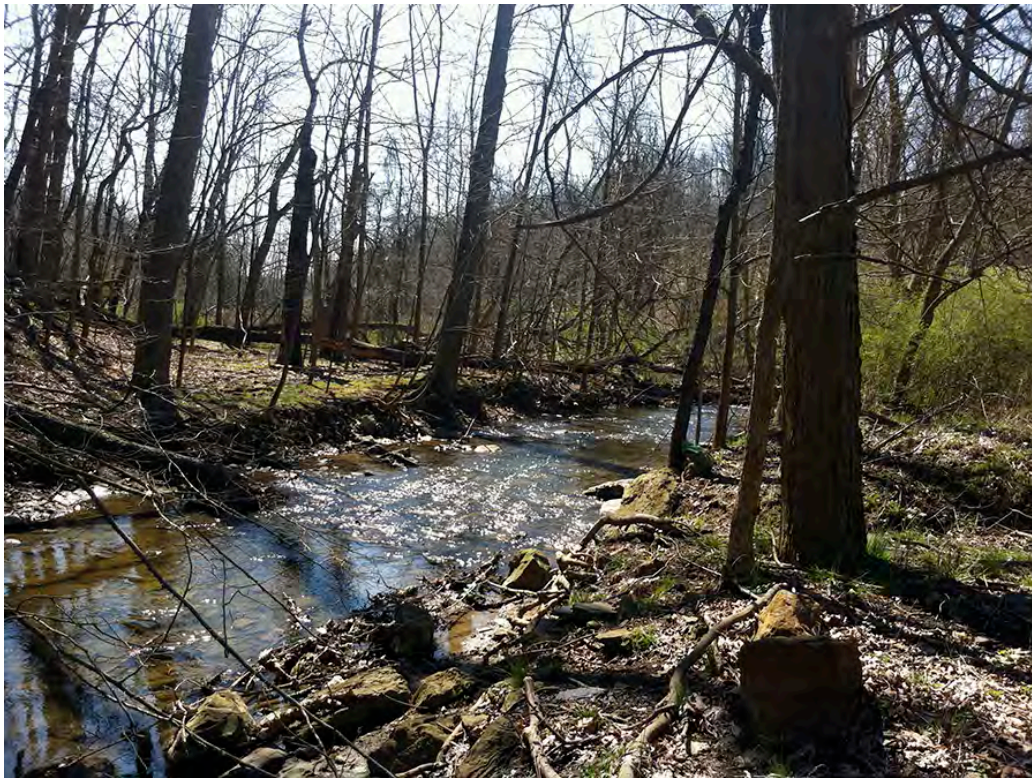
CR13 – Upon exiting the culvert at CR23 Catfish Run flows for 400 feet along the west side of Brownsville Rd and then is culverted to the east side of the road. It then flows between a steep slope along the western side of South Park High School and a commercial and residential area along Brownsville Rd. In this area the wooded buffer along Catfish Run would benefit from widening. The stream would also benefit from foresting the entire steep slope along the high school. From about CR13 to Wallace Rd, Catfish Run meanders through a naturally vegetated area. There are some issues with invasive plants at this location. South of Wallace Rd Catfish Run flows for approximately ½ mile through a naturally vegetated valley with steep forested slopes along the left ascending bank and wetland along the right ascending bank with a townhouse development at the top of the slope. Evidence of an old mining operation is present in the lower valley just north of Piney Fork Rd. South of Piney Fork Rd Catfish Run flows under the Montour Trail prior to entering Piney Fork Run just upstream of the Piney Fork Sewage Treatment Plant outfall.

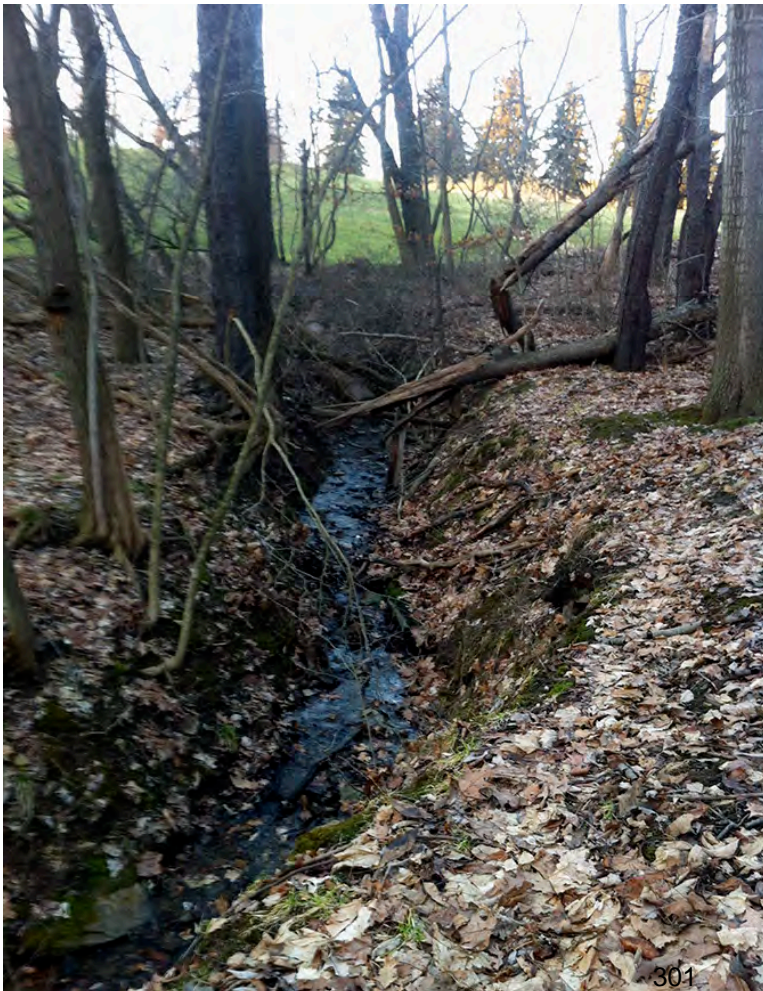
CRT19 – This is a drainage channel from the South Park Golf Course. The channel has become incised and delivers large quantities of storm water runoff to the East Branch of Catfish Run.

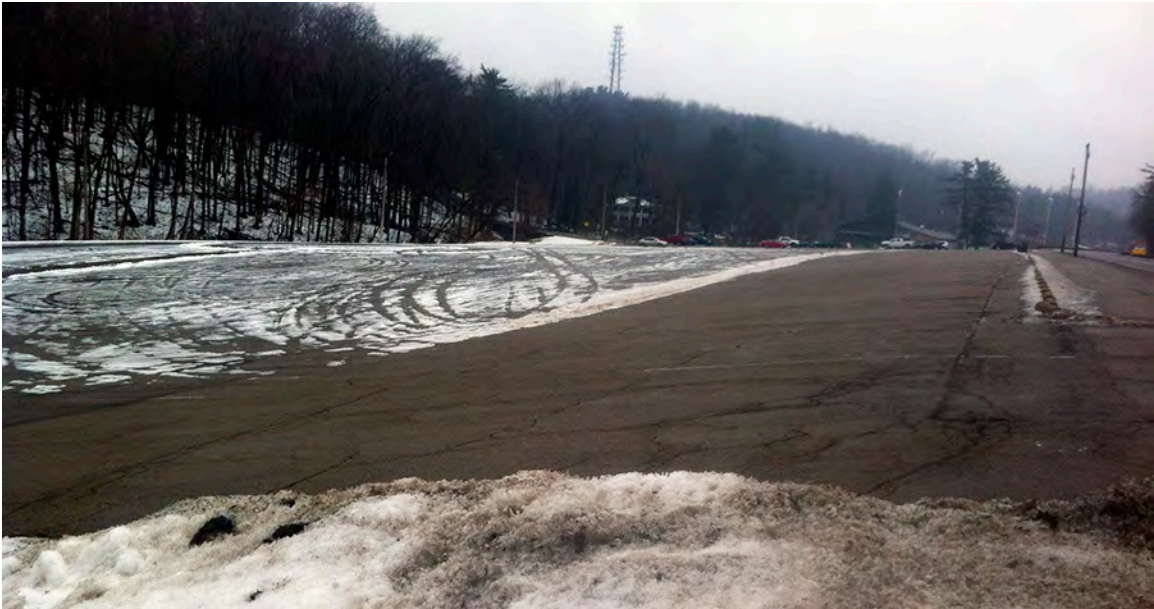
CR53 – Catfish Run flows along the bottom of this 4.5 acre asphalted parking lot between the South Park Ice Skating Rink and the VIP Zone. There is little vegetated buffer between the asphalt and the stream. Storm water runoff from this lot and from the adjoining impervious surface (~ 3.5 acres) of the VIP Zone during heavy precipitation events contributes to Catfish Run’s storm water problems.

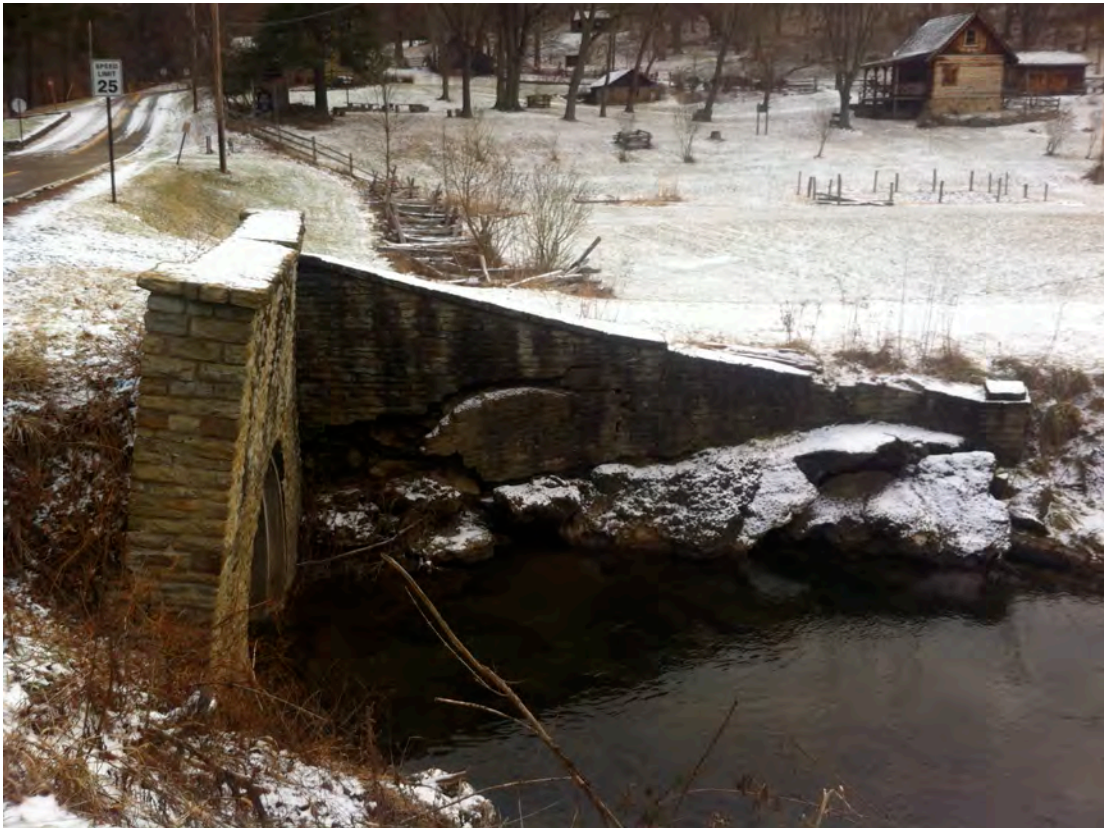
CR48 - Inadequate control of storm water leads to excess erosion downstream and damage to infrastructure such as this culvert headwall and wing wall at Stone Manse Drive.

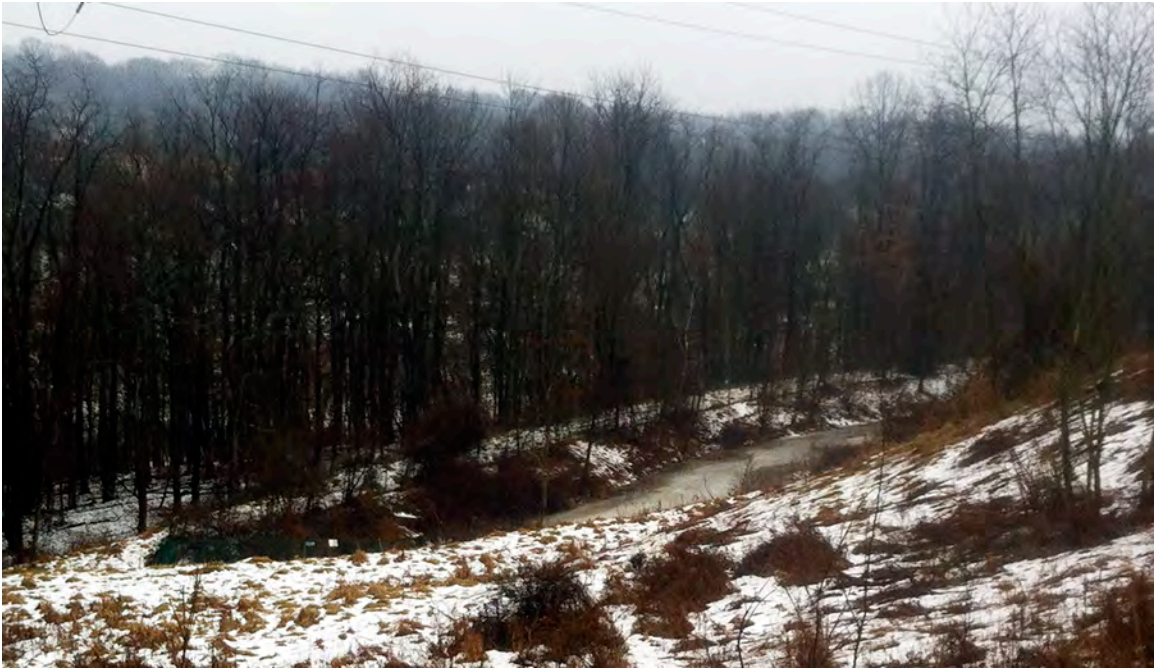
CR64 – A view of the stormwater detention basin associated with the Parkford Apartments off of Brownsville Rd. Catfish Run flows at the bottom of the steep wooded hillside behind the detention basin.

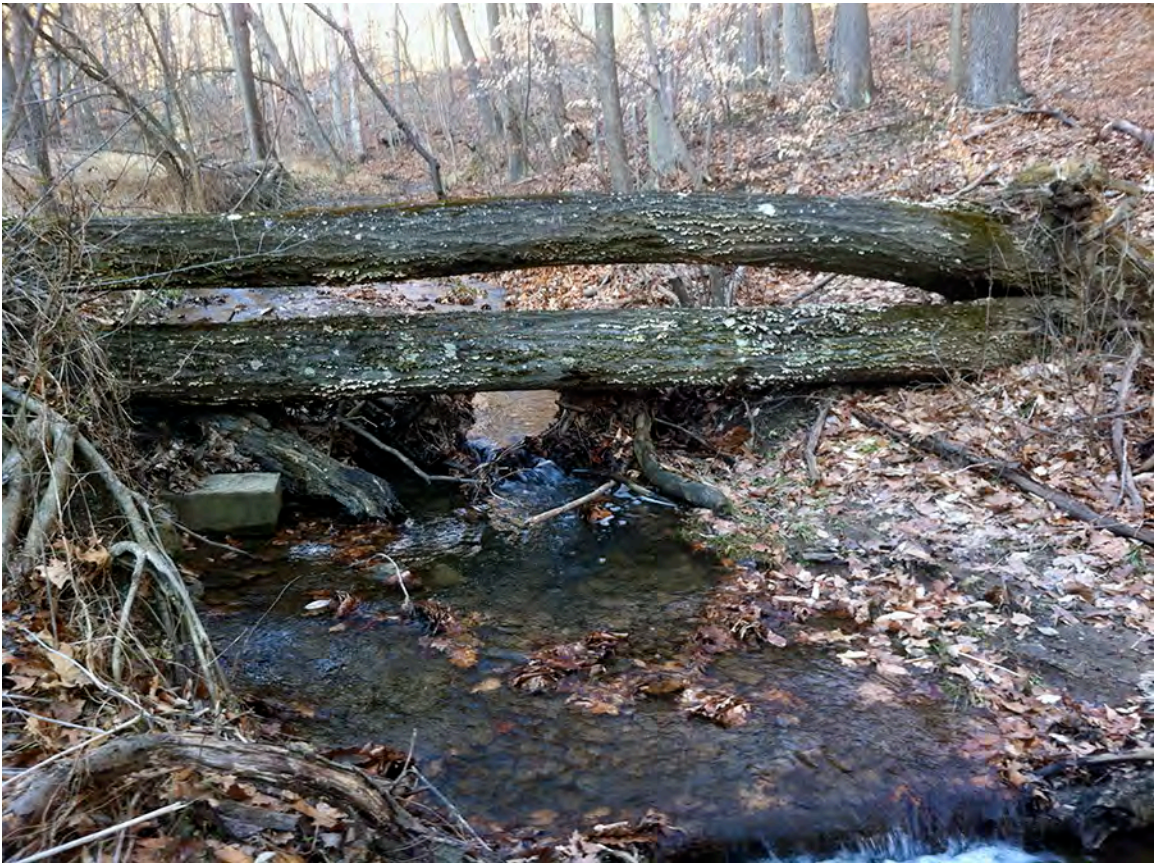
CRT13 – Fallen tree creating a debris jam that is encroaching on the stream channel of the East Branch of Catfish Run.

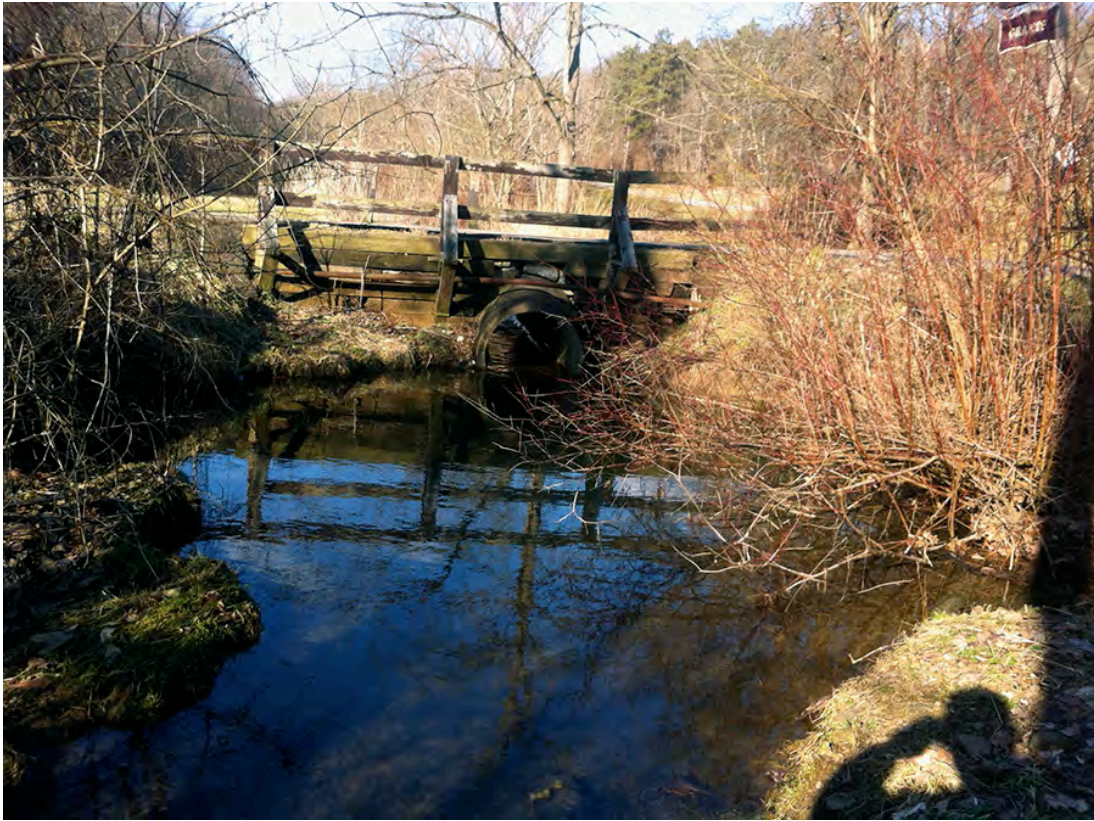
CRT03 - Improperly sized culvert at the access road to Grant Grove within the East Branch of Catfish Run is causing severe bank erosion both upstream and downstream of the culvert. This is a common problem at a number of crossings of the East Branch.

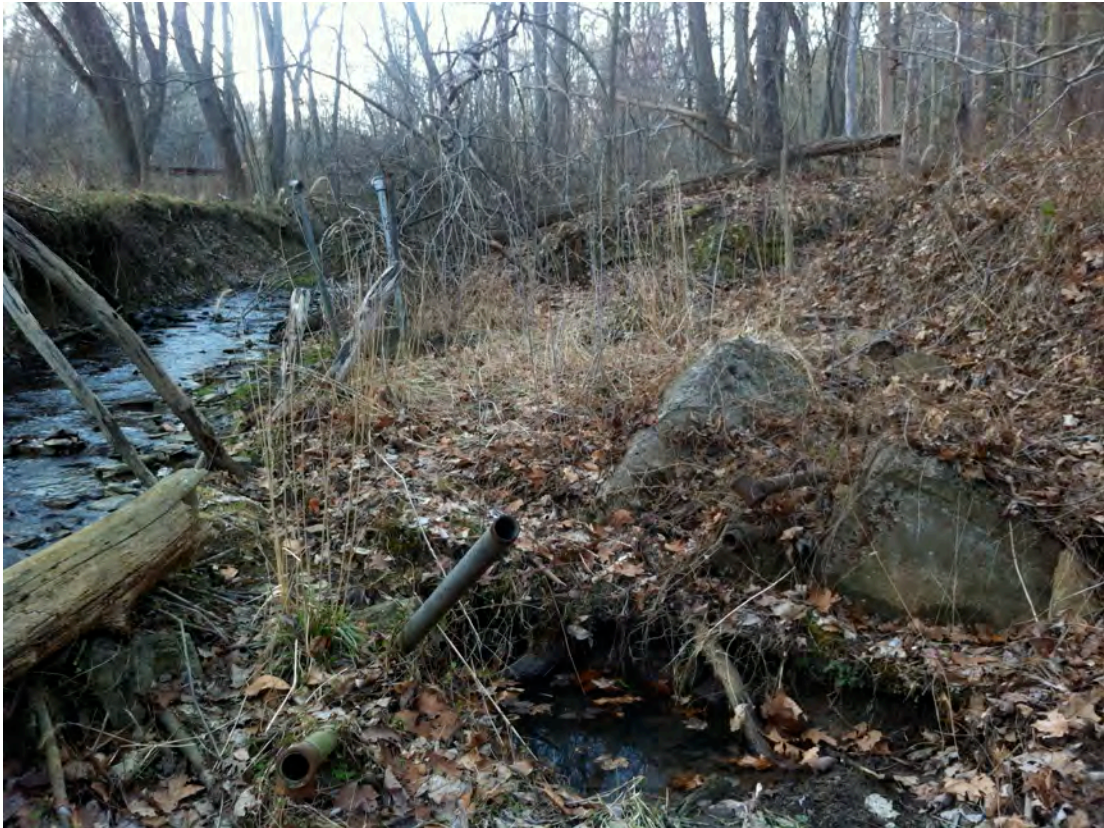
CRT16 - Remnants of an old concrete and metal structure along the right ascending bank of the East Branch of Catfish Run is creating bank erosion.

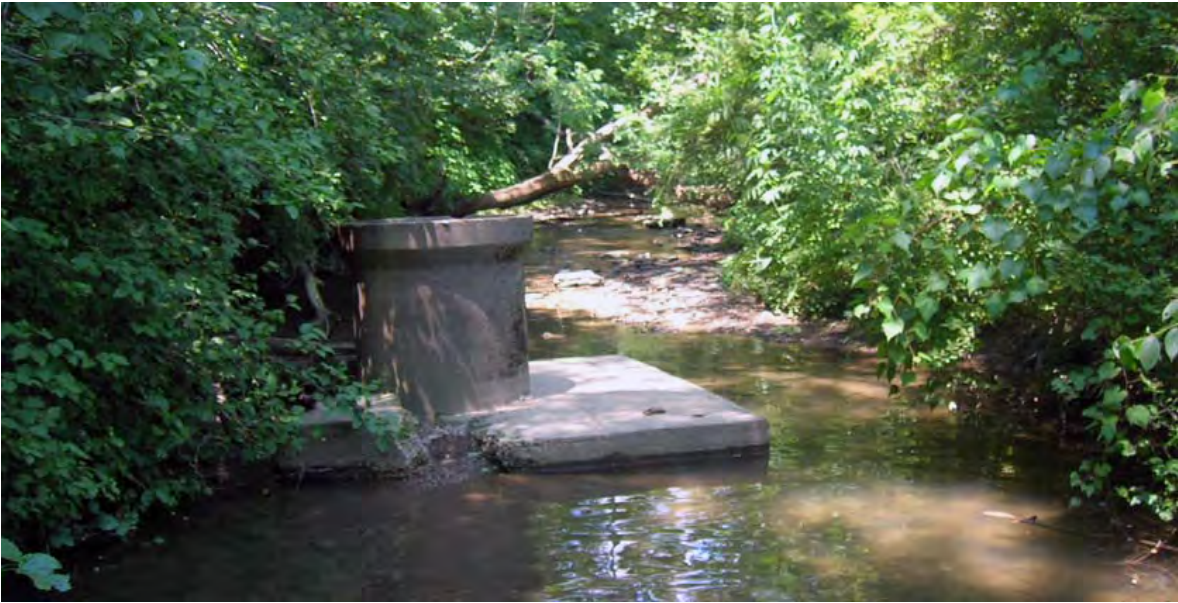
At a number of locations along the Corrigan Rd portion of the main stem of Catfish Run large concrete debris of various forms is found within the channel of Catfish Run. This particular culvert and headwall fragment is located near the off-leash dog park.

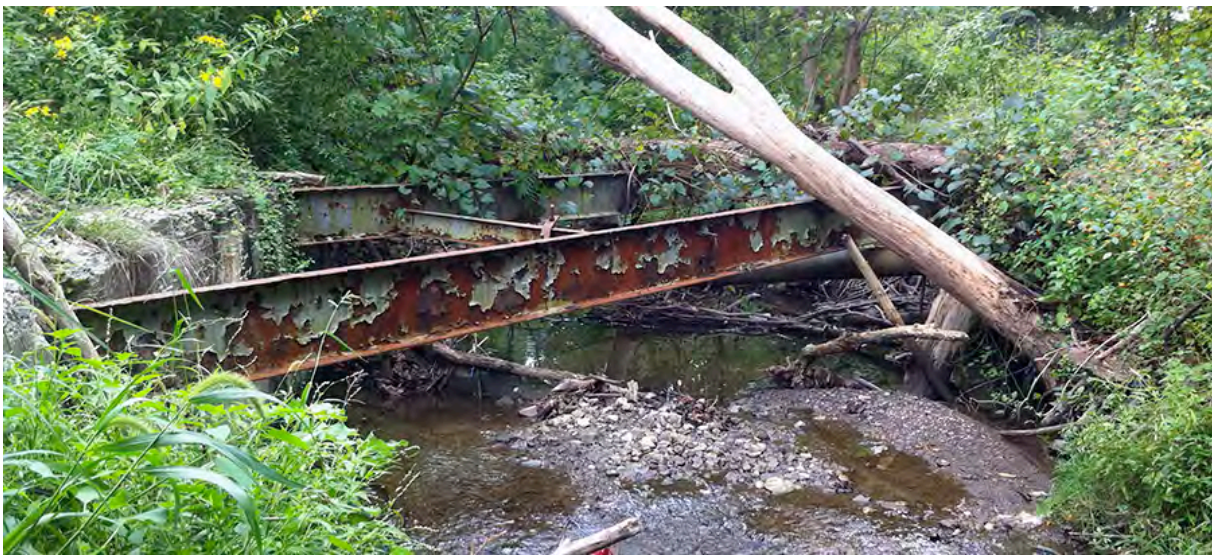
CR26 - Remnants of a nonfunctional bridge crossing of Catfish Run behind the fairgrounds buildings encroaches on the stream channel and is constantly creating debris jams that flood the surrounding area during heavy precipitation. Schoonmaker Hall and a sanitary sewer manhole also encroach on Catfish Run just upstream of this location.
