Peters Creek Watershed Assessment & Management Plan

April 2014

1.0 PETERS CREEK WATERSHED BACKGROUND

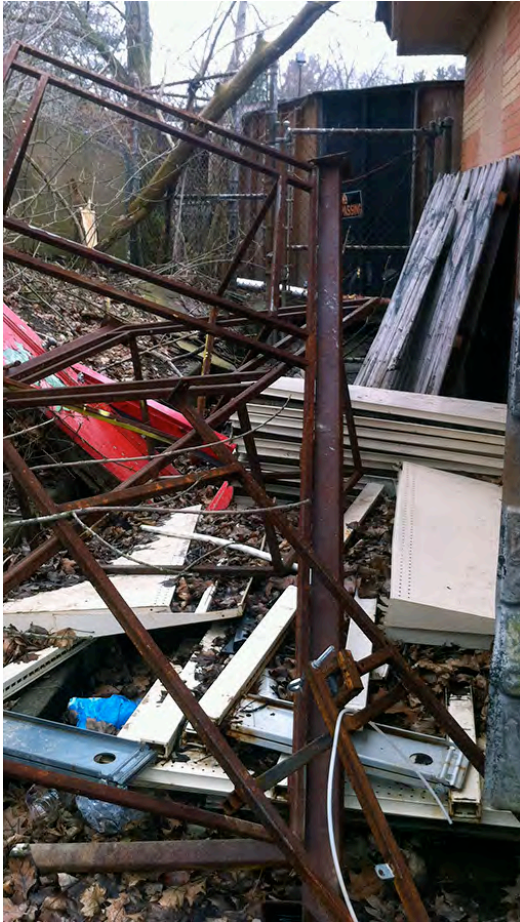
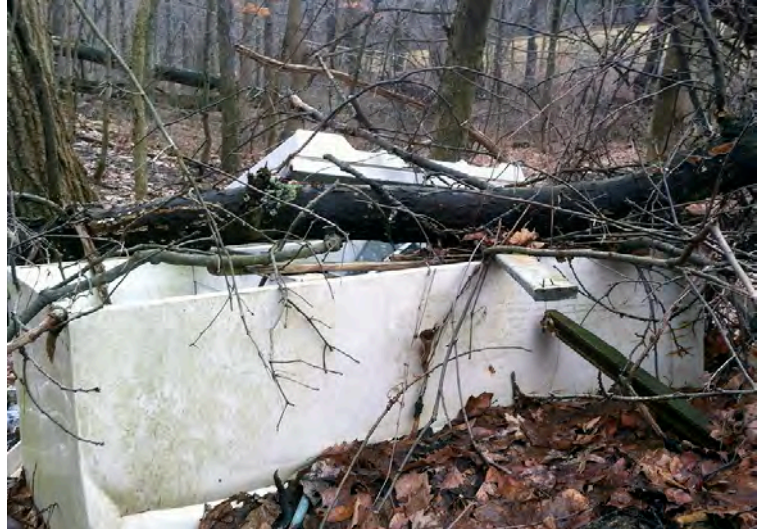
CRT26 - The area surrounding the Haunted House facility along Hundred Acre Drive near the headwaters of the East Branch of Catfish Run is one problem area. Significant trash and construction debris, some of it posing a hazard to the public, is present around the building.

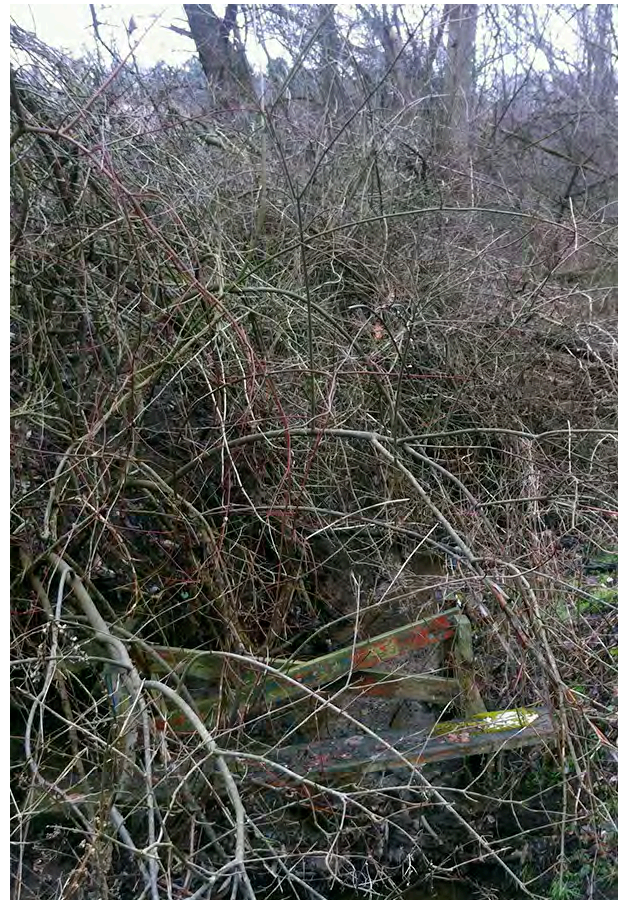
CRT29 - The headwaters area near the residential area also has a good bit of garbage present. Here a discarded picnic table is within the channel of the East Branch of Catfish Run. This tends to be a common problem in parts of the watershed near to residential development.

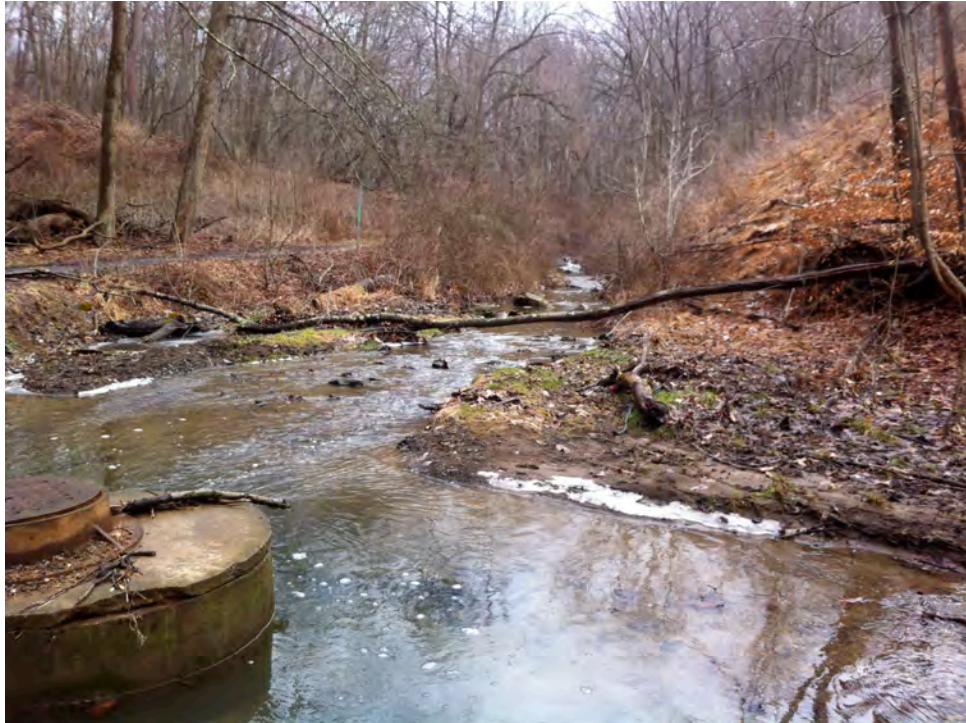
SH08 - Sewer manhole in stream channel. Creates excess erosion, widening of channel and debris jams. Sewage enters stream during heavy rain events.

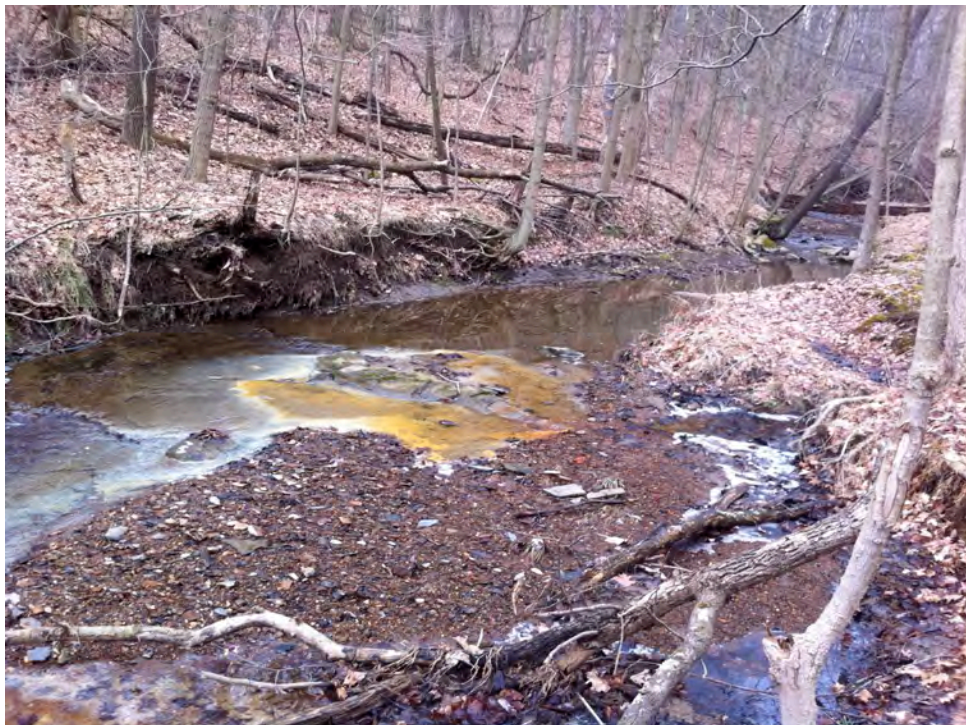
SH20-SH23 - 2 AMD tributaries and approximately 500 ft of right ascending bank floodplain filled with AMD seeps. No other AMD noticeable in the Sleepy Hollow Run watershed.

Two small tributary discharges along with a number of floodplain seeps impacted by acid mine drainage (AMD) were found flowing into this segment of Sleepy Hollow Run. Monitoring and sampling should be done on these AMD discharges. AMD abatement measures should be implemented after determining water chemistry and flow rates from these discharges.

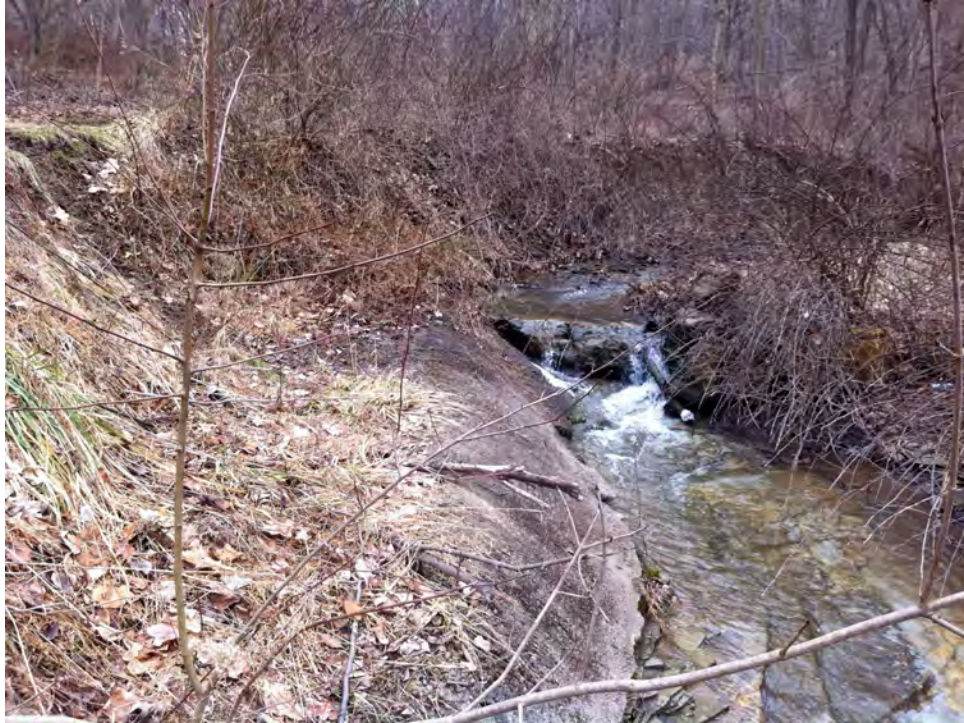
SH09 - Severe erosion on left ascending bank adjacent to trail. There is a 2-3 ft drop here onto a bedrock slide. Attempts are being made to stabilize bank with concrete.

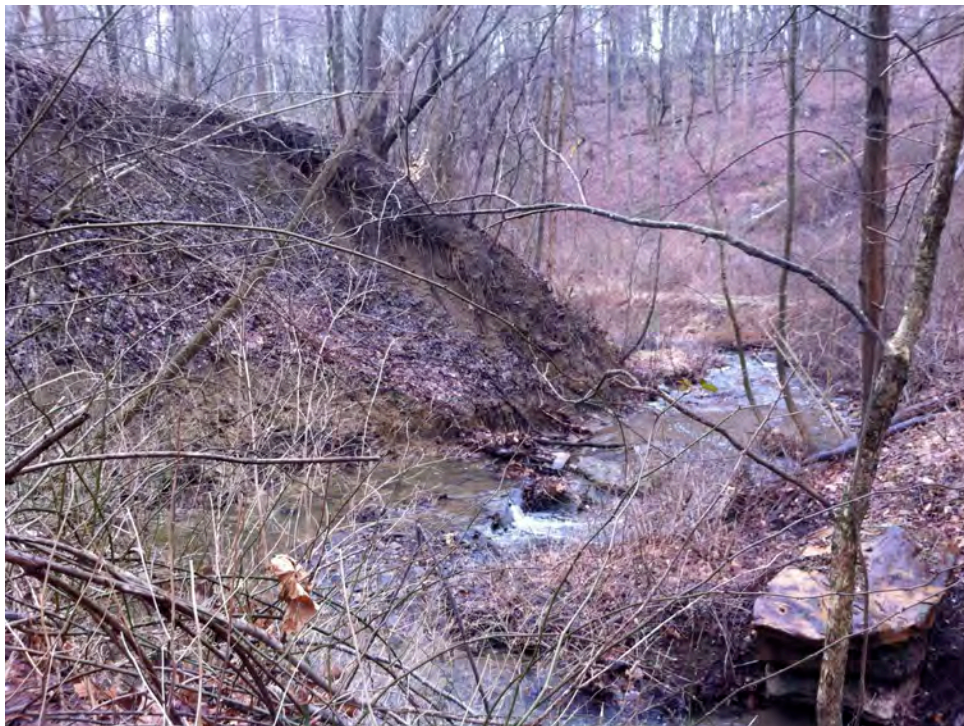
SH12 - Severely eroding right ascending bank through what appears to be some type of fill.

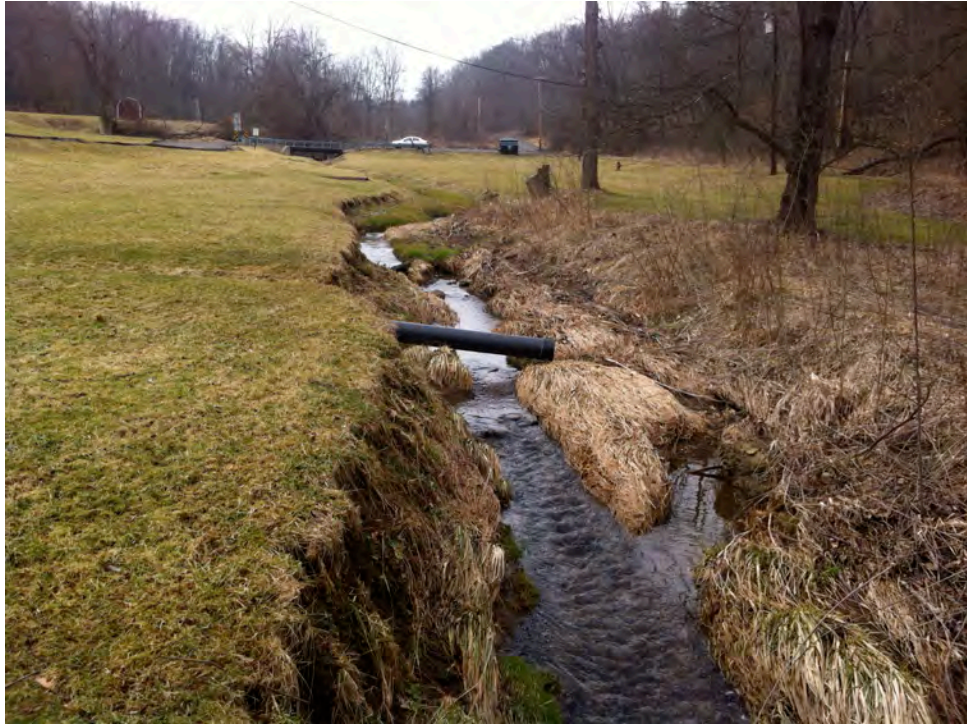
SH30 – Bank erosion and a floodplain detached from the stream along an approximately 400 ft reach within South Park County Park that has an inadequate riparian buffer. This section would benefit from a reforestation effort.

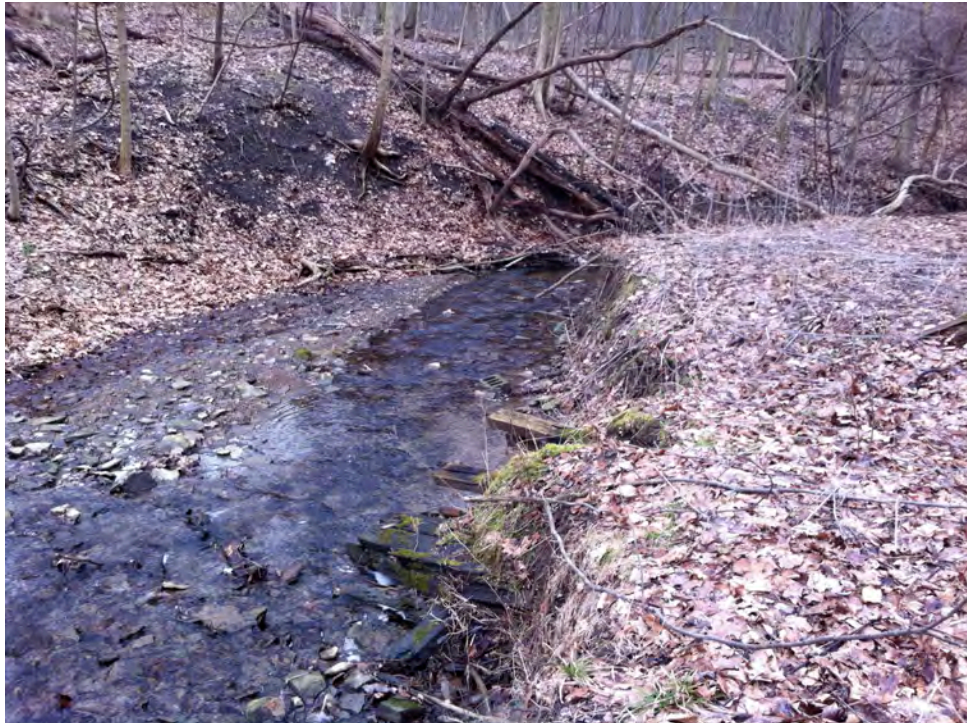
SH27 – Excess algae covers the streambed just downstream of the South Park Academy.

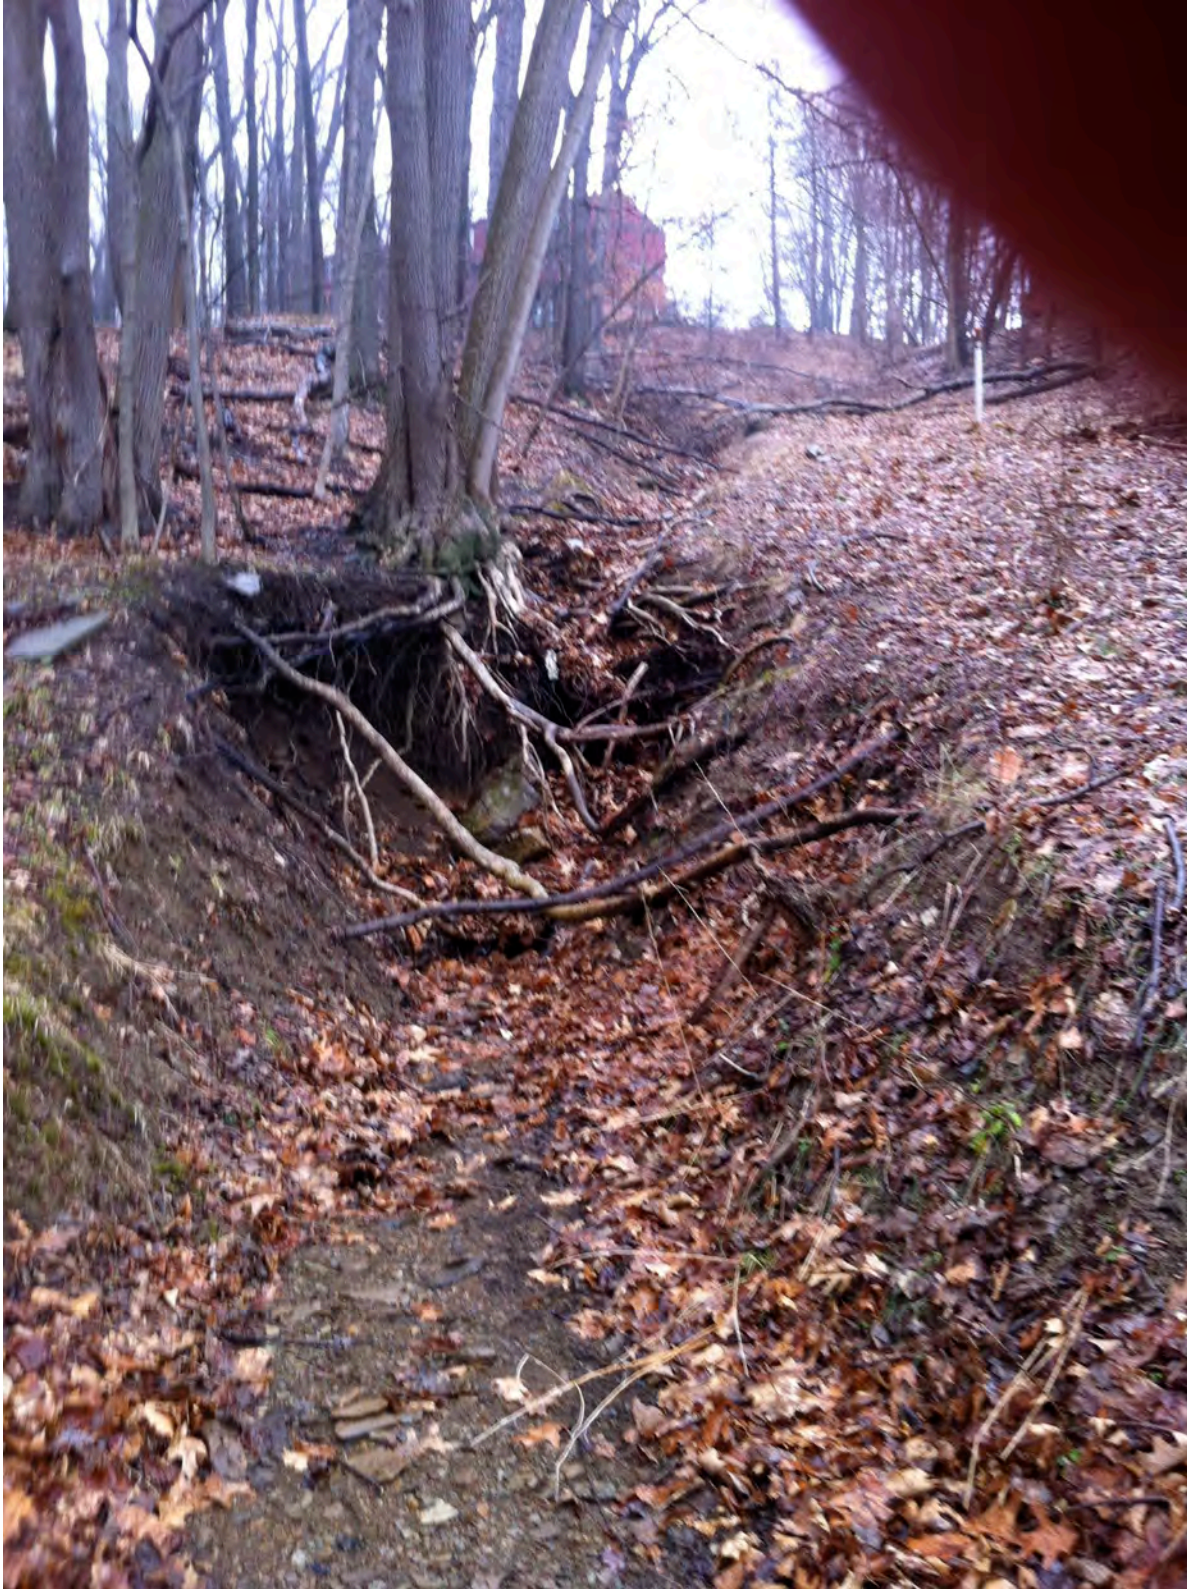
SH10 & SH15 – Inadequate stormwater controls have created deeply incised, eroding stormwater drainage channels from an apartment complex on Shelley Dr.

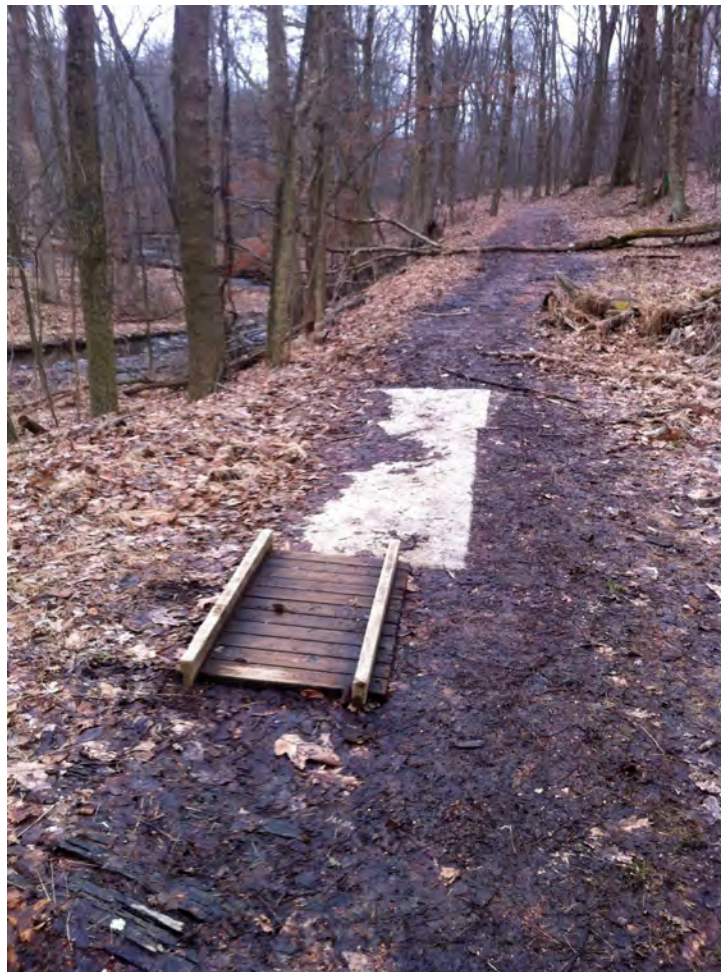
SH24 - A large old dump site on the left ascending bank that extends from the trail down almost to the stream. This dump site has a great deal of glass in it. Trail users have implemented safe passage for bikes and children.

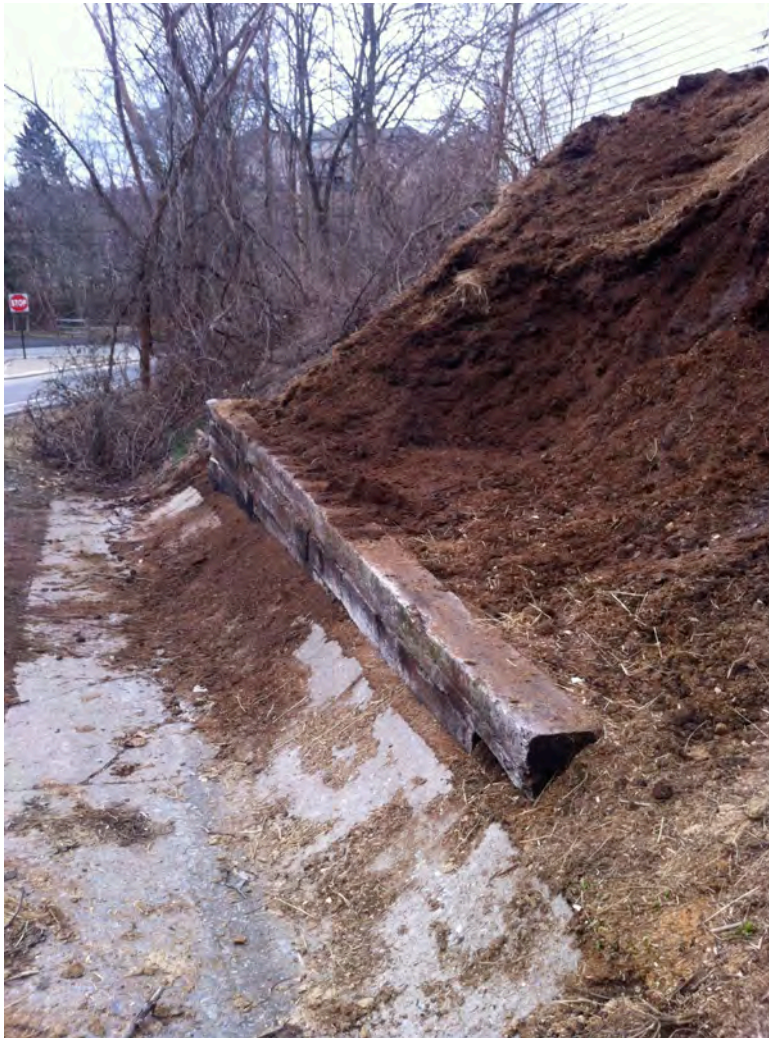
SH58 - Horse manure storage pile along McConkey Road. During rain events manure is washed into catch basin, across Stoltz Rd and into Sleepy Hollow Run.

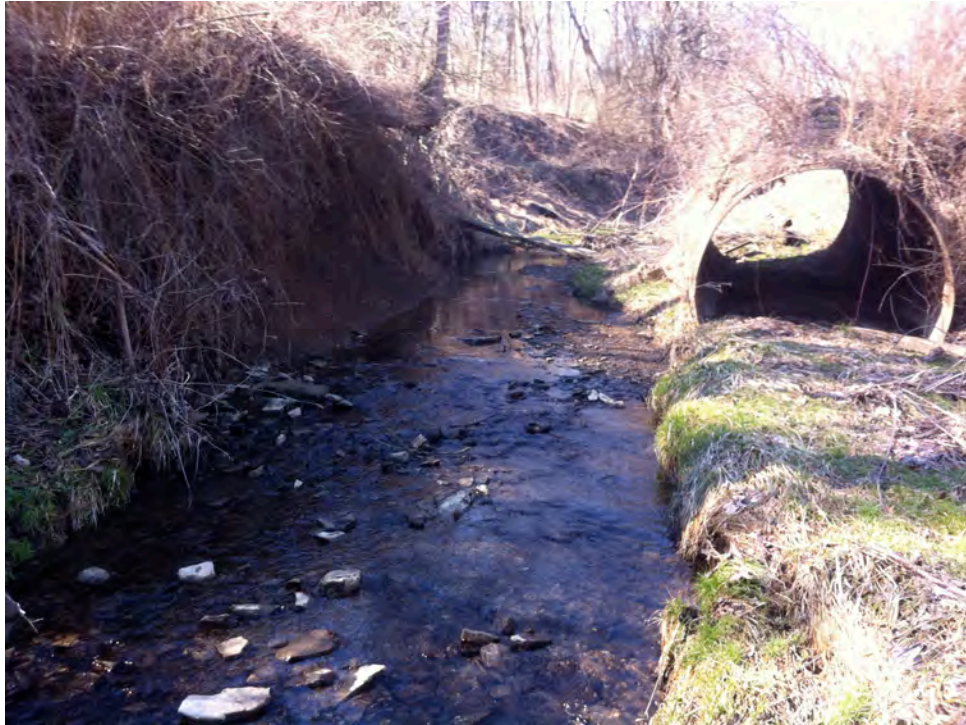
SH35 - Section of Sleepy Hollow Run near county park border has a severely eroding left ascending bank. Old piece of culvert along stream channel creates problems of its own.

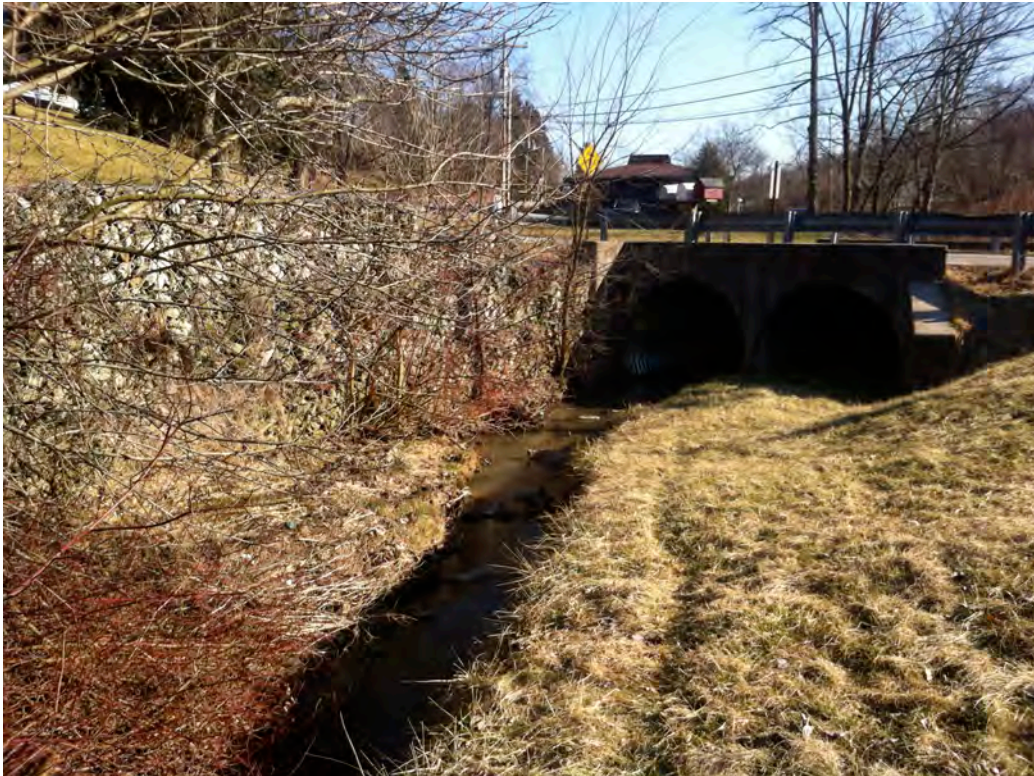
SH46 - One side of the double culvert under Sleepy Hollow Rd is clogged. Severe erosion is occurring on the left ascending bank below this culvert and on the right ascending bank above the culvert. A large section of gabioned riprap is being used to protect the bank above the culvert from eroding.

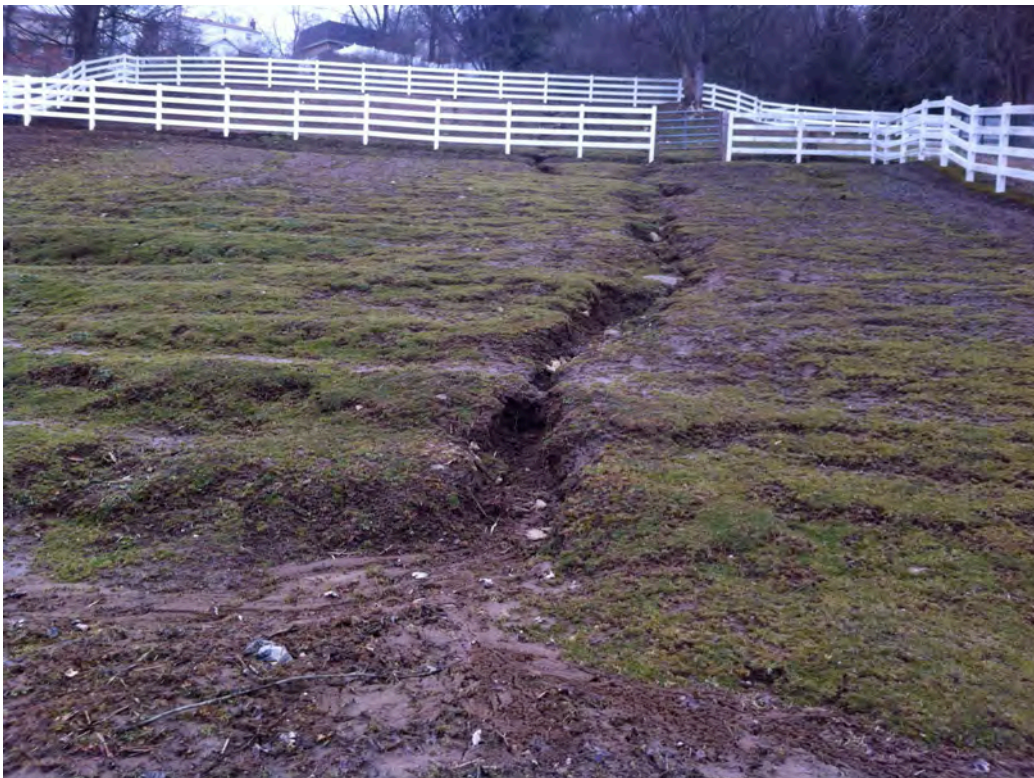
SH49 - Erosion in high use area of horse farm pasture along Stoltz Rd sends sediments and pollution to the creek.

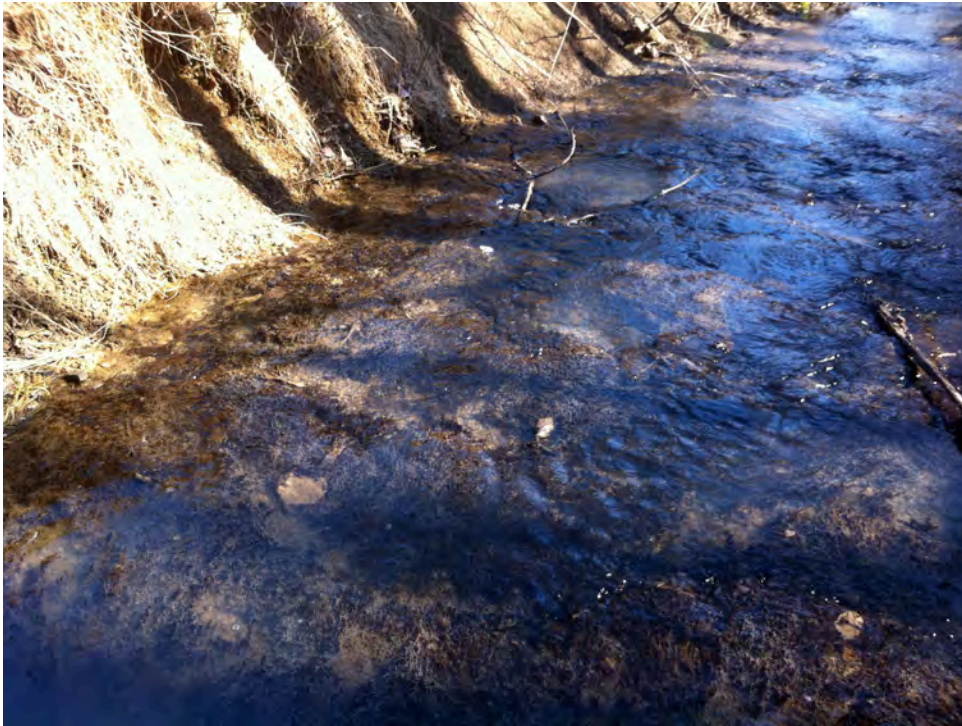
Excess algae covers stream substrate from about SH35 to SH40 and is especially bad at SH36. Also problems with excess algae in channel at SH52.

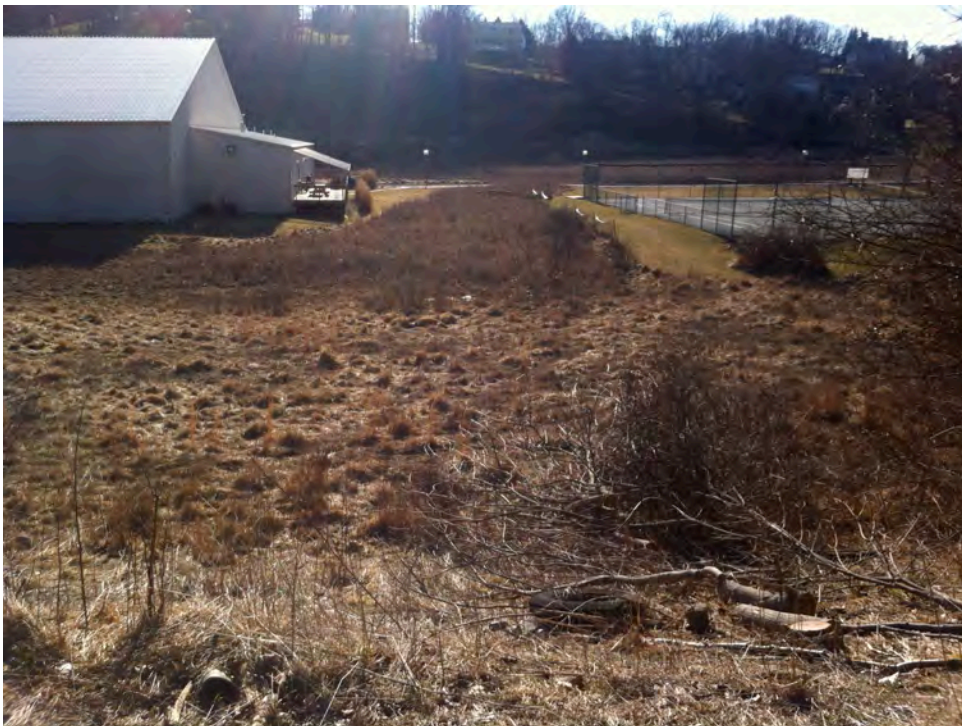
SH42 – Wetland at the tennis club complex along Sleepy Hollow Rd. Wetlands are located between Tennis Courts and building and behind tennis courts.

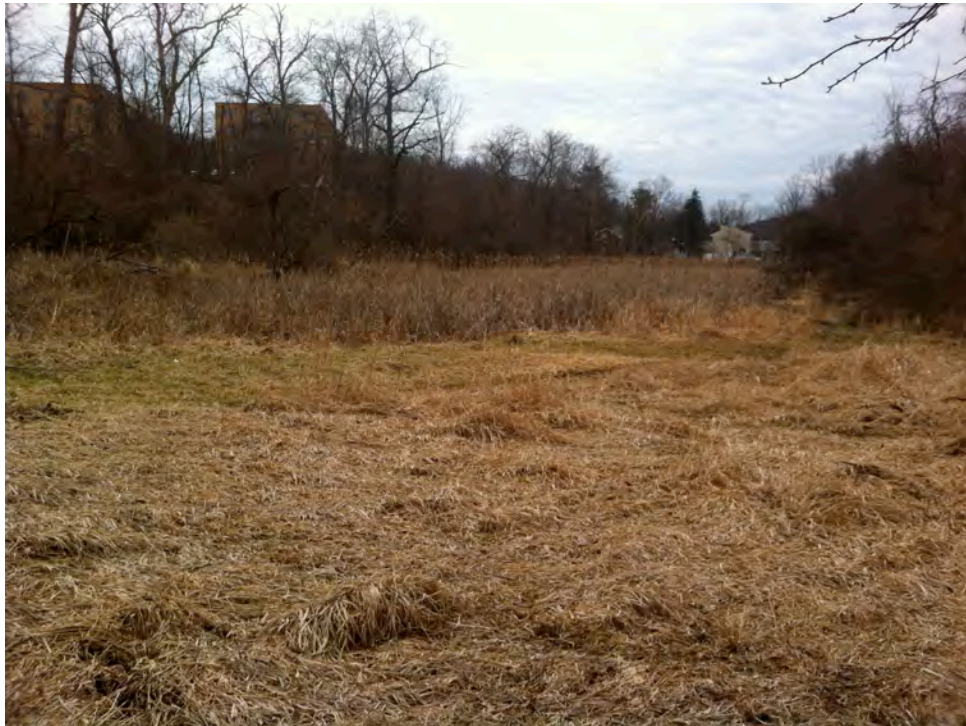
SH54 - A 1-2 acre wetland between Stoltz Rd and Sleepy Hollow Run just downstream of McConkey Rd.

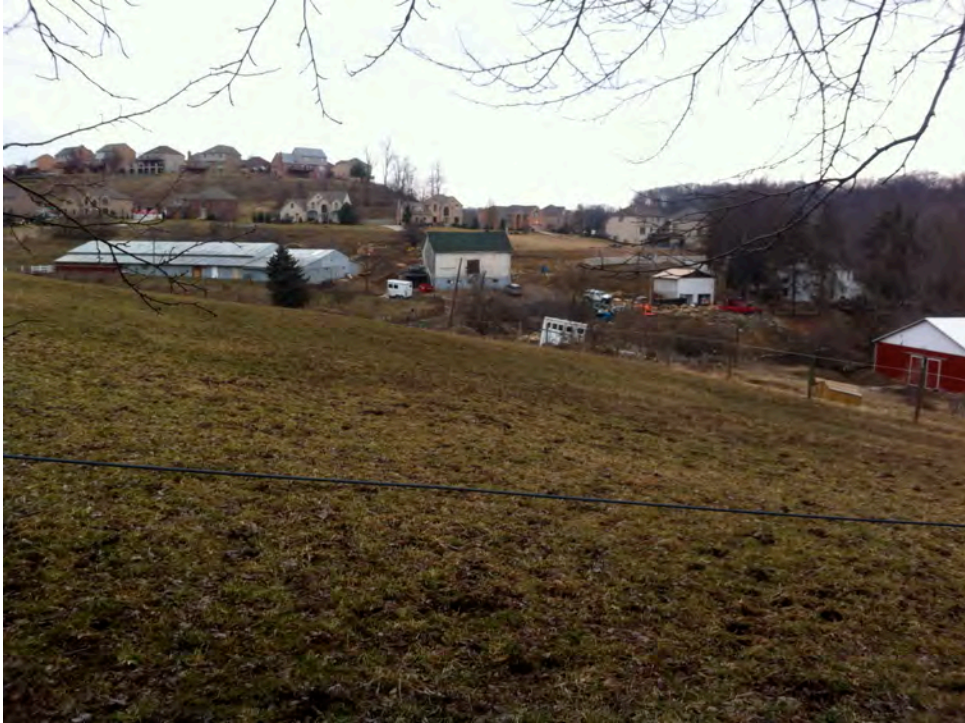
SH53 – A large detention basin helps to control stormwater runoff from Saddlebrook Dr. The basin is at left center of photo behind the pine tree. The outflow travels downslope toward right of photo behind red barn.

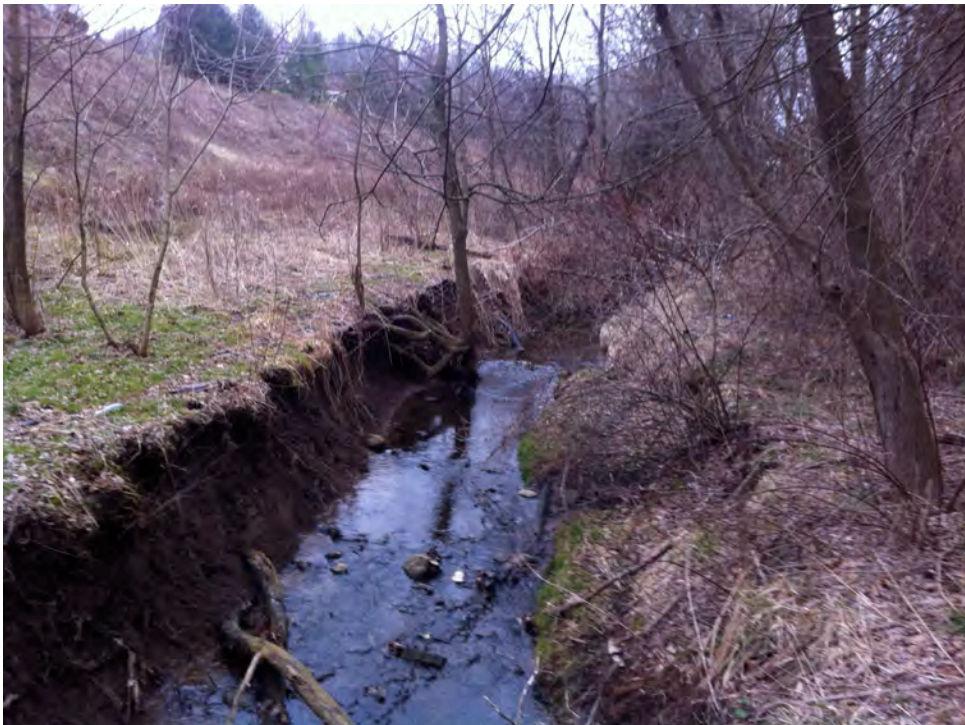
SH62 – The erosion along this section of stream above McConkey Road is the effect of too much stormwater entering the stream too quickly. The lack of trees on the steep slope along the left ascending bank also contributes to this problem.

Inadequate stormwater controls from impervious surfaces are impacting this segment of Sleepy Hollow Run. Excess stormwater is a major contributor to increased erosion and sedimentation of this stream. Providing adequate stormwater controls is essential.

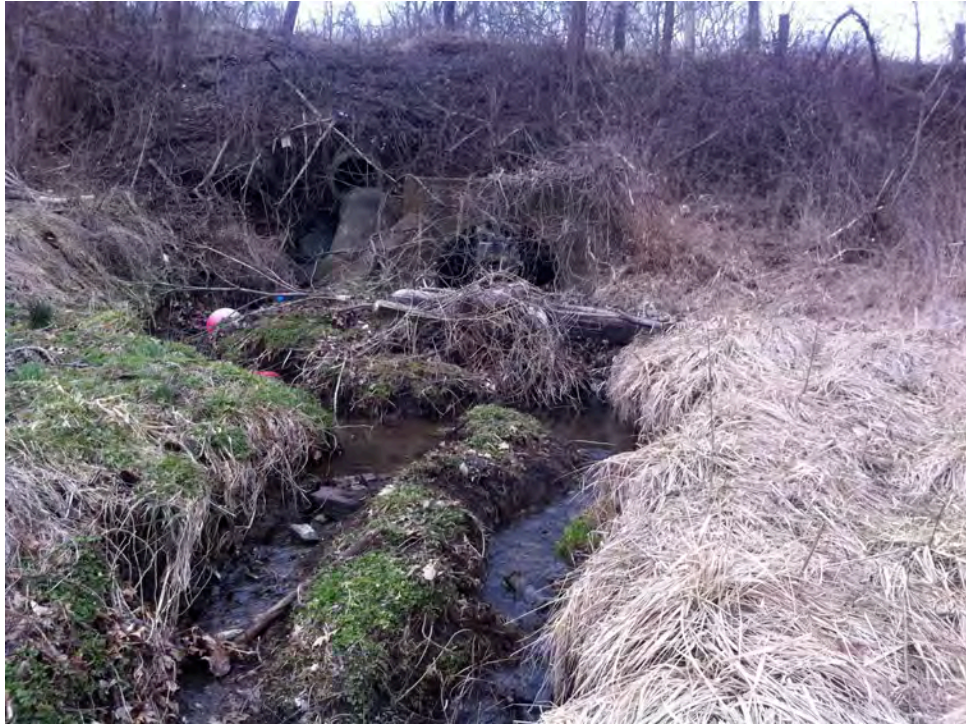
SH67 – A stormwater culvert in need of maintenance and an undersized culvert carrying Sleepy Hollow Run under Kings School Rd meets a debris jam at culvert exit and results in excess erosion both downstream and upstream of the culvert.

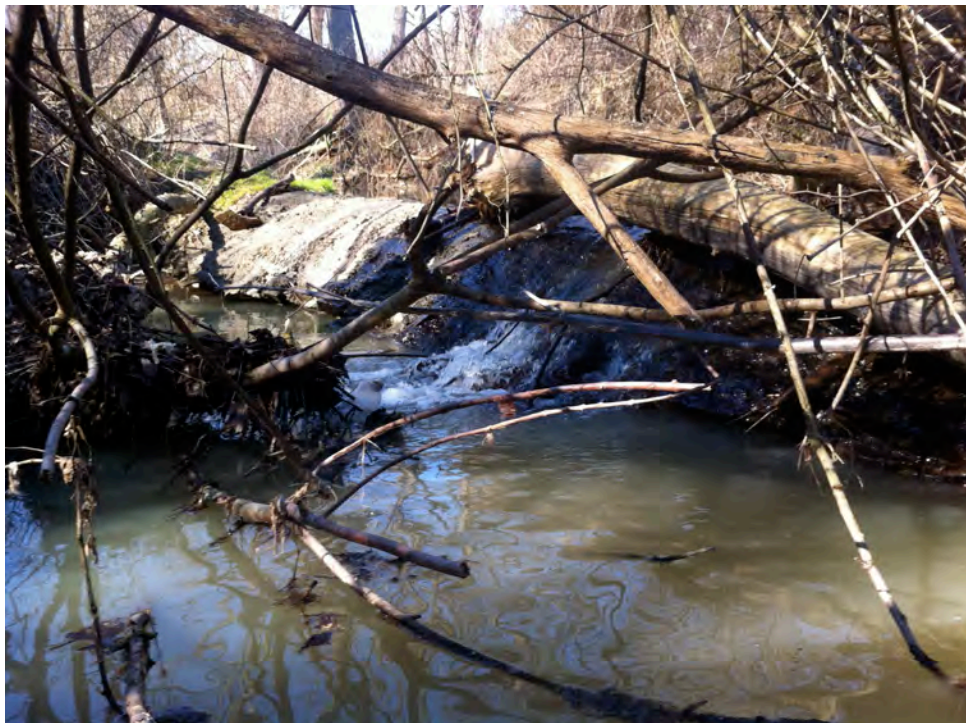
SH37 – A structure crossing Sleepy Hollow Run is being protected and reinforced by concrete. This structure creates a fish barrier and bank erosion at the site.

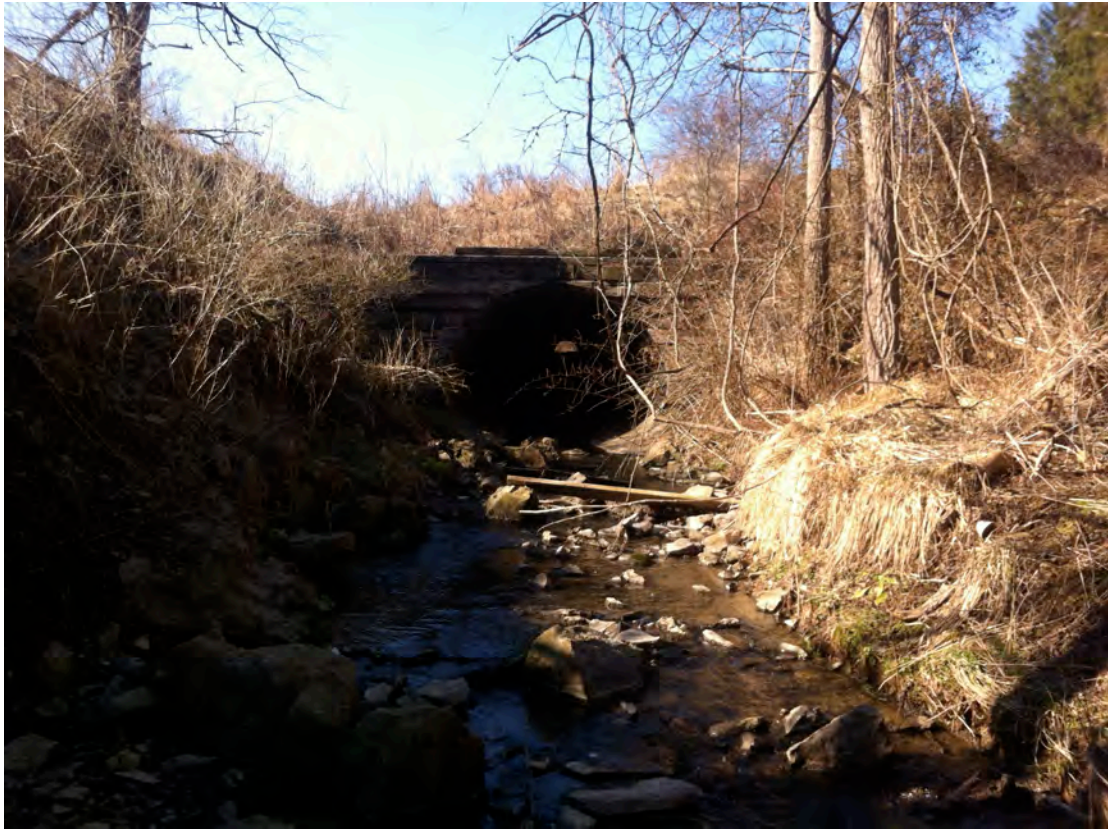
SH40 – Sleepy Hollow Run is culverted for approximately 400 ft at the tennis club along Sleepy Hollow Rd. There is a debris jam that is blocking about $\frac{1}{4}$ of the entrance to the culvert and causing pooling behind it. Sleepy Hollow Run is seen exiting the culvert.

A number of significant debris jams were found on this segment of Sleepy Hollow Run. These debris jams accelerate the rate of stream bank erosion and should be removed.

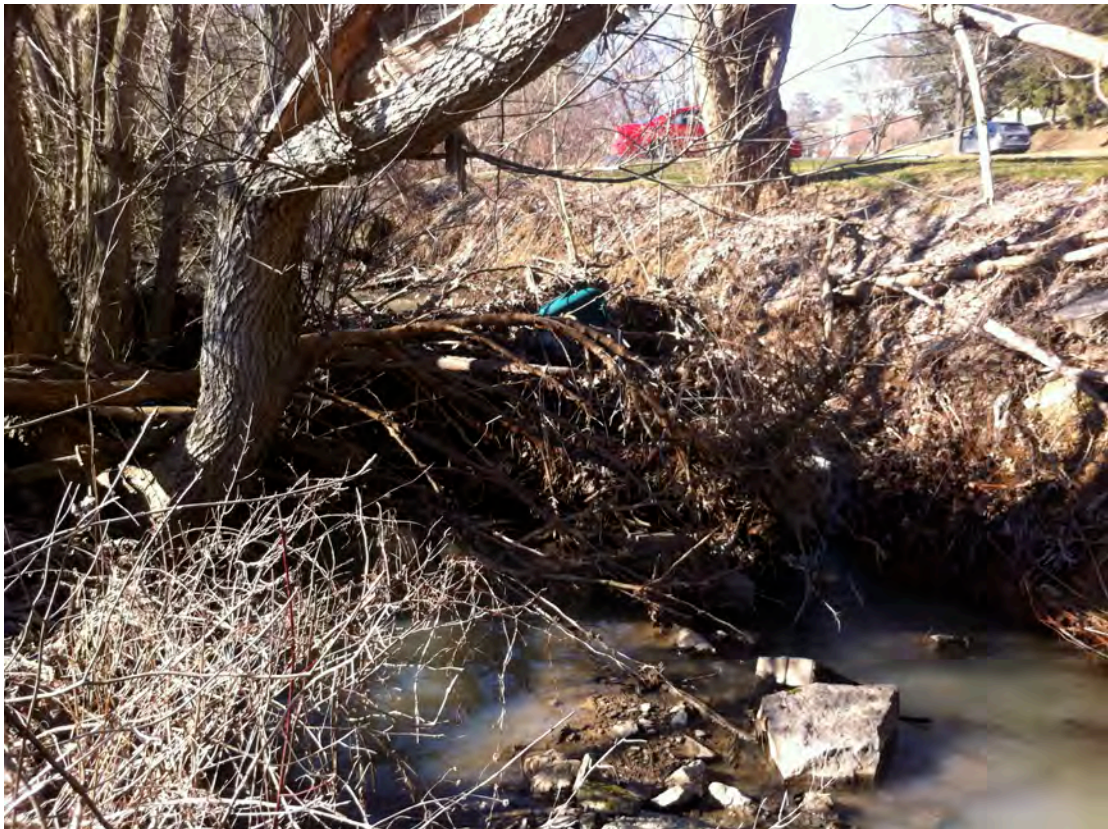
SH45 – A debris jam that is blocking the entire channel increases probability of flooding the adjacent parking lot and commercial buildings during significant rain events.

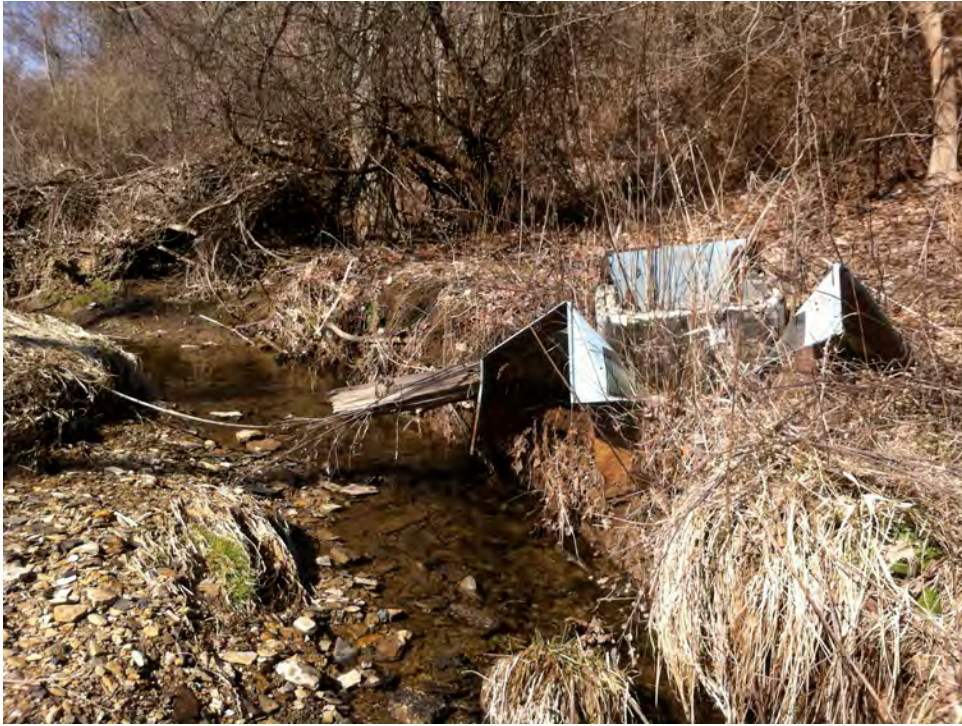
SH34 – Central Air Conditioner Compressor dumped within South Park County Park along Sleepy Hollow Run. There are also a few other large pieces of equipment dumped in the general vicinity and piles of construction debris along this segment of creek. Otherwise litter along Stoltz Rd is a problem and some illegally dumped tires.

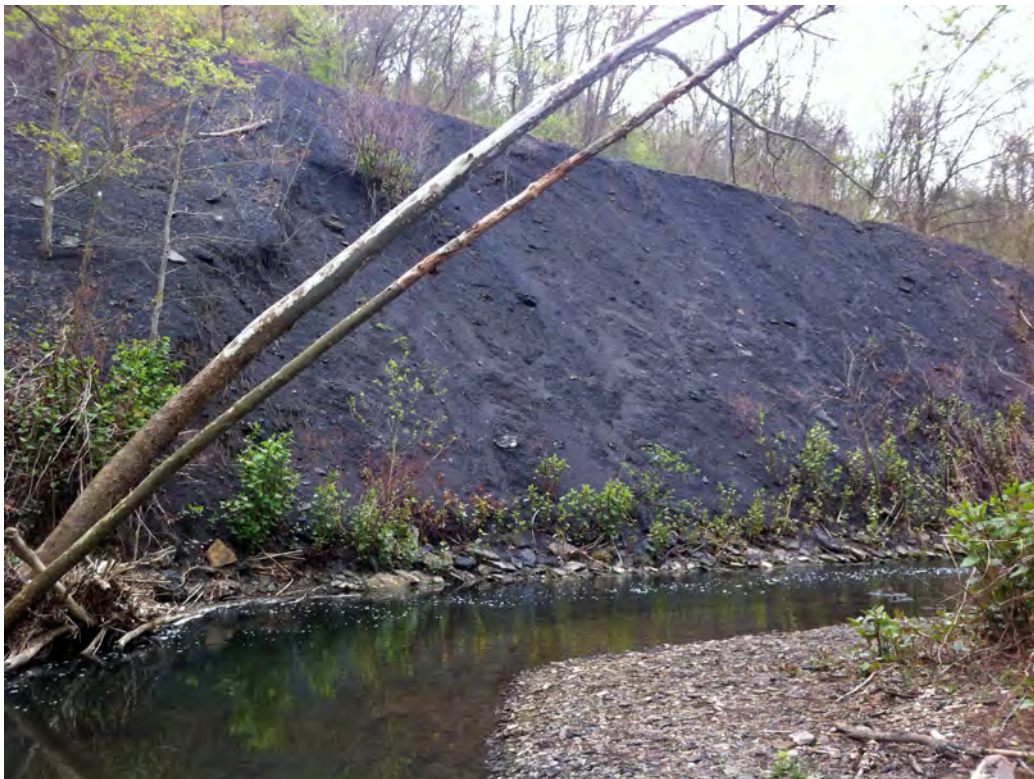
PCU005 – Coal waste pile from old Thompson Mine (circa. 1910–1915) forms left ascending bank of Peters Creek and is eroding into Peters Creek. Little will grow on steep embankment though Japanese Knotweed is attempting to establish on lower slope.

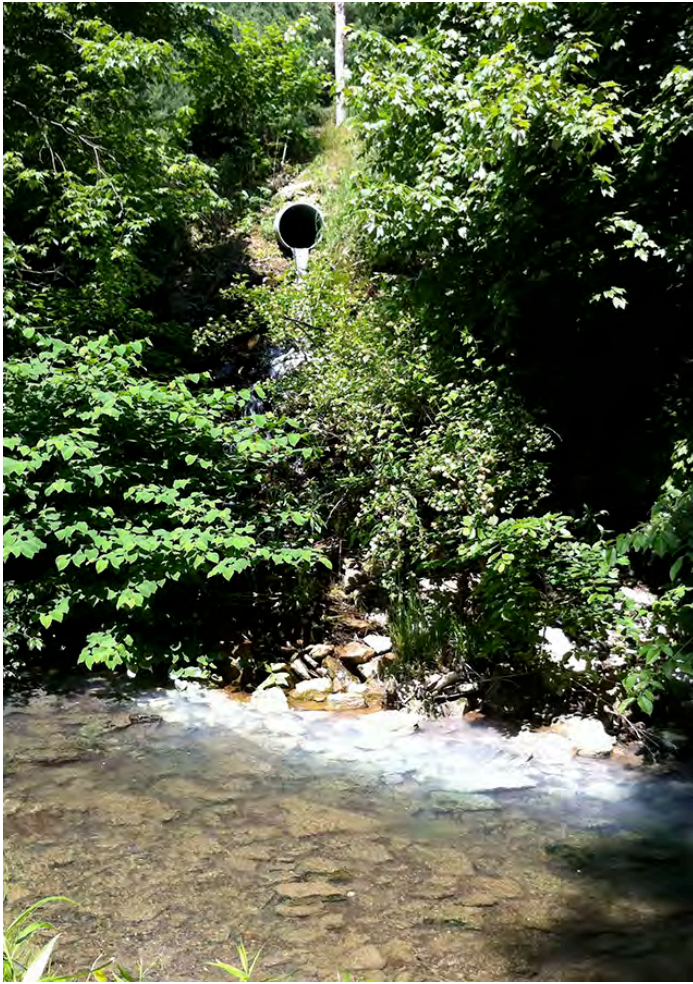
PCU048 – Culverted AMD discharge heavy with aluminum enters Peters Creek just east of Gastonville.

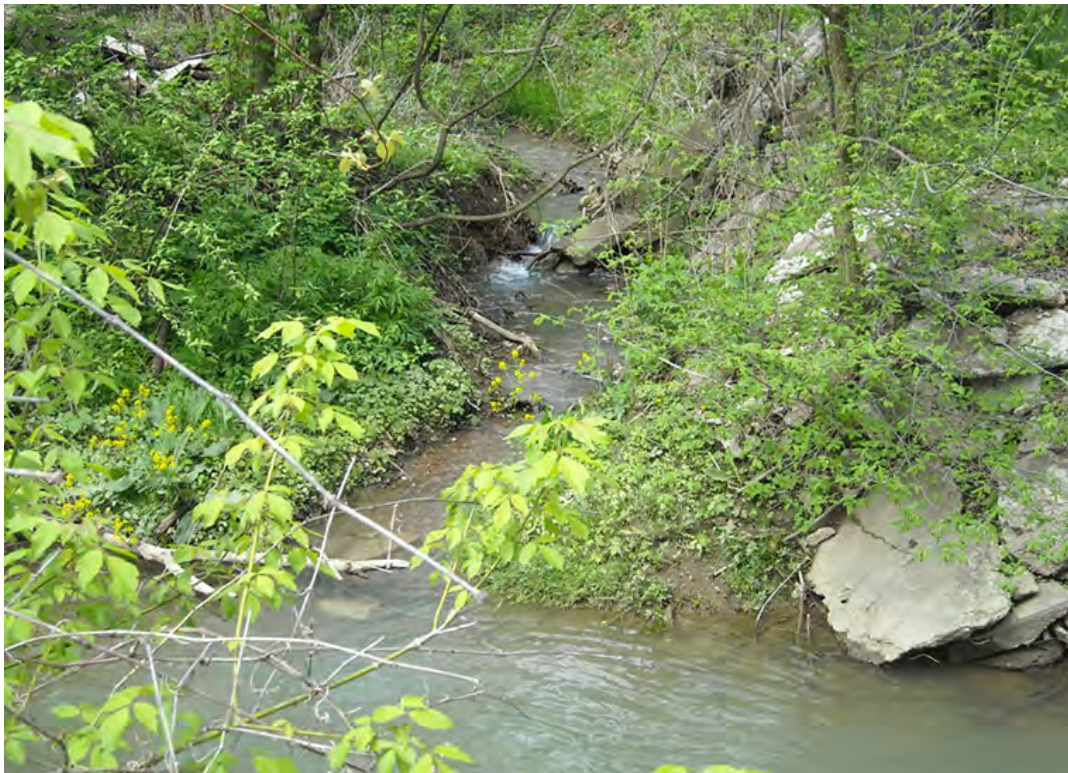
PCU053 – Tributary impacted by AMD discharge along McChain Rd enters Peters Creek's right ascending bank. Landowner has thrown concrete along bank of Peters Creek and tributary.
