Peters Creek Watershed Assessment & Management Plan

April 2014

1.0 PETERS CREEK WATERSHED BACKGROUND

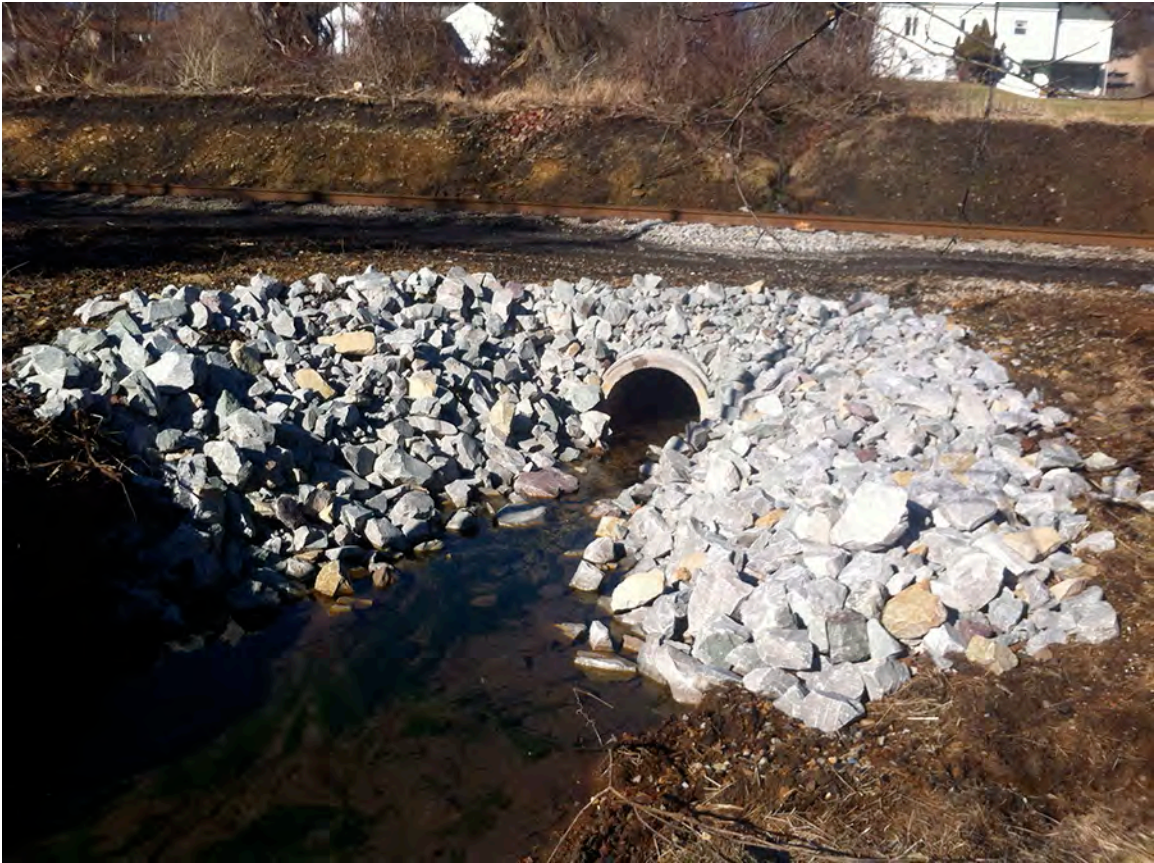
PCU090 – AMD discharge culverted under Allegheny Valley Railroad tracks just west of Finleyville enters floodplain wetland on Peters Creek’s right ascending bank.

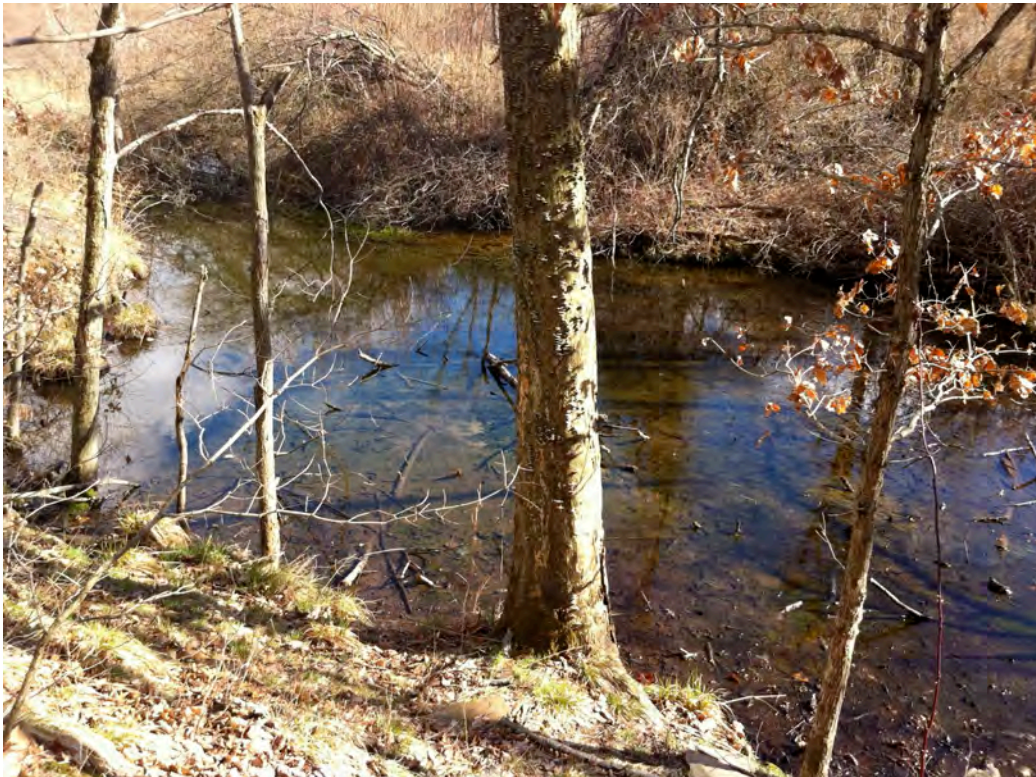
LT18 – Ponding of an AMD discharge on the west branch of the Landfill Tributary just below discharge source.

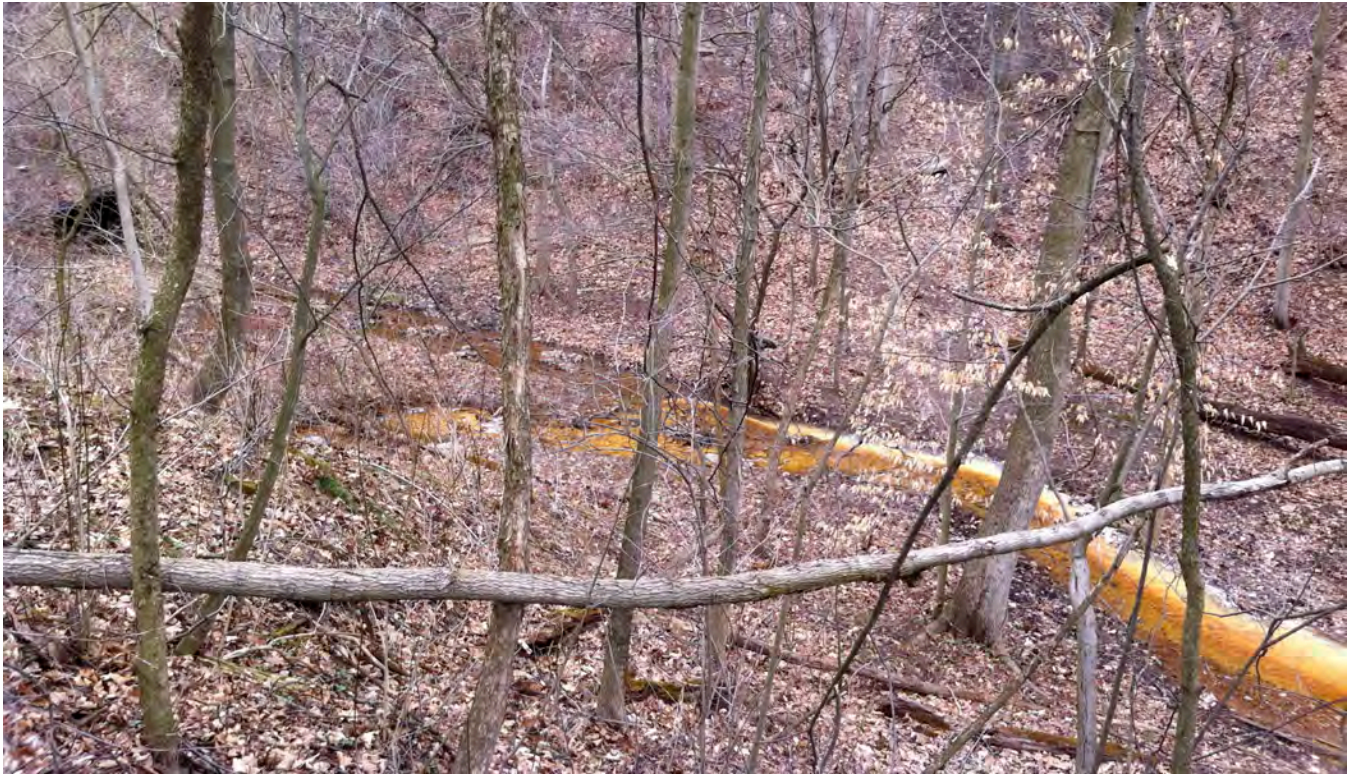
LT11 – Confluence of the AMD impacted west branch of the Landfill Tributary with the outflow of the east branch pond from the left of photo. Heavy precipitation of aluminum and iron downstream of confluence.

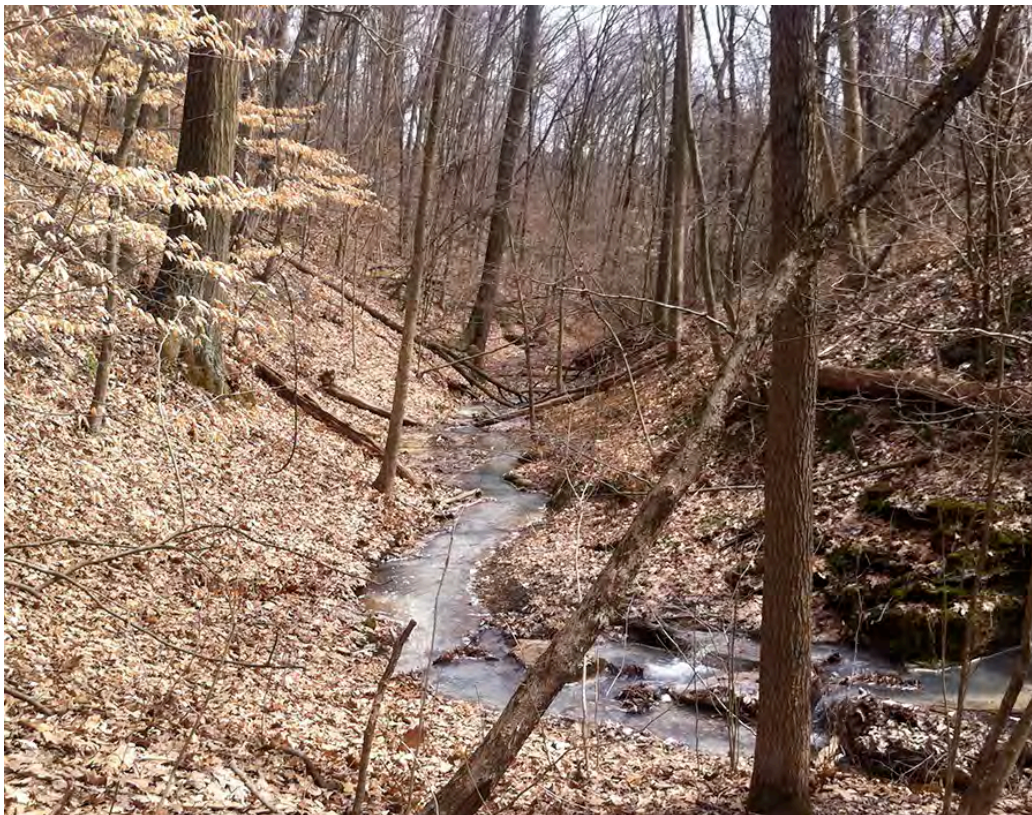
LT07 – Typical view of the steeply sloped, undeveloped valley through which the AMD impacted Landfill Tributary flows downstream of the confluence of east and west branches.

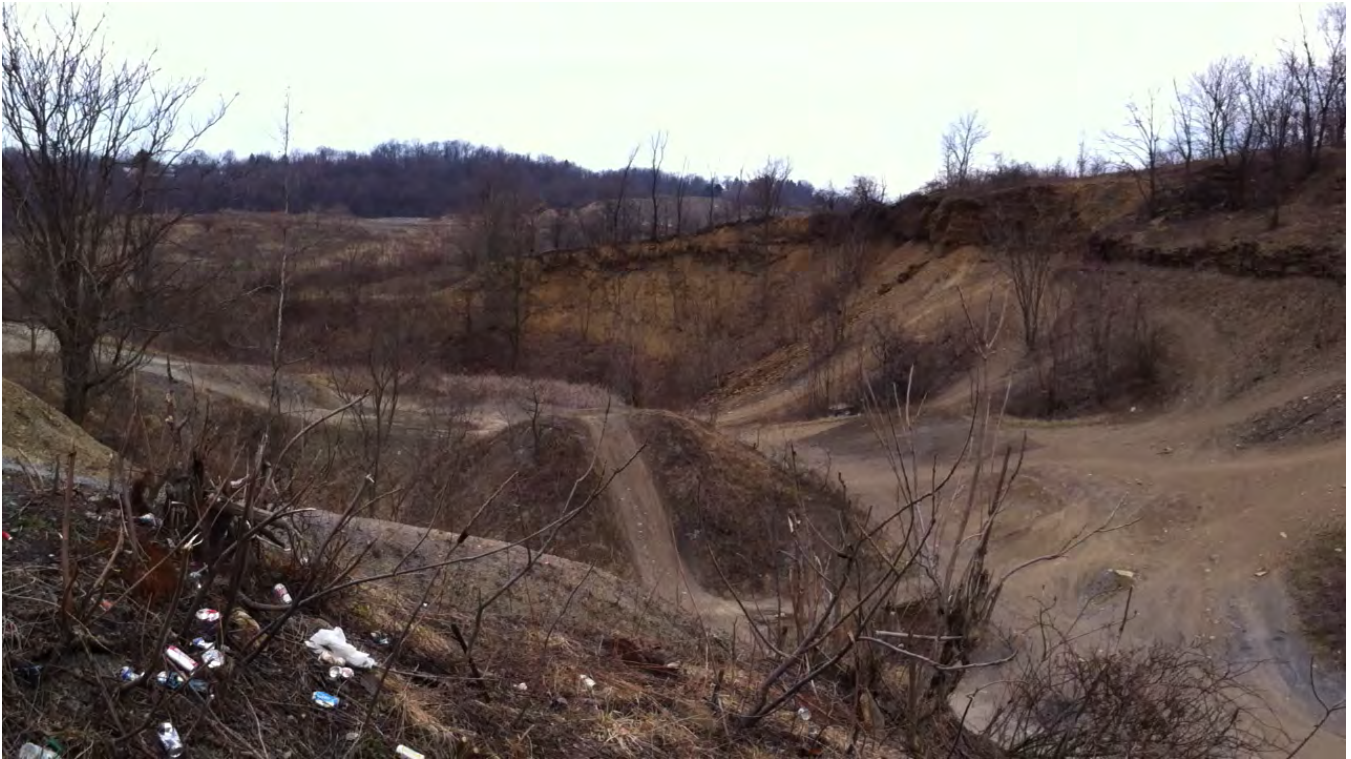
LT10 – This abandoned mining site just east of the enclosed Southhills Landfill is heavily utilized by off-road vehicles and is characterized by a number of dangerous features. The area is also utilized for illegal dumping.

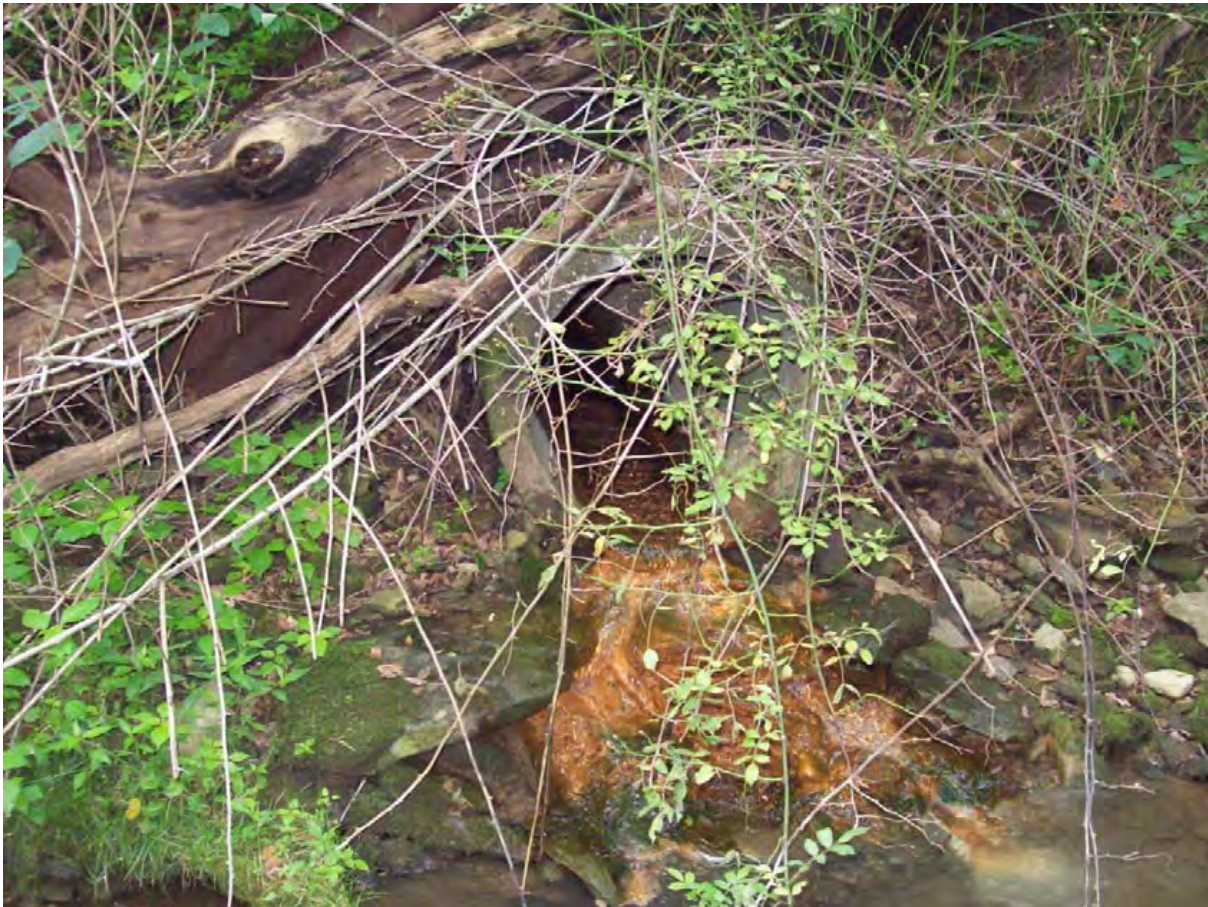
TFT05 – Culverted AMD discharge to Trax Farm Tributary in the lower reach of the stream.

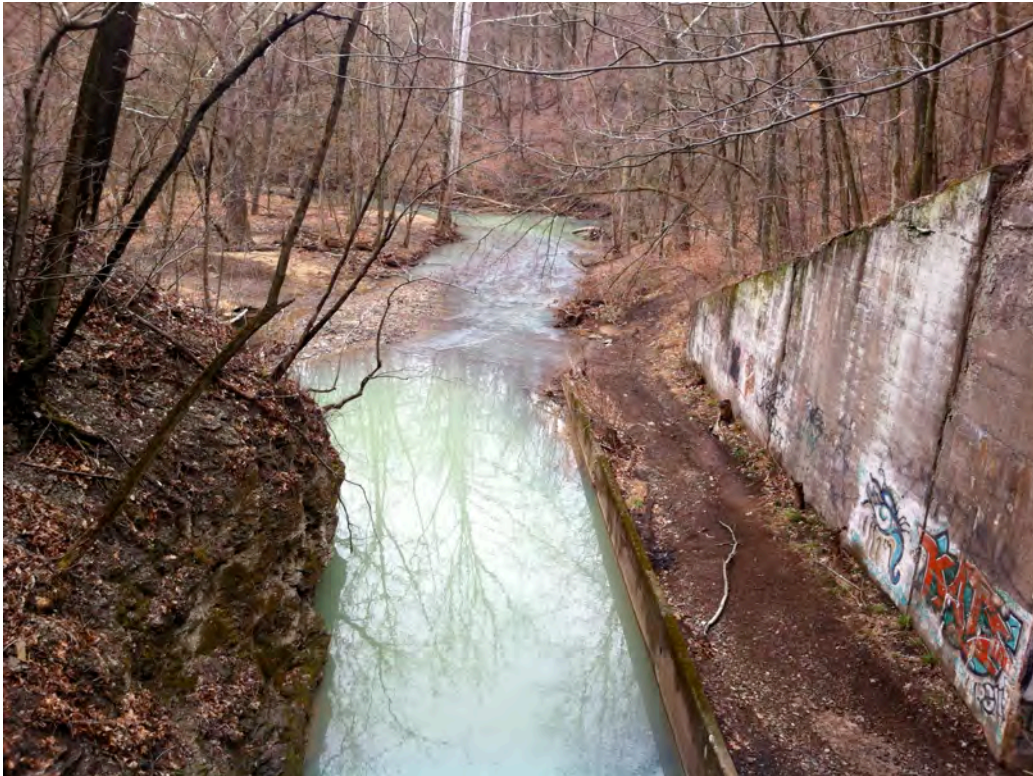
PCU029 – Peters Creek takes on an extremely murky appearance often during late winter/early spring (assumed to be AMD related). It was especially bad during the early spring of 2011 as seen here as the stream exits the Allegheny Valley Railroad underpass near the Allegheny County/Washington County border.

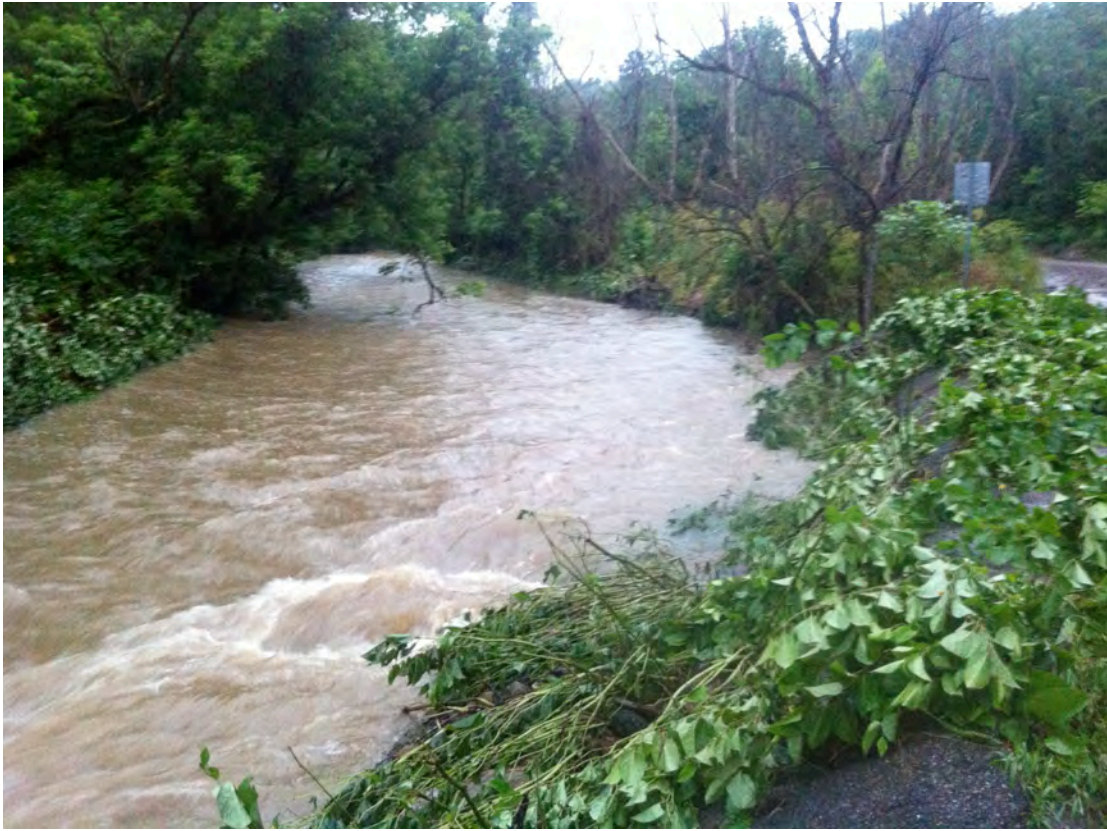
PCU021 – Peters Creek’s eroding right ascending bank consists of approximately 150 feet of gabioned rip-rap along Piney Fork Road in South Park Township just downstream of the Piney Fork confluence. The purpose of the rip-rap is to prevent the stream from undercutting the road. The stream is undercutting the rip-rap as the erosive force of the stream migrates upstream. Eddy currents downstream of the project are also eroding the right ascending bank downstream of the rip-rap. Asphalt was applied from the road to the rip-rap along this section. The purpose of this is unknown and most likely counterproductive. Japanese Knotweed has taken hold along this section of stream bank.

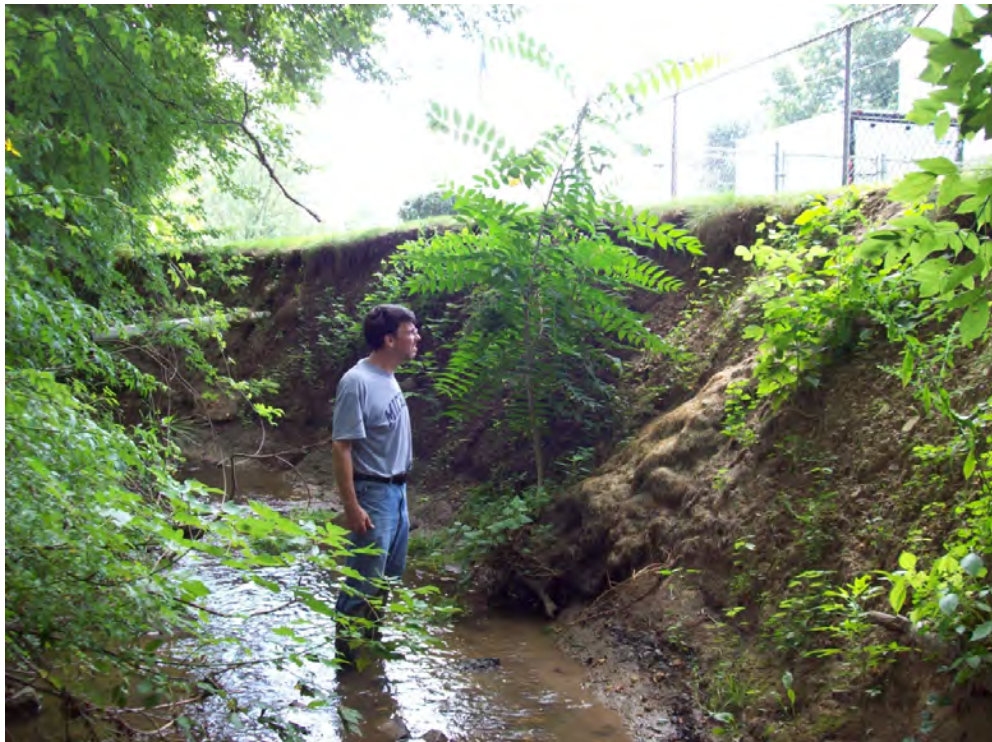
TFT10 – Stream bank erosion along the Trax Farm Tributary. The stream is detached from the floodplain. The landowner is contributing to organic enrichment by dumping grass clippings into the stream channel.

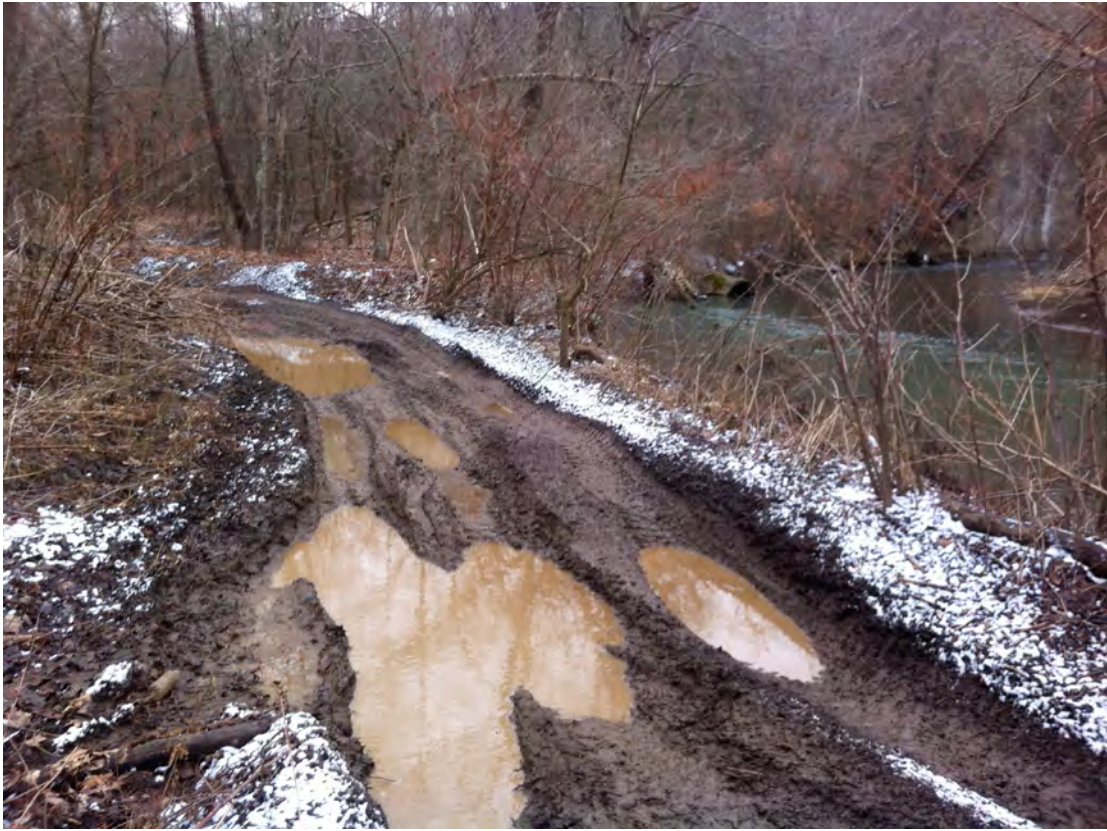
PCU025 – Heavy off-road activity along Peters Creek’s left ascending bank near the Piney Fork confluence erodes the stream bank and adds to the streams siltation load.

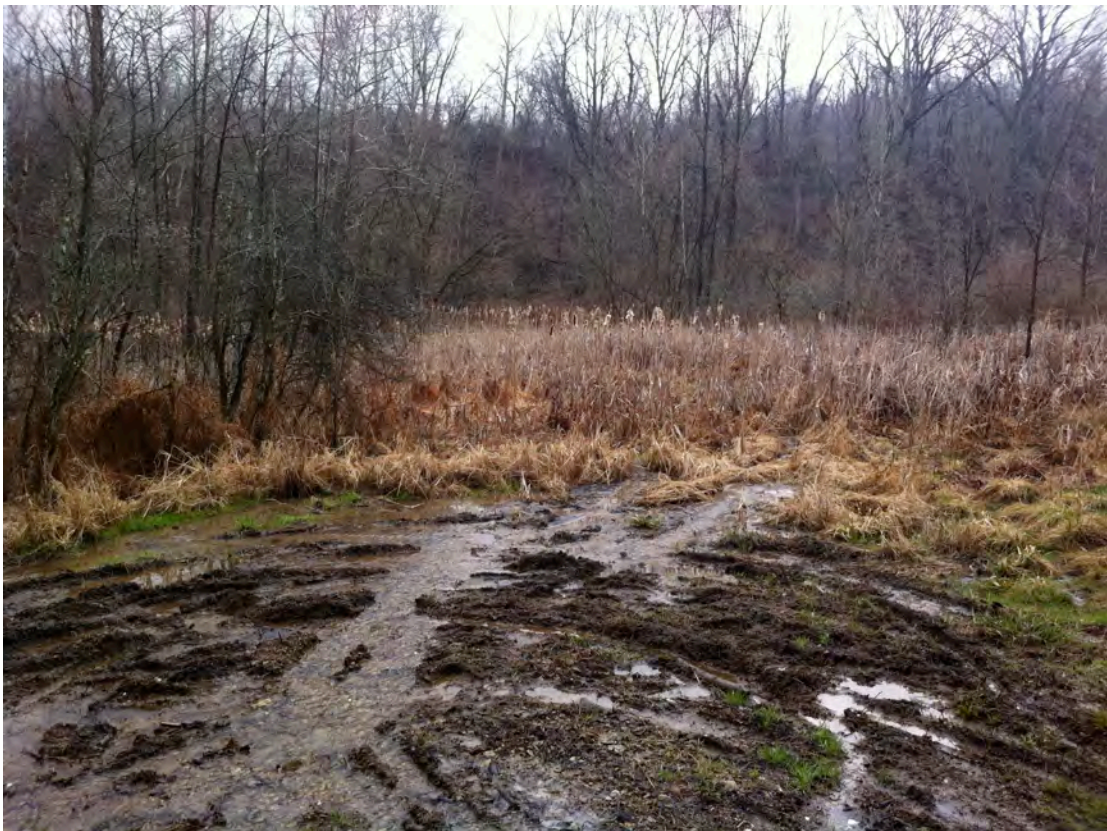
PCU032 – Off-road activity within Peters Creek’s right ascending floodplain just west of the Allegheny Valley Railroad tunnel alters the flow pattern of a tributary to Peters Creek, creates excessive erosion and siltation and damages a floodplain wetland.

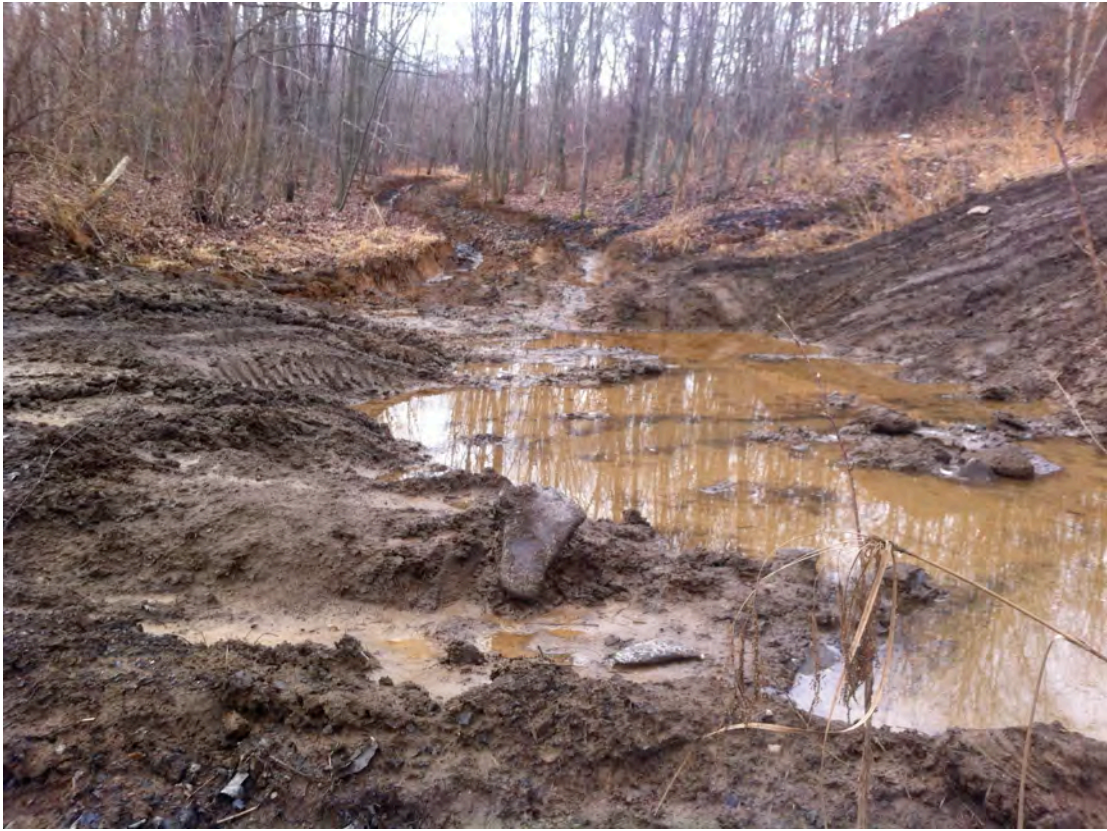
PCU040 – Heavy off-road vehicle use at the head of a tributary east of the Landfill Tributary is causing severe erosion and siltation within the tributary.

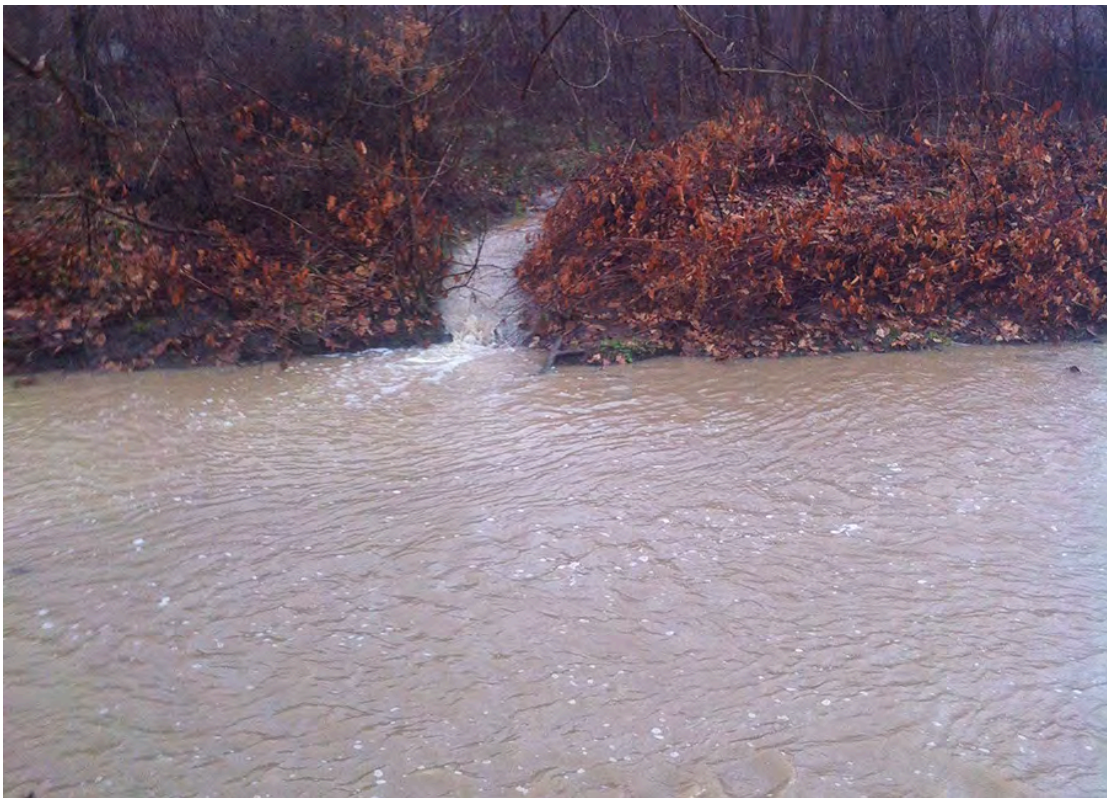
PCU020 – Silted runoff from a Turnpike stormwater detention basin enters an already heavily silted Peters Creek during a precipitation event. This detention basin stormwater is captured by an off-road vehicle trail prior to entering the stream. This causes the runoff to capture an added silt load and creates additional erosion within Peters Creek's left ascending floodplain.

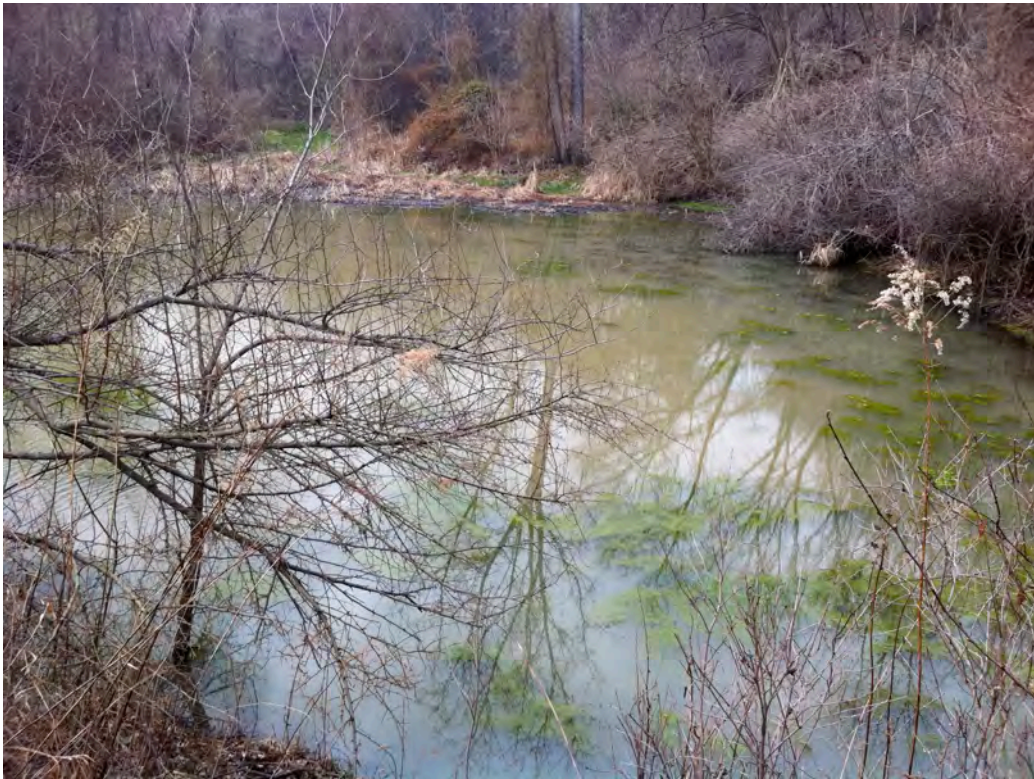
LT24 – Pond in the headwaters of the west branch of the Landfill Tributary is silted and filled with excess algae indicating a nutrient overload.

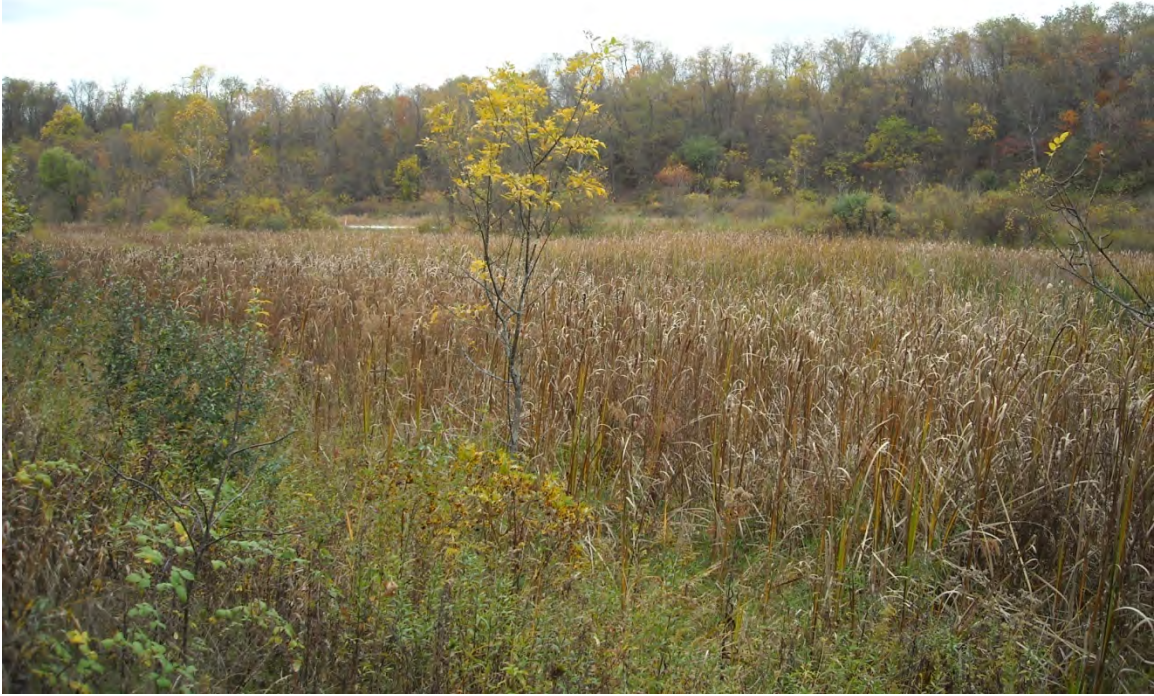
PCU010 – Snowden wetland within Peters Creek’s right ascending bank floodplain just east of Snowden Rd. Part of this wetland was created as mitigation for construction of the Mon-Fayette Expressway.

There are emergent wetlands (~ 5 acres) within Peters Creek's right ascending bank floodplain at PCU010. These wetlands were created partly as mitigation for the Mon-Fayette Expressway and are known as the Snowden Wetlands. There are also a number of other smaller wetlands located just north and west of the Snowden Wetlands.

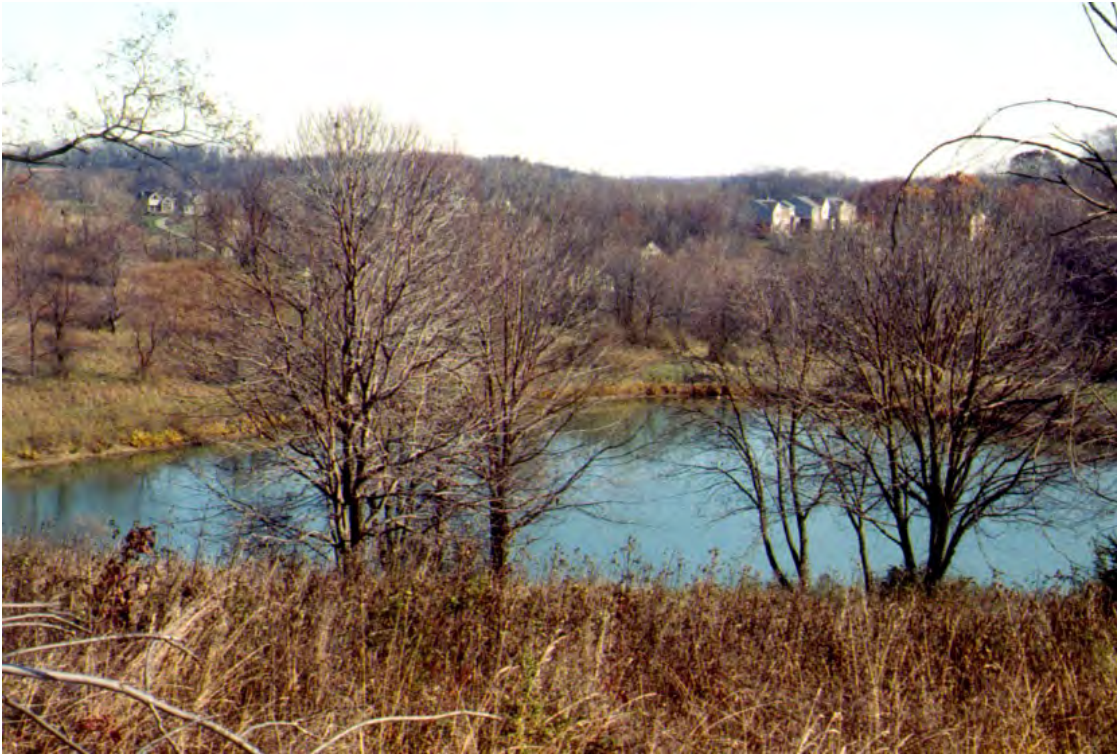
PCU122 – Impoundment at the head of a tributary that drains Scenic Ridge Drive in Peters Twp.

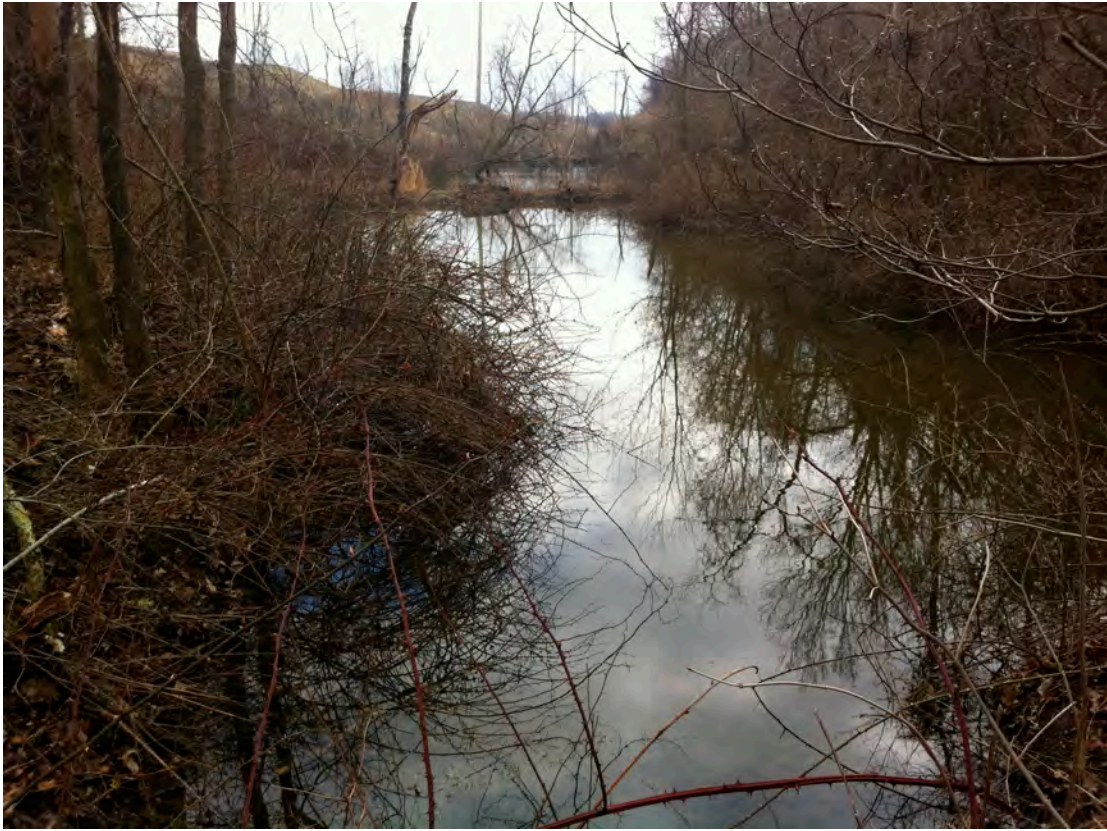
LT23 – Ponding of the west branch of the Landfill Tributary just west of the enclosed portion of the Southhills Landfill.

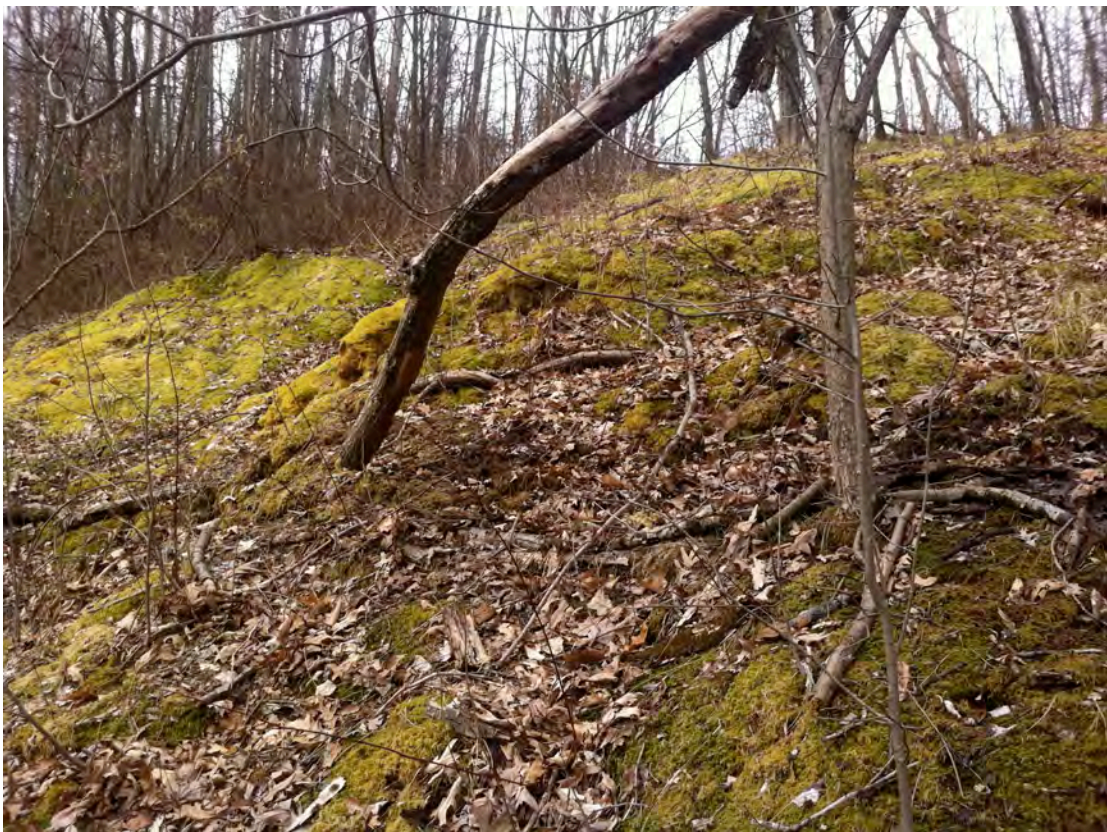
LT03 – Sphagnum wetland at the site of an AMD seep along the steep eastern slope of the Landfill Tributary.

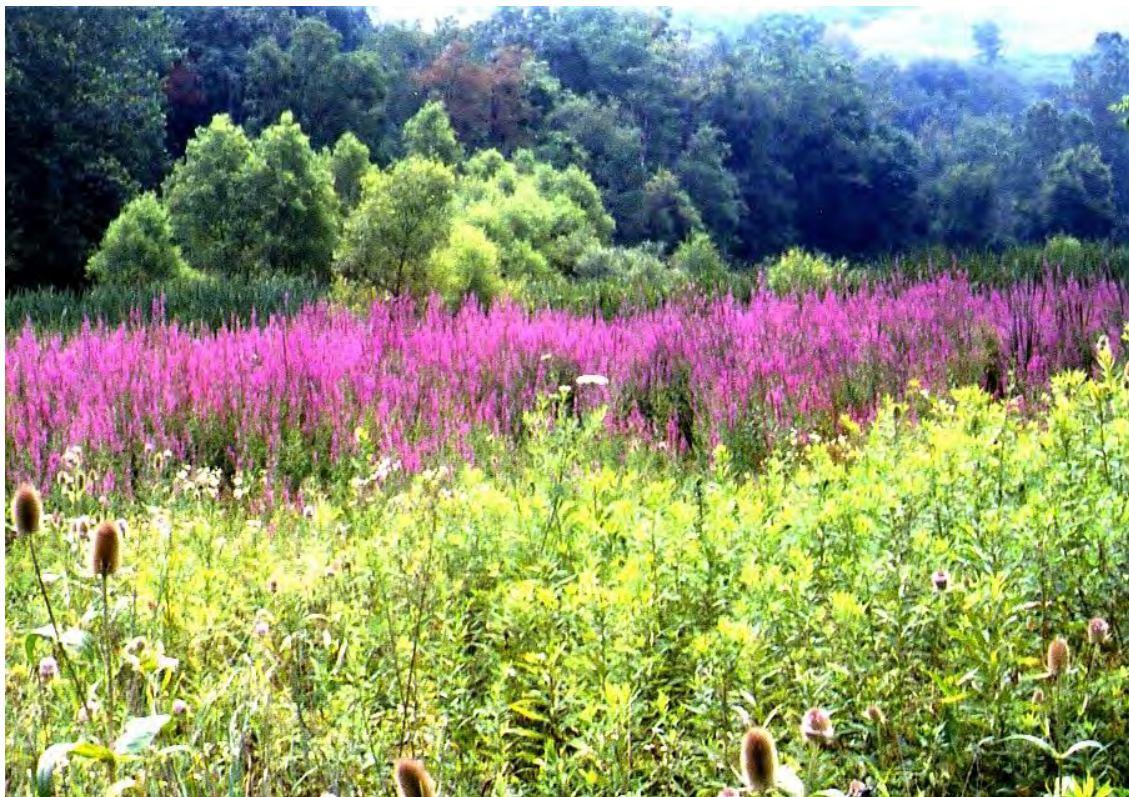
PCU010 – Purple Loosestrife, an invasive wetland species from Eurasia, is becoming established within the Snowden Wetland. This invasive provides very little wildlife value and out-competes most other wetland species. Subsequent to this photo Beaver flooded this portion of the wetland and it helped to control the Purple Loosestrife.

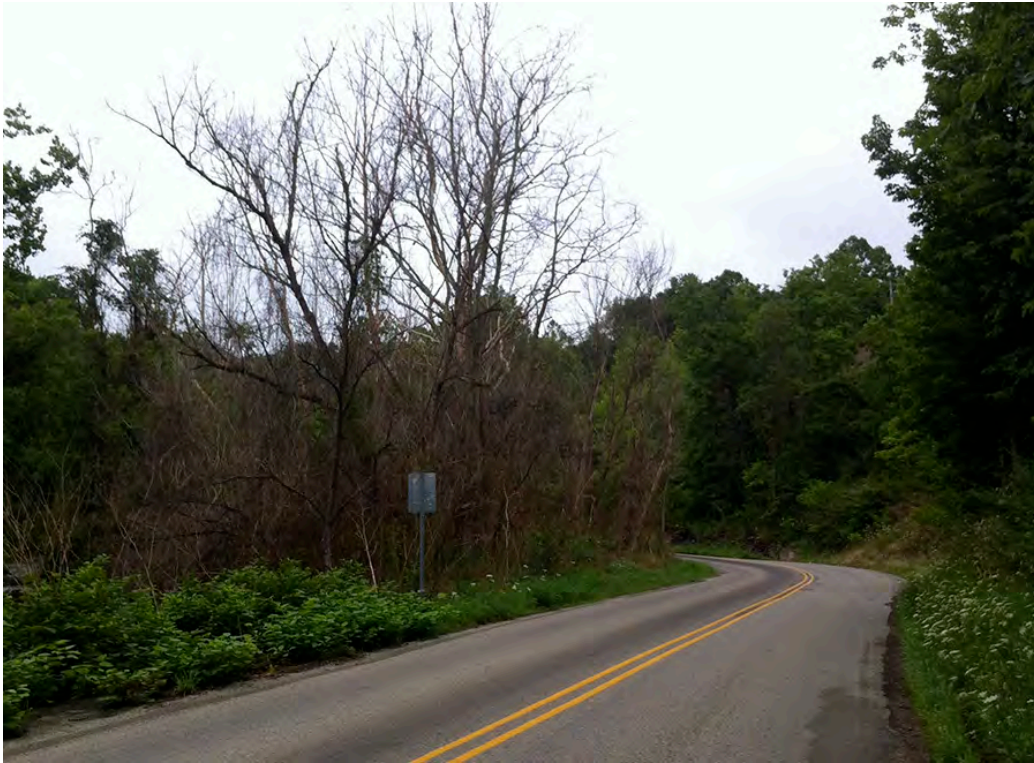
PCU022 – Piney Fork Rd in Peters Creeks floodplain near Greenman Tunnel. Japanese Knotweed establishing monoculture along road in lower left of photo. Dead trees within floodplain were killed by a water main break and salt spill from Greenman Tunnel in July of 2011.

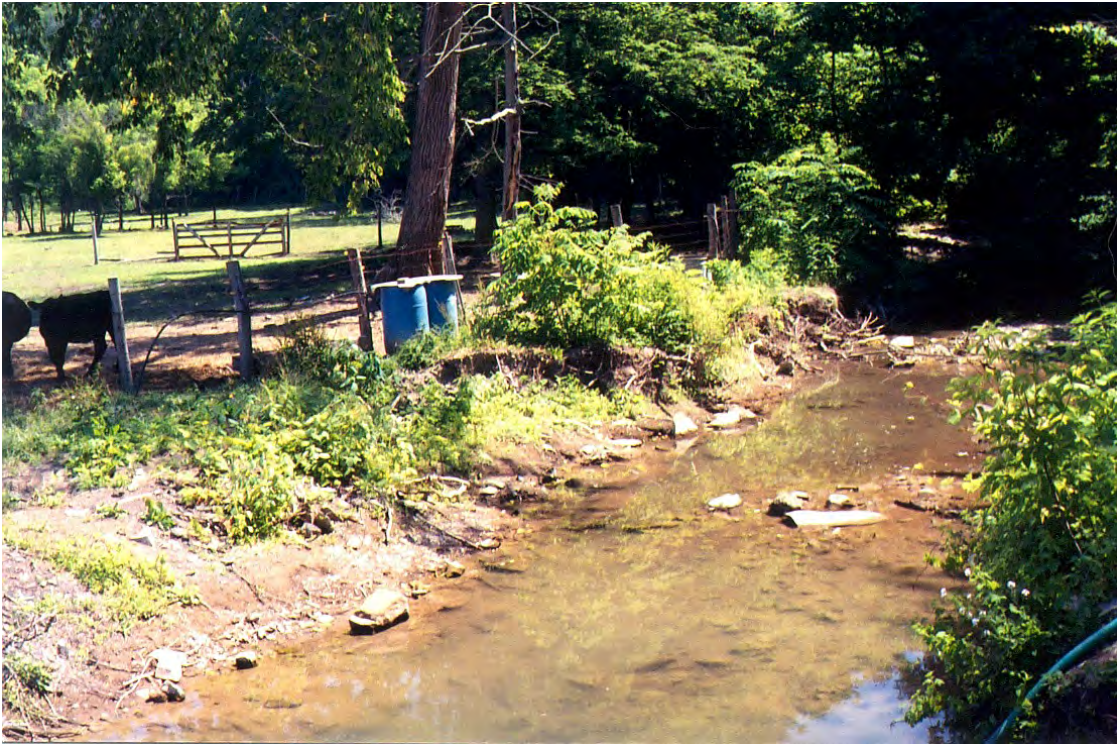
PCU100 – Livestock pasture in Peters Creek’s right ascending floodplain in Peters Township along Railroad St. Providing fencing to keep livestock out of the creek, as seen here, is important for maintaining water quality within the stream.

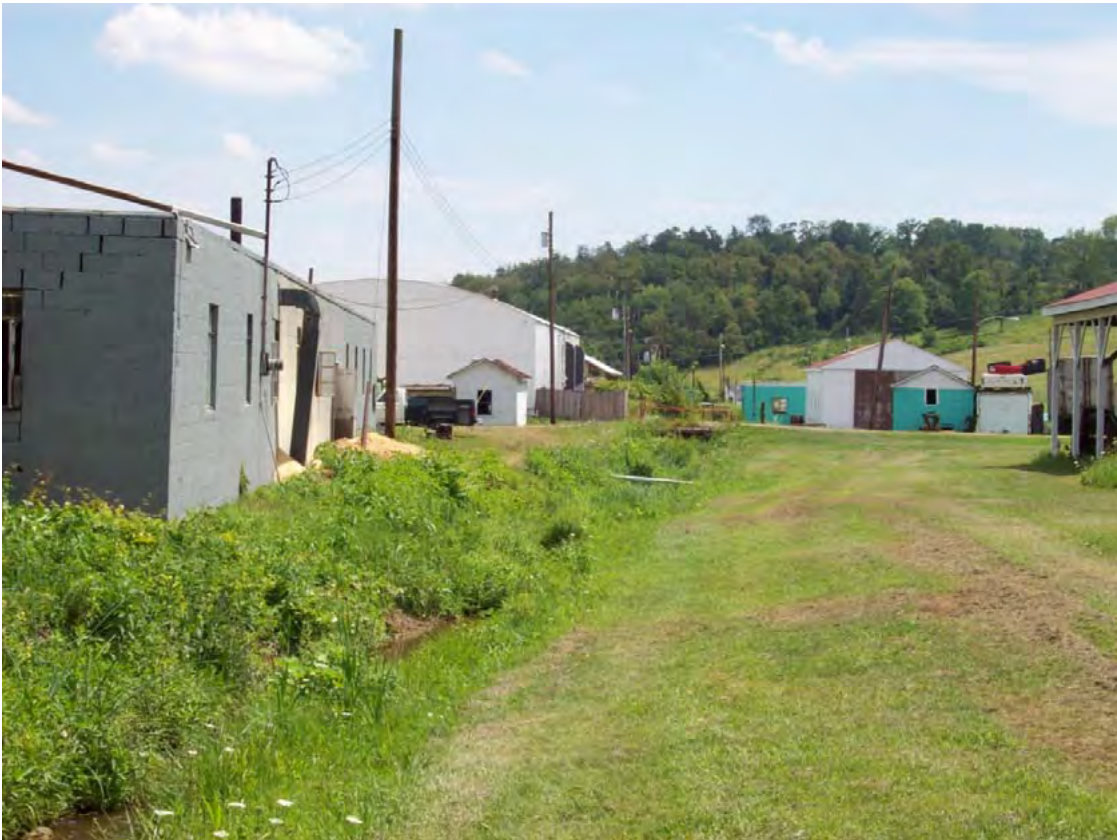
TFT39 – Trax Farm Tributary mowed right up to the stream with little natural vegetation left within the floodplain. This is a too typical occurrence along the Trax Farm Tributary and many other tributaries within the Upper Peters Creek sub-watershed.

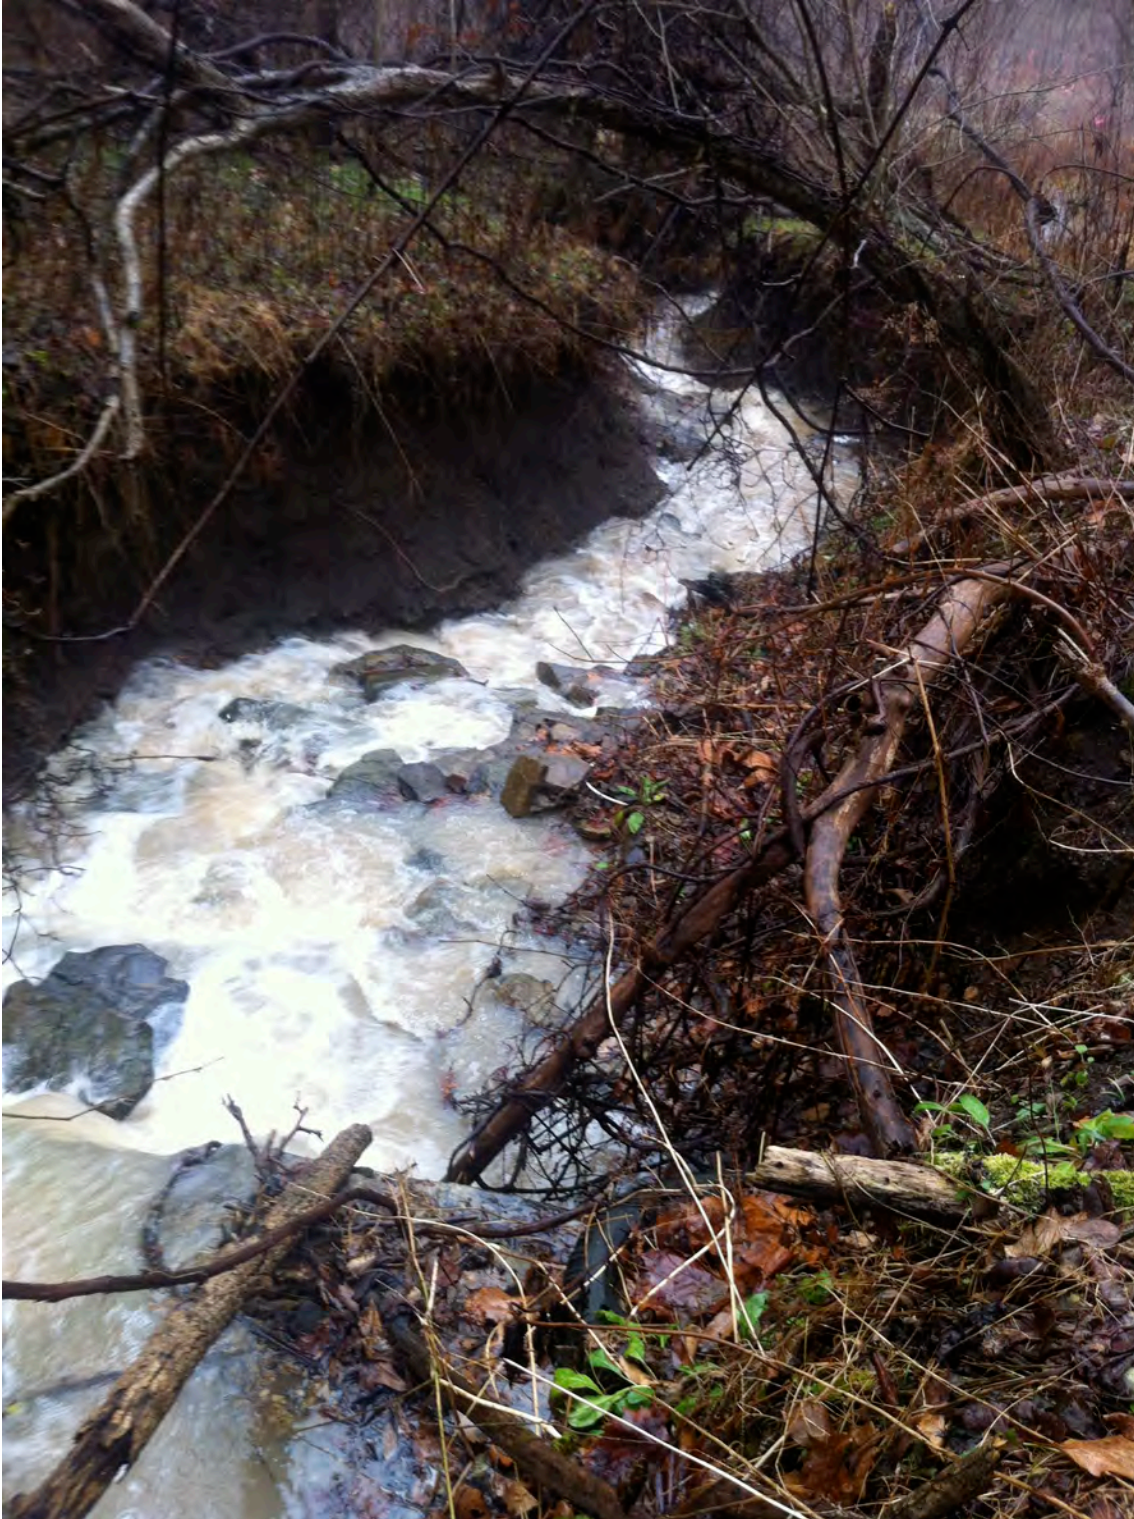
PCU020 – A deeply incised stormwater channel created by runoff from a Mon-Fayette Expressway stormwater detention basin at PCU019.
