Peters Creek Watershed Assessment & Management Plan

April 2014

1.0 PETERS CREEK WATERSHED BACKGROUND

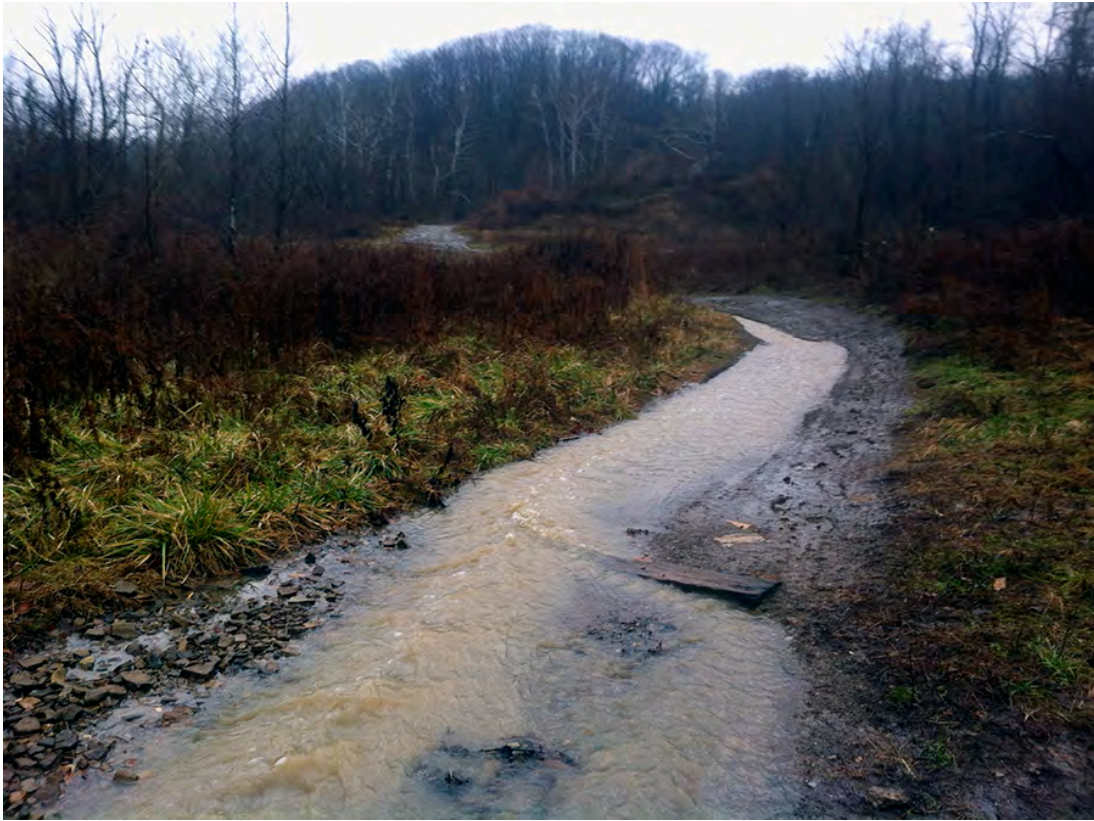
PCU020 – The stormwater runoff from the Mon-Fayette Expressway is captured by an off-road vehicle trail within Peters Creek’s left ascending floodplain; creating more erosion and accumulating more sediment prior to entering Peters Creek.

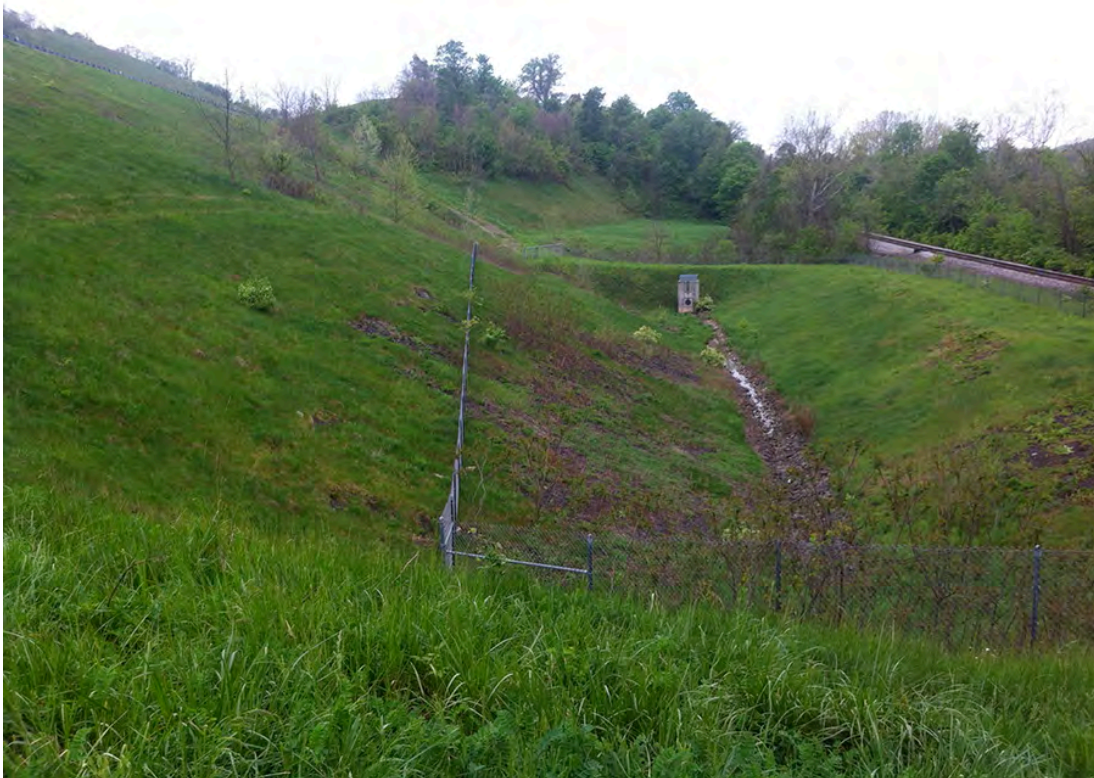
PCU019 – Stormwater detention basin accepting stormwater from the Mon-Fayette Expressway and conveying it to Peters Creek near Snowden in South Park Township.

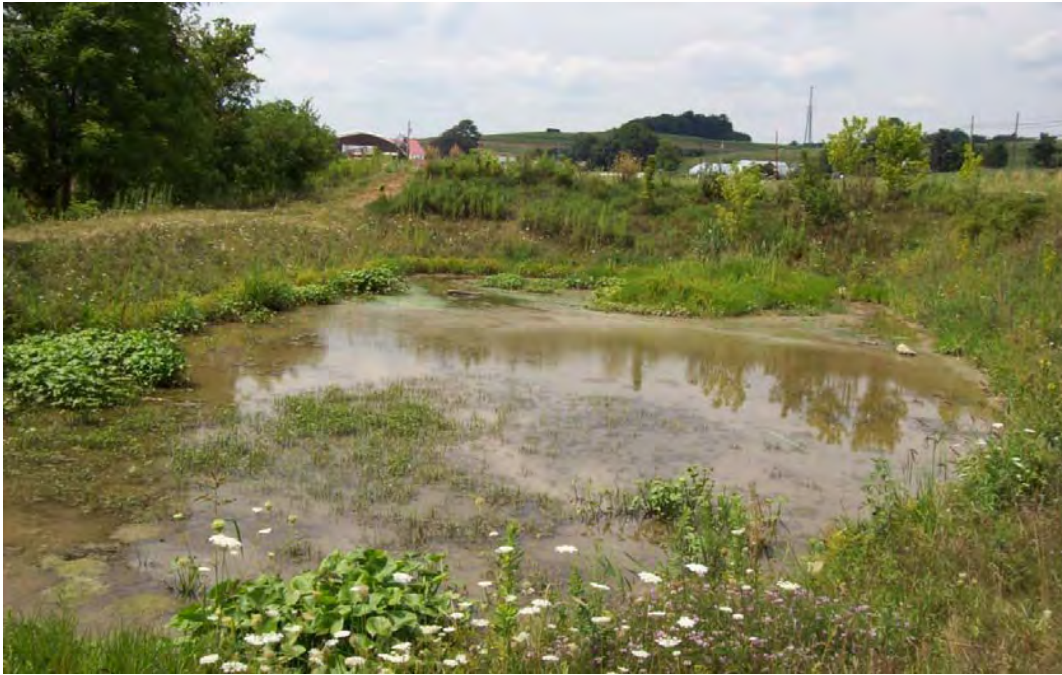
TFT45 – Stormwater detention pond along the Trax Farm Tributary just downstream of Trax Farm Market. The detention pond is filling with sediment which diminishes the basins capacity. Stormwater detention ponds require regular maintenance in order to perform the function they were intended for.

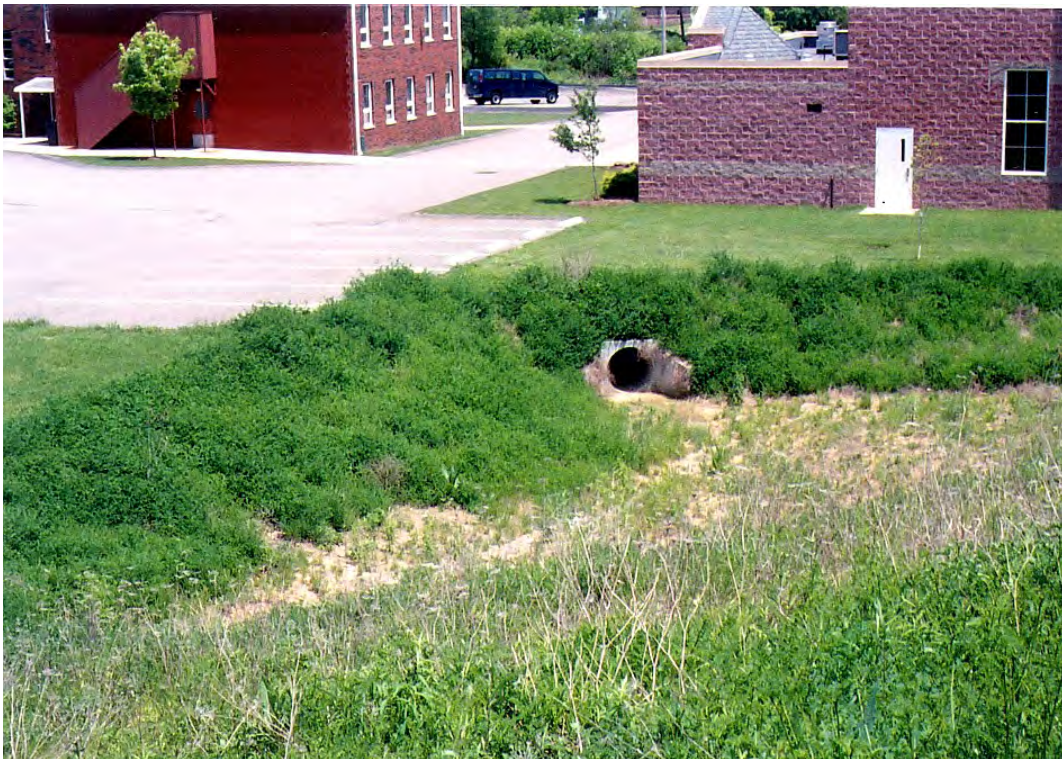
PCU146 – Stormwater runoff from Thomas Field and surrounding parkland along Linden Rd in Nottingham Township is culverted under a church lot and enters the extreme headwaters of Peters Creek's west branch.

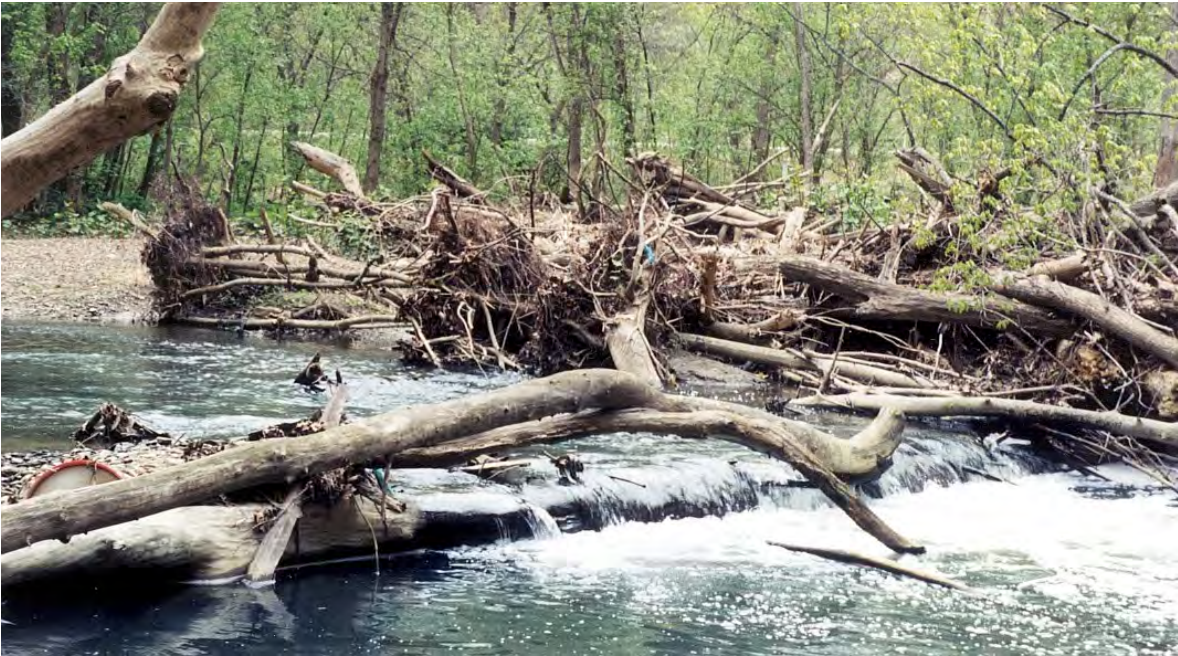
PCU002 – Formation of debris jams along streams is a natural process. This large debris jam is along a part of Peters Creek where the floodplain is wide and undeveloped. The debris jam is creating a pool along a section of stream that is mostly shallow run. Debris jams help to create diverse habitat within the stream. It is important to allow them to exist where the potential of flooding property does not exist.

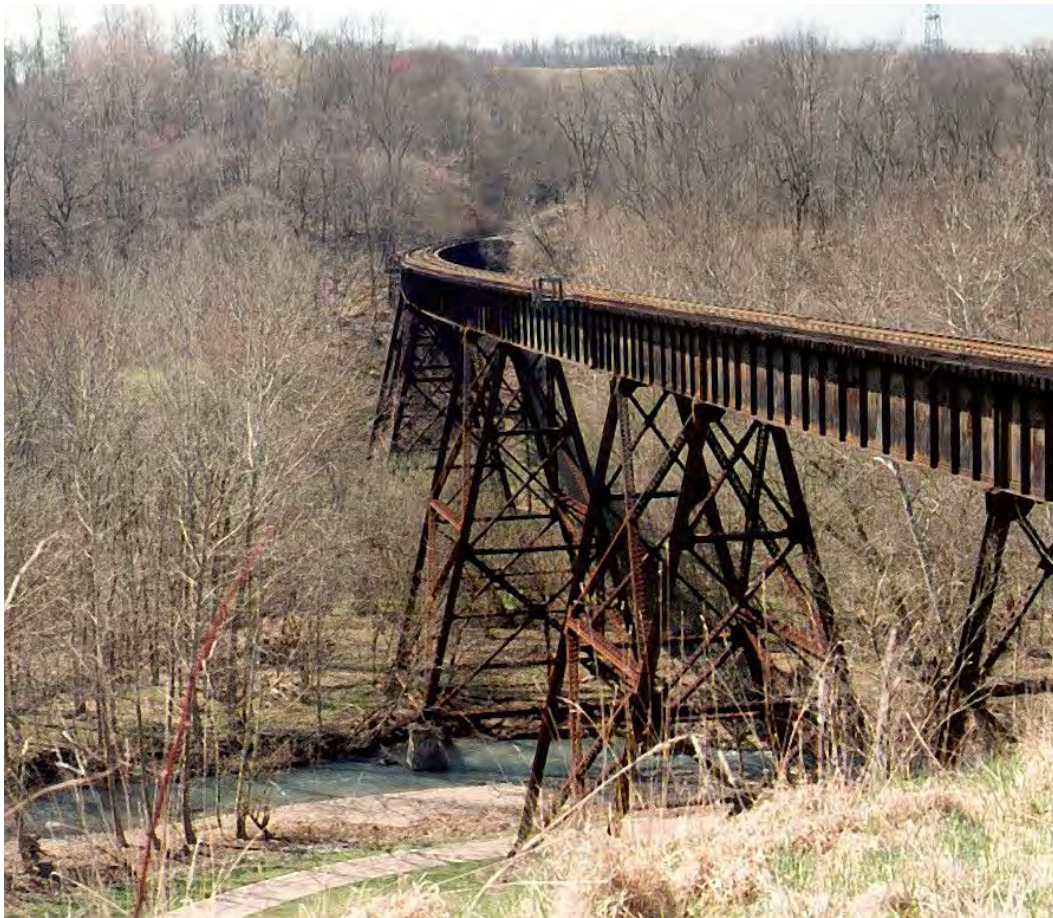
PCU006 – The Wheeling & Lake Erie Connellsville Branch Railroad Trestle abutment is within Peters Creeks channel and causes stream bank erosion at and downstream of the trestle crossing.

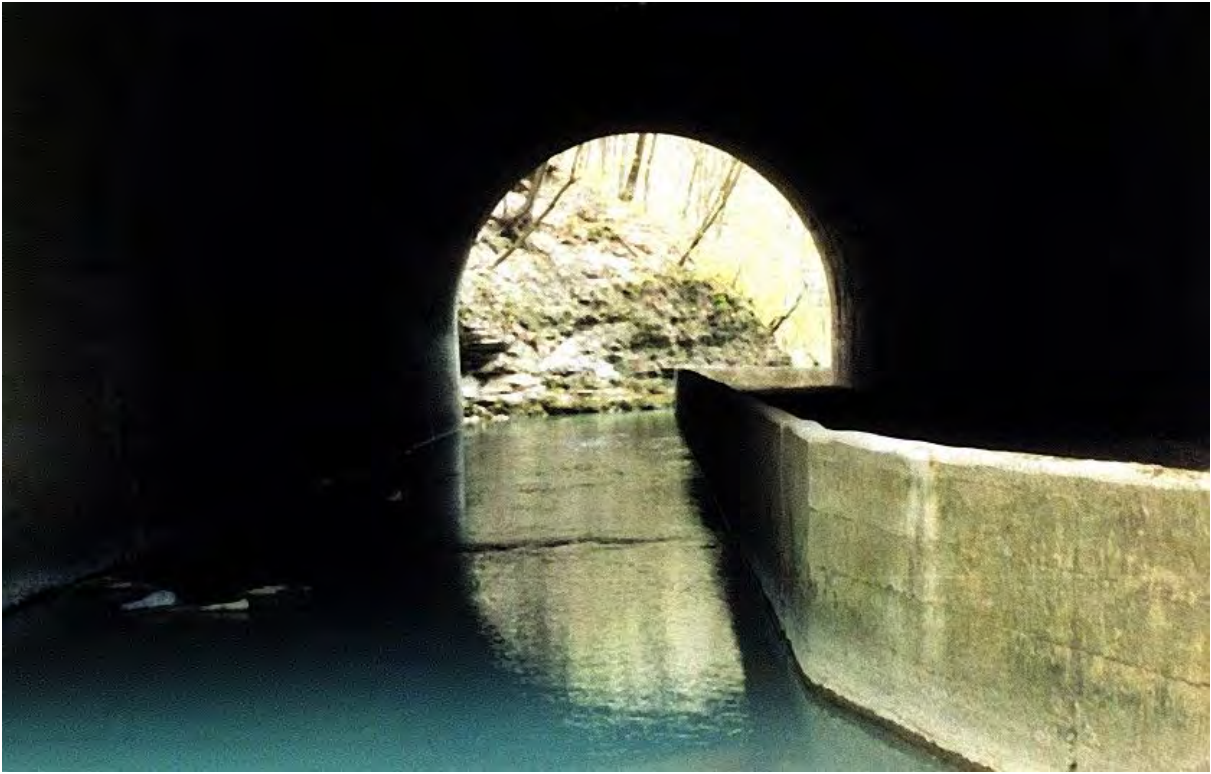
PCU029 – Peters Creek is channelized through a tunnel under the Allegheny Valley Railroad at the Allegheny and Washington County border. An undeveloped road runs along side the stream.

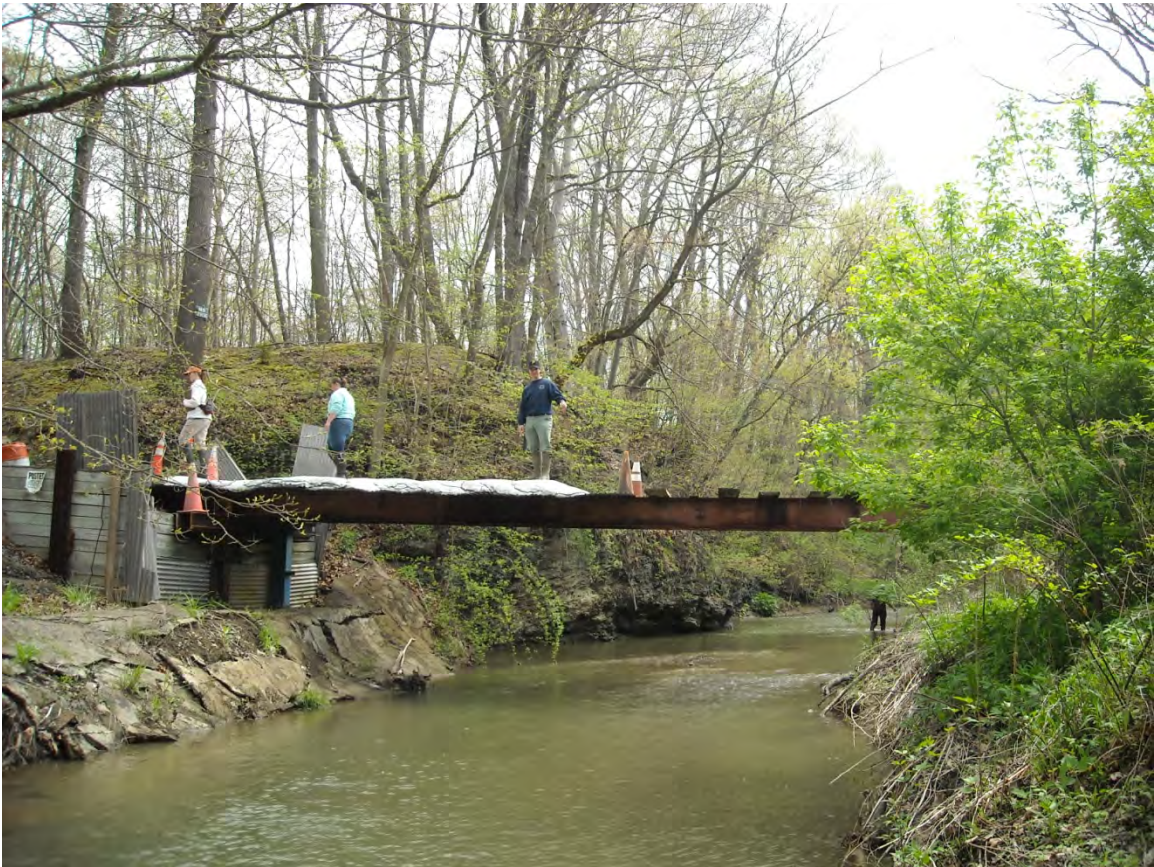
PCU037 – Homeowner bridge crossing of Peters Creek. Concrete poured along stream eroding into creek. Non-functional vehicles and other debris within floodplain of stream.

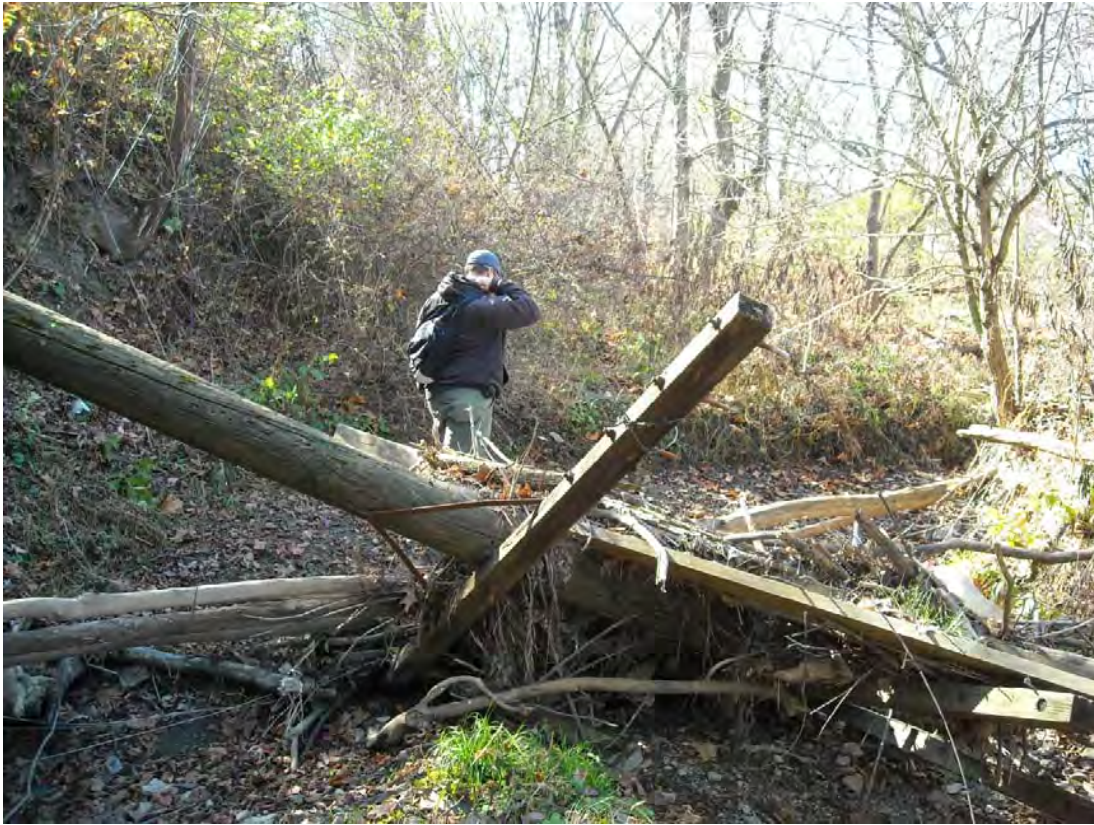
PCU126 – Fallen telephone pole creates a debris jam within Peters Creeks channel near headwaters of stream.

PCU126	-80.05928	40.24324	1015	10/23/08	Debris jam caused by telephone pole and wires in stream channel. Bank erosion on LAB.
PCU127	-80.0604	40.24306	1018	10/23/08	Debris jam caused by telephone pole in stream channel.
PCU128	-80.06328	40.24243	1022	10/23/08	Tributary that drains Bower Hill Rd enters Peters Creek on RAB.
PCU129	-80.06465	40.2419	1027	10/23/08	Peters Creek squeezed(3 ft wide) between AVR tracks and Joe Buck's Landscaping yard for several hundred ft. Inadequate buffer in this section.
PCU130	-80.06675	40.24095	1039	10/23/08	Rock stabilization along AVR tracks on LAB.
PCU131	-80.066775	40.240527	1056	7/12/13	Large coal waste deposit south of AVR tracks.
PCU132	-80.07128	40.239936	1049	7/12/13	Peters Creek bridge crossing of Valley View Rd. Culverted tributary enters Peters Creeks LAB just upstream.
PCU133	-80.07573	40.237685	1063	10/23/08	Tributary draining valley between Dyerstone Dr and Greenleaf Court enters on RAB (~10 GPM).

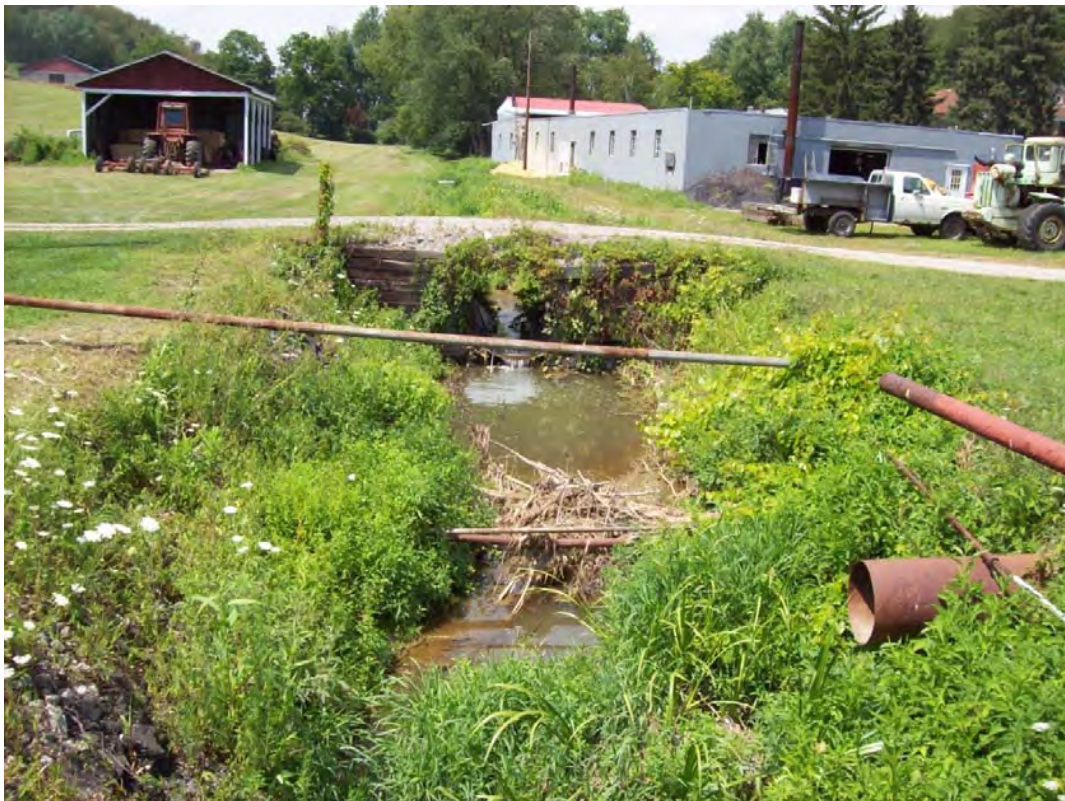
TFT38 – Inadequately sized culvert on a private drive creates erosion downstream of culvert. Piping running across the channel creates a debris jam. Stream mowed right up to stream. Upstream structures built within feet of the stream encroach on the stream.

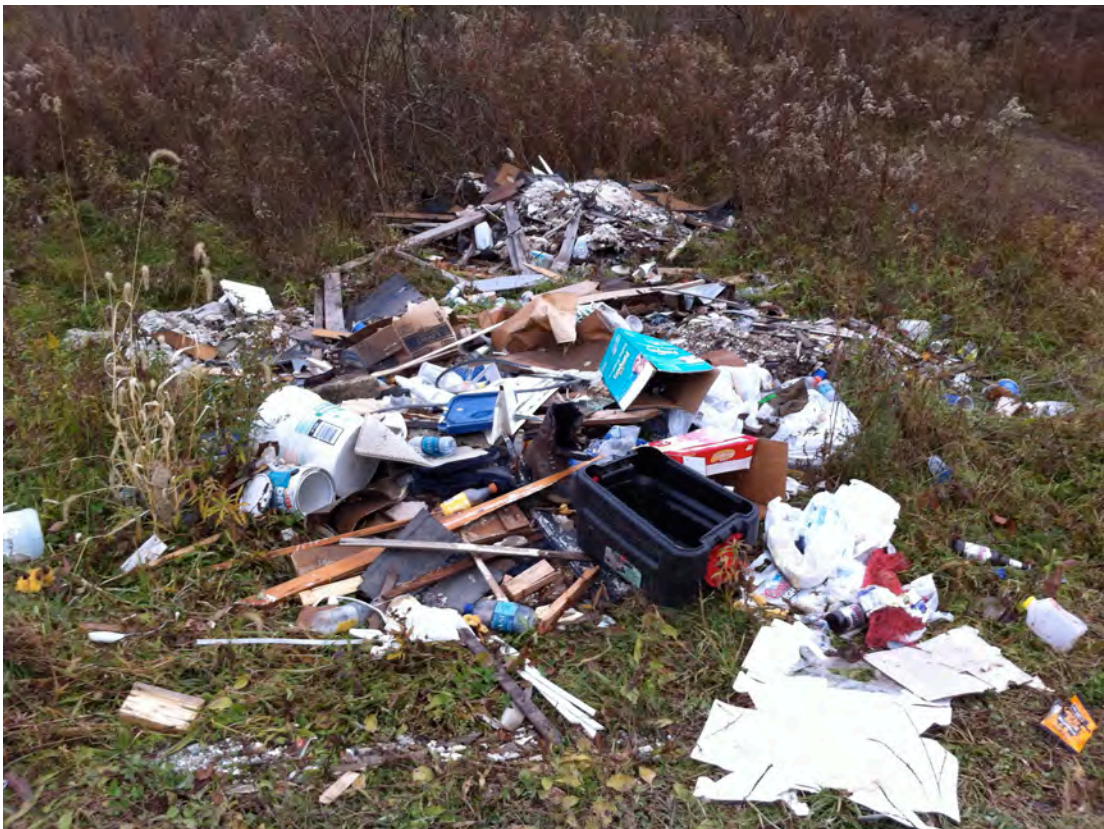
PCU016 - Illegal dumping becomes a serious problem within Peters Creek's left ascending bank floodplain directly behind and to the west of the SR3016 bridge when the bridge gate is not locked. Vandals often cut locks off of this gate to obtain off-road access to the area.

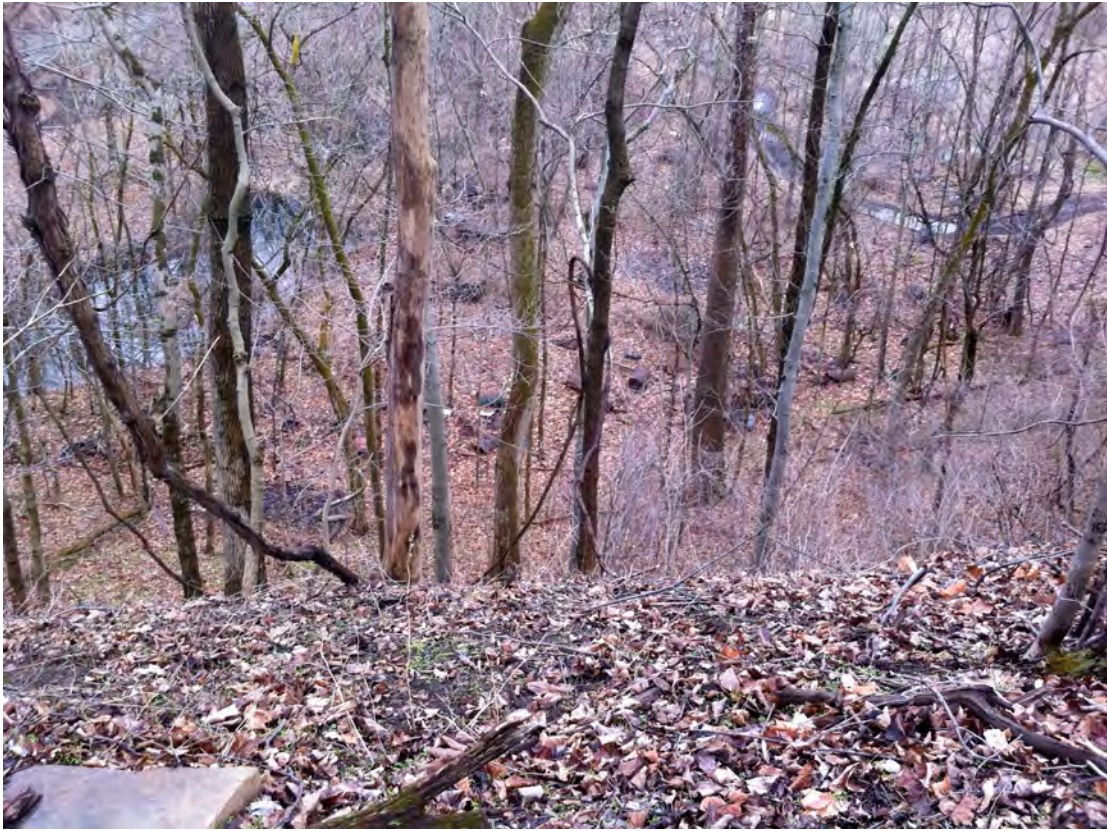
PCU030 - Peters Creek's right ascending bank floodplain wetland just west of the Allegheny Valley Railroad tunnel is littered with numerous 55 gallon drums and other assorted garbage and debris.

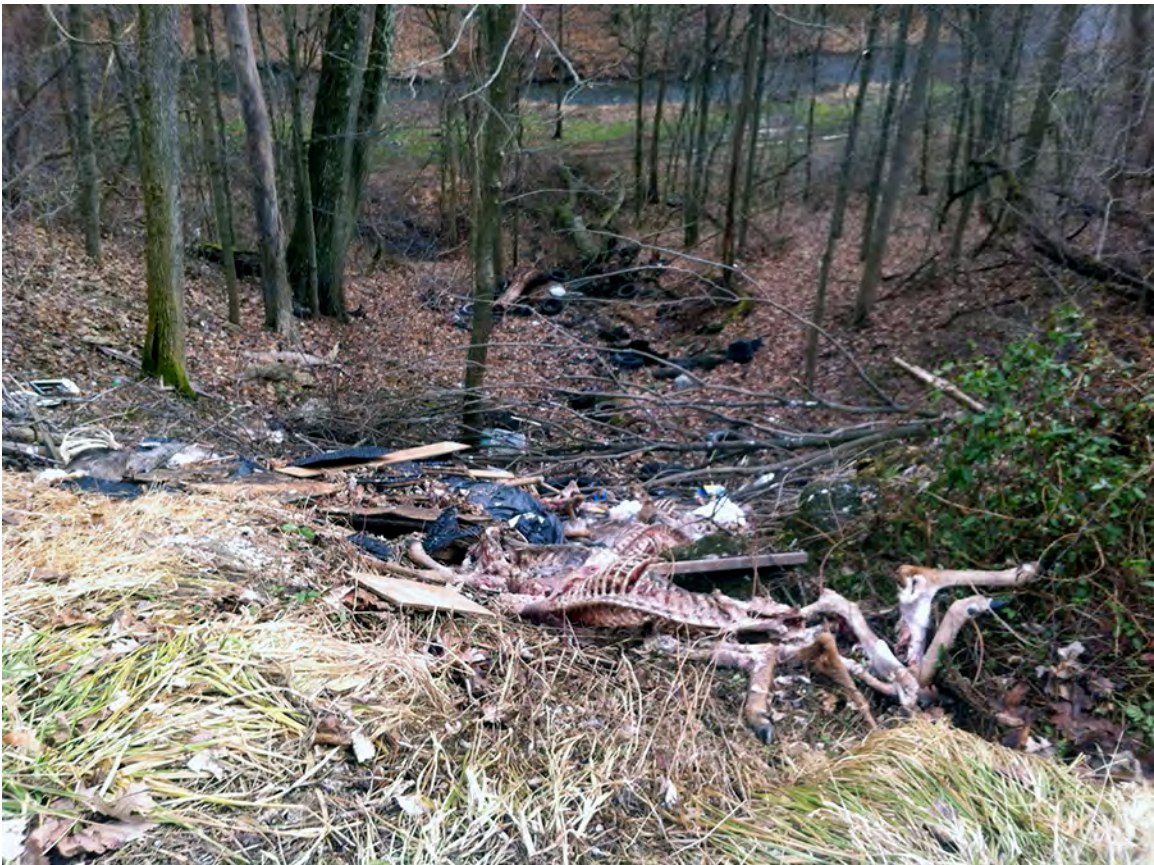
PCU041 - Illegal dump site in a ravine along Peters Creek's right ascending bank along Snee Rd east of the TR844 bridge.

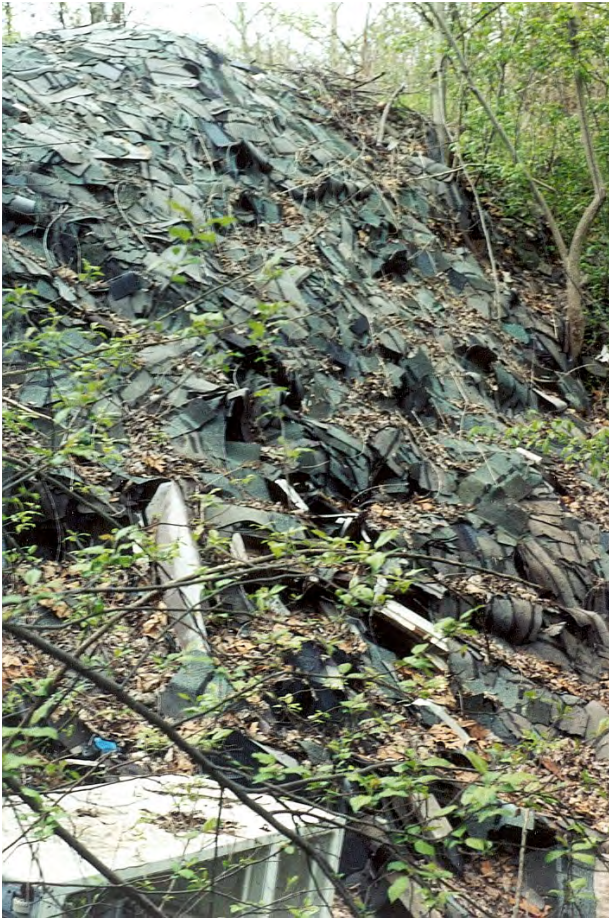
PCU029 – Large pile of illegally dumped shingles along the Allegheny Valley Railroad tracks near the Allegheny Valley Railroad tunnel.

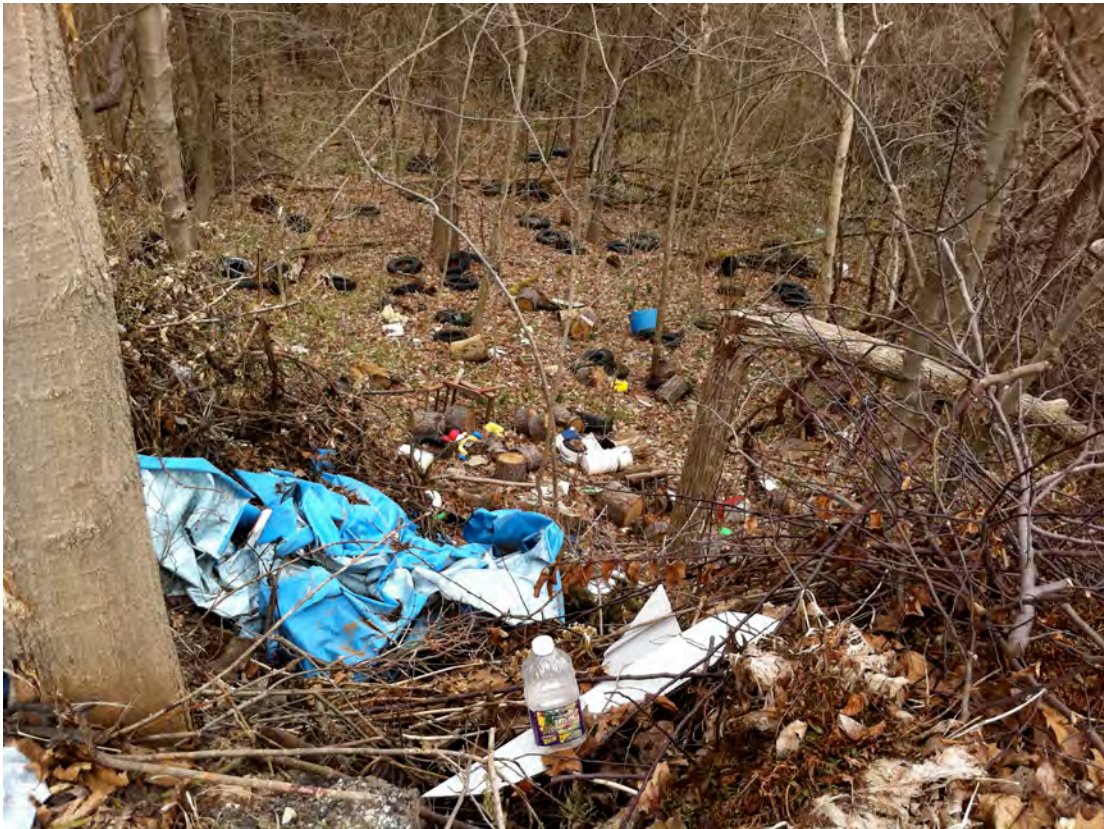
PCU040 – Large illegal dumping site north of Sneer Rd. east of the TR844 bridge.

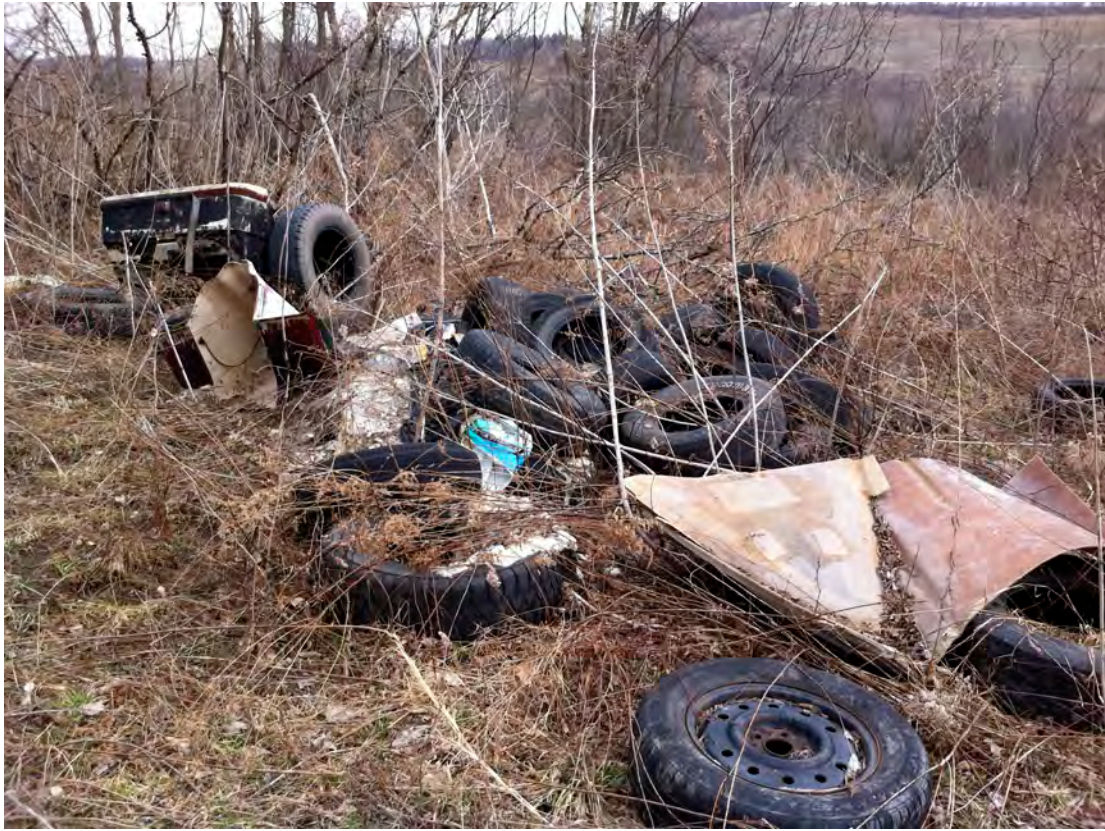
PCU044 – One of many illegal dump sites on the plateau north of Peters Creek and east of the enclosed Southhills Landfill area. The area is locally known as the “Finleyville Dumps” and is heavily impacted by off-road vehicle use.

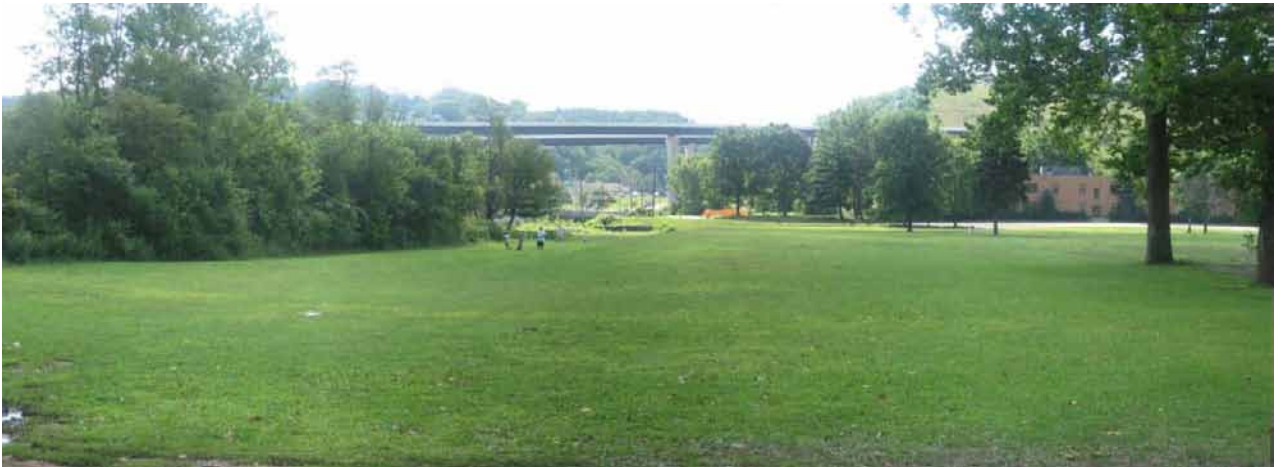
Figure 1.7 Mon-Fayette Expressway

Transportation also has had a major impact on the watershed. The Mon-Fayette Expressway was recently constructed within the watershed parallel to Peters Creek. At present, this highway is incomplete ending in Jefferson Hills Borough shortly after crossing Route 51 on its way north to the City of Pittsburgh. This highway has degraded the water quality of Peters Creek through increased stormwater runoff, as well as affected the scenic character.

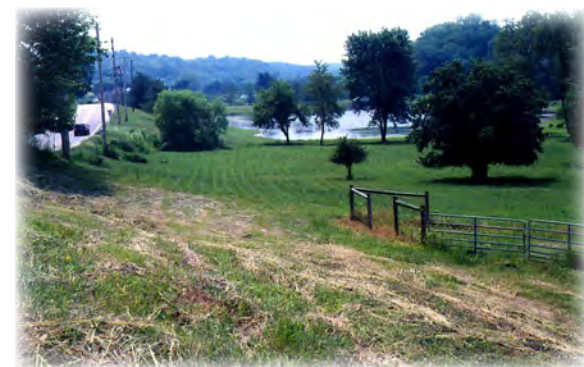
Stormwater detention ponds, like this one along Bebout Rd in Peters Twp, can be designed not only to decrease flooding but also to provide wildlife habitat and scenic character.

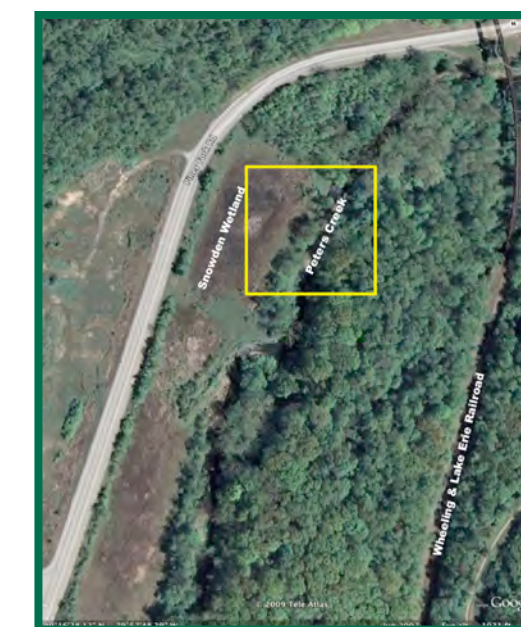
- Wetland 2
- Floodplain 2
- Hydric Soils 1
- Wooded Riparian Areas 3
- Wooded Riparian Steep Slopes 3
- Wooded Steep Slopes 3
- Woodlands 3

Total score for this grid cell: 17
