**Abandoned Mine  
Drainage  
Comprehensive  
Strategy**  
**for the**  
**Turtle Creek Watershed**

**Prepared by the  
Turtle Creek Watershed Association  
April 2006**

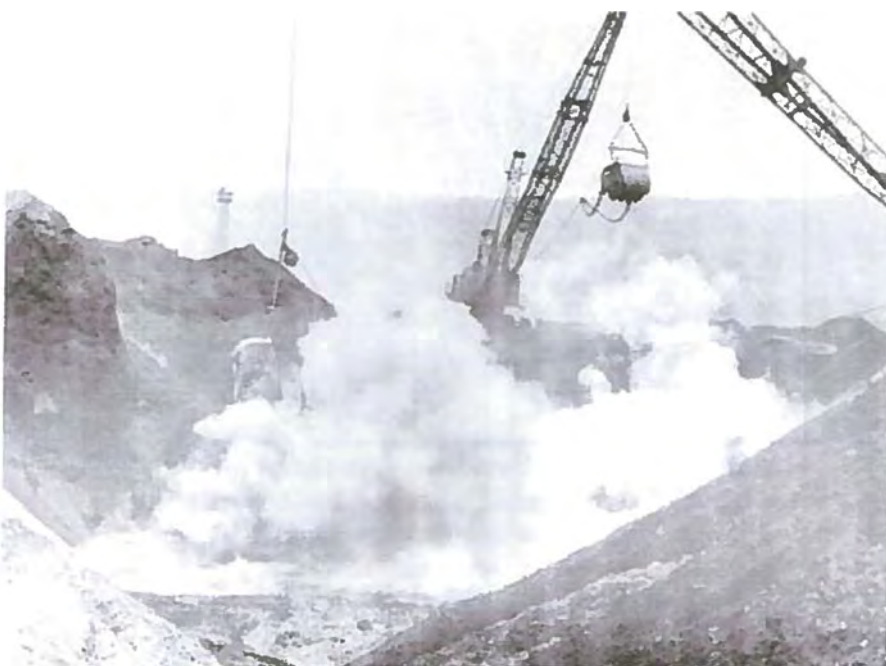
Gob piles of coal waste products also dot our landscape. These piles may contain inferior coal, coal ash (coal was sometimes burned at the mines as a power supply), sand, clay, rocks, and any other non-usable mining products. Pile materials can be the source of heavy metals that leach out, contaminating ground water and streams. The good news is that some of these piles do contain enough coal to make them useful as fuel at co-generation plants. Those are slowly being trucked away to these plants. Their ash is sometimes returned to the sites, becoming an alkaline cap. Ash can also be mixed with pile material that is not useful as co-gen fuel, but is safe to be used as fill when pH neutralized.

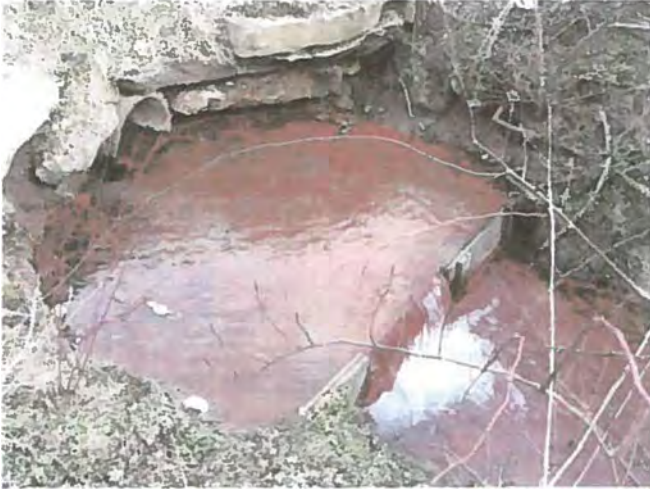
**Iron hydroxide from discharge**

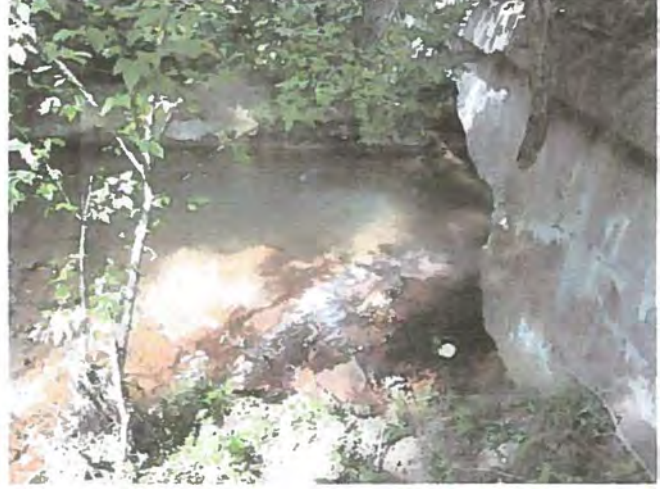
As the pH rises towards neutral, these ions bond with oxygen, once again forming aluminum oxides. This material colors our watershed streams in shades of milky white, green, or blue. Looking at stream water in a cup, tiny bits of the oxide floc are easily seen. In slow moving waters, thin layers of these colored sediments will form on the streambed.

**Aluminum oxides form as stream pH rises**

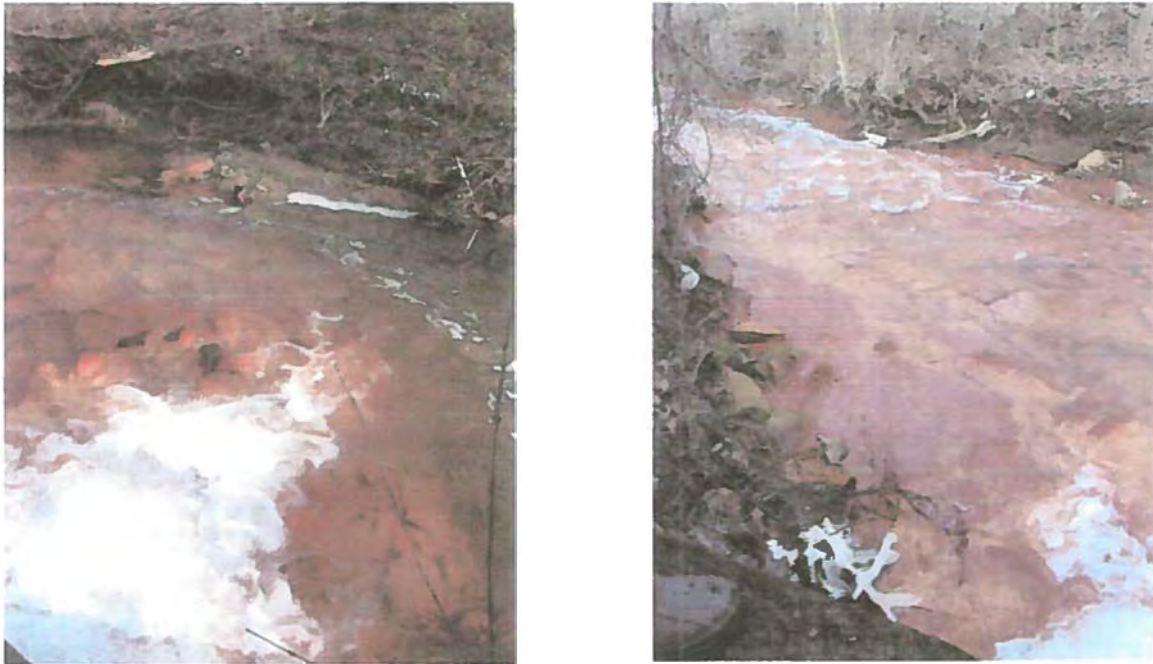
Named the Irwin Mine discharge, seven thousand gallons of mine water per minute flow out of two pipes underneath Alfieri Metals along Tinker's Run in North Huntingdon Township on its border with Irwin Borough. Due to the connections among many mines in the Irwin Syncline, this water is the combined flow of a number of them, rather than exclusively from the Irwin Mine.

**Two Views of the Irwin Discharge into Tinker's Run at Alfieri's Metals**

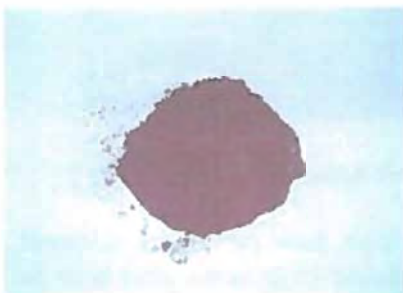
**Iron Oxide Powder**

The third project will construct the treatment system and begin operations. This phase is expected to cost \$6-8 million dollars if property values and construction costs do not increase substantially. Iron Oxide Recovery, Inc. is anticipated to handle system operations, maintenance, and repair. With dissolved iron loadings averaging the current figures of over 5,000 pounds per day, the system is expected to generate \$200,000 in gross annual earnings for iron oxide recovery.

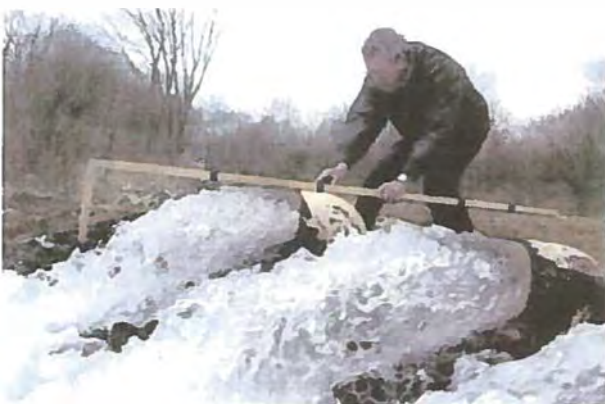
**Spreaders Sending Mine Water to Ponds**

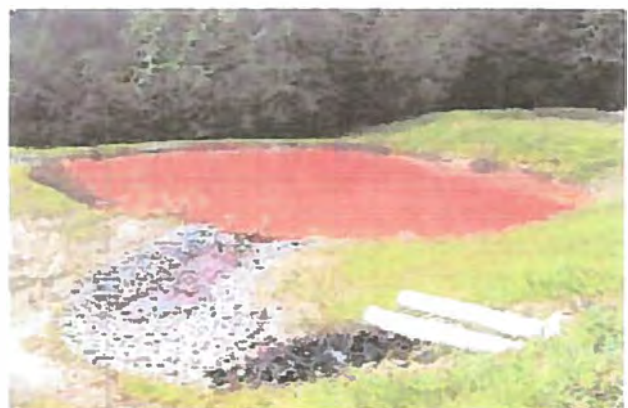
**Mine Water Emptying into a Limestone Channel then into the Primary Treatment Pond**

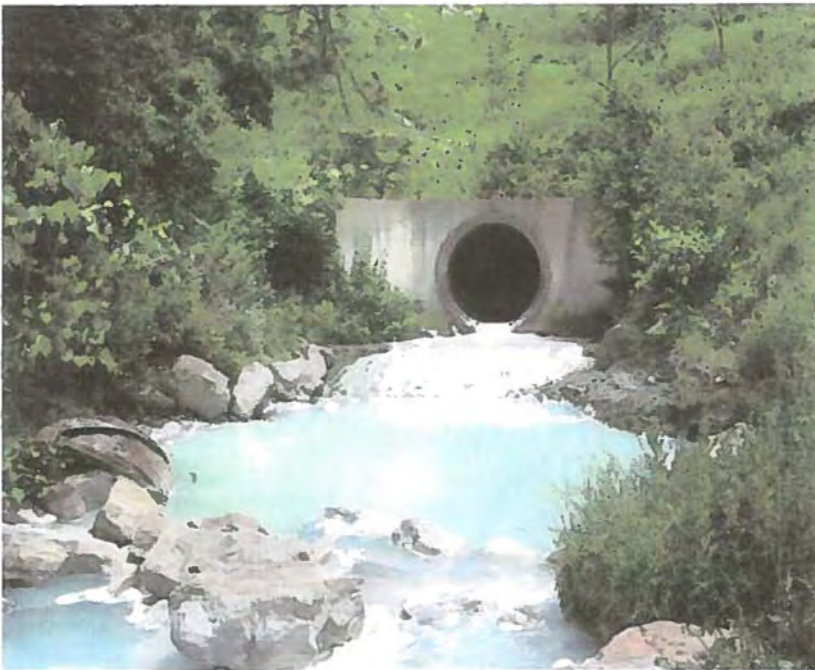
***Blue Lagoon:***

Aptly named the Blue Lagoon, this discharge is located below Business Route 22 in Monroeville and flows directly into Thompson Run. Showing the dearth of information about our discharges, as obviously dangerous as this site is, little has ever been known about it. The pipe seen at left was installed as part of the stormwater drainage system for the Monroeville commercial area. Carrying both storm and mine water, daily aluminum loads are in excess of 200 pounds. The extent of flocky precipitation demonstrates that the lagoon pH is approximately 5.0. The pH of Thompson Run at the confluence is near 6.0.

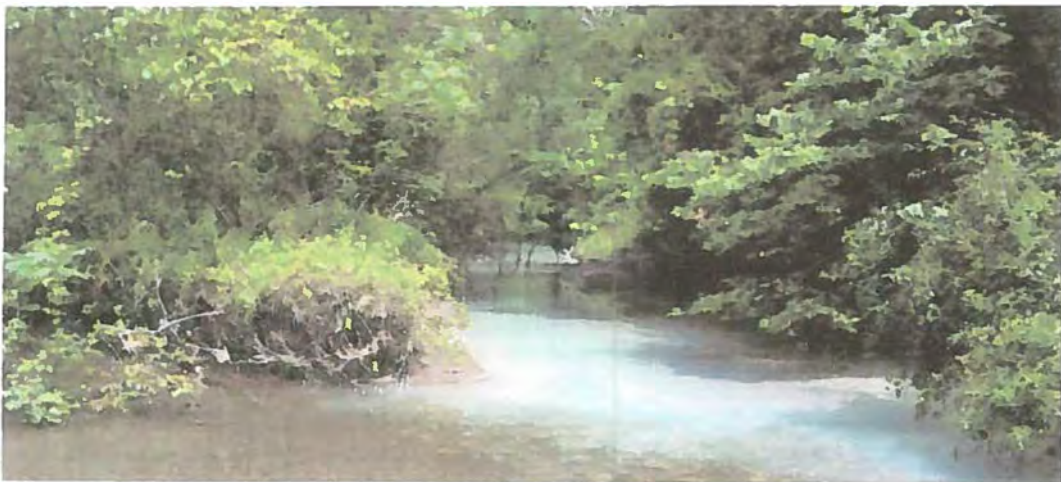
Regardless of any upstream or downstream efforts to remediate other sub-watershed unit mine discharges, as long as this site is not treated, all of Thompson Run downstream of the Blue Lagoon will remain polluted to the point that few life forms could survive. The photo below shows the confluence of the lagoon's discharge with the less polluted Thompson Run. This obvious hazard has health implications for Monroeville and Turtle Creek Borough residents. Contamination of Thompson Run also has economic implications in terms of neighborhood appeal as a place to live and work and of reflected property values.

Once Thompson Run reaches Turtle Creek, the aluminum laden water reacts with a substance as yet unidentified by the DEP to create a green color. At times this green is a deep shade. At others it has been accurately described as looking like lime Kool-Aid. As an anecdotal biological indicator, bass fishing in Turtle Creek above Thompson Run is quite popular among local residents, but few bass are found below.

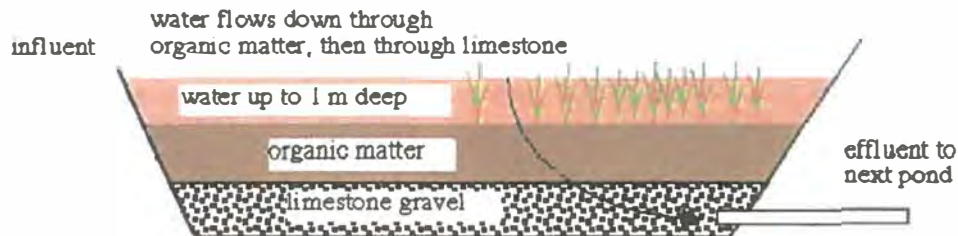
### SAPS - Successive Alkalinity Producing System

The water quality assessment report recommends use of vertical flow reactors (successive alkalinity producing systems) for many of the sampling sites located in residential areas. However, from a practical standpoint the combined construction costs for these systems would be substantial, and the annual operating costs prohibitive. If a treatment method can collect or combine mine pools underground, then treat one discharge in a suitable location, success becomes more likely.

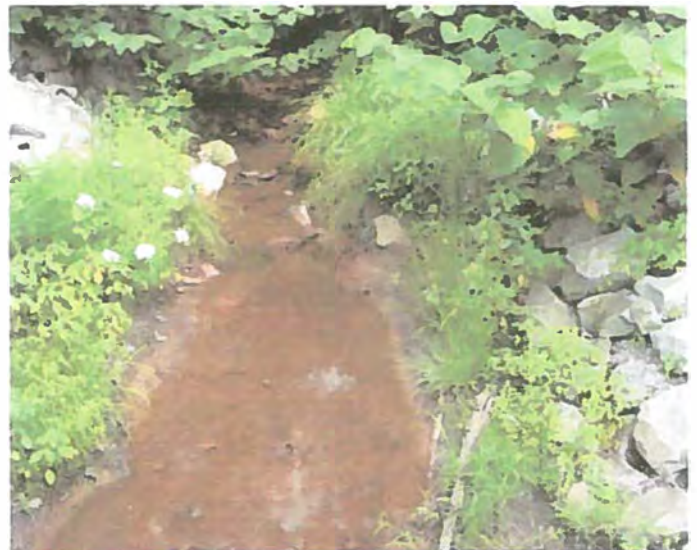
#### Lyons Run Near Boxcartown Road

Lyons Run flows south through central Murrysville and Penn Township, then turning west along the Pennsylvania Turnpike, joining Turtle Creek near the Franklin Township Municipal Sanitary Authority (FTMSA) plant. The Lyons Run Mine operated in the upper areas of the stream and most of the mine water discharges are along Boxcartown Road, crossing the municipal boundary. One of the most damaging aspects of this mining heritage is the aluminum-laden water polluting Lyons Run. In the upper reaches, the pH is low, so the aluminum is in solution and not visible. (In slower moving water, the long, green filamentous algae characteristic of acidic water grows freely.) However, the iron oxide contamination is visible, as shown in the photo above.

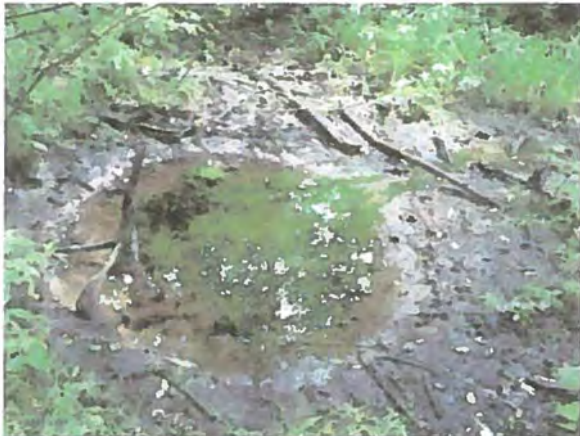
### Acid Mine Water Seep

However, several years later, mine subsidence changed this picture when two of the pipe discharges suddenly became numerous seeps and springs – an example is shown on the next page. (Note the filamentous algae present.) Preliminary evaluation by BAMR suggested that designing and constructing a treatment system for the new conditions would be extremely complicated in comparison to the old conditions.

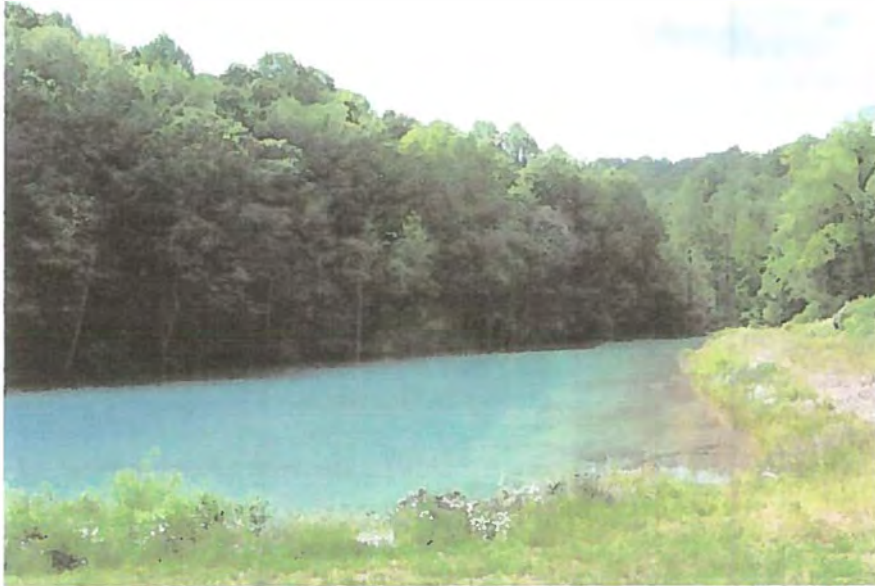
### **Contaminated Pond on the Crooks' Farm**

Another substantial source of aluminum contamination is located on the Crooks’ farm near the Pennsylvania Turnpike. Like the Blue Lagoon, this discharge has turned a pond (60 feet deep at the center) a deep blue color. Without an obvious mine water source, the pond’s depth suggests it has tapped into the mine under it. Near the shores, the bottom is covered with white aluminum oxide, creating the visual effect of a mini-Caribbean seascape with white sand and azure blue water. This pond empties into a tributary of Byers Run, which follows the turnpike for several miles and flows into Lyons Run at approximately Mile 61.

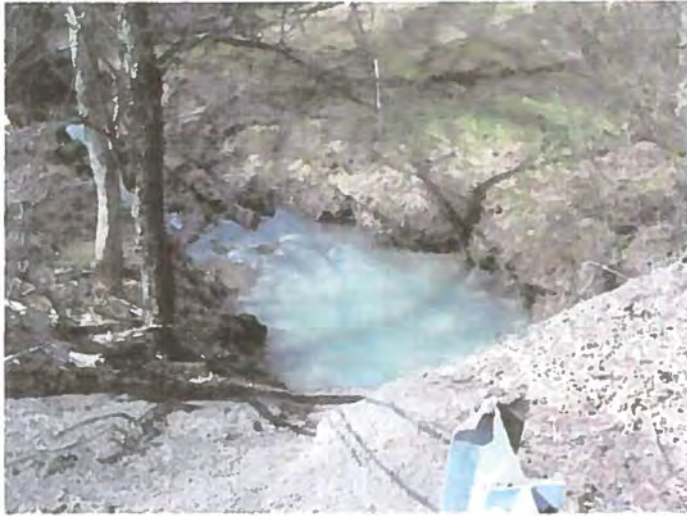
### Chalfant Run on Rt. 130 at Churchill Country Club

The most likely major sources for much of the mine water are the Sandy Creek Mine and the Oakhill #2, #3, and #4 Mines. However, some water samples also suggest smaller, more isolated sources. As shown in the photo of Sawmill Run above, aluminum contamination is a huge problem here too and ultimately contributes to the Thompson Run pollutant load in its lower reaches. The same can be said of Chalfant Run, shown in the photo to the left.
