LOYALHANNA CREEK WATERSHED

# **Assessment and Restoration Plan**

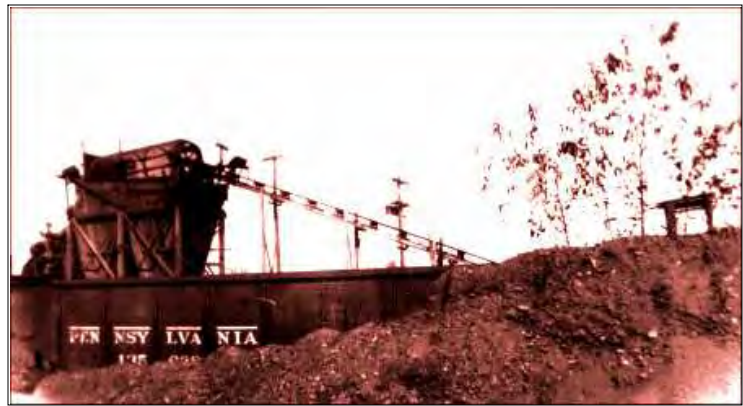
*Coal tippie at the Andrico No.5 Mine near  
New Alexandria, PA*

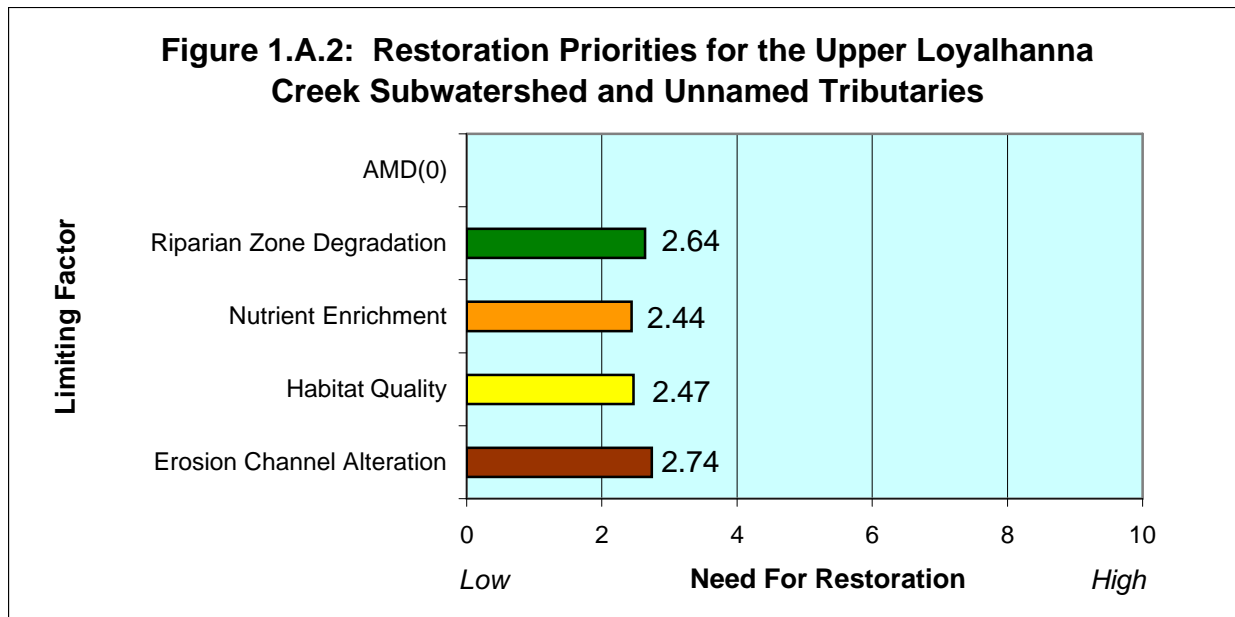
Figure 1.A.2 exhibits overall restoration priorities for the entire subwatershed. As indicated, the limiting factor that received the highest restoration priority rating is erosion and channel alteration. The remaining limiting factors are close in priority rating.

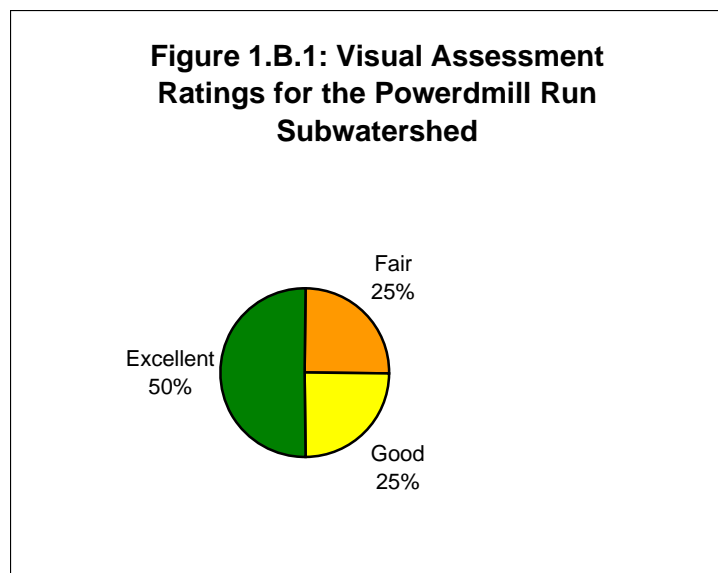
The Powdermill Run subwatershed was assessed in the middle of July 2003. A total of four stream segments were assessed. As depicted in Figure 1.B.1, 50% of the subwatershed received an excellent rating, 25% received a good rating, and 25% received a fair rating. An average score of 8.40 was given to the entire subwatershed, which is a good rating overall. The favorable rating reflects the quality of the subwatershed and the presence of very few limiting factors within the main stem and its tributaries. Individual stream ratings are depicted in Map 1.B.2.

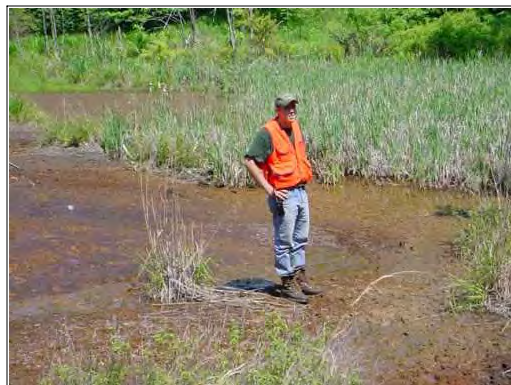
WPC staff member shown in mine drainage area on Hannas Run (HRWESTC)
