Anderson Creek Watershed

Assessment, Restoration and Implementation Plan

September, 2006

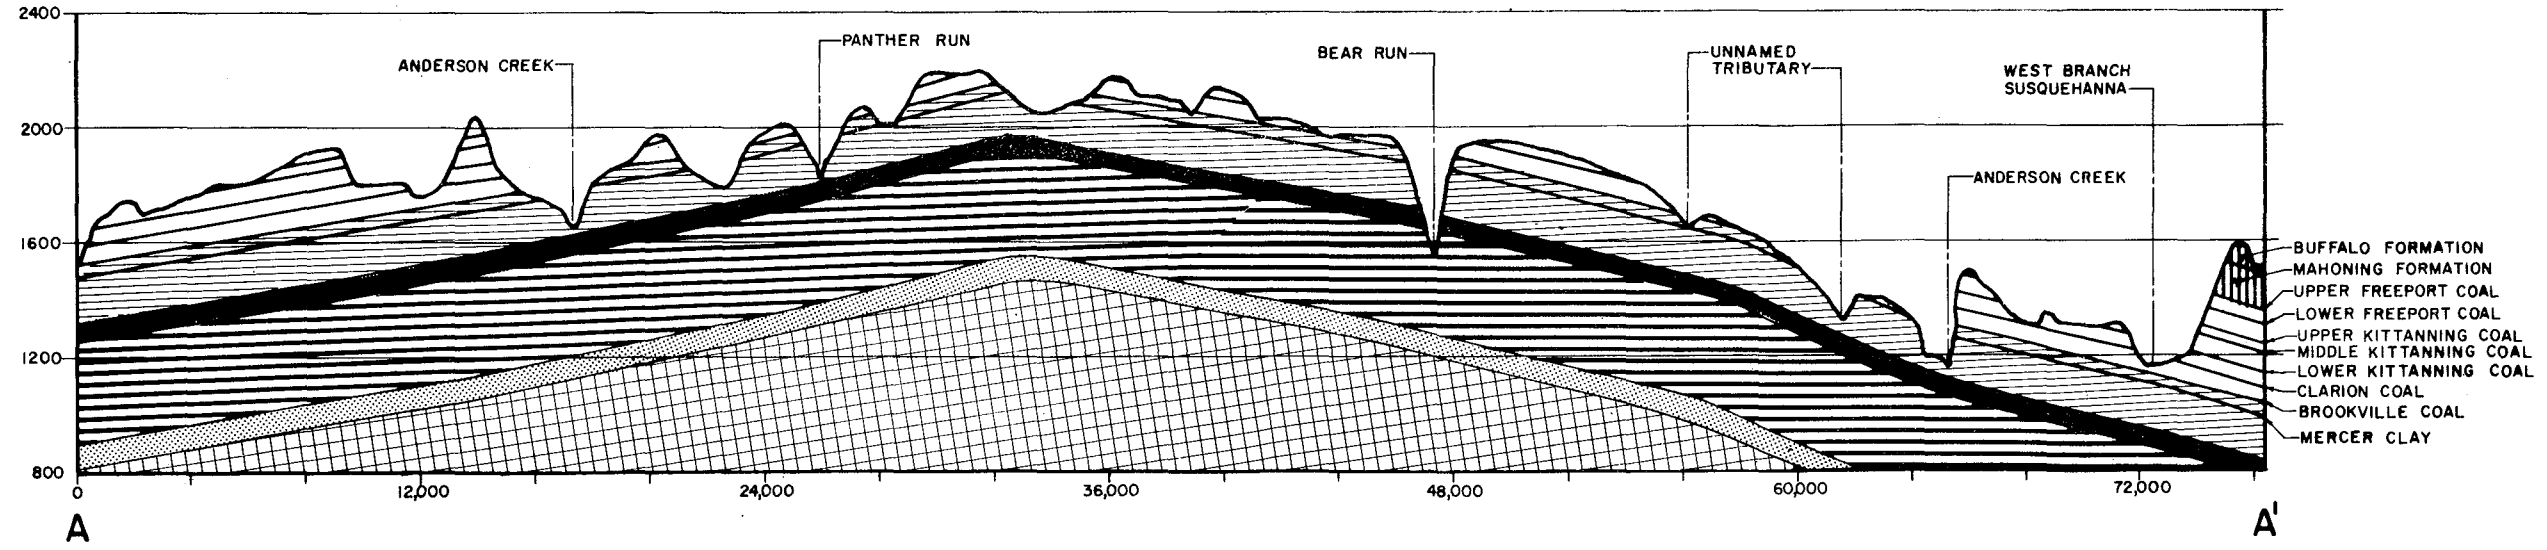
GENERALIZED COLUMNAR SECTION OF EXPOSED ROCKS

Brookville coal					Thin, variable.
	Homewood s.s.				Massive s.s. often separated by shale.	
	Elliott Park Fm.	Connoquenessing s.s.	Mercer coal		Variable, often several thin beds present at this horizon.	
			Mercer clay			
						Fine grained, quite shaly in places almost completely replaced by sandy shale.

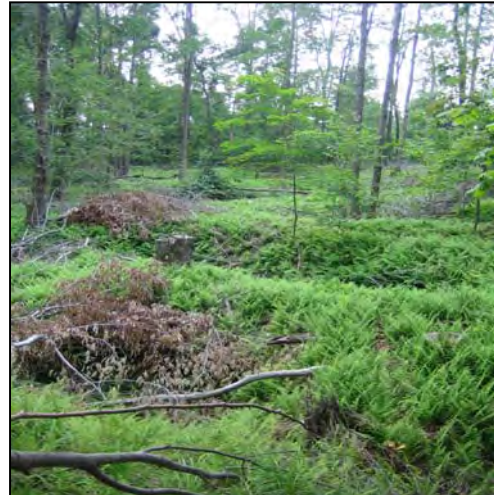
Subsidence area above the Spencer clay mine. Note the numerous depressions. Such areas direct rain and surface water directly into the underground mine, which increases pollution. Subsidence areas are extremely hazardous to nearby residents.

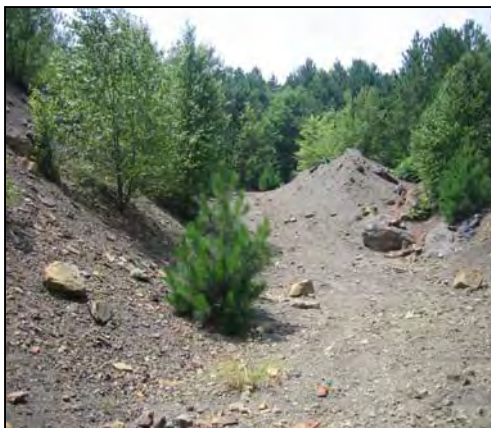
Poorly vegetated mine spoil on an abandoned surface mine.

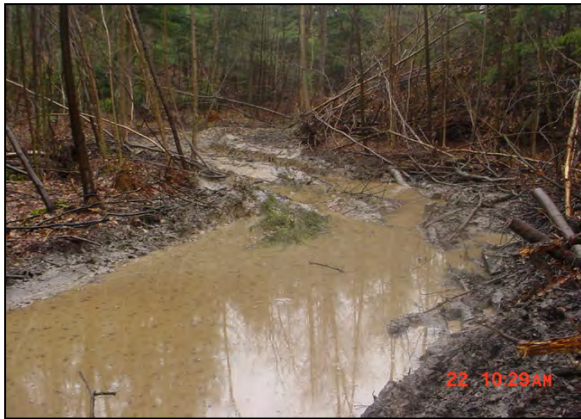
Improperly constructed logging road with poor drainage allows water to collect and sediment to enter the nearby stream.

Logging operations also often necessitate the crossing of streams. To assure minimal impacts, the construction of stabilized stream crossings is necessary. Proper construction of those crossings is critical in limiting erosion and sediment and protecting in-stream habitats. Logging roads should be constructed in a manner that limits erosion.

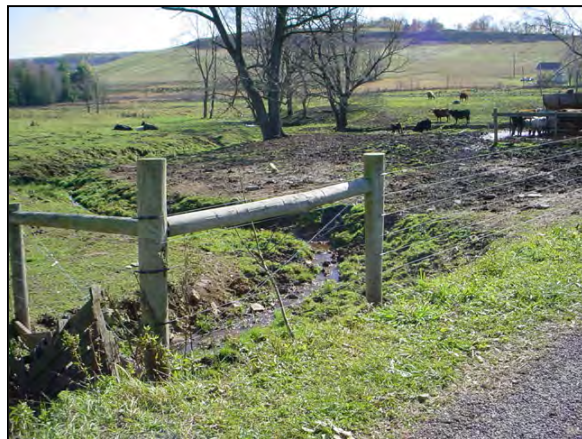
Unlimited cattle access to streams can cause sedimentation, erosion, and nutrient pollution.

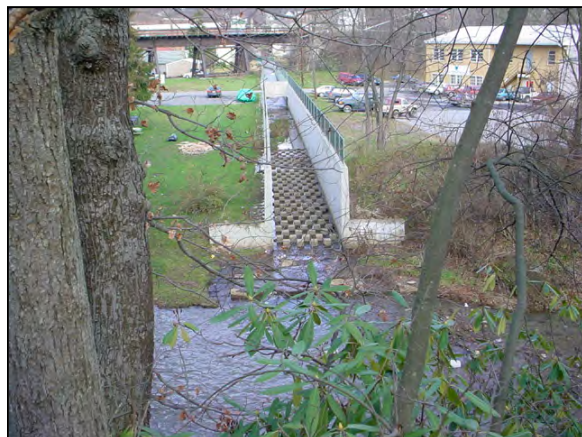
Tanners Run, a tributary to Anderson Creek, is enclosed in a concrete channel in Curwensville.

Some stream segments of tributaries within Curwensville have been channelized with hard structures (concrete channels) for flood control because homes and businesses within the town have been built within the floodplain. Although the structures control water during periods of high flow, they are detrimental to natural stream conditions and functions. However, it is unlikely the concrete-lined stream segments will be returned to anything resembling natural conditions. Therefore, for this assessment, the areas are just noted as impacted.

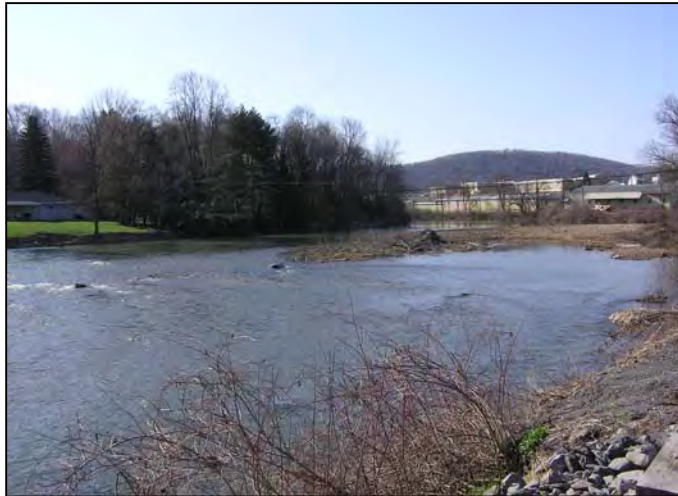
Gravel bar, which has formed in the West Branch of the Susquehanna River at the mouth of Anderson Creek, is causing erosion along the streambank in the background.

Anderson Creek braids into two distinct channels just below the State Route 879 Bridge, near the Pike Township Municipal building. The gradient remains steep enough through this segment that no significant sediment bars have appeared within the channel. Curwensville Borough has reported the formation of a large gravel bar below the mouth of the stream in the West Branch of the Susquehanna River. It was reported that during high-flow conditions, the gravel bar is causing water to be diverted towards homes and businesses located along the West Branch of the Susquehanna River. Borough officials planned to apply for a grant through the Growing Greener program in the winter of 2005 to address the problem. It is recommended that natural stream channel design techniques be incorporated into any proposed remediation effort for the gravel bar. A more detailed study of the entire lower main stem of Anderson Creek, from the bridge on Route 879 to the mouth, would likely provide additional opportunities to install natural stream channel design structures that would greatly improve in-stream habitat.

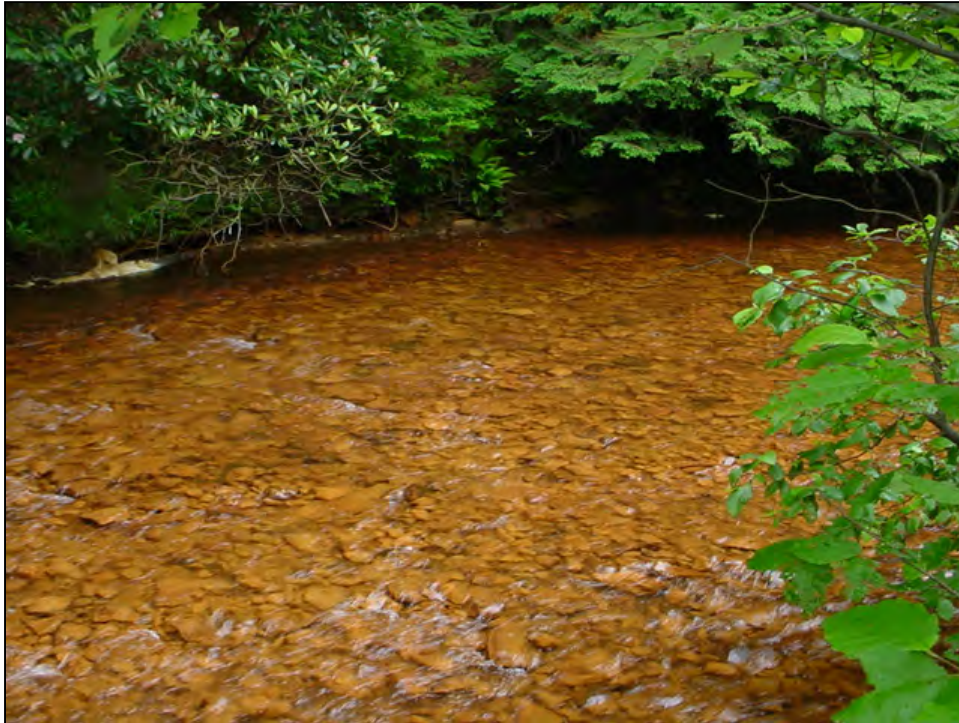
Iron from AMD pollution sources deposited on the streambed of Little Anderson Creek.

Abandoned mine drainage, or AMD, is a term given to water that has been polluted due to mining activities. A mineral called pyrite, which is often contained within coal and shale layers usually associated with coal, produces sulfuric acid through a series of complex chemical reactions when it is exposed to oxygen and water. Under normal or undisturbed conditions, little or no chemical reactions occur. After mining, whether underground or on the surface, oxygen and water comes in contact with pyrite and begins the chemical reaction. Depending on the chemical makeup of the rock layers, highly acidic water can be produced. This acidic water often leaches toxic metals from the rock layers it contacts. The metals often discolor the water or the streambed as they are deposited in the stream channel. Metal precipitation in AMD is highly dependent on pH. At very low pH, AMD-polluted water can look clear and unpolluted because the metals are completely dissolved in the water. As a general rule, as pH rises and acidity decreases the metals will begin to precipitate. At pH 4.5, aluminum will usually begin to precipitate

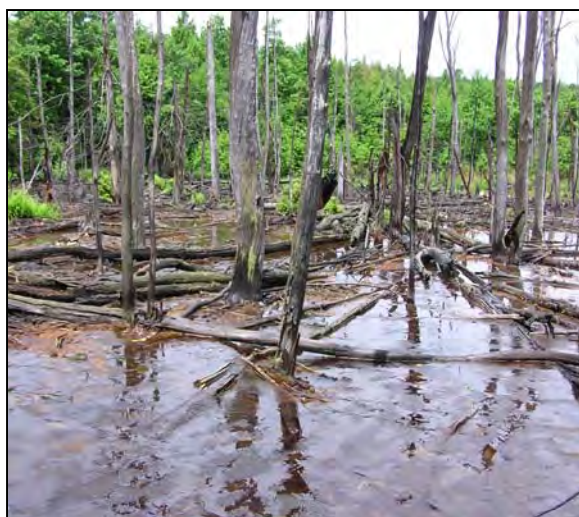
Large "kill zone" caused by AMD seeping out immediately downslope of a large surface mine known as the Smouse Strip, located on UNT-LA 4.3.

Vegetation appeared to be impaired by acidic groundwater conditions at numerous areas leading to the detention basins and can be observed as areas of dead, withered, or nonexistent plant life. A very large kill zone developed where there are AMD discharges on the adjacent property, creating a severely degraded wetland. Green and brown filamentous algae abounds. It is very difficult to estimate how much water is being produced within the degraded wetland. It appears that most of the AMD surfaces are near the toe of the mine spoil. There is also a large pond of AMD-polluted water located at the toe of the spoil. The depth of

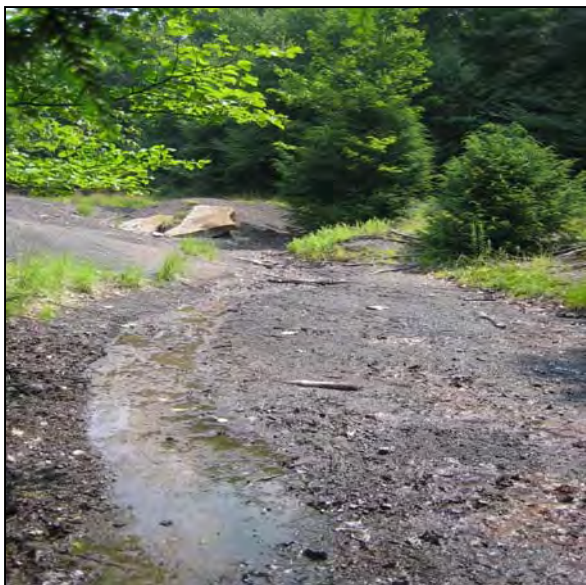
Discharge from main entry of the Spencer mine at low-flow conditions.

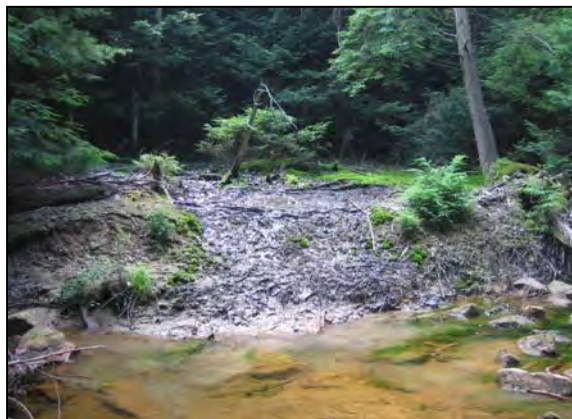
Numerous, very low-pH seeps appear just above the streambed of Little Anderson Creek far below the elevation of the Spencer mine.

The Spencer mine is likely having a severe negative effect on Little Anderson Creek. How much so is very difficult to determine at this time. The discharge from the mine opening flows on the surface only at high groundwater periods. There appears to be a significant amount of water that also enters the groundwater table and appears as severely polluted seeps adjacent to Little Anderson Creek, downslope of the Spencer mine. During low flows, the AMD infiltrates completely into the ground and appears as a series of seeps directly adjacent to the stream. Locations of the seeps make it nearly impossible to accurately measure the total actual flows entering Little Anderson Creek.

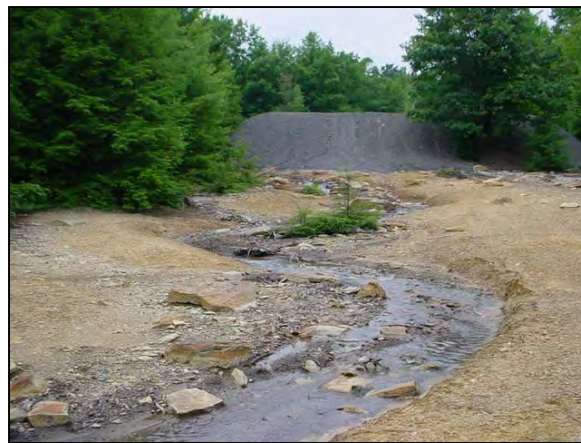
Combined Korb2 and Korb3 discharges draining into an unnamed tributary to Anderson Creek (UNT AC8.2).

Because of the location and the water chemistry of the DMP-Korb4 discharge, one option may be a self-flushing limestone pond. This technology has recently been successfully demonstrated as a possible treatment option for AMD containing aluminum. This system is similar to an Upflow Limestone Pond but differs in it that automatically drains itself after imparting alkalinity to the acidic water and before aluminum has an opportunity to precipitate in the limestone. Other passive AMD treatment system options that utilize methods that can handle high aluminum discharges, such as Sulfate Reducing Bacteria Bioreactors, SAPS, Upflow Limestone Ponds, and other such systems, might also be

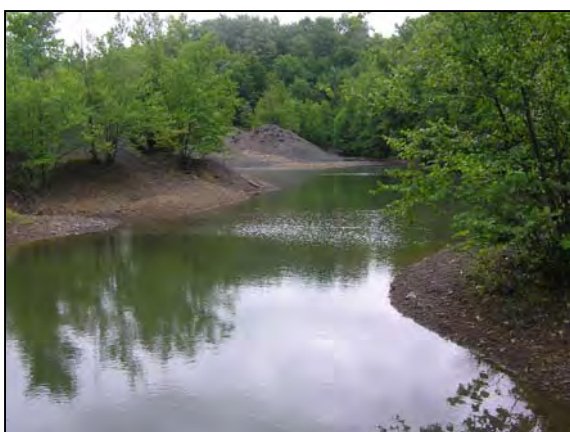
Large flows of very acidic AMD and unreclaimed mine lands make reclamation very challenging for Drauckers1—the highest priority site in the Anderson Creek watershed.

DMP-Drauckers1 emanates from an underground clay mine, which has also been partially surface mined (Scarlift Project Area XXIII & XXV, Project Map 15). DMP-Drauckers1 is the most significant source of pollution to Little Anderson Creek and the Anderson Creek watershed. Because there is a significant area of unreclaimed mine spoil associated with the discharge, it is also a significant source of runoff pollution. Typical for this area draining into UNT-LA 3.0, a coal seam overlies the clay seam. When the clay was surface mined, the coal was not considered valuable and was intermixed with the excavated material, adding to the pollution problem created by the unreclaimed spoil.

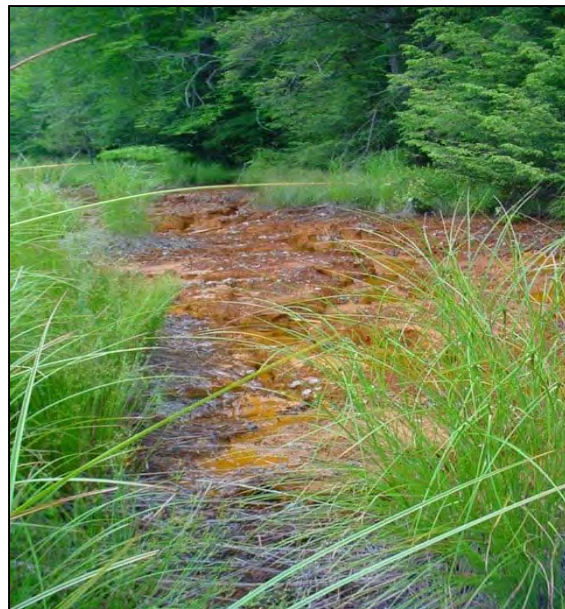
Drauckers2 discharge prior to mixing with acidic groundwater.

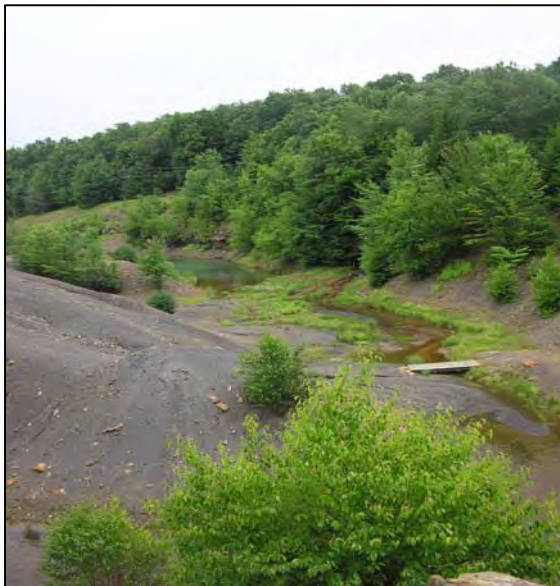
The Wingert site is perhaps the worst abandoned surface mine site in the Anderson Creek watershed. Here an unnamed tributary flows off the highwall into the open pit.

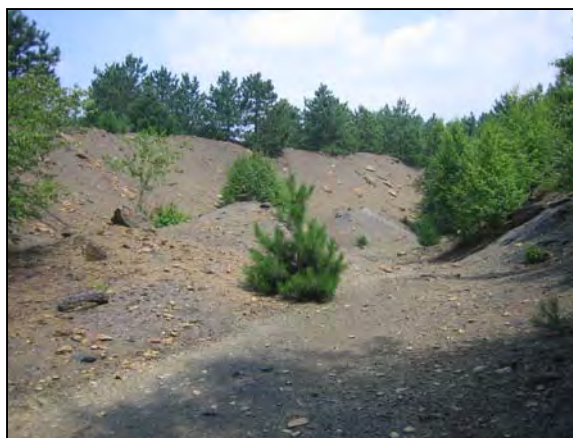
Large abandoned mine site at headwaters of UNT-LA2.10 appears to serve as a major source for AMD during wet periods.

This problem area is recommended for land reclamation and AMD treatment. It is recommended that land reclamation take place first, in order to reduce the amount of AMD being produced by the site. It is not known at this time whether re-mining is an option at this site, and investigation of that possibility should be pursued. If it is feasible, it may be possible to reclaim the site under a government financed construction contract (GFCC), which would reduce the cost of reclamation. As previously mentioned, re-contouring of the land to promote proper draining of surface water will help prevent that water from infiltrating into the mine spoil and creating higher volumes of AMD. In addition, the vegetation on the poorly reclaimed surface mine is very sparse and developing a thick mat of vegetation will also help to reduce water infiltration into the mine spoil, further reducing the flows of AMD. The addition of alkaline material into the spoil during reclamation will also serve to limit the production of AMD. Treatment of the AMD seeps is not recommended until land reclamation takes place.

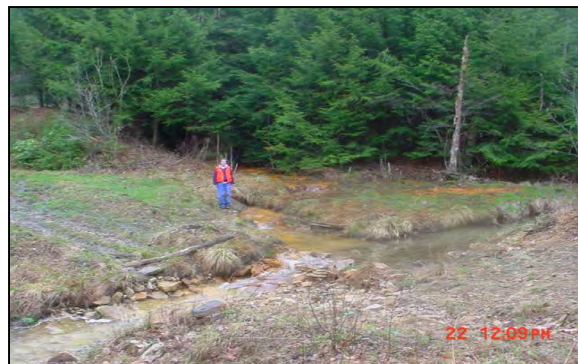
The Widemire Discharge pollutes an unnamed tributary to Kratzer Run (UNT-KR2.15) with acid and aluminum.

Below SMP-KR2 significant degradation of Kratzer Run water quality from AMD occurs. Just east of Stronach, two underground mines (Widemire and Irvin) and associated surface mines severely impact the stream. The worst impacts from the two mines come from the Widemire mine located south of State Route 879 along UNT-KR 2.15. Two significant sources discharge from the mine. Only one was sampled because of its significantly higher volume and lower water quality, DMP-Widemire. This source discharges net acid water with relatively low iron, aluminum, and manganese levels.

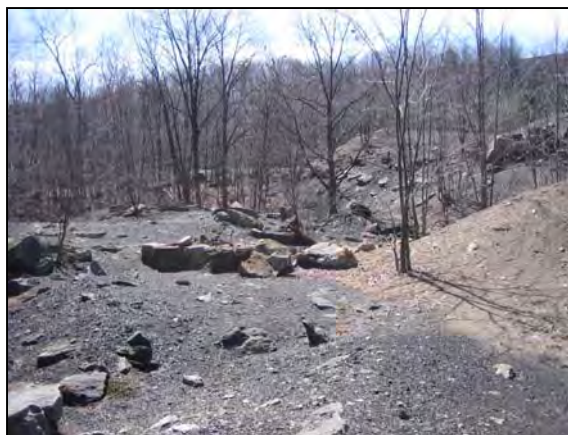
Abandoned mine located above monitoring point PAMP-KR 1.45.

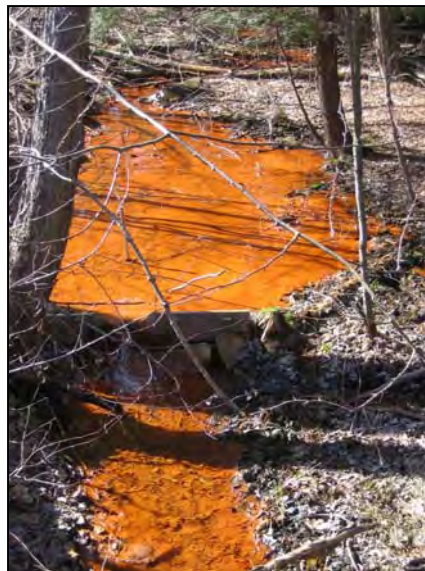
DMP-879 is located adjacent to Route 879 below the mouth of Bilger Run on the north-side berm of the road.

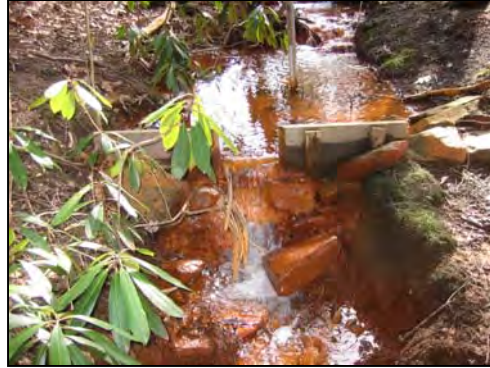
DMP-Wildwood is located just upstream of Route 879 on Bilger Run.

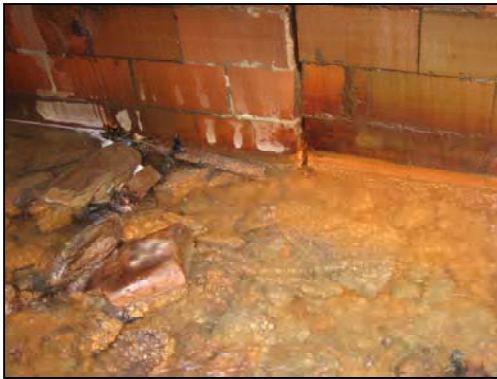
AMD discharges from crack in Route 879 Bridge pier on Bilger Run.

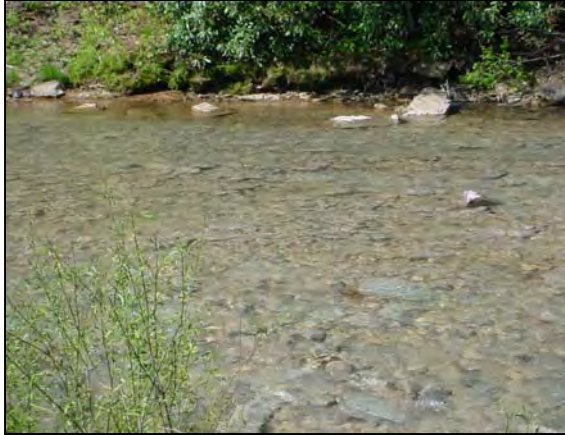
Aluminum staining in Anderson Creek, near its confluence with the West Branch of the Susquehanna.

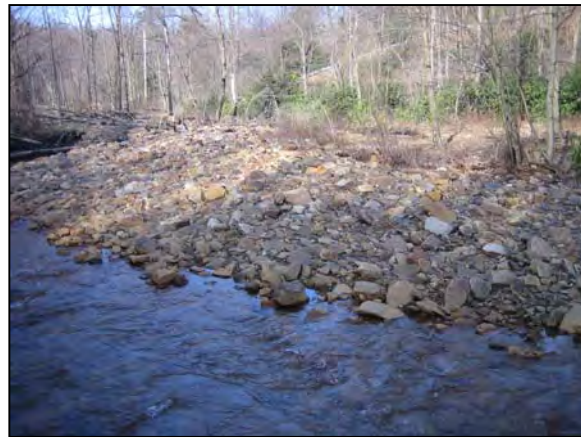
Large gravel bar deposited in lower Kratzer Run.

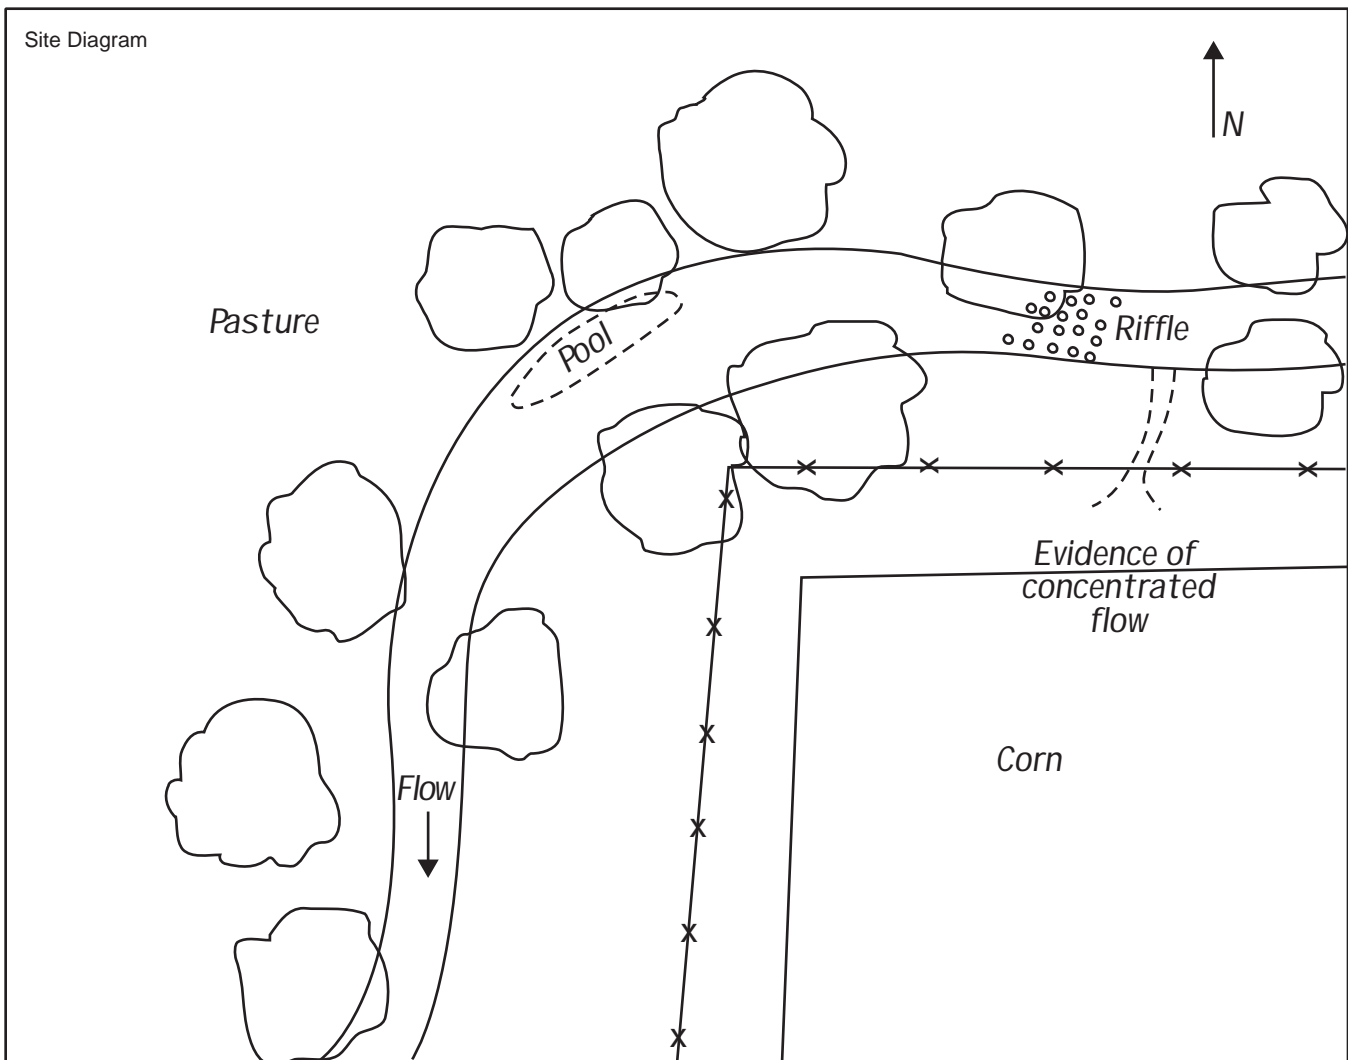
Figure 2 Stream visual assessment protocol worksheet—Continued

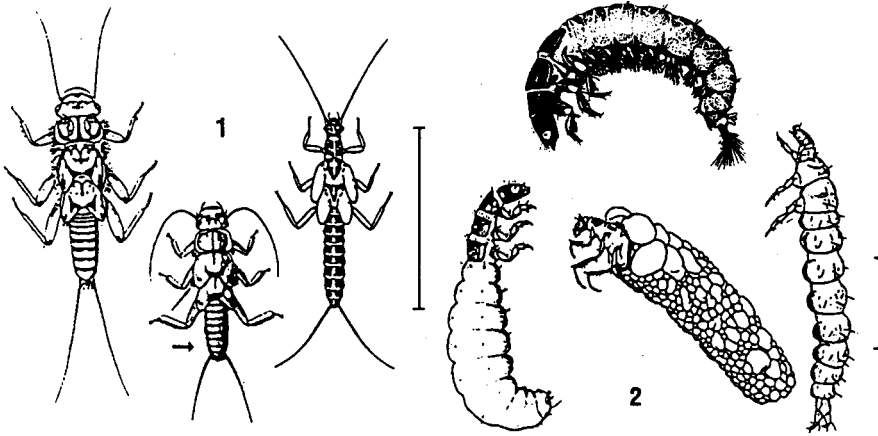
1 Stonefly Order Plecoptera. 1/2" to 1 1/2", 6 legs with hooked tips, antennae, 2 hair-line tails. Smooth (no gills) on lower half of body (see arrow).
