Captina Creek Watershed Action Plan

2014

A Collaboration of the Belmont Soil and Water Conservation District and
Captina Creek Watershed Stakeholders

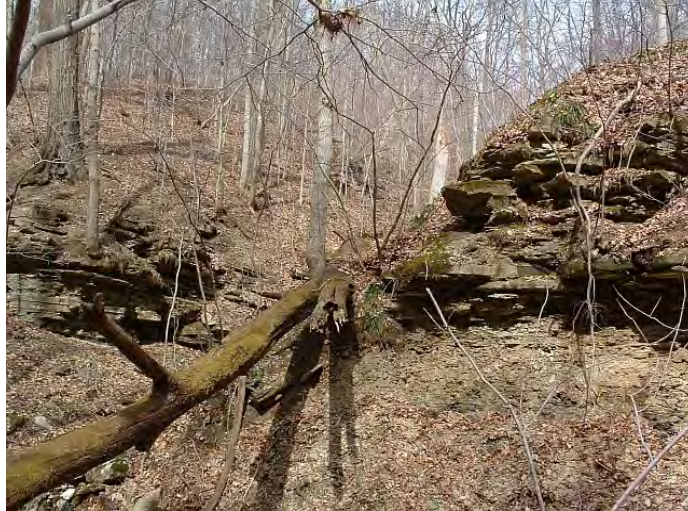
Figure 22. A rocky outcrop formed from uneven erosion of shale and siltstone layers on a forested hillside.

Shale, mudstone and siltstone alternate with sandstone layers on the ridgetops of the entire watershed region while the deeper valleys primarily contain layers of inorganic limestone and bituminous coal. Rocky overhangs, outcrops and caverns form on the steeper hillsides where less resistant shale layers are eroded away faster than overlying sandstone (Figure 22). In some cases these rock features can create microclimate habitats that support unique plant communities (Forsyth 1965).

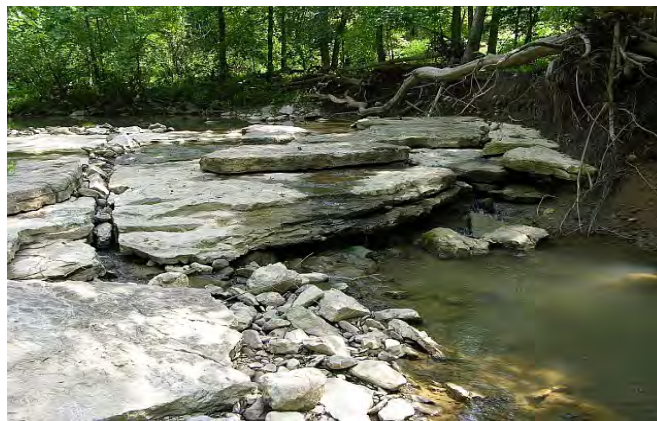
Figure 23. Thick beds of limestone exposed near the mouth of Anderson Run in the Pea Vine Creek subwatershed.

The most significant geological feature of the Captina Creek watershed region may be the Pennsylvanian Period limestone bedrock found within the deeper valleys (Figure 23). Limestone is naturally alkaline and raises pH levels of soils and water. Metals entering the creek from acid mine drainage would typically lower water pH levels and degrade aquatic life. Limestone rock layers lining the creek beds buffer the pH (many parts of the stream have natural pH values > 8), allowing aquatic life to thrive despite numerous coal slurry spills and drainage from mining operations. Rock formations of this geologic time period also contain the majority of the coal extracted from the watershed for energy production (ODNR 2011b).

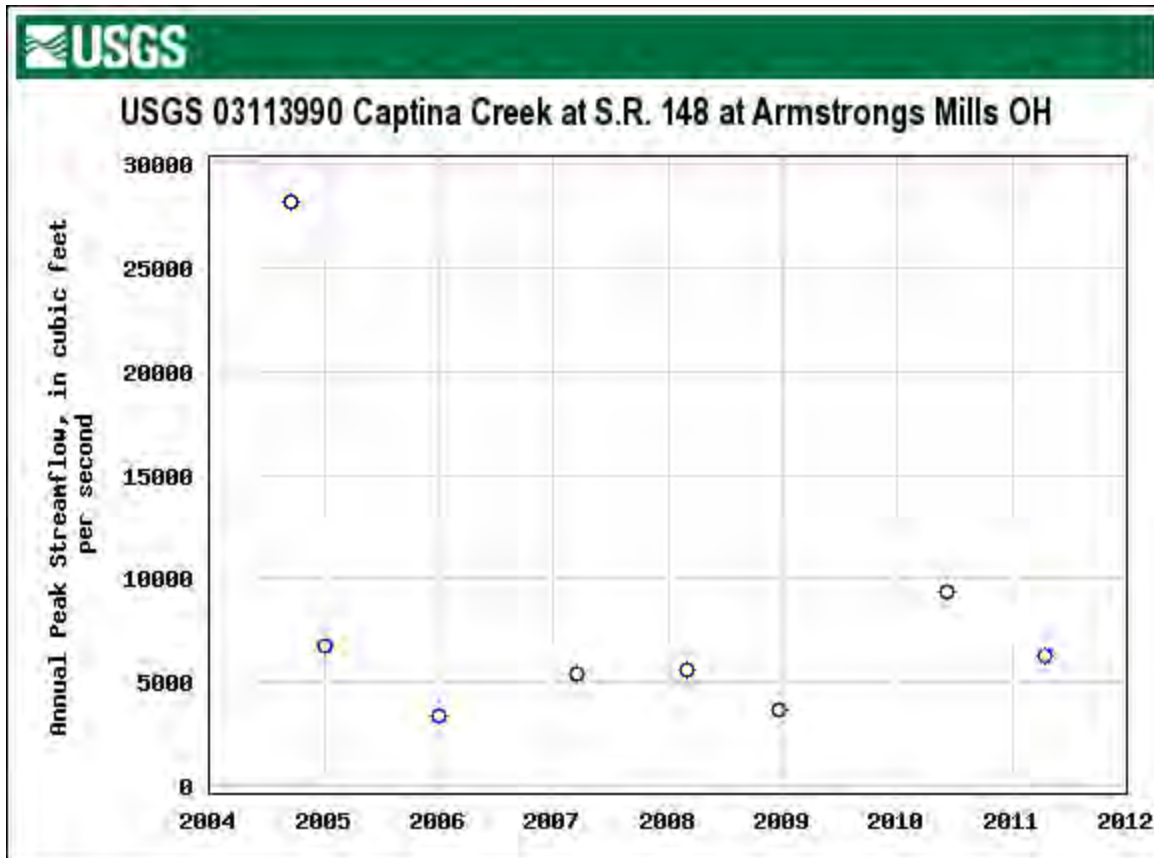
Figure 37. Captina Creek peak flows (in cubic feet per second) from 2004 – 2012 at Armstrongs Mills, Ohio gauge (03113990). *Source:* United States Geological Survey - National Water Information System, 2013.

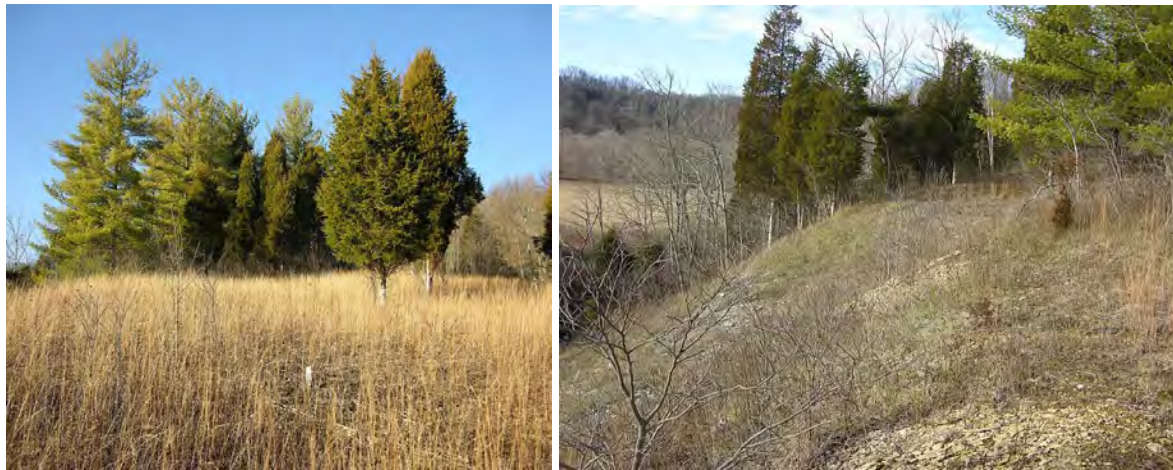
Figure 48. Hunter Prairie in Wayne Township (left) and rocky outcrops at Hunter Prairie consisting of limestone cobble with very shallow soils (right). Photo credit: Bryan Smith.

Not only are XLPs the rarest habitat type in the Captina Creek watershed, they are also one of the rarest in the state of Ohio with only a few other documented locations from Adams County over 100 miles southwest of the area (Table 21). Generally, XLPs can be identified by the growth of eastern red cedars among unique grasses and herbaceous plants which tolerate poor, alkaline soil conditions. The growth of cedars lends to the habitat's nickname as "cedar glades" or "cedar barrens." Oaks and white pines intersperse with the cedars and tower over understory shrubbery that is composed of redbud, dogwood and blackhaw viburnum (Lawless et al. 2006). There are two documented locations of XLPs in the watershed, each being less than 10 acres in coverage: Hunter Prairie and Armstrongs Mills Prairie (Figure 48).

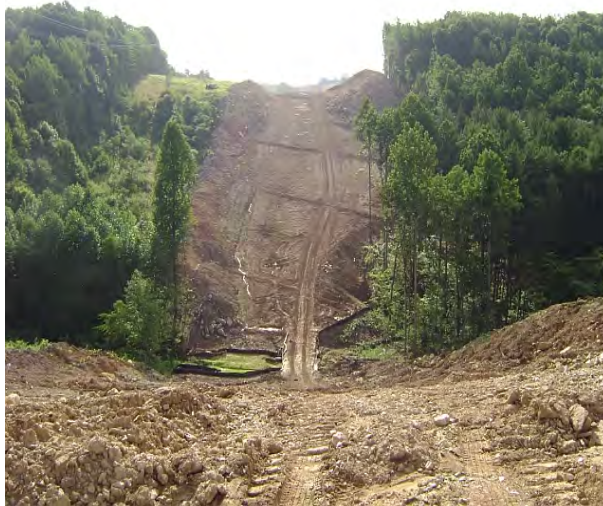
Figure 68. Installation of the REX pipeline in the South Fork subwatershed near New Castle.

There are no expected roads, highways, or development to be constructed in the foreseeable future in the South Fork subwatershed area (Table 25). The most recent development to occur was the installation of the Rocky Mountain Express (REX) natural gas pipeline in autumn of 2009 that transected the subwatershed area from northwest to southeast, passing north of Boston and Somerton on its way to Clarington along the Ohio River (Figure 68). Though the pipeline follows utility right-of-ways over most of its course, a significant amount of timber was cleared and streams were disrupted as equipment bored underneath them to accommodate the 36-inch vessel. Another natural gas pipeline right-of-way is under consideration for this area but is currently expected to pass to the south near the village of Malaga in Monroe County. Additional changes include the clearing of a forested hillside along the lower portion of South Fork in 2011 to accommodate upgrades to Murray Energy mine shafts and power lines.

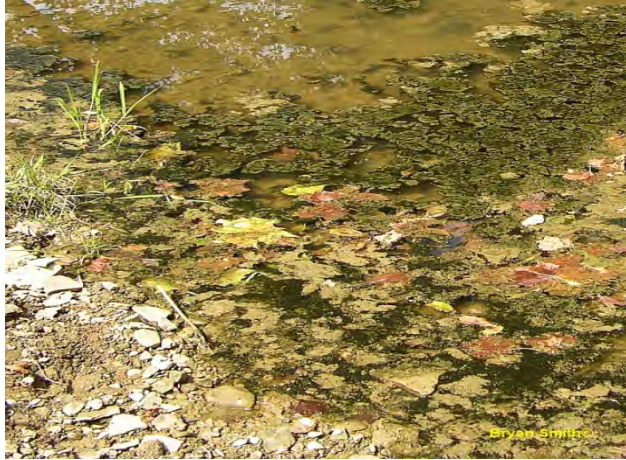
Figure 69. Excessive algae growth in a pool.

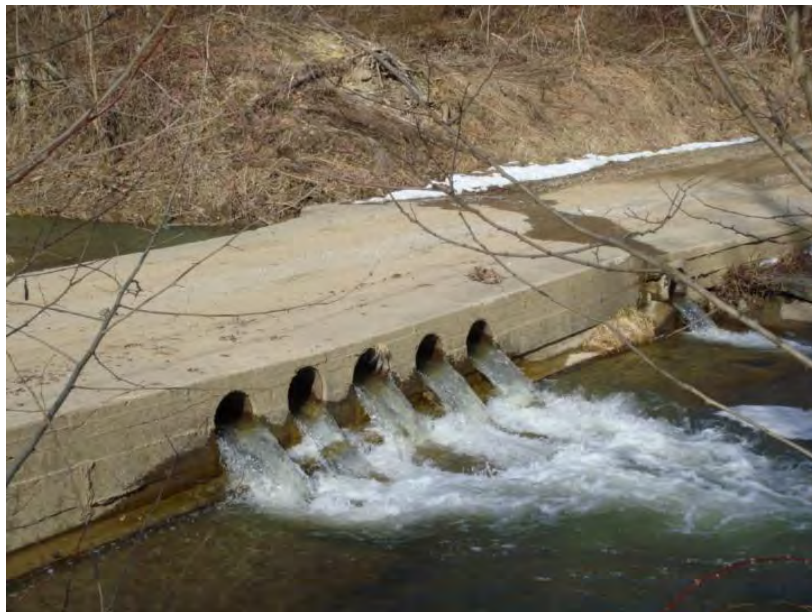
Figure 78. A fish barrier formerly located on Joy Fork, within the Bend Fork subwatershed (OEPA 2010).

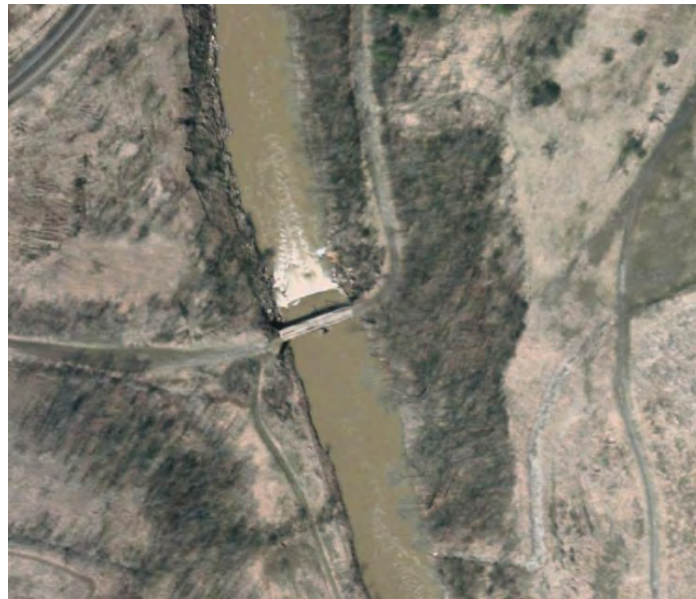
Figure 93. A 20-foot culvert passes under this access bridge across Captina Creek in York Township.

Linn Tipple. A bridge crossing the mainstem of Captina Creek in a remote area of Section 21 in York Township is partially obstructing the flow of water. The bridge (Figure 92) is part of an abandoned access road connecting State Route 148 to a limestone gravel pit and located on the north side of the railroad tracks in Section 21. There is no known indication of water quality impairment due to the bridge nor the smaller dams within the subwatershed.

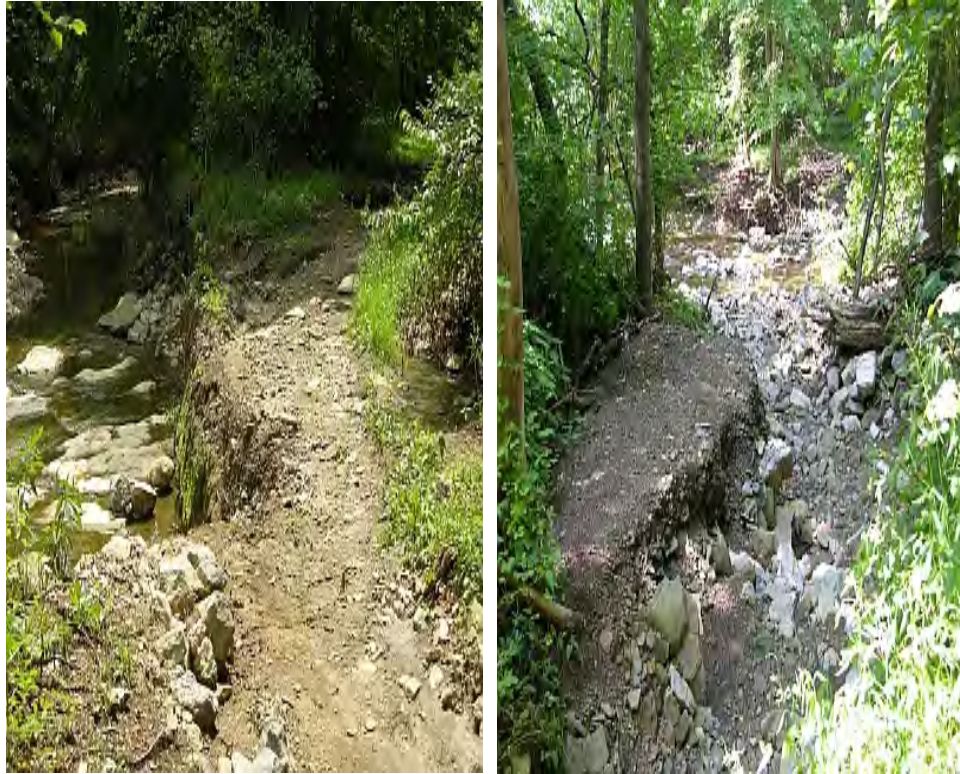
Figure 96. An all-terrain vehicle (ATV) trail along Anderson Run (*left*) and excessive sedimentation caused by ATV traffic passing through a small tributary to Anderson Run (*right*).

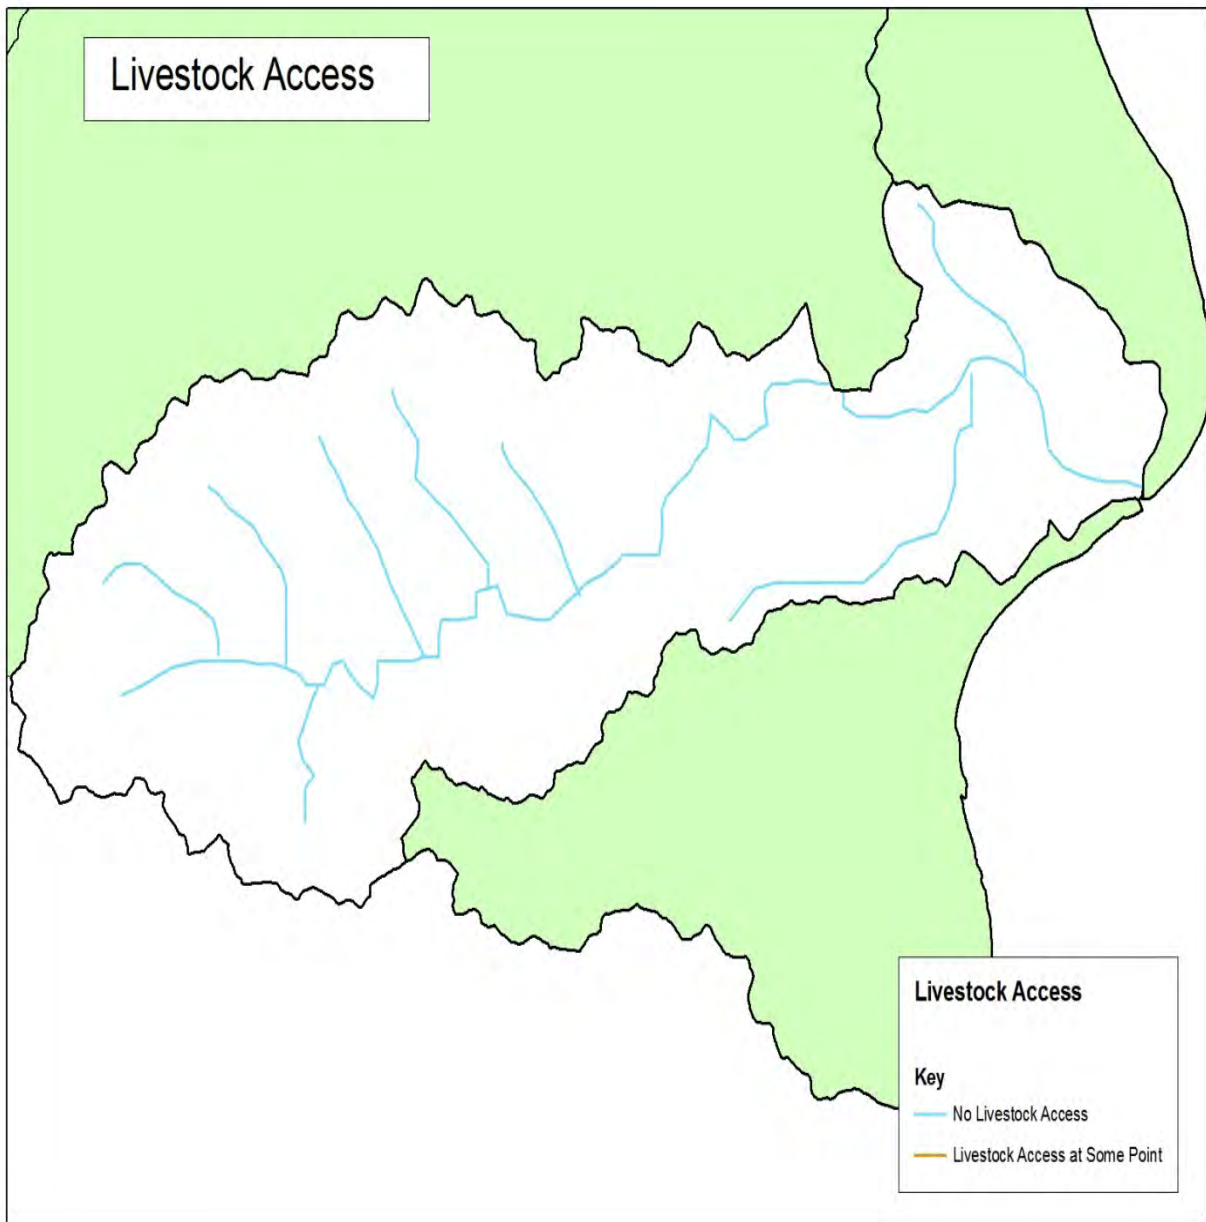
Figure 103. Livestock access within the Cat Run subwatershed.

Though livestock are prevalent along Cat Run, no locations exist where they have unrestricted access to the stream (Figure 103). All fields along the stream have fencing on or near the creek bank.

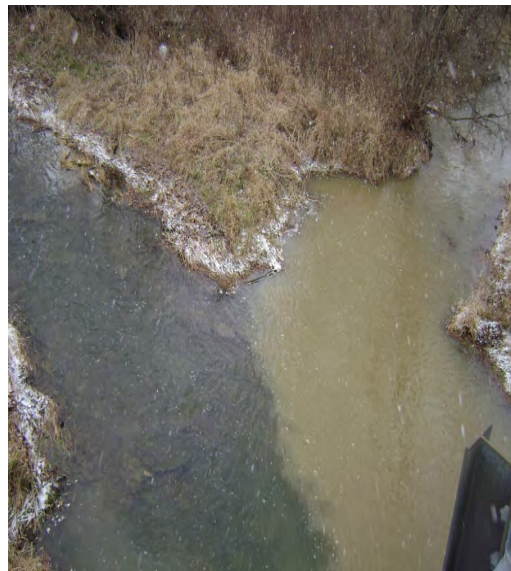
Figure 109. Differences in suspended solids can be seen at the confluence of the North Fork and Long Run, especially following precipitation events. *Photo source:* Belmont Soil & Water Conservation District, 2009.

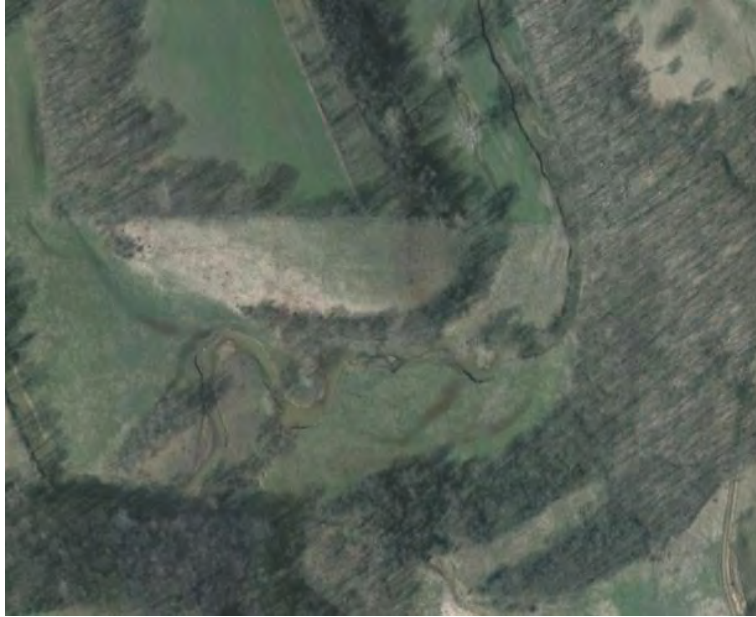
Figure 110. This portion of the South Fork lacks riparian cover where agricultural land uses extend to streambanks. These conditions are a source of increased water temperature and decreased dissolved oxygen concentrations, especially during warmer months.

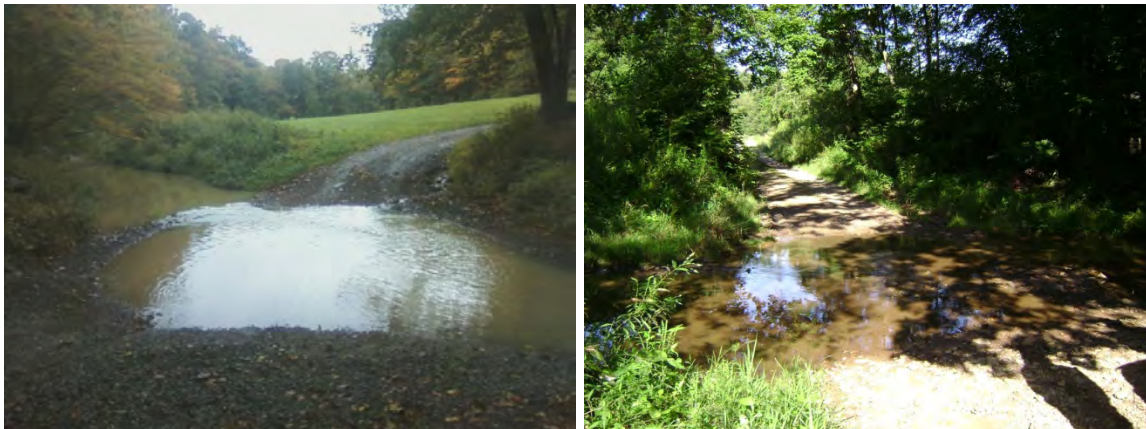
Figure 111. Public and residential stream crossings for vehicles, including these township roads located in the Bend Fork subwatershed (*left*, Goshen Township) and the Piney Creek subwatershed (*right*, Washington Township), can contribute to sedimentation downstream. *Photo sources:* Belmont Soil & Water Conservation District, 2012 and 2013.

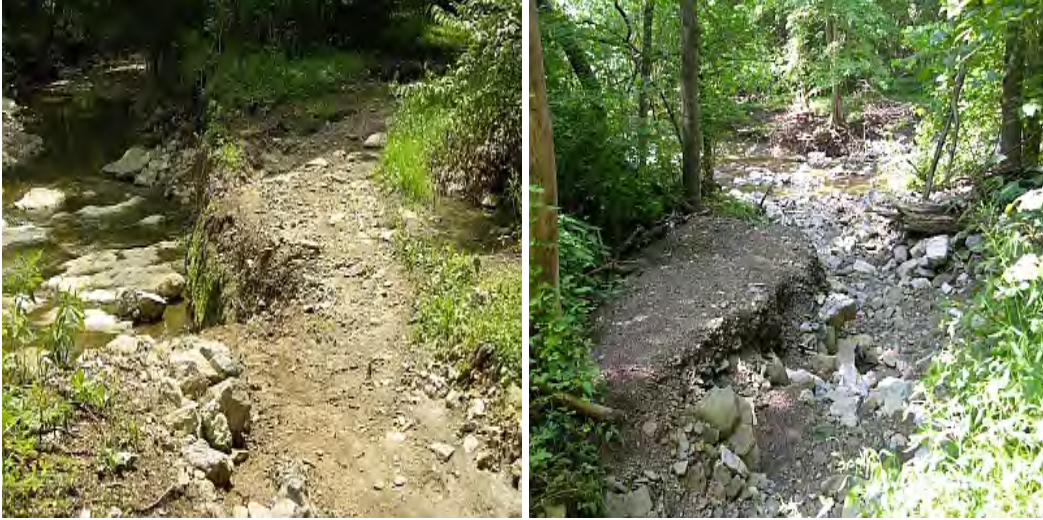
Figure 112. (Left and right) Anderson Run, in the Pea Vine Creek subwatershed. ATV traffic on abandoned township roads along this tributary has accelerated rates of erosion on exposed streambanks, resulting in increased sedimentation downstream. *Photo source:* Belmont Soil & Water Conservation District.

- 1) Unknown number of stream miles affected by ATV-induced erosion on abandoned township roads along Pea Vine Creek mainstem, and Moore and Anderson Runs (Figure 112)
- 2) 96.6 tons/year of sediment by water erosion from timber harvests in the subwatershed without the use of BMPs

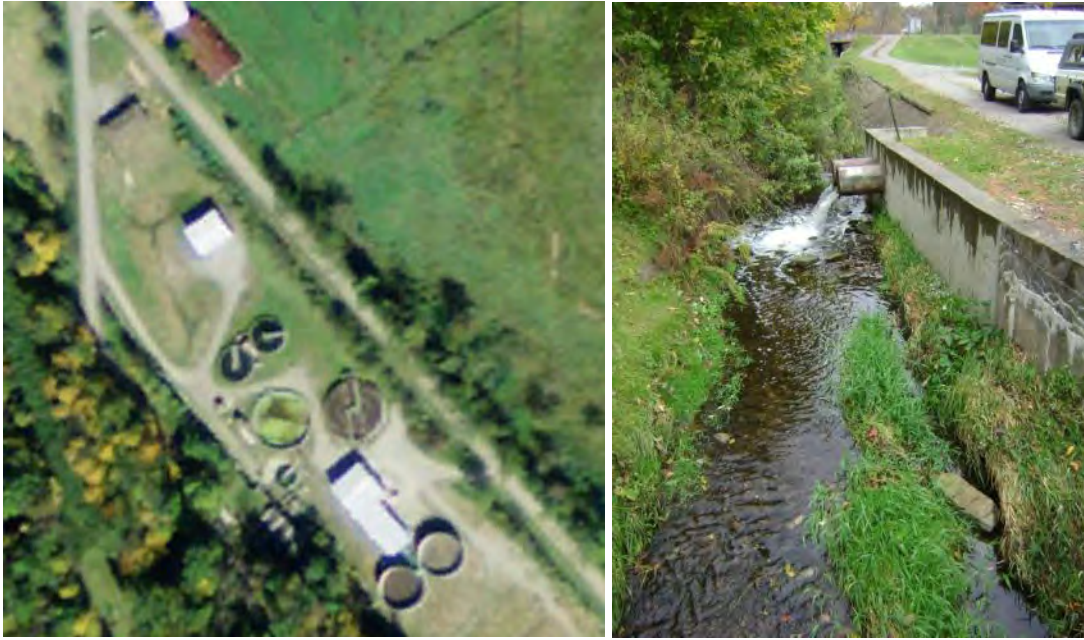
Figure 113. The Barnesville waste water treatment plant (*left*) after completion of 2011 upgrades. Treated discharge enters the North Fork of Captina Creek (*right*). *Map source*: “Barnesville Waste Water Treatment Plant.” 39°58’12.54” N and 81°09’45.75” W. **Google Earth**. October 27, 2011. October 22, 2012. *Photo source*: Belmont Soil & Water Conservation District, 2012.

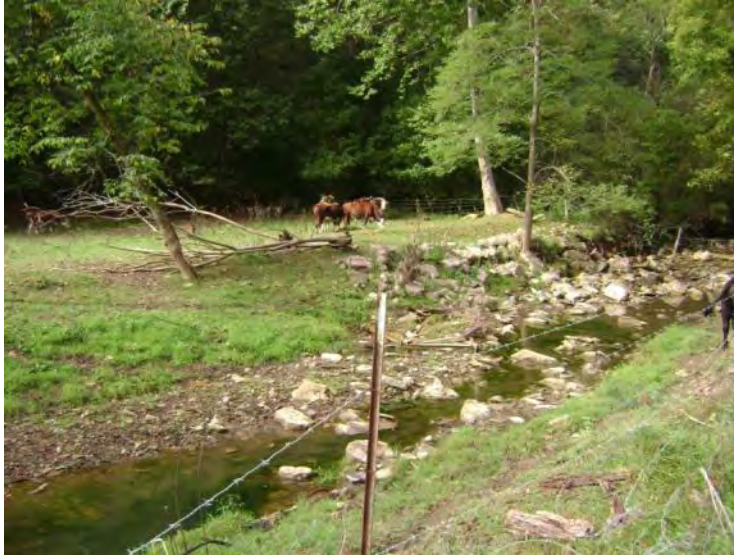
Figure 115. Ineffective restriction around a stream allows livestock to enter this stream in Belmont County. These conditions can be a source of increased nutrients and excessive algae growth downstream. *Photo source:* Belmont Soil & Water Conservation District, 2009.

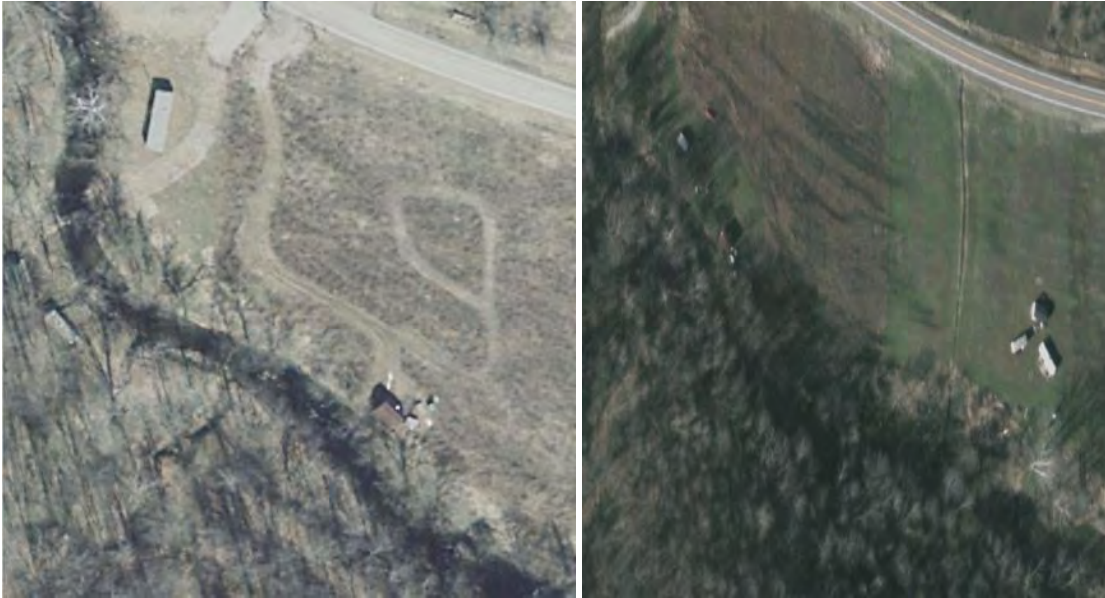
Figure 116. (Left and right) Trailers and cabins along the banks of the North Fork lacking septic tanks or adequate septic fields.

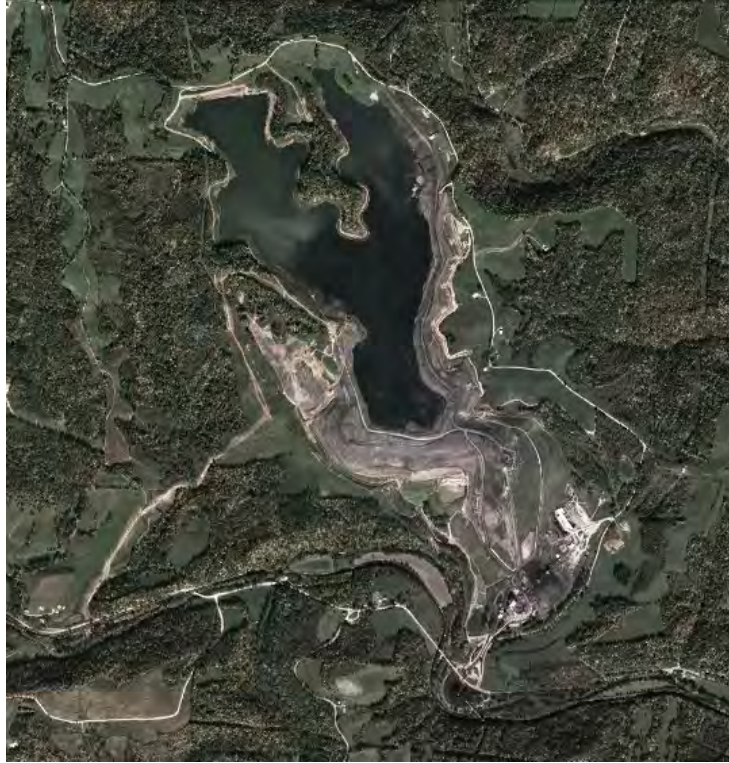
Figure 117. The OVCC Powhatan No. 6 mine and slurry impoundment facility near Alledonia, Ohio. The impoundment discharges into an artificially constructed outfall drainage to Captina Creek west of the Powhatan #6 mine. Although NPDES permit violations have occurred in the past, the Powhatan #6 mine remains below acceptable parameters for discharging metals and currently has no defined limits on discharging total dissolved solids (Wood-Pugh, personal communication, 2011). *Photo source:* "OVCC Slurry Impoundment." 39°55'08.23" N and 80°59'32.11"W. **Google Earth.** October 27, 2011. October 22, 2012.

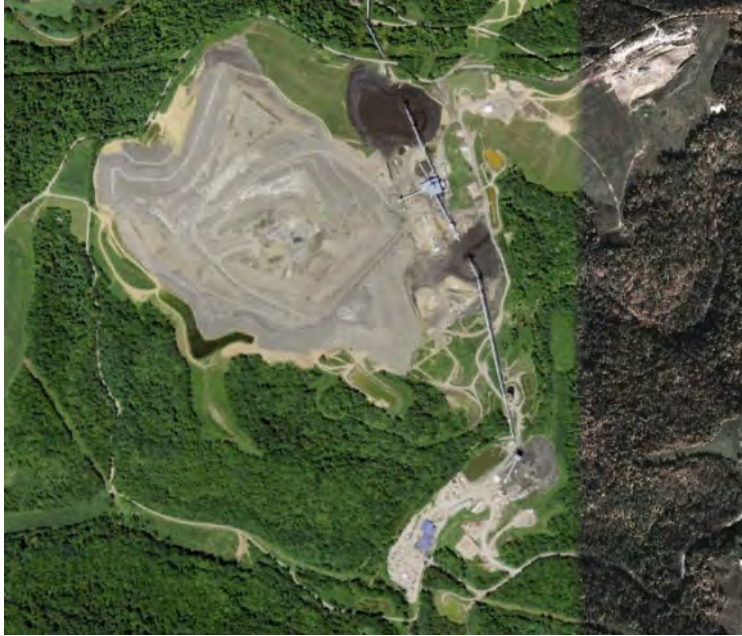
Figure 118. Located in Wayne Township, the AEC Century Mine has multiple NPDES discharges that are regularly monitored by the Ohio EPA for compliance within pollution limits, including mine water, sanitary wastewater, and industrial stormwater (OEPA 2010). Water quality parameters for Century mine discharges remain within NPDES requirements and the permit currently has no defined limits on discharging total dissolved solids (Wood-Pugh, personal communication, 2011). *Photo source:* “American Energy Corporation - Century Mine.” 39°53’43.88” N and 81°01’21.17” W. **Google Earth.** October 27, 2011. October 22, 2012.

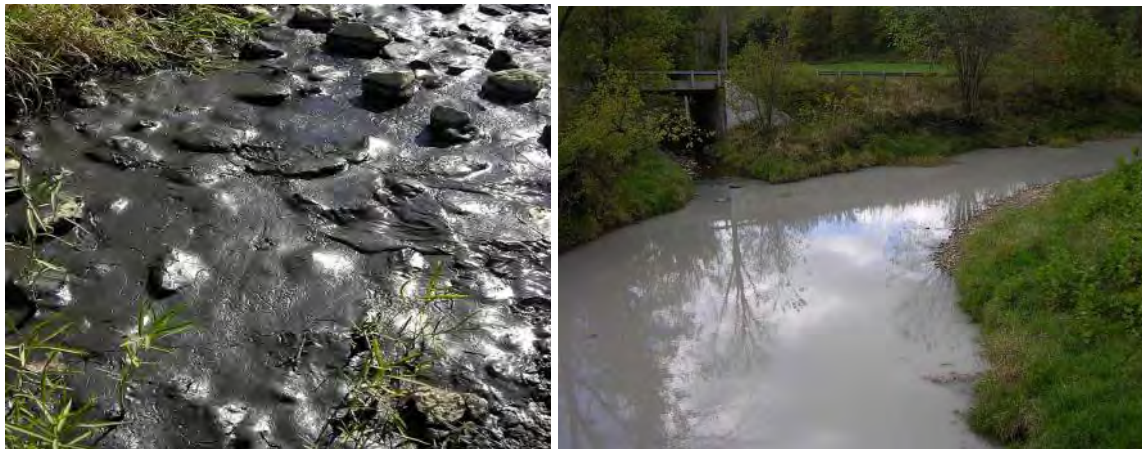
Figure 121. Slurry deposition along Captina Creek (*left*) and approximately one mile downstream of spill site (*right*) after the October 2010 release. *Photo sources:* Belmont Soil & Water Conservation District, 2010.

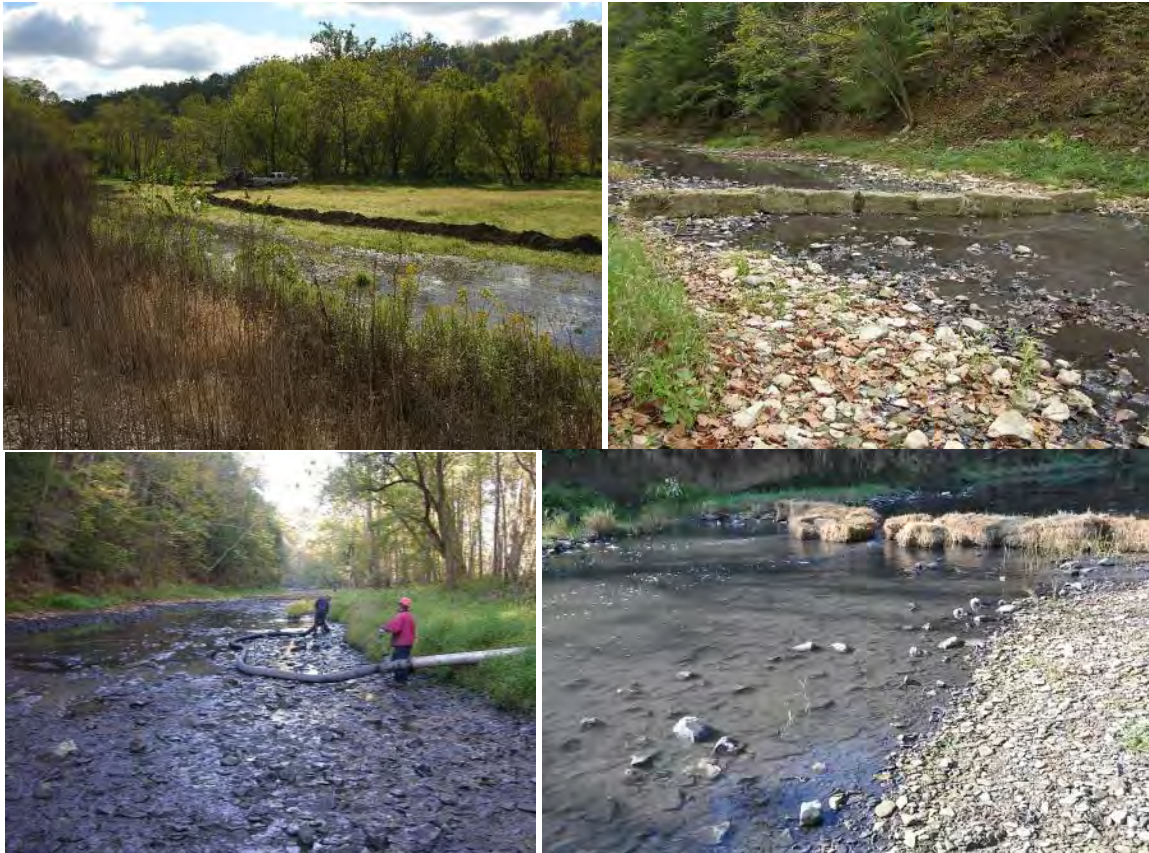
Figure 122. Slurry spill cleanup by Murray Energy Corporation (*from left to right*): an earthen levee dug around the October 2010 spill site; hay bale barriers in the stream; slurry removal with vacuum trucks; the downstream end of spill contamination zone after one week. *Photo sources*: Belmont Soil & Water Conservation District, 2010.

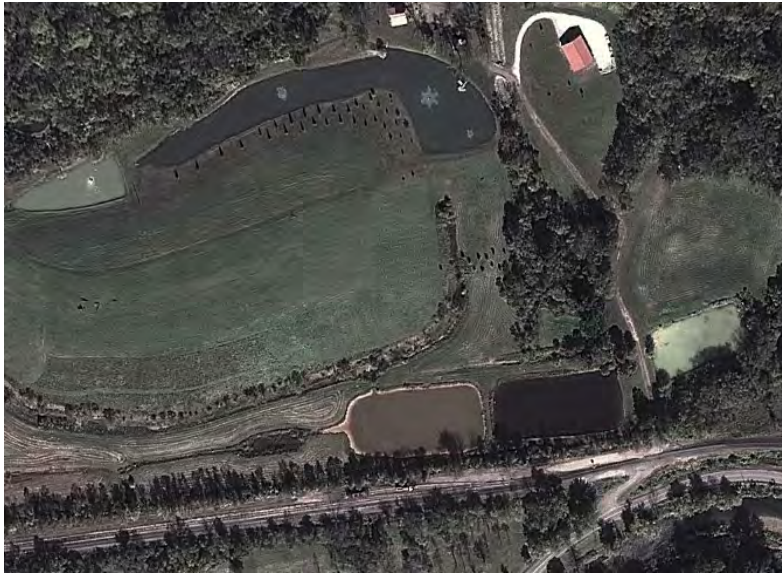
Figure 123. Settling ponds surrounding the reclaimed Cravat Coal gob pile, located in the Pea Vine Creek subwatershed. AMD from the pile is passively treated with limestone slag before entering the creek. Officials from Ohio Department of Natural Resources – Division of Mineral Resources Management (ODNR-DMRM) have stated that creating passive treatment wetland habitat around the edge of the gob pile would further decrease the threat of AMD entering the stream from this location. *Map source:* “Cravat Coal Reclamation.” 39°53’36.67” N and 80°53’28.36” W. **Google Earth.** October 7, 2011. October 22, 2012.

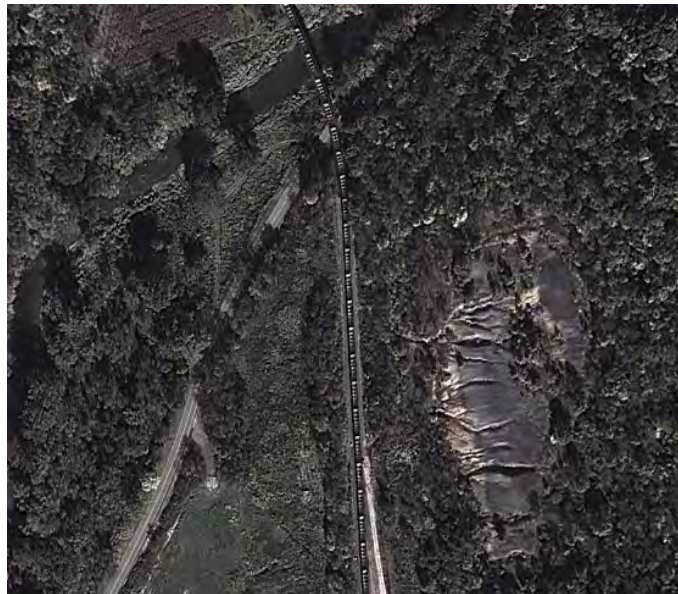
Figure 124. Located in Section 4 of Washington Township (Pea Vine Creek subwatershed), a portion of the gob pile at the Linn Tipple facility between State Route 148 and the railroad tracks was recently reclaimed by Murray Energy. A large area remains on the hillside east of the railroad tracks and leaches AMD into a roadside ditch along State Route 148, but effects on water quality downstream are minimal. *Map source:* “Linn Tipple Gob Pile.” 39°54’04.93” N and 80°54’18.76” W. **Google Earth.** October 7, 2011. December 27, 2012.

Objective 3: Full reclamation and revegetation of 3.2 acres of surface-mined land at the Linn Tipple gob pile site (Figure 124), which has been partially reclaimed by Murray Energy Corporation.

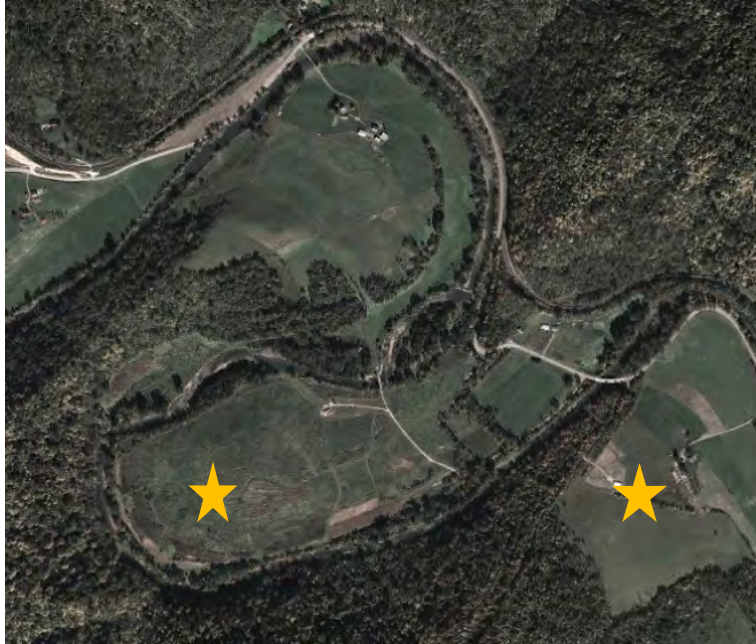
Figure 125. In the Pea Vine Creek subwatershed, AMD from reclaimed strip mine lands on the east and west sides of Dover Ridge Road (York Township Road 729) has been observed entering Captina Creek, but water quality monitoring indicates that it does not impair water chemistry, and dilutes to undetectable levels further downstream (OEPA 2010). *Map source:* “Dover Ridge AMD.” 39°53’08.38” N and 80°52’40.28” W. **Google Earth.** October 7, 2011. December 27, 2012.

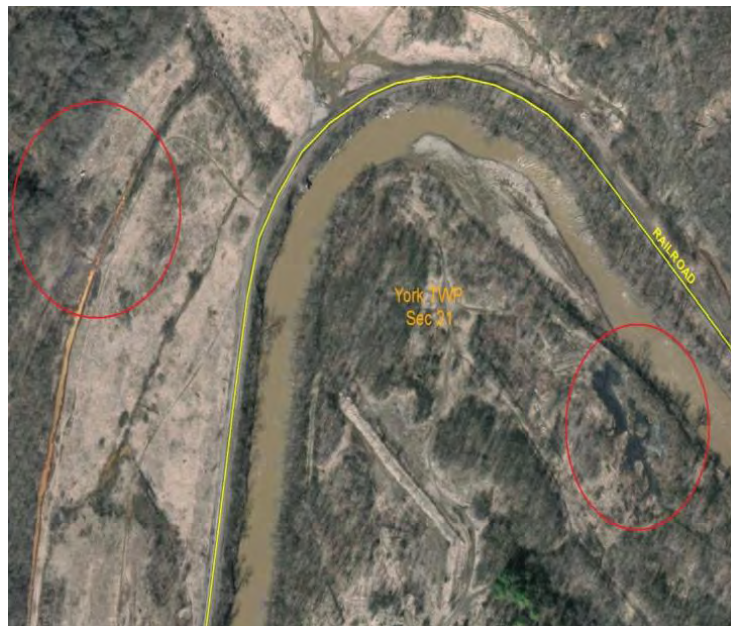
Figure 126. Remnants of two small gob piles exist in Section 21 of York Township (Pea Vine Creek subwatershed), originally occupied by Bellaire Corporation Powhatan No. 5 coal mine. This site was also the former location of a limestone gravel pit. AMD draining from the site does not impair water chemistry, and dilutes to undetectable levels further downstream (OEPA 2010).

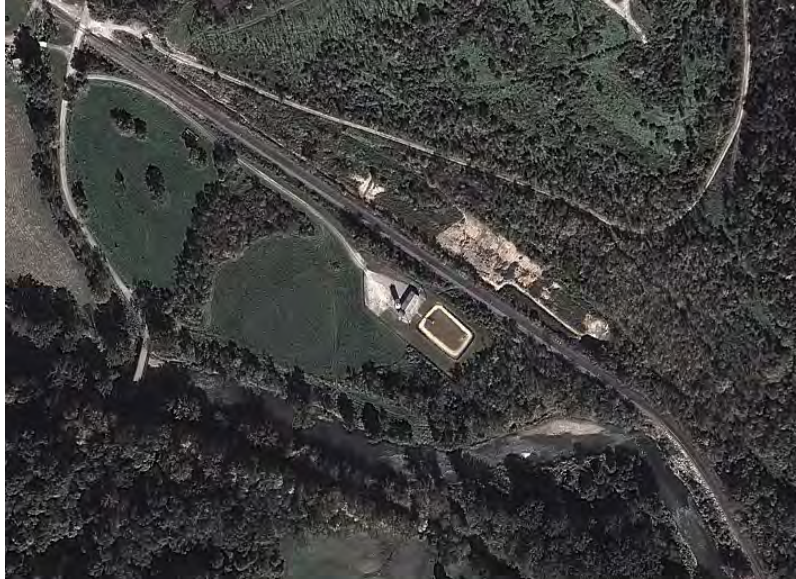
Figure 127. Located in the Pea Vine Creek subwatershed, Bellaire Corporation's Powhatan No. 5 coal mine in central York Township has been reclaimed and an NPDES permit requires monitoring for stormwater runoff and AMD seepage. A dosing silo and settling pond treat acidic water pumped out of abandoned mine shafts with alkaline material before it can enter Captina Creek. Additional reclamation is planned by North American Coal, the current owner of the site. *Map source:* "Town Run Reclamation Site." 39°52'51.32" N and 80°50'31.08" W. **Google Earth.** October 7, 2011. December 27, 2012.

Objective 2: Install project to improve remediation at Town Run site (Figure 127)

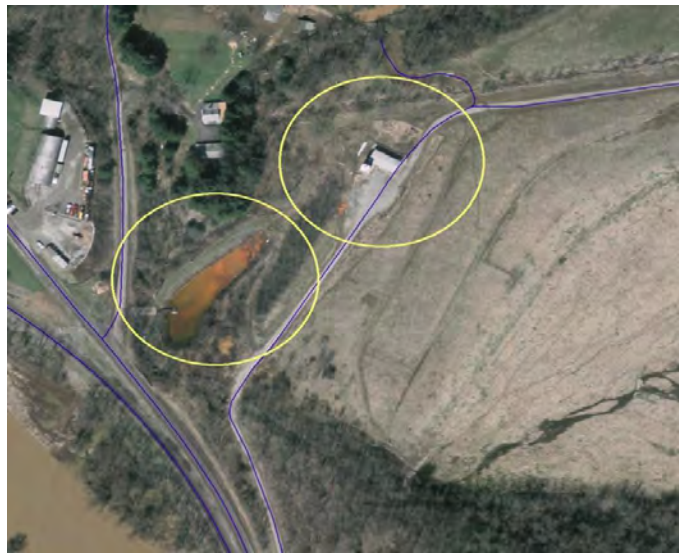
Figure 128. A dosing silo and settling ponds, located near the intersection of Cove and Lysein Roads just west of Powhatan Point (Cat Run subwatershed), treat acidic water pumped out of abandoned mine shafts with alkaline material before it can enter Captina Creek. This site is the former location of Bellaire Corporation's Powhatan No. 2 coal mine. Additional remediation is planned by North American Coal, the current owner of the site. *Photo source:* Google Earth.

- 1) At least two unreclaimed or partially reclaimed underground mines which drain acidity and heavy metals into Captina Creek (Figure 128)

Objective 1: Install additional remediation system to increase the effectiveness of the AMD treatment system at the Cove Road site (Figure 128)

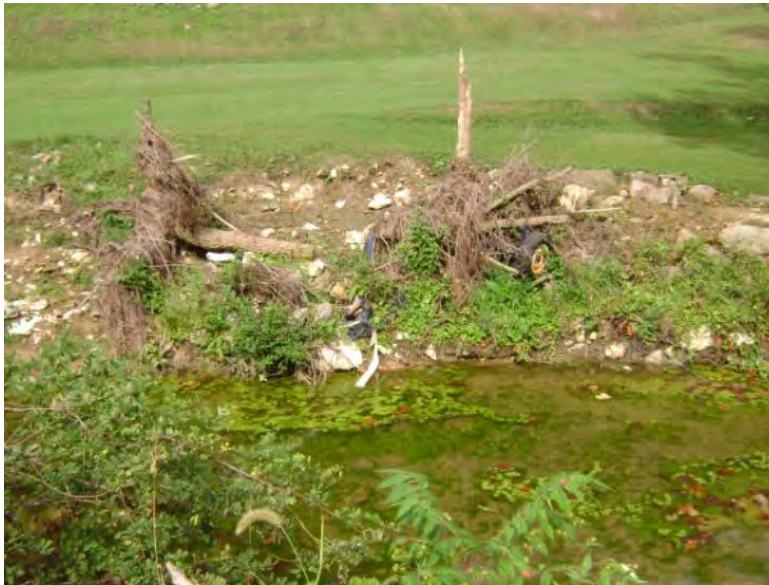
Figure 129. Trash and debris on streambanks, such as this Belmont County stream, can degrade the quality of riparian habitat. *Photo source:* Belmont Soil & Water Conservation District, 2009.

Illegal dumping of trash in undesignated areas, especially in and around streambanks, remains a problem in the watershed area and deteriorates wildlife habitat and the aesthetic value of the region (Figure 129). Trash and debris in and around streambanks can be carried downstream during heavy rain events, often making it difficult to determine the source. Other threats include debris jams that can worsen the effects of flooding, runoff of dump site chemicals into surface waters, and health risks posed to humans or livestock exposed to sharp objects. According to a 2011 survey of fifteen Captina Creek watershed stakeholders, when asked about the severity of specific problems in the watershed, trash/debris ranked an average score of 3.3 (1=major problem, 3=problem exists, 5=no problem).

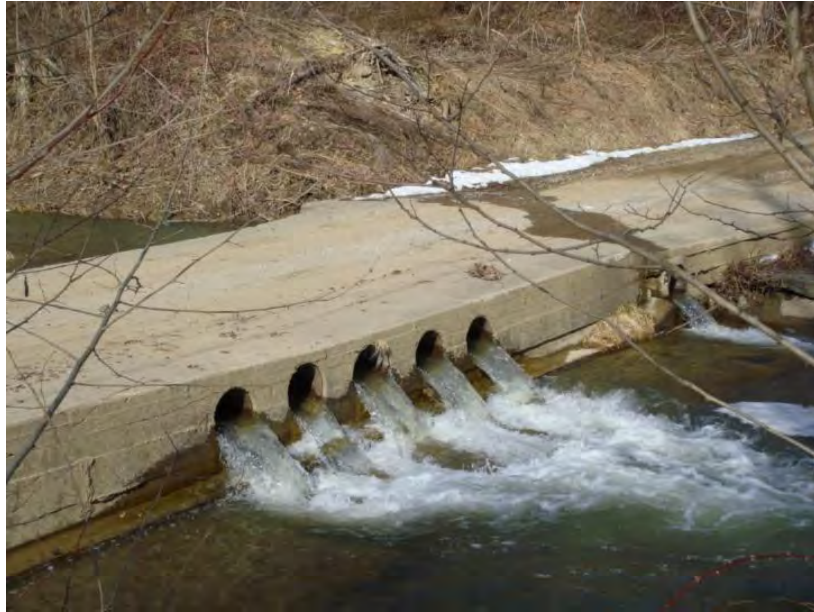
Figure 130. Located in Washington Township, this low-water bridge crossing Joy Fork is a barrier to fish migration upstream (OEPA 2010). *Source:* Belmont Soil & Water Conservation District.

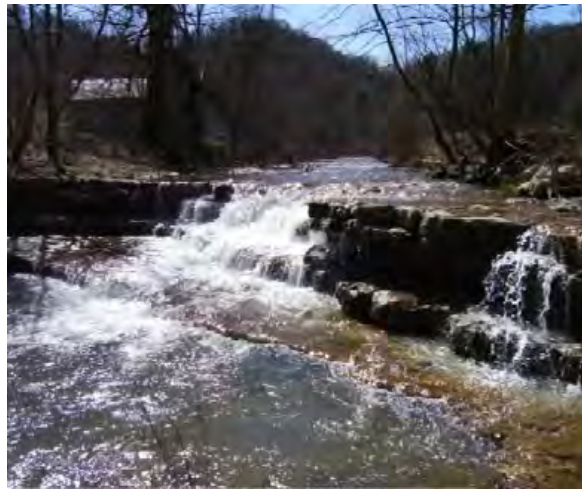
Figure 131. Natural waterfall barrier to fish migration in Cat Run. *Photo source:* Ohio Environmental Protection Agency, 2010.

Natural or human-made physical barriers to fish migration exist in at least two locations in the Captina Creek Watershed. These barriers, located in the Bend Fork and Cat Run subwatersheds (Figures 130 and 131), inhibit the movement of fish species to upstream reaches, may cause excessive expenditures of energy, and can impede sexual reproduction for fish. This can result in impaired biological diversity and degraded aquatic life use attainment in upstream reaches. Examples of natural barriers include waterfalls and log jams, and examples of artificial barriers include culverts, dams and submarine bridges. Improvements can be made by removing the barrier, raising pool levels, or installing a fish passage around the barrier. These solutions may be costly and careful analysis is required to compare costs with biological benefits, including an examination of alternative solutions (Powers and Orsborn 1985).

- 1) One natural waterfall, approximately six feet in height, on Cat Run (RM 3.3, Figure 131). Sampling in 2009 indicated Cat Run to be the only sampled tributary with a fair fish community (at RM 3.3 there was only partial attainment of the warmwater habitat aquatic life use designation and an IBI score of 31). Downstream sampling (RM 0.4) indicated exceptional fish communities at the mouth of Cat Run (IBI score of 58) (OEPA 2010).

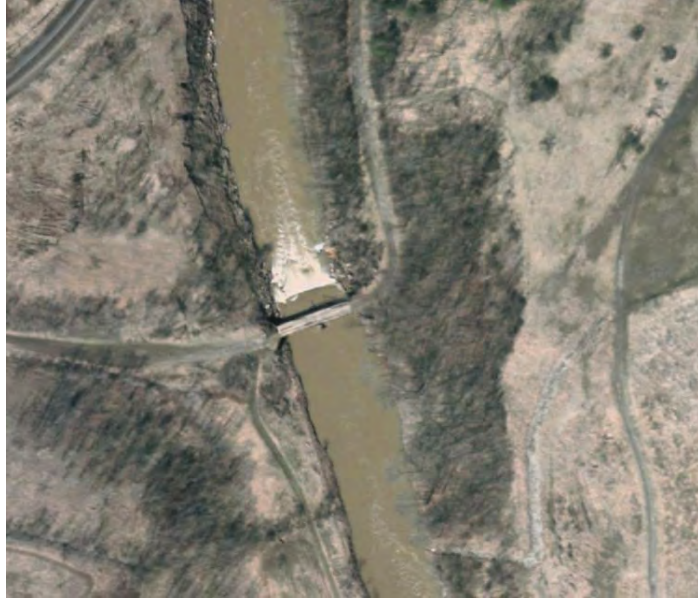
Figure 132. An abandoned bridge across Captina Creek (RM 5.5) in Section 21 of York Township partially obstructs flow and may be a barrier to fish movement upstream. The bridge serves as access to abandoned gravel pits from State Route 148. *Photo source:* Google Earth.

Biological sampling has not been collected upstream and downstream of additional barriers in the watershed, including a bridge across Captina Creek in the Pea Vine Creek subwatershed and a submarine bridge across Crabapple Creek in the Piney Creek subwatershed (Figures 132 and

- 2) One abandoned bridge across Captina Creek (RM 5.5) in Section 21 of York Township (Figure 132). The bridge partially obstructs flow and may be a barrier to fish movement upstream. Upstream (river mile 6.7) and downstream (river mile 3.3) sampling in 2008-

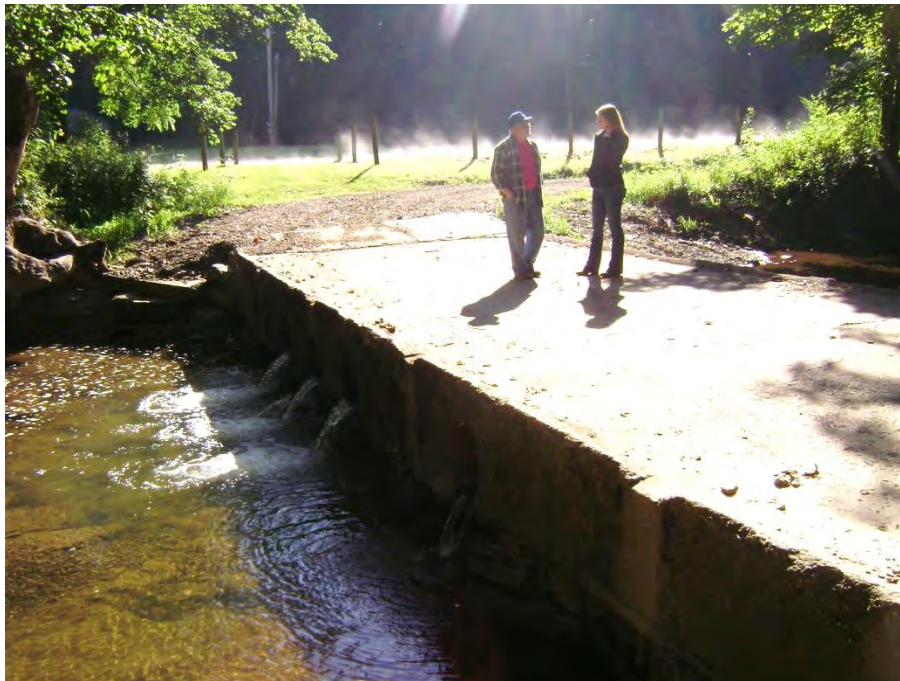
Figure 133. Submarine bridge through Crabapple Creek (RM 3.3). *Photo source:* Belmont Soil & Water Conservation District, 2013.

- 1) One submarine bridge on Washington Township Rd 84 crosses Crabapple Creek at RM 3.3 and may impede the stream's flow, contribute to debris buildup and flood conditions, and be a barrier to fish migration to upstream portions of the stream (Figure 133)

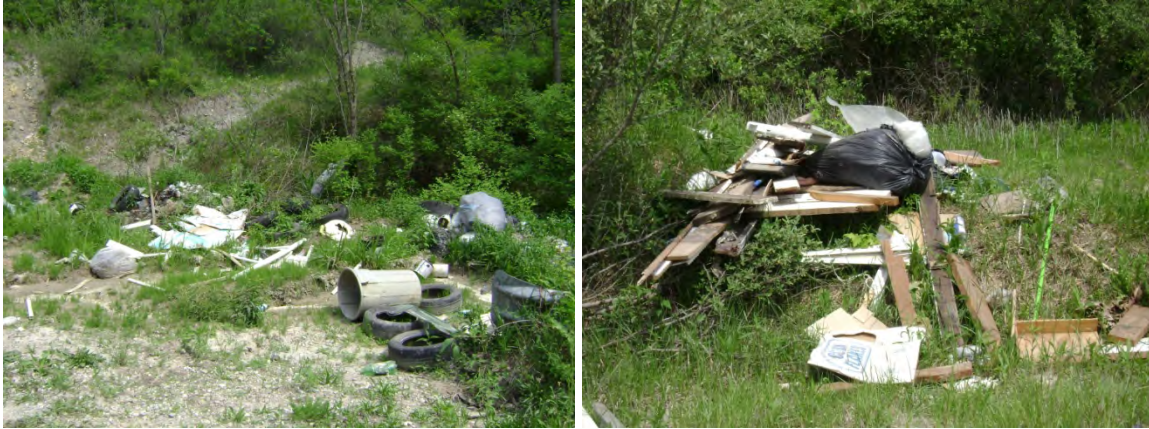
Figure 134. Illegal dumping along Long Run Rd (Goshen TR 184). *Source:* Belmont Soil & Water Conservation District, 2013.

- 1) At least five documented illegal dumping sites within the subwatershed. The worst site impacts 2.0 stream miles along Long Run (RM 2.0 to 4.0) and Goshen Township Road 184 (Figure 133).

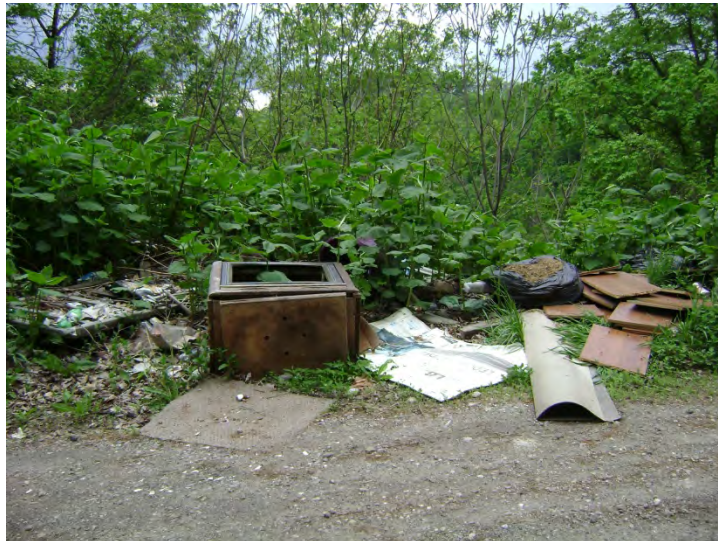
Figure 135. Trash along Town Run Hill Road (York Township) and upstream portions of Town Run. *Source:* Belmont Soil & Water Conservation District, 2013.

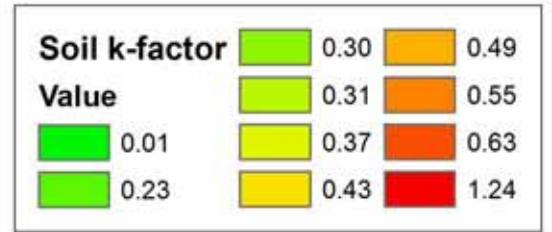
Soil K-factor: soil erodibility factor which represents both susceptibility of soil to erosion and the rate of runoff, as measured under the standard unit plot condition.

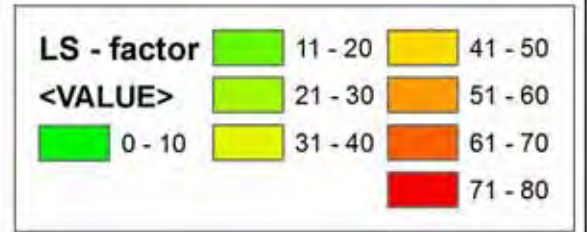
Slope Length and Steepness Factor (LS): The effect of slope length and slope steepness on erosion.
