Captina Creek Watershed Action Plan

2014

A Collaboration of the Belmont Soil and Water Conservation District and
Captina Creek Watershed Stakeholders

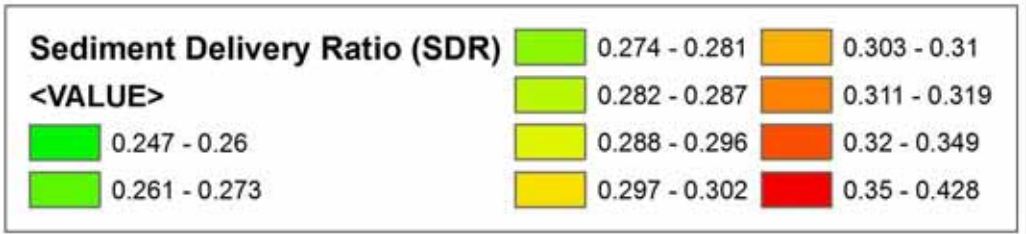
Sediment Delivery Ratio (SDR): the sediment yield from an area divided by the gross erosion of that same area. The SDR represents the efficiency of the watershed in moving soil particles from areas of erosion to the point where sediment yield is measured.
