Ohio's Nonpoint Source Pollution Implementation Strategy (NPS-IS)

Captina Creek:

Piney Creek 050301060904

Version 1.0 03-30-2018

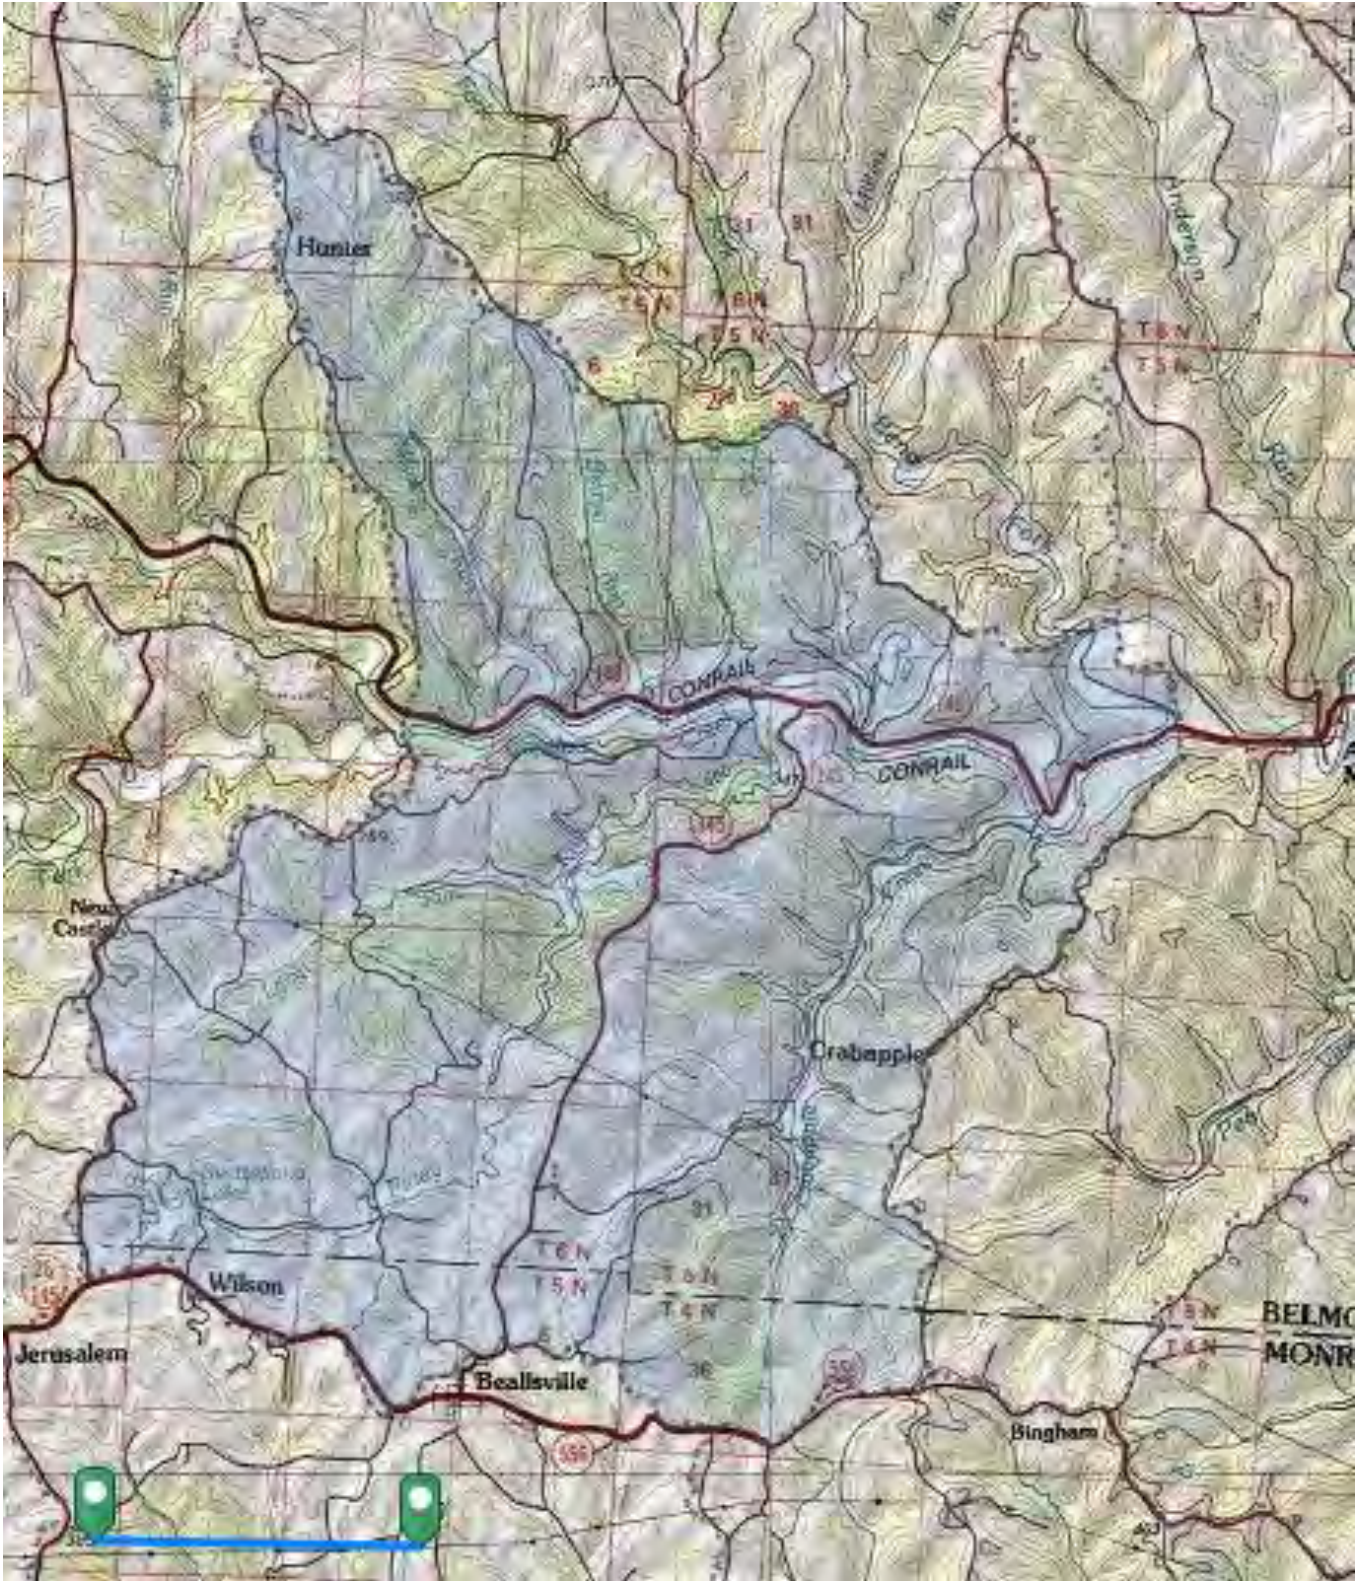
Figure 4 Topographic image of Piney Creek subwatershed. Blue line is 2 miles for scale.

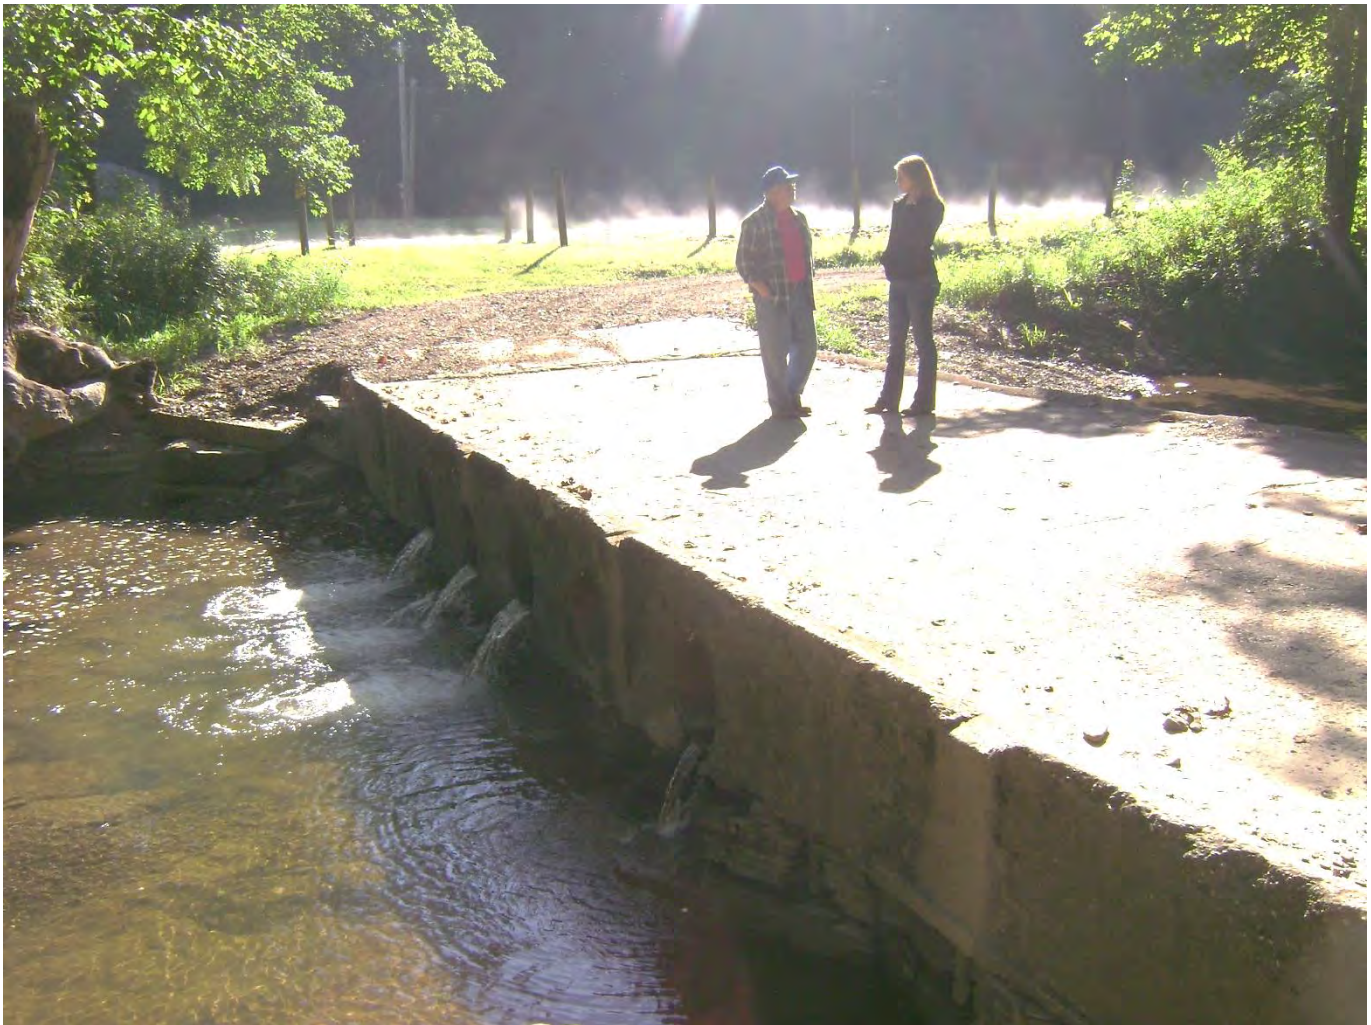
Photo 1 Washington Township Road 84 submarine bridge on Crabapple Creek. Notice the culverts and the water level of the stream.

The Captina Creek Watershed Action Plan identifies sedimentation and barriers to fish migration as causes impacting the Crabapple Creek. Associated sources are unstable banks and a submarine bridge, respectively. This submarine bridge can be viewed in Photo 1 under Objective 1.

- **Objective 1: Remove barrier to fish migration and restore natural flow to reconnect habitat and allow movement of organisms.**
 - Crabapple Creek, RM 3.3. Remove one submarine bridge, Photo 1.

- **Objective 2: Stabilize 70-100 feet of stream banks to minimize sediment movement at vehicle crossings.** Because the Belmont County Engineer will not allow a legally-defined bridge structure, options to completely avoid impact to the stream are unknown. The sites listed below will demonstrate the use of an articulated block design to maintain vehicle use of the township roads at each site.
 - Crabapple Creek, RM 3.3, once bridge is removed. See Photo 1.
 - Crabapple Creek, RM 3.8. See Photo 2.

<i>criteria d</i>	Estimated Total cost	Estimated: \$40,468, sub-contract <ul style="list-style-type: none"> • Company site prep/cleanup: \$6500 • Removal of ~40 cy sub. Bridge: \$10,000 • Stream and bank regrading: \$9968 • Erosion/sediment control: \$5000 • Articulated Block crossing: \$9000 Match: \$16,188, committed <ul style="list-style-type: none"> • In-kind: \$1077 <i>watershed coordinator position</i> • Cash: \$15,111 <i>ODOW agreement</i>
<i>criteria d</i>	Possible Funding Source	Section 319; Central Appalachia Habitat Stewardship Program
<i>criteria a</i>	Identified Causes and Sources	Causes: barrier to fish migration and sedimentation Sources: submarine bridge and unstable banks

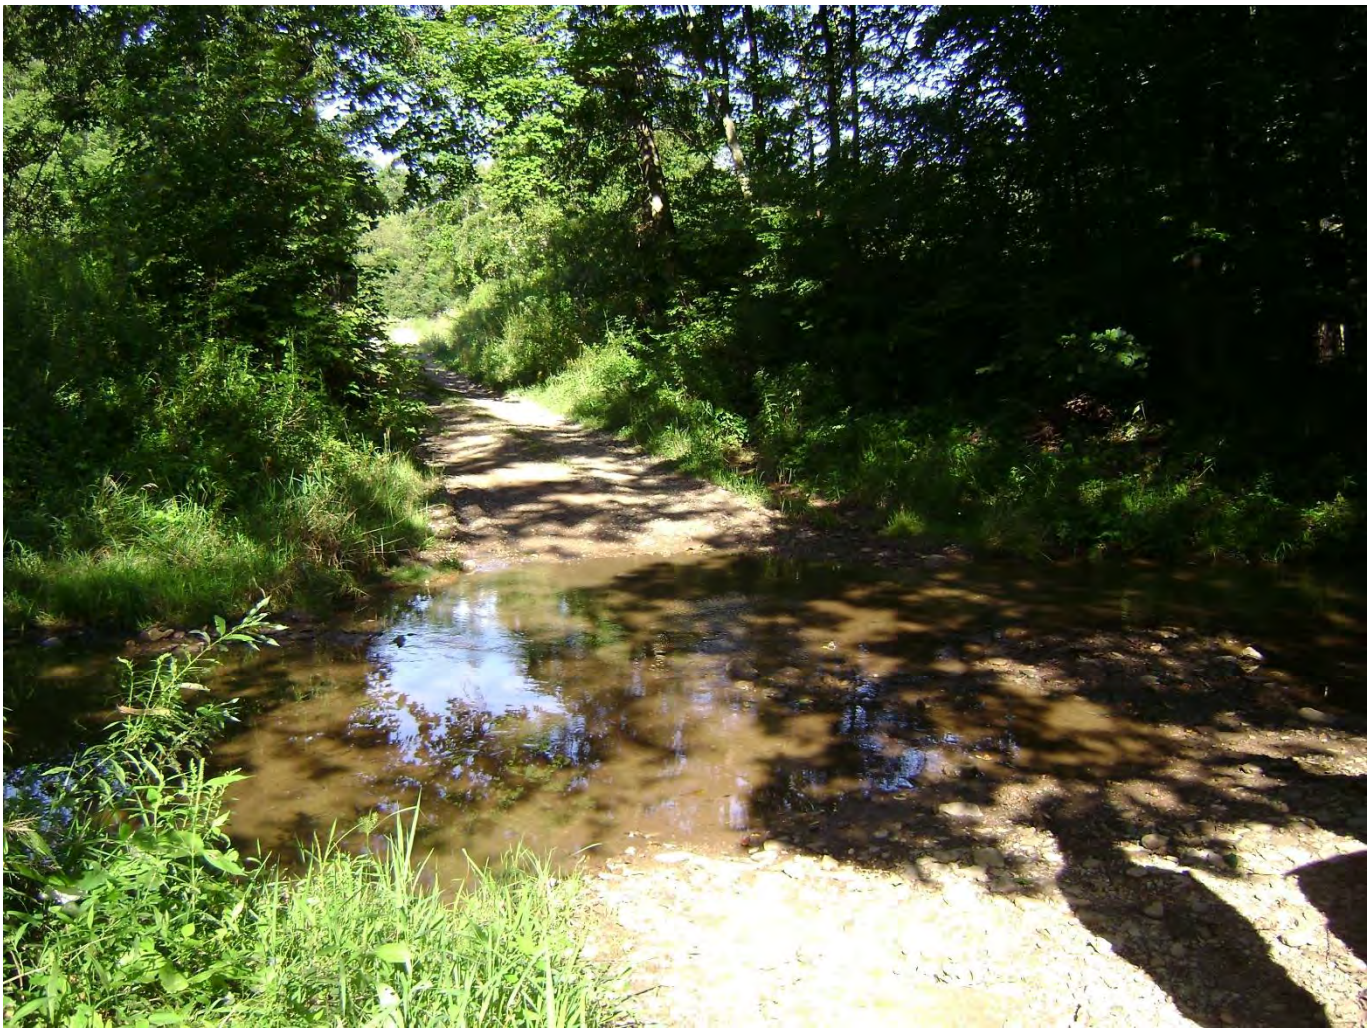
Photo 2 Vehicle crossing on Washington Township Road 84 through Crabapple Creek.

<i>criteria g</i>	Project Narrative	<p>An open stream crossing on Washington Township 84 passes through Crabapple Creek and has been identified as a potential source of sediment erosion and subsequent loading into Crabapple Creek. The goal of the Crabapple Creek Crossing Improvement Project is to install an alternative stream crossing for vehicle transportation. This will reduce the impact to the stream banks and maintain, perhaps improve, the aquatic use designation of Excellent Warmwater Habitat on Crabapple Creek.</p> <p>The Belmont SWCD is partnering with the Washington Township Trustees and the USFWS to complete this project, which has been a project since 2015. Upon securing remaining funding, the project will be bid out for a contractor to complete the project. The contractor will regrade the area as needed and install an articulated block mat to stabilize the banks for vehicle traffic. USFWS will complete pre and post-assessments to determine changes in IBI and habitat scores.</p> <p>Stabilizing the banks at the point of vehicle entry and exit with an articulate block mat will reduce sediment loading thus maintaining the aquatic use designation for Crabapple Creek. An estimated 30 feet of stream bank will be stabilized in this project.</p>
