# Nonpoint Source Implementation Strategy Plan for Chocolate Run-Mahoning River HUC-12 (05030103-04-06)

*Approved: August 14, 2019*

**EASTGATE**  
Regional Council of Governments

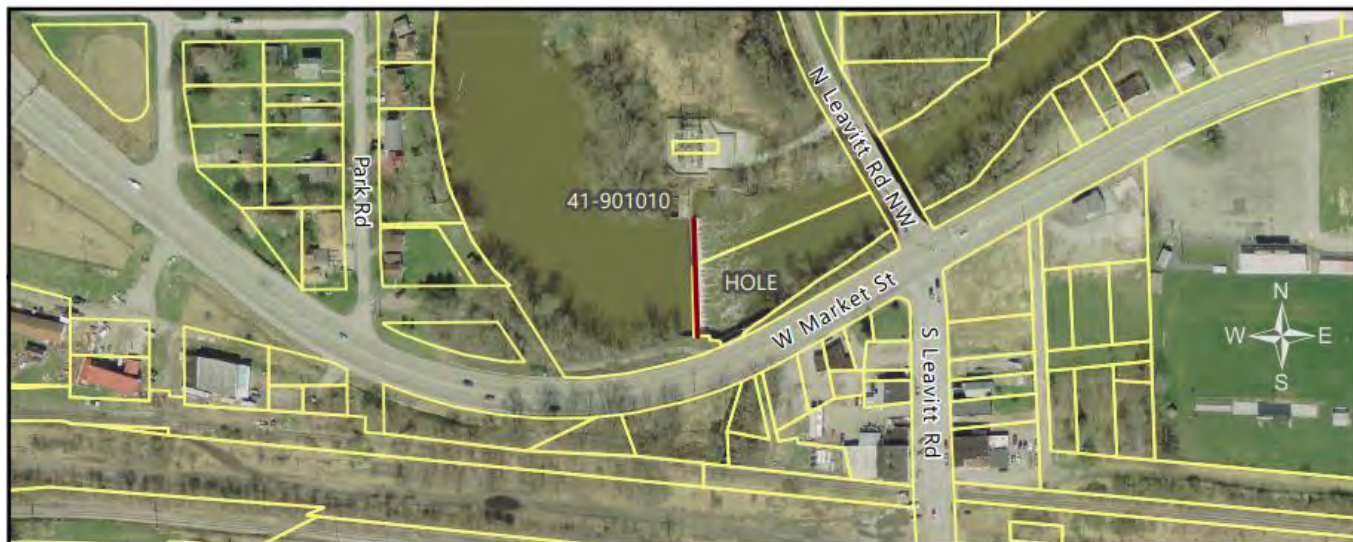
Figure 2: Location of the Leavittsburg Dam (in red) in the Chocolate Run HUC-12 (image courtesy Eastgate).

Located in the Chocolate Run HUC-12 on the Mahoning River at approximately RM 42.99, the Leavittsburg Dam is a low-head earthworks dam in Warren Township and owned by Trumbull County MetroParks. The dam is approximately 8 feet tall (USACE, 2006) and is one of a series of low-head dams located along the Mahoning River mainstem that have been targeted for removal by Eastgate and nearby communities to restore free-flowing conditions and improve water quality and alleviate flooding in this reach. The Leavittsburg Dam has frequently been cited as a source of flooding in surrounding neighborhoods and its presence accounts for nearly 10 miles of backwater conditions on the Mahoning River mainstem.

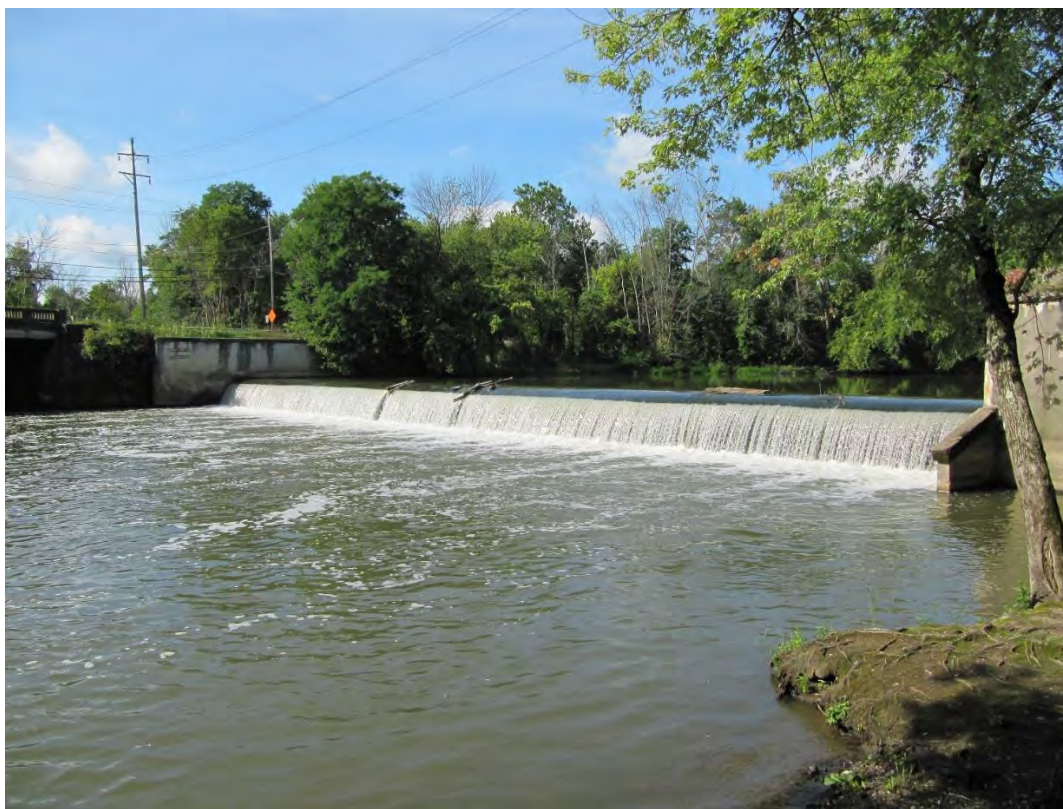
Figure 3: Photo of the Leavittsburg Dam looking upstream near the Canoe City MetroPark (photo courtesy Eastgate).

The area originally had a small dam upstream from the current dam site constructed in the early 1900s. The current Leavittsburg Dam was constructed a few years later and submerged the small upstream dam in the process. The Leavittsburg Dam's original use was to support an electric generation facility which has long been in disuse and has been replaced by an electrical substation still in use today. Trumbull County MetroParks reports that the dam and surrounding Canoe City MetroParks property is regularly submerged during seasonal floods.

The critical area also contains the Leavittsburg Dam, a low-head earthworks dam in Warren Township and owned by Trumbull County MetroParks as part of their Canoe City MetroParks facility. The dam is approximately 8 feet tall (USACE, 2006) and is one of a series of low-head dams located along the Mahoning River mainstem that have been targeted for removal by Eastgate and nearby communities to restore free-flowing conditions and improve water quality and alleviate flooding in this reach. The Leavittsburg Dam has frequently been cited as a source of flooding in surrounding neighborhoods and its presence accounts for nearly 10 miles of backwater conditions on the Mahoning River mainstem. Trumbull County MetroParks reports that the dam and surrounding Canoe City MetroParks property is regularly submerged during seasonal floods.
