Little Paint Creek

Coldwater Conservation Plan

Paint Creek
Regional
Watershed
Association

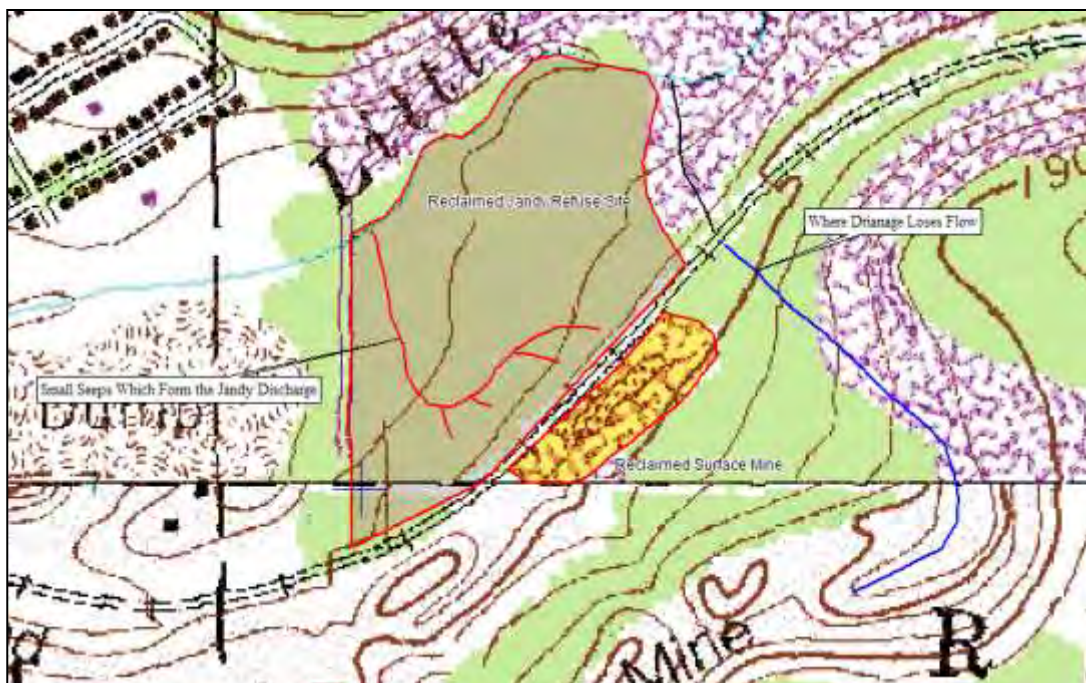
Figure 18. Drainage pattern of Jandy Discharge

Greenley Energy owns the former Jandy Coal Company Coal Refuse Pile. Several years ago, approximately 500,000 tons of refuse was moved from it to an adjacent permitted disposal site in cooperation with the DEP's Bureau of Abandoned Mine Reclamation. The contractor then installed erosion and sediment controls, filled in three ponds below the refuse pile, covered the disposal site with FBC [Fluidized Bed Combustion] ash, and regraded and revegetated the site (Clark 2005). The *Paint Creek Restoration Plan* states that, —Upon completion of the project, it was discovered that a discharge (LPC-D01) from an upslope reclaimed surface mine was still inputting heavy AMD loading into Little Paint Creek.” The Jandy Discharge is comprised of this and surface water that infiltrates the refuse pile, as illustrated in Figure 18 from the *Paint Creek Restoration Plan*.

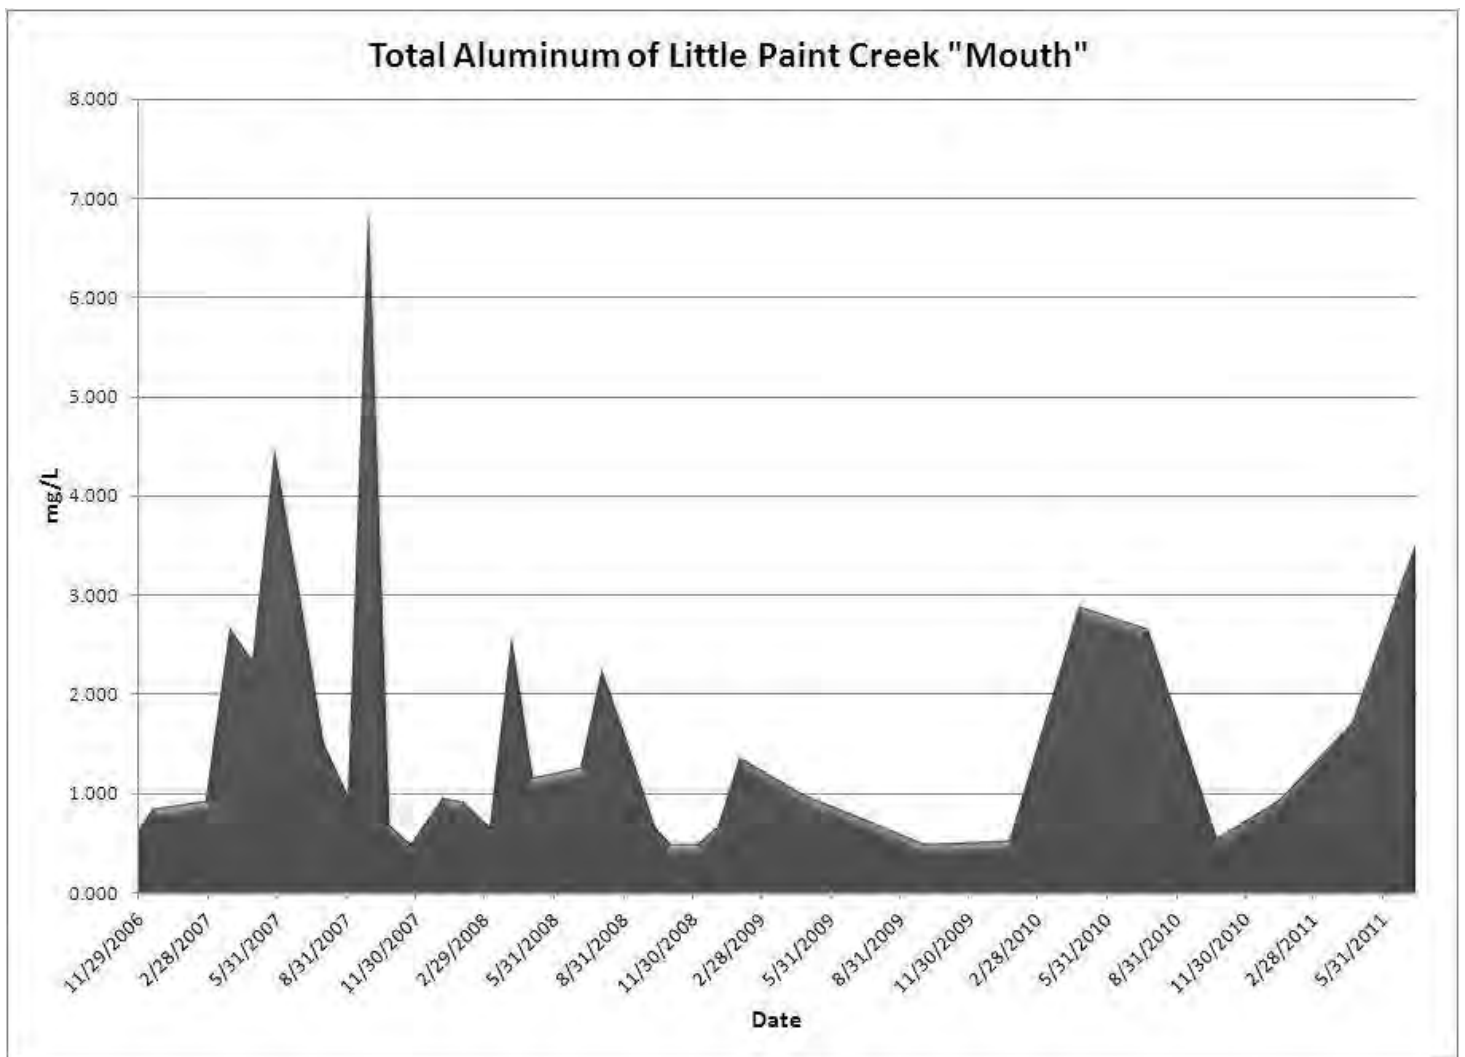
Figure 23. Aluminum concentrations of Little Paint Creek near its mouth from November 2006 – July 2011

The concentration of metals associated with AMD varied greatly over the sampling period at this site. The average total iron was 4.46 mg/L, with a minimum and maximum of 0.63 mg/L and 18.20 mg/L respectively. The average total aluminum was 1.77 mg/L, with a minimum of 0.53 mg/L and a maximum of 6.92 mg/L. The Pennsylvania Code states that iron concentrations should have a 30-day average of 1.5 mg/L. It also states that the maximum concentration of aluminum for fish and aquatic life is 0.750 mg/L. Little Paint Creek consistently exceeds the allowable concentrations for both iron and aluminum.

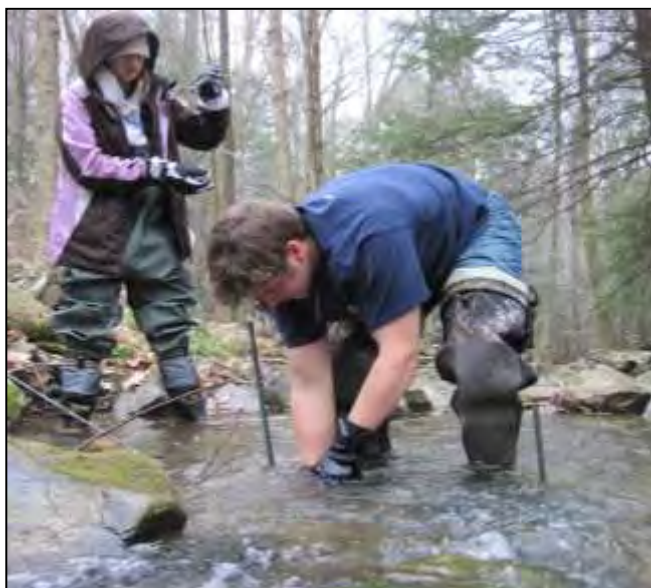
*Figure 27. Saint Francis University students deploy their sonde in Rocky Run
Photo by Dr. William Strosnider*

professors, students placed a sonde in the lower end of Rocky Run, another in Little Paint Creek before its confluence with Rocky Run, and a third in Little Paint Creek below the confluence of the two streams. After three weeks, students retrieved the sondes and analyzed the data. Their data confirmed that the high levels of conductivity are originating in Rocky Run (Appendix 2). Water testing on November 15, 2010 with a Hanna All-in-One meter along the length of Rocky Run showed elevated conductivity levels, particularly in the stormwater retention wetland adjacent the Richland Towne Centre shopping complex. Here, conductivity measured 1,612 uS/cm. Downstream readings ranged from 626-1,033 uS/cm.

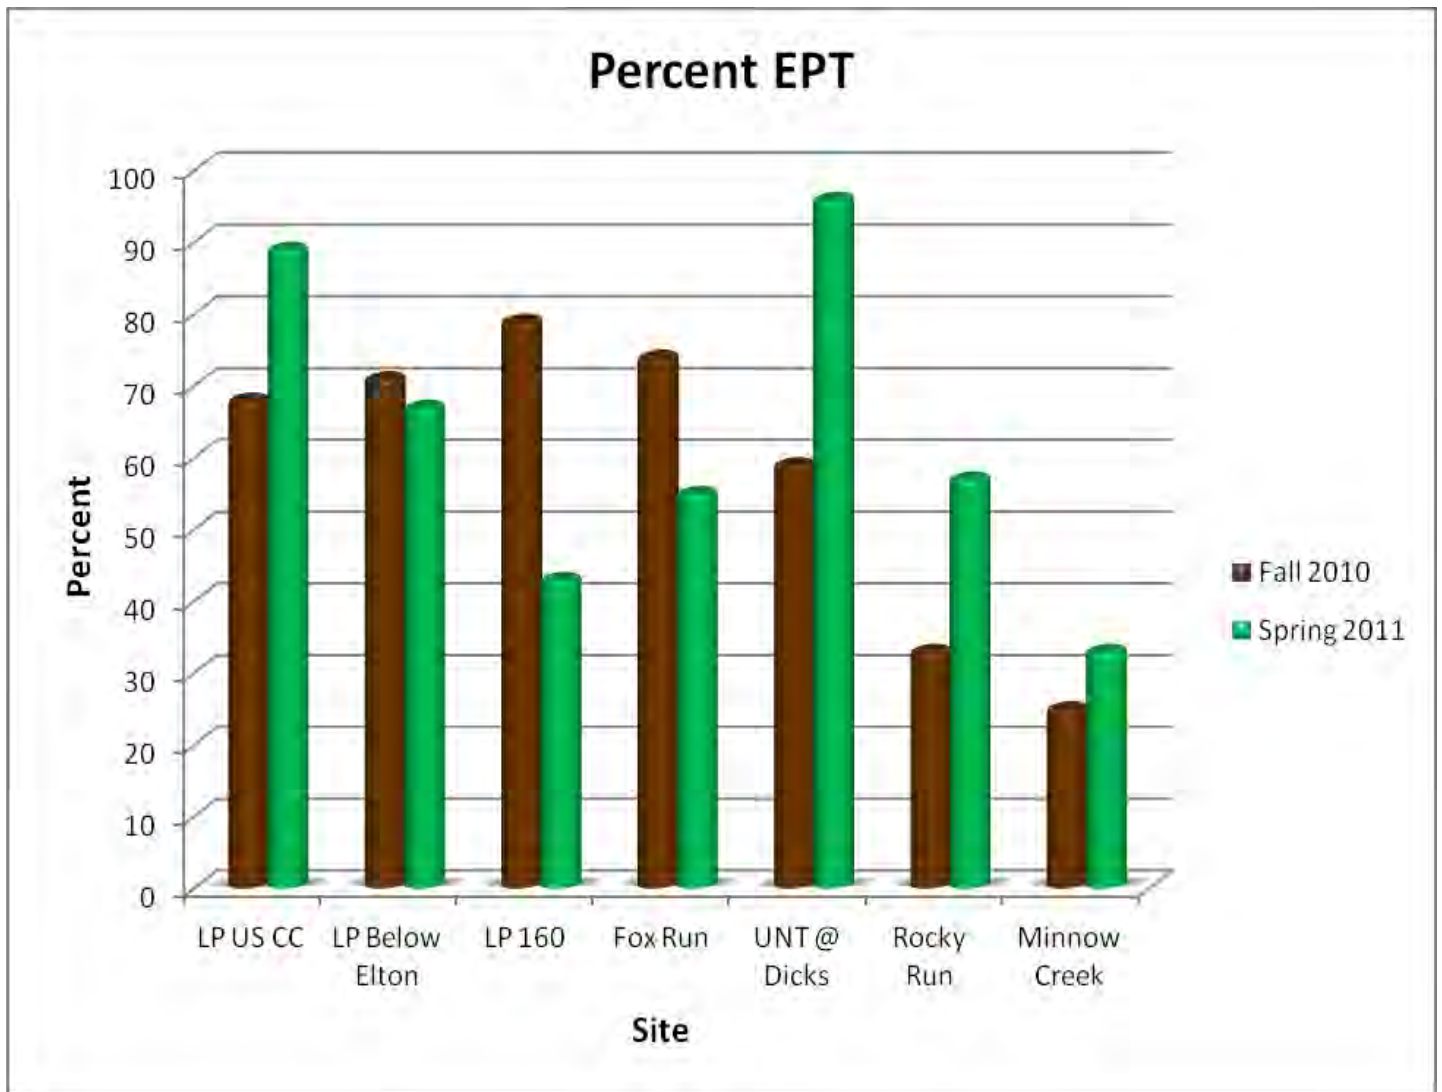
Figure 28. Percent composition of EPT (mayfly, stonefly, caddisfly) taxa

Specific benthic macroinvertebrate metrics can be used to measure for acid impacts. The metrics used in this survey to evaluate the effects of acidity on the Little Paint Creek watershed were percent composition of mayfly, stonefly and caddisfly taxa (Percent EPT). Usually when acid impacts are present, caddisfly and mayfly numbers will decrease, while some stonefly taxa, which are acid tolerant, flourish. The results of the EPT index for fall 2010 and spring 2011 are located in Figure 28.

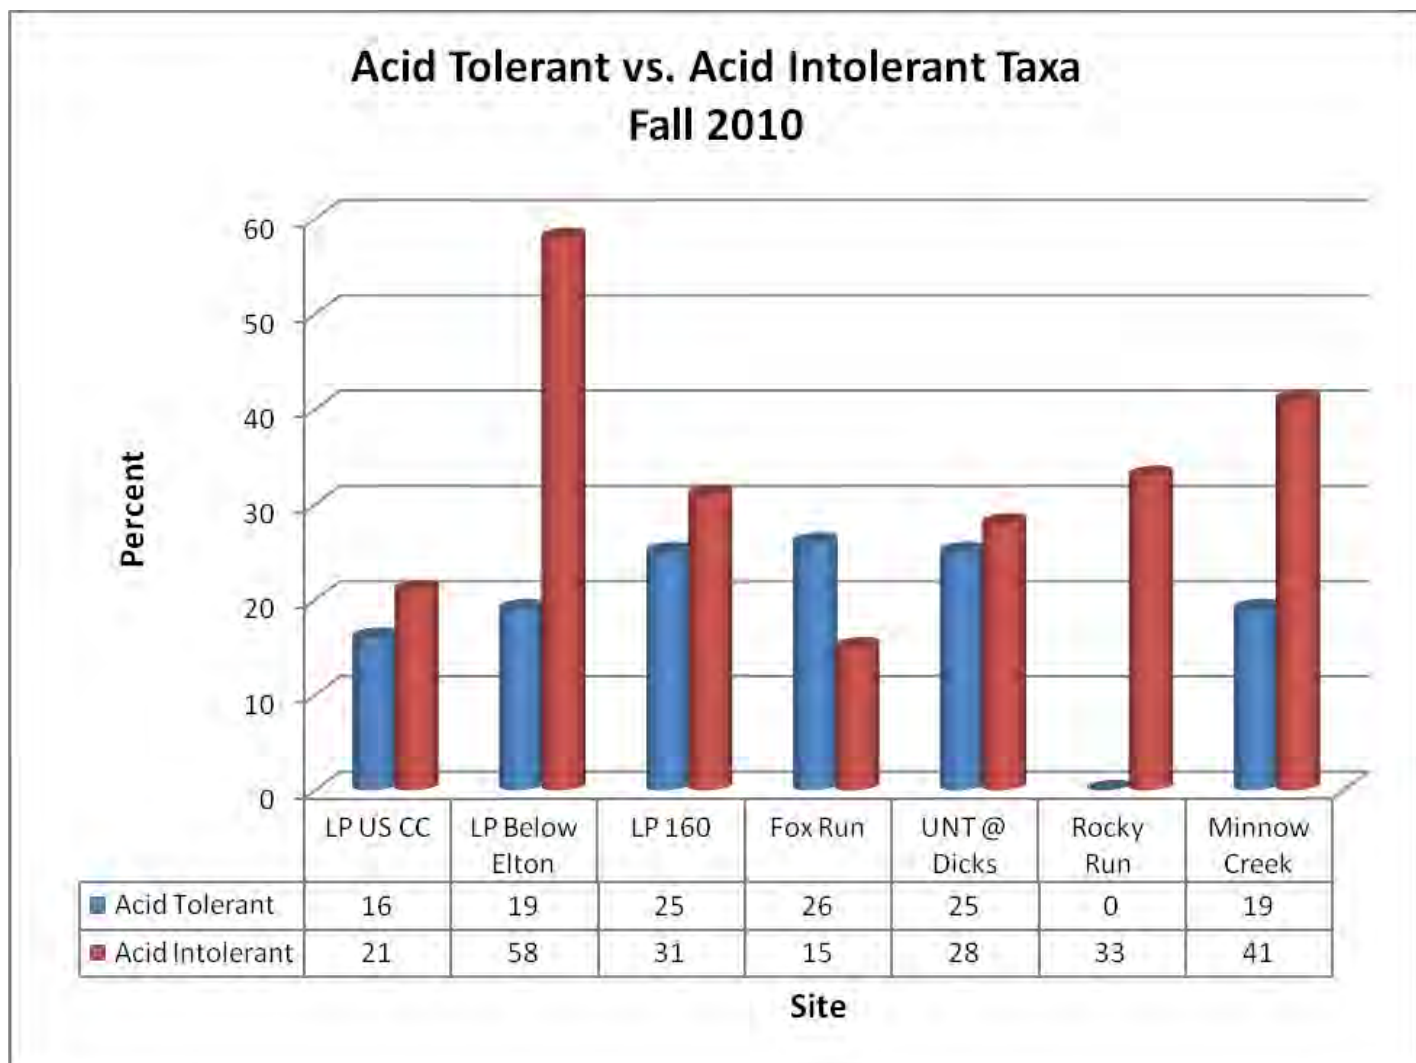
Figure 29. Percent acid tolerant taxa versus acid intolerant taxa ~ Fall 2010

Another metric used to measure acidity is the comparison of strictly acid tolerant taxa with strictly acid intolerant taxa. These acid tolerant taxa are the taxa that have specialized to survive in acidic conditions. If the percent composition of these individuals composes most of the sample, the likelihood of acid impacts is greater. The results for the acid tolerant to acid intolerant comparisons are located in Figures 29 and 30.

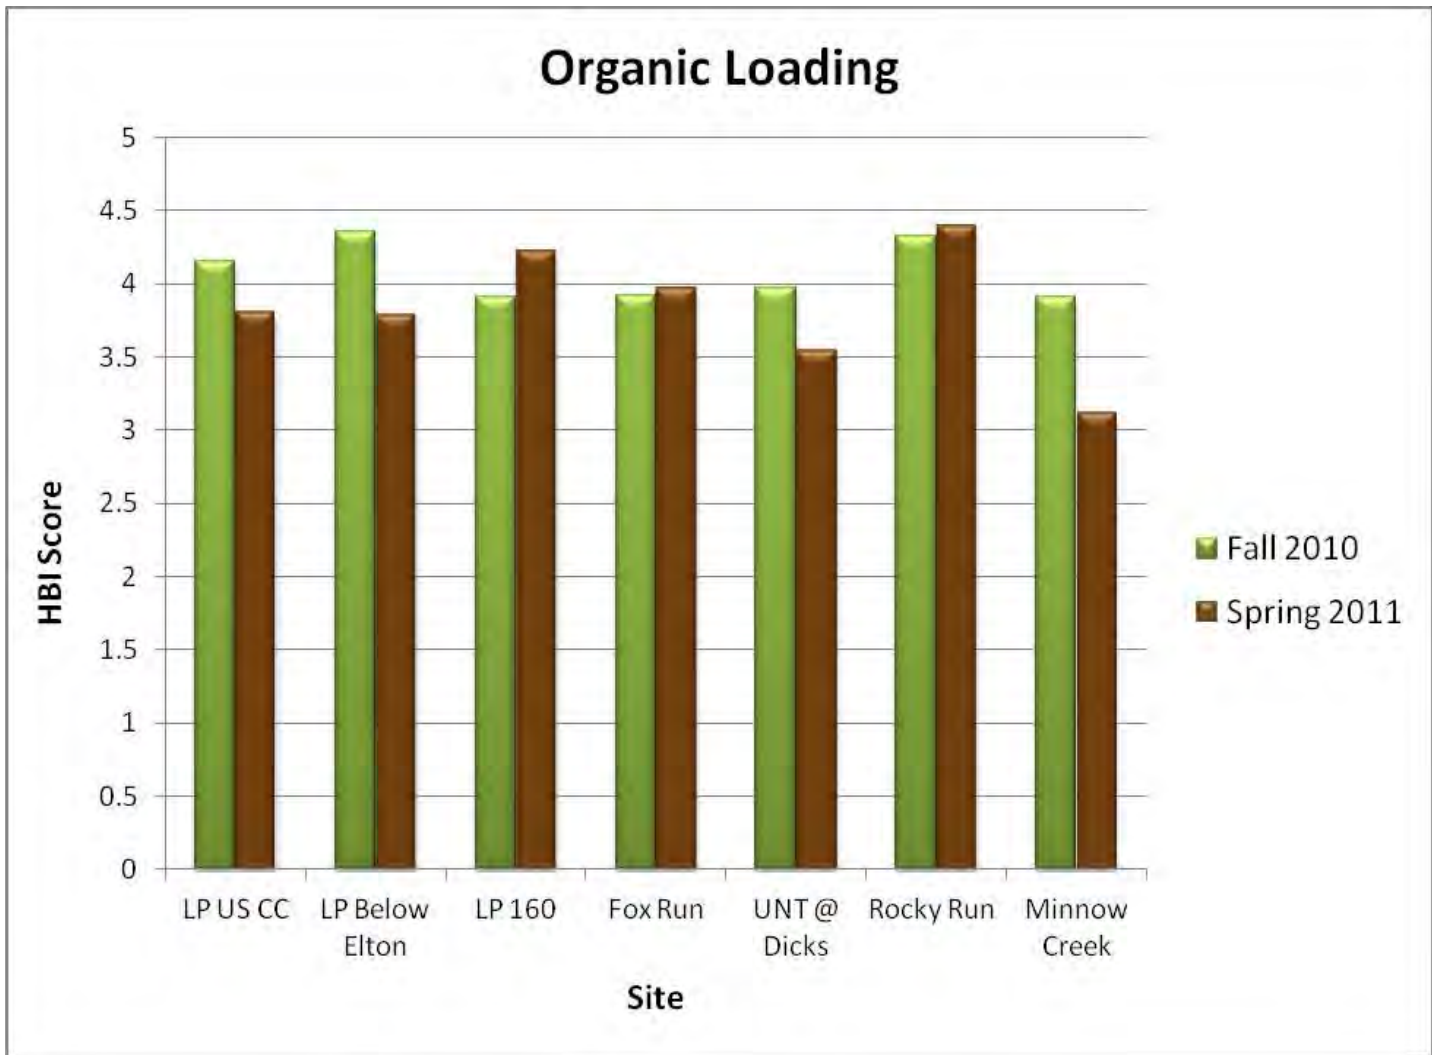
Figure 31. HBI scores for sites in the Little Paint Creek watershed

Organic loading impacts are measured using the Hilsenhoff Biotic Index (HBI). HBI scores increase as organic loading increases. HBI scores above 4.0 indicate organic loading is occurring within the stream reach (Barbour et al. 1999). The results for the HBI are located in Figure 31.

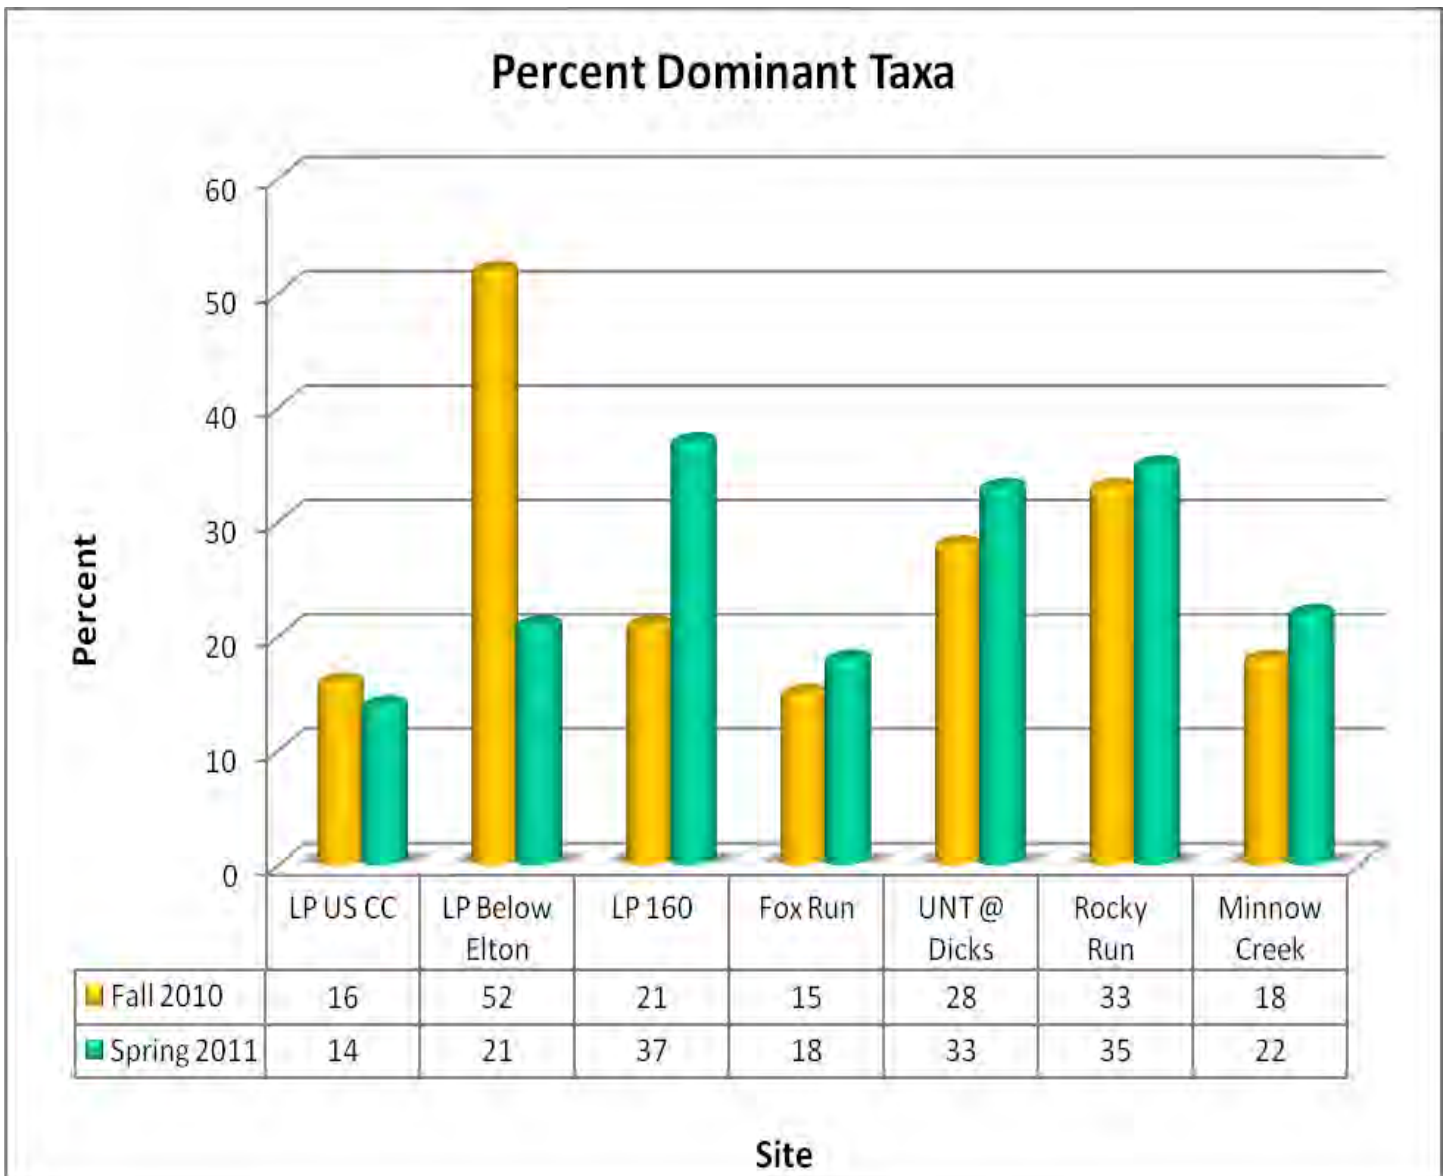
Figure 33. Percent dominant macroinvertebrate taxa at select sites in the Little Paint Creek watershed ~ Fall 2010 and Spring 2011

For communities that are not evenly distributed, like those in Rocky Run and the unnamed tributary to Little Paint Creek at Dick’s Auto, metrics like percent dominant taxa measure the composition of the most frequently collected taxa in a site. For example, if one individual composes the majority of the sample, the community at that site will be less diverse, which can indicate a stressor. The results of this metric are located in Figure 33.

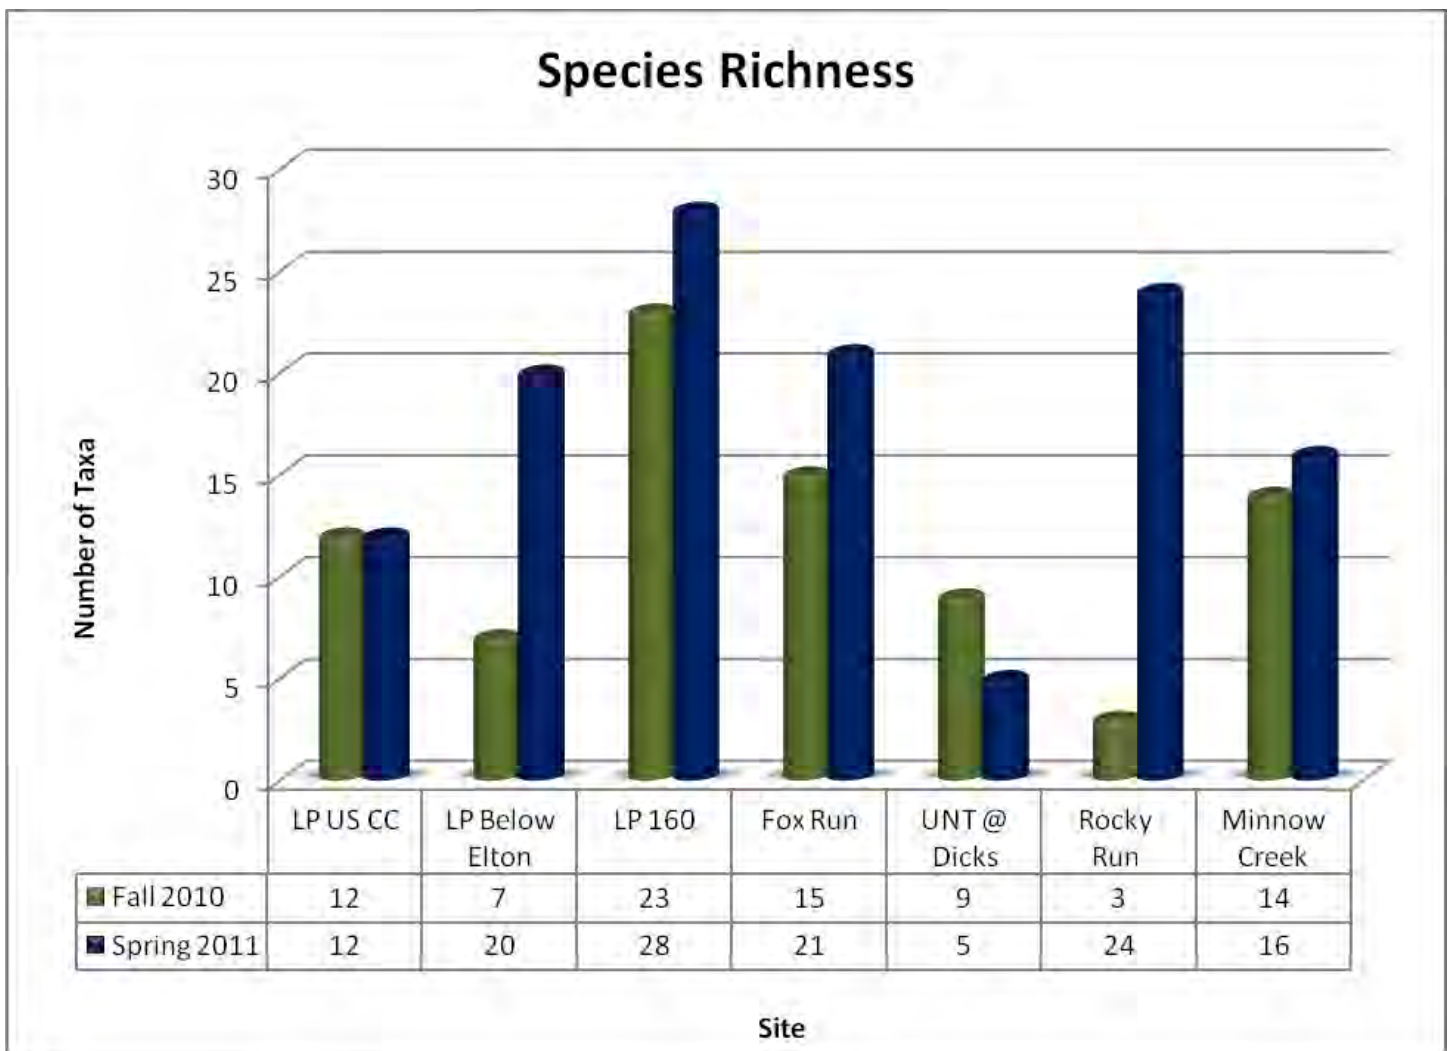
Figure 34. Species richness of Fall 2010 and Spring 2011 macroinvertebrates from select sites in the Little Paint Creek watershed

Species richness and total individuals collected are measures of community diversity and robustness. When water quality increases, usually species richness increases. When organic pollutants degrade the water quality, total individuals increase. If a stream is mildly impacted by acid, species richness decreases and total individuals increase. Streams that have severe acid impacts have decreased total individuals and species richness (Barbour et al. 1999). The results for these metrics are located in Figures 34 and 35.

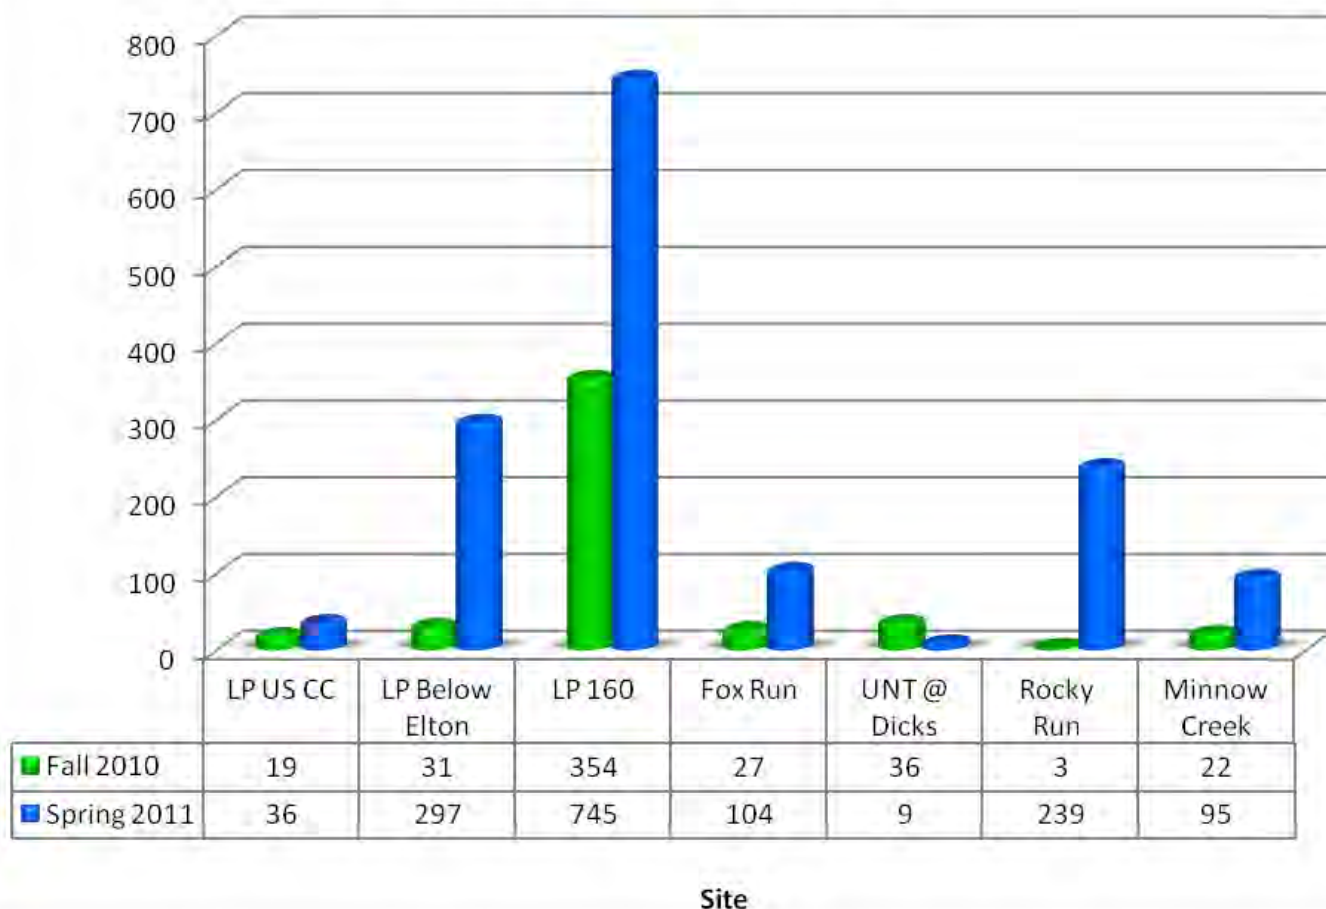
Figure 35. Total individuals collected from select sites in the Little Paint Creek watershed Fall 2010 and Spring 2011

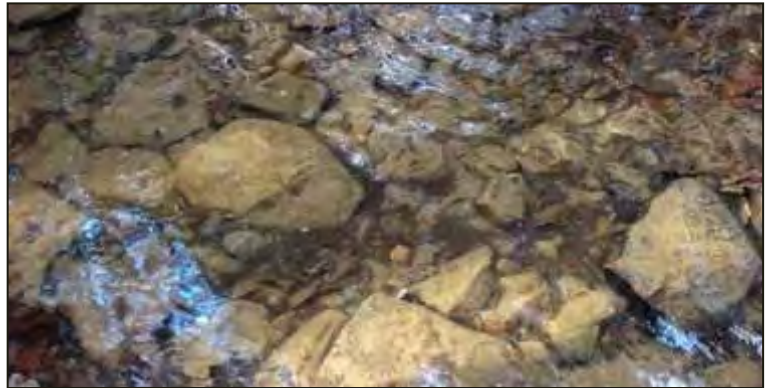
*Figure 50. Sedimentation in the headwaters of Little Paint Creek stifles aquatic life
Photo by Melissa Reckner*

The headwaters of Little Paint Creek (above the Windber Country Club) contain cold water, but are impacted by sedimentation. Sand and silt fill in most of the interstitial space of the bottom substrate creating an area non-conducive to trout spawning. The sedimentation impacts can be seen in the limited macroinvertebrate community and depressed fish community. The cause of this sedimentation appears to be the historic timbering of the area. While the forest is presently mature, a layer of sand has been exposed through historic timbering of the area. This sand is continuously deposited in the stream after high flow events.
