Nonpoint Source Implementation Strategy Plan for City of Warren-Mahoning River HUC-12 (05030103-06-03)

Approved: August 14, 2019

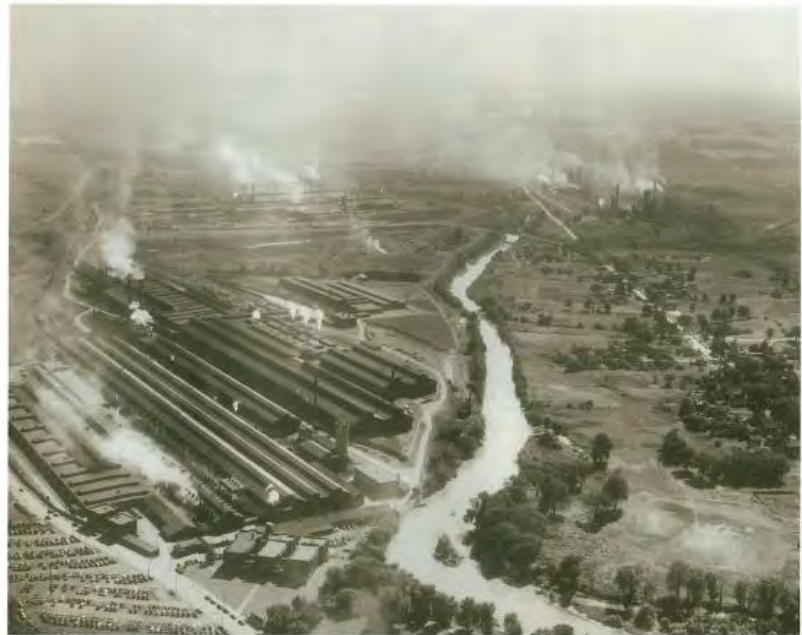
Figure 1: Legacy industry in the Mahoning River Valley.

have largely moved from the cities to the suburbs. The environmental impacts of the steel mill industry remain along the Mahoning, however, in the form of channelization and dams with their resulting impoundments, as well as legacy pollutants in the sediment along the lower Mahoning River.

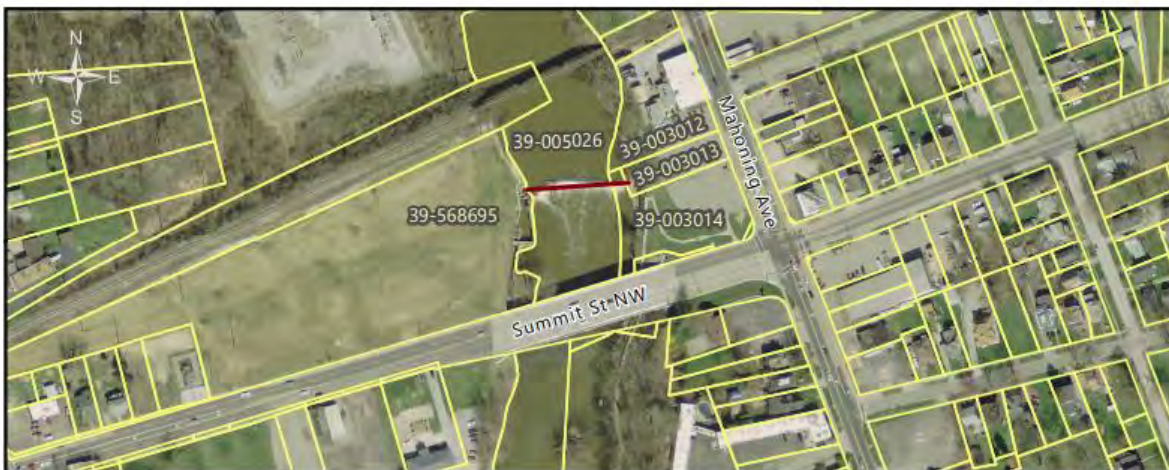
Figure 4: Location of the Summit Street Dam (in red) in the City of Warren HUC-12 (image courtesy Eastgate).

Located in the City of Warren on the Mahoning River at RM 39.9, the Summit Street Dam (or Warren Water Works Dam) is a low-head V-shape concrete structure with a sloped concrete weir owned by the City of Warren and Habosky-Davidson Enterprises. The dam is approximately 11.7 feet tall (USACE, 2006) and also consists of abutments and a spillway with two large metal gear wheels at the entrance. The original dam was constructed sometime shortly after or in 1884 to support the City of Warren’s original water plant and was remodeled to support hydroelectric power. It is no longer in use.

The Mahoning River's in-stream habitat in the City of Warren HUC-12 is degraded by the presence of two dams. The Summit Street Dam impounds approximately 2.5 miles of stream, while the ArcelorMittal Dam impounds one mile. The pools behind the Summit Street Dam and ArcelorMittal Dam are relatively short because the Mahoning River's gradient increases in this reach to 2.3 feet/mile, but the 2018 lower Mahoning TSD notes that the dam pools in the reach upstream of the Leavittsburg Dam to the ArcelorMittal Dam make it difficult to notice the river's dynamic change in size from a small creek-sized stream to a notable river. The natural gradient and flow should provide many unique habitat niches for aquatic organisms but cannot due to the presence of the dams. Instead, the dam pools collect silt and sediment and the assimilative capacity and aquatic diversity of the lower Mahoning will remain checked as long as it is dammed (Lower Mahoning TSD, 2018).

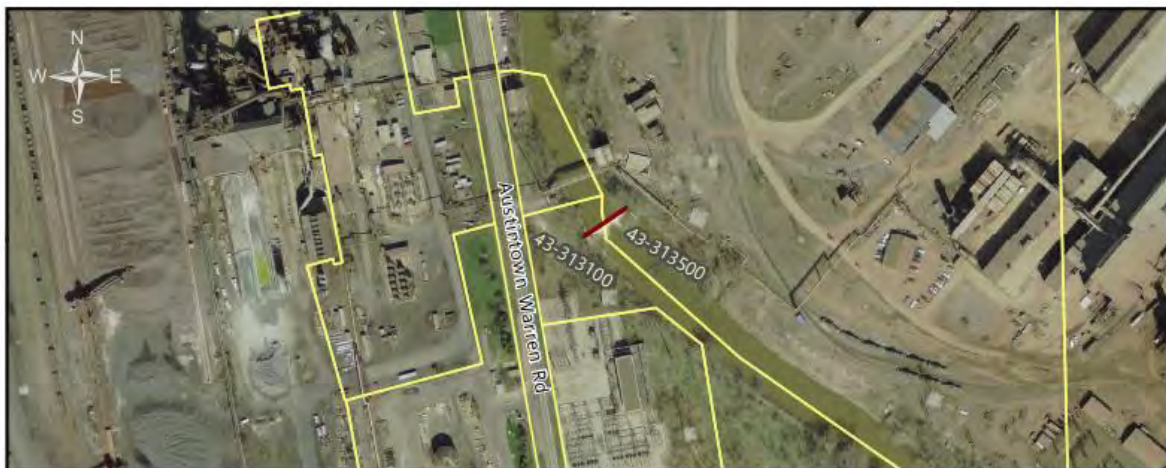
Figure 5: Location of the ArcelorMittal Dam (in red) in the City of Warren HUC-12 (image courtesy Eastgate).

Located in Warren Township on the Mahoning River at RM 36.7, the ArcelorMittal Dam (or Republic Steel Warren Works Dam) is a concrete weir with abutments that may be supported in some areas by submerged timber cribs. The dam is approximately 4.5 feet high (USACE, 2006) and is owned by ISG Warren, Inc. and BDM Warren Steel Holdings, Inc. It was constructed by Trumbull Steel in 1921, before Trumbull Steel was acquired by Republic Steel. The dam’s original purpose was to impound water used by Republic Steel and WCI Steel. With the closure of the steel mills, the impoundment is no longer needed.
