THE NORTH FORK OF BENS CREEK

COLDWATER CONSERVATION PLAN

February 2014

PREPARED BY THE SOMERSET CONSERVATION DISTRICT

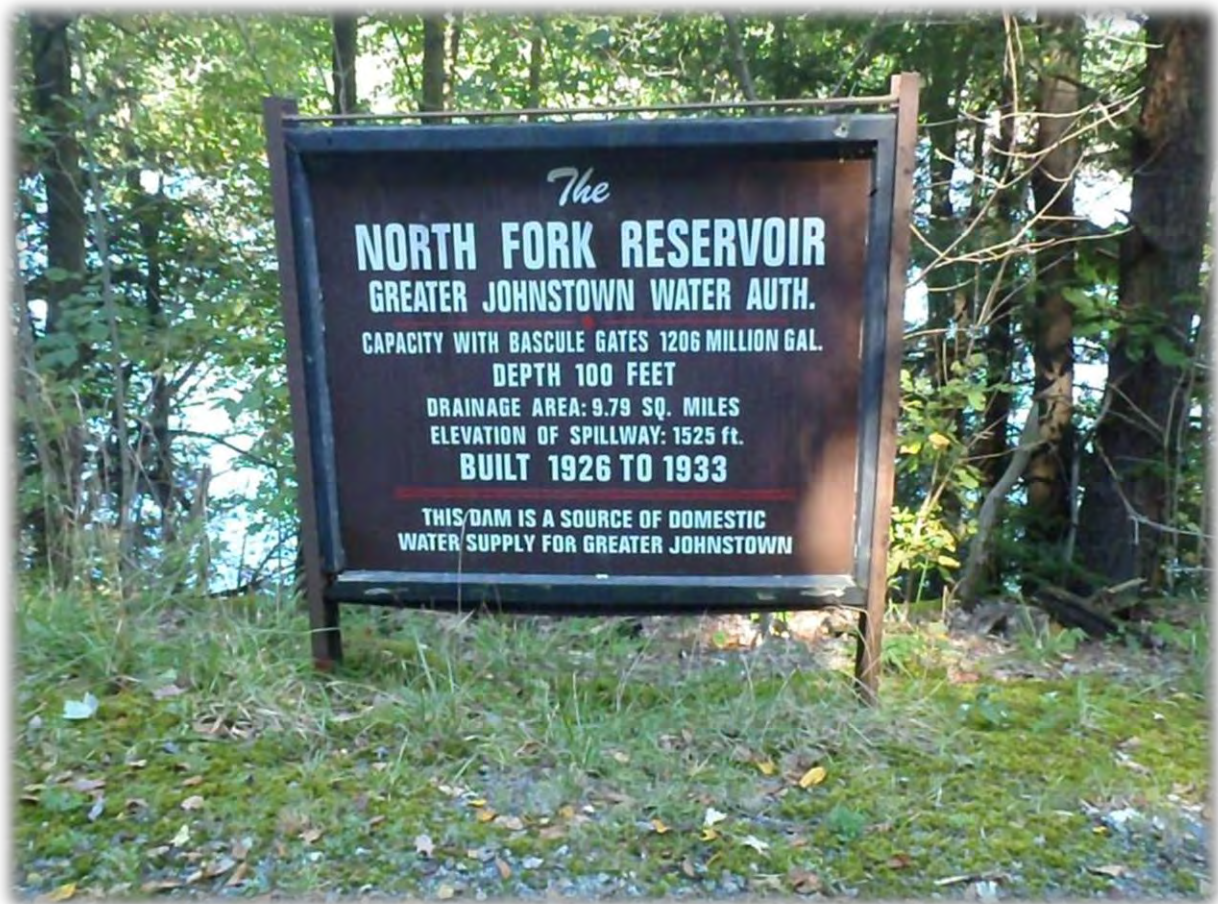
The dam is constructed of an earthen embankment lined with cut stone on its upstream side. The construction of the embankment began in 1926 and was completed in 1933. The North Fork Reservoir drains an area of 9.79 square miles, nearly 2/3 of the entire North Fork of Bens Creek

watershed. The North Fork Reservoir has had its storage capacity increased by the installation of 3 foot "basculer gates". These gates are raised typically in the fall when the reservoir no longer overflows its spillway. The gates add approximately 100 million gallons of storage. The gates can also be lowered during periods of high flows to maximize the capacity of the spillway. The majority of this portion of the watershed is also owned by the water authority. These lands are heavily forested and managed strictly to protect and preserve the integrity of the water quality of the tributaries. In addition the authority's Manager, RDM-Johnstown, LLC provides professional forester services to manage tree cutting practices within the watershed. These practices maintain the health of the forest and generate revenues for the water authority. The Water Authority keeps their lands open to public recreation, unless otherwise clearly marked by signs. North Fork Reservoir is closed to swimming, boating and fishing. The majority of the water from this reservoir supplies residents and businesses within the Greater Johnstown area water for drinking and industrial uses. However, a newly installed water line sends water over the Laurel Ridge to the residents of Ligonier, in Westmorland County. On average 520,000 gallons of water are pumped over the mountain daily. This extension line has allowed the authority to expand their customer base.

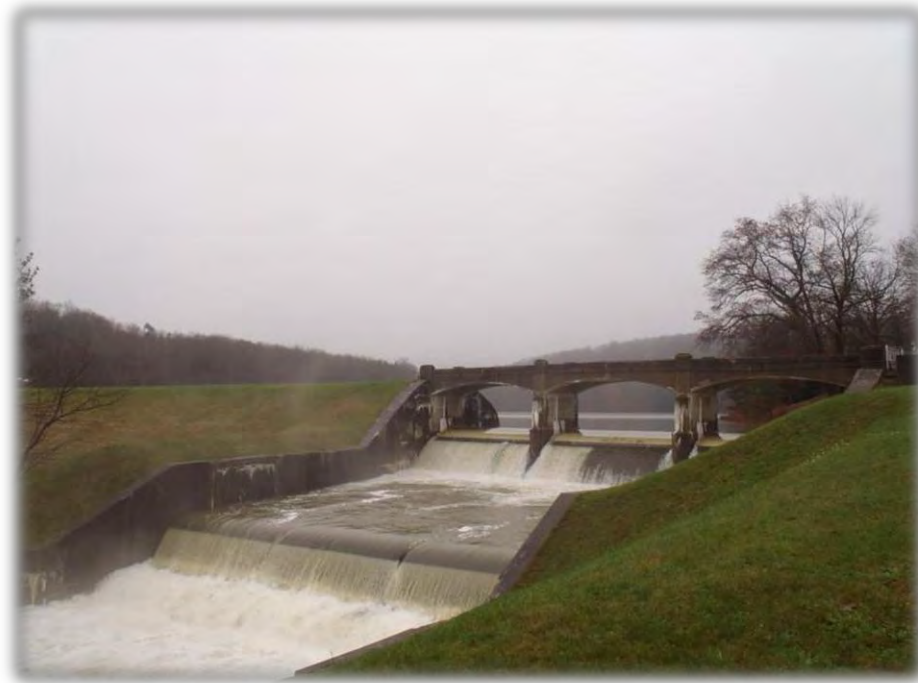
Figure 11: The spillway at North Fork Reservoir

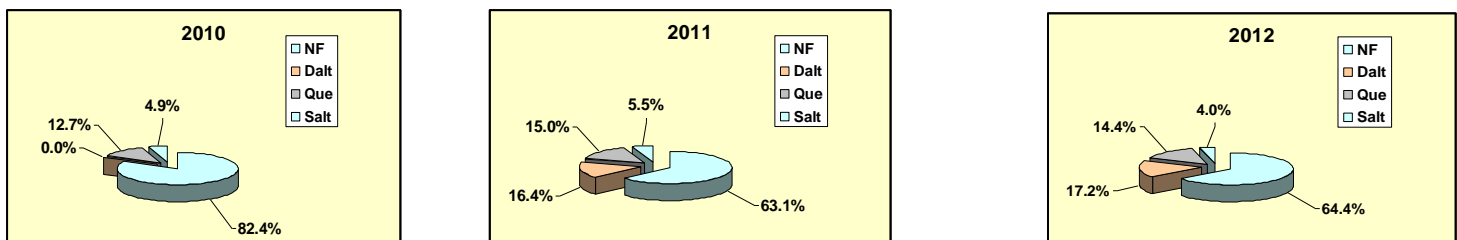
Figure 13: These pie charts show the percent of water used from GJWA owned reservoirs for the past three years. North Fork Reservoir supplies over 60% of the water sold to customers.

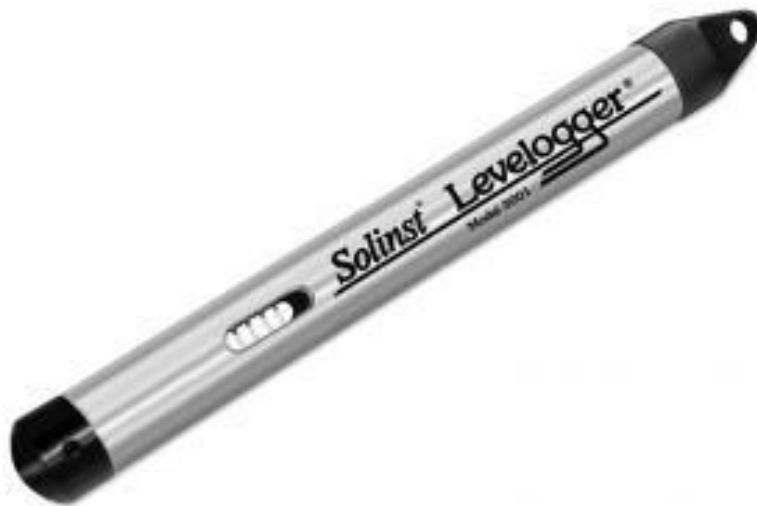
Figure 17: The device pictured is currently being used within the water shed to track water level, temperature and conductivity.

The Greater Johnstown Water Authority has been collecting base line stream data on Alwines Creek and the North Fork of Bens Creek by using submersible data loggers. The units are capable of tracking water level, conductivity and water temperature. The devices continuously take readings every fifteen minutes. The data recorded documents baseline stream chemistry and will allow the authority to identify a pollution event or other watershed threat that may occur within the head waters of the drinking water reservoir. To date no serious instances have been documented to have occurred.

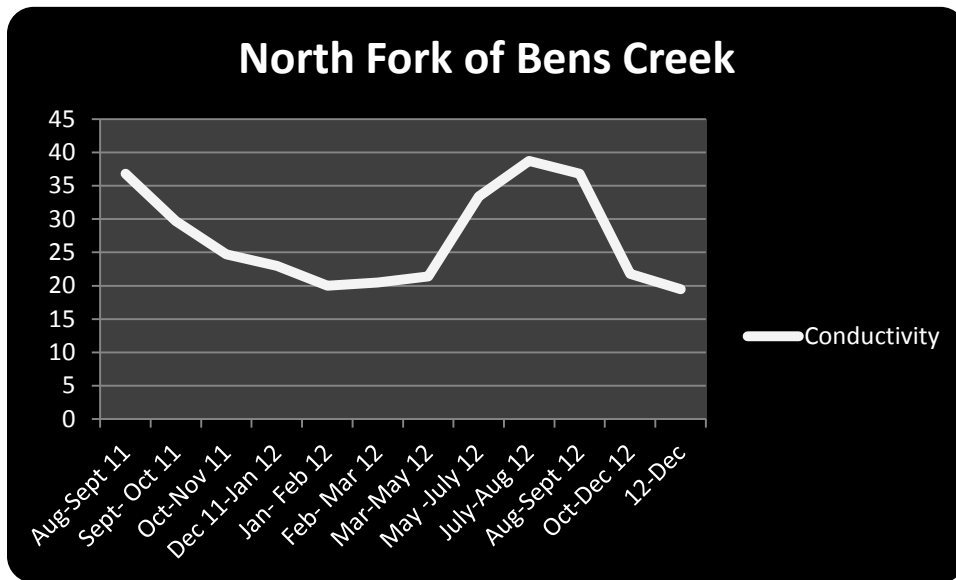
Figure 18: The graph above displays the conductivity in the North Fork of Bens Creek from Aug 2011 to Dec 2012

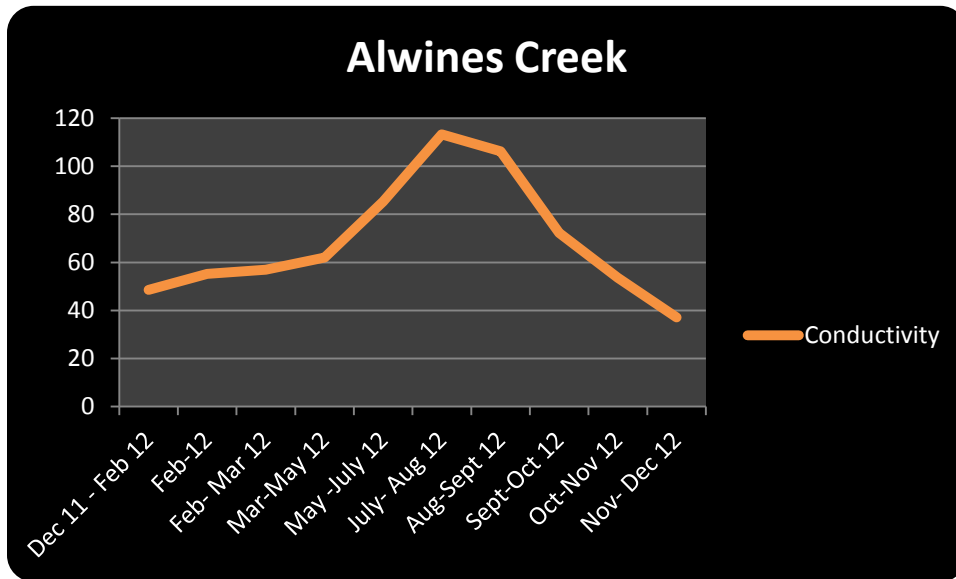
Figure 19: The graph above shows the recorded conductivity from Dec. 2011 to Dec 2012 on Alwines Creek.

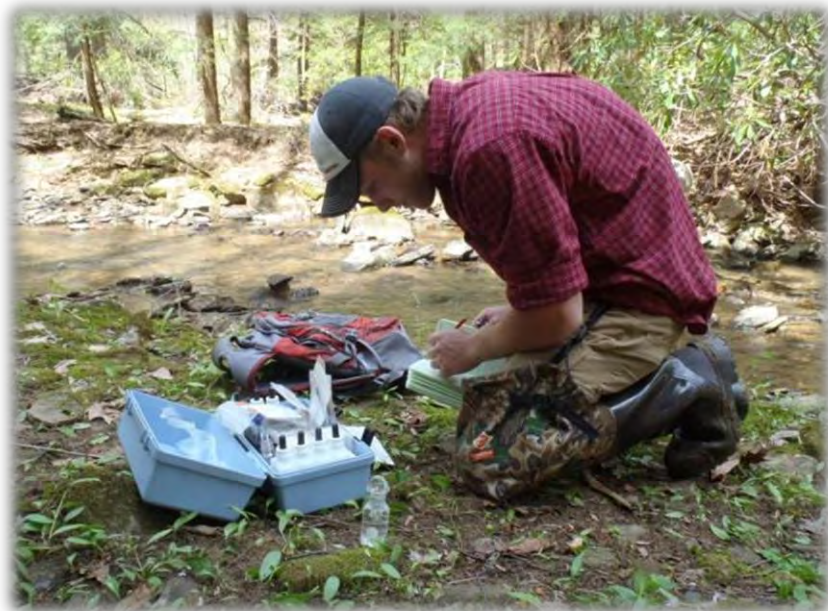
Figure 24: SCD intern Drew Walker perform water chemistry testing during macroinvertebrate sampling on Riffle Run.

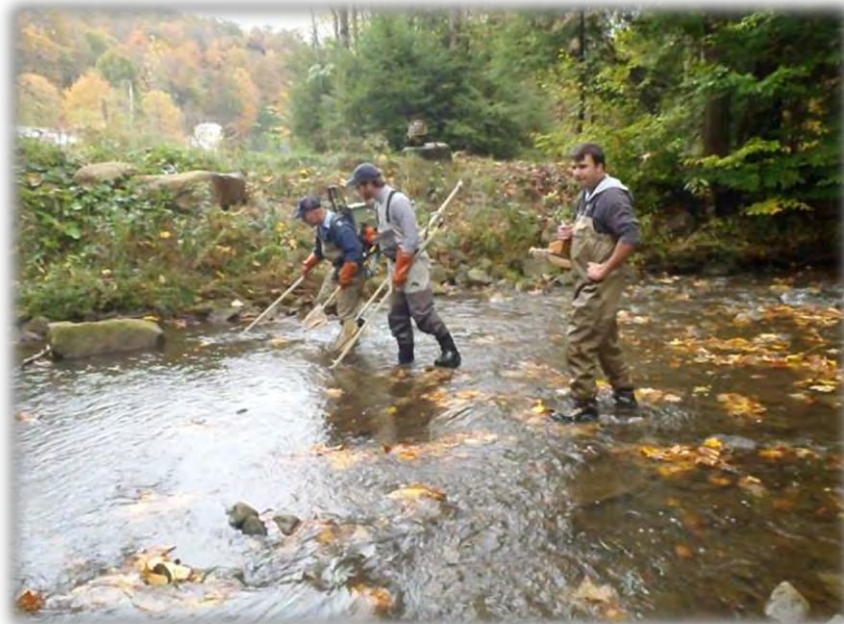
Figure 36: Pictured above PFBC and SCD staff electro-fish a section of the North Fork of Bens Creek.

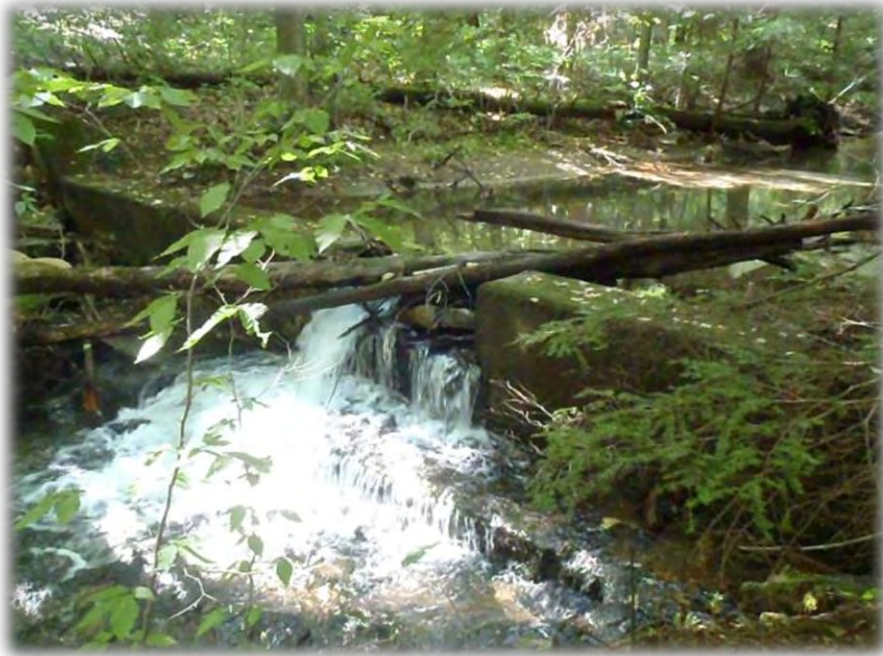
Figure 43: A concrete weir on Alwines Creek. This structure prevented wild rainbow trout from accessing the headwaters of this stream.

Another interesting observation that was brought to surface was that no wild rainbow trout were captured above an existing concrete weir that exists on Alwines Creek. This structure was built in the early 1900s to measure water flows entering the reservoir. This structure is too large for the rainbows to move upstream and isolates the populations. Brook trout populations exist both upstream and downstream of the structure, because they were naturally in the stream prior to the weirs placement. The original source rainbow trout is not documented, but prior to 1983 rainbow trout were released within the reservoir and have established a breeding population.

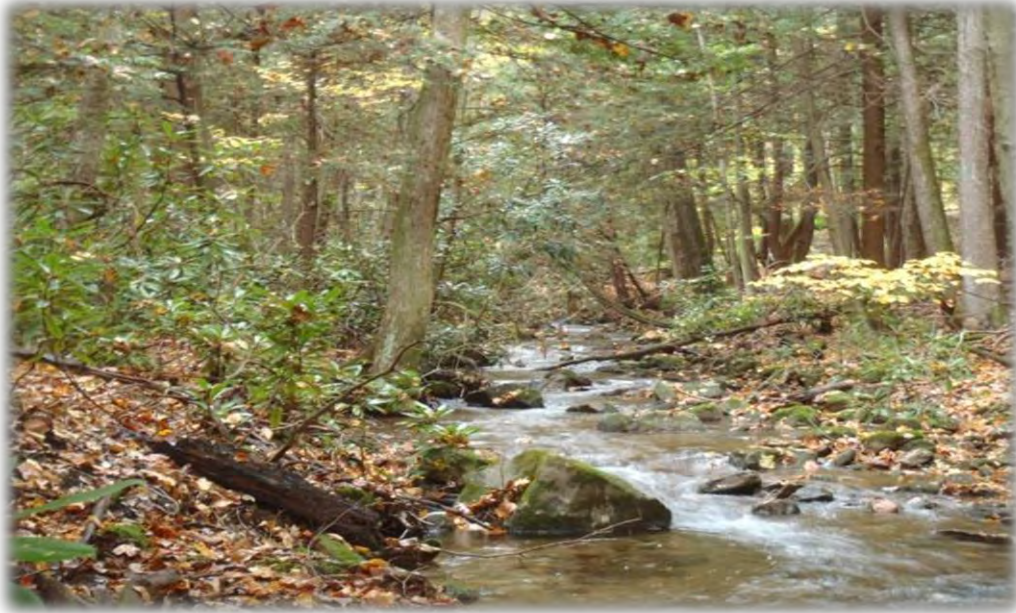
Figure 44: The headwaters of Riffle Run. The Stream is small and well shaded in the upper reaches with a good pool to run ratio.

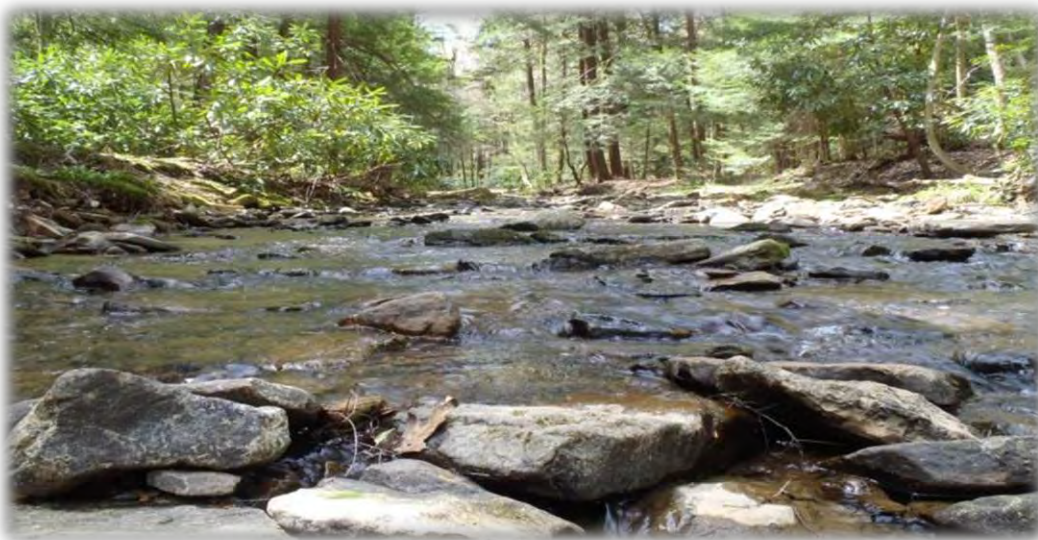
Figure 45: Riffle run near the mouth. The stream widens significantly as it approaches the reservoir, losing important habitat features.

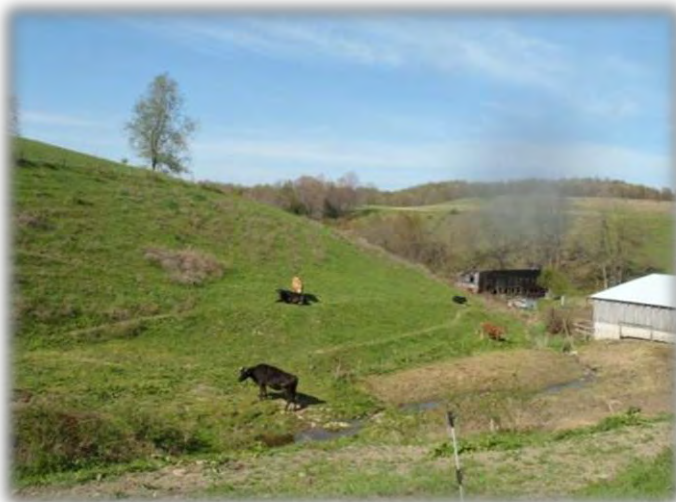
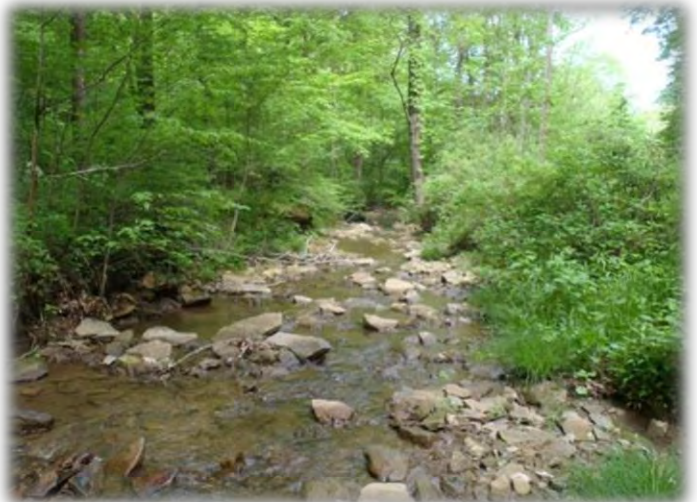
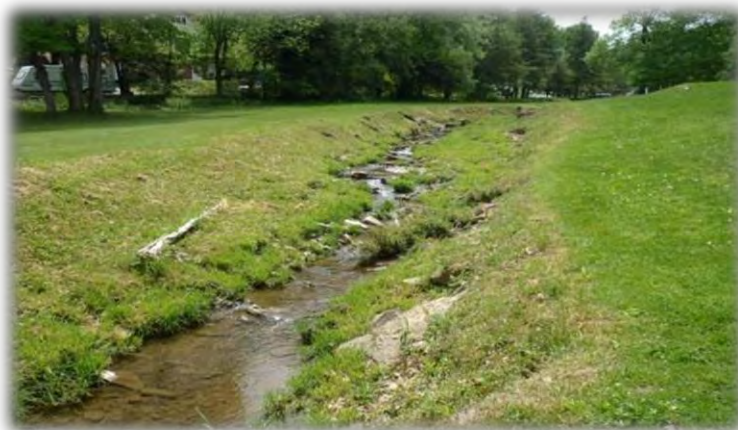
Figure 47: The photos above show the upper, middle and lower reaches of Heckman Hollow. The head waters begin in agriculture lands, the middle flows through a forested ravine and the lower section is day lighted in a golf course.

Although the wild brown trout population is relatively small and is below a Class D designation, this water serves as important rearing waters for the main stem of the North Fork of Bens Creek. Limiting factors for a small wild fish population are thermal impacts from the removal of canopy and water impoundments, siltation from agriculture lands and eroding stream banks. Stream habitat improvements could improve these existing conditions.

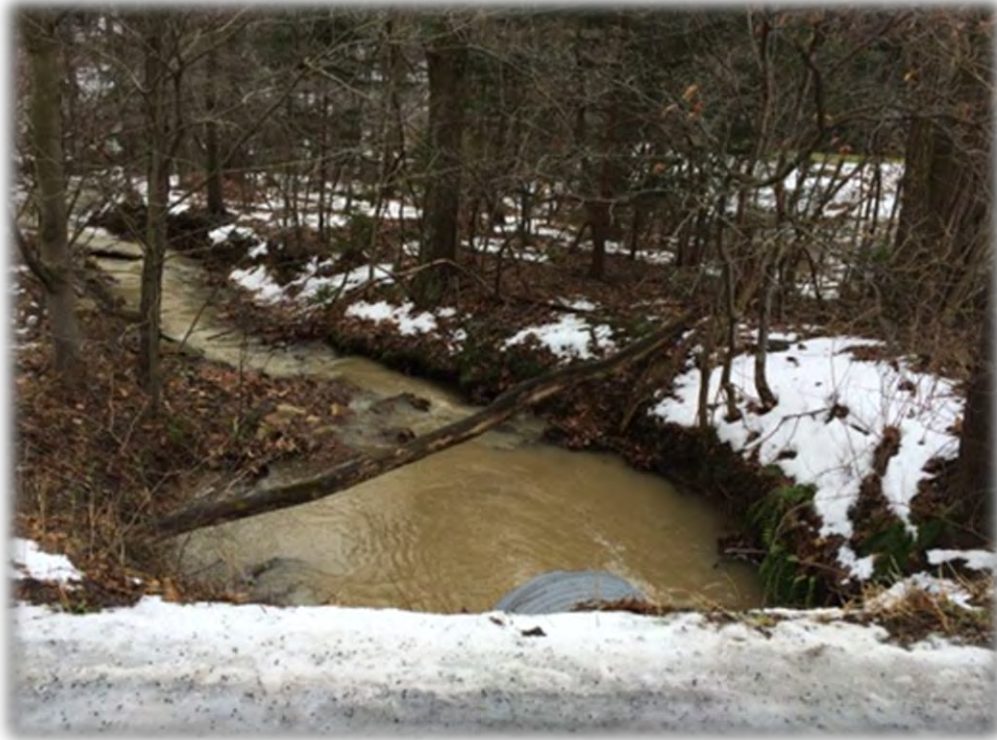
Figure 54: Sediment laden water on the headwater of Riffle Run. The source was tracked to an earth disturbance and abated shortly thereafter.

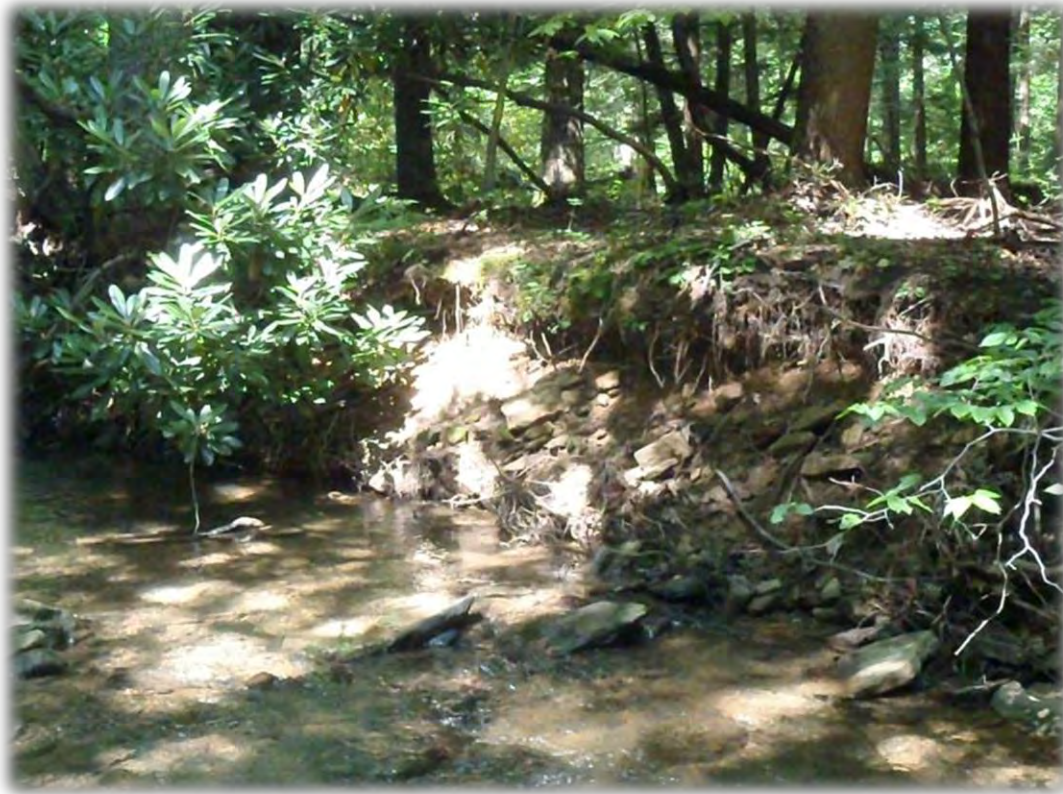
Figure 55 : A sluffing stream bank on the lower section of Riffle Run. This site is a perfect candidate for an in-stream stabilization structure to aid with bank protection.

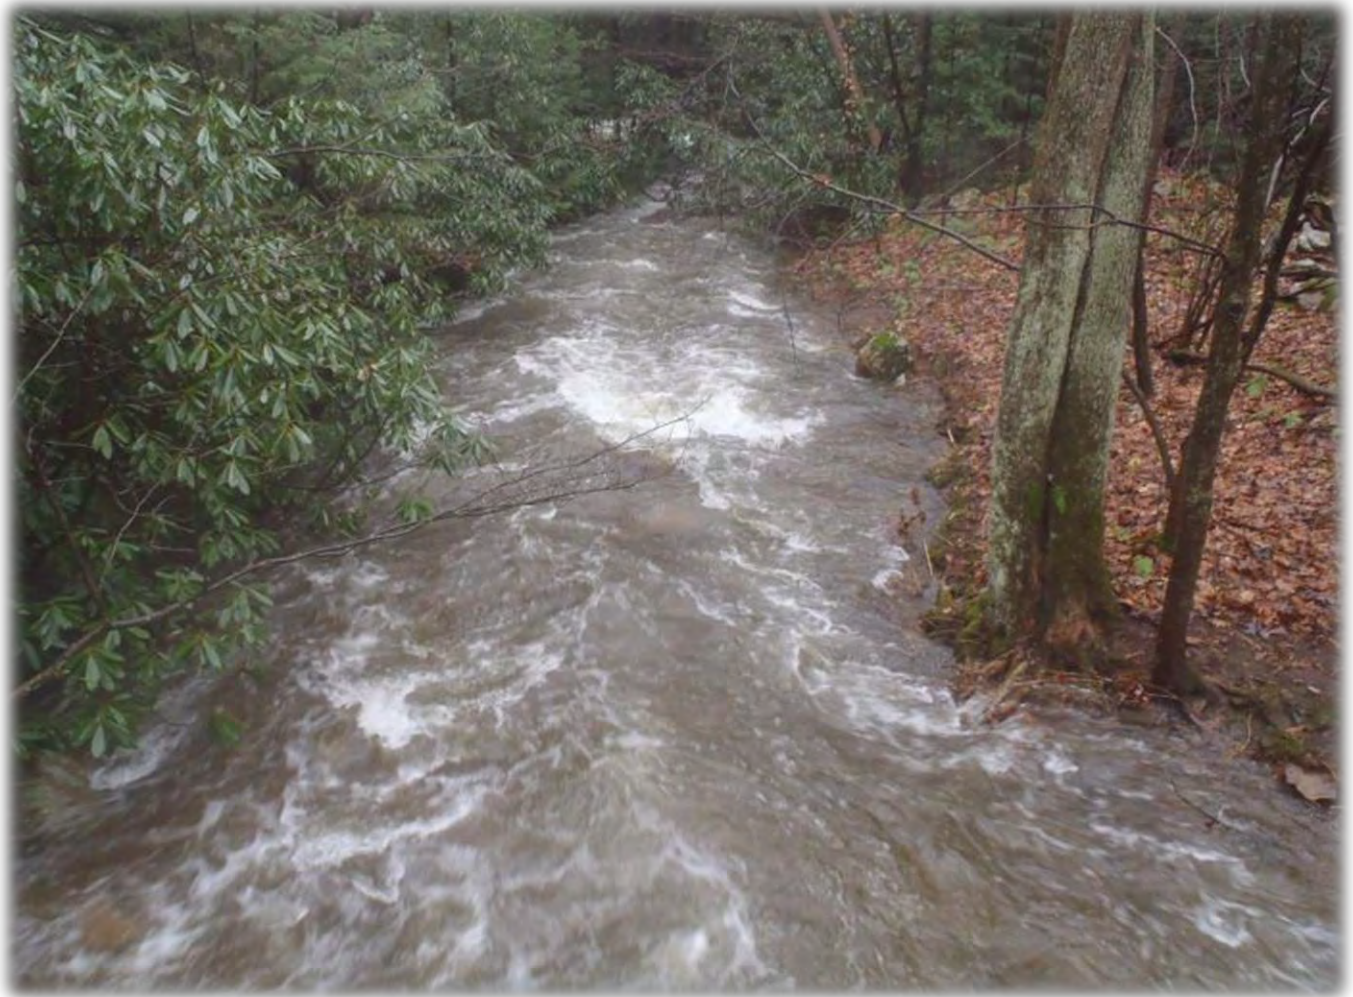
Figure 56: This shot is of the North Fork of Bens Creek above the reservoir. It was taken in 2012 just after hurricane Sandy. The stream is very high and slightly off color, but not muddy, rocks and the stream bottom are still visible. This is a great example of how riparian vegetation within the forested buffer keep the surface waters clean and manage storm flows.

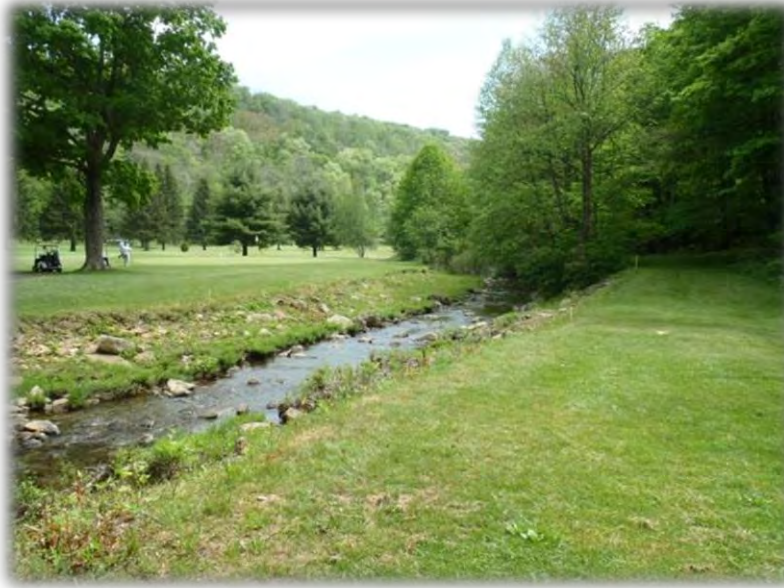
Figure 57: The North Fork of Ben Creek below the reservoir, note the removal of the riparian vegetation. This action can increase water temperatures and erosion by storm flows. The stream bank vegetation also offers fish overhead protection from predators.

Thermal impacts from impounded water the removal of overhead tree canopy and water with drawl can change the temperature regime or mico-climate of that stretch of stream, in- turn making the water temperatures less favorable to the aquatic species that inhabit these waters, particularly macroinvertebrates and cold water fishes that depend on cold water with high levels of oxygen for survival. Although there is a conservation release that has been mandated by the Pennsylvania Department of Environmental Protection, the lower portion of the North Fork of Bens Creek is still threatened by thermal impacts where it flows through a residential area.

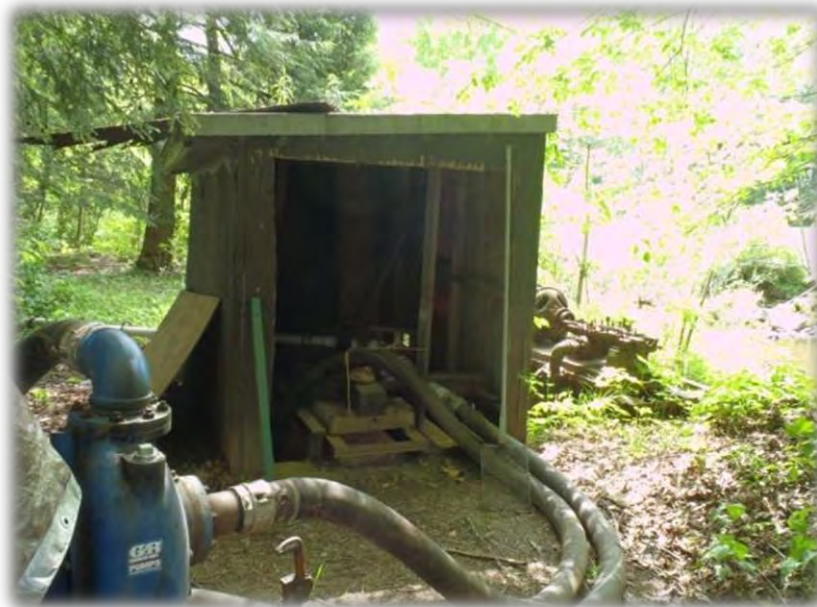
Figure 58: This photo is an irrigation pump used to withdrawal water directly from the main stem of North Fork of Bens Creek. It is used to water a golf course during dry summer months.

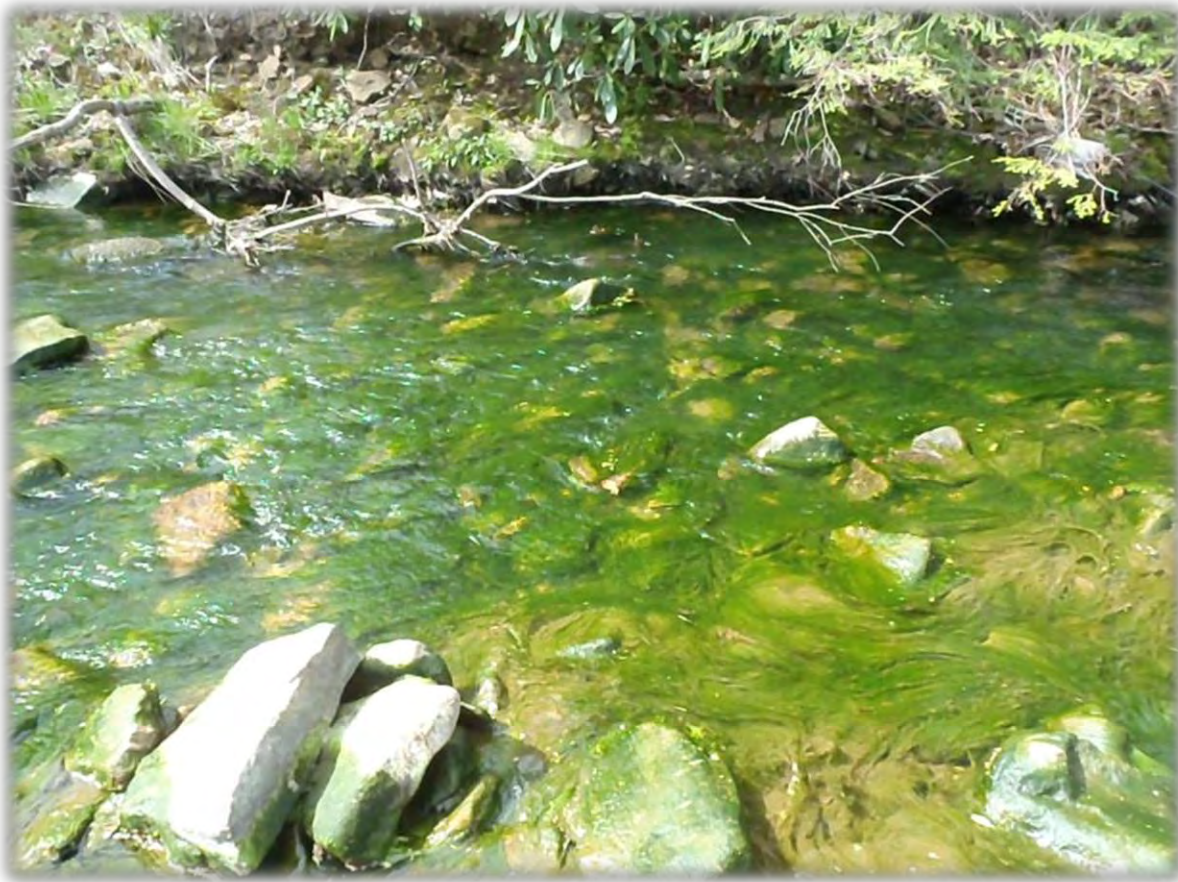
Figure 59: A filamentous algae bloom on the main stem of the North Fork of Bens Creek. Algal blooms are a result of excess nutrients and warm water temperatures and can be detrimental to aquatic systems.

Another significant impairment identified during this study was nutrient loading. Nutrient enrichment can come from many sources. It primarily causes algal blooms that coat the stream bottom and lower the quality of instream habitat for aquatic organisms. During night time hours a portion of this fast growing alga dyes and begins to rapidly decay. The action of the rapid decomposition uses large amounts of oxygen and depletes the stream water of dissolved oxygen. The reduction of oxygen stresses the aquatic life and in some cases this leads to fish kills. Nutrient enrichment, particularly from animal feces can introduce high levels of bacteria into the waterway. For obvious reasons high bacteria levels are not safe for the aquatic organisms living in the stream or the people that recreate there.

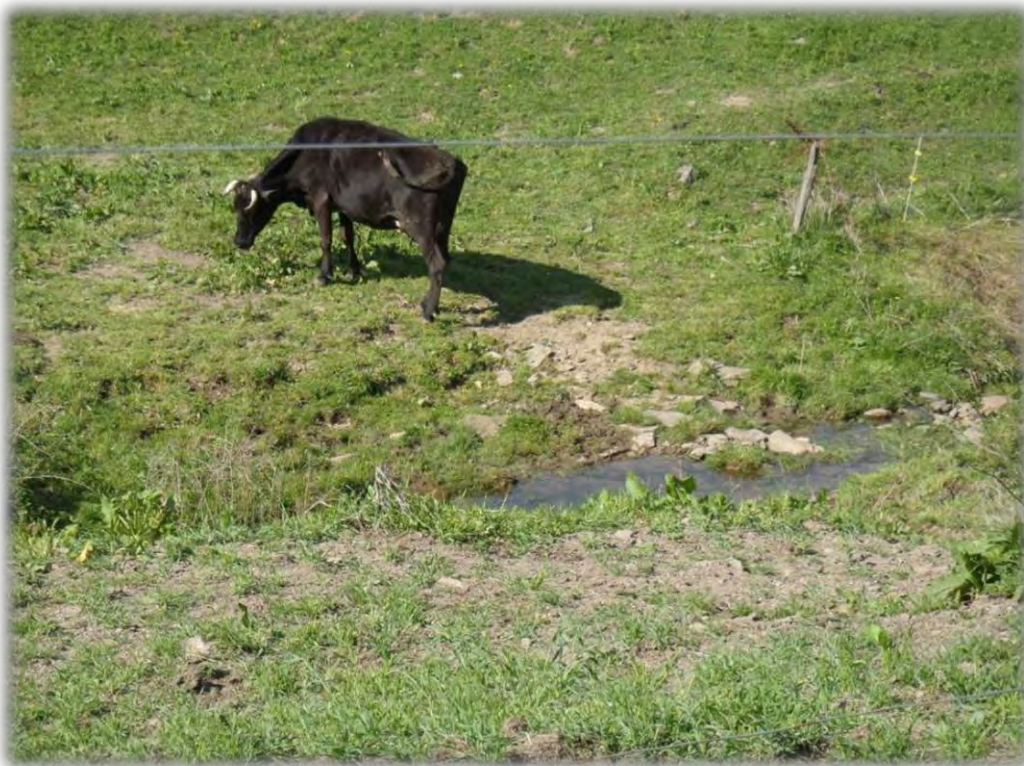
Figure 61: The photo above is a picture of the headwaters of Heckman Hollow. Raw livestock manure makes up a large percentage of the non-point source impairments to rural waterways. Stream bank fencing and a vegetated buffer is a simple solution to the issue.

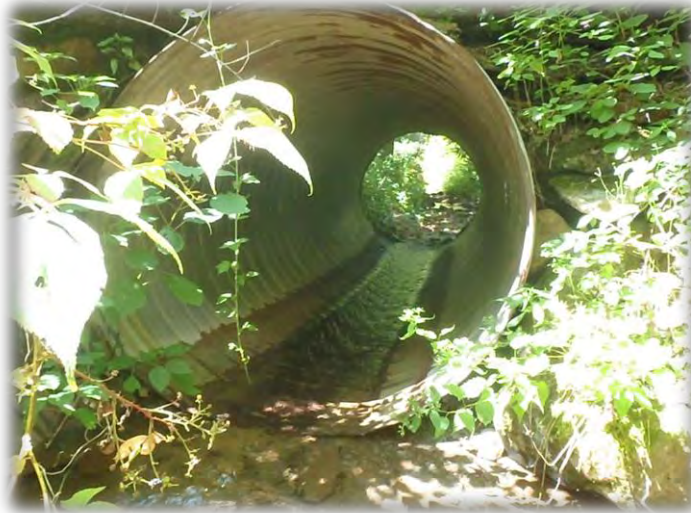
Figure 65: A large diameter culvert stream crossing. Although this particular pipe is installed with enough slope to allow seasonal fish passage low flow may inhibit fish movement. Bottomless arch culverts are the best solution to smaller stream crossing.

- IMPLEMENT FISH PASSAGE ENHANCEMENT WHERE FEASIBLE THROUGHOUT THE NORTH FORK OF BENS CREEK DRAINAGE. REMOVE ABANDONED STRUCTURES AND REPLACE INSUFFICIENT STREAM CROSSINGS THAT ENCUMBER FISH MOVEMENT.

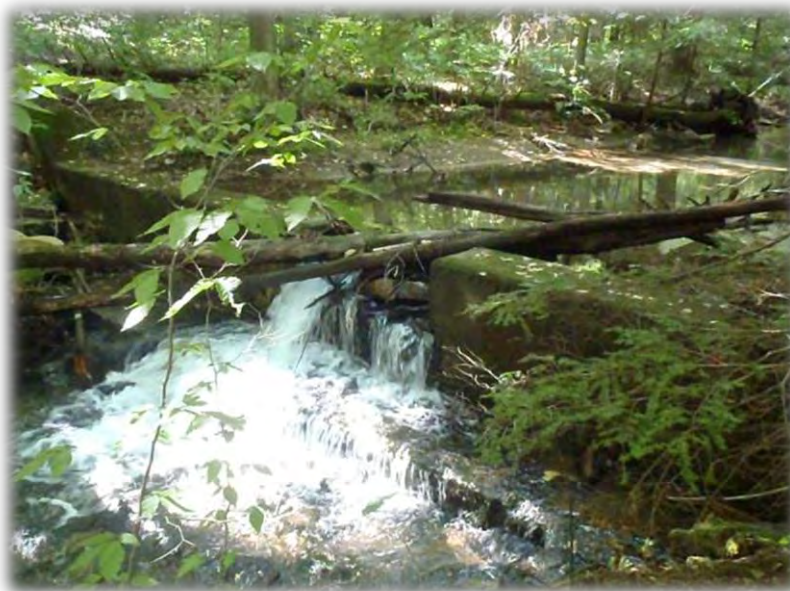
Figure 66: A concrete weir on Alwines Creek restricts fish movement throughout the stream. There are four of these weirs within the entire North Fork of Bens Creek watershed.
