# Rogues Harbor Run Coldwater Conservation Plan

Prepared by:  
Clearfield County Conservation District  
650 Leonard Street  
Clearfield, PA 16830

Funded by a grant from the Coldwater Heritage Partnership (CHP)

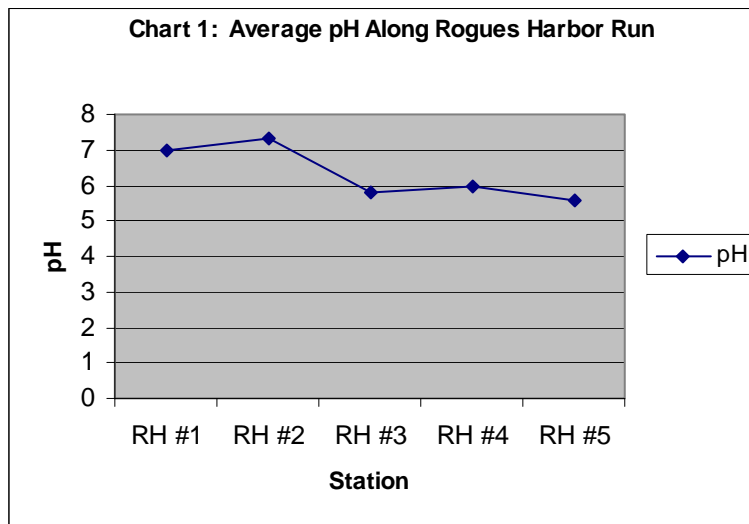
Findings in each section of stream are provided in more detail on the following pages. In general, overall average water quality meets the Pennsylvania standards along Rogues Harbor Run. As shown in Chart 1 below, the average pH is within the preferred range of 6.0-9.0 in the lower sections (RH #1 and RH #2) but this is not the case for the entire stream. The locations further up in the headwaters show a lower average pH and drop below the ideal range. The bad tributary (RH # 2), has a much higher pH than the upper section (RH # 3, 4, 5) and it increases the pH in the main stream.

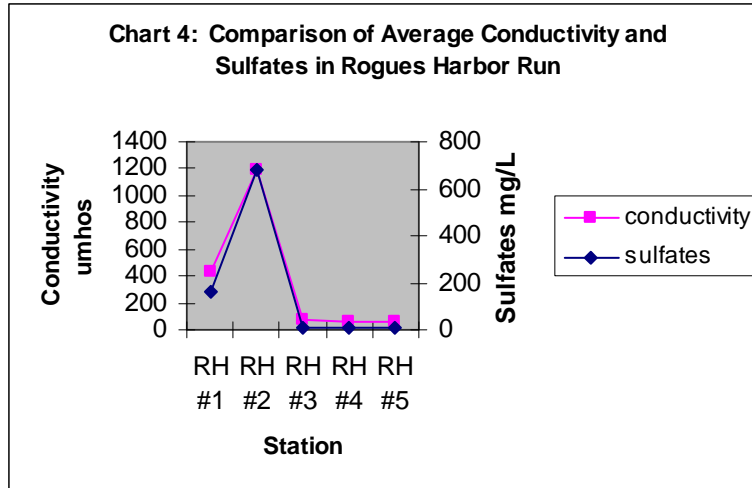
Chart 4 below shows that the bad tributary (RH #2) has a significant influence on the mouth of Rogues Harbor Run. The AMD located in this tributary causes a huge increase in conductivity and sulfates. Until that tributary enters, all readings for sulfates and conductivity are very low, which is a good indication that no mining has occurred in the watershed to that point.

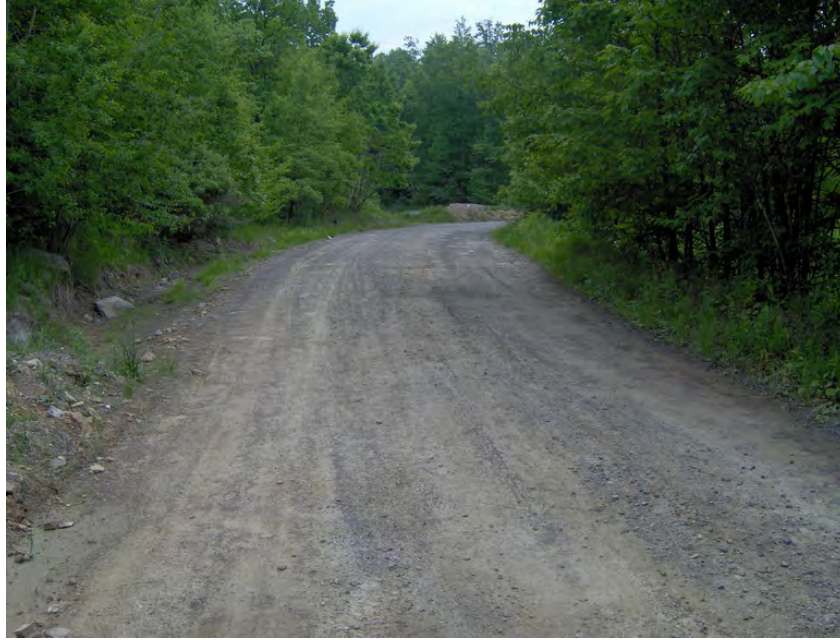
**Rock Run Recreational Road**

One of the most noticeable problems in this section of stream is the road for Rock Run Recreation Area. The road was originally used to gain access to the mining operations occurring in the Rock Run watershed. There appear to be some signs of erosion from this road that enters Rogues Harbor Run. Excess sediment may also be entering the stream from an area of exposed soil near where the road crosses the stream.

- 2). The watershed group may also want to work with the Rock Run Recreation Area on their access road that crosses Rogues Harbor Run. This road has caused excess sediment in the past and may continue to do so. Proper BMP's to help prevent excess runoff from the road should be installed. The size of the culvert should also be examined to confirm it is large enough for the drainage area.

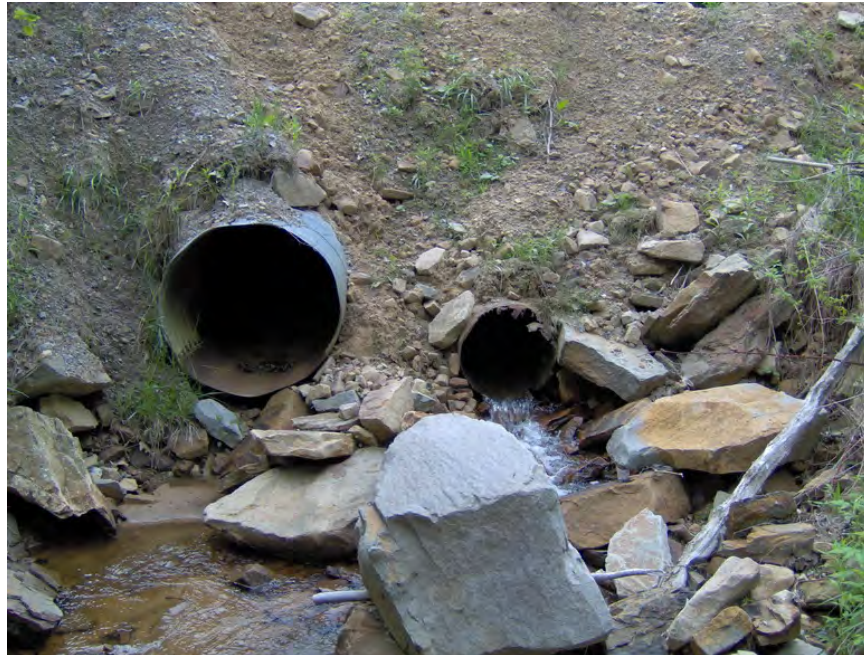
**Culvert pipes under Rock Run Road. Note the lack of vegetation to stabilize area.**

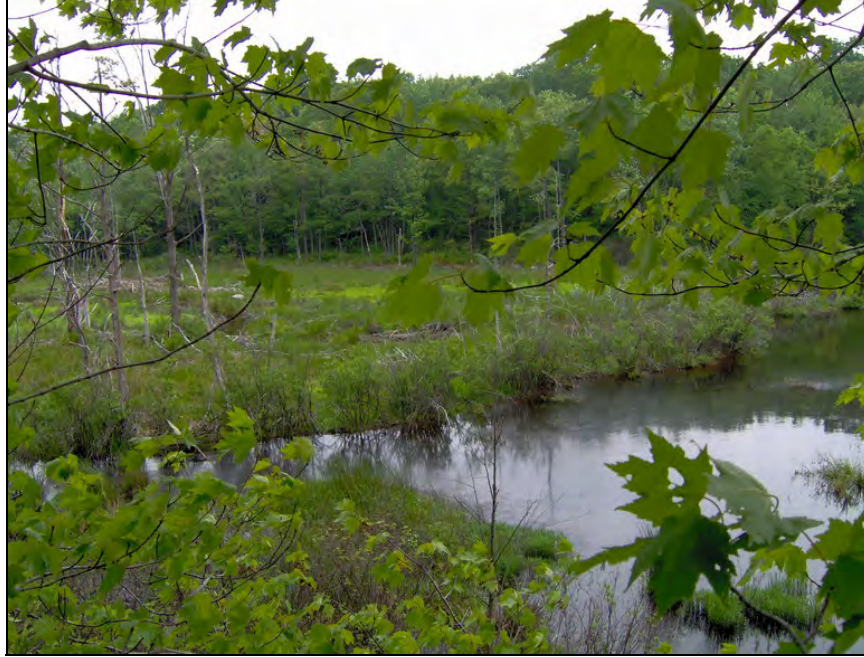
Above this road, there was a long series of wetlands constructed by beavers that covered about 20-30 acres, giving the water a tea color for a small section downstream. These beaver ponds were noted in a 1931 study conducted by a local group.

**Beaver Dam in headwaters above Rock Run Road**

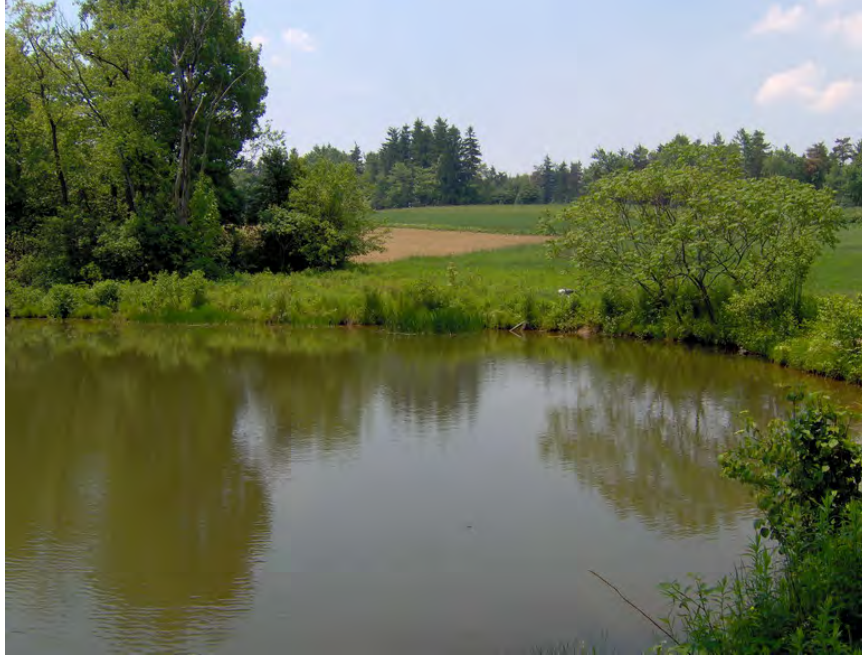
Moving upstream there is another dirt road crossing. The pipe that goes under the road is rusted out but water is still flowing through. The stream bottom is extremely sandy. Further up, there is a large field on the left side (facing downstream) that is uncultivated. There is limestone dumped at an old road crossing. It appears that there is a pipeline that crosses the stream at this point. Further upstream a wetland is encountered. By hiking around the wetland and towards the headwaters, it was discovered Rogues Harbor Run flows through a large farm. The stream seems to originate at some old farm ponds.

**Farm pond, Headwaters of Rogues Harbor Run**

Another concern in this section of the watershed is the suboptimal conditions due to sediment deposition that were observed during the Stream Habitat Assessment. Many sources of sediment were found in this section of the watershed. Between the two dirt road crossings, one being the road that leads to the Rock Run Recreation Area and another road with a pipeline, there are numerous opportunities for water to flow over the roads and in the ditches, transporting excess sediment into the stream. Finally, the headwaters begin in an agricultural area. Excess sediment can enter from plowed fields and the roads leading to them. Excess nutrients could also be a concern, but they were not tested for during sampling, nor was the possibility the ponds were causing an increase in the temperature of the water in the stream.

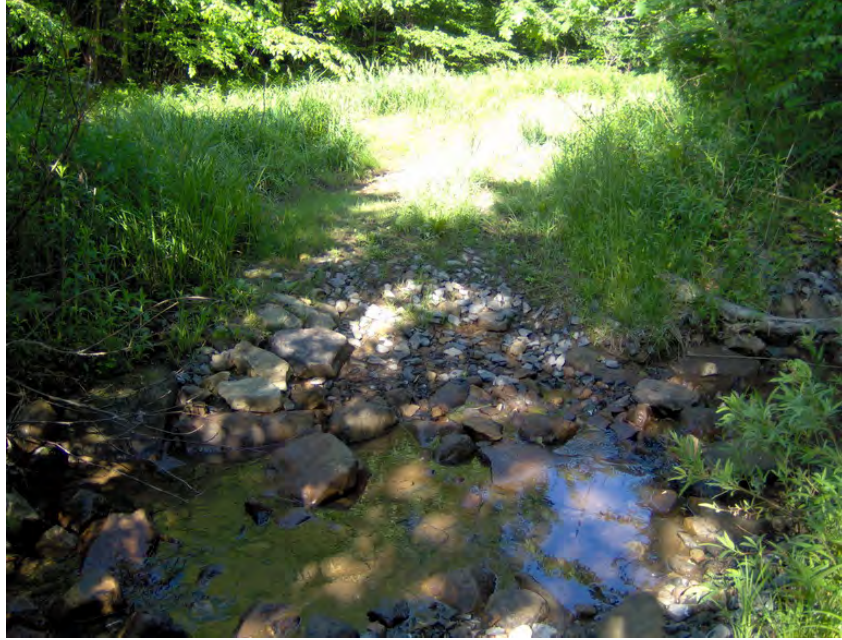
A pipeline crosses upstream from this point. The pipeline is also used as an ATV crossing. There were pieces of limestone on this crossing, but the limestone was washed downstream. This crossing seemed to be a rather well used trail.

**Pipeline erosion**

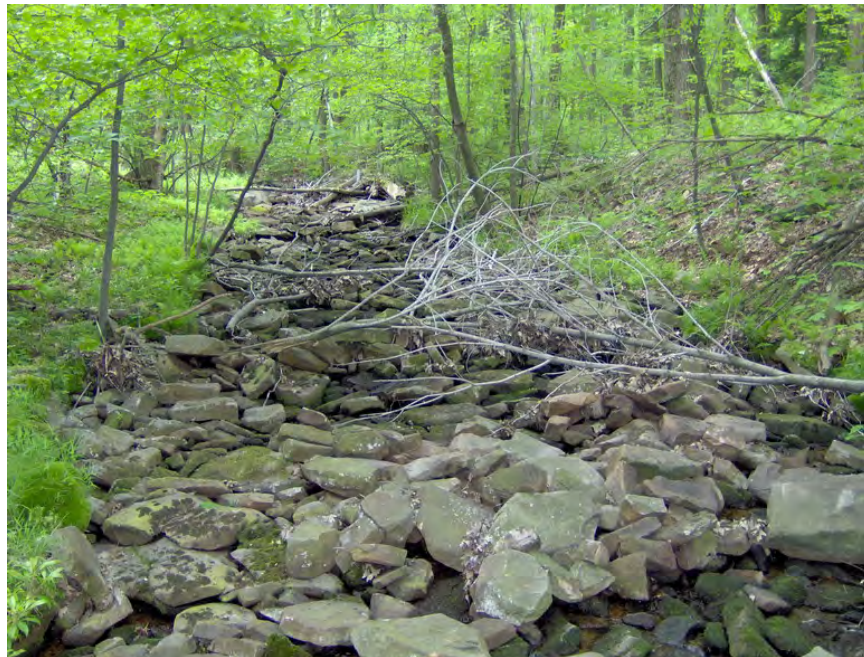
Just upstream from the pipeline crossing, an interesting geological feature occurs. The stream disappears underneath extremely large boulders and rocks for about a quarter of a mile. There were large rocks around the area. The stream could be heard in some areas in the valley but was not observable below the rocks.

**Large cobbles in stream channel**

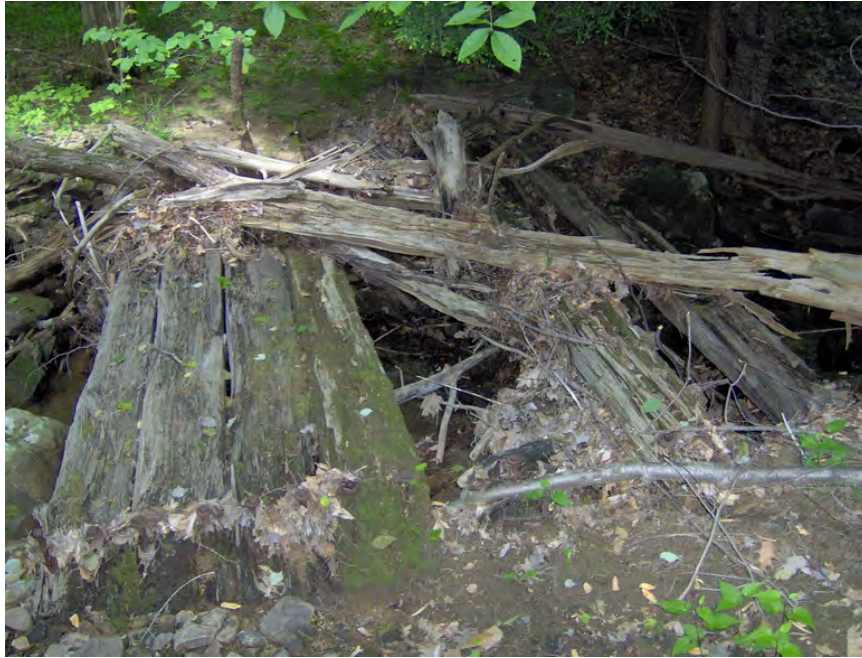
Also the pipeline tributary travels through an old logging area, therefore, some of the little tributaries run down logging roads. Also an old bridge was discovered during stream reconnaissance. It appears that it had been present there for many years.

**Old bridge located on the pipeline tributary.**

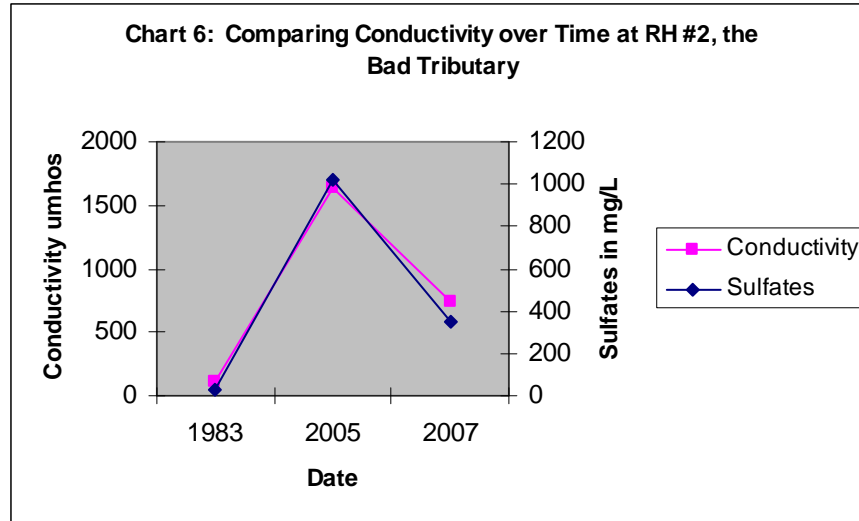
This sample point, RH #2, is located at the mouth of this tributary. The tributary enters Rogues Harbor Run just above the dirt road crossing and railroad tracks. (See Appendix A for detailed water quality). The values for pH ranged from 7.1 to 7.5. Alkalinity (36-89 mg/L) was higher than acidity (-69 to -17 mg/L) in both samples. It almost gave the impression that some type of treatment was occurring in this watershed. Conductivity ranged from 744-1630 omhos. Iron (.18 - .71 mg/L), aluminum (.09-.42 mg/L) and manganese (.04-.11 mg/L) concentrations were all below state standards. Sulfates ranged from 349-1021 mg/L, which is a good indication that mining impacts are occurring. Suspended solids (<6.2 mg/L) values show a non-polluted stream; however, total dissolved solids were high at 540-1483 mg/L, which indicates a pollution problem. In Chart 6 below, BMR data taken in the 1980's is compared to the sampling results in this particular study (BMR). There are definite differences over time. Both conductivity and sulfates have increased significantly. This would indicate an influence from mining.

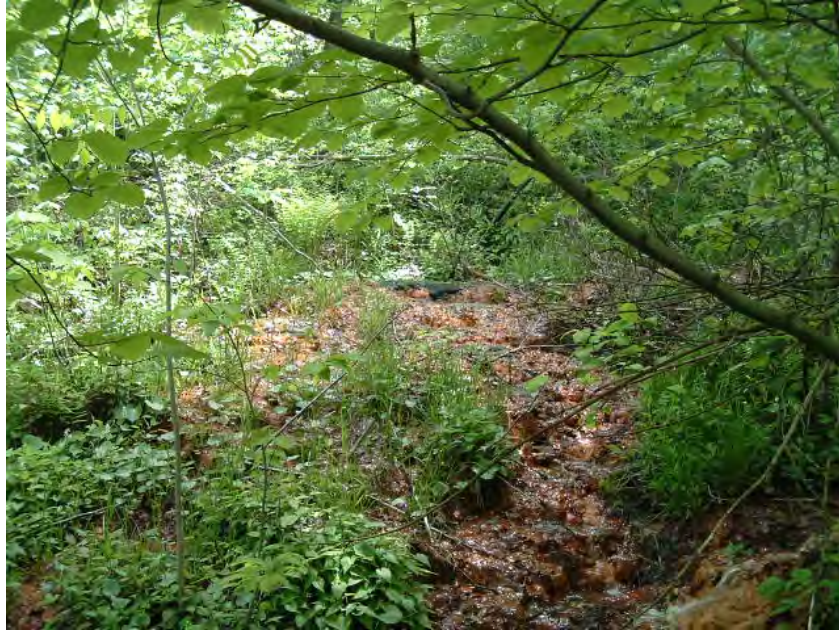
The bad tributary splits about halfway up the watershed. The first problem that was observed hiking up this stream was the high conductivity in the stream that was on the left (facing downstream). The headwaters start on the side of a hill where an iron mat is present as the water exits the hill. This is a great indicator of some type of mining influence in the area.

**Abandoned Mine Drainage Site along Bad Tributary**

There are several concerns for the watershed health in this tributary. The alkalinity is extremely high for this area due to the mine discharge. It also has a higher pH than all the readings found in Rogues Harbor Run. It is definitely an alkaline discharge. The question is what is causing it. No mining has occurred in the watershed but there was a mining job on the other side of the hill. This could be the cause for the discharge. There is a possibility that this was a small, old deep mine used only to extract coal for a few homes that could have been in the area. Whatever the reason for it, it definitely is affecting water quality in this tributary and also in Rogues Harbor Run. Fortunately, the effect is not large enough to destroy the aquatic life located in the watershed.

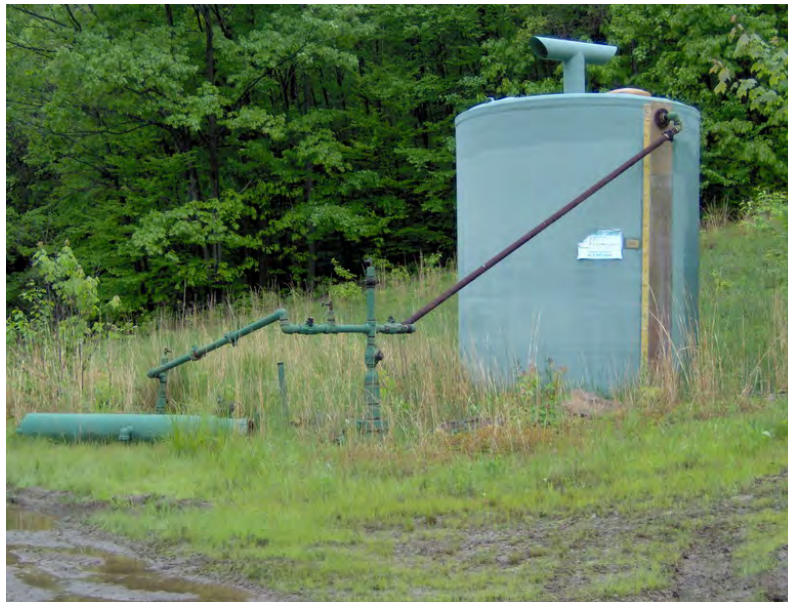
Secondly, gas wells were encountered on the way up the same stream. It was first thought that excess salinity might have been raising the conductivity in the stream. Conductivity was still high above these wells so the culprit seems to be the previous mentioned mine drainage. Along with gas wells there are dirt roads that lead to the wells. The pipeline also crosses the stream. Although excess erosion from these roads was not noted at this time, this could cause a problem in the future.

**Gas well located along Bad Tributary**

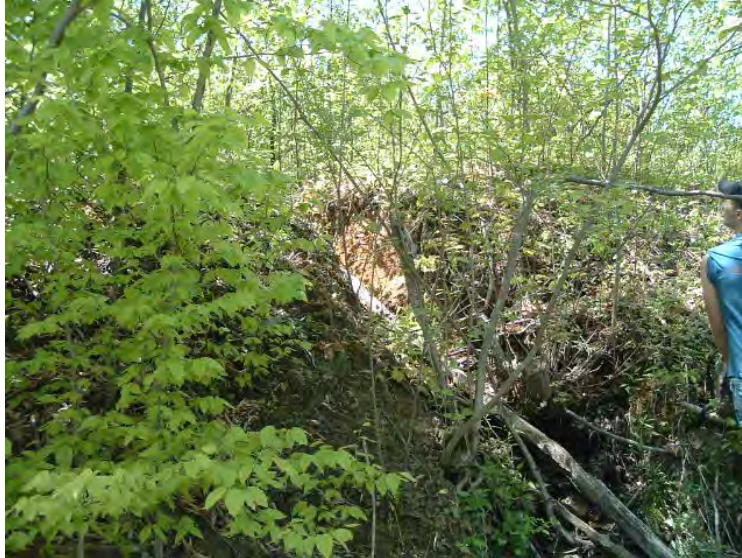
In the headwaters of the tributary on the right side (facing downstream) the logging seems to have a different effect. The stream actually runs down an old logging road. This would definitely be contributing sediment to the stream. Also water running down roads is causing deeply incised channels. This is increasing erosion.

**Deeply incised tributary**

Erosion is a huge issue. There are so many roads dissecting this tributary from gas wells, pipelines, logging and powerlines that the chances for extra sediment making it to the stream is high. The fact that ATVs are using some of the roads does not help the situation. There were many cases of very incised channels and high eroding banks in this little tributary. Much of the excess sediment that can be found near the mouth of Rogues Harbor Run is most likely from this tributary.

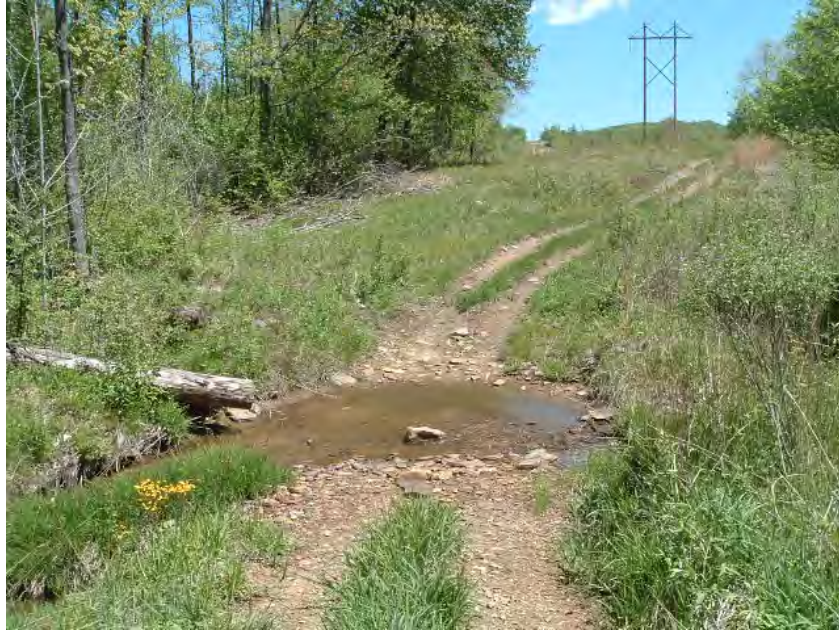
Lastly there is a powerline that crosses the tributary. The access road appears to be used as an ATV trail.

**Powerline with road**

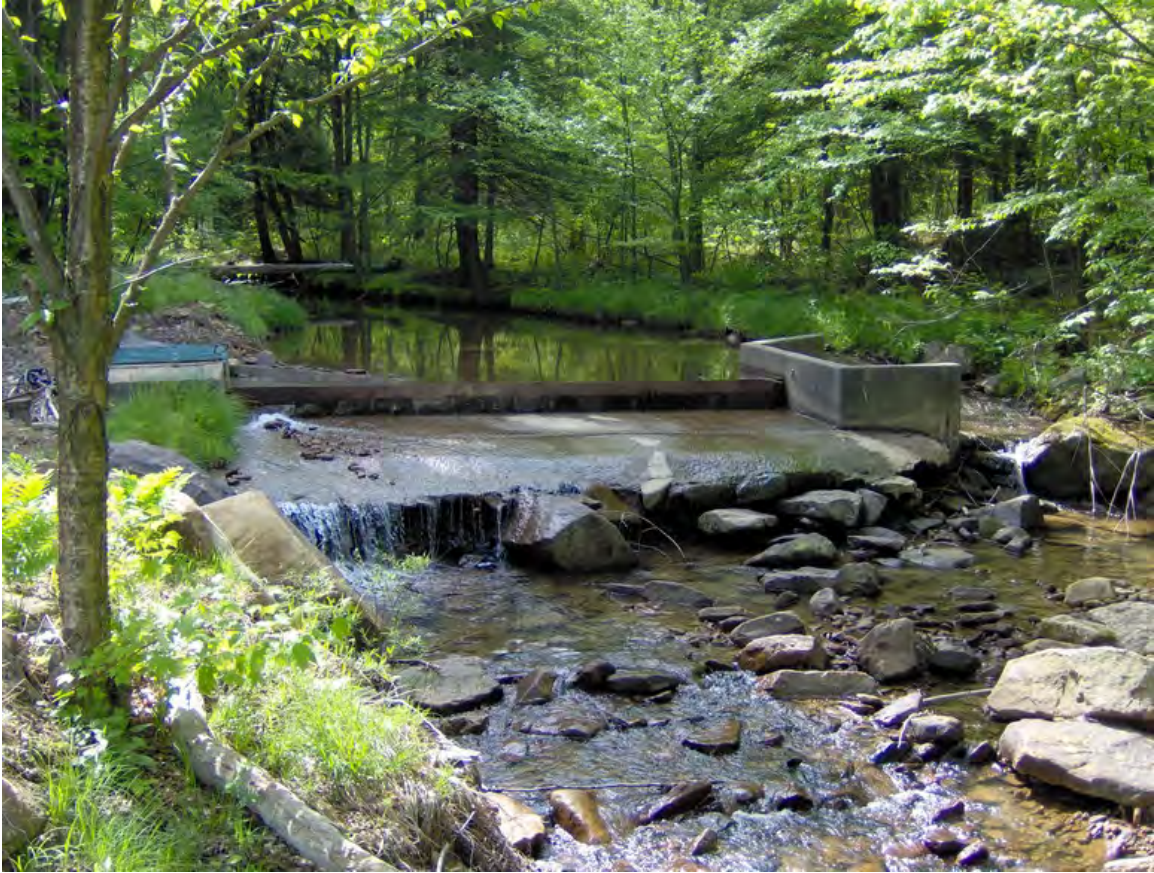
The Westover Municipal Authority draws their water from a dam in this area of Rogues Harbor Run. A new treatment plant was built in 2004. There are also several small springs that enter near the reservoir that have good water quality. There is an ATV path that crosses one of these small tributaries formed from the springs.

**Dam in stream for Westover Municipal Authority**

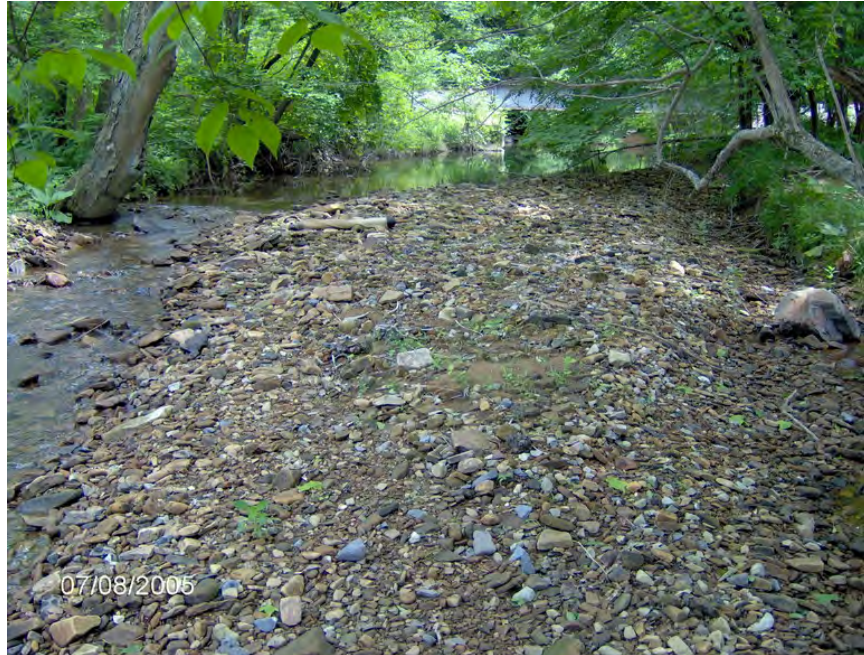
Near the mouth of Rogues Harbor there is a bridge for the railroad. Below the bridge there is large accumulation of substrate. Apparently after crossing under the bridge the stream slows down enough to deposit its sediment load. This excess sediment could be coming from the bad tributary.

**Gravel bar below railroad bridge**
