**SOUTH SANDY CREEK
WATERSHED ASSESSMENT / RESTORATION PLAN**

South Sandy Creek Watershed Association

L. Robert Kimball & Associates

February 2009

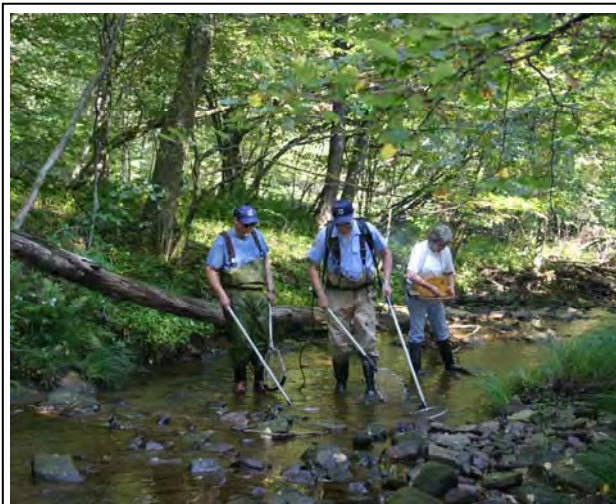
PFBC sampled the main branch of Williams Run at several locations using electro-fishing gear (see Photo 3). One point (river mile 1.62) was sampled in 1998 and again in 2005 to determine any changes (see Table 9). While there was a change, it was for the worse with 2 species of fish found in 1998 and then 0 in 2005.

Photo 3. PFBC & SSCWA sampling Unknown Tributary to Williams Run

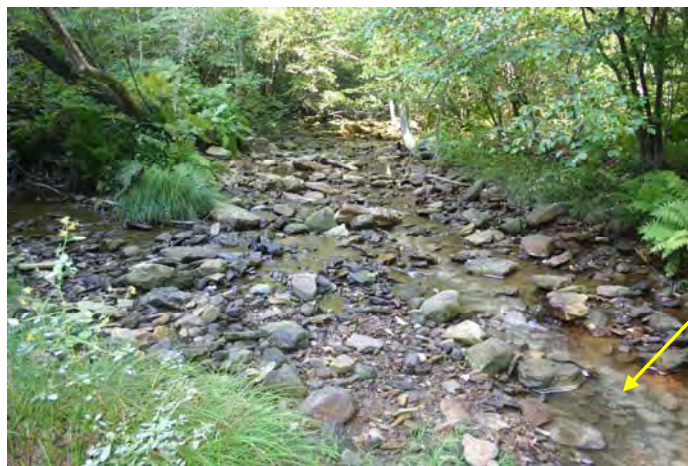
Photo 5. Confluence of Unknown Tributary & Williams Run. Note the aluminum (silver or whitish color) in Williams Run.
