Somerset Conservation District, 6024 Glades Pike Suite 103 Somerset, PA 15501

# Stonycreek River Watershed Reassessment

**May 2008**

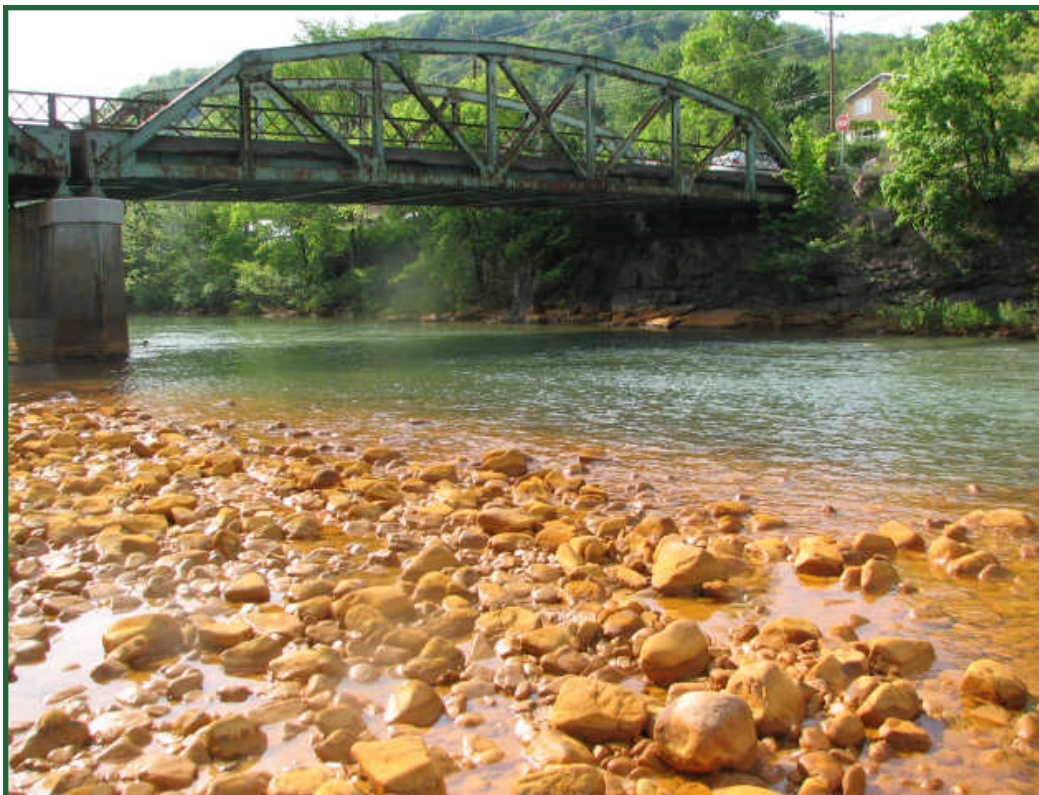
*The orange coloration on rocks in the Stonycreek River at Krings shows the visible effects of abandoned mine drainage.*

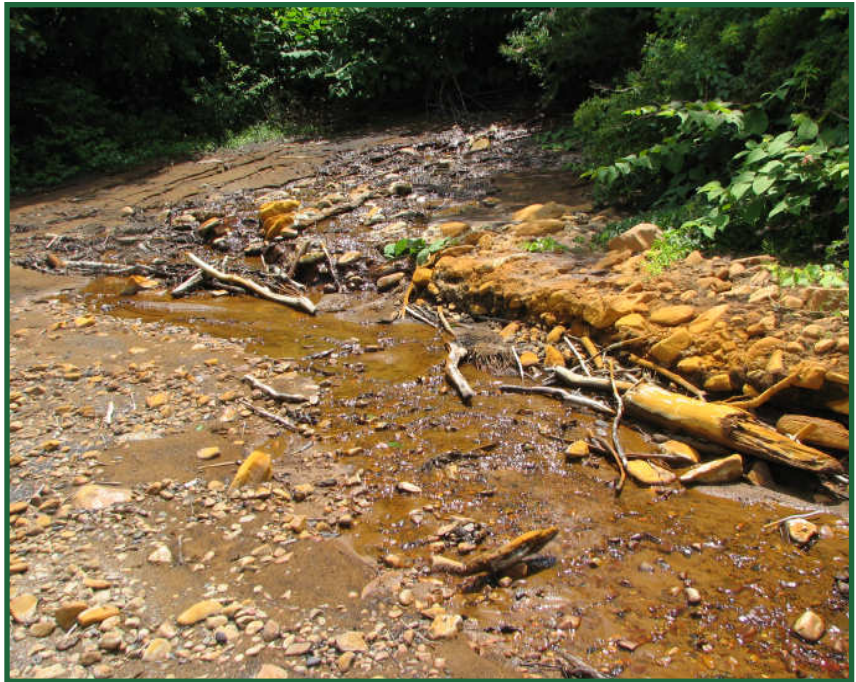
*A mine seep along Bens Creek.*

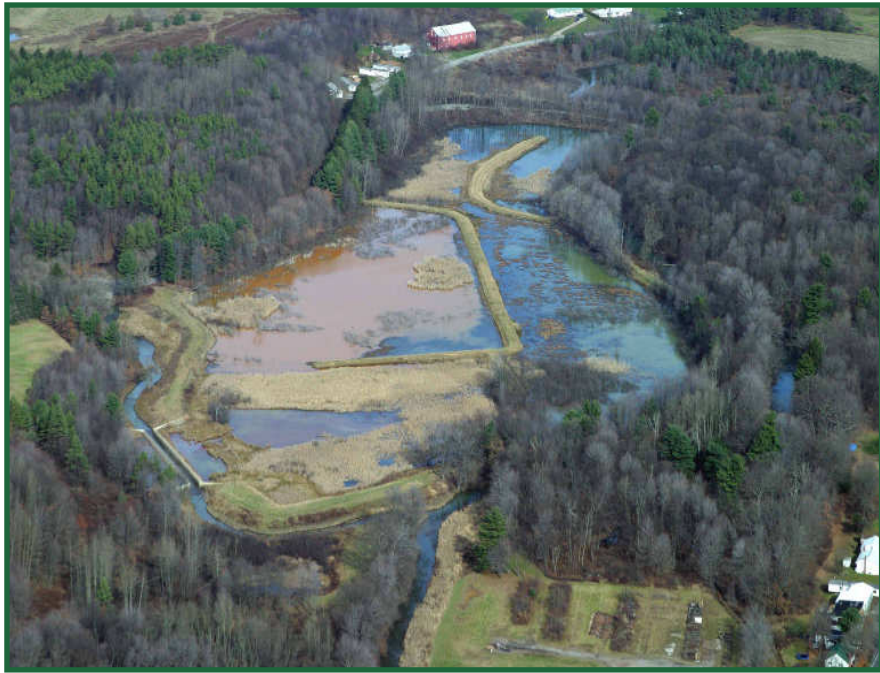
*An aerial view of the Boswell Passive Treatment System.*

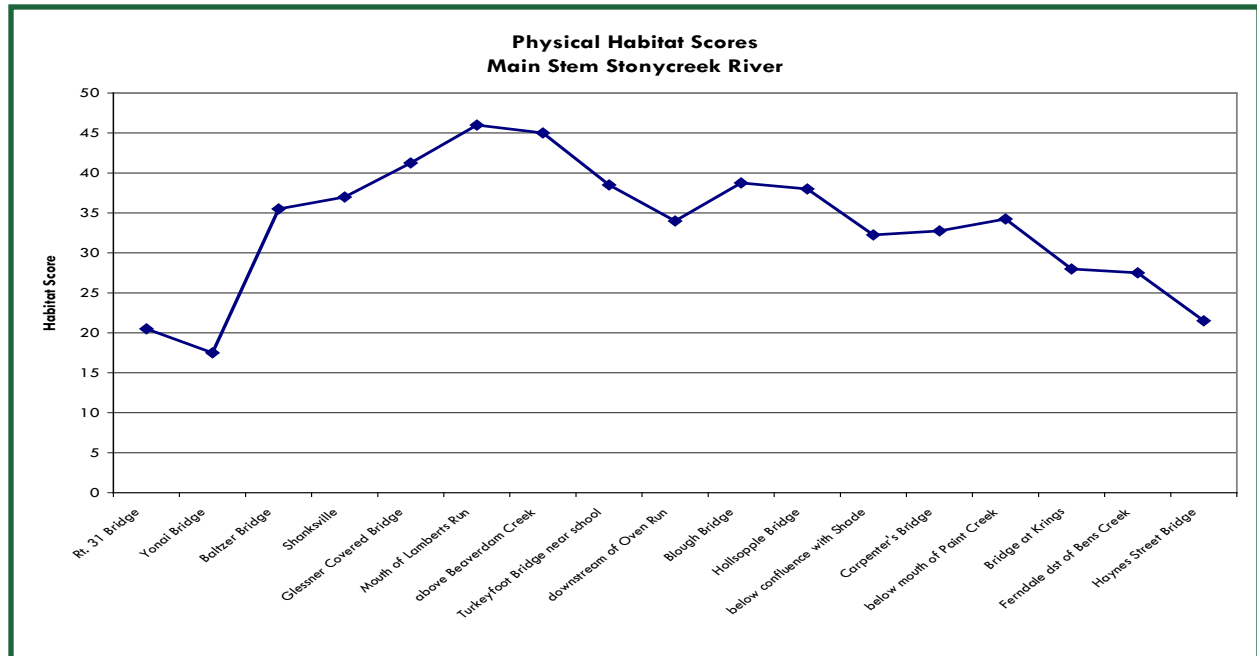
Figure 5. Physical habitat scores on the mainstem Stonycreek River.

Physical habitat scores on the main stem of the Stonycreek River ranged from 9 to 47. The highest scores were found in the middle reaches and the lowest scores were found in the headwaters and near the mouth (Figure 5). The average habitat score for main stem sites was 32.

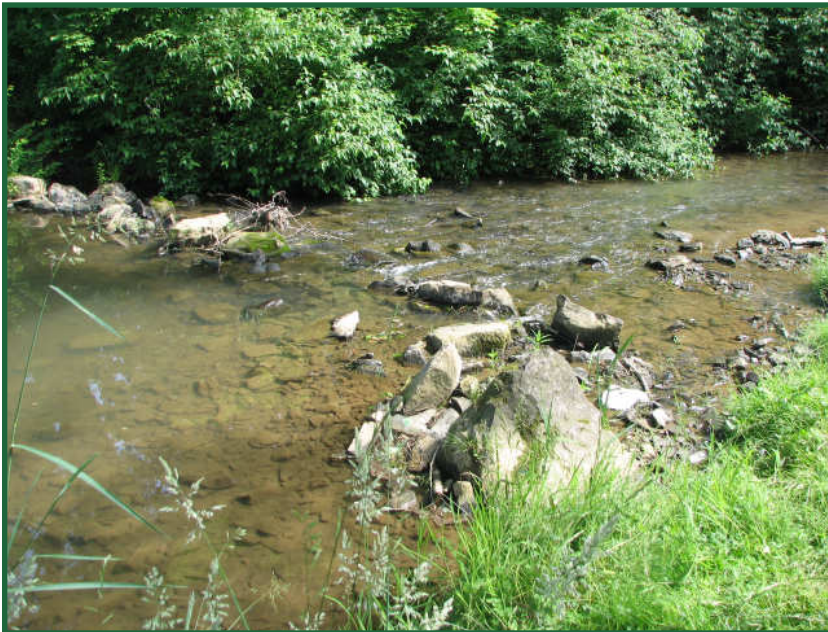
*(Left) Beaverdam Creek had one of the highest physical habitat scores in the reassessment.*

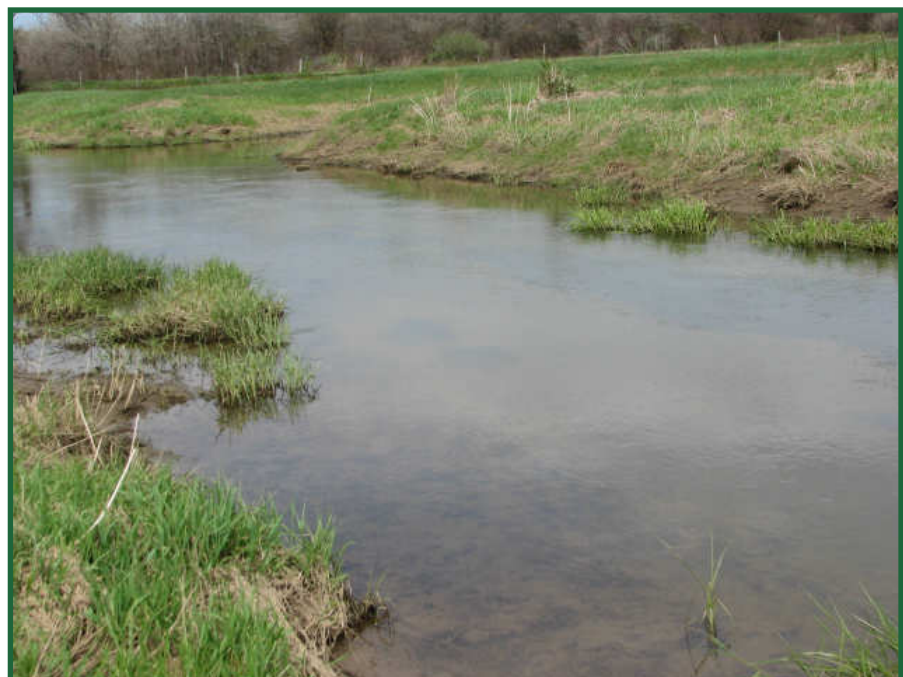
*(Right) The Upper reaches of the Stonycreek River had some of the lowest physical habitat scores.*

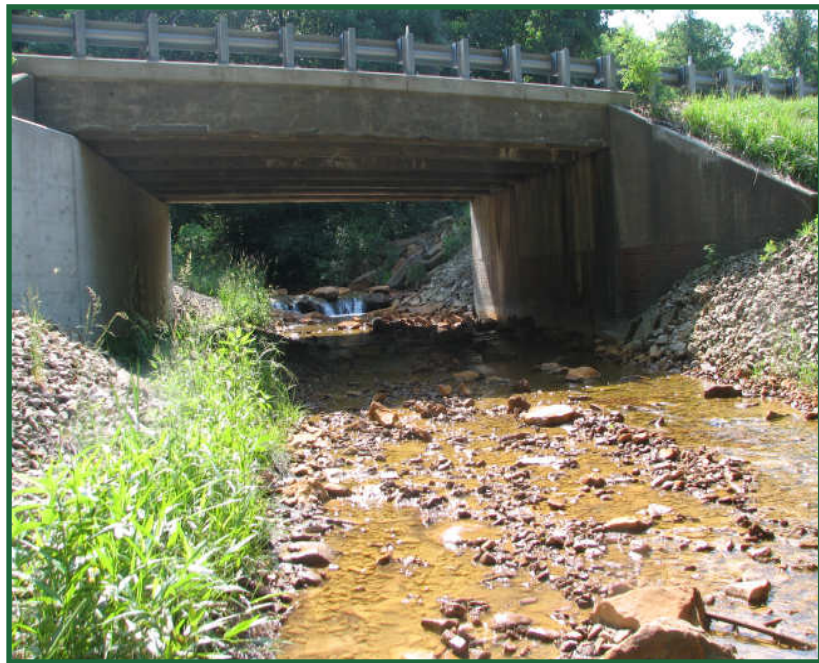
*Pokeytown Run shows the effects of AMD.*

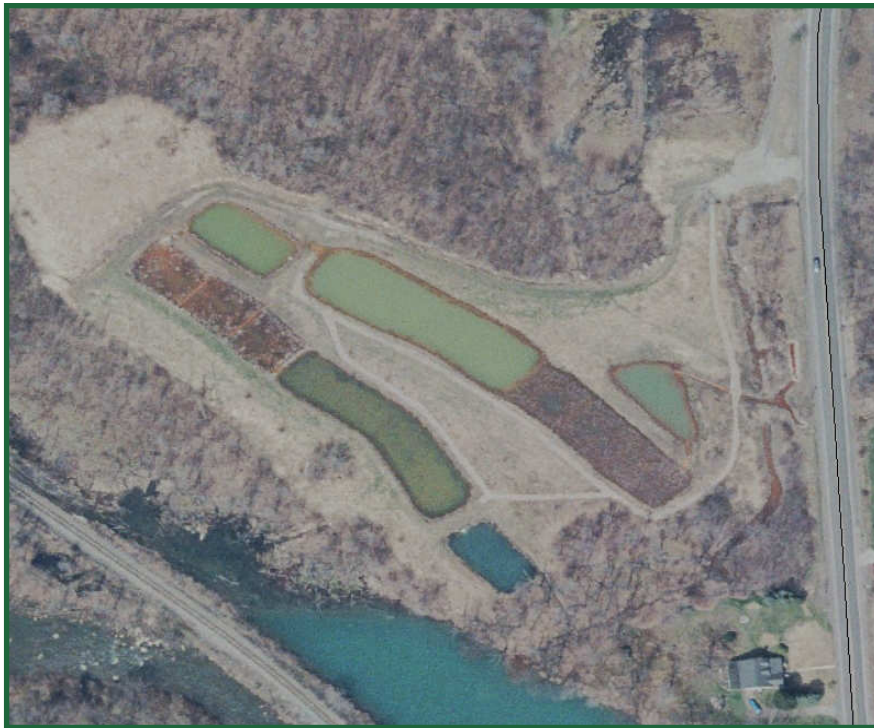
(Left) Site D of the six-site Oven Run Passive Treatment system as seen from an aerial photograph.

One of the most high-profile systems is the six-site, \$5 million, Oven Run Passive Treatment System. The systems were installed from 1995-2004 because of recommendations from the initial 1996 USGS study. The graph (Figure 8) below shows water chemistry as it moves through the system, and clearly illustrates that iron, aluminum, and acidity are drastically reduced and pH and alkalinity increase considerably.

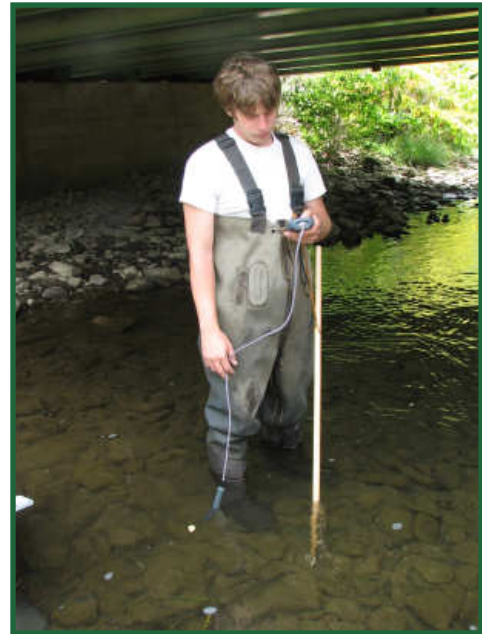
*Testing for conductivity.*

Conductivity is a measure of the ability of water to convey an electrical current and is related to the number of charged ions in water. Pure distilled water has a conductivity value of  $1\ \mu\text{S}$ . On the main stem of the Stonycreek River conductivity values ranged from  $479\ \mu\text{S}$  to  $932\ \mu\text{S}$  with an average of  $601\ \mu\text{S}$ . On the tributaries, conductivity values varied extensively with values ranging from  $43\ \mu\text{S}$  to  $2200\ \mu\text{S}$ . The highest conductivity measurements were generally taken on tributaries that are highly impacted by AMD, due to the high levels of metals present in AMD water and limestone used in treatment.

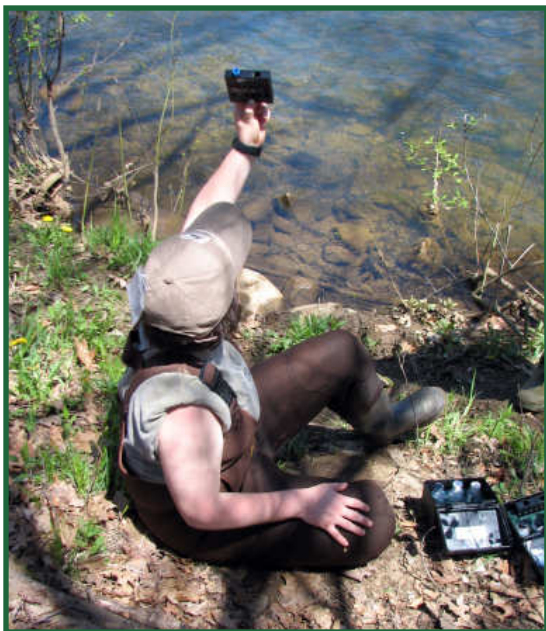
*Testing for nitrate levels in the stream.*

The highest nutrient levels were found in the watershed's upper reaches and near Hoffman Run on Quemahoning Creek, as nitrate levels at those sites were elevated. Phosphate measurements were generally low and sulfate values were generally high throughout the entire watershed. High sulfur concentrations are likely the result of iron pyrite that has been left behind following coal mining. TDS measurements on the main stem ranged from 201 ppm to 457 ppm with an average of 298 ppm. On the tributaries the values had a much wider span with measurements ranging from 21 ppm to 1100 ppm.

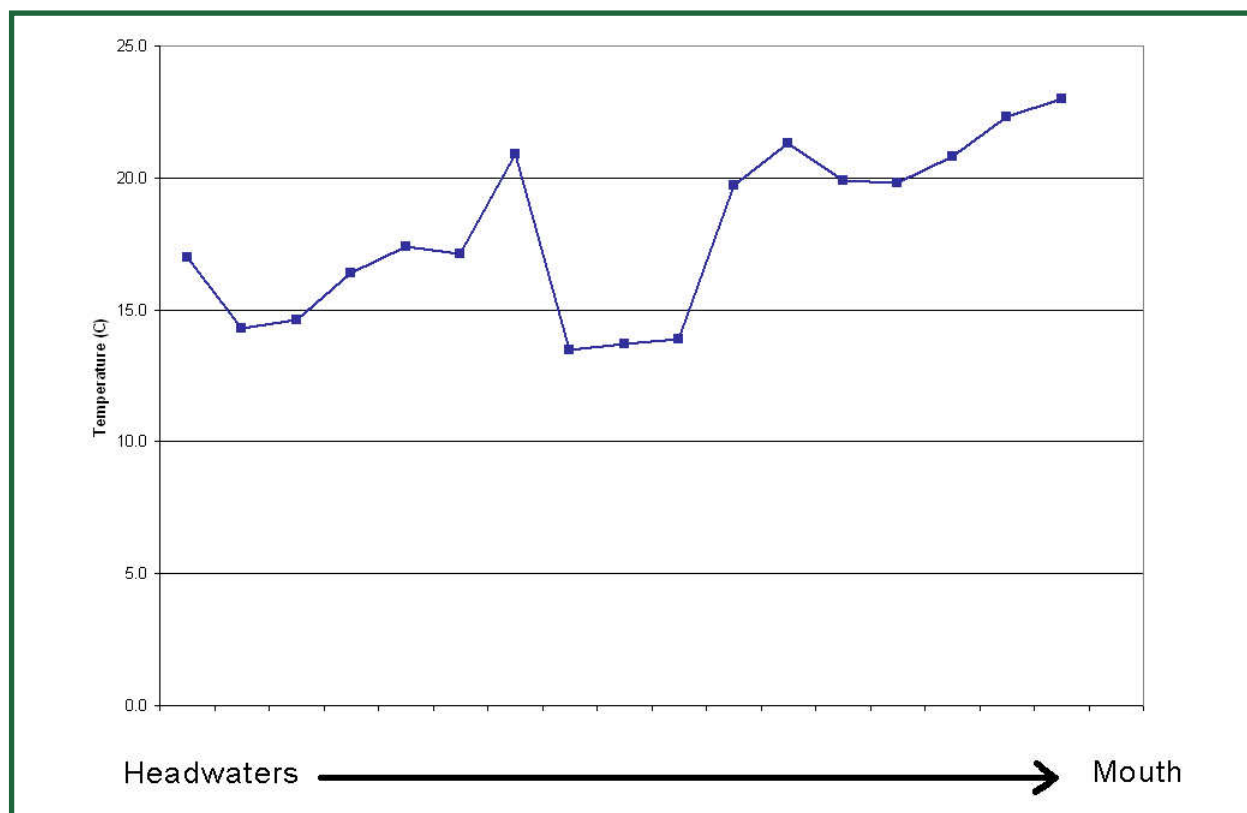
Figure 10. Temperature values on mainstem Stonycreek River.

Temperature measurements throughout the watershed show a general pattern of what would be expected—cooler temperatures in the forested headwater reaches and warmer temperatures in the lower reaches as the river increases in size and has a more open canopy (Figure 10). The upper sixteen miles of the Stonycreek River are classified as coldwater fisheries, the middle reaches are classified as trout stocked fisheries, and the lower sixteen miles are classified as warmwater fisheries. A few sites in the coldwater reaches showed higher than expected temperatures. On the main stem higher than expected temperatures were found at the upper most sampling site (site 19B), Glessner's Covered Bridge (site 15), below the mouth of Lamberts Run (site 14) and below Beaverdam Creek (site 12).

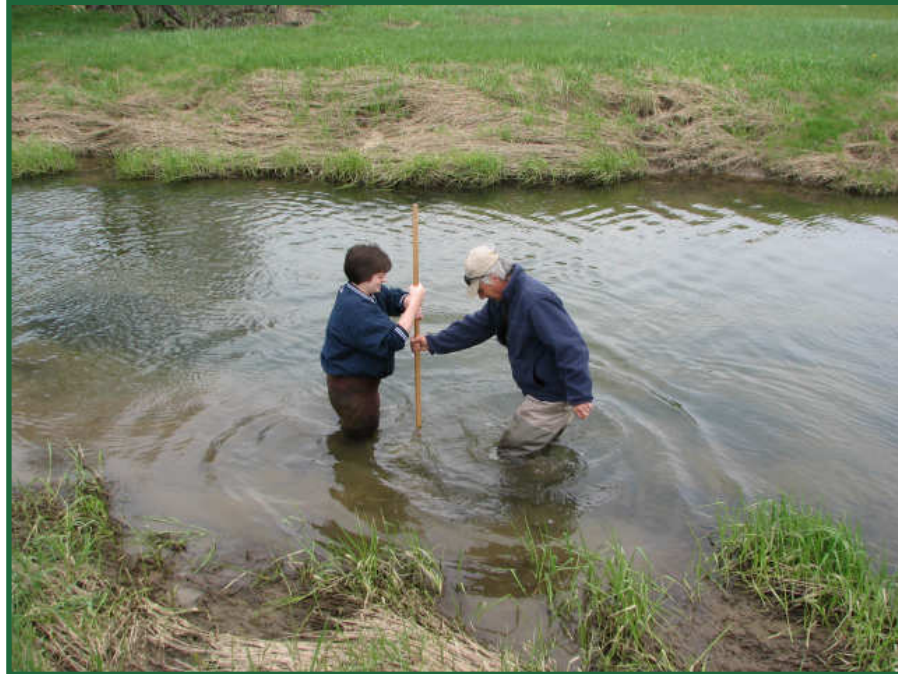
*Sampling macroinvertebrates  
with a D-frame kicknet.*

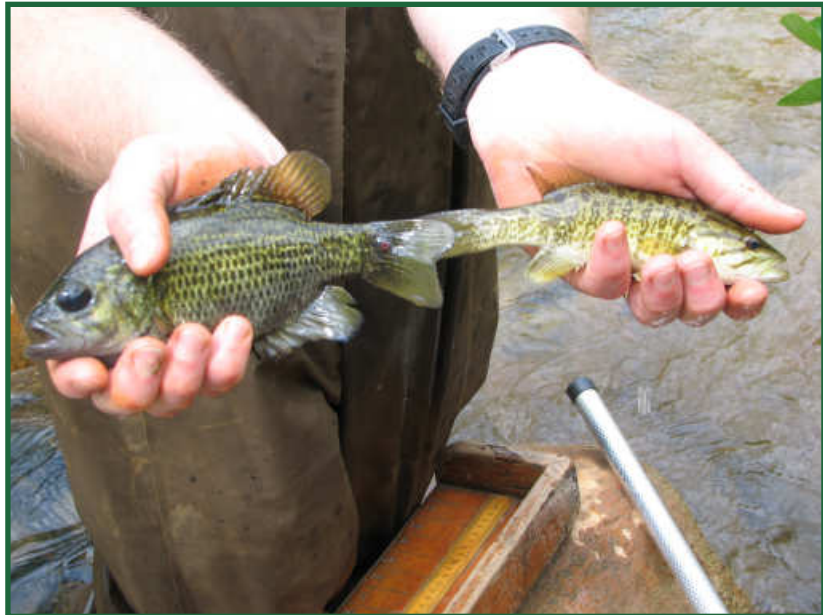
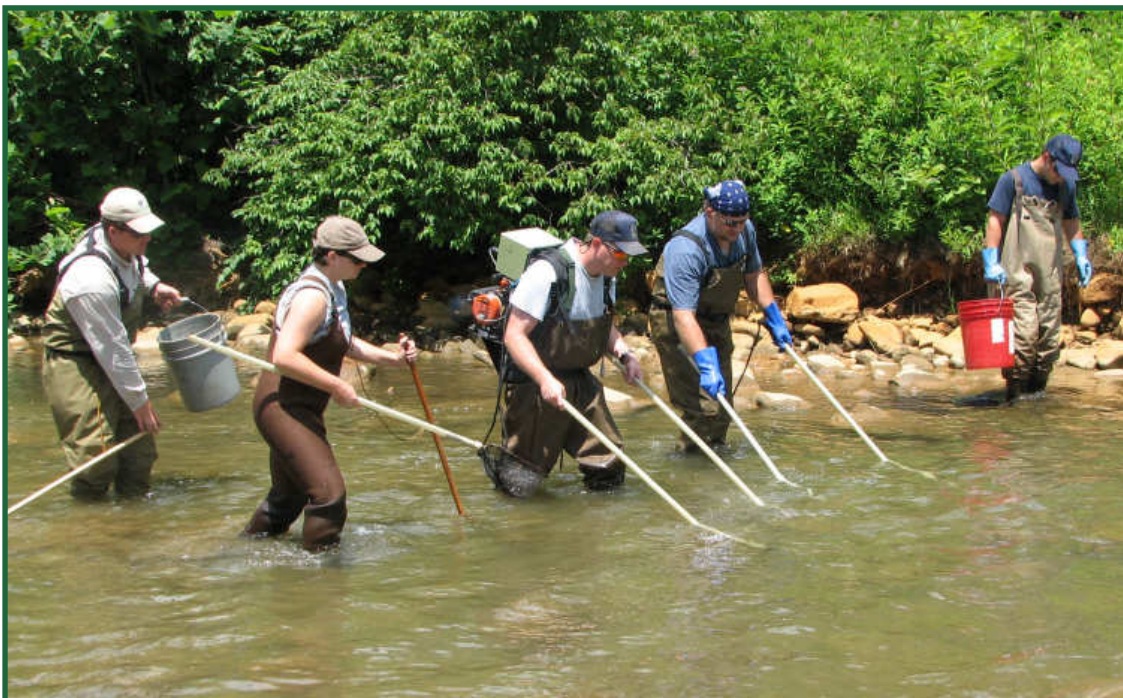
*Electrofishing during the reassessment.*

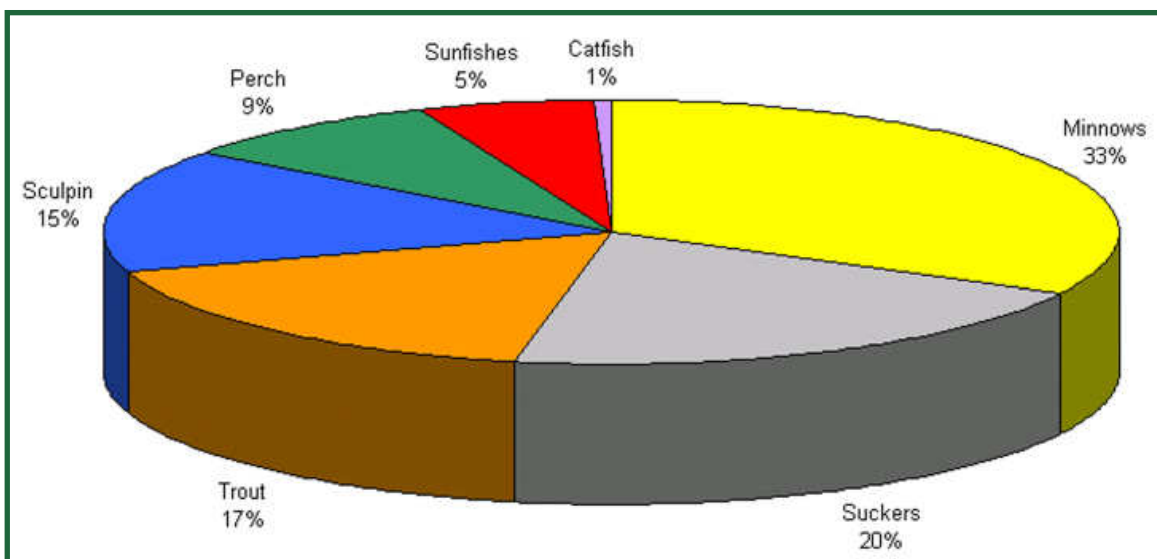
Figure 22. Abundance of fish families collected during reassessment.

However, most fishes caught on the survey were not game species. The most common species was the pollution-tolerant blacknose dace, which made up 18% of all fishes caught. mottled sculpin (15%) and white suckers (14%) were also present in high numbers. Of the seven fish families represented, minnows were the most abundant (Figure 22).

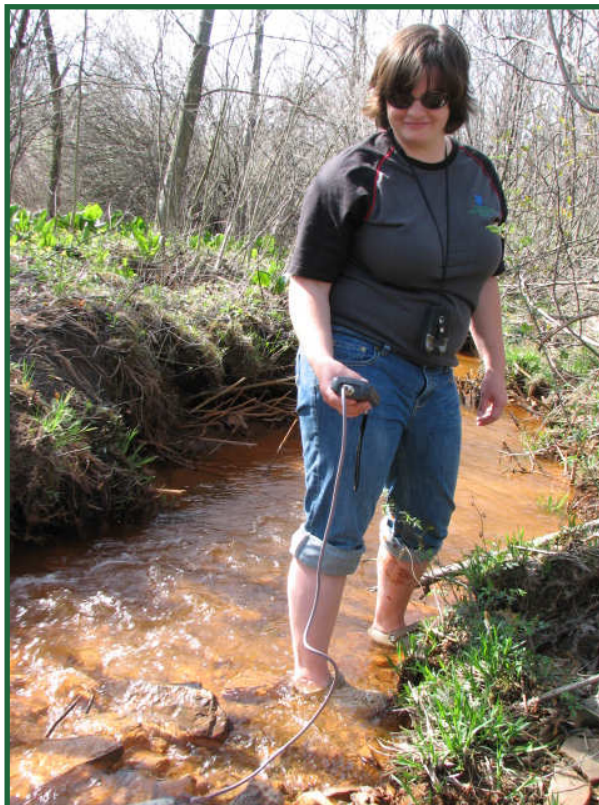
*Amanda Deal monitors an unabated mine discharge that flows into Hoffman Run, a tributary of Quemahoning Creek.*

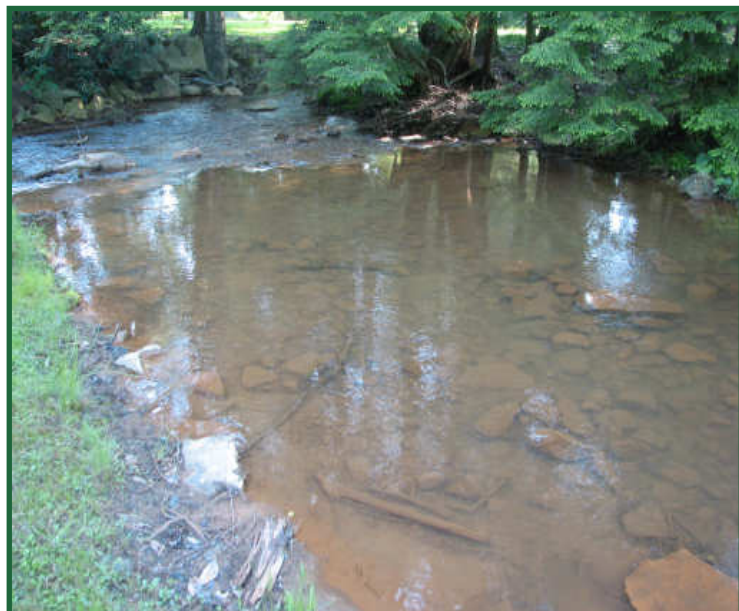
Lamberts Run is a tributary to the Stonycreek River that has had many ups and downs. Results of the reassessment identified the stream as moderately impacted at the present time. However, the presence of extremely high levels of iron and other metals result in exceptionally high conductivity levels and a poor macroinvertebrate community comprised mainly of tolerant taxa. The headwaters of Lamberts Run are within the boundaries of the proposed Flight

*Lamberts Run*

93 National Memorial a Trout Unlimited funded remediation plan has been developed and may be implemented as a component of the overall National Memorial creation.

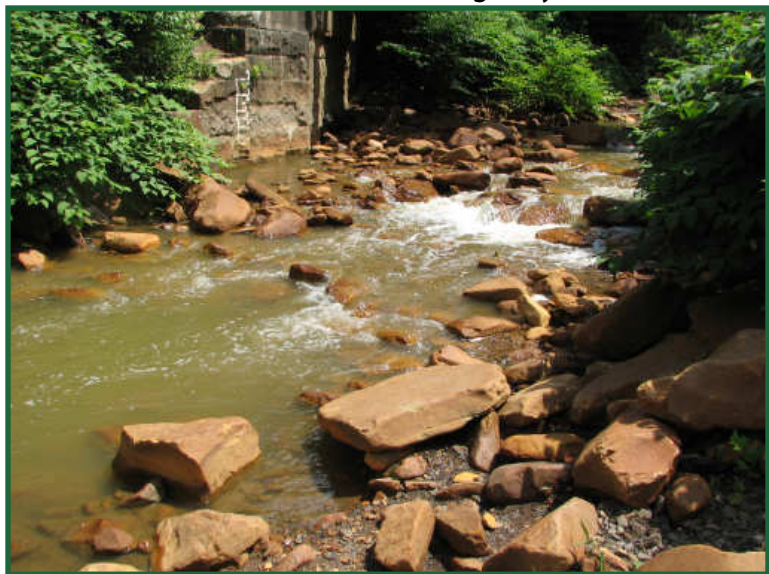
Paint Creek is the limiting factor for this entire stretch of the Stonycreek River. There were no samples taken from Paint Creek itself on this survey, but the sample below the mouth shows the transition from a recovery zone, which is signified by Site 6 Carpenters Bridge to a stream

*Paint Creek just before it enters the Stonycreek River.*

severely impacted by AMD. Carpenters Bridge is directly above the mouth of Paint Creek and has recovering fish and macroinvertebrate communities. The major limiting factor at the bridge is heavy metals precipitating out from the large Shade Creek discharge. Shade Creek does not impact the Stonycreek River biota to the point of decimation, but does remove the river's buffering capacity. When Paint Creek flows into the Stonycreek River there is a limited buffer. Therefore, Paint Creek is detrimental to the water chemistry and biota of the Stonycreek River all the way to its confluence with the Little Conemaugh River. The high amount of heavy metals that Paint Creek supplies the Stonycreek River can be seen for upwards of 1 mile downstream from its mouth as iron, aluminum, and manganese deposits can be seen on all rocks in this area. The sites below Paint Creek (Site 1, Site 2, and Site 4) have somewhat better fish populations than they did in previous PFBC samplings, but the macroinvertebrate communities, and physical habitat at all sites are severely degraded due to high volumes of heavy metals. There are other mine seeps that flow into the Stonycreek River between Paint Creek and the Conemaugh River, but none of them carry as many heavy metals as Paint Creek

The specific recommendations for projects in the watershed include the Jandy site, upstream of Mine 40 and the remaining Mine 40 refuse pile. Seese Run and its tributary, Weaver Run, require five discharge treatment systems between them to restore a fishery. The Cooney Brothers active treatment site on Big Paint Creek must also be completed and the removal of Mine 42 and Mine 37 coal refuse piles are also essential. A limestone doser is recommended on Babcock Creek for treatment of the Mine 42 discharge that would restore much of the Paint Creek headwaters. The UPCDO2 discharge site should be put on the DEP's PI or PII reclamation list and if implemented would also improve the headwaters of Paint Creek.

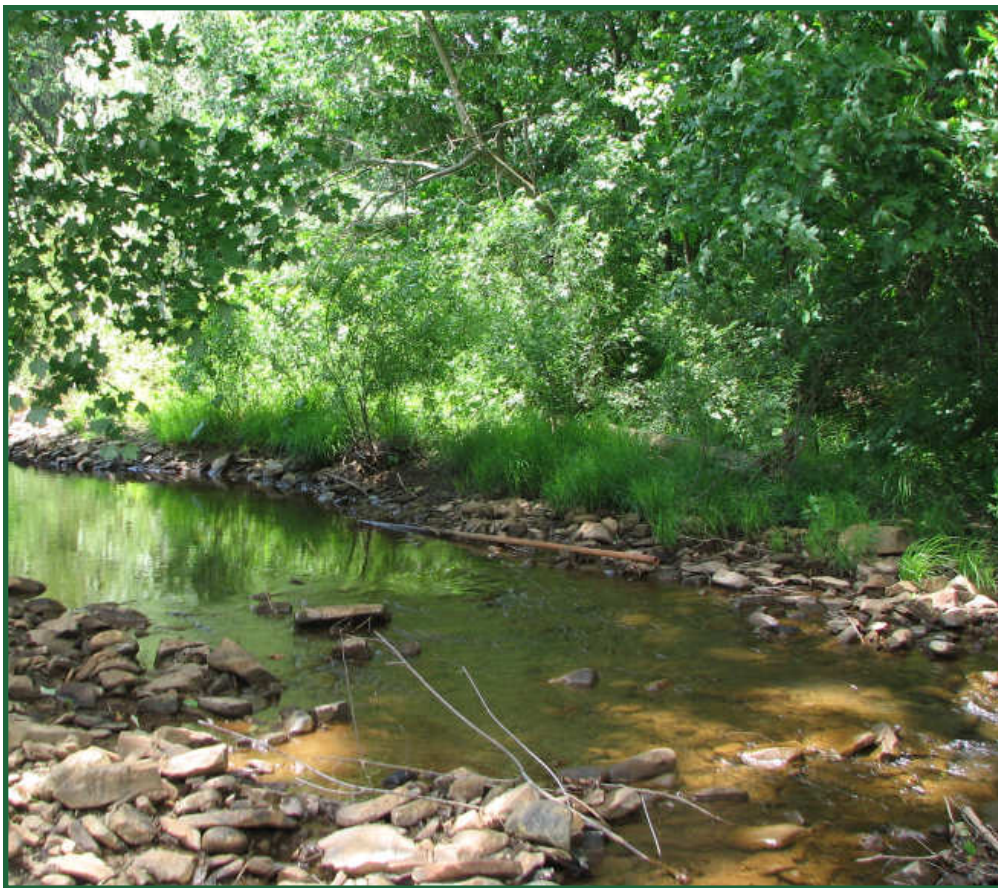
Bens Creek has faced AMD problems in the past including large treatment system failure, but with the help of various watershed and non-profit organizations as well as monitoring and enforcement from the PFBC and DEP, Bens Creek is on its way to a full recovery. The macroinvertebrate community has fully recovered as evidenced by the presence of acid intolerant two and three year old Pteronarcyid stoneflies. The headwaters of the stream above these impacts is considered an Exceptional Value Stream by PA93 and continued preservation of current land and water resources is essential to maintaining the recovery of this watershed.

*South Fork Bens Creek*

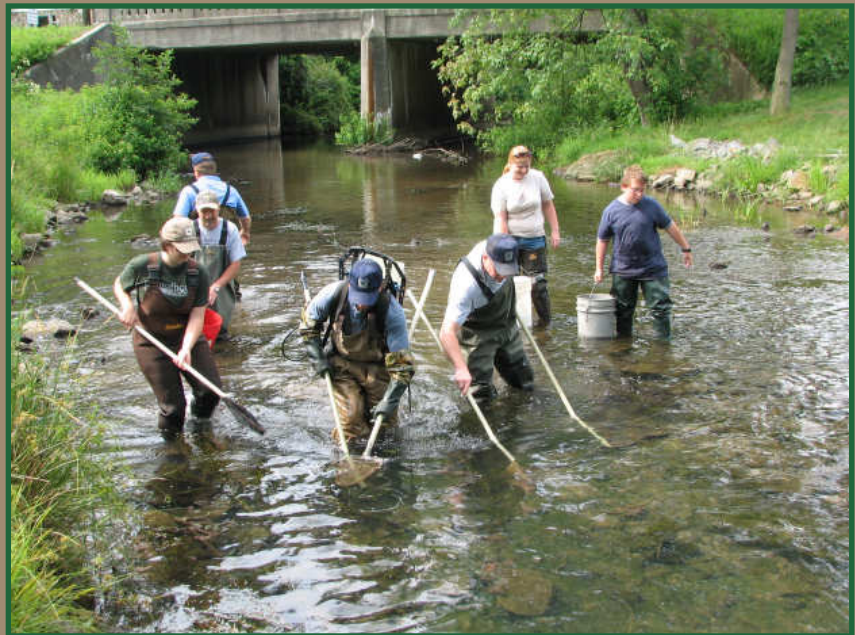
*Electrofishing on Rhoades Creek.*
