# Williams Run Watershed Assessment

Venango County, PA

Prepared for:  
South Sandy Creek Watershed Association  
August 2007

Prepared by:  
Jennifer Hedglin  
Wildlife Biologist

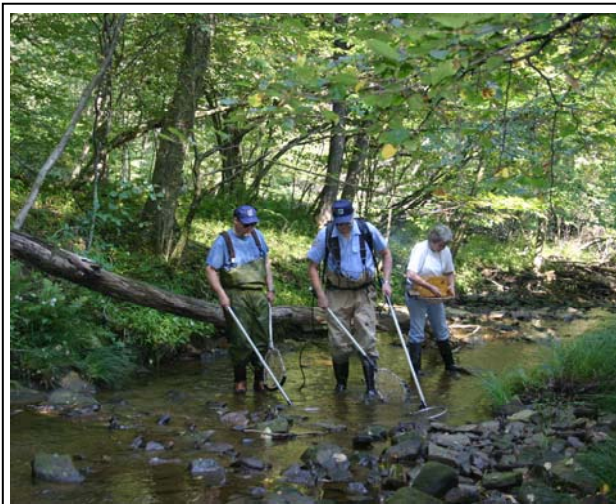
PFBC sampled the main branch of Williams Run at several locations using electro-fishing gear (see Photo 3). One point (river mile 1.62) was sampled in 1998 and again in 2005 to determine any changes (see Table 9). While there was a change, it was for the worse with 2 species of fish found in 1998 and then 0 in 2005.

Photo 3. PFBC & SSCWA sampling Unknown Tributary to Williams Run

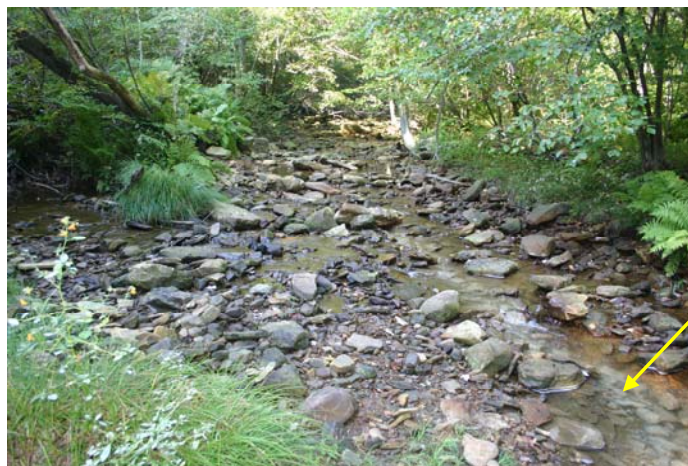
Photo 5. Confluence of Unknown Tributary & Williams Run. Note the aluminum (silver or whitish color) in Williams Run.

At the time of this assessment, several projects are getting started to help make the community safer by eliminating dangerous highwalls and alleviating some of the stress on the aquatic ecosystems. The projects include filling & sloping the highwalls along Hells Kitchen Road and directing the flow of AMD to an inclined limestone bed for treatment.

Recommendations: Continue working on remediation projects & educating the public about the significance of these projects to continue building local support.
