GIS, Hydrologic/Hydraulic Modeling – The Letort Spring Run Collaborative Stormwater Management Project

Water Resource Center
Southwestern Pennsylvania Commission

NEWELL TERESKA & MACKAY
ENGINEERING

March 23, 2021

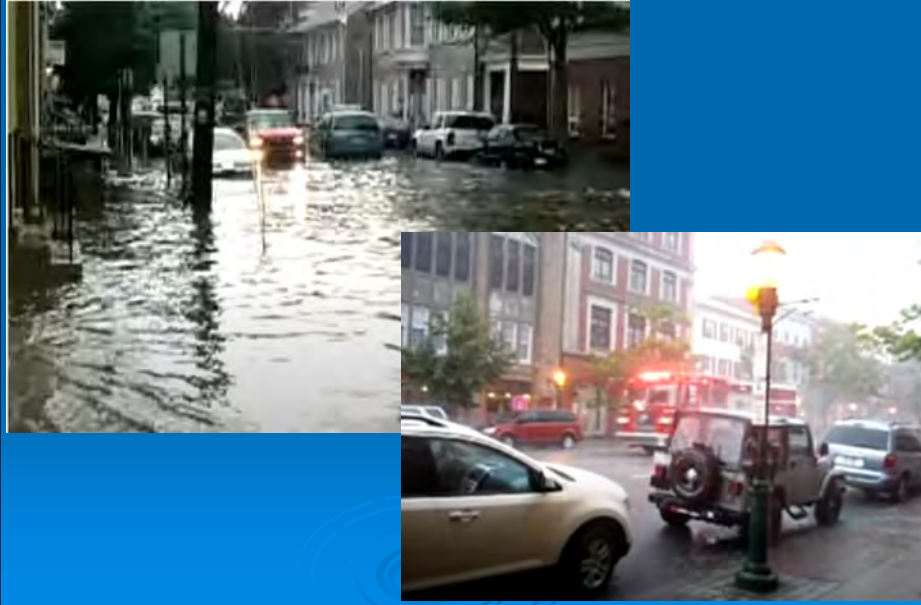
Flooding - May 14, 2010

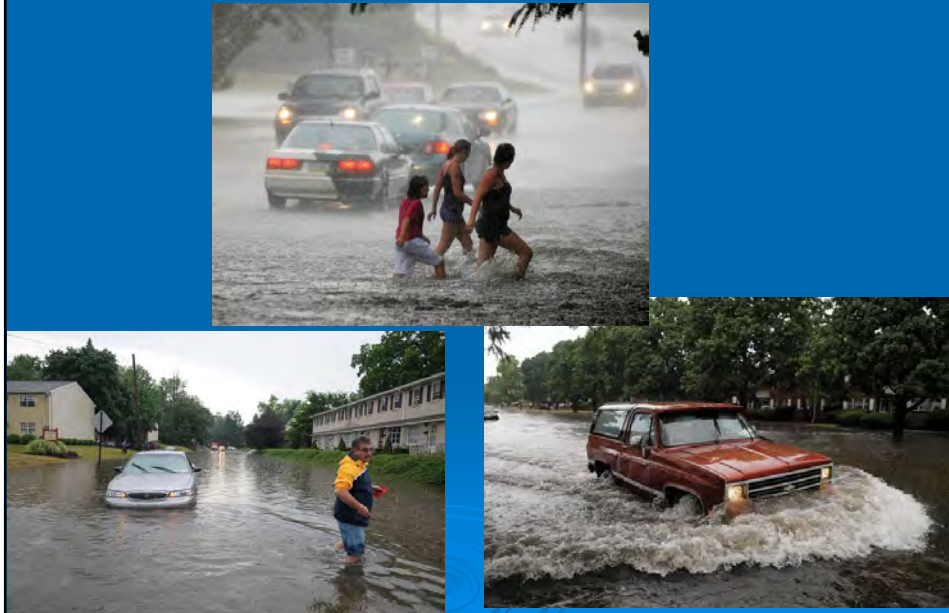
Flooding - July 11, 2012

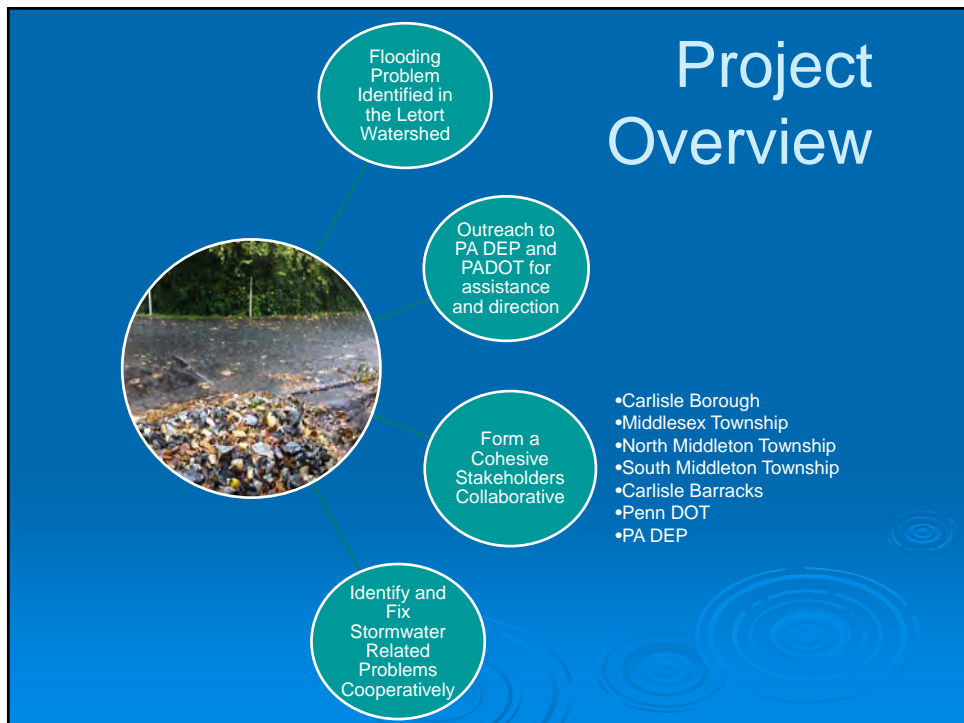
Flooding – October 11, 2013

Storm Sewer Surcharge or Stream Overbank Flow Causing Flooding

Storm Sewer Surcharge

October 11, 2013 4:10 PM
Intensity: 0.22 inches/hour
Total Rainfall : 3.90 inches

Letort Spr. Run Overbank Flooding

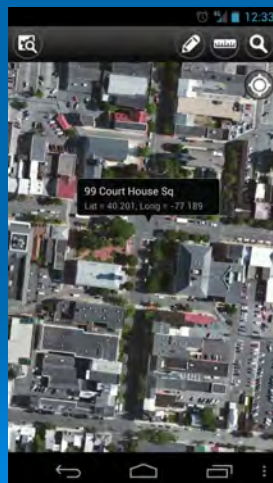
Sample: Mobile MS-4 Data Collection

Find Location

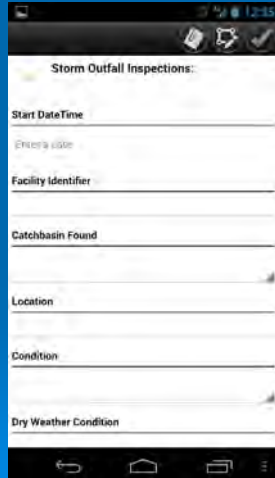
Sample: Mobile MS-4 Data Collection Fields Matching DEP Form *: Land Use Pull Down

* Outfall Reconnaissance Inventory/ Sample Collection Field Sheet

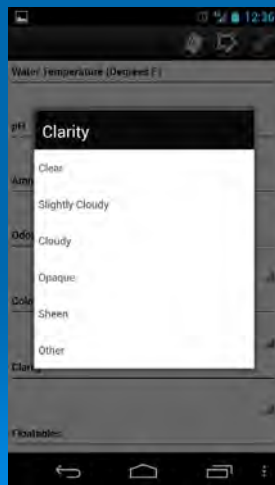
Sample: Mobile MS-4 Data Collection Clarity Pull Down

- Attach Pictures, Notes, PDFs
- Immediately uploaded to the Web for viewing and editing
- User controls viewing and editing permission
- Applications with same easy-to-use format:
 - **Infrastructure:** Signs, Utility Poles, Street Lights and Traffic Signals
 - **Stormwater Collection and Conveyance:** Inlets Manholes, Fittings Valves, Culverts, Pipes, etc.
 - **Citizen Request Forms:** Potholes, Graffiti, Service Repairs, Complaints, Other
 - **Inspections:** MS-4, Storm Water, Sanitary Sewer, Water , Poles, Signs
 - **Emergency Operations:** Damage Assessments, Incidents, Accidents, Shelters, Evacuation routes, etc.

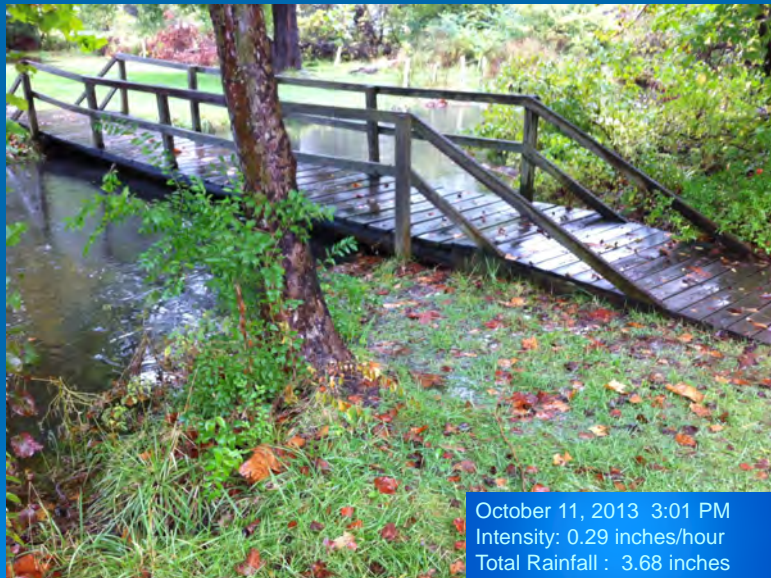
Bridge over Molly Grub

October 11, 2013 3:01 PM
Intensity: 0.29 inches/hour
Total Rainfall : 3.68 inches

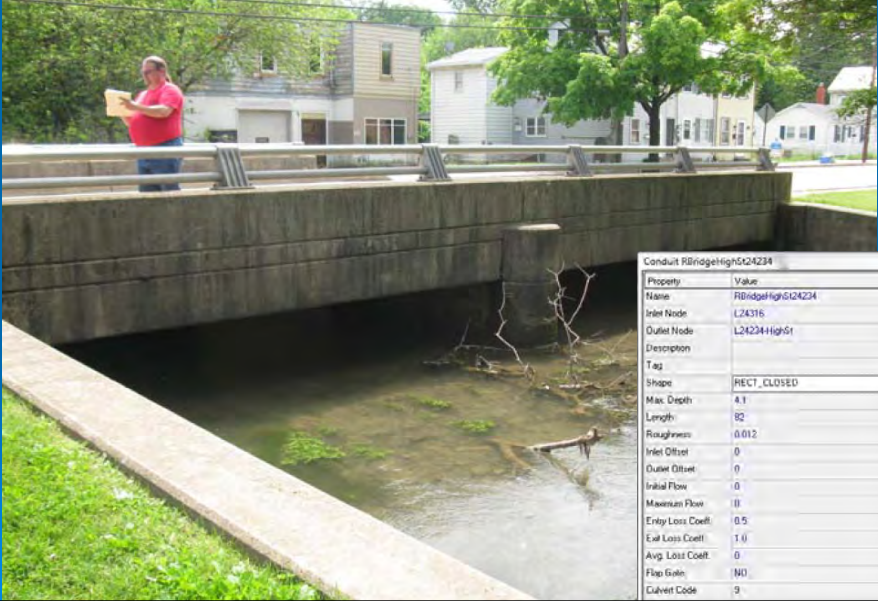
Bridges

Property	Value
Name	RBldgedHighSt24234
Inlet Node	L24316
Outlet Node	L24234HighSt
Description	
Tags	
Shape	RECT_CLOSED
Max. Depth	4.1
Length	82
Roughness	0.012
Inlet Offset	0
Outlet Offset	0
Inlet Flow	0
Maximum Flow	0
Entry Loss Coeff.	0.5
Exit Loss Coeff.	1.0
Avg. Loss Coeff.	0
Flag Code	IND
Culvert Code	9

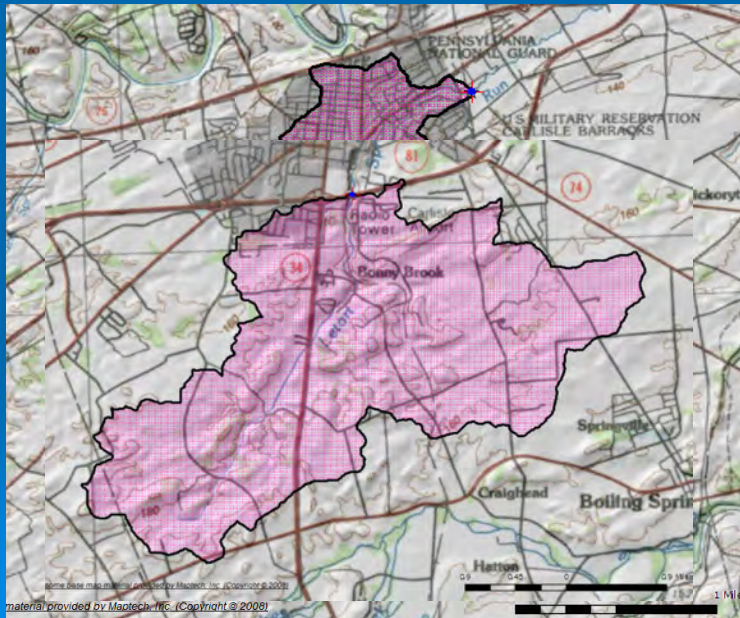
StreamStats Regression Equations

Parameter	Value
Area in square miles	14.65
Mean Basin Elevation in feet	516.3
Unadjusted basin slope, in degrees	2.5
Adjusted basin slope, in degrees	2.3
Total stream length in miles	7.61
Stream density (miles/square mile)	0.52
Percent of area covered by lakes, ponds, reservoirs and wetlands	0.3
Percent of area covered by carbonate bedrock	100.0
Percent of area covered by glacial activity	0.0
Depth to rock in feet	5.7
Mean annual precipitation in inches	39.0
Maximum Daily Temperature in degrees F	62.0
Percent of area covered by forest	9.0
Percentage of impervious area determined from NLCD 2001 impervious dataset	14.8
Percent of area covered by urban land according to an enhanced version of NLCD 1992	24.4
Percentage of urban land cover determined from NLCD 2001 land cover dataset	37.8
Drainage quality index from STATSGO	3.2
X coordinate of the centroid, in map projection, meters	68924.2
Y coordinate of the centroid, in map projection, meters	130956.5

Statistic	Flow (ft ³ /s)	Prediction Error (percent)	Equivalent years of record	90-Percent Prediction Interval	
				Minimum	Maximum
PK2	255		3		
PK5	510		5		
PK10	753		7		
PK50	1470		11		
PK100	1870		11		
PK500	3070		11

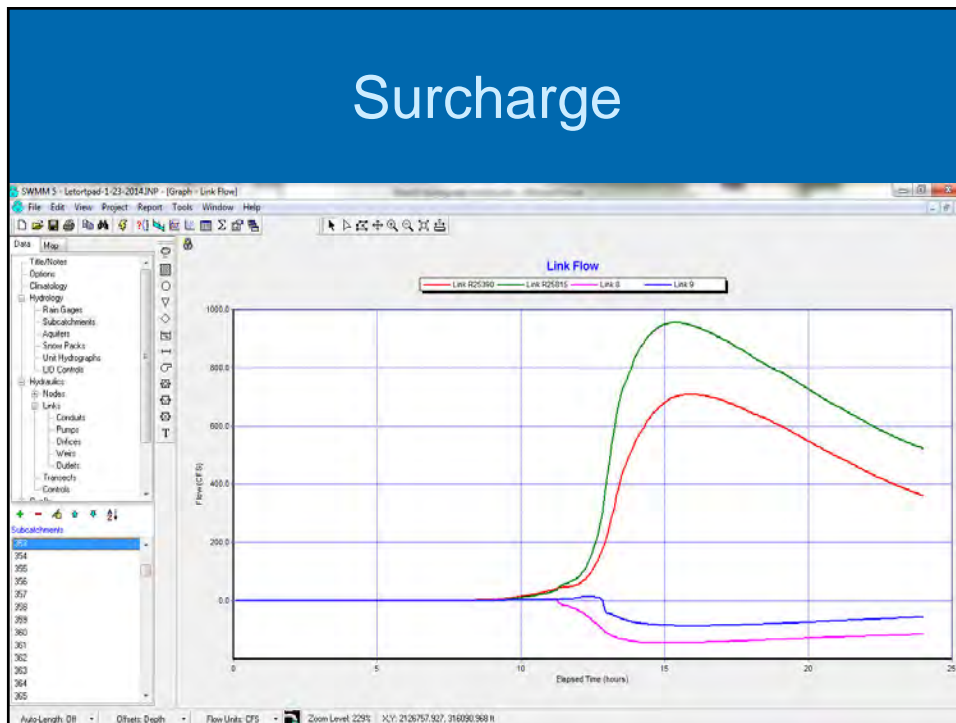
Surcharge

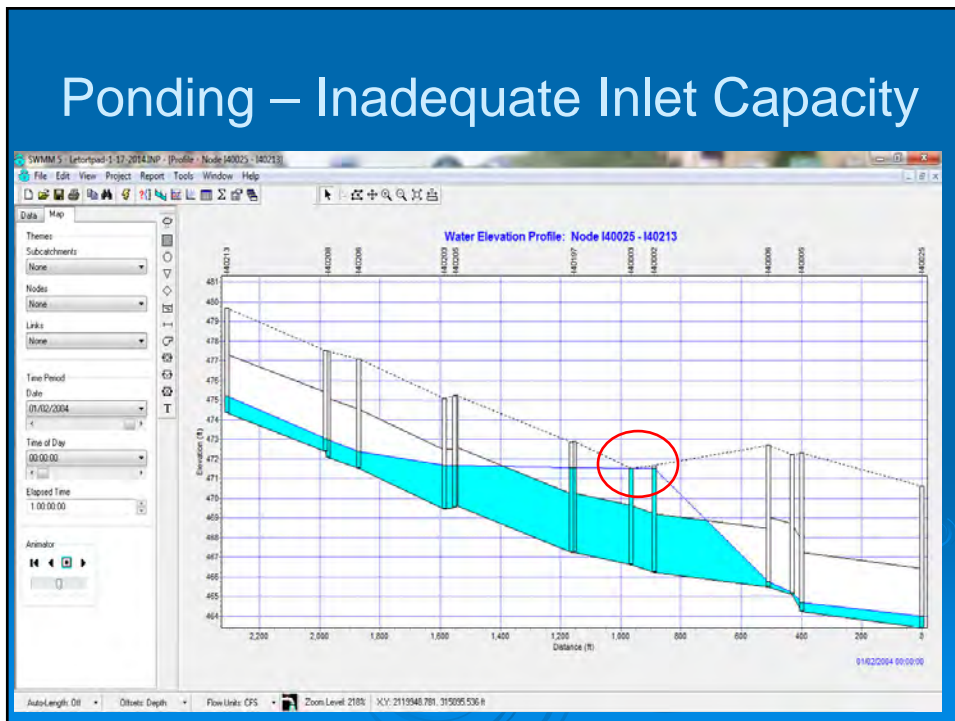
Ponding – Inadequate Inlet Capacity

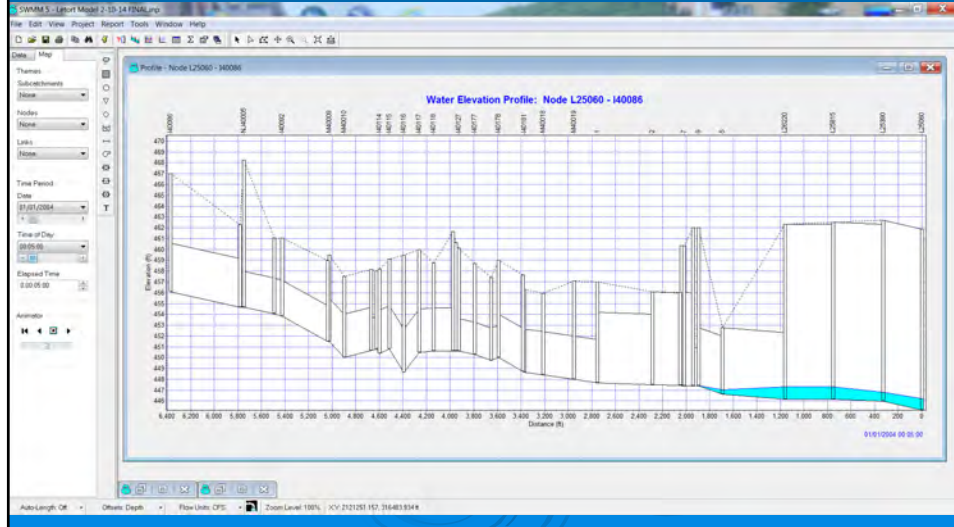
Animation Aids Timing Analysis

2-Stage flooding

- Surface runoff overwhelms the system, then subsides
- Letort crest backflows and causes a second inundation

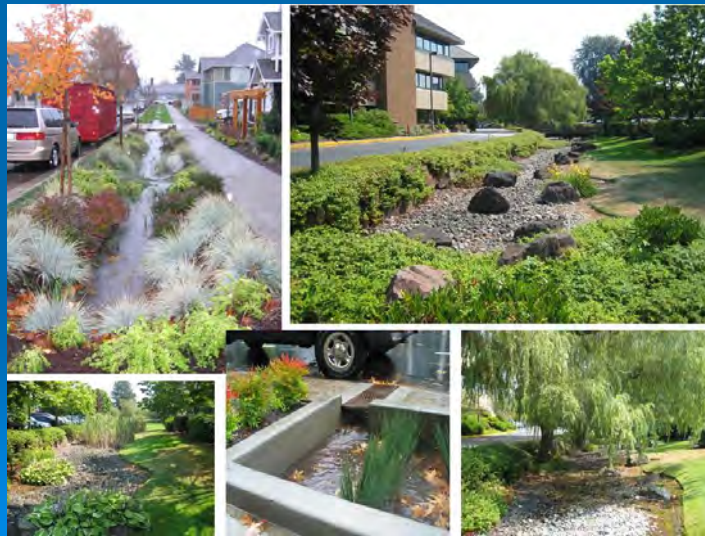
BMP No. 1- Source Area Samples
