# BIG SEWICKLEY CREEK WATERSHED ASSESSMENT, RESTORATION, & PROTECTION PLAN

OCTOBER 2010

BIG SEWICKLEY CREEK  
WATERSHED ASSESSMENT, RESTORATION, AND PROTECTION PLAN

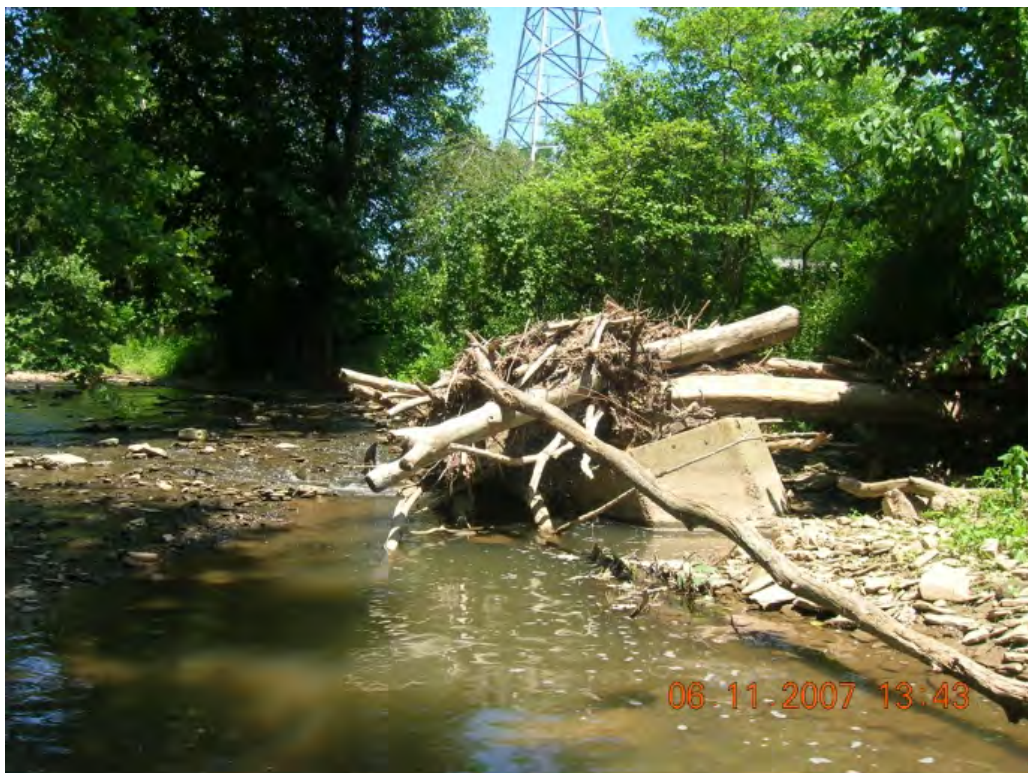
Photo 2: Debris piling up on concrete in stream. (BSC-14)

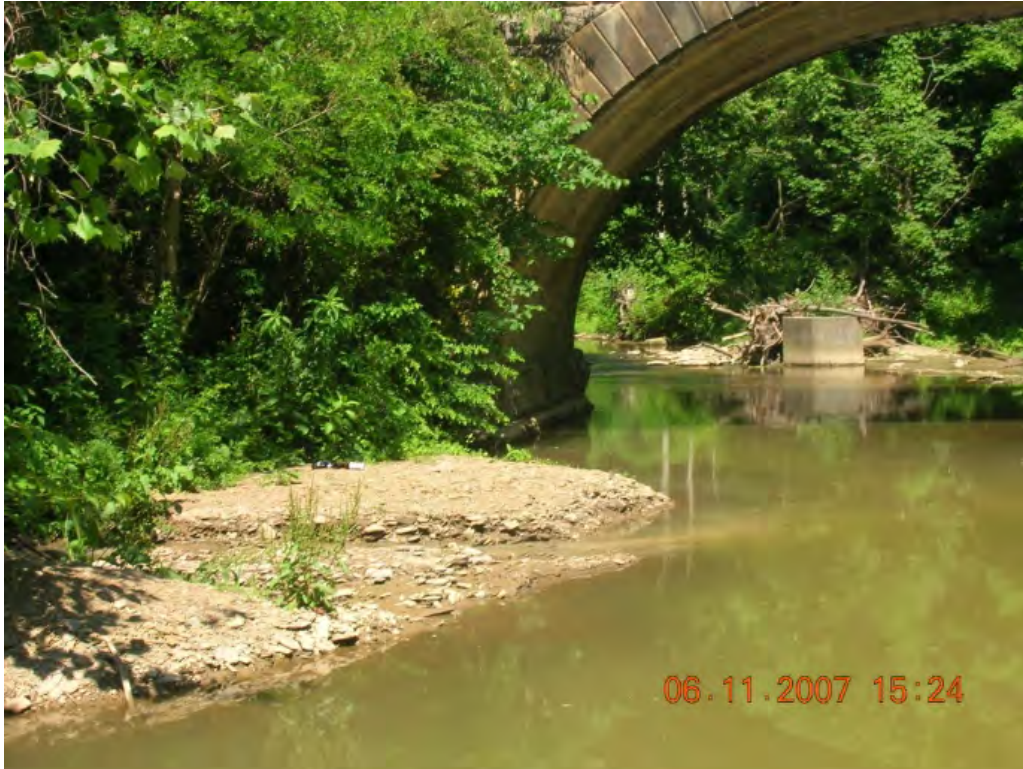
Photo 2: More evidence of debris piling up on concrete in the stream. (BSC-26)

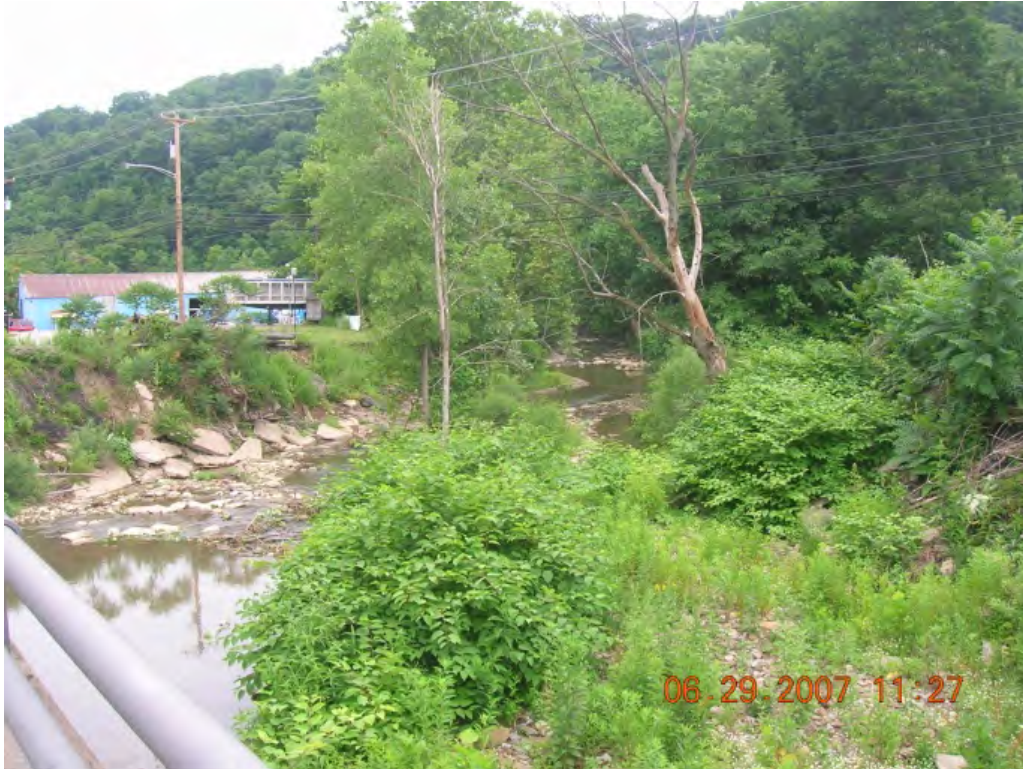
Photo 2: Right side of bridge by Zassick's Auto is silted in. (BSC-33)

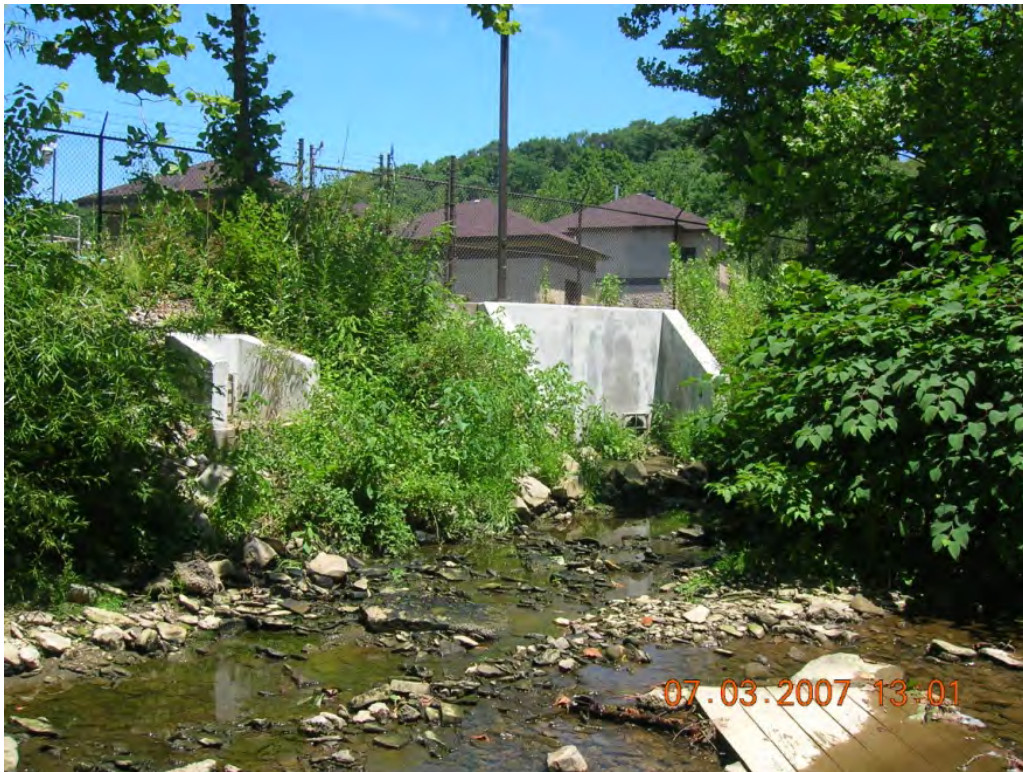
Photo 2: Sewage treatment plant. (BSC-36)

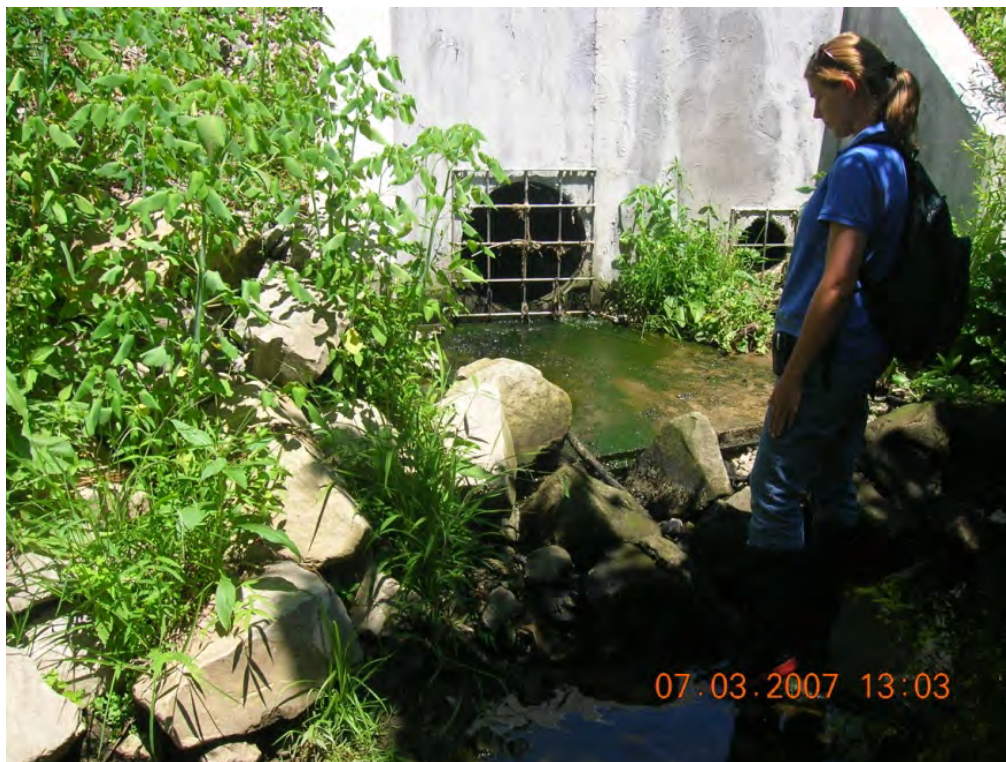
Photo 3: Greenish-black discharge from sewage plant. (BSC-36)

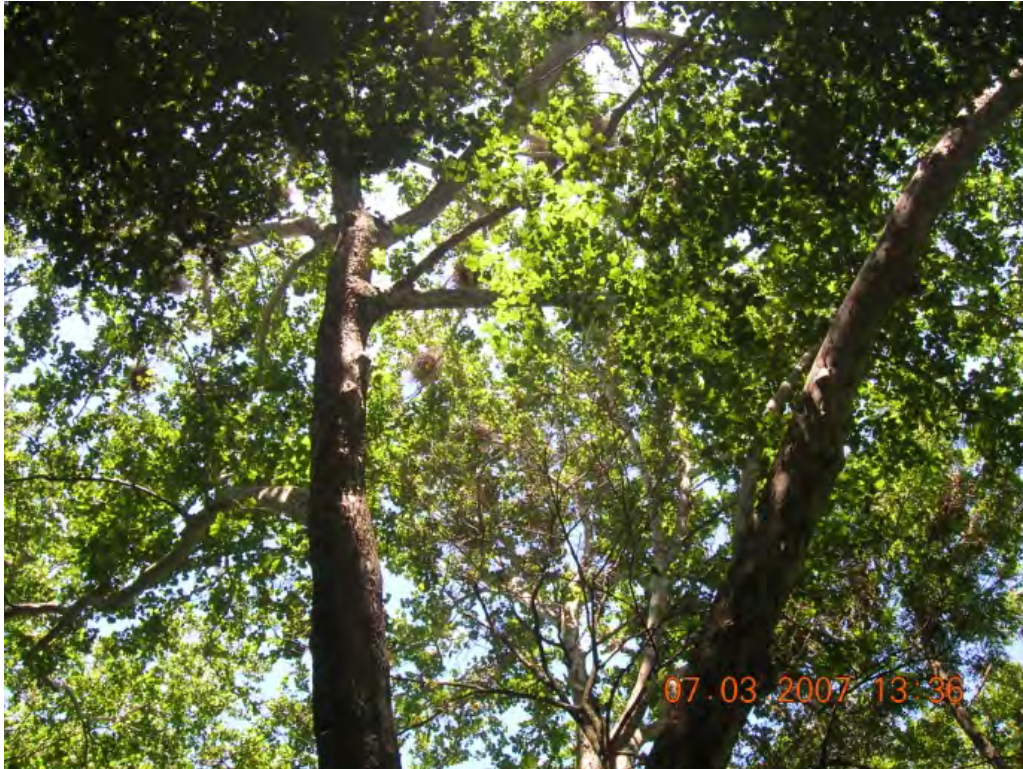
Photo 4: Blue heron nests (heronry) located on the south side of Big Sewickley Creek. (BSC-38)

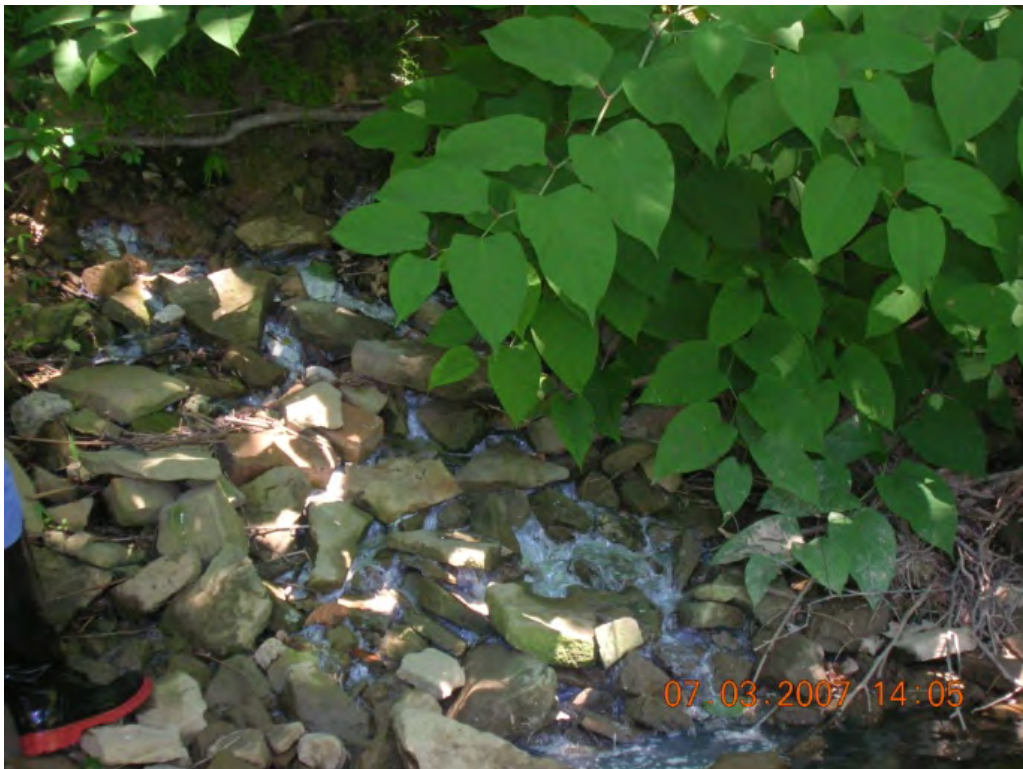
There is a white discharge seen coming out of the creek bank (see photo 5). BAI is not sure what was causing this discharge. Often times white discharges are indicative of aluminum in abandoned mine water. Fisherman Kevin Holman is seen showing off his catch of an orange koi (see photo 6). It should be noted that this species is invasive.

Photo 5: White discharge coming from a flow on the south side of the Creek. (BSC-41)

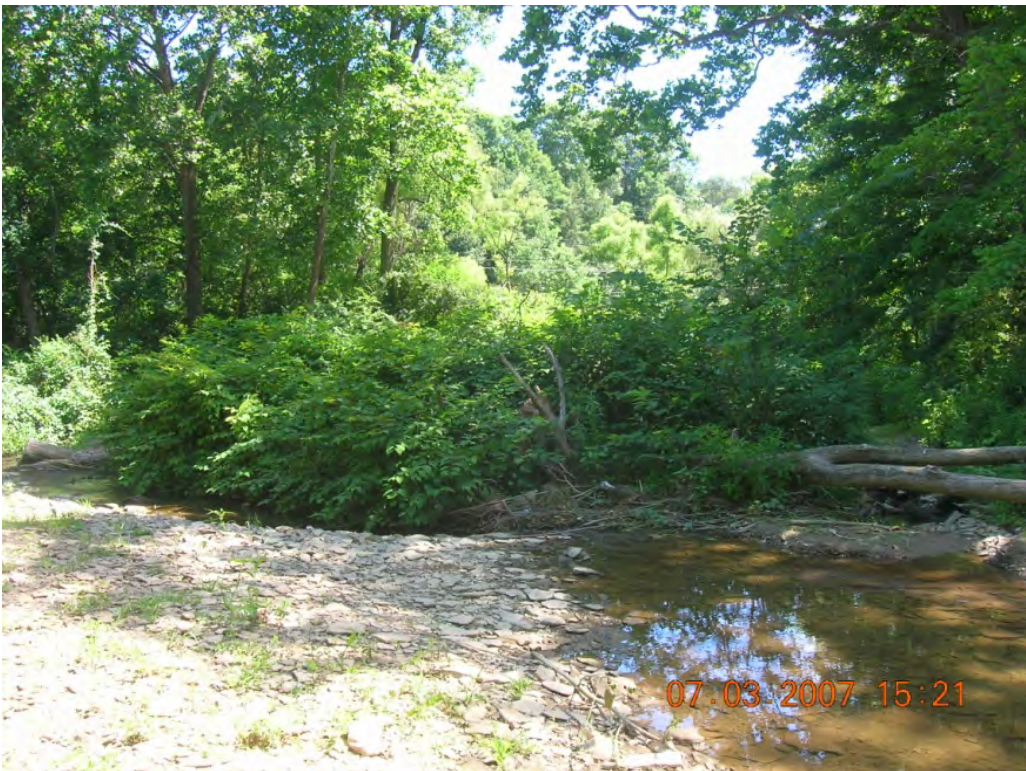
Photo 3: Large sediment build up and debris jam at a sanitary sewer crossing. (BSC-48)

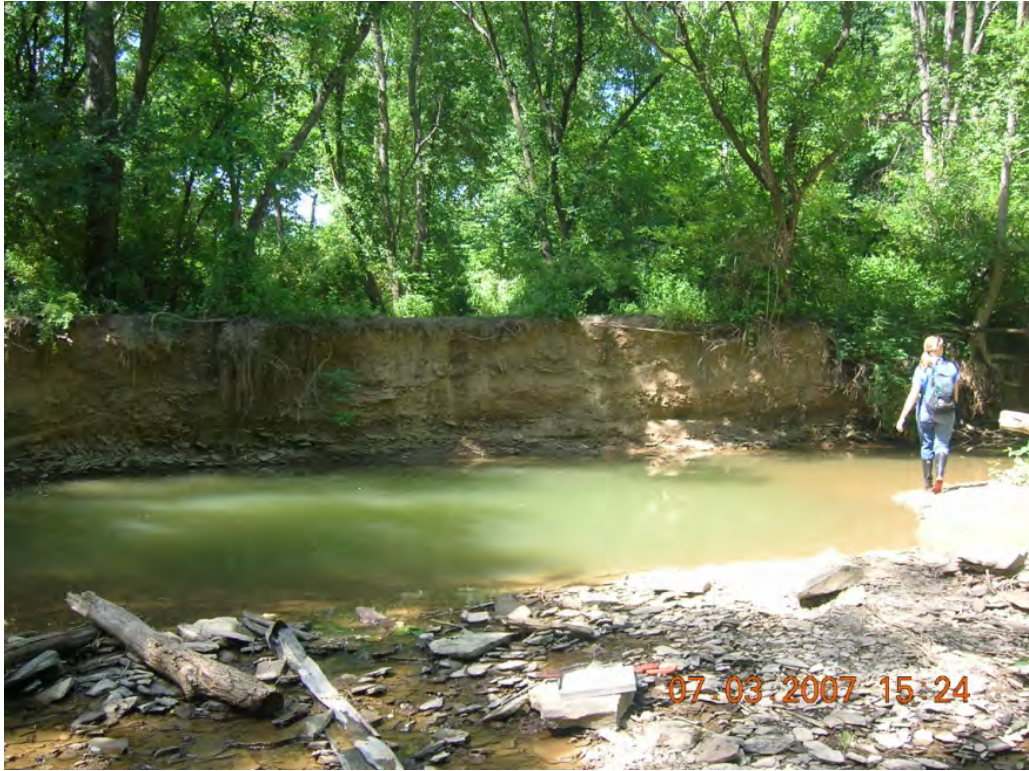
Photo 4: Seven foot high bank erosion and a deep greenish colored pool. (BSC-48)

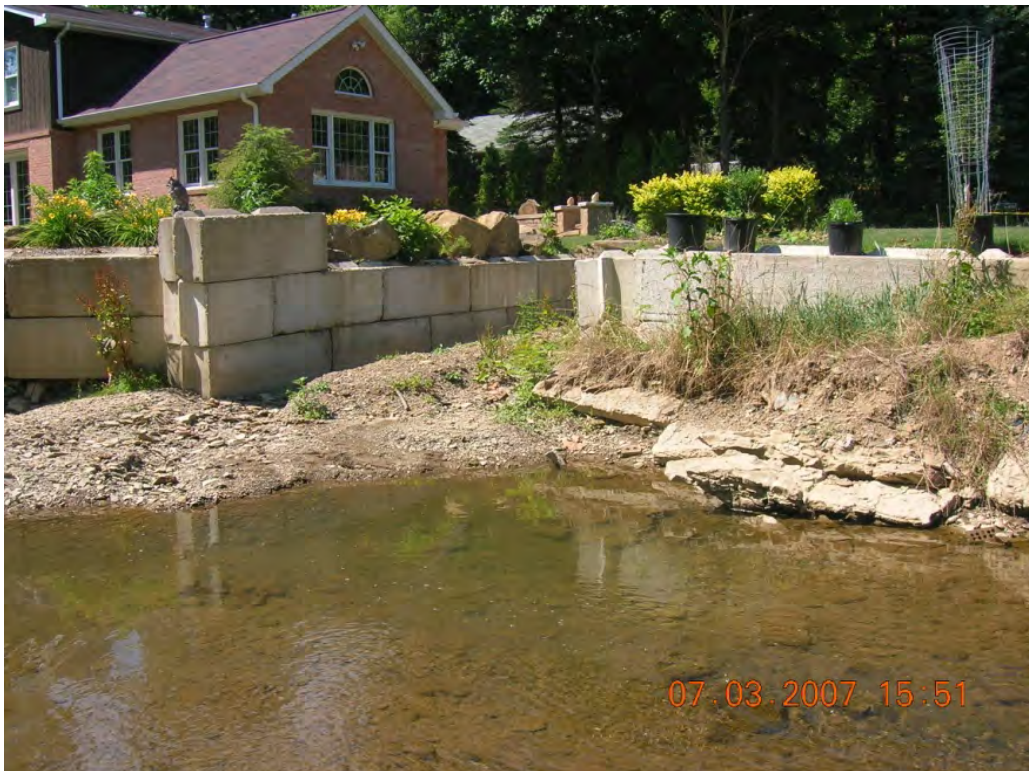
Photo 5: Location of the mouth of Cooney Hollow. Homeowners are encroaching the stream with concrete blocks. (BSC-50)

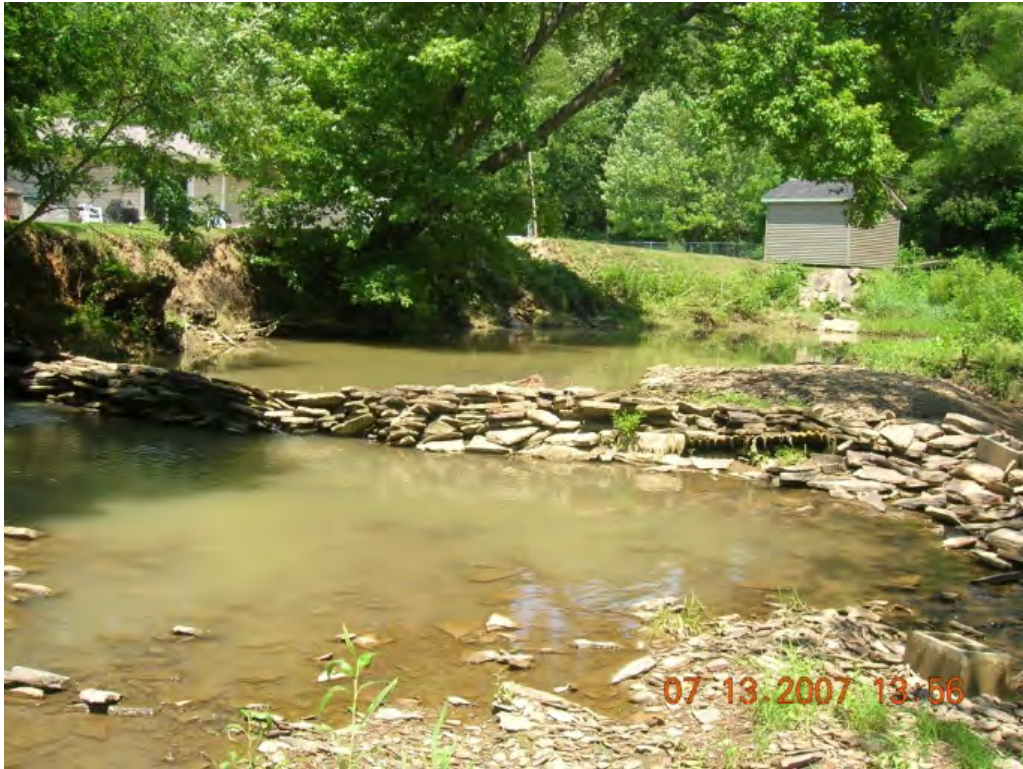
Photo 1: Man-made rock dam creating bank erosion in the bend on the left. (BSC-64)

People should also be discouraged from building rock dams along the stream. These dams slow the water flow causing sediment to build up, creating sand bars and clouding the water.

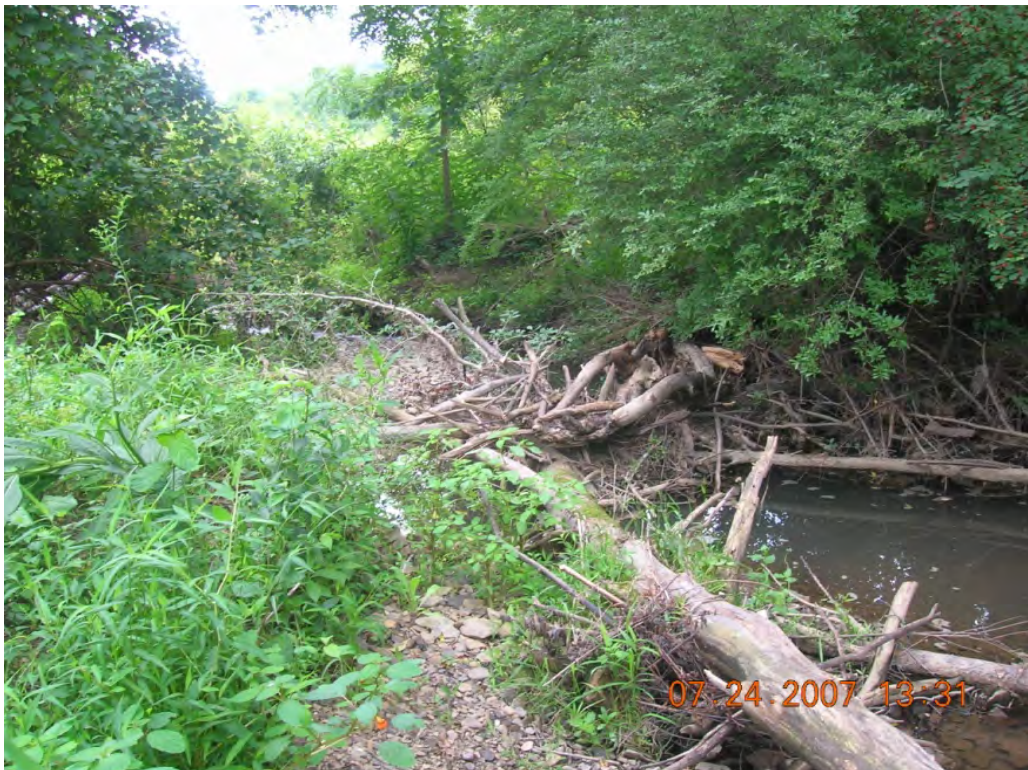
The debris jams along with the on stream pond at Markman Road act as fish barriers, preventing fish to travel past them.

Photo 2: Debris jam creating a large pool. (BSC-75) This jam has been removed as of 10/05/10 field check.

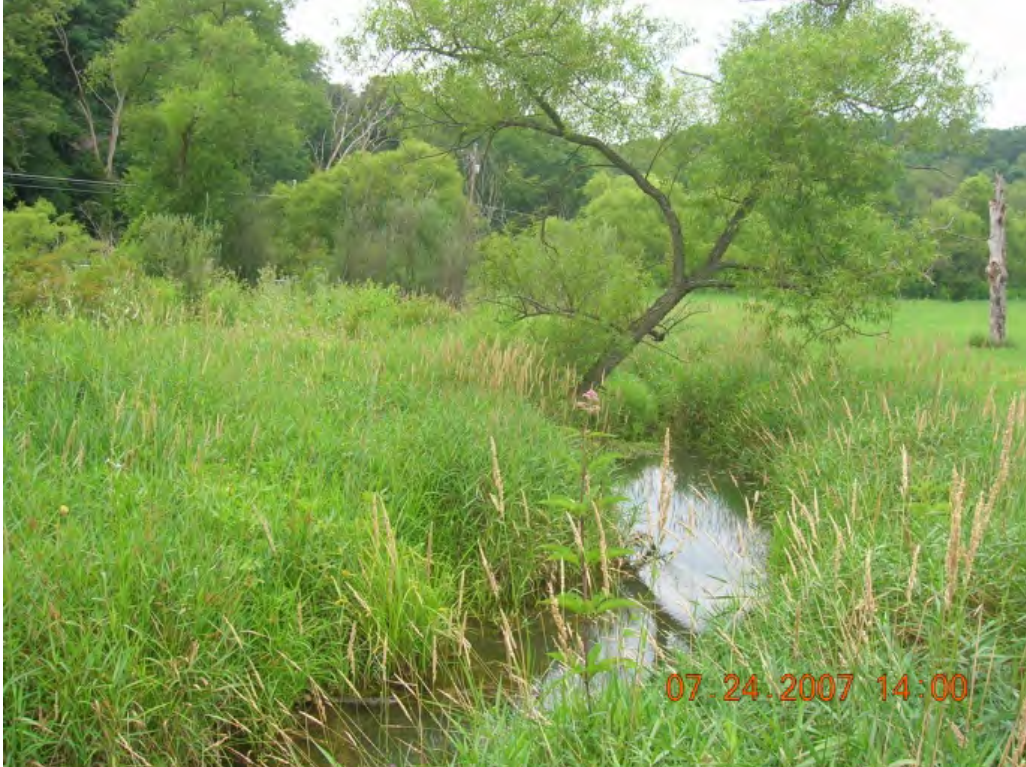
Photo 2: A sinuous channel that would make a good area for wetlands mitigation bank project. (BSC-78)

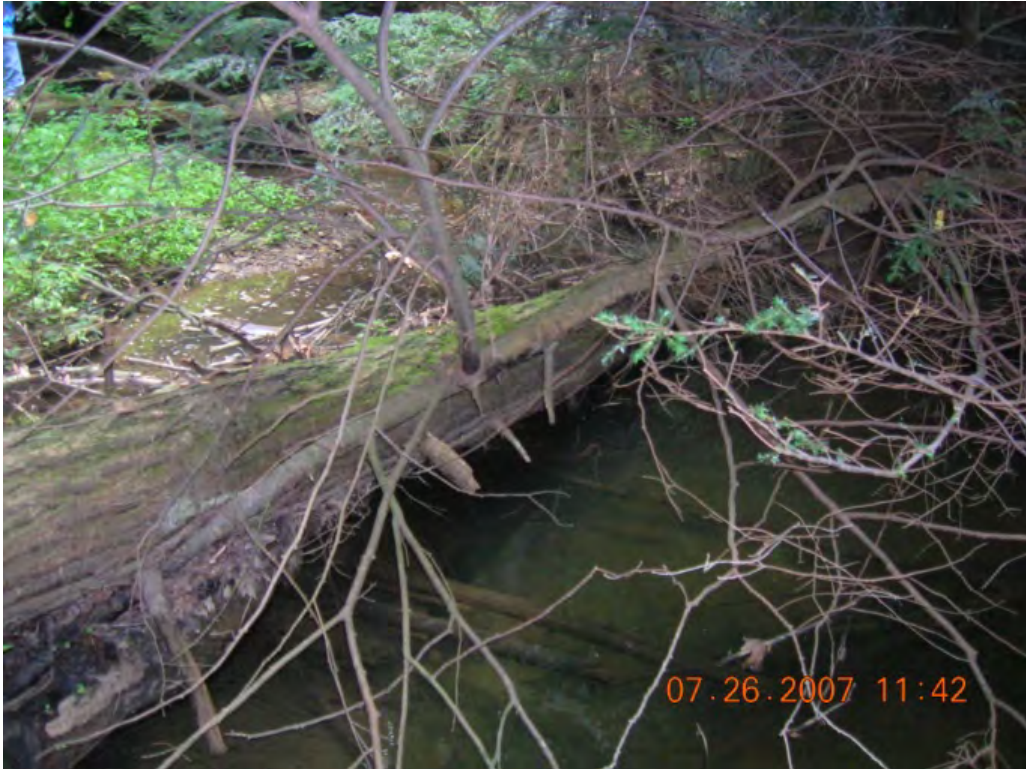
Photo 2: A fallen tree creating a debris jam and deep pool. (BSC-89)

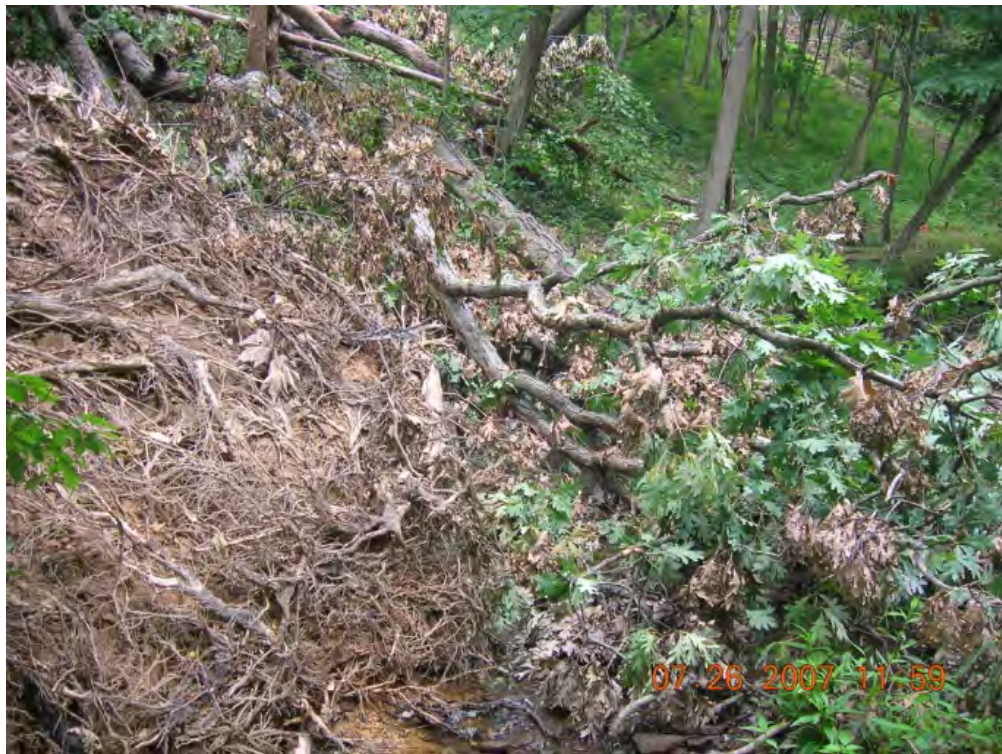
Photo 3: Trees that were cut and left in stream. There is also housing construction uphill. (BSC-91)

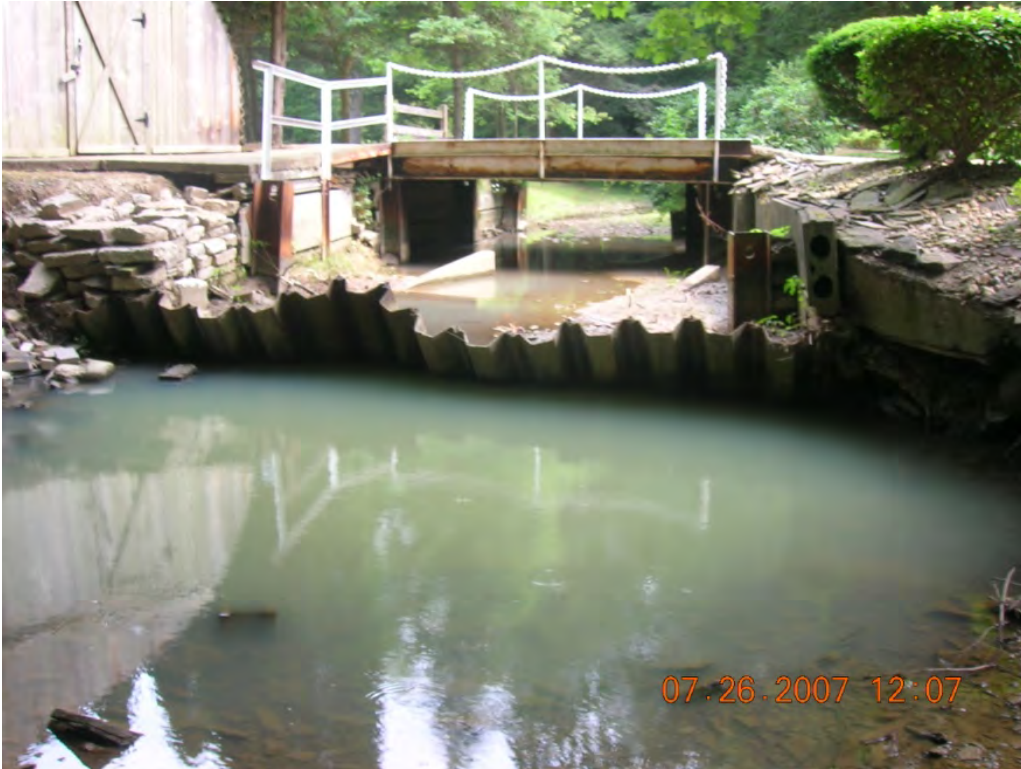
There was a man made dam made from a sheet of metal (see photo 4) that is acting as a fish impasse and causing downstream sedimentation. Downstream there were also a few culverts along the stream, one of which was too small and squeezes the channel (see photo 5), and another allowing a tributary to pass under a road (see photo 6).

Photo 4: Here a homeowner placed a piece of metal in the stream, creating dam, but also a fish impasse and downstream sedimentation. (BSC-92)

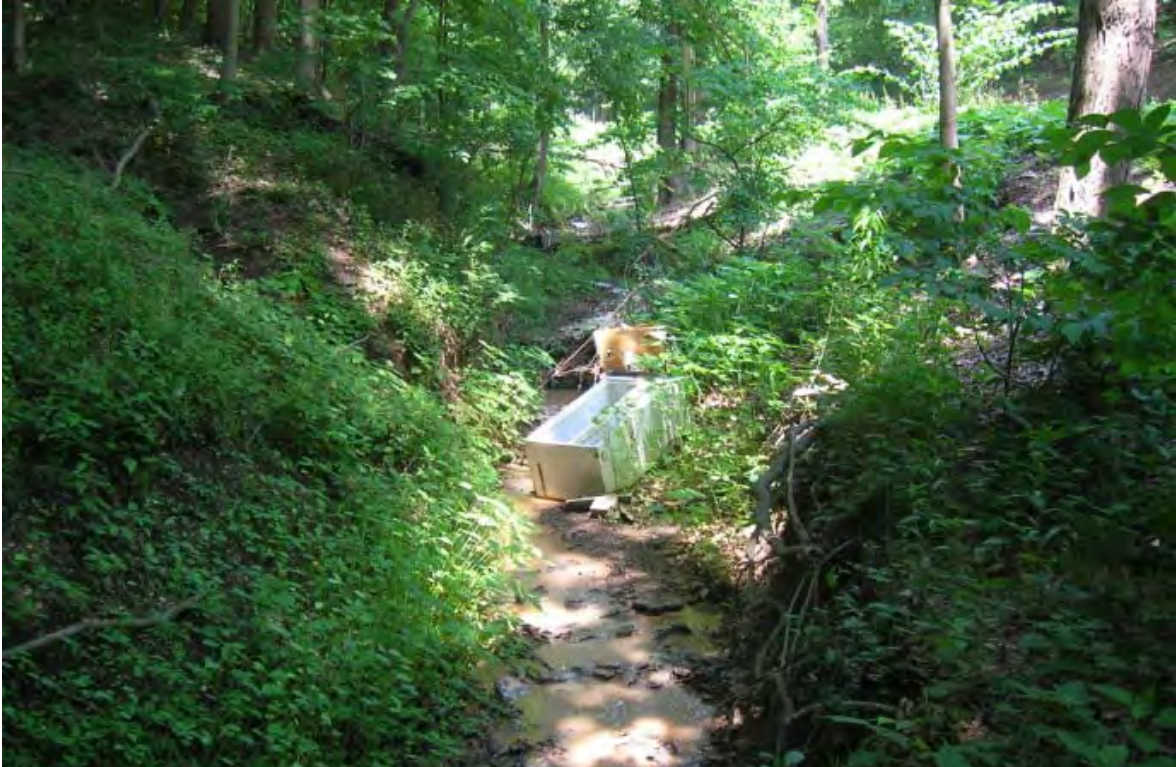
Photo 2: A dump site identified along the stream. (BSC-T1W4)

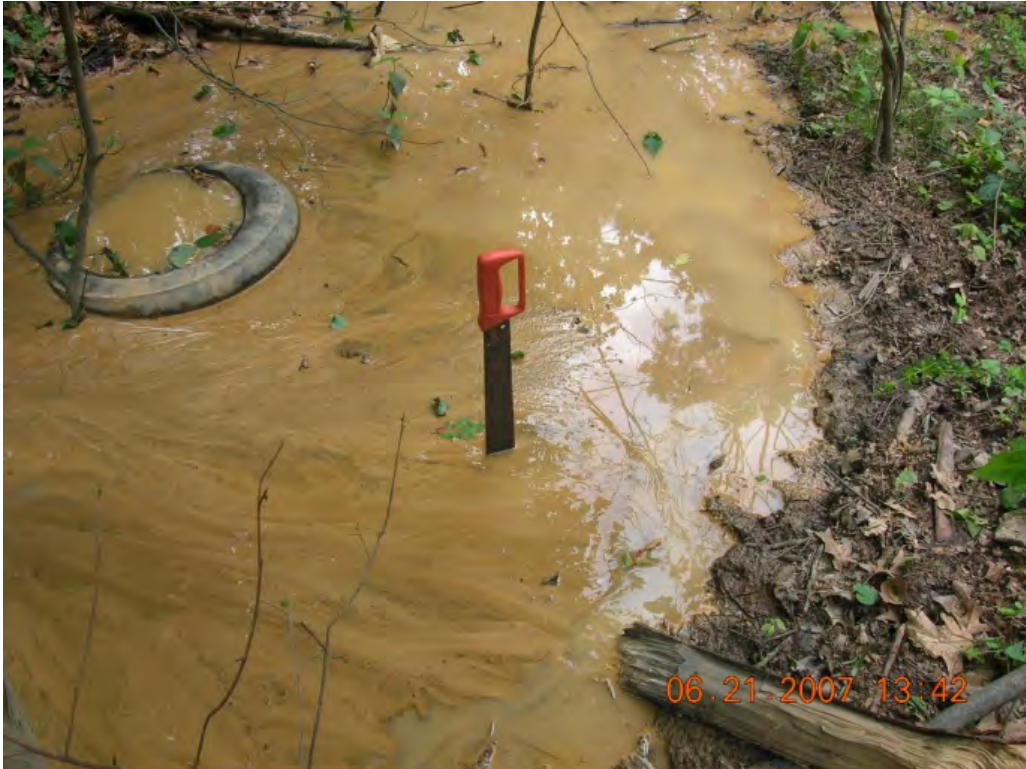
Photo 4: View of the heavily silted stream water below the landslide. (BSC-T1W7)

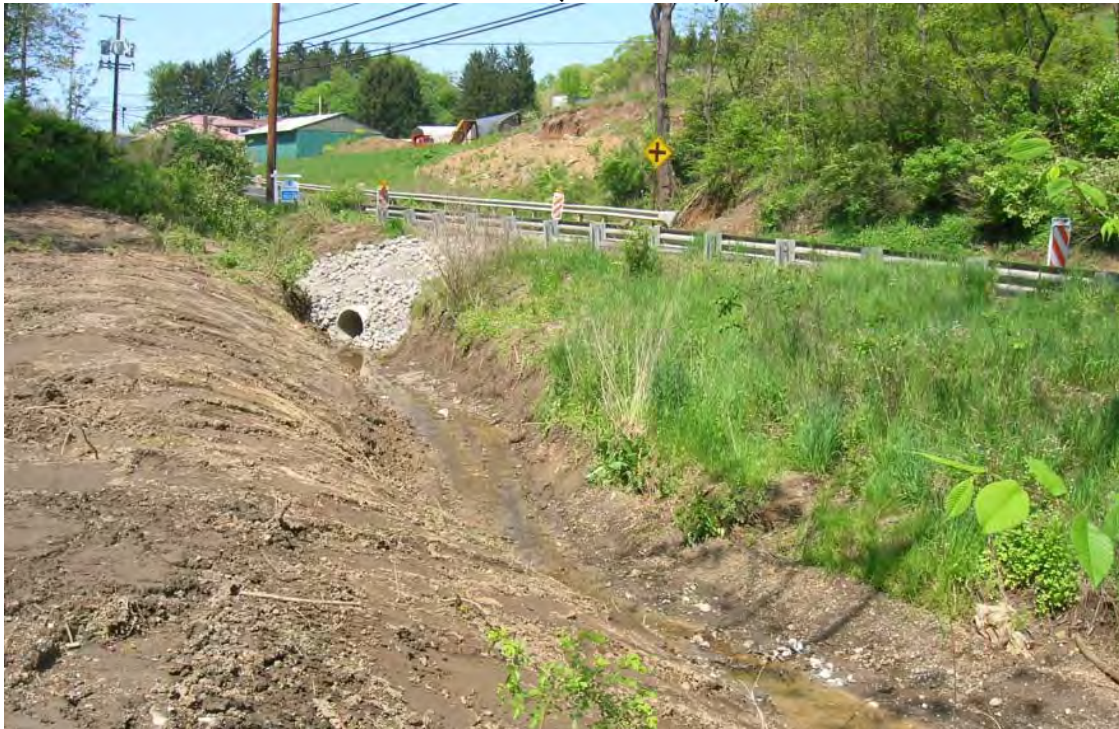
Photo 2: Culvert across Conway-Wallrose Road, leading to headwaters. Recent construction near the Economy VFW was leading to excess sedimentation in the tributary. (BSC-T4W3) (*Eastern Tributaries*)

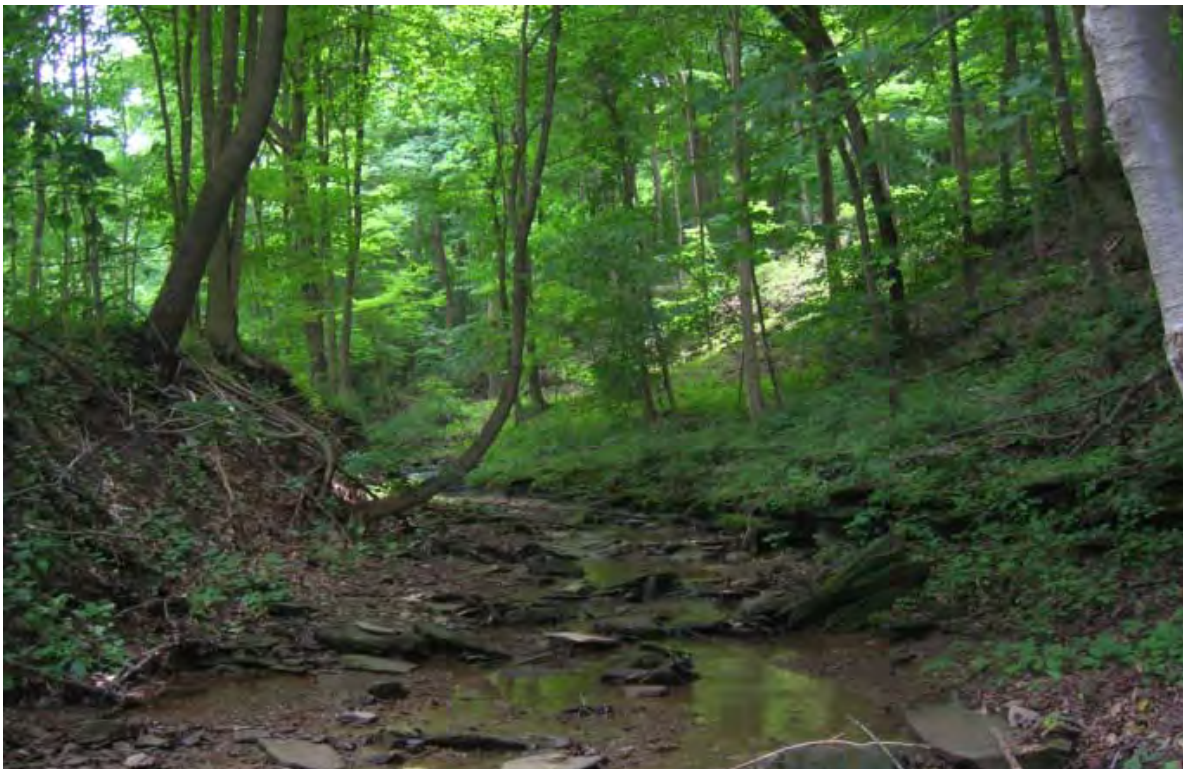
Photo 2: A nice section of this tributary flowing through a wooded area. (BSC-T1E3)

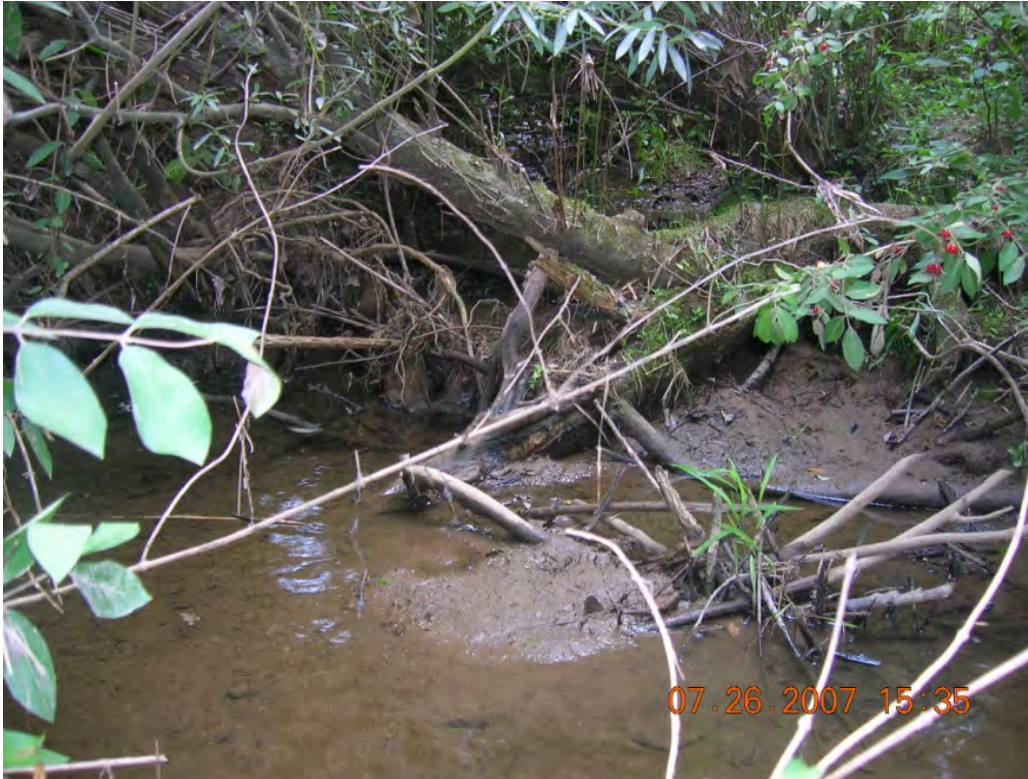
Photo 2: The confluence of Rippling Run with the East Branch is jammed with debris and excess sedimentation. (EF-06)

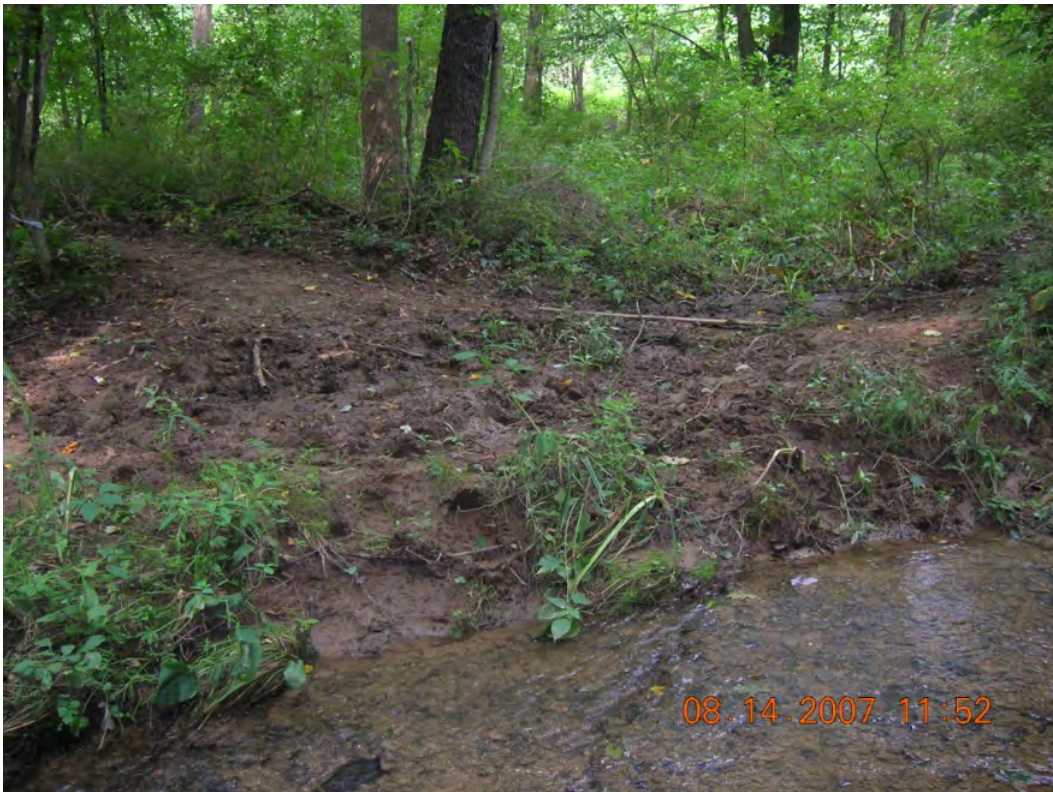
Photo 1: This section of streambank has been disturbed due to horse access to the stream. (EF-13)

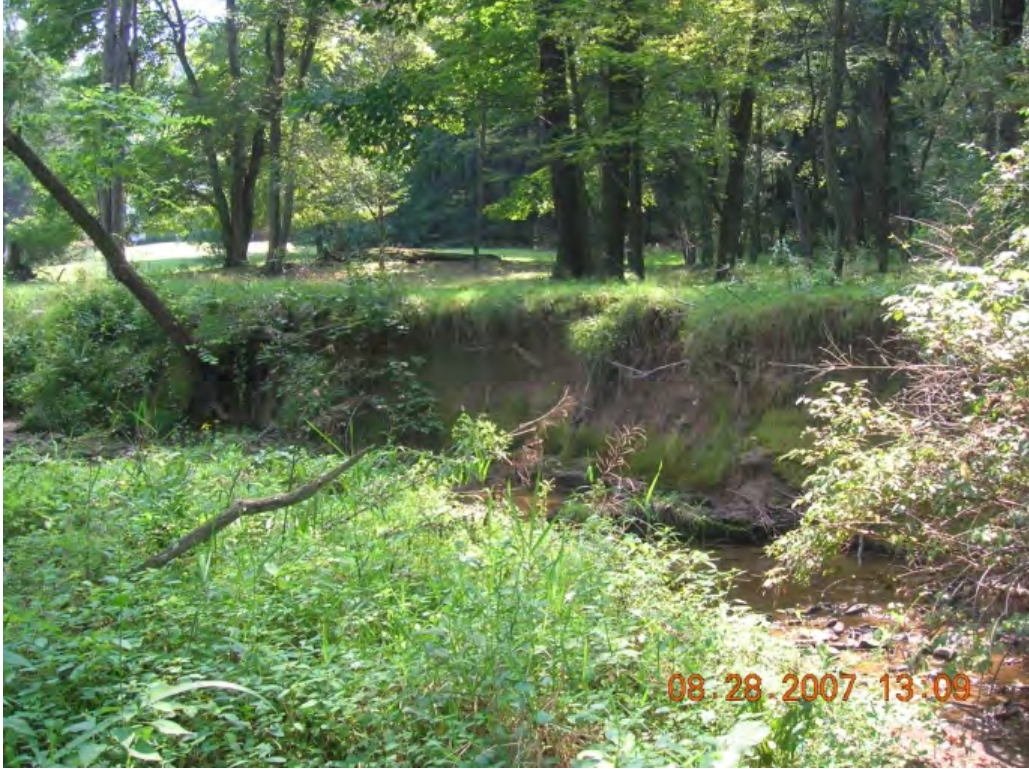
Photo 2: Bank erosion on a section of the East Fork just upstream of the Gamelands border. (EF-22)

The eroded stream banks should be stabilized or stream channel restoration work could be done to direct the flow into the middle of the channel and away from the stream banks. A bank stabilization project could be completed at EF22 with landowner cooperation.

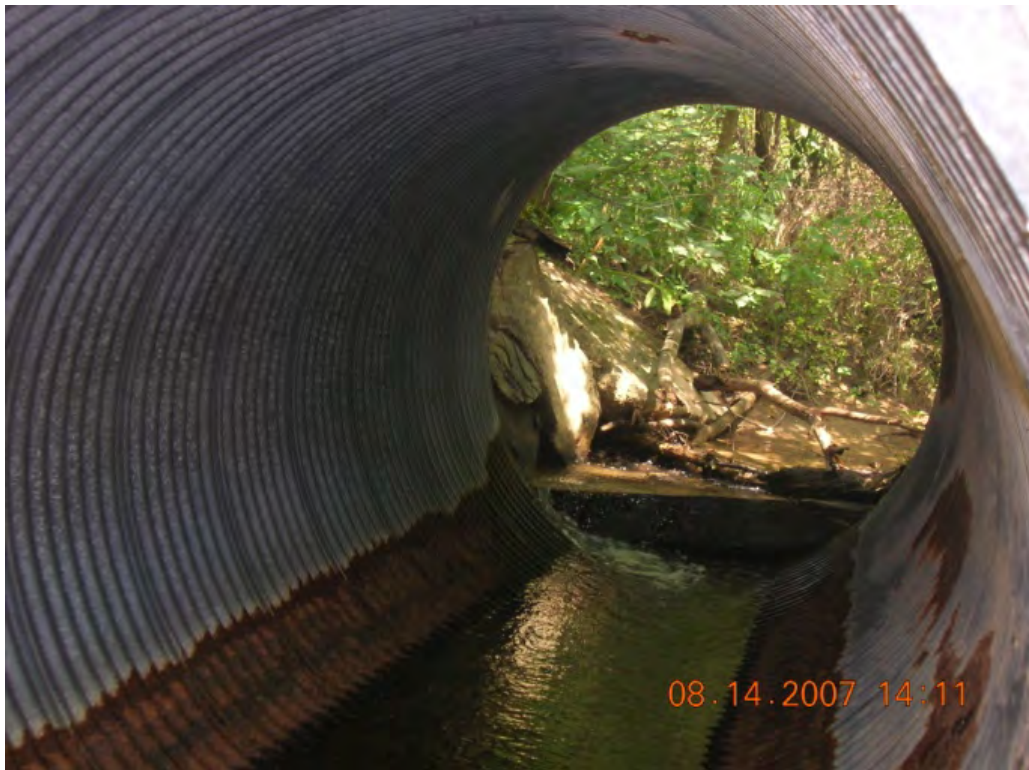
There is also a culvert acting as a fish impasse under the entranceway to the state game lands (see photo 3). In the game lands there are also several small trees with beaver chew marks in them (see photo 4), and just upstream of those trees a small beaver dam can be seen (see photo 5).

Photo 3: A culvert under a State Gamelands access road acts as a fish impasse. (EF-18)

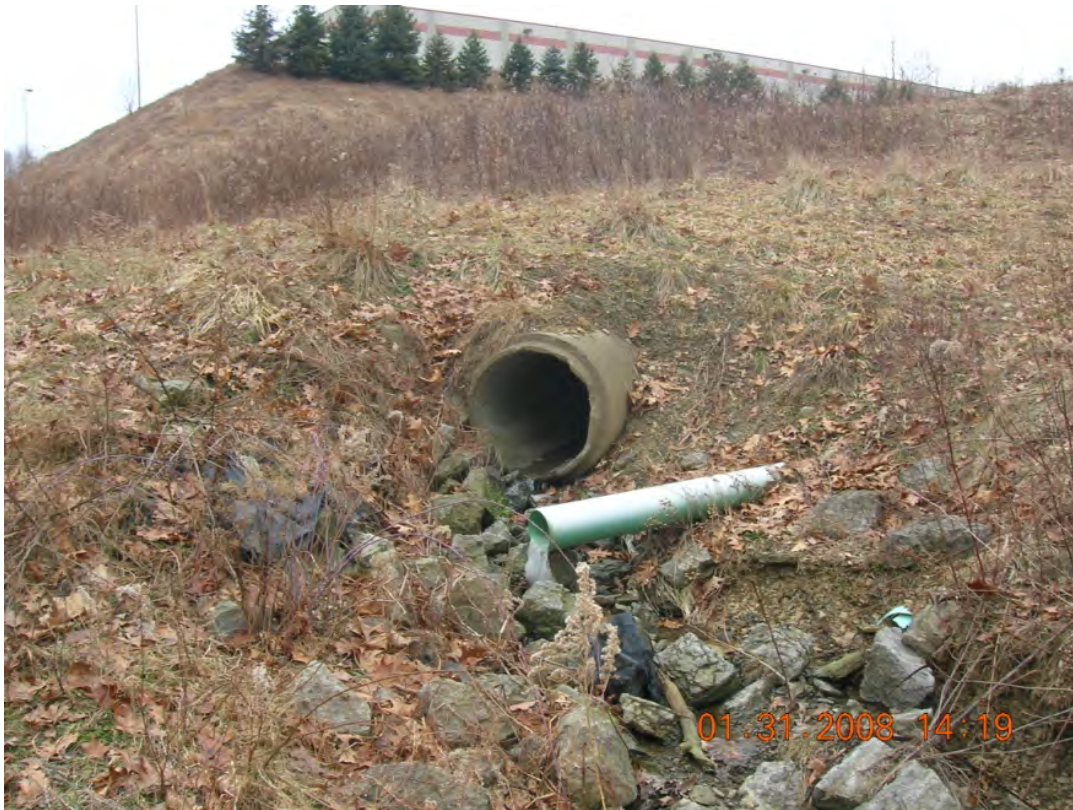
Photo 2: Storm water pond outlet from industrial park above that empties into the North Fork.  
(NF-38)

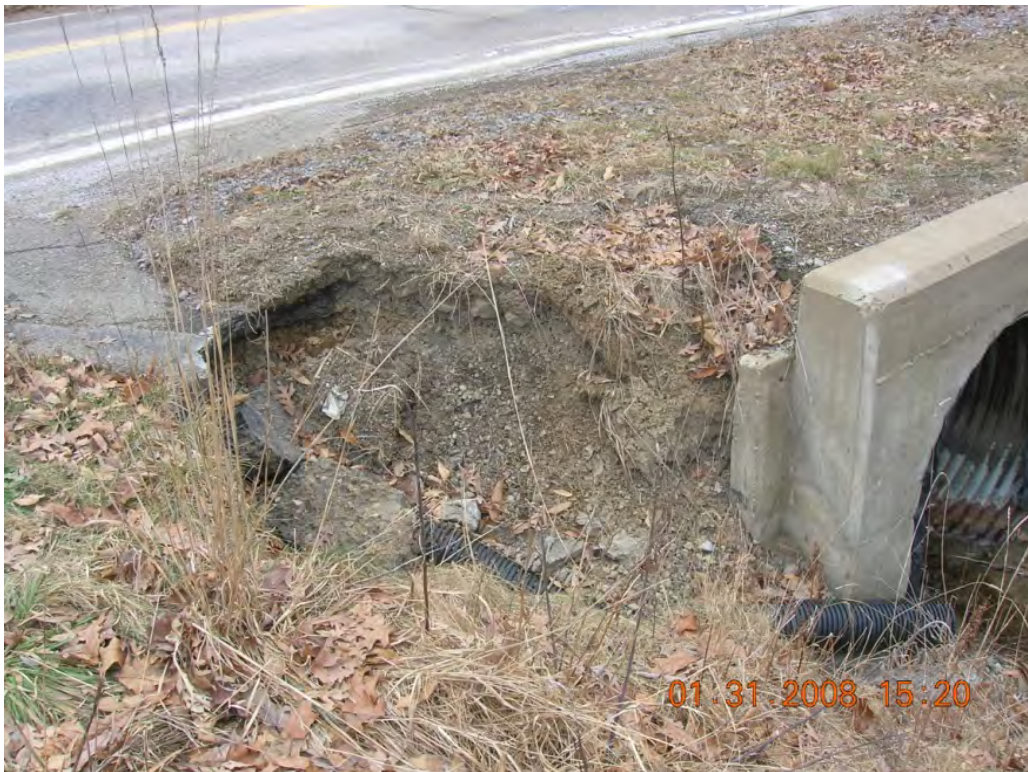
On this section of the stream there were a few erosion areas and some sedimentation. There was some erosion downstream of a possible old pond breach which caused some sedimentation in the channel. There is also a road cave-in (see photo 1) which is being washed into the stream when it rains and causing more sedimentation.

Photo 1: Roadside cave-in that is causing excess sedimentation in the stream during rain events. (NF-40)

The group could work with the local authority responsible for the road at NF40 to get that area stabilized and eliminate that source of sediment to the stream channel.

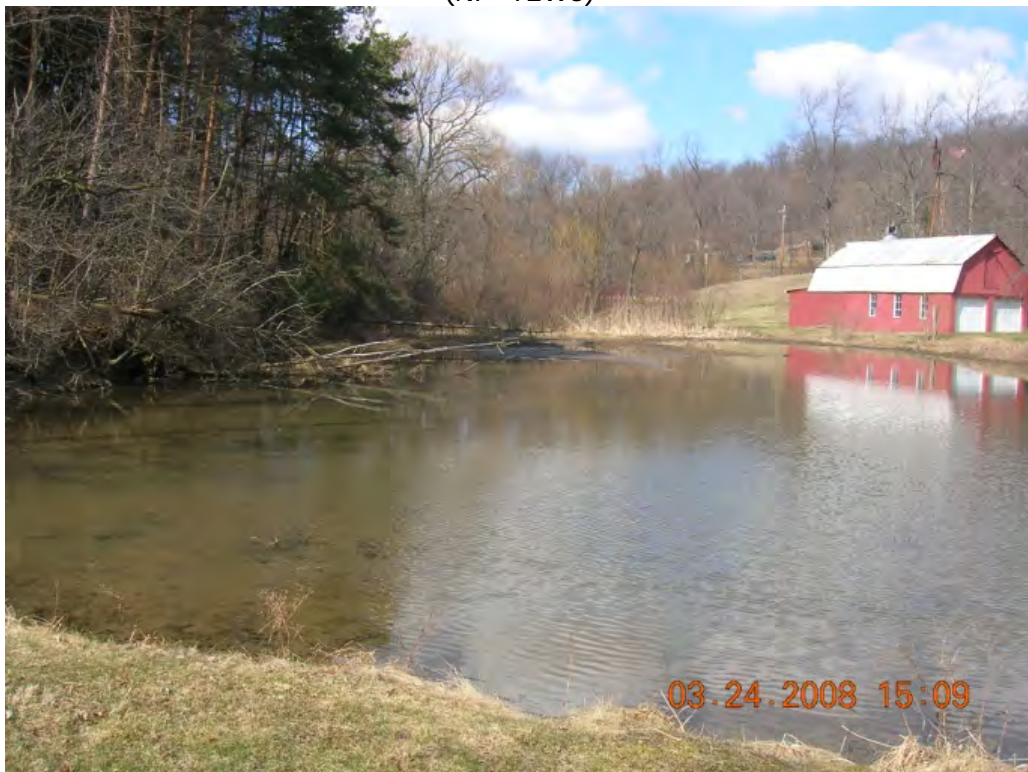
Photo 3: A pond along the tributary filled with excess sediment. (NF-T2W14)
