# BIG SEWICKLEY CREEK WATERSHED ASSESSMENT, RESTORATION, & PROTECTION PLAN

OCTOBER 2010

BIG SEWICKLEY CREEK  
WATERSHED ASSESSMENT, RESTORATION, AND PROTECTION PLAN

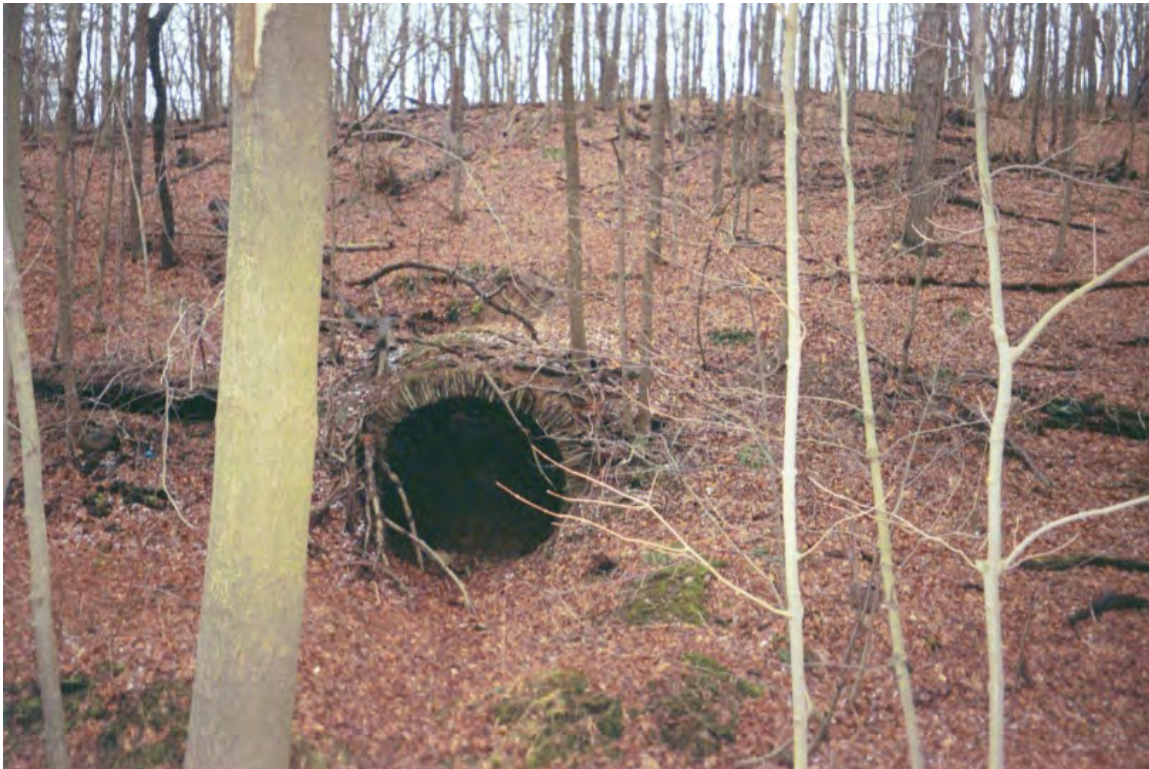
There is an interesting tunnel like structure that was observed in the hillside next to another stream nearby at NFT4W2 that appears to be an old coke oven (see photo 1). Also the silt fence that was left behind by construction needs to be removed.

Photo 1: An interesting structure (possible coke oven) noted alongside another tributary, in the hillside. (NF-T4W2)

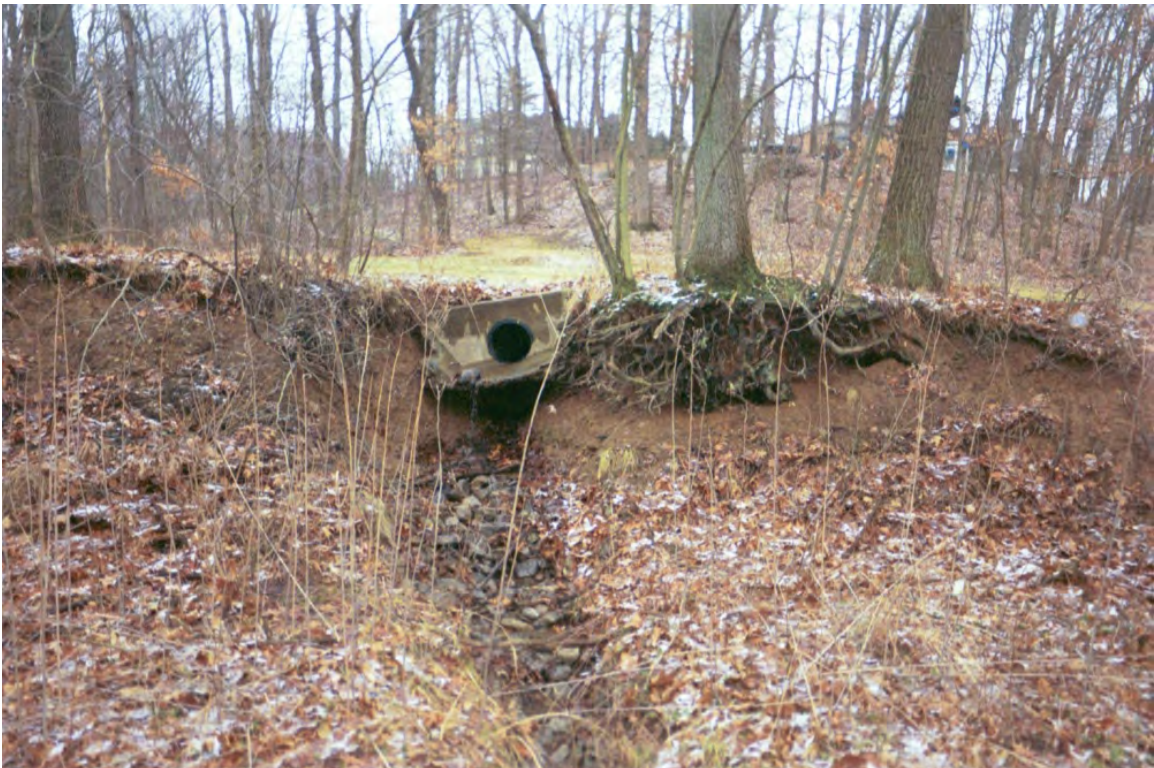
Photo 2: A storm water outlet that needs reconstructed. (NF-T5W6)

It is recommended that the storm water infrastructure be replaced/repared at NFT5W6 and W7 to improve water flow and reduce the causes of sedimentation in the stream channel.

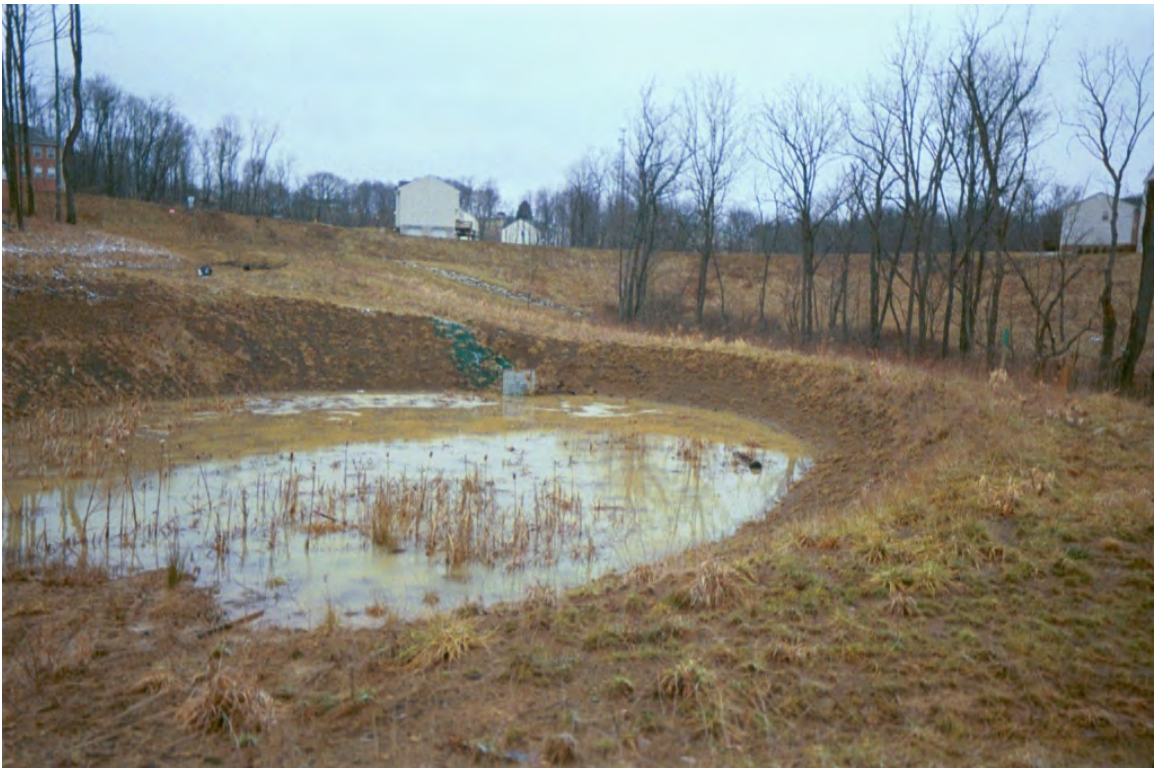
Photo 4: E&S Basin in Whispering Pines development. (NF-T5W11)

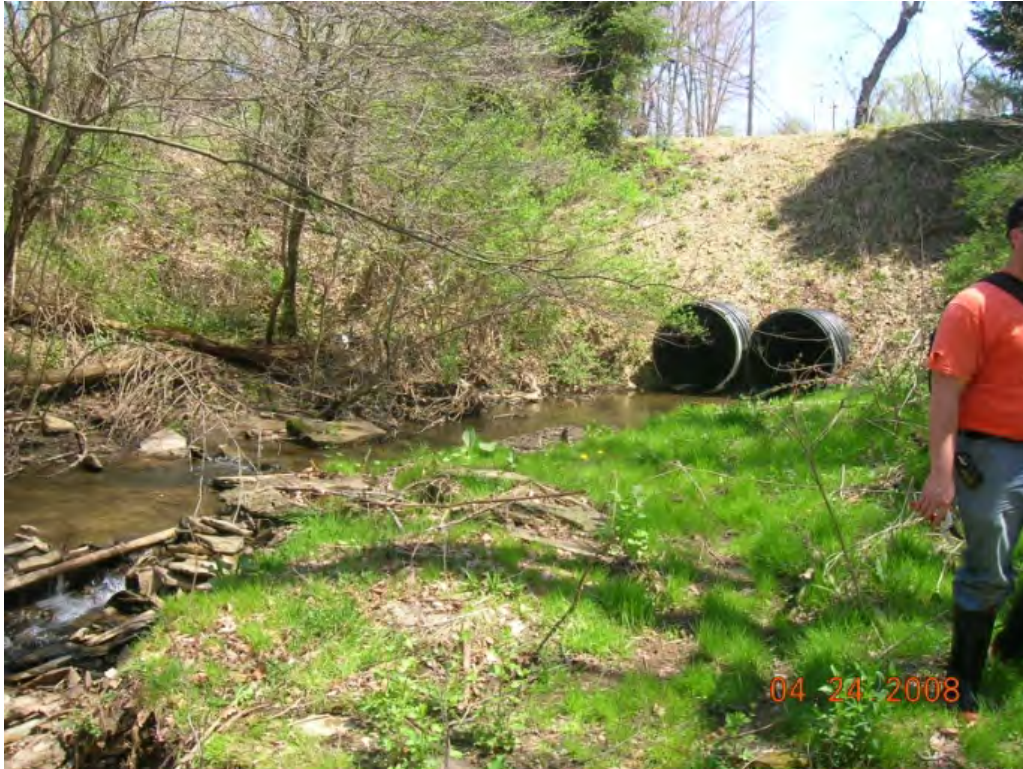
There is a culvert under a homeowner's driveway that looks properly sized for Rippling Run at RR06 (see photo 1), however the inlet side is clogged with debris (see photo 2). Rippling run also flows through Sechler's Lake at RR09 as it makes its way to BSC (see photos 3 & 4). Landowner needs to maintain the inlet side of the stream crossing so as not to cause flooding and downstream erosion.

Photo 1: Culverts under a driveway that seem properly sized on Rippling Run. (RR-06)

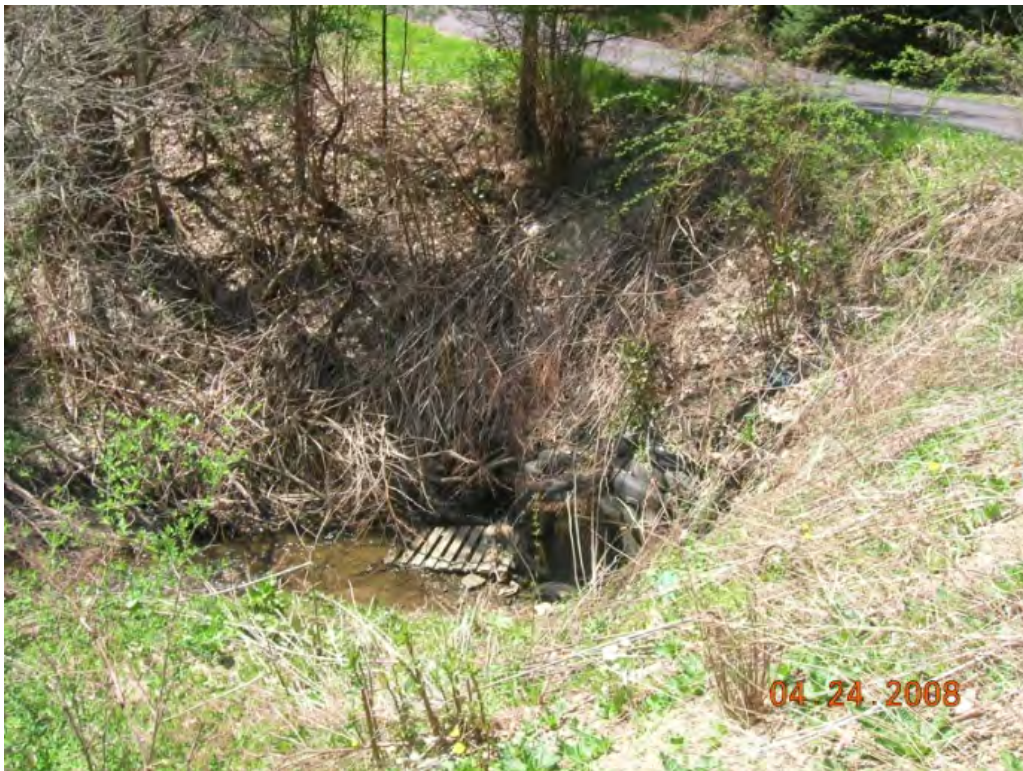
Photo 2: However, the inlets to these culverts are jammed with debris. (RR-06)
