South Fayette Visual Watershed Assessment

August 2013

**South Fayette
Watersheds Visual Assessment**

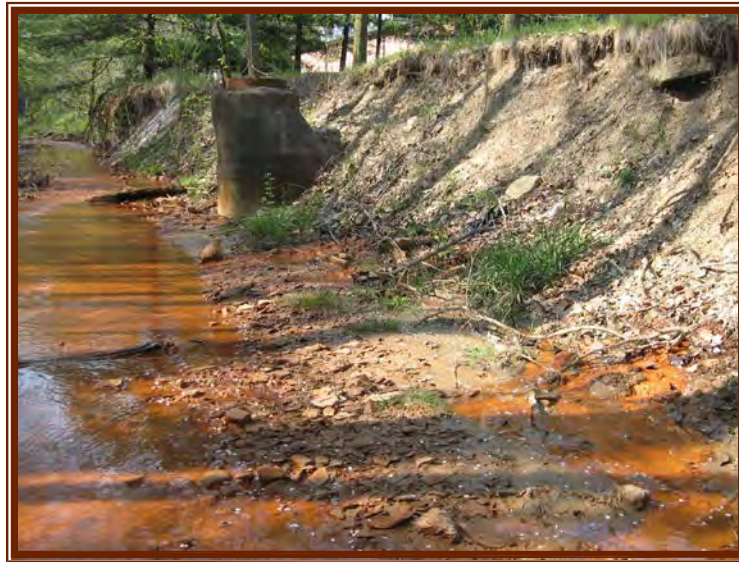
Severe erosion causing bank instability and compromising CSO system lines (CR-7 Photo 6)

The use of j-hooks or other directional in-stream structures can be installed to redirect the flow from the manholes to reduce the erosive stress on these features.

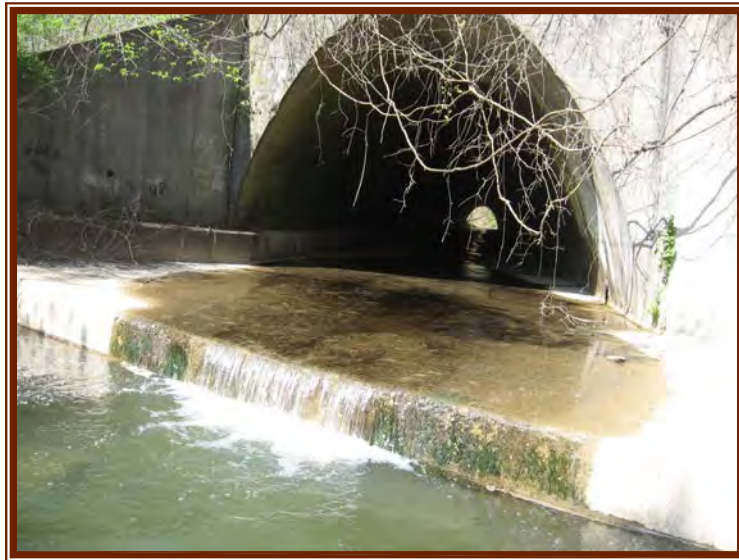
Interstate 79 crossing over Coal Run; note the concrete bottom barrier (CR-8 Photo 4)

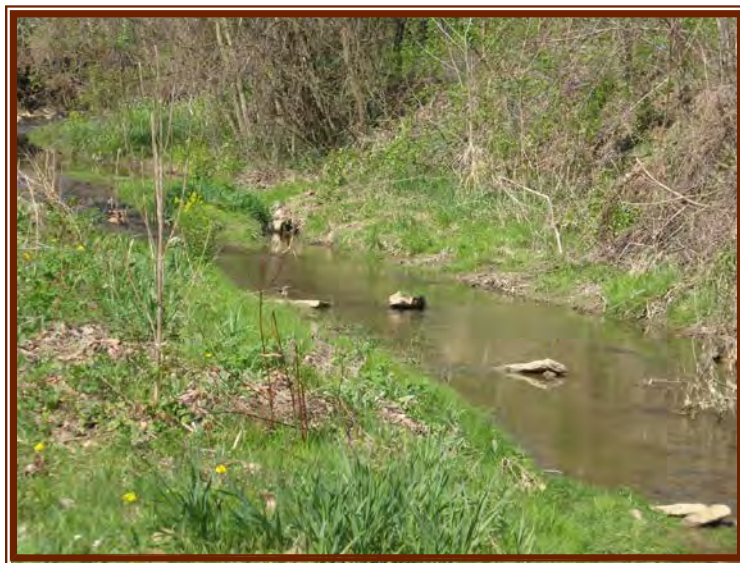
Riparian area where improvements can be implemented (CR-8 Photo 1)

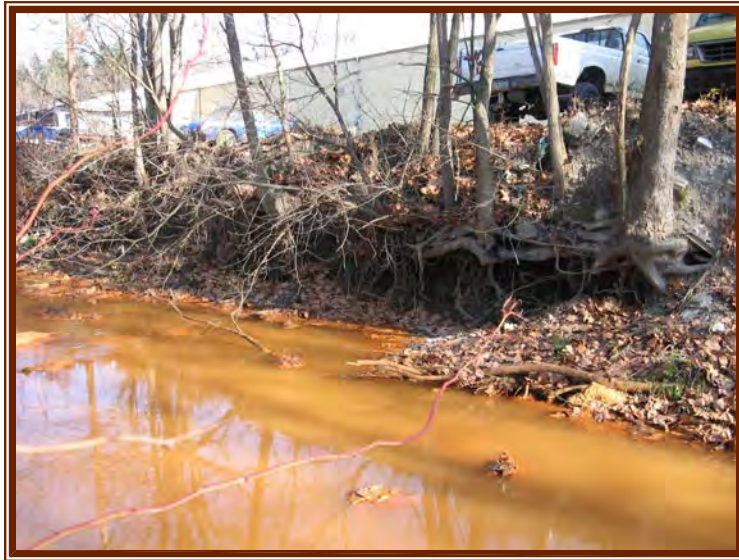
Severe erosion (MR-10 Photo 18)

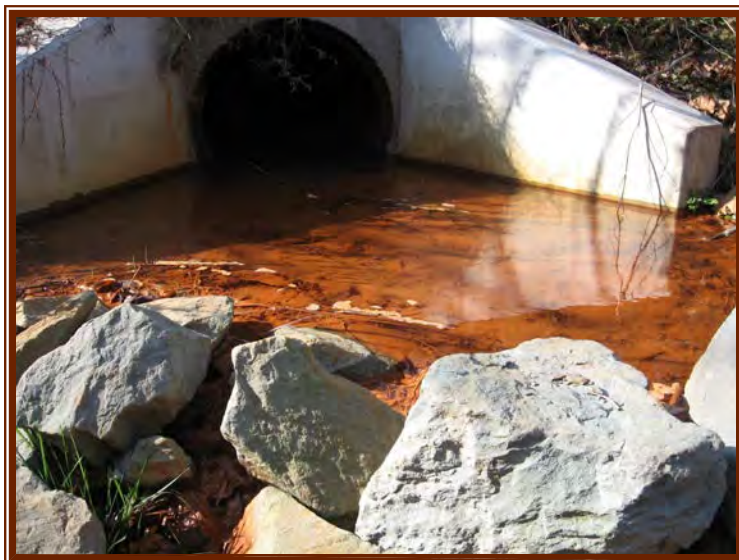
AMD problem with sulfur smell (MR-10 Photo 8)

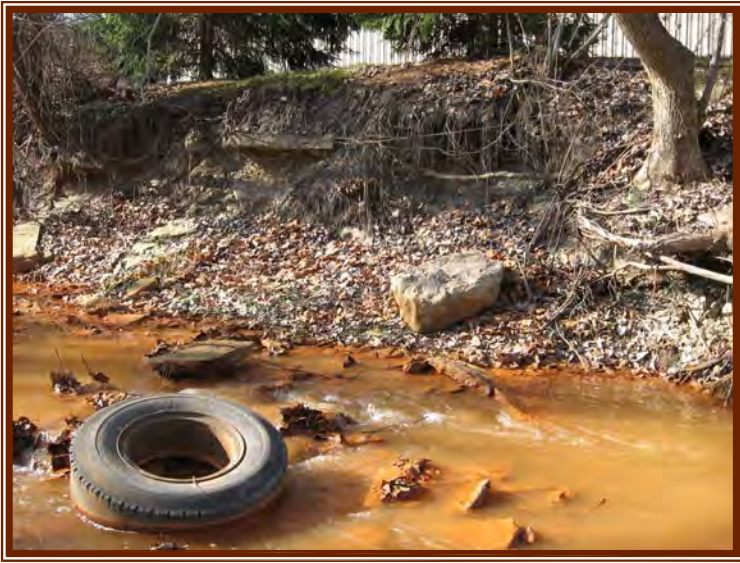
Obstructions (MR-10 Photo 14)

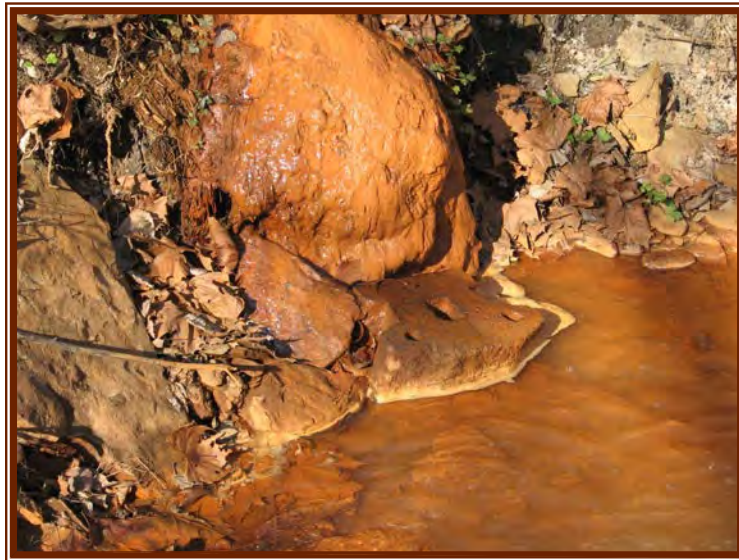
Foam at pipe discharge (MR-10 Photo 13)

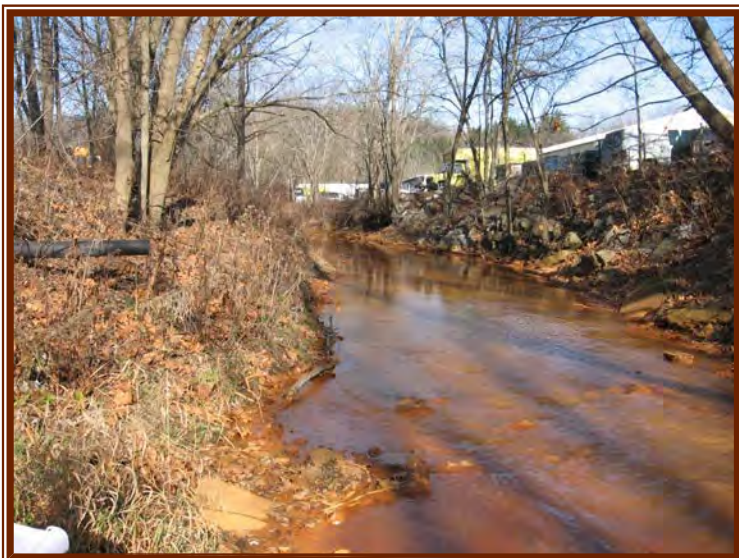
Vehicles adjacent to stream (MR-10 Photo 19)

Oil sheen is identified in this reach; identify source of sheen discriminating between true oil residue possibly from the adjacent parking lot or a type of iron bacteria intertwined with the presence of AMD. If it is found to be true oil, then approach adjacent landowners regarding the location of vehicles and the enhancement of the riparian area.

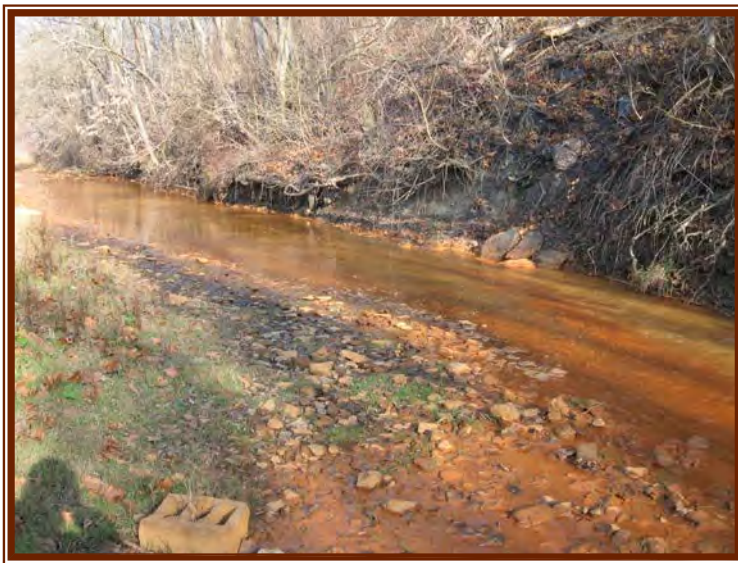
Erosion (MR-11 Photo 8)

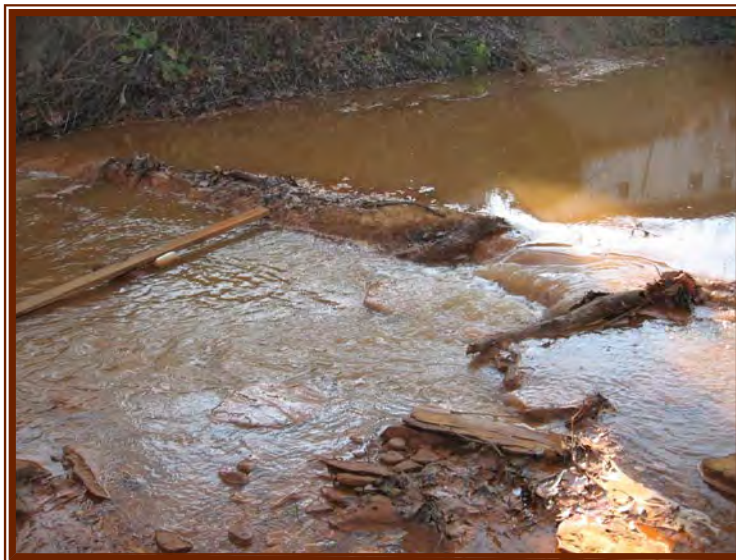
Obstructions (MR-11 Photo 18)

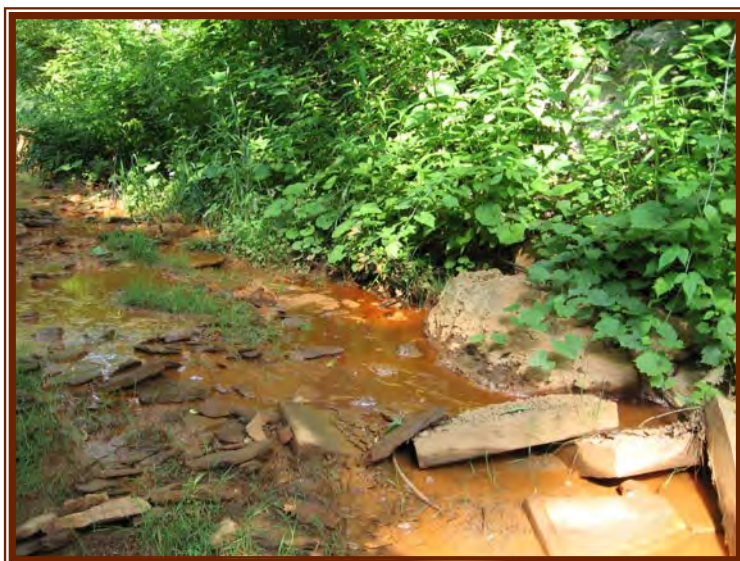
AMD seep (MR-12 Photo 9)

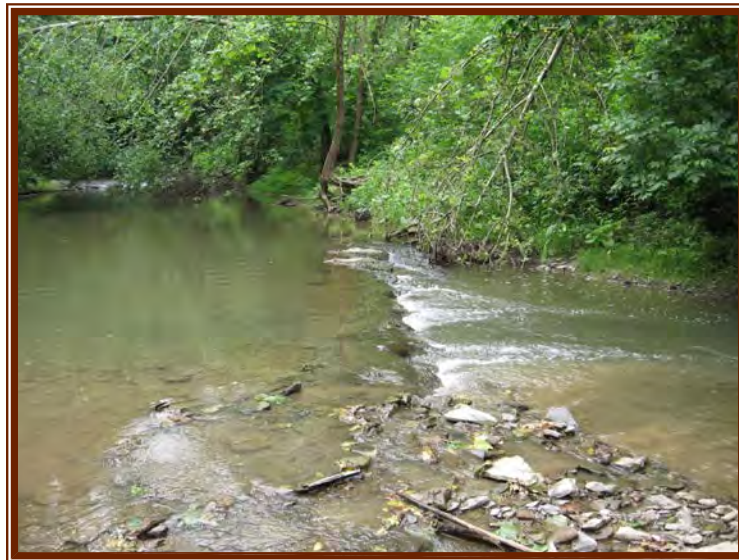
Sewer line crossing (MR-13 Photo 3)

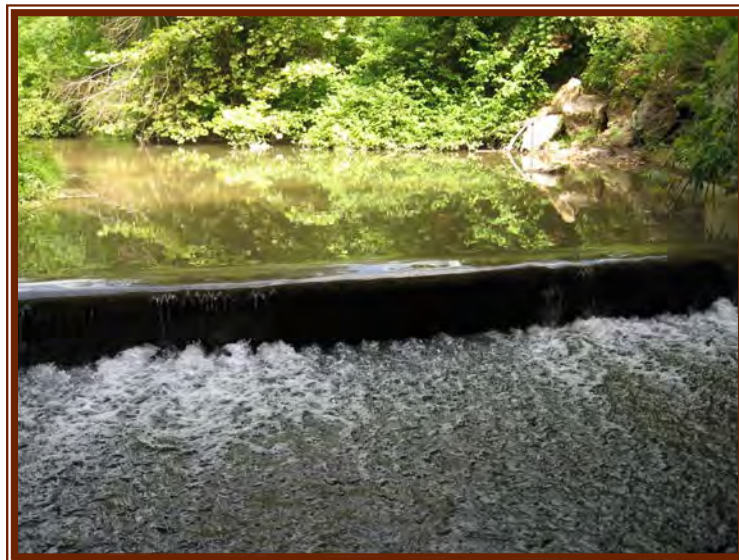
PA 50 Bridge and spillway (MR-13 Photo 8)

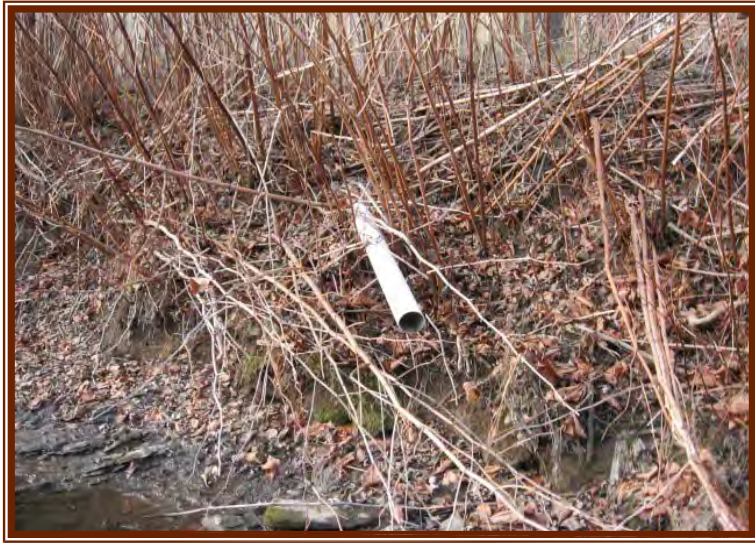
Pipe Outfall (RR-2 Photo 5)

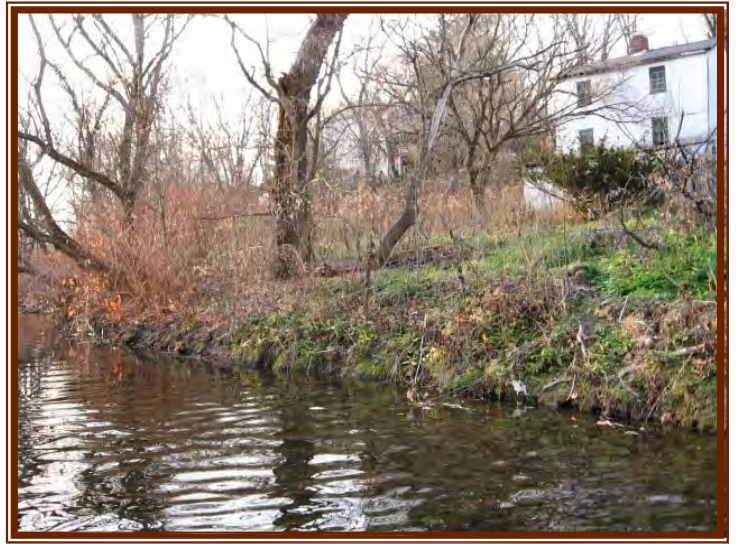
Poor Riparian Area (Robinson Run 1 019)

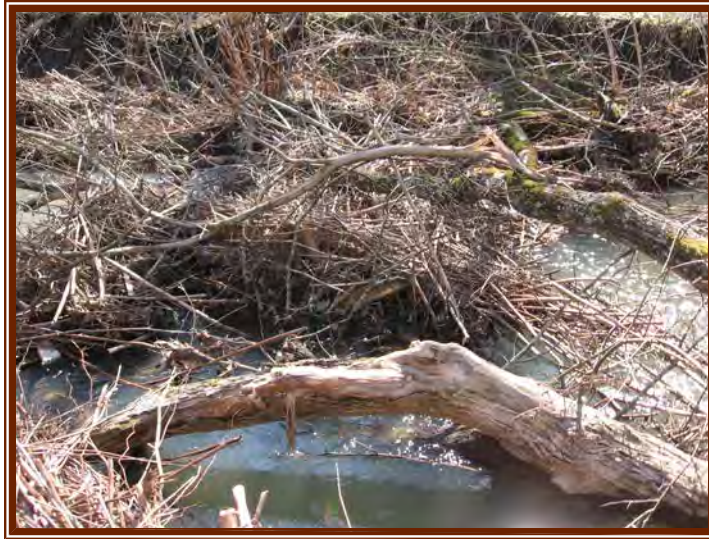
Natural blockage (RR-6 Photo 1)

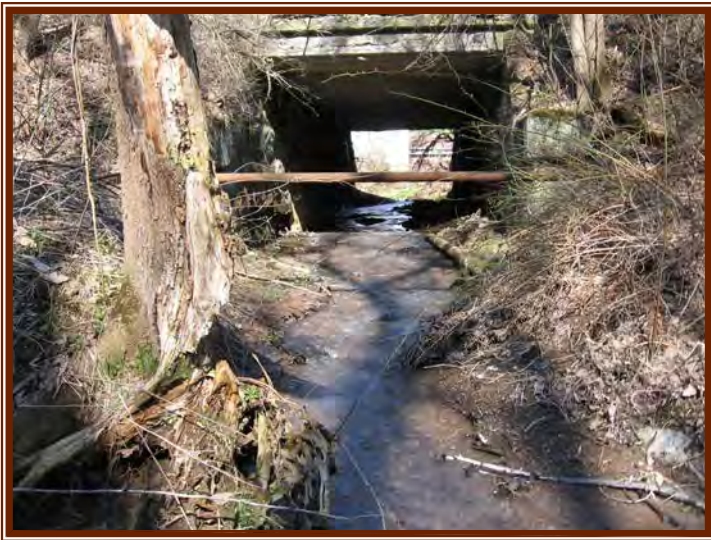
One of many crossings (RR-6 Photo 4)

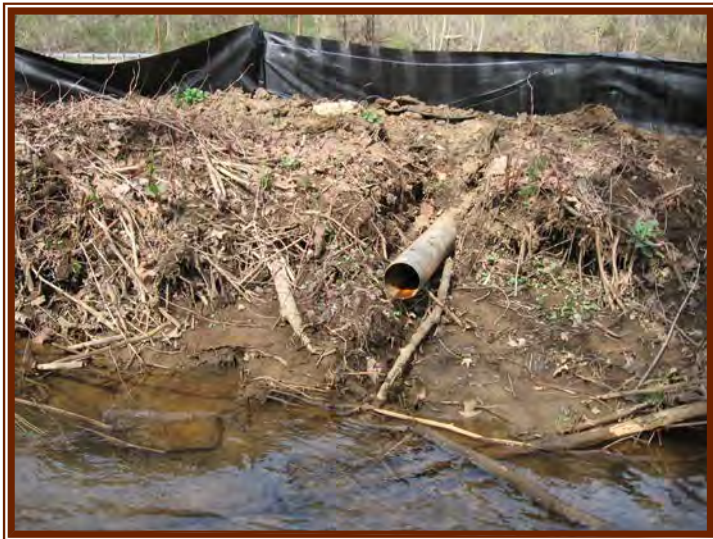
Drainage (RR-8 Photo 5)

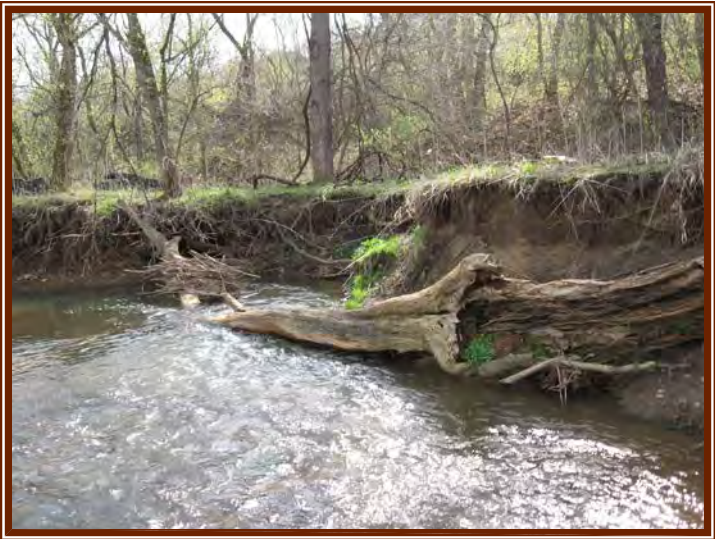
Bank erosion (RR-7 Photo 6)

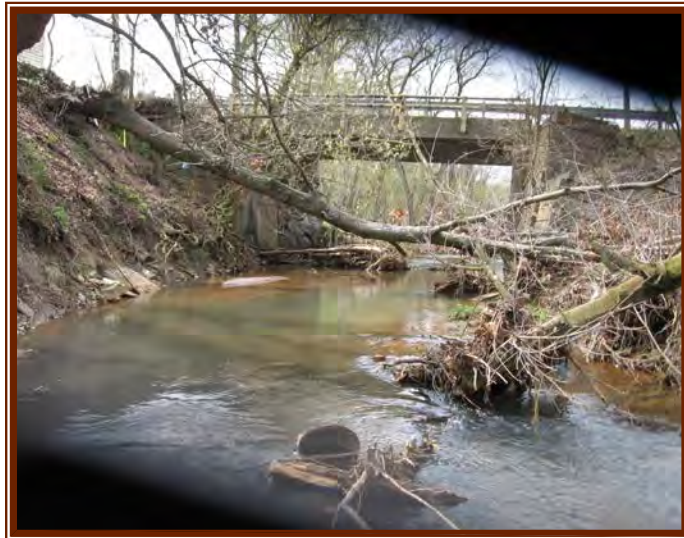
Multiple stream crossings in section (RR-8 Photo 9)
