East Branch Tionesta Creek

COLDWATER CONSERVATION PLAN

McKean, Warren, and Elk Counties

May 2017

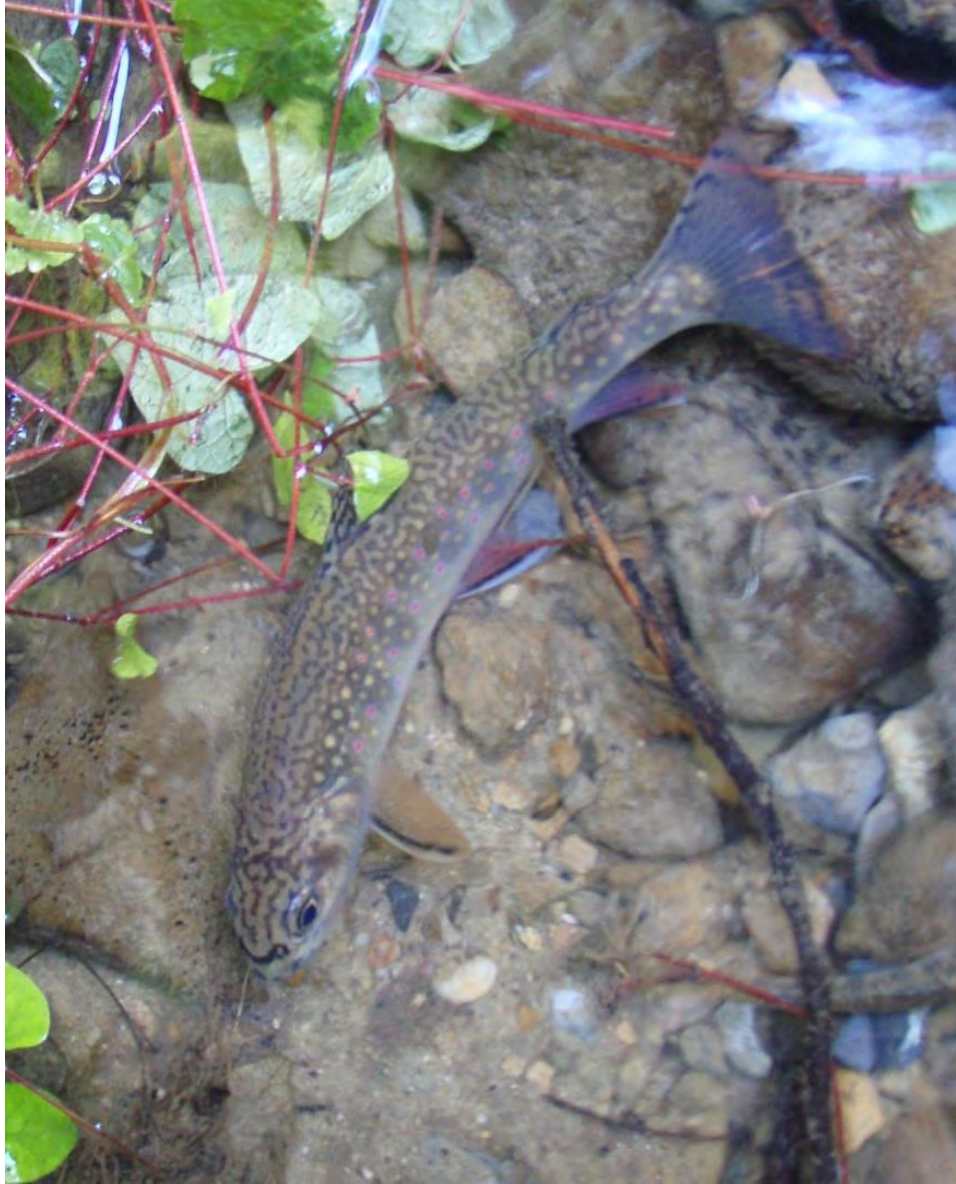
5806: Wild brook trout were observed in many stream segments and are considered to inhabit the entire watershed.

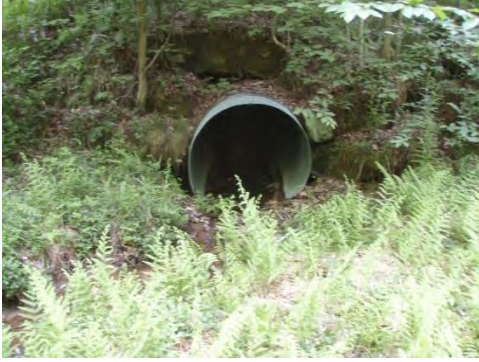
6164: Undersized culvert on Forest Road 462A.
