SANDY LICK CREEK HEADWATERS COLDWATER CONSERVATION PLAN

Spring 2015

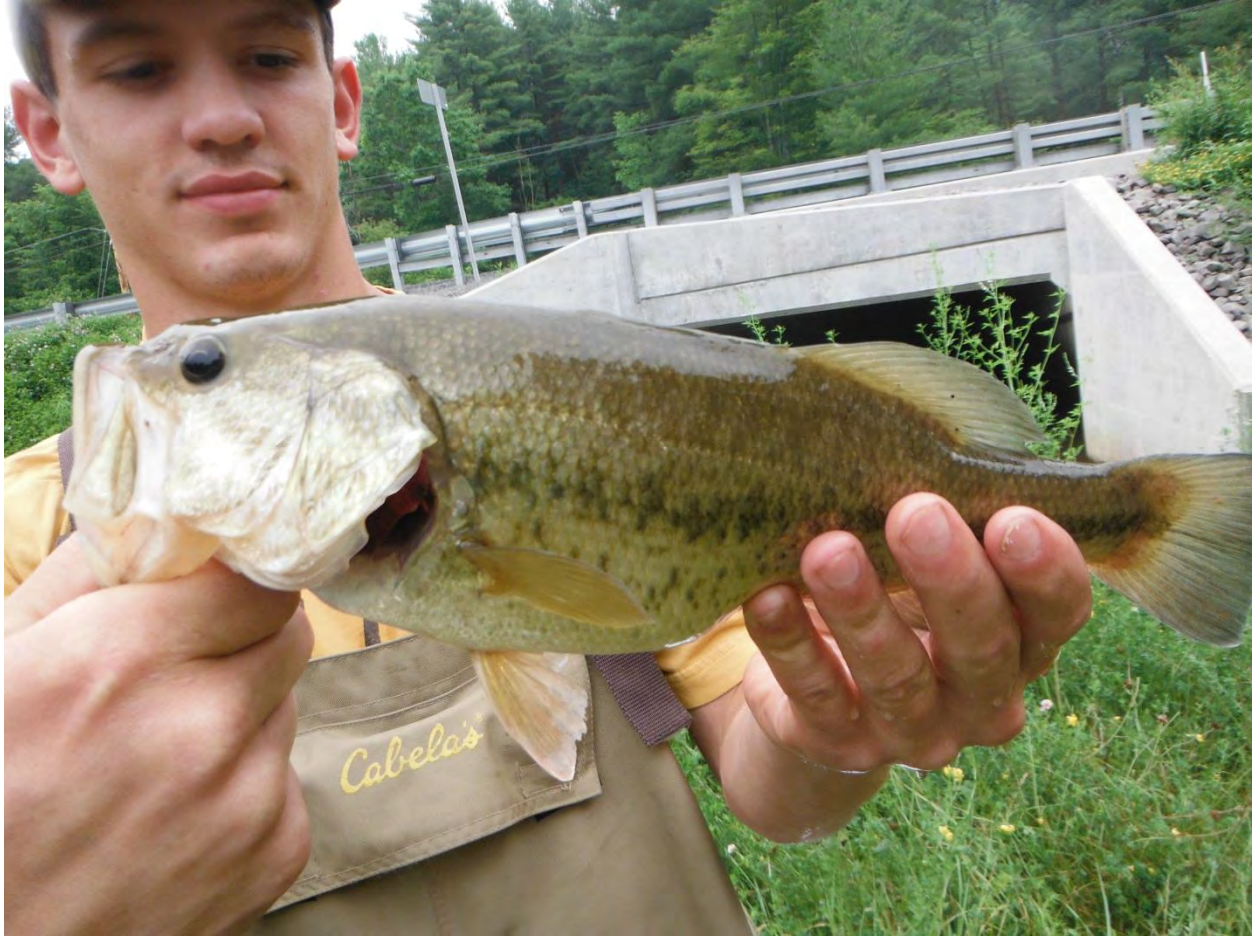
Site SL1: RT 255 above bridge along Mountain Run Road. There were no trout found at this site.

Largemouth bass caught at site SL1.

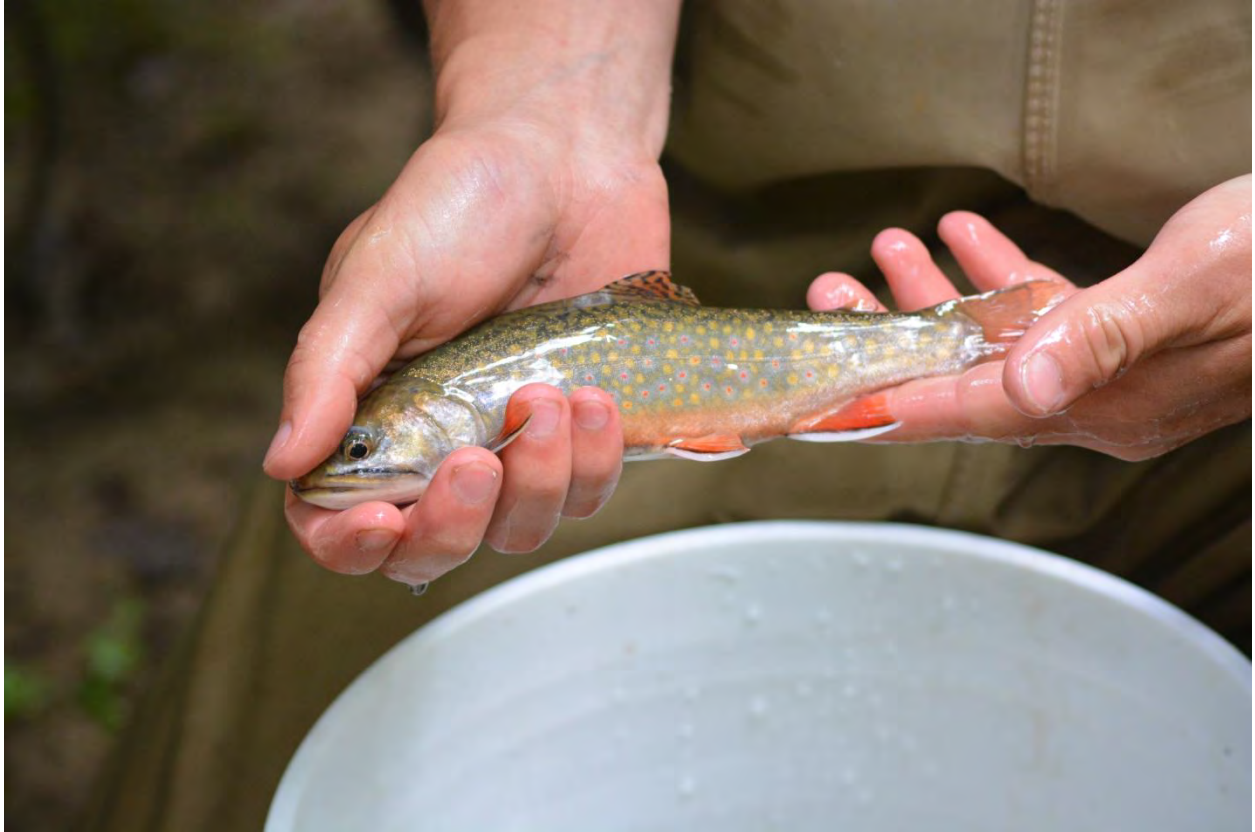
At SL2, a total of 26 brook trout were found throughout 7 size classes as seen in Table 8 above. The presence of the trout from the smaller size classes indicates natural reproduction is likely occurring in this tributary. There were also white suckers and blacknose dace found during the survey.

Site SL2: Pulled off of Mtn Run Rd. A total of 26 brook trout were found at this site throughout 7 size classes. The representation of the smaller size classes indicates natural reproduction could be present.

2 brook trout caught at site SL2

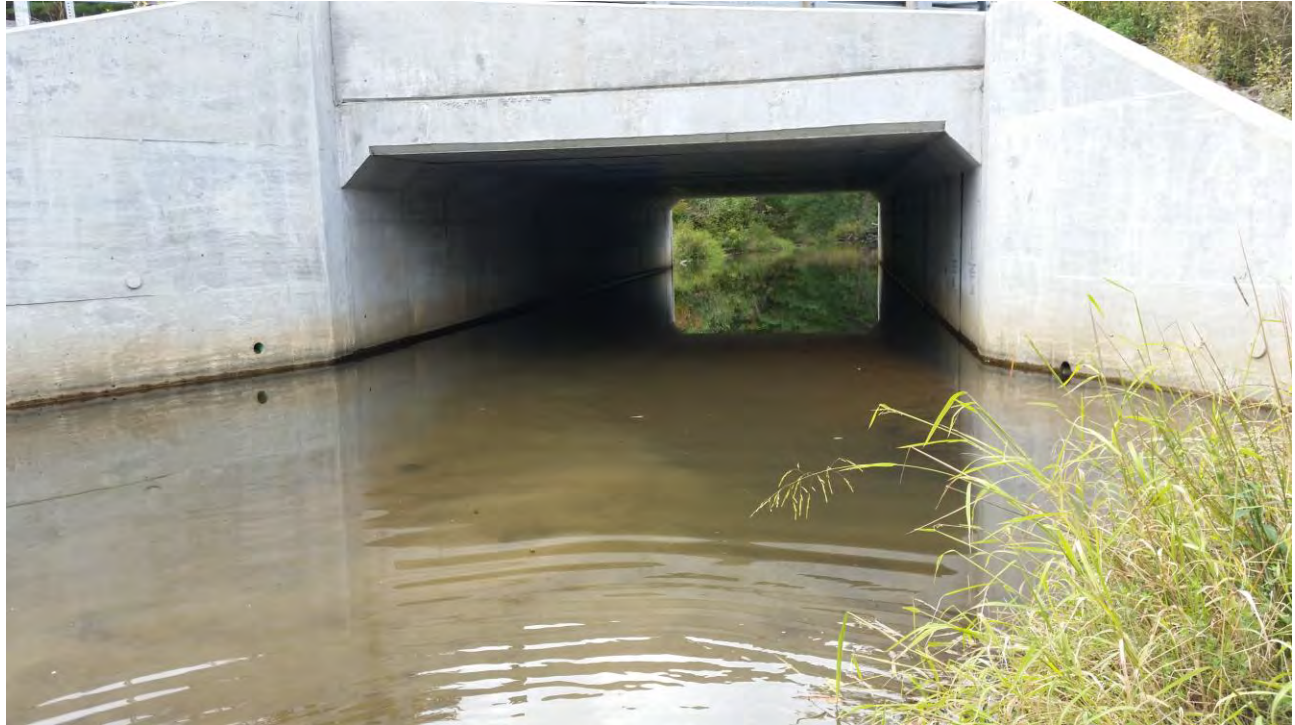
Figure D-3: Site SL2

Site SL2 is at the mouth of tributary #2 to the Sandy Lick Creek headwaters. The entirety of this tributary flows through forested land and there are no road crossings. The only way to access this site was through a backyard and by crossing the main stem of the Sandy Lick Creek.

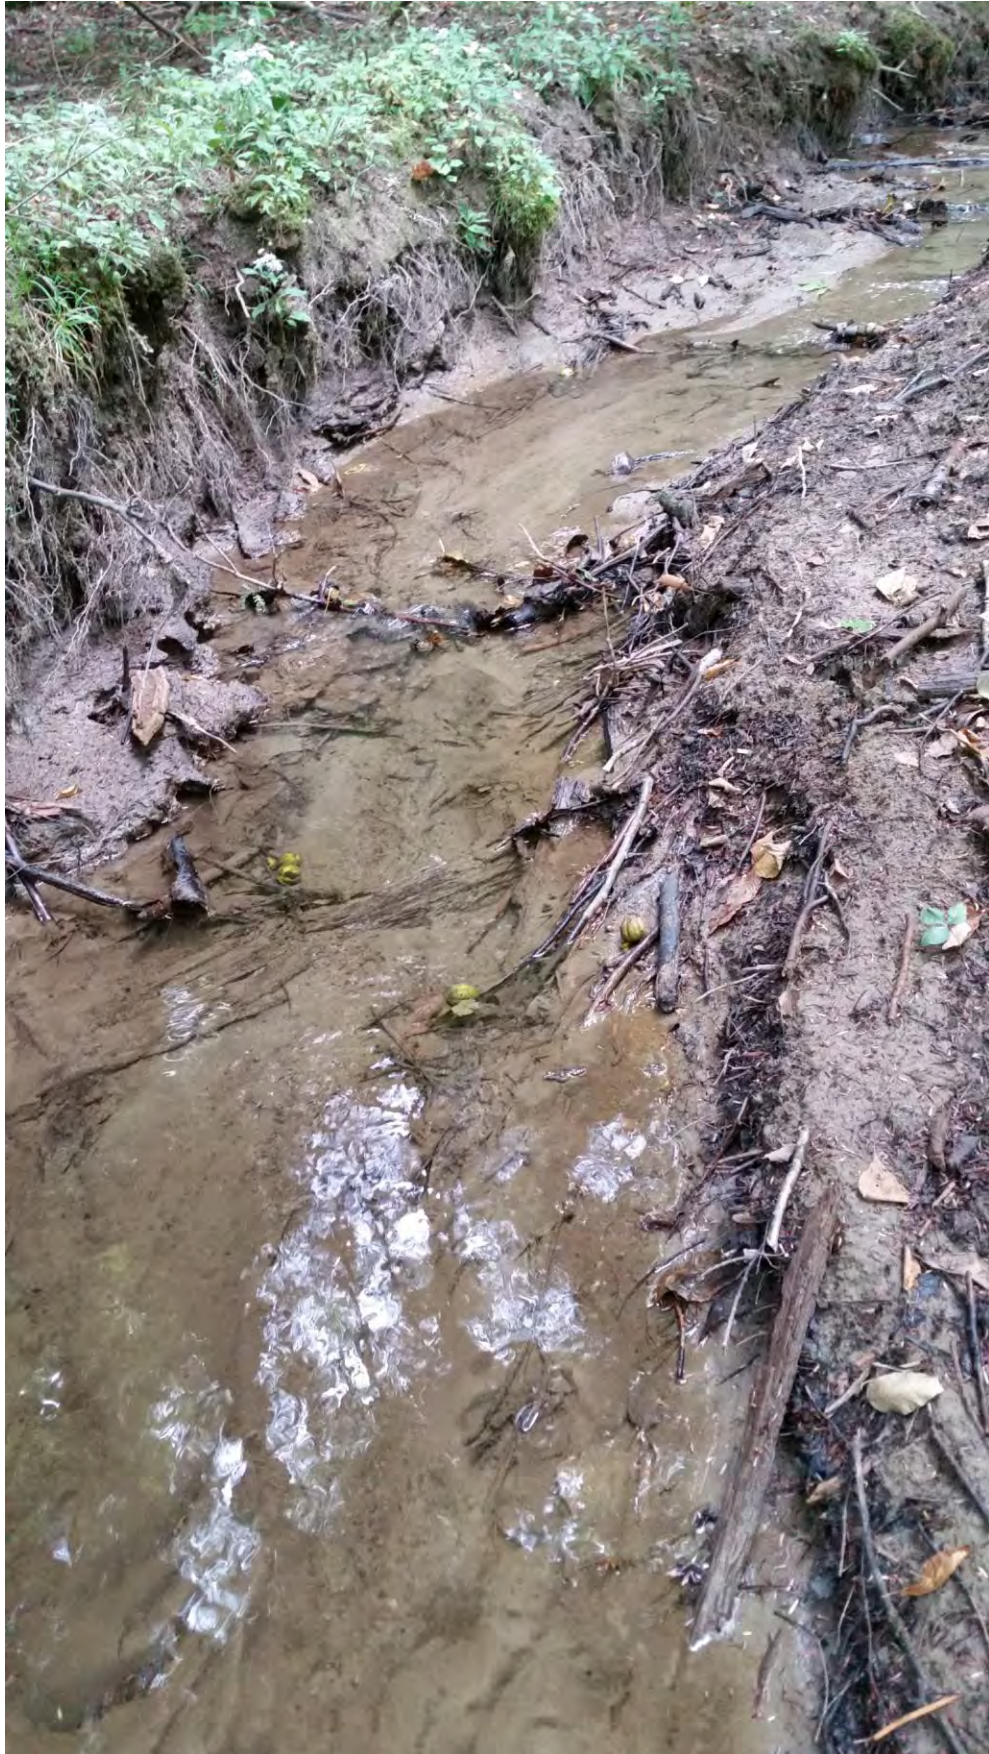
Figure D-4: Site SL3

Sample site SL3 is on the main stem of the Sandy Lick Creek downstream of the unnamed tributary #2 adjacent to Paul Short Road. This site was chosen to determine the extent of the thermal pollution on the main stem of the Sandy Lick Creek due to the ponds found on the unnamed tributary.

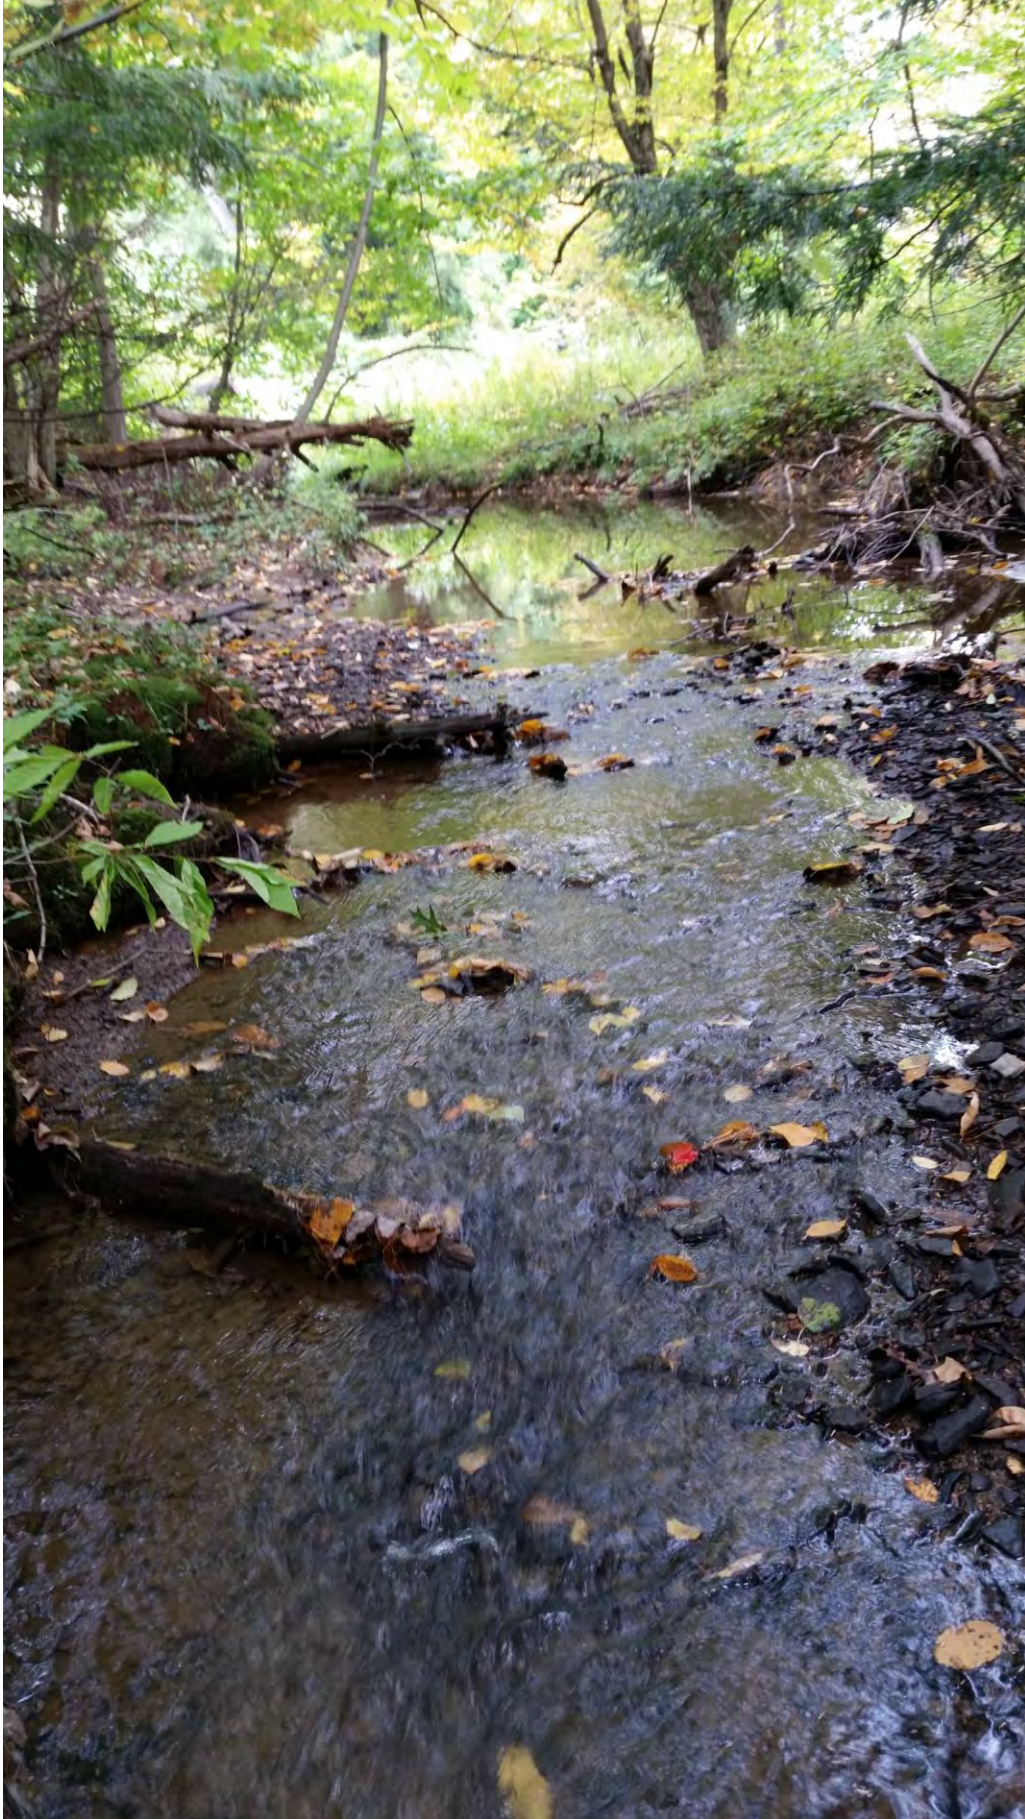
There are five road crossings on the headwaters of the Sandy Lick Creek. Of these, two are bridges while the remaining three are culverts. The bridges are located where SR255 crosses the Sandy Lick just upstream of Sabula Lake and where Paul Short Road crosses the Sandy Lick. Both bridges appear to be constructed in a manner that does not visually appear to hamper fish passage. The culvert installed where UNT #3 crosses Mountain Run Road is severely perched and impedes aquatic organism passage. The downstream end of the culvert sits two feet above the top of bank and causes a waterfall into a small pool.

Figure D-5: Culvert at SL4

1. A more in depth culvert inventory and aquatic organism passage study should be conducted on the culverts in the watershed. The culvert on the unnamed tributary #3 is the primary area of concern as it prevents fish passage freely through this tributary. Efforts should be made to work with Sandy Township to pursue proper replacement of this culvert.
