Substantial Damage Inspection Procedure

FEMA Region III

Substantial Damage Worksheet

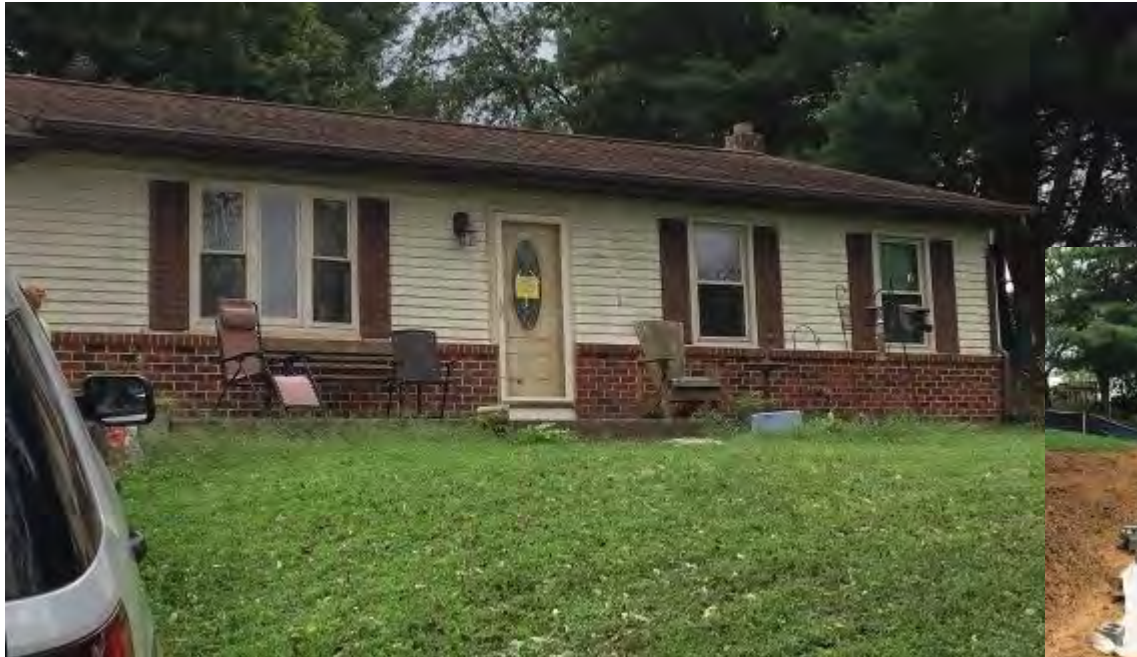
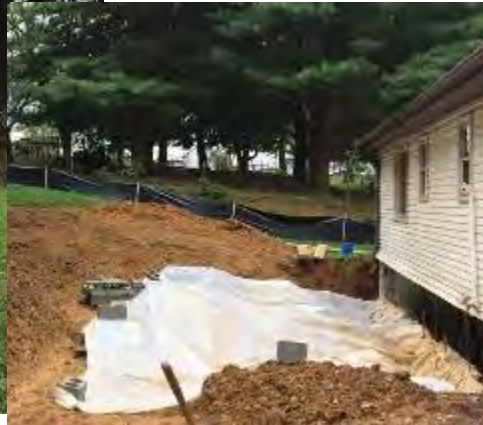
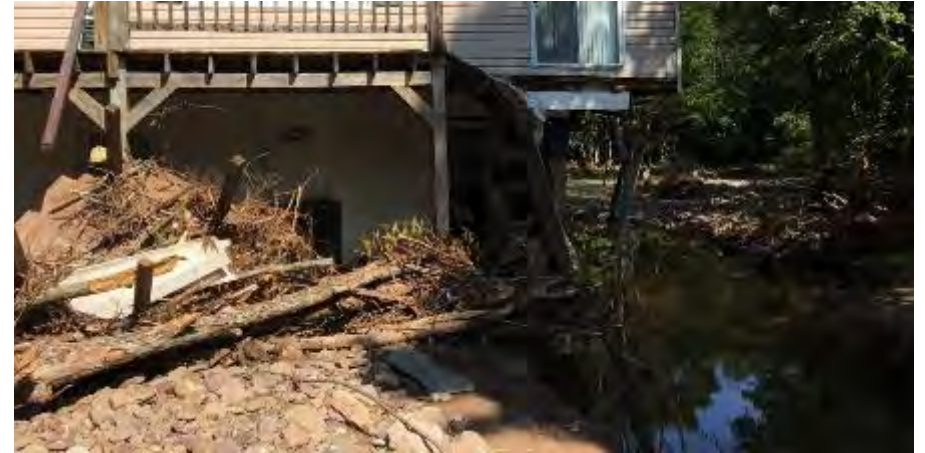
Footers and Foundation

- Check for damage around the house:
 - Was footers or foundation undermined and allowed to settle?
 - Are there cracks, if so are the cracks new or existing prior to the event?
 - Are there portions missing?

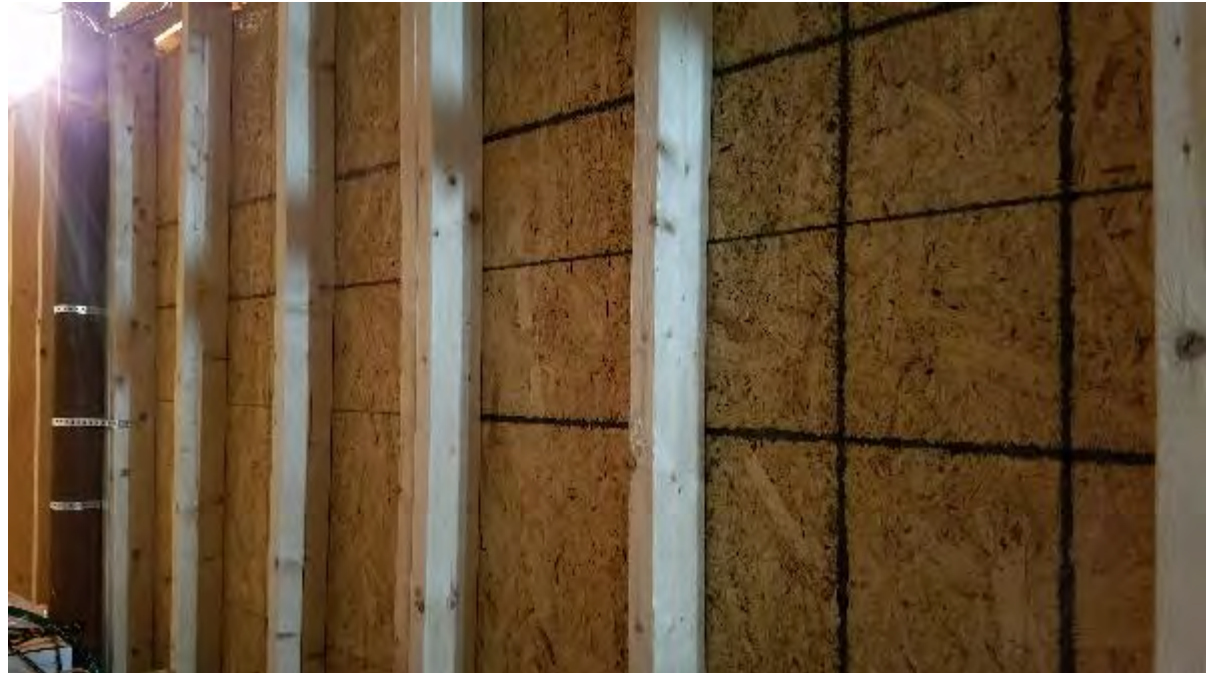
Superstructure

- Walls and Roof Support
 - Did they become inundated?
 - Are they twisted, bowed, or broken?
 - Are portions missing?

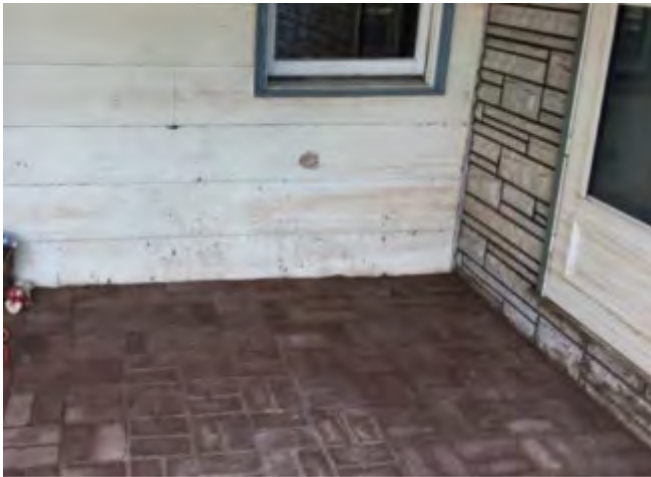
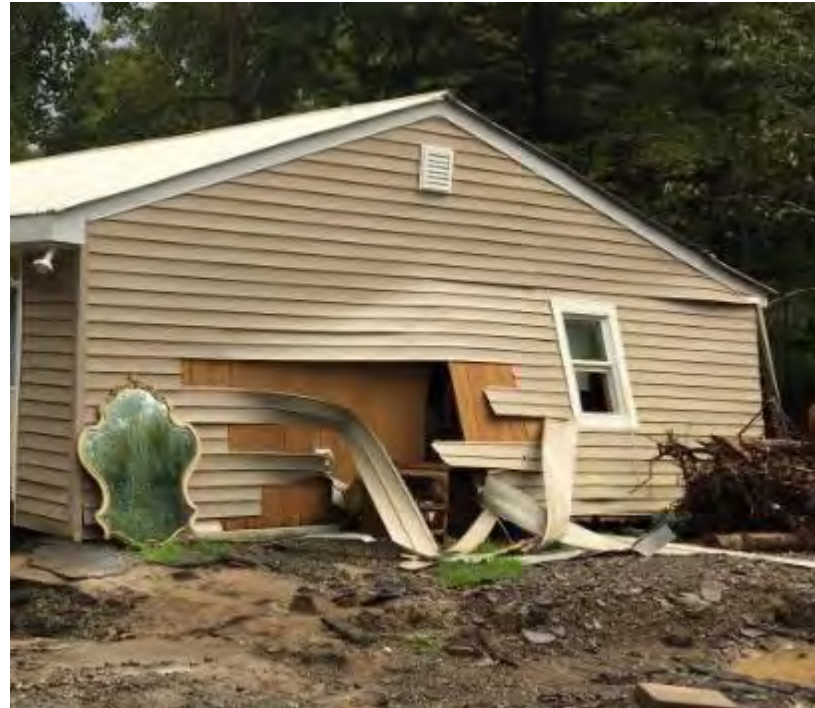
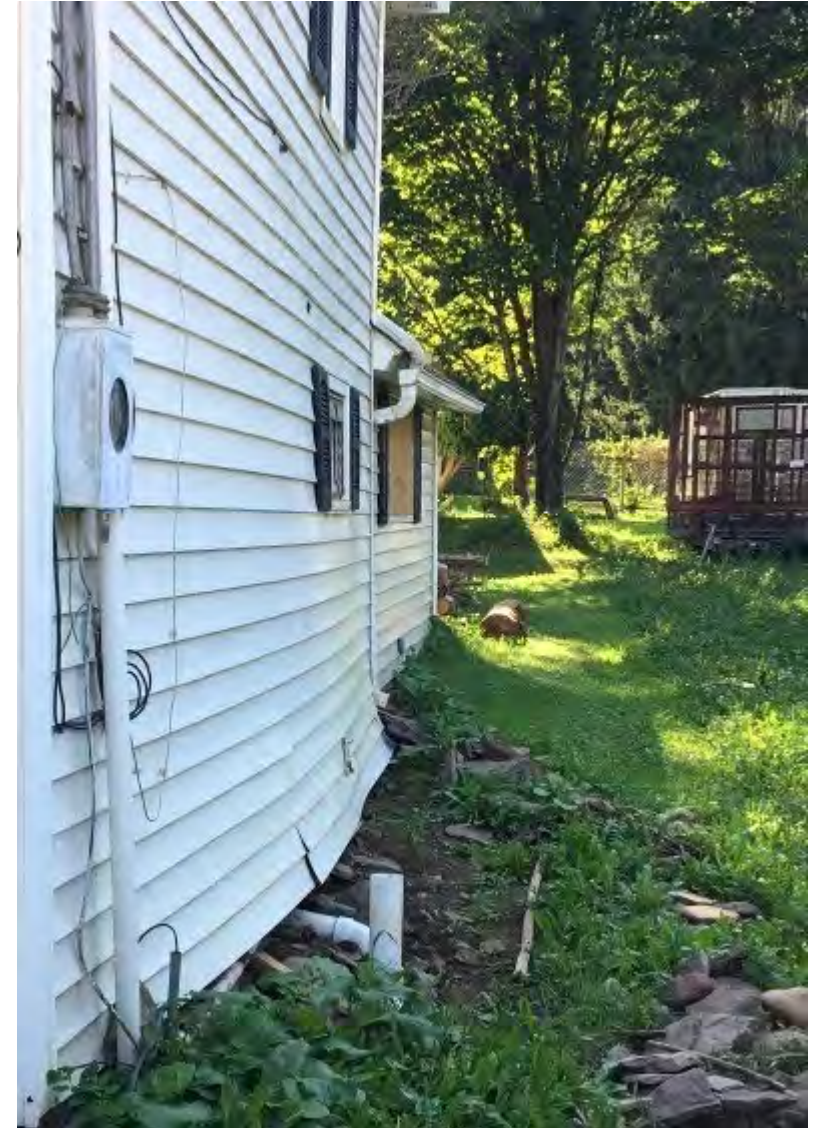
Exterior Finish

- Does it need cleaned?
- Damaged?
- Missing?

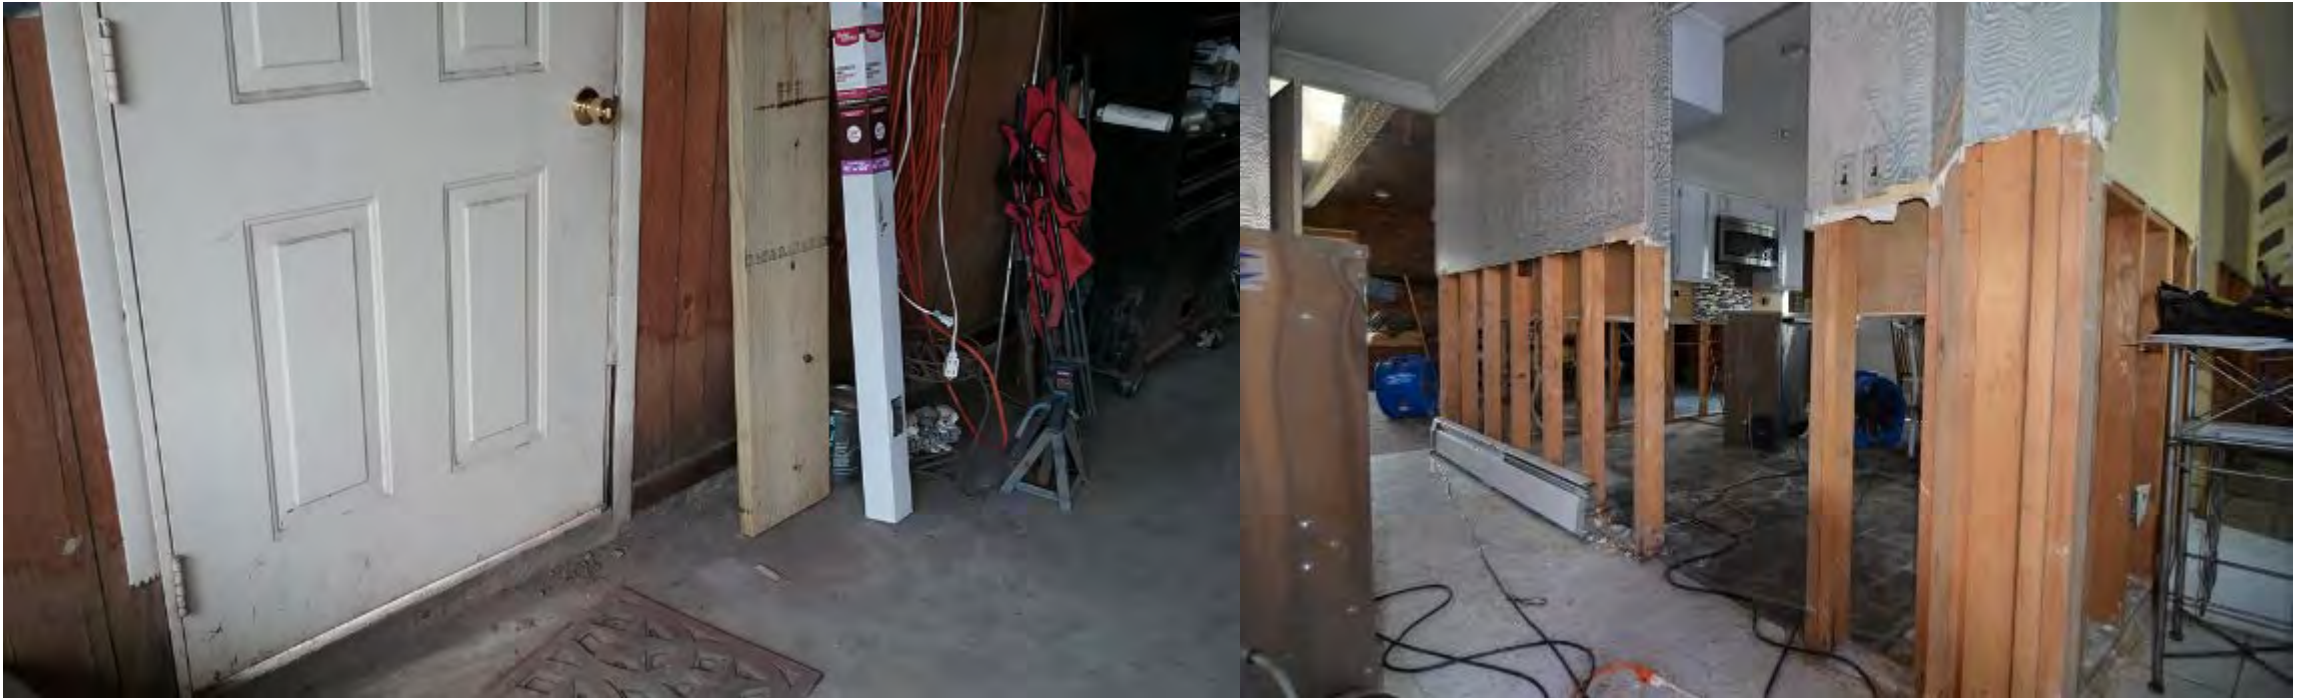
Interior Finish

- Damage to Drywall or other wall coverings?

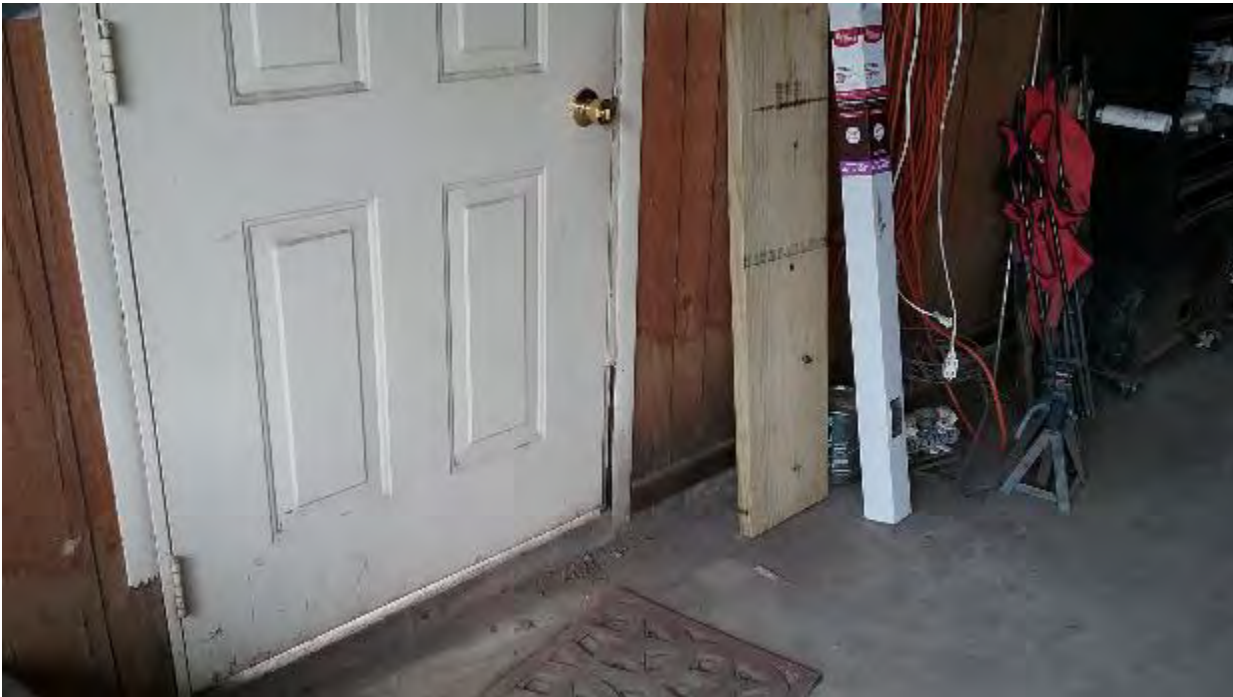
Doors and Windows

- Inundation may cause warping of frames and doors.
- Windows or doors broken or missing.

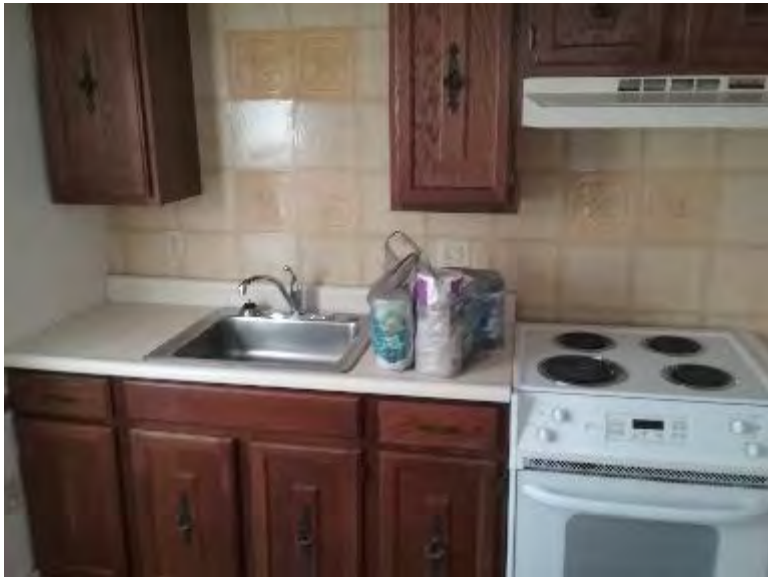
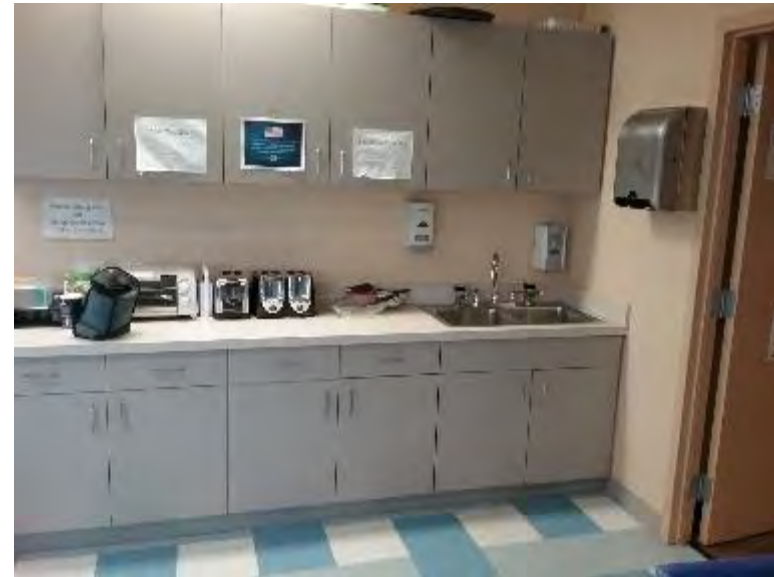
Cabinets and Countertops

- What are they made of (can they be cleaned)?
- What was the height of the flood? May only impact a portion of the cabinets.

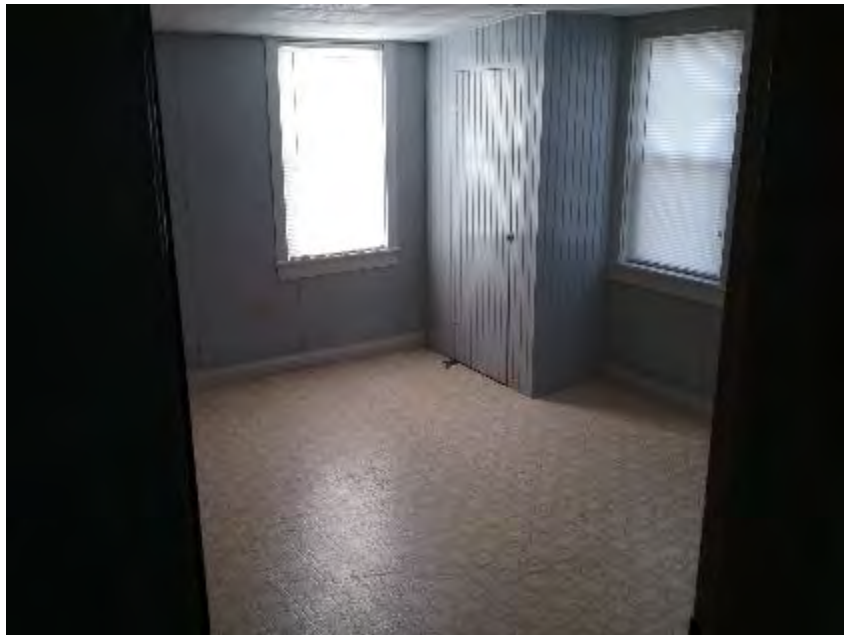
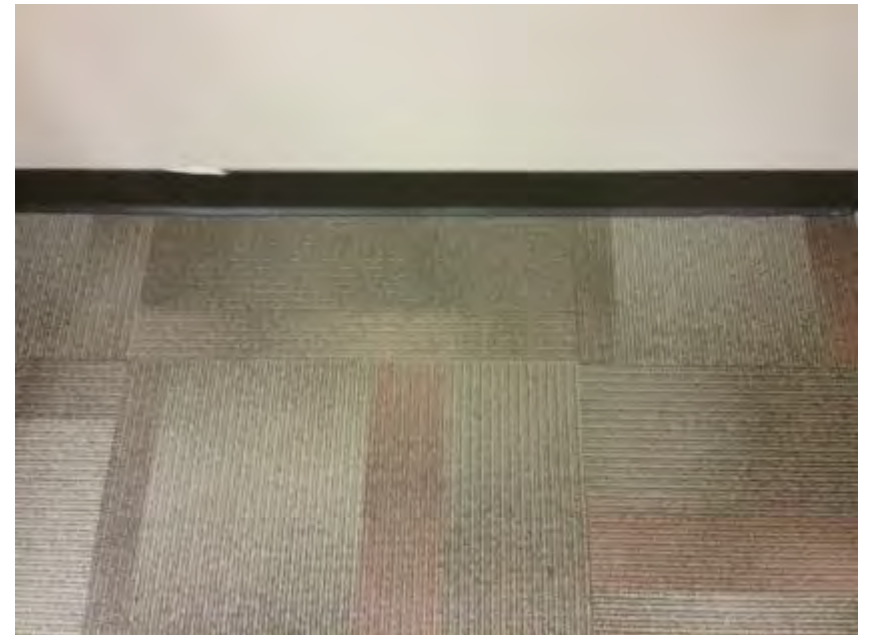
Floor Finish

- Typically flooring will have to be replaced if inundated with flood water for any duration. Environmental conditions may also factor in.

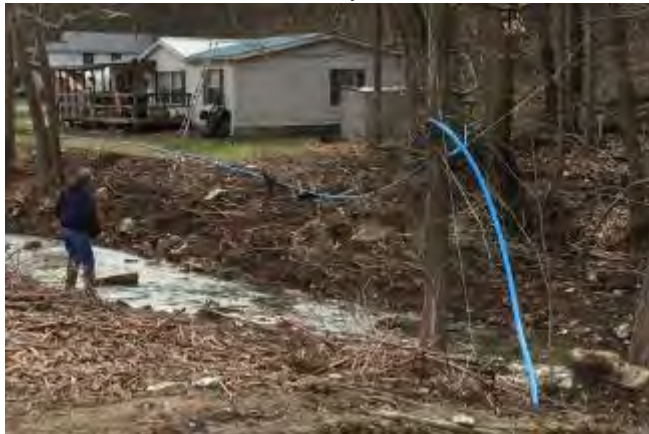
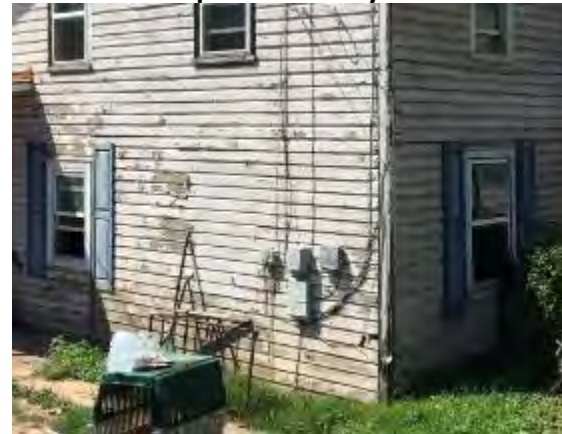
Plumbing and Electrical

- Electrical and Plumbing components inundated by water should at minimum be inspected before re-use or re-energized.
 - Electric refer to UL pamphlet: After the Storm, Floodwater Safety
 - Plumbing, test according to applicable code and type of plumbing. (example Section P2503 of the 2018 IRC)
 - Did foundation torque or twist, could impact electric and plumbing (settling or superstructure flexing may have broken pipes, chafed wires, or stripped wires from fixtures?)
 - Plumbing and electrical components allow the possibility of infiltration of contaminants, can plumbing be cleaned and disinfected, was electrical components impacted by sediment, silt, or other factors.

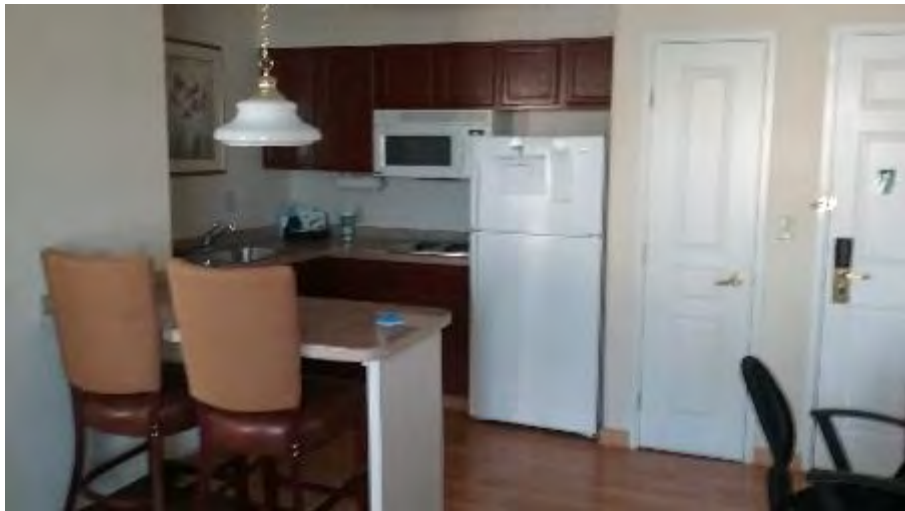
Appliances

- Built in appliances (fridge, stove, washing machine, dryer, furnace, built in microwave, dishwasher, water heater, water pump, etc.)

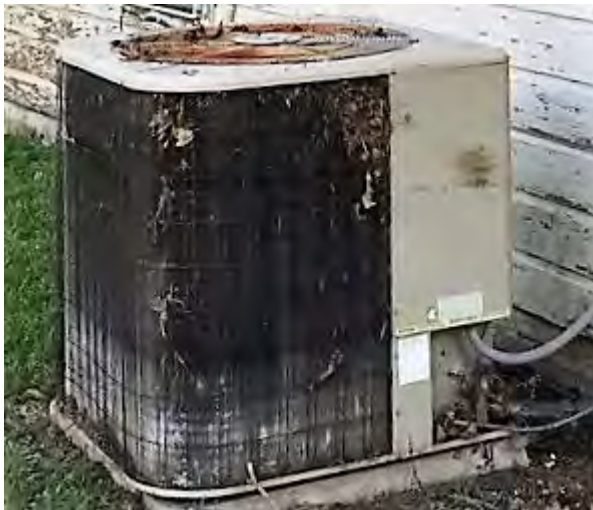
- Treat HVAC as any other plumbing or electrical components and inspect prior to re-energizing. For damage purposes if they were inundated, mark as needing to be replaced and let the AHJ have the conversation with the property owner.
