Blacks Creek Restoration Plan

January 2007 (Rev. 4/2007)

SLIPPERY ROCK WATERSHED COALITION

BioMost, Inc. and STREAM RESTORATION INCORPORATED (non-profit)

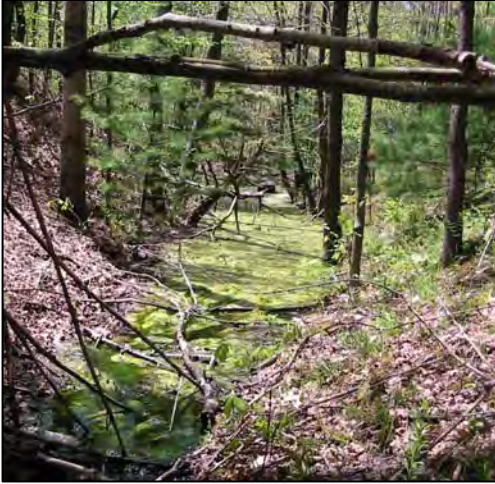
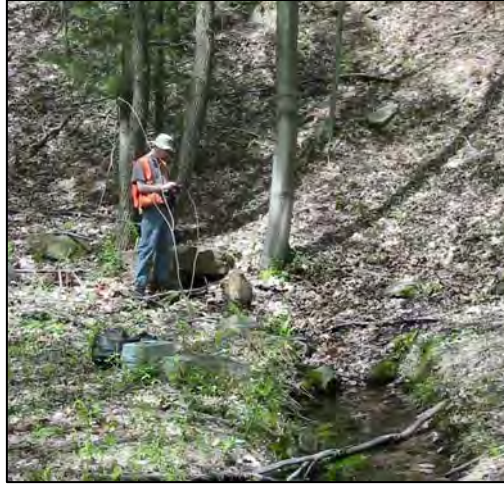
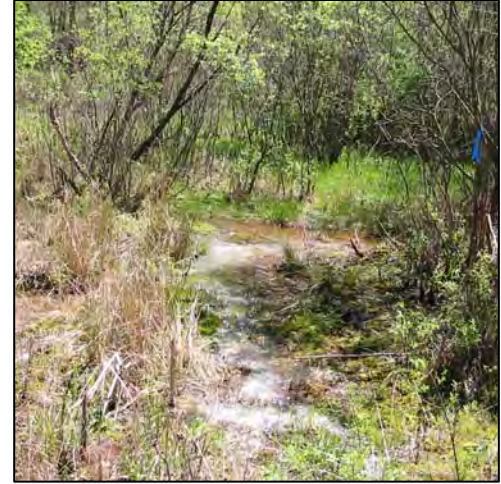
AMD discharges 906-4 (Left) and 906-5 (Center) as well as other seeps (Right) and good quality sources of water form unnamed tributary #18, which feeds into the large AMD impacted wetland complex.

Tributary #18, formed by two abandoned mine discharges (906-4 & 906-5), was sampled at point B-BC7.2B. Downstream from this point, the flow mixes with other sources of water of varying quality within a large wetland complex.

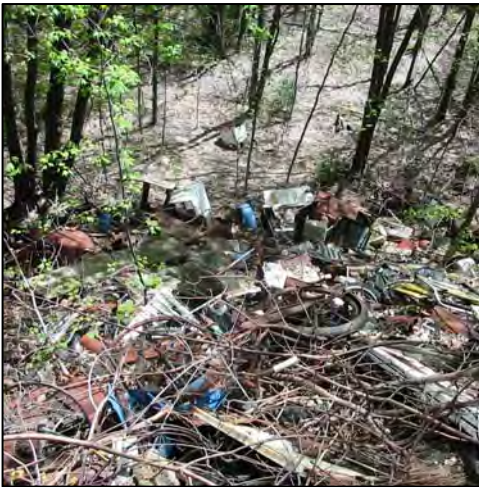
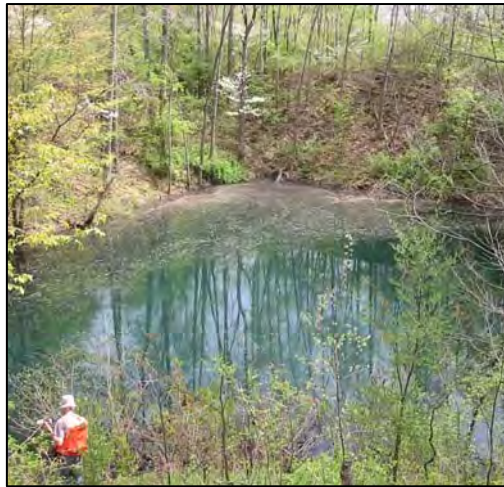
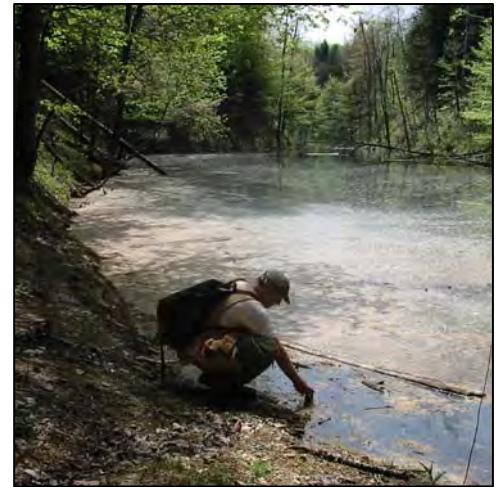
Illegal dumps (Left), highwalls (Left), and water-filled pits (Center and Right) are located throughout the watershed.

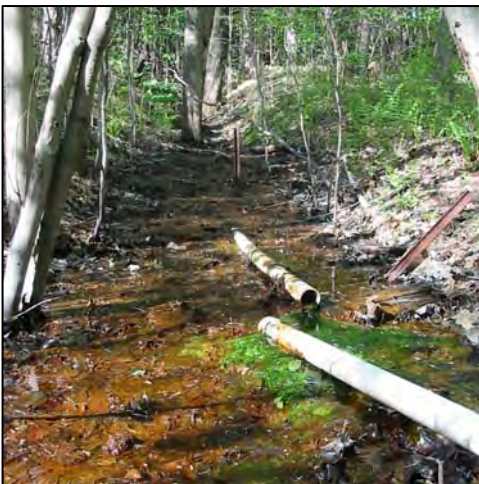
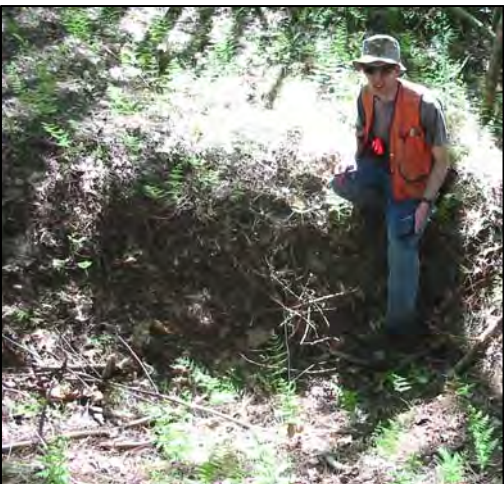
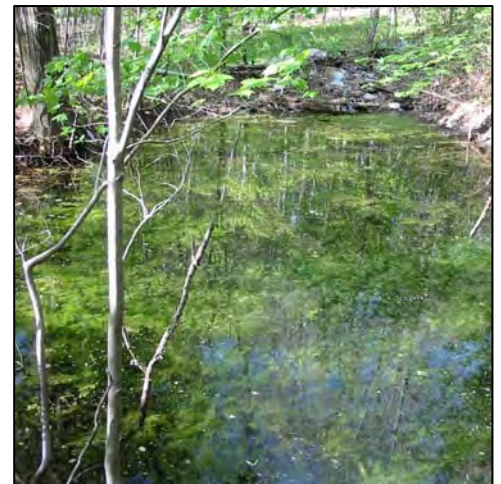
AMD discharges 906-8 (Left) and 906-9 (Right) emanate from an abandoned underground mine evidenced by numerous subsidence features (Center) present in the vicinity. These discharges are collected by a beaver dam.

Tributary #19 is also formed by abandoned mine discharges (906-7, -8, -9) and sources of good quality water. These discharges mix within a wetland created by a beaver dam. Below the beaver dam, at point 906-6, the applicable water quality criteria are met, except for manganese.

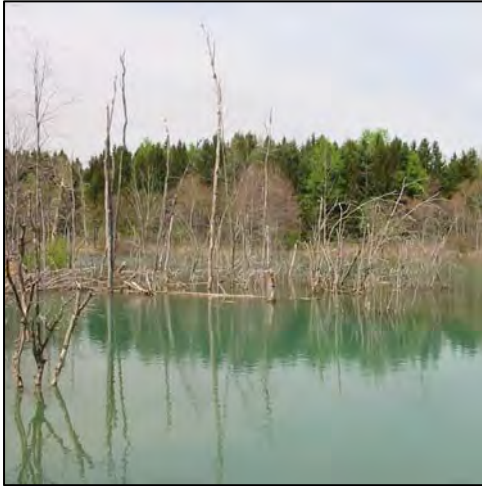
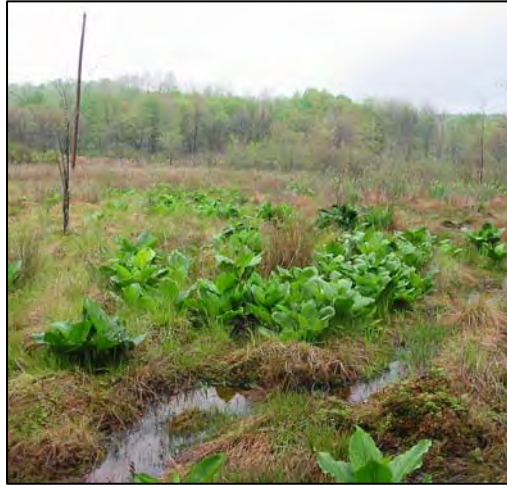
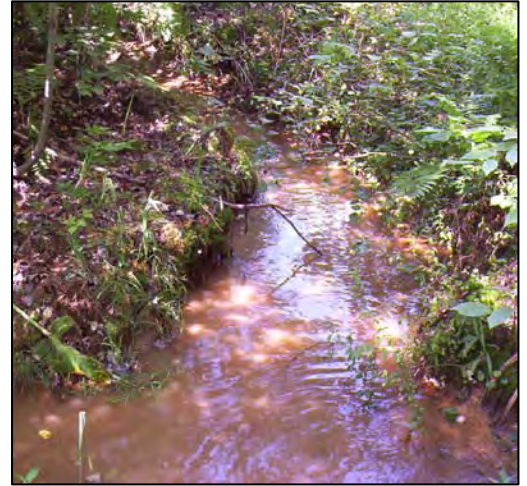
AMD discharges 906-7,-8,-9 mix with good quality water in a beaver dam wetland (Left) before entering the larger AMD impacted wetland complex (Center) with the outlet forming Blacks Creek (Right).

Tributaries #18 and #19 appear to confluence within a large wetland complex. The effluent of this wetland forms Blacks Creek and is represented by sample point 906-10 which does not meet the water quality criteria for pH, manganese, and aluminum. At sampling point 906-11,

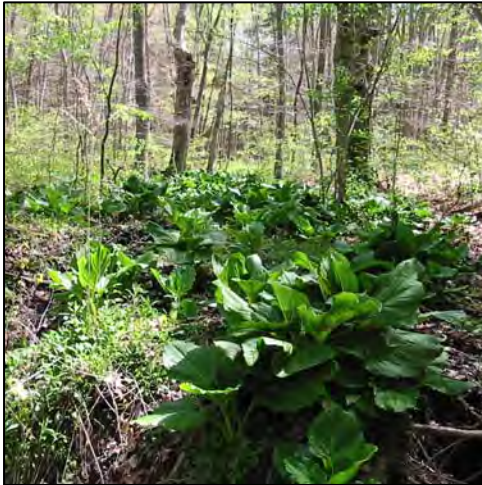
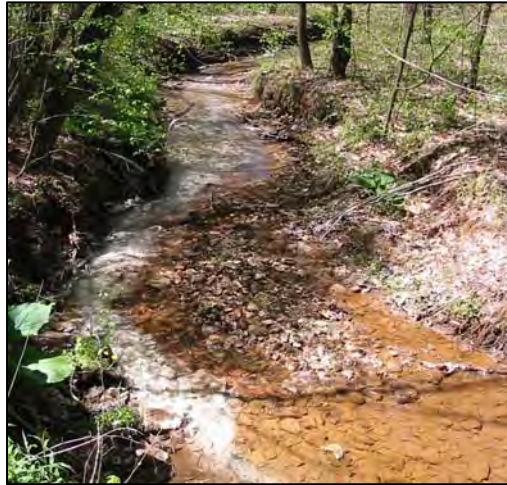
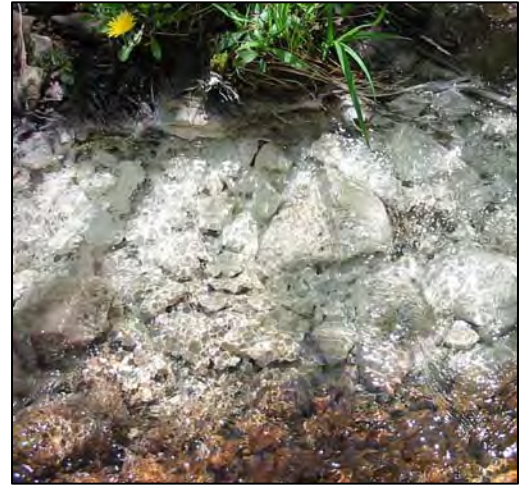
Wetlands/springs like 906-1(Left) are sources of good quality water to the watershed. 906-1 mixes with unnamed tributary #19 (Center), which raises the pH to precipitate aluminum (Center and Right) within the stream.

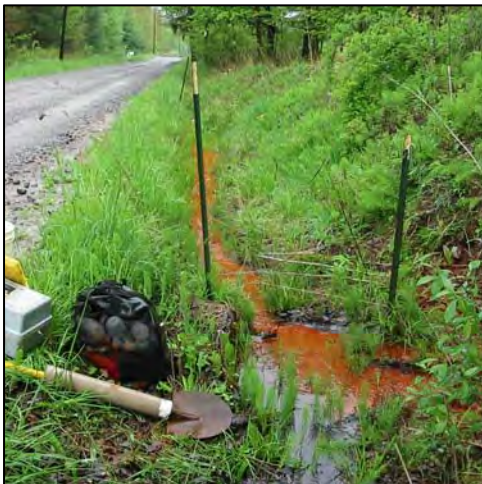
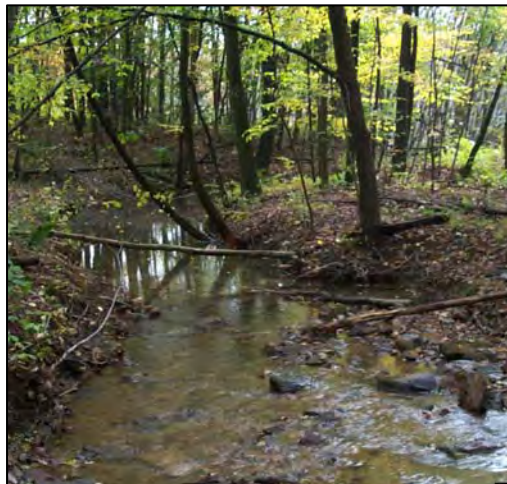
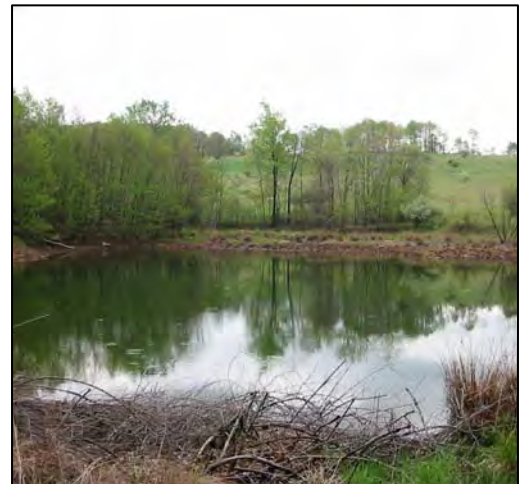
AMD discharge 906-14 (Left), along County Line Road, has minimal impact to good quality tributary #17 which confluent with Blacks Creek at 906-15 (Center)...Sediment Pond 906-16 (Right), at the headwaters of tributary #16 receives surface runoff from a reclaimed strip mine and AMD discharges 906-17, -17B.

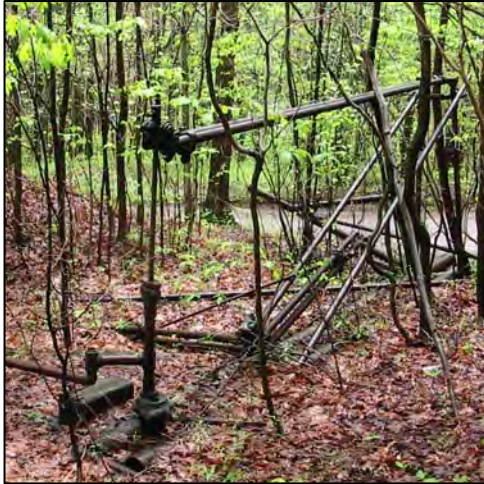
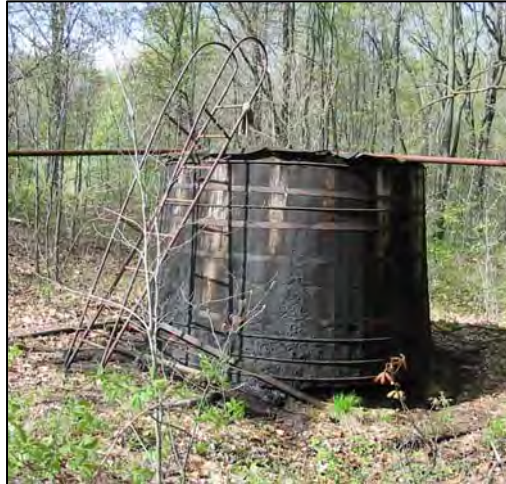
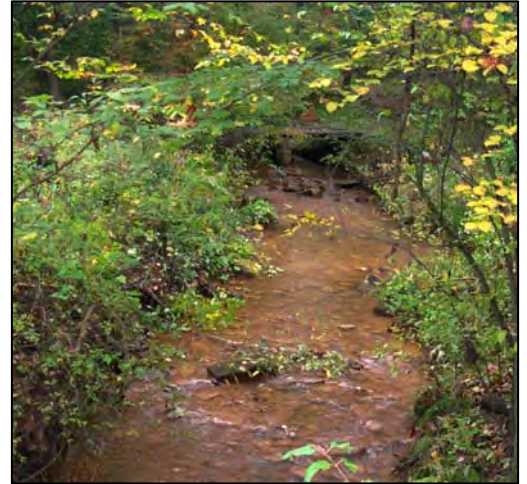
Historic oil wells (Left), piping systems, and storage tanks (Center) can be seen throughout the northern portion of the watershed. These old oil wells can provide a conduit for mine drainage to reach the surface. Discharges BC14 and BC15 severely impact Blacks Creek as can be seen downstream at sampling point 906-42 (Right).

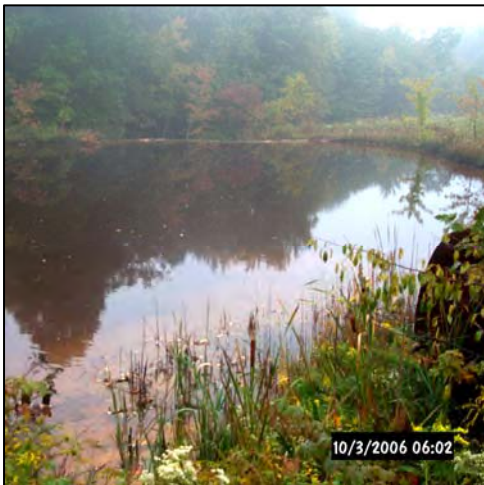
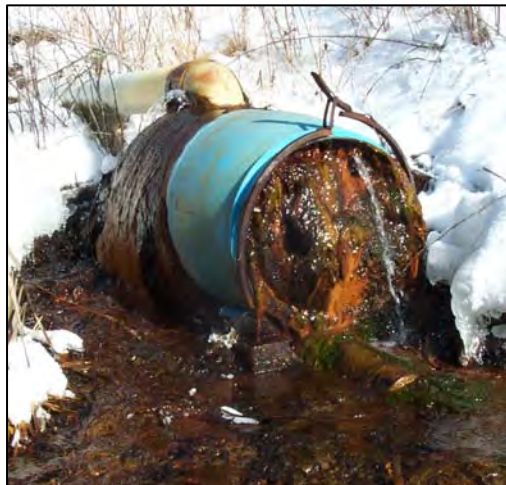
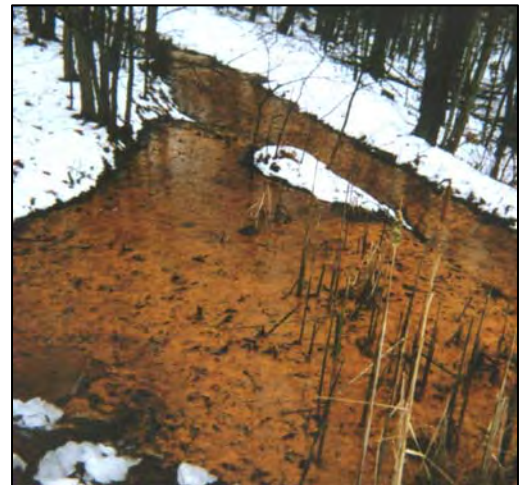
Existing treatment pond TB1 (Left) receives mine discharges MC1, MC2, and MC3 which emanate from the "McIntire" site. The effluent of TB1 (Right) forms tributary #15. The natural formation of iron minerals at low pH, plugging old piping (Center), is to be utilized and enhanced as part of the proposed passive system.

The single largest impact to Blacks Creek is the “McIntire” trib #15, impacted by two discharges (TB1 & BC16) with the highest metal loadings (~50%) in the Blacks Creek Watershed. As noted previously, TB1 is the effluent of an existing old chemical treatment pond which receives three discharges (MC1, MC2, MC3) from the H&D “McIntire” minesite in the headwaters of trib #15. The TB1 primary spillway has become plugged with iron minerals precipitating at low pH to the point that the water now discharges over the emergency spillway, forming trib #15. (See photos.) Trib #15 is conveyed in a reconstructed stream channel to an in-stream settling pond (SB1). The SB1 effluent (trib. 15) confluences with BC16 just prior to entering Blacks Creek.

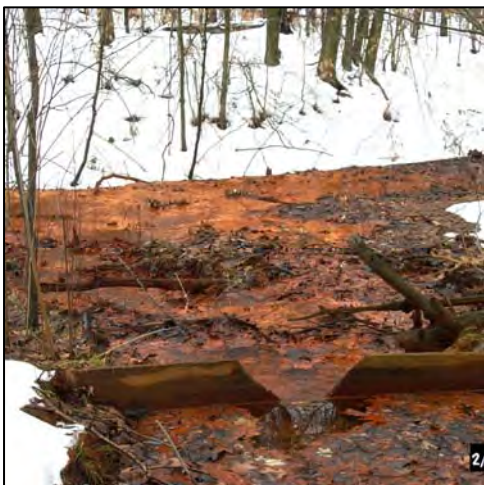
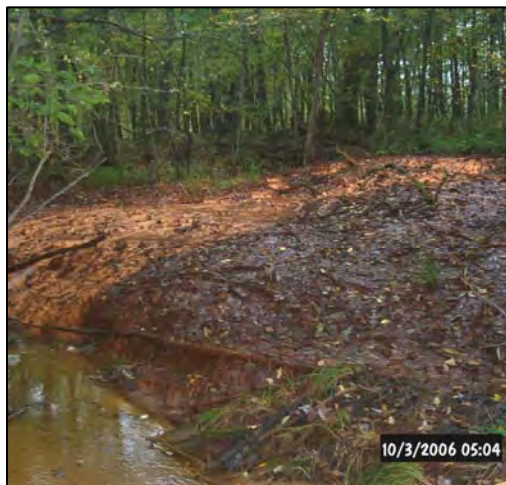
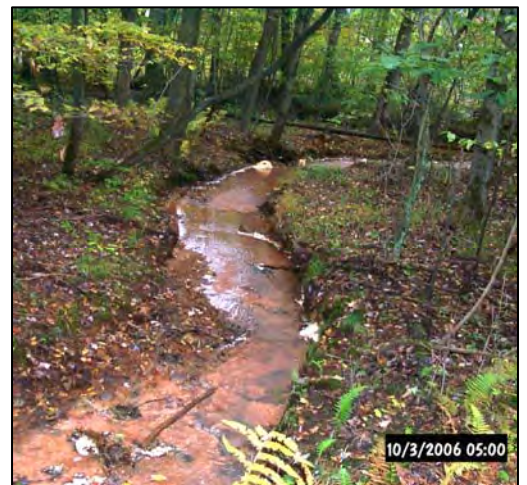
The BC16 discharge upwelling (Left) from an old oil well is the 2nd largest source of metal loadings in the watershed and flows into tributary #15 (Center & Right). A passive system is to be constructed in 2007.

Table XVII provides a proposed time table for implementing the restoration plan. Design and construction of the BC16 passive treatment system are expected to be completed in 2007. Seeking funding for the “McIntire” site will begin in 2007 as well. Following completion of these two passive systems, an evaluation of the impact to Blacks Creek will be conducted. Priorities may be rearranged following this evaluation. After completion of each additional major project, another evaluation is recommended to be completed in order to restore Blacks Creek in the most efficient and economical manner possible. Load reductions and the water quality criteria are to be used, primarily, for evaluating the progress of the restoration plan. This priority list and proposed time table are to serve as a guide to developing implementation projects within the Blacks Creek Watershed. The priority list and proposed time table are to be revised as needed.

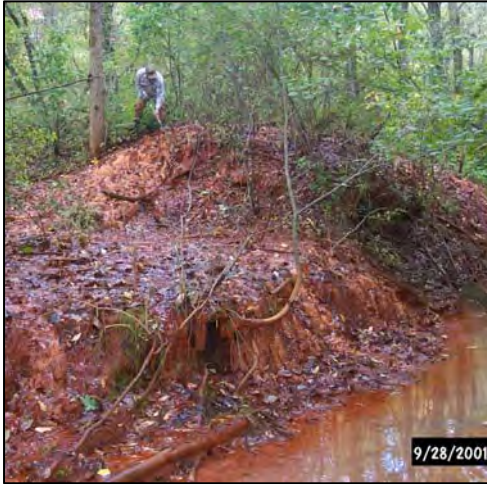
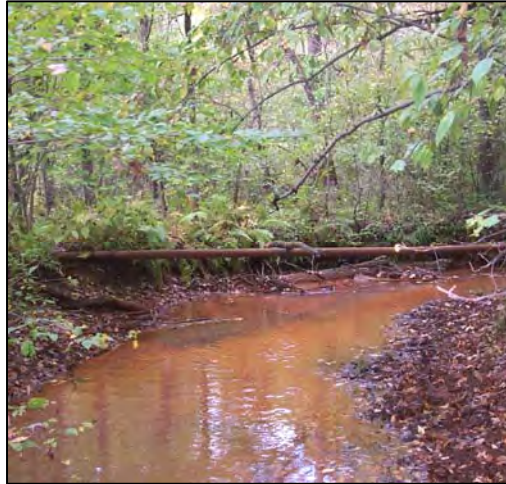
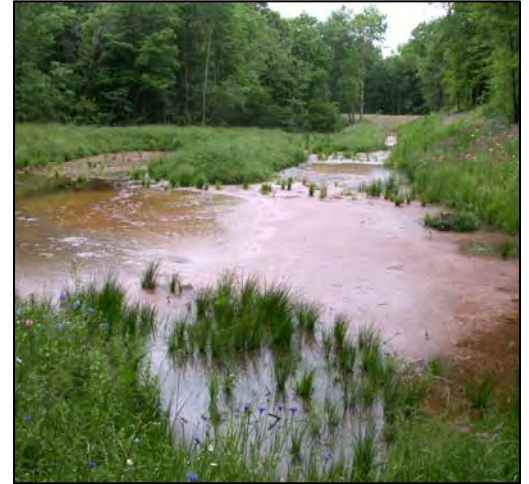
Discharges BC19 & 19B (Left) are upwellings from old oil wells, which use to flow directly into Blacks Creek, but are now captured and treated in a passive treatment wetland (Right). Blacks Creek sampling point BC2B (Center) is downstream of all known major AMD discharges. Note the historic oil pipeline crossing Blacks Creek.

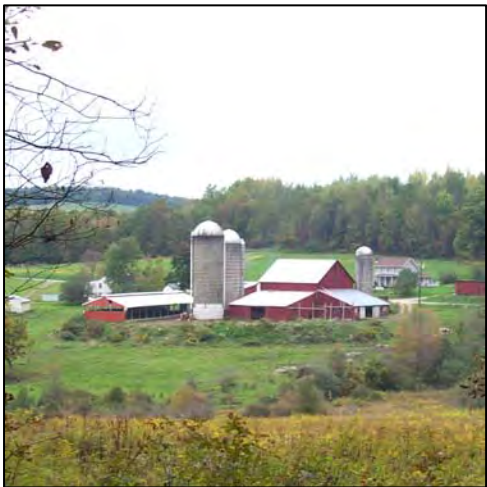
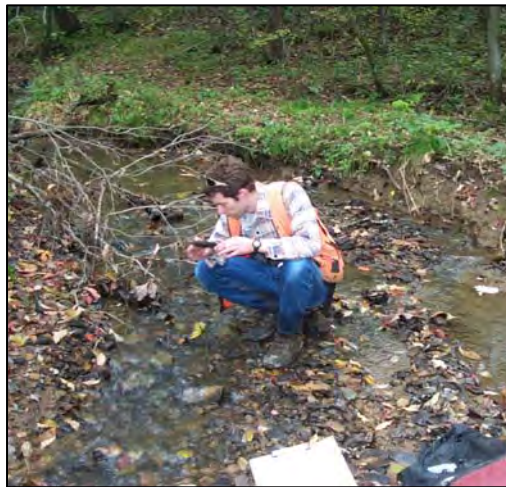
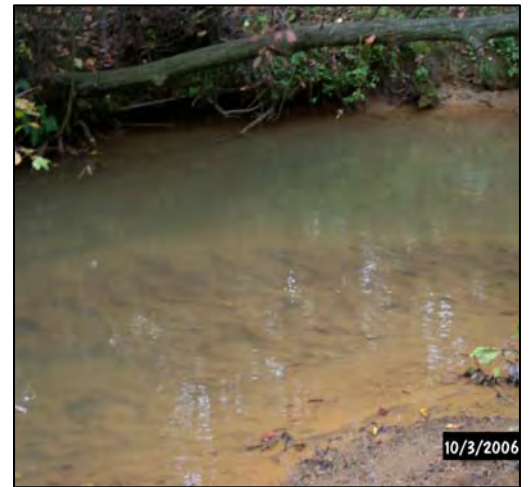
Several working farms, such as this one (Left) located downstream of BC2B, use the water resources within the watershed. Even though good quality streams such as tributary #14 (Center) improve Blacks Creek significantly it remains impacted at sampling point BC1 (Right) by sedimentation and metal loadings.

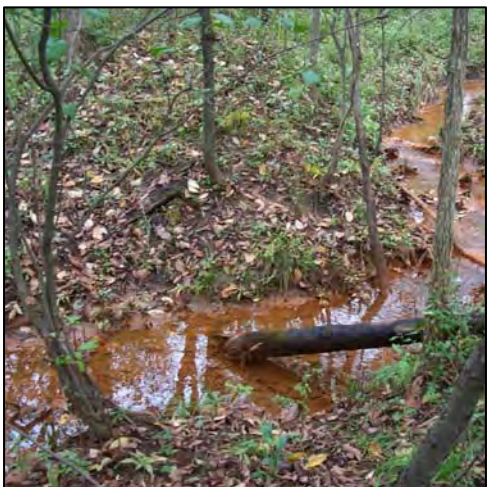
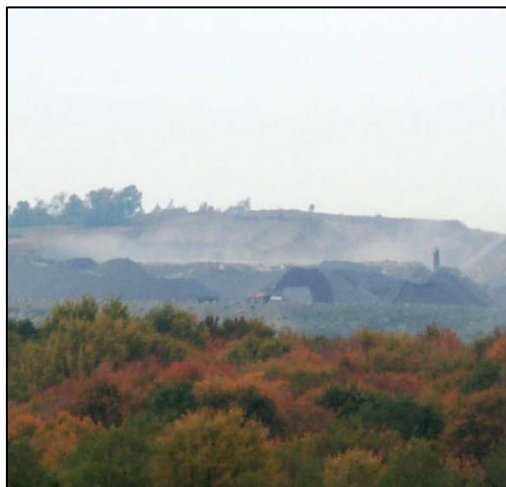
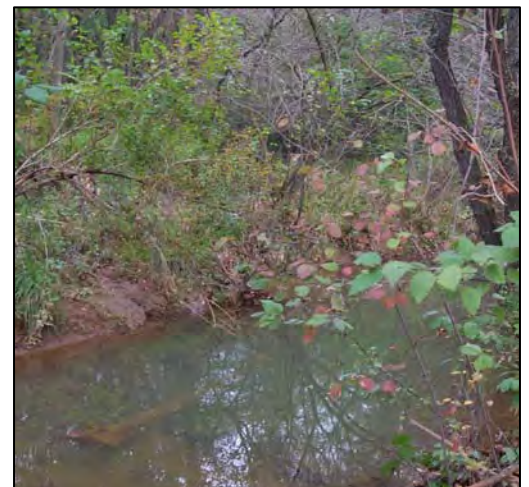
The oil well upwelling 906-36 (Left) has a minimal impact to Blacks Creek. An Allegheny Mineral limestone quarry (Center) has “eliminated” pre-existing AMD discharges. Blacks Creek remains slightly impacted at BC8 (Right).

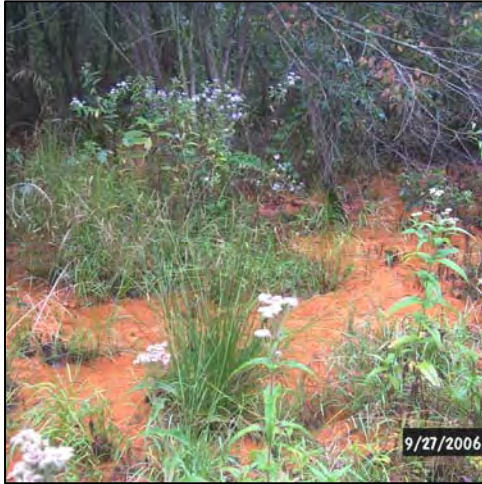
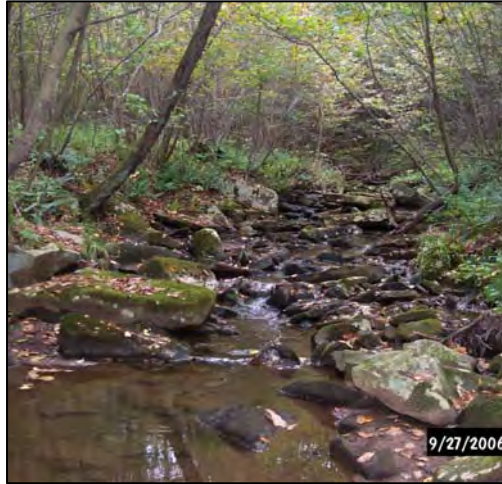
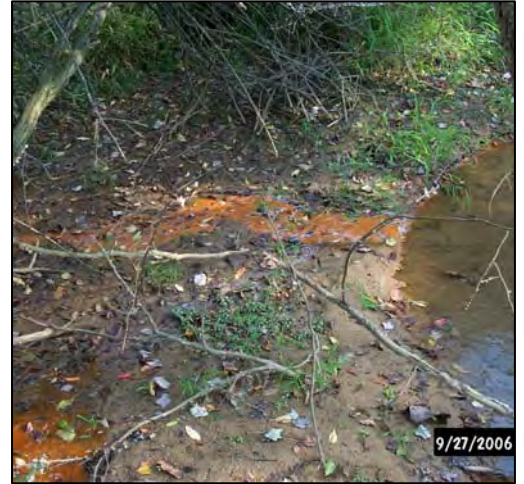
Unnamed tributary #7 is formed by two small AMD discharges 906-22 and 906-23; however, the tributary quickly assimilates the drainage and becomes a stream with excellent water quality and habitat (Center). Another small AMD discharge 906-21 enters the stream just before the confluence with tributary #6. Other small seeps with little impact exist in the watershed like this on unnamed tributary #8 (Right).

Tributary #7 is formed by the confluence of two small abandoned mine discharges (906-22 and 906-23), which as noted in Table V, are only slightly impacted. These discharges meet the typical surface mine permit effluent limits. Tributary #7 receives additional base flow and mixes with other water sources and, at downstream point 906-19, all criteria are met except for slightly exceeding the dissolved iron criterion of 0.3 mg/L. This may be due to a small abandoned mine discharge (906-21) that enters the tributary about 50 feet upstream of point 906-19.

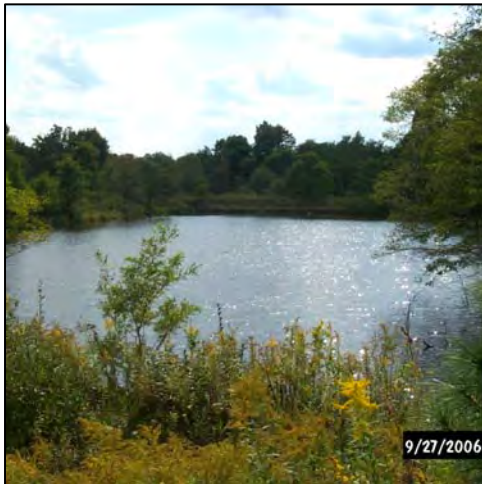
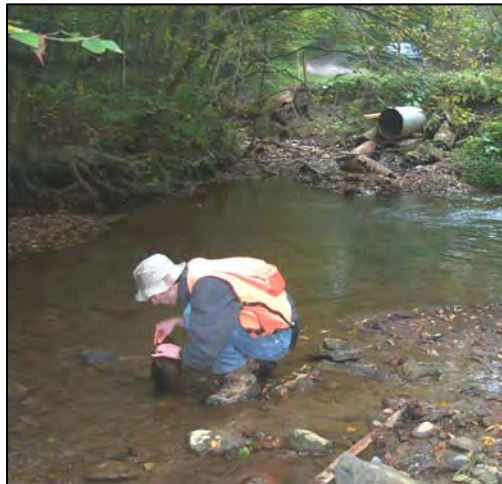
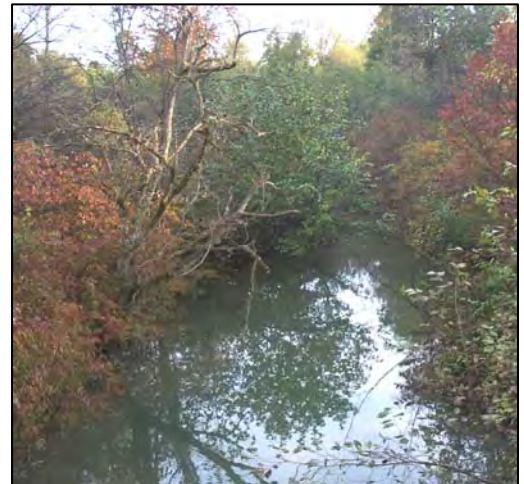
Tributary #6 is essentially formed by the effluent of several old settling ponds (Left) that receive runoff from a large successfully reclaimed surface mine. The water quality meets mining effluent limits, but is slightly higher than the stream water quality criteria identified in the TMDL. The tributary quickly assimilates the drainage and is of excellent quality at sampling point BC12 (Center). Tributary #6 then confluences with and improves the water quality of Blacks Creek. The final downstream sampling point QAS4 (Right) on Blacks Creek is located below a Quality Aggregates limestone quarry.

Tributary #6 meets the criteria for most of its length, except for the iron content at 906-24, which is the effluent from an in-stream, settling pond on a reclaimed surface mine within the headwaters. The pond discharge meets the surface mining permit effluent limit for total iron, which is 7 mg/L. Downstream the water becomes oxygenated, mixes with other sources, and the Table IV criteria are met at point 906-27.
