LANDSLIDES IN PENNSYLVANIA

Educational Series 9

Landslides in Pennsylvania

**by Helen L. Delano
and J. Peter Wilshusen**

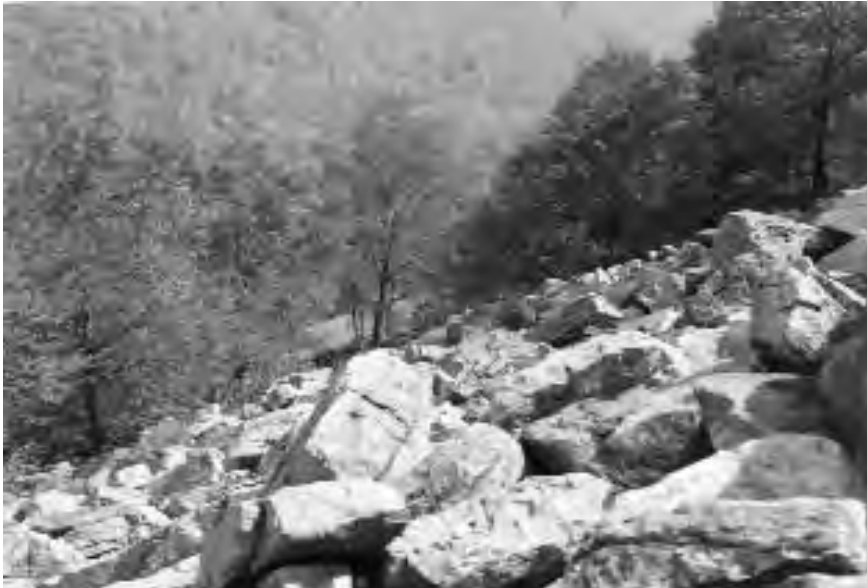
Figure 4. A dense accumulation of angular sandstone boulders forming a steep slope. As long as the slope is not disturbed, the accumulation commonly remains in a relatively stable configuration because there are no small rock fragments and soil between the boulders, and water drains freely from the hillside.

On a number of mountainsides, especially in the Ridge and Valley physiographic province, large areas of closely packed angular boulders blanket the steep slopes (Figure 4). Although their appearance is dramatic and suggests instability, in most cases they are stable. As long as the slopes remain undisturbed by works of humans (particularly the removal of material from the base of the slope), the rocks generally stay in place, wedged one against the other, forming tight boulder nests of interlocking pieces that have apparent long-term stability.

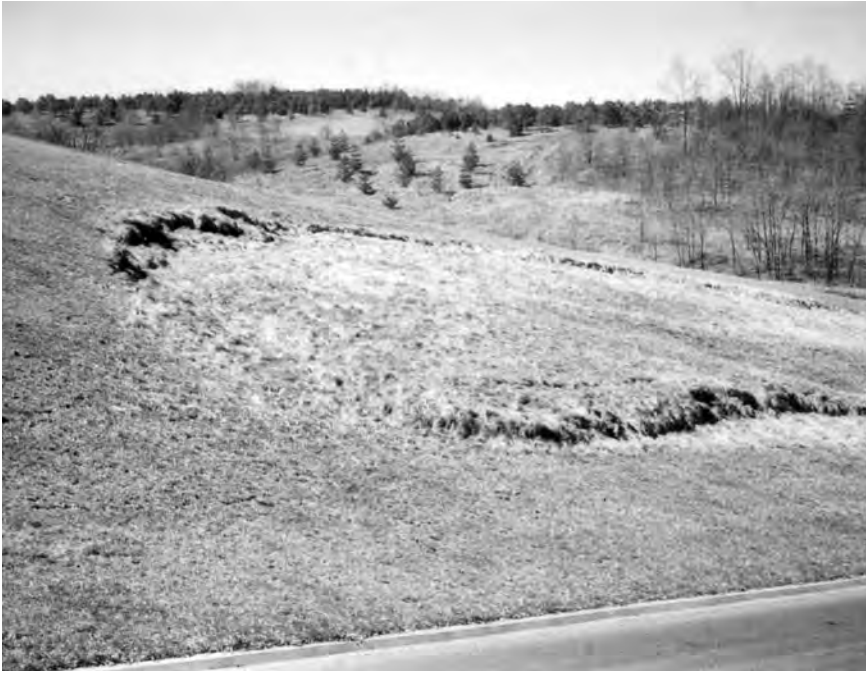
Figure 7. Earthflow, characterized by downslope movement of wet soil that acts as a thick, viscous fluid. Photograph by J. L. Craft.

Earthflow is a rapid mass movement characterized by down-slope flow of soil over a discrete basal surface (Figure 7). Bedrock movement is not involved. The soil is composed mostly of sand and smaller particles. The basal surface is more or less parallel to the ground surface in the lower portion of the flow. There are generally three distinct parts of an earthflow: (1) a source area; (2) a central section of broken and disrupted soil that has open fissures across the flow; and (3) a lower section of raised hummocky ground. Earthflow is typically the slowest moving of the three types of rapid flow that occur in Pennsylvania.

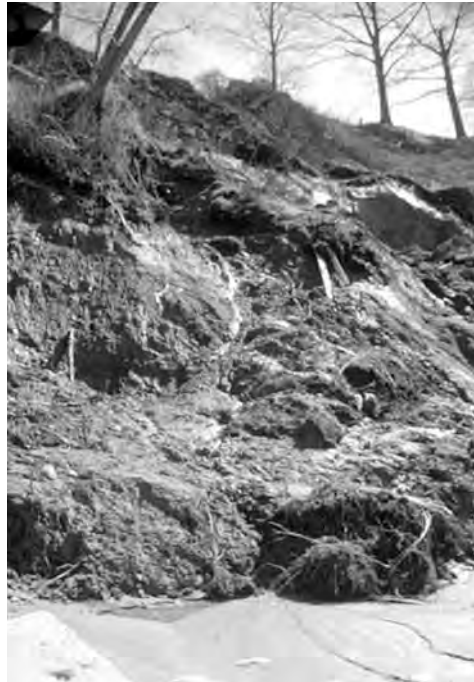
Figure 8. Debris flow in glacially derived sediments along Lake Erie bluffs.

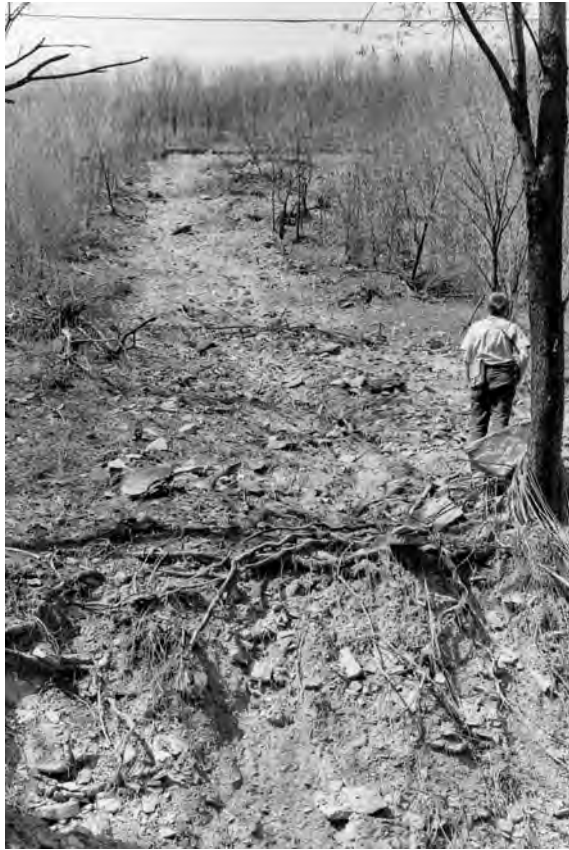
Figure 9. This long, narrow scar was created by a debris avalanche. Forest vegetation and most of the soil was stripped away from the upper and middle parts of the slide and deposited lower on the slope.

material at the toe (Figure 9). Debris avalanche scars in Pennsylvania are commonly a few tens of feet wide and a thousand or more feet long. Because they move very fast, with little warning, debris avalanches are potentially the most dangerous type of landslide in Pennsylvania. Evidence of the force of debris avalanches includes boulders caught in branches of trees, bark stripped off trees along the edge of the scar, and damaged roads and buildings. Once a debris avalanche occurs, it is usually many years before enough soil accumulates in the scar for a similar event to take place in the same location.

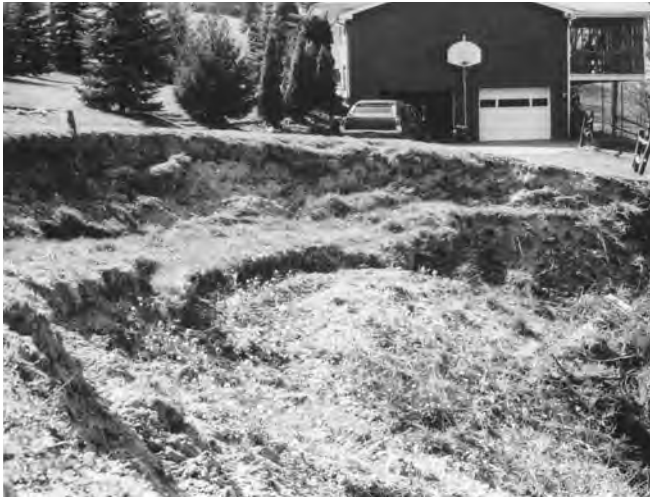
Figure 11. Slump failure and the steep scarp at the head above the disrupted ground. Photograph by R. P. Briggs.

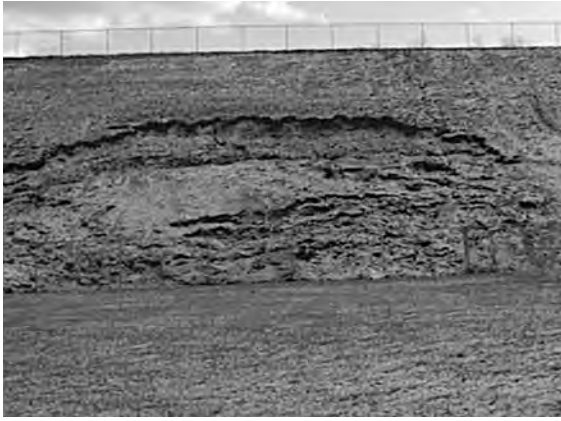
Figure 13. Small slump in the cut portion of a recent cut-and-fill slope. The slumped material is a thick claystone between layers of stronger rock.

such as fill and mine waste typically fail by slumping. Slump failure commonly occurs in thick, uniform soil and weathered rock, but it may also occur in bedrock. Most identified large bedrock slumps are very old but can still be active or can be easily reactivated. Slump is most commonly caused by (1) increased moisture content, which decreases strength; (2) removal of support at the toe of a slope; (3) adding material at the top of a slope; or (4) construction of a cut or filled slope that is too steep for the materials involved to be stable (Figure 13). Slump failures can be relatively

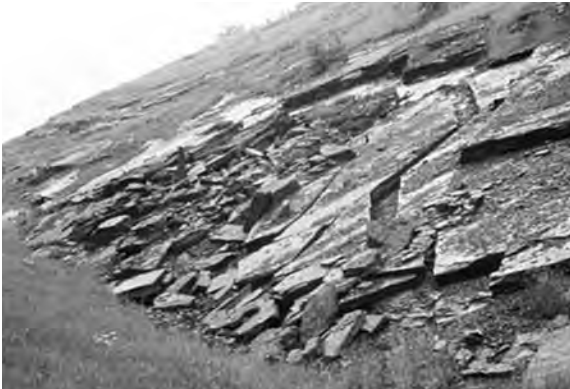
Figure 17. Sandstone bedrock in this highway cut dips steeply from right to left. Blocks in the top layer of rock have broken loose from the intact rock and are slowly sliding downslope along a bedding surface. A wide drop zone keeps the rock from sliding onto the highway.

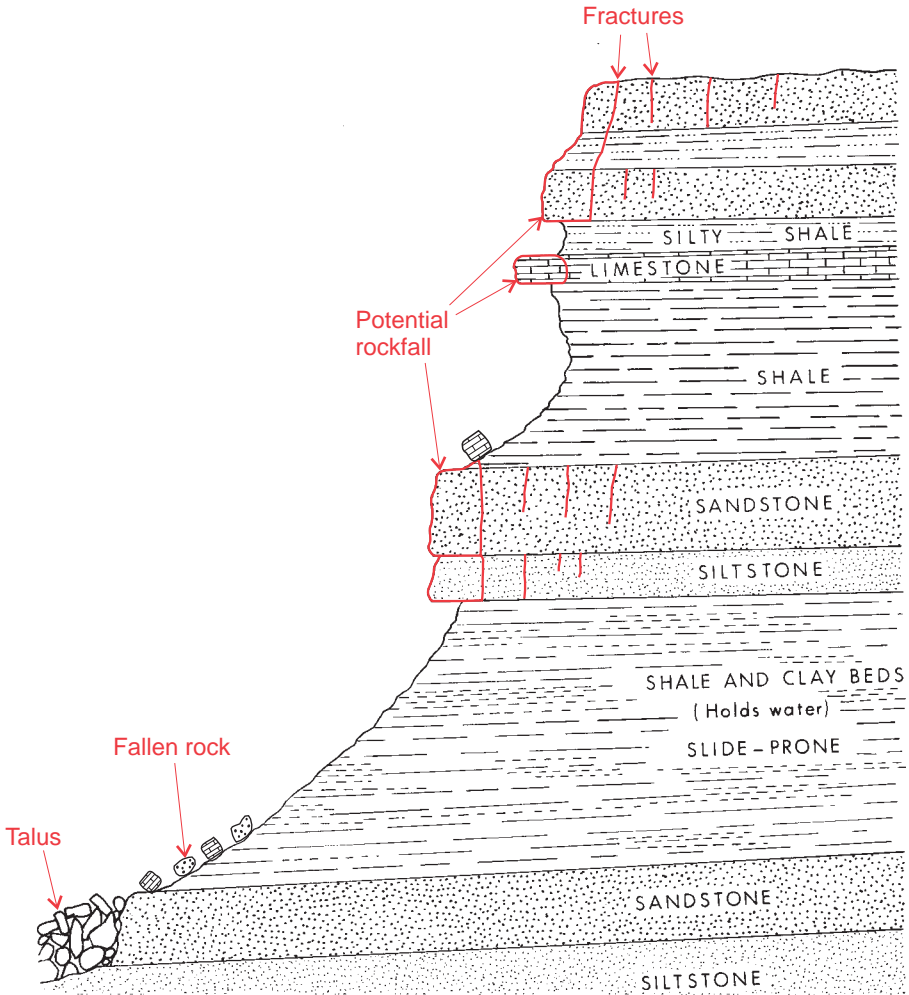
Figure 18. Shale and clay layers weather and erode more easily than stronger sandstone, siltstone, and limestone beds. The stronger layers are left unsupported and separate along fractures, leading to rockfall.

A combination of rockslide and rockfall is not unusual, especially in the Plateau, where soft, easily eroded shales are commonly overlain by more resistant sandstone or siltstone. Erosion of the thick shale near the base of the steep hillside undercuts the more resistant units, removing support from beneath them and allowing them to fall or slide to the toe, as illustrated in Figure 18.

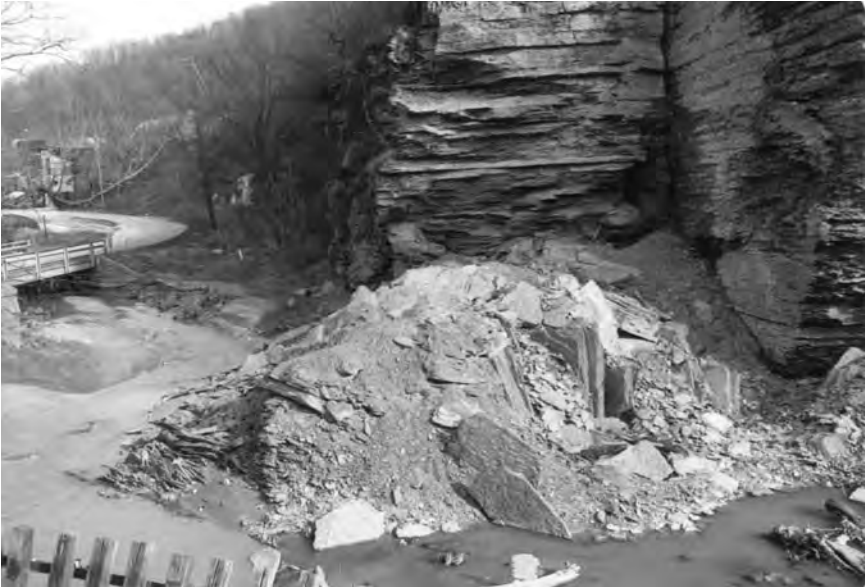
Figure 19. Rockfall from a cliff face into a stream channel. Note how the rock has fallen away along near-vertical joints, forming fresh cliff faces. Photograph by J. L. Craft.

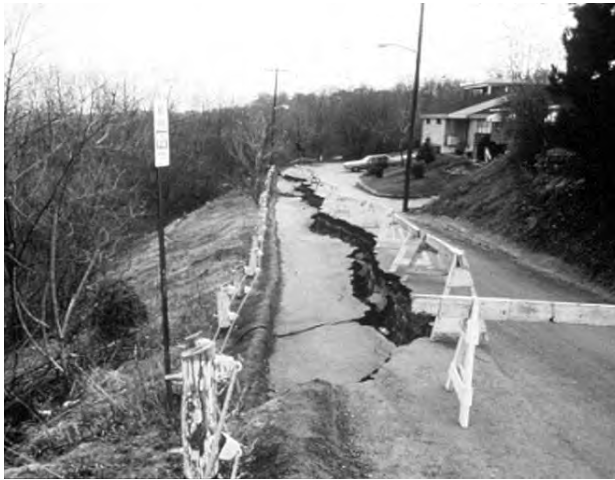
Figure 20. Slump failure of a road on a cut-and-fill slope.

The human-induced landslides that are most often seen are in roadcuts along hillsides (Figure 20). Modern roadcuts are generally designed with slide prevention in mind, but there are all too often unexpected conditions, such as an unknown concentration of groundwater flow, unexpected weak rock layers, or undetected fractures, that lead to failure of what was thought to be a stable slope.

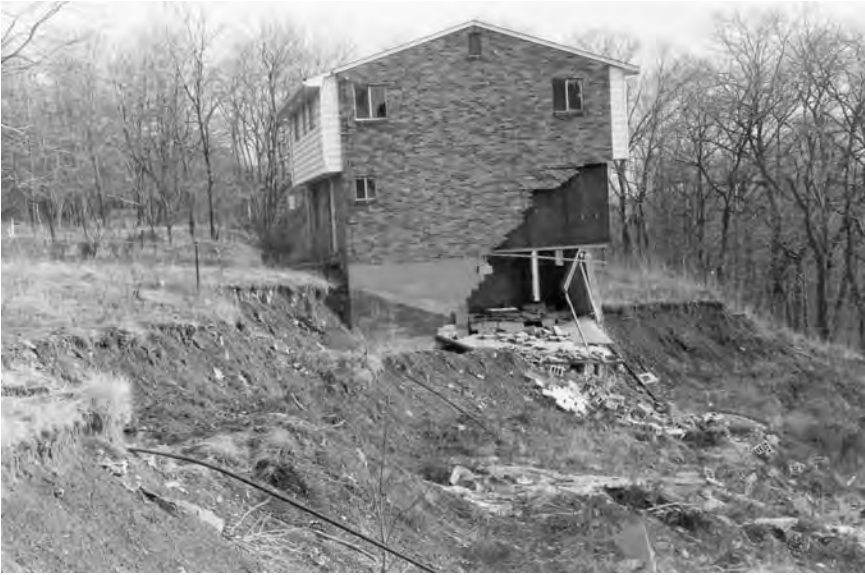
Figure 22. A new home that was severely damaged, and eventually totally destroyed, by slope failure. The remains of the home (since demolished) are at the head of an active slide developed in fill material placed on top of old landslide materials. Photograph by J. L. Craft.

Other types of construction and land modification may affect landslide occurrence as well. The placement of fill to modify a slope is a common trigger (Figure 21). The placement of fill on a slope adds to the load on what may be marginally stable materials. If the fill consists of weak, clay-rich material, or is not installed in compacted layers, it may slide or settle, affecting anything built on it. There are numerous examples throughout the state of cracked and damaged buildings, driveways, parking lots, and so on, which are located on unstable fill that is undergoing progressive failure by creep or slumping. In too many cases, unhappy homeowners may be left with cracking walls, breaking pipes, and tight windows and doors, and they may have little or no recourse to remedial measures. Failure may be complete (Figure 22), causing the total loss of a home.
