SPRING RUN AND SNYDER RUN COLDWATER CONSERVATION PLAN

**Clearfield County Conservation District
511 Spruce Street, Suite 6
Clearfield, PA 16830**

SPRING AND SNYDER RUNS COLDWATER CONSERVATION PLAN

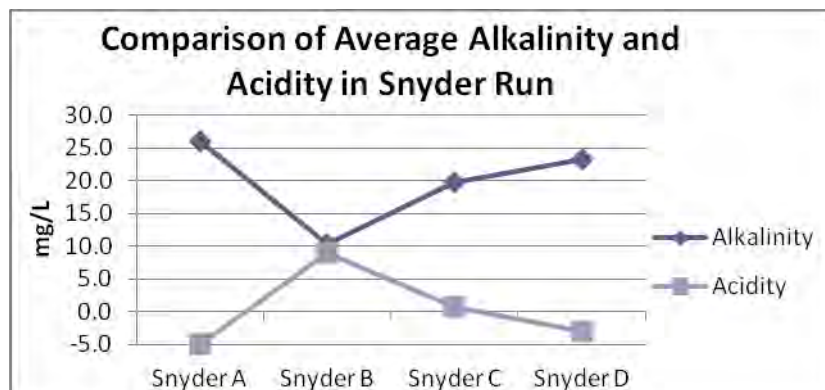
As shown in the chart below the average pH values at the four sample locations are between 6.0 and 7.0 which is ideal for aquatic life. Additionally, a comparison of the alkalinity vs. acidity shows that at each sampling location, we saw more alkalinity than acidity meaning Snyder Run is alkaline in nature and is capable of neutralizing any acidic pollution flowing into the stream.

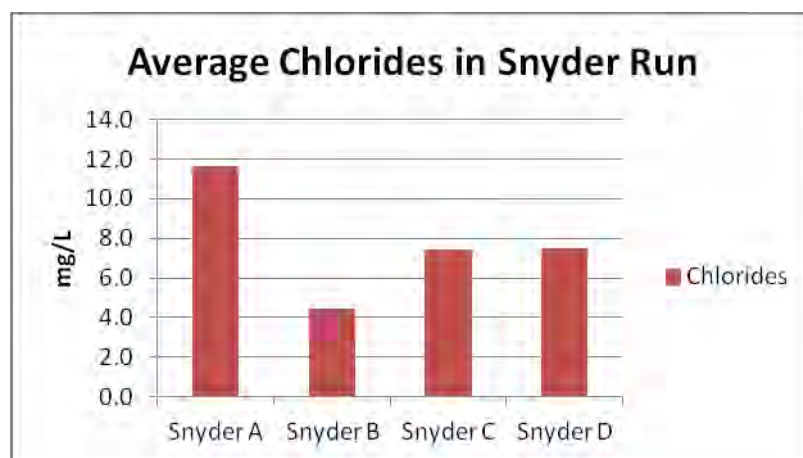
Drilling impacts, primarily future impacts, were a big concern in the watershed as well. Below you will see a chart detailing the average chloride levels at our sampling locations. According to the State Drinking Water Standards, 250 mg/L is the highest allowable value for chlorides in drinking water. Higher concentrations can indicate problems such as road runoff or sewage input. Gas waste fluids contain extremely high levels such as 100,000 mg/L. Our results show that we did register some chlorides at each sampling point but the averages were all well below 250 mg/L. This baseline water quality data will be important should unconventional gas well drilling ever occur in this watershed.

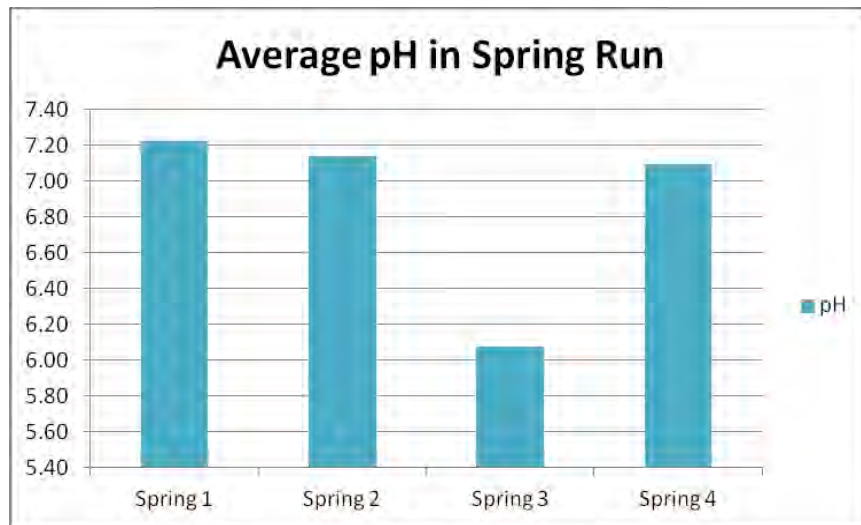
As shown in the chart below the average pH values at the four sample locations are between 6.0 and 7.2 which is ideal for aquatic life. Additionally, a comparison of the alkalinity vs. acidity shows that at Spring 1, 2, and 4 we saw more alkalinity than acidity meaning these locations in Spring Run are alkaline in nature and capable of neutralizing any acidic pollution flowing into the stream. As you can see, acidity was actually higher than alkalinity at Spring 3 which is a small trib that flows into Spring Run from the north. As there are no high metals or total dissolved solids readings, this may potentially be occurring from acid deposition to this tributary.

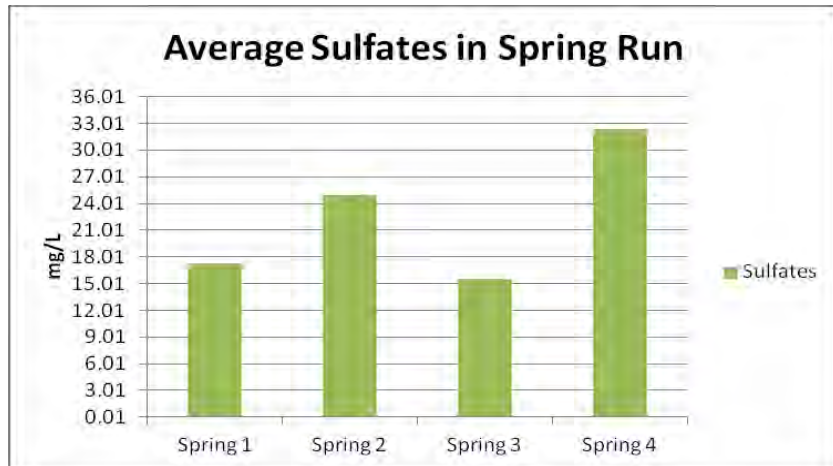
One of the primary concerns in Spring Run is impacts from mining practices and so below you will see a chart comparing the levels of iron, aluminum, and manganese in the stream as well as a chart outlining the average sulfate levels. EXPLAIN SULFATES

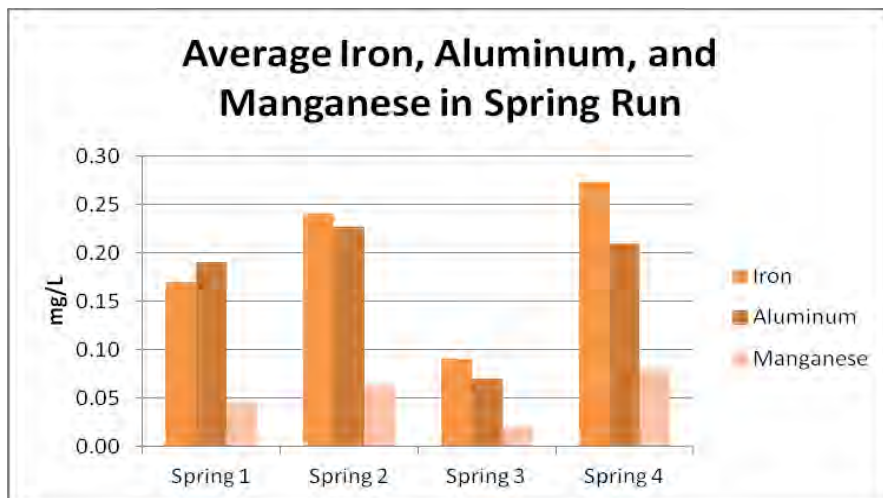
As you can see in the chart below, iron levels were 0.17 mg/L, 0.24 mg/L, 0.09 mg/L, and 0.27 mg/L. These levels were all below the State Drinking Water Standard level of 0.3 mg/L. Aluminum, which is much more toxic to fish, exceeded the State Drinking Water Standard of 0.2 mg/L at Spring 2 just below the Harmony Deep Mine with a level of 0.23 mg/L and again at the mouth at Spring 4 with a level of 0.21 mg/L. It is possible that the aluminum being detected is coming from the Harmony Deep Mine but it is also just as likely that this can be a legacy aluminum in the watershed from the identified AML features noted earlier. Further investigation will have to take place to determine the exact cause. Lastly, the State Drinking Water Standards for Manganese (0.05 mg/L) were also exceeded at Spring 2 and 4 with levels of 0.06 mg/L and 0.08 mg/L, respectively. Again, this could be a product of the Harmony Deep Mine but it could also be legacy mining issues in the watershed and further investigation would be needed to confirm the source.

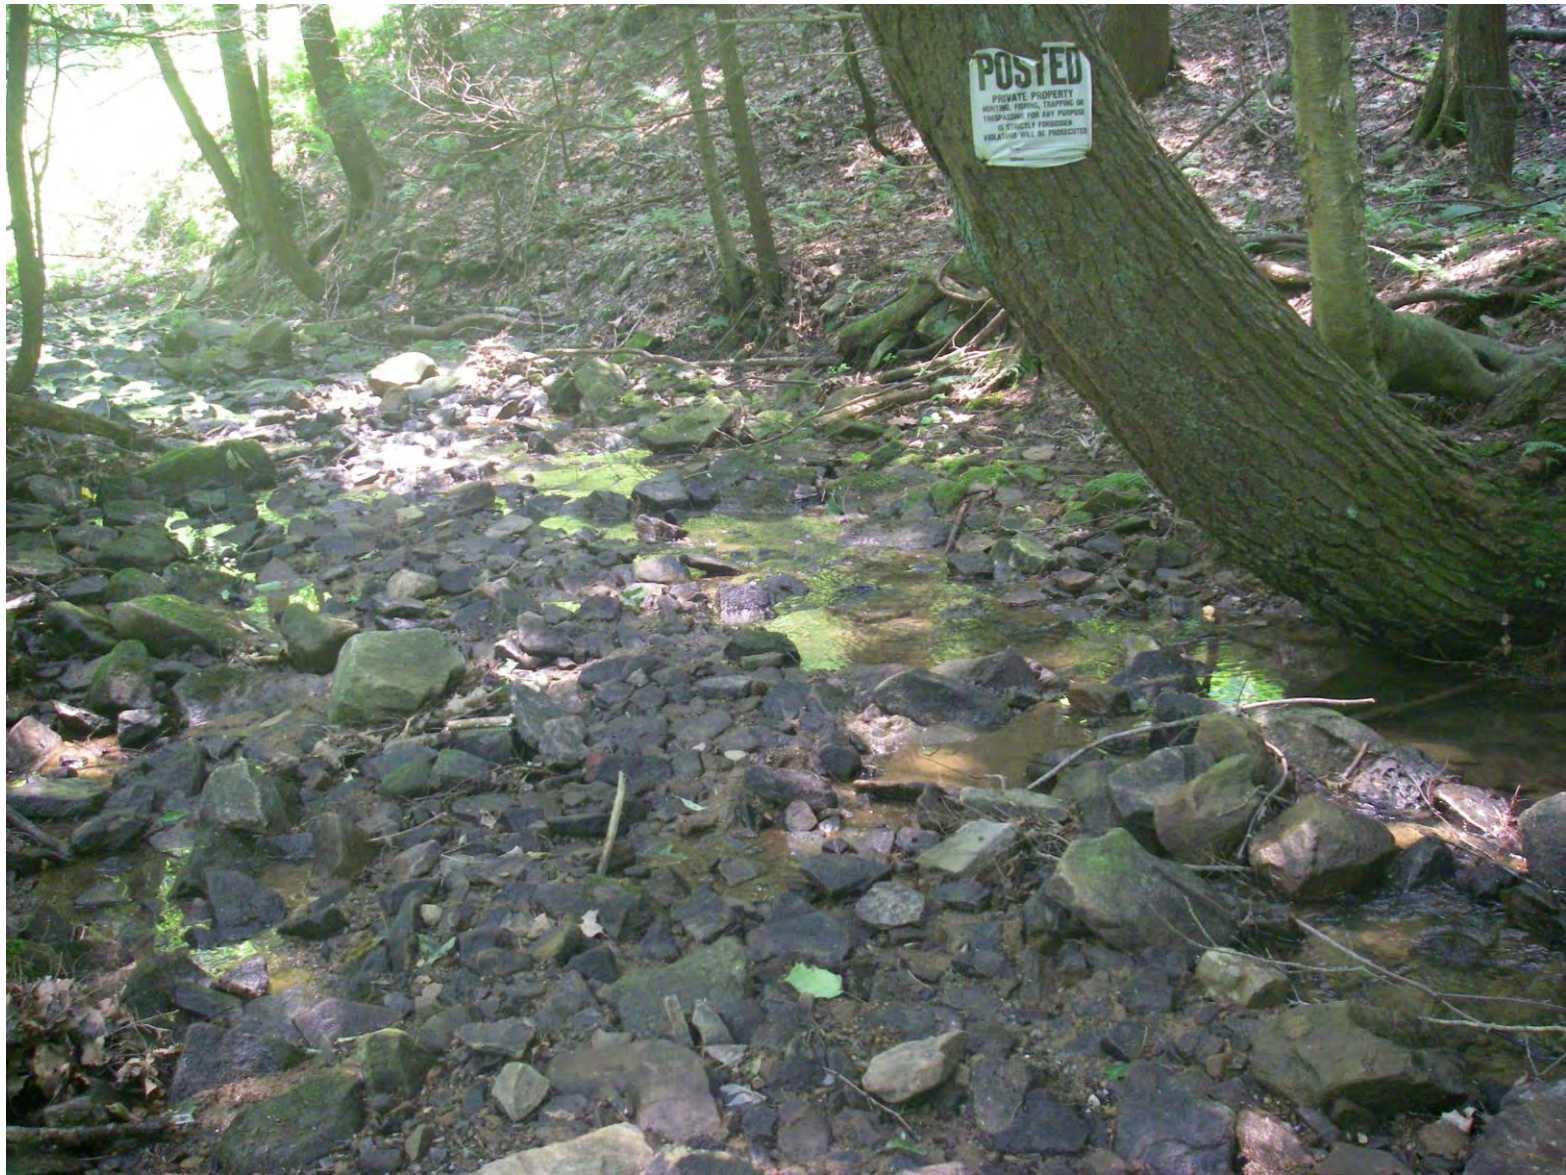
Snyder A: N 40.791772°, W -78.699858°

We encountered just 4 individuals at Snyder A with just 1 individual in the EPT taxa. This site was highly impacted by human encroachment and the habitat was just not suitable for macroinvertebrate life.

Sample point Snyder A at the mouth of northern branch of Snyder Run scored 130 out of 240. Snyder A was highly impacted by human encroachment in the form of hand placed dams, weirs, and bridges. It scored very low in Riparian Vegetative Zone Width, Channel Alterations, Velocity & Depth Regimes, Epifaunal Substrate, and Instream Cover.

2) Human encroachment is a problem on Snyder Run. There are numerous homes within 60 feet of the stream, numerous ponds that could cause thermal pollution to Snyder Run, some perched culverts, and human manipulation of the stream bed (such as hand placed dams). Efforts could be made to educate the landowners on the importance of floodplains, stream bank maintenance, pond management, and in stream habitat. Improvement of some of these conditions should also be priority such as proper in stream habitat construction per PA Fish and Boat Commission recommendations and repair of perched culverts.

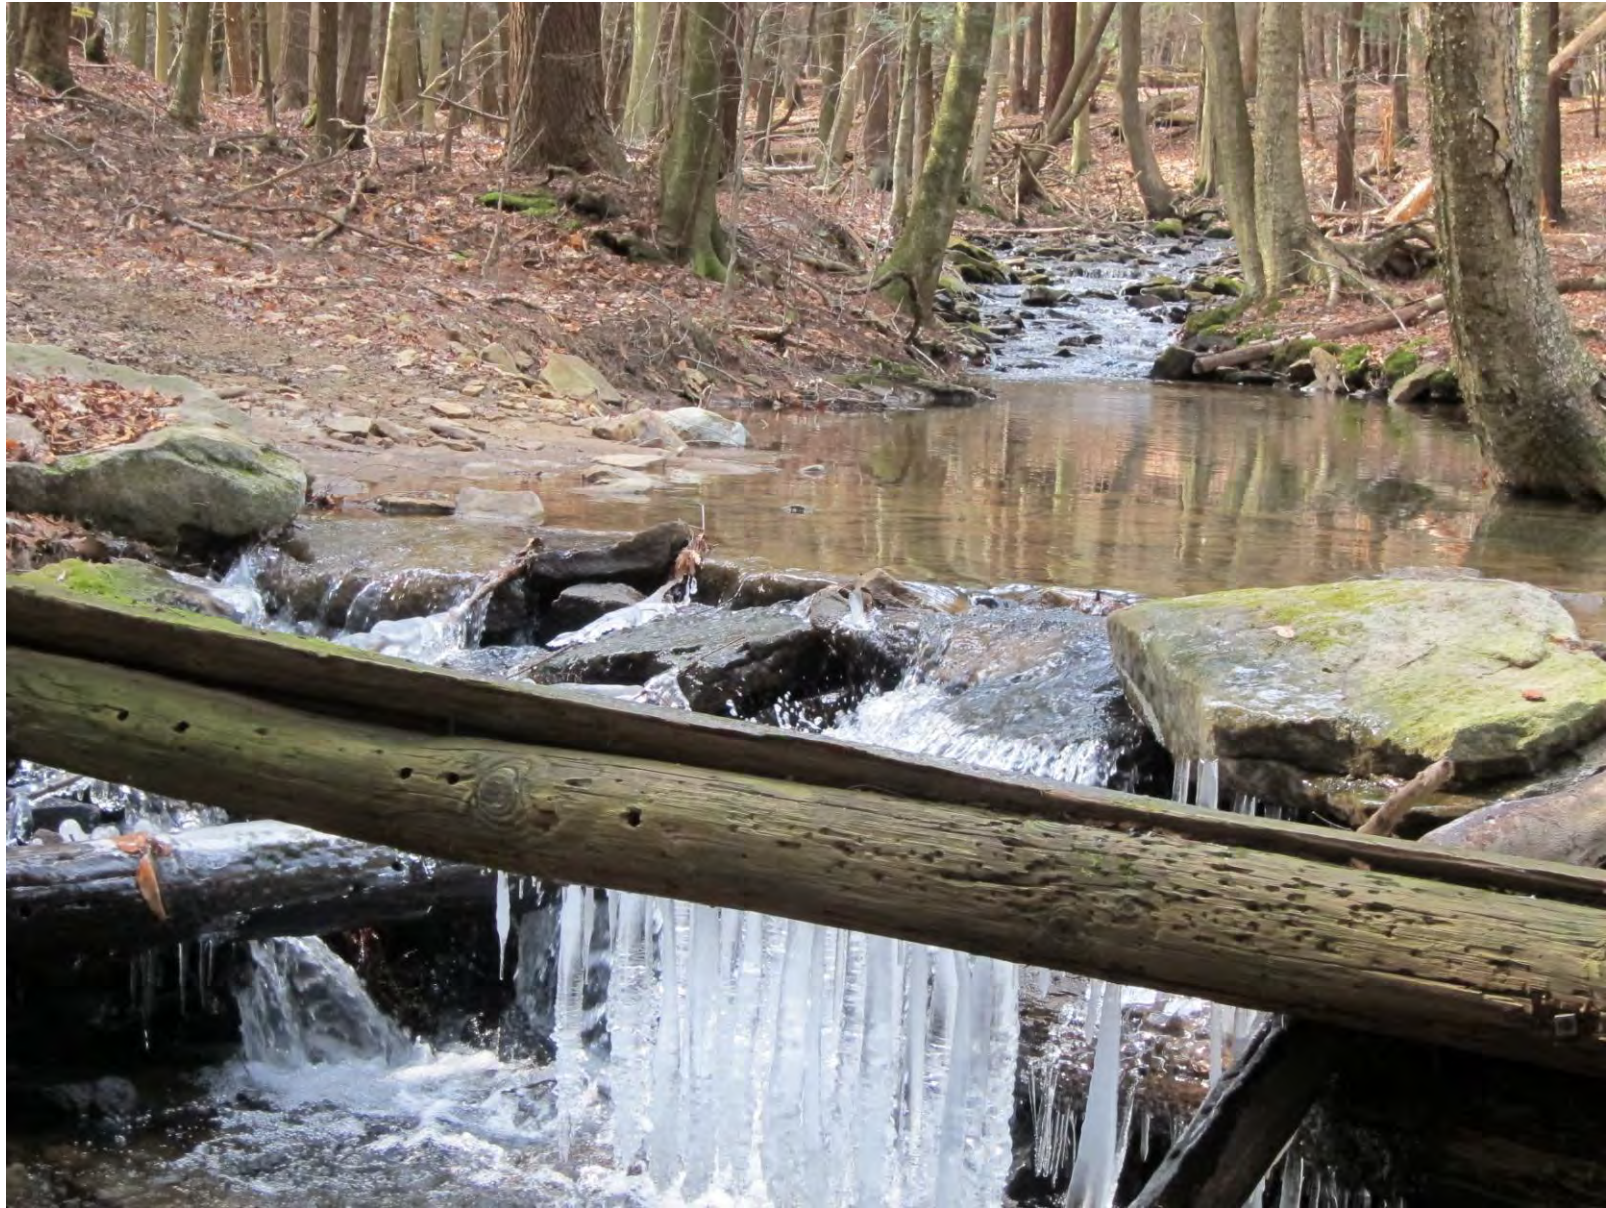
Snyder B: N 40.791094°, W -78.700351°

Sample point Snyder B at the mouth of the southern branch of Snyder Run scored 204, the highest of the three Snyder Run points. There is some but much less human encroachment to this branch so it scored high in Instream Cover, Epifaunal Substrate, Frequency of Riffles, Channel Flow Status, and Bank Vegetative Protection.

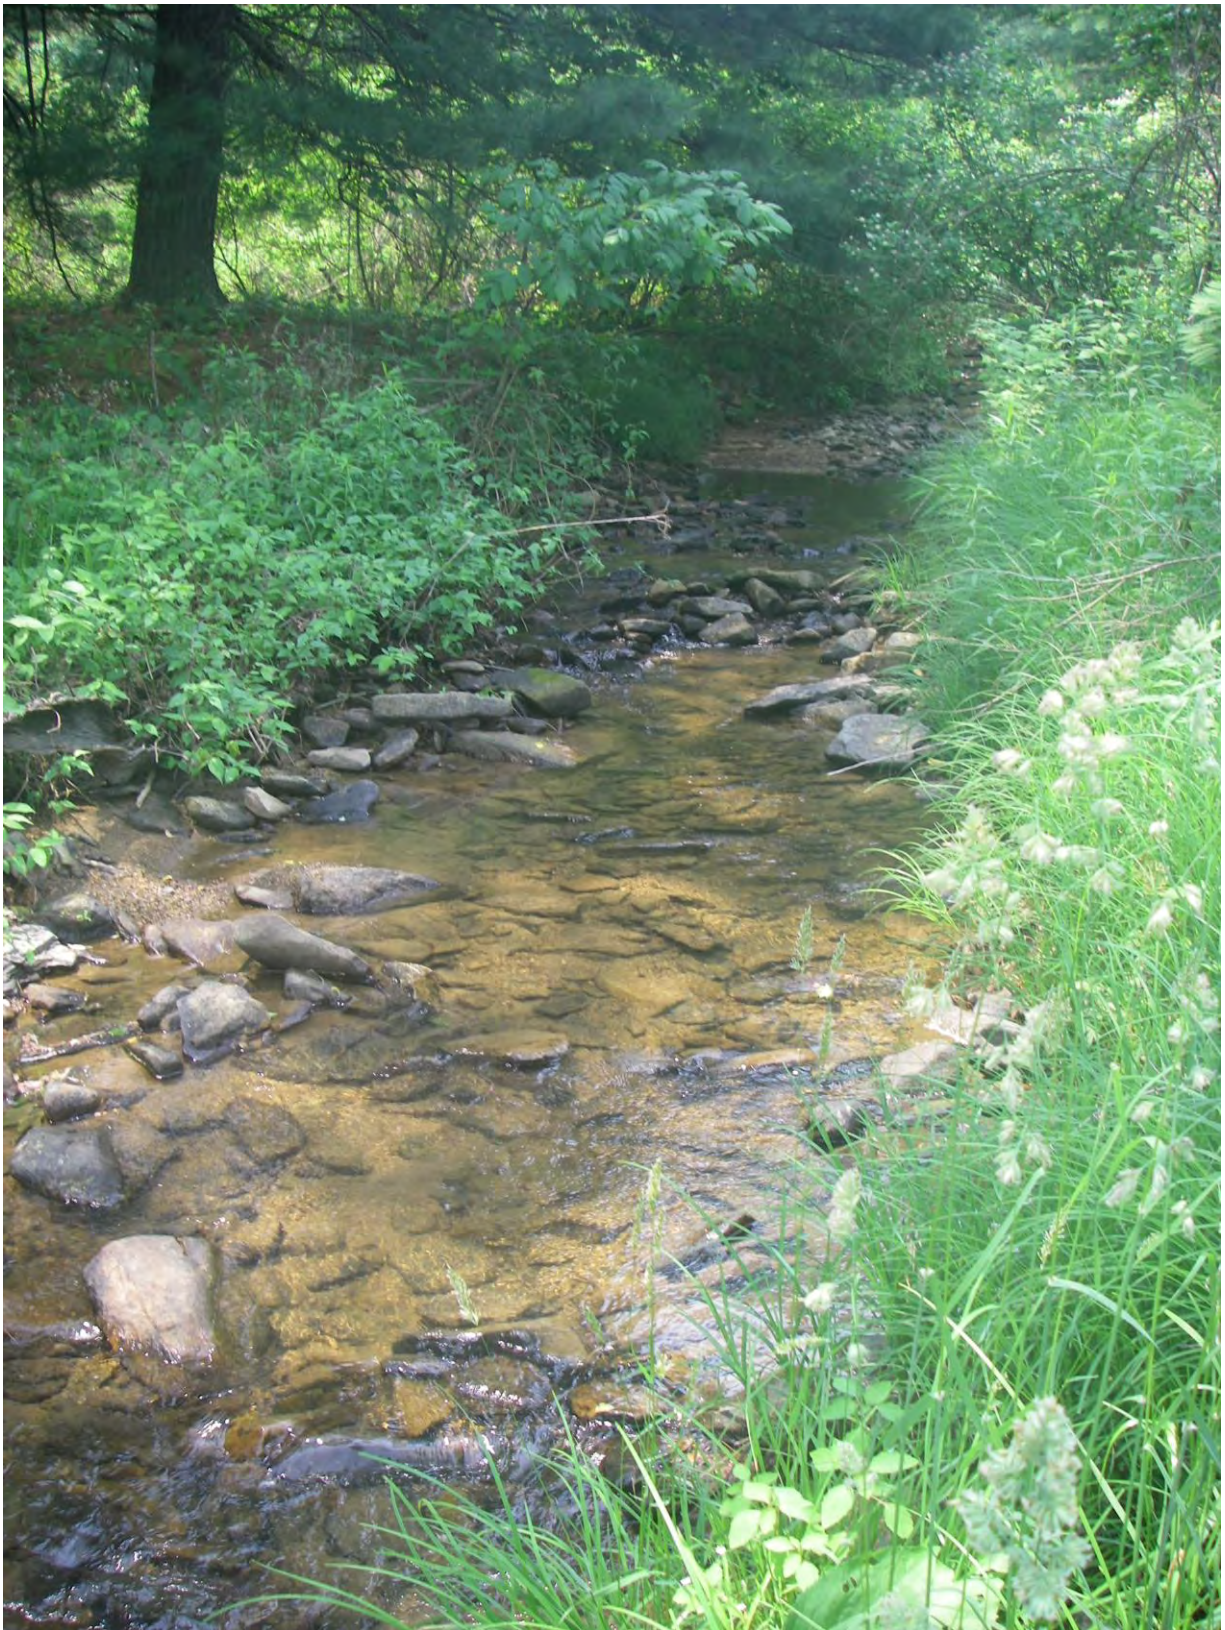
Snyder C: N 40.794764°, W -78.680705°

We encountered 76 individuals at Snyder C with 65 individuals in the EPT taxa, nearly 86% of the observed macroinvertebrates. This site had more flow and suitable habitat for macroinvertebrates as well as less human encroachment.

Sample point Snyder C was located just upstream of the first bridge crossing Snyder Run on Five Points Road and scored 197 out of 240. Due to its proximity to the road the habitat was somewhat degraded but not as bad

as other locations on the stream. This location scored high in Epifaunal Substrate, Embeddedness, and Frequency of Riffles but scored low in the Riparian Vegetative Zone Width and Channel Alteration.

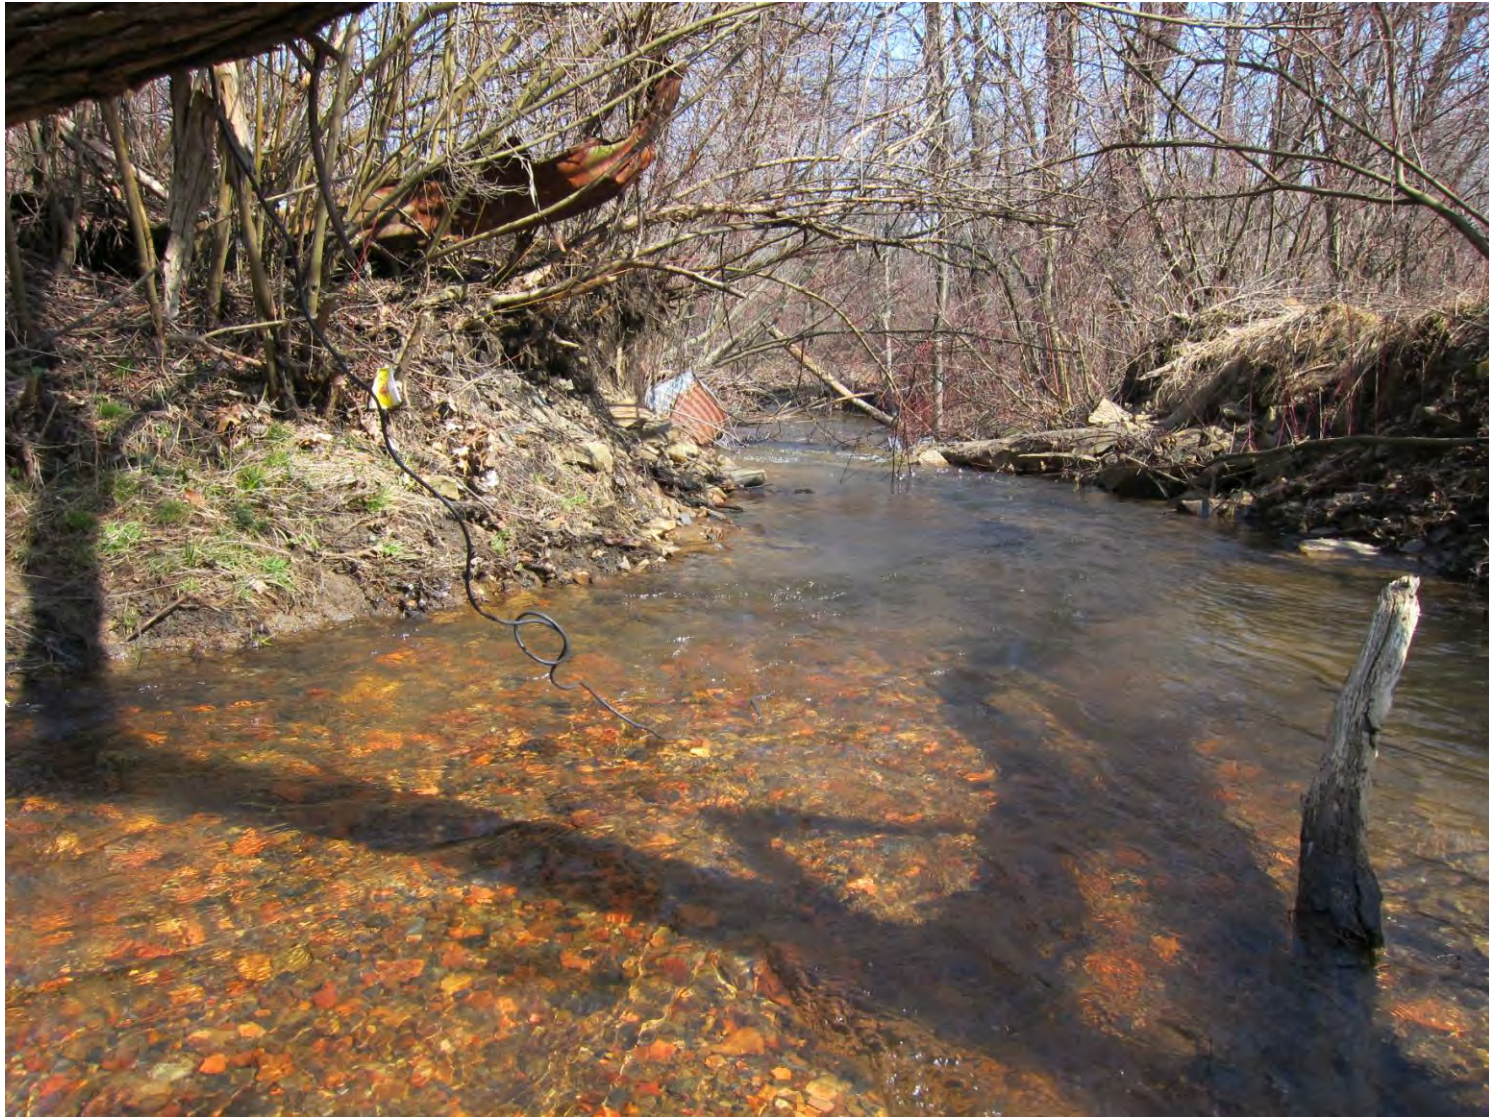
Snyder D: N 40.795608°, W -78.676560°

We were not able to collect macroinvertebrates at Snyder D because we were not able to locate suitable riffles to conduct the kick survey. Further explanation of the habitat can be found further on in the Habitat Assessment section of this narrative.

Sample point Snyder D was a very degraded site. There were immeasurable amounts of “red dog” in the stream and there were no larger stones present, everything was approximately 3” in diameter or smaller. We were not able to locate suitable riffle locations to sample for macroinvertebrates but did conduct a habitat assessment to document the conditions we encountered. Snyder D scored just 117 out 240. This location scored low in every category except Bank Vegetative Protection.

1) As seen on aerial photos, there is a large boney pile just west of Hugill Sanitation at the mouth of Snyder Run. Judging by the incredible amount of boney in the last quarter mile of Snyder Run, this pile is definitely impacting the stream. There is no real bed or habitat in the stream and there is no macroinvertebrate life. We recommend that the landowners, including Hugill Sanitation, investigate the removal or reclamation of this boney pile.

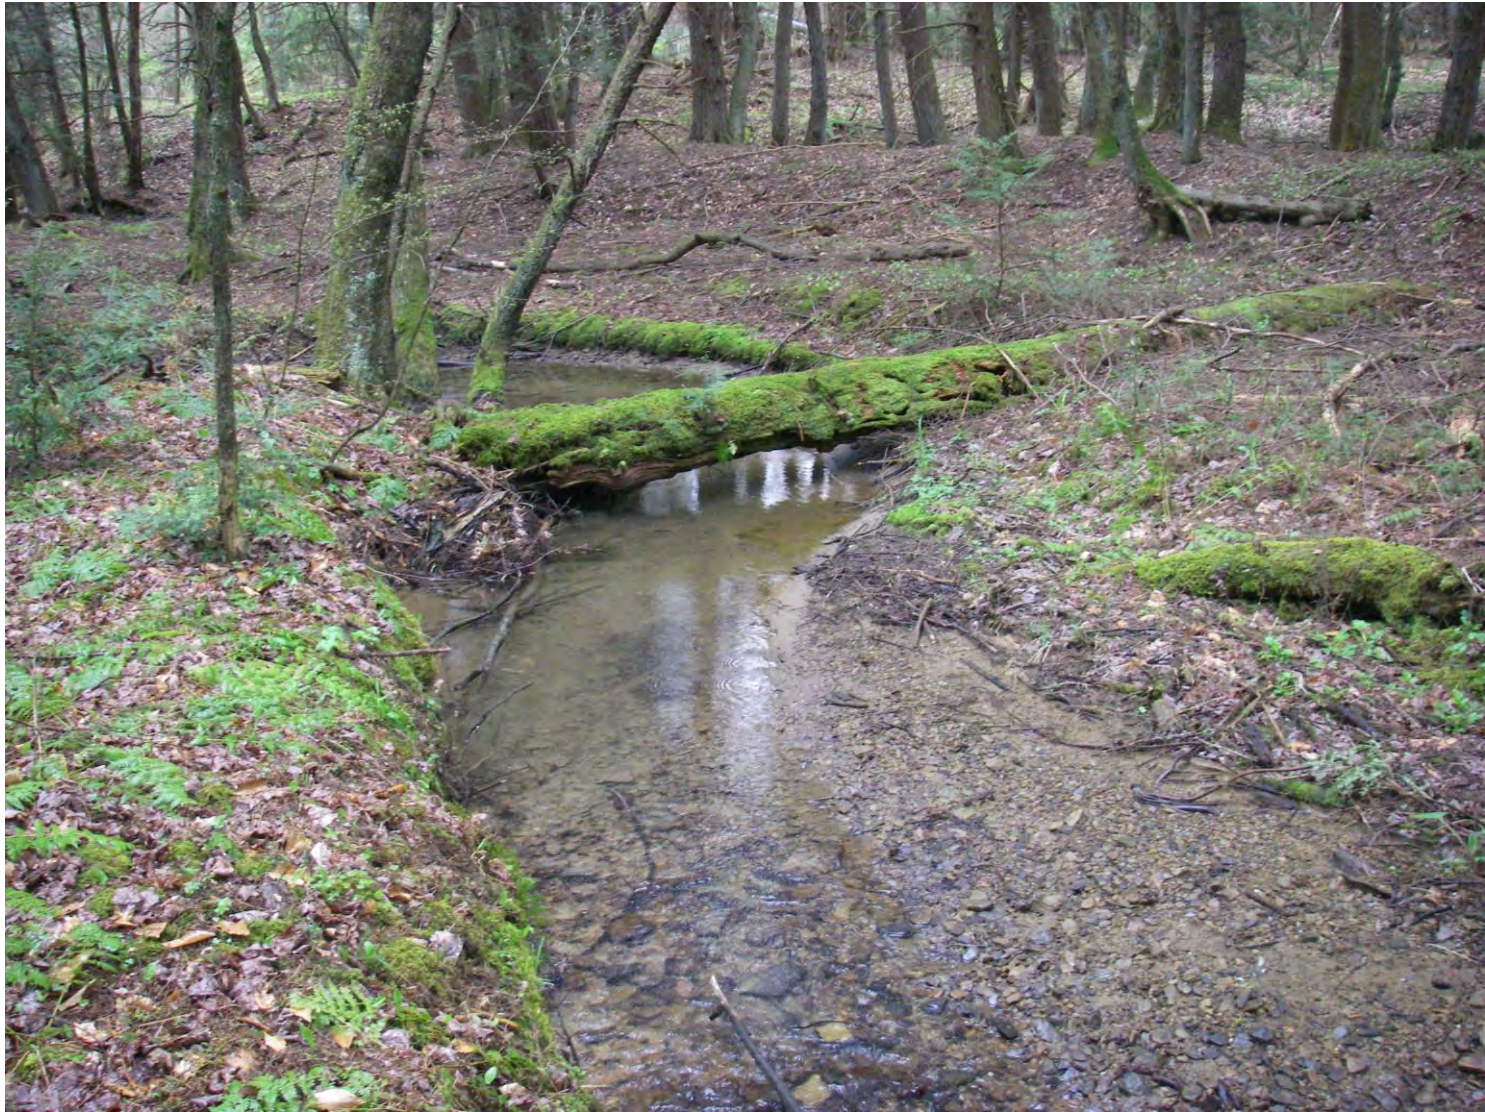
Spring 1: N 40.777749°, W -78.710914°

We encountered 65 individuals from 5 different taxa at Spring 1 with 32 individuals (nearly 50%) in the EPT taxa.

Sample point Spring 1 upstream of the Harmony Deep Mine scored 201 out of 240. Spring 1 was slightly impacted due to its proximity to Owens Road and as such it scored lower in the Condition of Banks and Riparian Vegetative Zone Width. It scored higher in every other category.

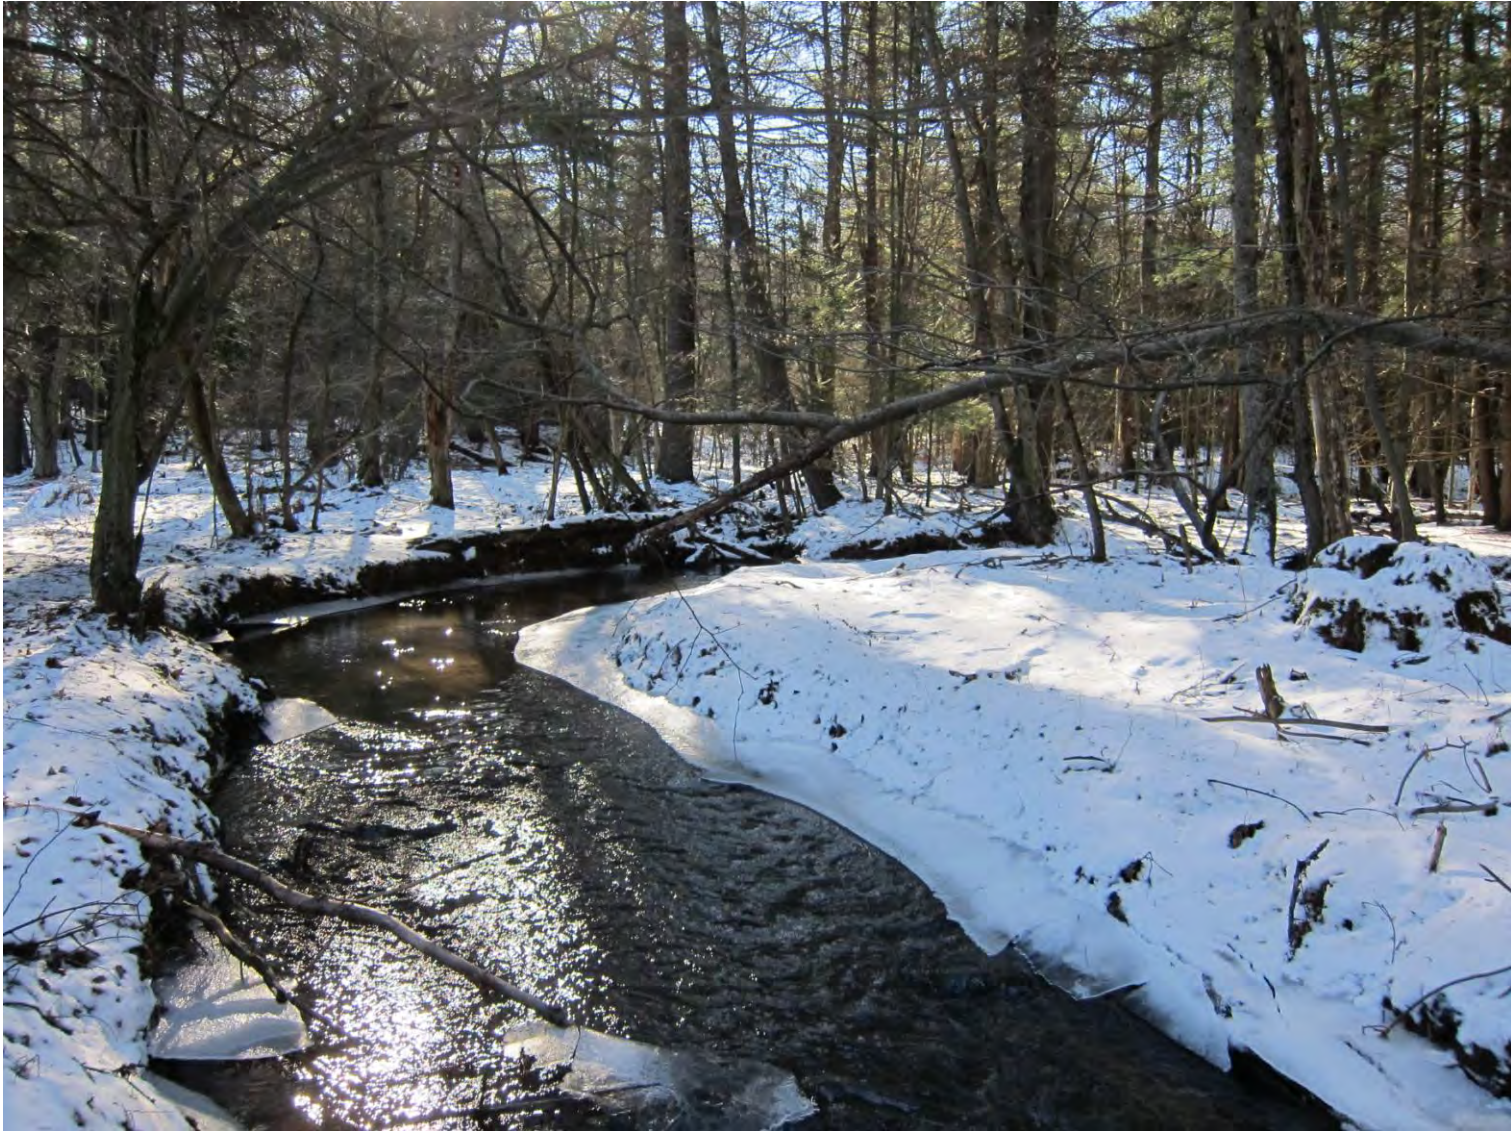
Spring 2: N 40.779725°, W -78.699918°

At Spring 2 we encountered a total of 35 individuals from 4 different taxa. The number of EPT taxa was 21, which was approximately 60% of the total number of individuals observed.

Sample point Spring 2 downstream of the Harmony Deep Mine but upstream of a beaver dam area mid way through the watershed 204 with its highest marks in Channel Alteration, Instream Cover, Epifaunal Substrate, and Sediment Deposition. This is the highest score for any of the Spring Run locations.

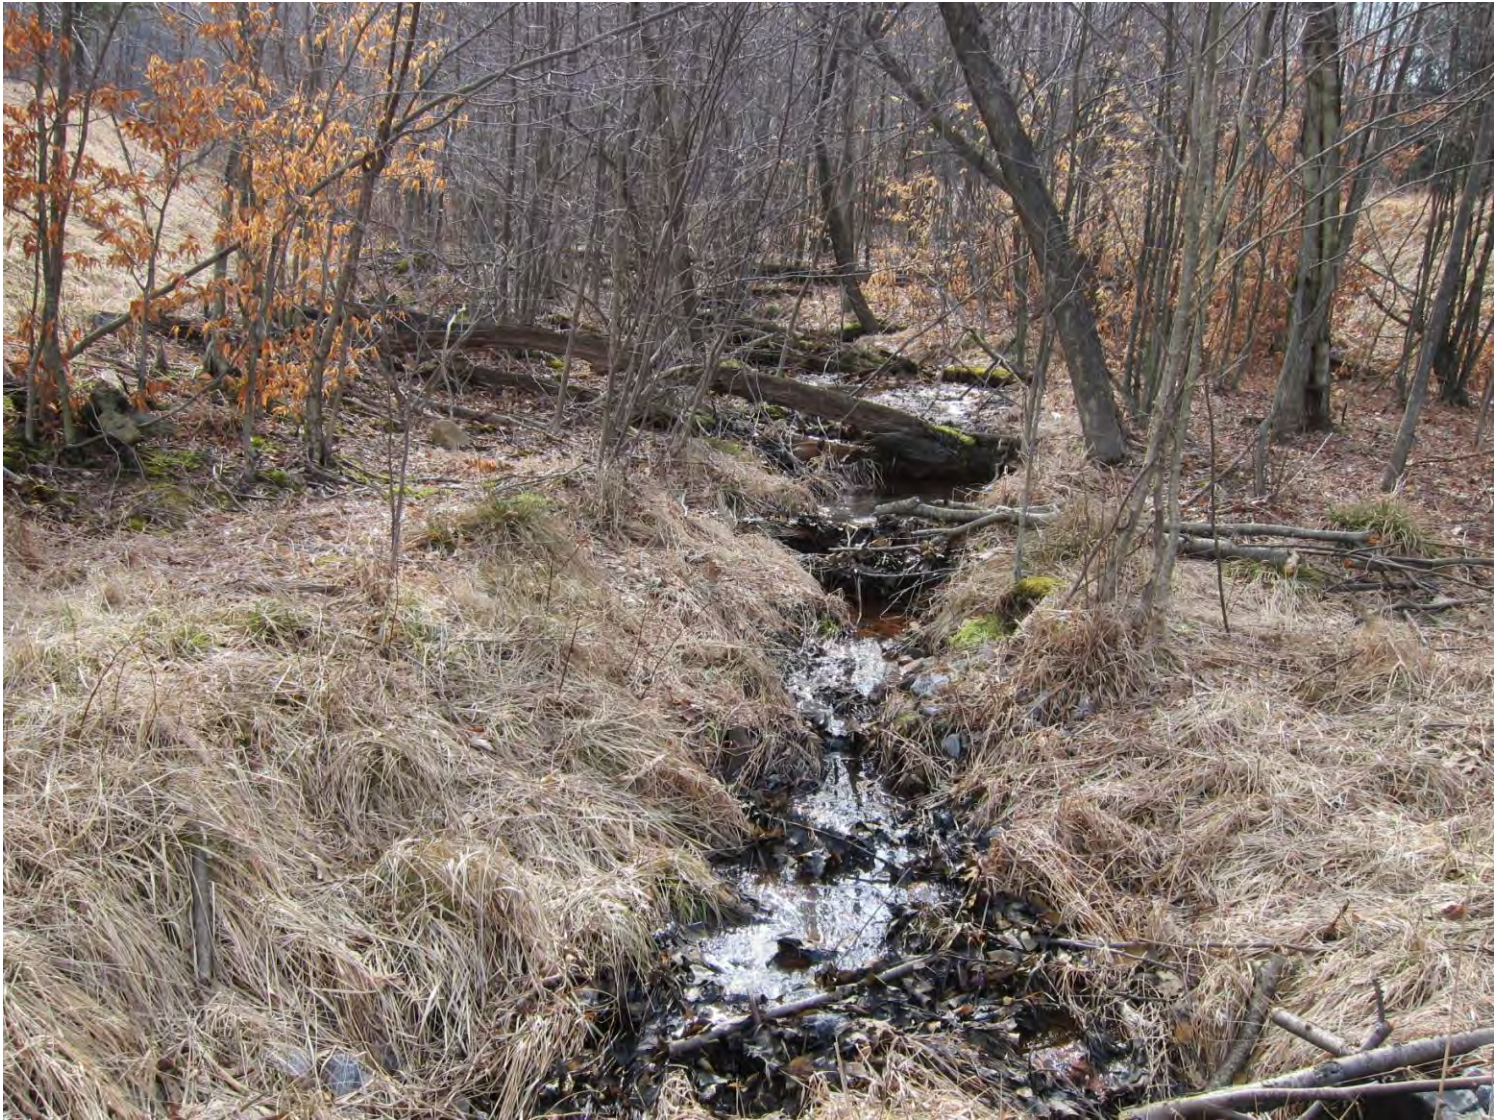
Spring 3: N 40.780046°, W -78.699861°

Spring 3 was dry on the date macroinvertebrates were collected so we were not able to collect any at this site.

As Spring Run 3, the only tributary to Spring Run, was dry when we were conducting the habitat assessment we did not complete one as it would be difficult to rate the tributary on many of the categories listed on the assessment sheet.

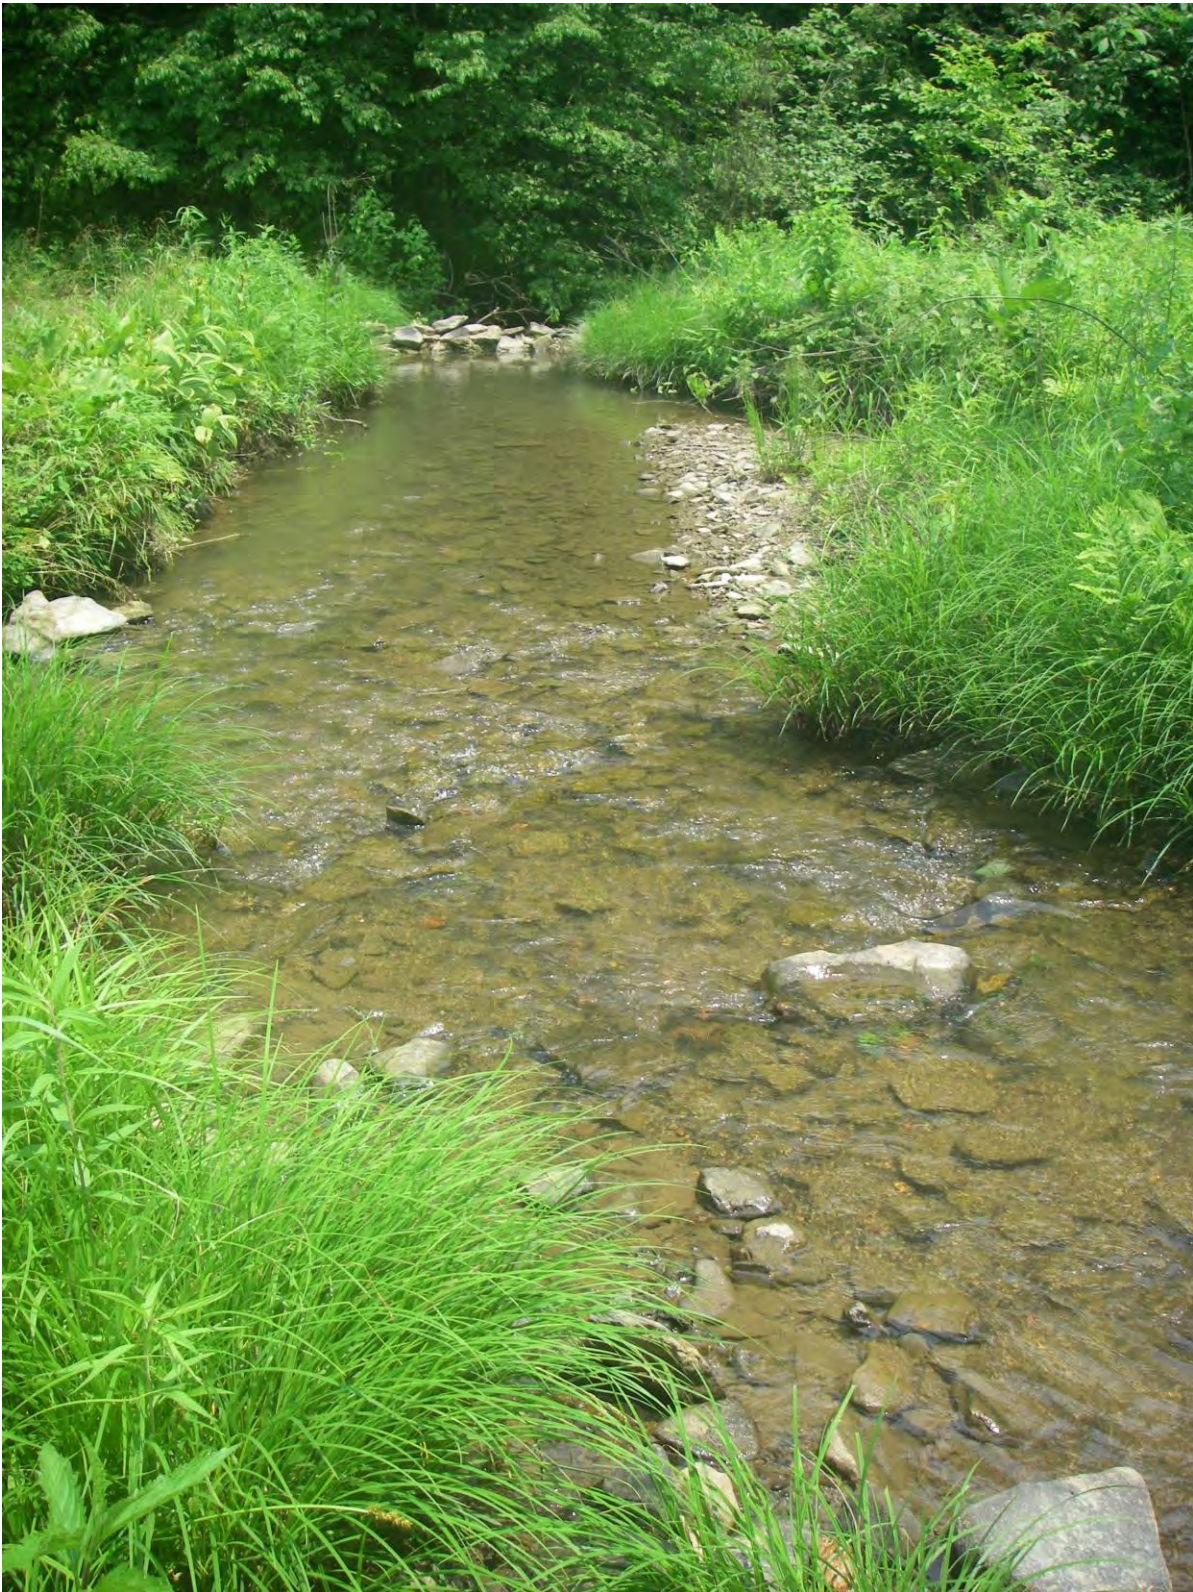
Spring 4: N 40.786189°, W -78.680294°

At Spring 4 we encountered 122 individuals from 6 different taxa. This was the highest overall count from any location in the study. The number of EPT taxa was 117 or 96% of the total number of individuals observed, this was also the highest EPT count observed during the study. This value was composed of more than 100 individuals in the Plecoptera Family (caddisflies) which are not as sensitive as either mayflies (Ephemeroptera) or stoneflies (Tricoptera) so this value, though great, would be even better if members of the Ephemeroptera and Tricoptera families were the primary constituents.

Lastly sample point Spring 4 was located just near the mouth of Spring Run and scored 163 out of 240. There was a man made bridge crossing Spring Run and a mowed field within the study stretch that impacted the habitat on this stretch of Spring Run. This location scored lower in Instream Cover, Embeddedness, Sediment Deposition, and Riparian Vegetative Zone Width. It scored higher in Bank Vegetative Protection and Epifaunal Substrate.
